Inspection Report

Property Address:
618 Prospect Ave
Hermosa Beach CA 90254

Ferguson Home Inspections

Date: 10/13/2022	Time: 02:00 PM	Report ID: 10132022Prospect
Property: 618 Prospect Ave Hermosa Beach CA 90254	Customer: Wendy & Scott Fletcher	Real Estate Professional: Amy Teitelbaum

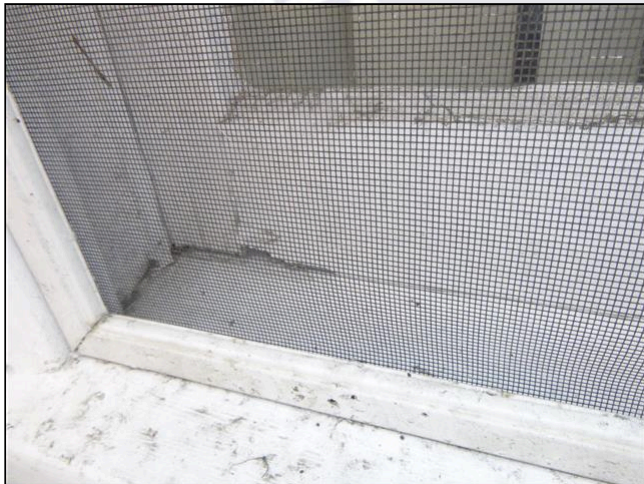
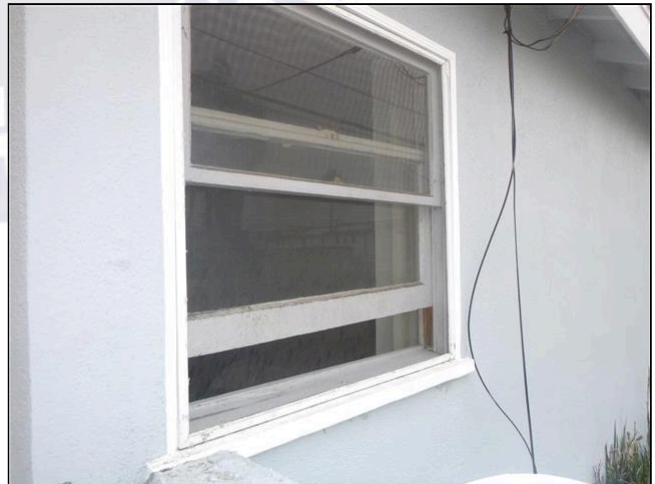
(4) Wood deterioration noted at various wood windows. Suggest review with termite company and/or a licensed contractor and repair/replace as needed.

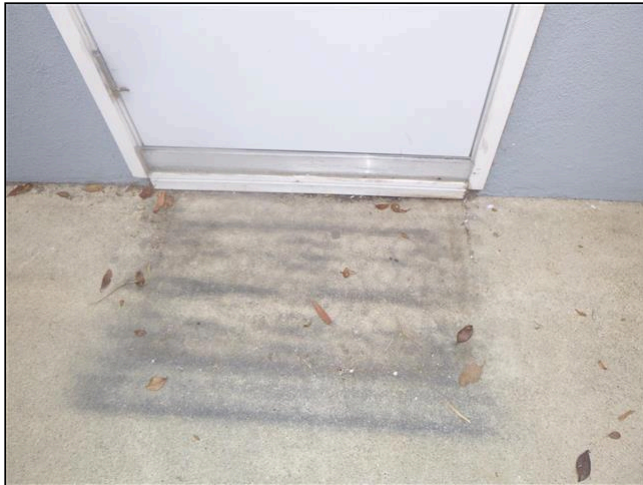
1.7 Item 1 (Picture)

Evidence of water intrusion was noted below the rear laundry door into the crawl space area. Suggest review with a licensed contractor for repair/replacement costs as needed.

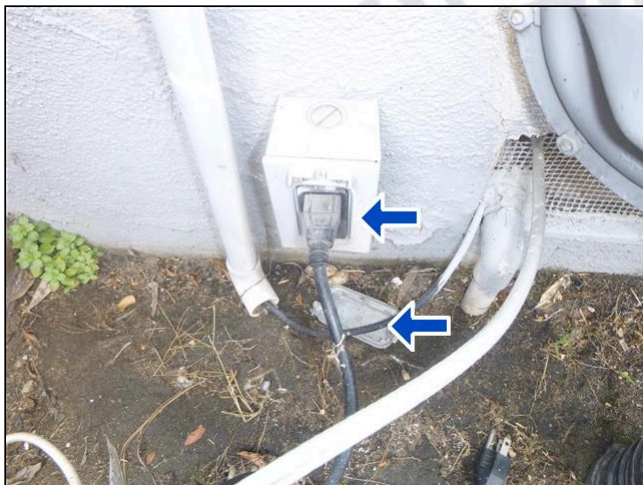
1.8 Item 1 (Picture)

The exterior outlet(s) weather cover(s) are damaged. Suggest repair for safety and as required.

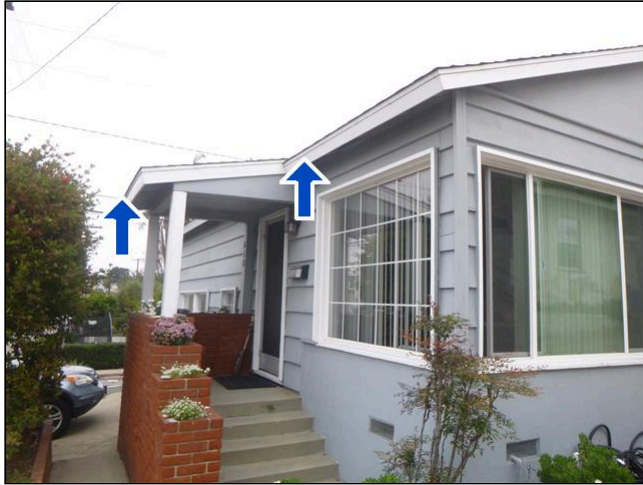
1.9 Item 1 (Picture)

Suggest installation of gutters throughout all eave areas and installation of an area drainage system to divert the water away from the foundation to the street as an upgrade.

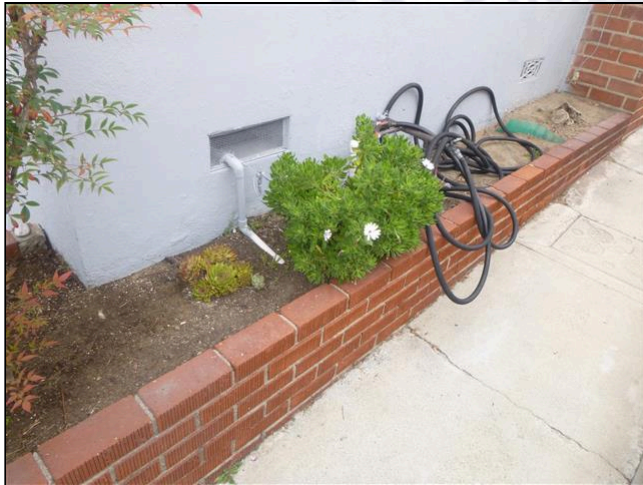
1.11 Item 1 (Picture)

(1) No drain holes noted in the planter(s). Suggest installing drain holes and/or removal of the planters to reduce/eliminate the water intrusion into the foundation/crawl space as needed.

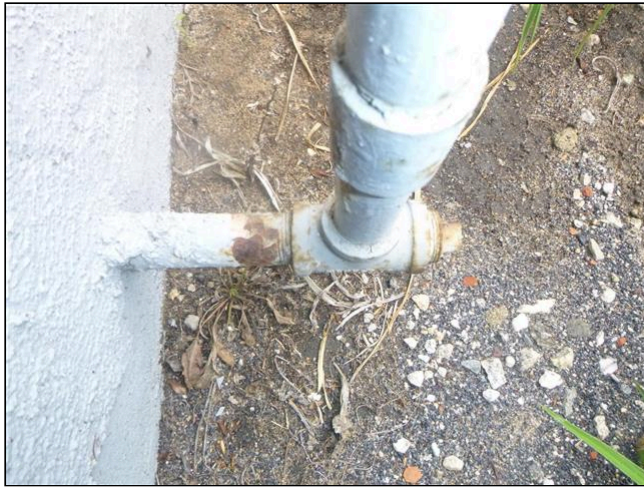
1.12 Item 1 (Picture)

Suggest painting or wrapping the exposed galvanized gas line to prevent excessive rusting.

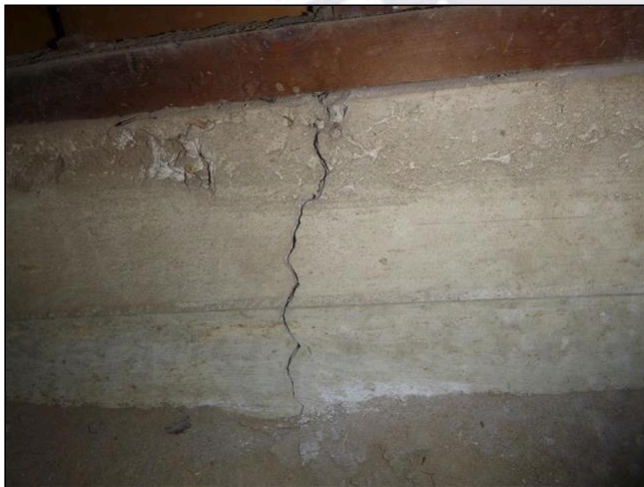
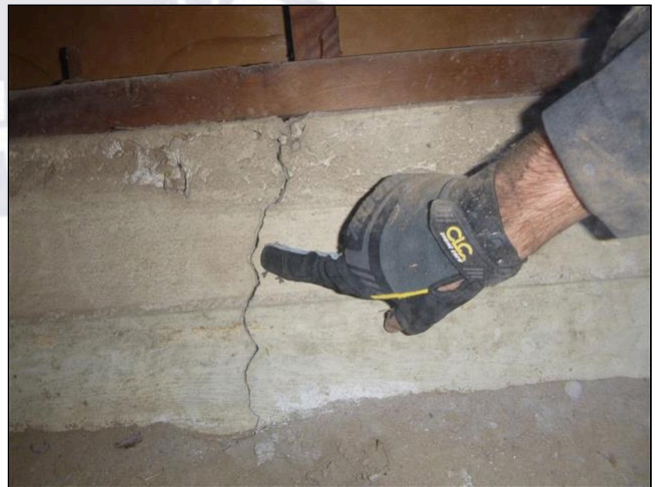
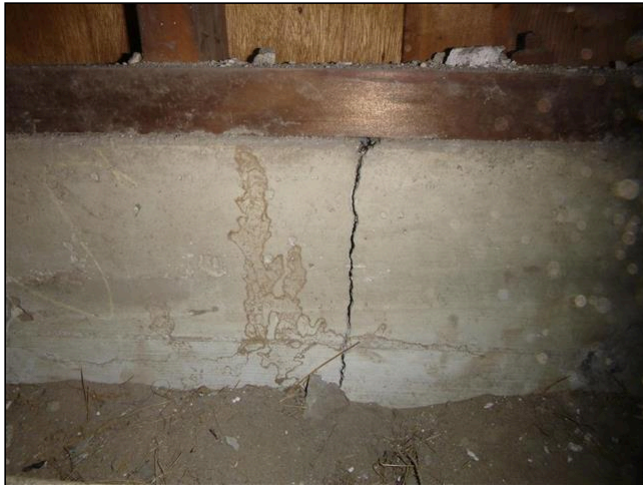
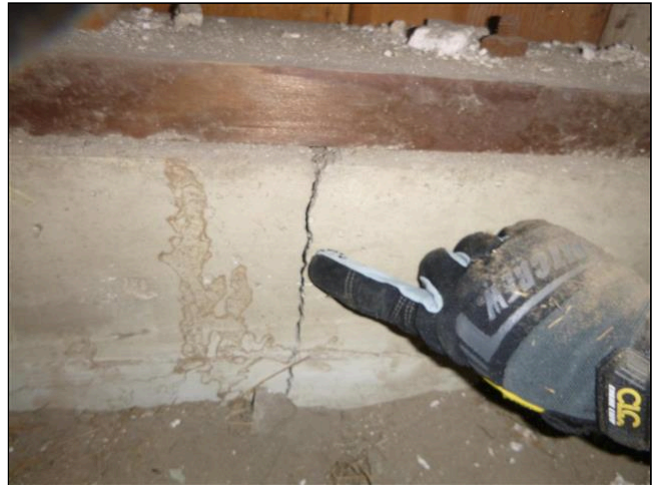
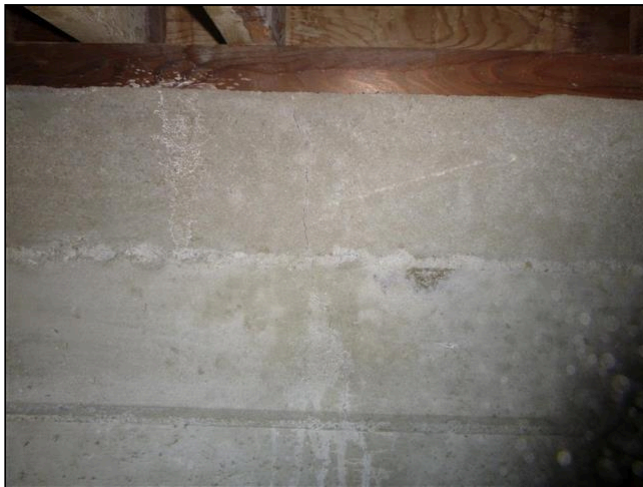
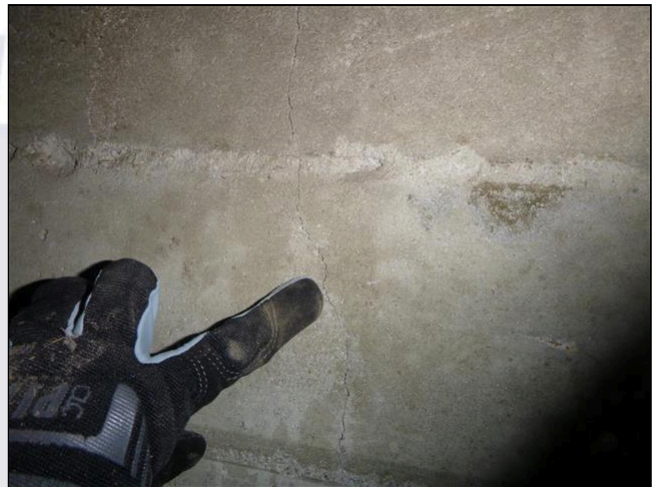
- (1) Suggest installation of gutters throughout all eave areas and installation of an area drainage system to divert the water away from the foundation to the street as an upgrade.
- (2) Re-grading where needed is recommended to assure all water drains away from the home's foundation. The inadequate drainage has caused minor settling/cracking/movement to the foundation, suggest review with a licensed contractor for installation of perimeter concrete walkways/barriers, rain gutters and an area drainage system to divert all the water away from the foundation.

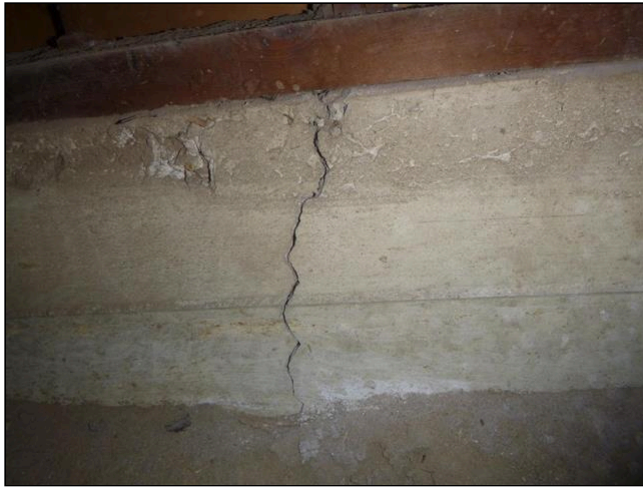
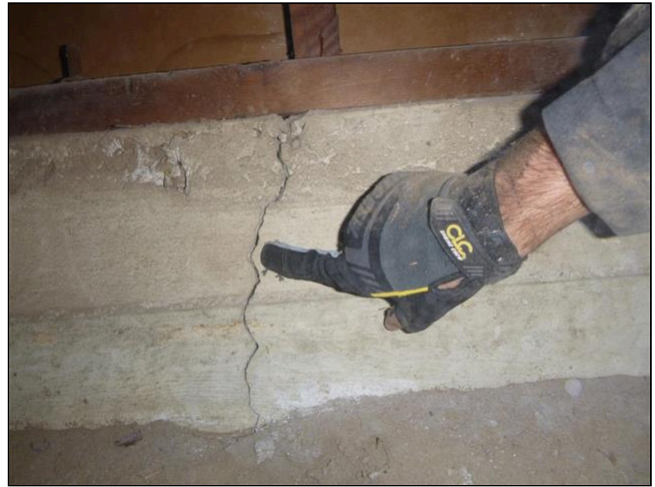
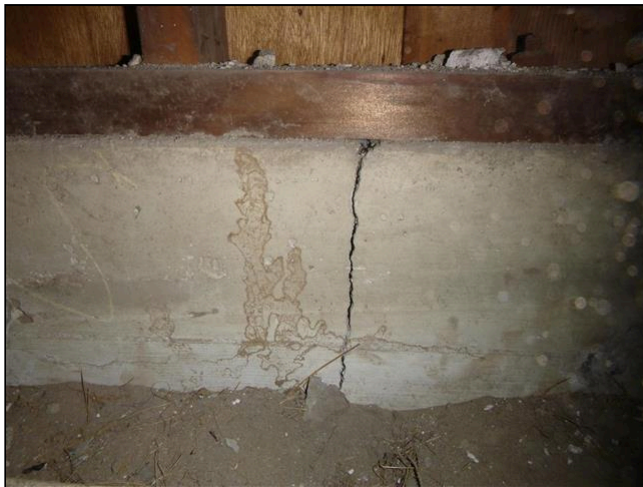
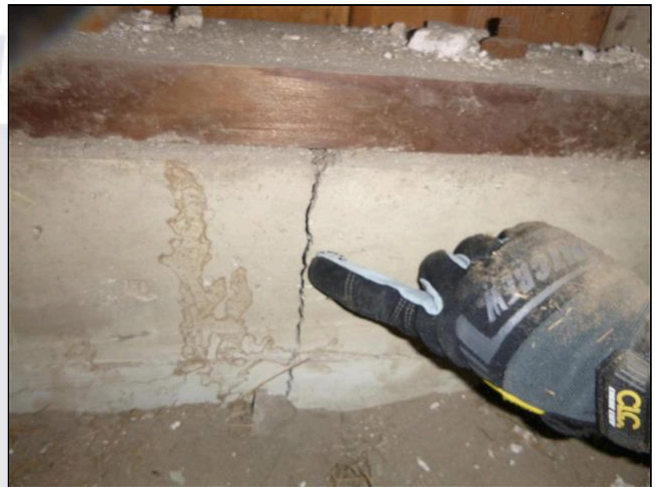
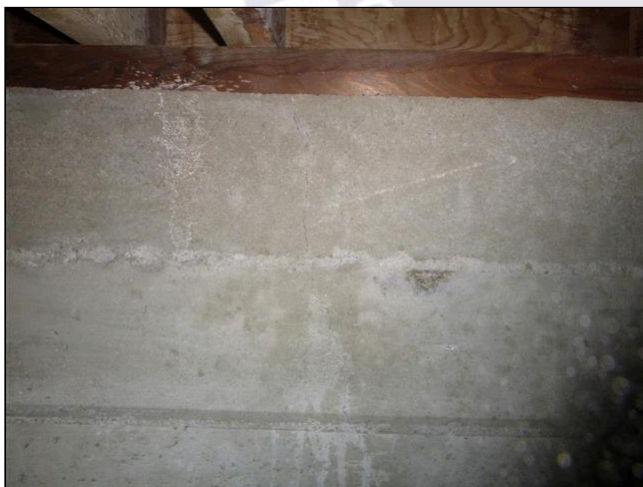
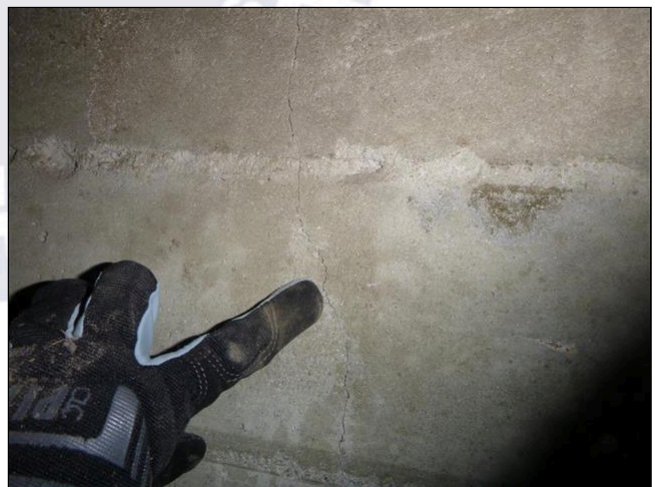
(1) Re-grading where needed is recommended to assure all water drains away from the home's foundation. The inadequate drainage has caused minor settling/cracking/movement to the foundation, suggest review with a licensed contractor for installation of perimeter concrete walkways/barriers, rain gutters and an area drainage system to divert all the water away from the foundation.

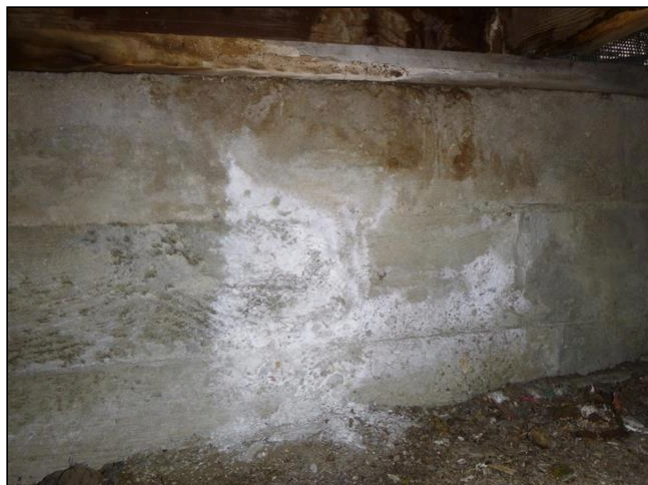
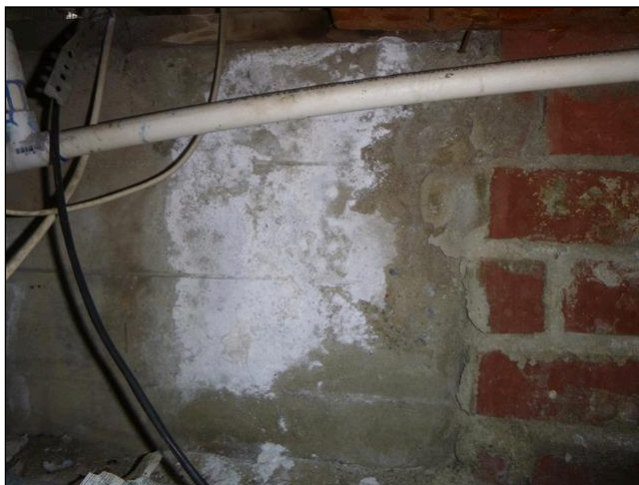
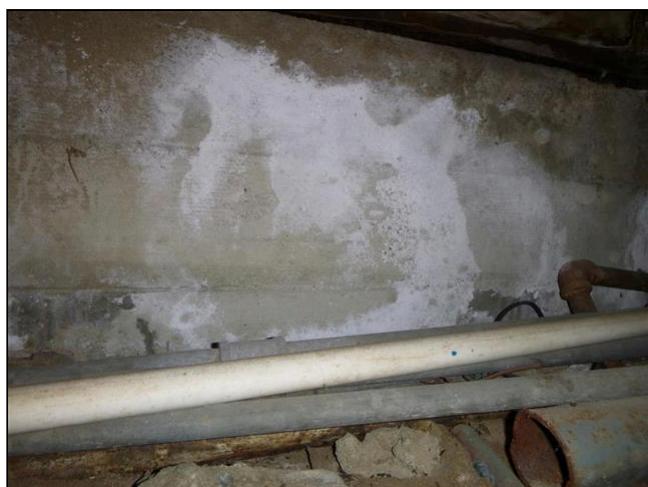
(2) White efflorescence (powder substance) on foundation footings indicates prior, and possibly ongoing, excessive moisture build up at the exterior of the foundation. Ongoing water intrusion at the foundations can, in some cases, cause the steel in the foundations to rust, called spalling, which can lead to horizontal cracking of the foundation (currently there are no major horizontal cracks visible at the foundation). Any future horizontal cracking/damage can be an expensive repair as the foundation would be considered structurally weak and susceptible to horizontal movement. Suggest review of the Lot/Grade and drainage systems, including rain gutters, to reduce and prevent further and future water buildup at the exterior of the dwellings foundations.

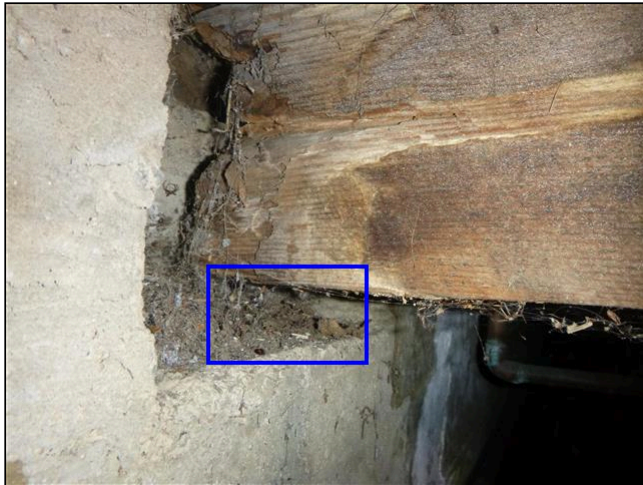
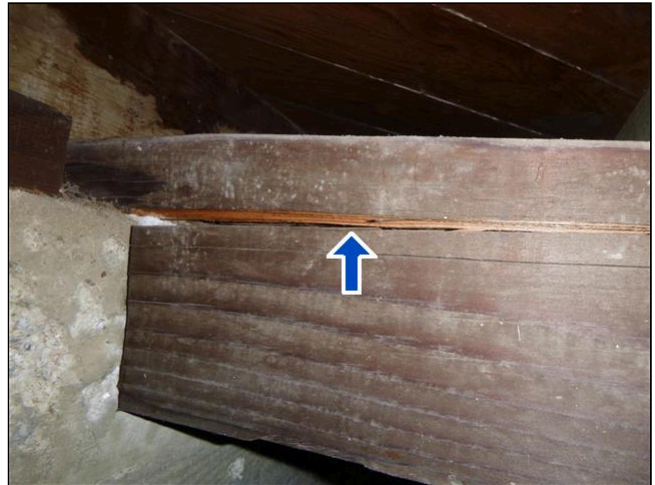
(1) Various interior floor girders have settled, cracked and are missing the lower shims, suggest review with a licensed contractor for repairs as needed to prevent ongoing settling of the foundation.

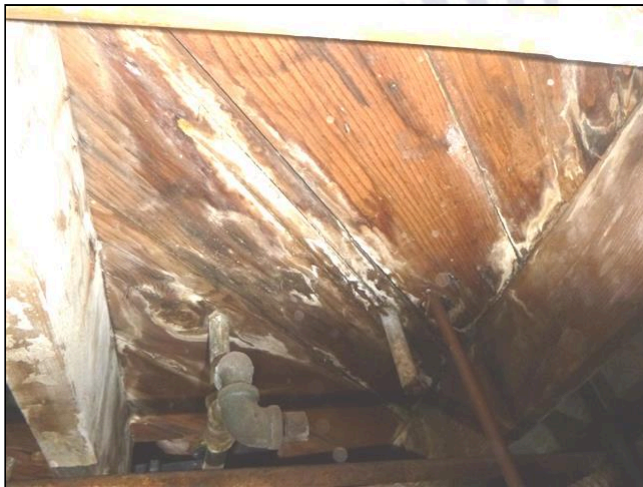
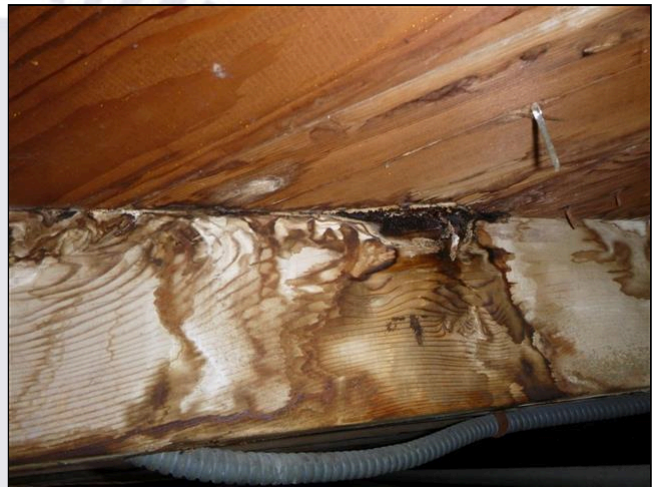
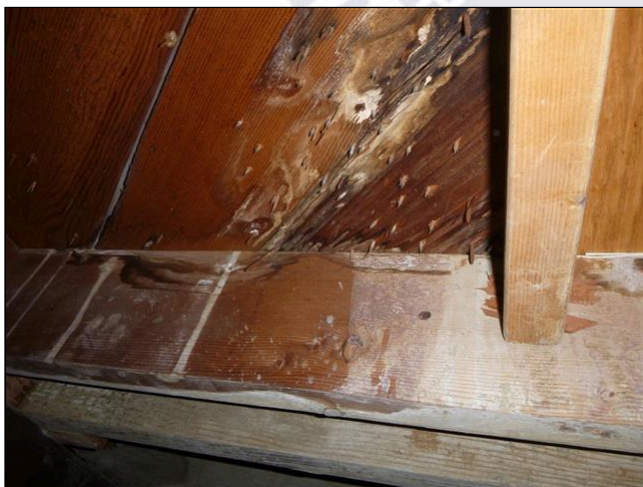
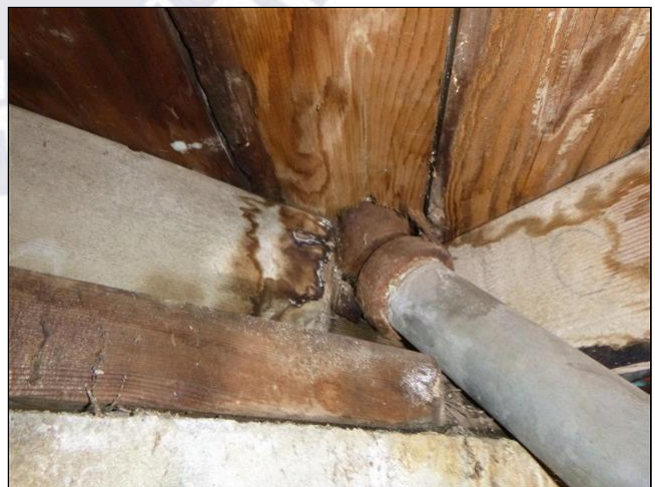
(2) Wet areas, stains and excessive wood deterioration noted at various flooring and supports from ongoing leaks and water intrusion from the exterior. Suggest review with a termite company and/or a licensed contractor and repair/replace as needed.

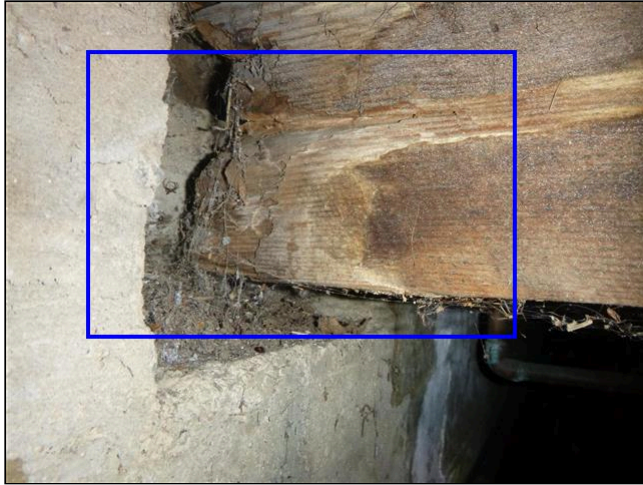
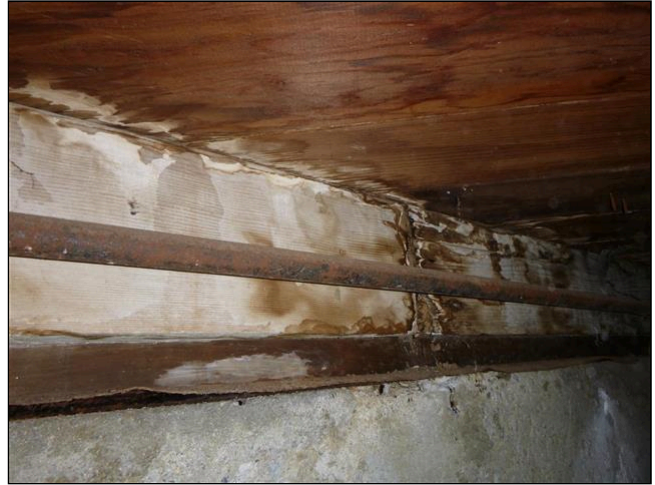
(3) Wood deterioration noted at various flooring and supports. Suggest review with a termite company and/or a licensed contractor and repair/replace as needed.

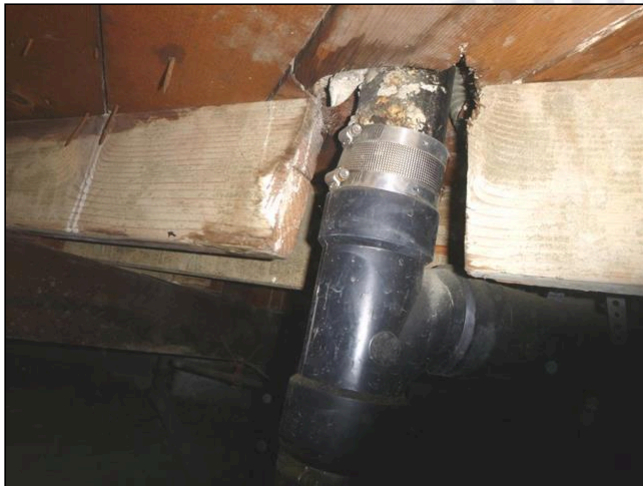
3.1 Item 9 (Picture)

(4) Excessive cutting and notching of various floor joists due to drainage installation. Suggest review by a licensed contractor for repair costs as needed.

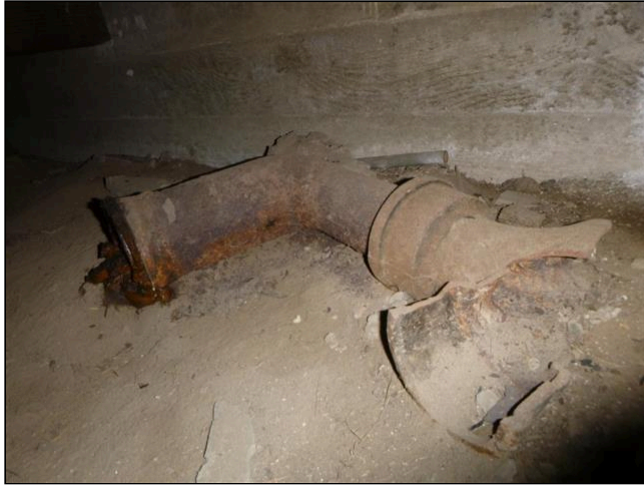
4.0 Item 1 (Picture)

(1) Suggest removal of debris and construction items from the crawl area.

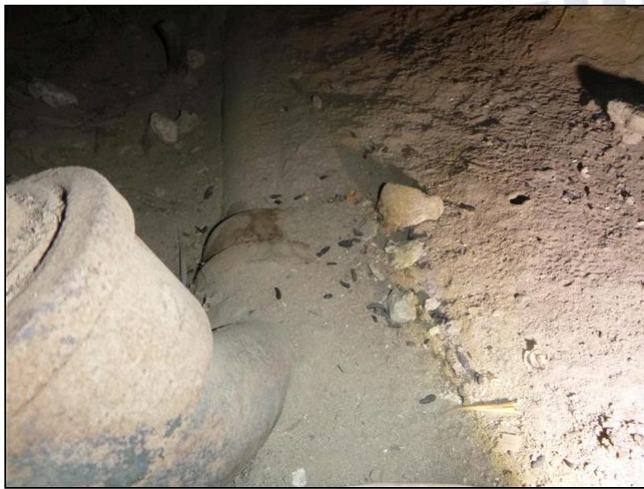
4.0 Item 2 (Picture)

(2) Pest droppings noted throughout the crawl space. Suggest review with a qualified pest control company.

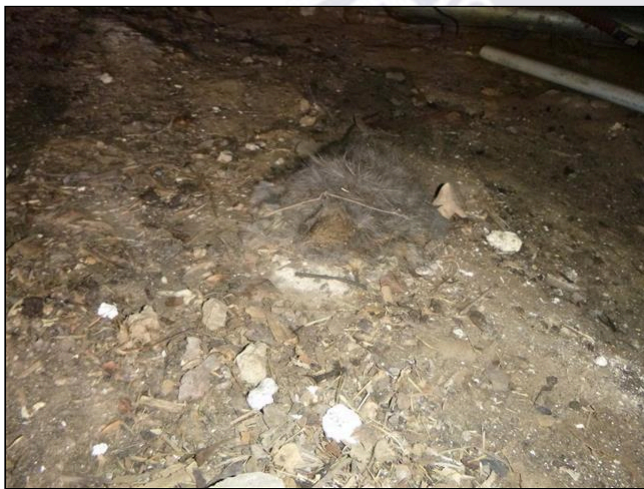
4.0 Item 3 (Picture)

(3) A decomposing animal/rodent was noted in the crawl space. Suggest review with a qualified pest control company for removal.

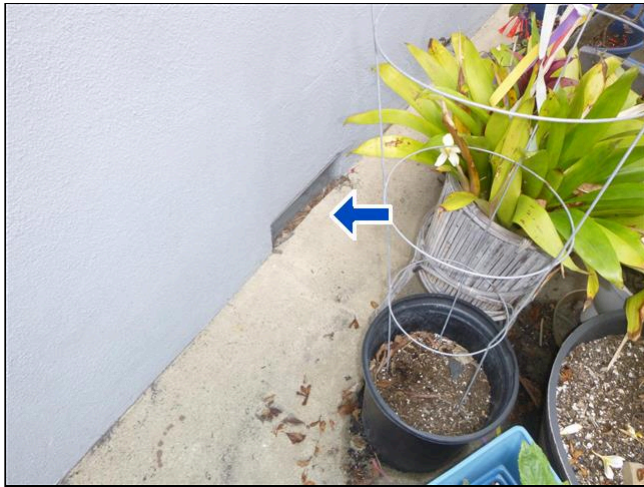
4.1 Item 1 (Picture)

Multiple crawl vents are below the exterior grade, suggest review by a licensed contractor and install a berm to

reduce the water intrusion into the crawl area.

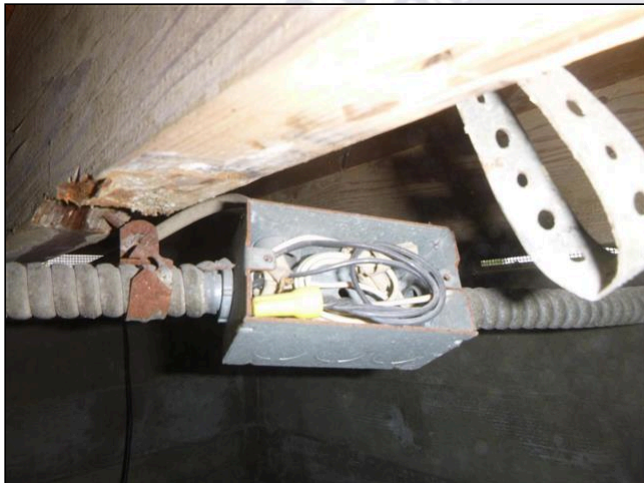
4.2 Item 1 (Picture)

Open junction boxes were noted. This is a safety concern. Whenever an electrical wire is cut and re-connected, the 'splice' should be encased in a covered junction box to prevent shocks and separation of the splice. Suggest review by a licensed electrician and repair as needed.

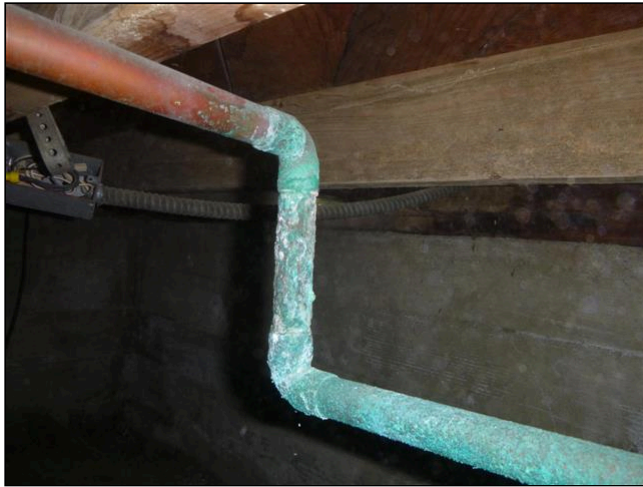
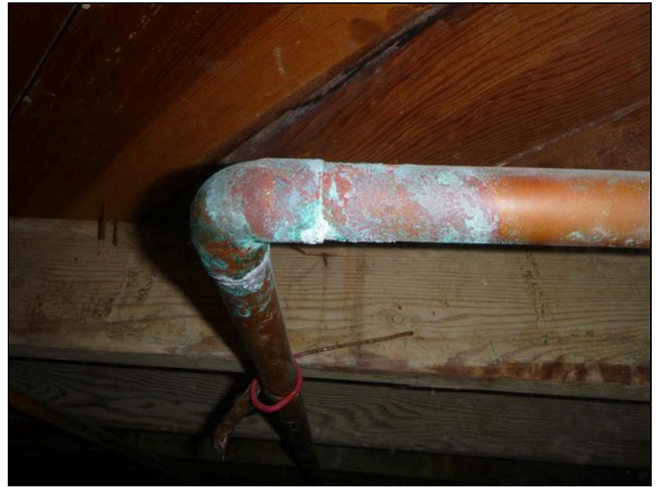
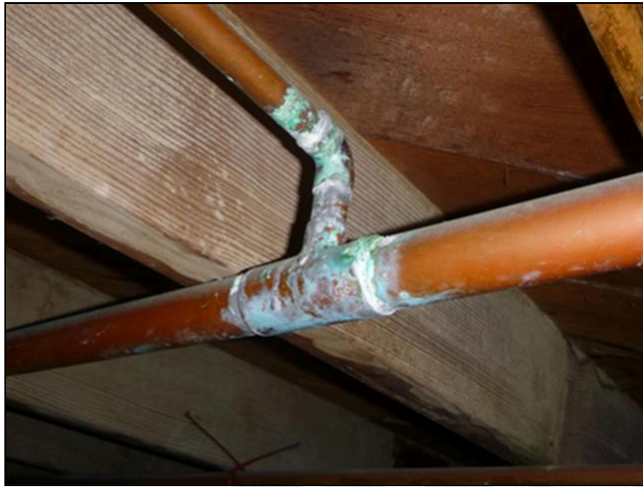
(1) Excessive blue staining/deterioration was noted at the copper plumbing supply lines in the crawl space area. This type of staining/deterioration is a pre-cursor to pin hole leaks. Suggest review with a licensed plumber to evaluate the copper supply line(s) in the dwelling/crawl space and for repair/replacement costs as needed.

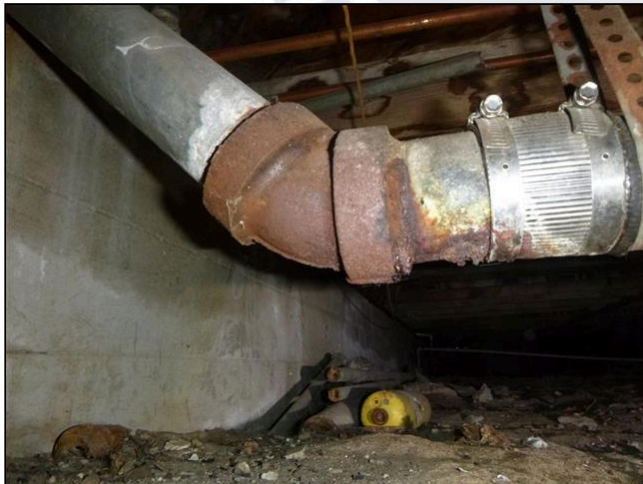
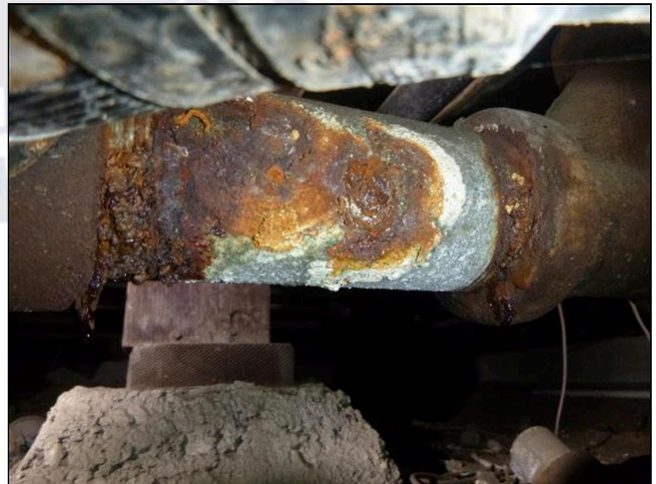
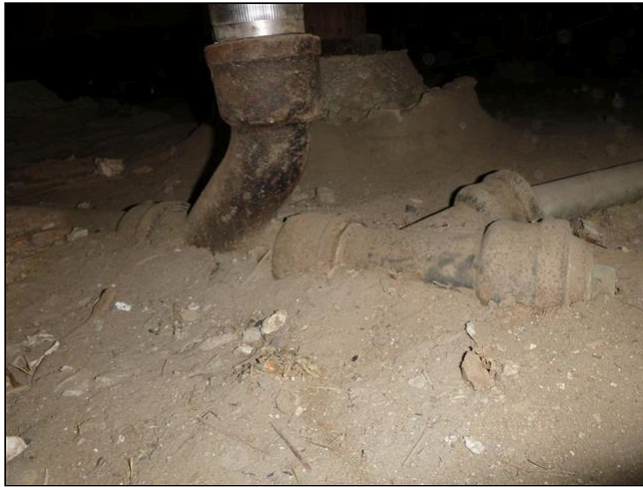
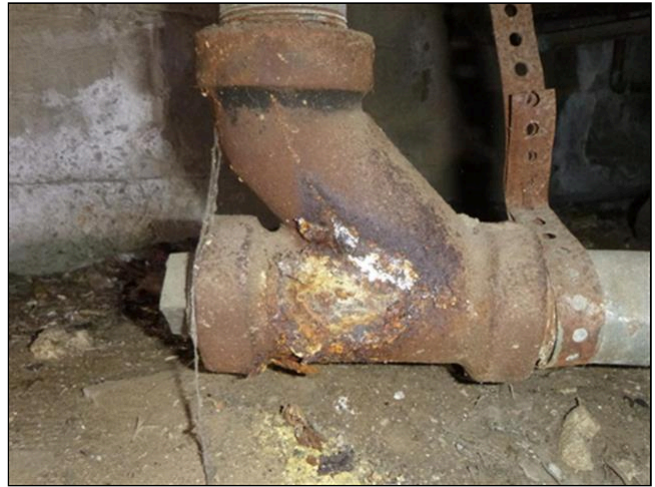
(2) Excessive rust and seepage/deterioration noted at various cast iron drain lines within the crawl space. Suggest review by a licensed plumbing contractor for replacement costs as needed to prevent leakage at the crawl area.

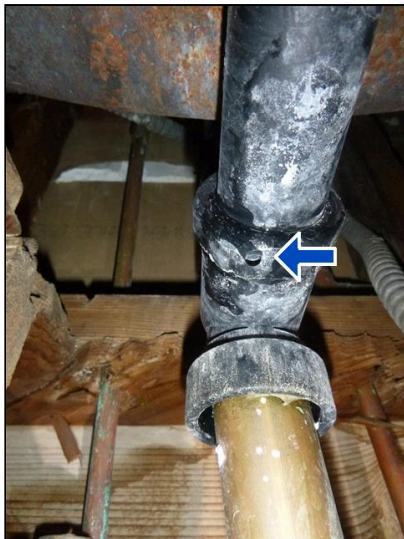
4.3 Item 8 (Picture)

(3) An actively leaking ABS drain line was noted at the rear hallway bathroom tub drain. The leaking drain line has caused saturation of the soil in the crawl area. Suggest review by a licensed plumbing contractor for replacement costs as needed to prevent on-going leakage at the crawl area.

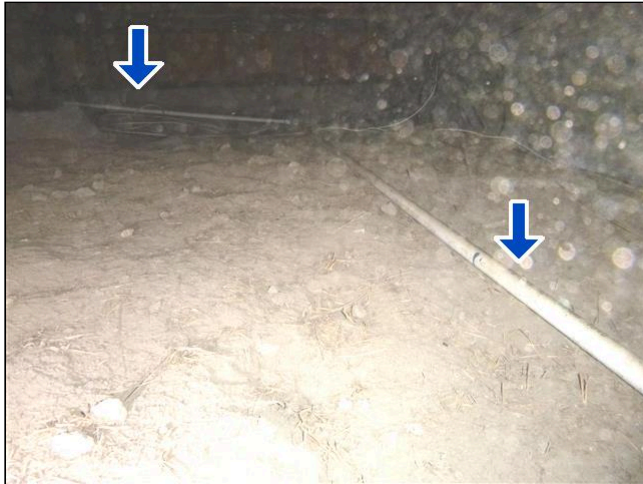
(5) Plastic PVC plumbing for the irrigation system noted transferring through the crawl area. Suggest review by a licensed plumber for removal of the PVC from the crawl area as this product is not suitable or allowable in this area.

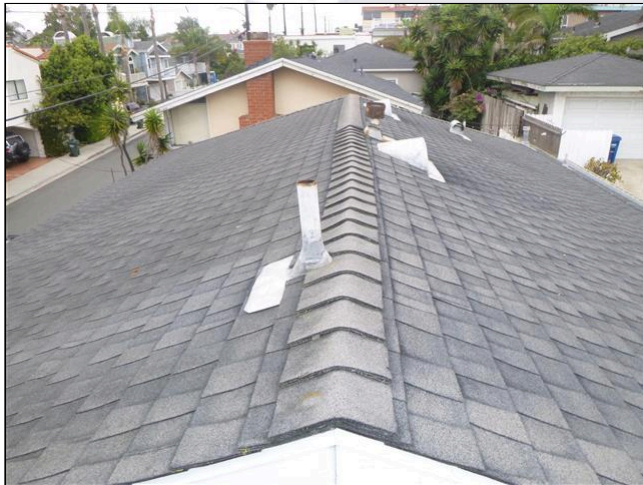
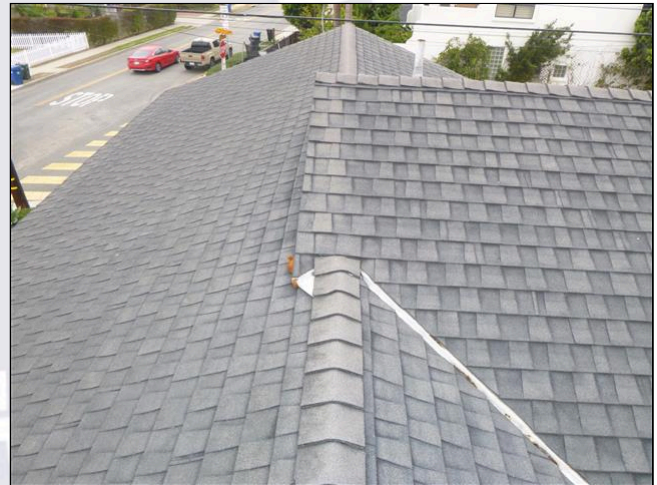
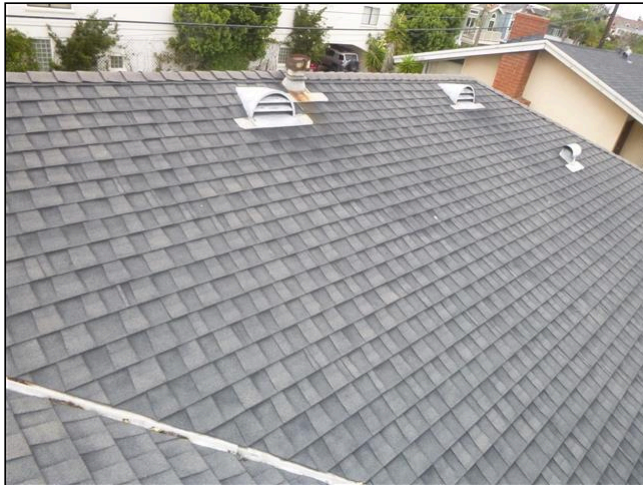
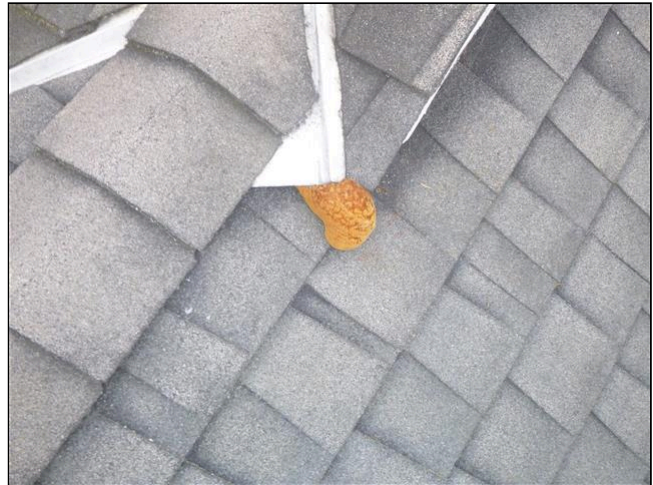
(1) Minor deterioration of the roofing was noted, suggest review with a licensed roofing contractor for repairs, periodic maintenance and to determine the remaining life expectancy of the roof.

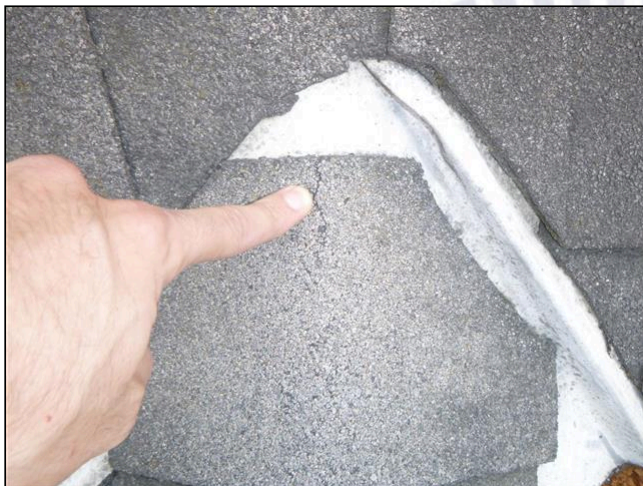
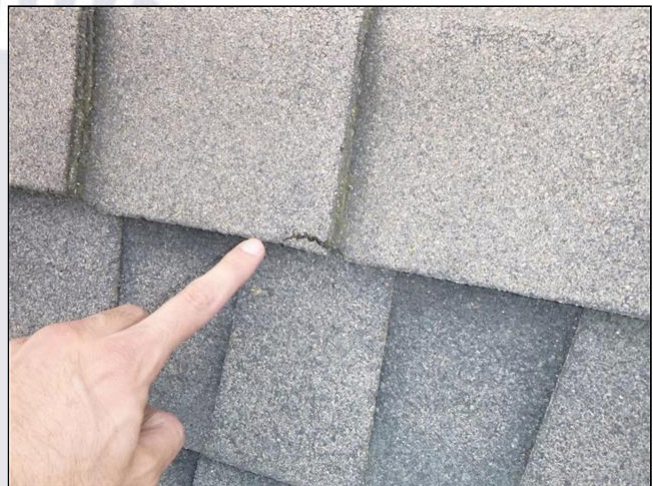
(2) Deteriorated ridge caps noted at the pitched roof, suggest review by licensed roofer for replacement costs and replace as needed.

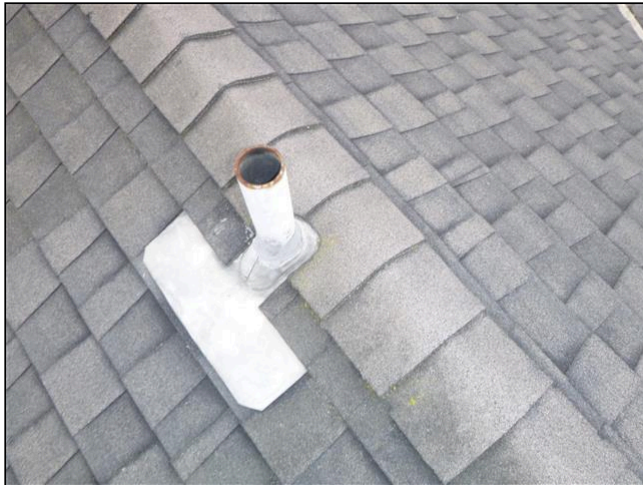
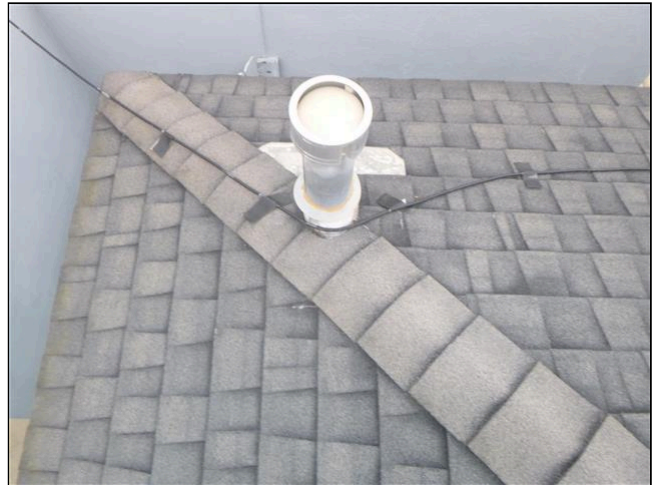
(1) Deteriorated sealant was noted at various penetrations/flashings. Suggest review by a licensed roofer and seal all penetrations at the roof to prevent water intrusion.

(2) Two flashings are incorrectly installed on the ridge (penetrations should not be installed on a ridge). Suggest review with a licensed roofer for repair/relocation costs as needed to prevent future leakage.

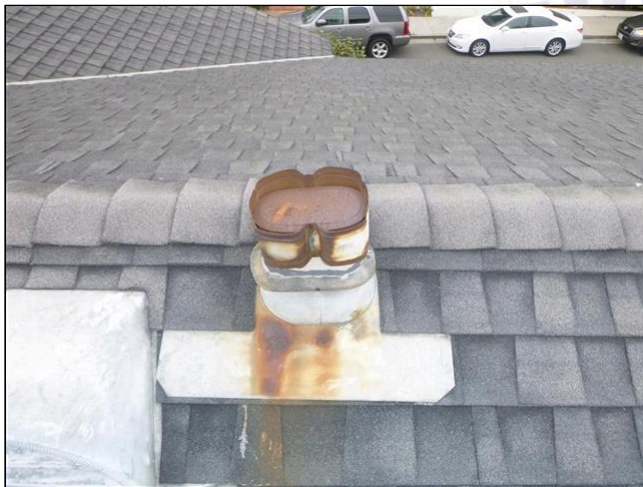
5.1 Item 3 (Picture)

(3) Rusted flashings noted at various areas, suggest review with a licensed roofer for repairs as needed.

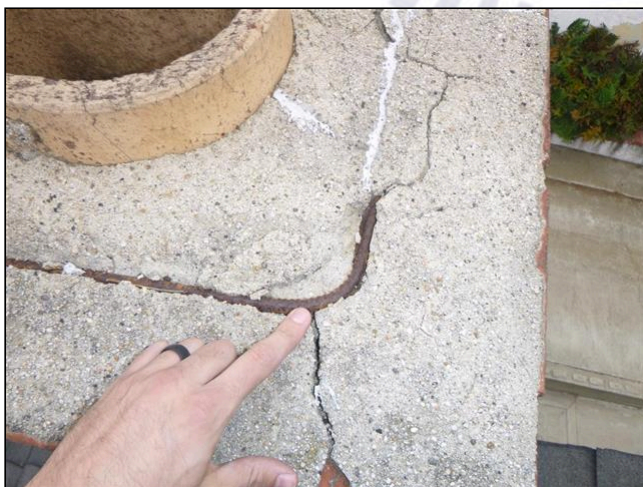
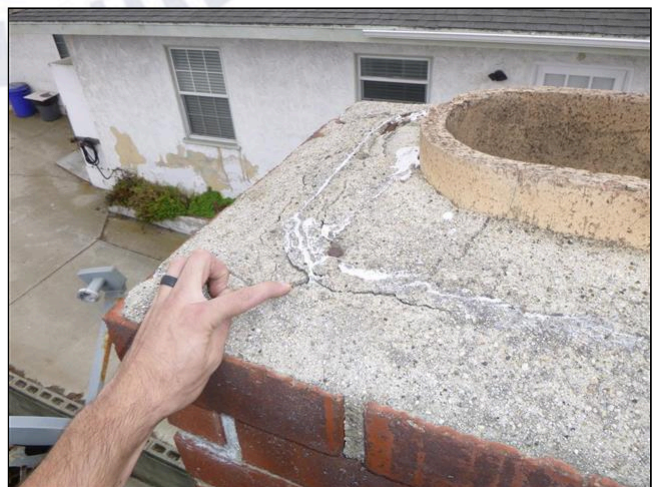
(1) Excessive cracks and exposed rebar was noted at the chimney crown, suggest repairs/sealing as needed to prevent future water intrusion and deterioration.

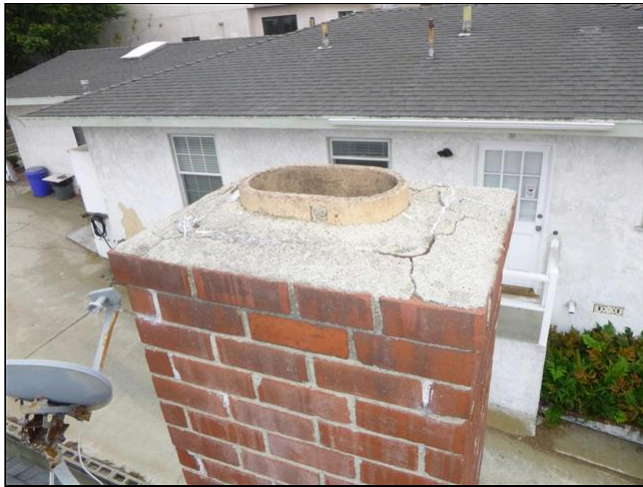
5.2 Item 3 (Picture)

(2) The chimney has no rain cap or spark arrestor. Suggest installation of a rain cap and a spark arrestor to prevent

water intrusion and a potential fire spread hazard.

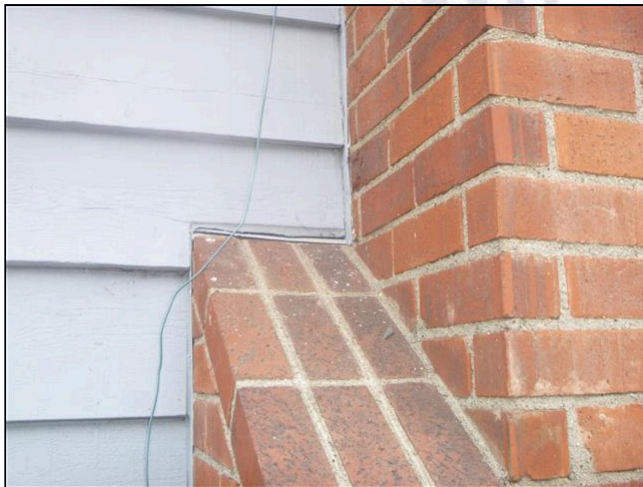
5.2 Item 4 (Picture)

(3) The chimney flashing to the siding is open at various areas, suggest sealing to prevent water and insect intrusion.

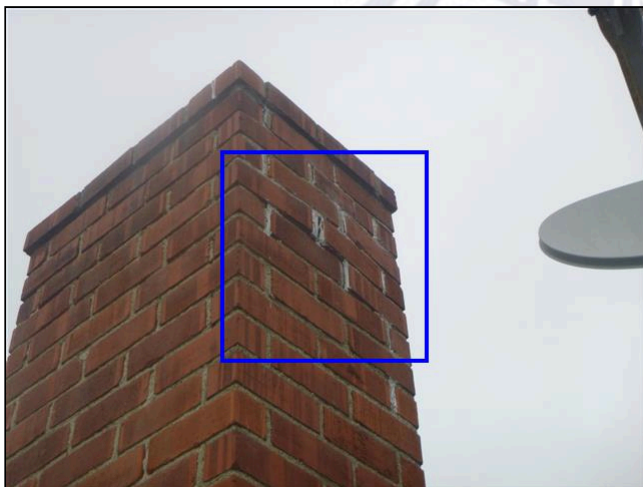
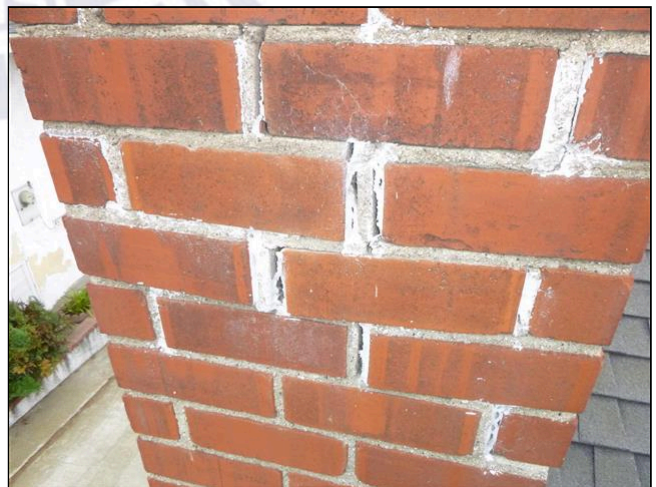
(4) Cracks/bulging was noted at the chimney bricks at the top section, suggest repairs and sealing to prevent future water intrusion and deterioration.

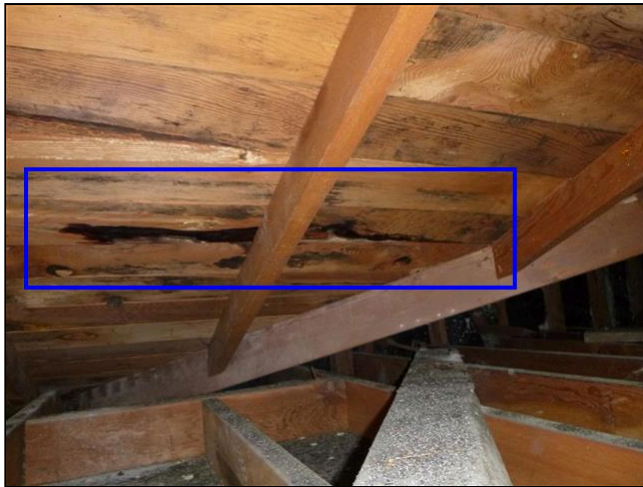
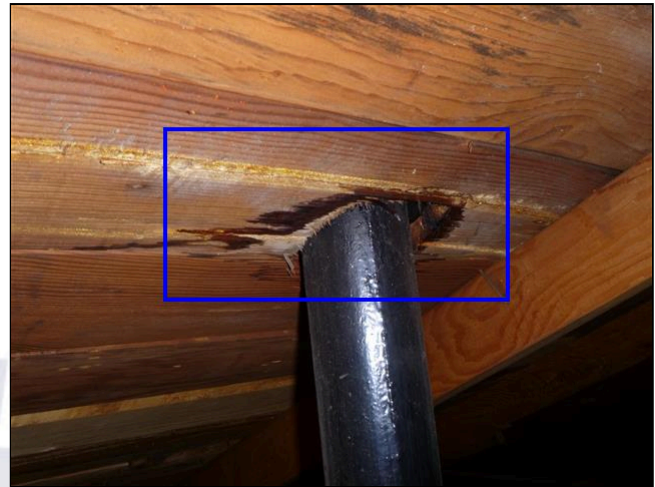
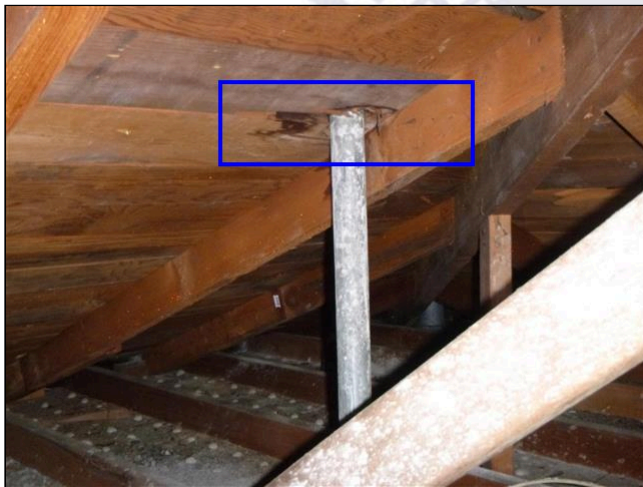
(1) Moisture stains noted at various areas of the attic sheathing/framing, unable to determine if the staining is past or present. Suggest review with the seller and a licensed roofer as needed.

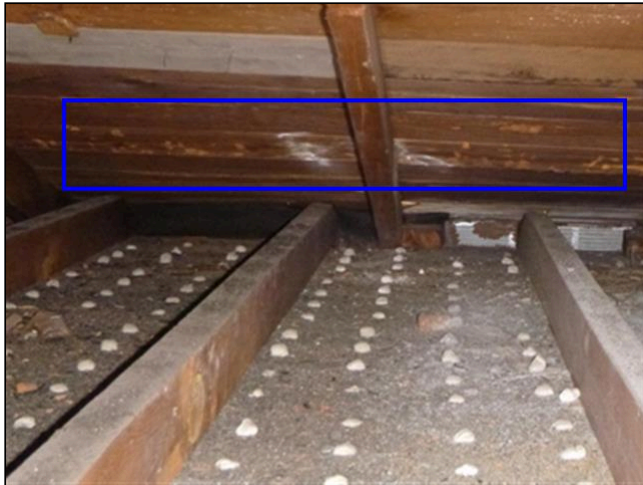
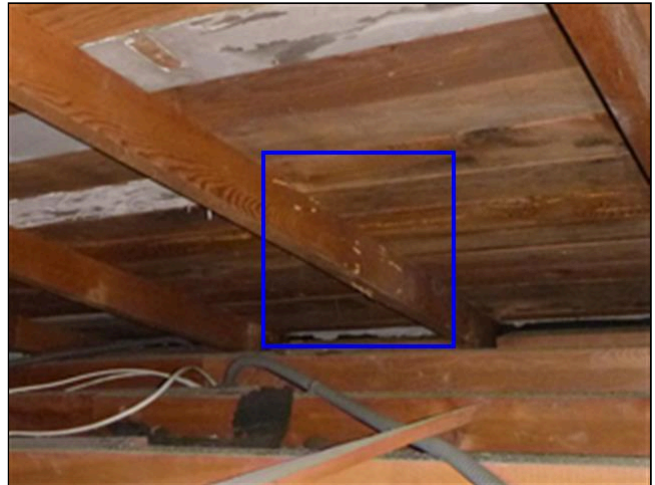
(2) Wood deterioration noted at various areas of the roof framing, suggest review with a termite company and/or a licensed contractor for repairs as needed.

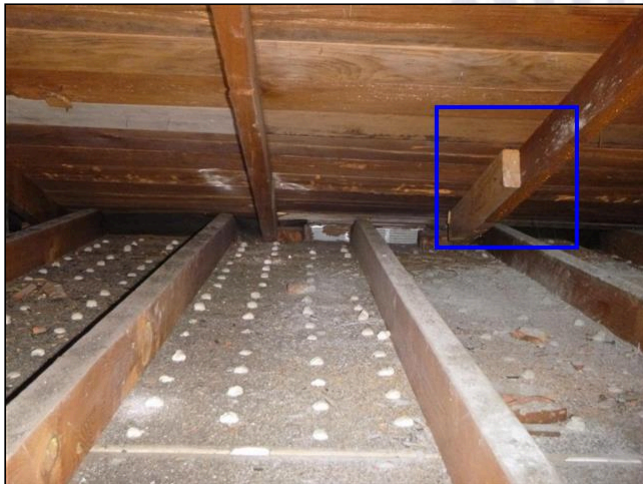
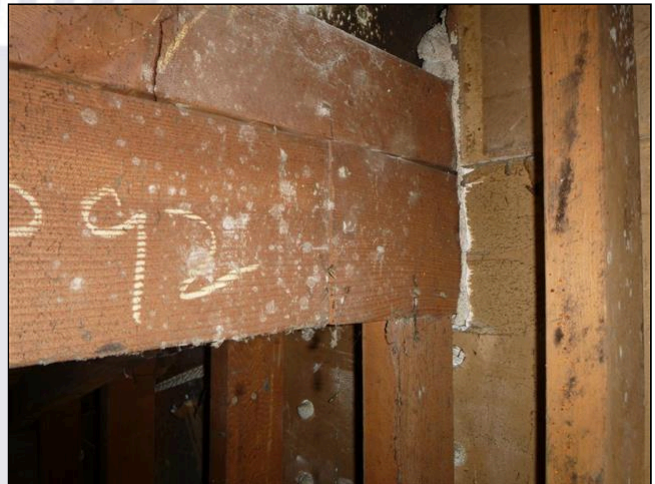
(3) Repaired roof rafters and additional beams/framing/ceiling supports noted at various areas within the attic. Suggest review with the seller/city and/or a licensed contractor/structural engineer on this installation as needed.
