Inspection Report

Property Address:
618 Prospect Ave
Hermosa Beach CA 90254

Ferguson Home Inspections

Date: 10/13/2022	Time: 02:00 PM	Report ID: 10132022Prospect
Property: 618 Prospect Ave Hermosa Beach CA 90254	Customer: Wendy & Scott Fletcher	Real Estate Professional: Amy Teitelbaum

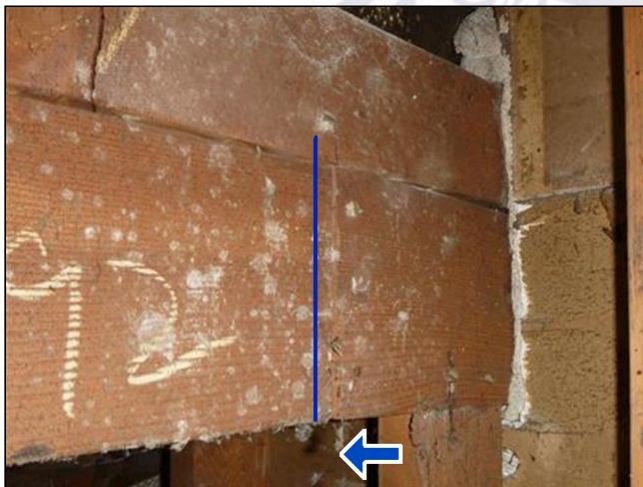
6.0 Item 8 (Picture)

(4) Typically, wood support members should have vertical supports at any splice/joint (this area does not), suggest review with a licensed contractor and for re-supporting costs as/if needed.

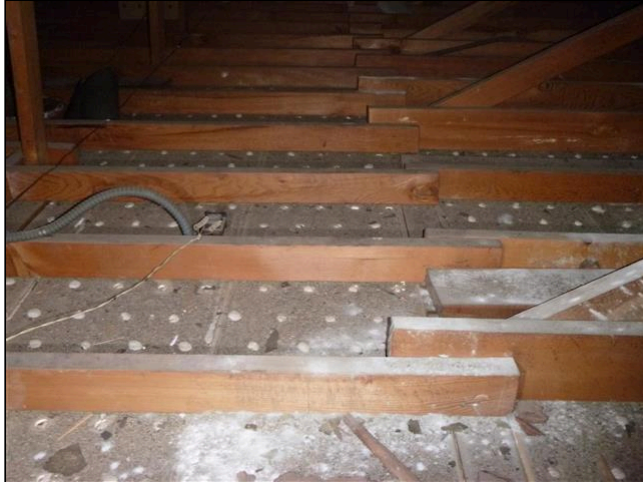
6.1 Item 1 (Picture)

No Insulation installed at the attic area, this is common for the original age of the home. Suggest review by a licensed contractor for installation costs as an upgrade.

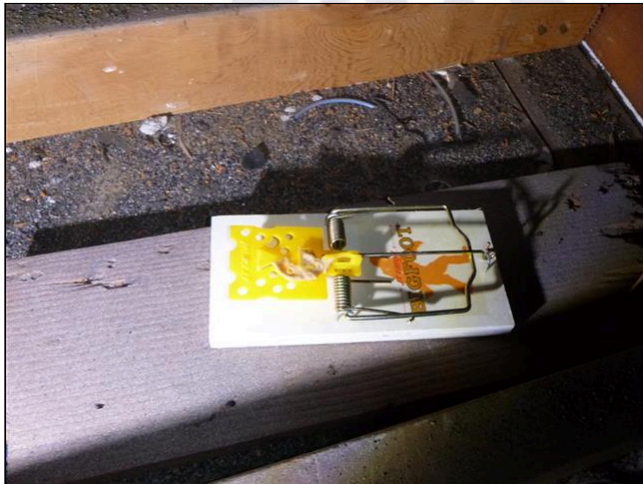
6.4 Item 1 (Picture)

(1) Pest droppings/traps noted within the attic. Suggest review with a qualified pest control company and/or a licensed contractor for removal costs of the droppings, re-screening of the vents and any removal/replacement of the attic insulation as needed.

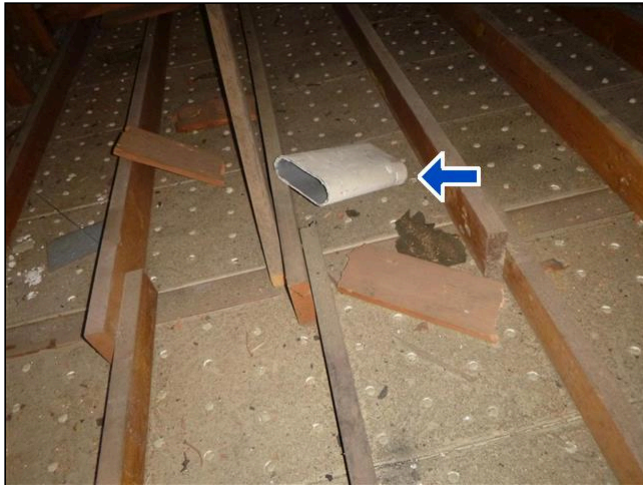
6.4 Item 2 (Picture)

(2) Abandoned asbestos vent pipes noted in the attic area, suggest review with a licensed contractor for removal costs as needed.

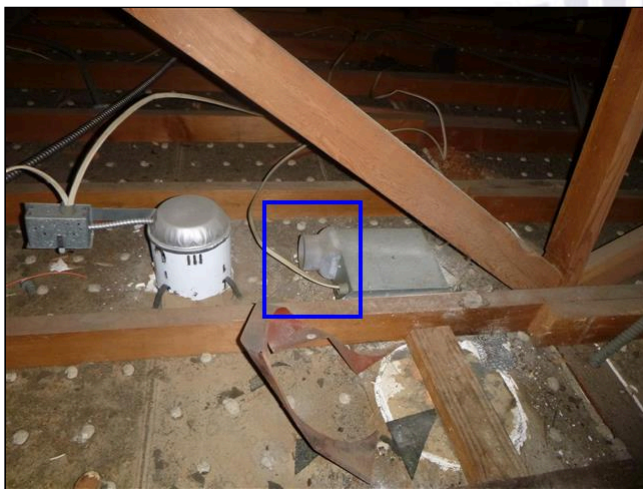
6.4 Item 3 (Picture)

(3) The kitchen's exhaust vents into attic, suggest review by a licensed contractor to vent to the exterior as required.

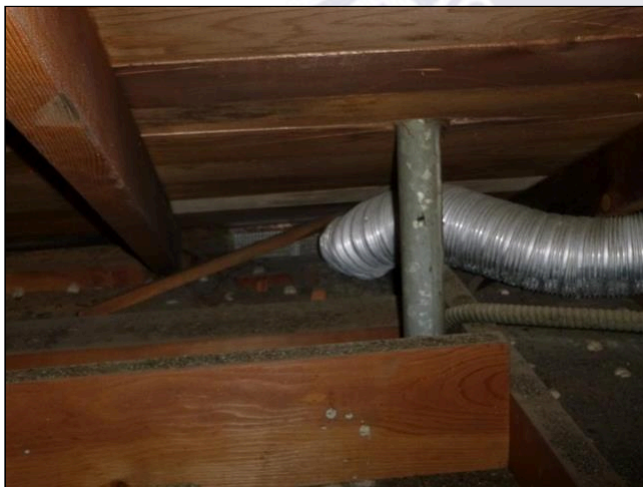
6.4 Item 4 (Picture)

(4) The exhaust fan systems for both bathrooms are currently venting into attic, suggest review by a licensed contractor to vent to the exterior as required.

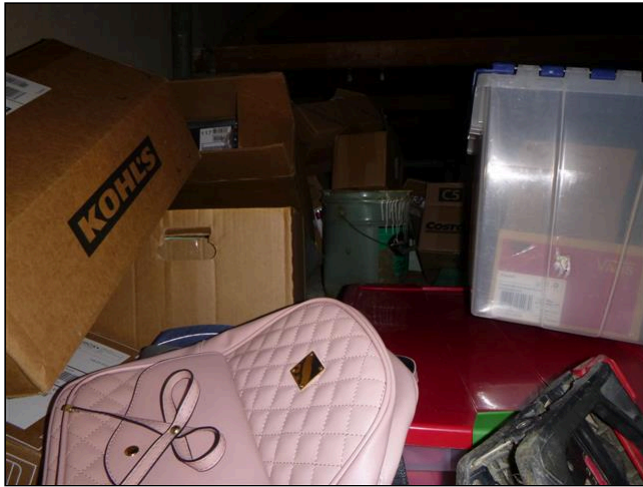
6.4 Item 5 (Picture)

(5) Access within the front left master attic was severely limited due to the restrictive clearances/personal effects.

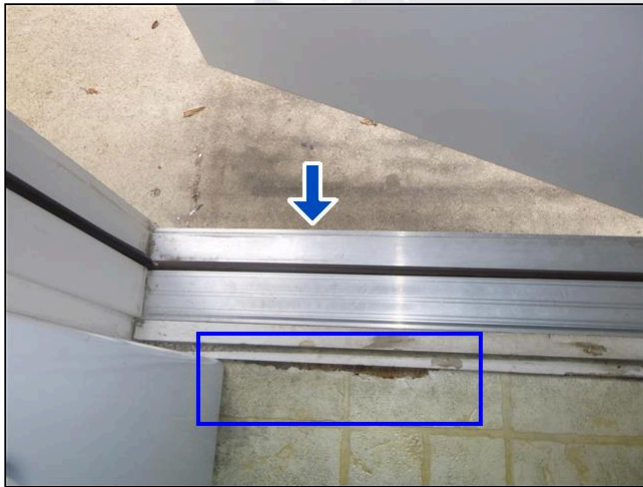
7.0 Item 1 (Picture)

The flooring is deteriorated and lifting. Water intrusion was noted below the door into the crawl space and has damaged the subflooring and sill plate. Suggest review with a licensed contractor for removal/repair/replacement costs as needed.

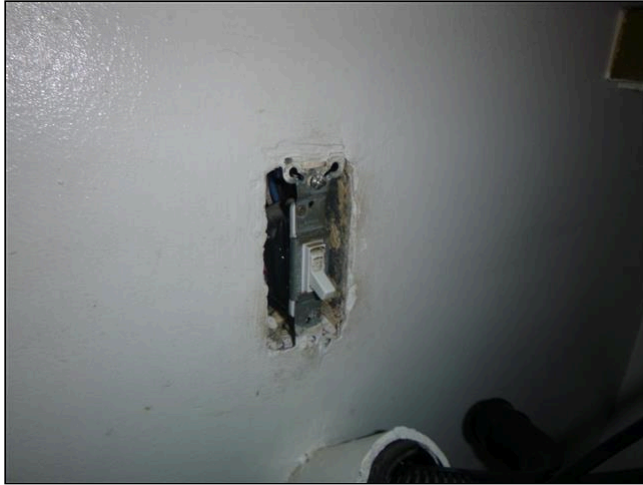
7.4 Item 1 (Picture)

(1) Various wall switch covers are missing, suggest installation for safety.

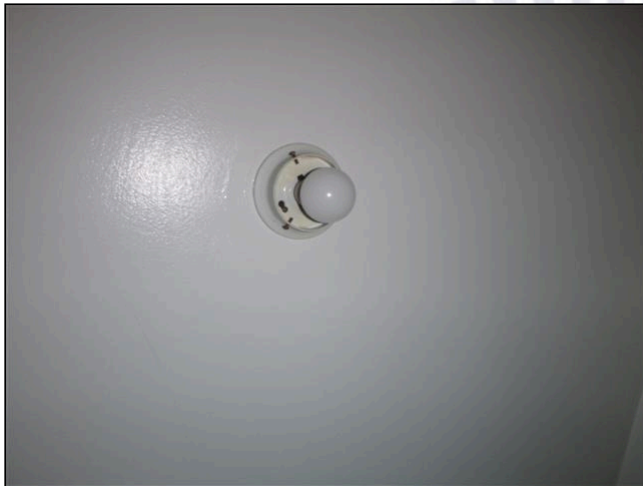
7.4 Item 2 (Picture)

(2) The cover globe(s) are missing at light fixture(s) at the time of the inspection. Suggest replacing the missing cover globe(s) for safety.

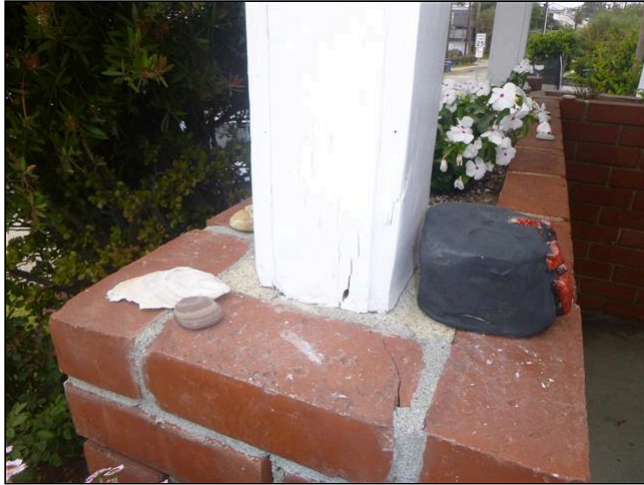
8.0 Item 1 (Picture)

Wood deterioration noted at various areas. Suggest review with termite company and/or review with a licensed contractor for repair/replacement costs as needed.

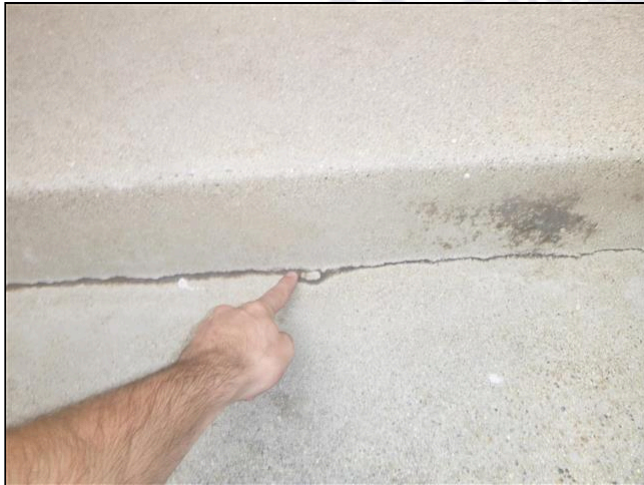
8.1 Item 1 (Picture)

Minor movement and settling noted at the patio, this is common for the original age of the dwelling. Suggest review with a licensed contractor for repairs as needed.

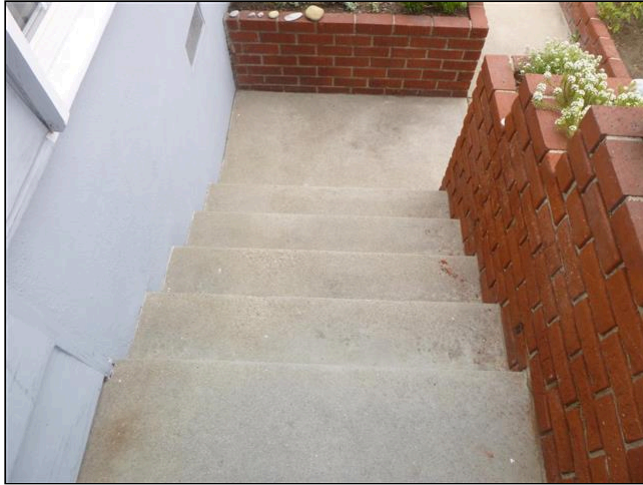
8.2 Item 1 (Picture)

No railing installed at the front steps at the time of the inspection. Common for the age of the property. Possible safety hazard. Suggest installation of railing to current standards to enhance safety.

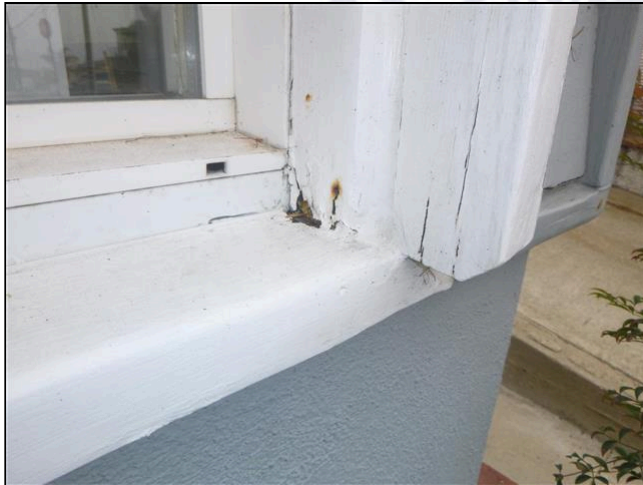
8.4 Item 1 (Picture)

Wood deterioration noted at various window frames. Suggest review with termite company and/or a licensed contractor and repair/replace as needed.

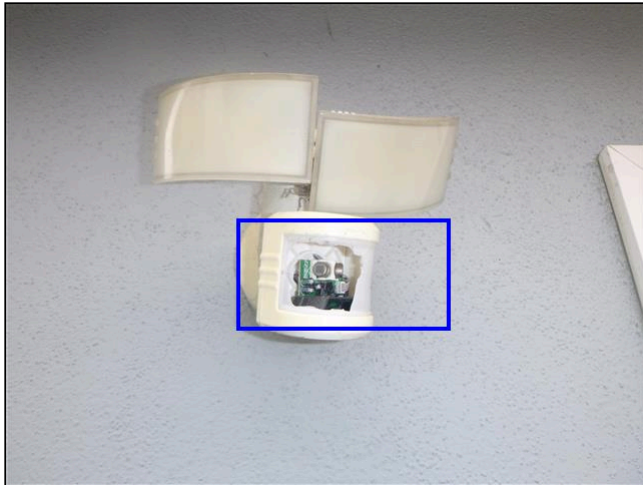
9.2 Item 1 (Picture)

The light fixture sensor was deteriorated. Suggest repair/replace as needed.

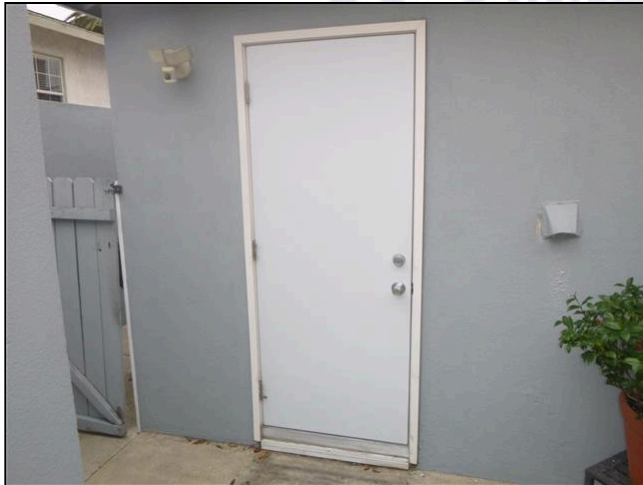
9.3 Item 1 (Picture)

(1) The existing door currently opens out from the dwelling. Generally exterior doors are required to open into the dwelling for safety. Suggest review with a licensed contractor to re-hang the door to open in as needed.

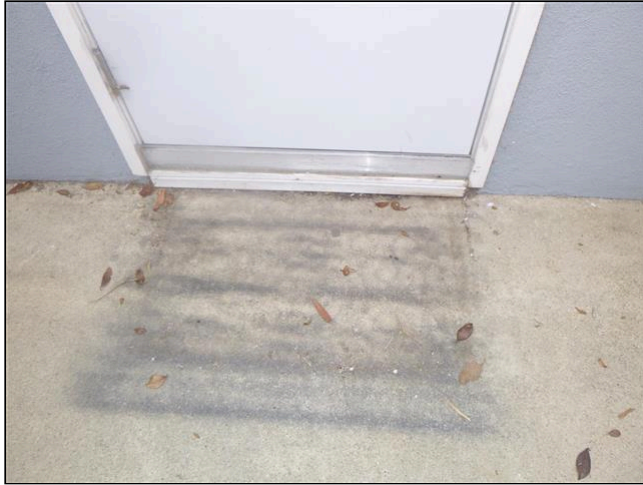
9.3 Item 2 (Picture)

(2) Evidence of previous and ongoing water intrusion noted at the door(s) to the interior. Deteriorated and stained flooring/wood members noted. Suggest review with a licensed contractor for repair/replacement costs as needed to prevent further and future water intrusion at this area.

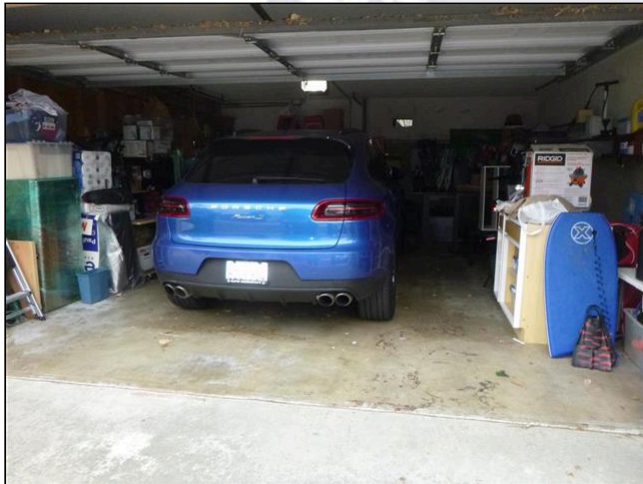
10.0 Item 1 (Picture)

(1) Access within this area was blocked or severely limited at the time of the inspection. An inspection of this area can be performed by appointment and at an additional cost when the area is made accessible.

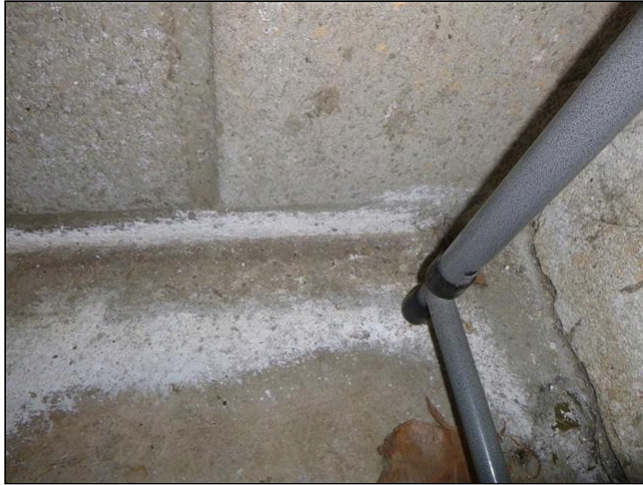
10.0 Item 2 (Picture)

(2) White efflorescence (powder substance) on foundation footings indicates prior, and possibly ongoing, excessive moisture build up at the exterior of the foundation. Ongoing water intrusion at the foundations can, in some cases, cause the steel in the foundations to rust, called spalling, which can lead to horizontal cracking of the foundation (currently there are no major horizontal cracks visible at the foundation). Any future horizontal cracking/damage can be an expensive repair as the foundation would be considered structurally weak and susceptible to horizontal movement. Suggest review of the Lot/Grade and drainage systems, including rain gutters, to reduce and prevent further and future water buildup at the exterior of the dwellings foundations.

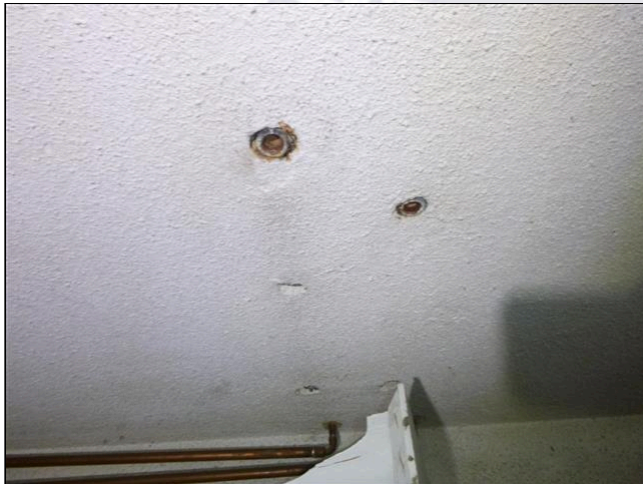
10.4 Item 1 (Picture)

(1) Patched and uneven areas of the ceiling noted, suggest review with the seller on the cause and any repairs needed. Suggest repair as needed.

(2) Holes and unfinished sections of firewall and ceiling were noted, this is a potential fire spread hazard. 5/8 inch sheetrock may be installed as a minimum standard material and as a requirement for a one hour burn through rating for firewall. Suggest review by licensed contractor for repair/installation costs as needed.

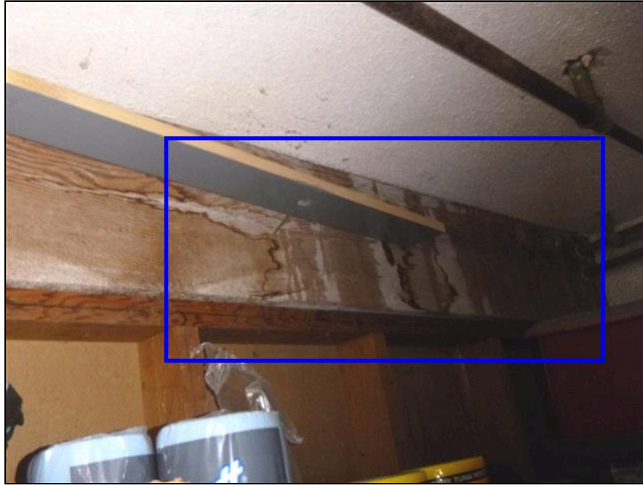
10.4 Item 2 (Picture)

(3) Holes and unfinished sections of the walls were noted, suggest review by licensed contractor for repair/replacement costs as needed.

(4) Water staining/damage was noted from the unit above, suggest repairs as needed.

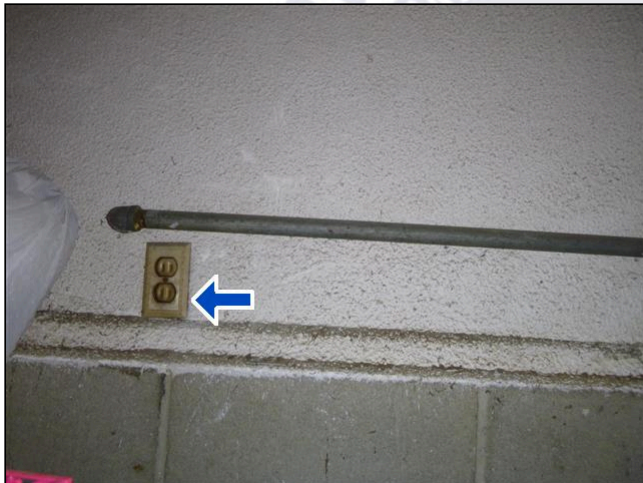
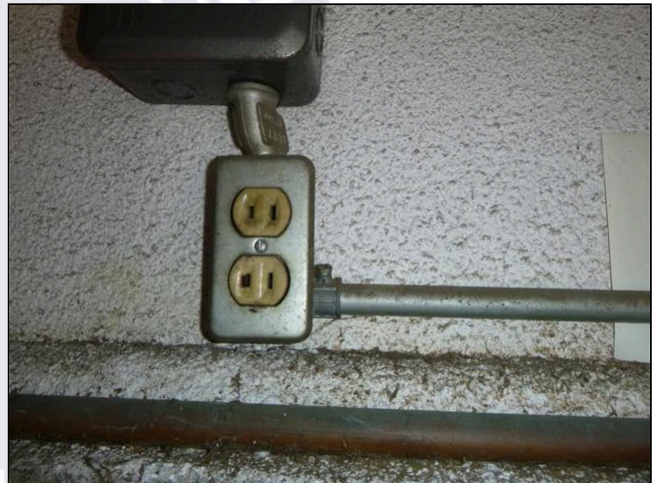
(1) Two wire and two prong electrical receptacles noted. At the time of the original construction this type of system was the acceptable standard and appears to be intact. If three prong and GFCI receptacles are desired a ground source is required. Suggest review with a licensed electrician for costs to ground the outlets as needed as an upgrade and/or protected the outlet(s) on a GFCI circuit where recommended.

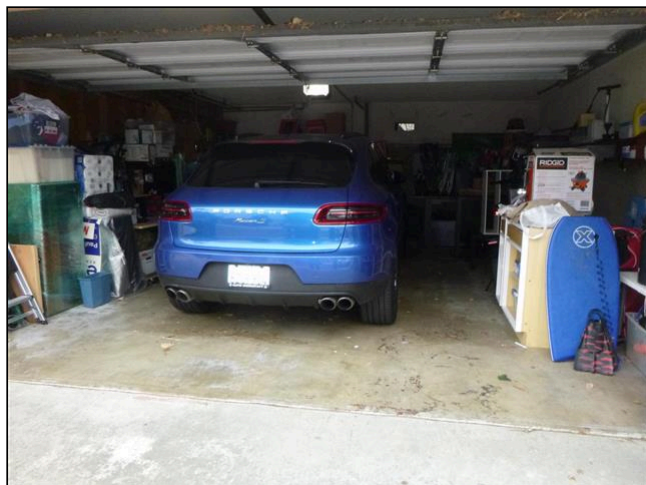
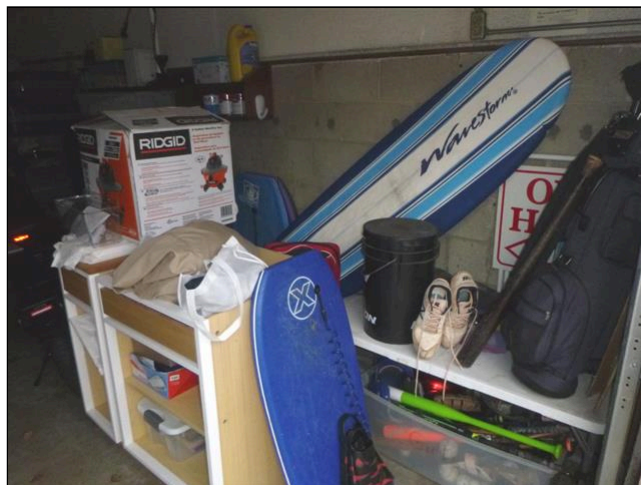
Access within this area was blocked or severely limited at the time of the inspection. An inspection of this area can be performed by appointment and at an additional cost when the area is made accessible.

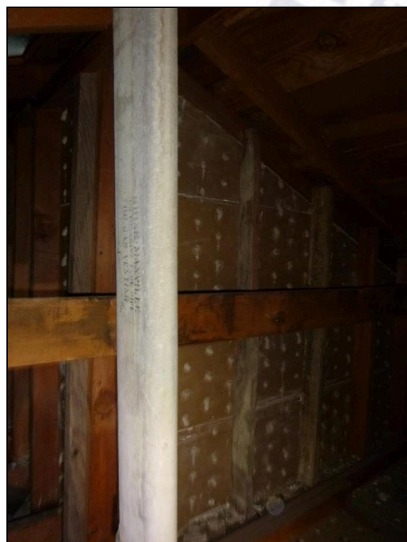
11.1 Item 1 (Picture)

(1) Asbestos-like material transite pipe/vent noted. Common for the age of the dwelling. No damage visible at the transite pipe at the time of the inspection.

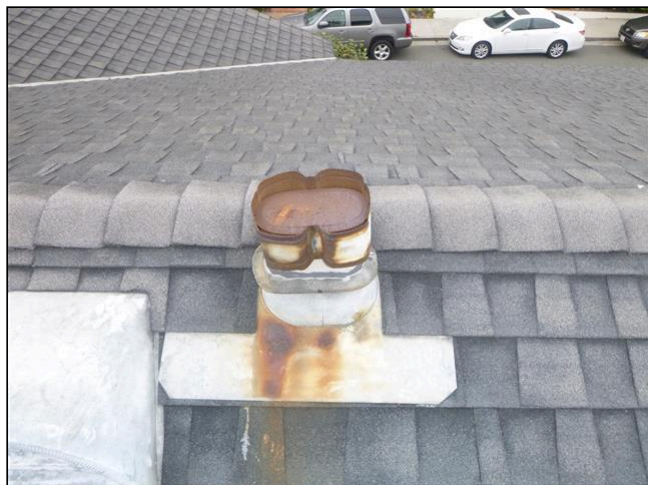
11.1 Item 2 (Picture)

(2) The heater's vent cap is rusted, suggest review with a licensed roofer for repairs as needed.

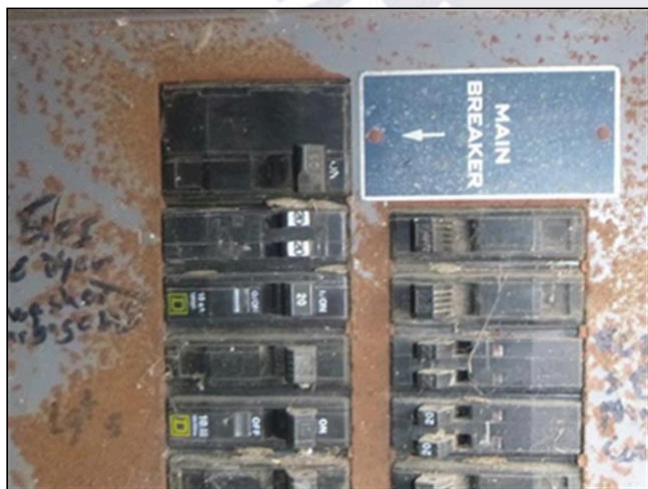
12.1 Item 1 (Picture)

(1) The main electrical panel is a Square D brand electrical panel. There are problems with these panels that can, in some cases, be serious. Some of the main electrical panels have been recalled, with other problems including counterfeit circuit breakers and faulty GFCI and AFCI breakers. Also, please be aware that various insurance companies will not insure homes with this style of electrical panel. Suggest review by a licensed electrician for review and repair/replacement costs as needed.

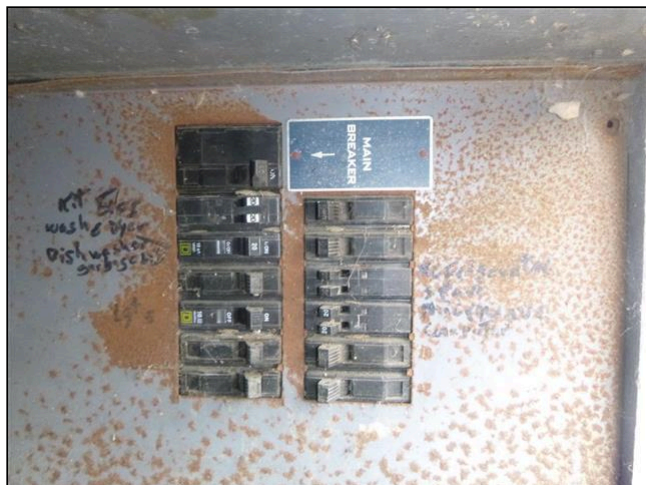
12.1 Item 2 (Picture)

(2) Suggest adding correct/complete indexing/labelling to all breakers for identification of each circuit for safety.

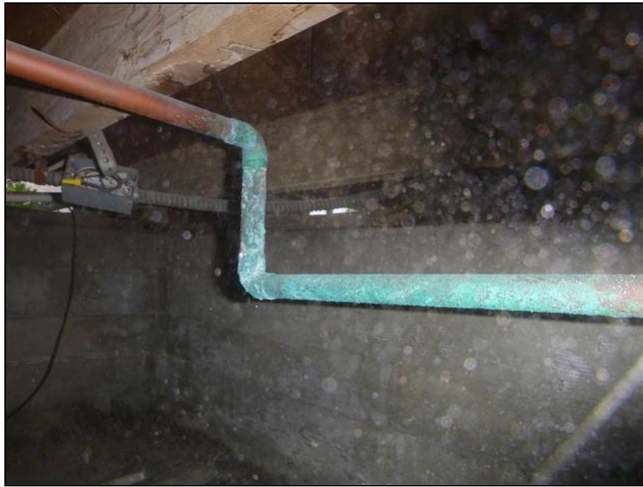
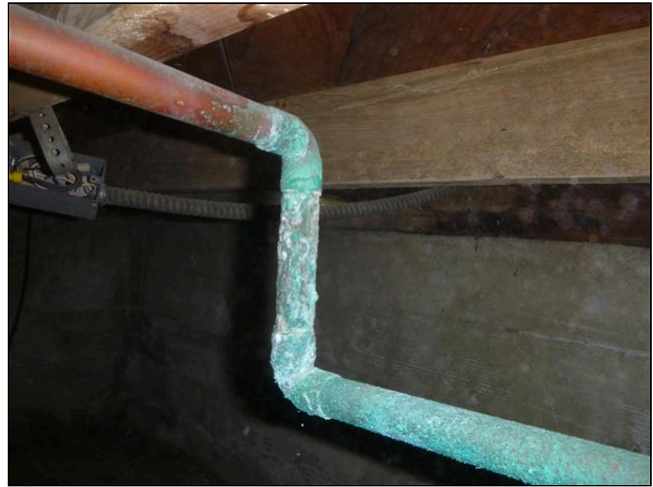
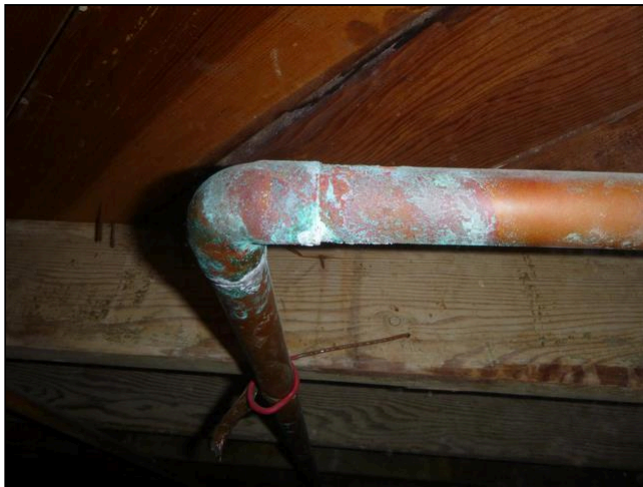
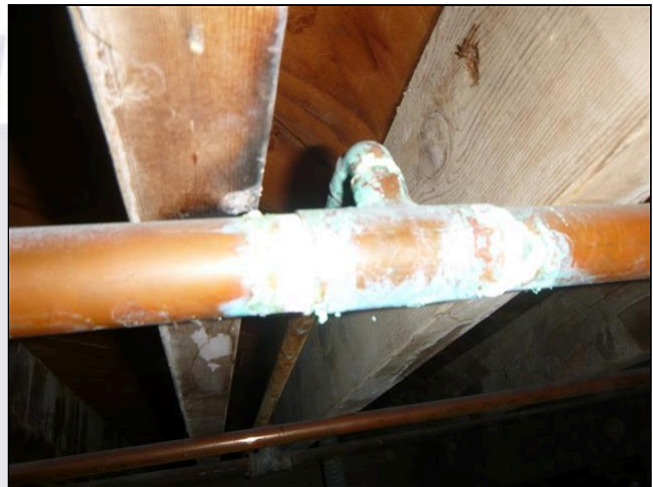
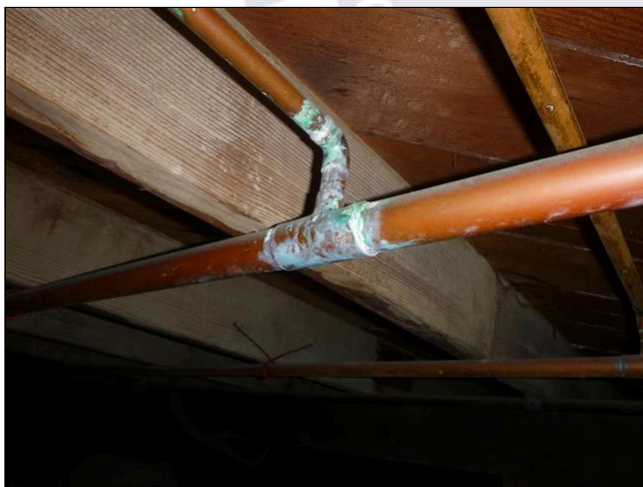
(1) See the crawl space comments and repair as needed.

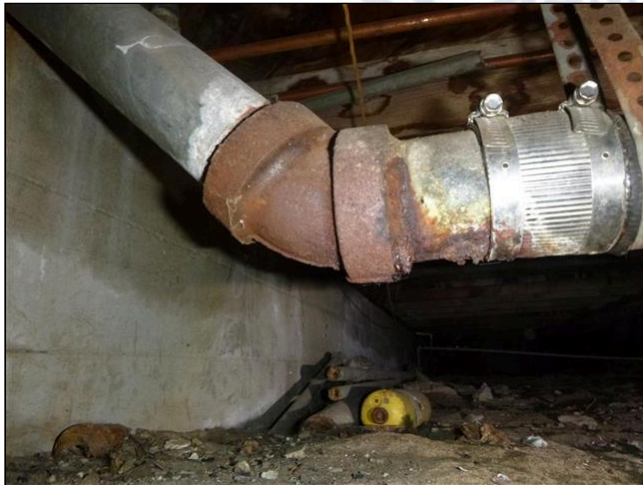
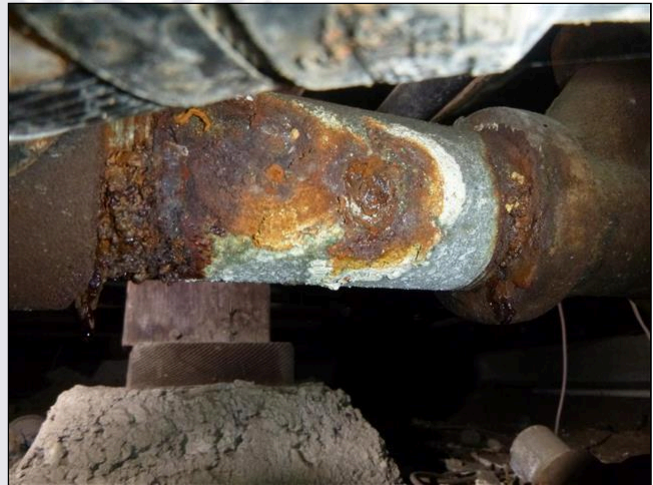
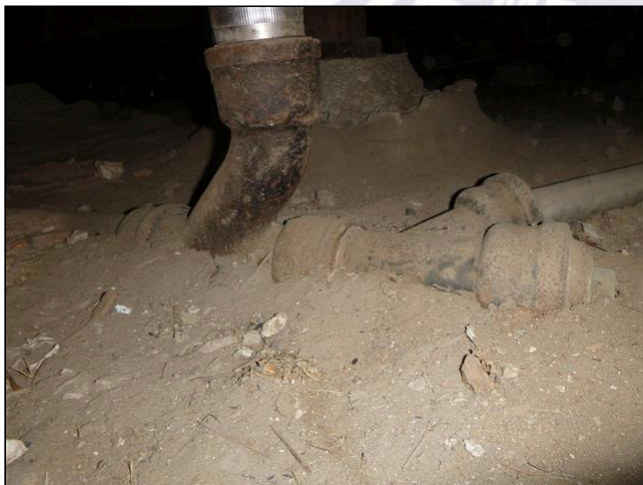
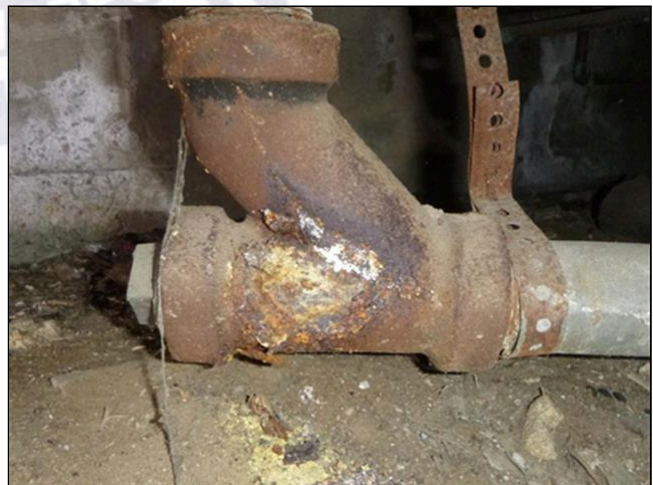
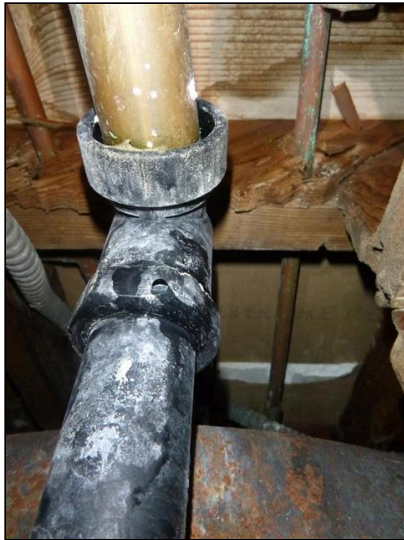
(3) See the crawl space comments due to the excessively corroded and leaking drains. Suggest review by licensed plumber for repair/replacement costs.

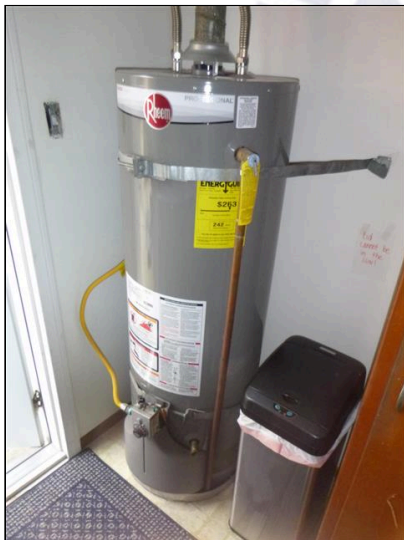
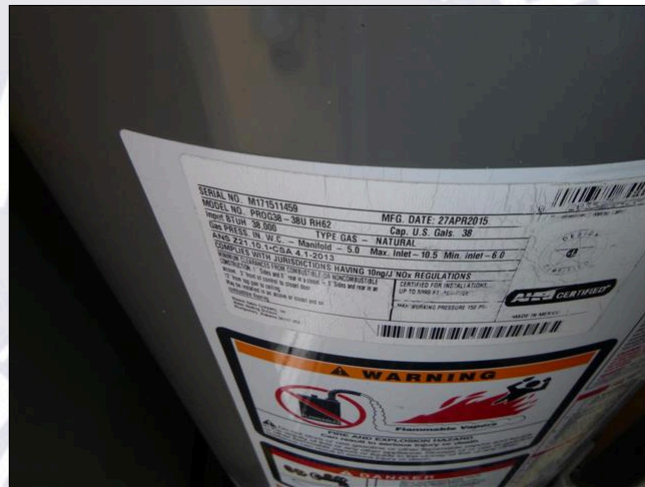
(1) The water heater was operational at the time of the inspection.

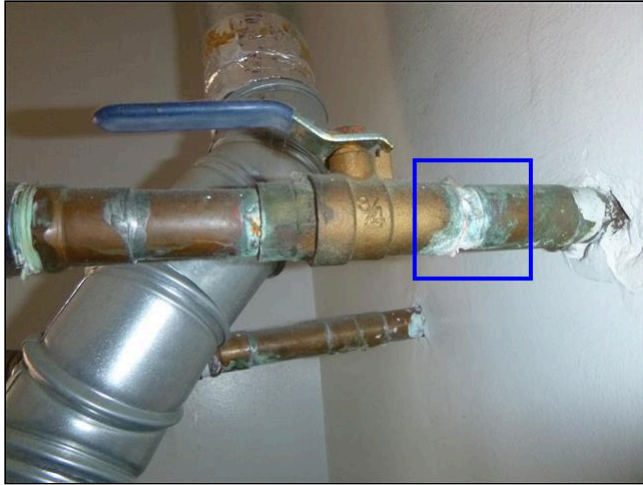
15.0 Item 3 (Picture)

(2) Rust and corrosion was noted at the cold water shut off, no leaking was visible at the time of the inspection. Suggest review by a licensed plumber for repair/replacement costs as needed.

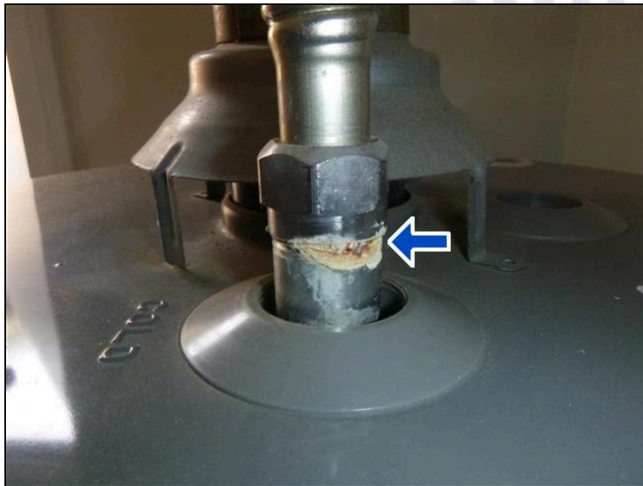
15.0 Item 4 (Picture)

(3) Rusted and corroded riser connection(s) noted, no leaking was visible at the time of the inspection. Suggest review by a licensed plumber for repair/replacement costs as needed.

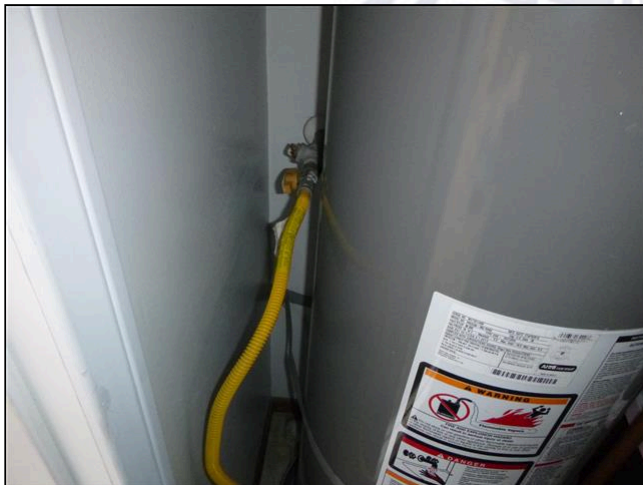
15.0 Item 5 (Picture)

(4) Currently no gas supply line drip leg/sediment trap is installed, please be aware that various cities do not enforce/require this installation. Suggest review with the local City Building Department and/or with a licensed plumbing contractor for installation costs as needed.

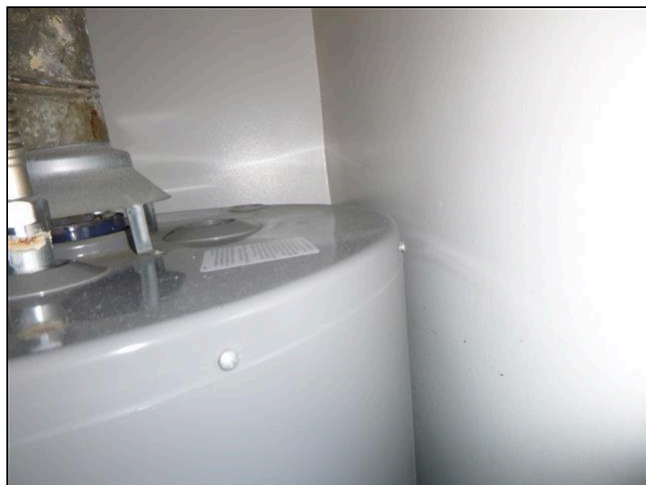
15.0 Item 6 (Picture)

(5) The water heating strapping is missing the rear bracing at the time of the inspection, suggest review by licensed plumber for installation costs as required.

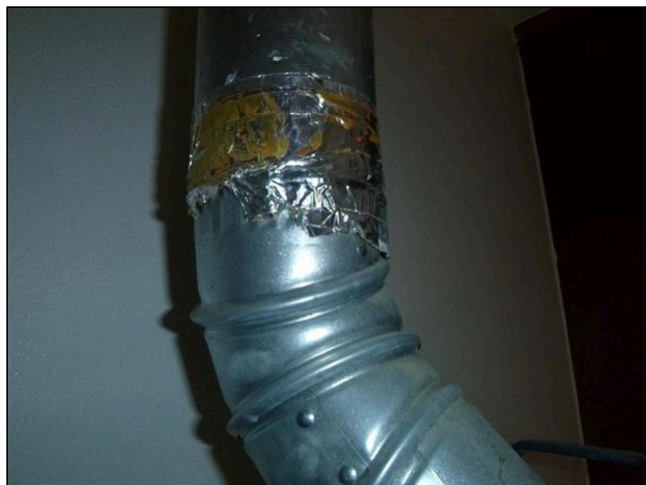
15.1 Item 1 (Picture)

- (1) Asbestos-like material transite pipe/vent noted. Common for the age of the dwelling. No damage visible at the transite pipe at the time of the inspection.
- (2) The fittings do not have the required screws installed, suggest installation as needed to prevent dislodging.

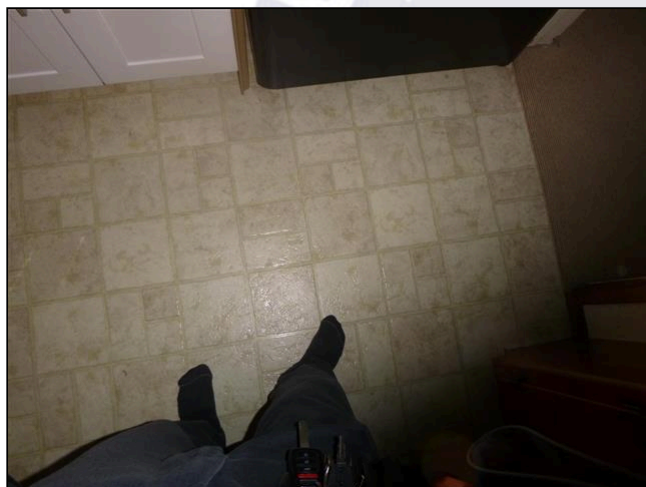
16.0 Item 1 (Picture)

(1) Floor slope and uneven flooring noted.

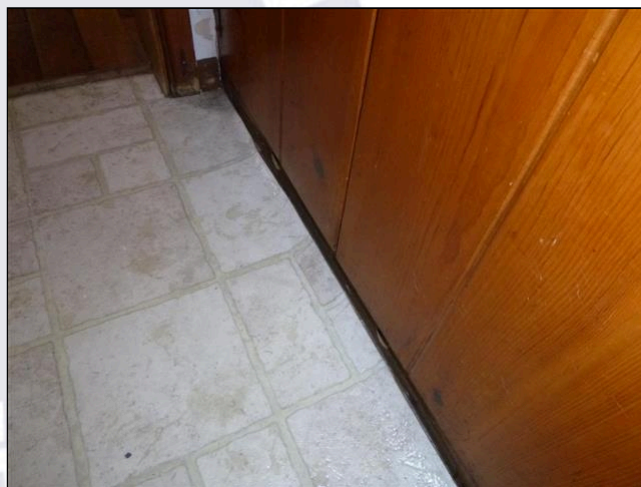
16.0 Item 2 (Picture)

(2) The flooring in the kitchen is soft, deteriorated and lifting, suggest review with a licensed contractor for removal/repair/replacement costs as needed.

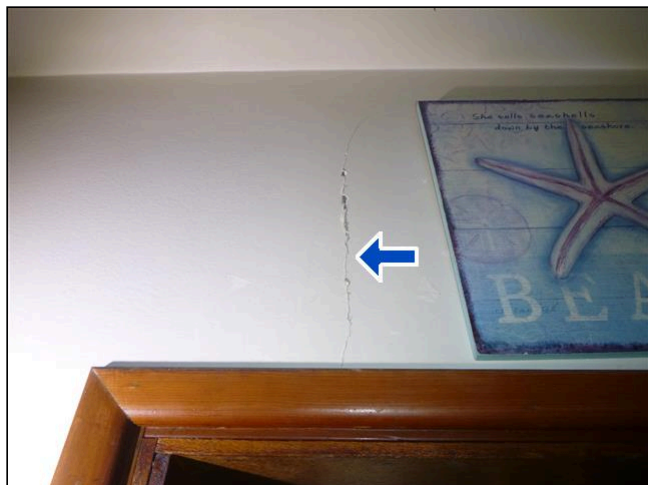
16.1 Item 1 (Picture)

Excessive settling cracks noted, see the foundation and Lot/Drainage comments. Suggest review with a licensed contractor for repair/replacement costs as needed.

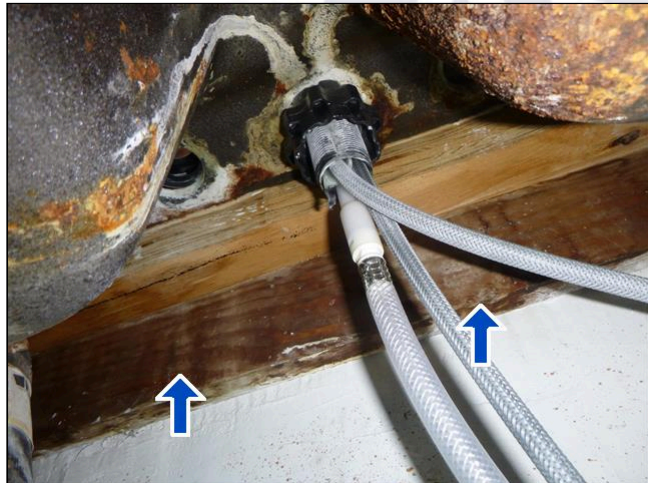
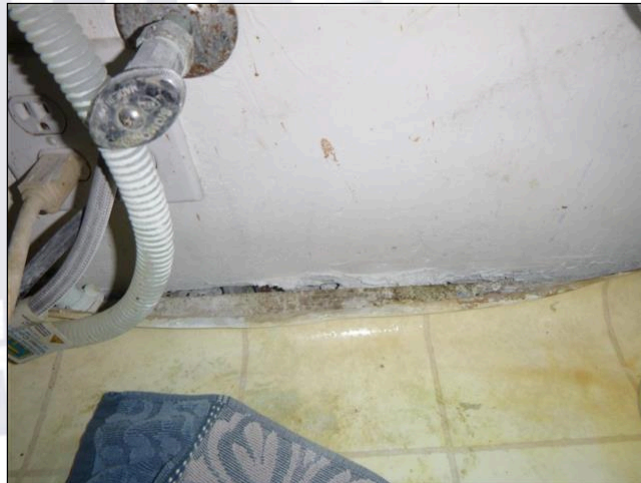
(1) The base cabinet under the sink is deteriorated/stained from leaks, suggest repair/replace as needed.

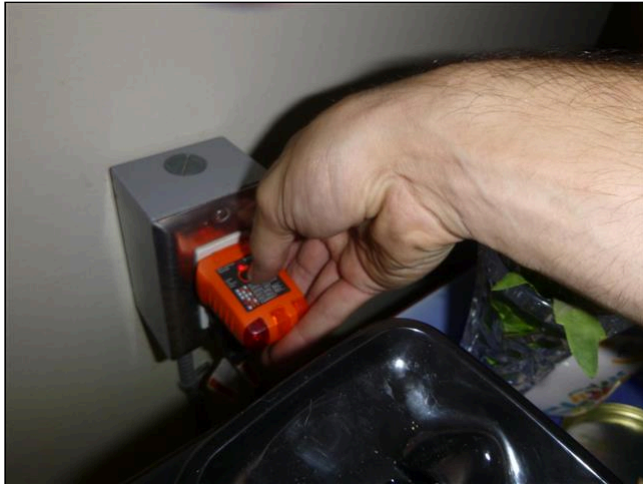
16.8 Item 1 (Picture)

(1) Inadequate countertop/appliance outlets/circuits installed, suggest review with a licensed electrician for installation costs as needed/required.

(2) Various countertop outlets are not GFCI protected as required. Countertop GFCI outlet(s)/protection has been

required within six feet of the sink since 1987 and all countertop outlets since 1996. Suggest review by a licensed electrician for installation costs as required for safety.

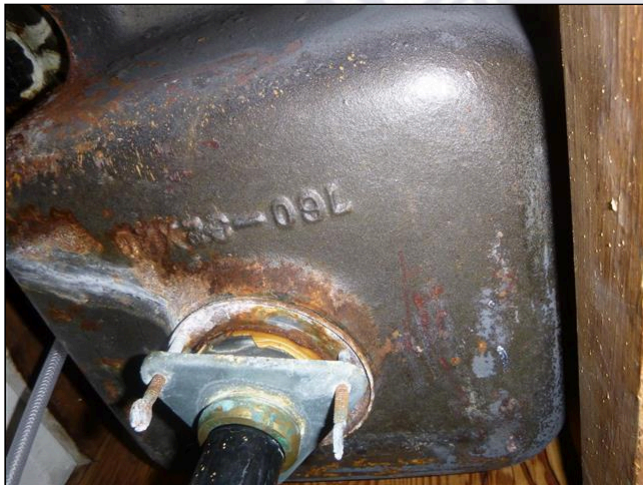
16.9 Item 1 (Picture)

Excessive rusting and deteriorated areas of the sink was noted, suggest repair/replace as needed.

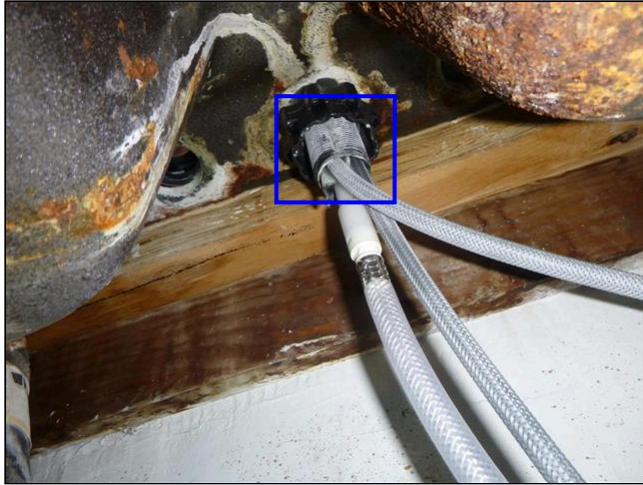
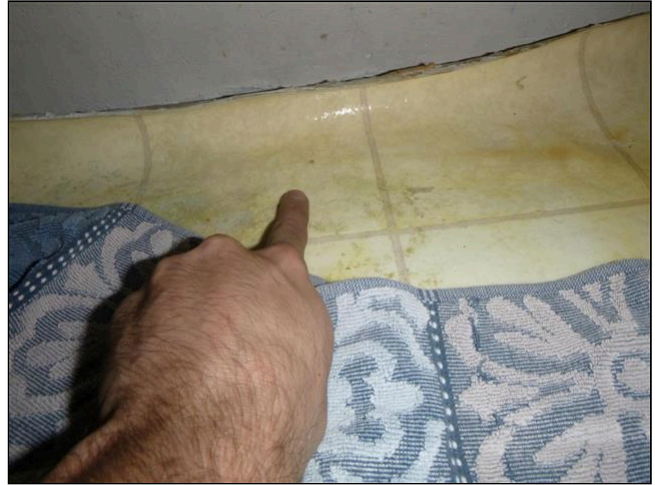
The sink faucet leaks, suggest repair/replace as needed to prevent future and further leaking water from damaging the cabinet base and surrounding areas.

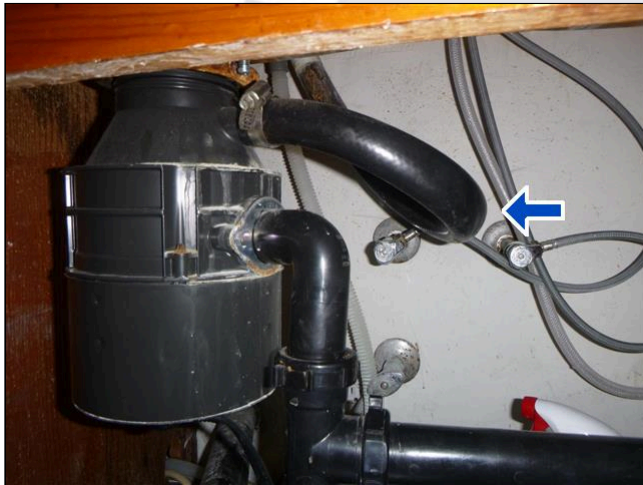
16.12 Item 1 (Picture)

Suggest review with a licensed plumber for costs to reduce the length of the drain from the air gap to the disposal as this has created a trap in the drainage system.

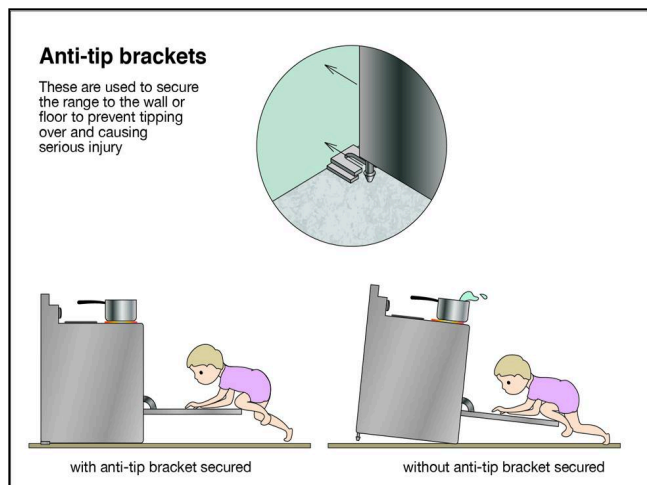
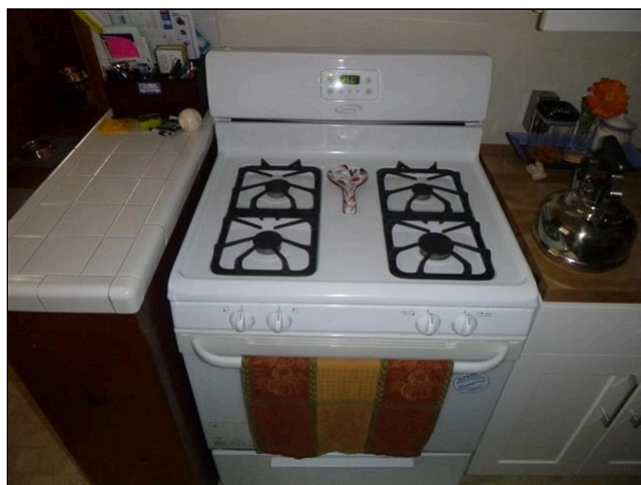
(1) The anti-tip bracket is not currently installed. An anti-tip bracket is usually installed on the floor and against the wall (towards the back of the stove) for one of the rear legs to slide into. Its purpose is to prevent the stove from tipping when a heavy load is placed on the door (possible child) or slide-out racks upsetting the center of gravity. Suggest installation for safety as required since 1991.

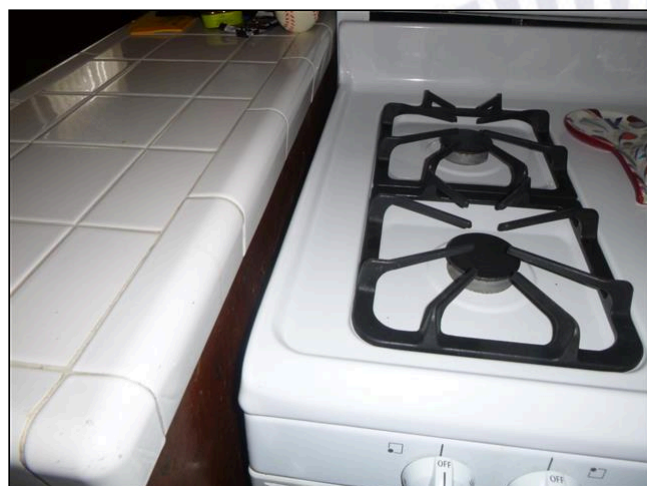
16.14 Item 3 (Picture)

(2) Potential fire spread hazard due to the stove is currently below the countertop height. Suggest review with a licensed contractor for cost to raise and level the stove to above the countertop height as required for safety.

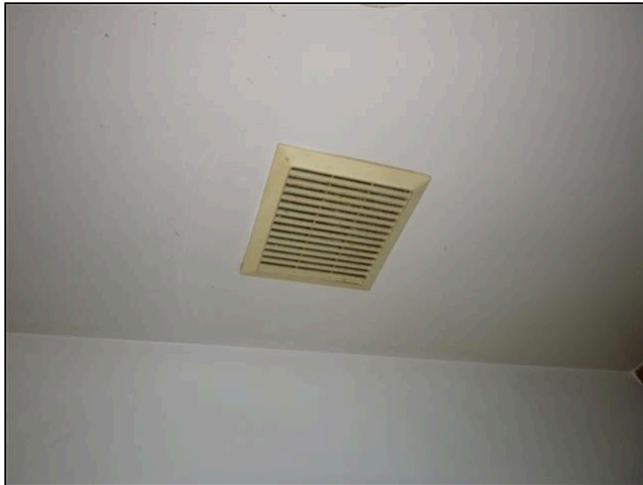
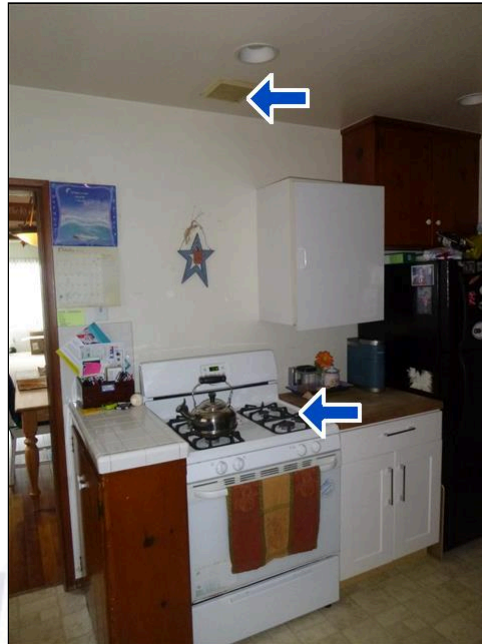
(1) The exhaust fan system over the gas range is the incorrect style (this style is typically seen in a bathroom/ laundry room) and is not located within 36-42 inches of the stove top. Suggest review with a licensed contractor for replacement costs as needed for safety.

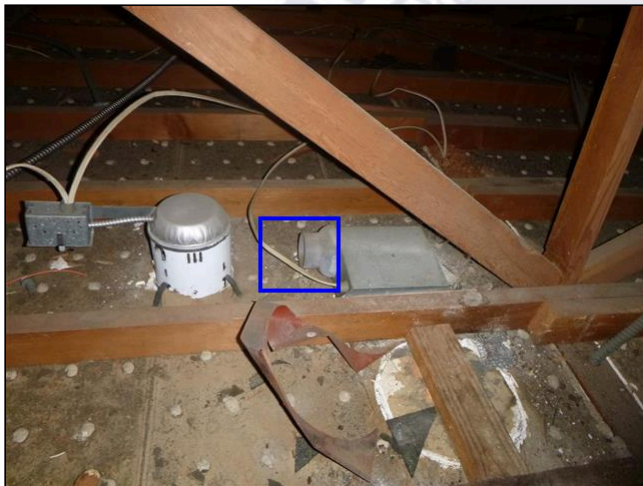
16.15 Item 3 (Picture)

(2) The range hood currently vents into the attic area, this is a potential fire safety hazard. Suggest review by a licensed contractor and vent to the exterior as required.

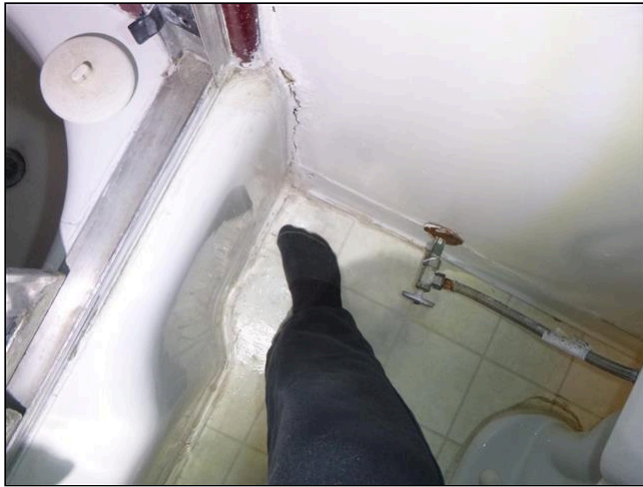
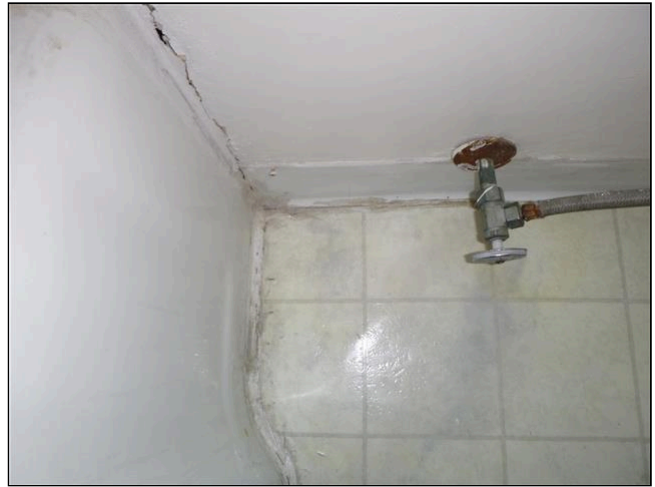
The flooring is soft and deteriorated near the shower, this is due to water leaking from the shower area and damaging the subflooring. Suggest review with a licensed contractor for removal/repair/replacement costs as needed.
