Inspection Report

Property Address:
618 Prospect Ave
Hermosa Beach CA 90254

Ferguson Home Inspections

Date: 10/13/2022	Time: 02:00 PM	Report ID: 10132022Prospect
Property: 618 Prospect Ave Hermosa Beach CA 90254	Customer: Wendy & Scott Fletcher	Real Estate Professional: Amy Teitelbaum

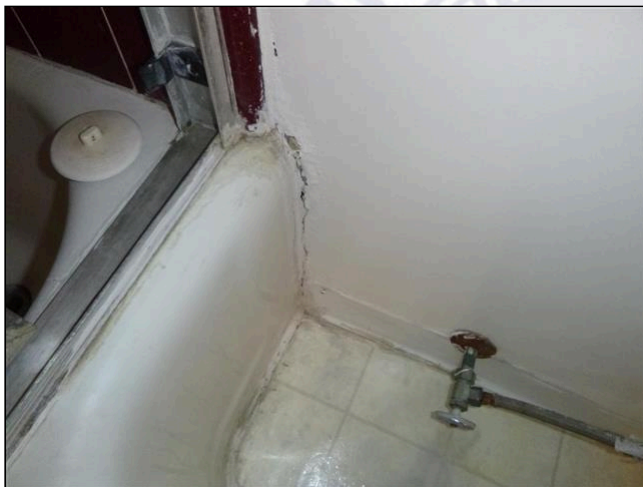
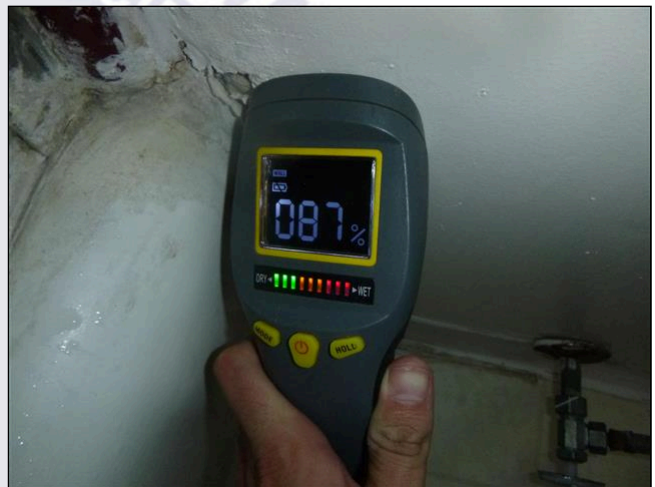
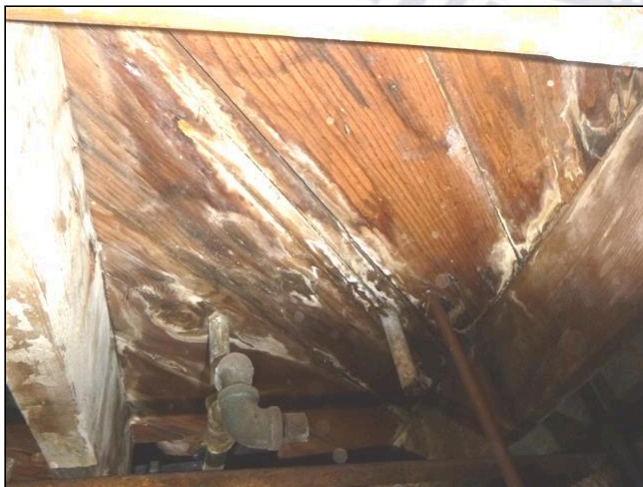
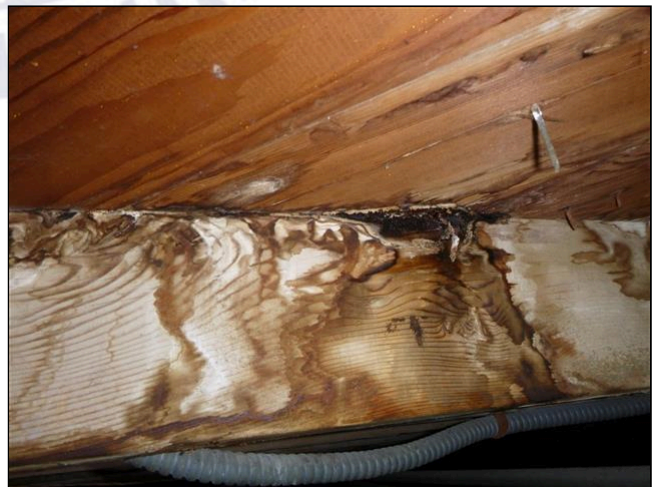
(1) Excessive moisture was detected at the walls adjacent to the shower. Water damage/deterioration was noted at the walls and the area below in the crawl space. Suggest review with the seller and/or a licensed mold/contractor for repair/replacement/removal costs as needed.

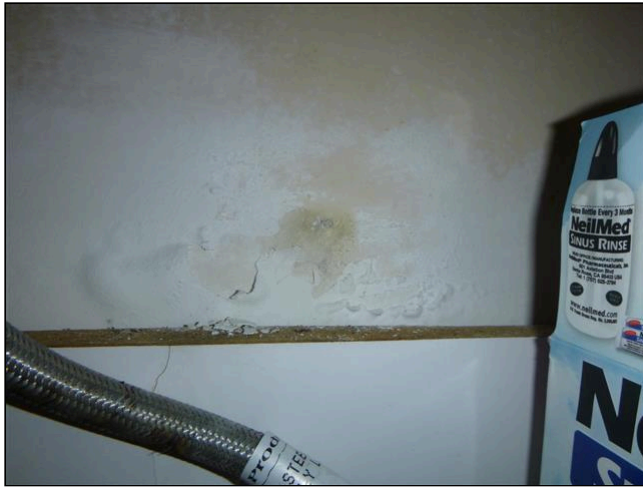
17.1 Item 5 (Picture)

(2) Old water stains/damage was noted under the sink area, suggest removal/repair/replacement costs as needed.

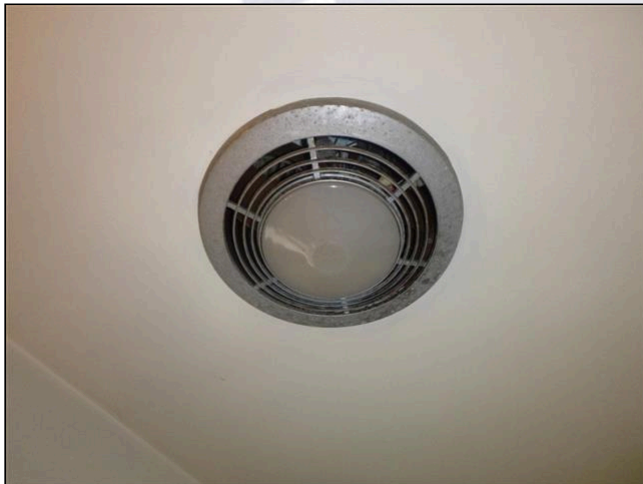
17.7 Item 1 (Picture)

(2) The exhaust fan is excessively noisy, suggest review with a licensed contractor for repair/replacement costs as needed.

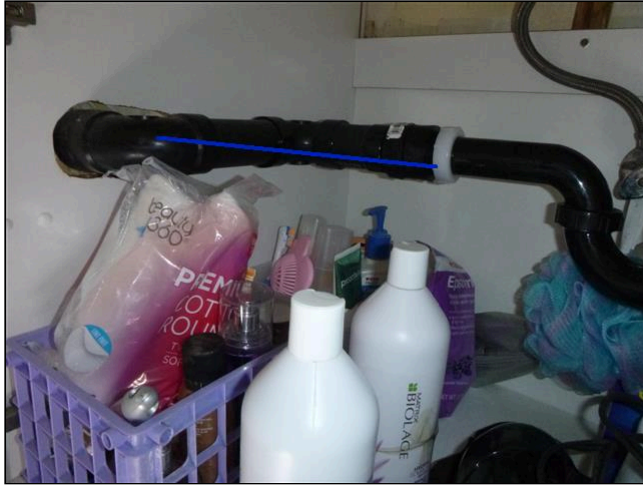
17.16 Item 1 (Picture)

Incorrect sloping was noted at the sink drain, suggest re-sloping as needed.

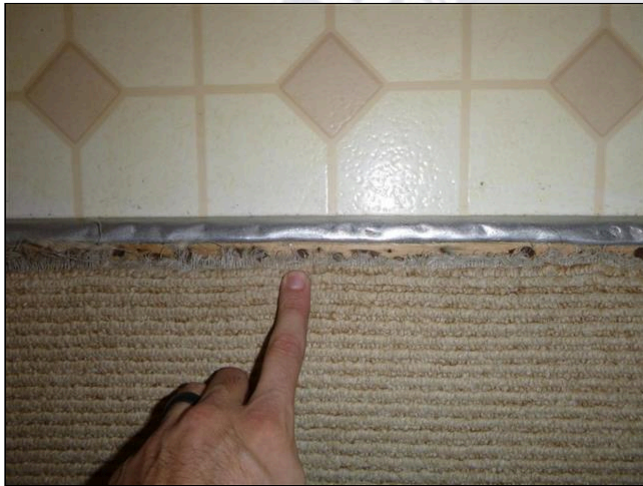
18.0 Item 1 (Picture)

The flooring transition is deteriorated, suggest repairs as needed.

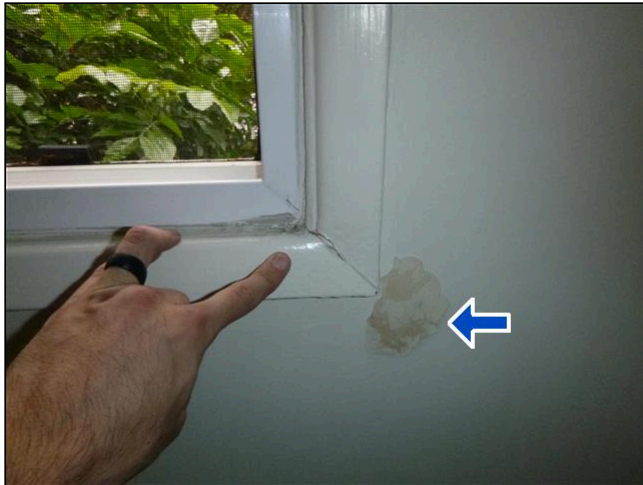
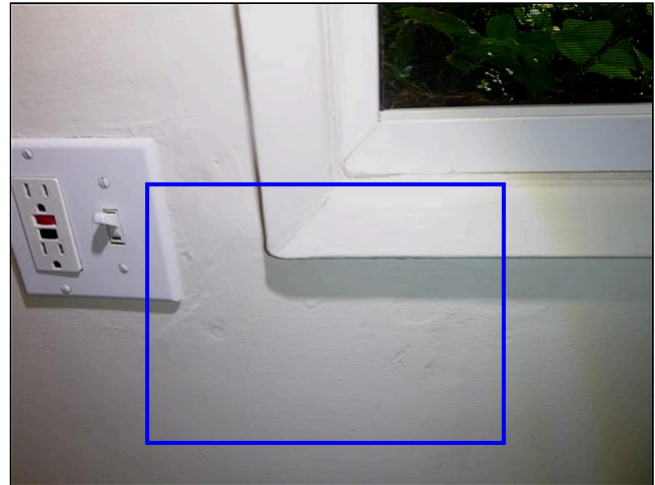
Stains, deterioration and water damage noted at the walls near the window. Suggest review of the exterior window comments and review with a licensed contractor for repair/removal/replacement costs as needed.

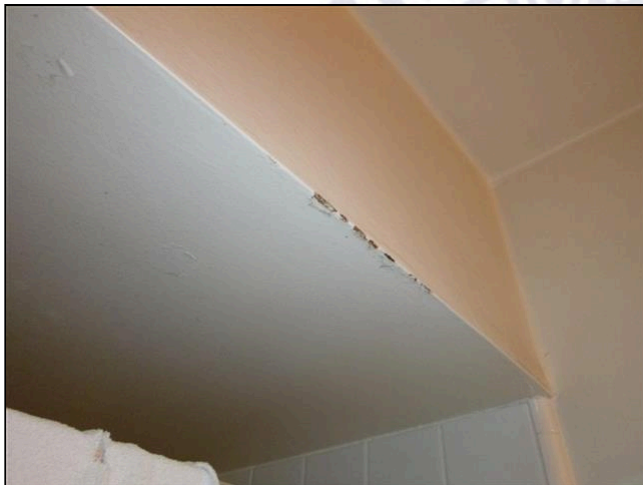
18.2 Item 1 (Picture)

Blistering and deterioration noted at the ceiling due to inadequate ventilation. See the exhaust fan comment and repair/install as needed.

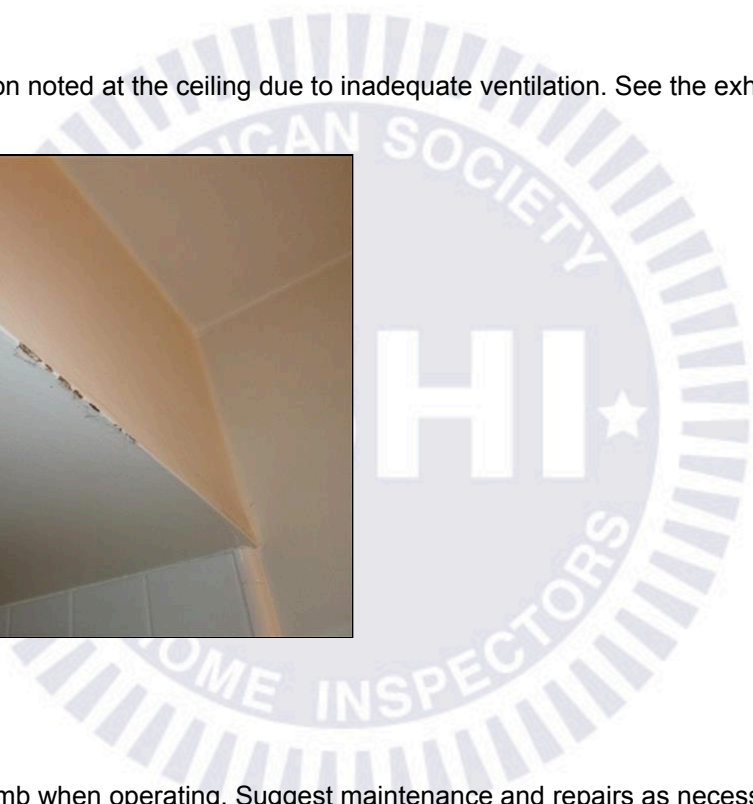
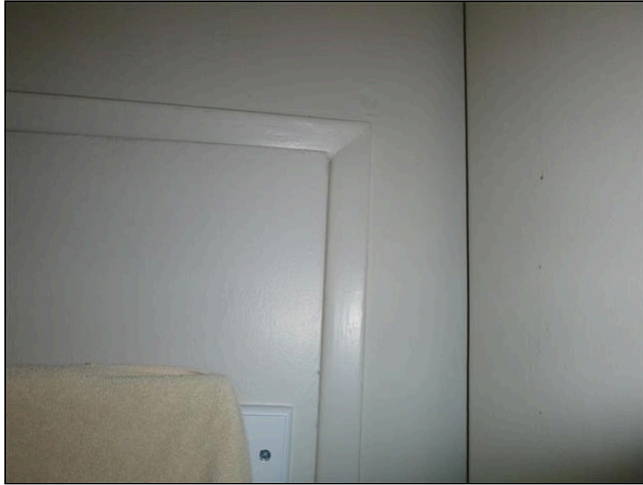
18.3 Item 1 (Picture)

The door sticks on the jamb when operating. Suggest maintenance and repairs as necessary.

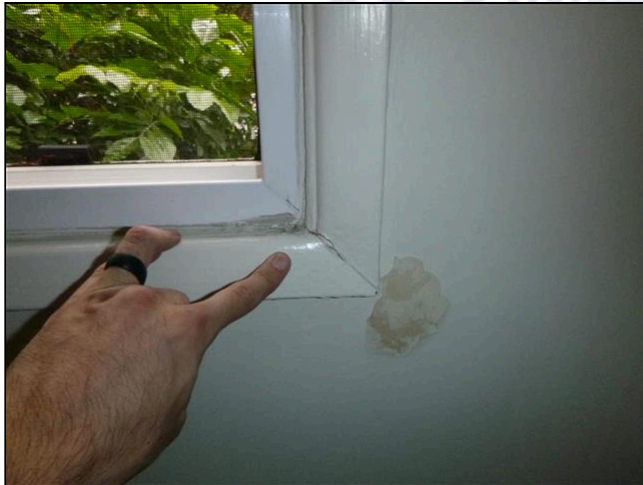
18.4 Item 1 (Picture)

Multiple stains and evidence of on-going leakage at various windows, suggest review with a licensed contractor for repair/replacement costs as needed.

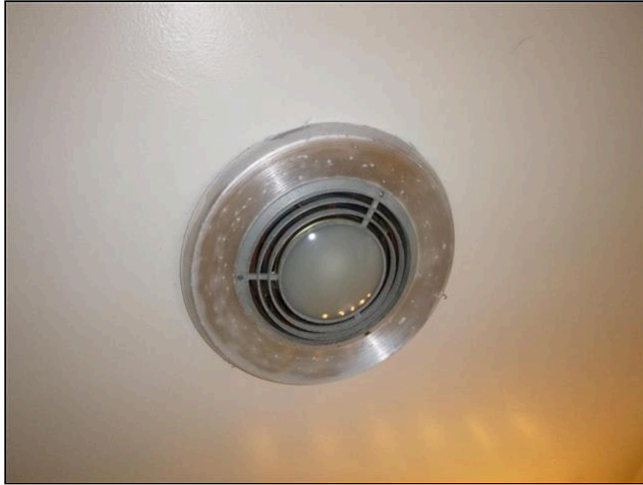
18.6 Item 1 (Picture)

Various light fixtures were inoperable, possible bulbs out. Suggest replacing the bulbs as needed.

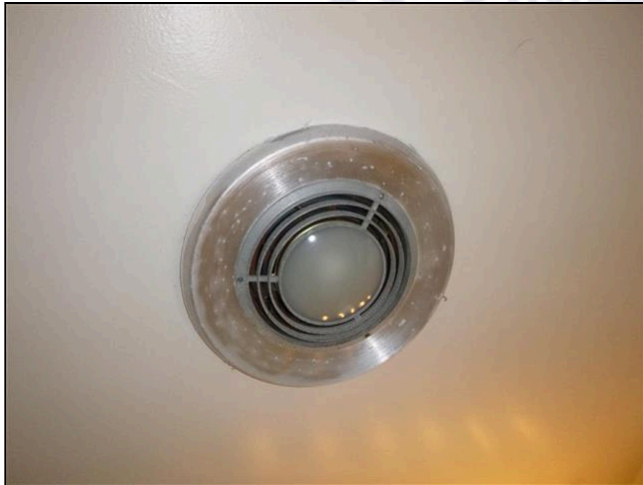
18.7 Item 1 (Picture)

(1) The exhaust vent is inoperable, suggest review with a licensed contractor for repair/replacement costs as required for ventilation at this area.

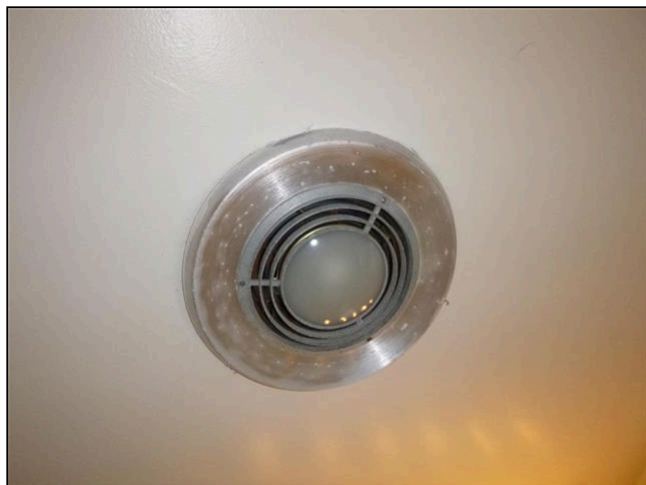
18.8 Item 1 (Picture)

The ceiling heat coil system was inoperable at the time of the inspection, suggest repair/replace as needed.

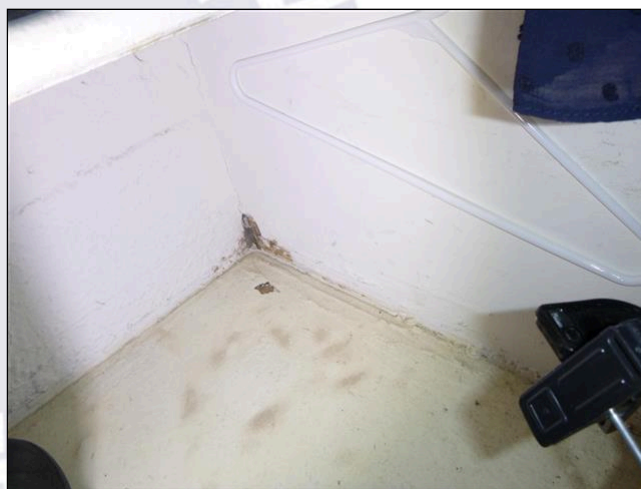
18.9 Item 2 (Picture)

Suggest caulking or re-grout as needed. The edges of the tub walls should be caulked to prevent moisture penetration. Failure to keep walls sealed can cause deterioration and extensive moisture damage to the interior walls, which is not always visible. However, water damage/deterioration was noted in the master bedroom's closet which is directly behind the shower/tub area which indicates that there is likely leakage from this shower/tub enclosure. Suggest review with a licensed contractor to verify/confirm and for removal/repair/replacement costs as needed.

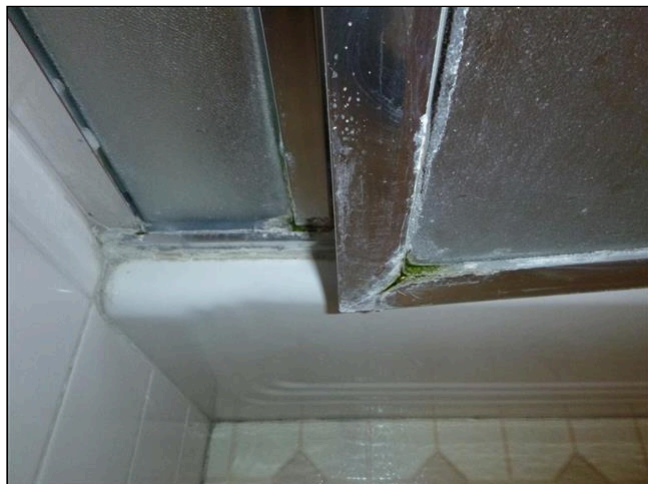
18.12 Item 1 (Picture)

Excessive corrosion was noted at the shower enclosure, suggest repair/replace as needed.

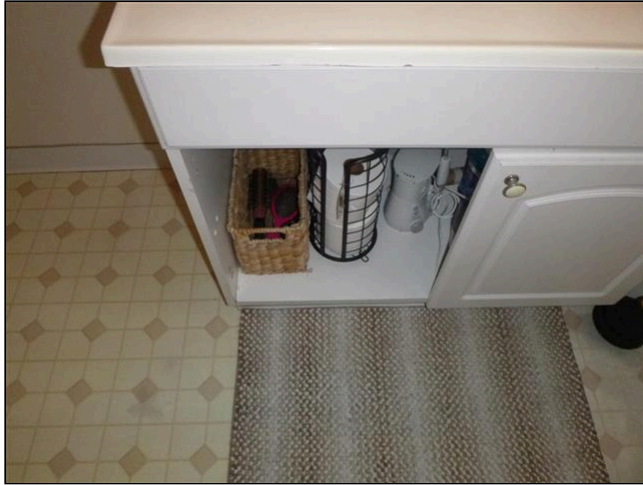
18.18 Item 1 (Picture)

A cabinet door is damaged/missing. Suggest repair/replace as needed.

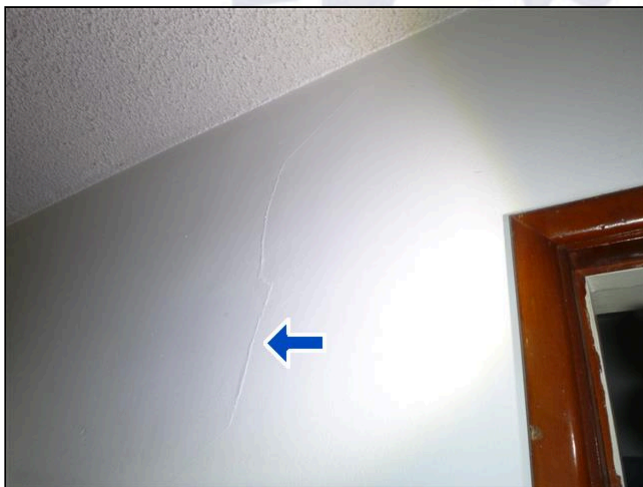
19.1 Item 1 (Picture)

- (1) Excessive settling cracks noted, see the foundation and Lot/Drainage comments. Suggest review with a licensed contractor for repair/replacement costs as needed.

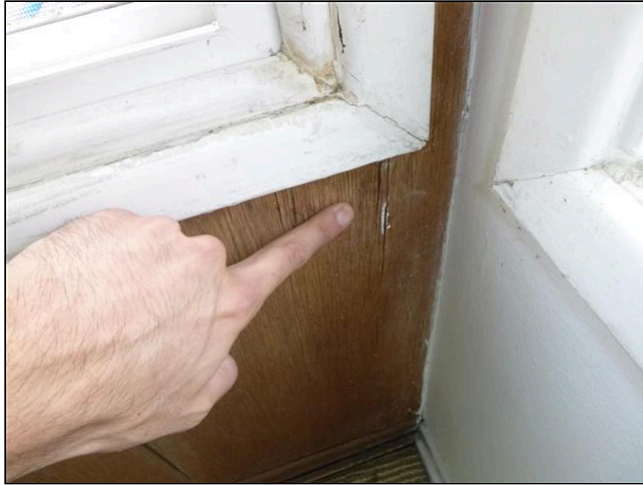
19.1 Item 2 (Picture)

- (2) Stains, deterioration and water damage noted at the walls near the window. Suggest review of the exterior window comments and review with a licensed contractor for repair/removal/replacement costs as needed.

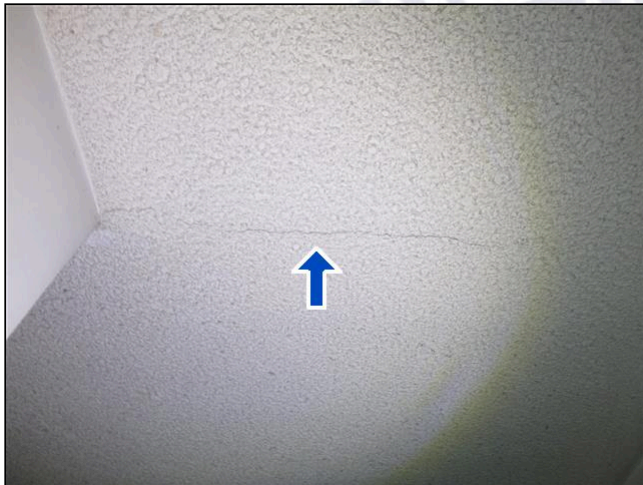
19.2 Item 1 (Picture)

Settling cracks and patching was noted, suggest repair as needed.

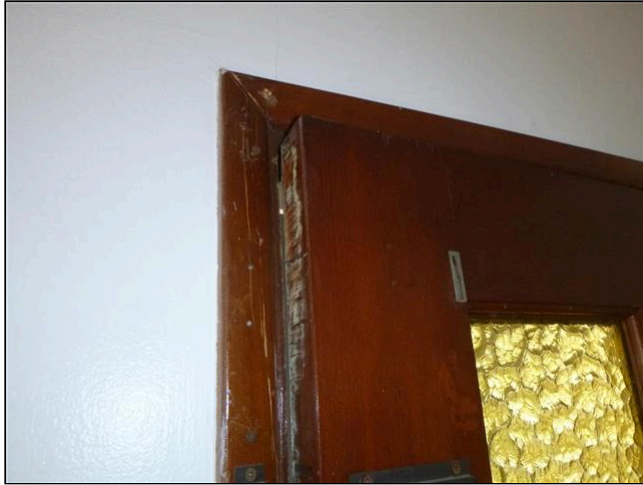
19.3 Item 1 (Picture)

(1) The door sticks on the jamb when operating. Suggest maintenance and repairs as necessary.

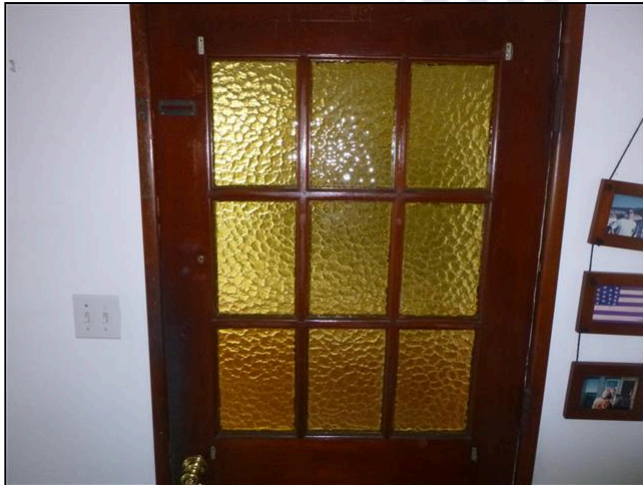
19.3 Item 2 (Picture)

(2) Unable to determine if tempered glass is installed at the window/door glass at this area (no labelling/etching is visible). Windows and doors with glass 18 inches off the floor area or windows within doors should have safety glass. Suggest review of these areas for possible costs to upgrade for safety.

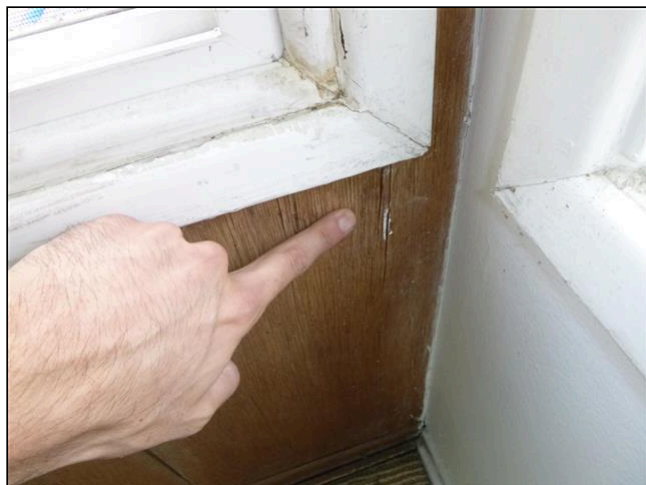
19.4 Item 1 (Picture)

Multiple stains and evidence of on-going leakage at various windows, suggest review with a licensed contractor for repair/replacement costs as needed.

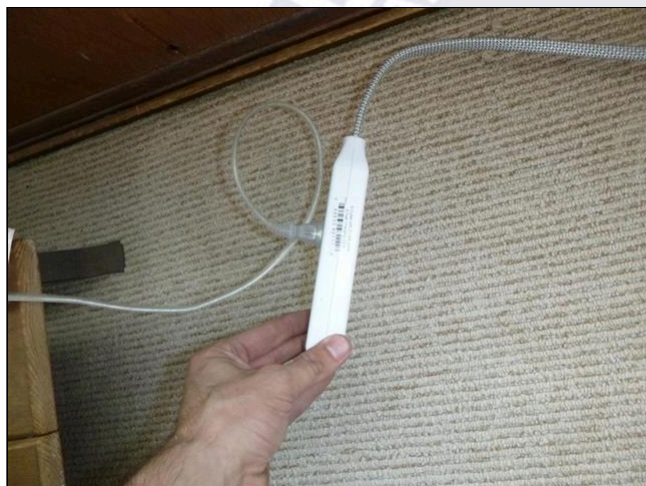
19.6 Item 1 (Picture)

(2) Excessive use of electrical plugs strips/extension cords used at this area, this is a potential fire safety hazard. Suggest review with a licensed electrician for additional electrical circuits/outlets costs as needed for safety.

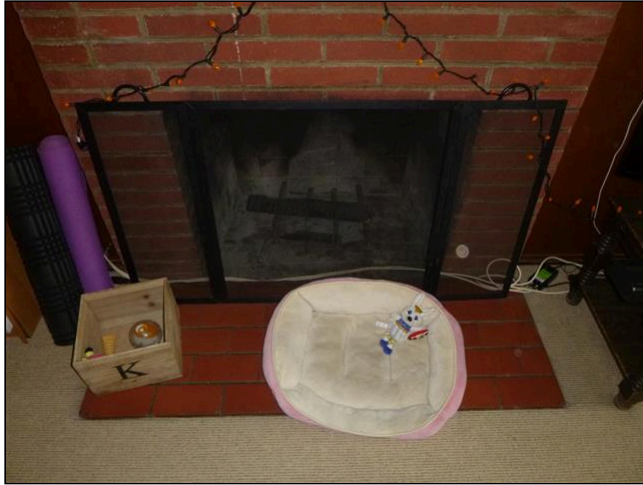
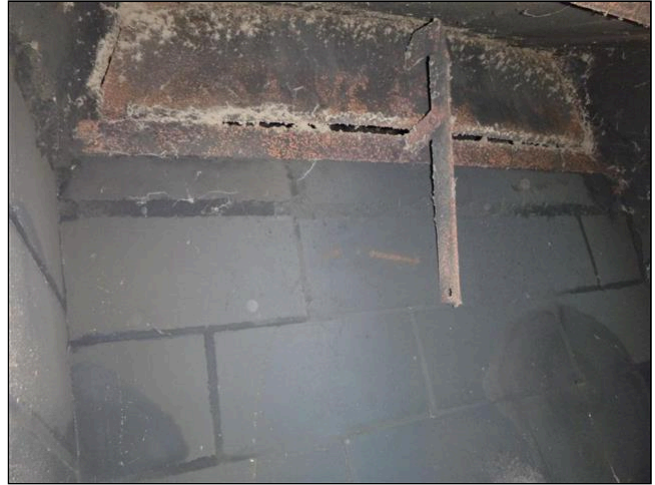
(1) Excessive creosote noted within the firebox, smoke chamber or chimney areas. Creosote build-up can cause chimney fires if not removed from voids, open seams or open mortar joints within the fireplace and chimney. This inspection is a 'Level 1' inspection and is limited to visible and accessible areas only. 'Level 2' and 'Level 3' inspections are invasive inspections performed by qualified personnel only with equipment designed for fireplace/chimney inspections, cleaning or repairs. Suggest periodic cleaning of the fireplace/chimney and remove the creosote and debris within the fireplace and chimney. Suggest review by a professional chimney sweep for estimates, repairs or cleaning.

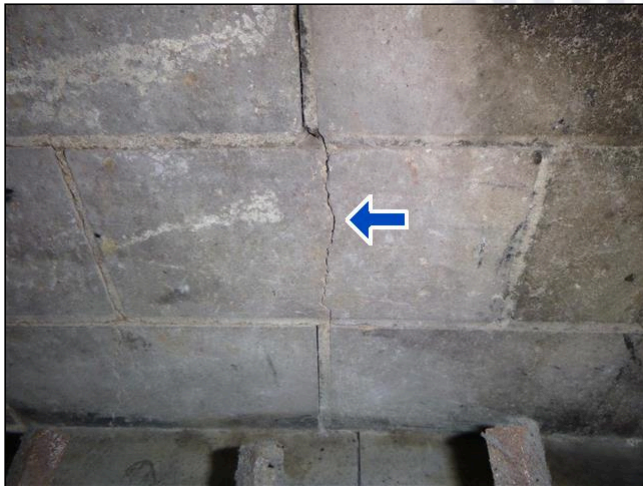
19.7 Item 3 (Picture)

(2) Surface cracks noted at the rear firebrick, suggest review with a licensed chimney sweep/contractor for repairs/ replacement as needed.

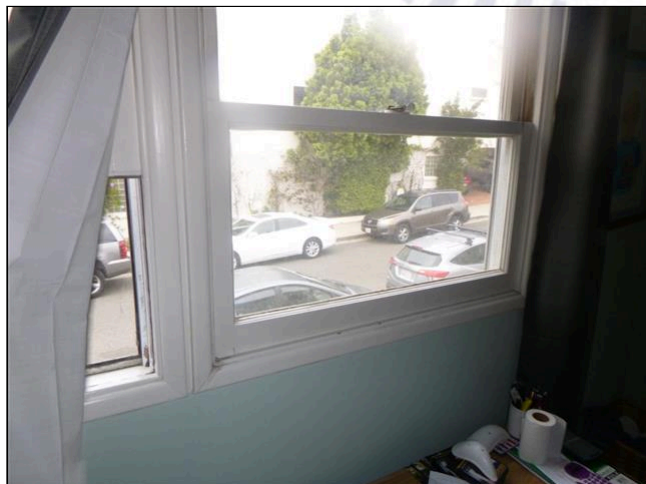
22.4 Item 1 (Picture)

(1) The windows are difficult to operate, suggest repair/replacement as needed/required to allow for emergency exit/egress and ventilation.

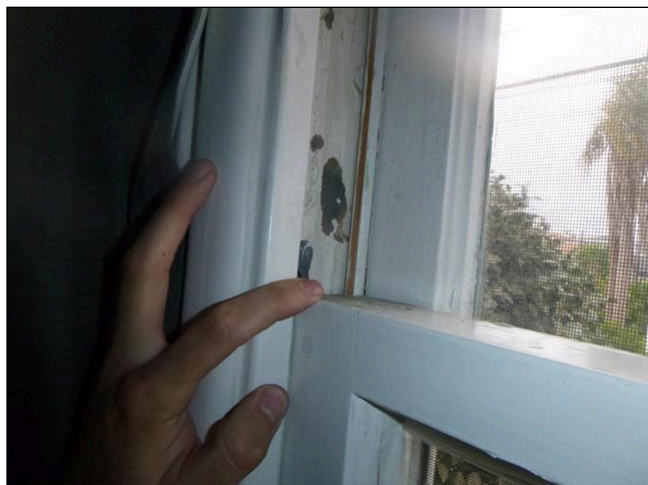
22.4 Item 2 (Picture)

(2) Broken sash/wire/cord noted on the window frame(s), this is a possible safety concern as the sash/wire/cord

should hold the window in an open position. Suggest review with a licensed contractor for repair/replacement costs and confirm correct operation as needed.

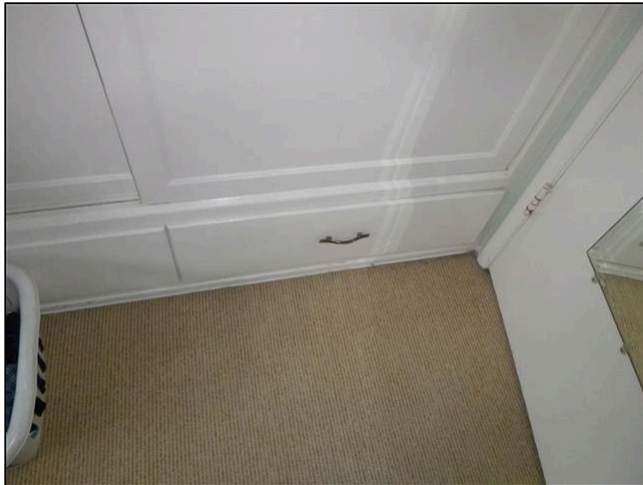
22.7 Item 1 (Picture)

Minor deterioration and worn/stuck areas noted at various cabinets, suggest repair/replace as needed.

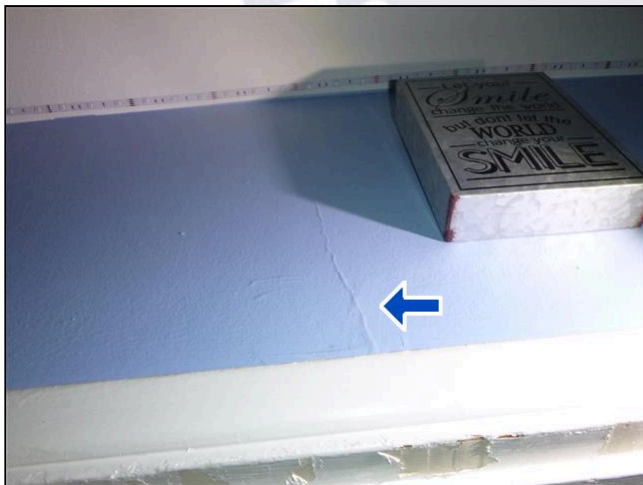
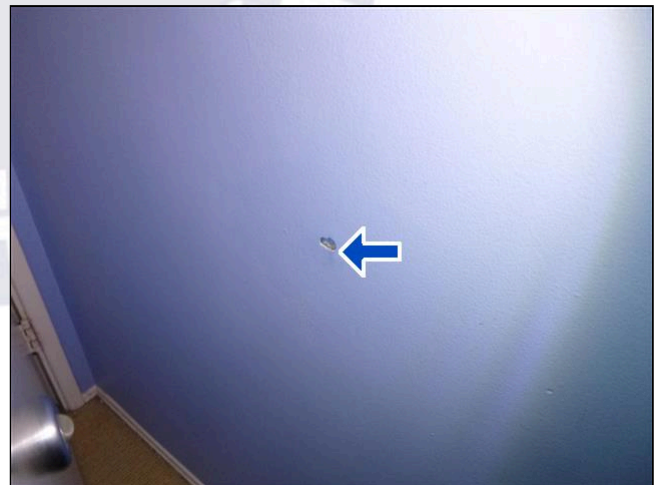
Settling cracks and minor damage was noted, suggest repair as needed.

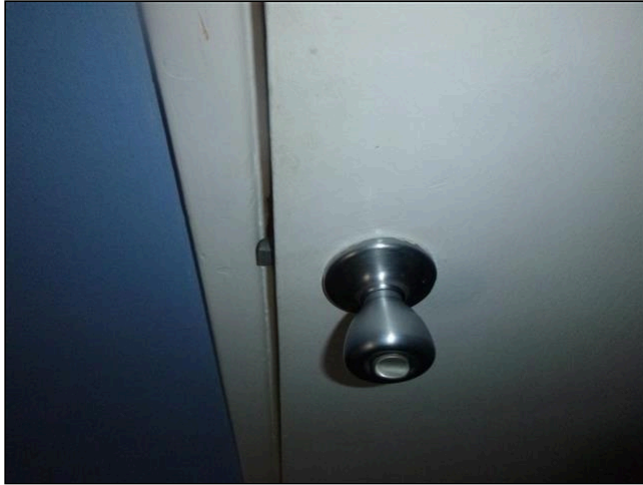
23.3 Item 1 (Picture)

The door will not close and latch correctly, suggest repair as needed.

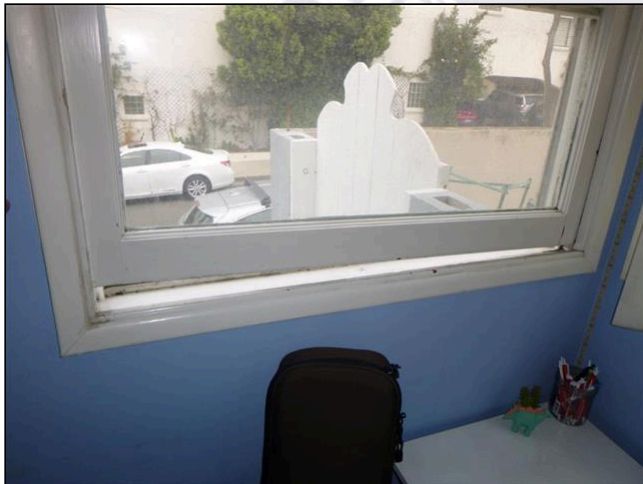
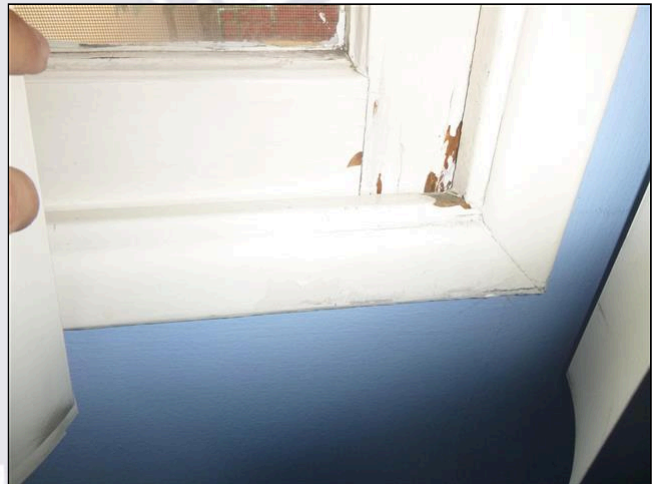
(1) The windows are difficult to operate, suggest repair/replacement as needed/required to allow for emergency exit/egress and ventilation.

(2) The wood windows are deteriorated and are slanted/off track in the frame, suggest review with a licensed contractor for repair/replacement costs as needed.

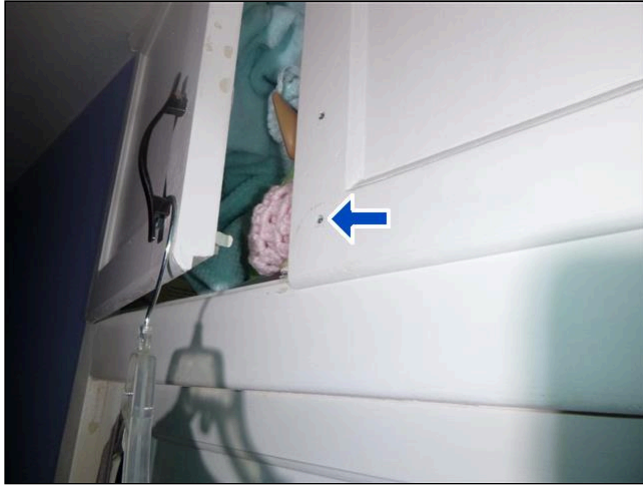
23.7 Item 1 (Picture)

The door pull(s) are missing. Suggest repair/replace as needed.

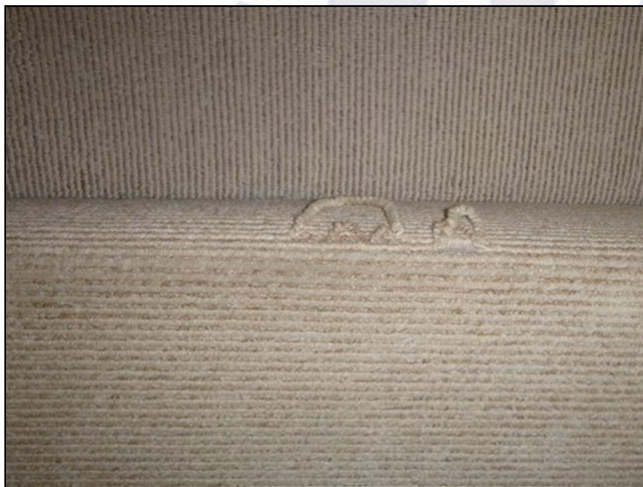
24.0 Item 1 (Picture)

Deteriorated areas were noted at the carpet, suggest repairs as needed.

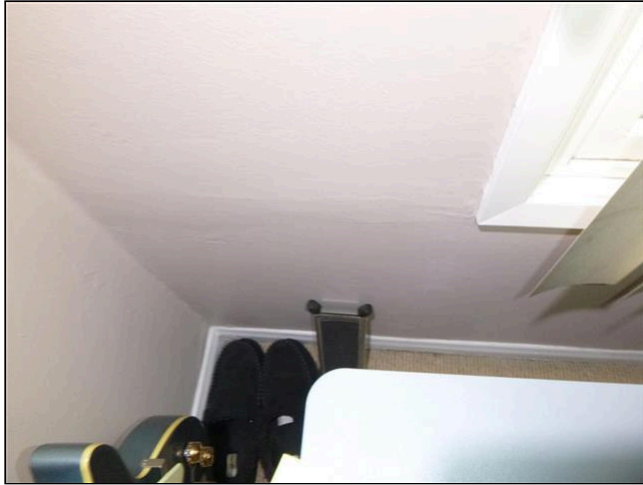
24.1 Item 1 (Picture)

(1) Settling cracks and patching was noted, suggest repair as needed.

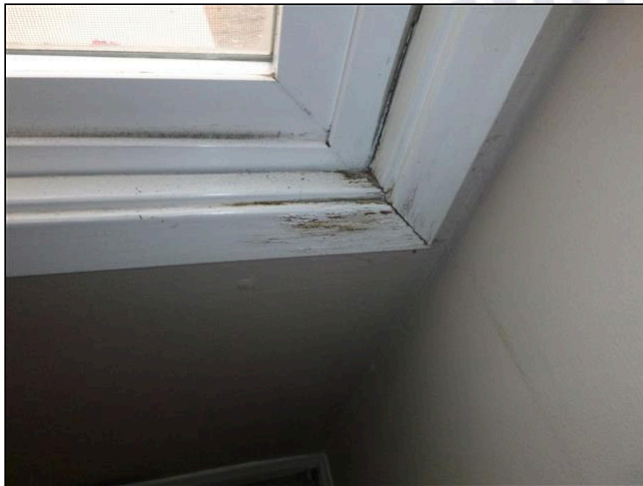
24.1 Item 2 (Picture)

(2) Stains, deterioration and water damage noted at the walls near the window. Suggest review of the exterior window comments and review with a licensed contractor for repair/removal/replacement costs as needed.

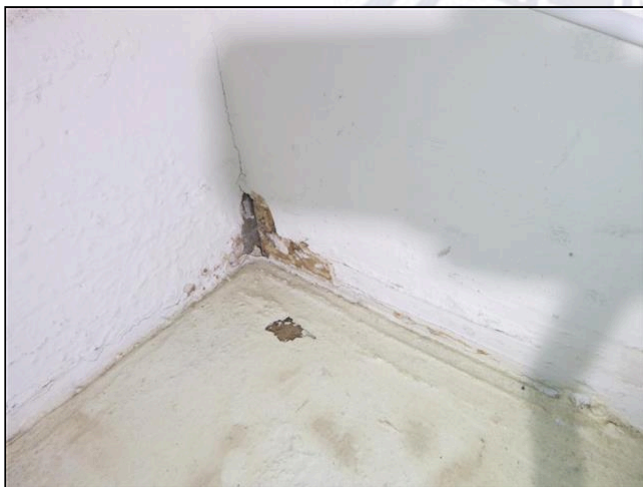
24.1 Item 3 (Picture)

(3) Water damage was noted at the walls in the closet that is adjacent to the master bathroom shower area. Suggest review of the master bathroom comments and review with a licensed contractor for repair/removal/replacement costs as needed.
