Inspection Report

Property Address:
1931 Ruhland Ave
Redondo Beach CA 90278

Professional Inspection Network

Property Address 1931 Ruhland Ave Redondo Beach CA 90278	Date of Inspection 2/15/2023	Report ID 20230215-1931-Ruhland-Ave
Customer(s) Sanjeev Bhatia	Time of Inspection 09:00 AM	Real Estate Agent Linda Hernandez Shorewood Realtors

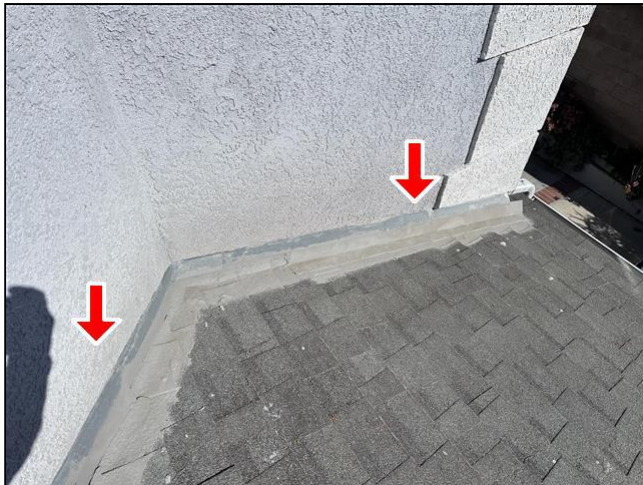
Item 1 - Item 1(Picture) Roofing

1. (1) **Major Concern:** The patching or repairs performed on this roof appear to have been done by a non-professional. They are not in accordance with industry standards are likely to leak or require ongoing maintenance. We suggest that the entire roof should be evaluated by a qualified roofer and repaired or replaced as necessary.

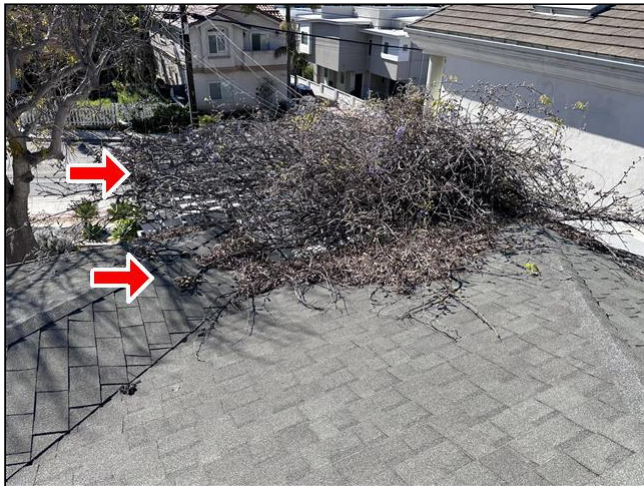
Item 2 - Item 1(Picture) Roofing

2. (3) **Improve:** It is suggested that all trees, tree limbs and vegetation in contact with the home be removed and/or trimmed away from the home to prevent damage and rodent activity.

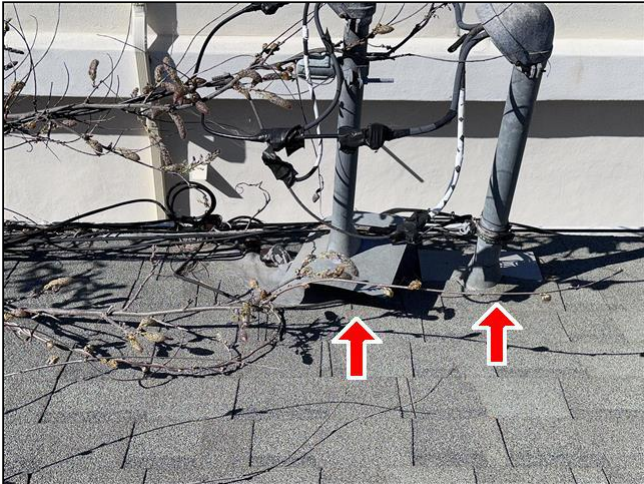
Item 4 - Item 1(Picture) Roofing

4. (1) **Repair or Replace:** The flashing for the main electrical service conduits at the front slope of the roof are surface mounted and/or not installed in accordance to industry standards. The flashings are improperly installed. This can allow leaks. We suggest a qualified roofer should make repairs or modifications as necessary.

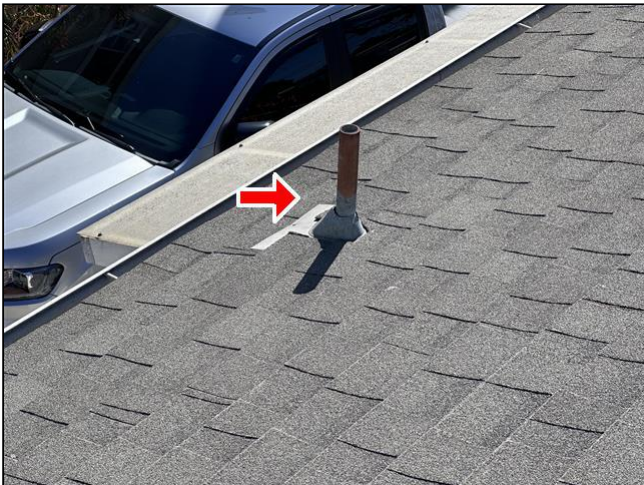
Item 5 - Item 1(Picture) Roofing

5. (2) **Repair or Replace:** The mastic at the front East slope of the roof vent penetration is missing. It is suggested that all vent and penetrations be examined and sealed with approved material by a qualified professional.

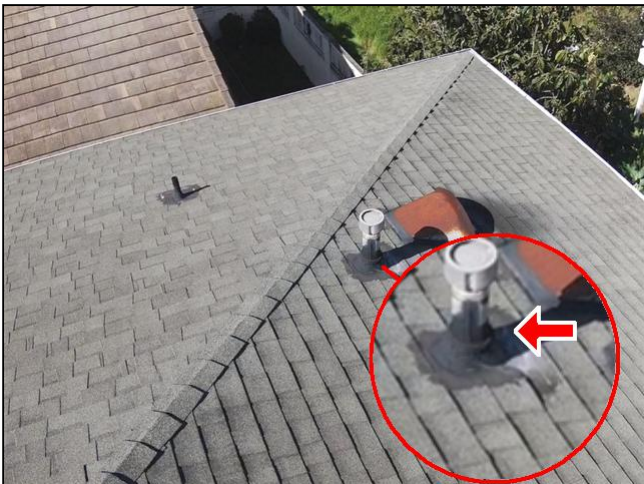
Item 6 - Item 1(Picture) Roofing

6. (3) **Repair or Replace:** The mastic at the **rear unit** heater metal vent penetration is missing. Also, the exhaust vent lacks a storm collar. It is suggested that all vent and penetrations be examined and sealed with approved material by a qualified professional.

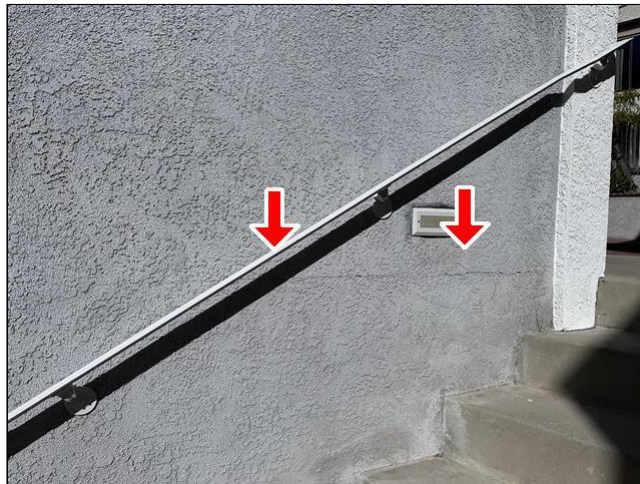
Item 7 - Item 2(Picture) Exterior

7. (1) **Repair/Replace/Monitor:** Visible cracking in the stucco cladding was observed at the exterior walls in one or more locations. Cracking in stucco walls happens when there is more stress placed on the wall than the material can withstand. The underlying cause of the hairline wall cracking may be due to problems with the wall's framing, contraction or expansion of wood sheathing, settling, thermal expansion or contraction, rapid changes in temperature, weak areas in the wall or abnormal vibrations in the ground. Suggest further evaluation by a qualified trades person for determination and/or corrective repairs within the inspection contingency period.

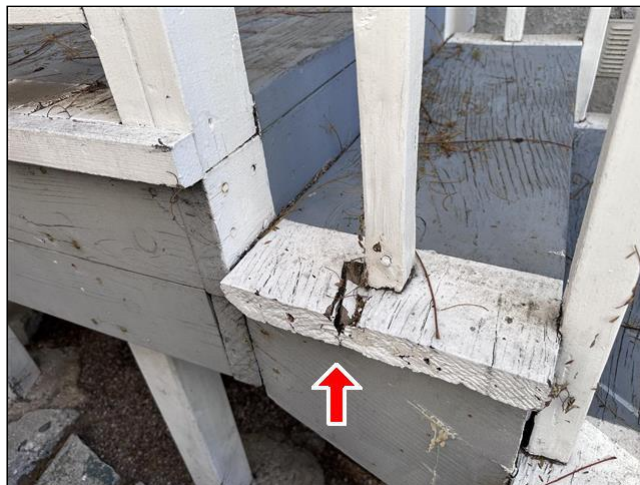
Item 8 - Item 2(Picture) Exterior

8. (2) **Repair or Replace:** Wood deterioration was observed at the West exterior wall **front unit** stairway/steps. If the home inspection reveals signs of damage you should have a pest control company inspect further for activity and possible hidden damage. Suggest repair/replacement of all deteriorated wood by a licensed contractor.

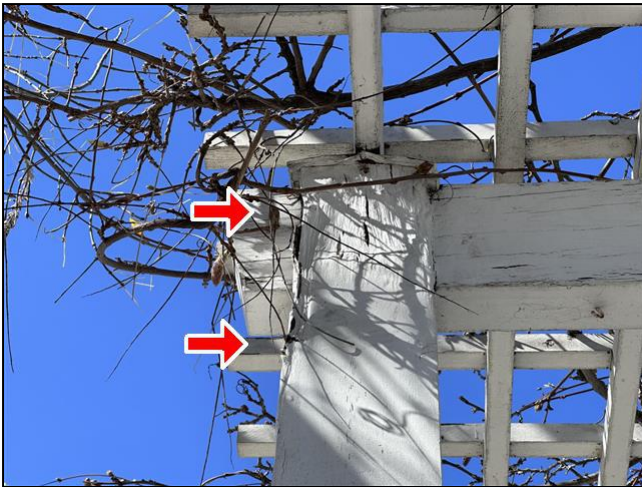
Item 9 - Item 1(Picture) Exterior

9. (3) **Repair or Replace:** Wood deterioration was observed at the front exterior wall **front unit** deck covering. If the home inspection reveals signs of damage you should have a pest control company inspect further for activity and possible hidden damage. Suggest repair/replacement of all deteriorated wood by a licensed contractor.

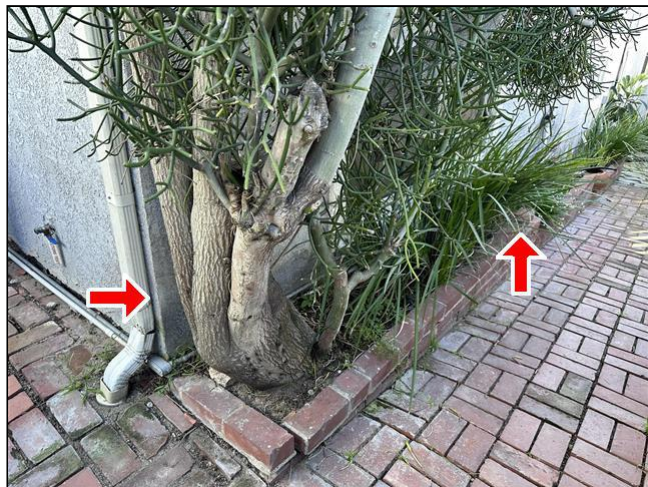
Item 13 - Item 2(Picture) Exterior

13. (7) **Improve:** It is suggested that all trees, tree limbs and vegetation in contact with the home be removed and/or trimmed away from the home to prevent damage and rodent activity.

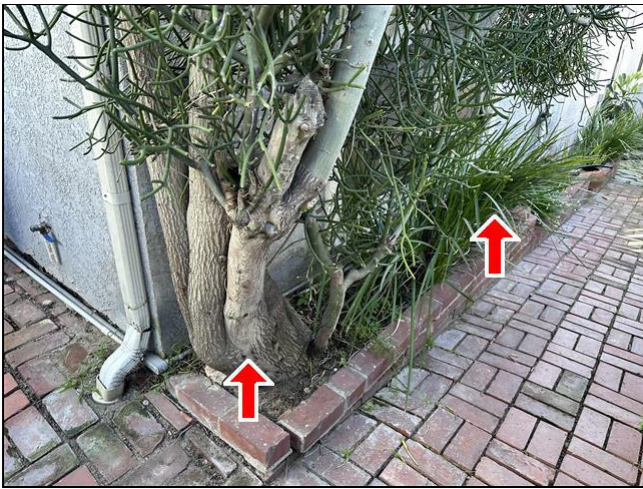
Item 14 - Item 1(Picture) Exterior

14. (8) **Improve:** The metal weep screed flashing at the rear exterior wall is covered and or does not have the required clearances from the ground. The weep screed should be placed a minimum of 4 inches above the earth, or 2 inches above paved areas, and should be of a type that will allow trapped water to drain to the exterior of the building. Suggest

removal of the soil these locations to prevent water damage and or moisture intrusion.

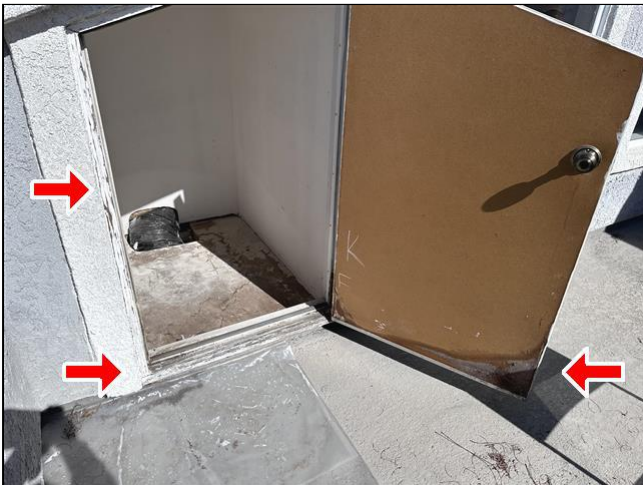
Item 15 - Item 1(Picture) Exterior

- 15. Major Concern:** Water damage was observed at the **rear unit** rooftop deck storage door, frame and interior closet area. The door is in this location is not ideal for exterior use. Areas of past and present moisture are favorable for growing many fungal like organisms. There is an extra risk of hidden damage/fungus/mold to be present in this location. The identification of molds, fungus and other microbial organisms is outside the scope of this inspection. We suggest a qualified environmental specialist should be retained to evaluate the surfaces and make further recommendations. Testing and remediation of mold growth can only be accomplished by a qualified environmental specialist. If strict protocol is not followed, spores can be released into the interior of the building and may create a health hazard for those with low tolerances to such organisms. Suggest repair/replacement by a qualified professional.

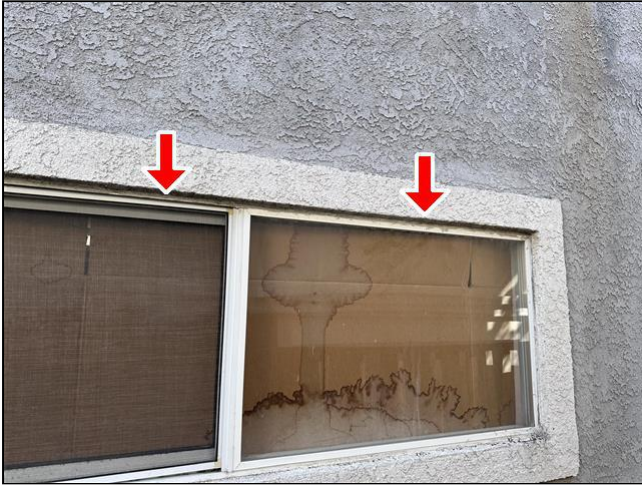
Item 16 - Item 1(Picture) Exterior

- 16. Repair/Replace/Monitor:** The rear West exterior wall window frame is covered with silicone in one or more locations. This is an indication of a past problem and note that these areas could not be properly viewed and will require ongoing maintenance. Inquire with the seller for more information Leaks can be difficult to repair, as the source of the leakage can be far removed from the water stain that shows up on the interior.

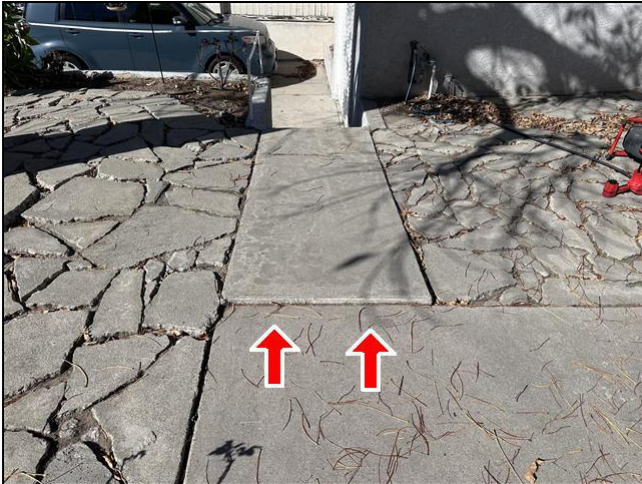
Item 17 - Item 1(Picture) Exterior

17. (1) **Safety Issue:** The uneven concrete walkway at the front area of the subject property poses a trip hazard. Suggest repair by a qualified professional.

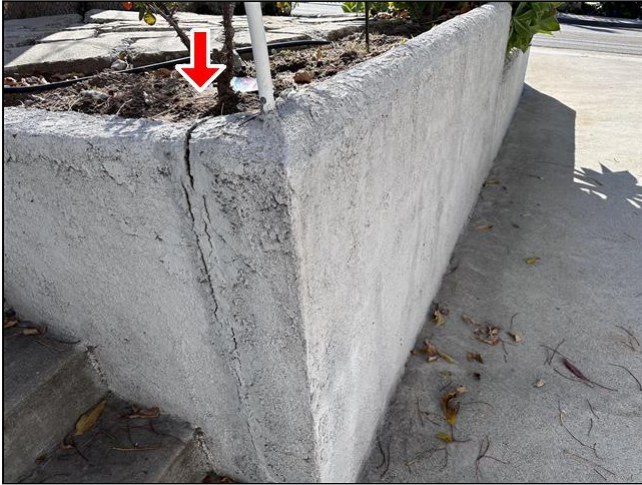
Item 18 - Item 1(Picture) Exterior

18. (2) **Repair/Replace/Monitor:** The retaining wall(s) at the front area of the subject property is cracked and shows signs of movement. Unable to determine the rate of movement during a one time visit to the subject property. The evaluation of soil conditions and/or retaining wall stability is not within the scope of this inspection. For information on soil and retaining wall stability and/or the potential for movement, we recommend that you determine if the owners have information on the soils condition, or contact a qualified geotechnical engineer who is familiar with conditions in this area.

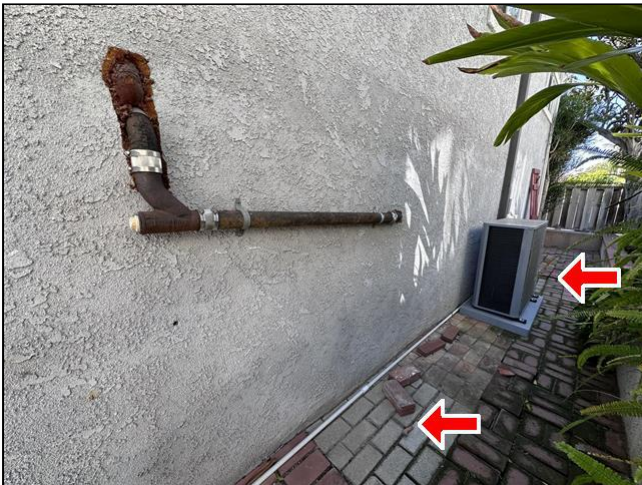
Item 19 - Item 1(Picture) Exterior

19. (3) **Repair or Replace:** There is a negative slope towards the building at the rear wall which will cause water to pond during rain or extended irrigation. This configuration can cause or contribute to water intrusion or deterioration of the foundation. Standing water can be detrimental to the integrity of the foundation of the house. It is important to prevent or minimize standing water around the house. Recommend further evaluation by a qualified grading contractor to determine corrections needed.

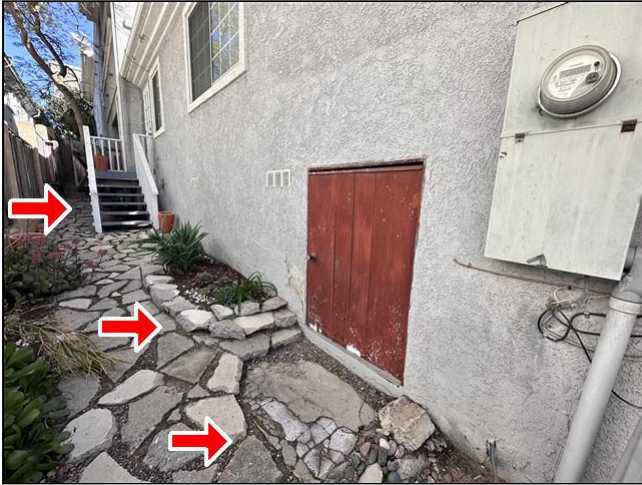
Item 20 - Item 1(Picture) Exterior

20. (4) **Repair or Replace:** There is a negative slope towards the building at the West exterior wall which will cause water to pond during rain or extended irrigation. This configuration can cause or contribute to water intrusion or deterioration of the foundation. Standing water can be detrimental to the integrity of the foundation of the house. It is important to prevent or minimize standing water around the house. Recommend further evaluation by a qualified grading contractor to determine corrections needed.

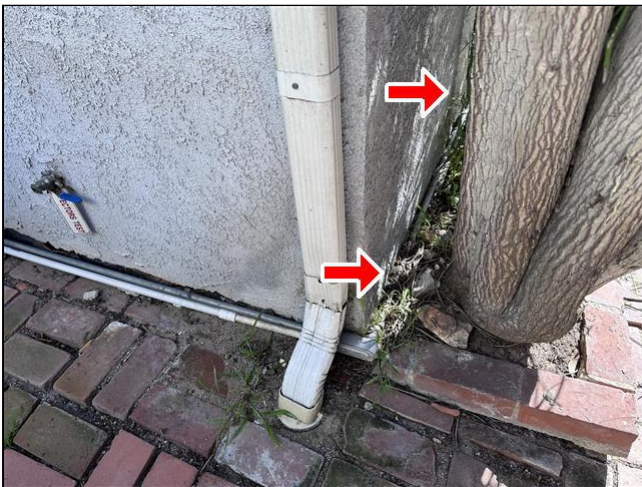
Item 21 - Item 1(Picture) Exterior

21. (5) **Improve/Monitor:** Unable to determine if a moisture barrier has been employed between the soil and exterior wall/foundation at the rear North-West corner of the home. The lack of a moisture barrier can allow to seep into the structure and cause damage. It is strongly advised that these exterior areas be further investigated and corrected by a qualified contractor.

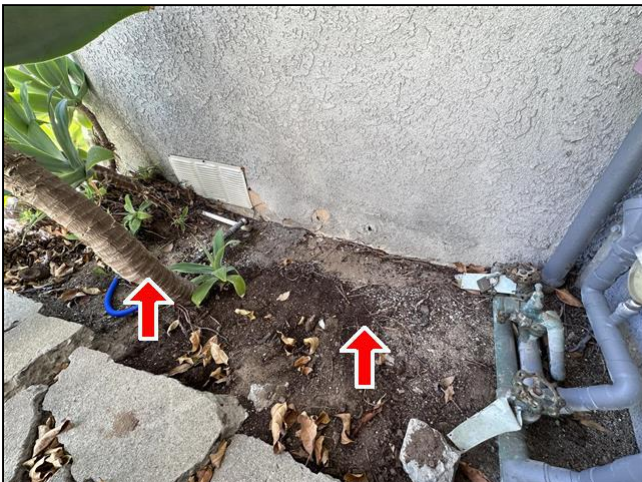
Item 22 - Item 1(Picture) Exterior

22. (6) **Improve/Monitor:** Low/neutral areas were observed at the grading which will cause water to pond during rain or extended irrigation. Standing water can be detrimental to the integrity of the foundation of the house. It is important to prevent or minimize standing water around the house. Recommend further evaluation by a qualified grading contractor to determine corrections needed.

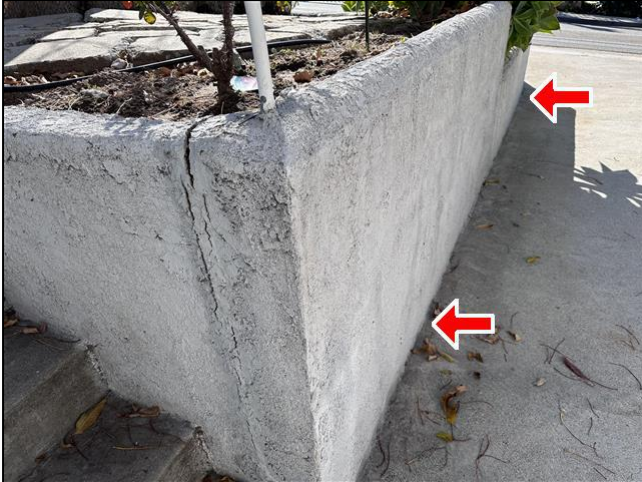
Item 23 - Item 1(Picture) Exterior

23. (7) **Monitor:** Unable to verify adequate drainage for the retaining walls throughout the subject property during the inspection. A retaining wall drainage pipe or toe drain is a pipe with perforations that collects water all along the wall and then drains it to the exterior; either to the sides or through the front of the wall. While tall walls need multiple pipe drains at different heights, most pipe drains are located at the base of the wall, vented every 30 to 50 feet. We suggest asking the current home owner/builder to provide any documents to verify conforming installation of the retaining walls and drainage systems prior to close of escrow to determine if further investigations are required. It is also suggested that all debris be cleared away from the swale. We suggest to keep the exterior moisture to a minimum, exterior surface drainage, including downspout water, should be directed as far away from the building as possible. Landscape watering should always be directed away from the retaining wall and limited to short durations.

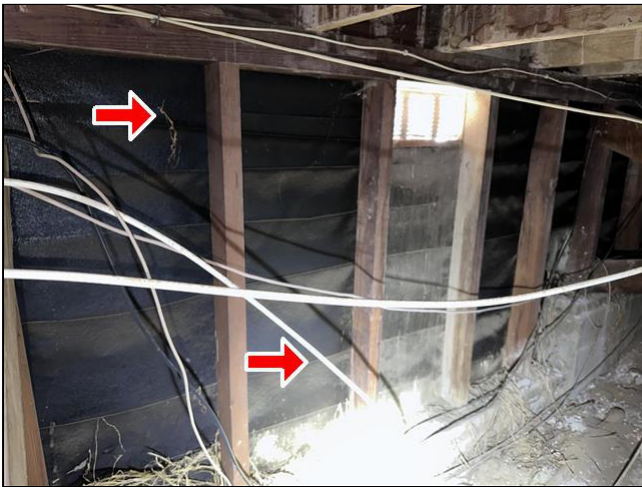
Item 24 - Item 1(Picture) Structural Components

24. (1) **Safety Issue/Repair/Replace:** The cripple walls at the **front unit** have not been reinforced. It is suggested that the foundation be improved/retrofitted with approved structural hardware and cripple walls be reinforced by a qualified professional. The primary purpose of earthquake retrofitting is to keep your home from being displaced from its concrete foundation and cripple walls from movement - making the building safer and less prone to major structural damage during an earthquake. Existing homes need to be retrofitted because our understanding of the effects of earthquakes as well as construction techniques have improved after the homes were built.

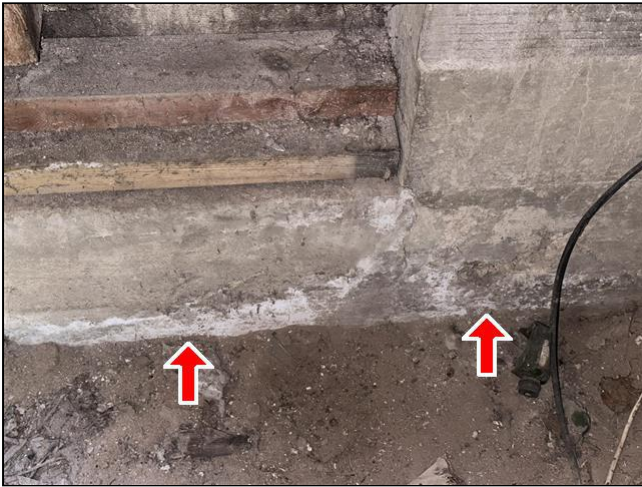
Item 25 - Item 1(Picture) Structural Components
Floors/Columns/Piers

25. (2) **Improve/Monitor:** A condition known as efflorescence is evident on portions of the concrete foundation walls or slab. This whitish, fuzzy material is a mineral deposit left when moisture in the concrete evaporates. The presence of efflorescence often indicates an occasional surplus of moisture on the outside of the foundation. We suggest to keep the exterior moisture to a minimum, exterior surface drainage, including downspout water, should be directed as far away from the building as possible. Landscape watering should always be directed away from the building and limited to short durations.

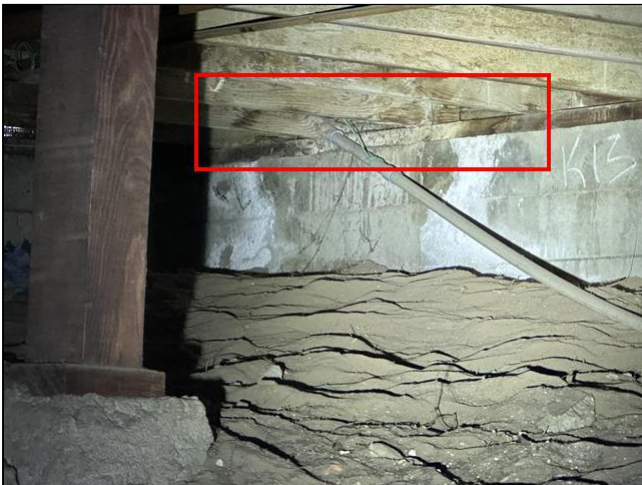
Item 26 - Item 1(Picture) Structural Components

26. (1) **Improve:** Water staining, possible wood deterioration and possible fungus was observed at the **front unit** subfloor and framing in one or more locations. It is suggested that the subfloor below bathrooms be further evaluated by a qualified contractor to determine if wood subfloors or in need of repair and or replacement.

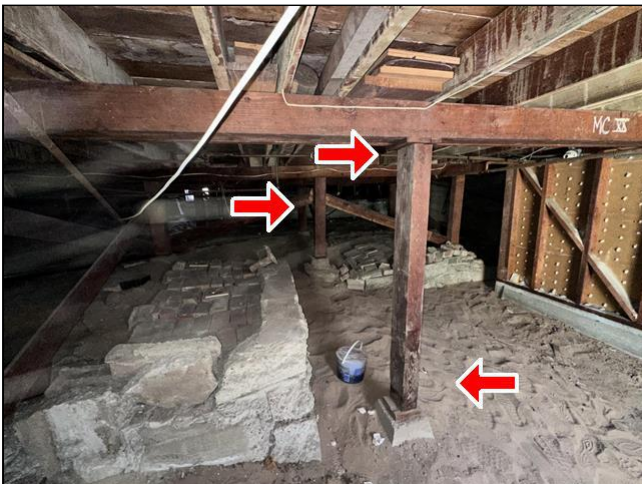
Item 27 - Item 1(Picture) Structural Components

27. (2) **Improve:** The girder and post connections are not reinforced according to modern standard building practice. No adverse effects resulting from this condition are noted. We suggest as an up-grading these connections would be considered optional.

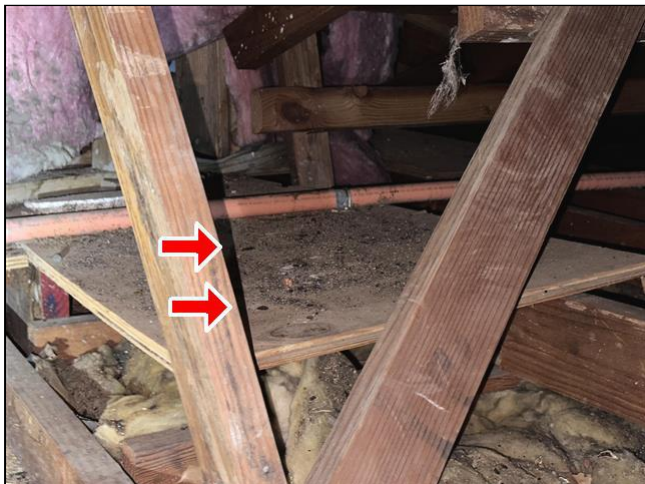
Item 28 - Item 1(Picture) Structural Components

28. (1) **Improve/Safety Issue:** Evidence of rodents was found in the form of feces was observed in the **front unit** attic space of the home. Consult with the property owner about this. A qualified person should make repairs to seal openings in the structure, set traps, and clean rodent waste as necessary. Future costs could be incurred from prior rodent damage not visible at time of inspection.

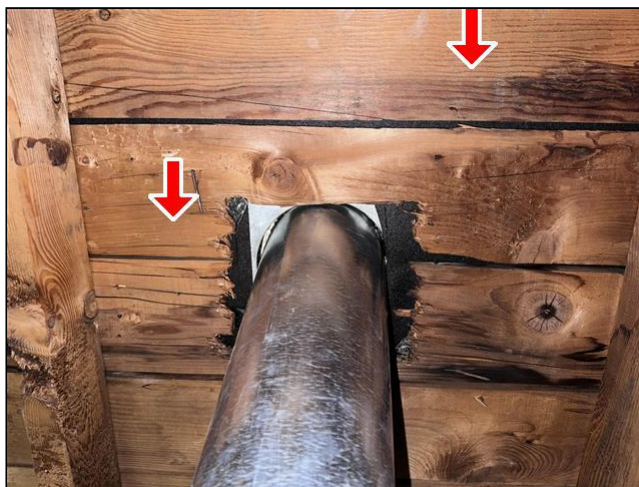
Item 29 - Item 2(Picture) Structural Components

29. (2) **Monitor:** Water staining was observed on the underside of the **front unit** roof sheathing and structure in various locations. We suggest asking the owner to provide you with information about the leak(s), and what corrective action (if any) was taken to repair the leak(s). Then if additional damage develops, the source of the leak(s) should be identified and repairs performed as necessary.

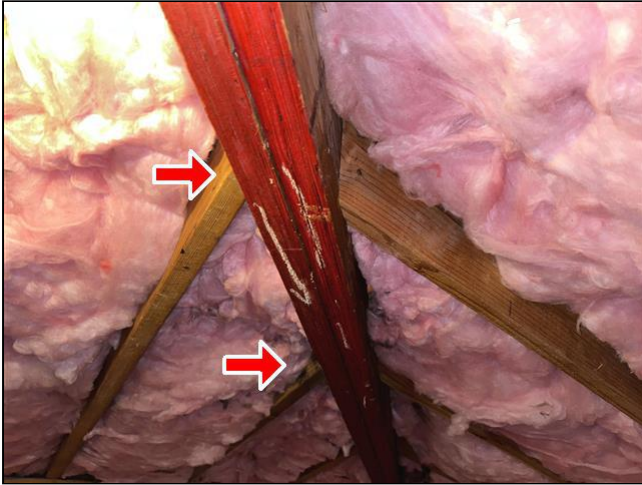
Item 30 - Item 1(Picture) Structural Components

30. (3) **Repair or Replace:** Signs of possible wood deterioration was observed at the **rear unit** roofing structure. If the home inspection reveals signs of damage you should have a pest control company inspect further for activity and possible hidden damage. Suggest repair/replacement of all deteriorated wood by a licensed contractor.

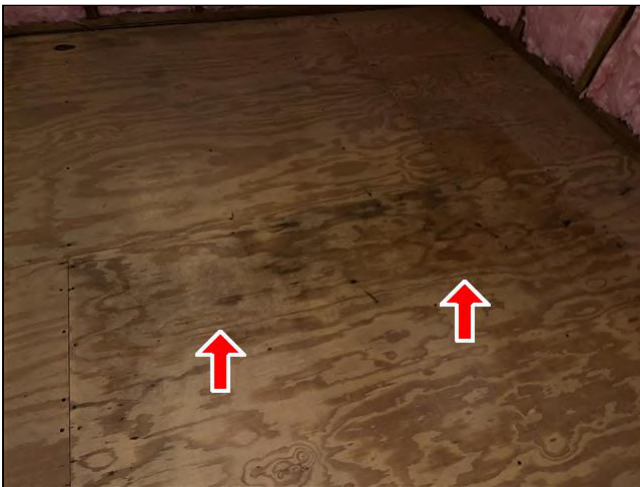
Item 31 - Item 1(Picture) Structural Components

31. (4) **Monitor:** Water staining was observed at the **rear unit** attic space platform and roof structure. We suggest asking the owner to provide you with information about the leak(s), and what corrective action (if any) was taken to repair the leak(s). Then if additional damage develops, the source of the leak(s) should be identified and repairs performed as necessary.

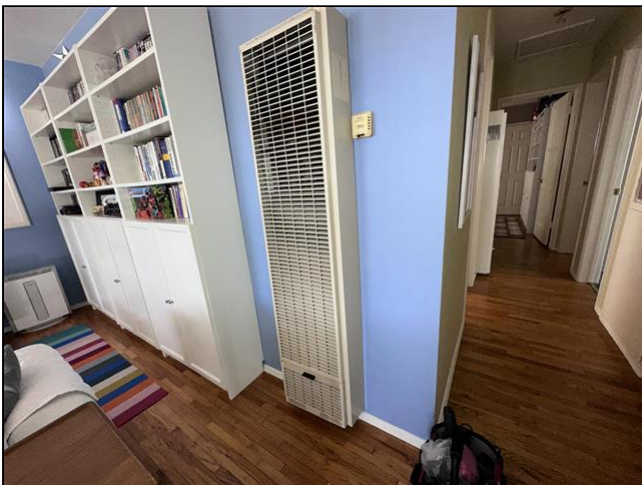
Item 32 - Item 1(Picture) Heating/Central Air

32. (1) **Repair/Replace/Monitor:** The **front unit** wall heater is at or approaching the end of its service life. The wall heater is 30+ years old. The wall heater can fail at any time. Eventual replacement of this system should be anticipated. - A qualified HVAC contractor can inspect the system and provide you with replacement options and costs.

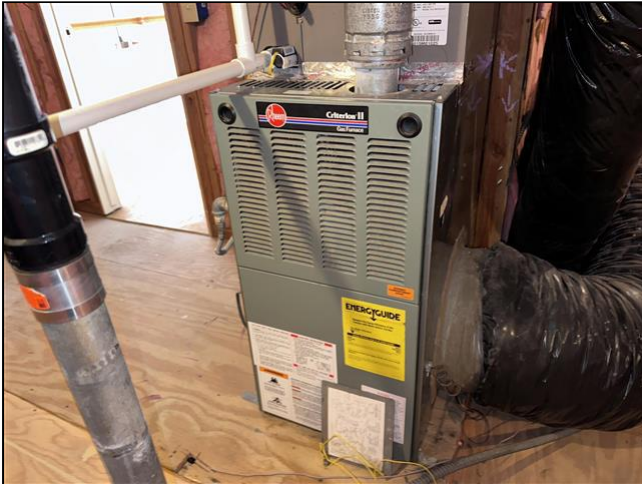
Item 33 - Item 1(Picture) Heating/Central Air
Flues and Vents (for gas heating systems)

33. (2) **Repair/Replace/Monitor:** The **rear unit** forced air heater is at or approaching the end of its service life. The wall heater is 20+ years old. The wall heater can fail at any time. Eventual replacement of this system should be anticipated.
 - A qualified HVAC contractor can inspect the system and provide you with replacement options and costs.

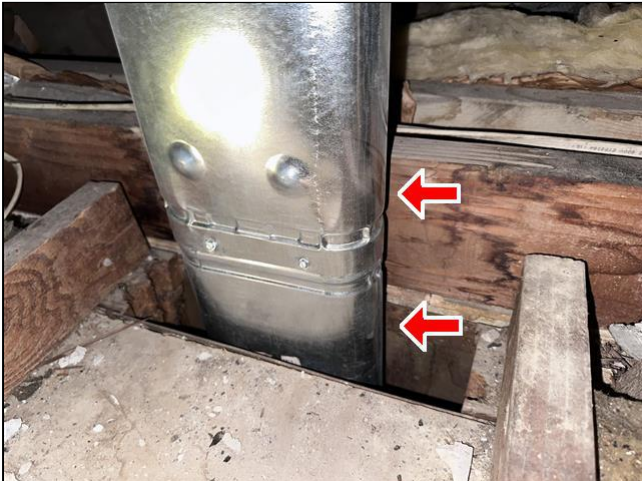
Item 34 - Item 1(Picture) Heating/Central Air

34. (1) **Safety Issue:** The **front unit** wall heater metal exhaust vent does not have safe clearance from combustible material. The metal vent is in contact with the underside of the roof sheathing and wall frame. Suggest further review and conforming installation by a licensed HVAC contractor.

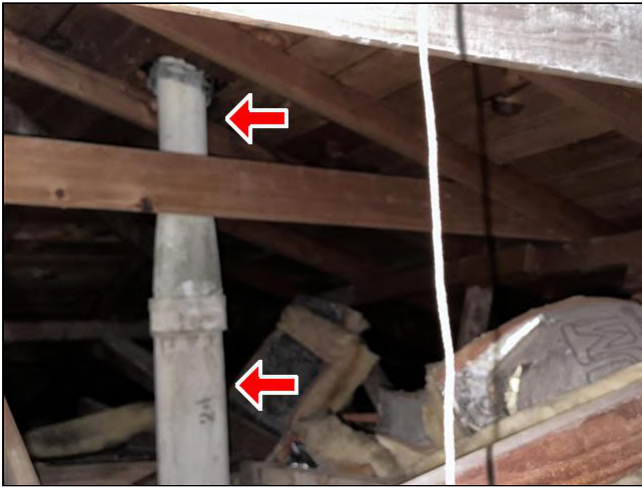
Item 35 - Item 1(Picture) Heating/Central Air Cooling and Air Handler Equipment

35. (2) **Monitor:** The older ceramic exhaust flue at the **front unit** living room wall heater may contain Asbestos. This can only be verified by laboratory analysis. The Environmental Protection Agency (E.P.A.) reports that asbestos represents a health hazard if "friable" (damaged, crumbling, or in any state that allows the release of fibers). Suggest further review, testing and removal by a qualified professional.

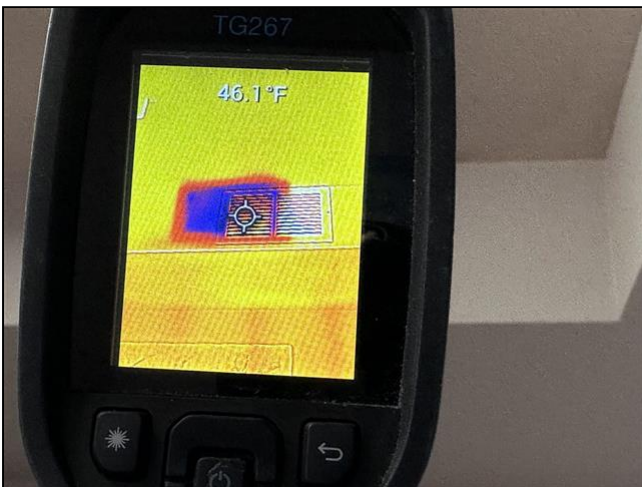
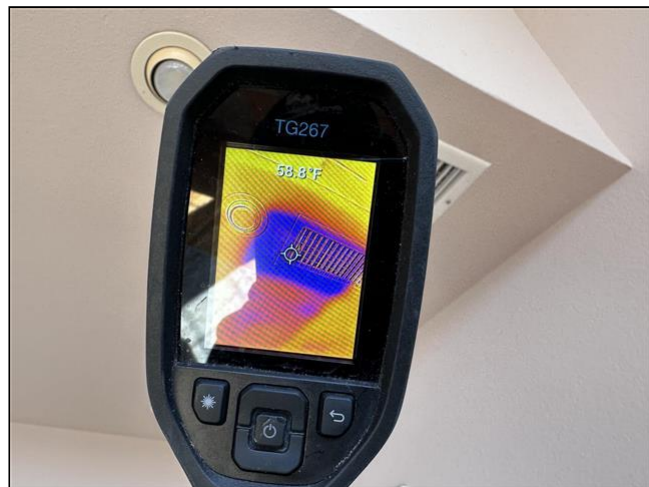
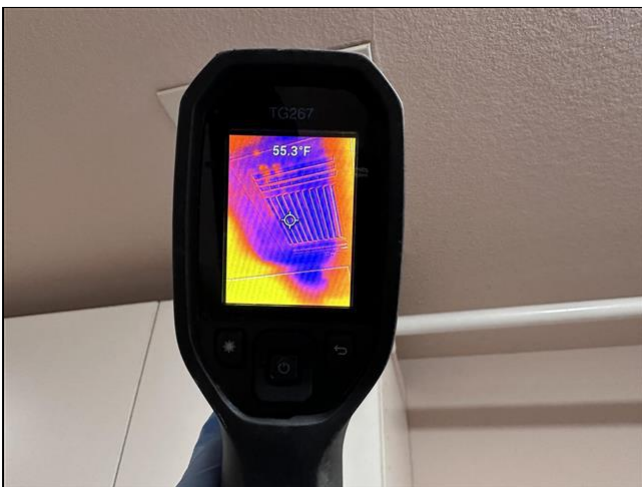
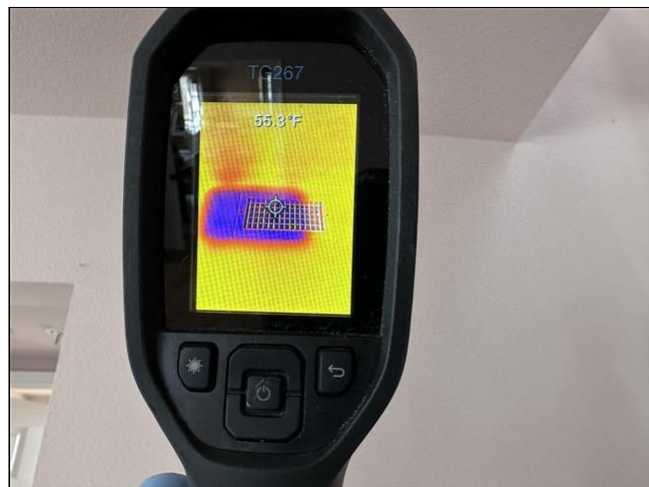
36. (1) **Repair or Replace:** The **rear unit** air conditioning system did not provide sufficient drop in temperature (cooling) during the inspection. It is suspected that the unit is not adequately sized for the rear unit. Also, there are air supply registers at the lower bonus room area. This does not appear to be the original design of the HVAC system and can reduce the efficiency of the HVAC system. Suggest further investigations by a qualified HVAC contractor to provide repair/replacement options and cost.

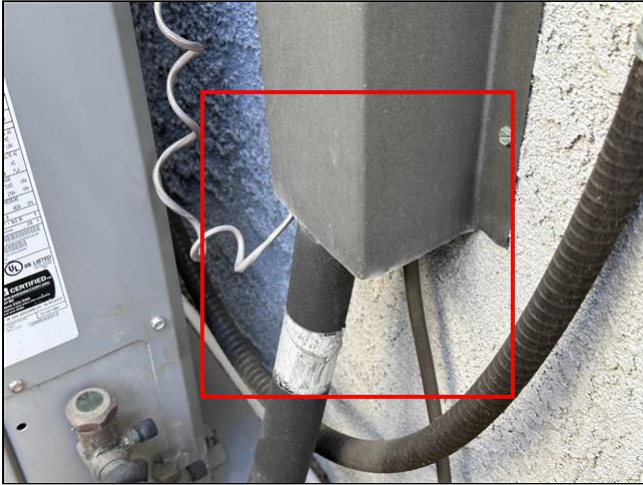
Item 37 - Item 1(Picture) Heating/Central Air

37. (2) **Improve:** The penetration(s) where the coolant refrigerant lines enter the building are not sealed. These areas are large enough to allow pest entry into the building. We suggest the holes in the penetrations should be properly sealed.

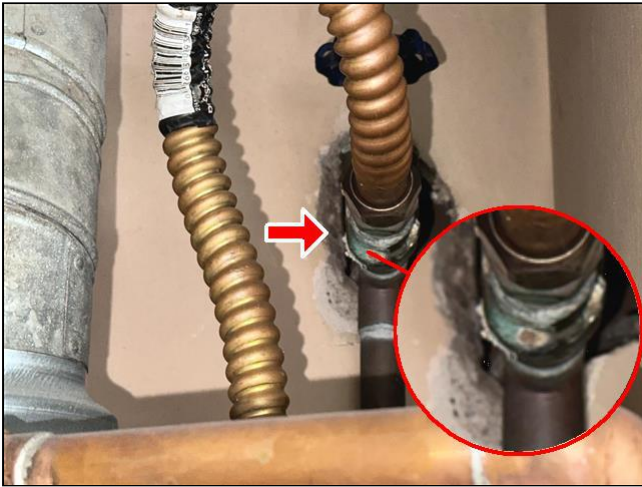
Item 41 - Item 1(Picture) Plumbing System

41. (1) **Repair or Replace:** The cold water supply valve for the front unit water heater is corroded. Although the valve is not leaking it is suggested that it be replaced by a qualified professional.

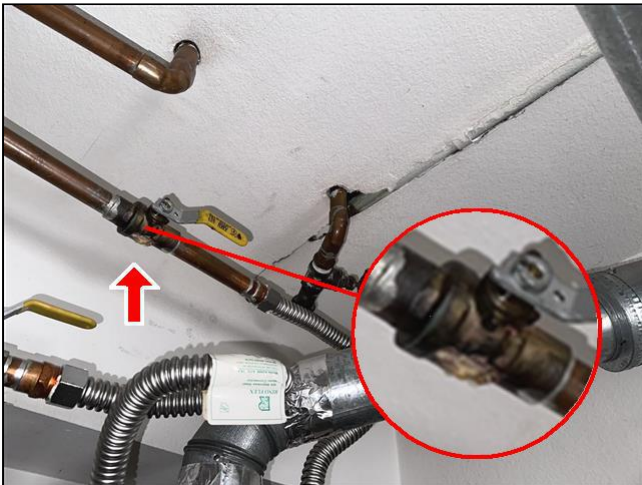
Item 43 - Item 1(Picture) Plumbing System

42. (2) **Repair or Replace:** The angle stop valve at the rear wall below the **front unit** primary bathroom sink are corroded. Although the valves are not leaking, it is suggested that they be replaced by a qualified professional to prevent water damage.
43. (3) **Repair or Replace:** The cold water supply valve for the **rear unit** water heater is corroded. Although the valve is not leaking it is suggested that it be replaced by a qualified professional.

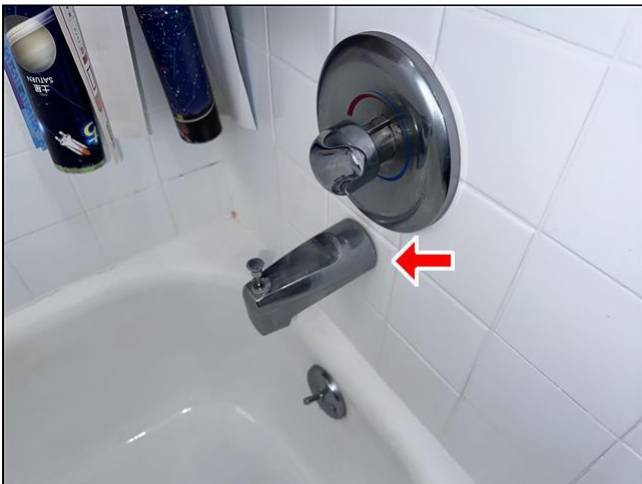
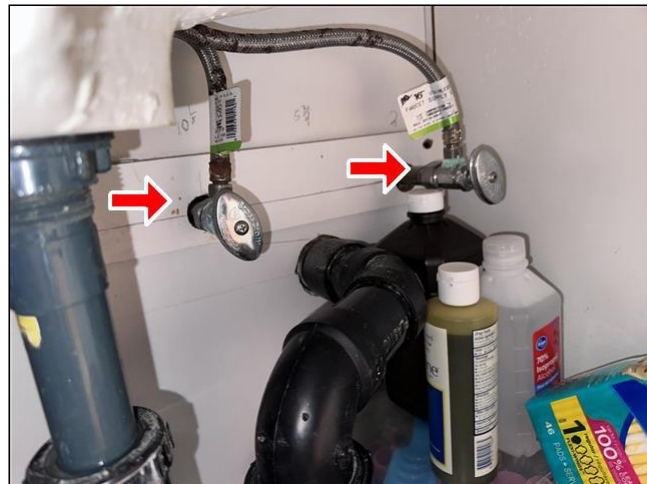
44. (4) **Improve:** Suggest the application of caulking between the bathroom tub spout and operation valve cover plates at the **front unit** hallway bathroom to prevent moisture damage.

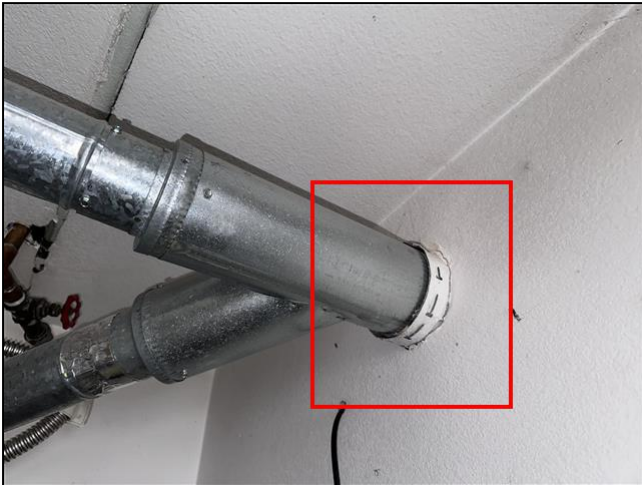
Item 45 - Item 1(Picture) Plumbing System

45. (1) **Safety Issue:** The **rear unit** water heater(s) vent passes through a ceiling or wall without the use of an approved thimble or spacer. This could be a fire hazard. We suggest a qualified technician should install an approved, listed thimble or spacer.

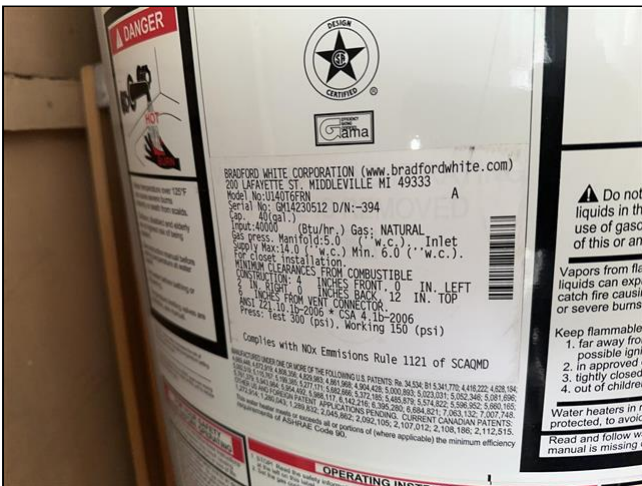
Item 46 - Item 1(Picture) Plumbing System

46. (2) **Repair/Replace/Monitor:** The **front unit** water heater is an older unit. The water heater may be nearing the end of its service life. Typical life expectancy of water heaters is 7 to 12 years. The existing unit is 13 years old. It is difficult to determine when replacement will be necessary. Suggest replacement of the water heater by a licensed and qualified plumber.

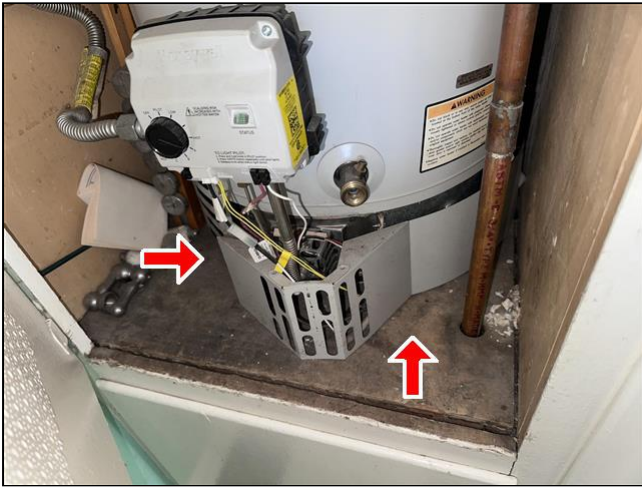
Item 47 - Item 1(Picture) Plumbing System

47. (3) **Improve:** There is no catch pan installed under the **front unit** water heater. A pan is required by the plumbing standards when the appliance is located in an area where a leak could damage the structure. - Installation of a pan and drain pipe to the exterior should be done by a qualified technician.

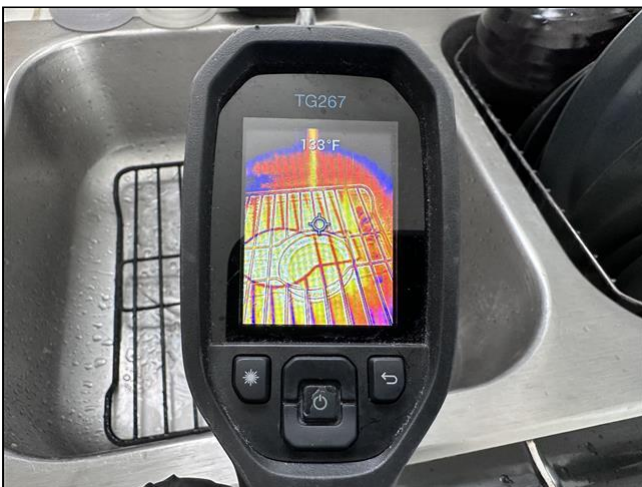
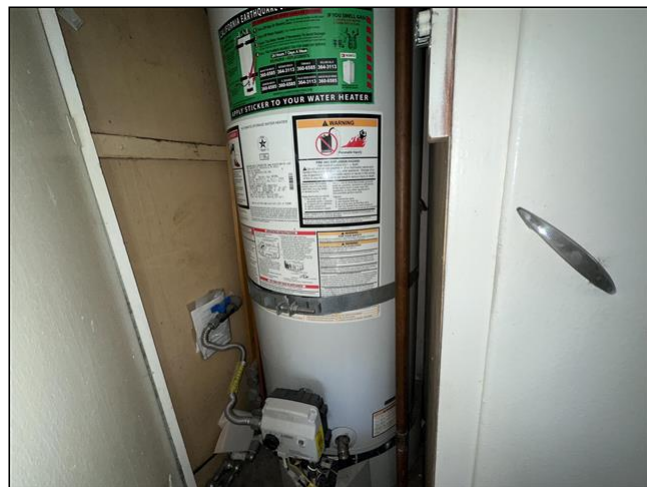
49. (6) **Note/Monitor:** The **front unit** water heater was operational and produced hot water at time of inspection.

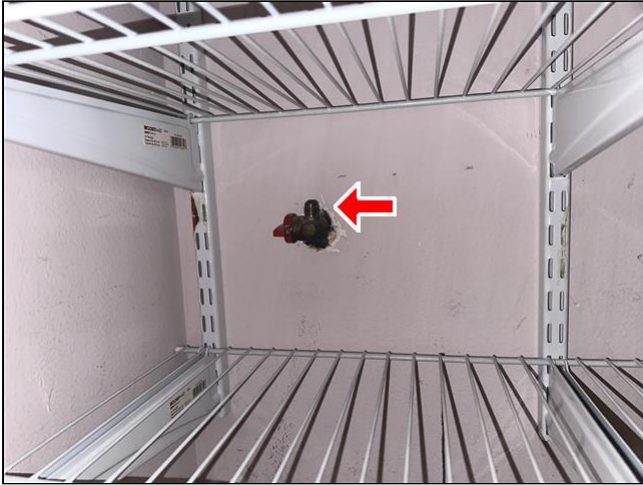
Item 50 - Item 1(Picture) Plumbing System

50. (1) **Safety Issue:** The gas valve at the **rear unit** second floor hallway laundry closet has not been capped. The valve should be covered with a cap/cover when not in use.

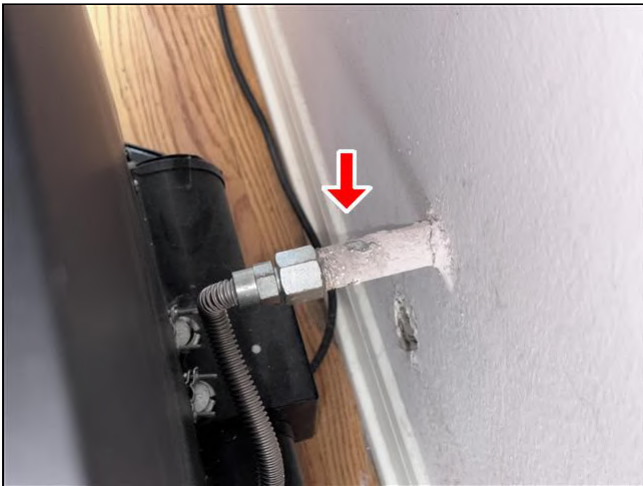
Item 51 - Item 1(Picture) Plumbing System

51. (2) **Safety Issue:** The gas supply pipe at the **rear unit** living room fireplace lacks a shut off valve. This is a safety concern. Suggest the installation of a shut off valve by a qualified professional.

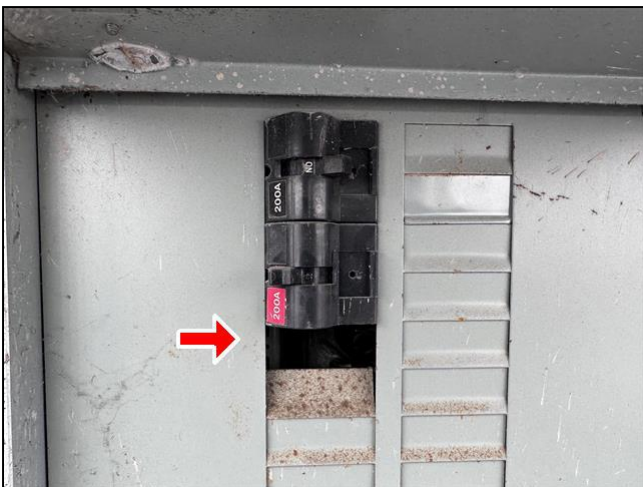
Item 52 - Item 1(Picture) Electrical System

52. (1) **Safety Issue:** It is suggested that all openings at the West exterior wall main electrical panel for the rear unit be covered with plastic covers.

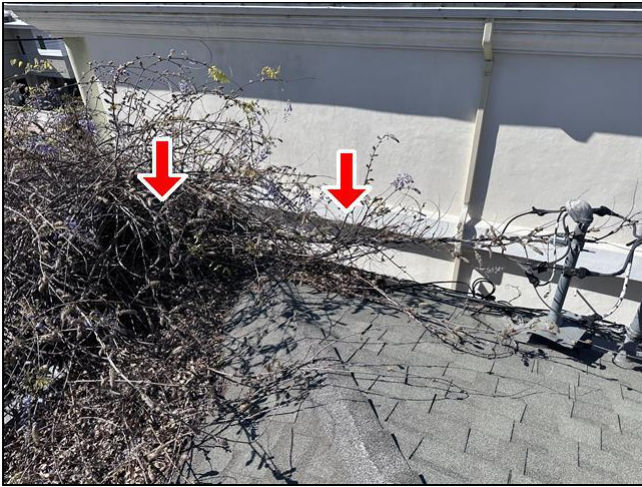
Item 53 - Item 1(Picture) Electrical System

53. (2) **Safety Issue:** Suggest trimming away tree limbs/vegetation from the main electrical service entrance wires at the

front of the property.

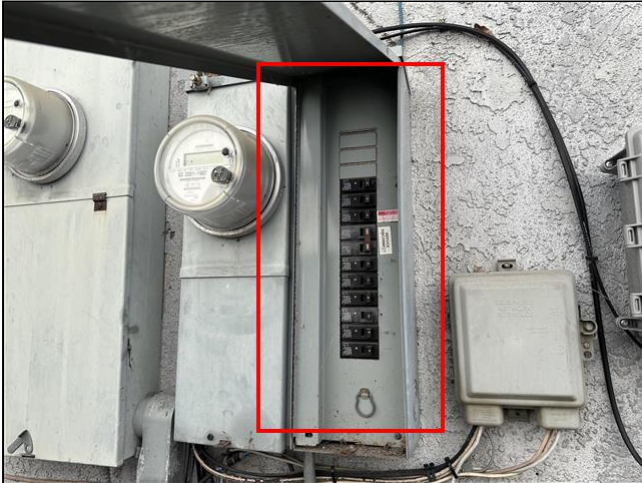
Item 54 - Item 1(Picture) Electrical System

54. (1) **Safety Issue:** Two circuit conductors within the **front unit** main distribution panel are doubled up (referred to as "double taps") to a single breaker and must be separated. Each circuit conductor is to be served by a separate breaker; suggest repairs by a licensed electrical contractor.

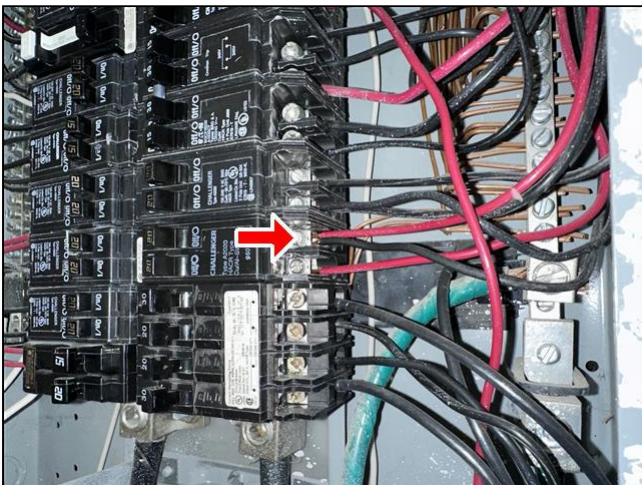
Item 55 - Item 1(Picture) Electrical System

55. (2) **Safety Issue:** Two circuit conductors within the **rear unit** main distribution panel are doubled up (referred to as "double taps") to a single breaker and must be separated. Each circuit conductor is to be served by a separate breaker; suggest repairs by a licensed electrical contractor.

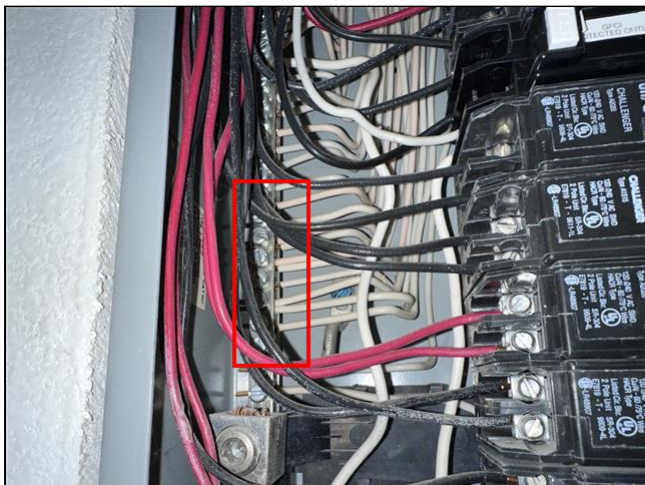
Item 56 - Item 1(Picture) Electrical System

56. (3) **Safety Issue:** Double tapped neutral wires were observed at the **rear unit** main electrical panel neutral bus bar. When more than one neutral wire is fed into a single screw/terminal on the neutral bus bar, the connections can become loose. When there are loose connections in your main panel from a double tapped neutral like this, they can cause overheating or arcing, which can then lead to shock, and an electrical fire. Suggest repair/replacement by a qualified professional.

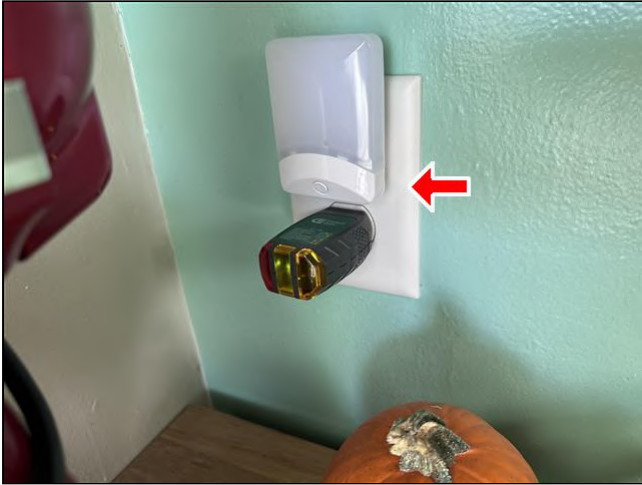
Item 58 - Item 1(Picture) Electrical System

58. (2) **Safety Issue:** The three prong electrical outlets at the **front unit** kitchen countertop are not grounded. Suggest further review and grounding of the outlets by a qualified electrician.

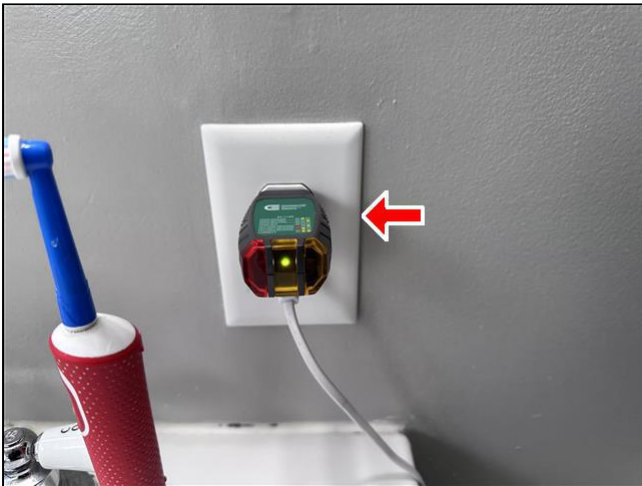
Item 59 - Item 1(Picture) Electrical System

59. (3) **Safety Issue:** The **front unit** hallway bathroom electrical outlet lacks GFCI (Ground Fault Circuit Interrupter) protection. Suggest the installation of a GFCI outlet by a qualified electrician.
