Inspection Report

Property Address:
1931 Ruhland Ave
Redondo Beach CA 90278

Professional Inspection Network

Property Address 1931 Ruhland Ave Redondo Beach CA 90278	Date of Inspection 2/15/2023	Report ID 20230215-1931-Ruhland-Ave
Customer(s) Sanjeev Bhatia	Time of Inspection 09:00 AM	Real Estate Agent Linda Hernandez Shorewood Realtors

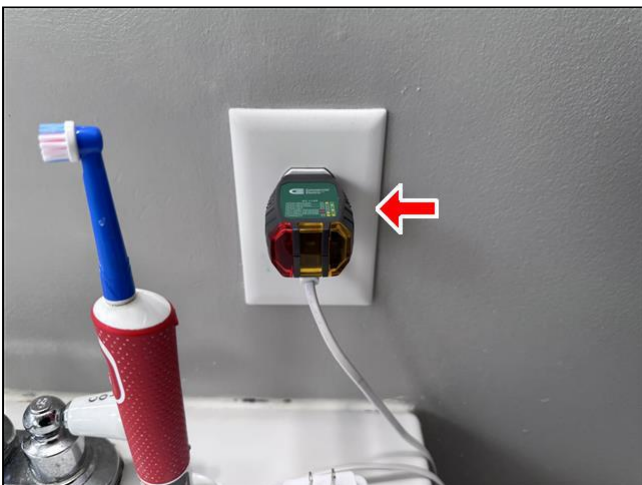
Item 60 - Item 1(Picture) Electrical System

60. (4) **Safety Issue:** The three prong electrical outlet at the **front unit** hallway bathroom is not grounded. Suggest further review and grounding of the outlets by a qualified electrician.

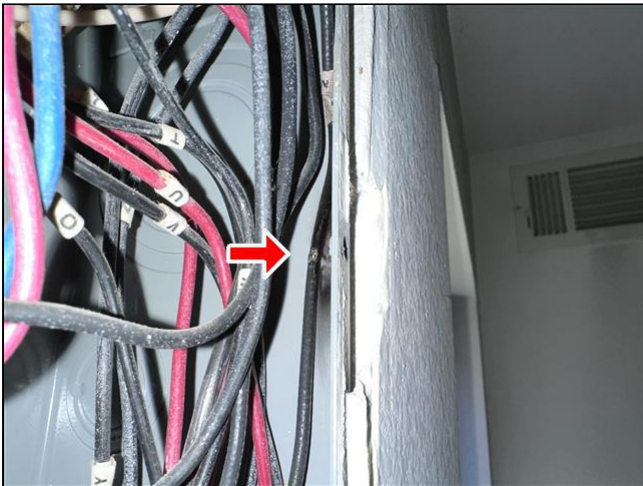
Item 62 - Item 1(Picture) Electrical System

62. (6) **Safety Issue:** Upon removing the top right side screw for the **rear unit** electrical panel, the screw cut the wire insulation and tripped the circuit for the distribution wire. Suggest further review and repair by a qualified electrician.

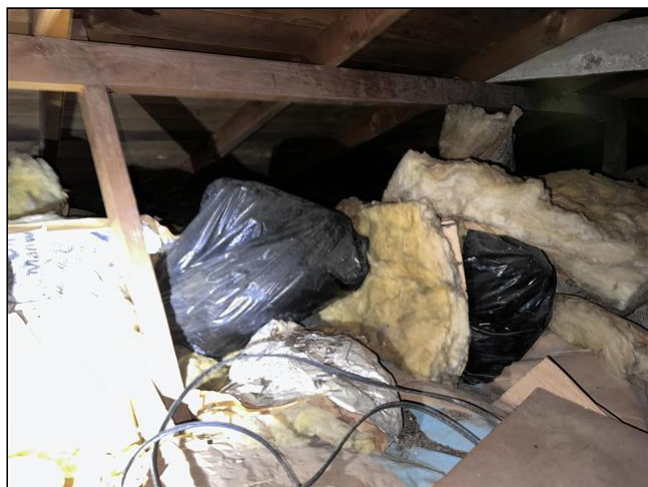
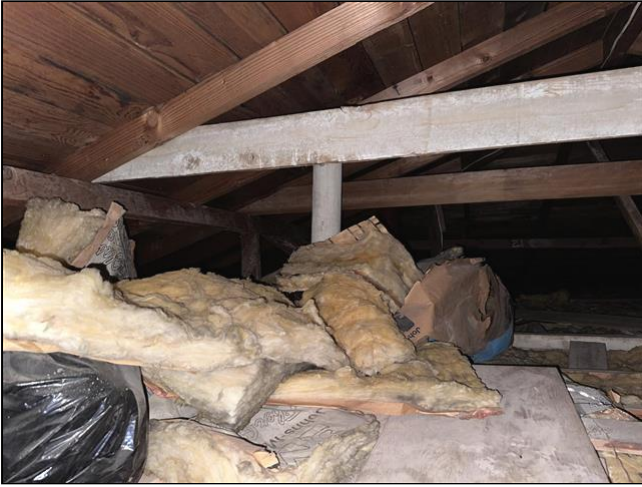
63. **Repair or Replace:** The front unit insulation is inconsistent. Insulation should be evenly distributed throughout the attic space. Suggest repair/replacement of the insulation by a qualified professional.

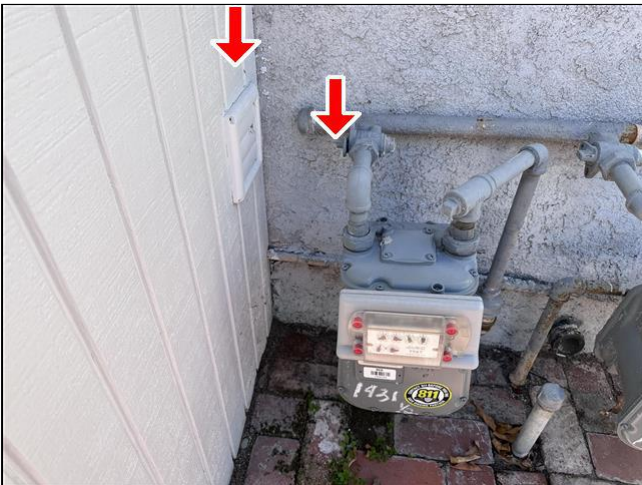
Item 64 - Item 1(Picture) Insulation & Ventilation

64. (1) **Safety Issue:** The **front unit** laundry dryer vent terminates in close proximity to the gas meters at the East exterior wall. The minimum distance of three feet clearance from the gas meter to the clothes dryer intake or exhaust vent opening is required. Suggest relocating the laundry dryer vent by a qualified professional.

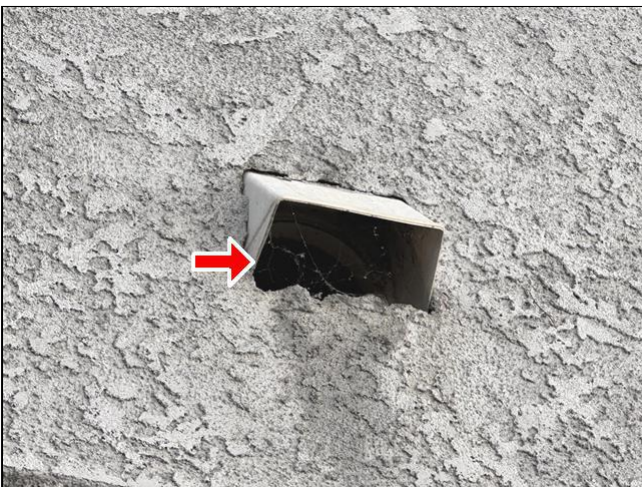
Item 65 - Item 1(Picture) Insulation & Ventilation

65. (2) **Repair or Replace:** The **front unit** primary bathroom exhaust vent opening lacks a baffle. Suggest further review and repair by a qualified professional.

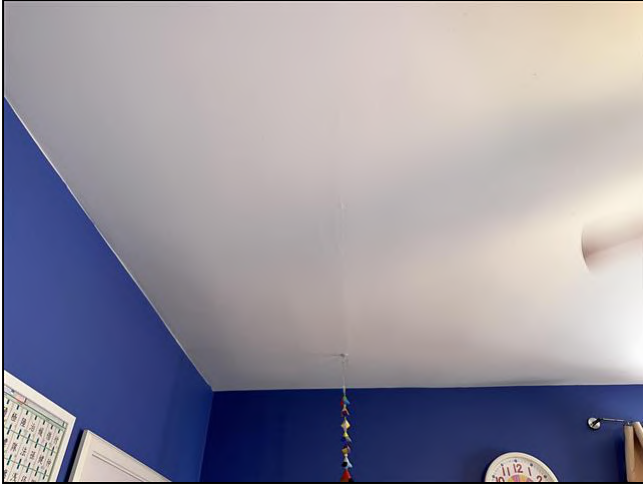
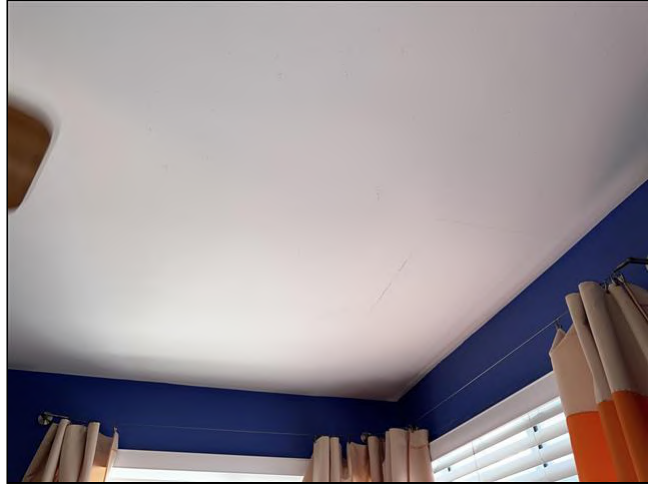
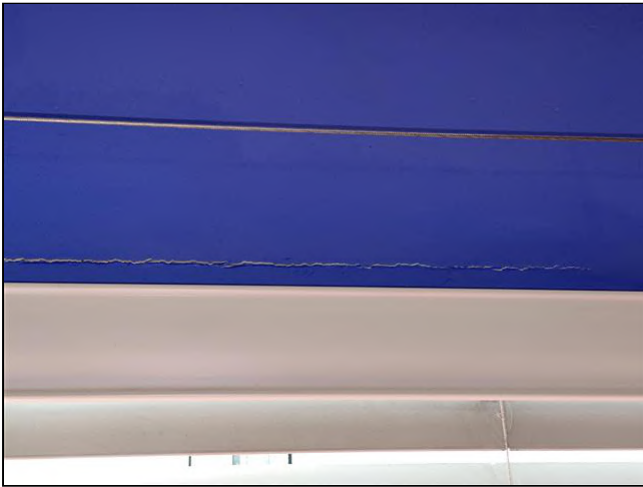
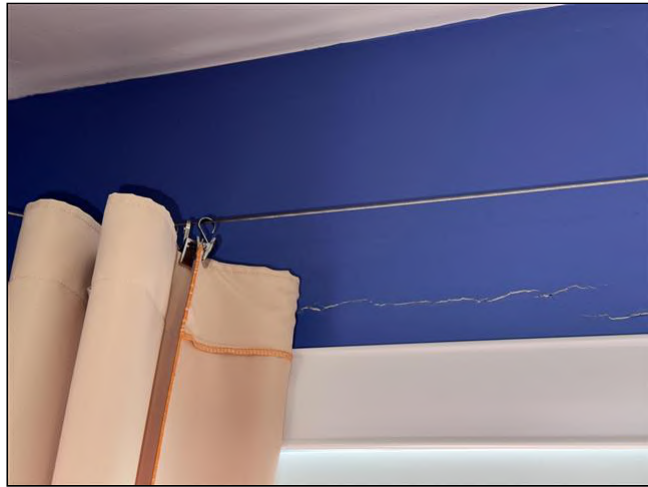
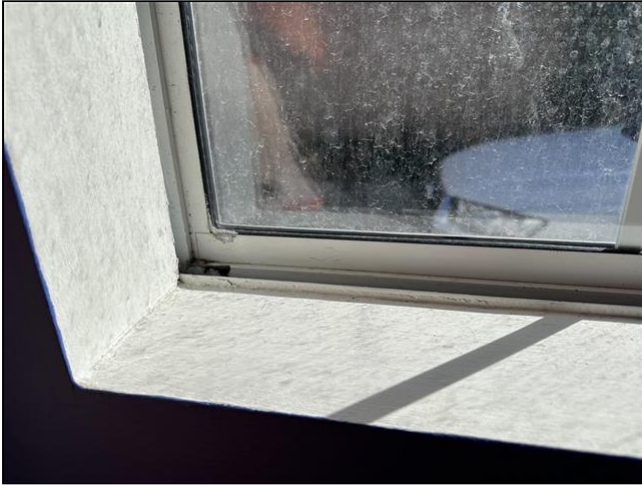
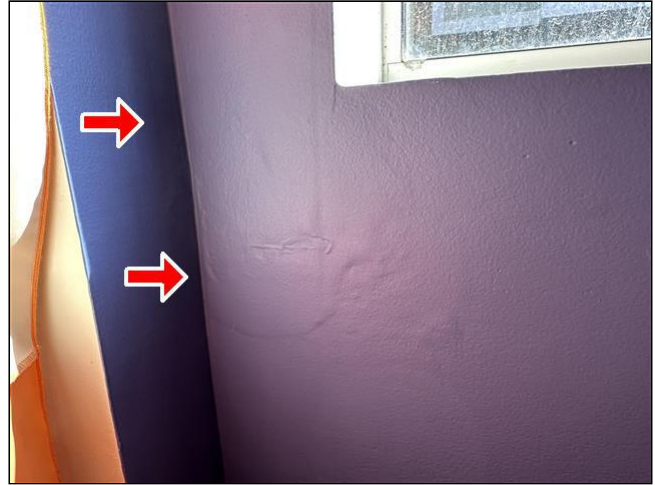
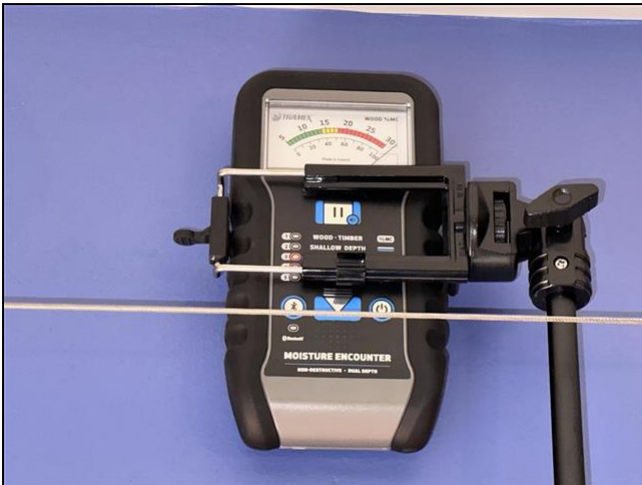
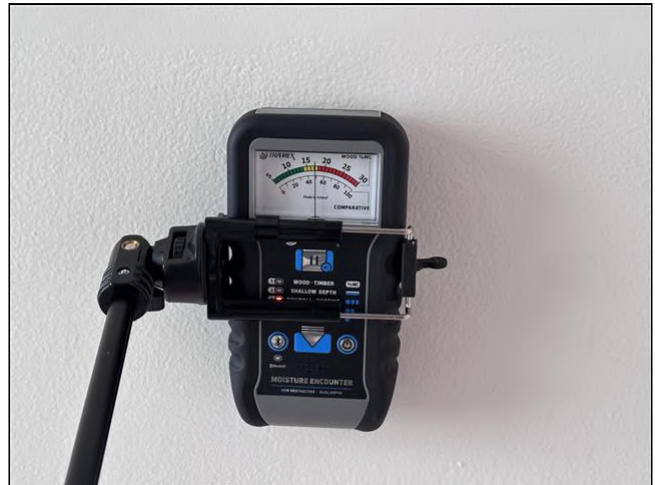
66. (1) **Major Concern:** Evidence of water damage/roof leak was observed at the **front unit** South-East bedroom interior wall and ceiling finishes. A higher than average moisture reading was observed at the interior surfaces in various locations. The source of the leak(s) should be identified and repairs performed as necessary. Suggest referring to the Roofing section of this report regarding additional information. Areas of past and present moisture are favorable for growing many fungal like organisms. There is an extra risk of hidden damage/fungus/mold to be present in this location. The identification of molds, fungus and other microbial organisms is outside the scope of this inspection. We suggest a qualified environmental specialist should be retained to evaluate the surfaces and make further recommendations. Testing and remediation of mold growth can only be accomplished by a qualified environmental specialist. If strict protocol is not followed, spores can be released into the interior of the building and may create a health hazard for those with low tolerances to such organisms.

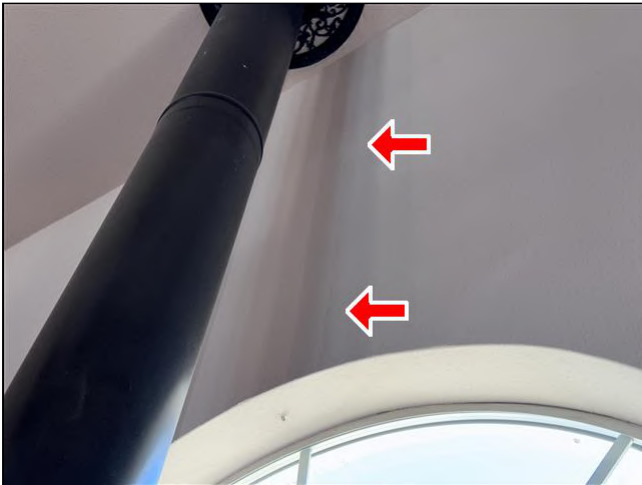
Item 67 - Item 1(Picture) Interiors

67. (2) **Repair/Replace/Monitor:** Evidence of water intrusion/roof leak was observed at the **rear unit** living room East interior wall. It appears that the chimney is leaking. We suggest asking the owner to provide you with information about the leak(s), and what corrective action (if any) was taken to repair the leak(s). Then if additional damage develops, the source of the leak(s) should be identified and repairs performed as necessary. There is surface growth on the kitchen sink cabinet floor and sidewalls. This may indicate the presence of mold, fungus or other microbial organisms. Areas of past and present moisture are favorable for growing many fungal like organisms. There is an extra risk of hidden damage/fungus/mold to be present in this location. The identification of molds, fungus and other microbial organisms is outside the scope of this inspection. We suggest a qualified environmental specialist should be retained to evaluate the surfaces and make further recommendations. Testing and remediation of mold growth can only be accomplished by a

qualified environmental specialist. If strict protocol is not followed, spores can be released into the interior of the building and may create a health hazard for those with low tolerances to such organisms.

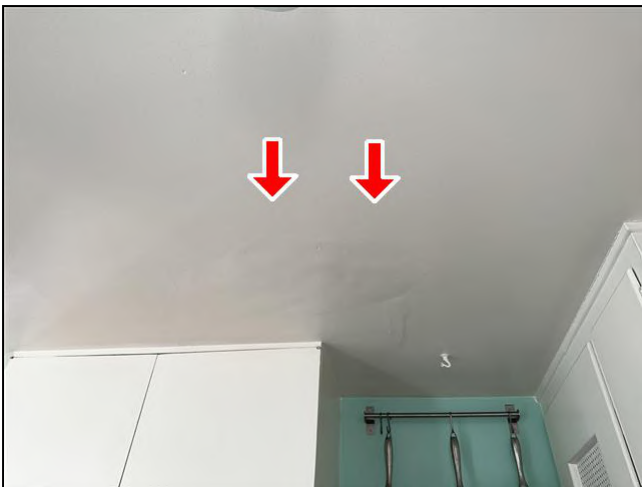
Item 68 - Item 1(Picture) Interiors

68. (3) **Improve/Monitor:** Evidence of patching was observed at the **front unit** kitchen interior ceiling finishes. However, we found no sign of active leaks. We suggest asking the owner to provide you with information about the leak(s), and what corrective action (if any) was taken to repair the leak(s). Then if additional damage develops, the source of the leak(s) should be identified and repairs performed as necessary. Areas of past and present moisture are favorable for growing many fungal like organisms. There is an extra risk of hidden damage/fungus/mold to be present in this location. The identification of molds, fungus and other microbial organisms is outside the scope of this inspection. We suggest a qualified environmental specialist should be retained to evaluate the surfaces and make further recommendations. Testing and remediation of mold growth can only be accomplished by a qualified environmental specialist. If strict protocol is not followed, spores can be released into the interior of the building and may create a health hazard for those with low tolerances to such organisms.

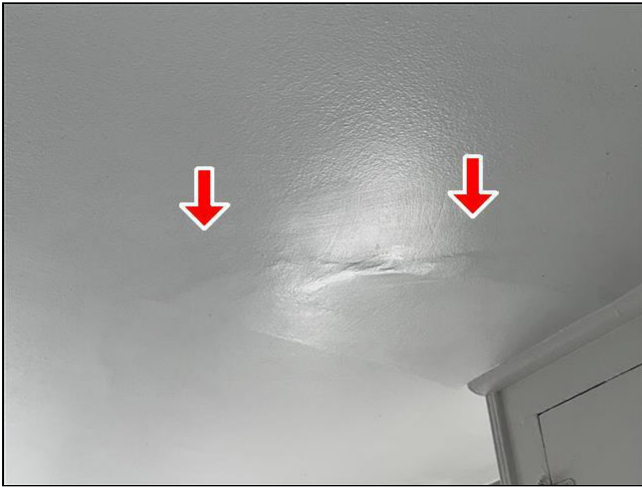
Item 69 - Item 1(Picture)

69. (5) **Improve/Monitor:** Evidence of patching was observed at the **front unit** hallway bathroom interior ceiling finishes. However, we found no sign of active leaks. We suggest asking the owner to provide you with information about the leak(s), and what corrective action (if any) was taken to repair the leak(s). Then if additional damage develops, the source of the leak(s) should be identified and repairs performed as necessary. Areas of past and present moisture are favorable for growing many fungal like organisms. There is an extra risk of hidden damage/fungus/mold to be present in this location. The identification of molds, fungus and other microbial organisms is outside the scope of this inspection. We suggest a qualified environmental specialist should be retained to evaluate the surfaces and make further recommendations. Testing and remediation of mold growth can only be accomplished by a qualified environmental specialist. If strict protocol is not followed, spores can be released into the interior of the building and may create a health hazard for those with low tolerances to such organisms.

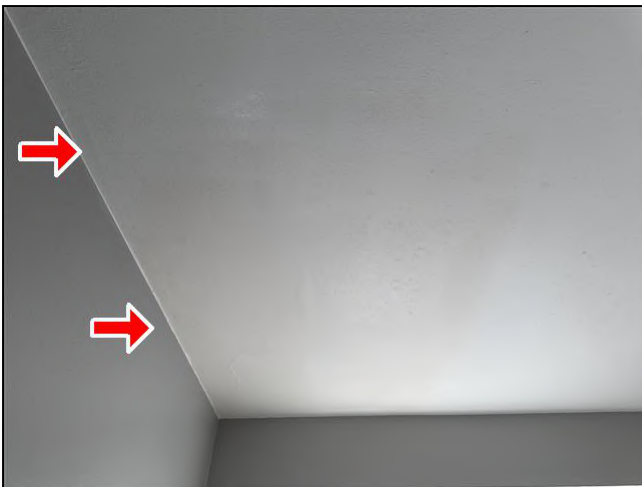
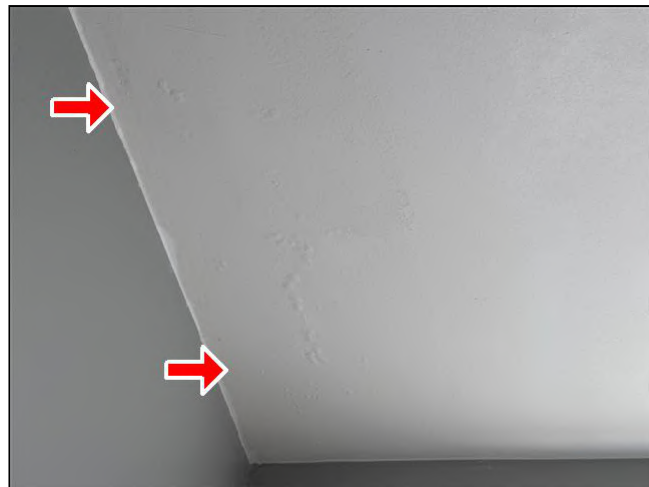
70. (6) **Improve/Monitor:** There is surface growth on the **front unit** hallway bathroom interior ceiling finishes. This may indicate the presence of mold, fungus or other microbial organisms. The identification of molds, fungus and other microbial organisms is outside the scope of this inspection. We suggest a qualified environmental specialist should be retained to evaluate the surfaces and make further recommendations. Testing and remediation of mold growth can only be accomplished by a qualified environmental specialist. If strict protocol is not followed, spores can be released into the interior of the building and may create a health hazard for those with low tolerances to such organisms.

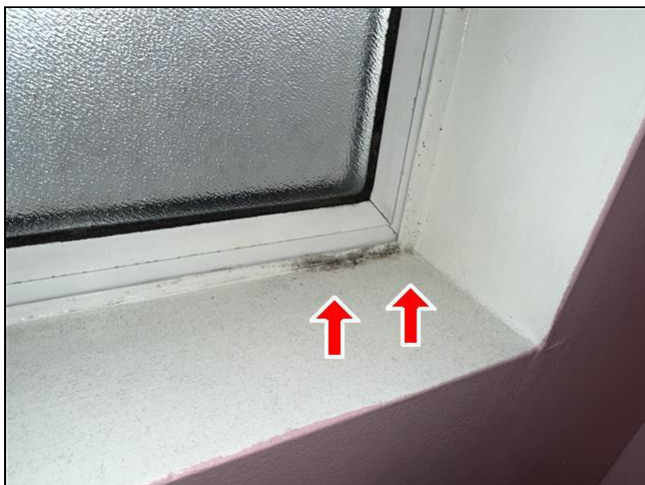
Item 71 - Item 1(Picture) Interiors

71. (7) **Improve/Monitor:** There is surface growth on the **front unit** primary bathroom interior window sill finishes. This may indicate the presence of mold, fungus or other microbial organisms. The identification of molds, fungus and other microbial organisms is outside the scope of this inspection. We suggest a qualified environmental specialist should be retained to evaluate the surfaces and make further recommendations. Testing and remediation of mold growth can only be accomplished by a qualified environmental specialist. If strict protocol is not followed, spores can be released into the interior of the building and may create a health hazard for those with low tolerances to such organisms.

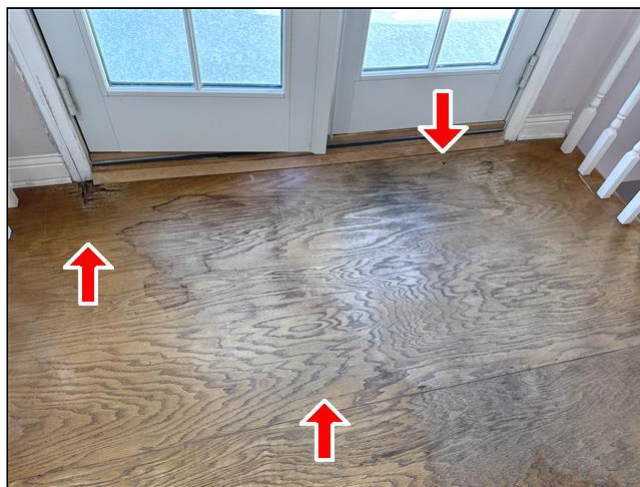
Item 72 - Item 2(Picture) Interiors

72. (1) **Repair or Replace:** Evidence of water damage/water leak was observed at the **rear unit** third floor area adjacent to the french doors. The floor is damaged. Areas of past and present moisture are favorable for growing many fungal like organisms. There is an extra risk of hidden damage/fungus/mold to be present in this location. The identification of molds, fungus and other microbial organisms is outside the scope of this inspection. We suggest a qualified environmental specialist should be retained to evaluate the surfaces and make further recommendations. Testing and remediation of mold growth can only be accomplished by a qualified environmental specialist. If strict protocol is not followed, spores can be released into the interior of the building and may create a health hazard for those with low tolerances to such organisms. Suggest repair/replacement of the floor by a qualified professional.

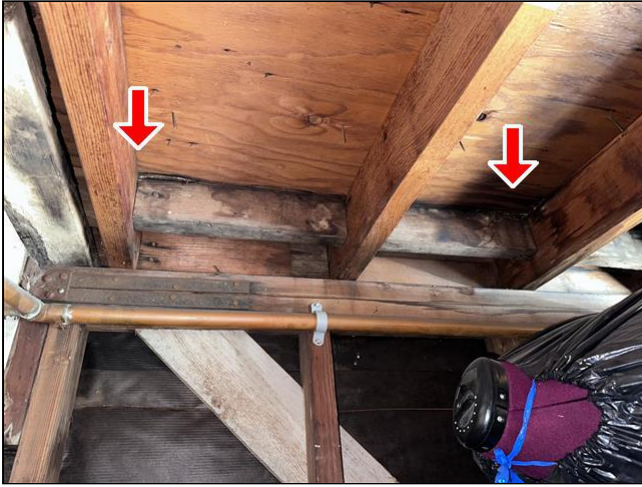
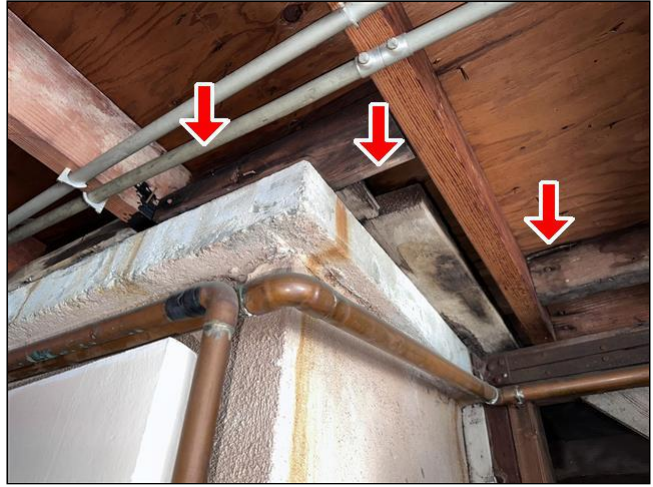
75. (1) **Major Concern:** Evidence of water intrusion and damaged wood was observed at the **front unit** garage along the East wall/ceiling and West areas as well. Water is entering from the exterior deck and/or faulty garage at the East exterior wall. The source of the water should be identified and repairs performed as necessary. Suggest referring to the Roofing section of this report regarding additional information. Areas of past and present moisture are favorable for growing many fungal like organisms. There is an extra risk of hidden damage/fungus/mold to be present in this location. The identification of molds, fungus and other microbial organisms is outside the scope of this inspection. We suggest a qualified environmental specialist should be retained to evaluate the surfaces and make further recommendations. Testing and remediation of mold growth can only be accomplished by a qualified environmental specialist. If strict protocol is not followed, spores can be released into the interior of the building and may create a health hazard for those with low tolerances to such organisms.

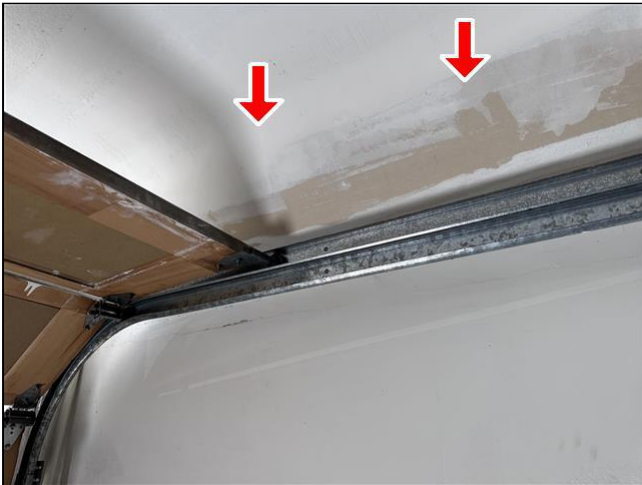
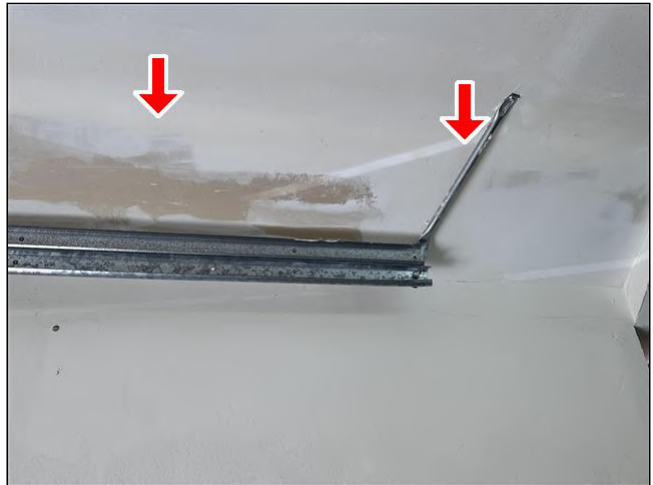
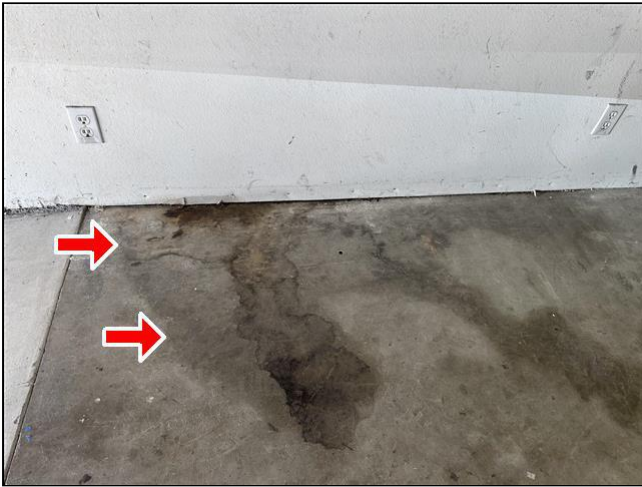
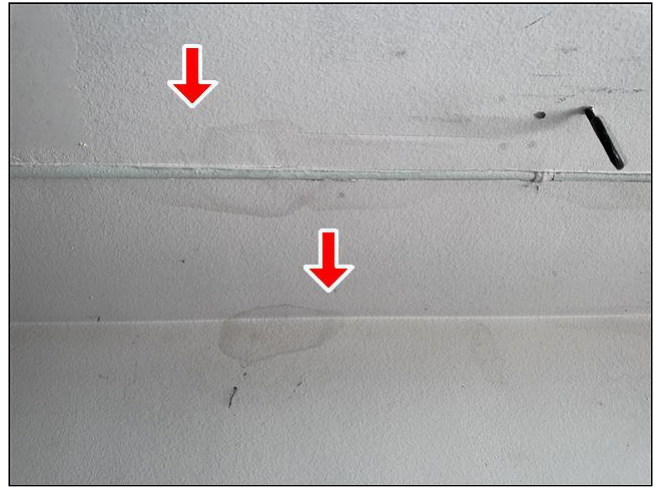
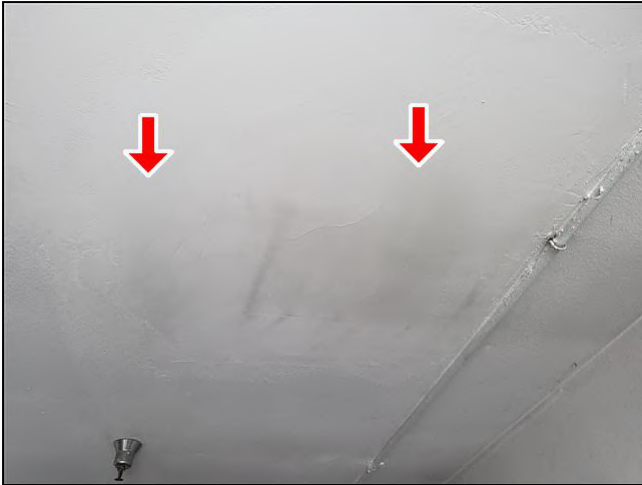
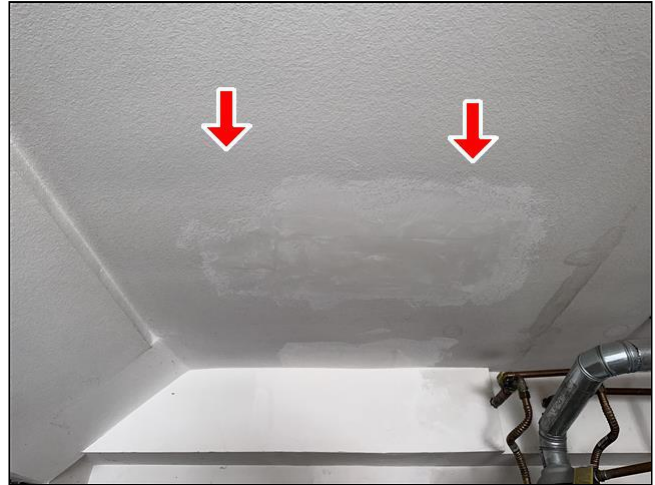
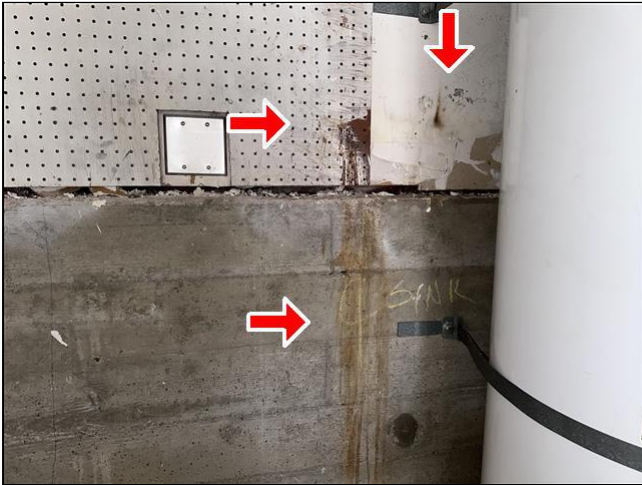
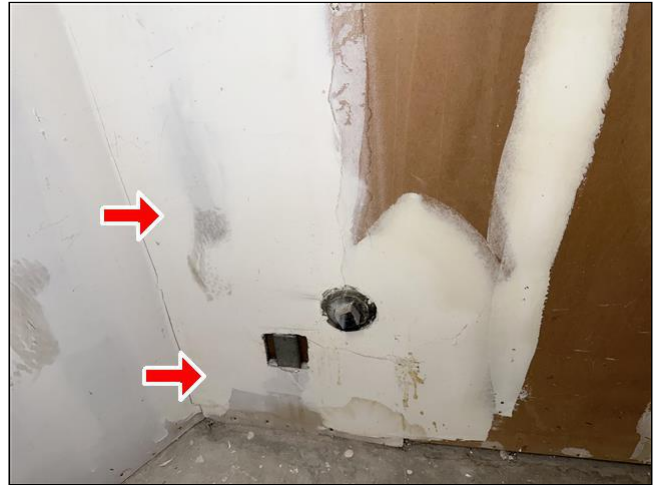
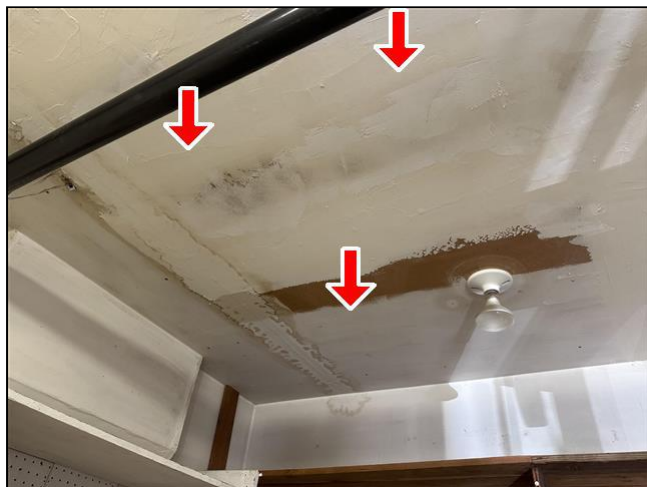
76. (2) **Major Concern:** Evidence of water intrusion was observed at the **rear unit** East garage in several locations. However, we found no sign of active leaks. We suggest asking the owner to provide you with information about the leak(s), and what corrective action (if any) was taken to repair the leak(s). Then if additional damage develops, the source of the leak(s) should be identified and repairs performed as necessary. Areas of past and present moisture are favorable for growing many fungal like organisms. There is an extra risk of hidden damage/fungus/mold to be present in this location. The identification of molds, fungus and other microbial organisms is outside the scope of this inspection. We suggest a qualified environmental specialist should be retained to evaluate the surfaces and make further recommendations. Testing and remediation of mold growth can only be accomplished by a qualified environmental specialist. If strict protocol is not followed, spores can be released into the interior of the building and may create a health hazard for those with low tolerances to such organisms.

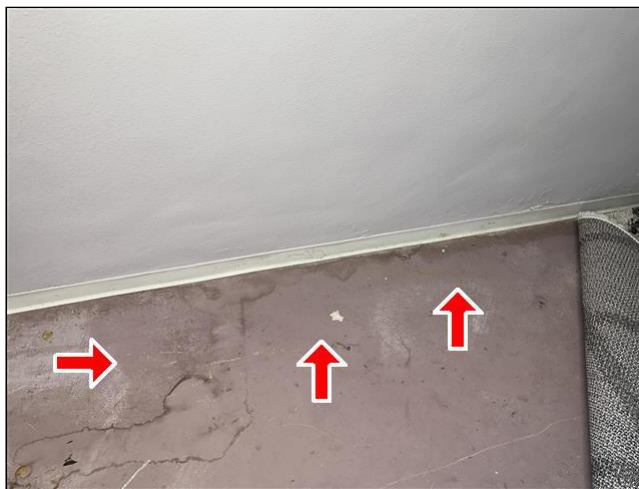
Item 77 - Item 2(Picture) Garage

77. (3) **Major Concern:** Evidence of water intrusion was observed at the **rear unit** West bonus room along the West and rear wall. The presence of water often indicates an occasional surplus of moisture on the outside of the foundation. We suggest to keep the exterior moisture to a minimum, exterior surface drainage, including downspout water, should be directed as far away from the building as possible. Landscape watering should always be directed away from the building and limited to short durations. Also, there is surface growth on the interior surfaces/finishes. This may indicate the presence of mold, fungus or other microbial organisms. The identification of molds, fungus and other microbial organisms is outside the scope of this inspection. We suggest a qualified environmental specialist should be retained to evaluate the surfaces and make further recommendations. Testing and remediation of mold growth can only be accomplished by a qualified environmental specialist. If strict protocol is not followed, spores can be released into the interior of the building and may create a health hazard for those with low tolerances to such organisms.

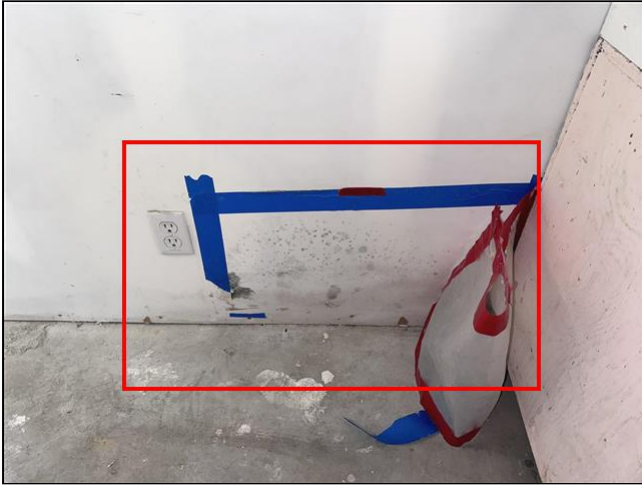
Item 78 - Item 1(Picture) Garage

78. (4) **Improve/Monitor:** There is surface growth on the **rear unit** East garage interior wall finishes. This may indicate the presence of mold, fungus or other microbial organisms. The identification of molds, fungus and other microbial organisms is outside the scope of this inspection. We suggest a qualified environmental specialist should be retained to evaluate the surfaces and make further recommendations. Testing and remediation of mold growth can only be accomplished by a qualified environmental specialist. If strict protocol is not followed, spores can be released into the interior of the building and may create a health hazard for those with low tolerances to such organisms.

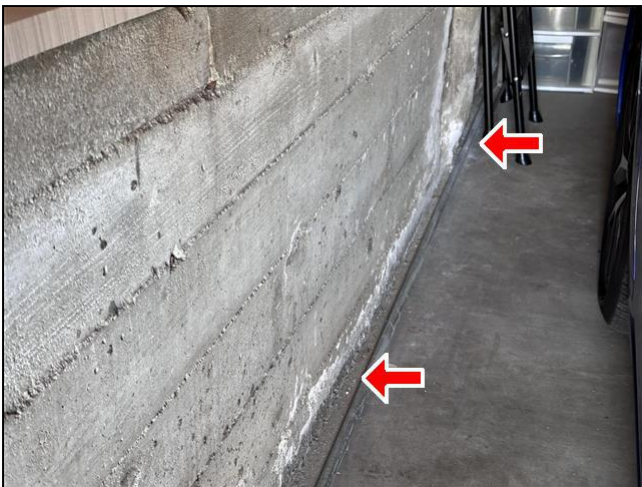
Item 79 - Item 1(Picture) Garage

79. (5) **Improve/Monitor:** A condition known as efflorescence is evident on portions of the **front unit** garage concrete foundation walls or slab. This whitish, fuzzy material is a mineral deposit left when moisture in the concrete evaporates. The presence of efflorescence often indicates an occasional surplus of moisture on the outside of the foundation. We suggest to keep the exterior moisture to a minimum, exterior surface drainage, including downspout water, should be directed as far away from the building as possible. Landscape watering should always be directed away from the building and limited to short durations.

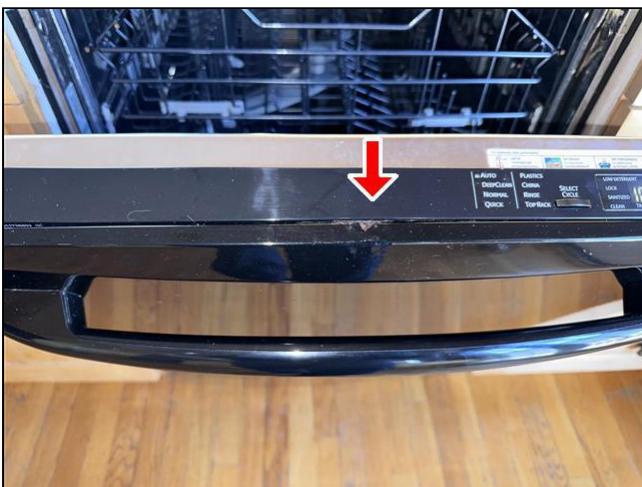
Item 80 - Item 1(Picture) Appliances

80. **Repair or Replace:** The rear unit dishwasher metal door is rusted. Suggest replacement of the dishwasher.

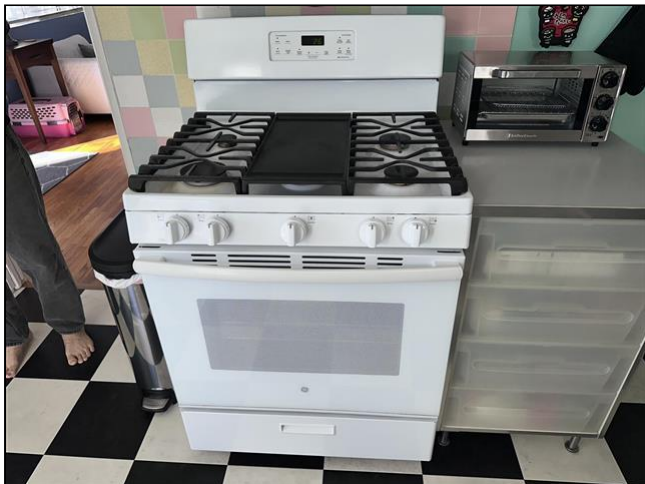
Item 81 - Item 1(Picture) Appliances

81. **Safety Issue:** The anti-tip bracket for the **front unit** kitchen stove has not been installed. The anti-tip bracket provides extra protection when excess force is applied to an open oven door. Suggest the installation by a qualified professional.

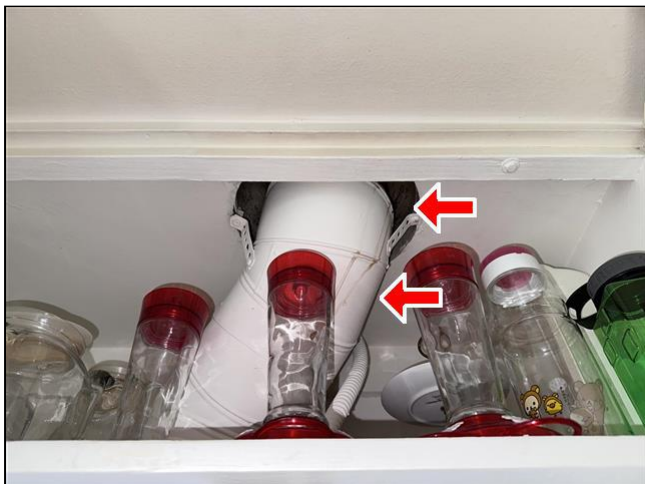
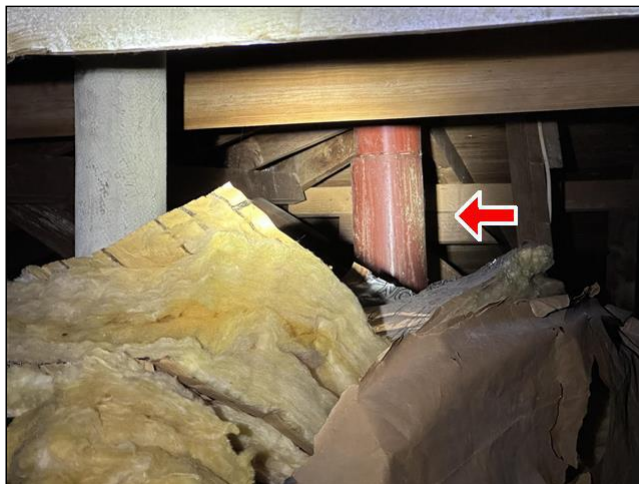
82. **Repair or Replace:** Water stains were observed at the **front unit** kitchen exhaust vent. However, we found no sign of active leaks. We suggest asking the owner to provide you with information about the leak(s), and what corrective action (if any) was taken to repair the leak(s). Then if additional damage develops, the source of the leak(s) should be identified and repairs performed as necessary.

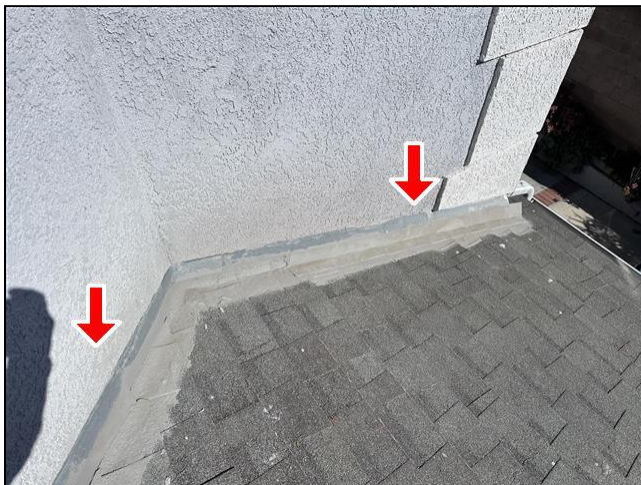
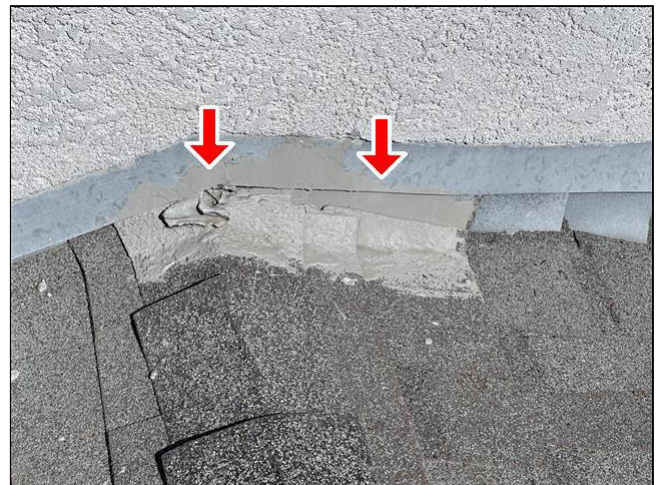
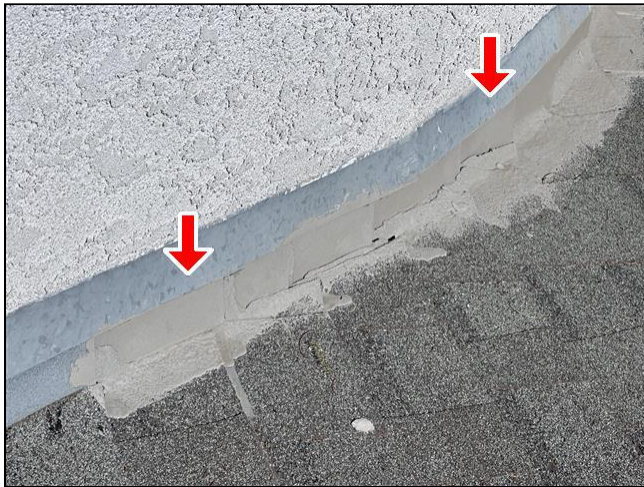
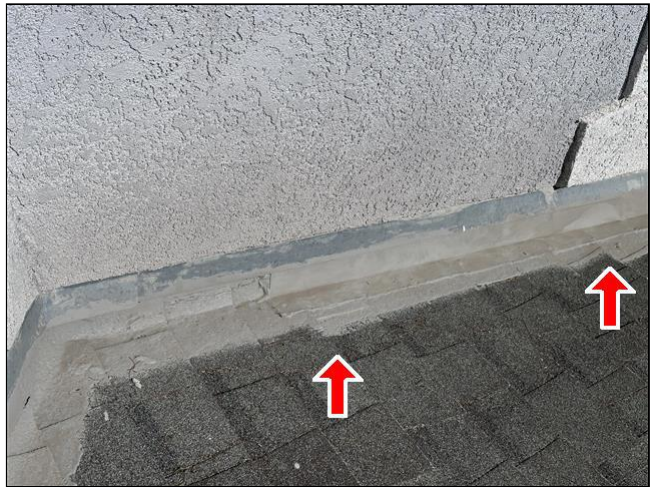
(1) **Major Concern:** The patching or repairs performed on this roof appear to have been done by a non-professional. They are not in accordance with industry standards are likely to leak or require ongoing maintenance. We suggest that the entire roof should be evaluated by a qualified roofer and repaired or replaced as necessary.

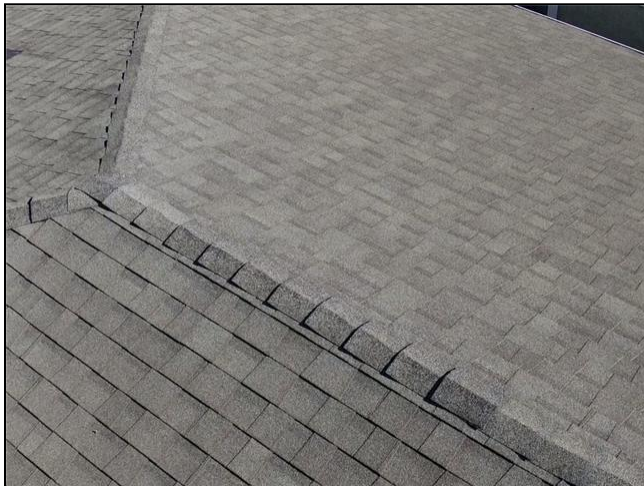
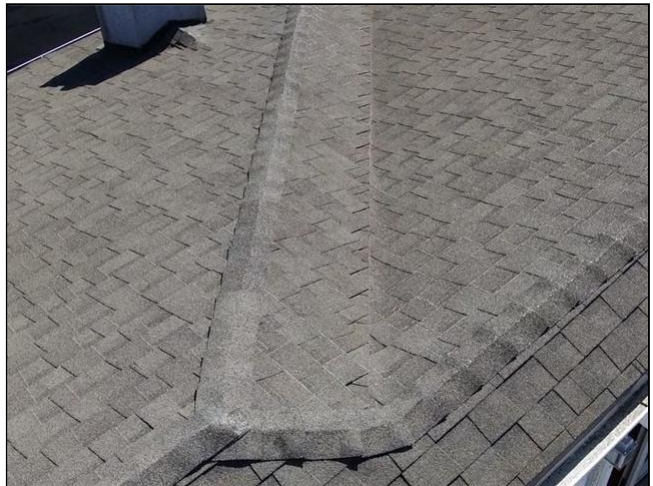
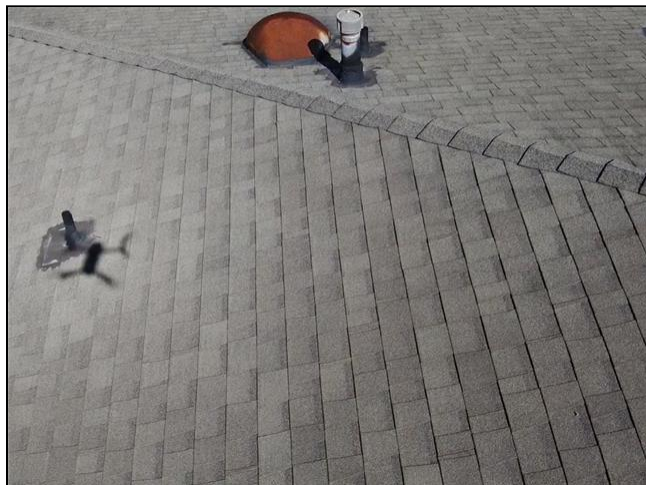
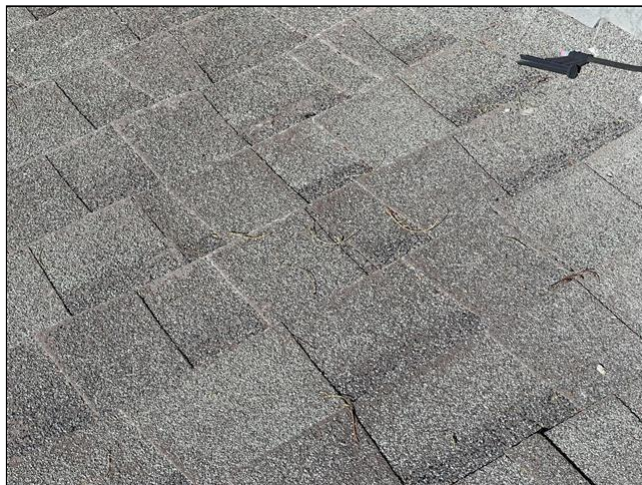
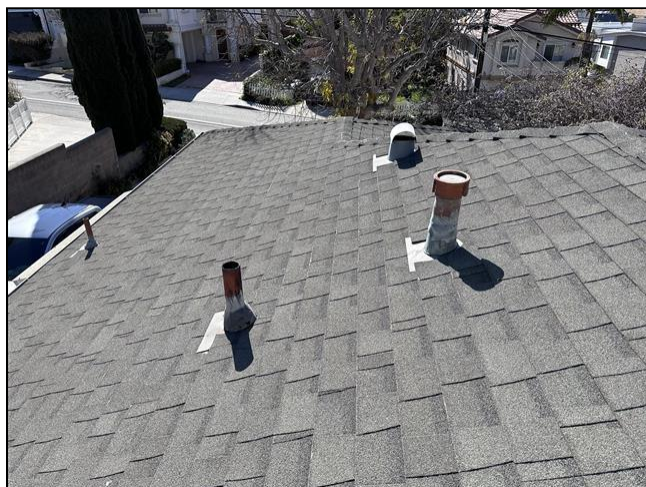
(2) **Repair/Replace/Monitor:** The composition shingle roofing is wearing at uneven rates. The sides of the roofing that are more exposed to the sun's light are wearing more quickly than other areas. Replacement of some areas may be required prior to the entire roofing requiring replacement. Unable to determine how long the roofing will remain serviceable. As with any roof, periodic review by a licensed roof contractor is advised to repair any needed areas.

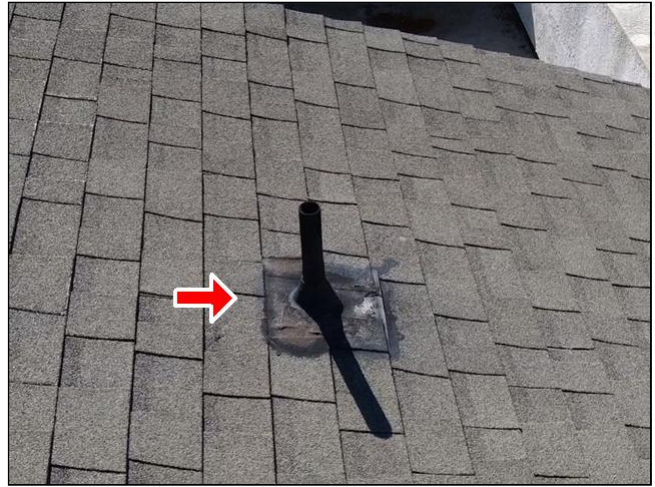
1.0 Item 12(Picture) Roofing

and note that these areas could not be properly viewed and will require ongoing maintenance. Inquire with the seller for more information. Leaks can be difficult to repair, as the source of the leakage can be far removed from the water stain that shows up on the interior.

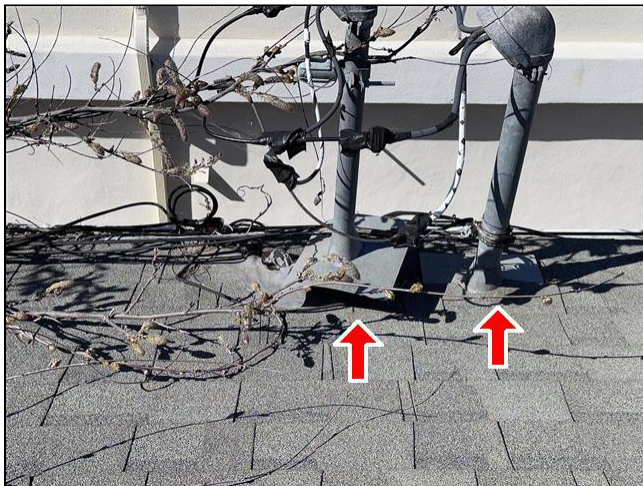
1.1 Item 1(Picture) Roofing

(1) **Repair or Replace:** The flashing for the main electrical service conduits at the front slope of the roof are surface mounted and/or not installed in accordance to industry standards. The flashings are improperly installed. This can allow leaks. We suggest a qualified roofer should make repairs or modifications as necessary.

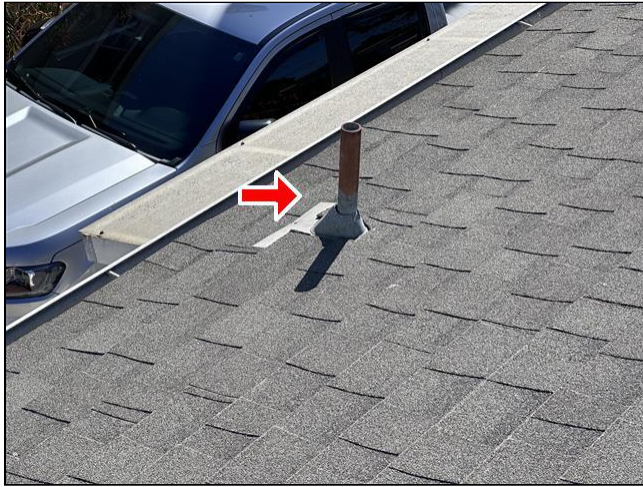
1.1 Item 2(Picture) Roofing

(2) **Repair or Replace:** The mastic at the front East slope of the roof vent penetration is missing. It is suggested that all vent and penetrations be examined and sealed with approved material by a qualified professional.

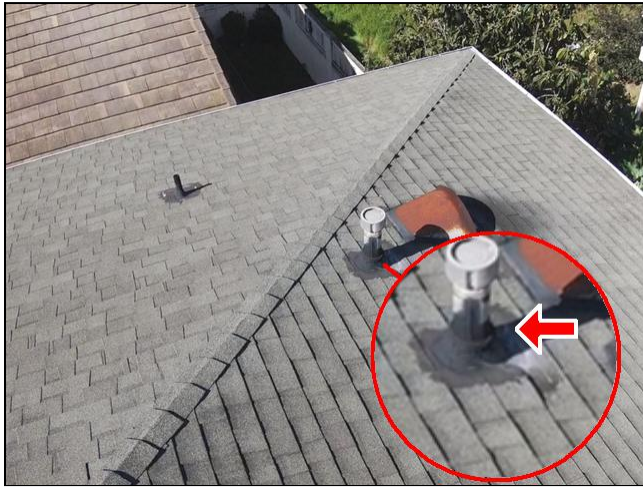
1.1 Item 3(Picture) Roofing

(3) **Repair or Replace:** The mastic at the **rear unit** heater metal vent penetration is missing. Also, the exhaust vent lacks a storm collar. It is suggested that all vent and penetrations be examined and sealed with approved material by a qualified professional.

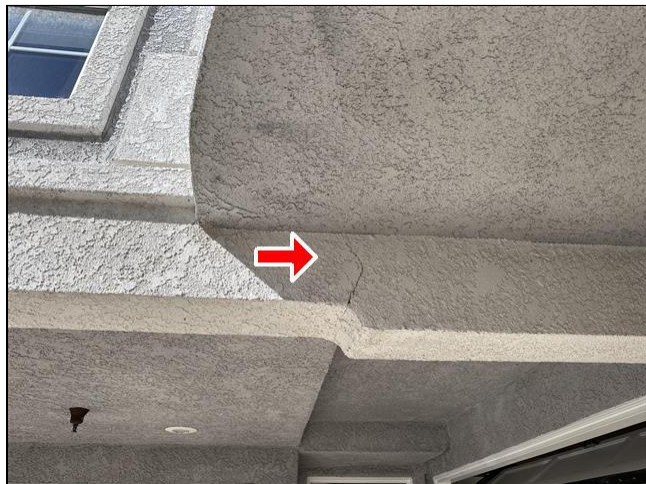
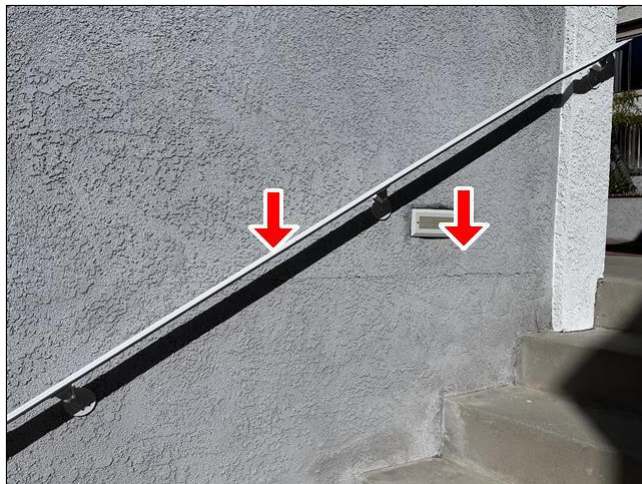
(1) **Repair/Replace/Monitor:** Visible cracking in the stucco cladding was observed at the exterior walls in one or more locations. Cracking in stucco walls happens when there is more stress placed on the wall than the material can withstand. The underlying cause of the hairline wall cracking may be due to problems with the wall's framing, contraction or expansion of wood sheathing, settling, thermal expansion or contraction, rapid changes in temperature, weak areas in the wall or abnormal vibrations in the ground. Suggest further evaluation by a qualified trades person for determination and/or corrective repairs within the inspection contingency period.

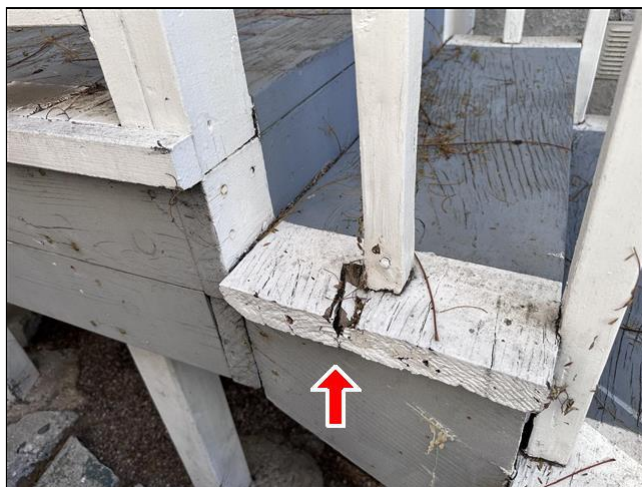
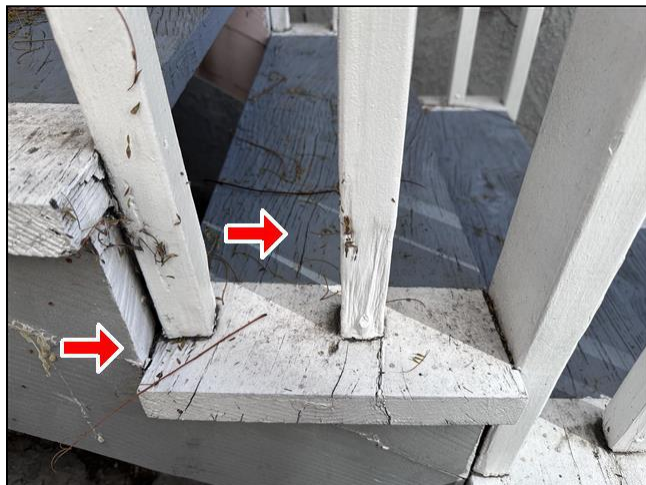
(2) **Repair or Replace:** Wood deterioration was observed at the West exterior wall **front unit** stairway/steps. If the home inspection reveals signs of damage you should have a pest control company inspect further for activity and possible hidden damage. Suggest repair/replacement of all deteriorated wood by a licensed contractor.
