Inspection Report

Property Address:
1931 Ruhland Ave
Redondo Beach CA 90278

Professional Inspection Network

Property Address 1931 Ruhland Ave Redondo Beach CA 90278	Date of Inspection 2/15/2023	Report ID 20230215-1931-Ruhland-Ave
Customer(s) Sanjeev Bhatia	Time of Inspection 09:00 AM	Real Estate Agent Linda Hernandez Shorewood Realtors

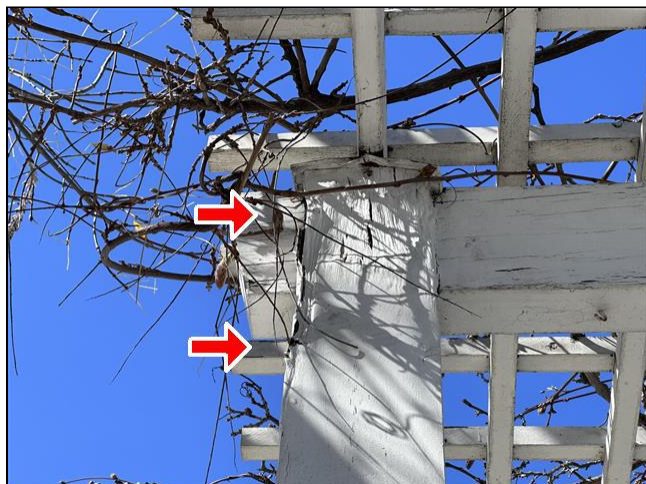
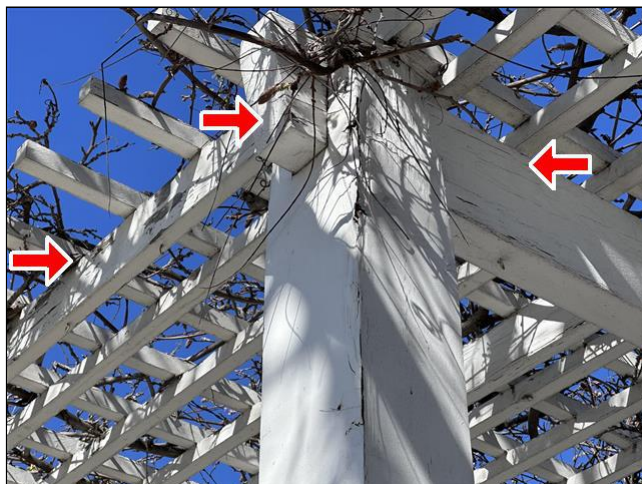
(3) **Repair or Replace:** Wood deterioration was observed at the front exterior wall **front unit** deck covering. If the home inspection reveals signs of damage you should have a pest control company inspect further for activity and possible hidden damage. Suggest repair/replacement of all deteriorated wood by a licensed contractor.

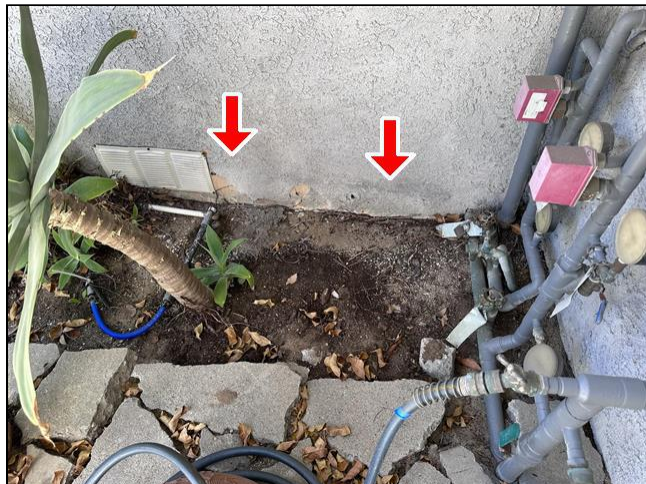
2.0 Item 8(Picture) Exterior

(5) **Repair or Replace:** The stucco cladding at the base of the exterior walls of the building is deteriorated in one or more locations. This type of deterioration is common in many older homes. The home was built in an era before weep screeds were installed at the bottom edge of the stucco siding, the stucco was extended into the soil. The stucco wicks water up out of the soil which causes the stucco to deteriorate from being moist for prolonged periods. We recommend minimizing moisture around the building to help protect the stucco and the foundation from moisture damage. Suggest further evaluation by a qualified trades person for determination and/or corrective repairs within the inspection contingency period.

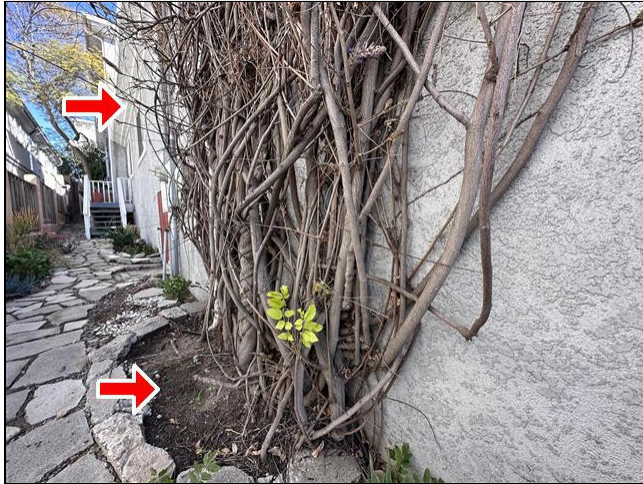
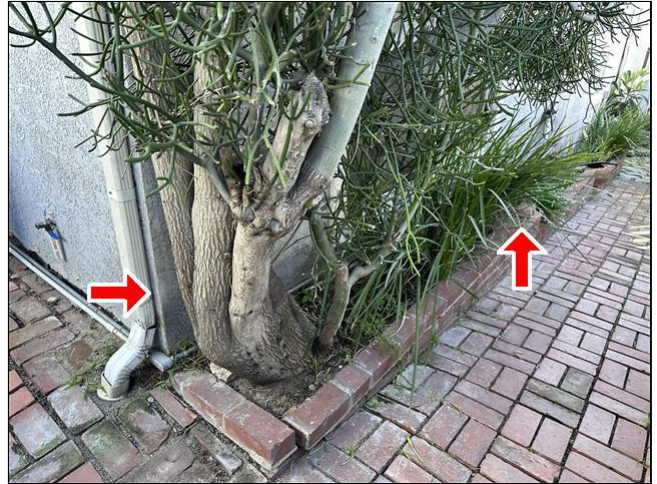
(7) **Improve:** It is suggested that all trees, tree limbs and vegetation in contact with the home be removed and/or trimmed away from the home to prevent damage and rodent activity.

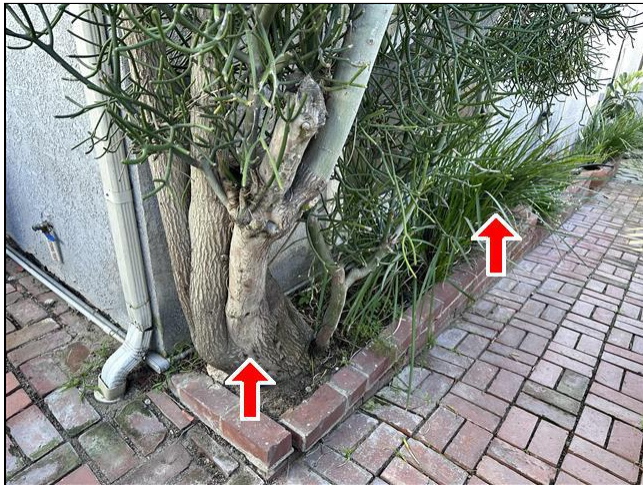
2.0 Item 12(Picture) Exterior

(8) **Improve:** The metal weep screed flashing at the rear exterior wall is covered and or does not have the required clearances from the ground. The weep screed should be placed a minimum of 4 inches above the earth, or 2 inches above paved areas, and should be of a type that will allow trapped water to drain to the exterior of the building. Suggest removal of the soil these locations to prevent water damage and or moisture intrusion.

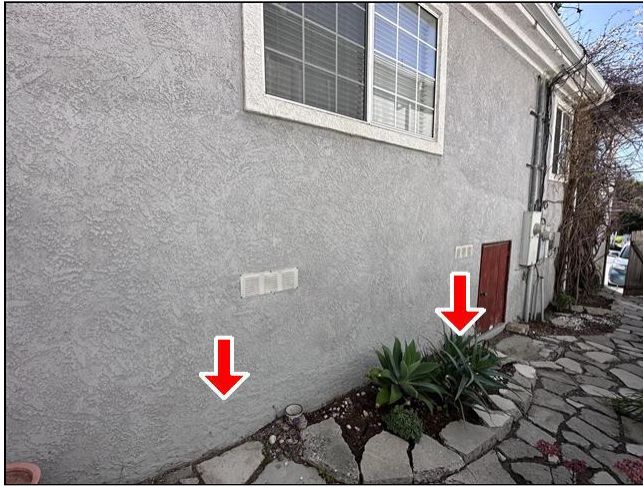
2.0 Item 13(Picture) Exterior

(9) **Monitor:** The front section of the subject property/home was built in an era before weep screeds were installed at the bottom edge of the stucco siding, the stucco was extended into the soil. The stucco wicks water up out of the soil which causes the stucco to deteriorate from being moist for prolonged periods. We recommend minimizing moisture around the building to help protect the stucco and the foundation from moisture damage.

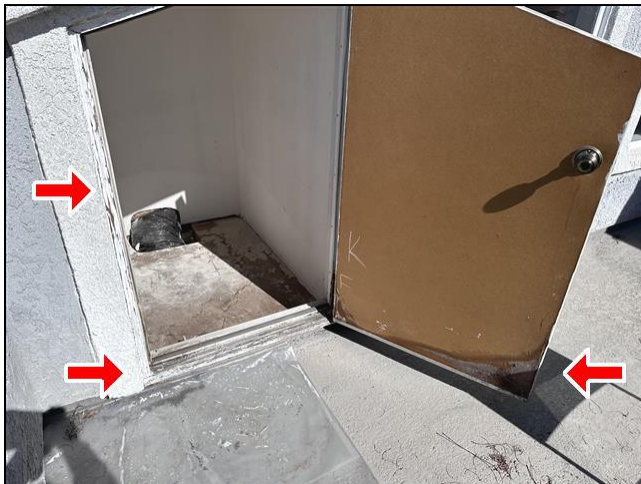
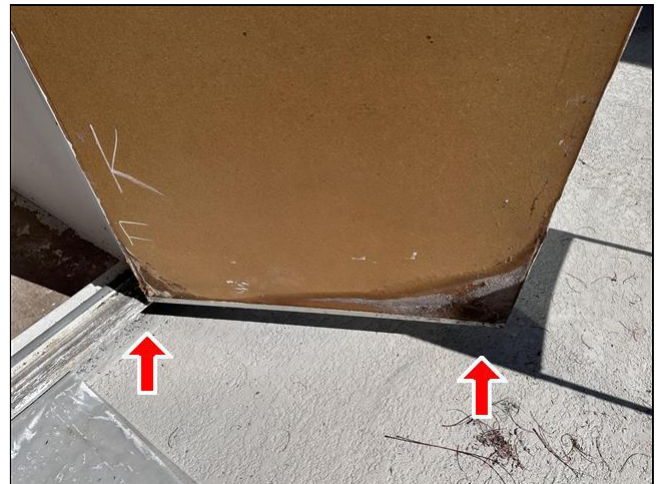
Major Concern: Water damage was observed at the **rear unit** rooftop deck storage door, frame and interior closet area. The door is in this location is not ideal for exterior use. Areas of past and present moisture are favorable for growing many fungal like organisms. There is an extra risk of hidden damage/fungus/mold to be present in this location. The identification of molds, fungus and other microbial organisms is outside the scope of this inspection. We suggest a qualified environmental specialist should be retained to evaluate the surfaces and make further recommendations. Testing and remediation of mold growth can only be accomplished by a qualified environmental specialist. If strict protocol is not followed, spores can be released into the interior of the building and may create a health hazard for those with low tolerances to such organisms. Suggest repair/ replacement by a qualified professional.

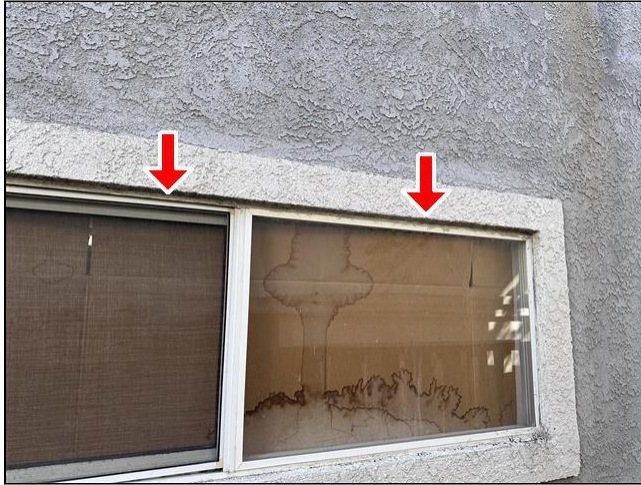
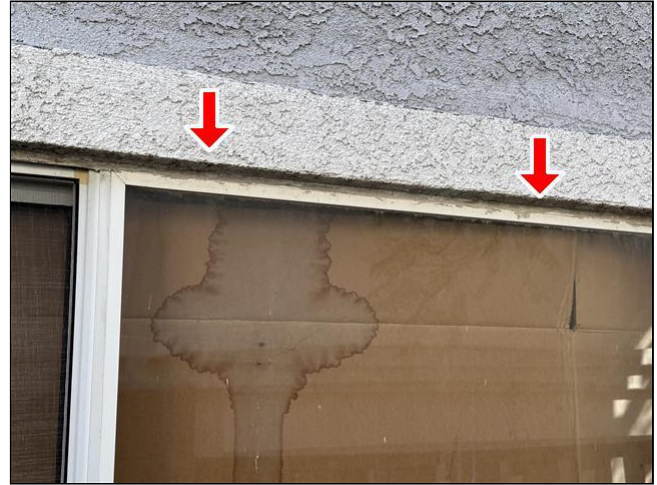
Repair/Replace/Monitor: The rear West exterior wall window frame is covered with silicone in one or more locations. This is an indication of a past problem and note that these areas could not be properly viewed and will require ongoing maintenance. Inquire with the seller for more information Leaks can be difficult to repair, as the source of the leakage can be far removed from the water stain that shows up on the interior.

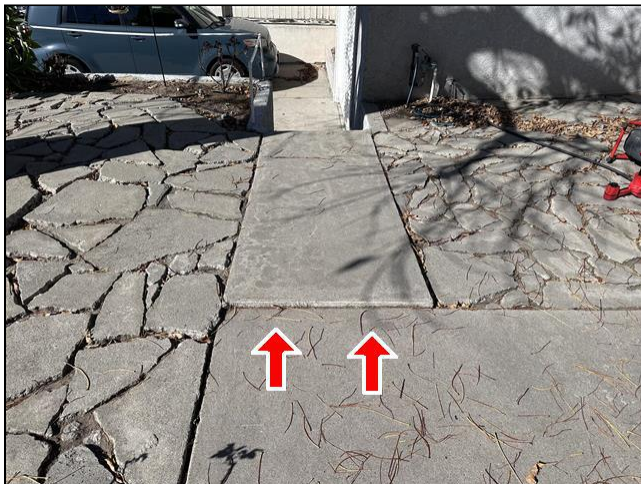
2.4 Item 1(Picture) Exterior

(1) **Safety Issue:** The uneven concrete walkway at the front area of the subject property poses a trip hazard. Suggest repair by a qualified professional.

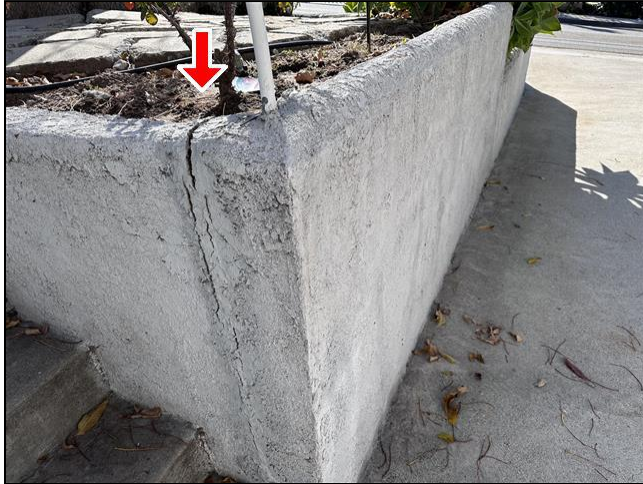
2.4 Item 2(Picture) Exterior

(2) **Repair/Replace/Monitor:** The retaining wall(s) at the front area of the subject property is cracked and shows signs of movement. Unable to determine the rate of movement during a one time visit to the subject property. The evaluation of soil conditions and/or retaining wall stability is not within the scope of this inspection. For information on soil and retaining wall stability and/or the potential for movement, we recommend that you determine if the owners have information on the soils condition, or contact a qualified geotechnical engineer who is familiar with conditions in this area.

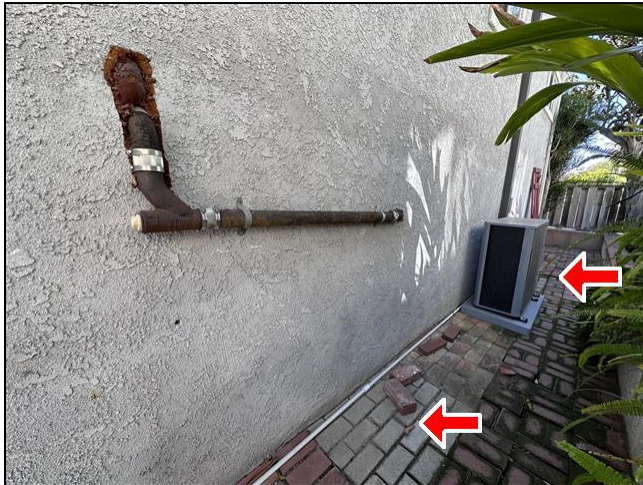
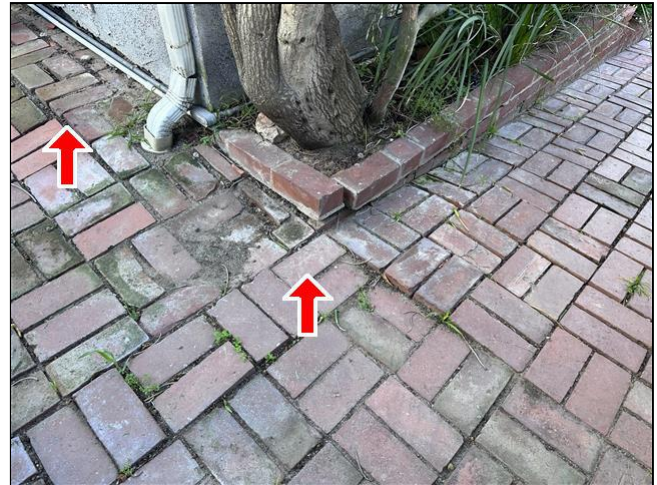
(3) **Repair or Replace:** There is a negative slope towards the building at the rear wall which will cause water to pond during rain or extended irrigation. This configuration can cause or contribute to water intrusion or deterioration of the foundation. Standing water can be detrimental to the integrity of the foundation of the house. It is important to prevent or minimize standing water around the house. Recommend further evaluation by a qualified grading contractor to determine corrections needed.

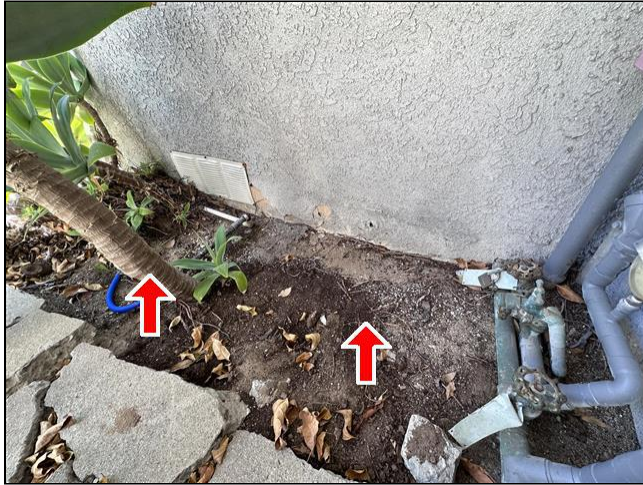
2.4 Item 7(Picture) Exterior

(6) **Improve/Monitor:** Low/neutral areas were observed at the grading which will cause water to pond during rain or extended irrigation. Standing water can be detrimental to the integrity of the foundation of the house. It is important to prevent or minimize standing water around the house. Recommend further evaluation by a qualified grading contractor to determine corrections needed.

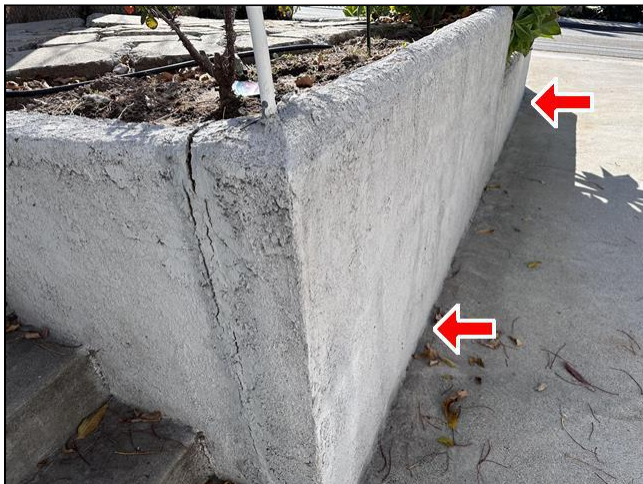
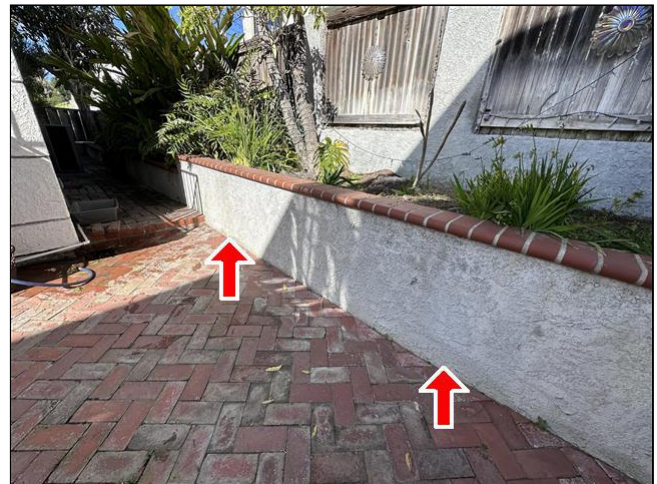
(7) **Monitor:** Unable to verify adequate drainage for the retaining walls throughout the subject property during the inspection. A retaining wall drainage pipe or toe drain is a pipe with perforations that collects water all along the wall and then drains it to the exterior; either to the sides or through the front of the wall. While tall walls need multiple pipe drains at different heights, most pipe drains are located at the base of the wall, vented every 30 to 50 feet. We suggest asking the current home owner/builder to provide any documents to verify conforming installation of the retaining walls and drainage systems prior to close of escrow to determine if further investigations are required. It is also suggested that all debris be cleared away from the swale. We suggest to keep the exterior moisture to a minimum, exterior surface drainage, including downspout water, should be directed as far away from the building as possible. Landscape watering should always be directed away from the retaining wall and limited to short durations.

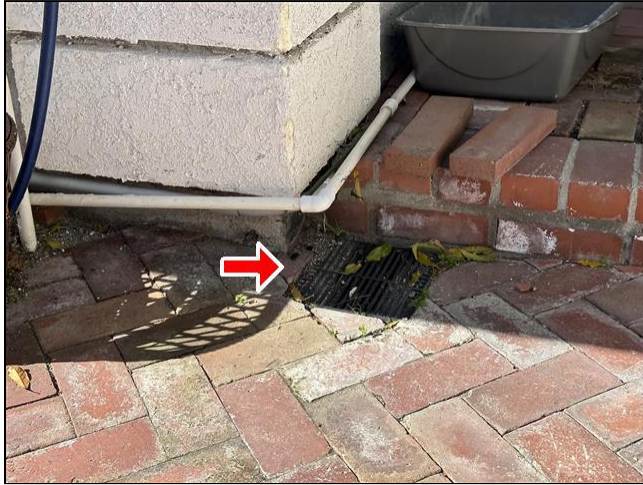
2.4 Item 10(Picture) Exterior

(8) **Monitor:** The property drainage system was not water-tested during the inspection. We make no representations as to its nature or effectiveness. The operation of the drainage system should be observed during adverse weather. Inquires should be made to the seller(s) as to their knowledge of its past and present

condition.

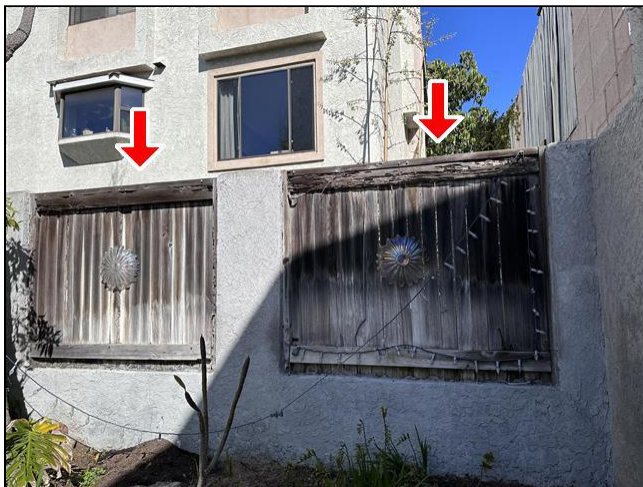
2.6 Item 1(Picture) Exterior

Repair or Replace: Wood deterioration was observed at the exterior wooden fence throughout. The wood fence is in need of replacement.

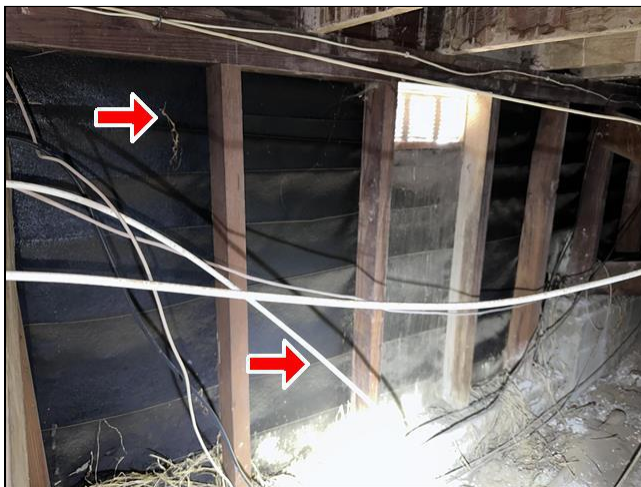
3.0 Item 1(Picture) Structural Components

(1) **Safety Issue/Repair/Replace:** The cripple walls at the **front unit** have not been reinforced. It is suggested that the foundation be improved/retrofitted with approved structural hardware and cripple walls be reinforced by a qualified professional. The primary purpose of earthquake retrofitting is to keep your home from being displaced from its concrete foundation and cripple walls from movement - making the building safer and less prone to major structural damage during an earthquake. Existing homes need to be retrofitted because our understanding of the effects of earthquakes as well as construction techniques have improved after the homes were built.

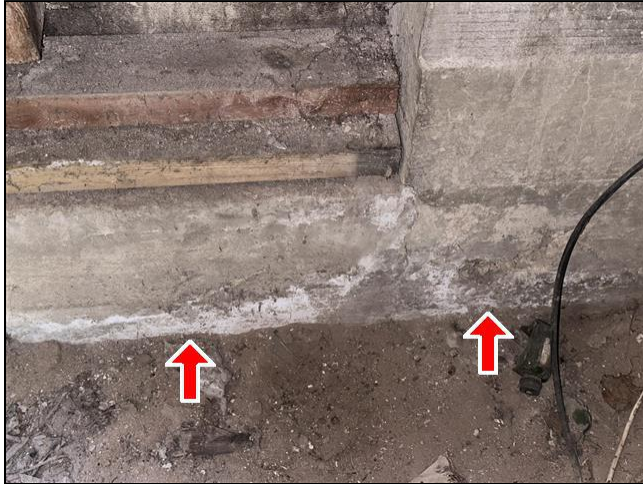
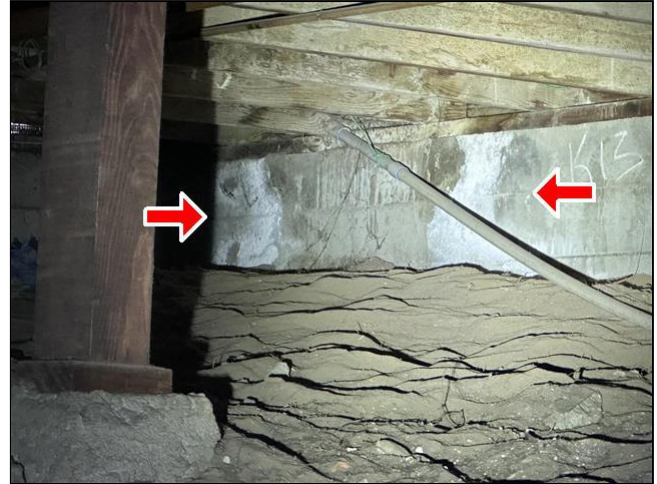
(2) **Improve/Monitor:** A condition known as efflorescence is evident on portions of the concrete foundation walls or slab. This whitish, fuzzy material is a mineral deposit left when moisture in the concrete evaporates. The presence of efflorescence often indicates an occasional surplus of moisture on the outside of the foundation. We suggest to keep the exterior moisture to a minimum, exterior surface drainage, including downspout water, should be directed as far away from the building as possible. Landscape watering should always be directed away from the building and limited to short durations.

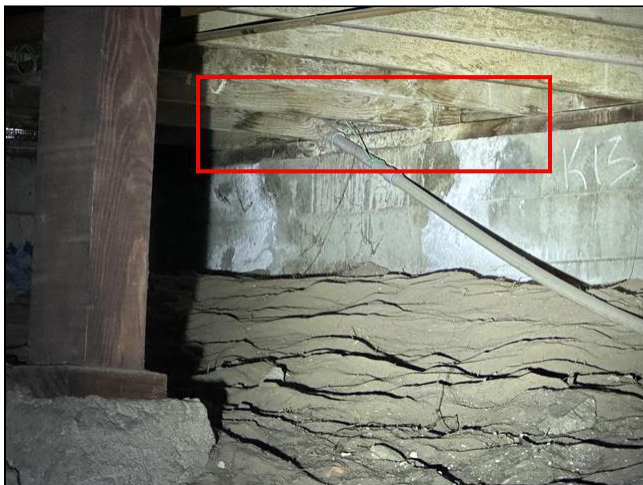
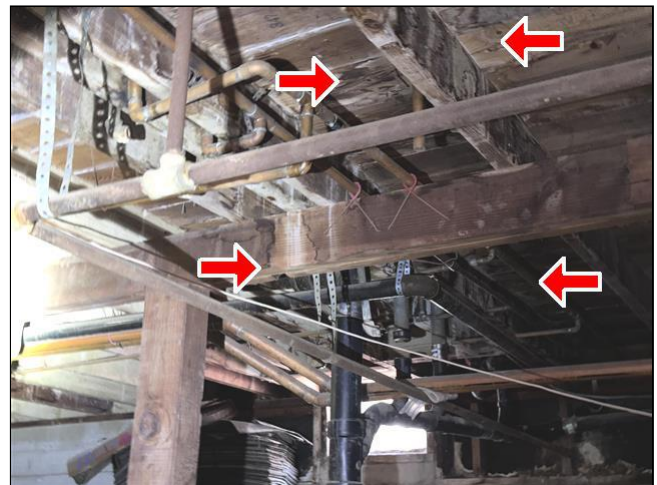
(1) **Improve:** Water staining, possible wood deterioration and possible fungus was observed at the **front unit** subfloor and framing in one or more locations. It is suggested that the subfloor below bathrooms be further evaluated by a qualified contractor to determine if wood subfloors or in need of repair and or replacement.

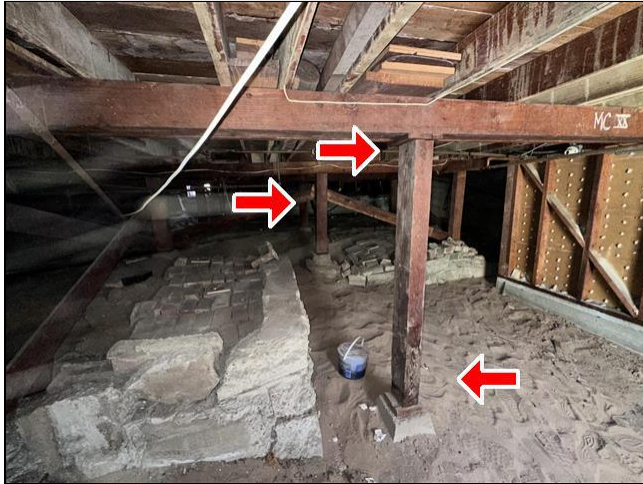
3.2 Item 3(Picture) Structural Components

(2) **Improve:** The girder and post connections are not reinforced according to modern standard building

practice. No adverse effects resulting from this condition are noted. We suggest as an up-grading these connections would be considered optional.

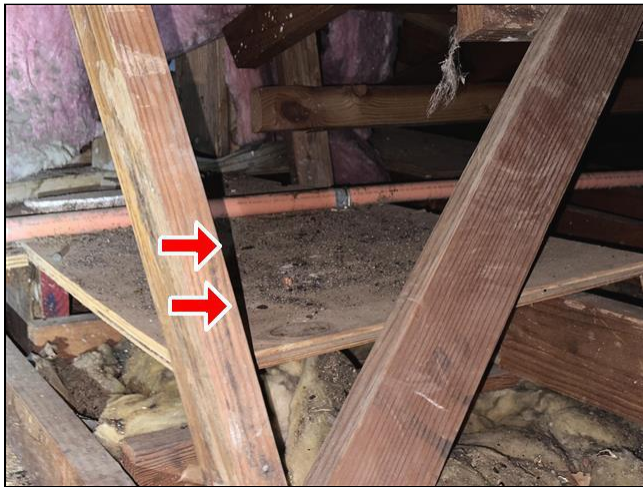
3.5 Item 1(Picture) Structural Components

(1) **Improve/Safety Issue:** Evidence of rodents was found in the form of feces was observed in the **front unit** attic space of the home. Consult with the property owner about this. A qualified person should make repairs to seal openings in the structure, set traps, and clean rodent waste as necessary. Future costs could be incurred from prior rodent damage not visible at time of inspection.

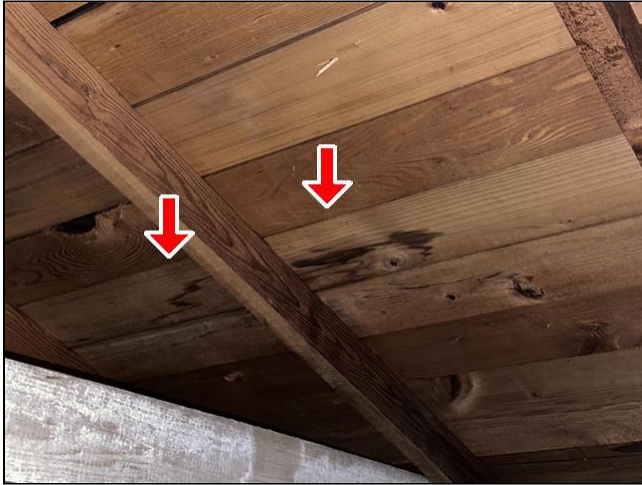
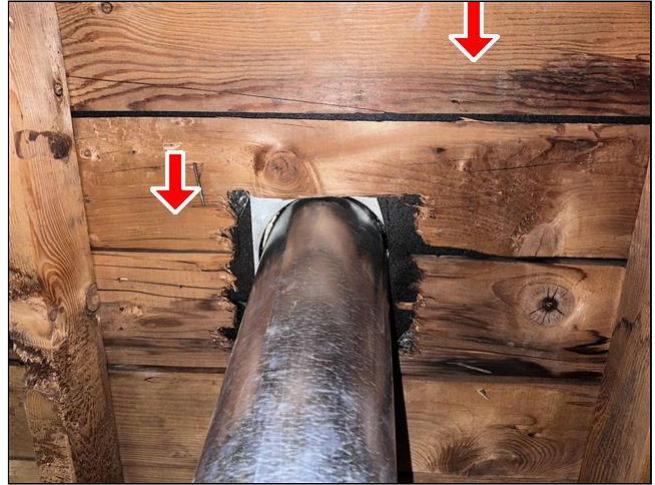
(2) **Monitor:** Water staining was observed on the underside of the **front unit** roof sheathing and structure in various locations. We suggest asking the owner to provide you with information about the leak(s), and what corrective action (if any) was taken to repair the leak(s). Then if additional damage develops, the source of the leak(s) should be identified and repairs performed as necessary.

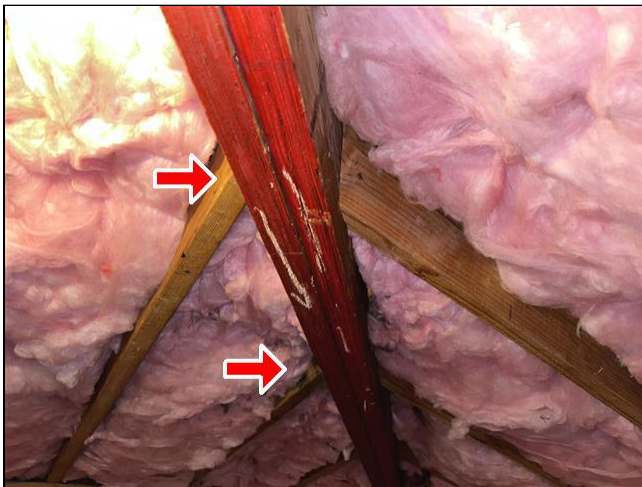
3.5 Item 3(Picture) Structural Components

(3) **Repair or Replace:** Signs of possible wood deterioration was observed at the **rear unit** roofing structure. If the home inspection reveals signs of damage you should have a pest control company inspect further for activity and possible hidden damage. Suggest repair/replacement of all deteriorated wood by a licensed contractor.

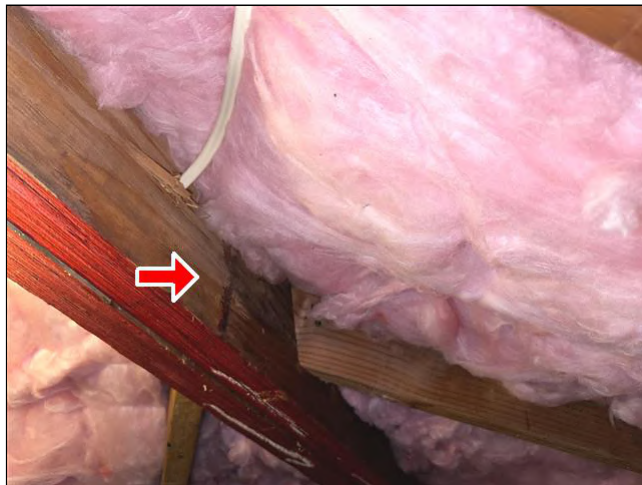
3.5 Item 5(Picture) Structural Components

(4) **Monitor:** Water staining was observed at the **rear unit** attic space platform and roof structure. We suggest asking the owner to provide you with information about the leak(s), and what corrective action (if any) was taken to repair the leak(s). Then if additional damage develops, the source of the leak(s) should be identified and repairs performed as necessary.

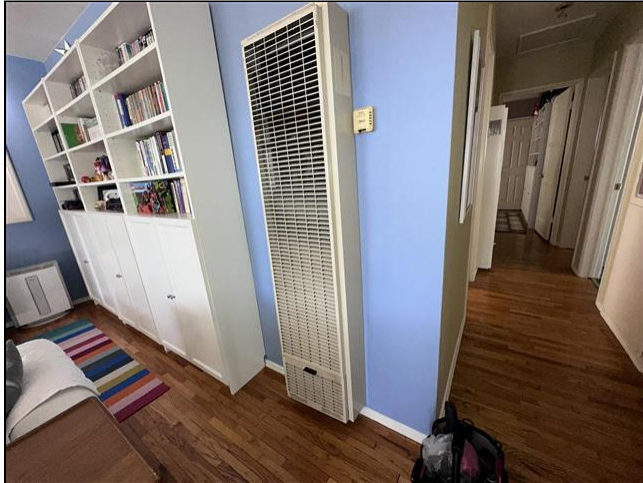
4.0 Item 1(Picture) Heating/Central Air

(1) **Repair/Replace/Monitor:** The **front unit** wall heater is at or approaching the end of its service life. The wall heater is 30+ years old. The wall heater can fail at any time. Eventual replacement of this system should be anticipated. - A qualified HVAC contractor can inspect the system and provide you with replacement options and costs.

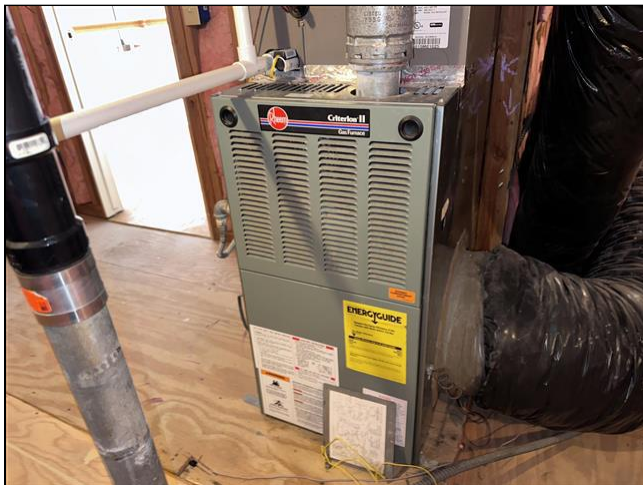
4.0 Item 2(Picture) Heating/Central Air

(2) **Repair/Replace/Monitor:** The **rear unit** forced air heater is at or approaching the end of its service life. The wall heater is 20+ years old. The wall heater can fail at any time. Eventual replacement of this system should be anticipated. - A qualified HVAC contractor can inspect the system and provide you with replacement options and costs.

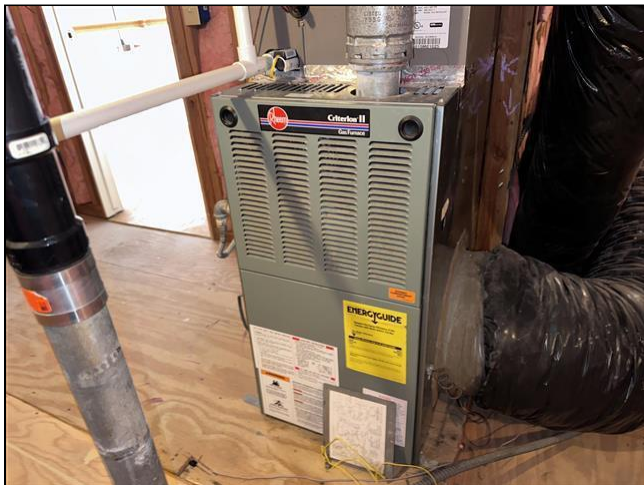
4.0 Item 6(Picture) Heating/Central Air

(5) **Monitor:** The **rear unit** forced air heater was operational and produced heat at time of inspection. However, due to the many components that are not visible (such as the heat exchanger and the entire length of the flue pipe), our inspection of the system is limited. Because of this, we recommend further evaluation/ safety check be performed by the local gas company before the end of your contingency period.

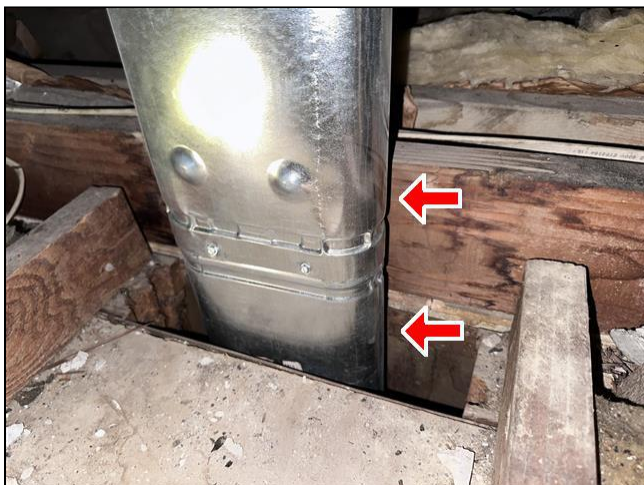
4.3 Item 1(Picture) Heating/Central Air

(1) **Safety Issue:** The **front unit** wall heater metal exhaust vent does not have safe clearance from combustible material. The metal vent is in contact with the underside of the roof sheathing and wall frame. Suggest further review and conforming installation by a licensed HVAC contractor.

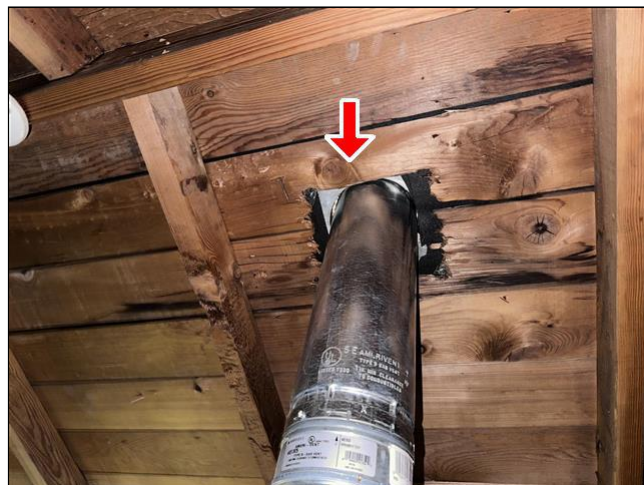
4.3 Item 2(Picture) Heating/Central Air

(2) **Monitor:** The older ceramic exhaust flue at the **front unit** living room wall heater may contain Asbestos. This can only be verified by laboratory analysis. The Environmental Protection Agency (E.P.A.) reports that asbestos represents a health hazard if "friable" (damaged, crumbling, or in any state that allows the release of fibers). Suggest further review, testing and removal by a qualified professional.

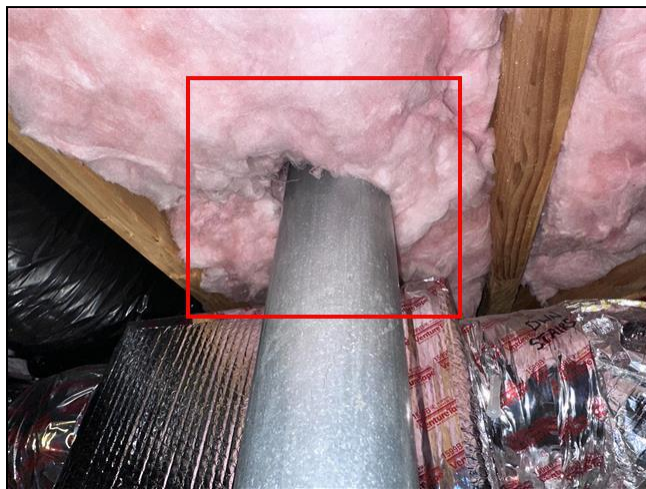
4.3 Item 4(Picture) Heating/Central Air

(3) **Monitor:** Insulation on the underside of the **rear unit** roof sheathing prevents view of the heater vent penetration.

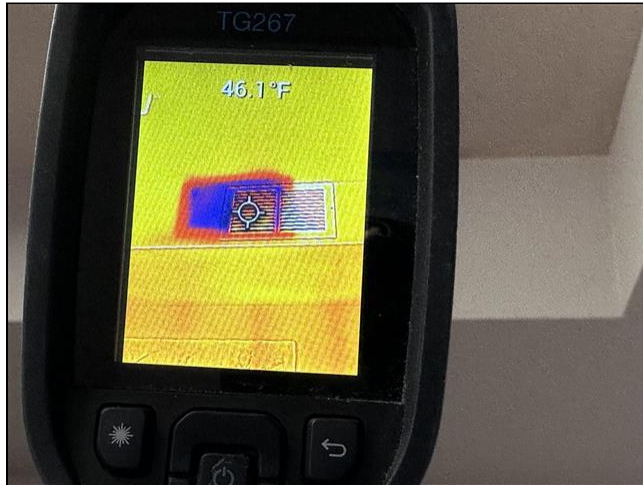
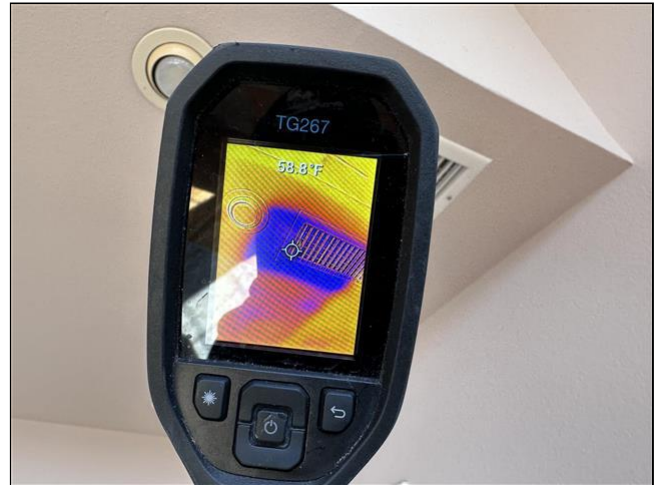
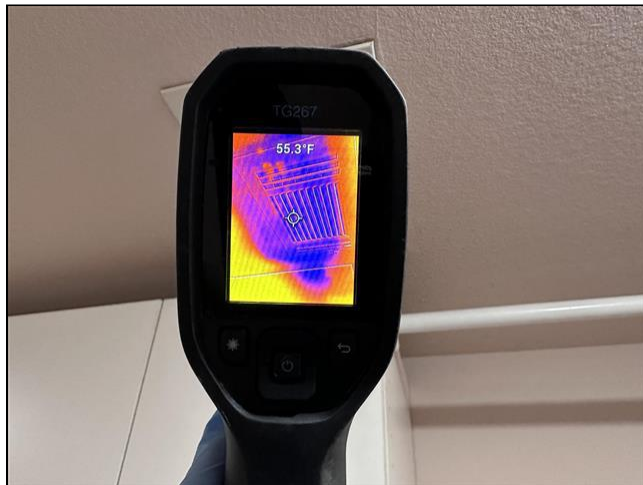
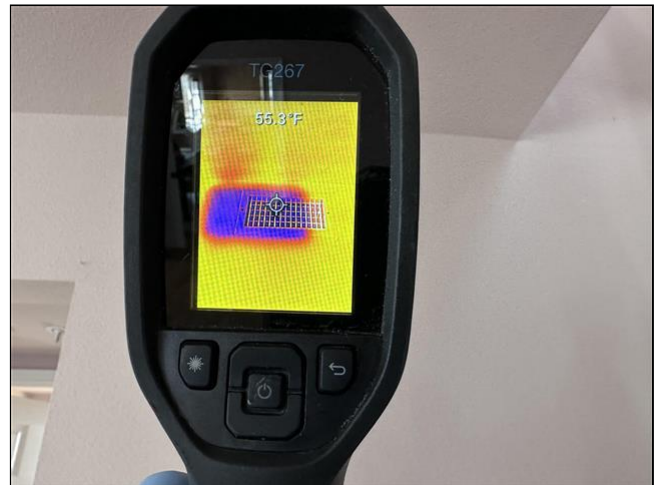
4.7 Item 1(Picture) Heating/Central Air

(1) **Repair or Replace:** The **rear unit** air conditioning system did not provide sufficient drop in temperature

(cooling) during the inspection. It is suspected that the unit is not adequately sized for the rear unit. Also, there are air supply registers at the lower bonus room area. This does not appear to be the original design of the HVAC system and can reduce the efficiency of the HVAC system. Suggest further investigations by a qualified HVAC contractor to provide repair/replacement options and cost.

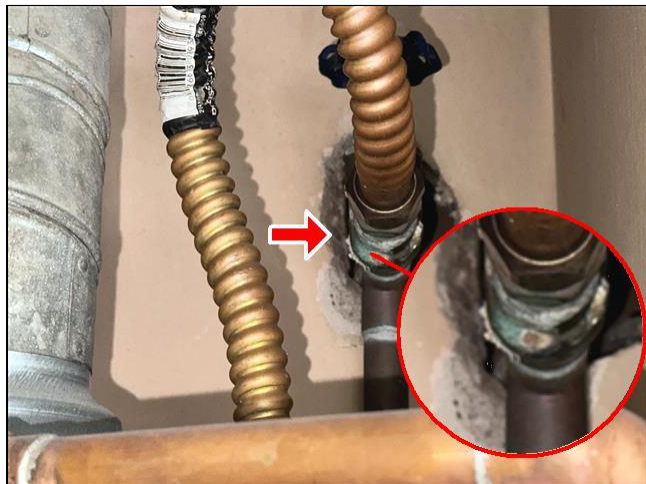
5.1 Item 1(Picture) Plumbing System

(1) **Repair or Replace:** The cold water supply valve for the **front unit** water heater is corroded. Although the valve is not leaking it is suggested that it be replaced by a qualified professional.

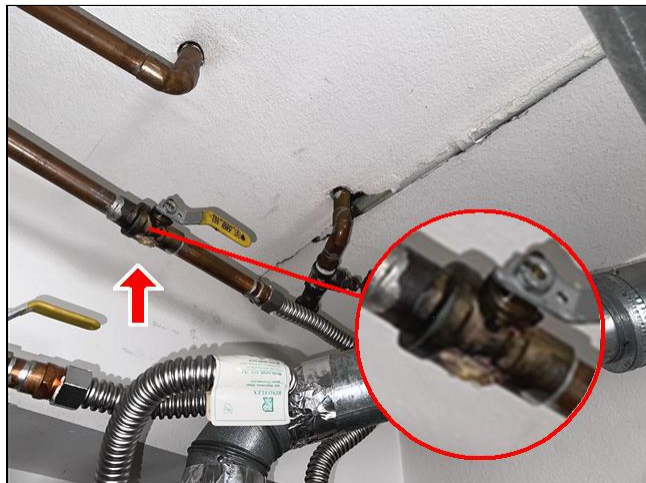
5.1 Item 2(Picture) Plumbing System

(3) **Repair or Replace:** The cold water supply valve for the **rear unit** water heater is corroded. Although the valve is not leaking it is suggested that it be replaced by a qualified professional.

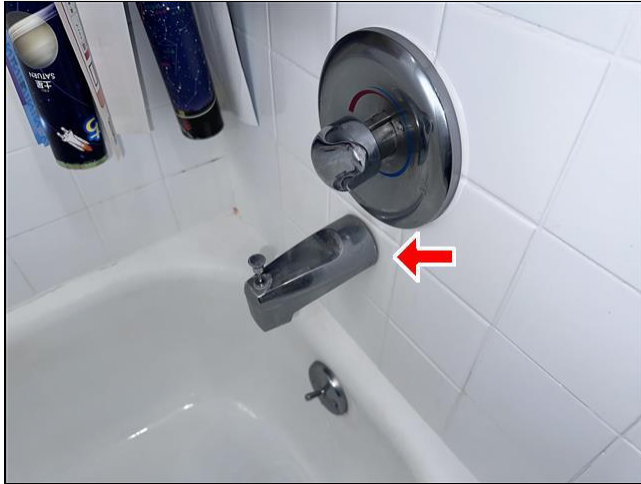
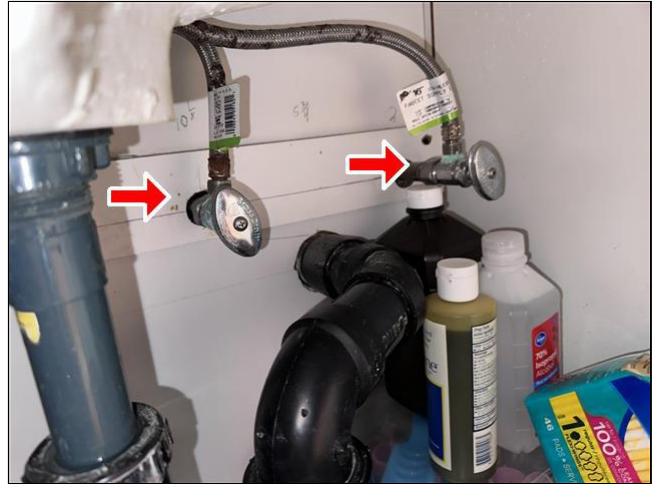
5.1 Item 3(Picture) Plumbing System

(4) **Improve:** Suggest the application of caulking between the bathroom tub spout and operation valve cover plates at the **front unit** hallway bathroom to prevent moisture damage.

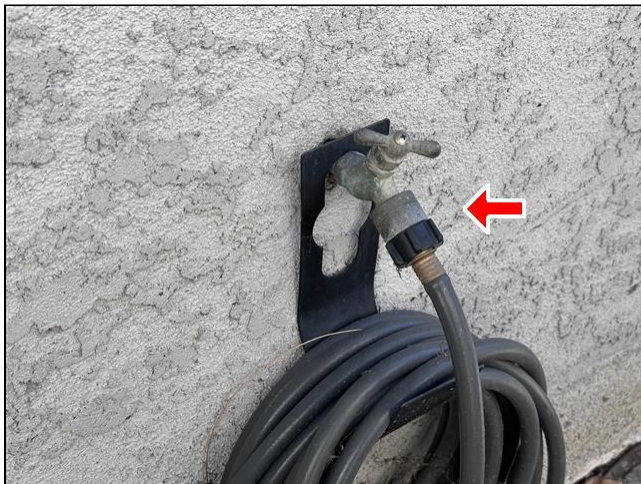
5.1 Item 5(Picture) Plumbing System

(5) **Improve:** All exterior hose bibs should provided vacuum breakers to prevent hose water from being drawn back into the home's water supply system.

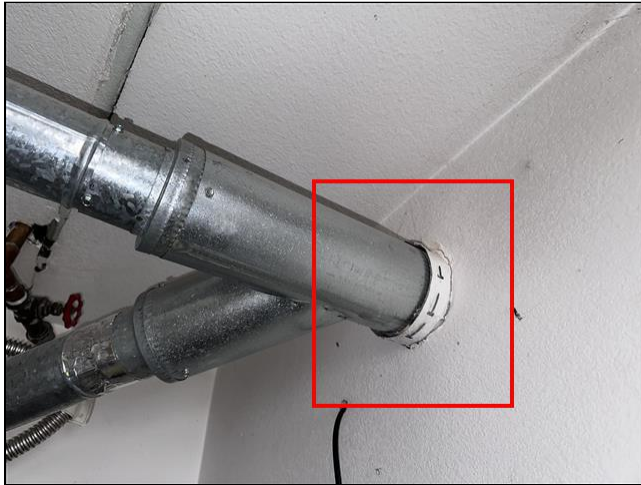
5.2 Item 1(Picture) Plumbing System

(1) **Safety Issue:** The **rear unit** water heater(s) vent passes through a ceiling or wall without the use of an approved thimble or spacer. This could be a fire hazard. We suggest a qualified technician should install an approved, listed thimble or spacer.

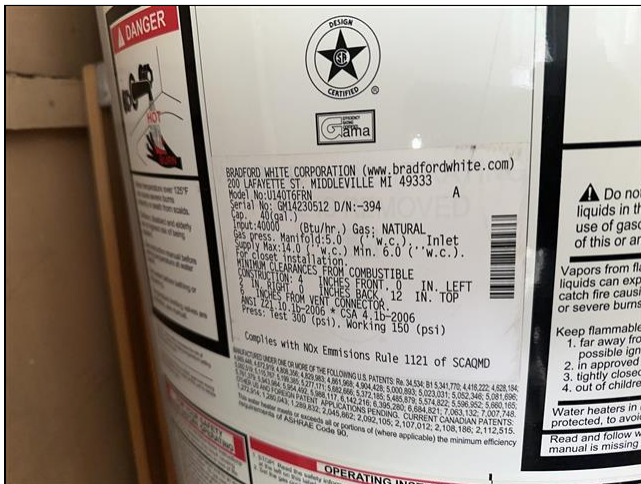
5.2 Item 2(Picture) Plumbing System

(2) **Repair/Replace/Monitor:** The **front unit** water heater is an older unit. The water heater may be nearing the end of its service life. Typical life expectancy of water heaters is 7 to 12 years. The existing unit is 13 years old. It is difficult to determine when replacement will be necessary. Suggest replacement of the water heater by a licensed and qualified plumber.

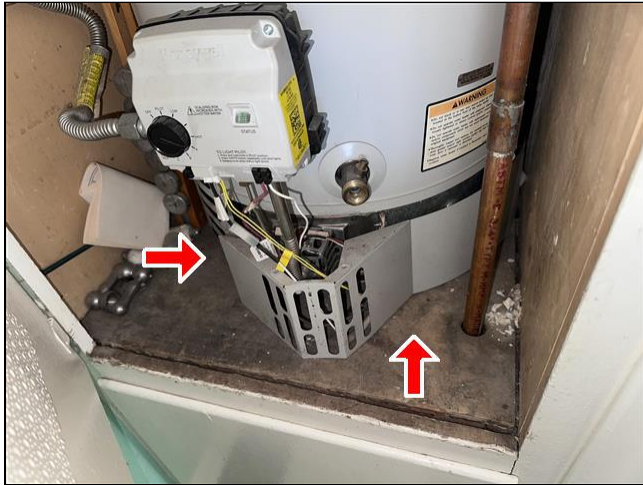
5.2 Item 3(Picture) Plumbing System

(3) **Improve:** There is no catch pan installed under the **front unit** water heater. A pan is required by the plumbing standards when the appliance is located in an area where a leak could damage the structure. - Installation of a pan and drain pipe to the exterior should be done by a qualified technician.

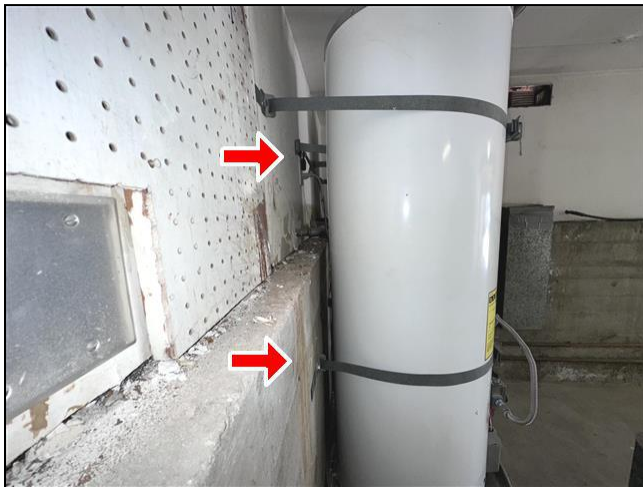
5.2 Item 4(Picture) Plumbing System

(4) **Safety Issue:** The water heaters at the **rear unit** garage are not "rigidly" reinforced (there is a gap between the unit and the walls) - "blocking" or equivalent is needed to prevent earthquake movement. Suggest further review and repairs by a licensed plumber.

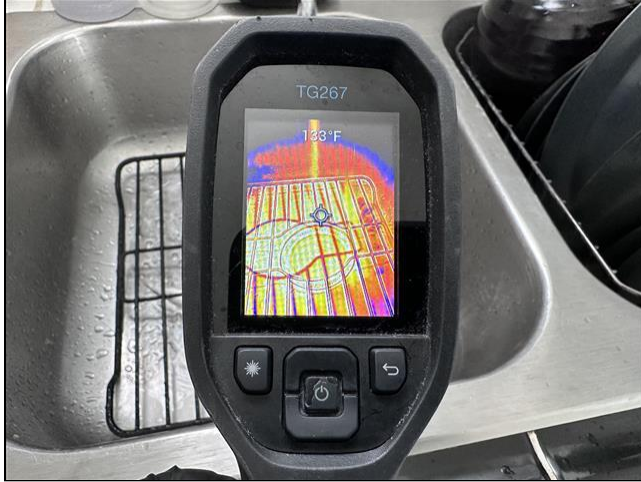
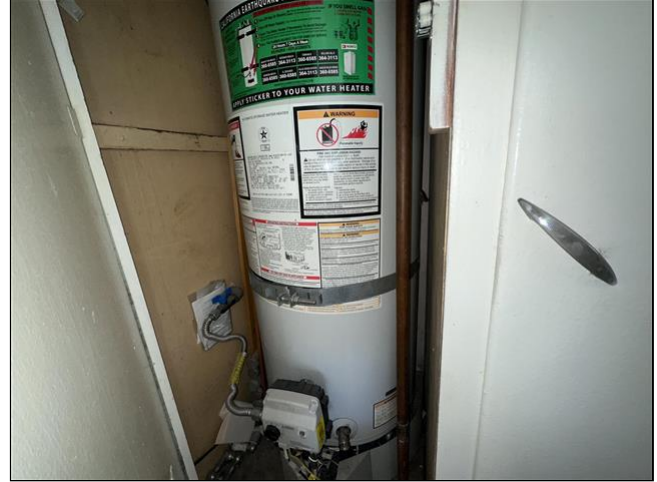
5.2 Item 5(Picture) Plumbing System

(6) **Note/Monitor:** The **front unit** water heater was operational and produced hot water at time of inspection.

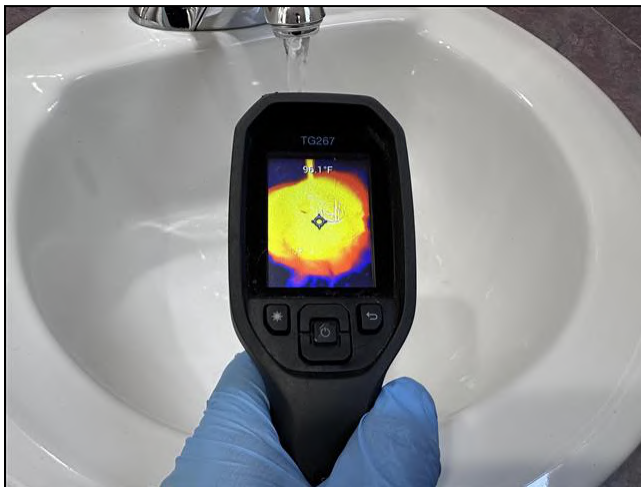
5.2 Item 7(Picture) Plumbing System

(7) **Note/Monitor:** The **rear unit** water heaters were operational and produced hot water at time of inspection.

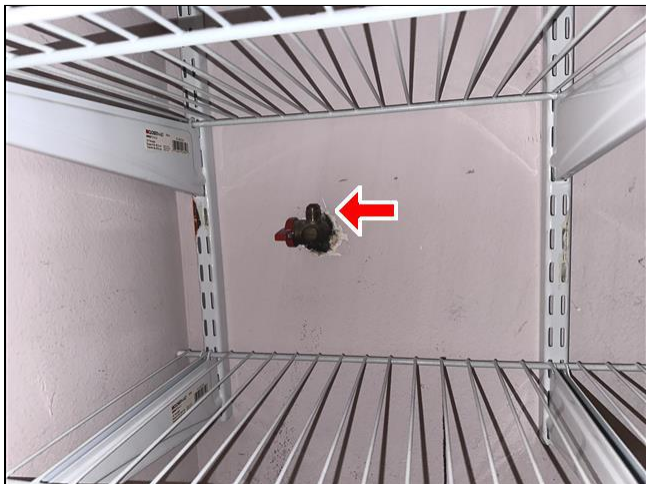
5.4 Item 1(Picture) Plumbing System

(1) **Safety Issue:** The gas valve at the **rear unit** second floor hallway laundry closet has not been capped. The valve should be covered with a cap/cover when not in use.

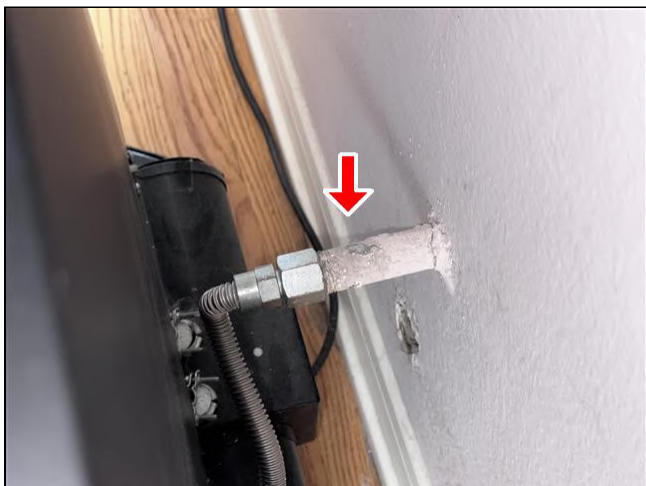
5.4 Item 2(Picture) Plumbing System

(2) **Safety Issue:** The gas supply pipe at the **rear unit** living room fireplace lacks a shut off valve. This is a safety concern. Suggest the installation of a shut off valve by a qualified professional.

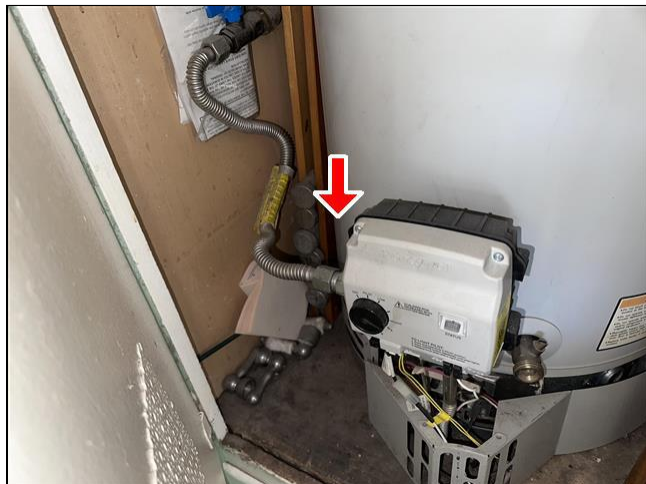
5.4 Item 3(Picture) Plumbing System

(3) **Improve:** The gas supply pipe at the **front unit** water heater lacks a sediment trap. It is suggested that one be installed by a licensed plumber.

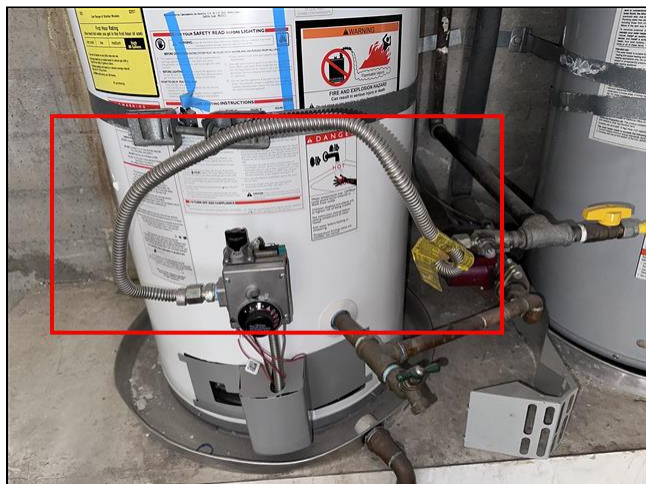
5.4 Item 4(Picture) Plumbing System

(4) **Improve:** The gas supply pipe at the **rear unit** left side water heater lacks a sediment trap. It is suggested that one be installed by a licensed plumber.

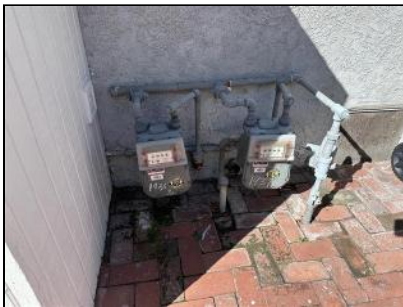
5.5 Item 2(Picture) Plumbing System

(2) **Improve:** The main gas meters lack a seismic shut off valve. It is suggested that one be installed by a licensed plumber as needed and required.
