Inspection Report

Property Address:
1931 Ruhland Ave
Redondo Beach CA 90278

Professional Inspection Network

Property Address 1931 Ruhland Ave Redondo Beach CA 90278	Date of Inspection 2/15/2023	Report ID 20230215-1931-Ruhland-Ave
Customer(s) Sanjeev Bhatia	Time of Inspection 09:00 AM	Real Estate Agent Linda Hernandez Shorewood Realtors

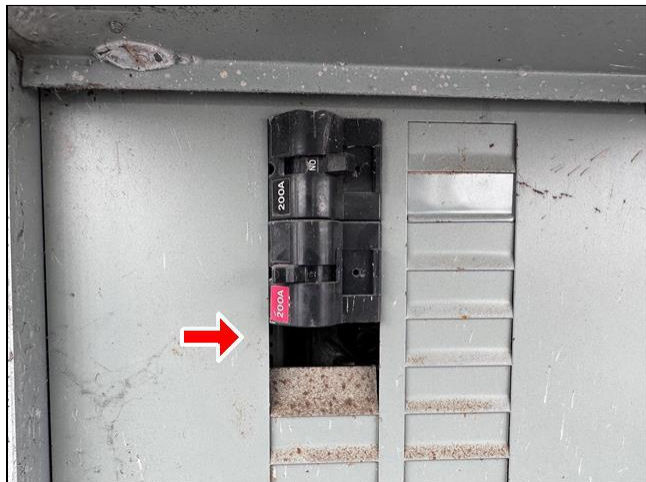
6.0 Item 1(Picture) Electrical System

(1) **Safety Issue:** It is suggested that all openings at the West exterior wall main electrical panel for the rear unit be covered with plastic covers.

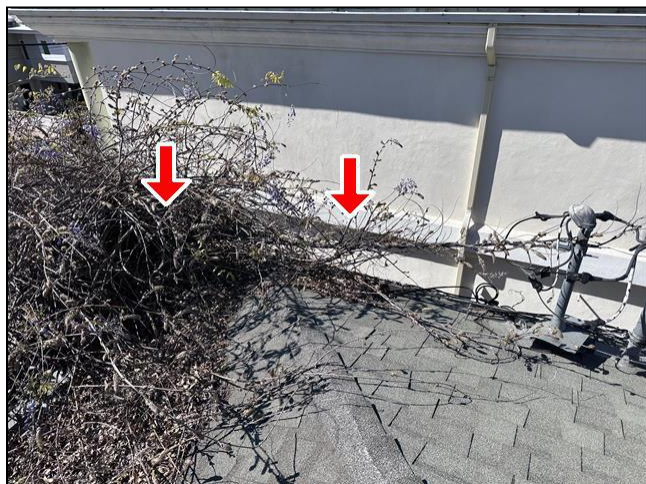
6.0 Item 2(Picture) Electrical System

(2) **Safety Issue:** Suggest trimming away tree limbs/vegetation from the main electrical service entrance wires at the front of the property.

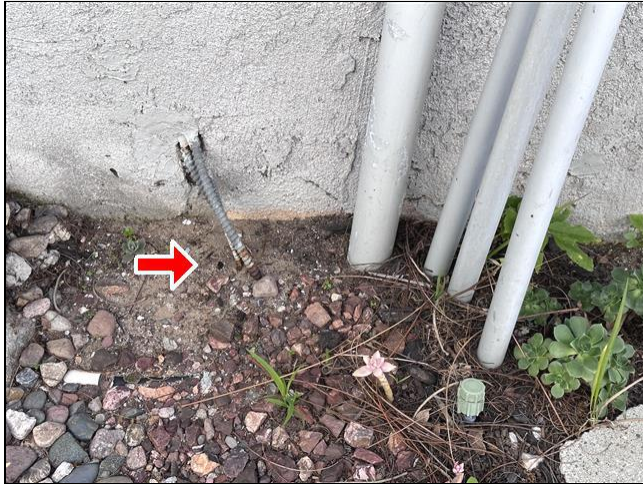
6.0 Item 3(Picture) Electrical System

(3) **Monitor:** Unable to verify the grounding connections for the electrical panels at the West exterior wall. This should be further investigated by a qualified electrician to verify conforming grounding of the electrical systems.

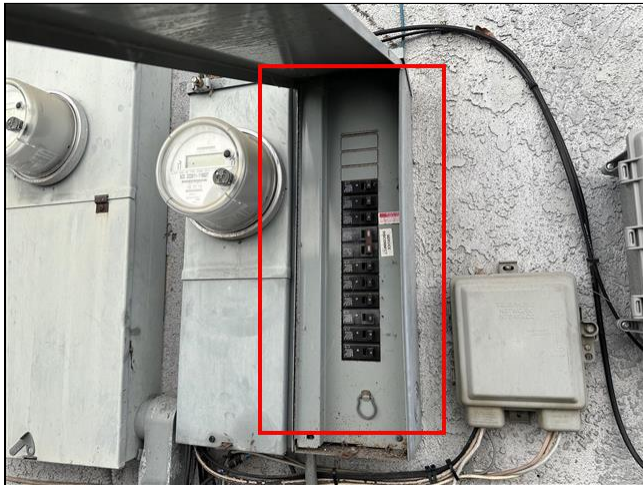
6.1 Item 1(Picture) Electrical System

(1) **Safety Issue:** Two circuit conductors within the **front unit** main distribution panel are doubled up (referred to as "double taps") to a single breaker and must be separated. Each circuit conductor is to be served by a separate breaker; suggest repairs by a licensed electrical contractor.

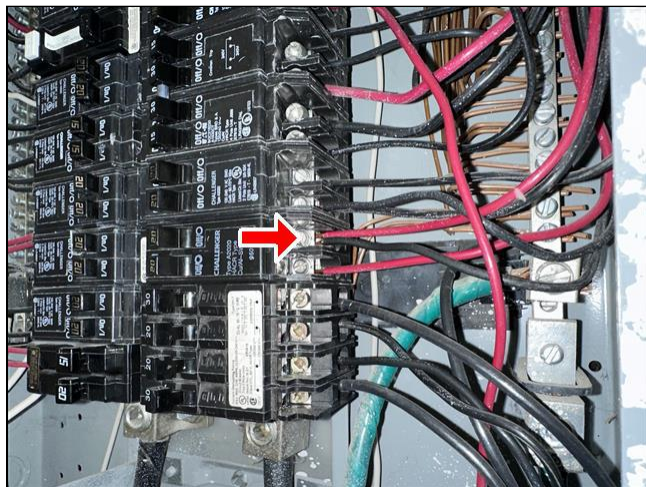
6.1 Item 2(Picture) Electrical System

(2) **Safety Issue:** Two circuit conductors within the **rear unit** main distribution panel are doubled up (referred to as "double taps") to a single breaker and must be separated. Each circuit conductor is to be served by a separate breaker; suggest repairs by a licensed electrical contractor.

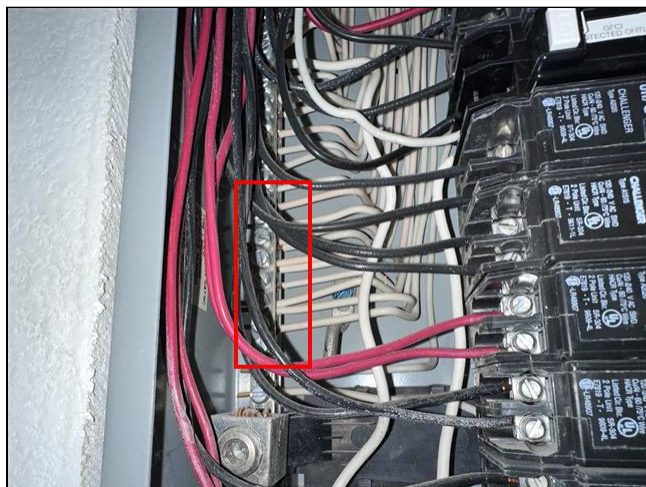
6.1 Item 3(Picture) Electrical System

(3) **Safety Issue:** Double tapped neutral wires were observed at the **rear unit** main electrical panel neutral bus bar. When more than one neutral wire is fed into a single screw/terminal on the neutral bus bar, the connections can become loose. When there are loose connections in your main panel from a double tapped neutral like this, they can cause overheating or arcing, which can then lead to shock, and an electrical fire. Suggest repair/replacement by a qualified professional.

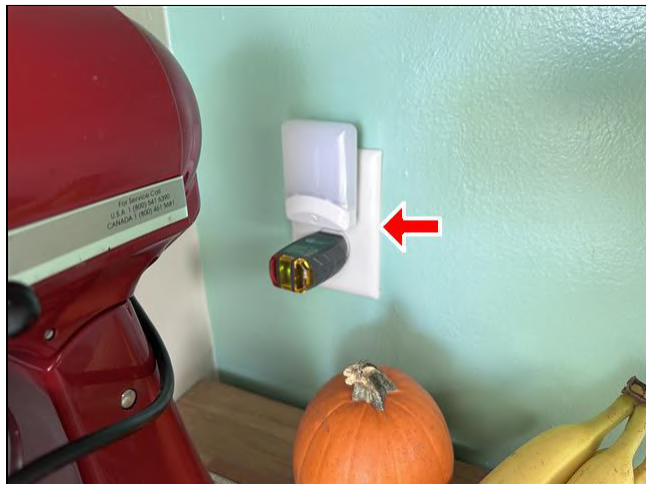
6.2 Item 1(Picture) Electrical System

(1) **Safety Issue:** The **front unit** kitchen countertop electrical outlet lacks GFCI (Ground Fault Circuit Interrupter) protection. Suggest the installation of a GFCI outlet by a qualified electrician.

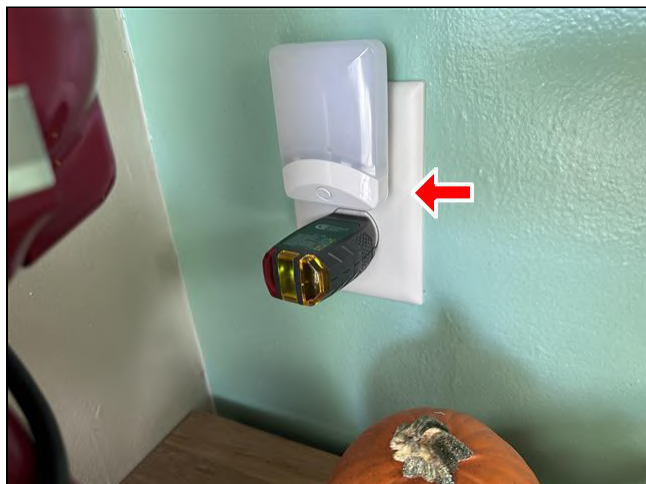
6.2 Item 2(Picture) Electrical System

(2) **Safety Issue:** The three prong electrical outlets at the **front unit** kitchen countertop are not grounded. Suggest further review and grounding of the outlets by a qualified electrician.

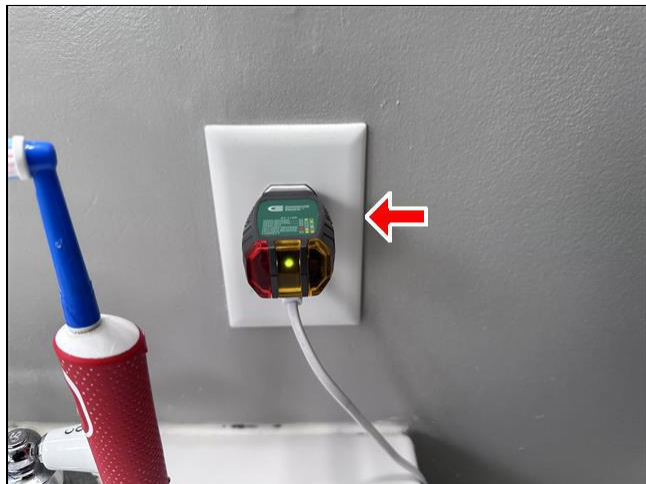
6.2 Item 3(Picture) Electrical System

(3) **Safety Issue:** The **front unit** hallway bathroom electrical outlet lacks GFCI (Ground Fault Circuit Interrupter) protection. Suggest the installation of a GFCI outlet by a qualified electrician.

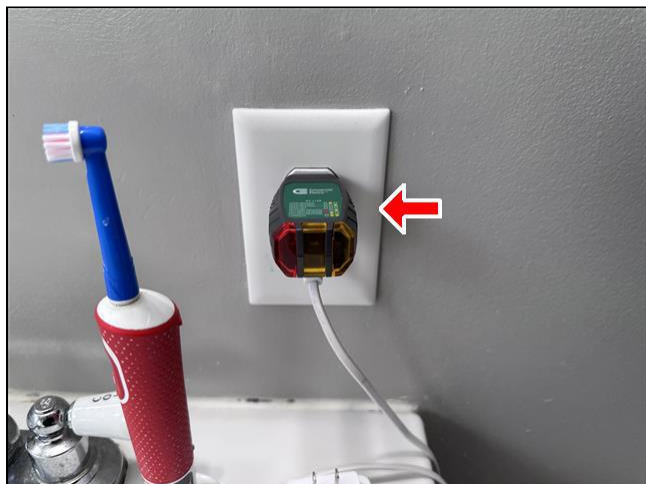
6.2 Item 4(Picture) Electrical System

(4) **Safety Issue:** The three prong electrical outlet at the **front unit** hallway bathroom is not grounded. Suggest further review and grounding of the outlets by a qualified electrician.

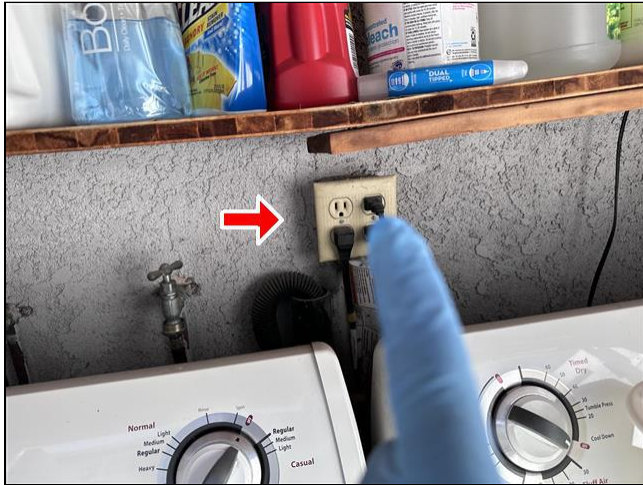
6.2 Item 5(Picture) Electrical System

(5) **Safety Issue:** The installation of ground fault circuit interrupter (GFCI) devices is advisable at all exterior and garage outlets. GFCI's are strongly recommended. A ground fault circuit interrupter (GFCI) offers protection from shock or electrocution; suggest repairs by a licensed electrical contractor.

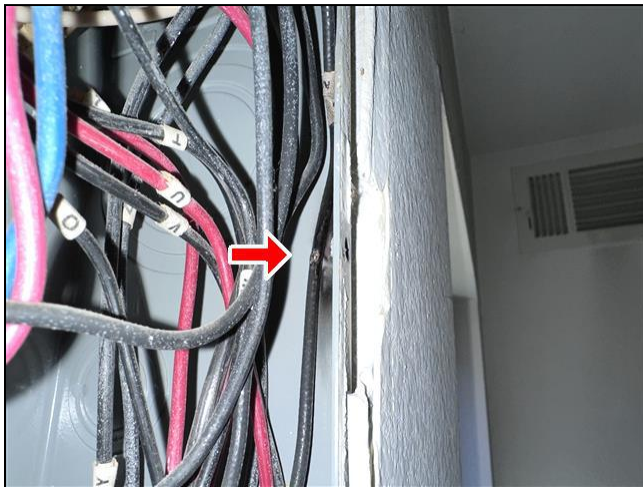
6.2 Item 6(Picture) Electrical System

(6) **Safety Issue:** Upon removing the top right side screw for the **rear unit** electrical panel, the screw cut the wire insulation and tripped the circuit for the distribution wire. Suggest further review and repair by a qualified electrician.

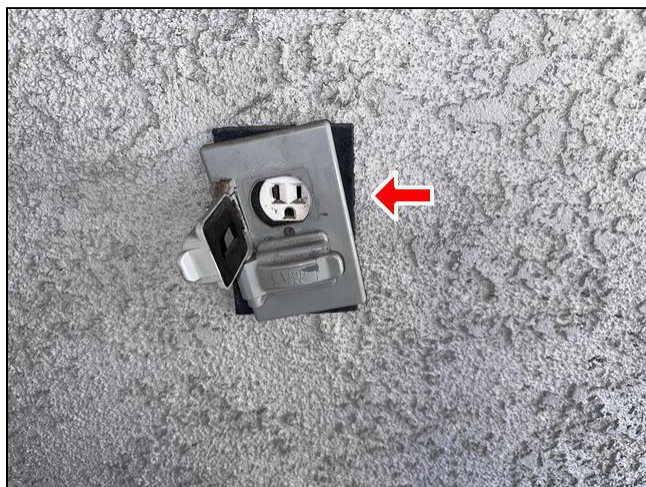
6.2 Item 7(Picture) Electrical System

(7) **Safety Issue:** The electrical outlet cover at the carport exterior wall is loose. Suggest repair.

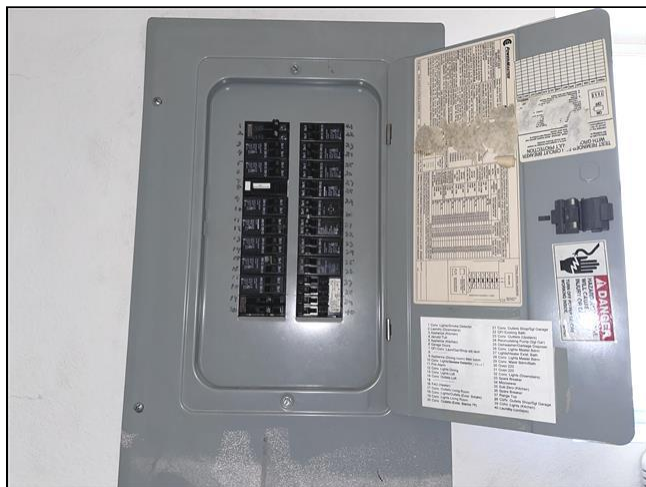
6.6 Item 1(Picture) Electrical System

Improve: It should be noted that the building's electrical systems are not equipped with branch circuit Arc-Fault-Interrupter protection device(s) controlling all electrical outlets in the family room, dining room, living room, parlors, libraries, dens, bedrooms sunrooms, recreation rooms, closets, hallways, or similar rooms or areas. It is recommended that consideration be given to having this important electrical protection installed by a qualified electrician.

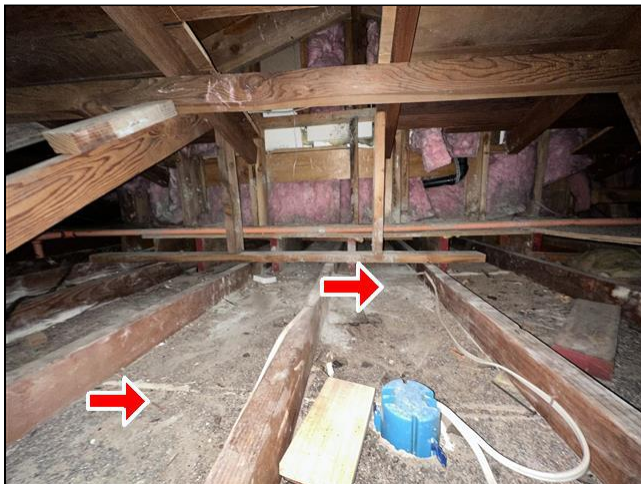
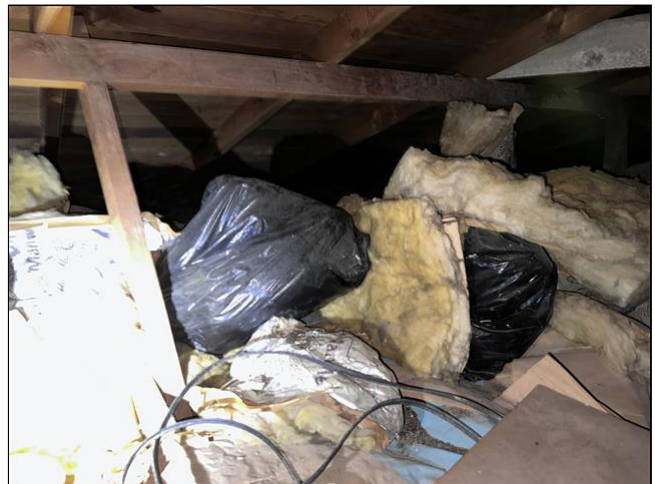
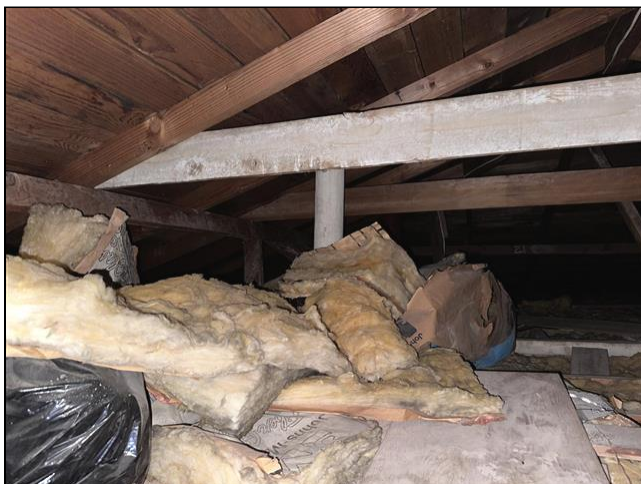
Repair or Replace: The front unit insulation is inconsistent. Insulation should be evenly distributed throughout the attic space. Suggest repair/replacement of the insulation by a qualified professional.

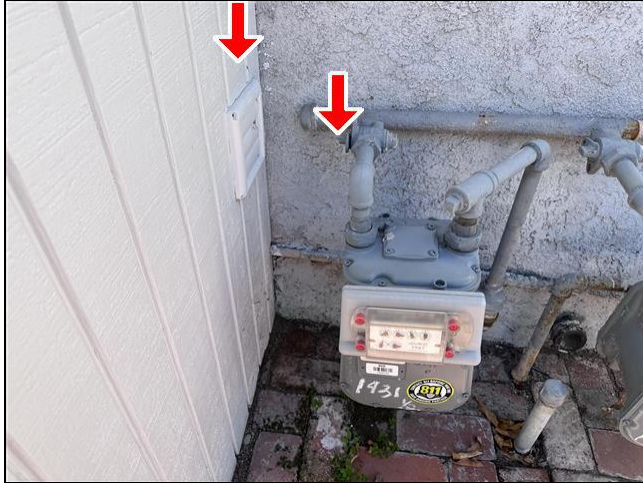
7.4 Item 1(Picture) Insulation & Ventilation

(1) **Safety Issue:** The **front unit** laundry dryer vent terminates in close proximity to the gas meters at the East exterior wall. The minimum distance of three feet clearance from the gas meter to the clothes dryer intake or exhaust vent opening is required. Suggest relocating the laundry dryer vent by a qualified professional.

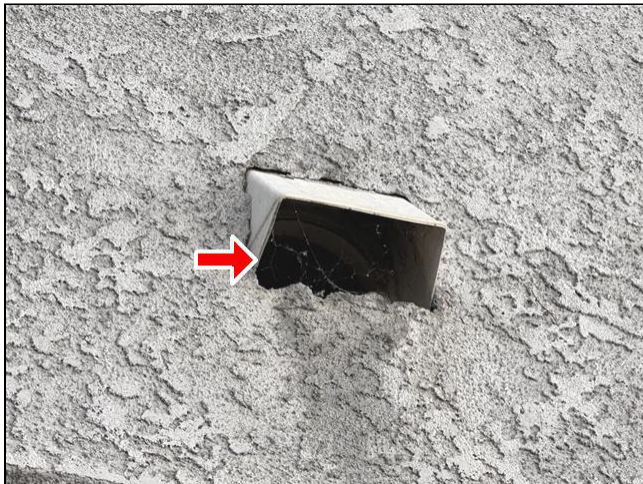
7.4 Item 2(Picture) Insulation & Ventilation

(2) **Repair or Replace:** The **front unit** primary bathroom exhaust vent opening lacks a baffle. Suggest further review and repair by a qualified professional.

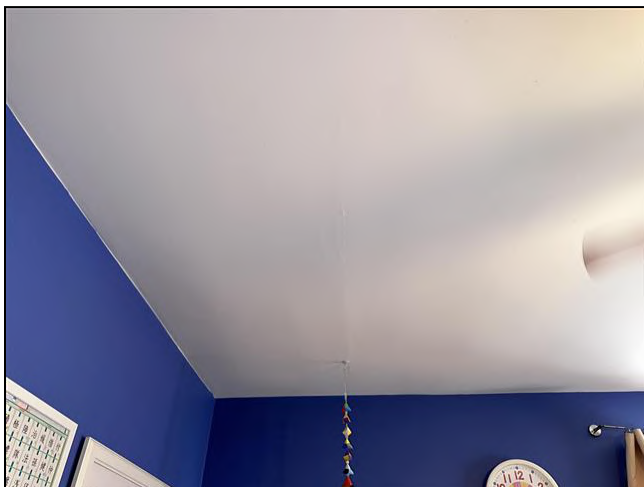
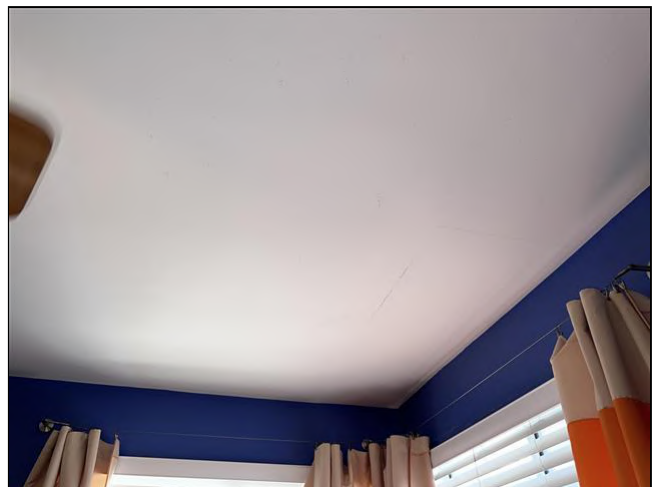
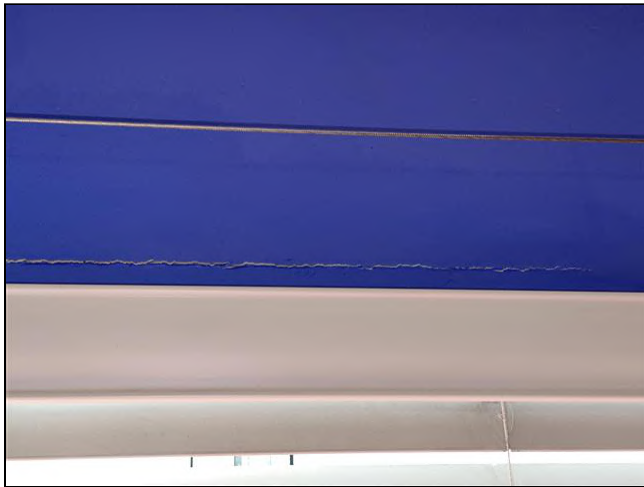
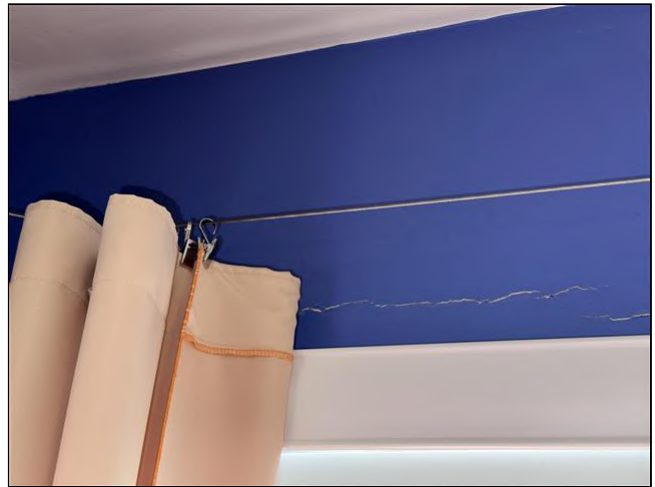
(1) **Major Concern:** Evidence of water damage/roof leak was observed at the **front unit** South-East bedroom interior wall and ceiling finishes. A higher than average moisture reading was observed at the interior surfaces in various locations. The source of the leak(s) should be identified and repairs performed as necessary. Suggest referring to the Roofing section of this report regarding additional information. Areas of past and present moisture are favorable for growing many fungal like organisms. There is an extra risk of hidden damage/fungus/mold to be present in this location. The identification of molds, fungus and other microbial organisms is outside the scope of this inspection. We suggest a qualified environmental specialist should be retained to evaluate the surfaces and make further recommendations. Testing and remediation of mold growth can only be accomplished by a qualified environmental specialist. If strict protocol is not followed, spores can be released into the interior of the building and may create a health hazard for those with low tolerances to such organisms.

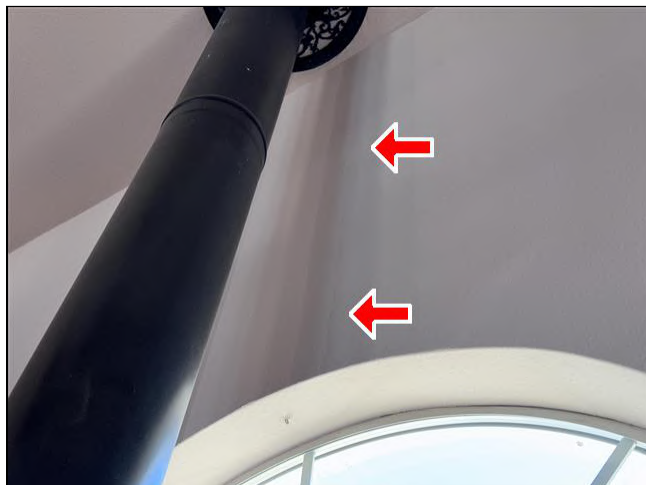
8.1 Item 10(Picture) Interiors

(2) **Repair/Replace/Monitor:** Evidence of water intrusion/roof leak was observed at the **rear unit** living room East interior wall. It appears that the chimney is leaking. We suggest asking the owner to provide you with information about the leak(s), and what corrective action (if any) was taken to repair the leak(s). Then if additional damage develops, the source of the leak(s) should be identified and repairs performed as necessary. There is surface growth on the kitchen sink cabinet floor and sidewalls. This may indicate the presence of mold, fungus or other microbial organisms. Areas of past and present moisture are favorable for growing many fungal like organisms. There is an extra risk of hidden damage/fungus/mold to be present in this location. The identification of molds, fungus and other microbial organisms is outside the scope of this inspection. We suggest a qualified environmental specialist should be retained to evaluate the surfaces and make further recommendations. Testing and remediation of mold growth can only be accomplished by a qualified environmental specialist. If strict protocol is not followed, spores can be released into the interior of the building and may create a health hazard for those with low tolerances to such organisms.

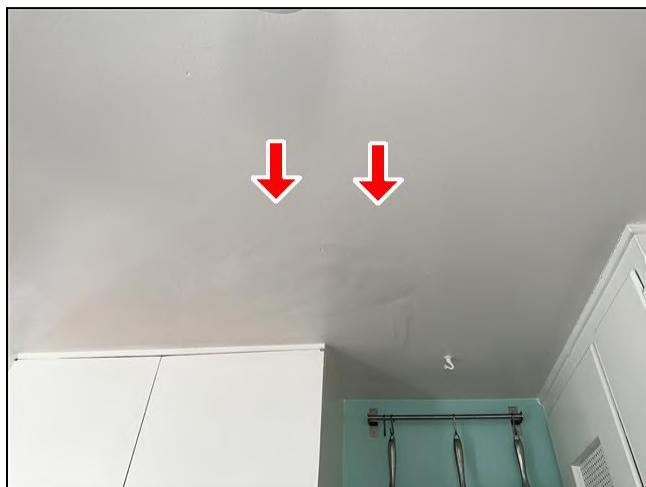
8.1 Item 11(Picture) Interiors

(3) **Improve/Monitor:** Evidence of patching was observed at the **front unit** kitchen interior ceiling finishes. However, we found no sign of active leaks. We suggest asking the owner to provide you with information about the leak(s), and what corrective action (if any) was taken to repair the leak(s). Then if additional damage develops, the source of the leak(s) should be identified and repairs performed as necessary. Areas of past and present moisture are favorable for growing many fungal like organisms. There is an extra risk of hidden

damage/fungus/mold to be present in this location. The identification of molds, fungus and other microbial organisms is outside the scope of this inspection. We suggest a qualified environmental specialist should be retained to evaluate the surfaces and make further recommendations. Testing and remediation of mold growth can only be accomplished by a qualified environmental specialist. If strict protocol is not followed, spores can be released into the interior of the building and may create a health hazard for those with low tolerances to such organisms.

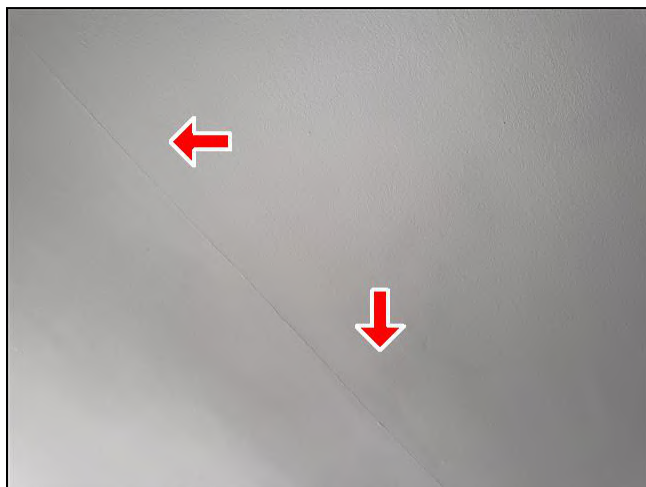
8.1 Item 12(Picture) Interiors

(4) **Improve/Monitor:** Evidence of settlement was observed at the **front unit** living room and primary bedroom interior ceiling finishes. The ceiling finishes are cracked in various locations within the home. This appears to be common settlement and/or movement with older homes. It is suggested that these areas be repaired and patched by a qualified professional and monitored for additional movement to determine if additional repairs to the home will be required.

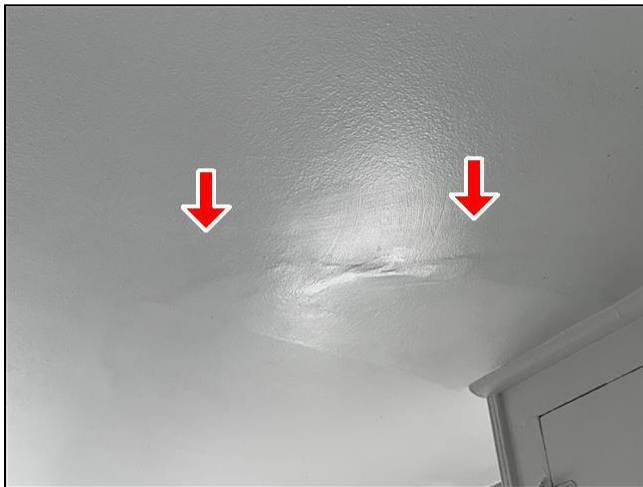
8.1 Item 13(Picture)

(5) **Improve/Monitor:** Evidence of patching was observed at the **front unit** hallway bathroom interior ceiling finishes. However, we found no sign of active leaks. We suggest asking the owner to provide you with information about the leak(s), and what corrective action (if any) was taken to repair the leak(s). Then if additional damage develops, the source of the leak(s) should be identified and repairs performed as necessary. Areas of past and present moisture are favorable for growing many fungal like organisms. There is an extra risk of hidden damage/fungus/mold to be present in this location. The identification of molds, fungus

and other microbial organisms is outside the scope of this inspection. We suggest a qualified environmental specialist should be retained to evaluate the surfaces and make further recommendations. Testing and remediation of mold growth can only be accomplished by a qualified environmental specialist. If strict protocol is not followed, spores can be released into the interior of the building and may create a health hazard for those with low tolerances to such organisms.

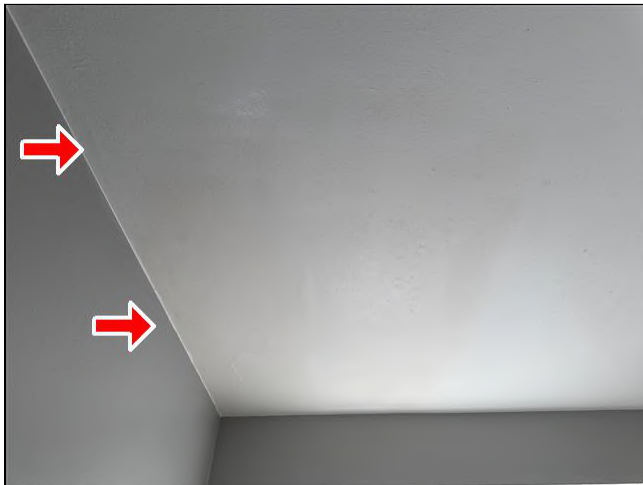
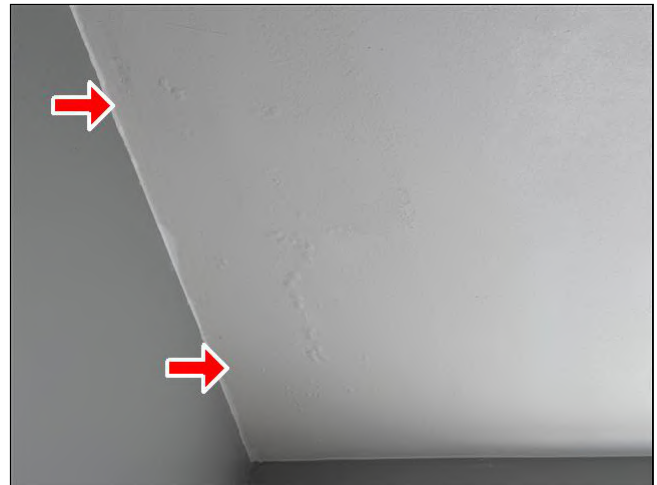
(6) **Improve/Monitor:** There is surface growth on the **front unit** hallway bathroom interior ceiling finishes. This may indicate the presence of mold, fungus or other microbial organisms. The identification of molds, fungus and other microbial organisms is outside the scope of this inspection. We suggest a qualified environmental specialist should be retained to evaluate the surfaces and make further recommendations. Testing and remediation of mold growth can only be accomplished by a qualified environmental specialist. If strict protocol is not followed, spores can be released into the interior of the building and may create a health hazard for those with low tolerances to such organisms.

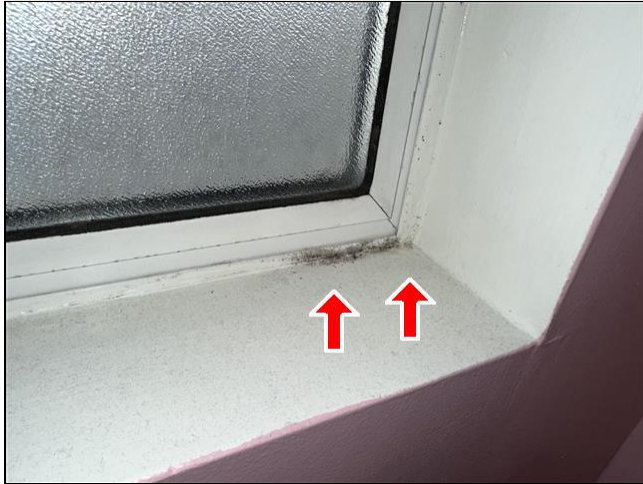
8.1 Item 16(Picture) Interiors

(7) **Improve/Monitor:** There is surface growth on the **front unit** primary bathroom interior window sill finishes. This may indicate the presence of mold, fungus or other microbial organisms. The identification of molds, fungus and other microbial organisms is outside the scope of this inspection. We suggest a qualified environmental specialist should be retained to evaluate the surfaces and make further recommendations. Testing and remediation of mold growth can only be accomplished by a qualified environmental specialist. If

strict protocol is not followed, spores can be released into the interior of the building and may create a health hazard for those with low tolerances to such organisms.

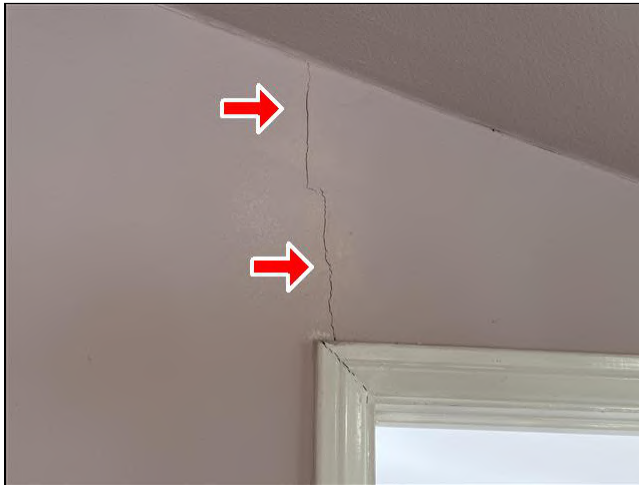
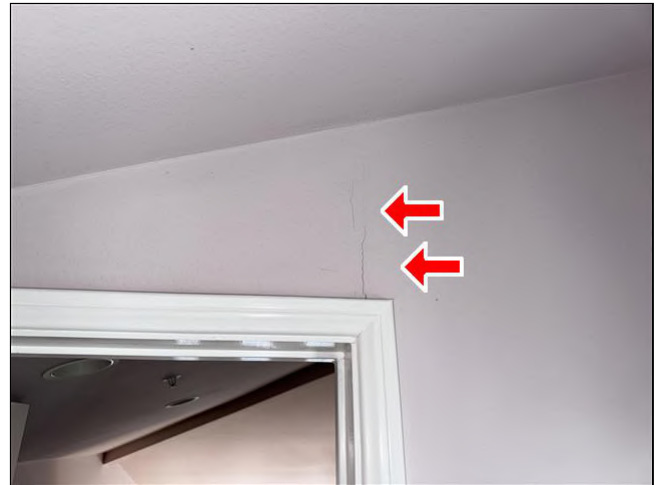
(8) **Improve/Monitor:** Evidence of settlement was observed at the **rear unit** interior ceiling finishes in one or more locations. The ceiling finishes are cracked in various locations within the home. This appears to be common settlement and/or movement with older homes. It is suggested that these areas be repaired and patched by a qualified professional and monitored for additional movement to determine if additional repairs to the home will be required.

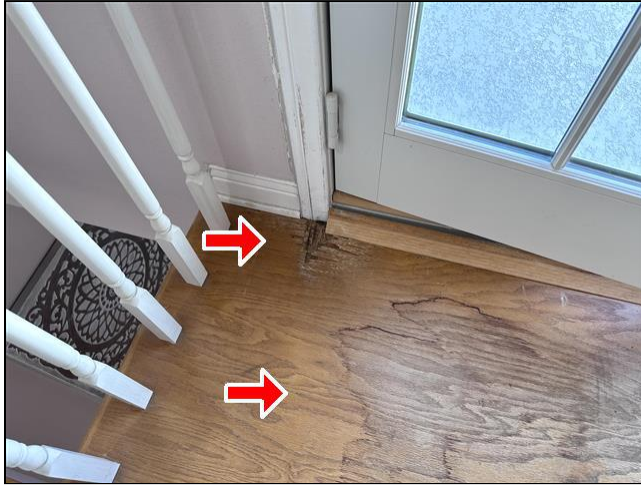
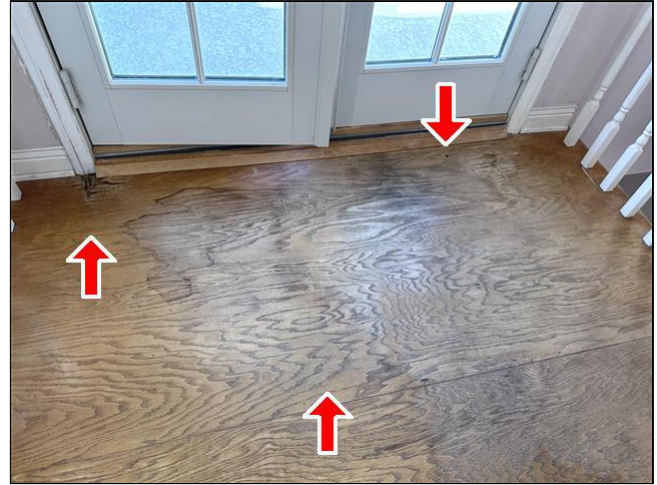
(1) **Repair or Replace:** Evidence of water damage/water leak was observed at the **rear unit** third floor area adjacent to the french doors. The floor is damaged. Areas of past and present moisture are favorable for growing many fungal like organisms. There is an extra risk of hidden damage/fungus/mold to be present in this location. The identification of molds, fungus and other microbial organisms is outside the scope of this inspection. We suggest a qualified environmental specialist should be retained to evaluate the surfaces and make further recommendations. Testing and remediation of mold growth can only be accomplished by a qualified environmental specialist. If strict protocol is not followed, spores can be released into the interior of the building and may create a health hazard for those with low tolerances to such organisms. Suggest repair/

replacement of the floor by a qualified professional.

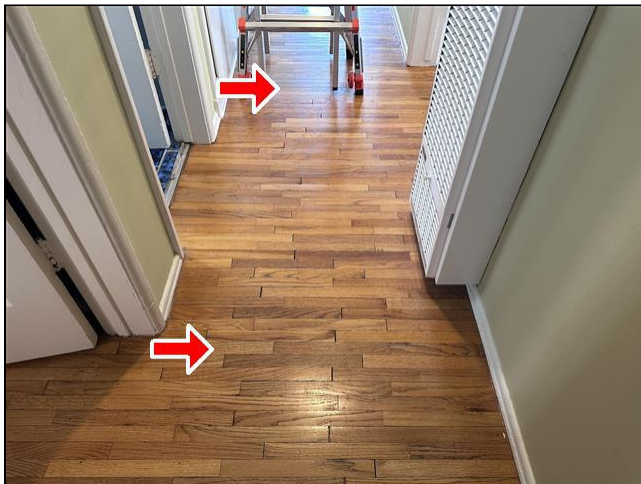
8.2 Item 3(Picture) Interiors

(2) **Monitor:** The **front unit** interior floor has an apparent slope in one or more locations. It is difficult to determine the reason for the apparent floor slope at the time of the inspection. This might be the result of the age and framing design of the home. Suggest further evaluation by a qualified trades person and structural engineer for determination, evaluation and/or corrective repairs if required. Since this inspection is visual in nature, it is always recommended that any movement observed be further evaluated to prevent damage and to insure the integrity of the structure is kept in tact. The type of movement may ultimately not represent a concern to the integrity of the home but we recommend further specialist review for determination of cause and repair options within the inspection contingency period.

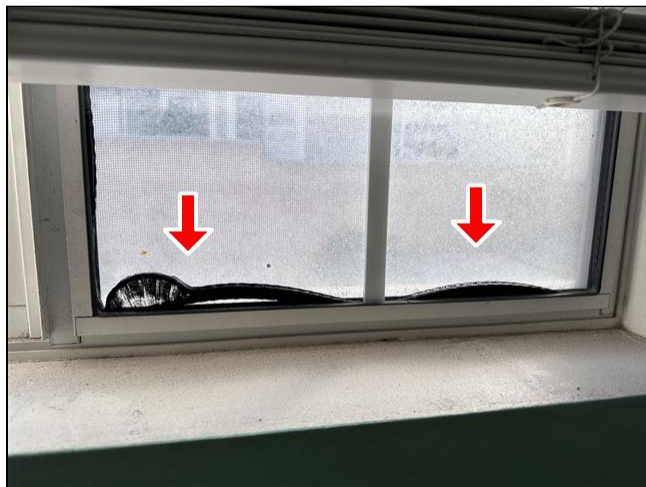
8.3 Item 1(Picture) Interiors

Repair or Replace: The **front unit** kitchen East wall dual pane widow interior gasket is bulging. This is common with many older dual pane window. This indicates that the gasket/seal is defective. Replacement of the window is suggested by a qualified professional.

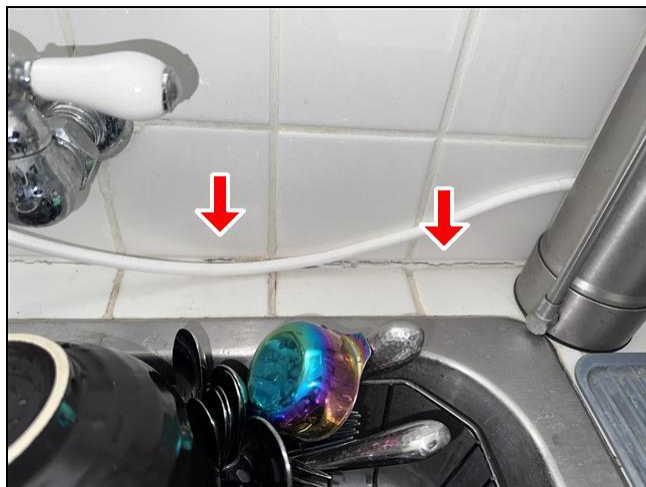
8.6 Item 1(Picture) Interiors

Repair or Replace: The **front unit** kitchen sink backsplash/countertop is in need of caulking with silicone at various areas to prevent moisture damage. Recommend repair or replace as necessary.

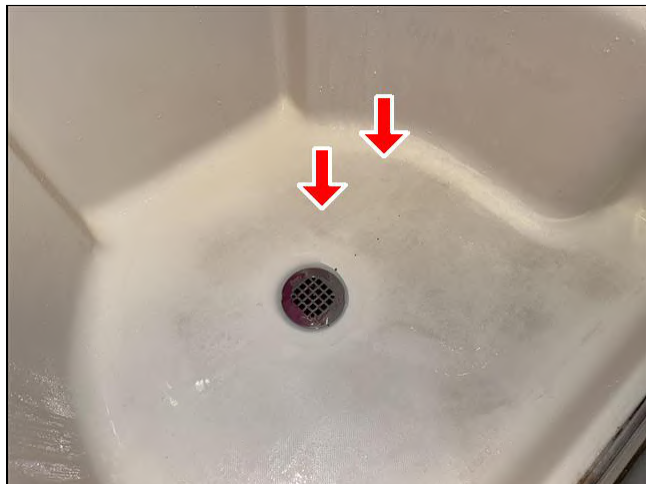
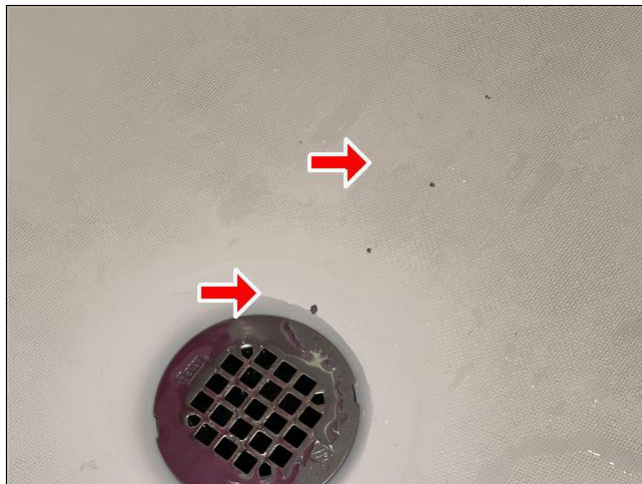
(1) **Repair or Replace:** The **front unit** primary bathroom shower fiberglass floor is slightly chipped/damaged. Suggest repair by a qualified professional as required.

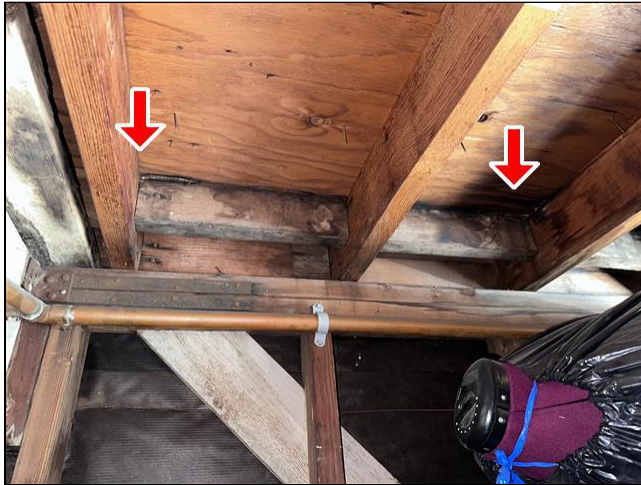
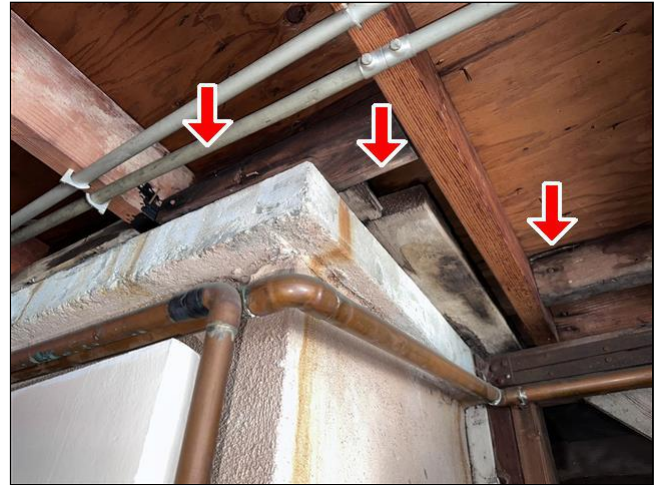
(1) **Major Concern:** Evidence of water intrusion and damaged wood was observed at the **front unit** garage along the East wall/ceiling and West areas as well. Water is entering from the exterior deck and/or faulty garage at the East exterior wall. The source of the water should be identified and repairs performed as necessary. Suggest referring to the Roofing section of this report regarding additional information. Areas of past and present moisture are favorable for growing many fungal like organisms. There is an extra risk of hidden damage/fungus/mold to be present in this location. The identification of molds, fungus and other microbial organisms is outside the scope of this inspection. We suggest a qualified environmental specialist should be retained to evaluate the surfaces and make further recommendations. Testing and remediation of mold growth can only be accomplished by a qualified environmental specialist. If strict protocol is not followed, spores can be released into the interior of the building and may create a health hazard for those with low tolerances to such organisms.

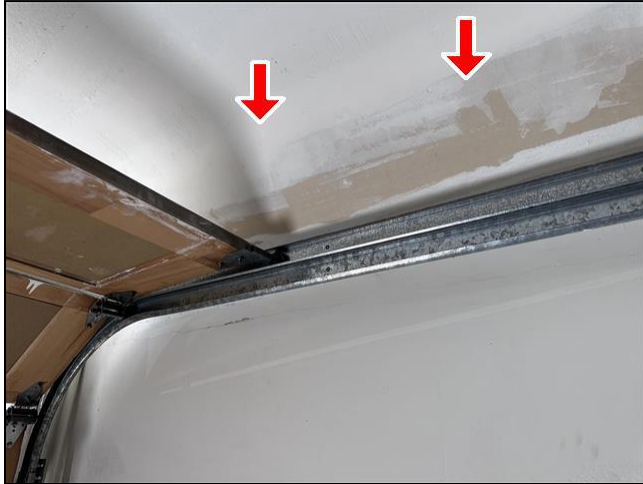
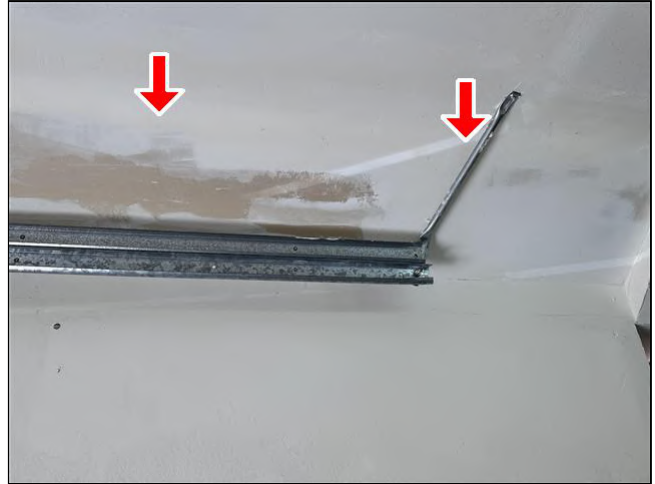
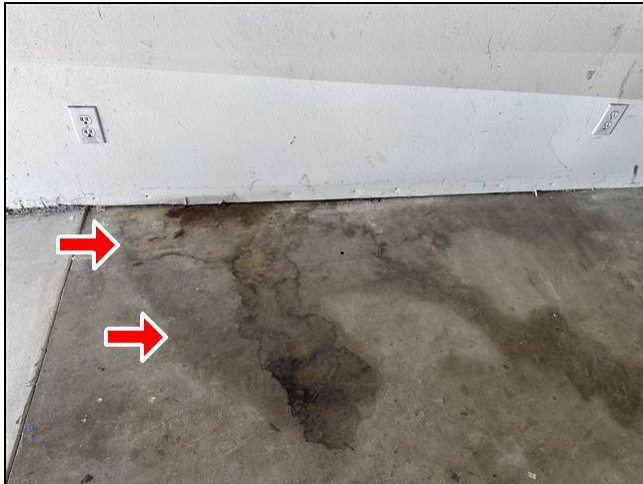
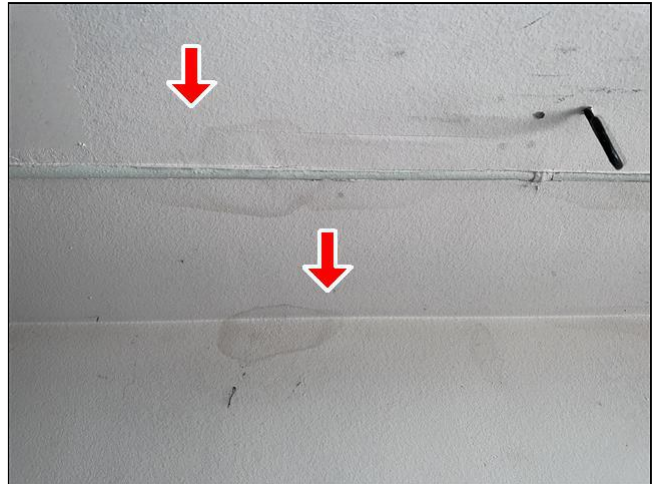
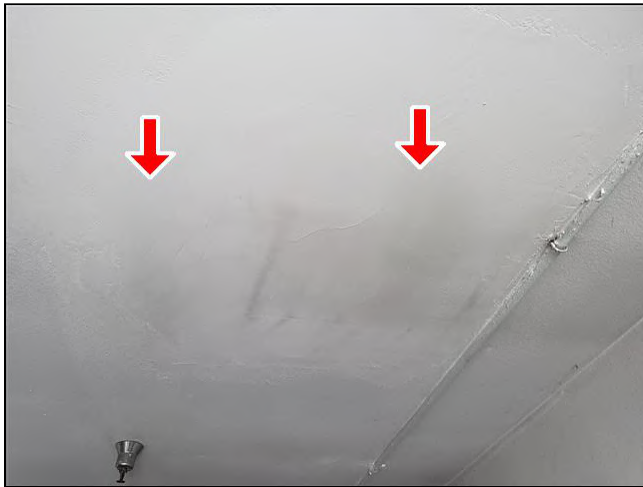
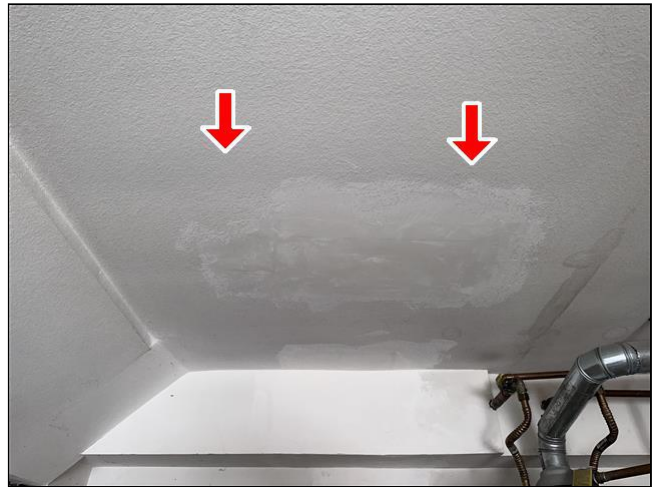
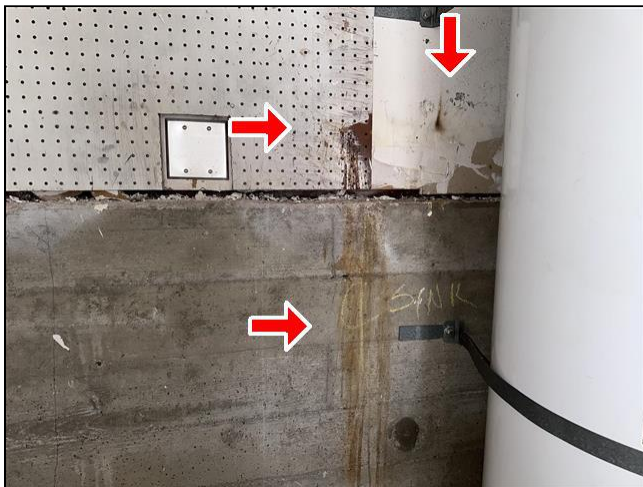
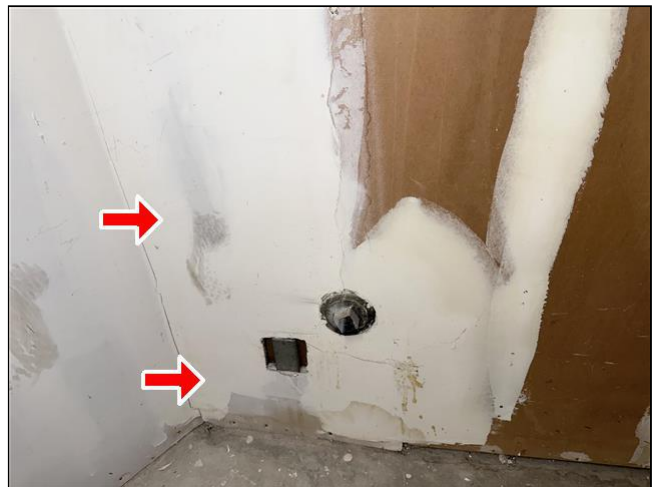
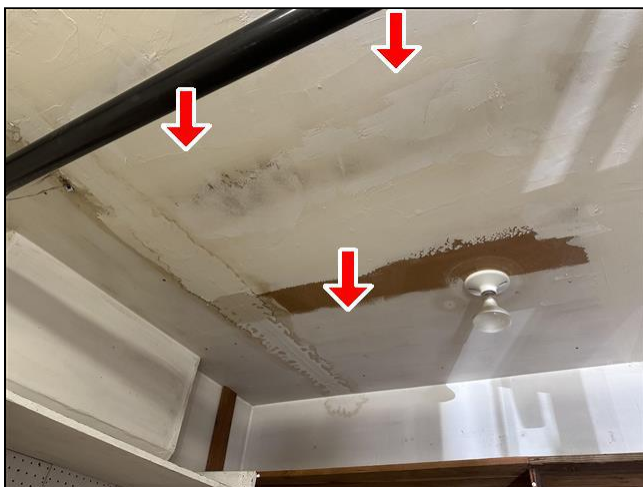
(2) **Major Concern:** Evidence of water intrusion was observed at the **rear unit** East garage in several locations. However, we found no sign of active leaks. We suggest asking the owner to provide you with information about the leak(s), and what corrective action (if any) was taken to repair the leak(s). Then if additional damage develops, the source of the leak(s) should be identified and repairs performed as necessary. Areas of past and present moisture are favorable for growing many fungal like organisms. There is an extra risk of hidden damage/fungus/mold to be present in this location. The identification of molds, fungus and other microbial organisms is outside the scope of this inspection. We suggest a qualified environmental specialist should be retained to evaluate the surfaces and make further recommendations. Testing and remediation of mold growth can only be accomplished by a qualified environmental specialist. If strict protocol is not followed, spores can be released into the interior of the building and may create a health hazard for those with low tolerances to such organisms.

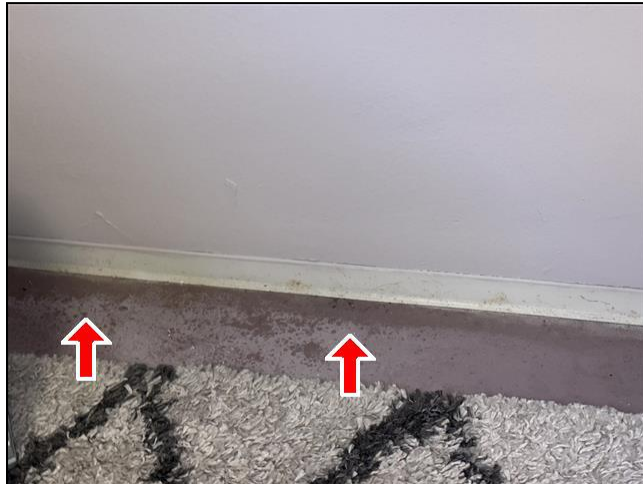
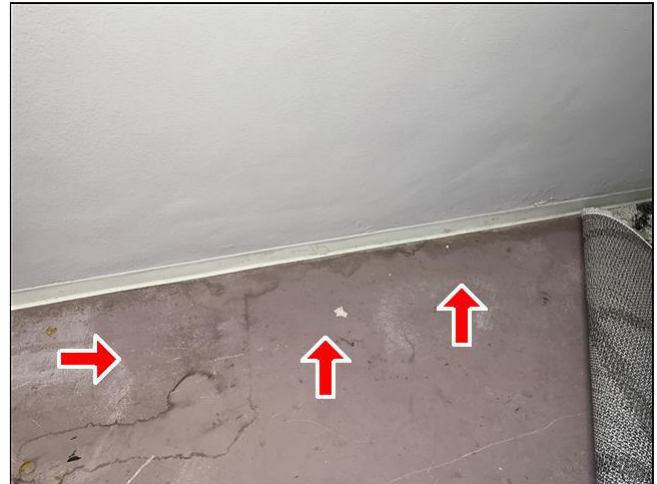
(3) **Major Concern:** Evidence of water intrusion was observed at the **rear unit** West bonus room along the West and rear wall. The presence of water often indicates an occasional surplus of moisture on the outside of the foundation. We suggest to keep the exterior moisture to a minimum, exterior surface drainage, including downspout water, should be directed as far away from the building as possible. Landscape watering should always be directed away from the building and limited to short durations. Also, there is surface growth on the

interior surfaces/finishes. This may indicate the presence of mold, fungus or other microbial organisms. The identification of molds, fungus and other microbial organisms is outside the scope of this inspection. We suggest a qualified environmental specialist should be retained to evaluate the surfaces and make further recommendations. Testing and remediation of mold growth can only be accomplished by a qualified environmental specialist. If strict protocol is not followed, spores can be released into the interior of the building and may create a health hazard for those with low tolerances to such organisms.

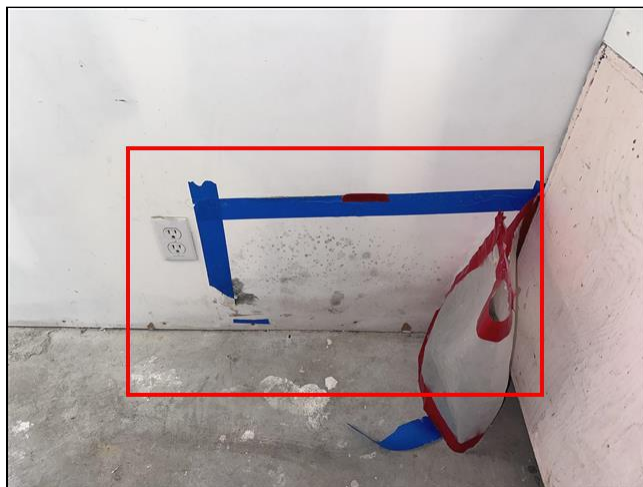
9.4 Item 14(Picture) Garage

(4) **Improve/Monitor:** There is surface growth on the **rear unit** East garage interior wall finishes. This may indicate the presence of mold, fungus or other microbial organisms. The identification of molds, fungus and other microbial organisms is outside the scope of this inspection. We suggest a qualified environmental specialist should be retained to evaluate the surfaces and make further recommendations. Testing and remediation of mold growth can only be accomplished by a qualified environmental specialist. If strict protocol is not followed, spores can be released into the interior of the building and may create a health hazard for those with low tolerances to such organisms.

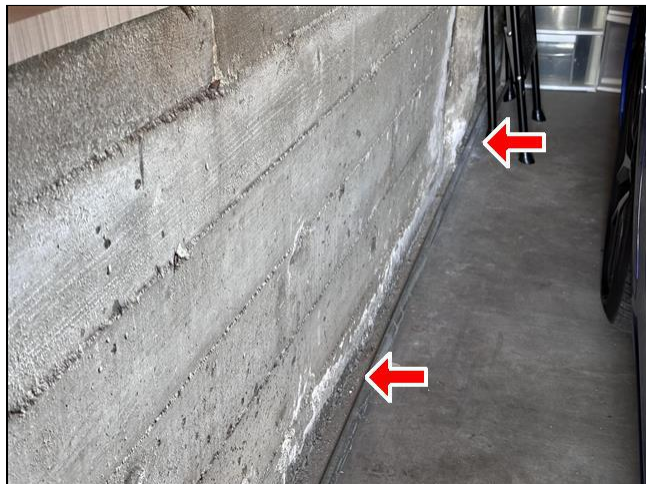
9.4 Item 15(Picture) Garage

(5) **Improve/Monitor:** A condition known as efflorescence is evident on portions of the **front unit** garage concrete foundation walls or slab. This whitish, fuzzy material is a mineral deposit left when moisture in the concrete evaporates. The presence of efflorescence often indicates an occasional surplus of moisture on the outside of the foundation. We suggest to keep the exterior moisture to a minimum, exterior surface drainage,

including downspout water, should be directed as far away from the building as possible. Landscape watering should always be directed away from the building and limited to short durations.
