Inspection Report

Property Address:
1931 Ruhland Ave
Redondo Beach CA 90278

Professional Inspection Network

Property Address 1931 Ruhland Ave Redondo Beach CA 90278	Date of Inspection 2/15/2023	Report ID 20230215-1931-Ruhland-Ave
Customer(s) Sanjeev Bhatia	Time of Inspection 09:00 AM	Real Estate Agent Linda Hernandez Shorewood Realtors

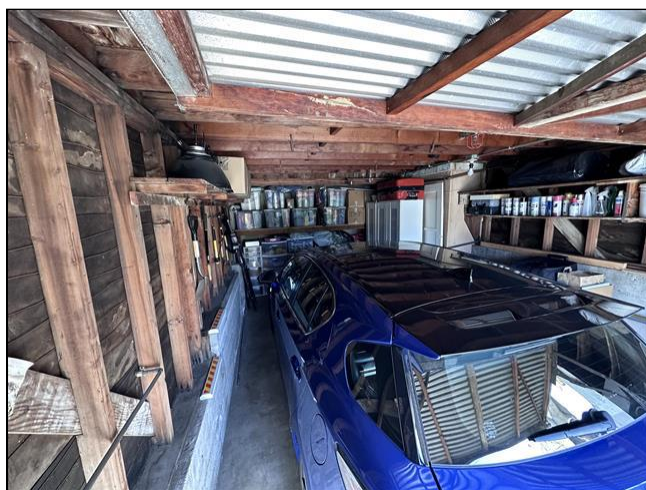
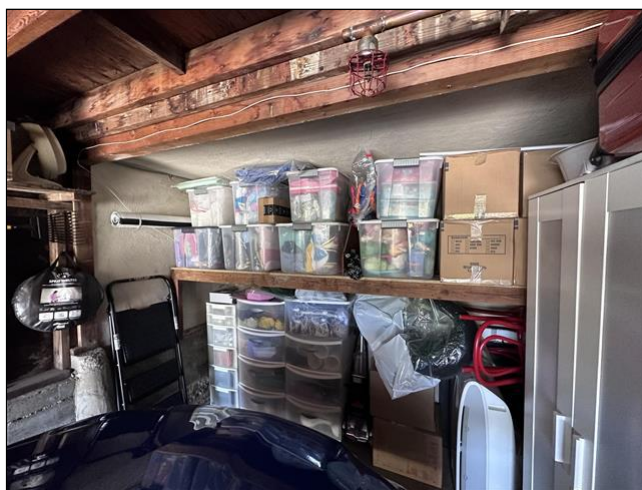
9.4 Item 16(Picture) Garage

(6) **Monitor:** The occupants belongings at the **front unit** garage prevents full view.

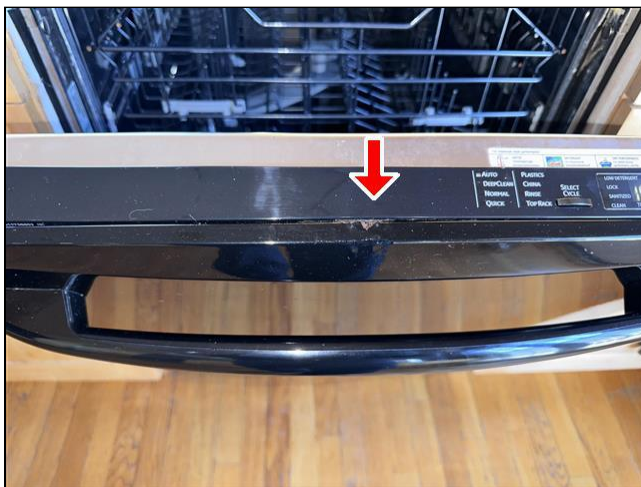
10.0 Item 1(Picture) Appliances

Repair or Replace: The rear unit dishwasher metal door is rusted. Suggest replacement of the dishwasher.

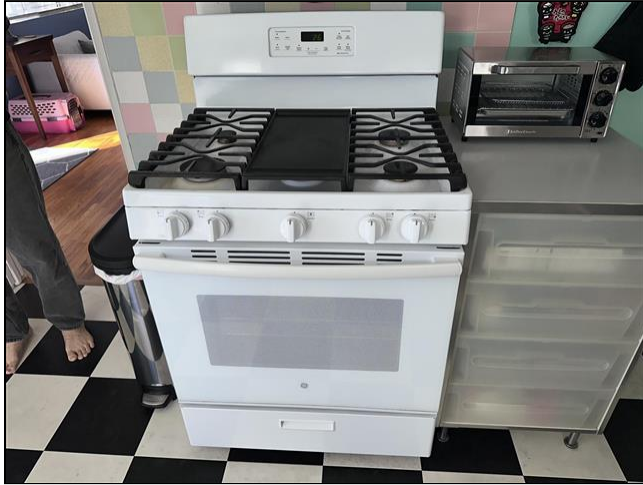
10.1 Item 1(Picture) Appliances

Safety Issue: The anti-tip bracket for the **front unit** kitchen stove has not been installed. The anti-tip bracket provides extra protection when excess force is applied to an open oven door. Suggest the installation by a

qualified professional.

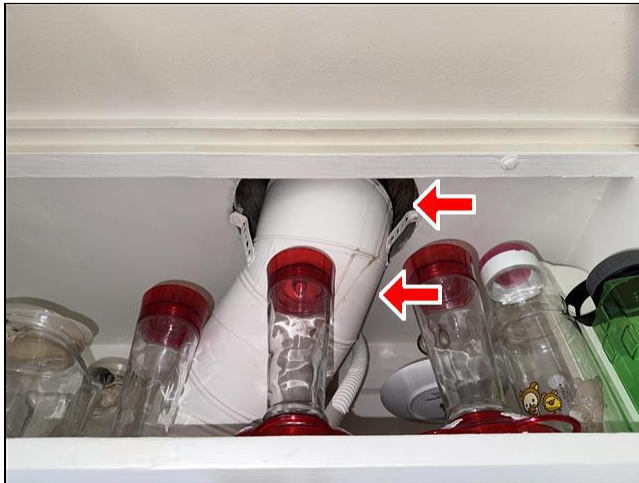
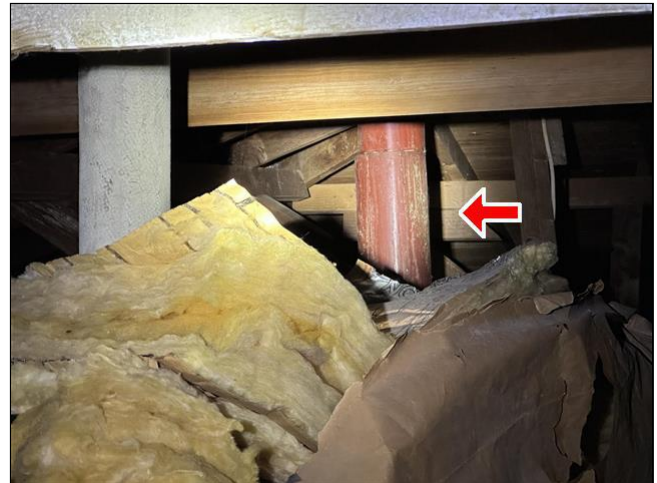
10.3 Item 1(Picture) Appliances

Repair or Replace: Water stains were observed at the **front unit** kitchen exhaust vent. However, we found no sign of active leaks. We suggest asking the owner to provide you with information about the leak(s), and what corrective action (if any) was taken to repair the leak(s). Then if additional damage develops, the source of the leak(s) should be identified and repairs performed as necessary.
