## **Property Inspection Report**

**2650 Main St, Unit 7, Cambria, CA 93428**  
**Inspection prepared for: Patrick Forrest**  
**Real Estate Agent: -**

**Date of Inspection: 2/8/2024 Time: 10:00 AM**  
**Age of Home: 1971 Size: 800**  
**Weather: Overcast**  
**Order ID: 10402**

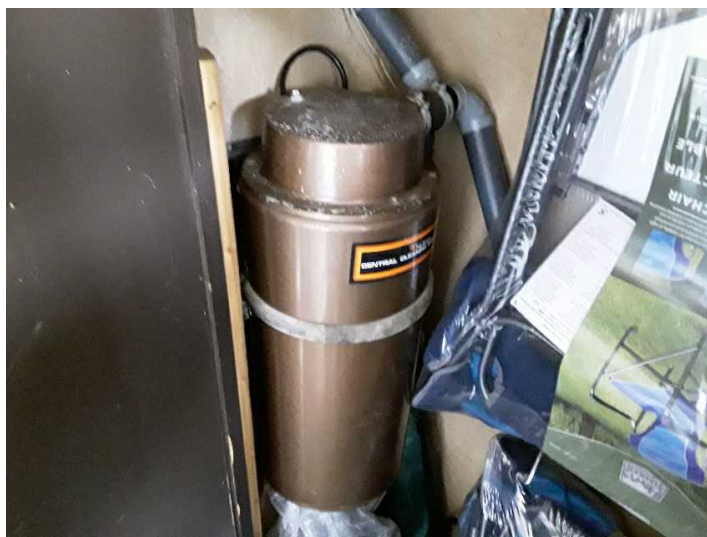
We do not evaluate or inspect Central Vacuum systems, which are a specialty item. You should have the sellers demonstrate its features and service history.
