Inspection reference: 22001

# Confidential Inspection Report

25531 Polaris Ln  
Lake Forest CA 92630

January 5, 2022

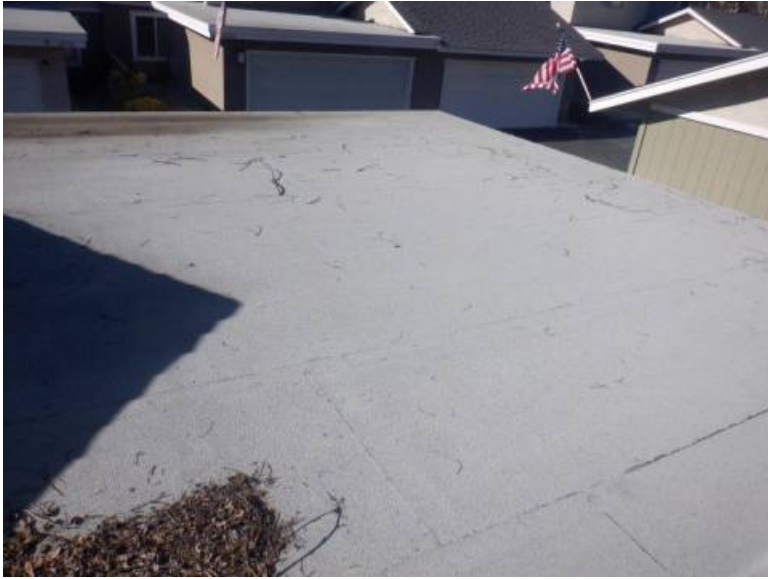
There is tree debris lying on the roof, remove to prevent damage and potential leakage.  
The roof may be maintained by the Homeowners Association, review the CC&R's for extent of coverage.

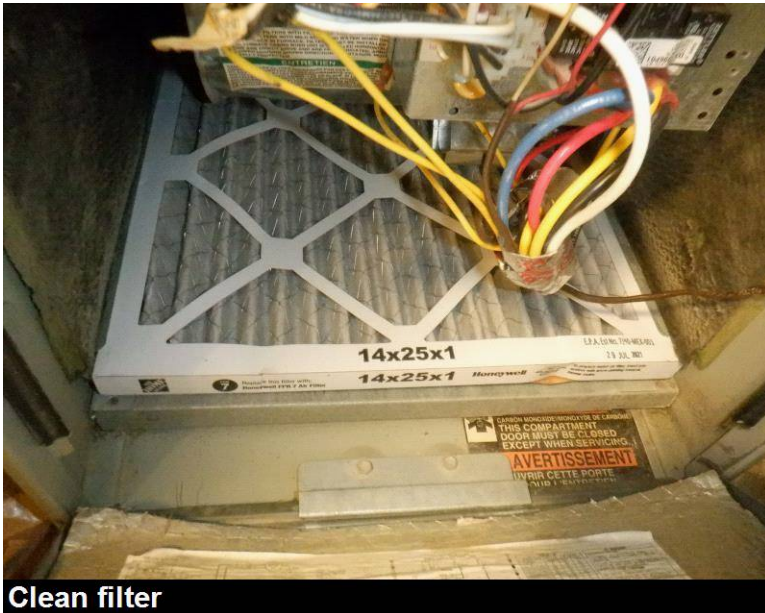
**Clean filter**

The heating system fuel is natural gas.

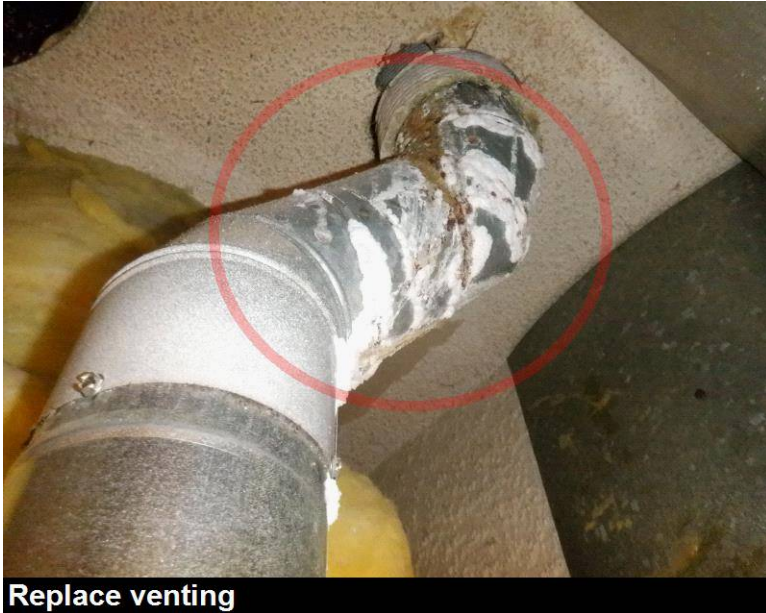
The heater venting is corroded, contact licensed contractor for review and repair as this is a safety concern due to possible carbon monoxide leakage.

**Corroded vent needs replacement**

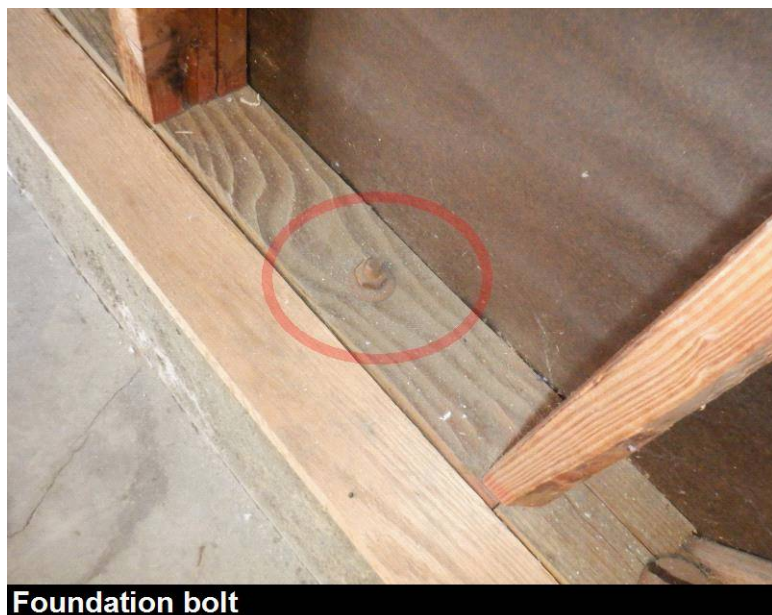
**Foundation bolt**

**\*HOMEBUYER HIGHLIGHT\*FOUNDATION BOLTED-** Foundation bolting typically means that bolts are added to improve the connections between the wooden framing members of a building and its concrete foundation. Usually this means adding bolts through the piece of wood that lies flat on top of the foundation, referred to as the sill or mudsill, into the concrete. Earthquake bolting became standard practice in Southern California in the 1930's. The visible portions of this structures bottom plate do show foundation bolts.

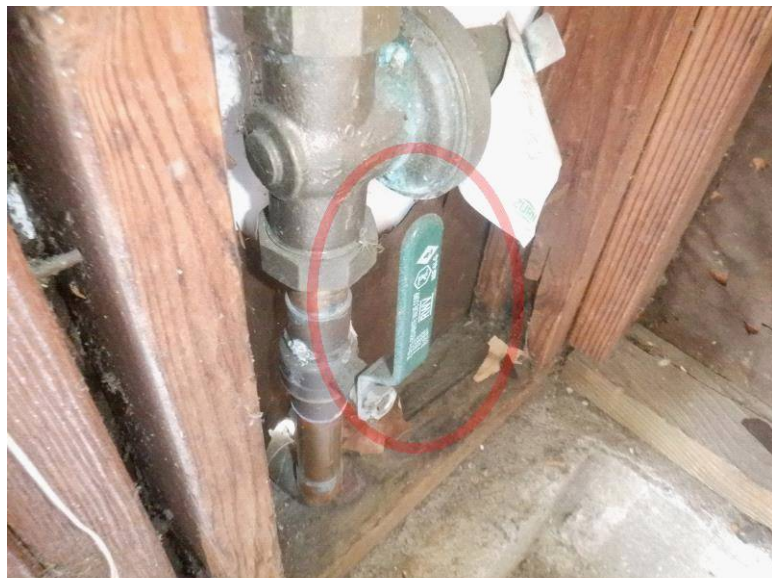
The main water shut off valve is located in the garage.

**The main water shut off valve**

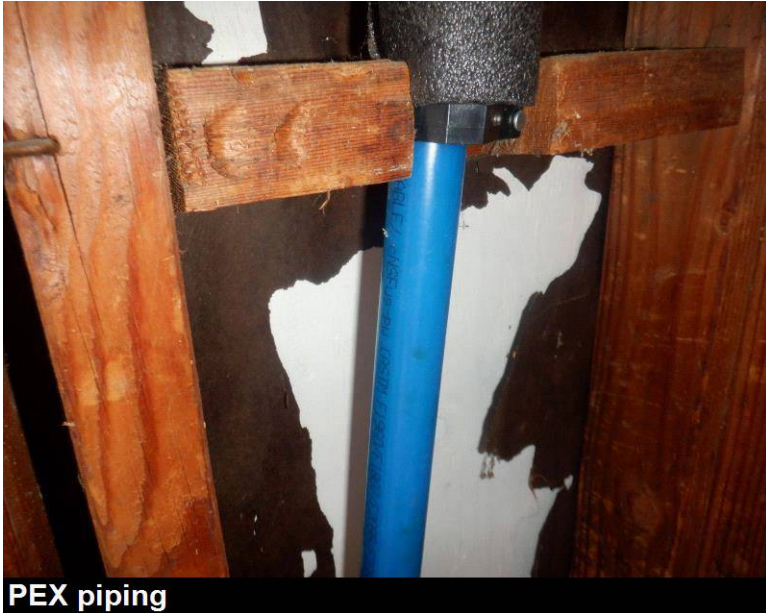
**PEX piping**

**\*HOMEBUYER HIGHLIGHT\* PEX PIPING-** The visible supply piping is PEX. PEX (or crosslinked polyethylene) is part of a water supply piping system that has several advantages over metal pipe (copper, iron, lead) or rigid plastic pipe (PVC, CPVC, ABS) systems. It is flexible, resistant to scale and chlorine, doesn't corrode or develop pinholes, is faster to install than metal or rigid plastic, and has fewer connections and fittings. **\*HOMEBUYER HIGHLIGHT\* COPPER PLUMBING SUPPLY LINES-** This structure has a copper supply lines for plumbing where visible. Copper is durable and naturally corrosion resistant. Copper piping has been the favored material for pipes for over 70 years. Copper piping is environmentally friendly and is also recyclable.

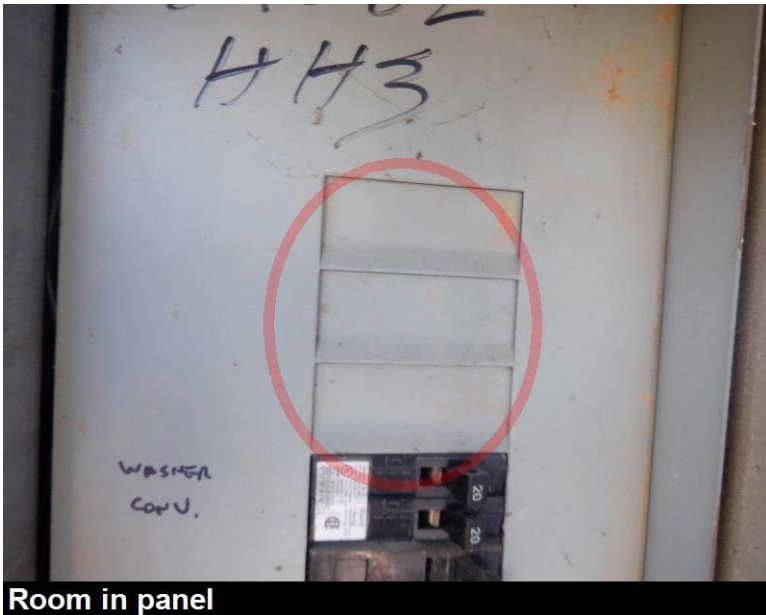
**Room in panel**

**\*HOMEBUYER HIGHLIGHT\* ROOM IN ELECTRICAL PANEL-** There is room available for in the electrical panel for expansion (addition of circuits).
