# INSPECTION REPORT

For the Property at:  
**1085 COLORADO DRIVE**  
MERCED, CA 95340

Inspection Date: Wednesday, September 24, 2025

RE: Report No. 8446  
1085 Colorado Drive  
Merced, CA  
95340

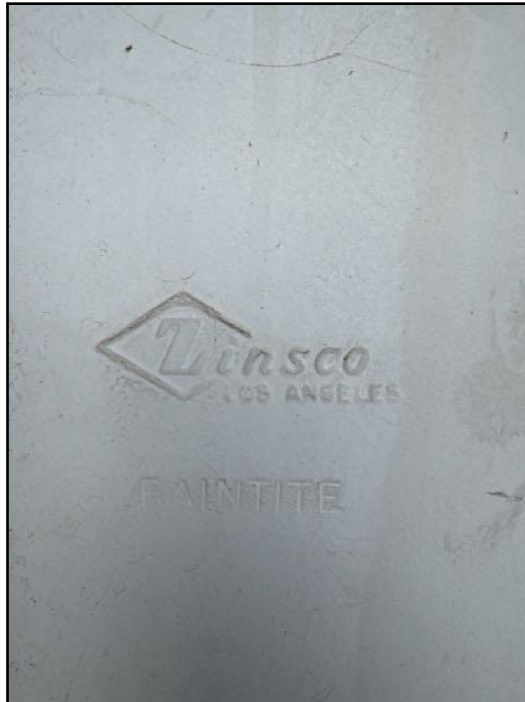
43. Federal Pacific & Zinsco Electrical Panels

**Task:** Further Evaluation

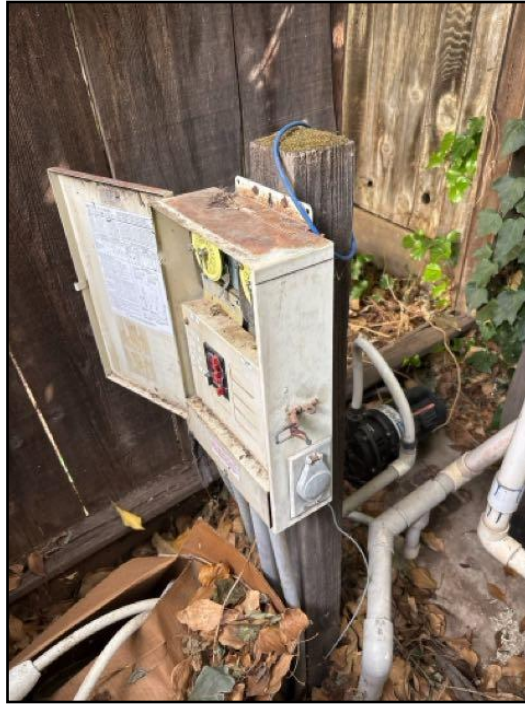
44. Not well secured

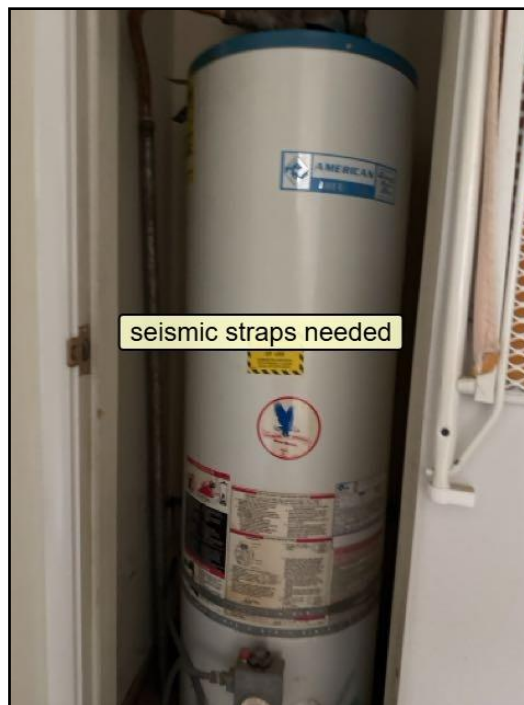
70. Seismic Strapping Needed.

**23. Condition:** • Seismic Strapping Needed.

Two Seismic straps required. Repairs recommended by a licensed contractor.

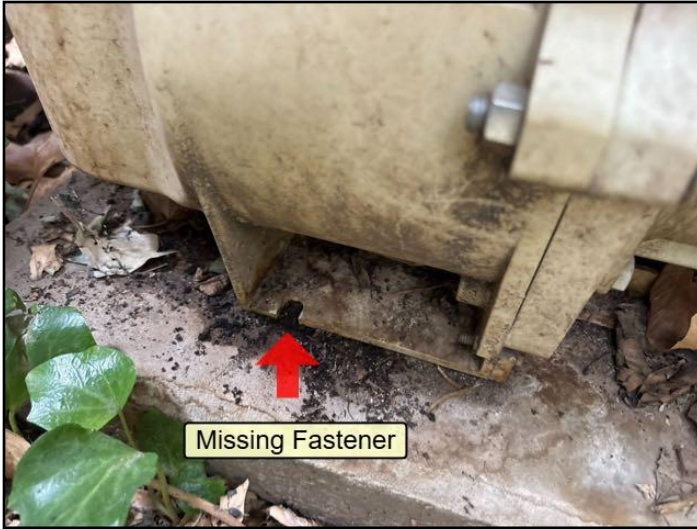
92. Pump has no attachment

36. Condition: • Pump has no attachment

Repairs recommended by a qualified handyman or licensed pool contractor.
