## ***INSPECTION REPORT***

1338 Hermosa Drive, Merced

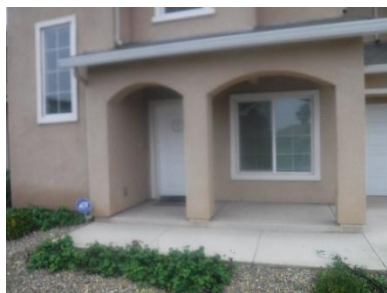
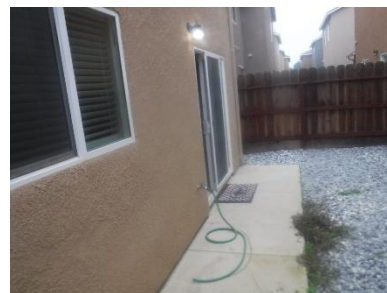
**Comments:** Reviewed and noted stucco system present. Majority of typical settlement/stress cracks were present at corners of windows and doors. These cracks are not a structural issue but rather cosmetic in nature. If crack becomes wider than the thickness of a quarter, then these cracks should be filled with clear, paintable caulking. This will prevent possible moisture infiltration and/or insect infestation. Recommend using a good elastomeric paint when painting exterior of home. Minor damage and signs of previous repair noted at base of siding at front of home. Recommend ensuring that areas remain adequately sealed in order to prevent possible moisture infiltration.

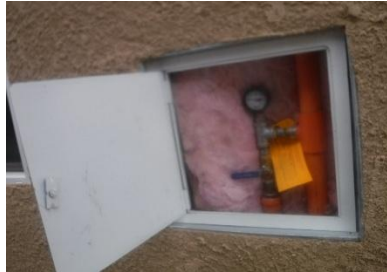
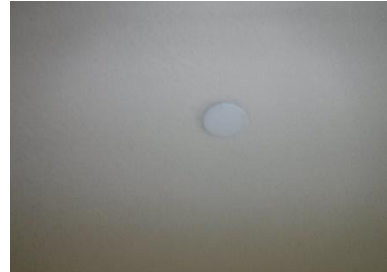
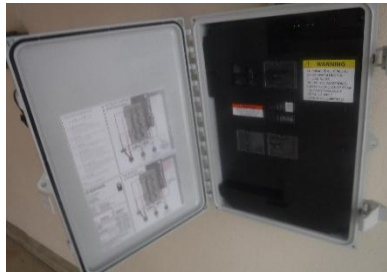
**Comments:** Overall, site appears to be in good condition with no sunken, unusually damp or wet areas noted. We do not inspect or certify fire suppression/sprinkler systems for condition or functionality. Similarly, we do not inspect or certify functionality of photovoltaic solar system equipment. Recommend contacting appropriate licensed companies to perform further inspections if desired.

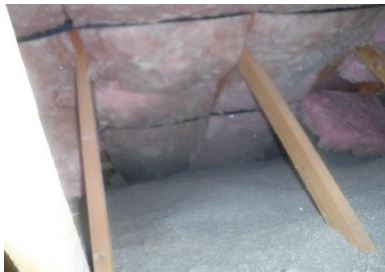
**Comments:** Inspected and cellulose insulation present/ Approximate R-Value=38+/- . Also, fiberglass batting present at sheathing/ Approximate R-Value=13.

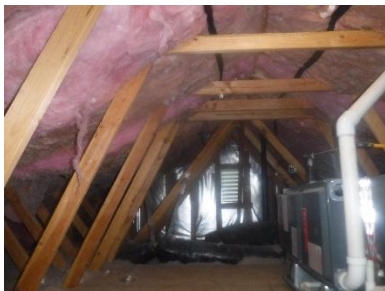
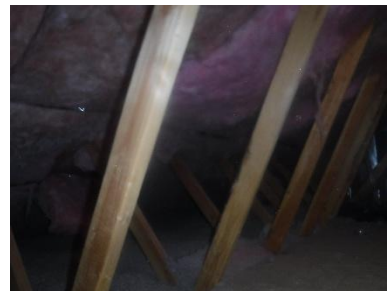
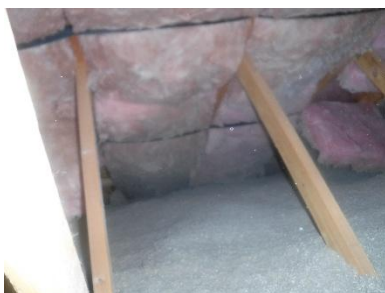
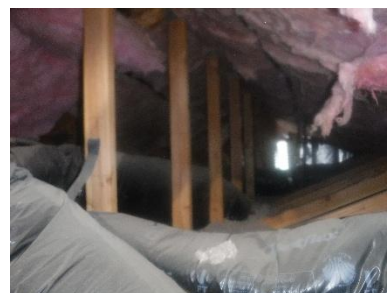
**Comments:** Engineered trusses present.

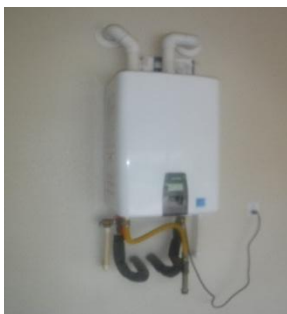
**Comments:** Water heater located in garage and installed a minimum of 18" above floor. Water heater appeared to be functioning properly at time of inspection.

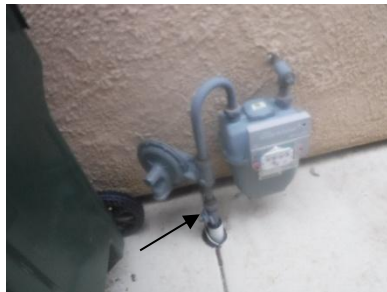
**Comments:** Gas meter located on side of garage. Gas meter appeared to be in serviceable condition with no leaks noted. Arrow indicates location of shut off valve for gas.

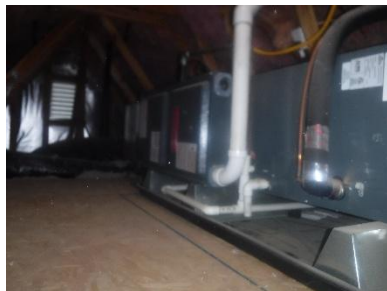
**Comments:** Heating unit located in attic, appeared to be in serviceable condition, and appeared to be functioning properly when operated.
