TRIDENT INSPECTION GROUP

PROPERTY INSPECTION V 5.0

8812 Sapphire Ave Westminster, CA 92683

> Tricia Vandermarlierre 11/07/2025

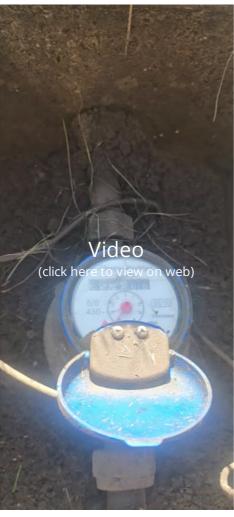
Main Water Shut-off Device & water supply lines: Bonding Interior Piping

This may not have been required at the time of installation. It is recommended that a bonding jumper be installed at the hot water heater lines as seen in the diagram. This will help ensure grounding continuity through the plumbing system.
