# Property Inspection Report

Date of Inspection: 5/8/2026

**27809 Alpen Dr**

**Lake Arrowhead, CA. 92352**

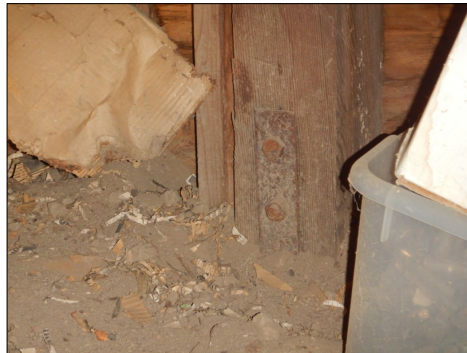
The bottoms of the post(s) in the garage crawl space were supported at or below the grade of the crawl space soil. This condition is conducive to deterioration. Action should be taken to ensure that a 6-inch clearance is maintained between wood and soil.

Suggest complete review/correction including cost estimate (bids) by a qualified licensed foundation contractor before the end of the contingency period.

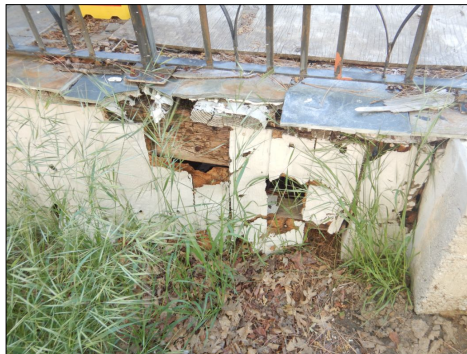
The siding at the front entryway was bowed and damaged; further evaluation and correction are recommended. Hidden damage may exist.

Suggest complete review/correction including cost estimate (bids) by a qualified licensed contractor before the end of the contingency period.

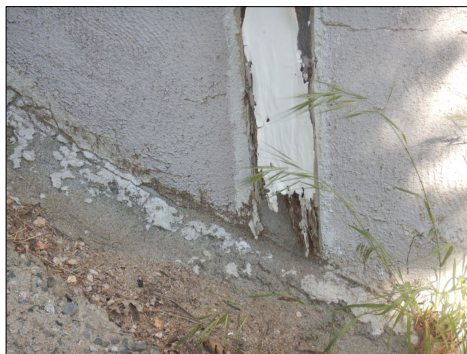
Signs of wood-destroying pest/organism damage noted at the trim; recommend further evaluation and correction by a licensed pest control operator before removing any contingencies.

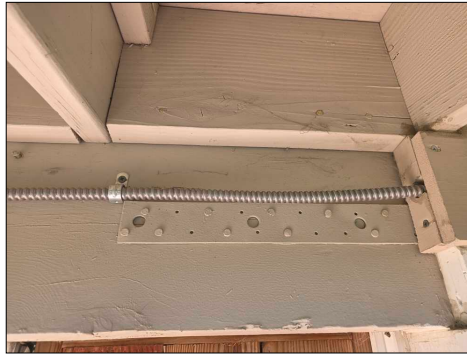
Unsupported conduit was found at the rear of the house; further evaluation and correction are recommended.

There are non-exterior rated materials used in a number of locations around the house. Non-exterior materials are not weather tight and can become damaged over time due to exposure, we recommend all non-exterior rated materials be replaced with approved materials.

Lamp cord or extension cord wiring has been installed as permanent wiring. This type of wiring is easy to overload, easily damaged, and is not rated for exterior use.

Suggest complete review/correction including cost estimate (bids) by a qualified licensed electrical contractor before the end of the contingency period.

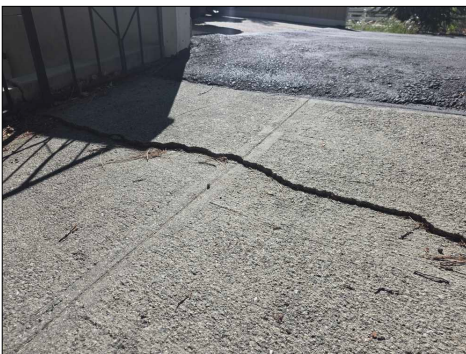
The driveway surface was raised and creating trip hazards, corrections are recommended.

Suggest complete review/correction including cost estimate (bids) by a qualified licensed general contractor before the end of the contingency period.

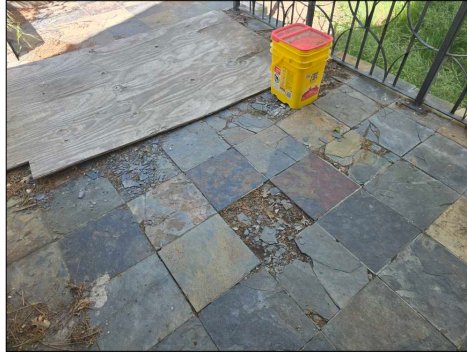
The main entry walkway had damaged tiles and failed substrates, this is a safety hazard, further evaluation and correction are recommended.

Suggest complete review/correction including cost estimate (bids) by a qualified licensed general contractor before the end of the contingency period.

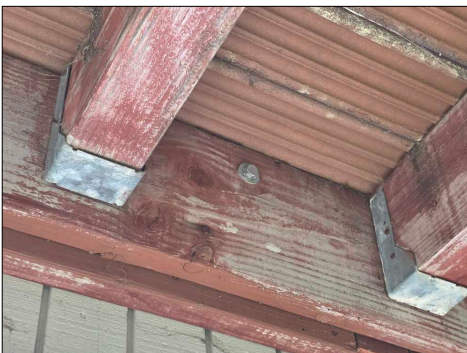
The deck board attached to the structure has been installed without flashing, creating a condition conducive to deterioration. We recommend this board be flashed or caulked to help prevent deterioration at this location.

One of the deck joists had significant checking that may compromise the integrity; further evaluation and correction are recommended.

Suggest complete review/correction including cost estimate (bids) by a qualified licensed general contractor before the end of the contingency period.

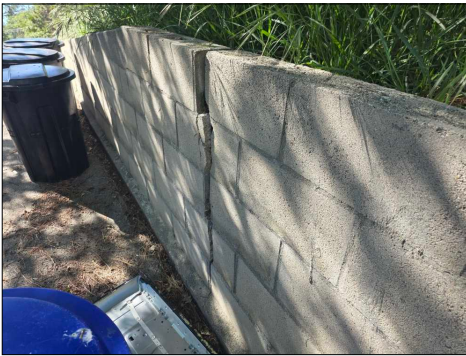
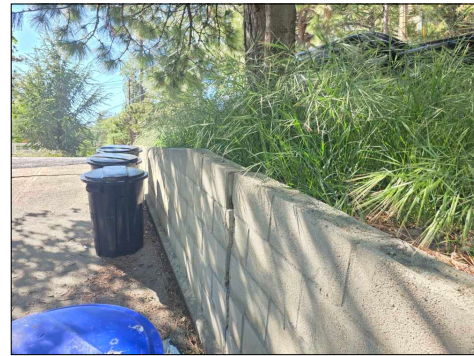
The roots of nearby trees have grown towards the wall resulting in damage. We recommend the damaged areas be repaired or replaced. A qualified tree specialist might determine that roots could be cut to minimize future upheaval. The trees may need to be removed.

Suggest complete review/correction including cost estimate (bids) by a qualified licensed engineer before the end of the contingency period.

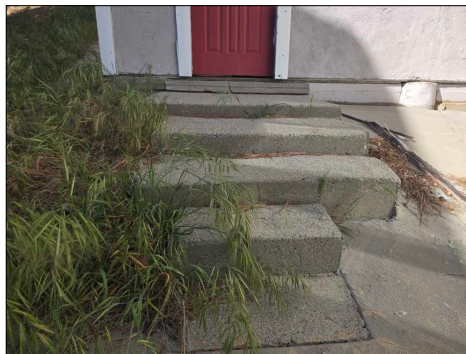
The exterior steps are nonconforming. Standards require all steps to be almost identical in "rise" and "run" for safety. Ideally, the stairs should be rebuilt. If not, we recommend caution in the use of this stairway.

Suggest complete review/correction including cost estimate (bids) by a qualified licensed contractor before the end of the contingency period.

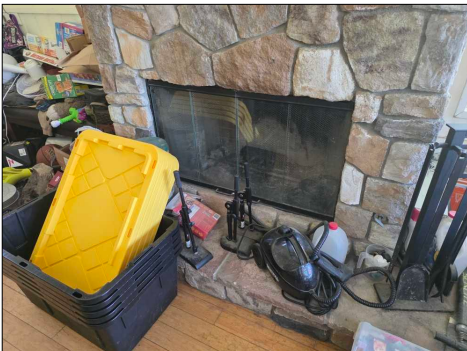
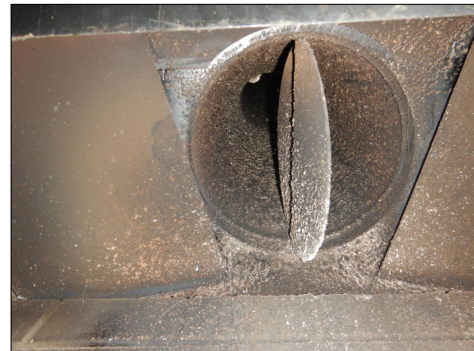
The chimney flue was dirty we recommend a qualified chimney sweep clean and evaluate the chimney and complete any and all repairs needed.

Suggest complete review/correction including cost estimate (bids) by a qualified licensed chimney contractor before the end of the contingency period.

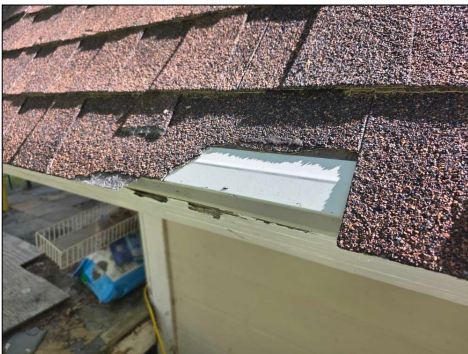
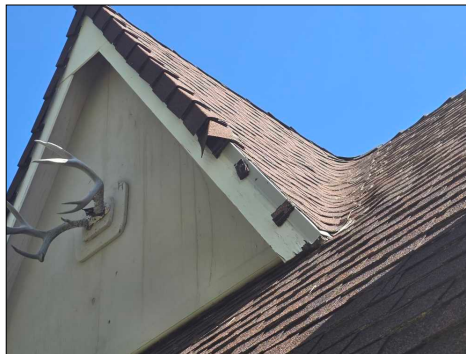
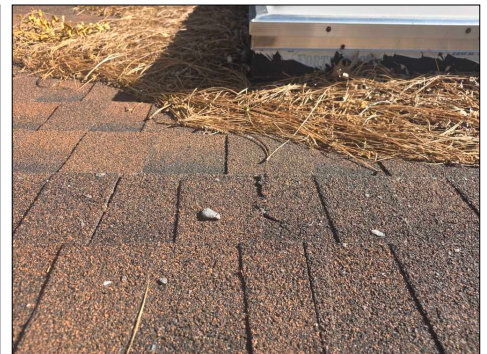
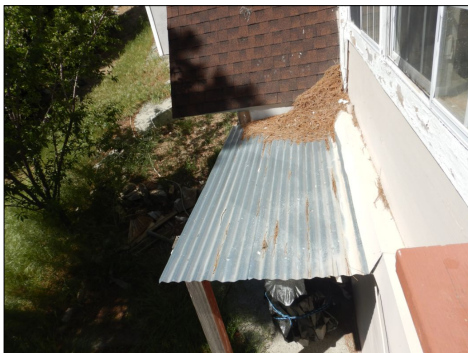
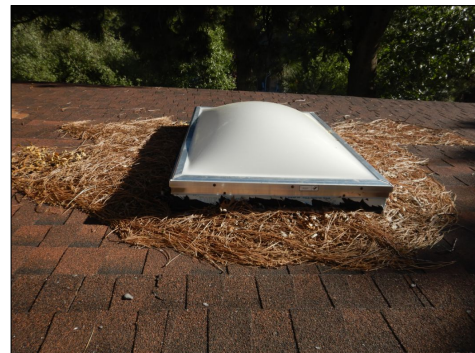
Extensive granule loss, erosion and cracking were observed throughout the shingled surface of the garage. These conditions often indicate the end of the useful life of this type of roofing. Further evaluation is recommended.

Suggest complete review/correction including cost estimate (bids) by a qualified licensed roofing contractor before the end of the contingency period.

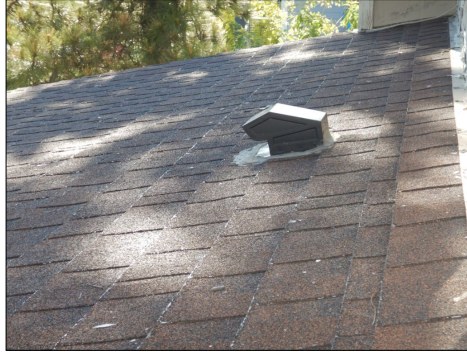
The appliance vent flashing was improperly installed and can be a source of leaks; further evaluation and correction are recommended.

Suggest complete review/correction including cost estimate (bids) by a qualified licensed roofing contractor before the end of the contingency period.

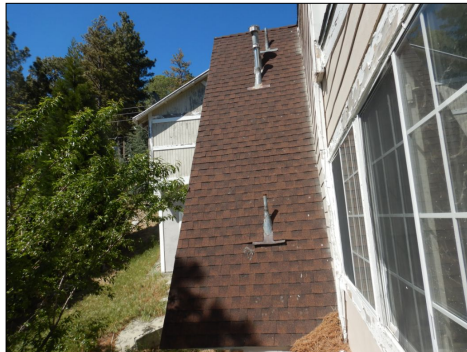
There are a number of lifted flashings at the plumbing vents, this can allow moisture to penetrate under the flashing, correction is recommended.

Suggest complete review/correction including cost estimate (bids) by a qualified licensed roofing contractor before the end of the contingency period.

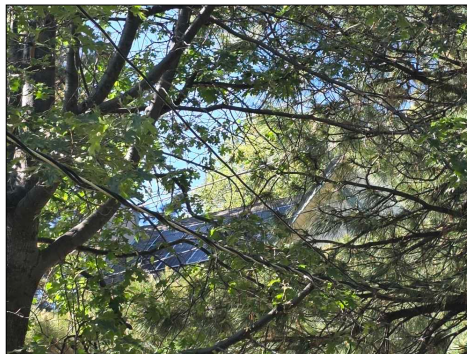
The overhead service was in contact with the neighboring trees; recommend contacting the local utility for corrections.

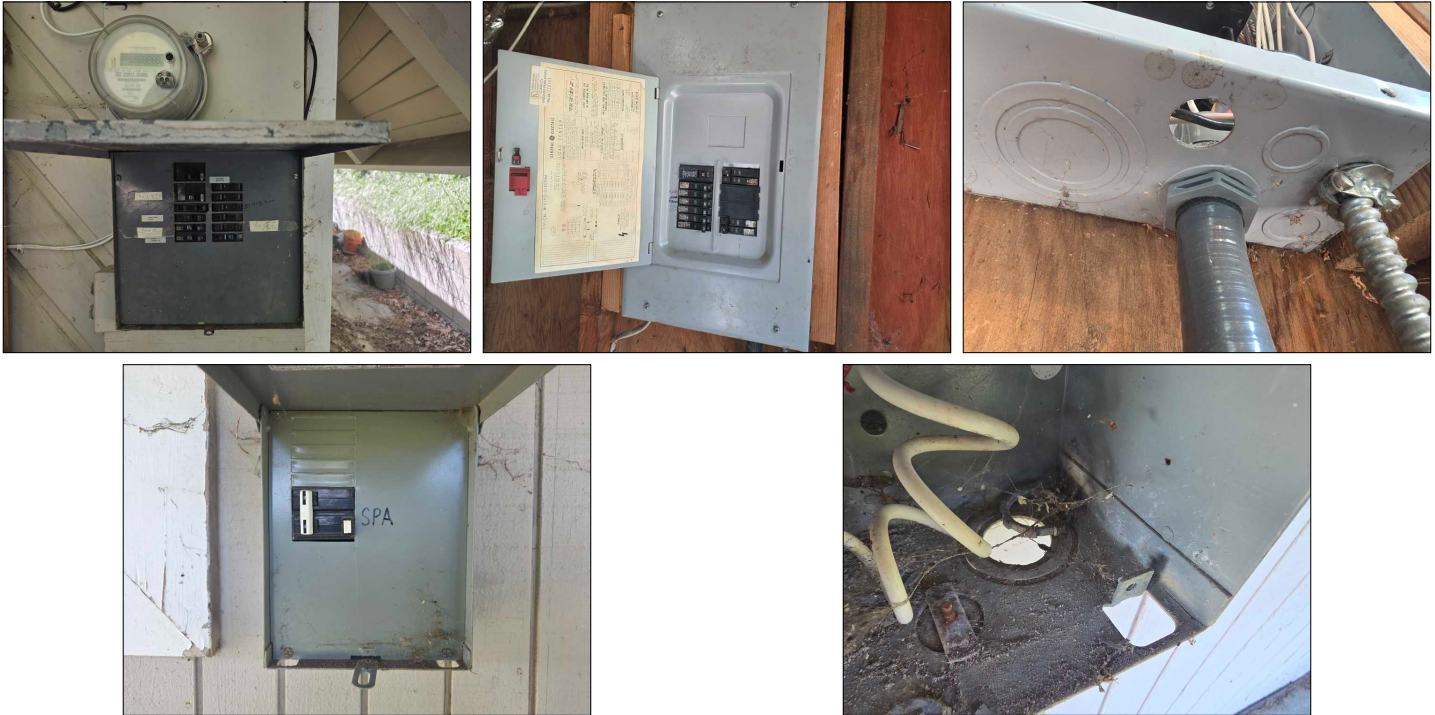
One of the sub panel cover screw was improper; recommend a proper, blunt-end screw be installed.

Suggest complete review/correction including cost estimate (bids) by a qualified licensed electrical contractor before the end of the contingency period.

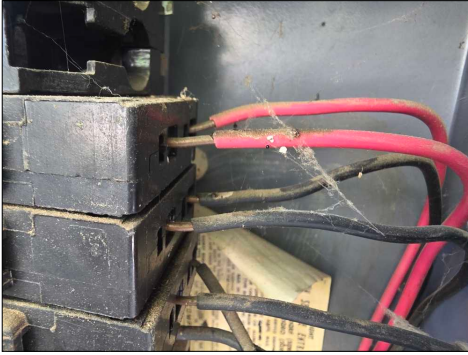
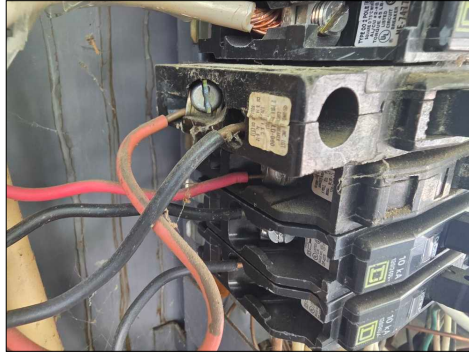
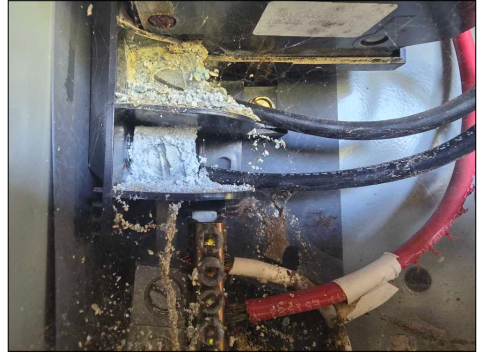
The GFCI breaker was tested with its button and did not trip. We recommend it be replaced.

Suggest complete review/correction including cost estimate (bids) by a qualified licensed electrical contractor before the end of the contingency period.

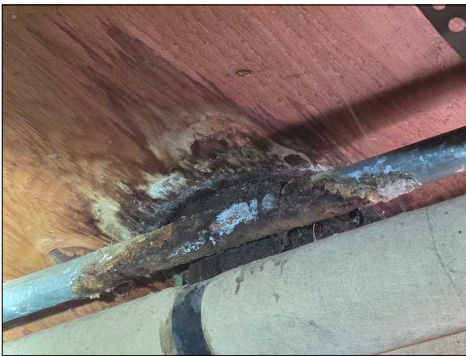
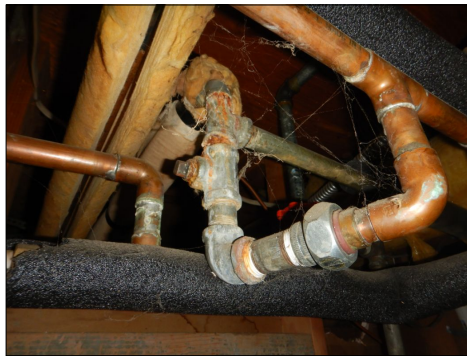
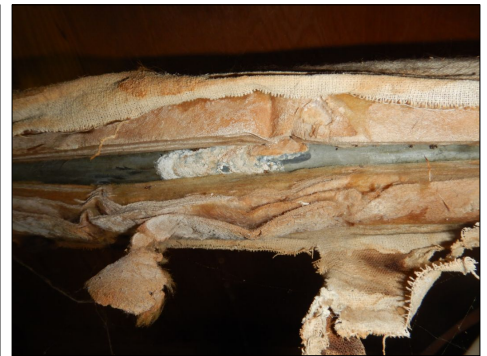
Corrosion and rust was found at the galvanized piping in a number of locations; further evaluation and correction are recommended.

Suggest complete review/correction including cost estimate (bids) by a qualified licensed plumbing contractor before the end of the contingency period.

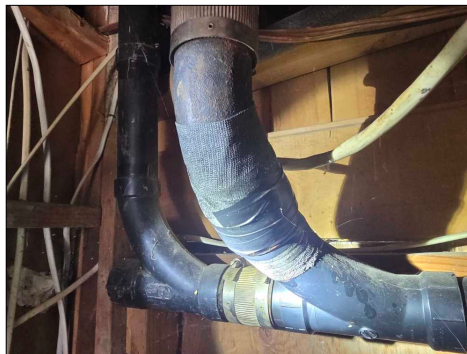
A substandard repair was found in the crawlspace; further evaluation and correction are recommended.

Suggest complete review/correction including cost estimate (bids) by a qualified licensed plumbing contractor before the end of the contingency period.

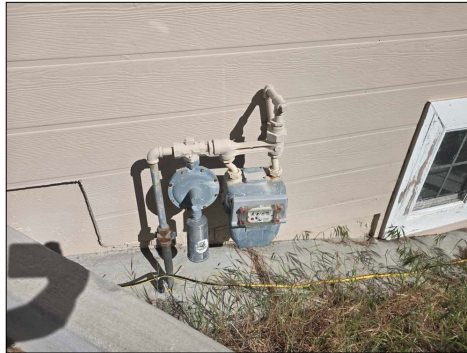
The condition and placement of the gas meter were acceptable. A meter wrench could not be located in the vicinity of the gas meter as recommended in areas subject to seismic activity. A proper wrench should be chained to the meter to provide a convenient means for shut-off in an emergency. The valve can be turned 90 degrees in either direction to shut the gas supply off.

The meter was not equipped with an automatic seismic gas shut-off valve. We recommend further investigation regarding local jurisdiction requirements for installation of these devices upon sale or transfer of the dwelling. A competent, licensed plumber should be retained to install such shut-off devices as required to help prevent gas leakage in the event of an earthquake.

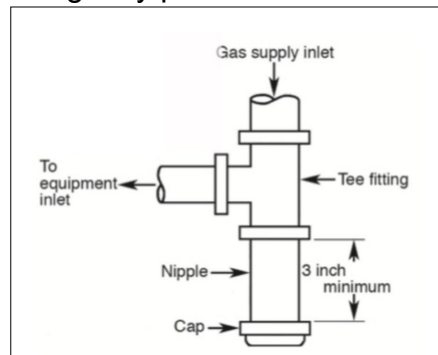
Absence of a sediment trap may void manufacturers warranties. I recommend that you refer to manufacturers installation instructions for appliance requirements. The installation of a sediment trap at all gas appliances where required by a qualified state licensed plumbing contractor is recommended as a fire safety upgrade.

Suggest complete review/correction including cost estimate (bids) by a qualified licensed HVAC contractor before the end of the contingency period.

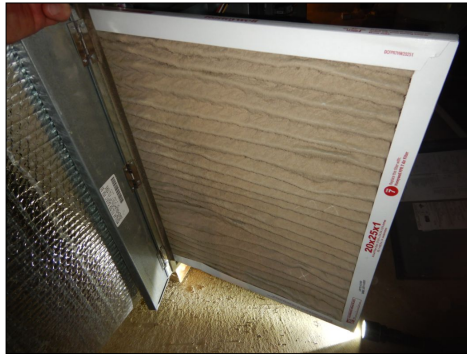
The filter has accumulated debris which decreases its effectiveness and blocks air flow. This can dramatically decrease the efficiency of the heating system. We recommend removing and replacing the filter.

Suggest complete review/correction including cost estimate (bids) by a qualified licensed HVAC contractor before the end of the contingency period.

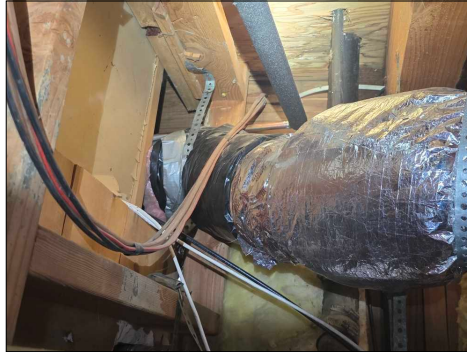
New to old ductwork connections were present; recommend checking with the building department and consulting sellers regarding all past repairs, modifications and/or upgrades.

Suggest complete review/correction including cost estimate (bids) by a qualified licensed HVAC contractor before the end of the contingency period.

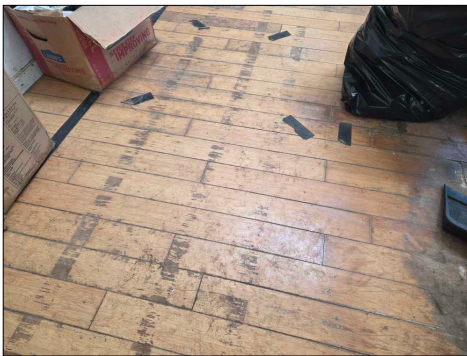
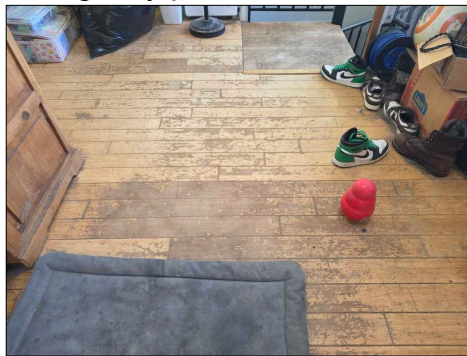
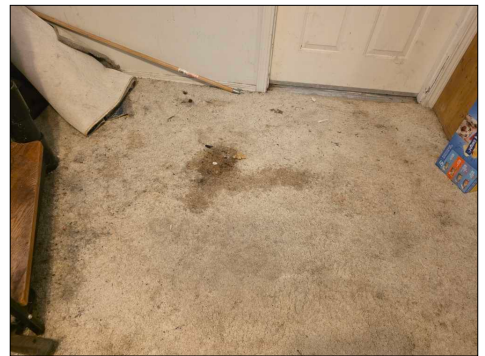
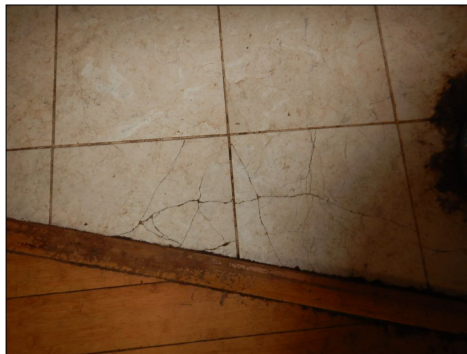
The carpets are heavily soiled and should be replaced.

The laminate flooring was worn and damaged in several areas; replacement is recommended.

Some floor tiles are cracked and/or damaged. For a better appearance and to minimize additional damage, we recommend the affected tiles be replaced.

Suggest complete review/correction including cost estimate (bids) by a qualified licensed flooring contractor before the end of the contingency period.

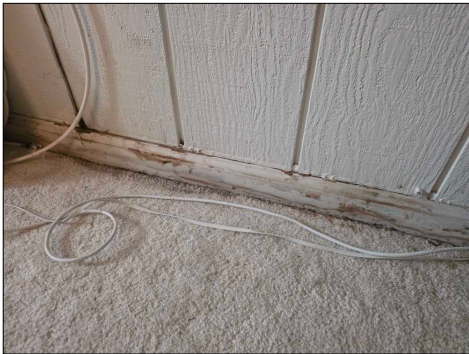
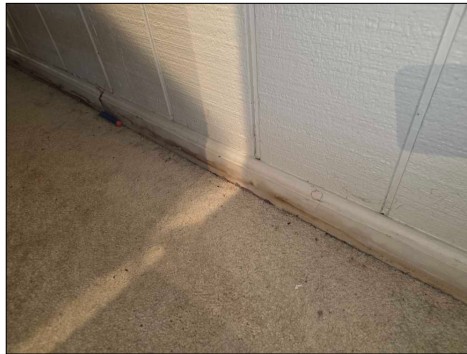
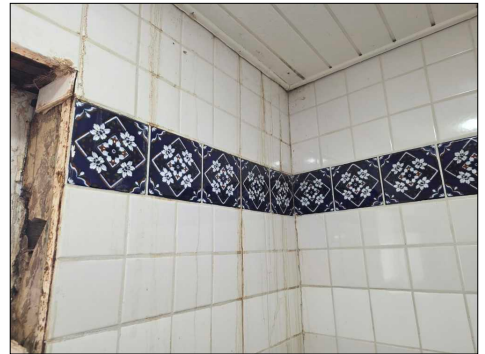
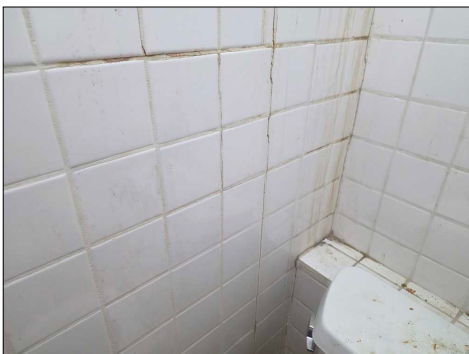
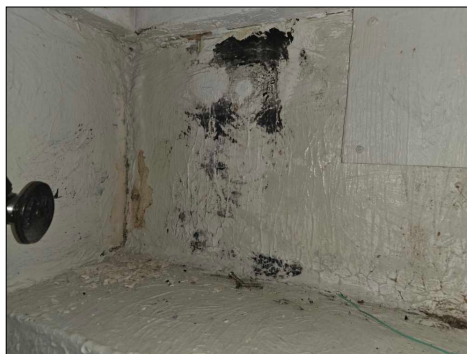
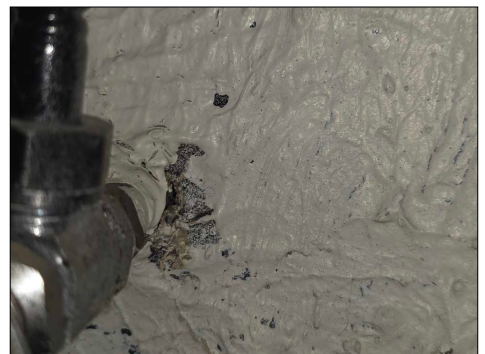
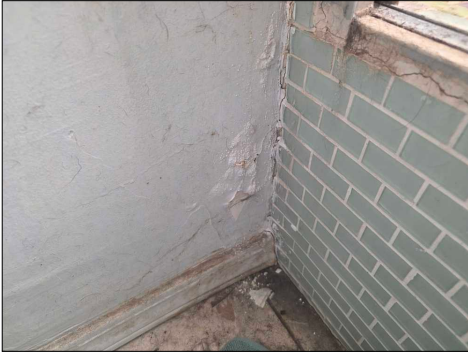
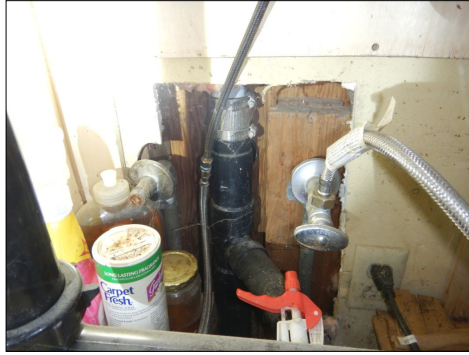
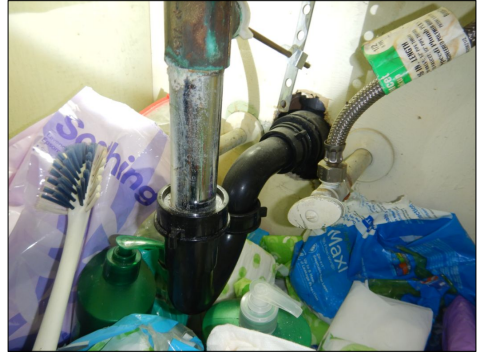
There are holes in the wall in the kitchen sink cabinet and master bathroom cabinet; recommend this be corrected to improve appearance and as security against insects, rodent, and pests.

Water stains were noted at the baseboards in the music room; further evaluation and correction are recommended.

The tiled wall in the lower bathroom near the toilet had cracked grout and hollow tiles, this can be an indication of hidden water damage; further evaluation and correction are recommended. Hidden damage is likely.

Black staining observed at the wall below the sink in the lower level bathroom. It is beyond the scope of the inspection to identify this type of material. This material is present because of a moisture problem. Recommend a qualified moisture intrusion specialist, identify the source of the moisture and make repair recommendations. You may also wish to have an air quality test done by a state licensed industrial hygienist.

Water damage was found near the tub in the upper bathroom; further evaluation and correction are recommended. Hidden damage may exist.

Suggest complete review/correction including cost estimate (bids) by a qualified licensed drywall contractor before the end of the contingency period.

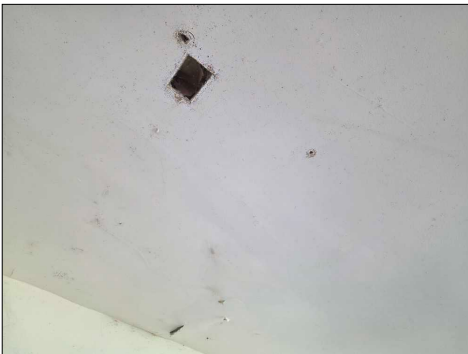
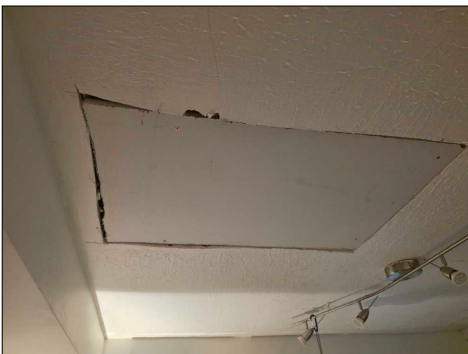
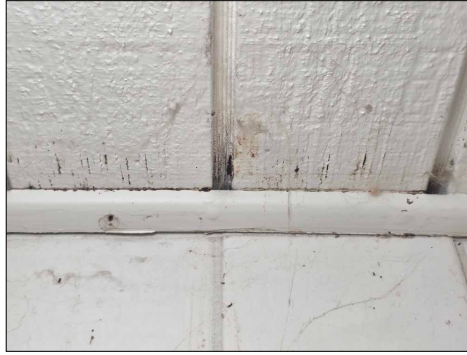
The lower level ceiling had unfinished repairs; further evaluation and correction are recommended.

Recommend repairing the holes in the ceiling; further evaluation and correction are recommended.

Water stains were found in the lower level bathroom ceiling; further evaluation and correction are recommended.

Water damage was noted in the sun room; further evaluation and correction are recommended.

Suggest complete review/correction including cost estimate (bids) by a qualified licensed drywall contractor before the end of the contingency period.

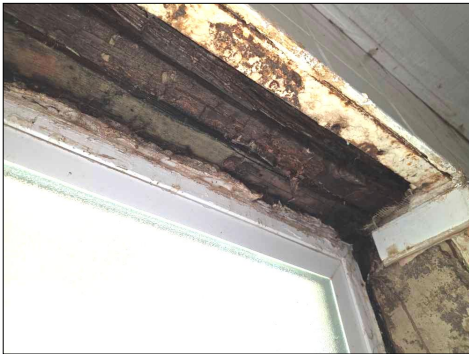
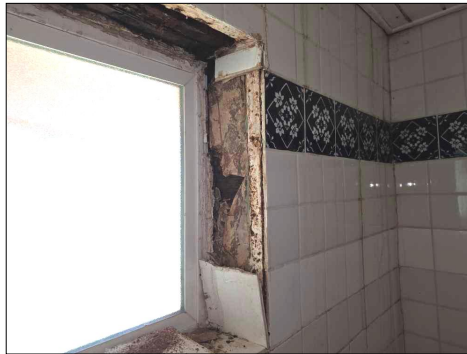
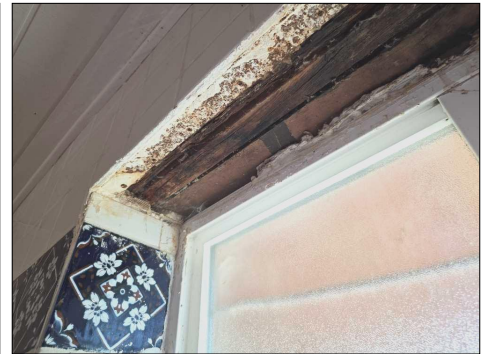
Bedroom window(s) does not appear to meet current emergency exiting and rescue requirements. We recommend installing a proper exiting window in every sleeping room for enhanced safety.

The lower level bathroom window had signs of wood destroying pest/organisms at the exposed wood and signs of water damage; further evaluation and correction are recommended. Hidden damage is likely.

Suggest complete review/correction including cost estimate (bids) by a qualified licensed window contractor before the end of the contingency period.

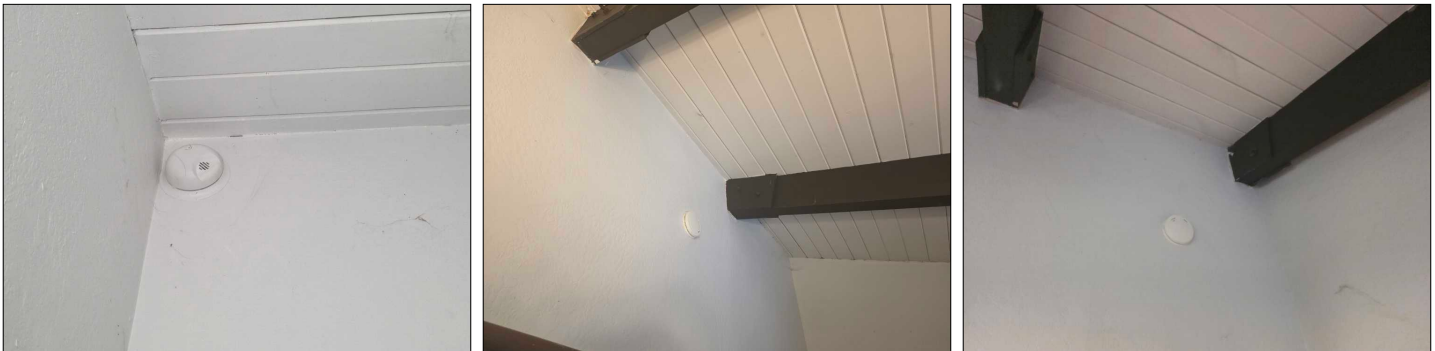
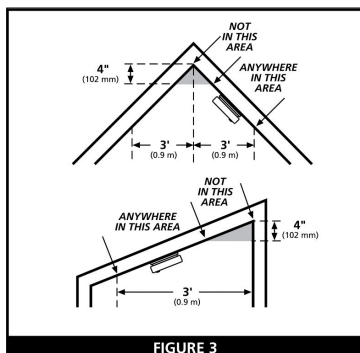
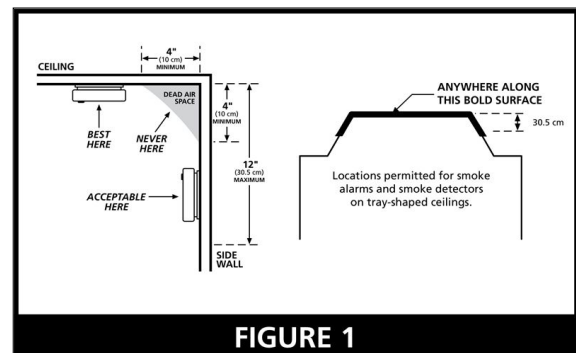
Cathedral ceiling smoke alarm was too low. The alarms should be installed within 12-inches of the highest point of the ceiling but no closer than 4-inches of any corner; recommend the alarm(s) be relocated in accordance with the manufactures requirements prior to removal of contingencies.

The smoke alarm was not in the proper location recommended by the manufacturer. They should be installed within 12-inches of the highest point of the ceiling but no closer than 4-inches of any corner; recommend the alarm(s) be relocated in accordance with the manufactures requirements prior to removal of contingencies.

Suggest complete review/correction including cost estimate (bids) by a qualified licensed contractor before the end of the contingency period.

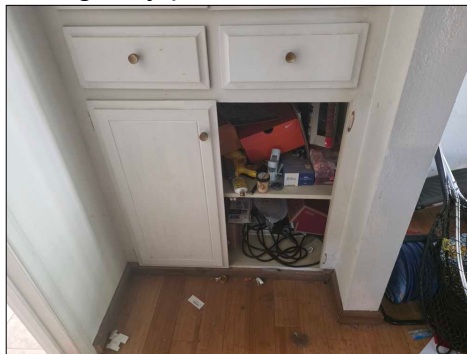
One of the cabinet doors was missing; replacement is recommended.

Suggest complete review/correction including cost estimate (bids) by a qualified licensed drywall contractor before the end of the contingency period.

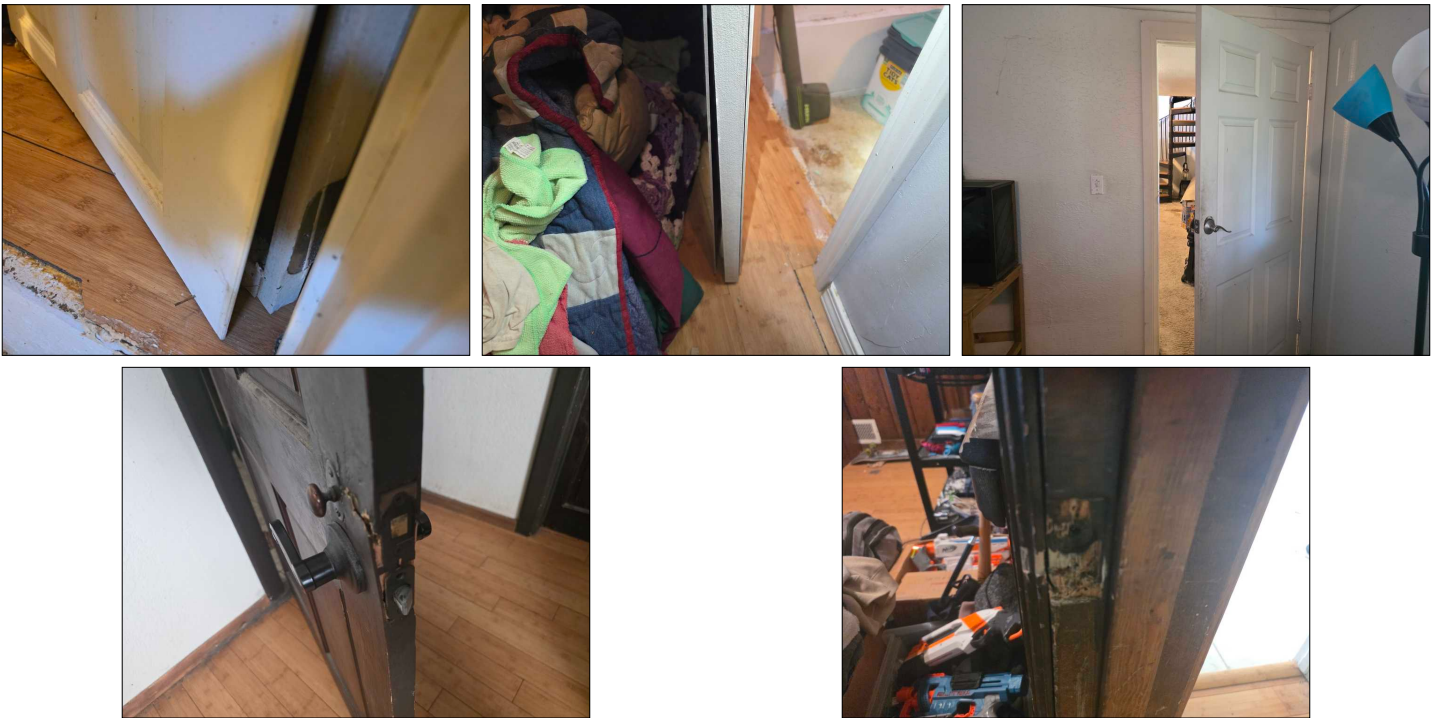
A number of the doors are missing their door stops. This condition will lead to damage to the wall surfaces. We recommend door stops be installed where needed.

The entry-level bedroom door was damaged; replacement is recommended.

The laundry room door was separated; further evaluation and correction are recommended.

The strike plate was missing. We recommend the strike plate be replaced to restore this latch to its proper function.

The door in the lower level bedroom appears to be out of plumb, the door swings closed under its own weight; recommend further evaluation and correction.

Suggest complete review/correction including cost estimate (bids) by a qualified licensed contractor before the end of the contingency period.

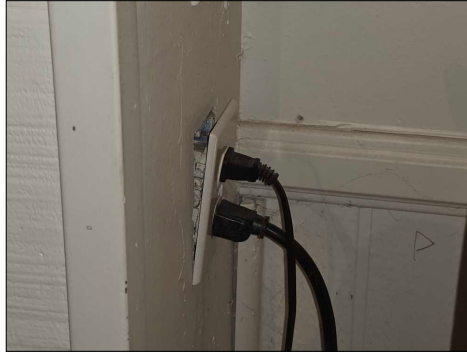
One of the receptacles in the music room was loose; further evaluation and correction are recommended to.

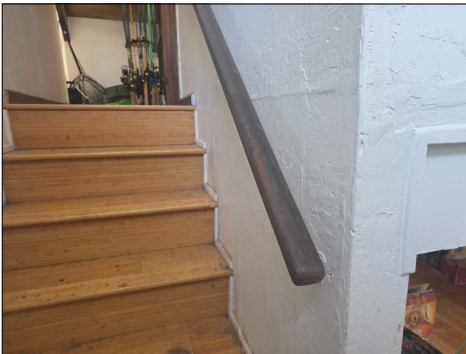
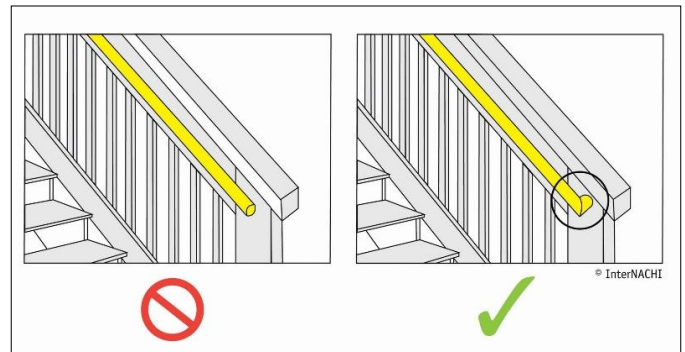
The handrail does not return to post and creates a snag hazard for loose clothing and purse straps, although at the time of construction this may have been permissible; recommend correcting this issue as a safety upgrade.

Suggest complete review/correction including cost estimate (bids) by a qualified licensed contractor before the end of the contingency period.

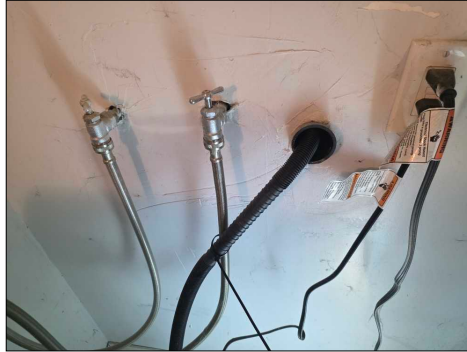
The hook ups for the washer appear to be in serviceable condition. The washer stand pipe was not visible and was not tested. The supply valves were not tested. Expect these valves to leak when used and most likely maintenance will be needed.

Most manufactures recommend the water supply hoses be replaced every five years.

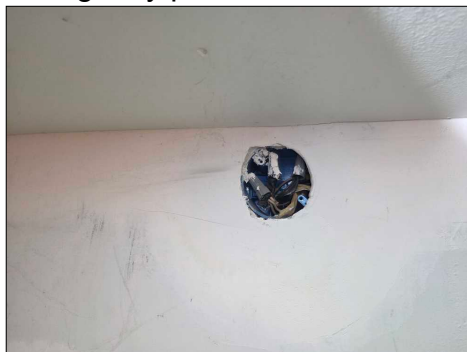
One of the light fixtures was missing; replacement is recommended.

Suggest complete review/correction including cost estimate (bids) by a qualified licensed electrical contractor before the end of the contingency period.

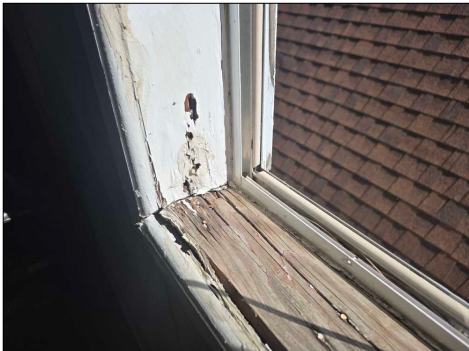
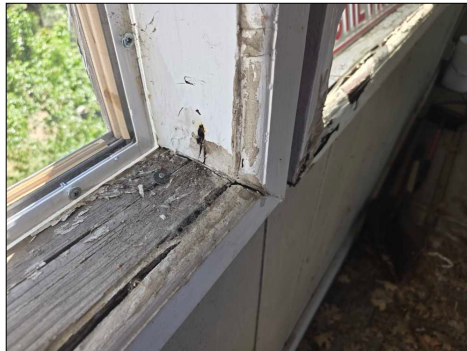
Signs of wood-destroying pest/organism damage noted at the window frames; recommend further evaluation and correction by a licensed pest control operator before removing any contingencies.

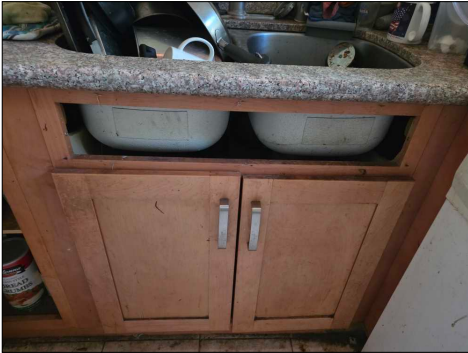
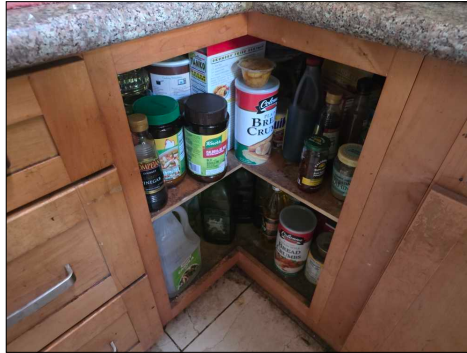
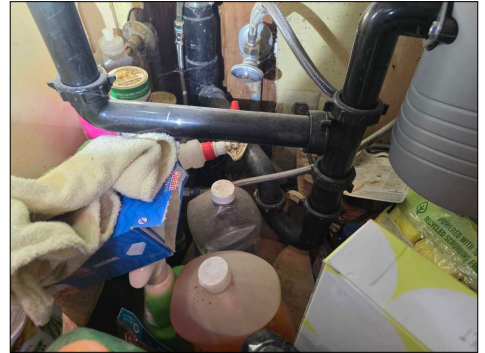
The cabinets were missing doors and faces; further evaluation and correction are recommended.

The cabinet surfaces are worn. We recommend they be refinished to restore their cosmetic appearance.

The sink cabinet base was damaged; further evaluation and correction are recommended.

Suggest complete review/correction including cost estimate (bids) by a qualified licensed contractor before the end of the contingency period.

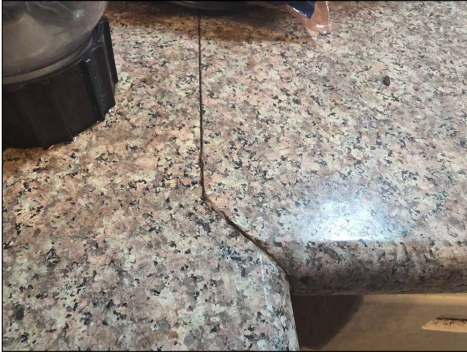
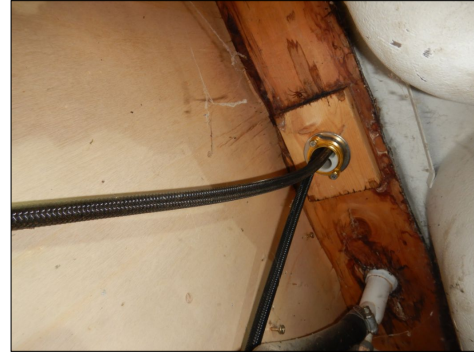
The grout in the countertop was missing in a number of locations. Grouting will keep moisture from getting below the surface and damaging the substrates below. Correction is recommended.

Water stains were found on the underside of the countertop near the sink faucet; further evaluation and correction are recommended.

Suggest complete review/correction including cost estimate (bids) by a qualified licensed contractor before the end of the contingency period.

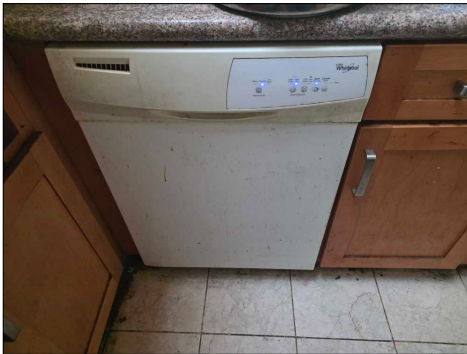
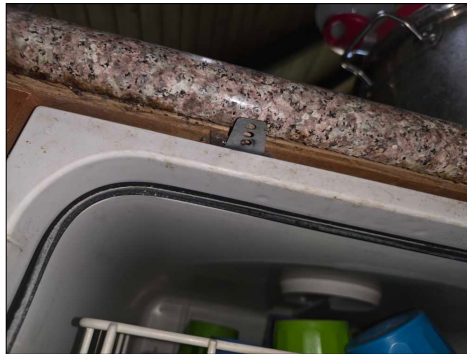
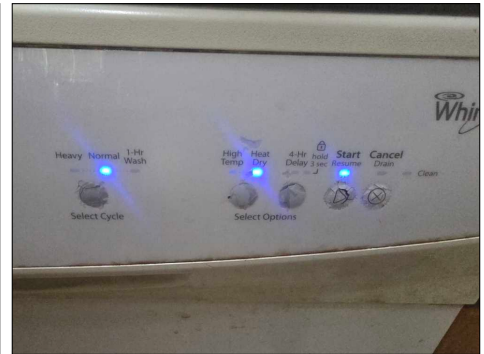
The dishwasher was not secured to the cabinets, further evaluation and correction is recommended.

The dishwasher controls are damaged, correction is recommended.

Suggest complete review/correction including cost estimate (bids) by a qualified licensed repair technician before the end of the contingency period.

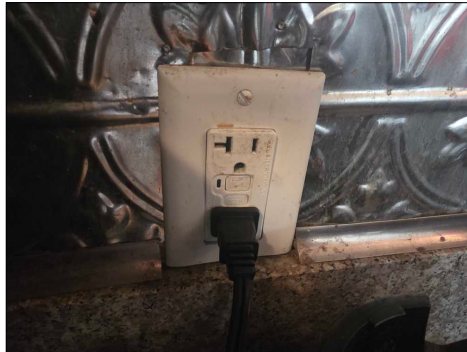
A number of the receptacles are loose, we recommend they be properly secured to prevent damage to the wires or receptacles.

The GFCI did not respond to the test button, we recommend replacement of the receptacle.

Suggest complete review/correction including cost estimate (bids) by a qualified licensed electrical contractor before the end of the contingency period.

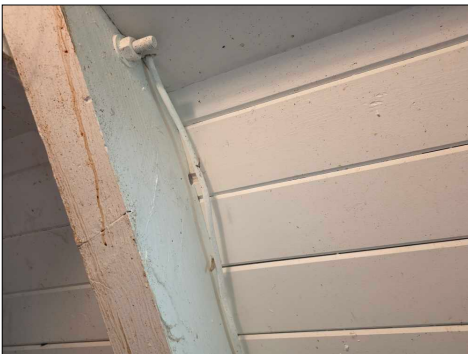
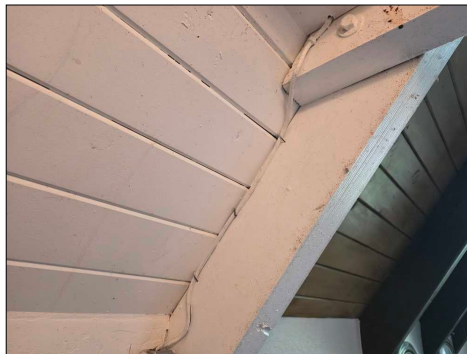
Exposed wires found at the lights. The wiring was not well protected and is subject to physical damage; recommend the installation of mechanical protection to help prevent physical damage.

Suggest complete review/correction including cost estimate (bids) by a qualified licensed electrical contractor before the end of the contingency period.

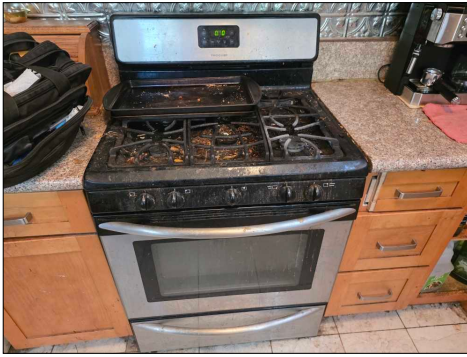
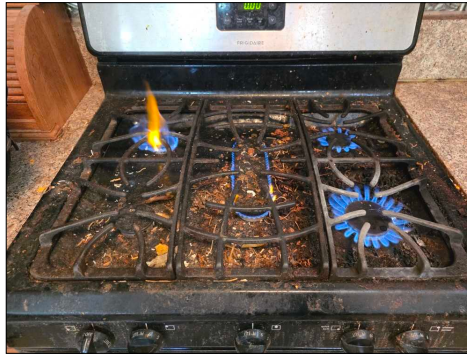
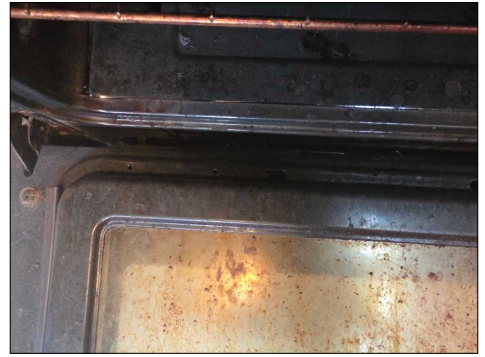
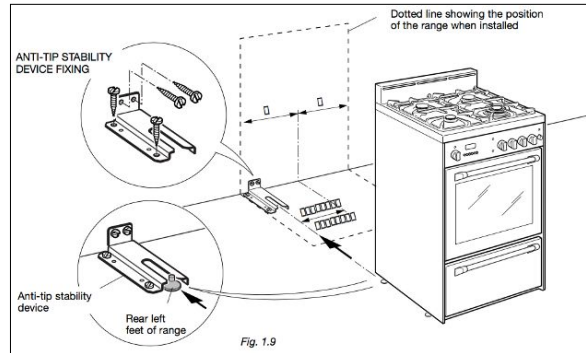
Part of the door gasket was missing; further evaluation and correction are recommended.

The stove was not equipped with the required anti tipping hold down bracket. This can be very hazardous to children potentially resulting in burning or other injury if the child opens the oven door and stands on it in an attempt to reach something on the stove top. We recommend an anti tip bracket be installed.

The burner did not respond when tested; correction is recommended.

Suggest complete review/correction including cost estimate (bids) by a qualified licensed contractor before the end of the contingency period.

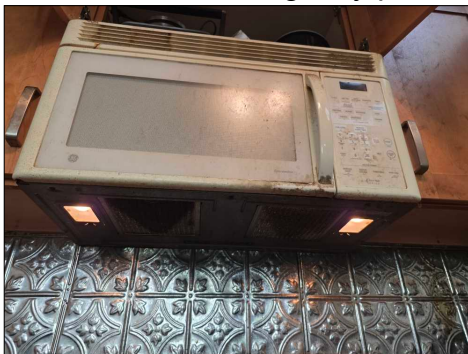
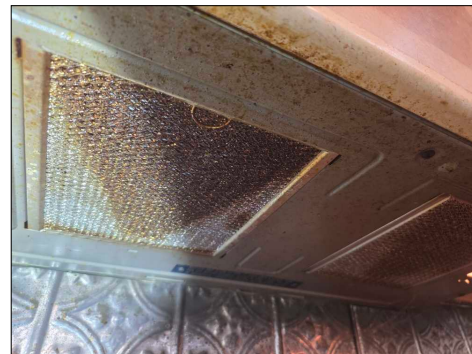
The vent screen(s) are dirty and should be cleaned or replaced.

The exhaust fan was a recirculation type with a charcoal filter; the charcoal filter should be replaced every 6 months. While this may have been acceptable at the time of construction, it would not meet today's standards; upgrading where practical is recommended.

The exhaust vent was noisy when operated, we recommend further evaluation and correction.

Suggest complete review/correction including cost estimate (bids) by a qualified licensed contractor before the end of the contingency period.

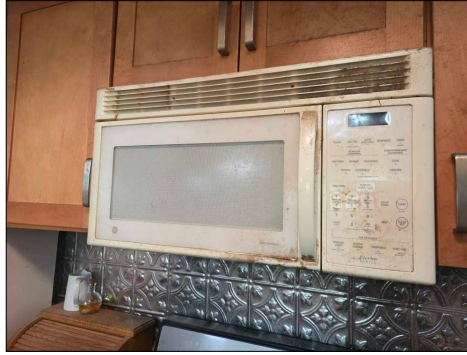
The microwave operated when tested but was unsanitary; recommend a thorough cleaning or replacement.

For attention to the condition(s) noted, and/or cost estimates, if necessary, we recommend the advice and services of a general or specialty contractor.

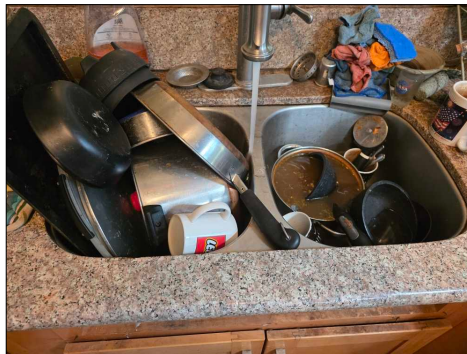
Dishes in sink prevent complete inspection. We recommend they be removed and a full inspection completed.

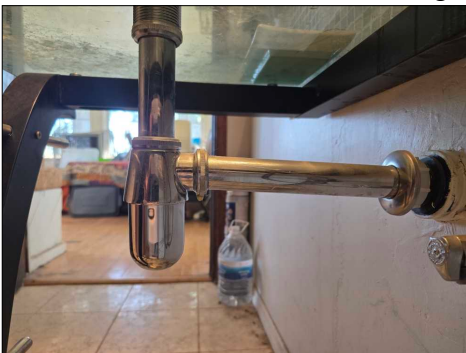
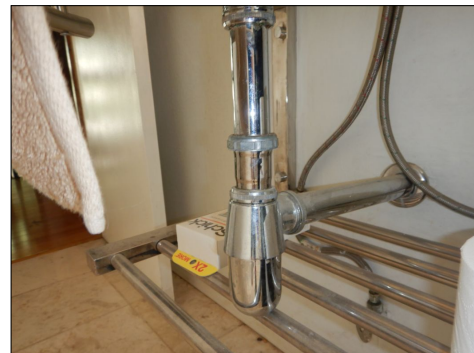
Bottle trap(s) found in the powder bathroom and upper bathroom. These types of traps depend on movable internal parts to function properly, and are generally not permitted without specific approval from the local Authority Having Jurisdiction. These traps are generally slow to drain. For these reasons we do not recommend or endorse the use of these traps and recommend that a standard P-trap be installed.

Suggest complete review/correction including cost estimate (bids) by a qualified licensed plumbing contractor before the end of the contingency period.

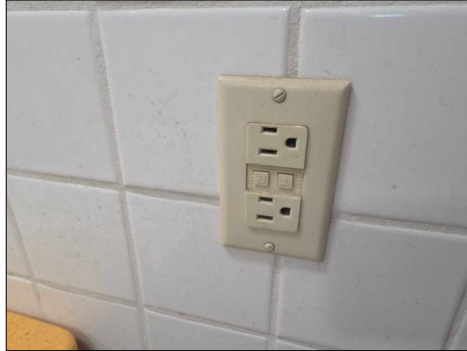
The GFCI receptacle in the Lower-level bathroom did not respond to the test button; recommend replacement of the receptacle.

Suggest complete review/correction including cost estimate (bids) by a qualified licensed electrical contractor before the end of the contingency period.

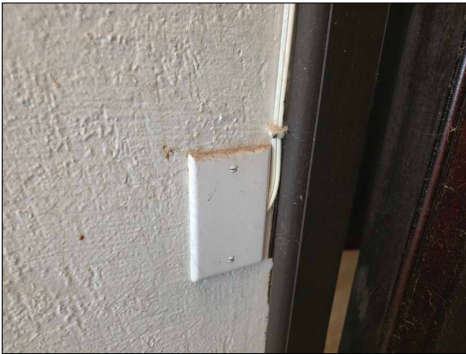
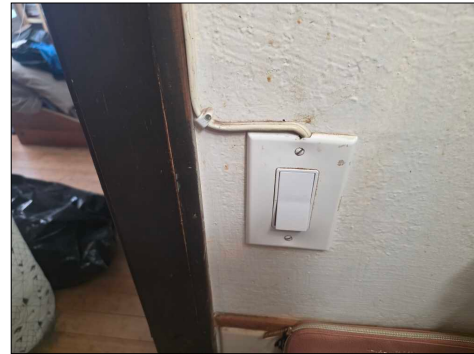
Lamp cord was used at the entry-level bathroom light switches; further evaluation and correction are recommended.

Suggest complete review/correction including cost estimate (bids) by a qualified licensed electrical contractor before the end of the contingency period.

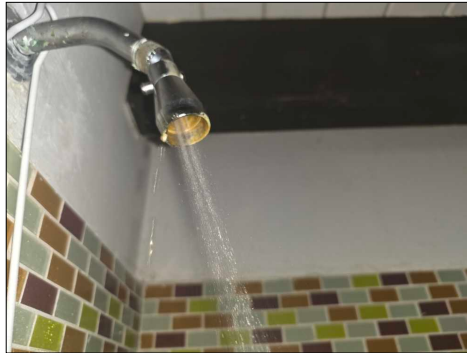
The master bathroom shower head had low flow; replacement is recommended.

For attention to the condition(s) noted and/or cost estimates, if necessary, we recommend the advice and services of a general contractor.

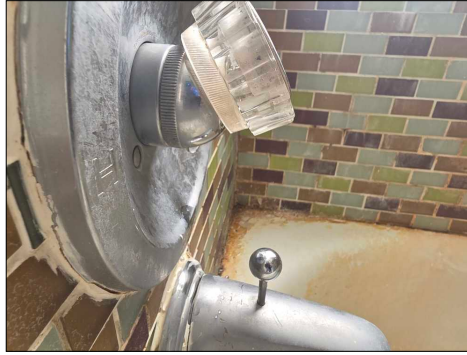
The upper-level bathroom tub/shower mixing valve leaks when operated; recommend repair or replacement.

Suggest complete review/correction including cost estimate (bids) by a qualified licensed plumbing contractor before the end of the contingency period.

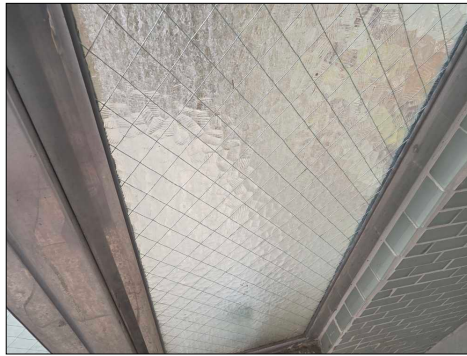
The wire reinforced glass enclosure in the upper bathroom was not an approved safety glass; recommend replacement of the shower enclosure for increased safety.

Suggest complete review/correction including cost estimate (bids) by a qualified licensed plumbing contractor before the end of the contingency period.
