### *Inspection Report*

Address: 2556 Nutmeg Ave Morro Bay, CA 93442

09/04/2025

Inspector: Taylor Vreeken, CCI

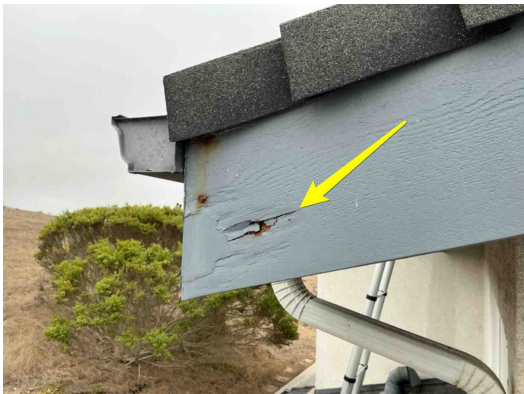
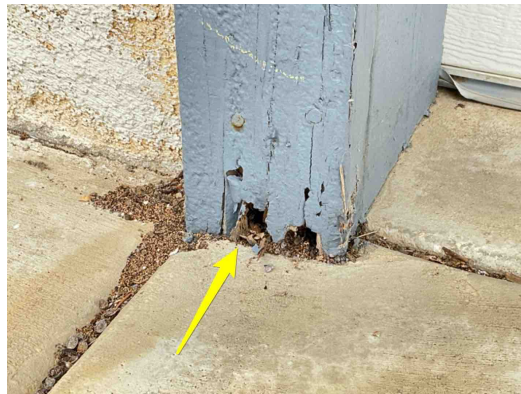
**E&C s-29:** Some moisture and/or bug type damage & deterioration found at exterior areas such as eaves, fascia and/or trim. Refer to the termite report for locations and extent.

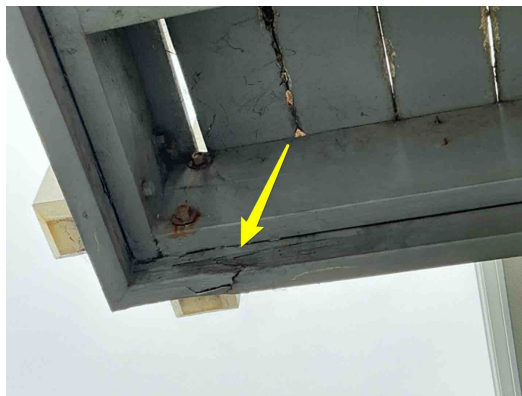
**E&C s-33:** Some moisture and/or bug-type damage and deterioration found at areas of the wood decking and/or wood deck railings: UPSTAIRS DECK OFF THE LIVING ROOM and SOUTH DECK. *Refer to the termite report for additional comments and recommendations.*

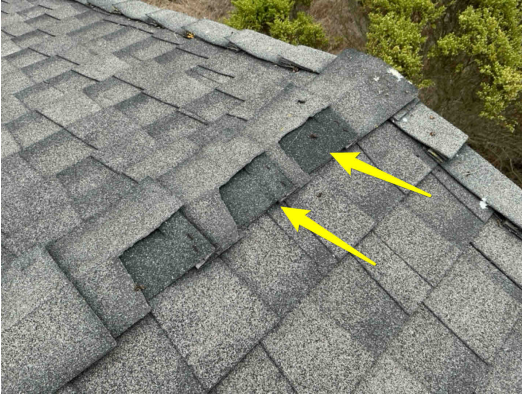
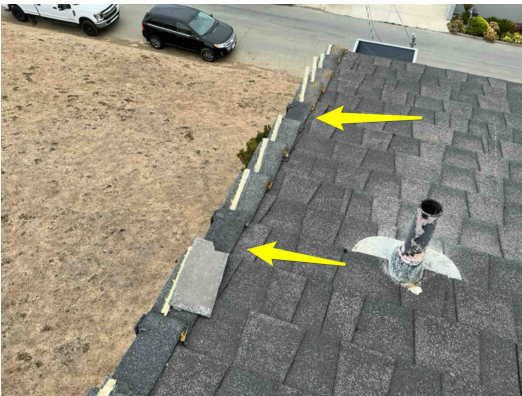
**E&C s-65:** Some damaged and missing roof shingles noted at areas of the roof. Corrections are needed. Contact a qualified roofer to evaluate the roof and make the appropriate recommendations and repairs as needed.

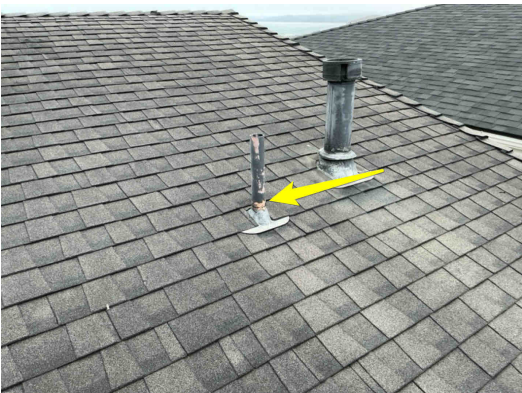
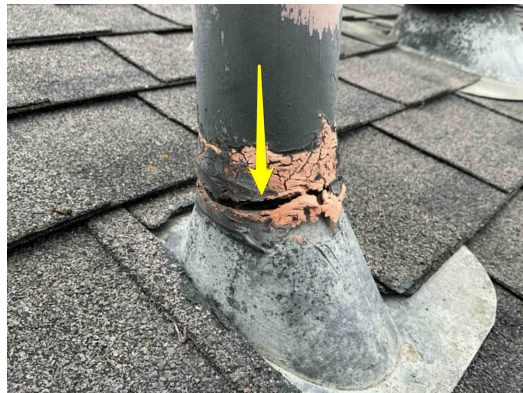
**MR s-67:** Deteriorated sealant at some roof flashings, around the roof penetrations. Maintenance recommended to help prevent water intrusion into areas of the attic. Have roofer evaluate the roof flashings and correct as needed.

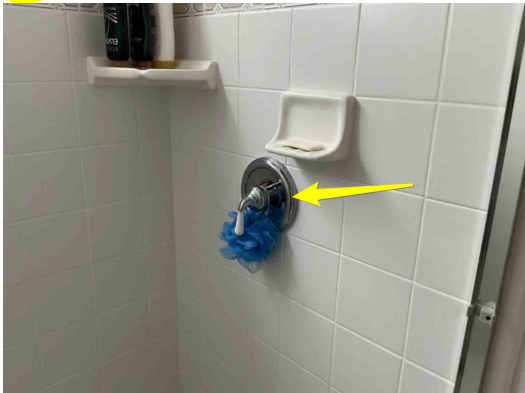
**SU** s-154: Hot & cold reversed at the shower faucet: HALLWAY BATHROOM

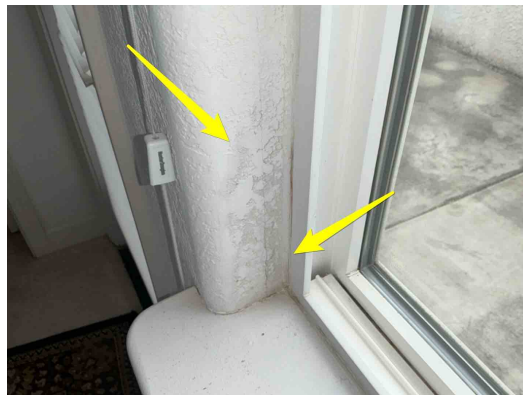
**DS** s-166: Some of the dual-pane window seals have failed and are visibly fogged or have a defective UV film. If concerned have all windows tested by a licensed or certified window company professional to determine exact locations and quantity of defective windows.

**FI** s-167: Moisture stains and/or damage on the inside at some window sills. Refer to the termite report for additional comments and recommendations.

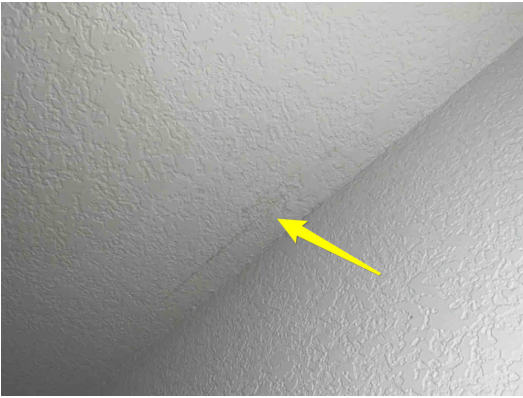
**FI s-182:** Evidence of past moisture stains & damage at ceiling area in BEDROOM-2. Recommend further review of the water stains to determine the cause, the current condition and if repairs are needed.

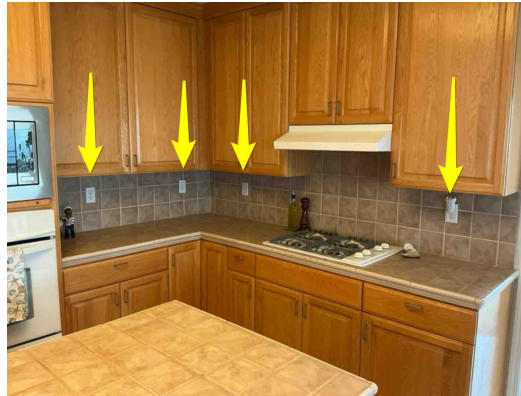
**SC s-210:** Missing GFCI protected outlets in some required locations. Recommend repairs and upgrades by a qualified and licensed electrical professional familiar with the minimum GFCI protection requirements: EXTERIOR (REQ.1971)  
FIVE OUTLETS IN THE KITCHEN (REQ.1987)

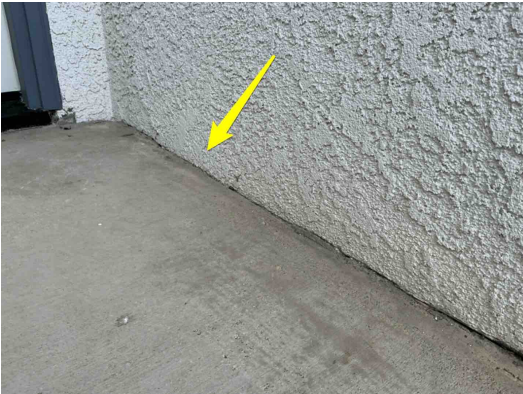
**UPG DS 19: Disclosure:** Areas of the patios were installed high at or above the exterior siding and/or trim. This can potentially under certain conditions, allow for moisture to collect at the base of the sliding and can cause deterioration or water intrusion.

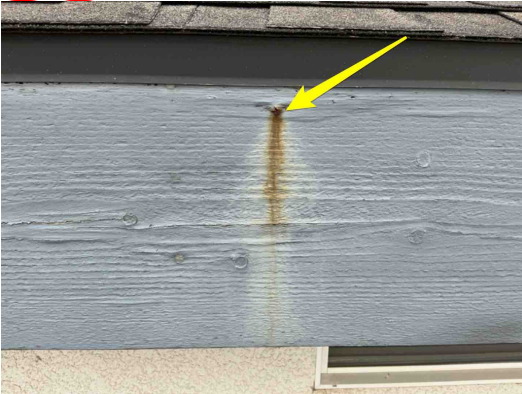
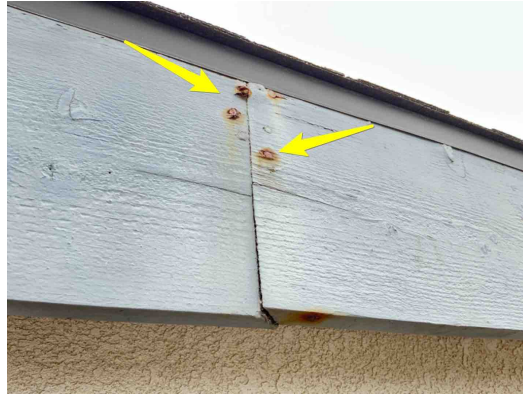
**E&C** **FI** **25:** Several exterior fasteners found rusted and deteriorated.

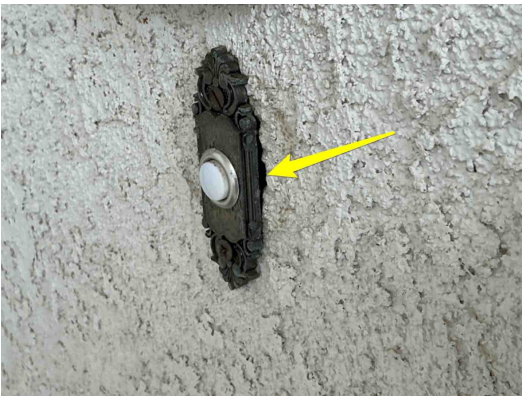
**MR** **26:** Recommend sealing holes in exterior walls to prevent water intrusion around areas such as unused open holes in the exterior sliding and trim, exterior light fixtures, around exterior electrical boxes and covers, and where utility pipes and/or wires pass through the exterior walls. Have a qualified painter or licensed professional evaluate the entire exterior and seal where needed.

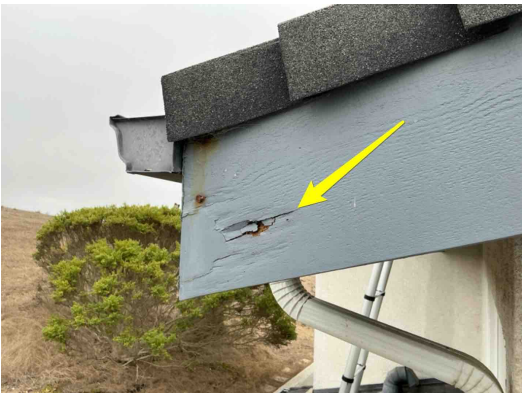
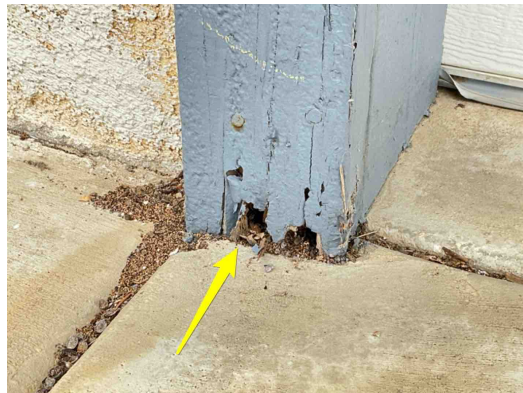
**E&C** **29:** Some moisture and/or bug type damage & deterioration found at exterior areas such as eaves, fascia and/or trim. Refer to the termite report for locations and extent.

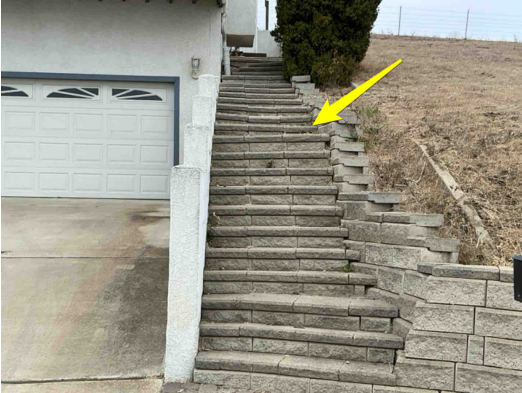
**E&C 30:** The SOUTH exterior stairway does not meet minimum construction and safety standards, potential fall hazard.

Uneven treads/ trip hazards/ no graspable handrails

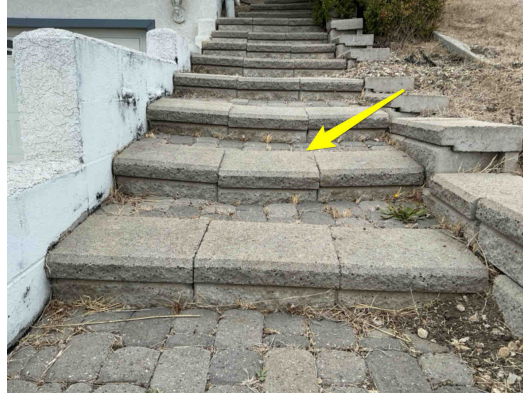
Uneven treads/ trip hazards

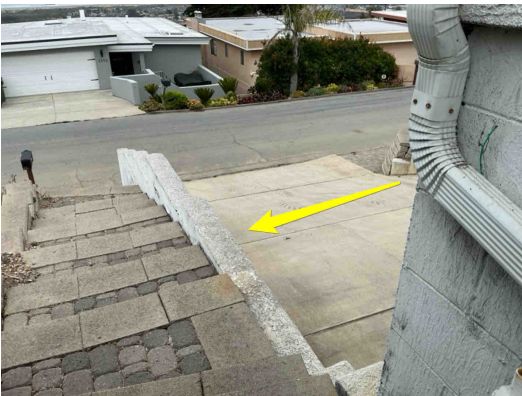
Missing required railings/ fall hazard

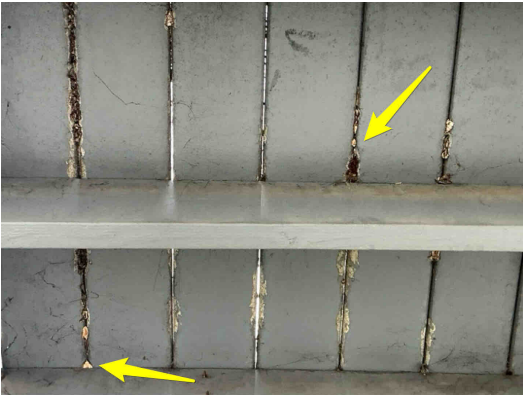
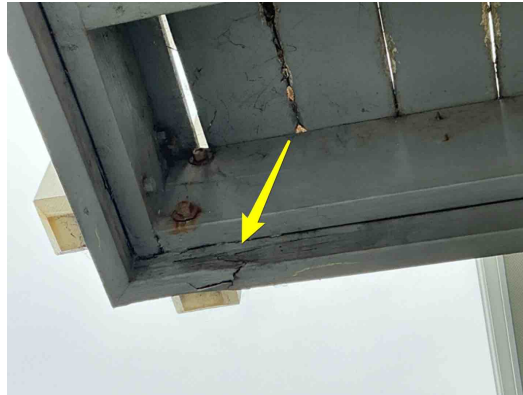
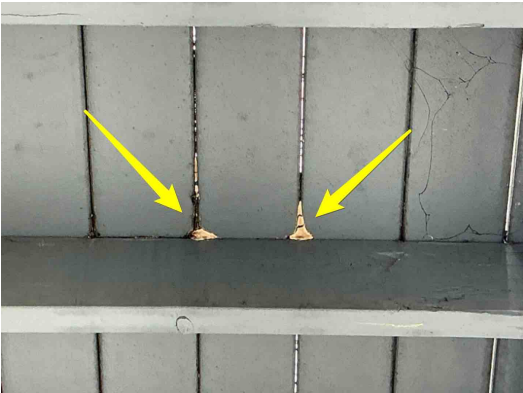
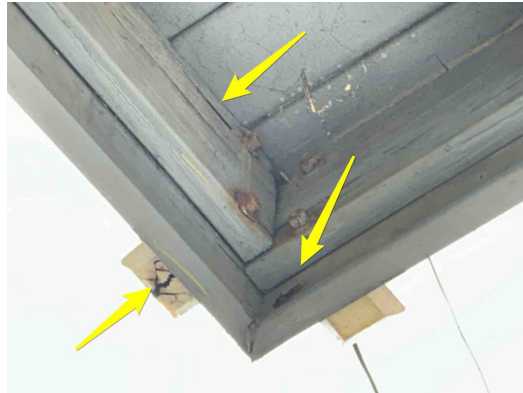
**E&C 33:** Some moisture and/or bug-type damage and deterioration found at areas of the wood decking and/or wood deck railings: UPSTAIRS DECK OFF THE LIVING ROOM and SOUTH DECK. *Refer to the termite report for additional comments and recommendations.*

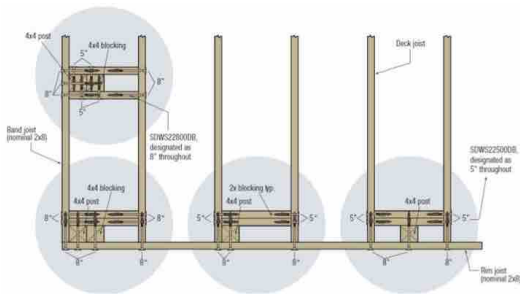
**34:** The deck railing attachments do not meet minimum installation standards. Contact a qualified contractor for upgrade and/or repair recommendations: UPSTAIRS DECK OFF THE LIVING ROOM

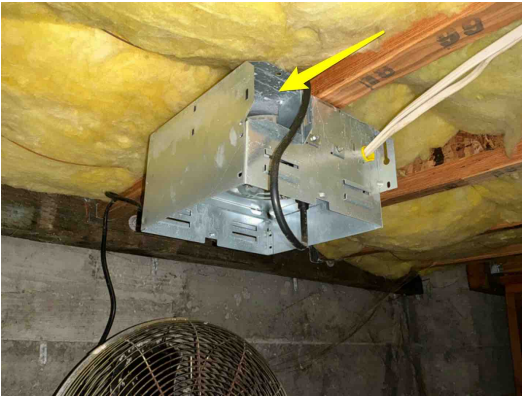
**E&C FI 59:** The crawlspace ventilation system appears to be partially installed and/or abandoned. Full condition is unknown. Ventilation systems are not currently functional. Contact a qualified contractor for evaluation and upgrades/repairs or completion.

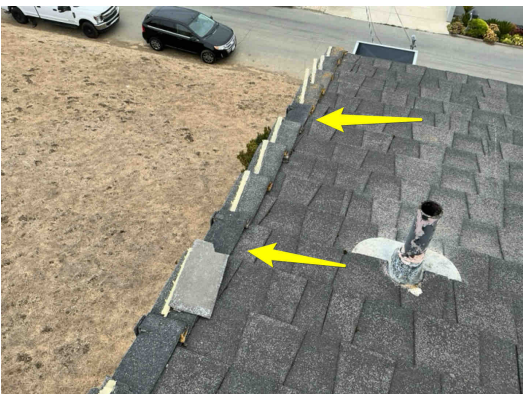
**E&C DS 64: ROOF CONDITION:** The asphalt composition roof shingles are old, weathered, deteriorated and is nearing or at the end of its life expectancy. Recommend contacting a licensed roofing contractor for a price and proposal for replacement.

**E&C 65:** Some damaged and missing roof shingles noted at areas of the roof. Corrections are needed. Contact a qualified roofer to evaluate the roof and make the appropriate recommendations and repairs as needed.

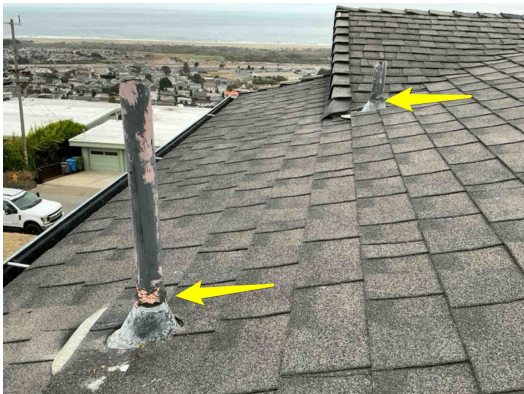
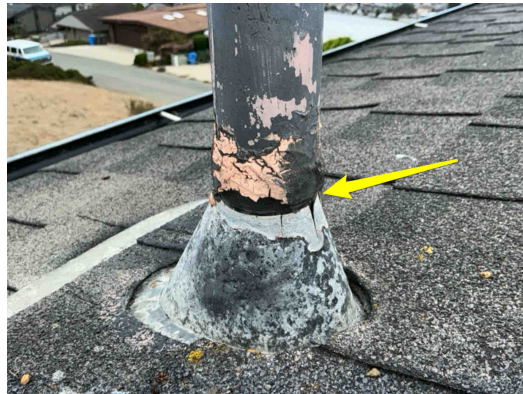
**E&C MR 66: ROOF FLASHING CONDITION:** Some roof flashing were found to be needing maintenance, servicing and/or repair. Contact a qualified roofing professional to review all roof flashings and provide maintenance and/or repairs as needed.

**MR 67:** Deteriorated sealant at some roof flashings, around the roof penetrations. Maintenance recommended to help prevent water intrusion into areas of the attic. Have roofer evaluate the roof flashings and correct as needed.

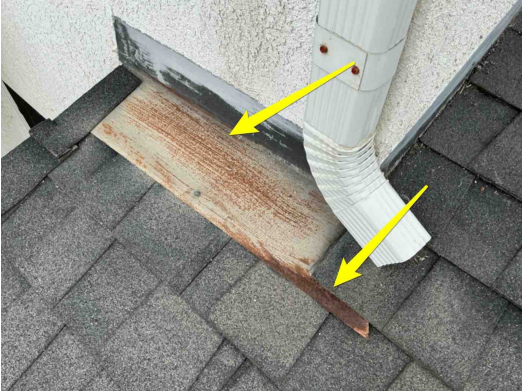
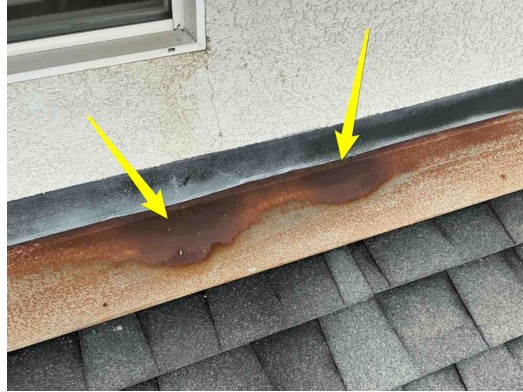
**FI 68:** Some roof flashings found rusted and deteriorated. Maintenance or replacement of deteriorated and damaged roof flashings are recommended.

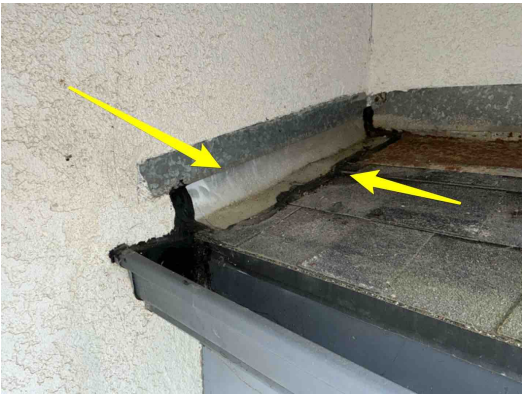
**E&C FI 69:** An improper and unusual roof flashing repair noted on the east exterior. Cause unknown. Condition underneath the unusual flashing is unknown. Contact a licensed roofing contractor for professional evaluation and repairs.

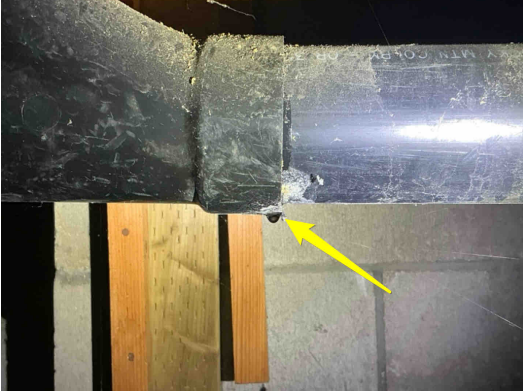
**FI 87:** Active water leak(s) found in the waste pipe in the crawlspace: LAUNDRY AREA. Have plumber check all waste piping throughout the crawlspace for any additional leakage.

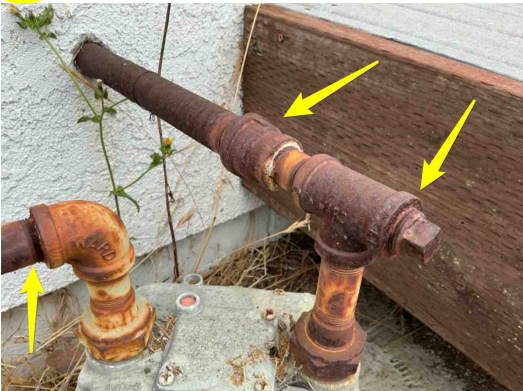
**MR 90:** Some Gas pipes at the meter found a little corroded. Recommend some typical and ongoing maintenance.

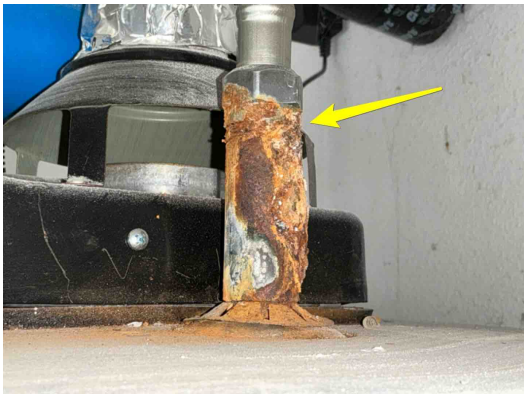
**FI** 103: Evidence of past leaking with corrosion at the COLD water supply piping at the water heater. Contact a qualified plumber to evaluate and correct.

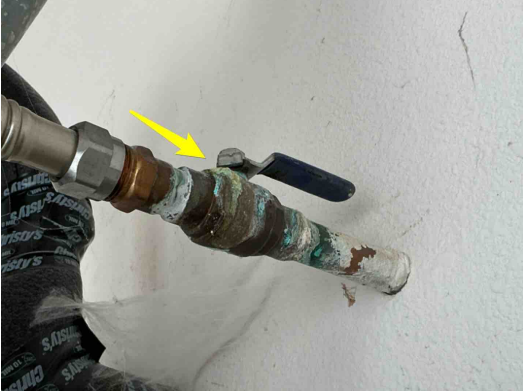
**E&C 106:** Evidence of past leaking with corrosion at the COLD water supply shut-off valve at the water heater. Recommend replacement.

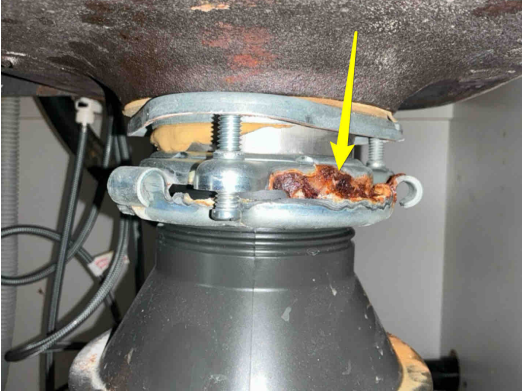
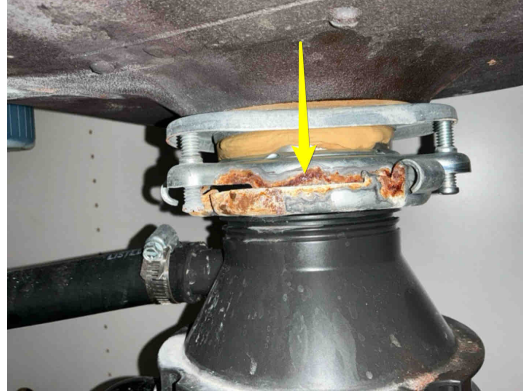
**FI 124:** Kitchen sink disposal is worn & corroded and may be nearing the end of its useful life and may fail or leak without warning.

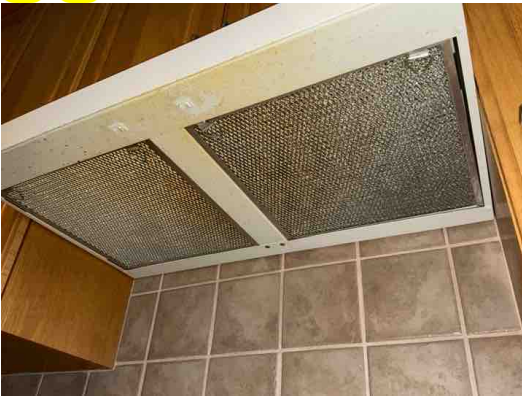
**MR SU 126:** Kitchen cook top exhaust hood and filter are dirty.

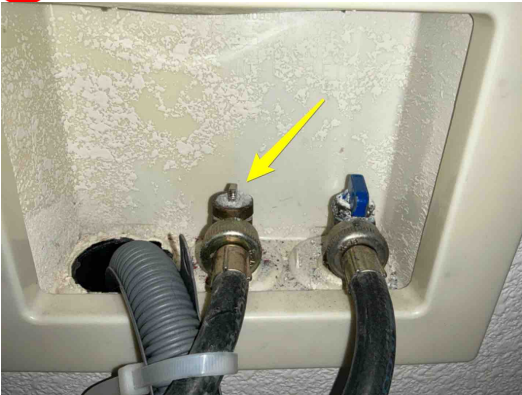
**E&C 139:** Missing the HOT water supply valve handle at laundry.

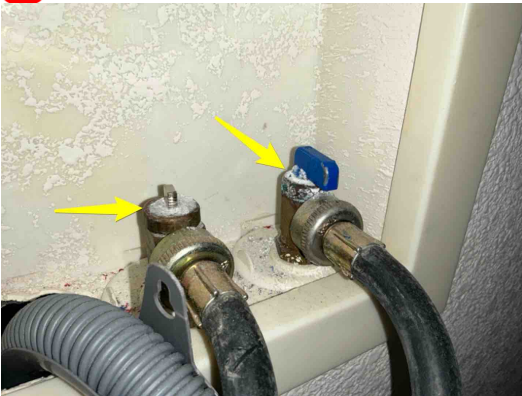
**E&C 140:** Some corrosion / past leaking found at the HOT and COLD water supply valve at laundry.

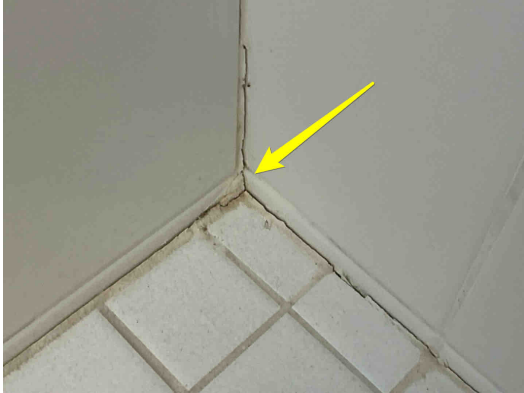
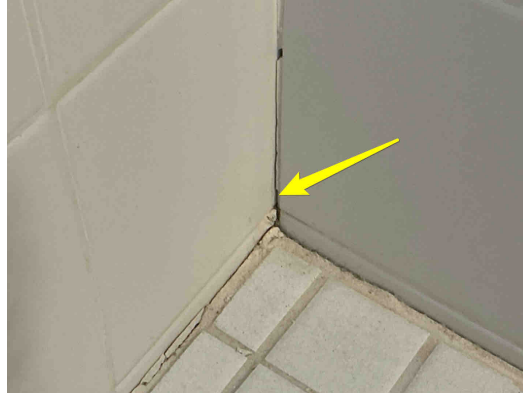
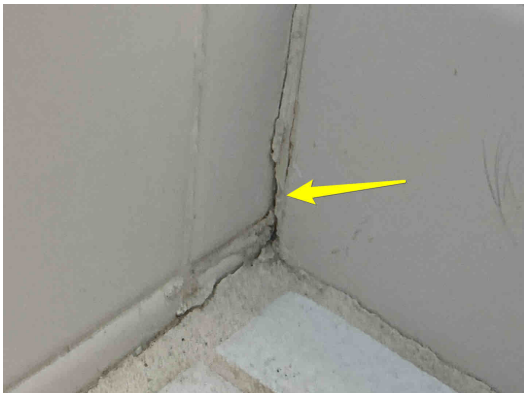
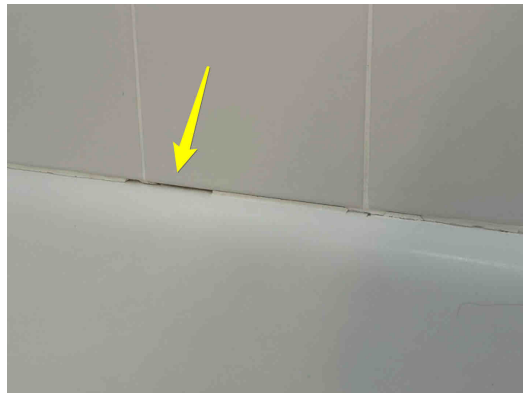
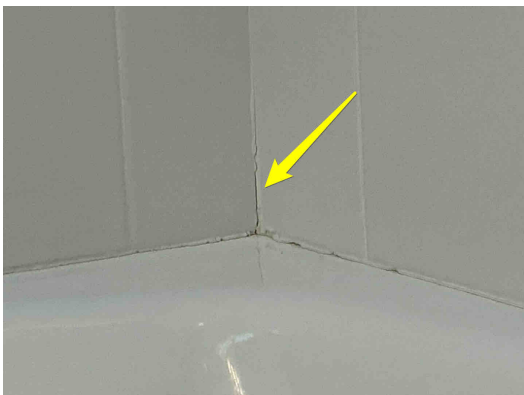
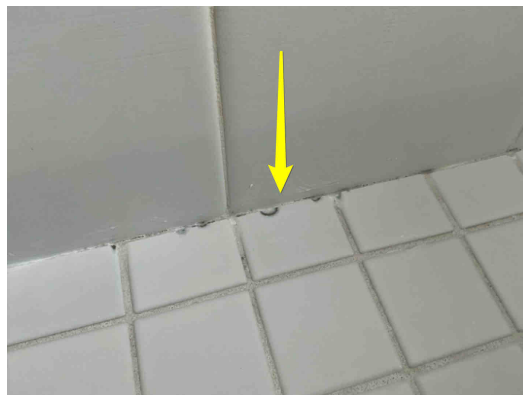
**FI MR 153:** Some cracked and separated grout found in areas of the shower at the walls and/or floor connections in the bathrooms. Maintenance or repairs recommended.

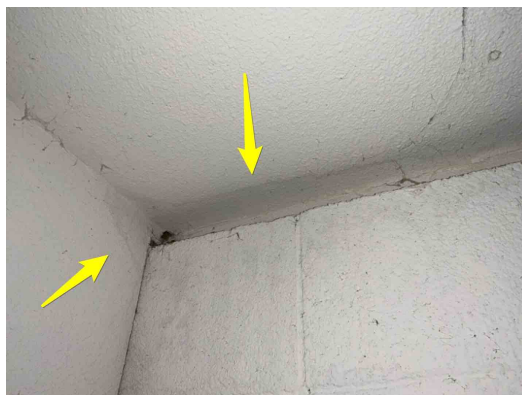
**FI 180:** Evidence of past moisture stains & damage at ceiling area in the GARAGE (southeast corner). Recommend further review of the water stains to determine the cause, the current condition and if repairs are needed.

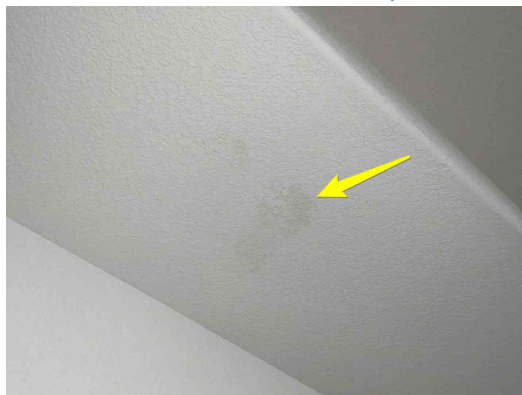
**FI 181:** Evidence of past moisture stains & damage at ceiling area in the LIVING ROOM. Recommend further review of the water stains to determine the cause, the current condition and if repairs are needed.

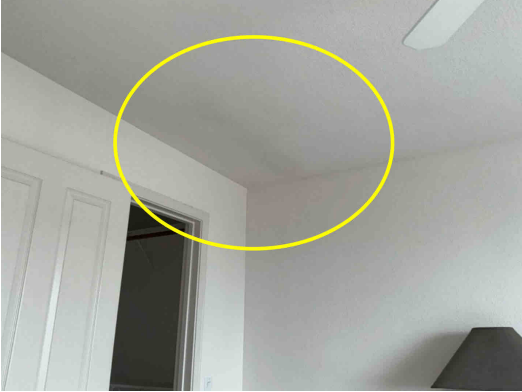
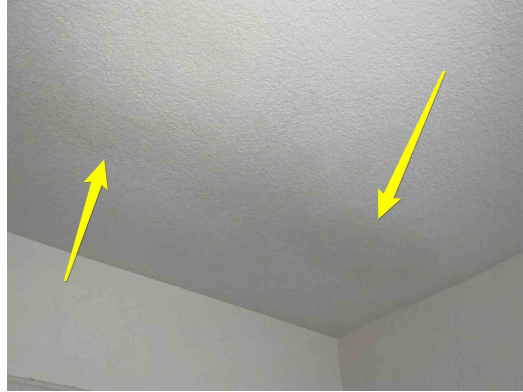
**FI 182:** Evidence of past moisture stains & damage at ceiling area in BEDROOM-2. Recommend further review of the water stains to determine the cause, the current condition and if repairs are needed.

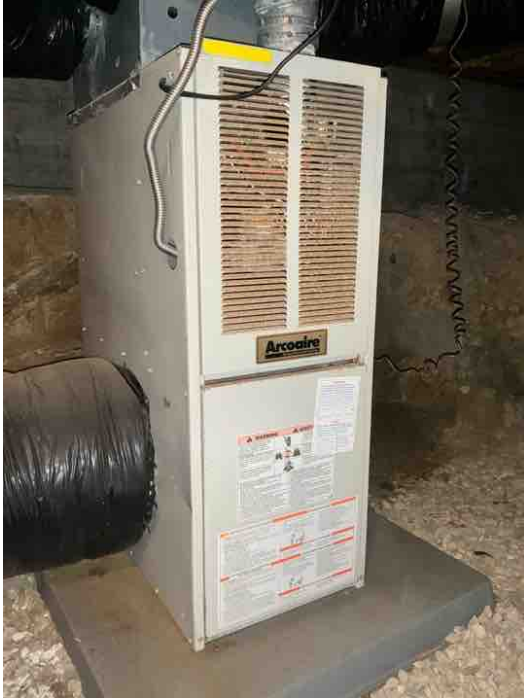
**186: LOCATION: CRAWLSPACE**  
**FURNACE TYPE: Gas Forced Air**  
**FUEL TYPE: Natural Gas**  
**Approx. BTU RATING: 75,000**  
**DATE: 1999**

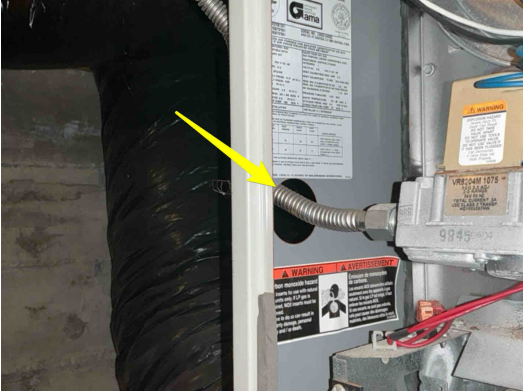
**SU 190: Disclosure:** It is considered an improper installation to have the flex gas connector pass through the metal sidewall of the furnace cabinet. Upgrades recommended.

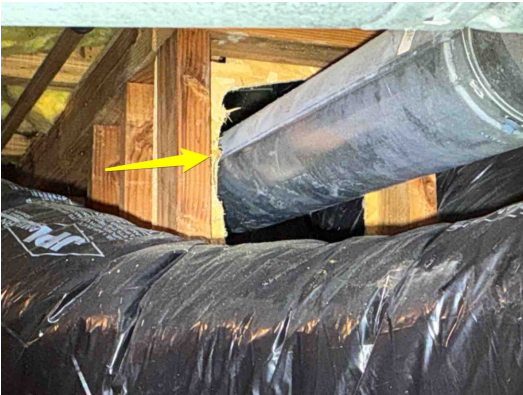
**E&C 192:** Furnace vent pipe lacks proper clearance to combustibles. A minimum of 1 inch of space between the vent pipe and combustibles is needed per minimum standards.

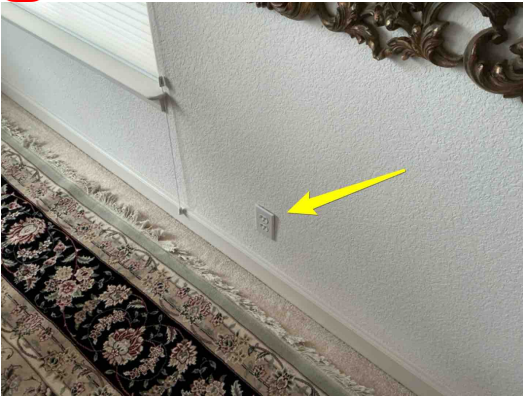
**SC 207:** An electrical outlet found loose in wall. Corrections warranted for safety: DINING AREA

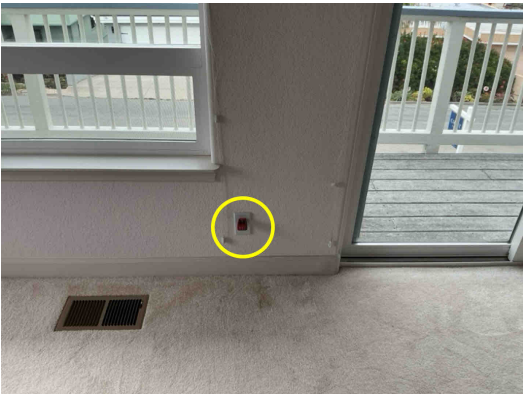
**SC 208:** Miswired electrical outlet (Reverse polarity) found LIVING ROOM EAST WALL. Have electrician check all outlets and correct as needed.

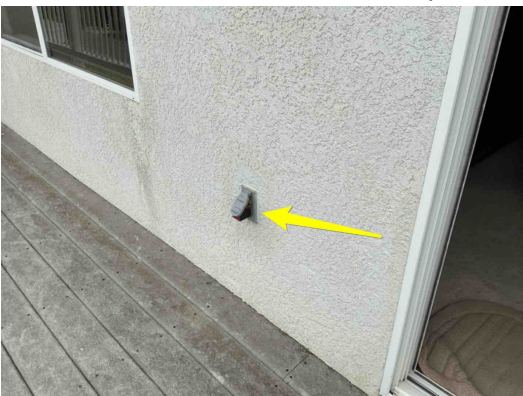
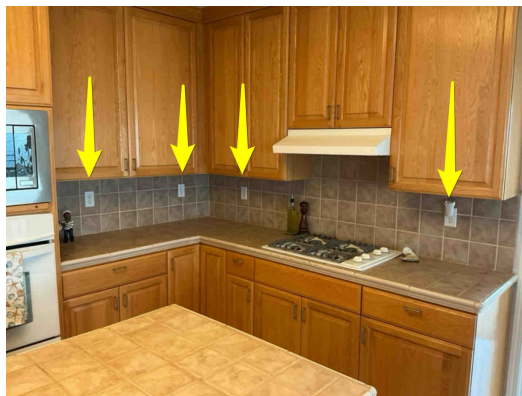
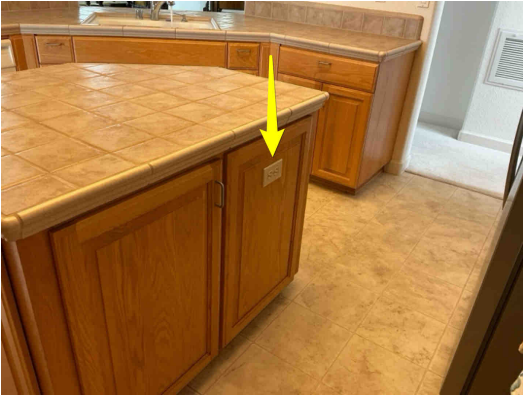
**SC 210:** Missing GFCI protected outlets in some required locations. Recommend repairs and upgrades by a qualified and licensed electrical professional familiar with the minimum GFCI protection requirements: EXTERIOR (REQ.1971)  
FIVE OUTLETS IN THE KITCHEN (REQ.1987)

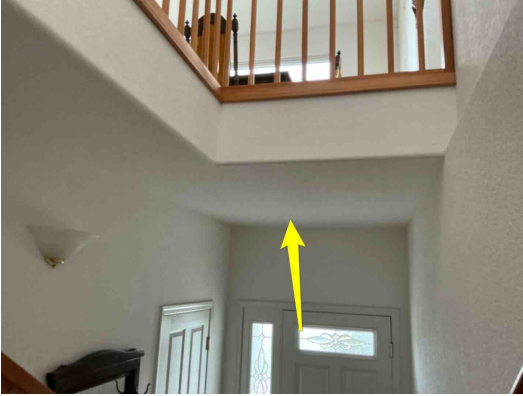
**SC 213: Smoke detector AND Carbon Monoxide detector are missing at required location: ENTRY LEVEL**

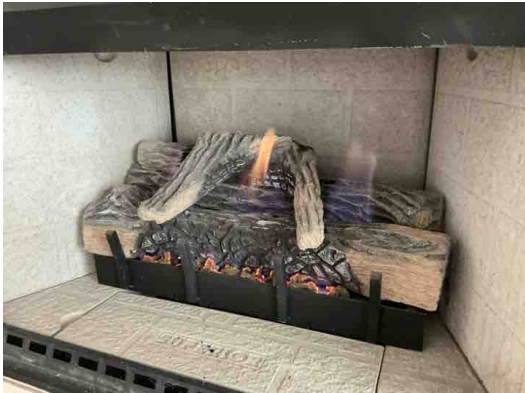
233: **GAS FIREPLACE CONDITION**: The LIVING ROOM GAS fireplace operated when tested.

**MR** 234: The living room gas fireplace did not ignite on the first several attempts. Recommend servicing and cleaning by a qualified fireplace/chimney professional.

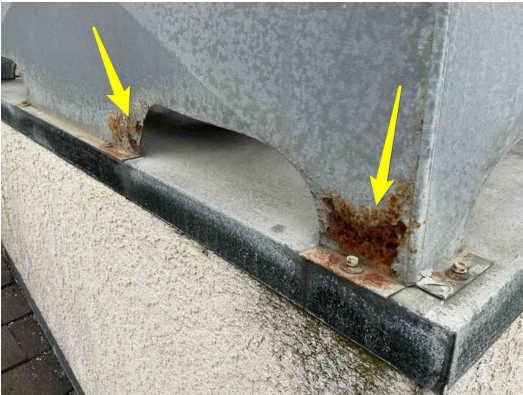
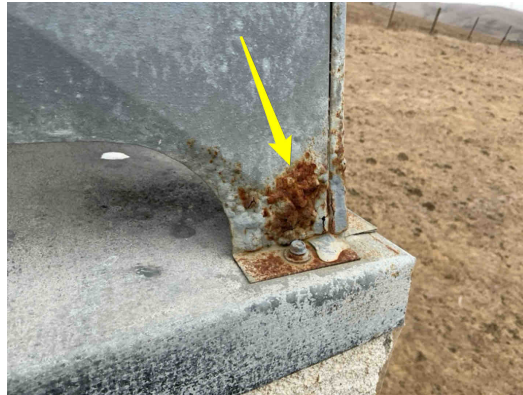
**E&C MR 236:** The metal chimney chase surround is rusted, deteriorated and damaged. Further evaluation and replacement is recommended.

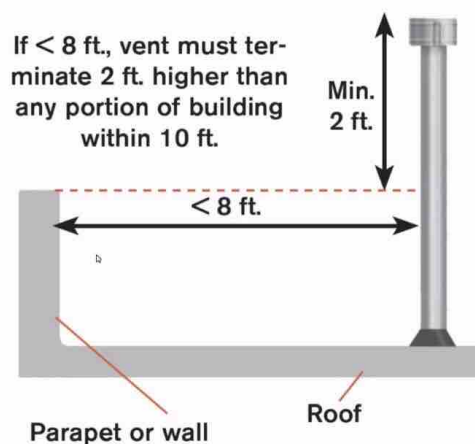
**FI DS 237:** The gas fireplace chimney vent pipe terminates too low at roof. This can negatively affect the drafting of the water heater. A vent pipe within 8 feet of a headwall is required to terminate 24 inches above the upper roof. Contact a qualified plumbing professional familiar with minimum safety requirements.
