**Inspection
Service Inc.**

Exclusive Property Inspection Report Prepared For

Property Address: 12 Arrowhead Ln. Rolling Hills Estates CA.

Inspection Date: 1/6/2024

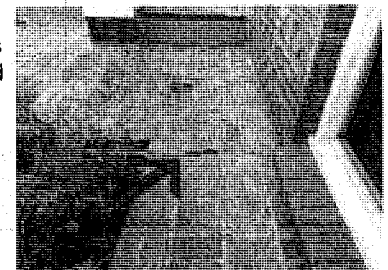
- Significant crack damage is visible to bricks at the front walkway. The condition is causing the surface to be uneven, therefore a trip hazard exists. We recommend correction using appropriate methods by a qualified masonry contractor.

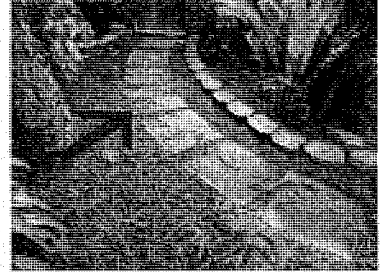
- Gaps are visible between the pavers at the left side walkway which is causing the surface to be uneven. The condition poses a trip hazard. We recommend correction using appropriate methods.
- Moss is visible on the surface of the left side walkway. The condition poses a slip hazard. Removal of the moss is recommended.

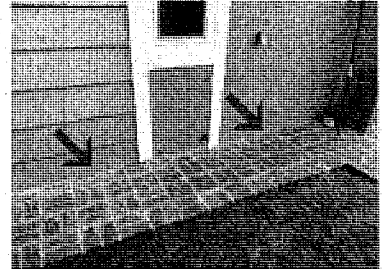
- The surface of the right side walkway is installed above the level of the exterior wall siding and weep screed drainage flashing which is improper. Moisture can become trapped between the surface and the exterior wall resulting in damage to the building. We recommend correction using appropriate methods by a qualified masonry contractor.

- Determining if any damage exists as a result is beyond the scope of this inspection due to inaccessibility, therefore we recommend further evaluation by a qualified moisture intrusion specialist.

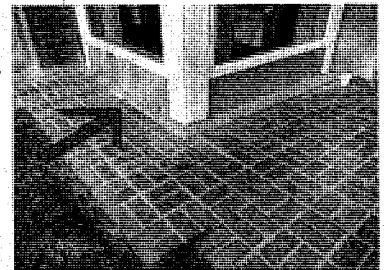
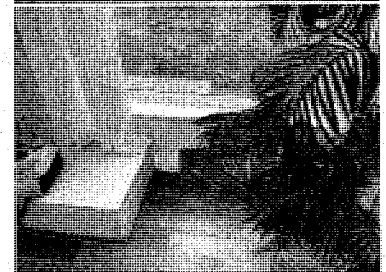
- The surface of the rear walkway is installed above the level of the slab foundation which is improper. Moisture can become trapped between the surface and the exterior wall resulting in damage to the building. The existing patching is likely an attempt to correct the condition and may indicate moisture intrusion has occurred. We recommend correction using appropriate methods by a qualified masonry contractor.

- Determining if any damage exists as a result is beyond the scope of this inspection due to inaccessibility, therefore we recommend further evaluation by a qualified moisture intrusion specialist.

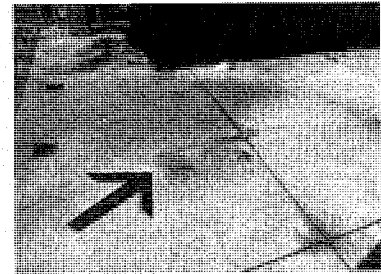
- Moss is visible on the surface. The condition poses a slip hazard. Removal of the moss is recommended.

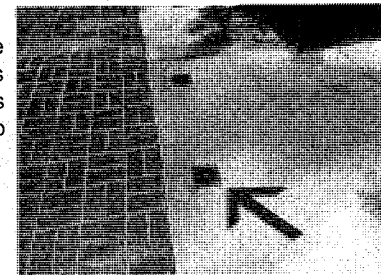
- A sub surface drainage system is installed. Determining the condition of the underground drains and location of the drain terminations is beyond the scope of this inspection, therefore not inspected. Water testing is beyond the scope of this inspection. Further evaluation by a qualified specialist should be considered. We also recommend consulting with the seller to confirm the location of drain terminations.

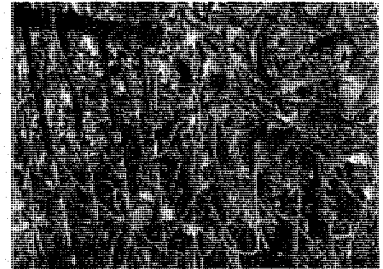
- The left side wrought iron fence is leaning and detached as viewed near the pool equipment area. We recommend correction using appropriate methods by a qualified wrought iron fence contractor.

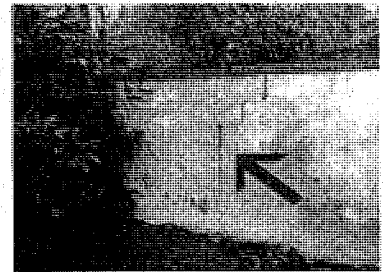
- Significant crack damage is visible to the right side fence. Determining the cause is beyond the scope of this inspection. We recommend correction using appropriate methods by a qualified masonry contractor. We also recommend further evaluation by a qualified geo-technical engineer to determine if the damage is caused by any adverse geological conditions.

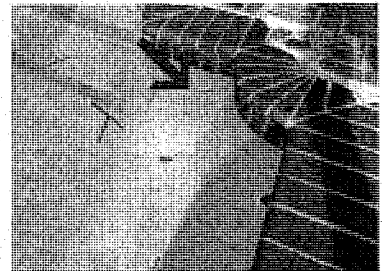
- The swimming pool system is beyond the scope of this inspection, therefore not inspected. However, obvious crack damage is visible to the pool plaster. We recommend a complete system evaluation by a qualified swimming pool specialist.

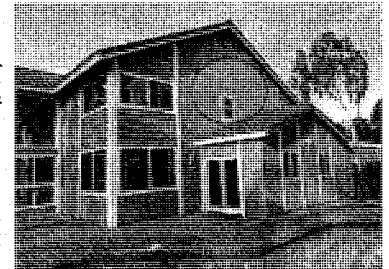
- Significant crack damage is visible to the stucco at the upper left side exterior wall. Determining the cause is beyond the scope of this inspection. We recommend further evaluation of this system / cost estimate for corrections by a qualified lathing & plastering contractor.

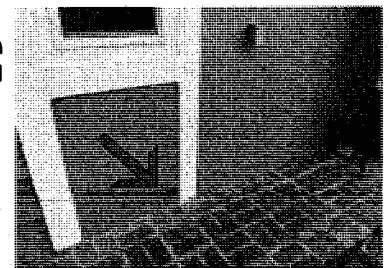
- An opening is visible through the stucco at the right side exterior wall. The condition is conducive to moisture intrusion and subsequent damage. We recommend correction using appropriate methods by a qualified lathing & plastering contractor.

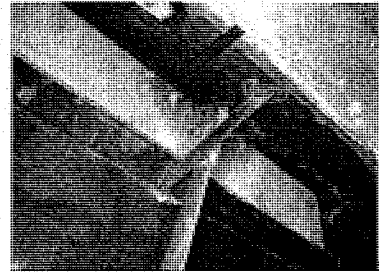
- Damper block devices are absent at each fireplace. The function of a damper block device is to keep the flue damper in an open position as using the gas with the damper in the closed position poses a carbon monoxide poisoning hazard from spillage of hazardous exhaust gases into the living area. Installation of appropriate damper block devices is recommended.

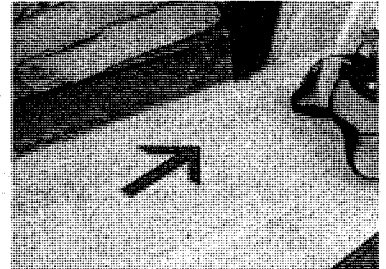
- Crack damage is visible to the extension material at the living room fireplace. Determining the cause is beyond the scope of this inspection.

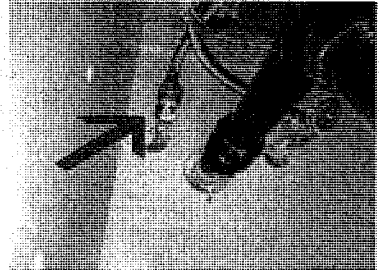
- Corrosion related damage caused by leakage is visible to multiple angle stop valves which are located below the sinks. We recommend replacing any damaged angle stop valves by a qualified plumbing contractor.

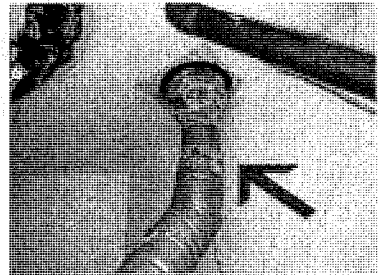
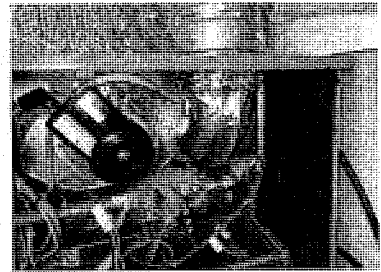
- Single wall vent piping is installed between sections of type B vent piping which is improper as viewed at the downstairs heater. Spillage of hazardous exhaust gases can occur as a result, therefore a carbon monoxide poisoning hazard exists. We recommend correction using appropriate methods by a qualified Warm-Air Heating, Ventilating and Air-Conditioning contractor.

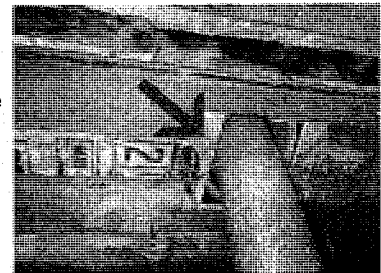
- Insufficient clearance (less than 1") is visible between the upstairs heater vent pipe and combustible wood roof sheathing. The condition poses a risk of fire hazard from heat transfer. We recommend correction using appropriate methods. Refer to the instructions stamped on the vent pipe for clearance requirements.

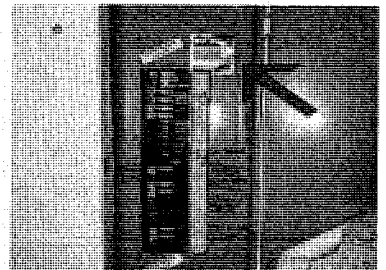
- The panel is manufactured by Sylvania. The clip to bus style of circuit breaker is conducive to failure at the point of contact. Hazards may be present in the electrical panel which could result in overheating, fire, or inability to turn off the electrical power in the home. The inspector does not remove the circuit breakers and does not perform any other disassembly of the electrical panel components, therefore visual inspection may not identify significant damage or other failures that may be present. Also, the panel components may be near / at the end of their service life due to age. Replacement with a panel meeting current construction standards should be considered for safety enhancement. We recommend further evaluation of this system / cost estimate for replacement by a qualified electrical contractor.

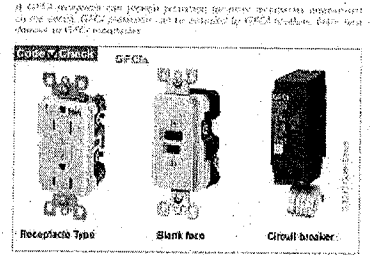
- Receptacles are not protected by a Ground Fault Circuit Interrupter (GFCI) at the laundry area, dishwasher, kitchen island counter, wet bar counter, and multiple at the garage interior. The function of a Ground Fault Circuit Interrupter is to protect people from electrical shock hazards. We recommend correction using appropriate methods by a qualified electrical contractor.

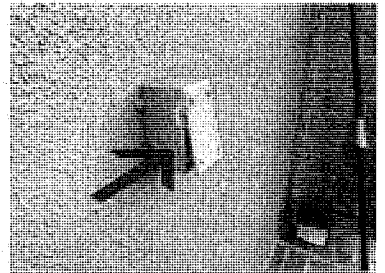
- Protection cover is separated from a junction box at the right side exterior wall. The condition poses an electrical shock hazard due to exposure of the wiring within. We recommend correction using appropriate methods by a qualified electrician. Calculating the wire fill in the boxes is beyond the scope of this inspection.

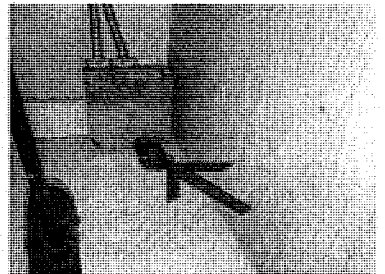
- Conduit is cut short of the outlet box which exposes the wiring to damage as viewed within the kitchen sink base cabinet. We recommend correction using appropriate methods by a qualified electrical contractor.

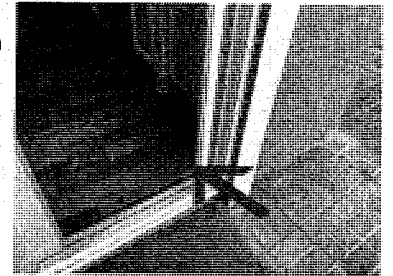
- The screen is torn away from the frame on the kitchen door. Replacement of any torn screens is recommended.

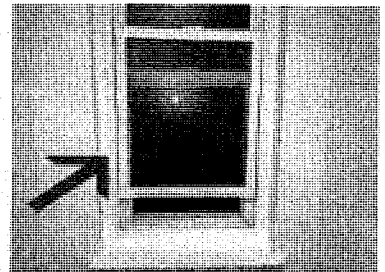
- Sash balance is disengaged from a window at the primary bedroom. The condition prevents the window from functioning as intended. We recommend correction using appropriate methods by a qualified window specialist.

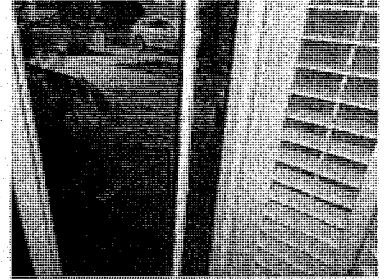
- The frame is separated from the glass on a window at the downstairs bedroom. We recommend correction using appropriate methods by a qualified window specialist.

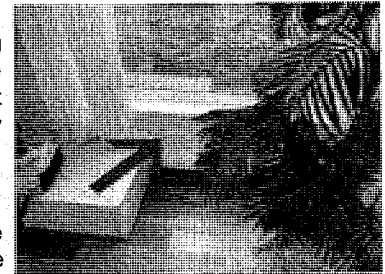
- Moisture related damage is visible to the wall cladding at the living room. Determining the origination of the moisture or if any active leakage conditions exist is beyond the scope of this inspection. Further evaluation by a qualified moisture intrusion specialist is recommended. We also recommend inquiring with the seller to confirm the history of any moisture intrusion.

- Moisture is conducive to adverse mold / microbial growth. Determining the presence of any type of mold / microbial growth is beyond the scope of this inspection. We recommend further evaluation by a qualified specialist to determine if such conditions exist.

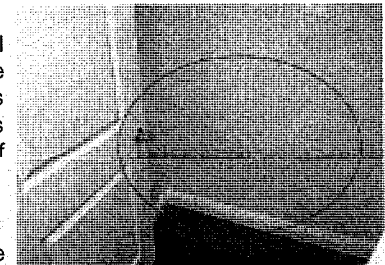
- Patching and what appears to be moisture related damage is visible to the wall cladding within the downstairs hallway closet. Determining the origination of the moisture or if any active leakage conditions exist is beyond the scope of this inspection. Further evaluation by a qualified moisture intrusion specialist is recommended. We also recommend inquiring with the seller to confirm the history of any moisture intrusion.

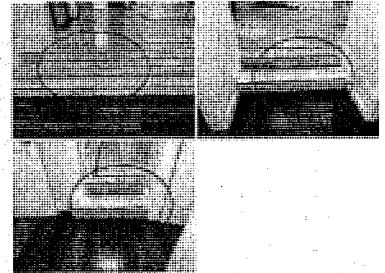
- There are step risers that are uneven in relation to each other at the steps to the living room, kitchen, and downstairs bedroom. The condition poses a trip hazard. We recommend correction using appropriate methods by a qualified stair specialist.

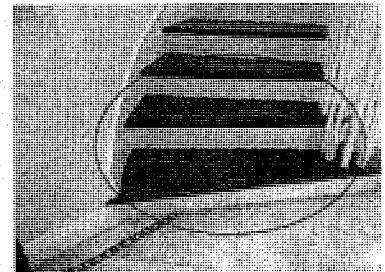
- The height of the step riser(s) is greater than 7-3/4". The step risers are also uneven in relation to each other. The condition poses a trip hazard. We recommend correction using appropriate methods by a qualified stair specialist.

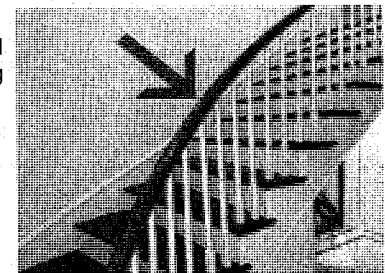
- The hand grip railing is installed too low (the railing should be no lower than 34" and no higher than 38" from the nose of the step tread). We recommend correction using appropriate methods by a qualified stair specialist.

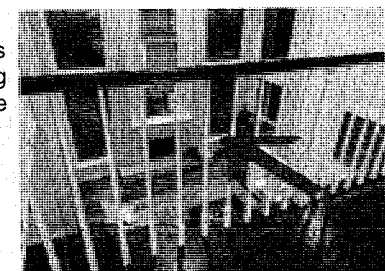
- Caution, the openings between the guard rail balusters are too wide by today's construction standards (opening width should prevent a 4" sphere from passing through). Upgrading the railing system to current construction standards should be considered for safety enhancement.

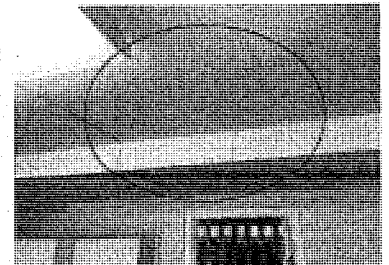
- Patching is visible to the ceiling cladding at multiple locations. We recommend consulting with the seller to confirm the reason. Cracks may reappear at a later date.

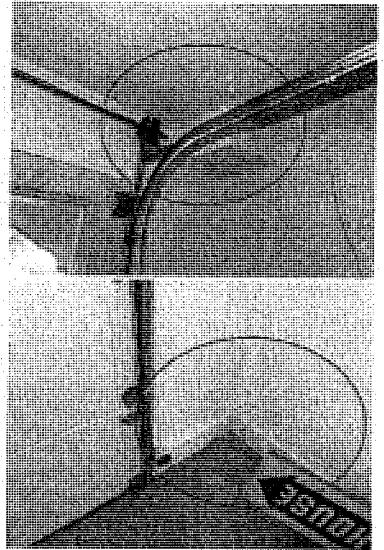
- Moisture related damage is visible at the walls and ceiling. Determining if active roof leakage exists is beyond the scope of this inspection. Further evaluation by a qualified roofing contractor is recommended.

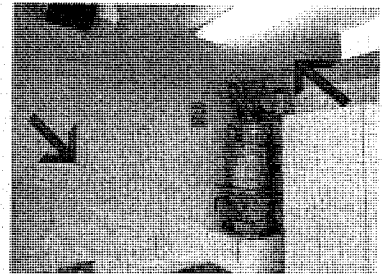
- Significant crack damage to the wall and ceiling clings at the left side of the garage. The condition may indicate structural movement has occurred. We recommend further evaluation by a qualified geo-technical engineer to determine if the damage is caused by any adverse geological conditions.

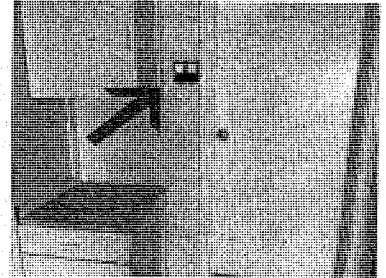
- Auto openers: Anti entrapment safety labeling is absent adjacent the automatic opener controls. We recommend correction using appropriate methods by a garage door specialist.

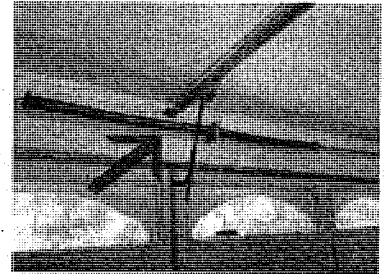
- Auto openers: Spring warning labeling is absent at the torsion bar. We recommend correction using appropriate methods by a garage door specialist.

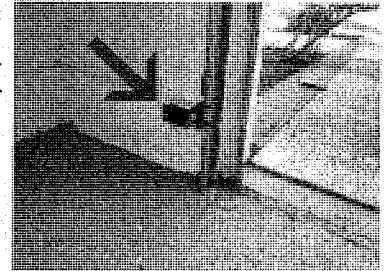
- Auto openers: The auto-reverse edge sensors are not within 6" of the floor for safety. We recommend correction using appropriate methods by a qualified garage door specialist. Refer to the auto opener manufacturers installation manual for instructions.

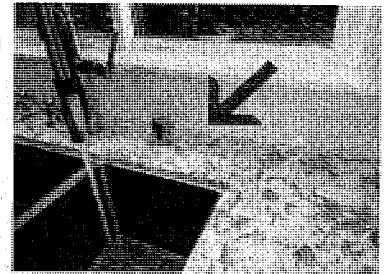
- Deteriorated sealant is visible at the splash seam. We recommend correction using appropriate methods to prevent moisture intrusion into the base cabinet.

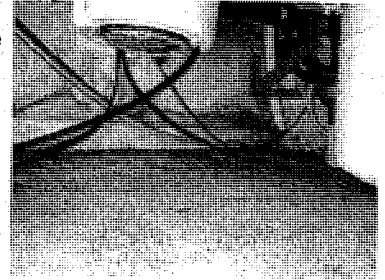
- Moisture related damage is visible to the floor of the sink base cabinet. We recommend correction using appropriate methods.

- An undetermined black substance is visible on the wall cladding within the sink base cabinet. Determining the presence of any type of mold / microbial growth is beyond the scope of this inspection. We recommend further evaluation by a qualified specialist to determine if such conditions exist.

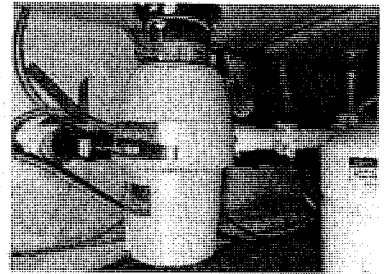
- Drain: Pipe slope for drainage is insufficient. The condition is conducive to poor drainage and sludge accumulation. Slow drainage occurred at the right sink. We recommend correction using appropriate methods by a qualified plumbing contractor.

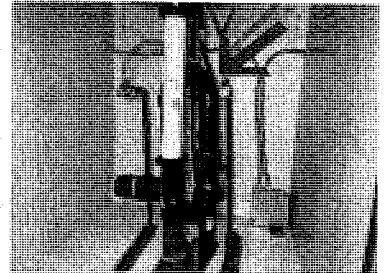
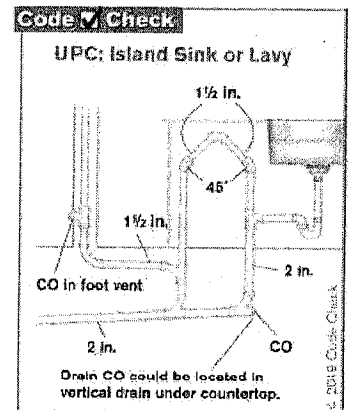
- Drain: The island sink drain installation is improper as the vent loop is located below the drain opening in the sink. Installation of a foot vent is not determined. The condition is conducive to poor drainage. We recommend correction using appropriate methods by a qualified plumbing contractor.

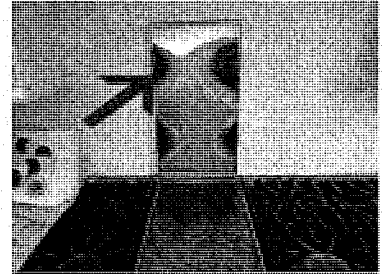
- Cooktop: Burnt protective film is visible on the underside of the griddle cover.
Removal of the film is recommended.

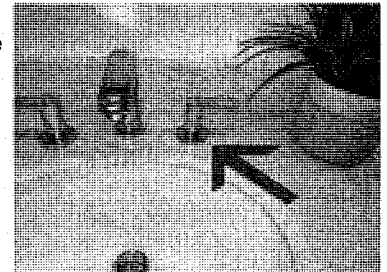
- Faucet fixture: The cold water faucet valve is stuck, therefore not functional. We recommend correction using appropriate methods by a qualified plumbing contractor.

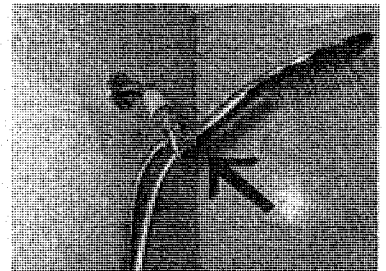
- Shower head: Leakage occurred from the hose fitting on the hand held shower head. We recommend correction using appropriate methods.

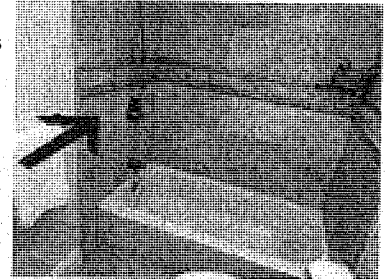
- Enclosure: An enclosure is not provided. Installation of an appropriate enclosure is recommended.

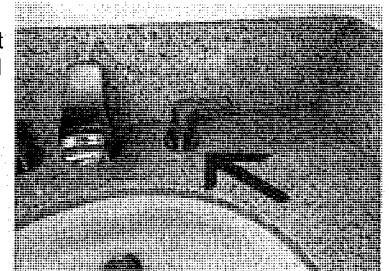
- Faucet fixture: The cold water faucet valve is stuck at the right sink, therefore not functional. We recommend correction using appropriate methods by a qualified plumbing contractor.

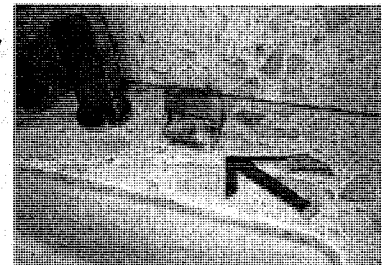
- Faucet fixtures: Corrosion related damage is visible to the fixtures. Replacement may be needed.

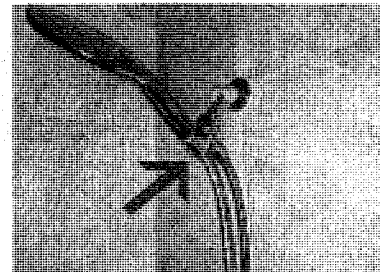
- Shower head: Leakage occurred from the hose fitting on the hand held shower head. We recommend correction using appropriate methods.

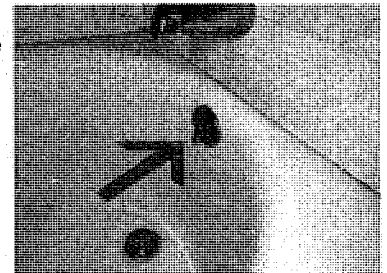
- Drain: The stopper is not functional. We recommend correction using appropriate methods by a qualified plumbing contractor.
