# National Property Inspections

Seashine Financial LLC, 22303 Vista Verde Drive, Lake Forest, CA, 92630

Inspection Date:  
01/10/2022

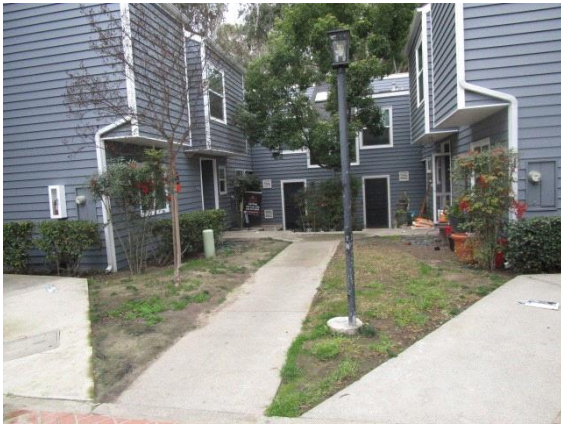
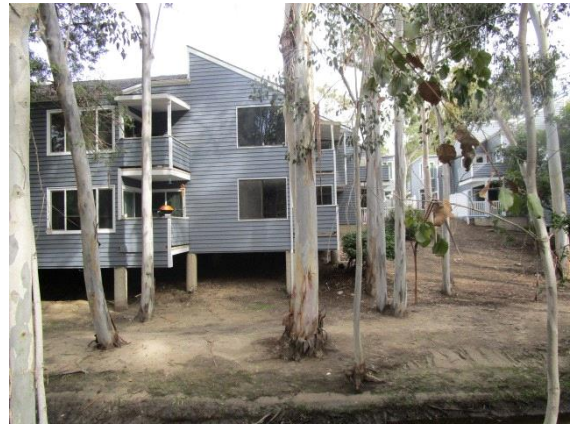
Grading / Drainage:

Grading/drainage appeared to be a positive slope around all sides of the home. The roof covering may be maintained by the HOA. Any areas of concern may need to be addressed with the HOA.

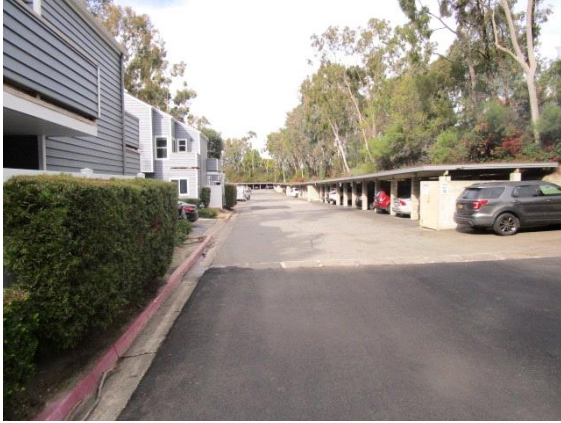
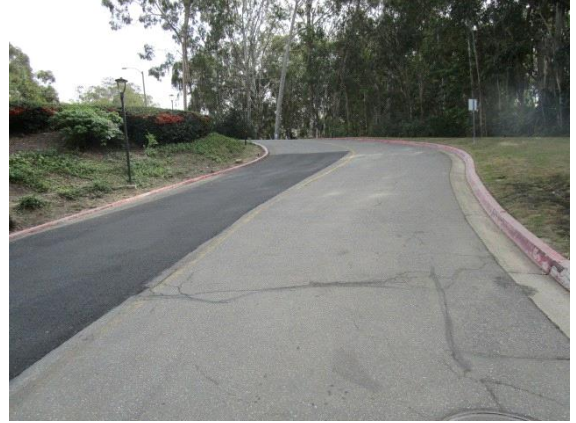
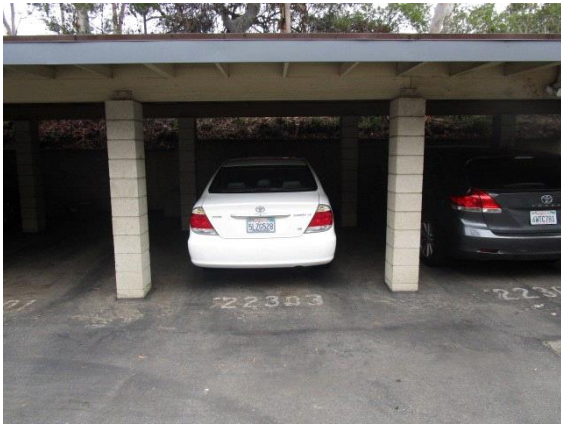
Driveway:

The driveway was in generally good condition with minor cracks, no settlement and had an acceptable surface.

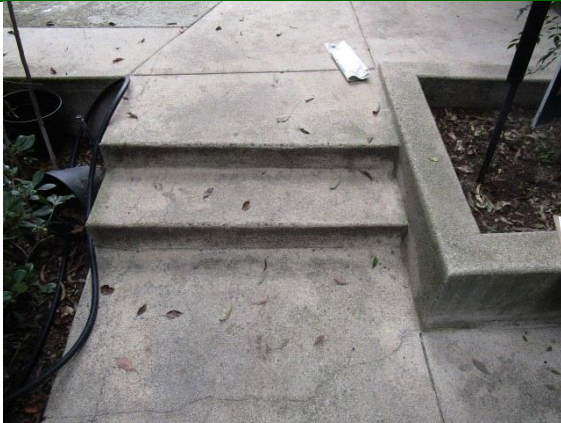
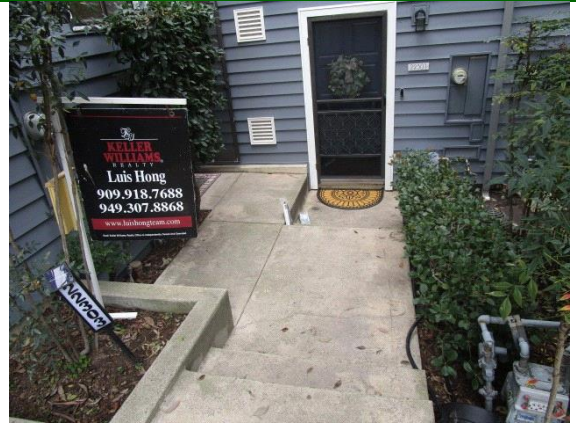
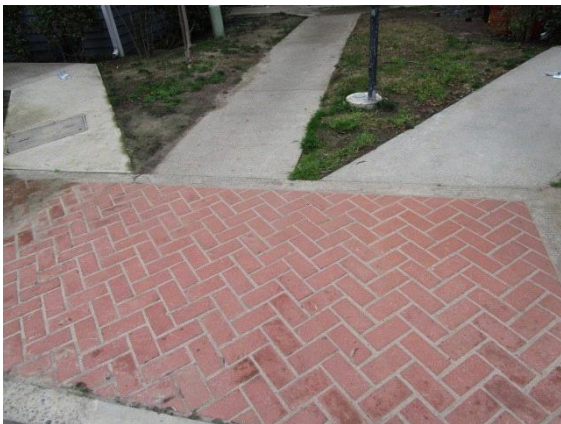
Walks / Steps:

Walkways/steps to the house and around the property were in good condition at time of the inspection.

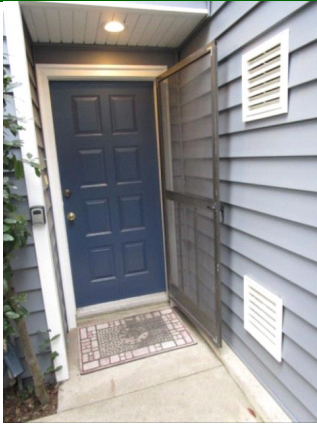
Porches / Stoops:

Porch was functional at time of inspection with no major defects noted.

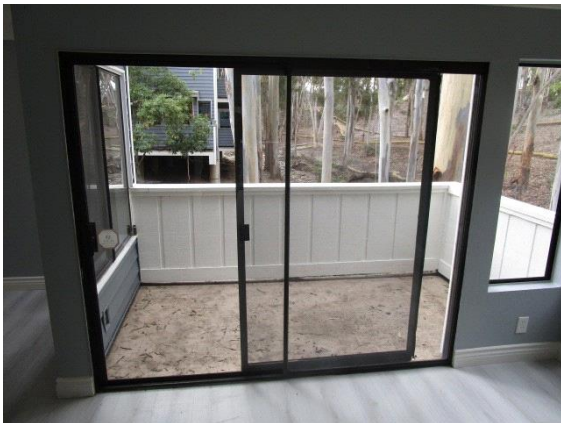
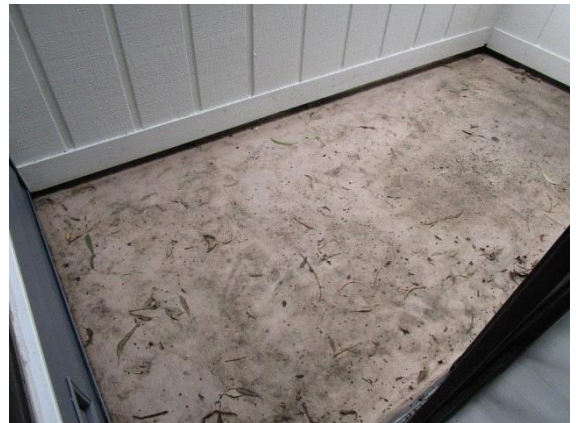
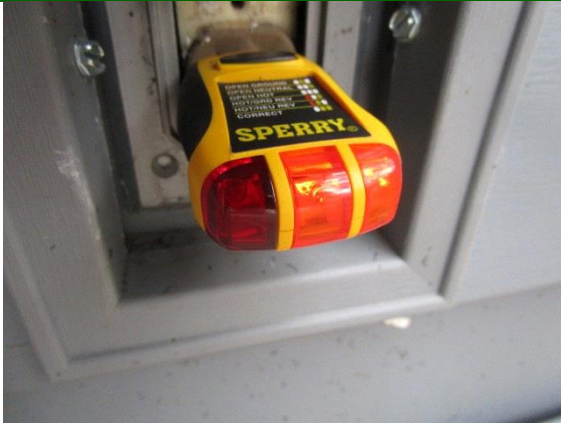
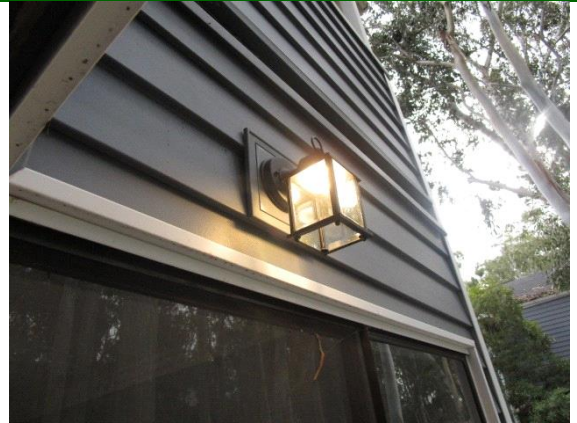
Patio:

Patio has general deterioration present. No major defects noted.

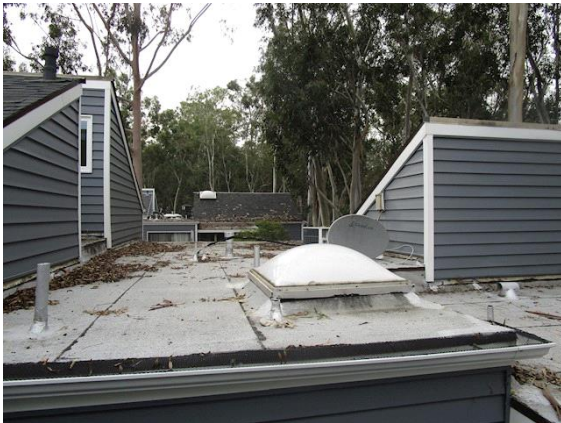
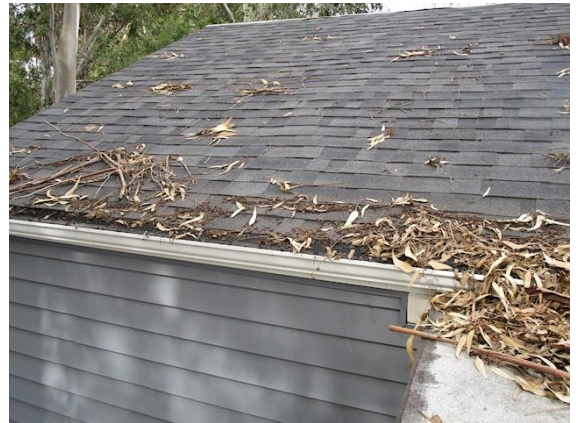
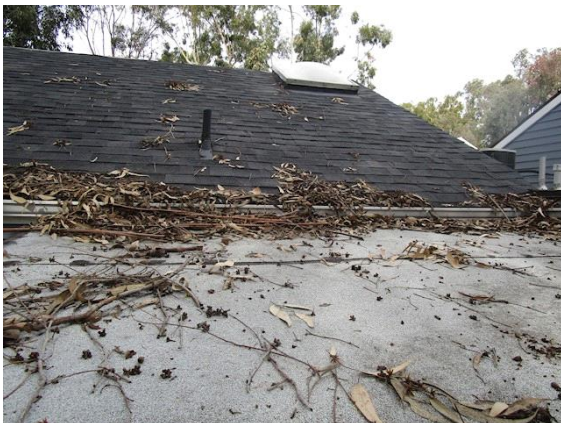
Roofing:

- The roof is generally maintained by the HOA (Home Owners Association). Any areas of concern may need to be addressed with the HOA. Roof did not appear to leak at time of inspection, however, roof was at or near life expectancy. Water leaks could occur at any time and a periodic inspection of the roof and attic area is recommend to identify any water intrusion. Remove debris from roof.

Leaks not always detectable.

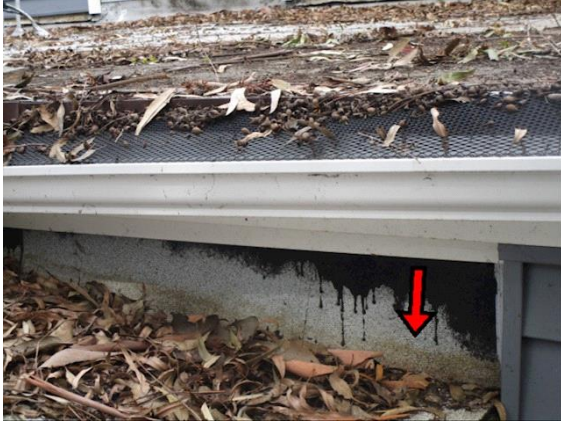
Flashing/Valleys:

- Metal flashing around perimeter of eave was loose and needs repair. Recommend further evaluation/repair by qualified contractor(s).
- Some older/rusty flashings noted which were not replaced at the time of re-roof. Paint and/or seal as necessary. Monitor for leakage and replace/repair as required. Recommend further evaluation/repair by qualified contractor(s).
- Flashing not visible at dormer where shingles meet siding. Recommend further evaluation/repair by qualified contractor(s).
- Kick Out Flashing missing near gutters. Recommend further evaluation/repair by qualified contractor(s).

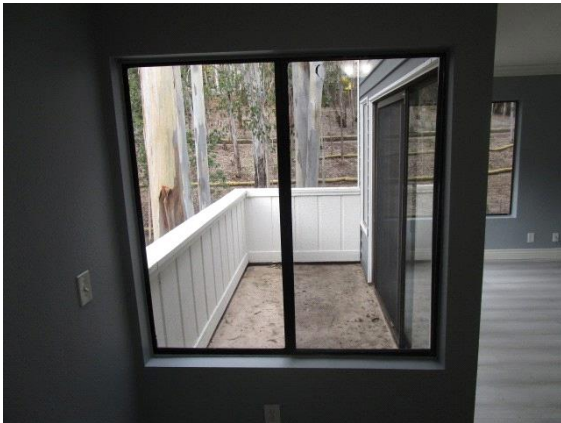
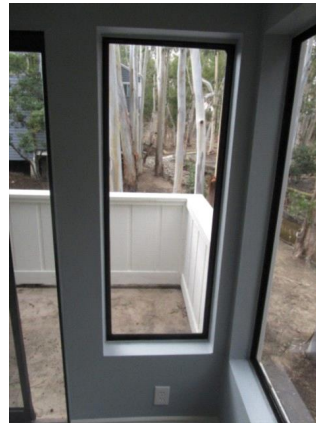
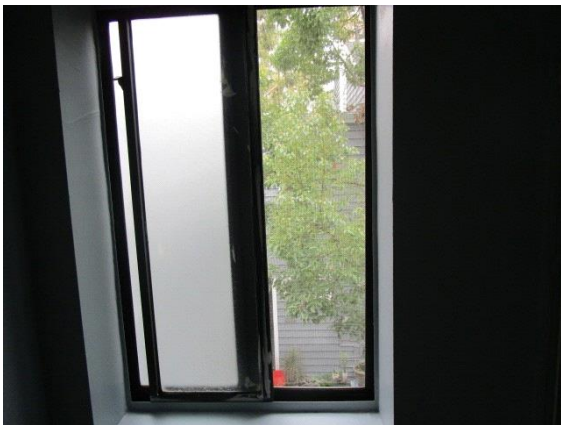
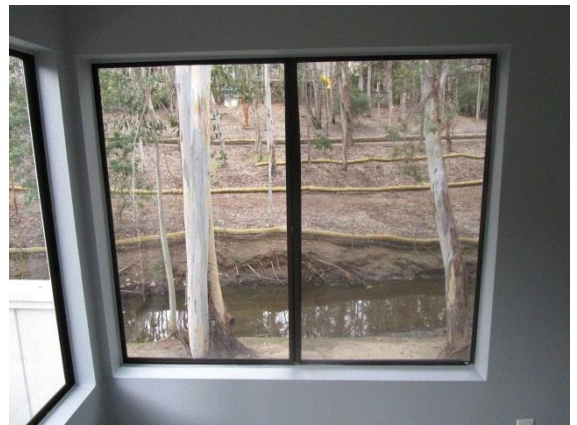
Windows:

The exterior of the windows and screens looked acceptable at time of inspection.

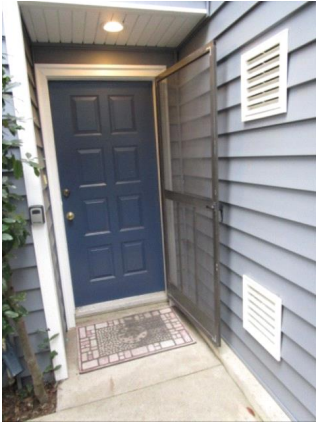
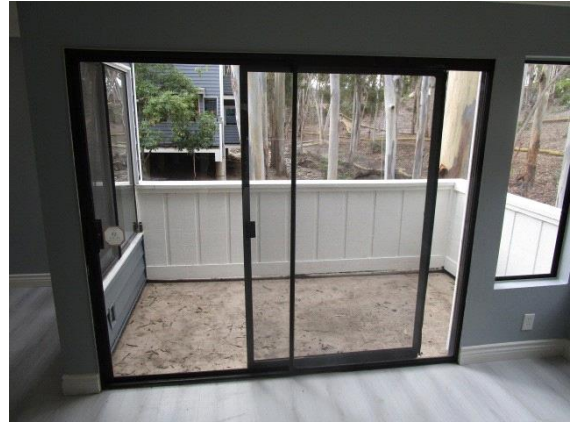
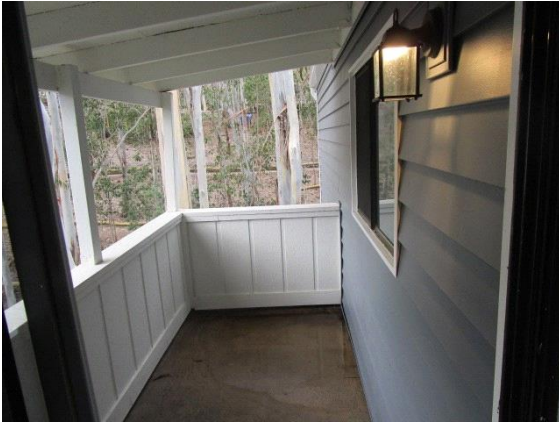
Exterior Doors:

The sliding door(s) was difficult to open and close, suggesting the rollers/wheels need to be cleaned and lubricated.

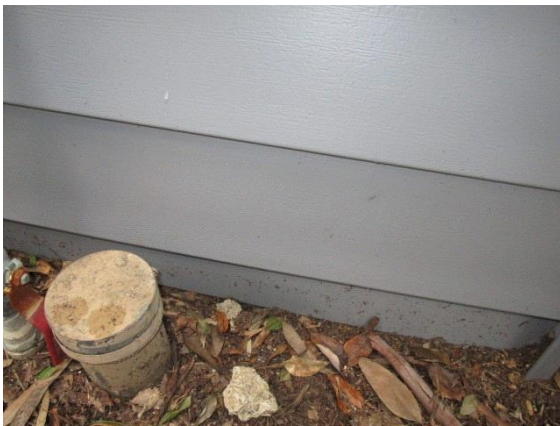
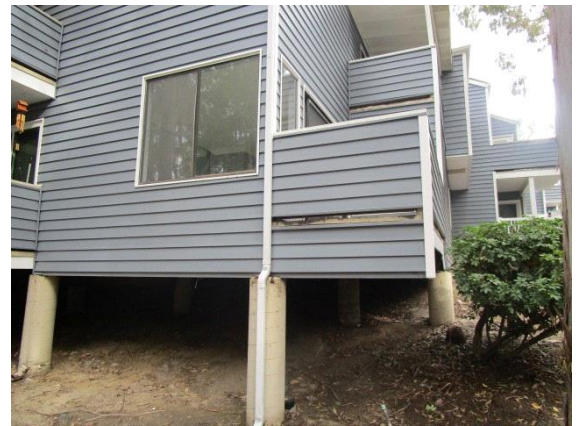
Foundation:

Generally, the common areas are maintained by the HOA (Home Owners Association). A general foundation inspection around the outside of the building was performed and found to be acceptable with no visual flaws or defects. The post/piers were in good condition. No leaning or cracking noted. Cement footers present.

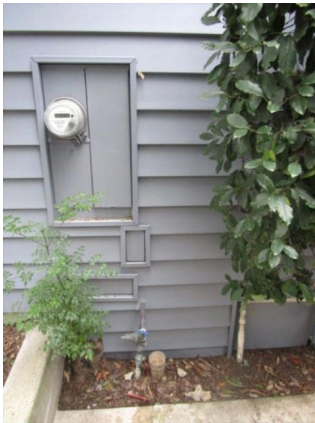
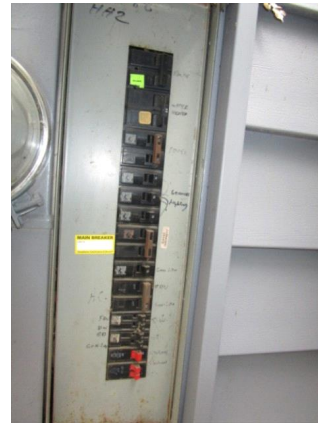
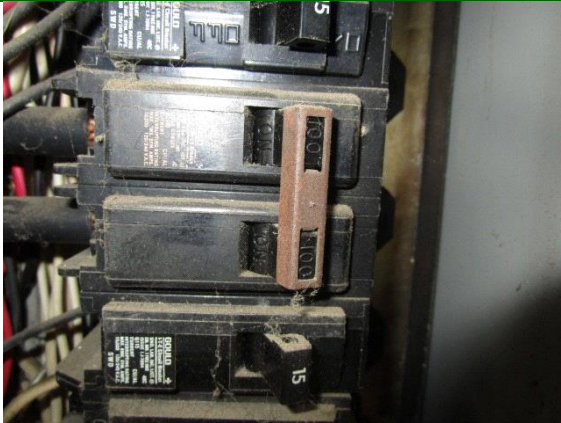
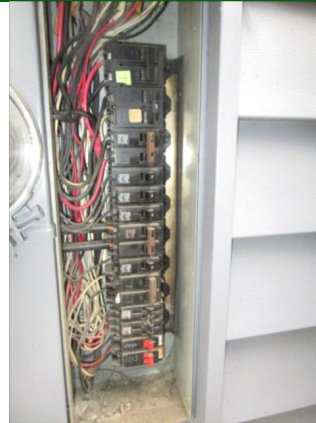
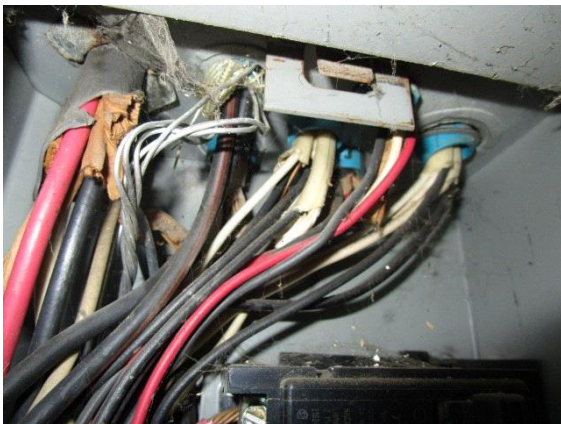
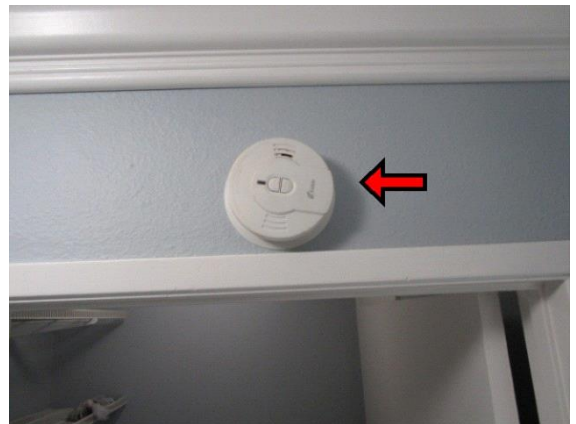
Electrical:

- Recommend relocating the smoke detector to the ceiling at least one foot away from the walls.
- Front cover on sub-panel not clearly labeled to identify what breakers supply what circuits. For additional safety, recommend identification and labeling of all specific breaker functions. Recommend further evaluation/repair by qualified contractor(s).

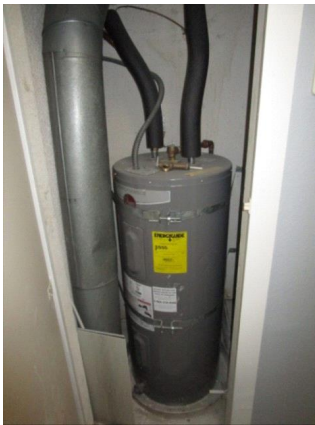
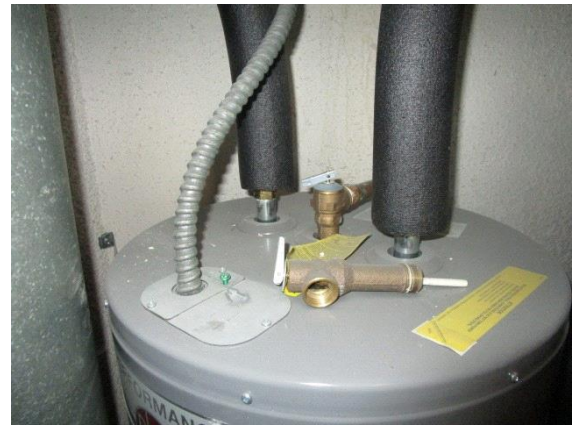
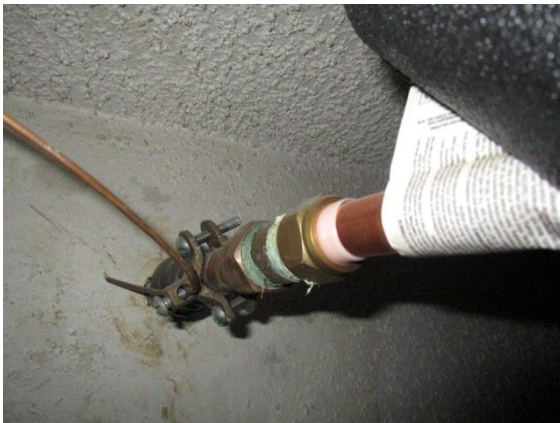
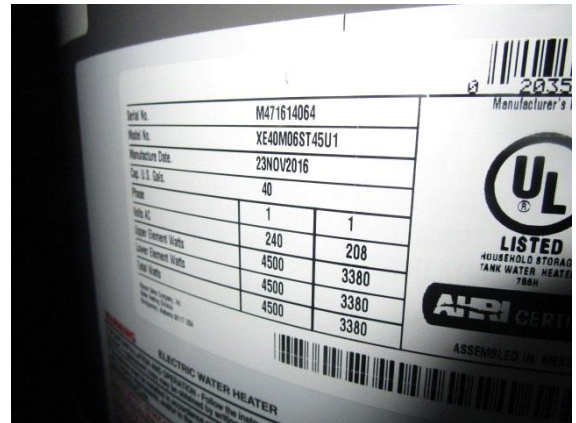
The operation and installation of the water heater appeared to be satisfactory at time of inspection. Routine maintenance such as draining the water heater could prolong its lifespan. Always refer to manufactures' specifications before doing any maintenance on your water heater.

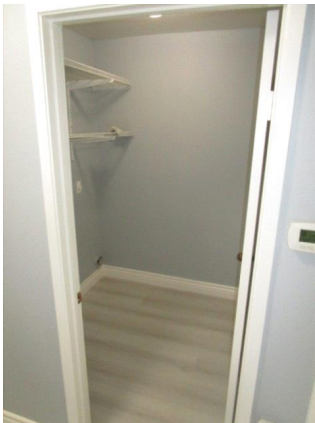
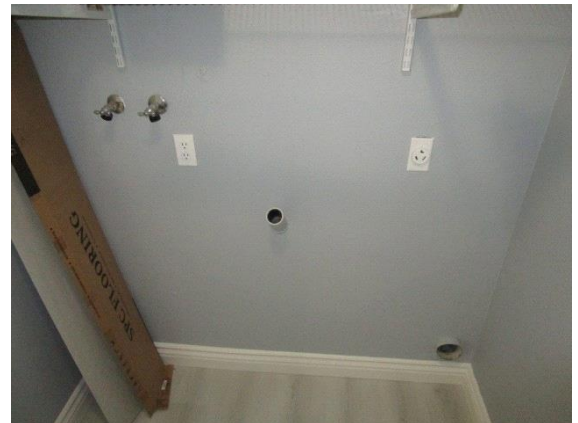
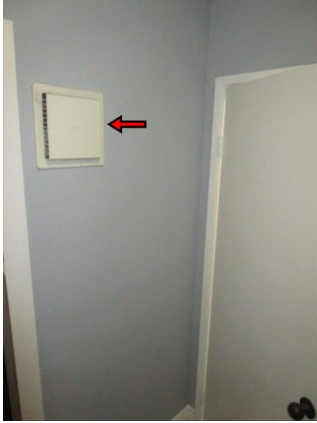
Laundry appliances not installed at time of inspection. Inspected hook-ups only. No floor drain present. Recommend further evaluation/repair by qualified contractor(s).

- Exhaust fan was dirty and needs to be cleaned. Recommend further evaluation/repair by qualified contractor(s).
- Ceiling(s) are of the age (vintage) that may contain asbestos. If concerned, should have the ceiling tested by certified lab.
- Two abandoned air ducts noted in the water heater closet, Could not determine if they have been properly abandoned. Recommend further evaluation/repair by qualified contractor(s).
- Two metal pipes noted in the water heater closet with insulation wrapped around piping that have asbestos. Could not determine if they have been properly abandoned. Recommend further evaluation/repair by qualified contractor(s).

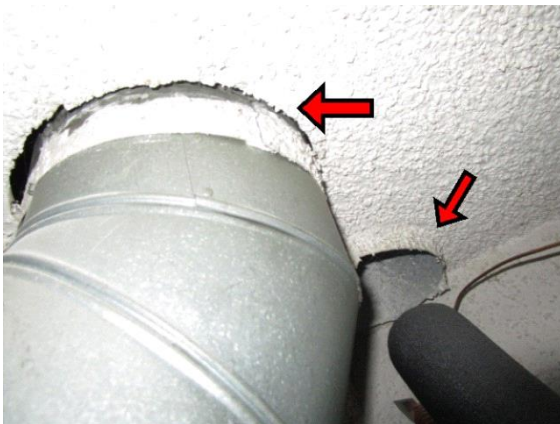
Laundry Facilities: Two air ducts

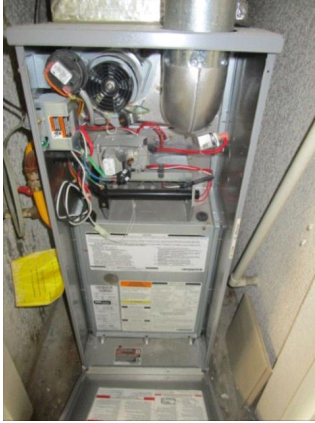
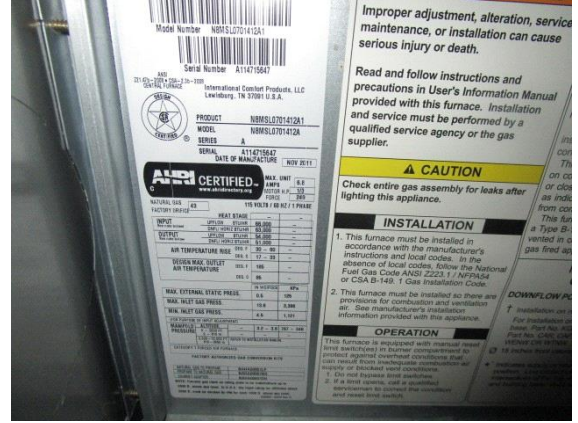
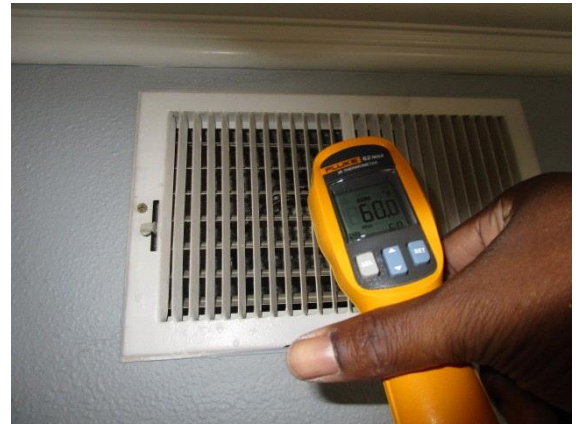
Tested in heat mode; did not produce heat after 40 minutes. Recommend further evaluation/repair by qualified contractor(s).

Heat Exchanger - Unable to detect cracks/holes without dismantling unit.

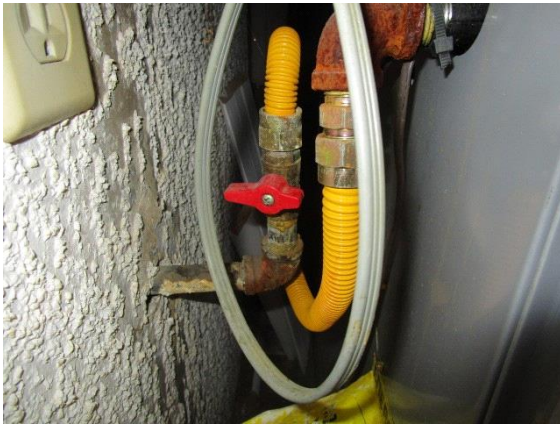
Heating: Shut-off valve

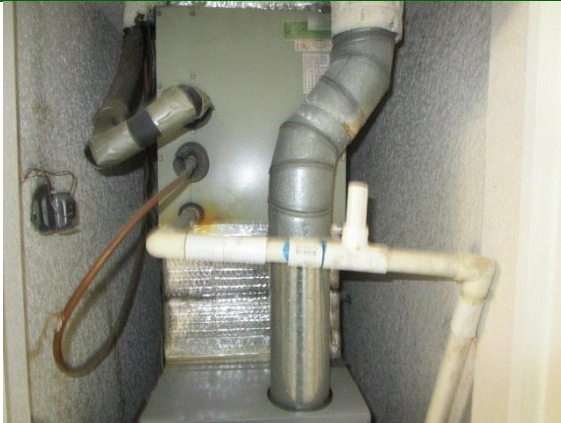
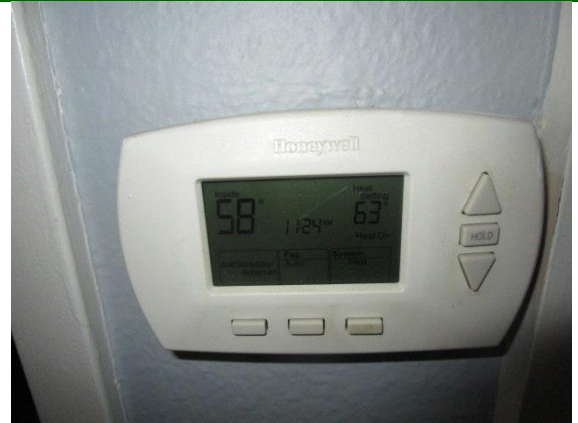
Low flow at registers was likely related to type of furnace. Monitor for even heat and seek further evaluation/adjustment of blower as required. Recommend further evaluation/repair by qualified contractor(s).

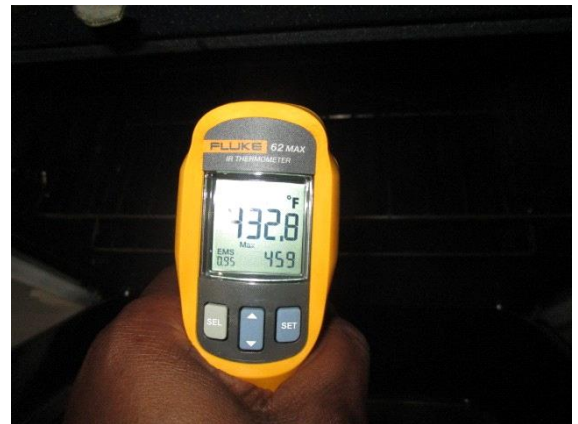
Kitchen: Oven temperature

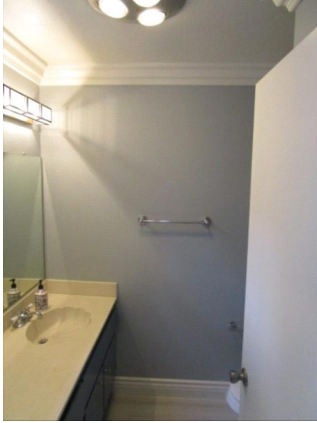
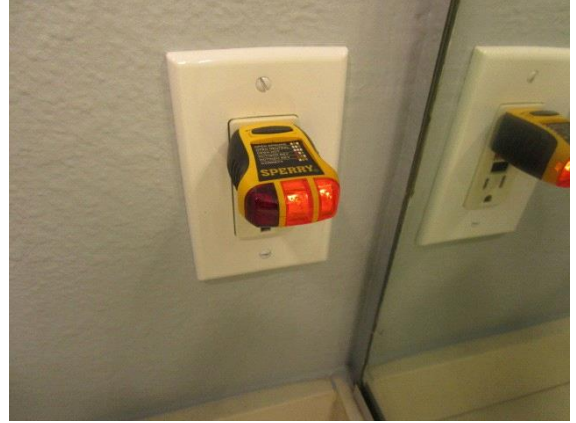
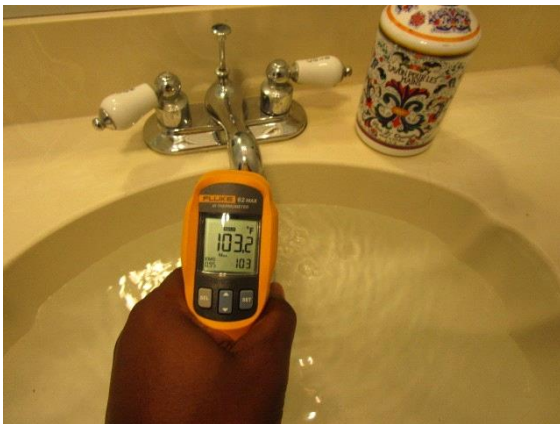
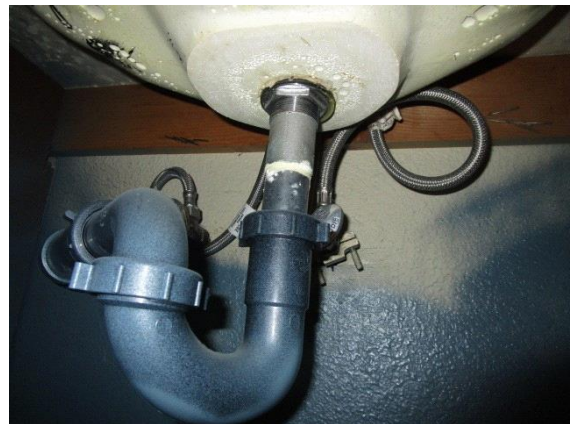
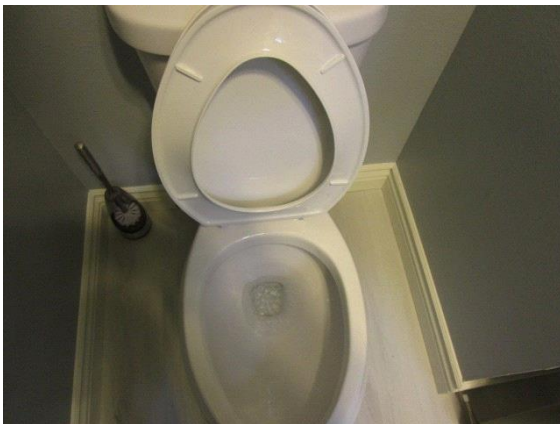
Door locking mechanism noted as being located on the outside of door, instead of inside the bathroom door.

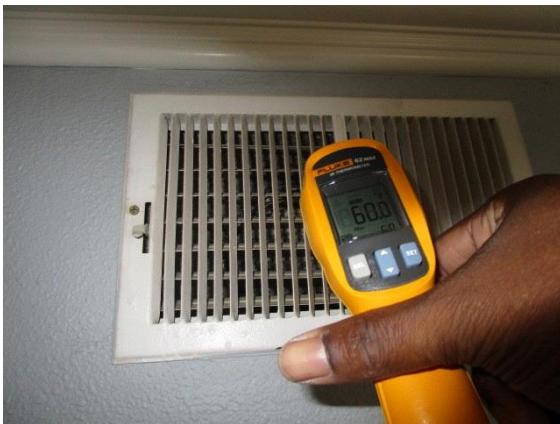
Dining Room:

- Stains observed on ceiling. Possible previous and/or present leak. Noted area tested dry at time of inspection. Recommend monitoring conditions for future possible water intrusion.
- The air distribution was very low. Recommend further evaluation/repair by qualified contractor(s).

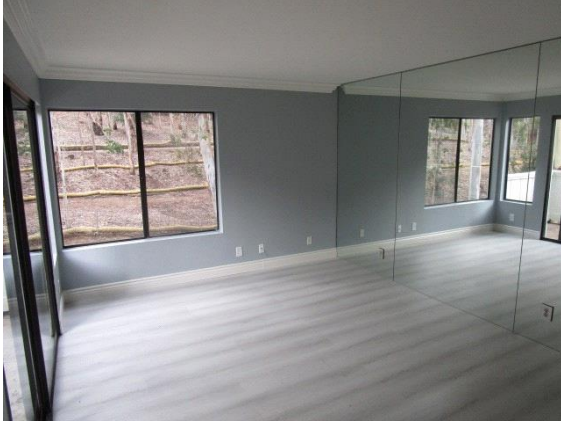
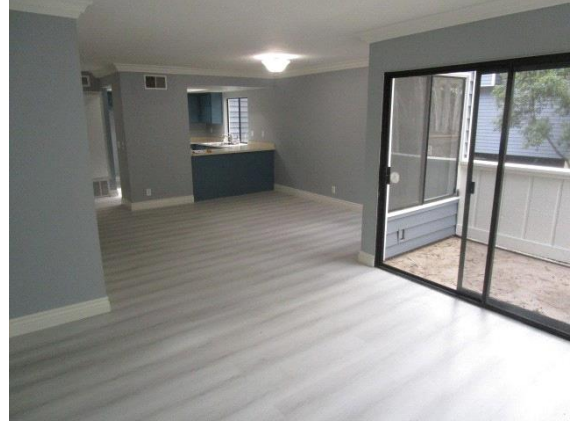
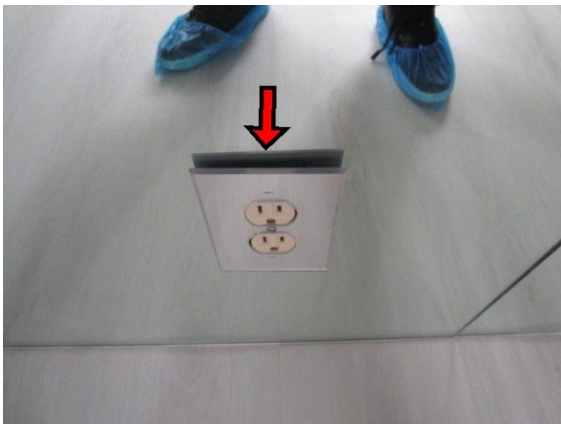
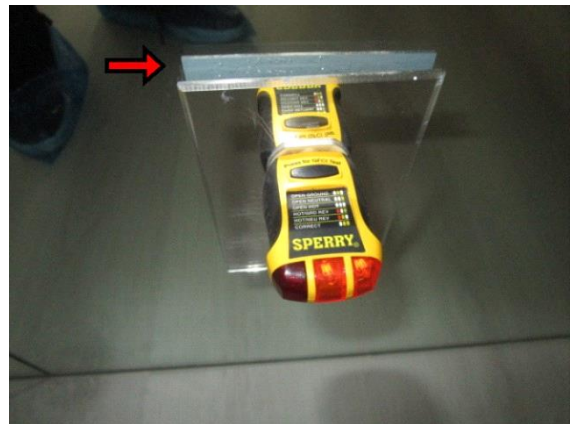
- Two cover plates were loose on outlet. Recommend further evaluation/repair by qualified electrician(s).

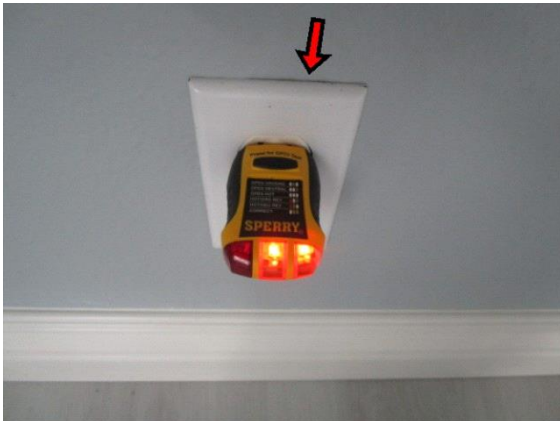
Bedroom 1 :

- Cover plate were loose on outlet. Recommend further evaluation/repair by qualified electrician(s).
- The air distribution was very low. Recommend further evaluation/repair by qualified contractor(s).

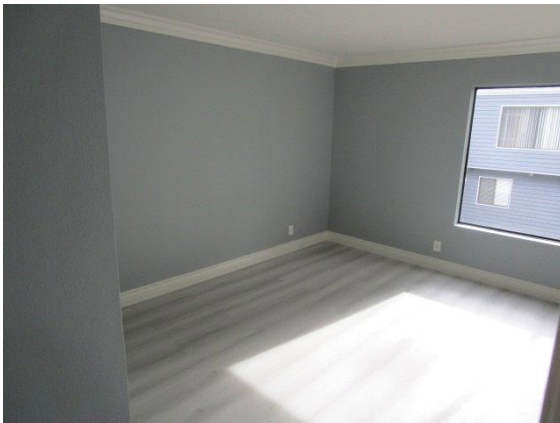
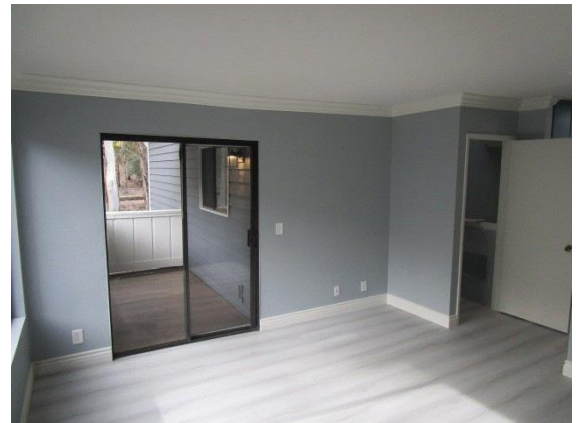
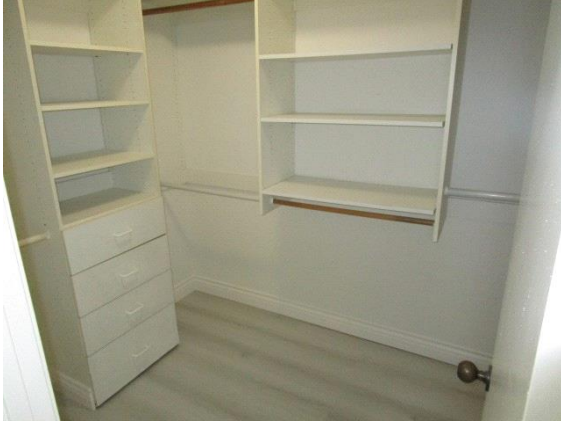
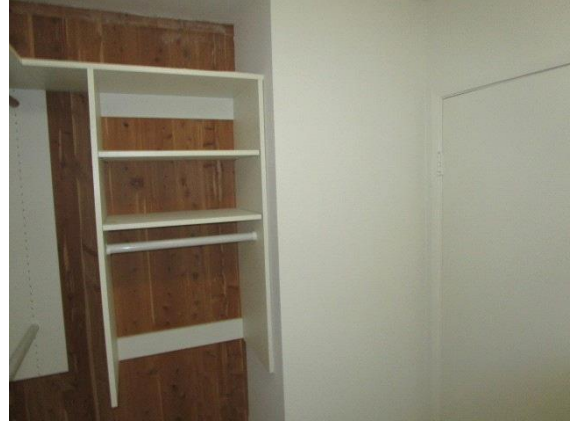
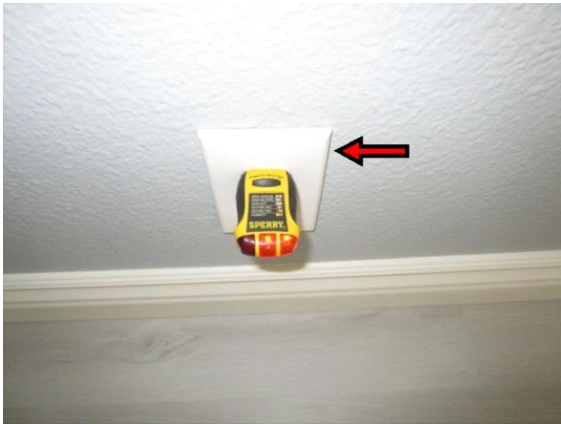
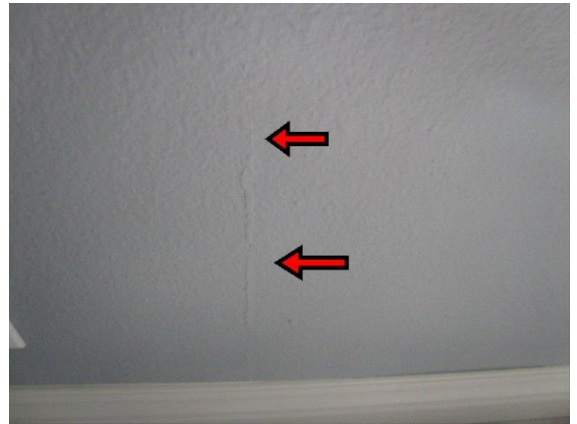
Minor irregularities (i.e. unevenness) observed in the floor structure, which is not unusual for a home of this age. Some cracking was noted in the wall. No specific cause for the cracking was apparent. Monitor.

- Cover plate were loose on outlet. Recommend further evaluation/repair by qualified electrician(s).
- The air distribution was very low. Recommend further evaluation/repair by qualified contractor(s).
