Confidential Inspection Report

LOCATED AT:
3227 Weldon Avenue
Los Angeles, California 90065

INSPECTED ON:
Wednesday, July 3, 2019

Inspector, Tom de Spain
Advanced Building Inspections
26500 Agoura Road, Ste 102-567
Calabasas, CA 91302
Office 818.883.9810

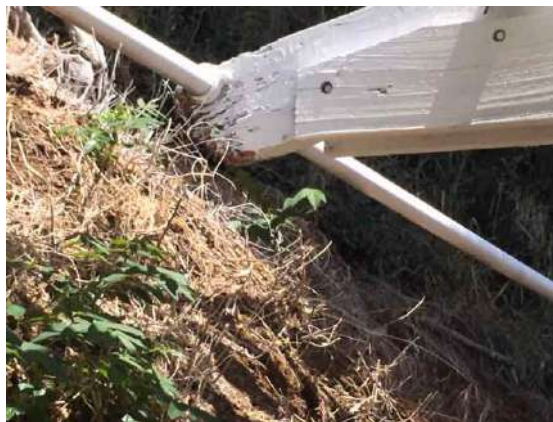
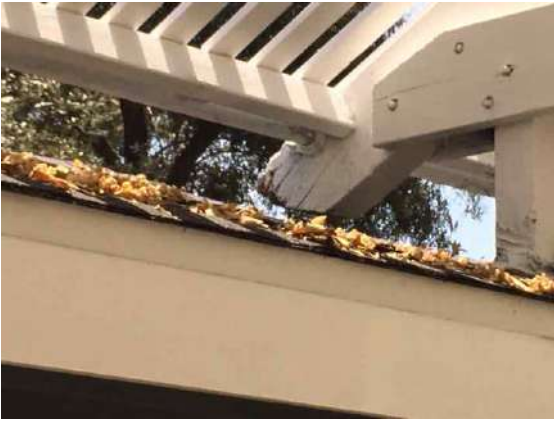
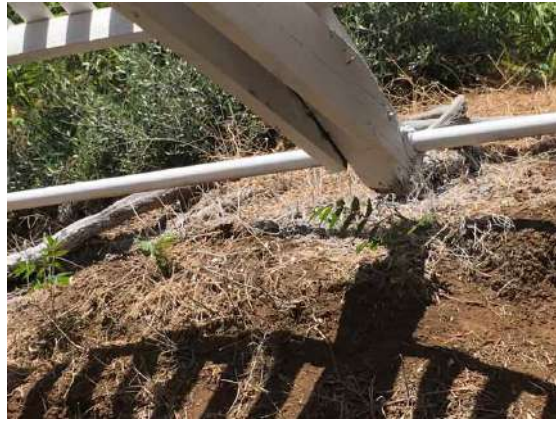
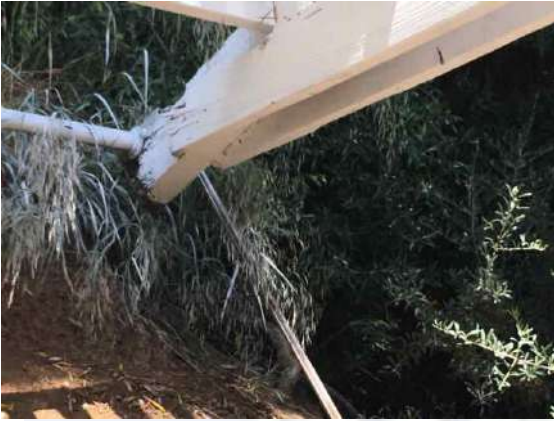
FE 39: There is evidence commonly associated with wood-destroying pest and/or organism activity. We recommend consultation with a licensed pest control operator.

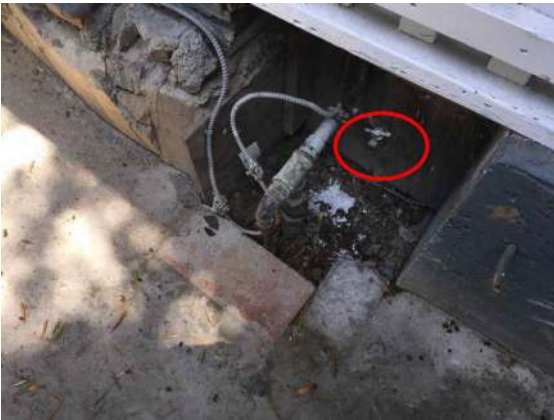
43: BIB HANDLES: Backflow prevention devices are now required on exterior hose bibs to prevent contamination of the domestic water supply. Upgrading the hose bibs should be considered.

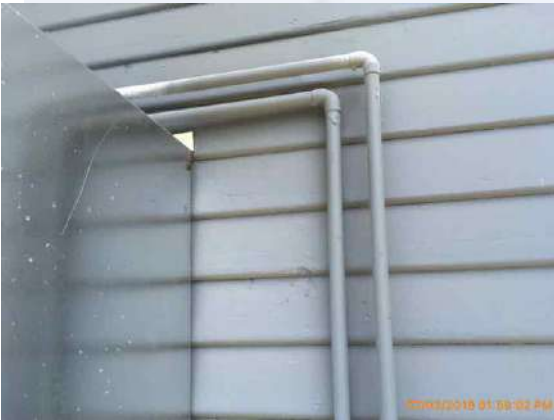
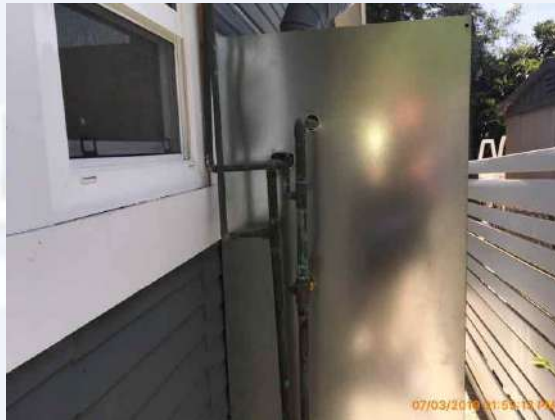
44: The plumbing lines are not insulated as per current code. We recommend upgrading for energy savings.

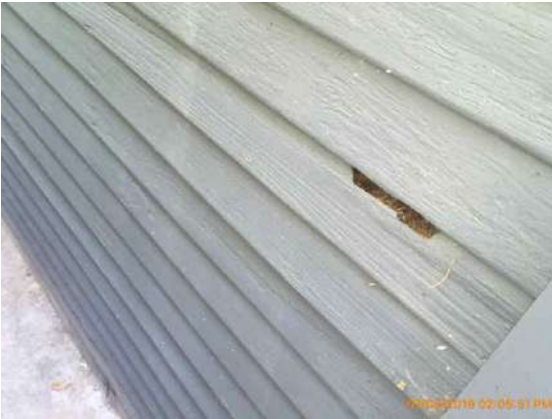
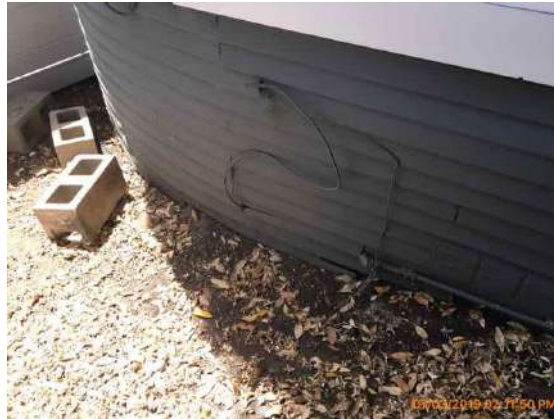
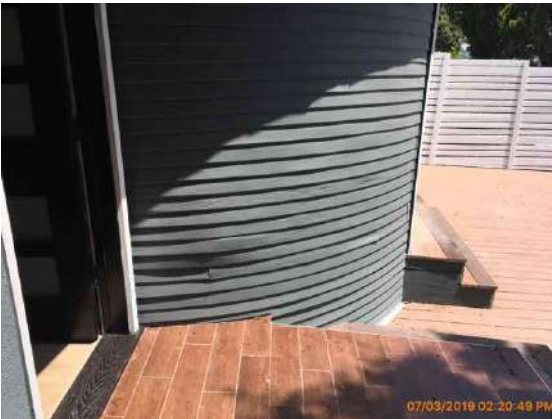
CORR 53: Sections of the siding are damaged. We recommend these sections be repaired or replaced.

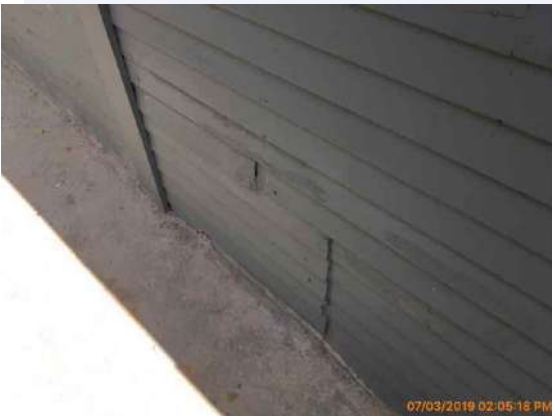
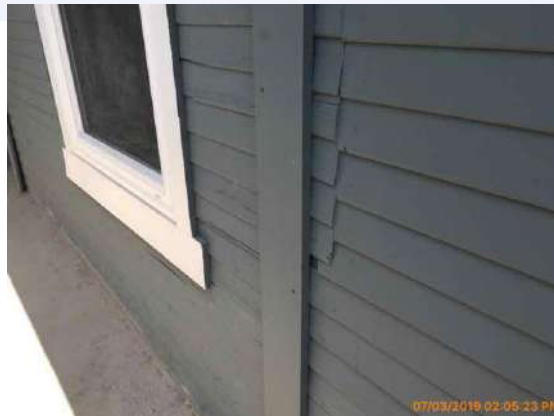
CORR 54: There are unsealed joints in the siding that may allow water penetration. We recommend the joints be caulked and sealed to prevent leakage and damage.

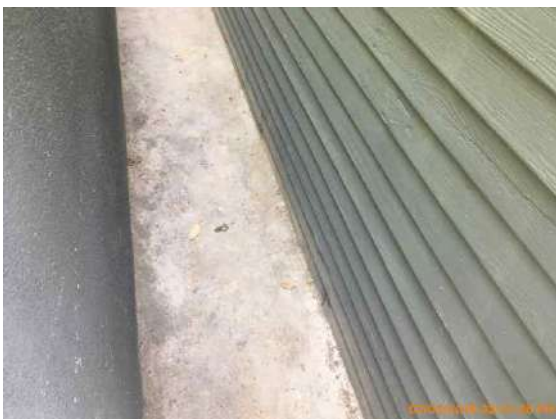
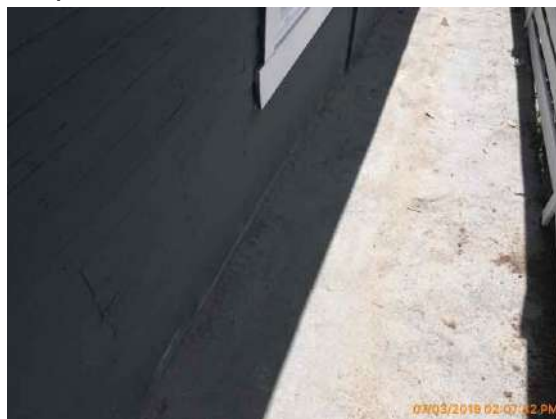
CORR 56: Portions of the siding are in contact with and/or embedded in concrete. This is not an accepted practice, but modification would be difficult. As preventive maintenance, we recommend the area be flooded with a wood preservative from time to time.

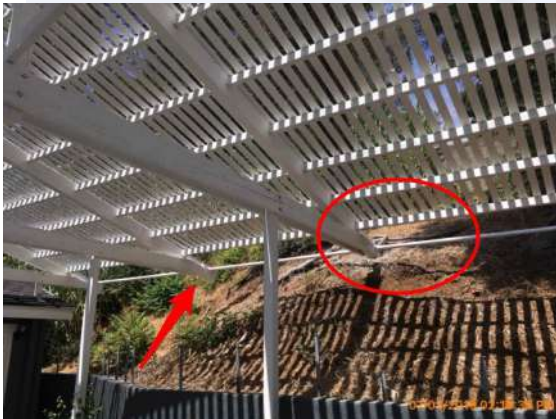
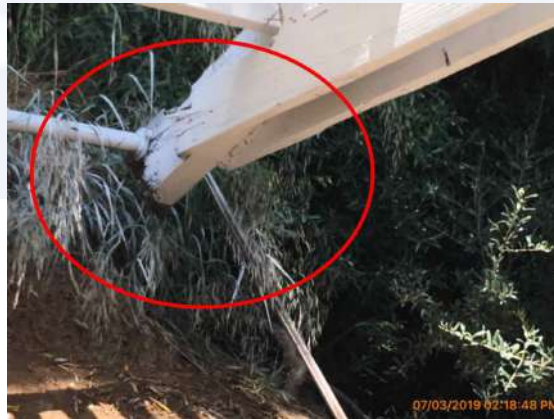
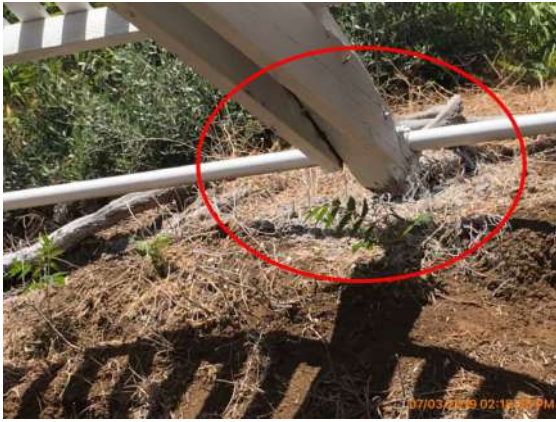
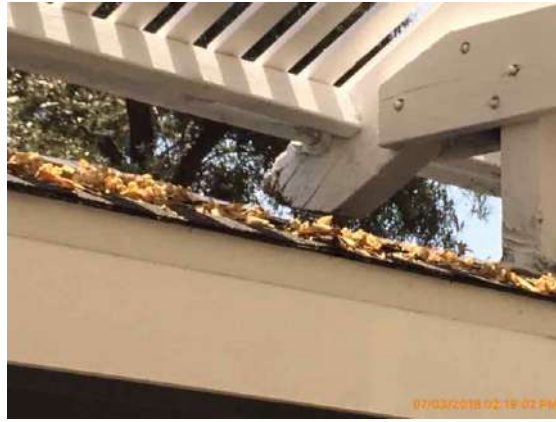
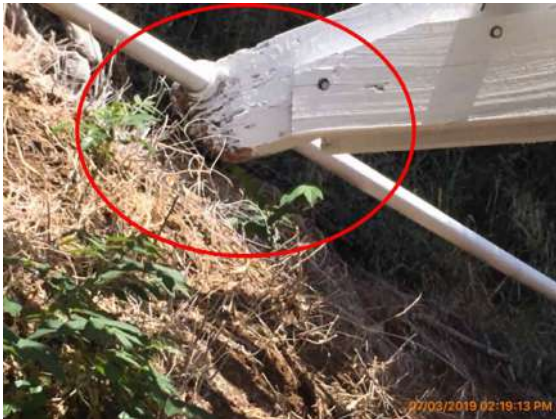
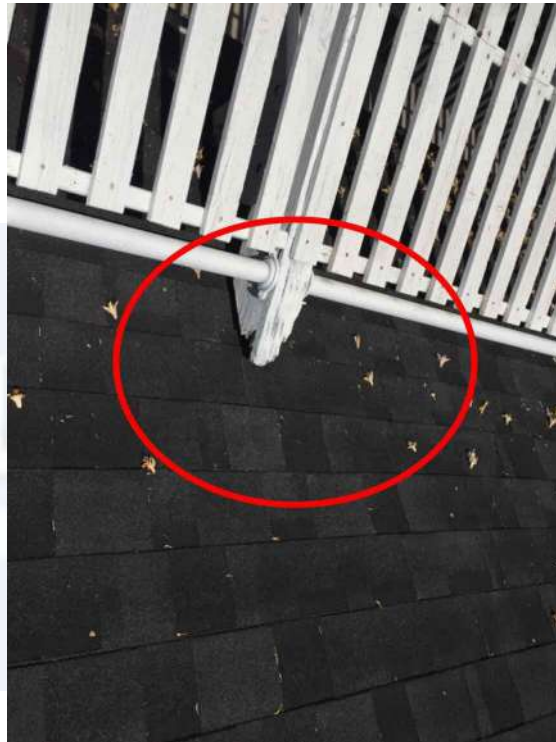
FE CORR 66: The patio cover & framing is deteriorated, showing evidence commonly associated with pest infestation. We recommend the damaged parts be replaced. Advice regarding possible pest infestation should be obtained from a licensed pest. We recommend further evaluation and corrections.

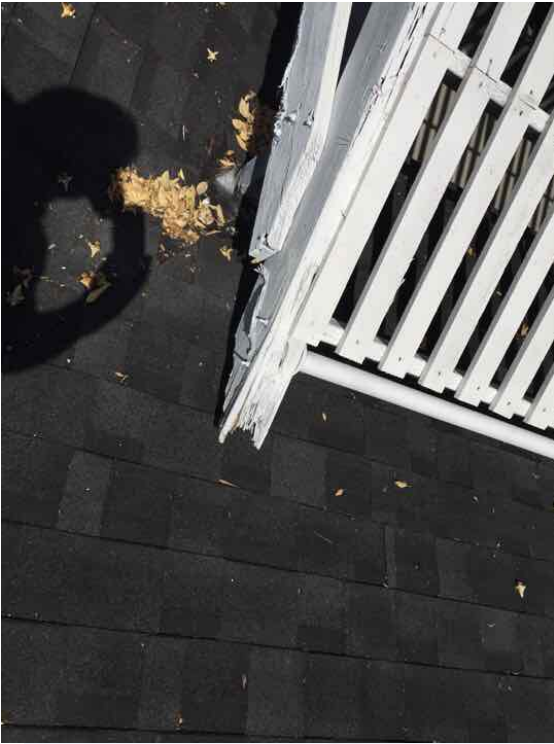
CORR 67: There is earth-to-wood contact at the patio cover. This condition is conducive to infestation of wood-destroying pests/organisms. We recommend that all earth-to-wood contacts be broken and any damaged materials be replaced.

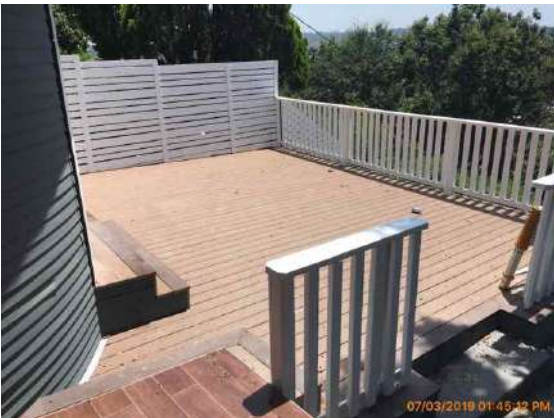
70: The wood deck was constructed too close too the ground. This condition is conducive to moisture damage and deterioration.

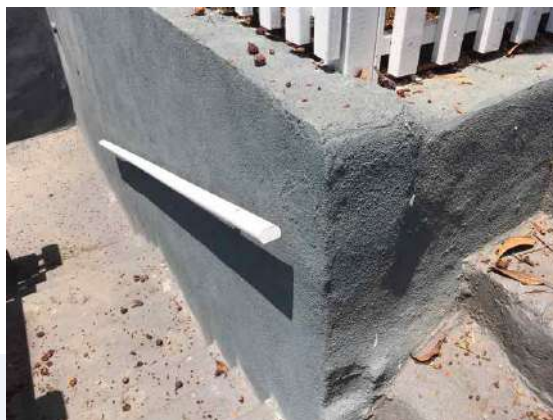
SFTY CORR 72: The steps at the front are nonconforming. Standards require all steps to be almost identical in 'rise' and 'run' for safety. Ideally, the stairs should be rebuilt. If not, we recommend caution in the use of this stairway.

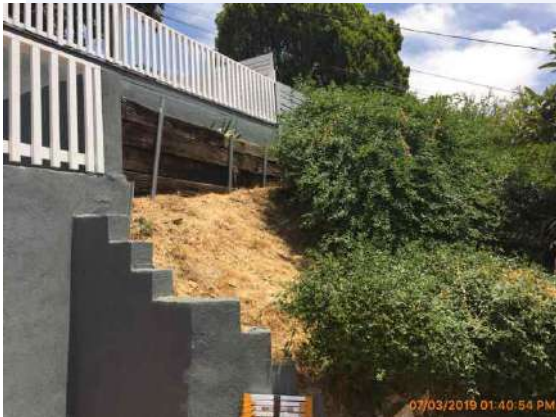
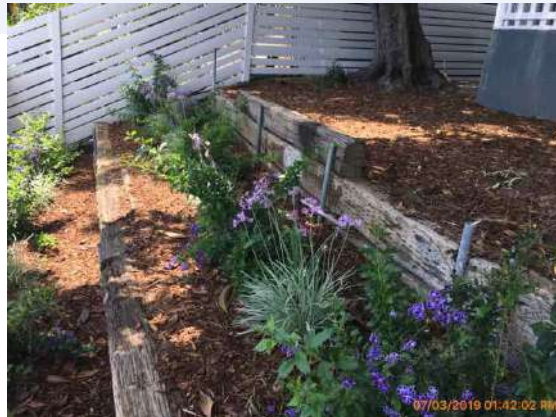
CORR 82: DECORATIVE: The decorative retaining walls appear to have performed as intended and are in serviceable condition.

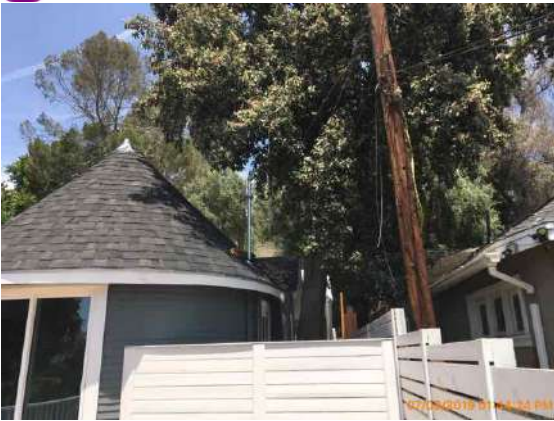
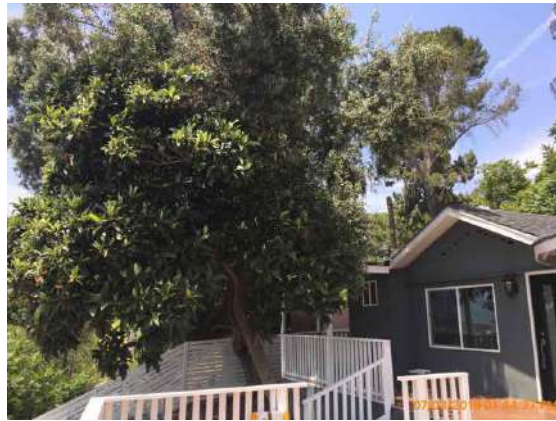
FE 83: Trees may have an impact on the site, structure and main sewer line.

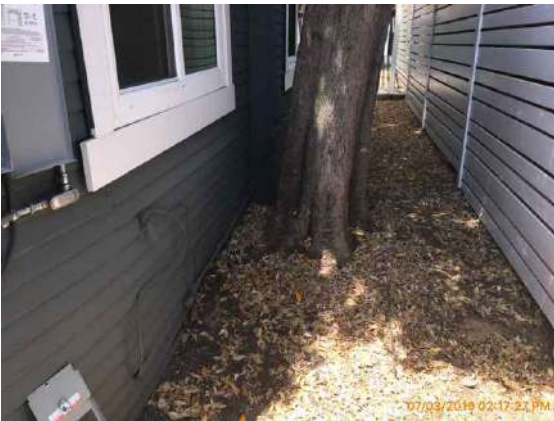
84: Trees were planted too close to the structure. This condition limits the inspection and is conducive to moisture intrusion/deterioration and provides ready access to rodents and insects.

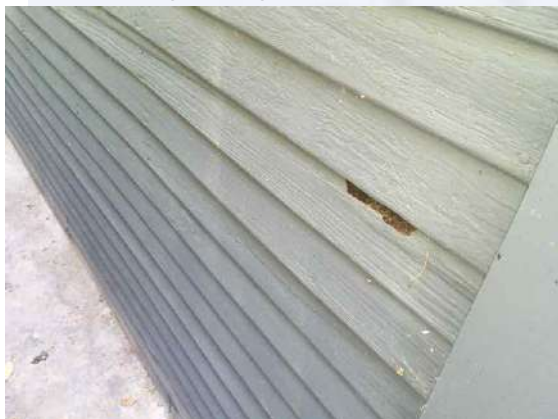
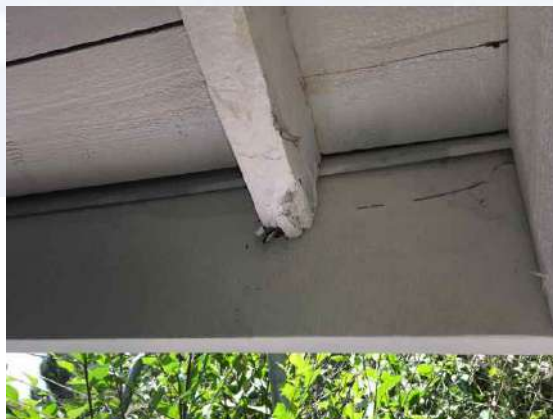
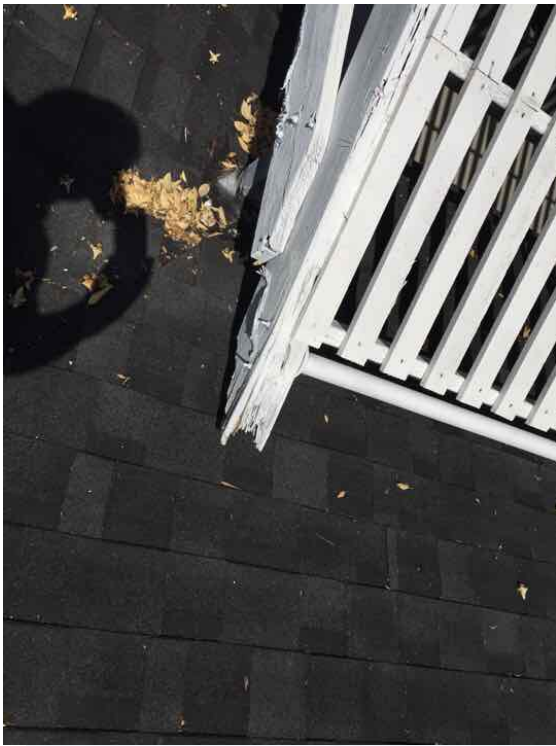
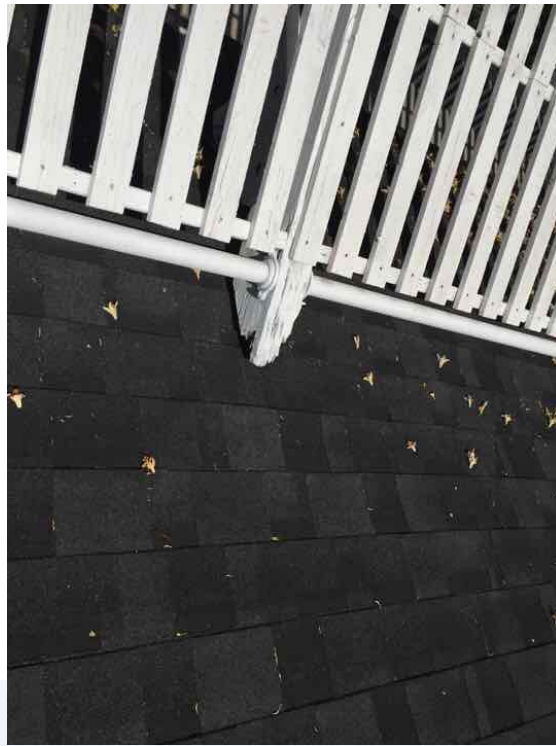
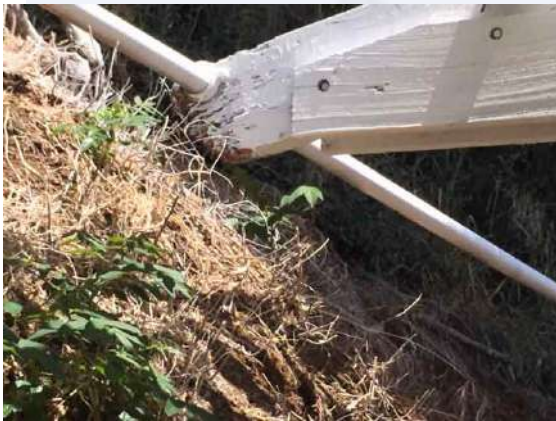
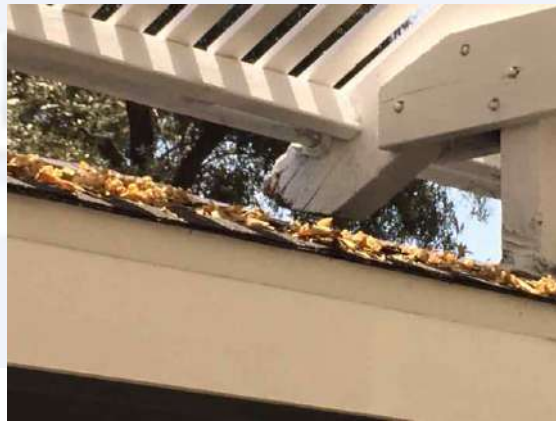
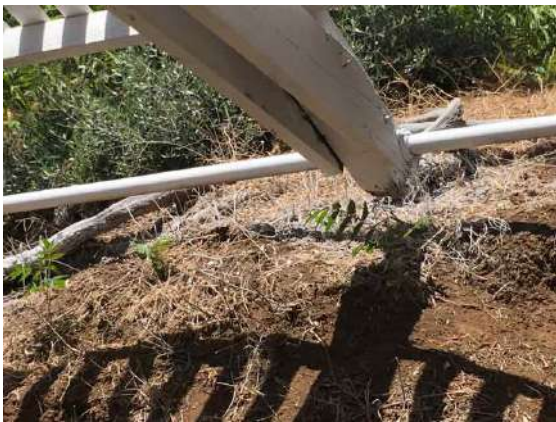
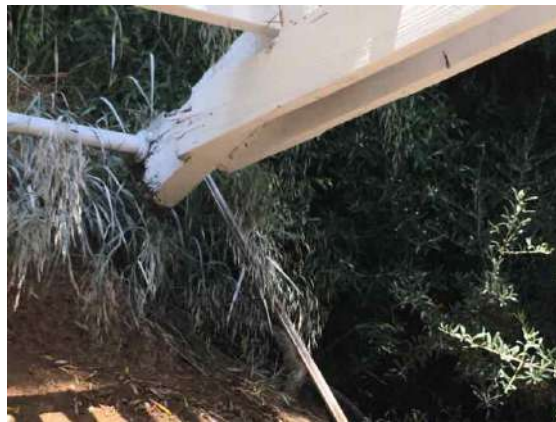
FE 91: There are isolated areas where evidence commonly associated with pest infestation or infection was observed. We recommend obtaining a current report from a licensed pest control operator regarding repair or treatment of these areas.

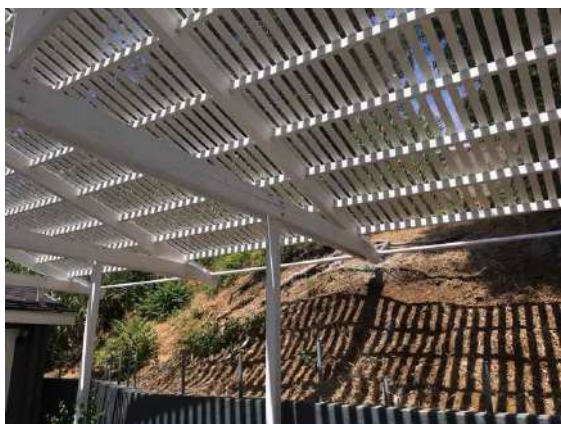
FE 92: Non-original construction was noted. We suggest review of all plans and permits with the owner and/or the local building official for information regarding this work.

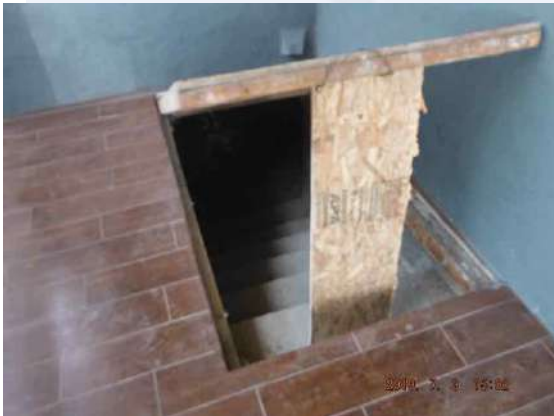
98: The basement/crawlspace is accessible from the exterior of the house.

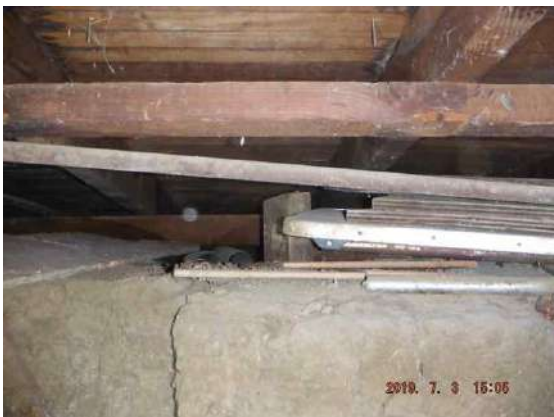
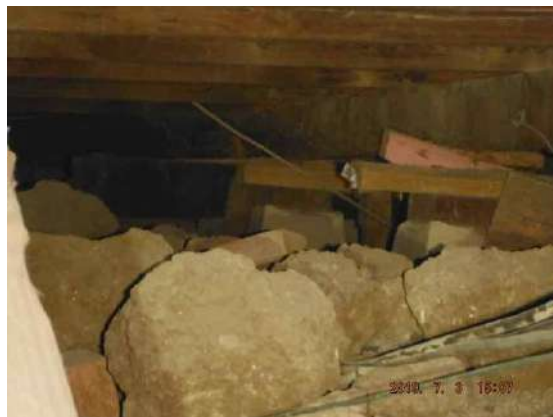
FE 99: Access to the right side and rear area of the crawl space was restricted by plumbing lines, moisture personal items and/or low clearances. The crawlspace could be only partially inspected.

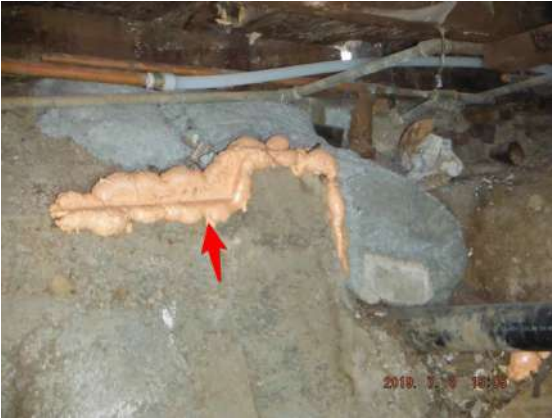
100: CONCRETE/BLOCK: Hairline and/or small cracks, within normal tolerances, are visible. This type of cracking is often a result of shrinkage of materials and/or minor settlement and usually does not affect the strength of the foundation. No action is indicated.

Crack patch?

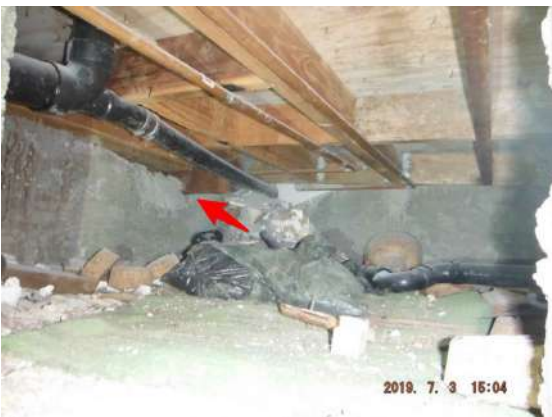
CORR 104: The mudsill is the wood member resting directly on the foundation. There are voids between the mudsill and the foundation which is not considered good practice. We recommend these voids be filled for full support of the framing.

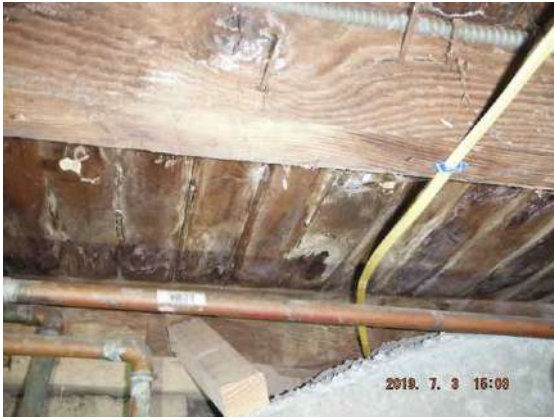
CORR 105: The subfloor beneath the left front area is damaged. We recommend the subflooring be repaired and all damaged material replaced.

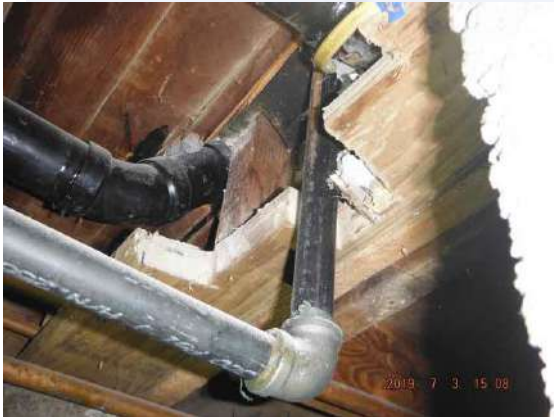
CORR 106: There is excessive notching in the floor framing at the left front area. This has weakened the framing. We recommend repair or modification to conform to accepted standards.

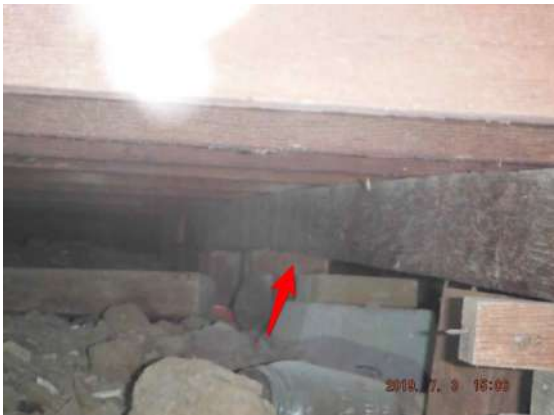
UPGR 107: The girders or support beams of the floor structure are 'overspanned' by today's standards and sagging was noted. We recommend repairs by a qualified specialist.

Bowing in middle

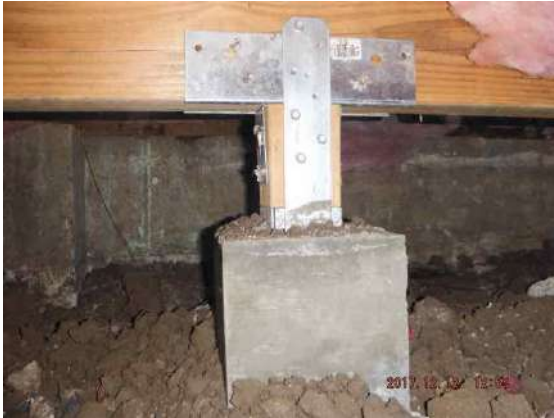
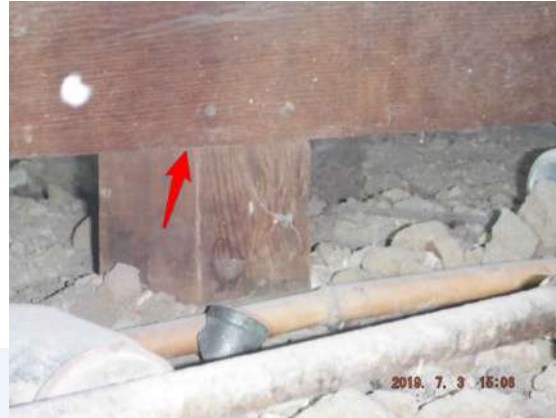
SFTY **UPGR** **109:** Wooden support posts were not securely fastened to beams above. This is a safety hazard since they can separate during a seismic event. A qualified contractor should evaluate and make repairs as necessary, such as installing metal ties, bracing with lumber and/or plywood gussets as per standard building practices. Proper strapping example shown in first photo.

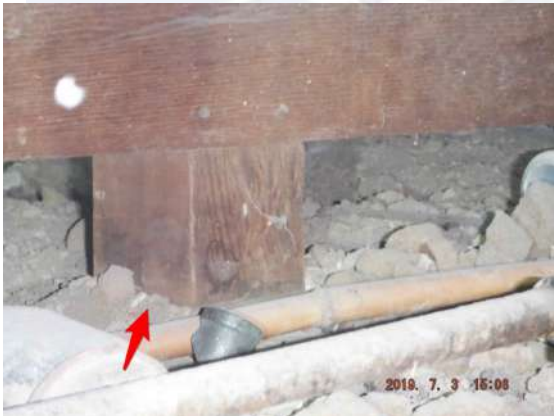
FE **CORR** **110:** The bottoms of the posts are supported at or below the grade of the crawl space soil. This condition is conducive to deterioration. Action should be taken to insure that a 6 inch clearance is maintained between wood and soil.

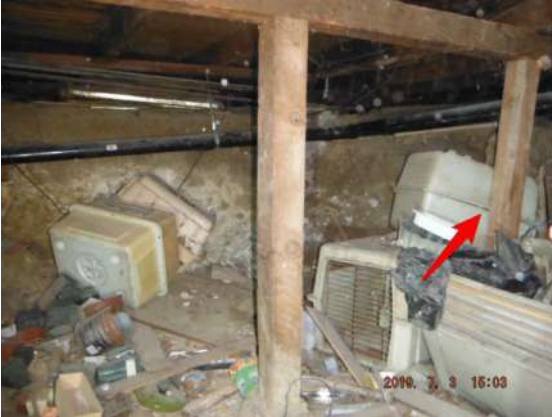
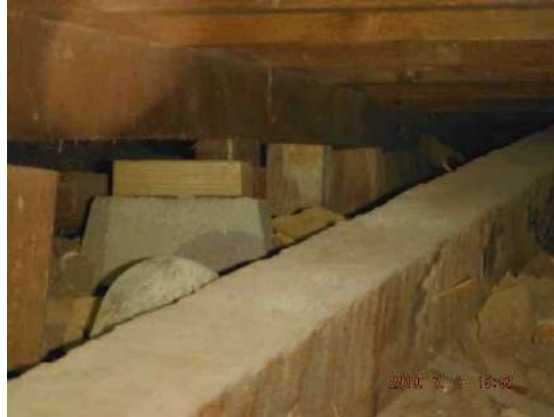
FE CORR 111: A number of the supports are out of plumb or have shifted to the side. We recommend adjustment to provide full support.

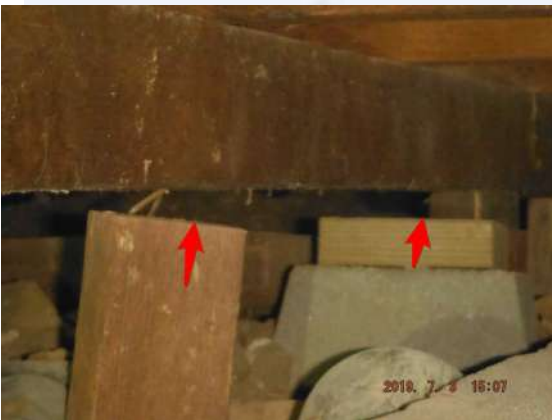
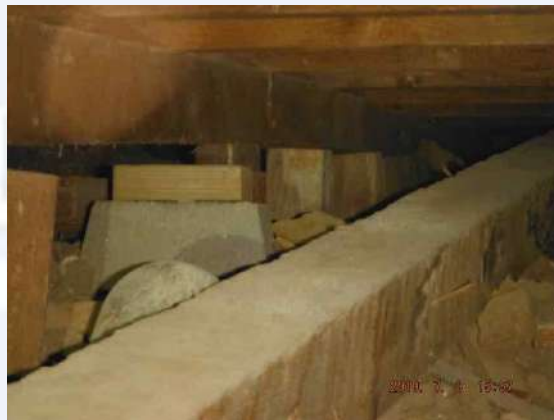
CORR 112: The floor supports are marginally connected and are subject to failure in the event of excessive soil movement and/or seismic activity. We recommend additional connections be installed.

Disconnected posts

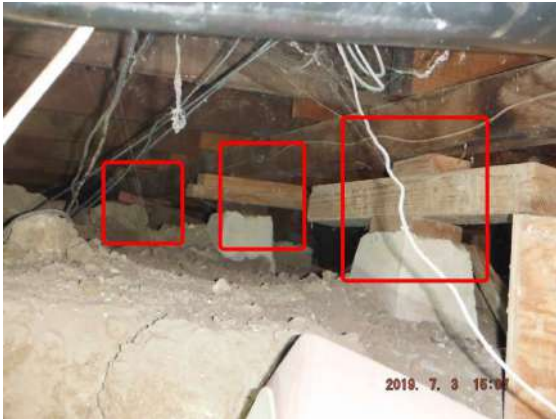
114: The support posts are installed in a substandard manner, as compared to present standards. We feel that upgrades should be considered.

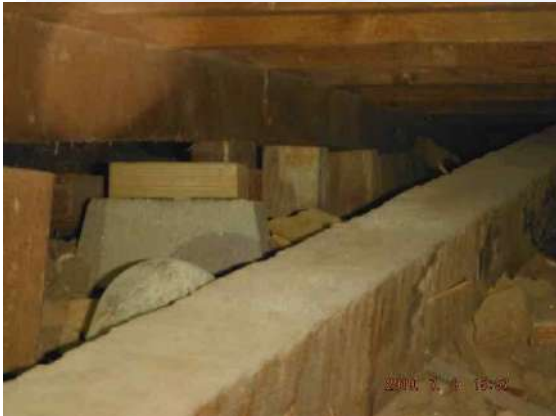
115: The support piers are installed in a substandard manner. We recommend new piers be installed as an upgrade, especially if other major improvements are undertaken.

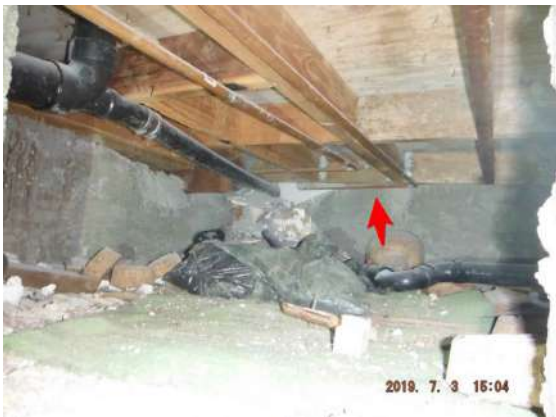
116: Anchor bolts were located at the addition only. We recommend upgrades to the original foundation.

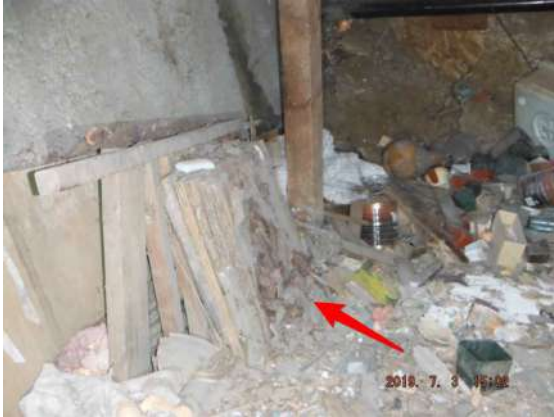
FE 123: In the area near the left front area, there is evidence commonly associated with wood-destroying pest and/or organism activity. We recommend consultation with a licensed pest control operator.

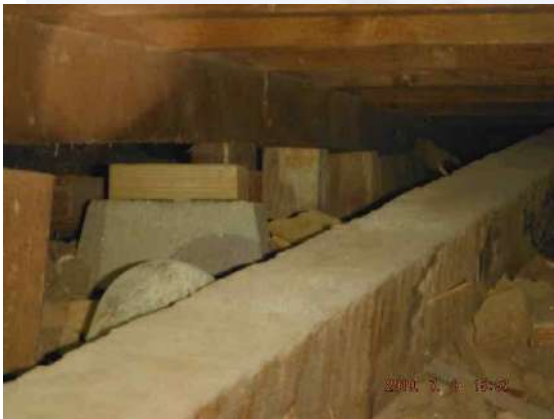
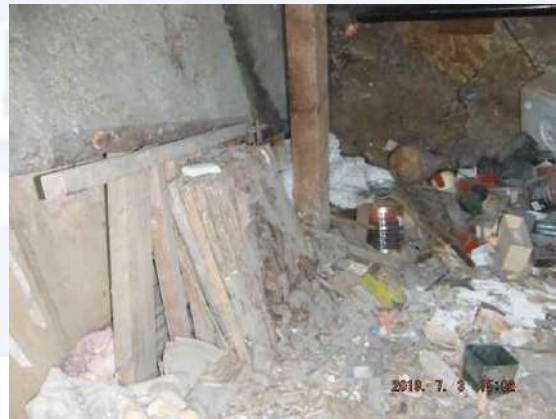
CORR 124: There is scrap wood on the soil in the area. Cellulose debris can result in wood-destroying organism activity. We recommend removal of the wood scrap.

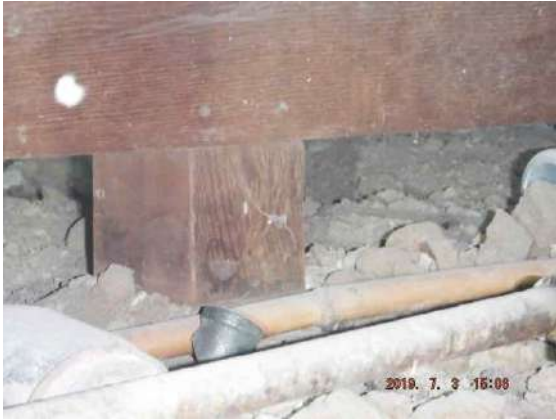
125: There is earth-to-wood contact in several areas. This condition is conducive to wood destroying organism activity. We recommend a minimum clearance of 6 inches be maintained between soil and the bottom of the wood line. Any damaged or deteriorated material discovered in the course of this work should be replaced or removed.

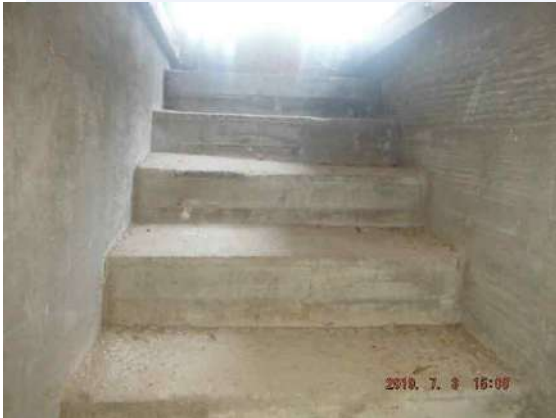
127: There are no railings where needed. As a safety upgrade, we recommend installing railings

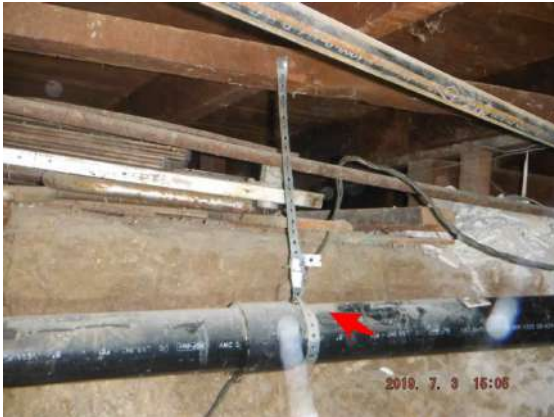
UPGR **129:** Improper hangers/strapping is used for the ABS/PVC drain piping. We recommend using correct strapping materials.

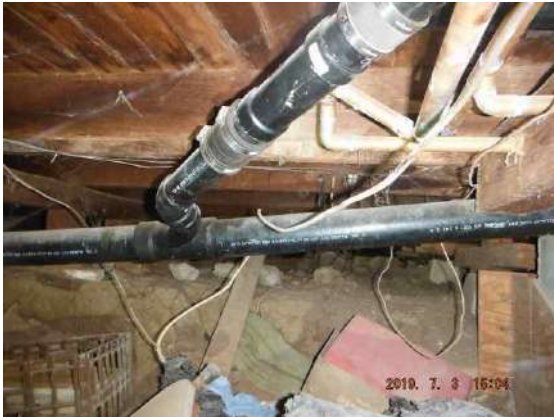
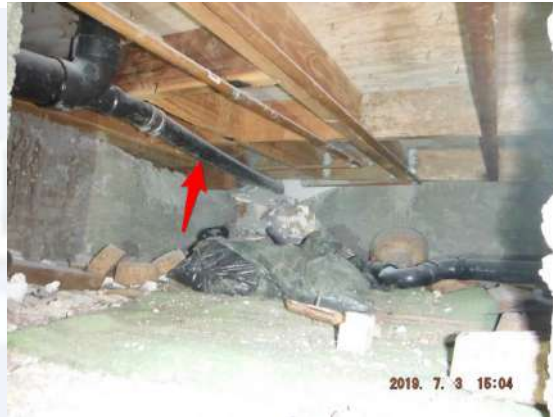
CORR **130:** There is a long section of the waste line that is not properly supported. We recommend strapping to the framing in accordance with present standards.

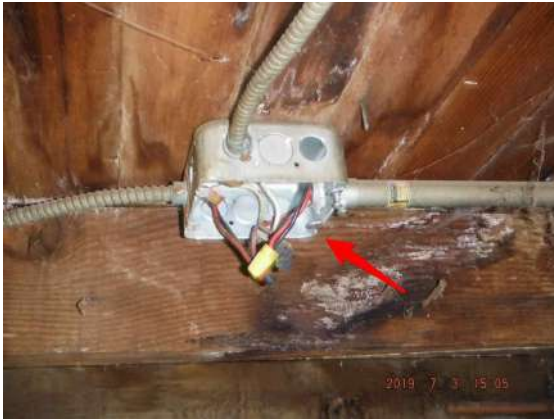
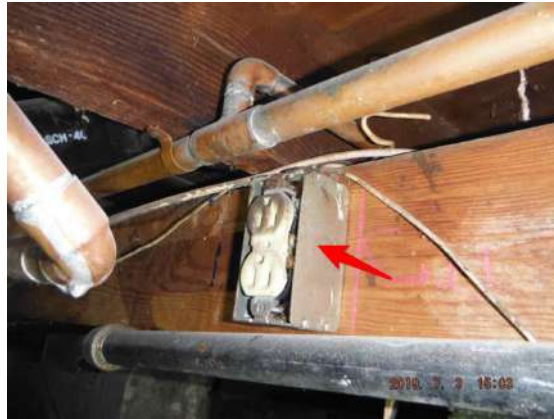
CORR 135: There is abandoned electrical at the left front area. We recommend disconnecting the wiring and electrical components.

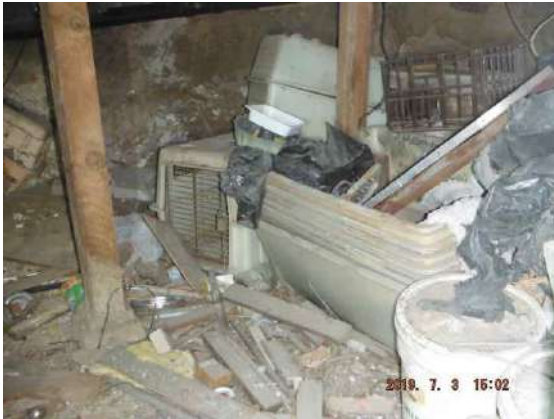
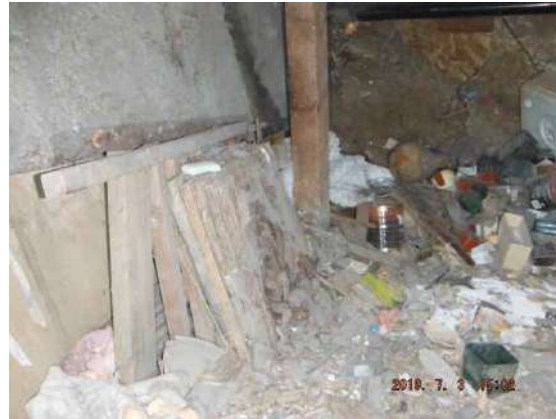
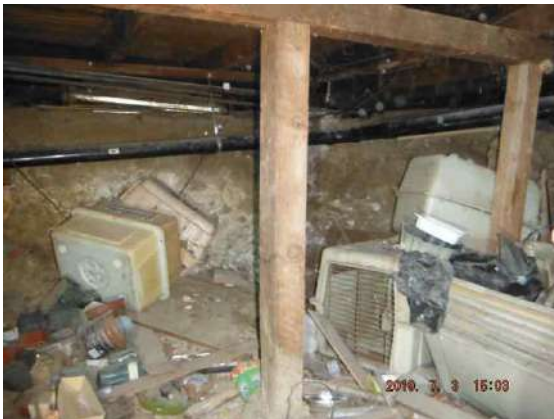
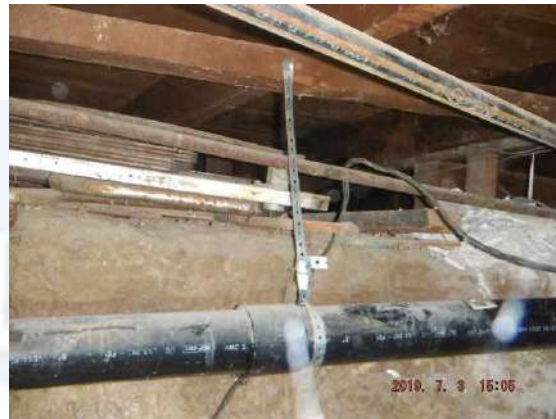
CORR 138: Debris/trash was observed. This is conducive to rodent and termite infestation. We recommend removal of debris.

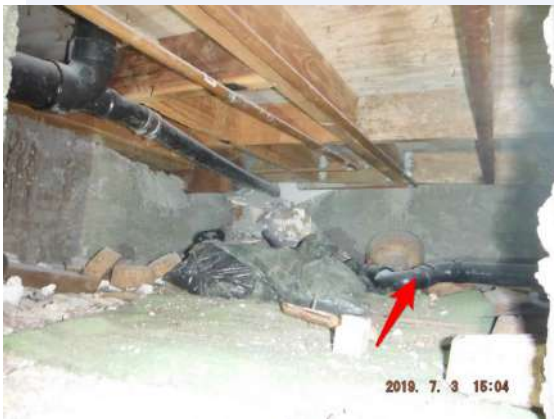
CORR 139: Abandoned pipes were noted in the crawlspace. We recommend disconnecting and removing all unused plumbing pipes.

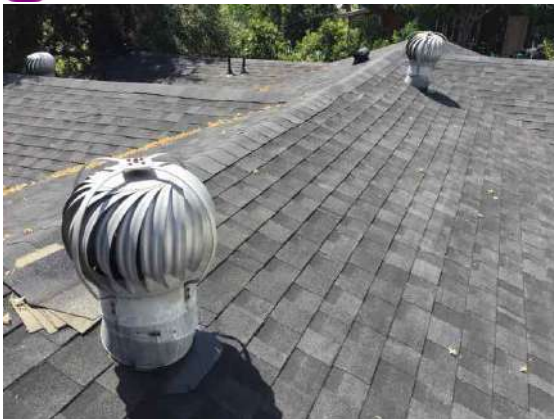
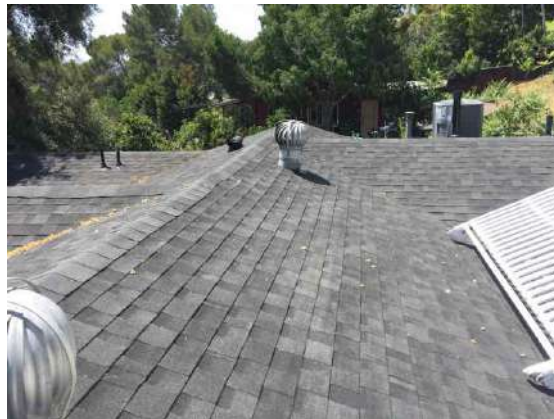
FE 144: The composition roof area(s) appeared to be in generally serviceable condition.

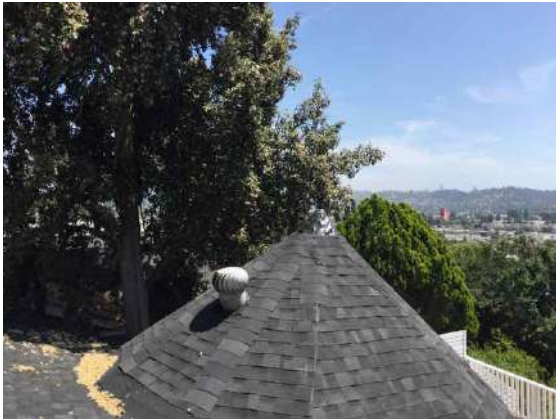
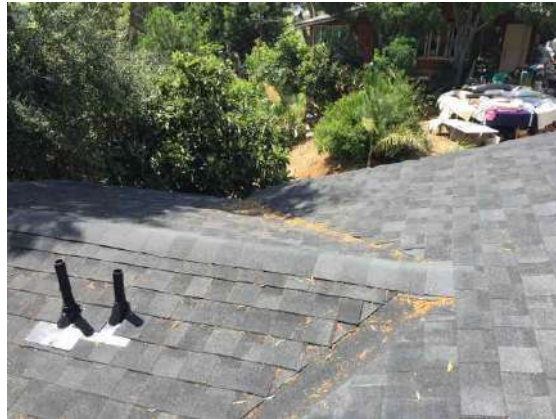
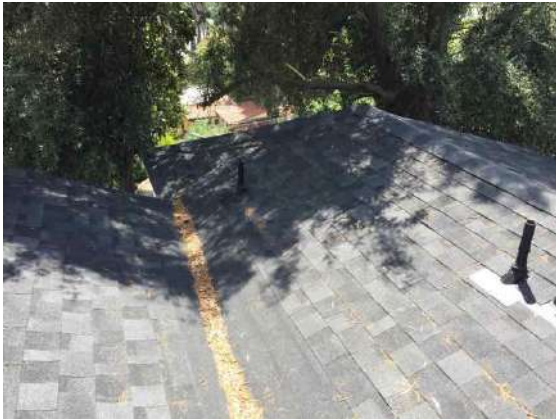
145: Debris has accumulated on the roof. This condition restricts roof-water runoff and is conducive to moisture intrusion and damage to the building components.

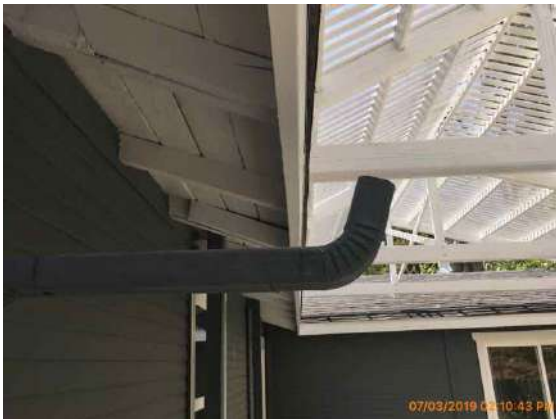
146: GUTTERS: There were no gutters to control the roof-water runoff. These systems capture and divert water away from the building. We recommend installation as an upgrade.

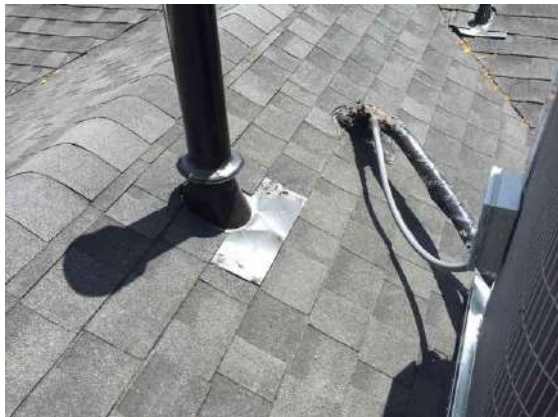
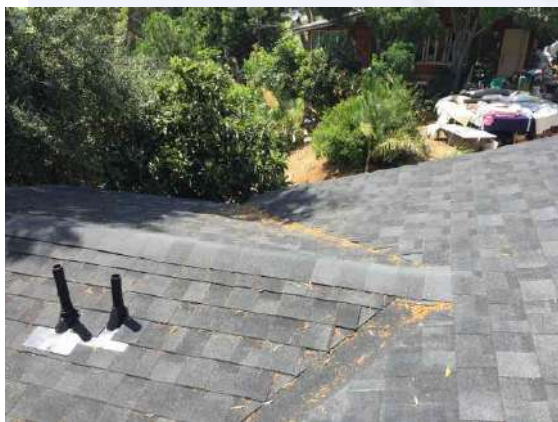
FE 147: A number of the vent flashings were over exposed at the lower edges. More of the flashings should be covered to prevent moisture intrusion and damage to the building components. We recommend further evaluation and repair.

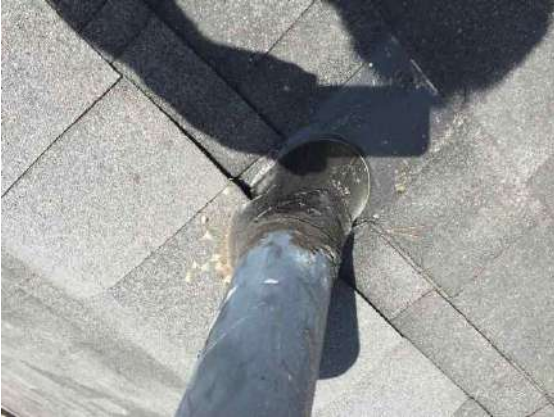
CORR 148: PENETRATIONS: The mastic (tar-like sealant) used to seal components at the roof penetration was cracked. This condition is conducive to moisture intrusion and deterioration. We recommend repair.

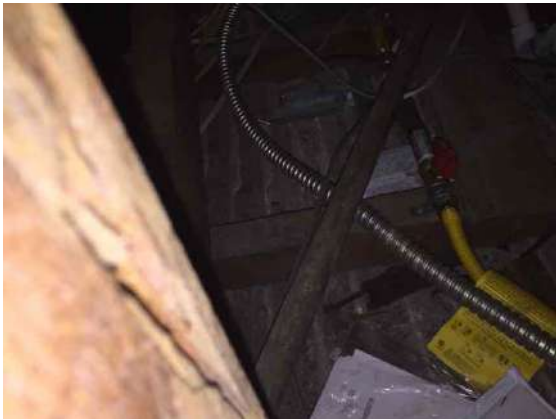
161: The original roof framing appeared functional. Although the roof framing does not conform to present building standards, no adverse conditions were noted.

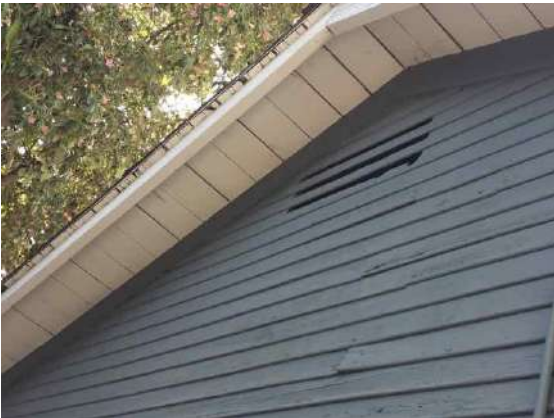
CORR 165: One or more attic vent screens were missing. This condition allows birds, insects and other creatures to enter and nest the attic space. We recommend they be replaced.

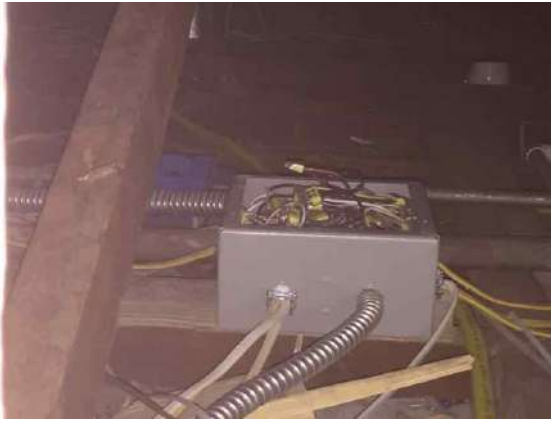
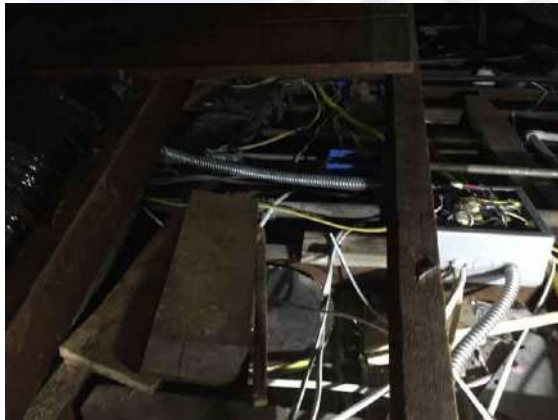
168: Missing electrical cover plates.

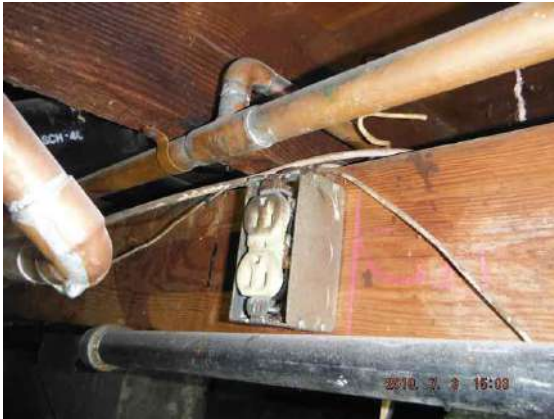
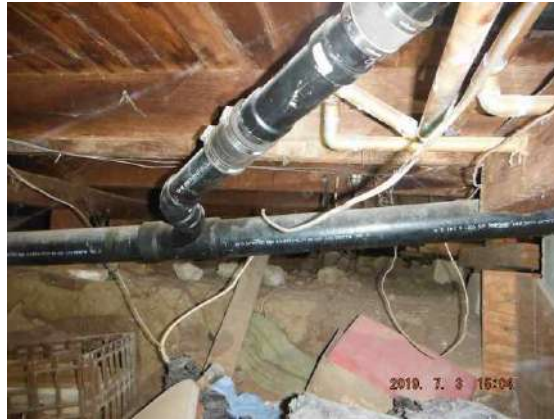
SFTY **CORR** **199:** Unsecured wiring was noted in one or more areas. We recommend that it be secured in accordance with present standards.

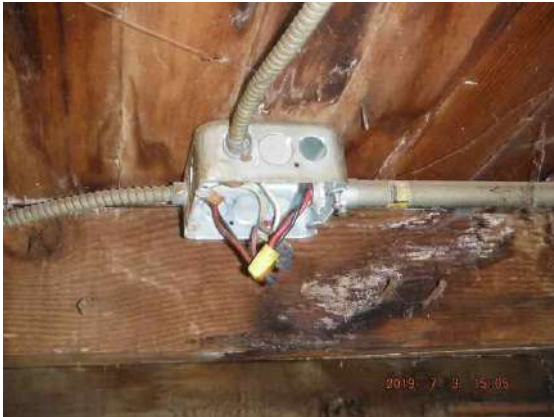
SFTY **CORR** **200:** There are uncovered junction box(es). We recommend these be covered to protect the wiring connections.
