Confidential Inspection Report

LOCATED AT:
3227 Weldon Avenue
Los Angeles, California 90065

INSPECTED ON:
Wednesday, July 3, 2019

Inspector, Tom de Spain
Advanced Building Inspections
26500 Agoura Road, Ste 102-567
Calabasas, CA 91302
Office 818.883.9810

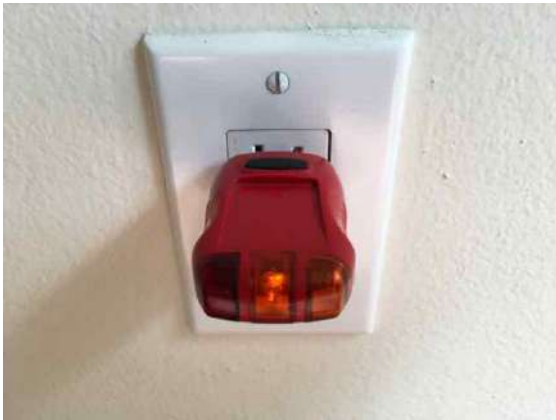
202: There are ungrounded three prong receptacles in one or more areas. We recommend all ungrounded 3 pronged receptacles be properly grounded or restored to their original two prong configuration. Generic photo shown.

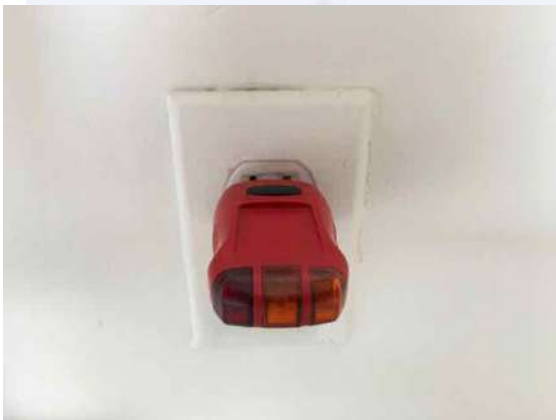
203: One or more receptacles are not working. We recommend the circuit and receptacles be checked and repaired as necessary. Generic photo shown.

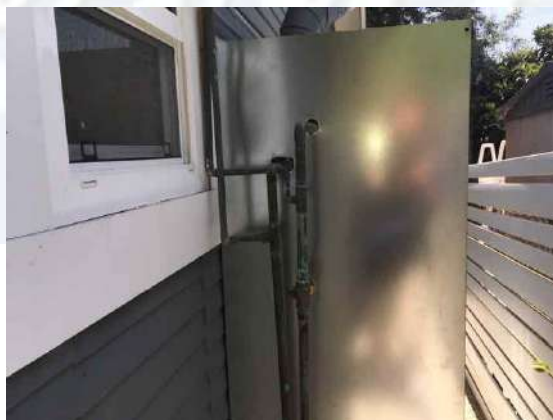
UPGR 225: The exterior & interior plumbing lines are not insulated as per current code. We recommend upgrading for energy savings.

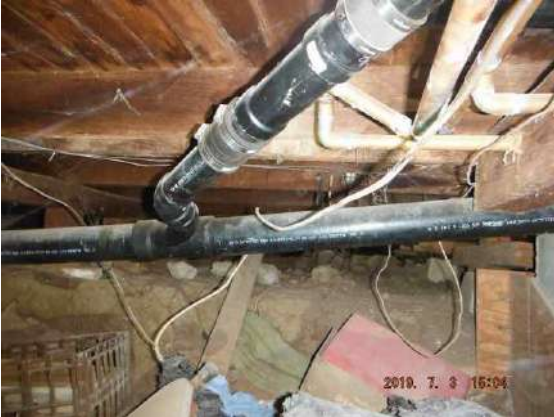
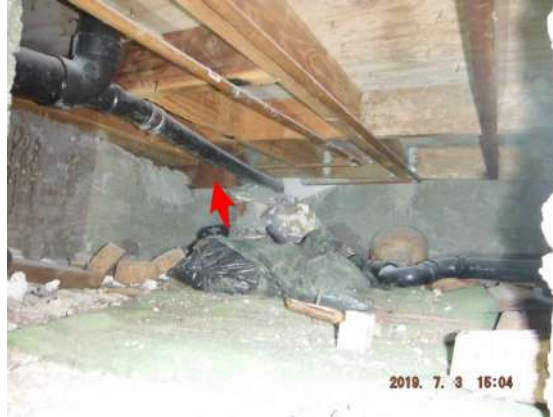
CORR 236: There is a long section of the waste line that is not properly supported. We recommend it be strapped to the framing in accordance with present standards.

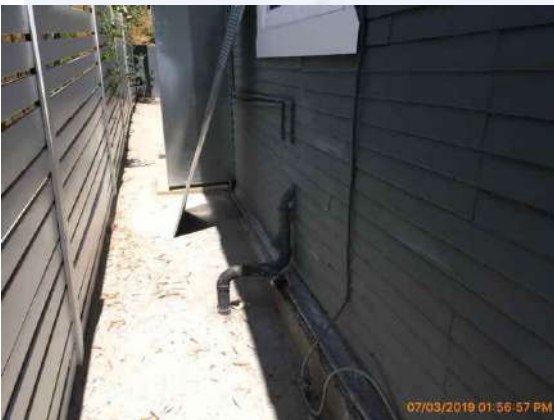
CORR 237: There are plastic plumbing pipes at the exterior. Standards require this type of pipe be protected and, in most jurisdictions, this has been interpreted to mean painted for protection against the sun. We recommend the pipes be painted.

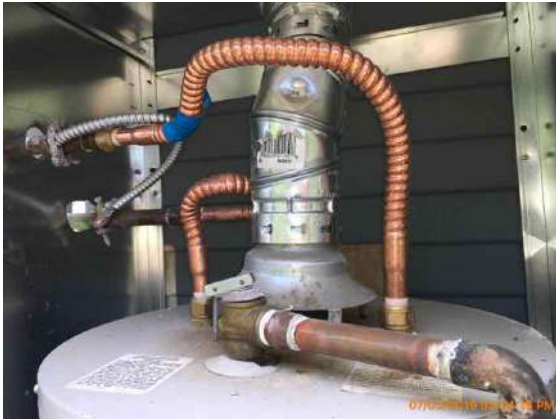
271: INLET/OUTLET: The visible water supply connectors for the water heater were not insulated to minimize heat loss.

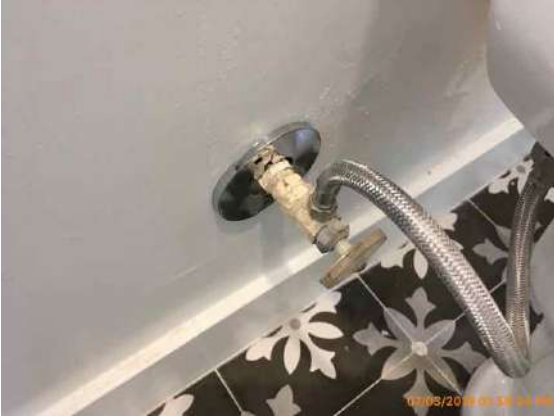
FE 332: Galvanized water supply was noted at the toilet. Galvanized steel pipe has a life expectancy between 35 and 45 years. Galvanized steel pipes will rust and corrode from the inside out, can become restricted over time and eventually leak. When loss of pressure/flow is noted at plumbing fixtures, restrictions may have already occurred. We suggest further review by a qualified licensed plumber prior to closing.

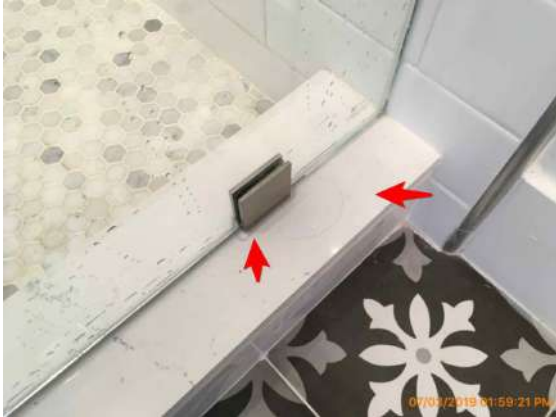
CORR 344: The glass enclosure has been leaking at the lower corners. No damage was visible, but resealing or repairing the enclosure is recommended.

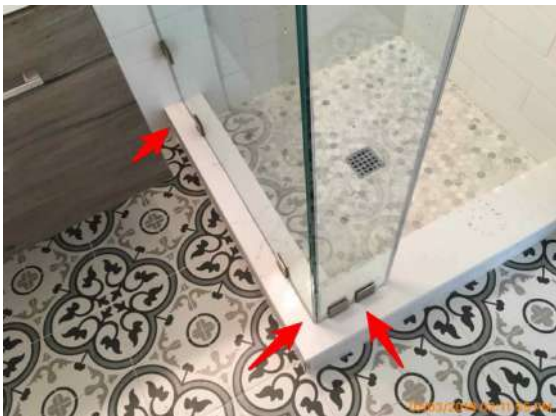
CORR 371: The glass enclosure has been leaking at the lower corners. No damage was visible, but resealing or repairing the enclosure is recommended.

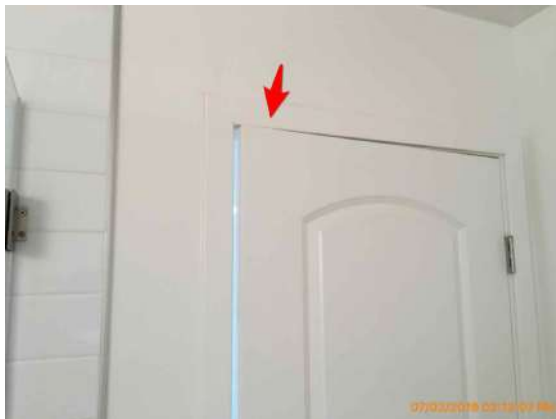
375: SWINGING: The entry door rubs on the frame. We recommend planing or sanding for smoother operation.

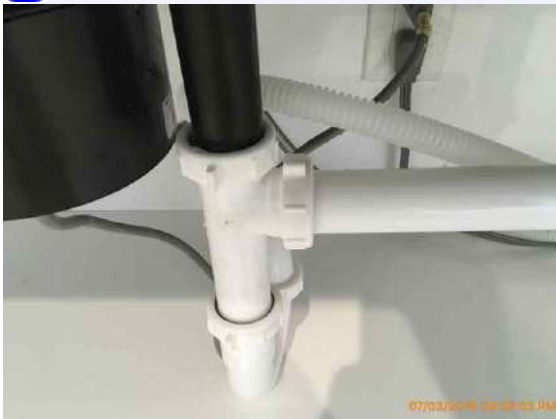
382: The drain pipe fitting is leaking. We recommend repair or replacement.

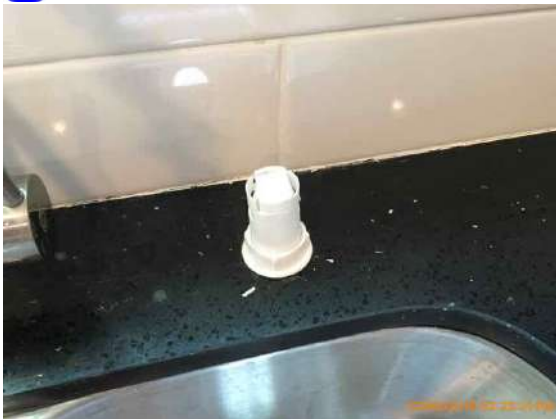
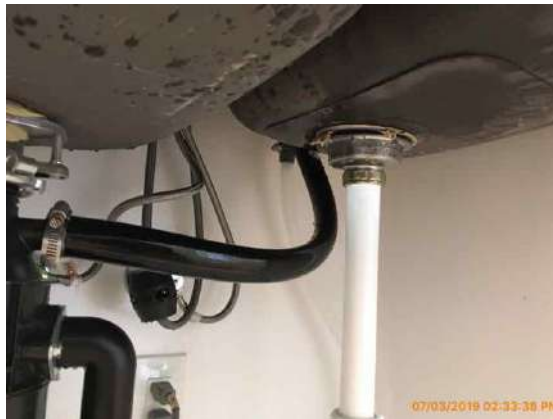
CORR **384:** The air gap leaks. We recommend repair.

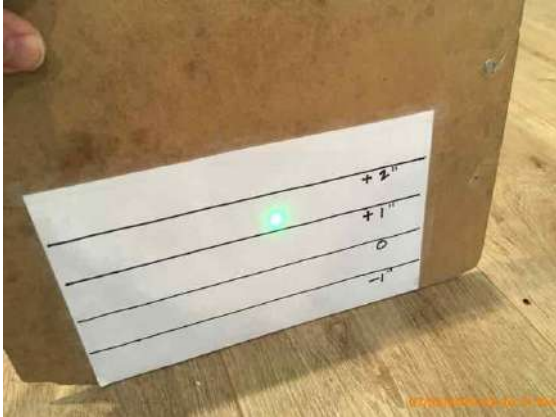
FE 396: GENERAL: There is a minor slope in the flooring. We noted no resulting weakness or failure as a result of the slope. No immediate corrective actions are required.

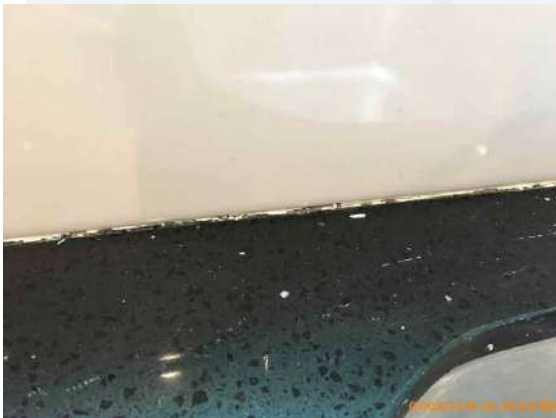
CORR 399: The rigid grout joint between the counter and the backsplash is standard practice. There are hairline cracks and this condition is likely to return even after patching. We recommend a flexible sealant at this location.

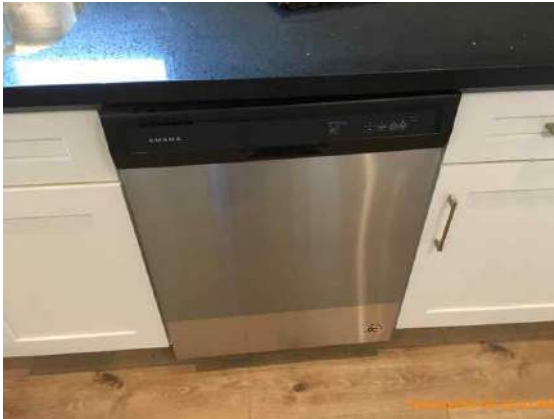
CORR 404: The dishwasher is not properly attached to the cabinets. We recommend attachment according to the manufacturer's installation instructions.

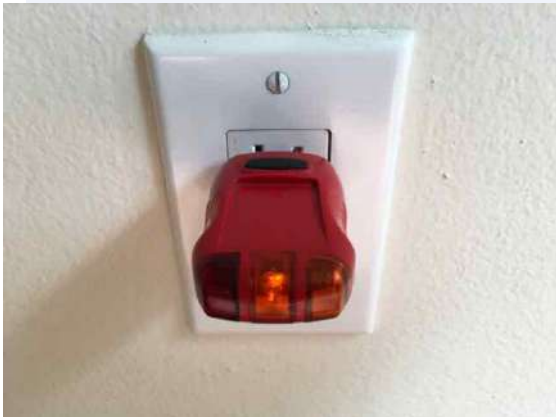
SFTY CORR 427: There are one or more ungrounded 3 prong receptacles. We recommend all ungrounded 3 pronged receptacles be properly grounded or restored to their original two prong configuration. Generic photo shown.

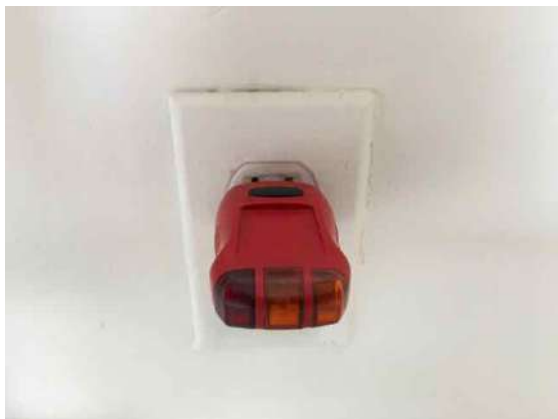
428: One or more receptacles are not working. We recommend further investigation and repair, if necessary.

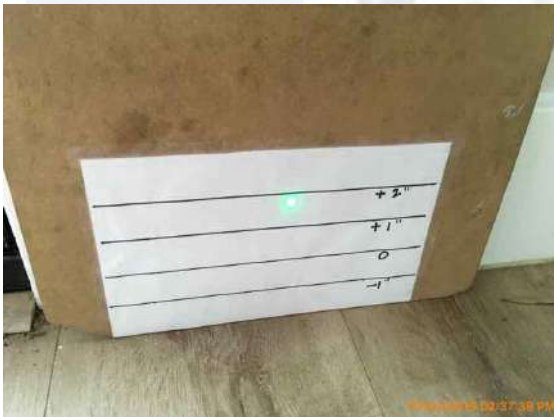
FE 456: GENERAL: There is a minor slope in the flooring. We noted no resulting weakness, failure or nonperformance as a result of the slope. No immediate corrective actions are required. See foundation and/or other sections of this report regarding this issue.

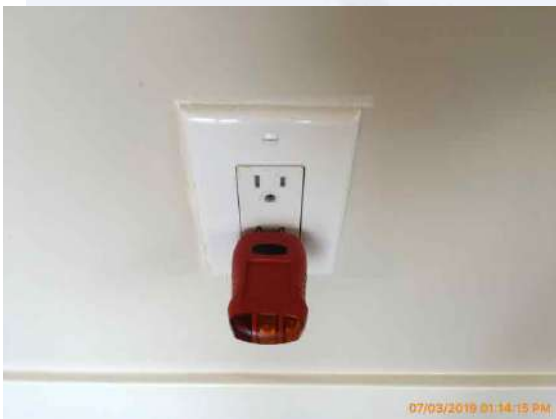
CORR 458: The receptacle is not working. We recommend further investigation and repair, if necessary.

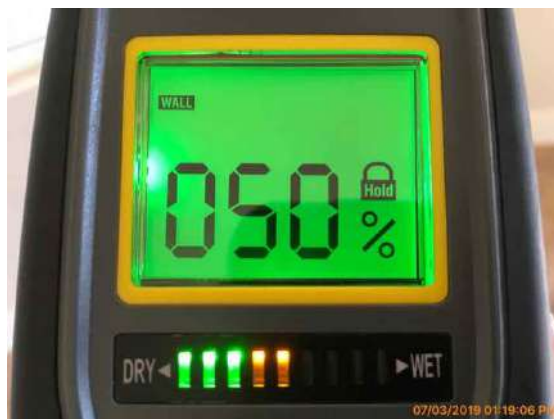
FE **CORR** **459:** Moisture was detected on the wall. The source of moisture should be identified and corrected.

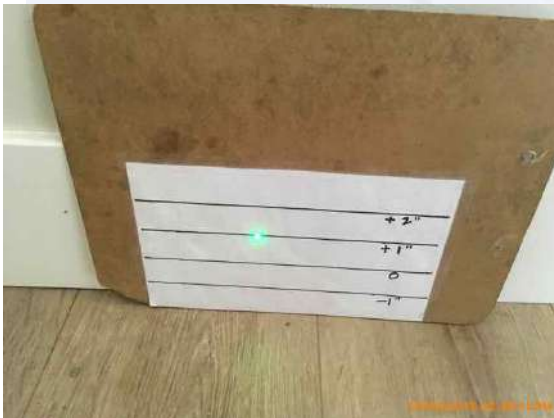
1 inch in two feet

FE 465: GENERAL: There is a minor slope in the flooring. We noted no resulting weakness, failure or nonperformance as a result of the slope. No immediate corrective actions are required. See foundation and/or other sections of this report regarding this issue.

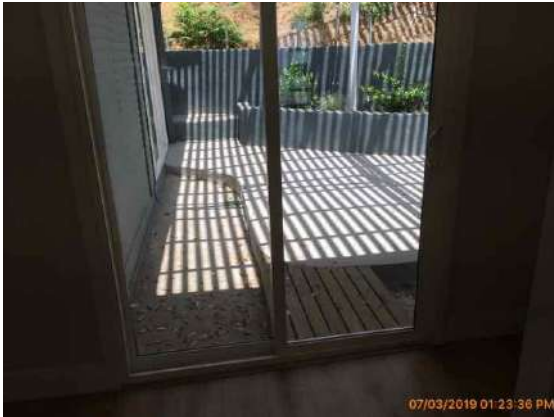
CORR 466: SLIDING: The sliding door does not operate properly, indicating the track is misaligned, dirty, or the wheels are damaged. We recommend repair or replacement.

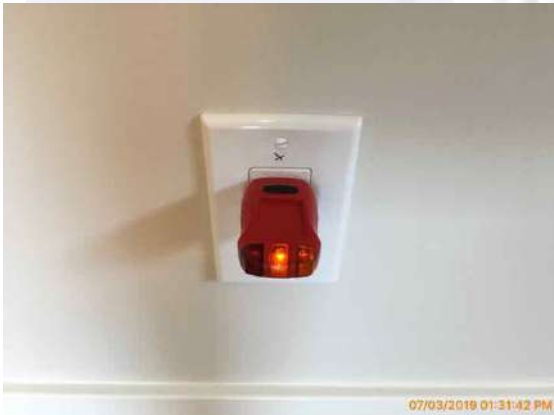
469: There are one or more ungrounded three prong receptacles in this area. We recommend they be properly grounded or restored to their original two prong configuration.

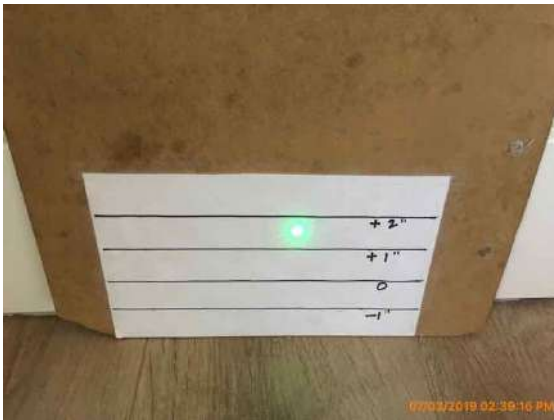
FE 470: GENERAL: There is a minor slope in the flooring. We noted no resulting weakness, failure or nonperformance as a result of the slope. No immediate corrective actions are required. See foundation and/or other sections of this report regarding this issue.

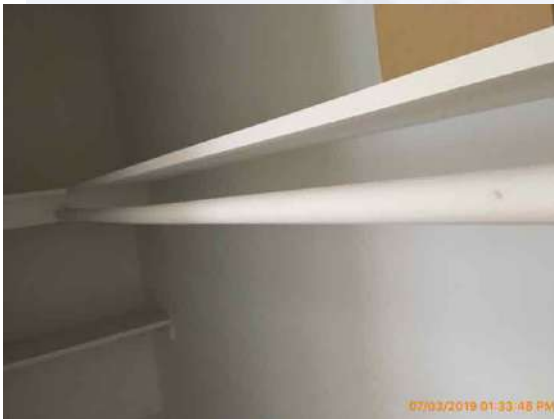
CORR 471: The clothing bar in the closet sags. Additional support could be added for a better appearance and to minimize chances for breakage.

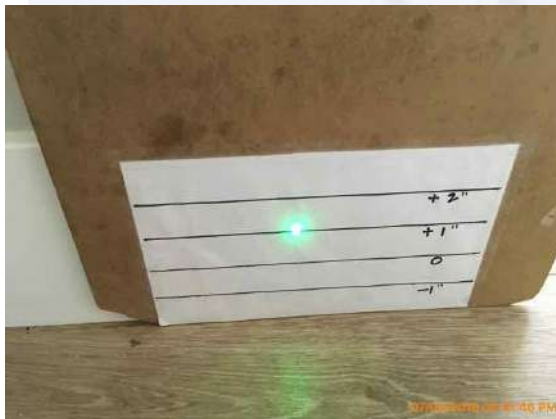
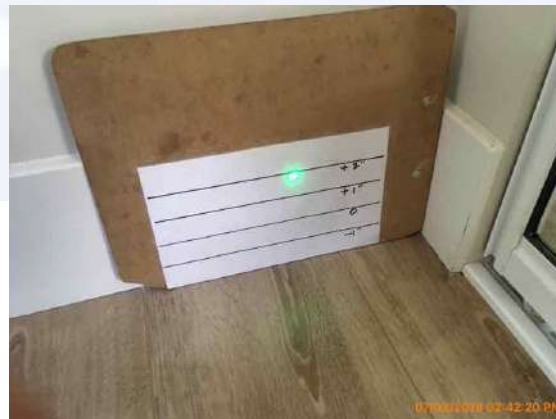
FE 474: GENERAL: There is a minor slope in the flooring. We noted no resulting weakness, failure or nonperformance as a result of the slope. No immediate corrective actions are required. See foundation and/or other sections of this report regarding this issue.

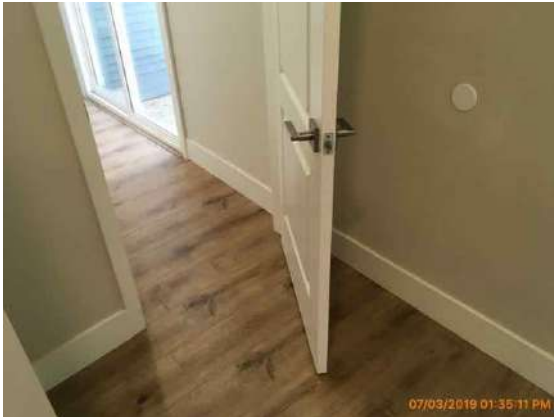
CORR 475: SWINGING: The entry door is out of alignment swinging back to the closed position when fully opened. We recommend adjustment.

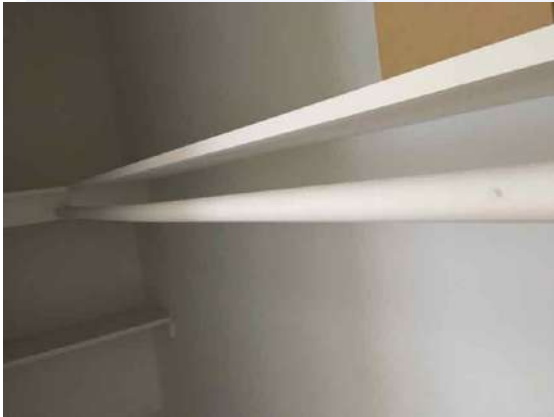
CORR 476: The clothing bar in the closet sags. Additional support could be added for a better appearance and to minimize chances for breakage.

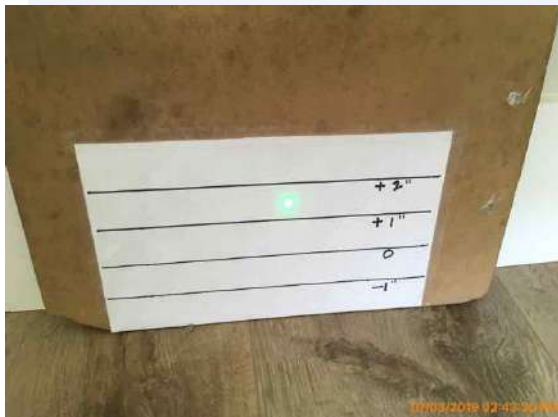
FE 480: GENERAL: There is a minor slope in the flooring. We noted no resulting weakness, failure or nonperformance as a result of the slope. No immediate corrective actions are required. See foundation and/or other sections of this report regarding this issue.

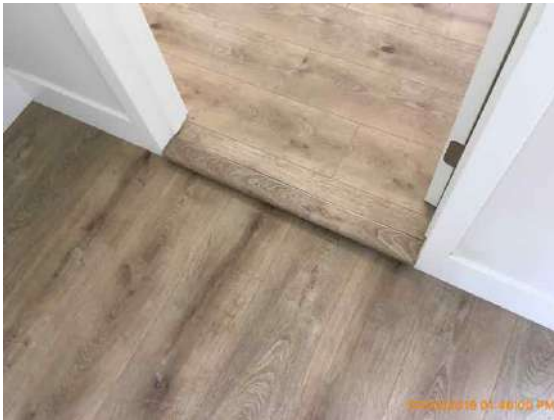
481: GENERAL: Portions of the flooring are uneven. This condition appears to result from mismatching of the underlying framing or subflooring. We recommend repair for a better appearance and a more even walking surface.

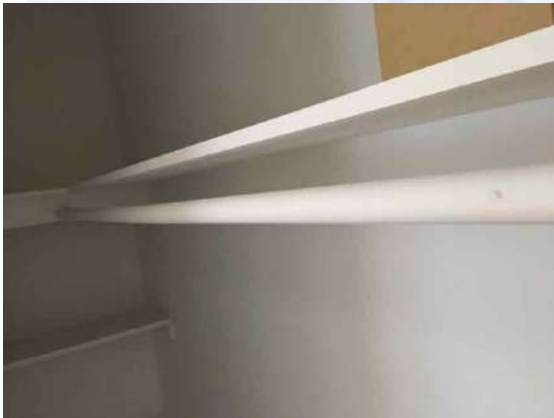
483: The clothing bar in the closet sags. Additional support could be added for a better appearance and to minimize chances for breakage.
