## **Diana Andreassen**

4064 Huerfano Ave #251  
San Diego, California 92117

Chris Dembroski NACHI10071406  
Smart Home Inspection  
(619) 846-5737  
chris@smarhomeinspection.net  
5582 Forbes Ave  
San Diego, CA  
92120  
[www.smarhomeinspection.com](http://www.smarhomeinspection.com)

Friday  
April 12, 2024

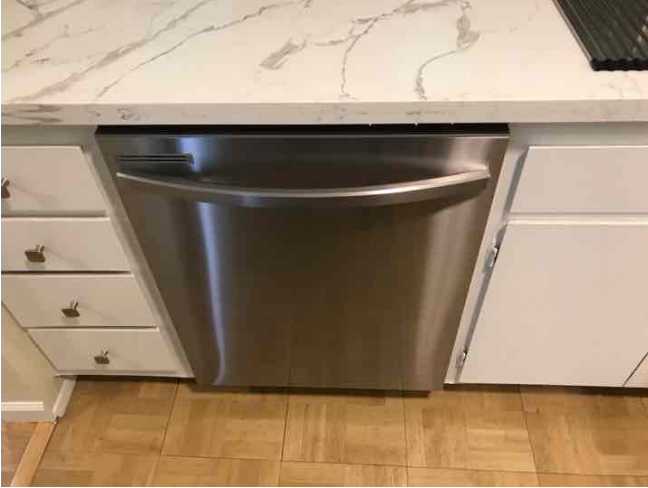
153: Manufacturer: Samsung.

154: The dishwasher responded to normal user controls and was found in good condition.

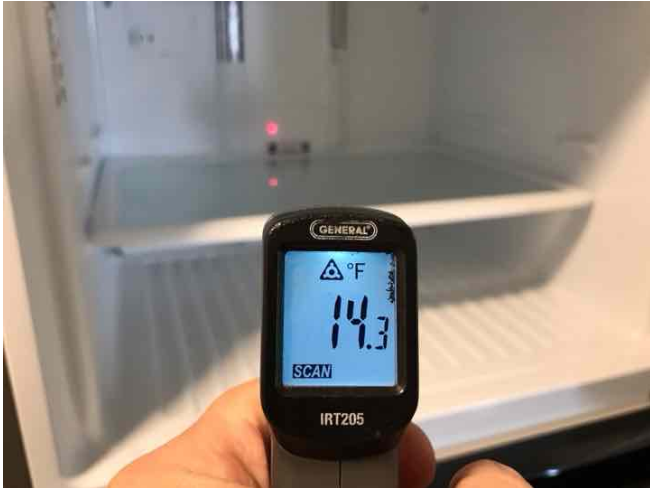
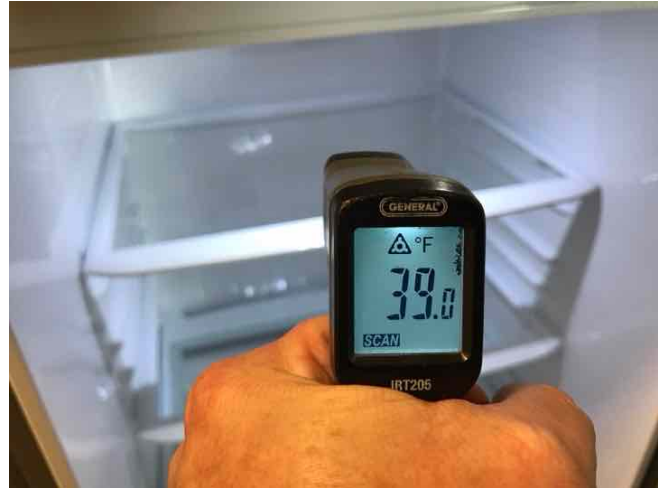
**157:** The refrigerator/freezer responded to normal user controls and was found in good condition. The interior temperature was 39 degrees and 14 degrees at the time of inspection.

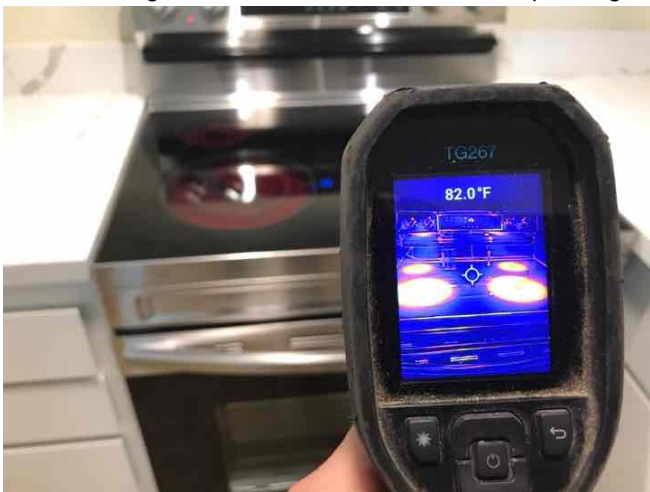
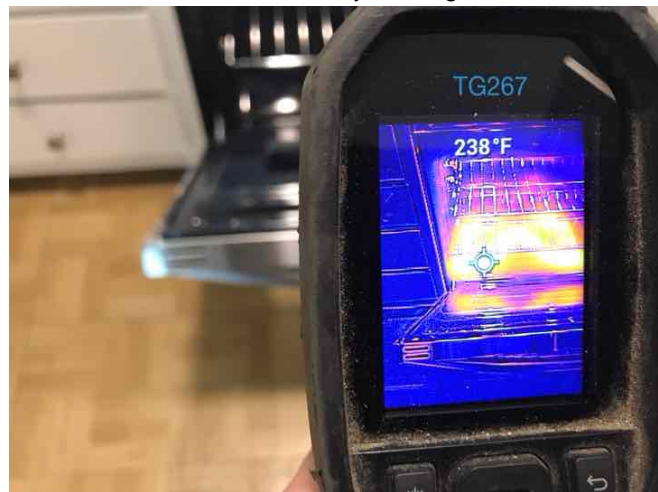
**159:** The range was turned on with the normal operating controls and found to be in satisfactory working condition.

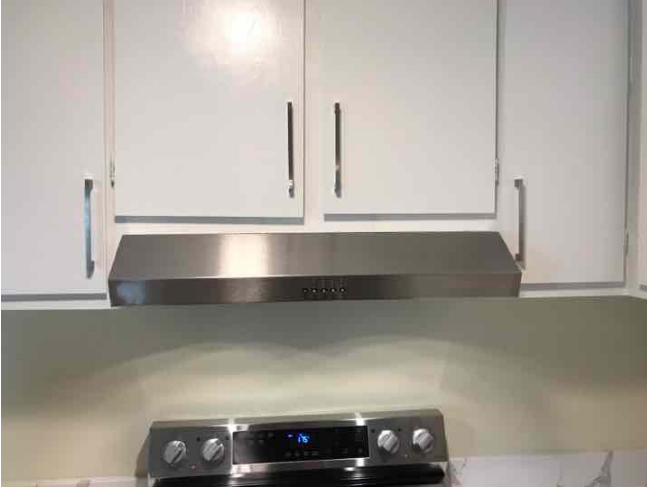
**160:** Manufacturer: Unknown Maker.

**161:** Kitchen ventilation is provided by a range hood over the burners. The fan appears to be properly installed and in serviceable condition.
