**Exclusive Property Inspection Report Prepared For
Gus Guerrero**

Property Address: 5701 E. Walton St. Long Beach CA.

Inspection Date: 11/8/2024

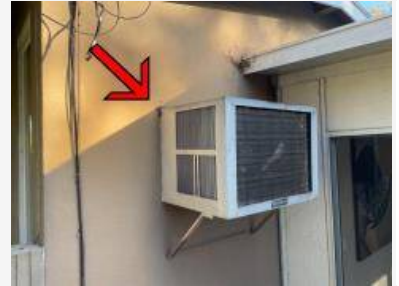
- Flashing is absent at the wall mount air conditioner. The condition is conducive to moisture intrusion and subsequent damage. We recommend correction using appropriate methods by a qualified state licensed lathing & plastering contractor.

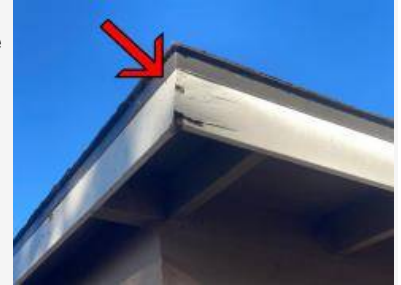
- Moisture related damage is visible to the wood at multiple roof eave locations. We recommend correcting the cause of the damage and repairing the wood using appropriate methods. We also recommend further evaluation by a qualified state licensed Structural Pest Control Operator to determine if any wood decay and / or pest related damage exists.

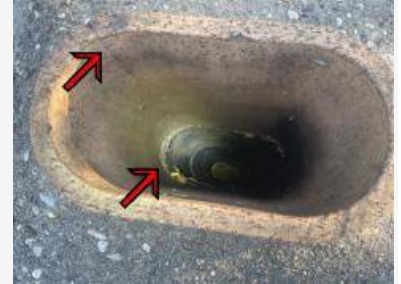
- Crack damage is visible to the top course of flue liner. A cracked liner poses a risk of fire hazard from heat transfer. Offset joints are also visible between the courses of flue liner material. Any gaps in the joints poses a potential risk of fire hazard from heat transfer. We recommend further evaluation / correction using appropriate methods by a qualified chimney specialist.

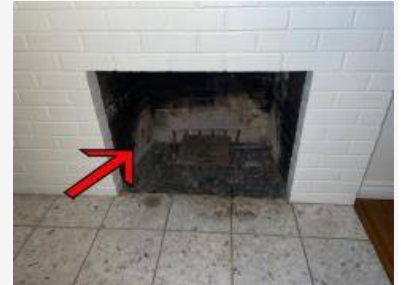
4.5 Fireplace:

- A fireplace safety screen is absent. Installation of an appropriate fireplace safety screen is recommended.

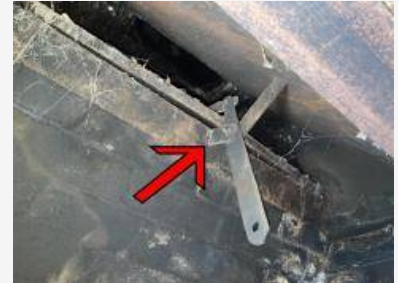
4.6 Flue damper:

- The damper is stuck in the open position. We recommend correction using appropriate methods by a qualified chimney specialist.

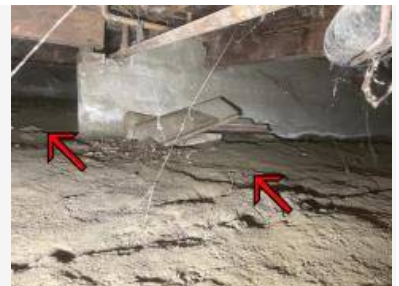
- Earth moisture is visible at the front portion of the sub area. Likely caused by poor drainage conditions adjacent the building. Correction of the site drainage adjacent the foundation is recommended to prevent future moisture infiltration.

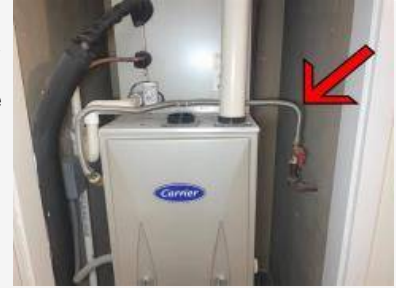
- There is no sediment trap at the gas line supplying the heater. The purpose of a sediment trap is to catch potential debris that could clog and block an automatic gas valve in the open position, preventing the appliance from shutting off. A gas valve blocked in the open position poses a risk of fire hazard. We recommend correction using appropriate methods by a qualified state licensed Warm-Air Heating, Ventilating and Air-Conditioning contractor. Refer to the heater manufacturers installation manual for gas piping installation instructions.

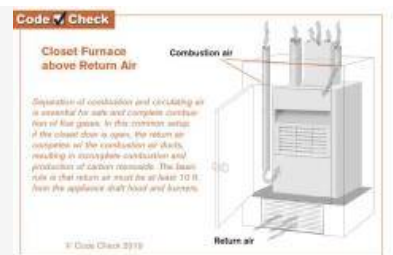
- The return air plenum is located below the closet door which is not acceptable by today's construction standards. Hazardous products of combustion air can be drawn from within the closet and into the air distribution system as a result, therefore a carbon monoxide poisoning hazard exists. We recommend correction using appropriate methods by a qualified state licensed Warm-Air Heating, Ventilating and Air-Conditioning contractor.

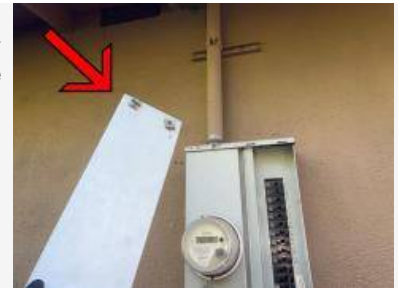
- The hinges on the weather cover are not functional as the cover does not stay attached to the panel when opened. We recommend correction using appropriate methods by a qualified state licensed electrical contractor.

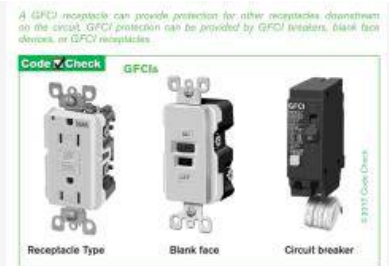
- Receptacles are not protected by a Ground Fault Circuit Interrupter (GFCI) at the bathrooms, garage interior, laundry area, kitchen counters, and kitchen appliances. The function of a Ground Fault Circuit Interrupter is to protect people from electrical shock hazards. We recommend correction using appropriate methods by a qualified state licensed electrical contractor.

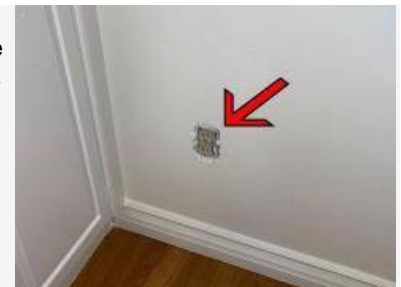
- Protection covers are absent from multiple outlets. The condition exposes the energized receptacle components, therefore an electrical shock hazard exists. Replacement of any absent protection covers is recommended.

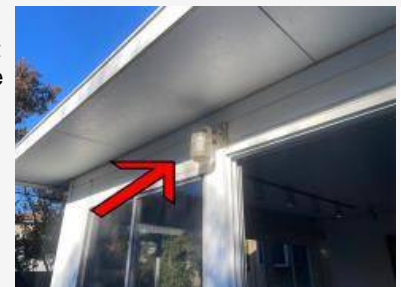
- A light fixture is not functional at the patio enclosure exterior fixture. The cause is not determined. We recommend further evaluation / correction using appropriate methods by a qualified state licensed electrical contractor.

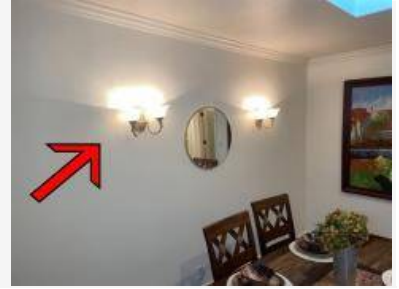
- Switches are not installed for the wall fixtures at the dining area. We recommend correction using appropriate methods by a qualified state licensed electrical contractor.

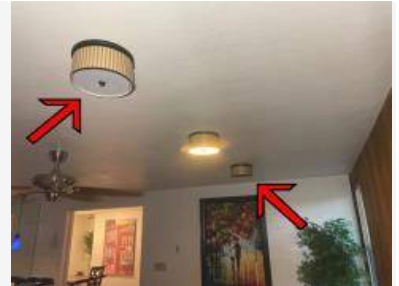
- Multiple light fixtures are not functional at the family room. The cause is not determined. We recommend further evaluation / correction using appropriate methods by a qualified state licensed electrical contractor.

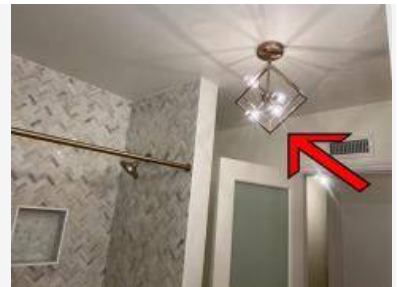
- A pendant fixture is installed too close to the shower at the hallway bathroom. The condition poses an electrical shock hazard. We recommend correction using appropriate methods by a qualified state licensed electrical contractor.

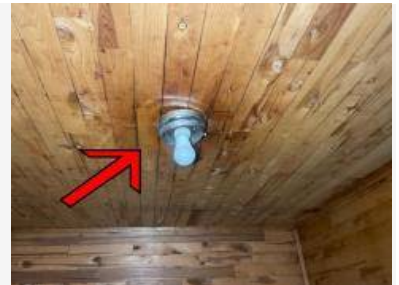
- Bulb protection globe is absent from a fixture within the primary bedroom closet. Installation of an appropriate replacement globe is recommended. Caution, the bulb needs to be rated for the fixture and for installation within a globe. Refer to the listing on the fixture for the types of bulbs that can be used.

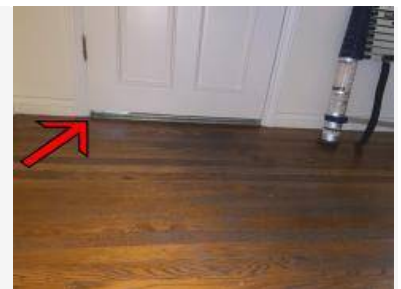
- A gap is visible at the bottom of the door when closed. We recommend correction using appropriate methods.

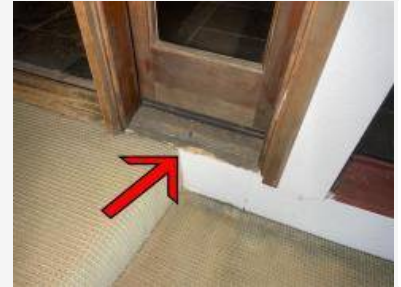
- Damage is visible to the wood. The damage may be pest related. We recommend further evaluation by a qualified state licensed Structural Pest Control Operator.

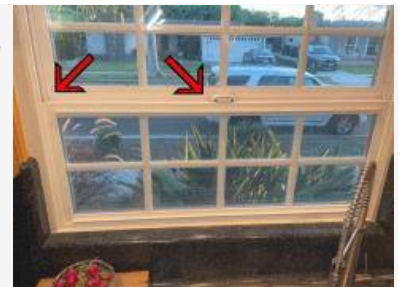
- A damaged latch and disengaged sash balance is visible at the kitchen window. We recommend correction using appropriate methods by a qualified window specialist.

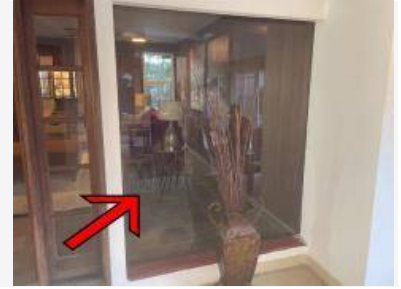
- The family room fixed window is within 18" of the floor and has more than 9 sq. ft. of glass. The glass does not appear to be safety glazing as there is no visible etching listing the glass as such. The purpose of safety glazing is to reduce the risk of injury in the event of broken glass. We recommend correction using appropriate methods by a qualified window specialist.

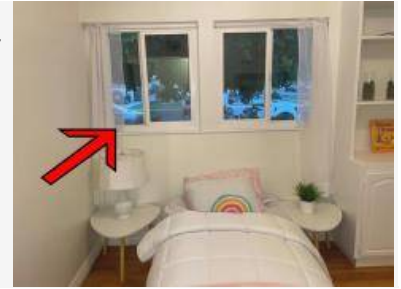
- The left front bedroom windows do not meet today's construction standards for emergency escape & rescue as the sills are not located within 44" from the floor and the diameter of the openings are too small. Upgrades to current construction standards should be considered for safety enhancement.

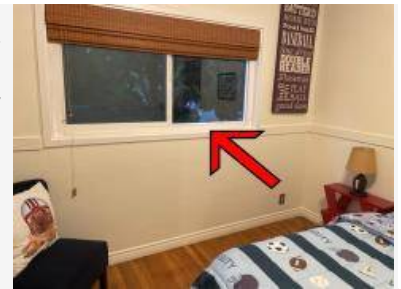
- The right front bedroom window does not meet today's construction standards for emergency escape & rescue as the sill is not located within 44" from the floor. Upgrades to current construction standards should be considered for safety enhancement.

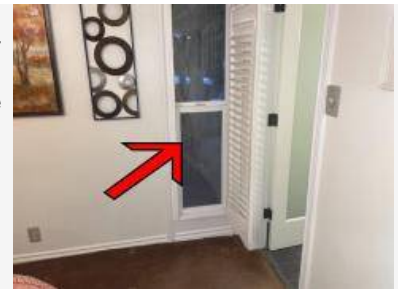
- The primary bedroom windows do not meet current construction standards for emergency escape & rescue as the diameter of the openings are too small. Correction with an installation that meets current construction standards should be considered for safety enhancement.

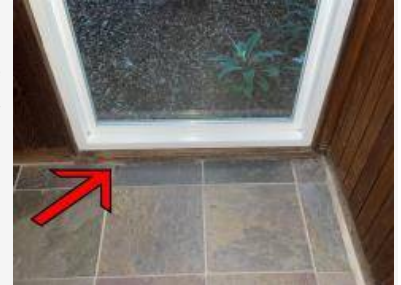
- Moisture related stains are visible on the wall claddings below the family room windows. Determining the origination of the moisture or if any active leakage conditions exist is beyond the scope of this inspection. Further evaluation by a qualified moisture intrusion specialist is recommended. We also recommend inquiring with the seller to confirm the history of any moisture intrusion.

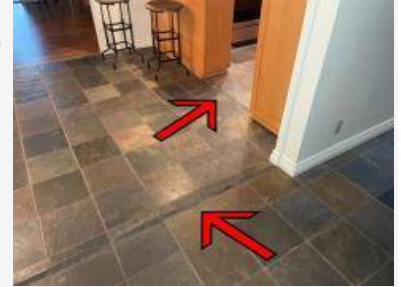
- Uneven joints are visible at the kitchen area. The condition poses a trip hazard. We recommend correction using appropriate methods by a qualified state licensed tile contractor.

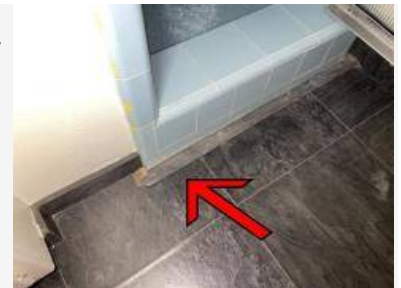
- Damaged / loose trim is visible at the primary bedroom bathroom floor to shower interface. We recommend correction using appropriate methods by a qualified state licensed tile contractor.

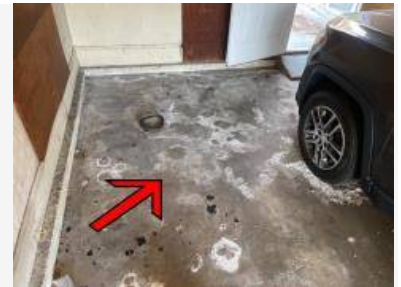
- Significant deterioration is visible to the concrete. The cause is not determined. Replacement may be needed. We recommend further evaluation / correction using appropriate methods by a qualified state licensed concrete contractor.

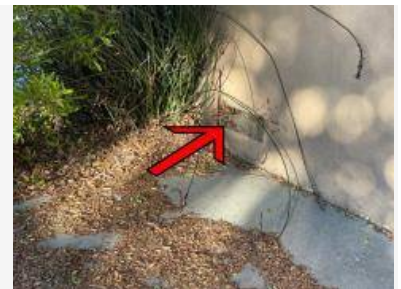
- The vents are blocked. The purpose of static ventilation is to reduce the risk of carbon monoxide hazards within the garage. We recommend removing the material that blocks the vents.

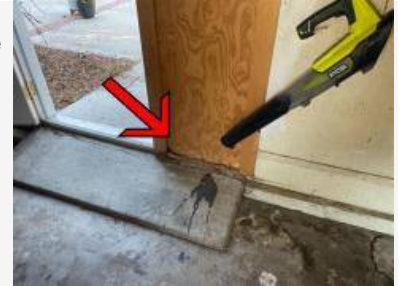
- Moisture related damage is visible to the wall cladding as a result of moisture intrusion from the exterior. We recommend correction using appropriate methods.

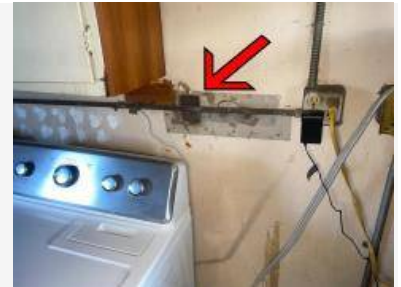
- Multiple holes / openings are visible in the fire separation cladding. The condition is a breach of the fire separation. We recommend correction using appropriate methods to prevent flame spread in the event of fire.

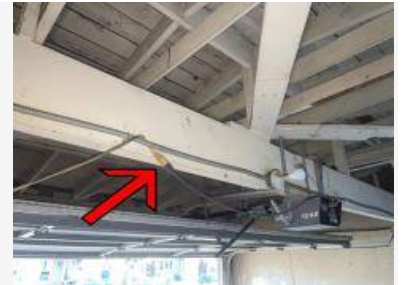
- Auto opener: An extension cord is used as permanent wiring to the auto opener which is an improper installation. There should be a receptacle outlet installed within reach of the factory installed appliance cord. We recommend correction using appropriate methods by a qualified state licensed electrical contractor.

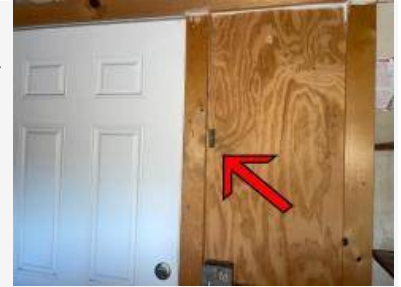
- Auto opener: Anti entrapment safety labeling is absent adjacent the automatic opener control. We recommend correction using appropriate methods by a garage door specialist.

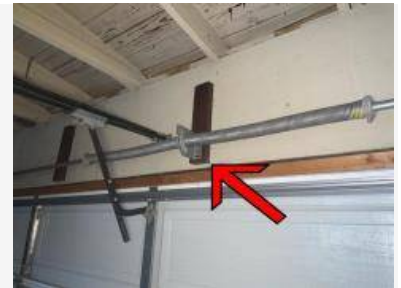
- Auto opener: Caution, spring warning labeling is absent at the torsion bar. Any replacement / repair / adjustment should be performed by a qualified garage door specialist only. We recommend correction using appropriate methods by a garage door specialist.

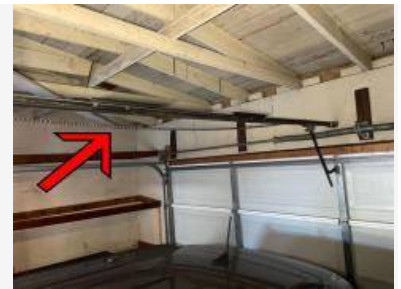
- Auto opener: The chain on the drive arm is loose. We recommend correction using appropriate methods by a garage door specialist.

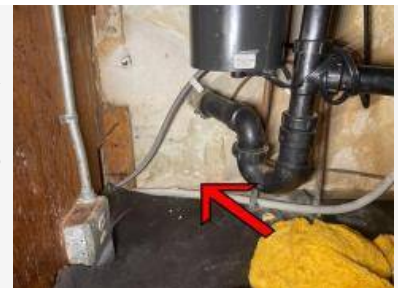
- Moisture related damage is visible to the wall and floor within the sink base cabinet. We recommend correction using appropriate methods. An undetermined black substance is also visible on the wall cladding within the sink base cabinet. Determining the presence of any type of mold / microbial growth is beyond the scope of this inspection. We recommend further evaluation by a qualified specialist to determine if such conditions exist.

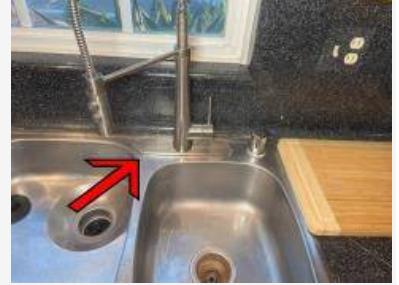
- Faucet fixture: The fixture mount is loose. Leakage into the base cabinet occurred. We recommend correction using appropriate methods by a qualified state licensed plumbing contractor.

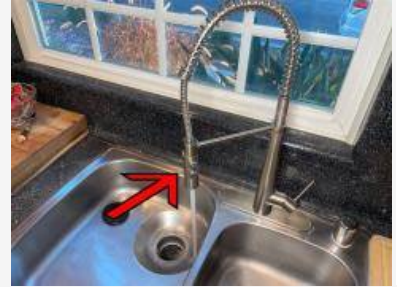
- Faucet fixture: The spray control is not functional. We recommend correction using appropriate methods by a qualified state licensed plumbing contractor.

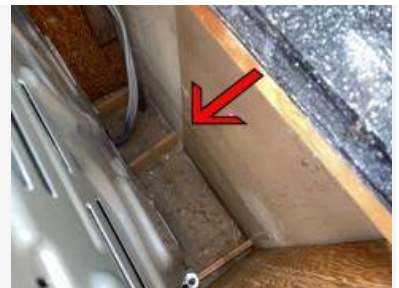
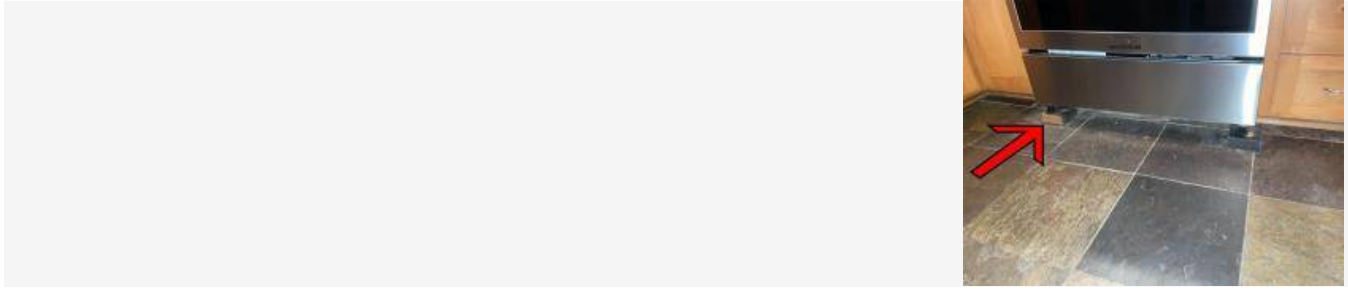
- An anti tip device is absent. We recommend correction using appropriate methods. See warning label on oven door. Refer to the manufacturers installation manual for instructions.

- The appliance rests on loose boards, therefore subject to tipping. We recommend correction using appropriate methods.

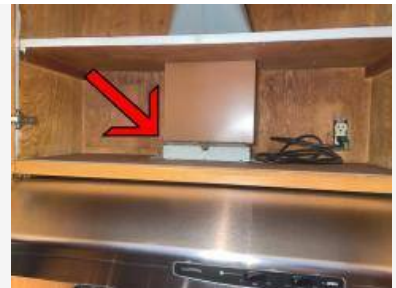
12.6 Cooktop ventilation:

- Exhaust duct: The exhaust duct is separated, therefore not functional, within the cabinet above the appliance. We recommend correction using appropriate methods.

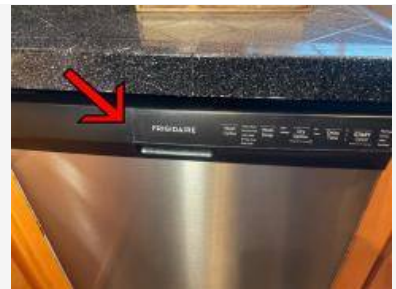
12.7 Dishwasher:

- The appliance did not respond to the normal user controls. We recommend correction using appropriate methods by a qualified appliance technician.

- Crack damage is visible to the plastic door grab. Replacement may be needed.

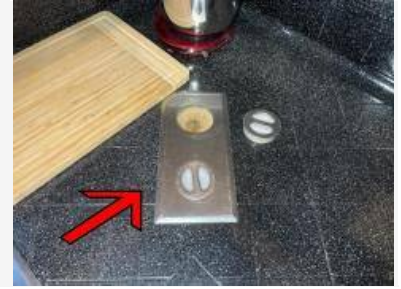
12.8 Counter mountain blender:

- The appliance did not respond to the normal user controls. We recommend correction using appropriate methods by a qualified appliance technician.

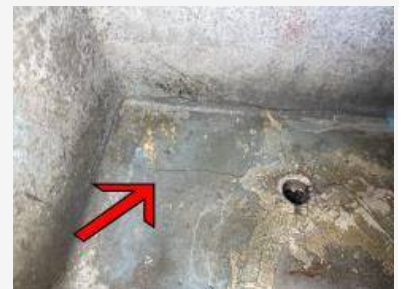
- Crack damage is visible to the basin. Leakage occurred. We recommend correction using appropriate methods by a qualified state licensed plumbing contractor.

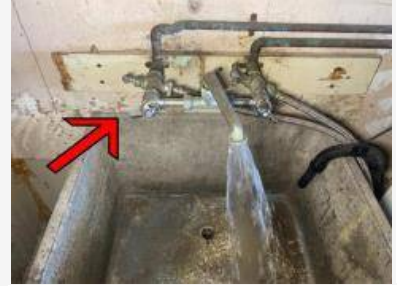
- Faucet fixture: Leakage occurred from the faucet valves. We recommend correction using appropriate methods by a qualified state licensed plumbing contractor.

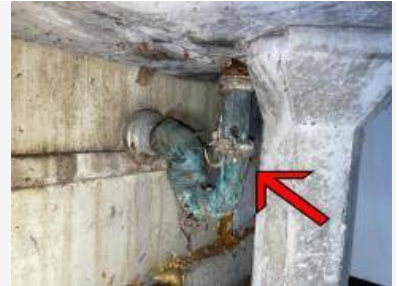
- Drain: Corrosion damage caused by leakage is visible on the piping. We recommend correction using appropriate methods by a qualified state licensed plumbing contractor.

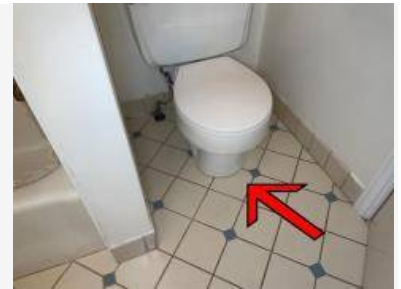
- Base sealant is absent at the floor. The toilet mount can loosen resulting in leakage and subsequent damage. The toilet mount is loose. We recommend correction using appropriate methods by a qualified state licensed plumbing contractor.

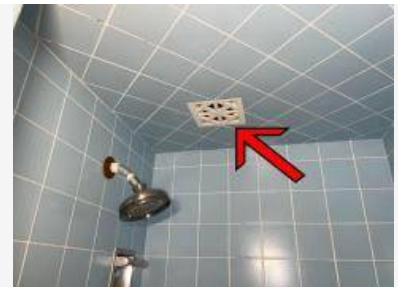
- The static ceiling vent in the shower stall terminates within the attic which is improper. The duct should terminate to the exterior through an appropriate termination hood. We recommend correction using appropriate methods.

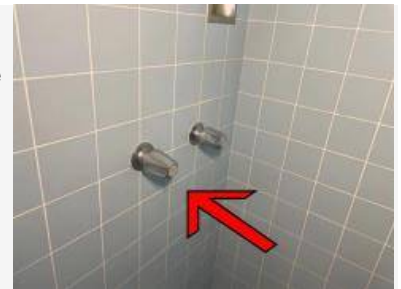
- Faucet fixture: Low cold water flow occurred. We recommend correction using appropriate methods by a qualified state licensed plumbing contractor.

- Faucet fixture: The faucet is a manual mixing type, therefore a scalding hazard exists. The installation of a pressure balance / thermostatic control type faucet should be considered for safety enhancement.

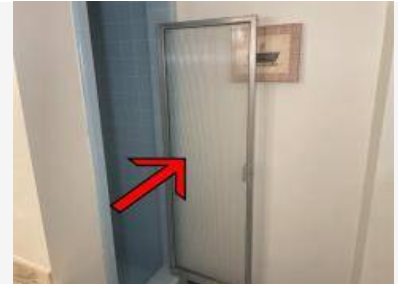
- Enclosure: The glass in the shower door does not appear to be safety glazing as there is no visible etching listing the glass as such. The purpose of safety glazing is to reduce the risk of injury in the event of broken glass. Replacement with approved safety glazing is recommended.
