**HomeGuard**  
**Incorporated**

# HOME INSPECTION REPORT

1115 Savoy Street, San Diego

681861

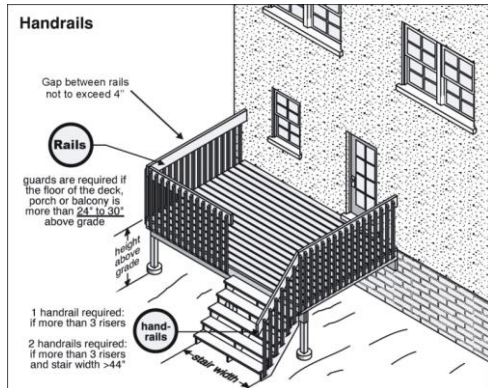
Illustration 3J

- ! 3. The railing is loose at the deck. It is recommended that this be repaired for improved safety.  
[\(See Photo 13\)](#)
- ! 4. For safety purposes, railing(s) should be provided at the exterior.  
[\(See Illustration 3J\)](#) [\(See Photo 29\)](#)

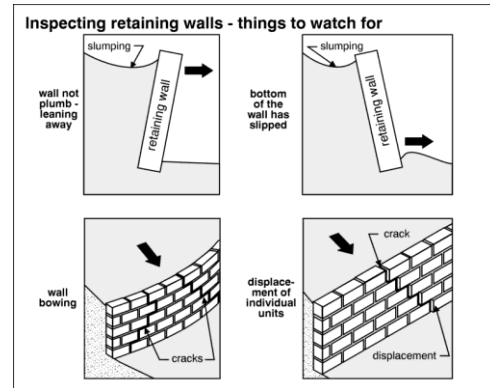
Illustration 3E

- ! 6. The retaining wall at the rear shows evidence of significant movement and/or cracks. It is not within the scope of our expertise to determine when rebuilding will become necessary. Further evaluation of this condition by the appropriate tradesperson is recommended.  
[\(See Illustration 3E\)](#) [\(See Photo 16\)](#)

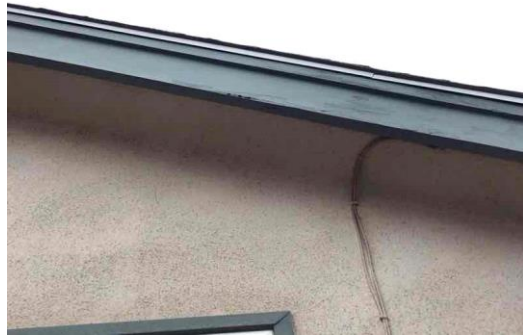
Photo 10

- ! 7. Water damage was observed to the fascia at the rear. We recommend the services of a licensed general contractor and/or structural pest control company.  
[\(See Photo 10\)](#)

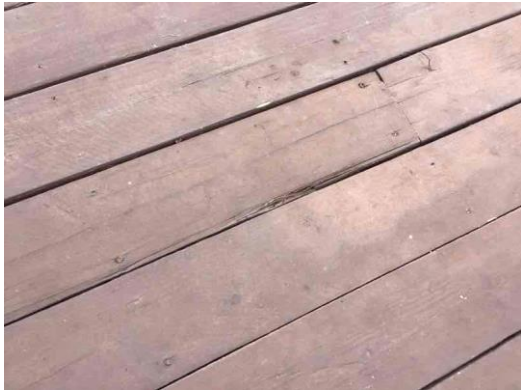
Photo 11

1. The drywall or wall finish in the garage is damaged, cracked or blemished in one or more areas. We recommend repair or refinishing
- ! 2. Water damage was noted at the rear deck(s). We recommend the services of a licensed general contractor and/or structural pest control company.  
[\(See Photo 11\)](#)

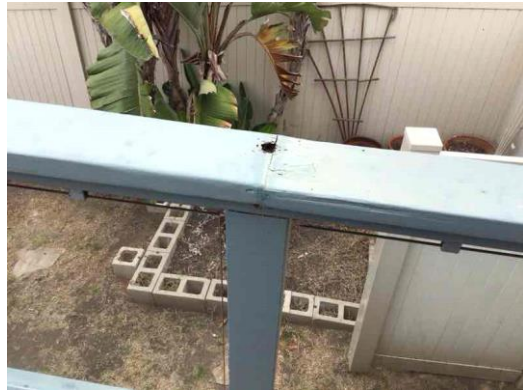
Photo 12

- ! 8. The railing at the deck is water damaged. We recommend the services of a licensed general contractor and/or structural pest control company.  
[\(See Photo 12\)](#)

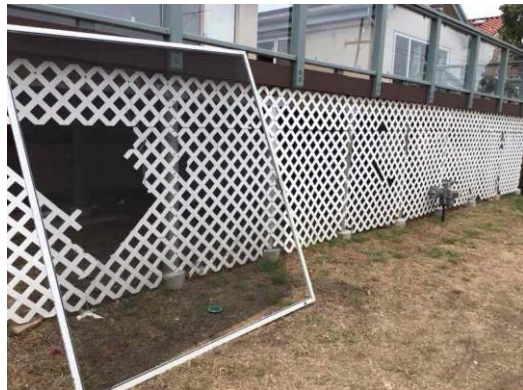
Photo 14

- ! 11. The lattice is damaged at the deck. We recommend repairing this for cosmetic purposes.  
[\(See Photo 14\)](#)

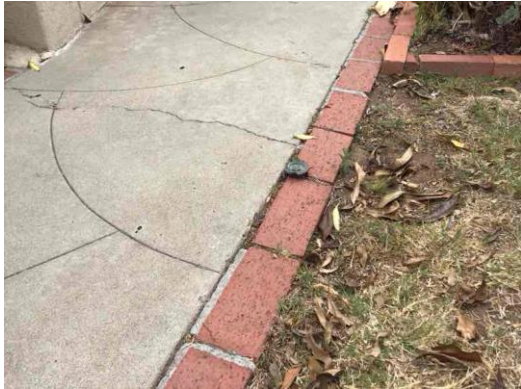
Photo 17

- ! 9. The sprinkler valve at the front section of the walkway presents a trip hazard. This condition should be altered for improved safety.  
[\(See Photo 17\)](#)

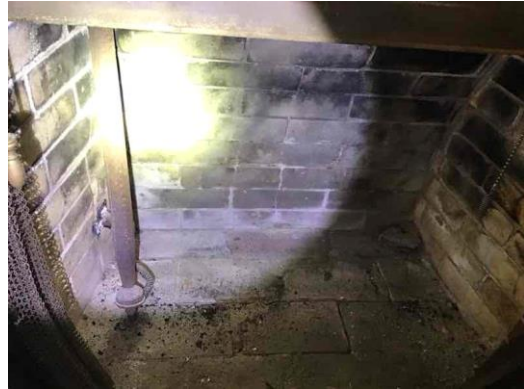
Photo 18

35. The interior of the fireplace firebox should be repaired where the bricks or mortar are heavily eroded, loose, or cracked. We recommend the advice and servicing of a licensed masonry contractor or fireplace specialist.  
([See Photo 18](#))

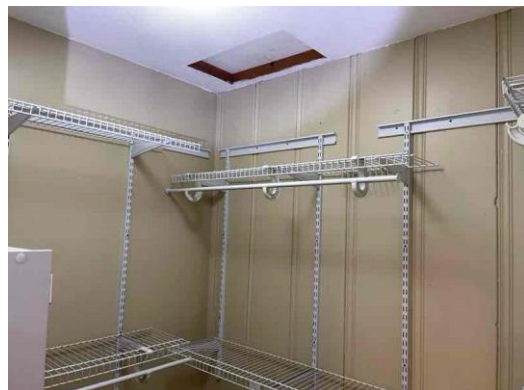
Photo 30

2. Clothes racks were blocking the attic access opening, therefore, the attic space was not inspected. With access and an opportunity for a complete inspection, conditions in need of attention may be discovered. The personal belongings should be removed so the attic may be inspected.

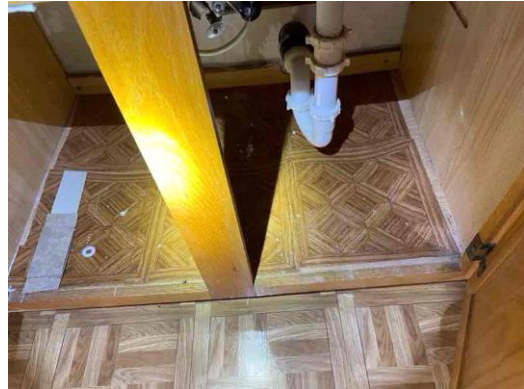
Photo 34

33. The base and/or side of the garage kitchen cabinet sink shelf is deteriorated. We recommend the advice and services of a licensed pest control operator for investigation and possible repair of this condition.  
([See Photo 34](#))

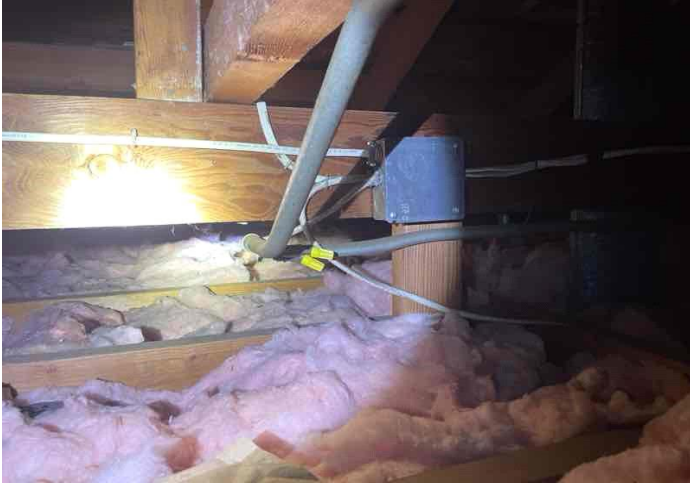
Photo 01

- ! 1. Running splices, which are improper connections outside of a junction box, were observed in the attic. We recommend connections be joined with approved connectors inside a junction box to prevent accidental contacts or mechanical damage.  
[\(See Photo 1\)](#)

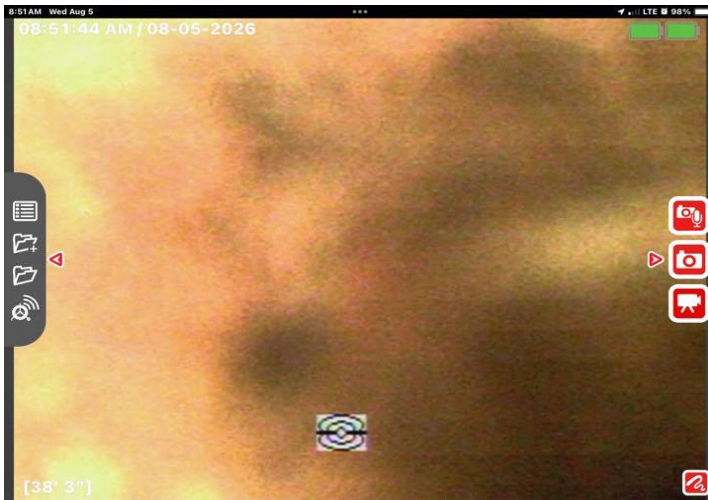
Photo 1

1. We could not complete the sewer lateral inspection due to the obstruction and/or blockage as noted in item 1. The inspection was terminated at 29 feet.
2. The pipe material changed as noted in the inspection log, cast iron, ABS and PVC are currently in use.
