**TITLE 25 HEALTH & SAFETY INSPECTION**

# INSPECTION REPORT

## 5540 W. 5th st, #69

| INSPECTOR | INSPECTION DATE | REPORT ID | STATUS |
|---|---|---|---|
| Clinton Dotson | 23 Jul 2026 | INS-07232026-2 | FINAL |

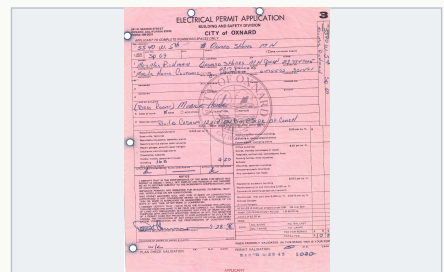
5540 w 5th Spc 69 Permit\_page\_4

**Action** Informational — An addition was observed, and permit status was verified. Copies of the permit are included in this report. Any deficiencies were noted in the body of the report.
