# Inspection Report

**Property Address:**  
2301 Plumb St  
San Diego California 92106

**Nation Wide Inspections**

<b>Date:</b> 2/4/2025	<b>Time:</b> 08:44 AM	<b>Report ID:</b> J020425A
<b>Property:</b> 2301 Plumb St San Diego California 92106	<b>Customer:</b> Lynn Grimm	<b>Real Estate Professional:</b>

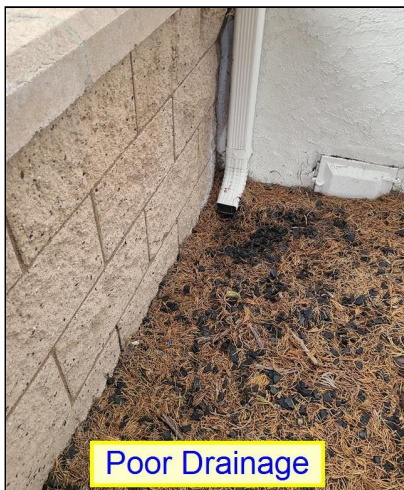
📍 (1) **Poor Drainage.** There are areas around the house where the drainage is poor or there was no directional slope away from the house. There were no visible surface drains noted at these locations. It is important that all water shed away from the house and foundation. Ideally there should be a minimum slope of 6 inches within the first 10 feet of the house. It is recommended that swales, french drains or other means of drainage be provided to keep water away from house and foundation.

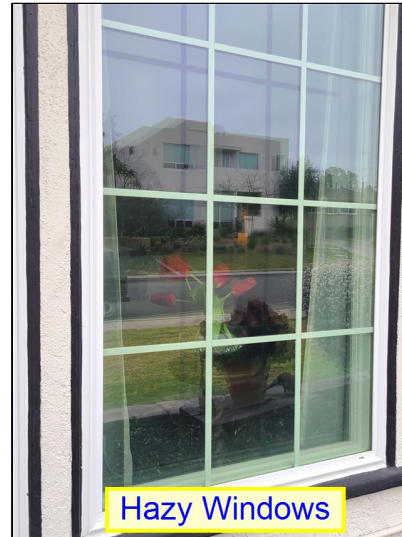
(2) **Hazy Windows.** There were windows at the exterior of the property that were hazy. **It was not able to be determined if the seals have been compromised.** Due to climatic and weather conditions, some windows may not show signs indicating that there are issues present. We cannot always determine if seals are broken and will not be held liable for broken window seals. Currently it appears that there are at least 2 windows that appear to have damaged seals. **It is recommended that all of the windows be further evaluated for potential damage and repaired as needed by a licensed contractor or specialist.**

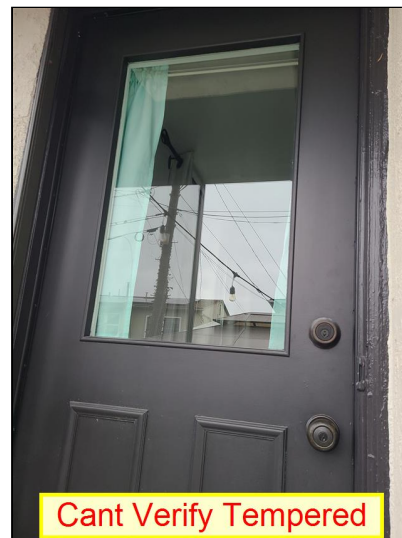
**Cant Verify Tempered.** There are a few exterior doors that contain glass that could not be verified as being safety glass. Tempered glass is a safety glazing that is required in hazardous locations, it is usually indicated as being such by labeling in corner of pane. **This is typical to find in older homes and precautions should be taken. Recommend further analysis and replacement if necessary.**

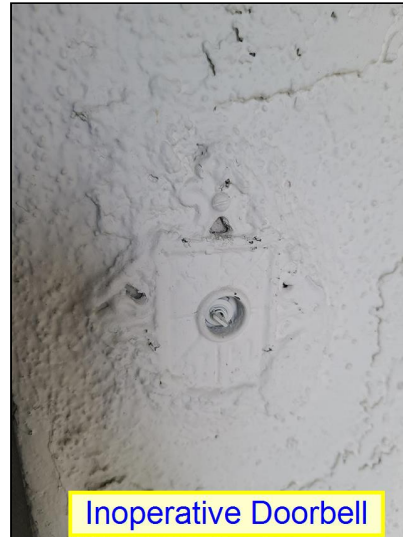
📍 (2) **Inoperative Doorbell.** The door bell did not operate at time of inspection. It is recommended that this be repaired by a qualified person.

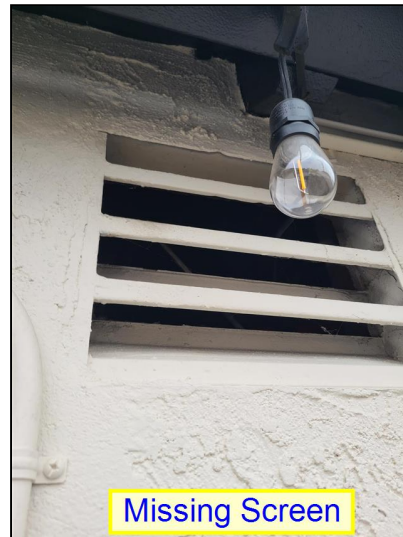
📍 **Missing/ Damaged Screen.** There was a missing or damaged screen noted at the garage. Screens help ventilate your garage and keep out unwanted bugs, cats, opossums, rodents and other creatures who may want to explore or reside within your garage. It is recommended that all missing or damaged screen are repaired or replaced as needed.

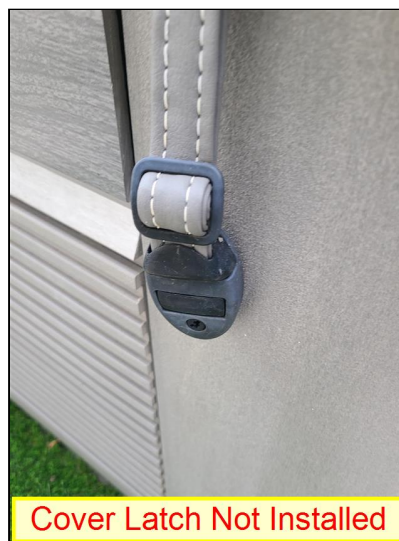
**There were broken or missing straps/ locking mechanisms.** "An approved safety pool cover" means a manually or power-operated safety cover that meets **ALL** of the **performance standards** of ASTM Standard F1346-91. **Due to the limitations of our inspections it is not known if this cover meet's all of the performance standards of ASTM F1346-91.**

Some of the requirements call for specific tests to determine if the standards are met. Some of these tests cannot be done visually and are described in ASTM F1346-91. **Due to the limitations of our inspections this cover was not verified as complying with SB442.** It is recommended that this cover be further inspected, evaluated and tested by a licensed pool specialist who is familiar with the standards of F1346-91 as well as all of the new standards of California SB442 of the Pool Safety Act.

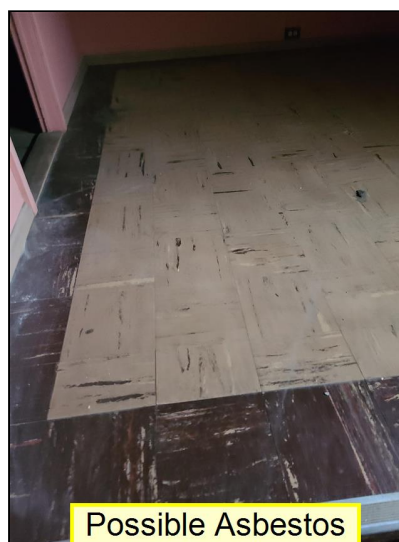
(2) **NOTE: Possible Asbestos.** This house has linoleum flooring at some areas of the house. Often linoleum of this age was made with the use of asbestos. Although asbestos in this form is not dangerous; disturbing, or removing it can often cause the asbestos to become airborne increasing the the risk and dangers. It could not be verified if this linoleum was made with the use of asbestos. It is recommended that if any work is to be done and removal or disturbance is required, that testing of the linoleum be conducted by qualified licensed testing agency to determine if asbestos is present. This is noted for your health and safety.

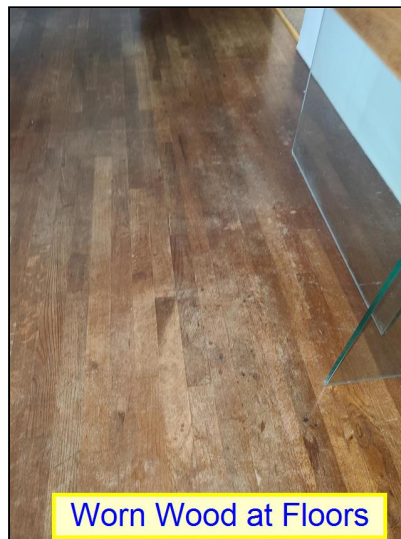
🏠 (3) **Worn Wood at Floors.** There were several areas of wood floor that were worn and should be refinished. Refinishing protects the wood from damage, prolonging the life of the wood. **We do not determine if these floors are capable of be resurfaced.** Sometime it is not possible to resurface flooring due to the diminished wood depth. **It is recommended that the wood floors be further evaluated by a qualified or professional flooring specialist.**

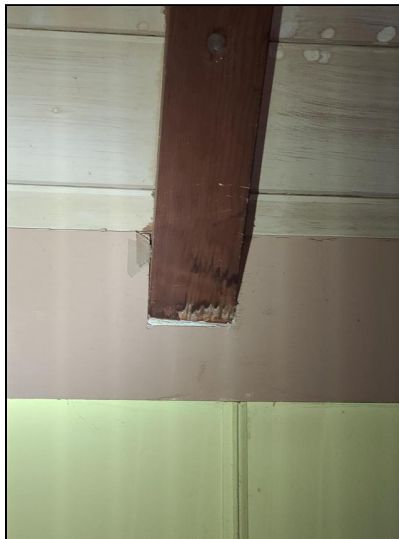
(2) **Ceiling Water Stains.** There was some water staining noted on the ceilings of the upstairs loft area. It appears that there have been a roof leaks at these locations at one time. **It could not be determined if these leaks have been properly repaired.** It is recommended that you ask the current owner about these stains and that a roofing contractor be hired to further evaluate these areas if needed.

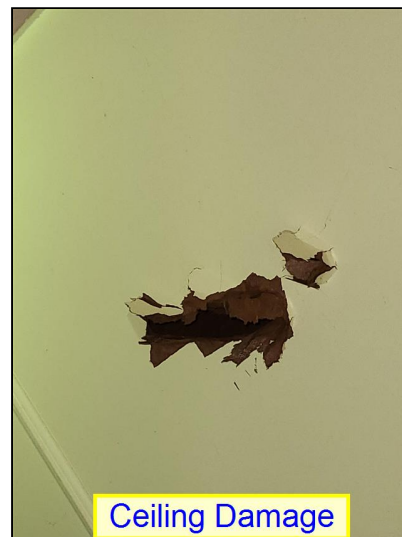
(3) **Damage at Ceiling.** There was an area of ceiling that was damaged in the upper loft area. It is recommended that this be repaired or replaced as needed by a licensed contractor.

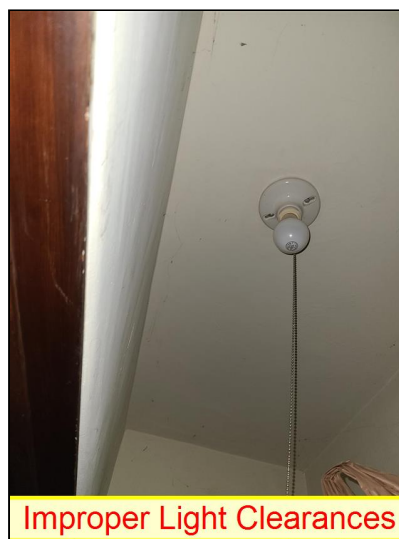
(3) **Improper Light Clearance:** Due to the age in which this house was built, different standards have come into play. One of the newer standards is the clearance of light fixtures within closets. Currently the closet light fixture in some of the rooms does not meet today's standards for this type of fixture. **This is now considered a safety hazard.** It is recommended that this fixture be replaced to meet today's standards.

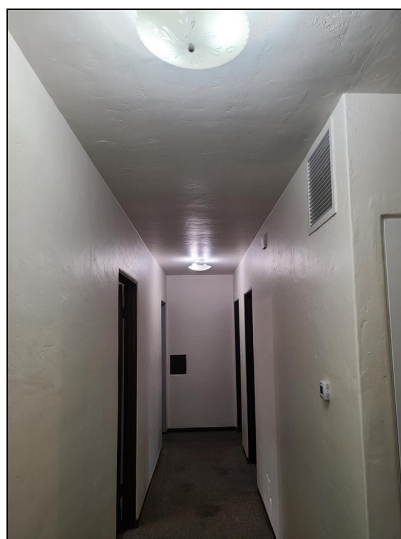
(4) **Improper Wiring of Switch.** The three-way switch provided for the hallway was incorrectly wired, and did not properly function. Currently one of the switches may not work if not in the correct configuration . It is recommended that this switch be properly wired by a licensed electrician.

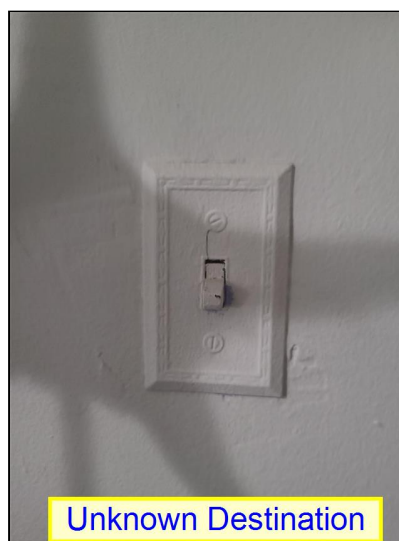
(5) **Unknown Destination.** There were a switch in the primary bedroom, in which the destination could not be determined at time of inspection. It is possible that many of these switches operated half-hot receptacles that were not able to be accessed due to furnishings. It is recommended that you test all outlets at time of final walk through to ensure proper working order of all outlets and switches.

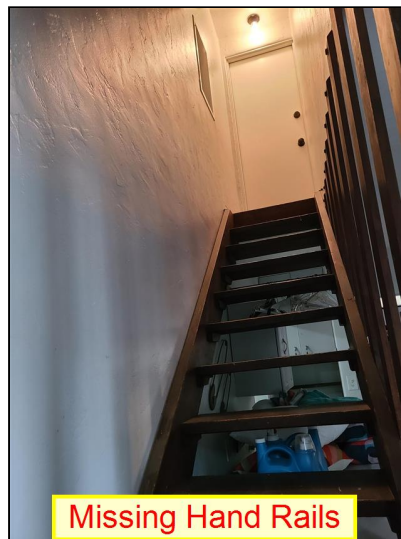
(1) **Missing Hand Rails.** There are currently no hand railings for the stairs. Stairs are the most frequent location of injury accidents in the home. For safety reasons it is recommended that handrails be provided for stairways with 4 or more steps. Handrails should be located at a height of 34-36 inches from the floor and should have a grippable surface between 1.25 inches and 2 inches.

Recommend that handrails be provided at this location.

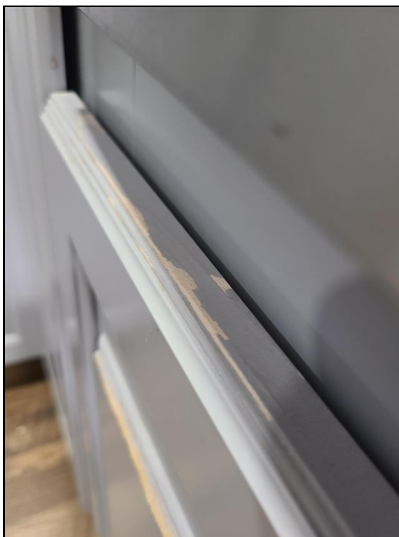
Worn Areas of Cabinets

(1) **Worn Areas of Cabinets.** It was noted that a few areas of the kitchen cabinets show some wear at heavily used areas of the cabinet doors. **This is noted for your information.**

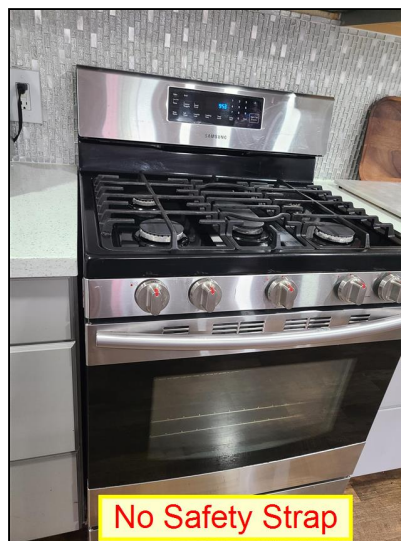
**No Safety Strap on Oven.** Ovens come with a child safety strap (Anti-tip strap) to prevent the oven from tipping and falling if children use the oven door as a step. **It is recommended, especially if children are present, that this oven be equipped with a safety strap.**

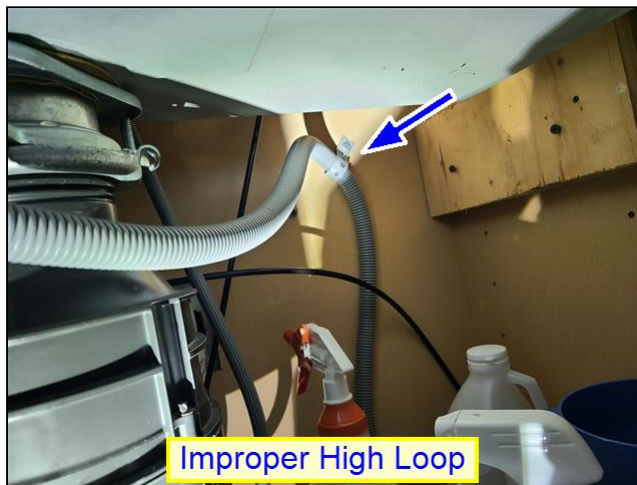
🏠 (1) **Improper High Loop.** The dishwasher had a "low" high loop that was not supported. High loops should extend to the underside of the counter to help inhibit sewer water from backing into the dishwasher through the possibility of siphonage. It is recommended that this be corrected as needed by a qualified person.

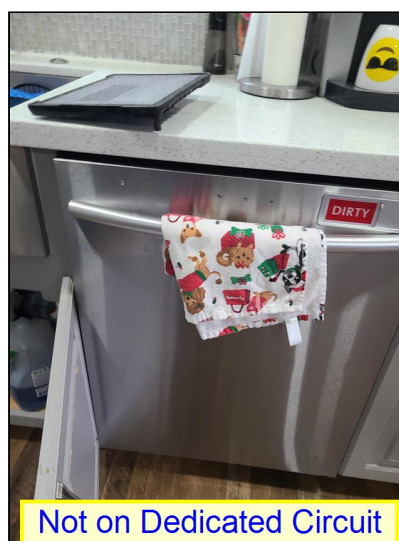
(2) **Not on Dedicated Circuit.** The dishwasher was not on a dedicated circuit and shared the circuit with the countertop circuits. Dishwashers should be on a dedicated circuit (shared with the garbage disposal). It is recommended that these be on a circuit not shared with the countertop outlets.

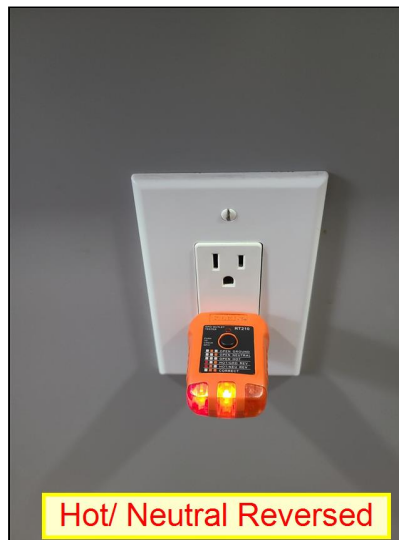
(2) **Hot/ Neutral Reversed.** There were outlets, at the island, that appear to have improperly wired. The hot and neutral have been reversed at both of the island outlets. **Because of the improper wiring of this outlet the GFCI does not properly function.** This is improper wiring and should be wired properly to reduce the risk of injury.

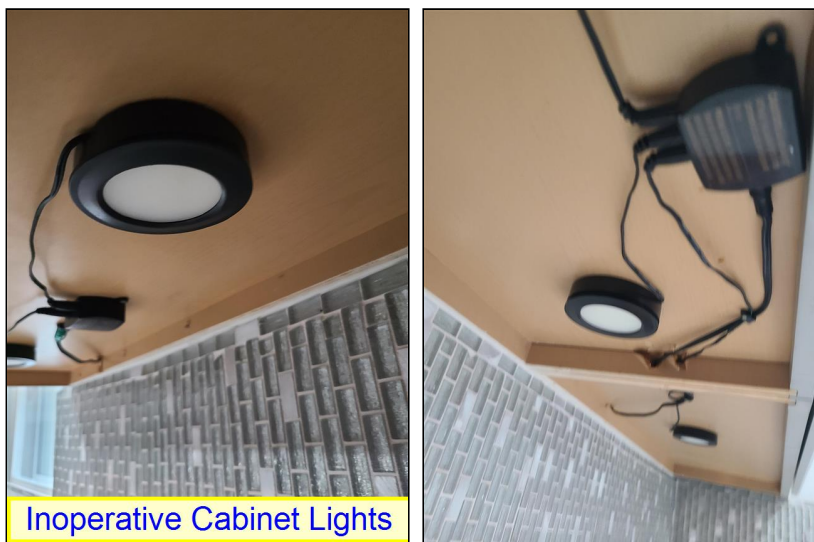
(3) **Inoperative Under Cabinet Lights.** The under cabinet lights did not function at the time of the inspection. It could not be determined if they do not work because of the bulb, the fixture, or a more extensive electrical issue. It is recommended that the bulb be replaced, and the light be tested. If that does not work, it is recommended that a licensed electrician be called out to further inspect and repair this issue.

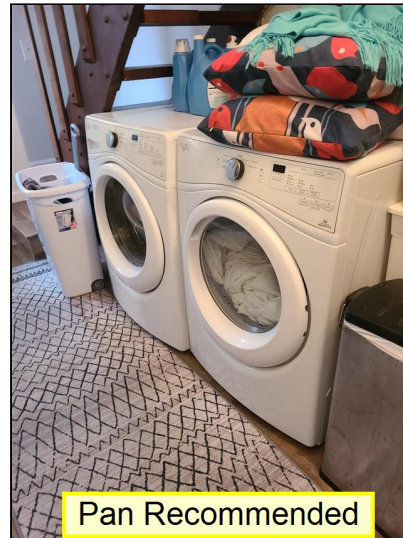
(2) **NOTE: Pan Recommended.**

Although it is not required, it is recommended that a pan with a drain be installed in the laundry area. This laundry sits on a raised foundation over structural wood framing. A water leak at the fixture can cause serious damage. **This is a recommendation and can be conducted at your convenience.**

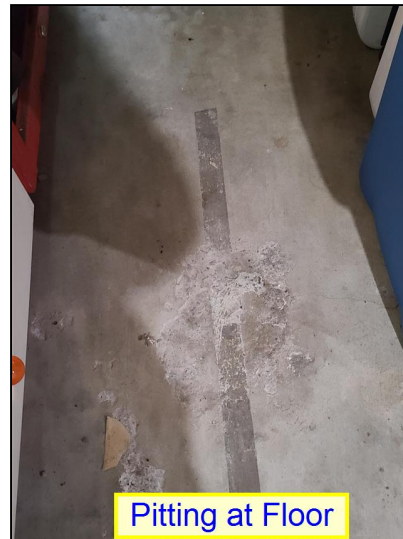
(1) **Pitting at Garage Floor.** There was some moderate pitting of the concrete at the garage floor. The cause of this was not able to be determined. Often this can be the result of sitting water. There was no evidence of water intrusion or efflorescence at this location. **The cause of this was not able to be determined. This is noted for your information.**

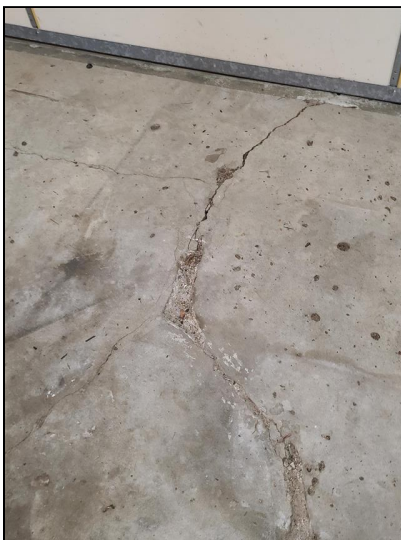
(2) **Cracks at Garage Floor.** There were several cracks at the garage floor . This is noted for your information and does not appear to be structural in nature.

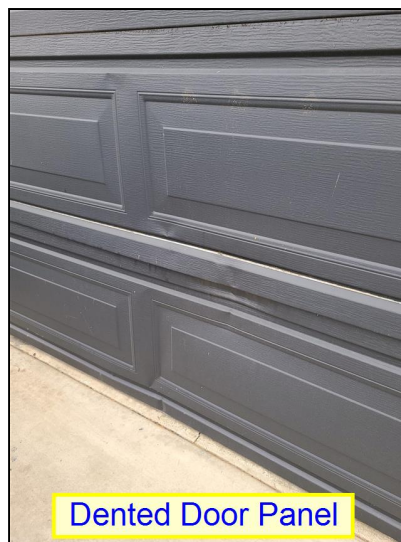
**Damaged Garage Door Panel.**

The garage door is dented. This dent currently does not affect the opening/closing function of the garage, but is noted for your information. This panel can be replaced at your convenience if so desired.

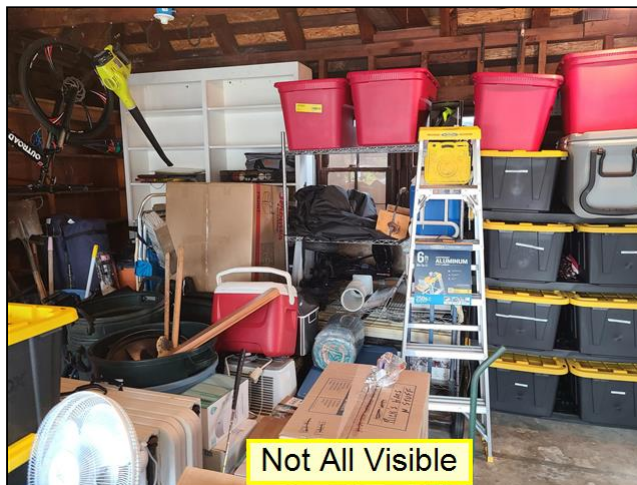
**NOTE: Not All Visible.** The walls of the garage were not all visible due to personal belongings and could not be inspected. It is recommended that these walls and other areas, which views are obstructed, be further inspected once belongings have been removed and access is available.

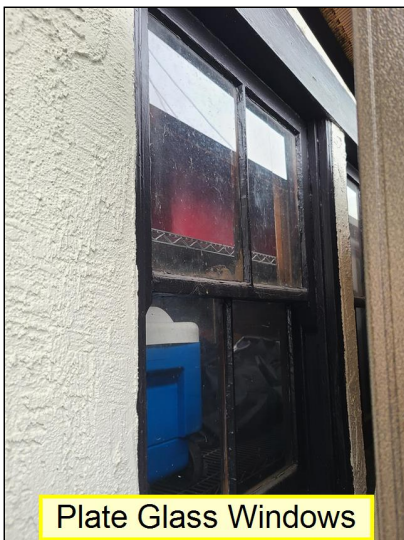
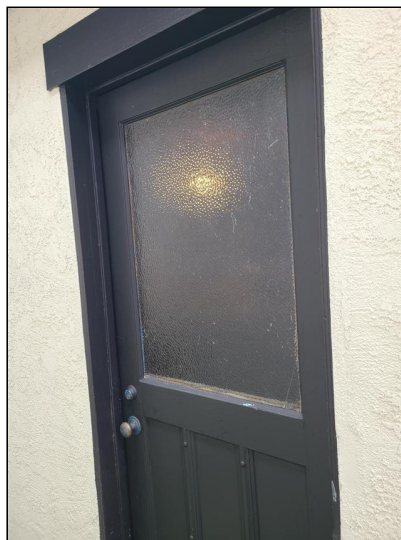
(1) **NOTE: Plate Glass Windows.** Due to the age of the garage, the original windows are plate glass. In newer construction, windows in hazardous locations (within 18 inches from the ground, within 24 inches from a door, at the bottom of a stairwell. All glass within a door, and within areas of a pool...) are required to be equipped with safety glass. Glass which is less likely to cause severe injury when broken. Due to the year in which this garage was constructed, safety glass was not installed. If any of these windows were to break, the glass will be very sharp, and break in large shards. **It is recommended that if glass is replaced at hazardous locations, it be equipped with safety or tempered glass.** This is noted for your safety and information. Care should be taken with these windows.

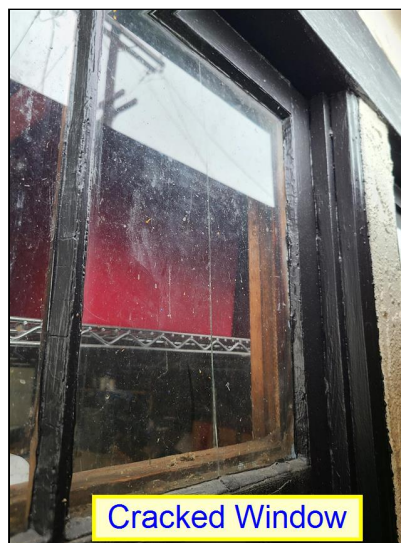
(2) **Cracked Window.** The garage window was cracked at time of inspection. Due to the serious nature and the increased risk of injury, it is highly recommended that this window be replaced as right away. Recommend that this window be replaced by a qualified professional.

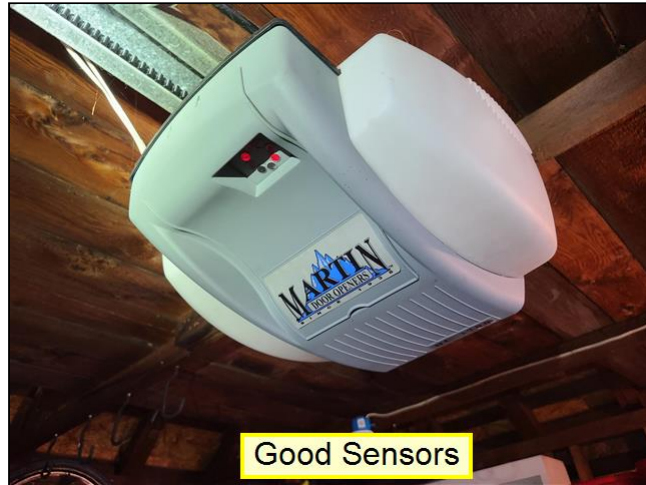
**NOTE: Safety Devices In Working Order.** The garage door retracted, when (both) safety measures were tested: **(1.)** safety beam (six inches from ground) was disrupted. **(2.)** When pressure was applied to the garage door while closing. These are safety devices installed to ensure less risk of injury while door is closing. These items worked perfectly at time of inspection, and are mentioned solely for your awareness .

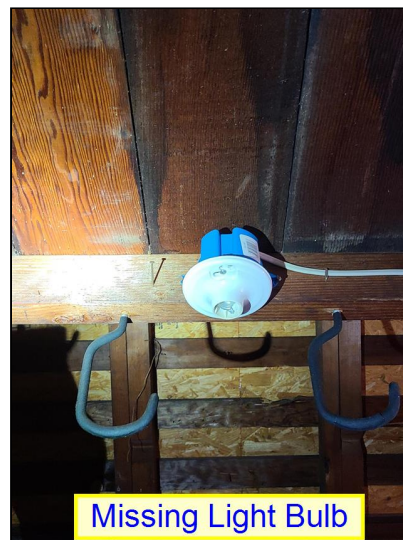
(1) **Protection of Wires.** All Romex less than 7'6" should be protected from damage. Currently there were some areas of Romex (NM Cable) that were not protected from physical damage. **It is recommended that these wire runs be protected from damage.**

(2) **Missing Light Bulb.** The light in the garage was missing the bulb. The power to this this location was not tested or inspected. It is not known if this fixture works. **It is recommended that this be tested and a light installed as needed by a licensed electrician.**

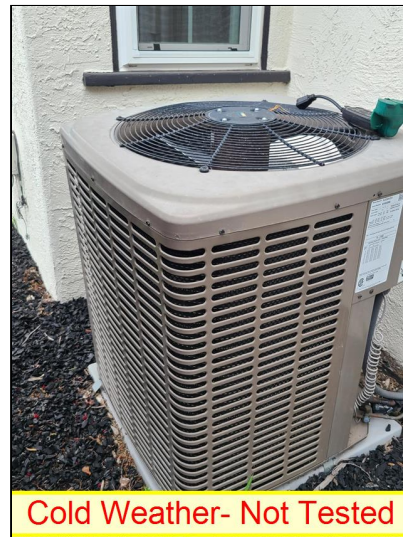
(1) **Cold Weather- Not Tested.** Due to the damage that can be caused by running an A/C unit at temperatures below 65 degrees, this unit was not tested. It is recommended that this unit be further inspection before initial use by a licensed HVAC specialist.

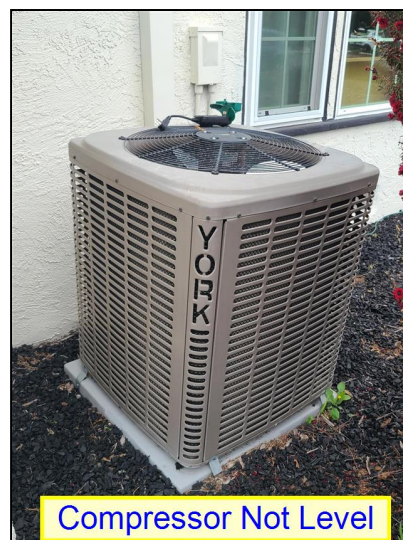
(2) **Compressor Not Level.** The A/C unit, at the exterior of the house was not level. These units should be level to ensure proper working order. Generally when it is slightly out of level, it is best not to try an level the unit. This is noted for your information.

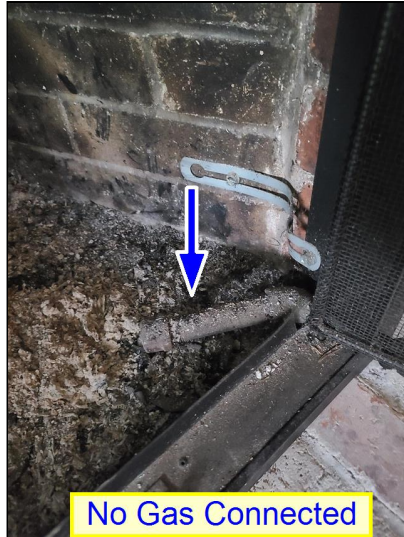
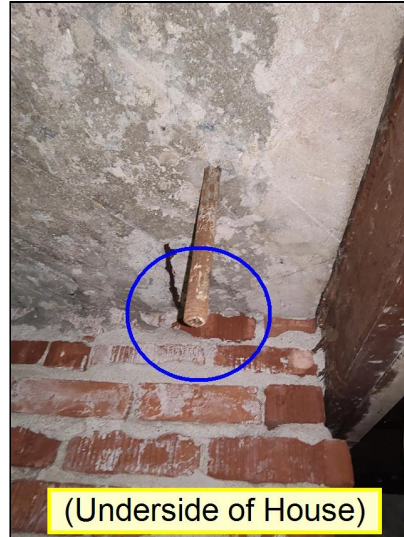
**Gas Line Capped- Not Connected.** The gas line for the fireplace has been capped and is not in use. **There was not a gas line leading to this location at the underside of the house.** This is noted for your information.

**NOTE: Damper Lock.** Should this fireplace use the gas option, the damper should be locked in the "open" position. This is to ensure that gas can properly vent if there is a leak, or the gas was accidentally left on.

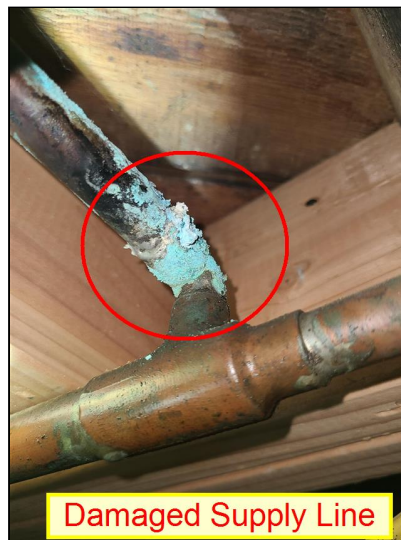
(2) **Corrosion at Supply Line.** There was a section of copper supply line, at the underside of the house, that had some moderate to severe corrosion. **There was some corrosion to the line at this location that could begin to leak.** It is recommended that this be further evaluated and repaired as needed by a licensed plumber.

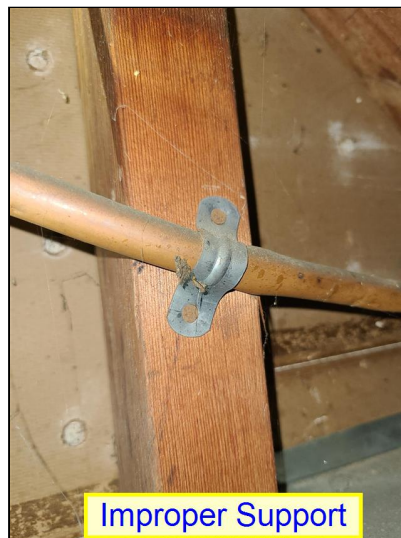
(3) **Improper Support.** The copper piping, for the water supply lines, have some areas (in the attic) that are being supported by galvanized metal straps. Copper piping should be supported by a non-metallic plumbing strap or other means to avoid contact with incompatible materials. **Improper support can cause electrolysis, leading to pipe deterioration and the increased risk of leaks.** It is recommended that the plumbing supply lines be properly supported and protected from damage by a licensed plumber.

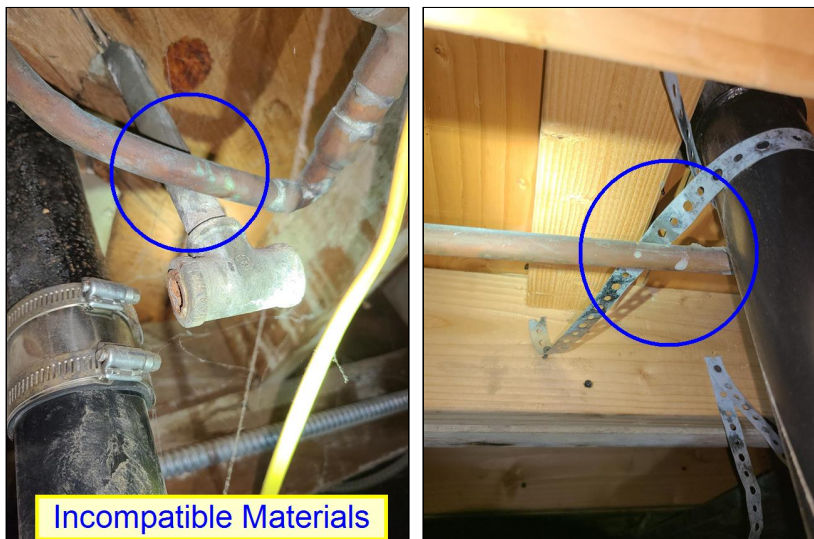
(4) **Incompatible Materials.** The copper piping, for the water supply lines, have areas that are in contact with incompatible materials. **Incompatible material contact can cause electrolysis, which can lead to pipe deterioration and increased risk of leaks.** It is recommended that the plumbing supply lines be further evaluated and protected from damage by a licensed plumber.

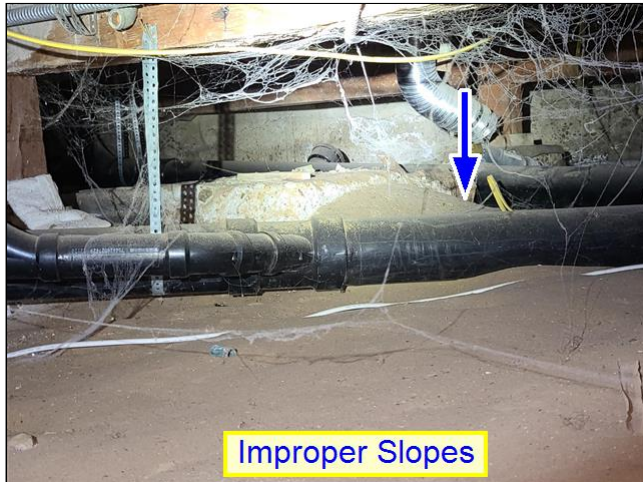
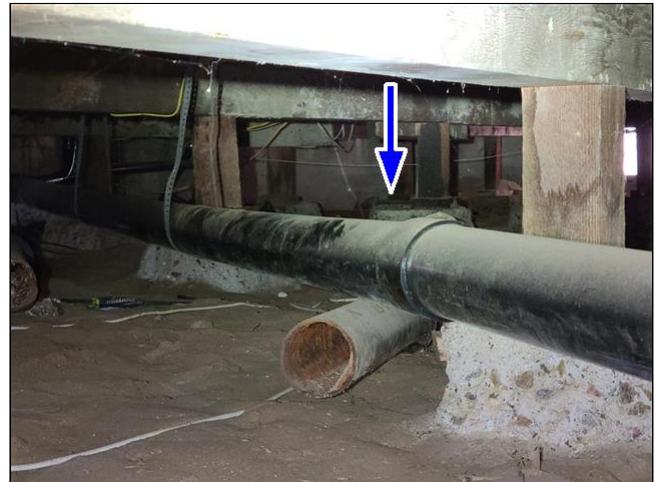
(3) **Improper Slopes at Waste Lines.** There are waste lines at the underside of the house that do not have proper directional slopes. **Waste lines should always maintain a downward slope.** In this application there are sections of the plumbing that did not appear to have proper slopes. This can cause water and debris to remain within the pipe at this location. **It is recommended that these areas be further evaluated and that the slopes at these locations be corrected by a licensed plumber.**

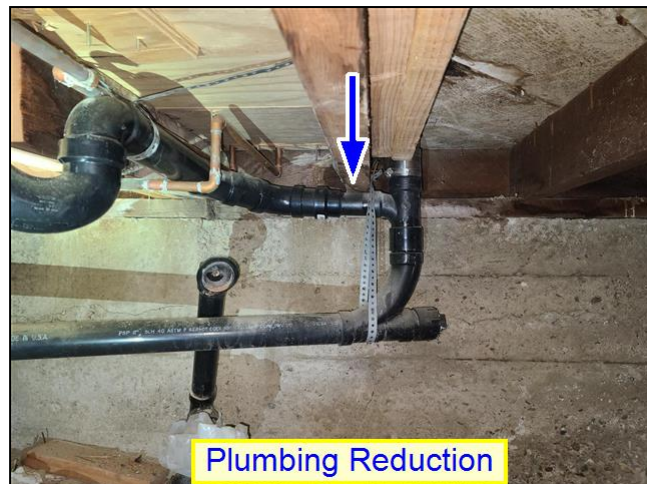
(4) **Pipe Reduction.** There was a pipe reduction noted at the underside of the house. This was noted at the underside of the hall bathroom. Pipe reductions are not permitted in waste line runs. **These reductions increase the risk of blockage.** **It is recommended that these be corrected as needed by a licensed and qualified plumber.**

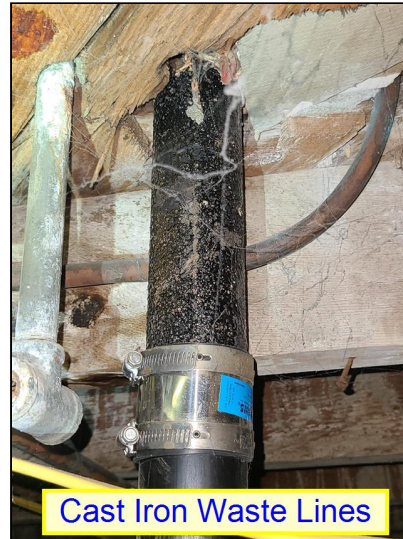
(5) **Cast Iron Waste Lines.** This house is equipped with cast iron waste lines which are over 80 years old.

**Most visible sections have been replaced.** Although there were no leaks detected in the exposed pipes under the house at time of inspection, it is only a matter of time before leaks will develop. **Recommend that waste lines be replaced with ABS as leaks develop.**

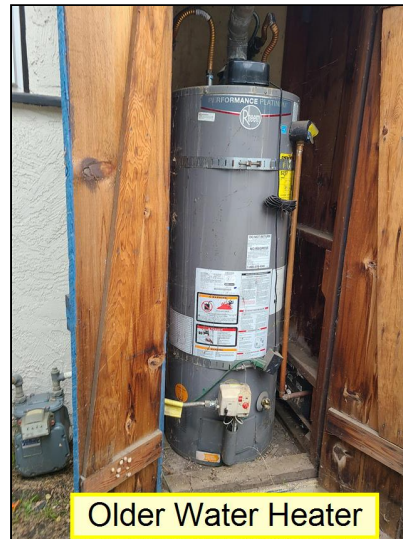
(1) **Water Heater Note:** On Average water heaters typically have a 10 to 15 year life expectancy. **Currently this water heater was about 10 years old.** This is noted for your information.

**NOTE: Older Water Heater.** It is noted that this water heater is over 10 years old and is about at it's life expectancy. (Water heaters typically last 10 to 15 years- but have also been known to last longer). This heater may need replacement soon.

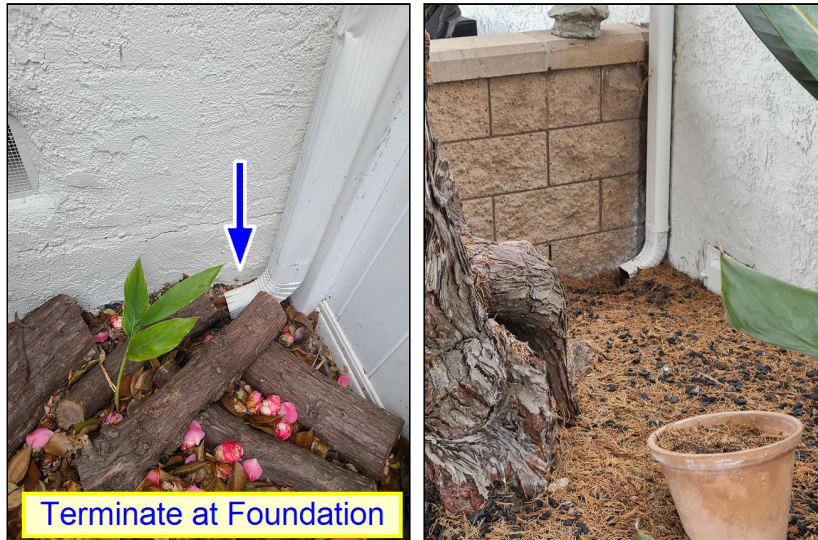
(1) **Partial Gutters.** The partial drainage system for this roof is inadequate. Roof gutters direct water away from the house and foundation and are crucial in areas with drainage issues. It is recommended a complete gutter system be supplied for the house, and that the drainage system discharge away from the foundation of the house.

(2) **Gutters Terminate at Foundation.** The gutter system has a few down spouts that terminate at the house foundation. It is recommended that these termination points have fittings installed to kick water away from the house and foundation.

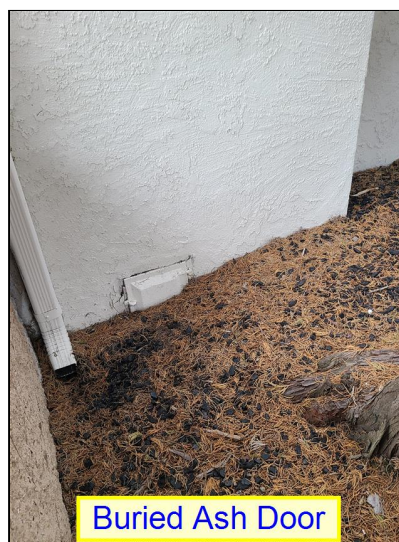
(2) **Buried Ash Door.** The fireplace for this house had a buried door at the chimney ash dump. **It is recommended that this be repaired as needed to not only ensure proper working order, but also to ensure that animals do not enter or occupy this area.**

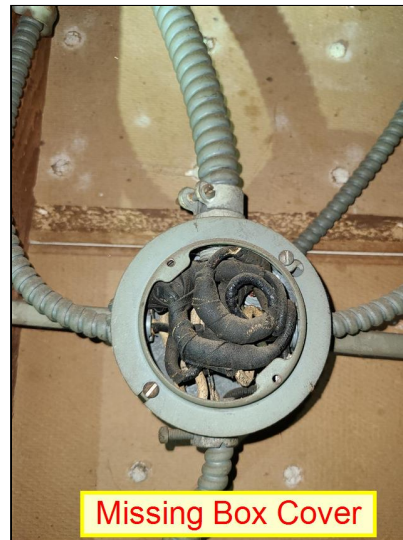
**Missing Cover on Junction Boxes.** There is at least one missing covers at the junction boxes in the attic. Junction boxes are used to conceal wire connections, protecting them from damage and decreasing the risk of fire and shock. **Recommend installation of cover plates on all outlet boxes.**

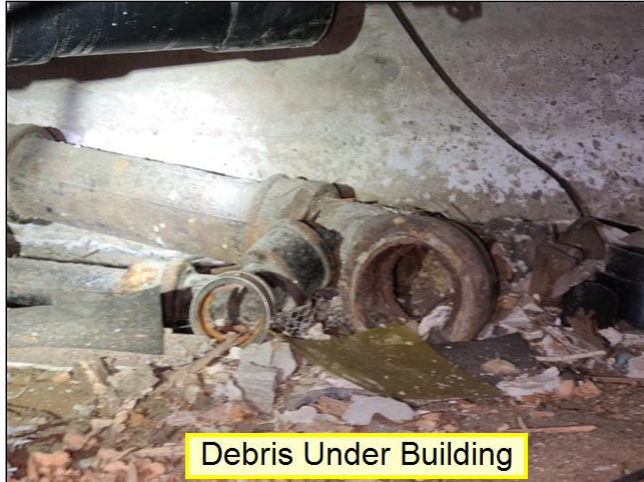
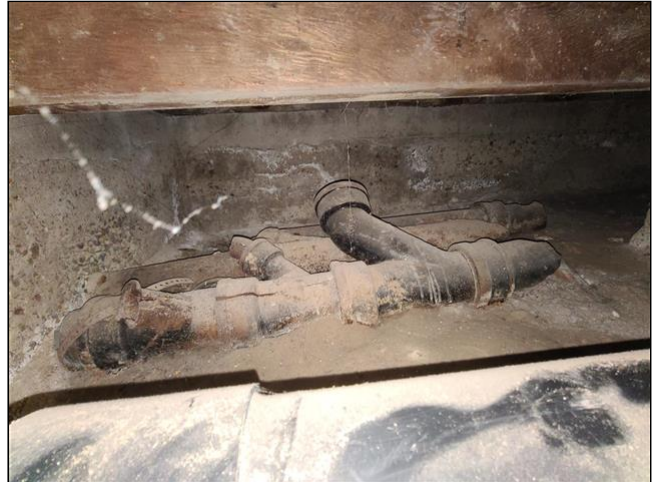
📍 (1) **NOTE: Debris Under Building.** There was debris at the underside of the building. Currently there were sections of old cast iron waste lines laying on the ground. It is recommended that these abandoned objects be removed from the underside of the building.

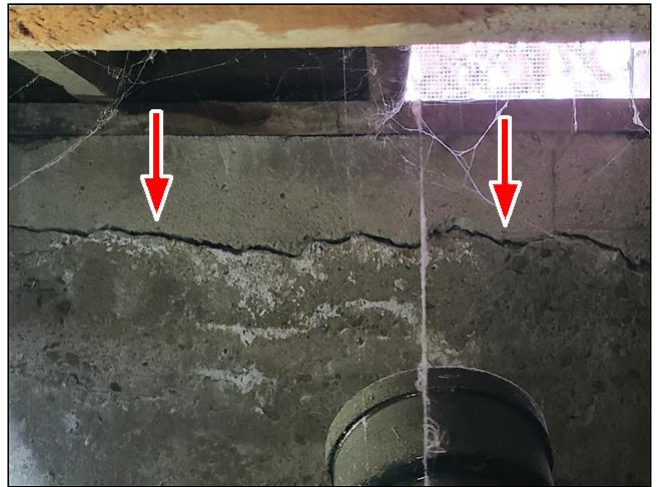
(Left Rear Corner)

(2) **Large Horizontal Cracks.** There were areas at the underside of the house that have large horizontal cracks. These cracks were noted across the rear and left side of the property. These cracks had areas that were very deep, and some appear to penetrate through the entire wall. **These are considered structural deficiencies needing further evaluation and repair.** It is recommended that these locations be further evaluated by a structural engineer and or foundation specialist.

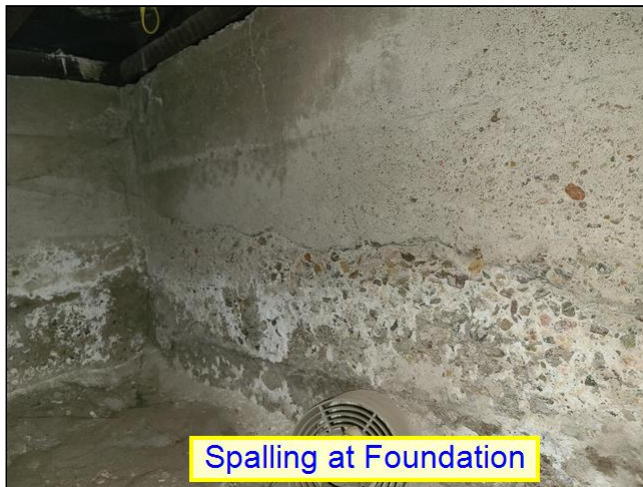
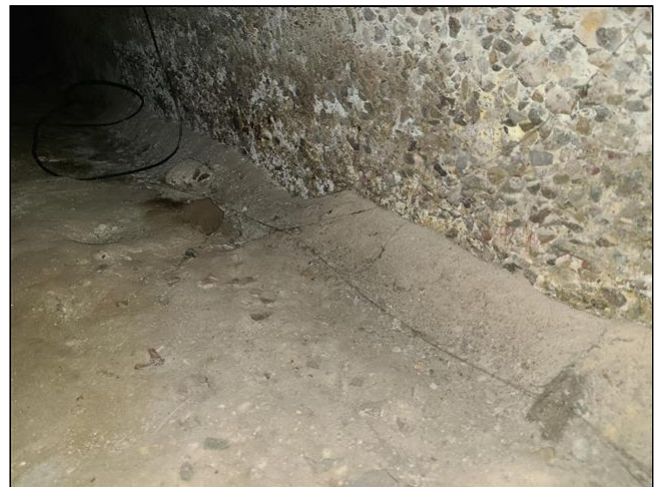
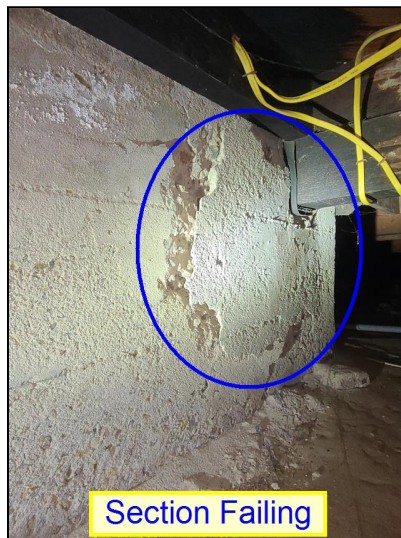
(4) **Minor/ to Severe Spalling.** There were a few areas in which there was spalling noted. Spalling is when the surface concrete begins to delaminate or flake away from the wall. Eventually this can lead to deterioration and weakening of the foundation. There were areas that range from minor to severe spalling. The worst of which is a section to the right of the front entry, where there is a large section of concrete pulling. **It is recommended that the spalling of the foundation be checked periodically, and if these areas dramatically worsen over time, that a licensed concrete specialist be called out for further analysis and repair.**

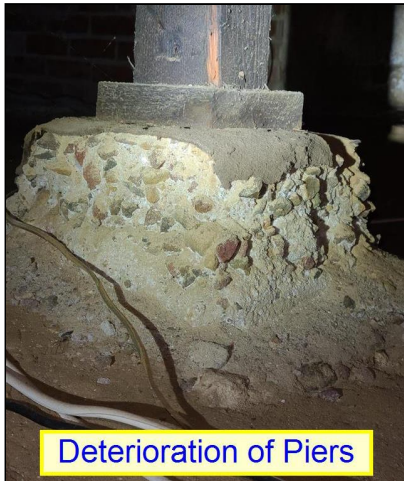
(2) **Deterioration of Piers.** There are at least 4 piers at the underside of the house have some moderate deterioration. **It is recommended that a licensed foundation contractor be called out for further evaluation and repair.**

Deterioration of Piers

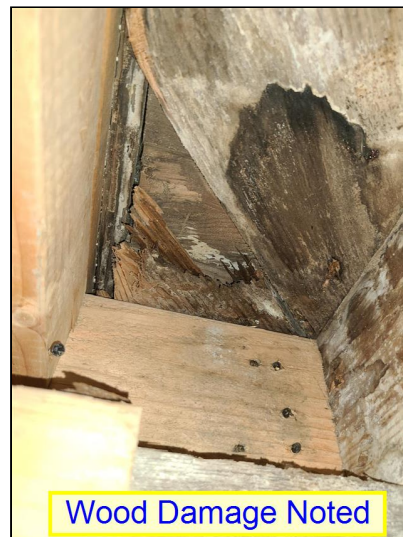
🏠 (2) **Wood Damage Noted.** There was some wood damage to the flooring members noted under the #1 (laundry) bathroom. **It is recommended that a termite specialist be called out for further analysis and that all damaged wood be repaired or replaced by a licensed contractor.**

Wood Damage Noted

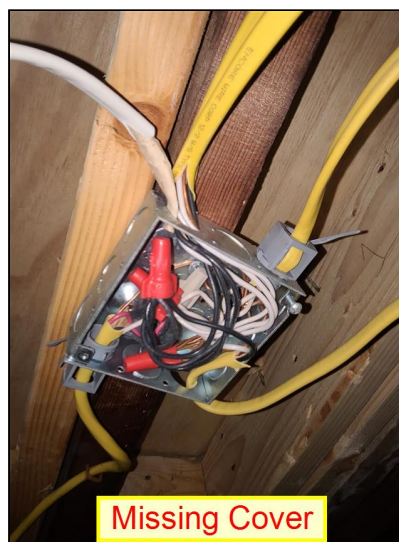
(1) **Missing Cover on Junction Box.** There is a missing cover on a junction box in the crawl space. Junction boxes are used to conceal wire connections, protecting them from damage and decreasing the risk of fire. **Recommend installation of cover plates on all outlet boxes.**

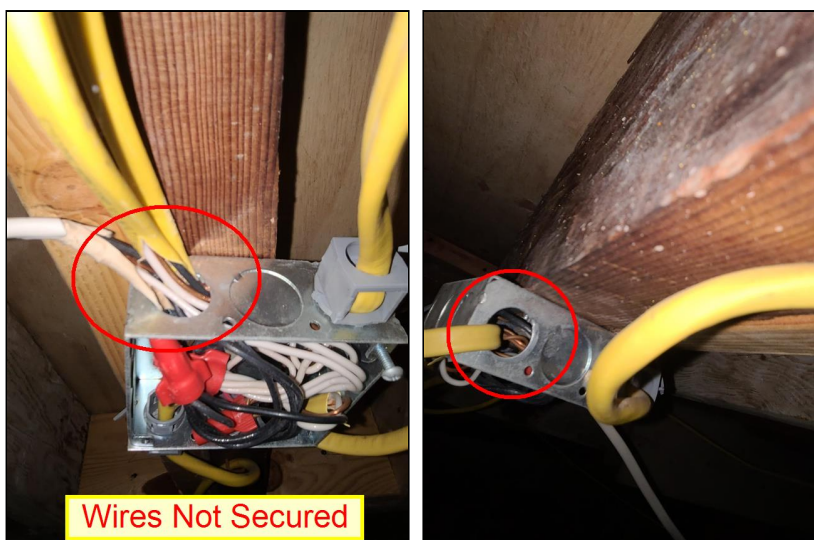
(2) **Wires Not Secured to Boxes.** There are junction boxes in which the wires are not secured to the boxes. All junction boxes should have the wires secured to the box via bushings or wire clamps. Not having secured wires can cause the wires to become loose or damaged causing increased risk of damage or injury. **It is recommended that a licensed electrician be called out to repair these boxes.**
