# Inspection Report

**Property Address:**  
4768-72 Coronado Ave  
San Diego CA 92107

**Foresight Building Inspection**

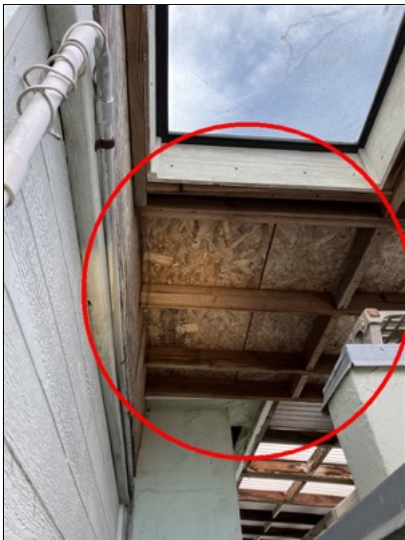
Visible defects were observed at areas of the roof covering . It is recommended to contact a licensed roofer for a complete evaluation of all roof defects and repair/replace as needed.

1.0 Item 2(Picture) view from second floor patio: substandard roof covering construction observed / recommend further evaluation and correction as needed

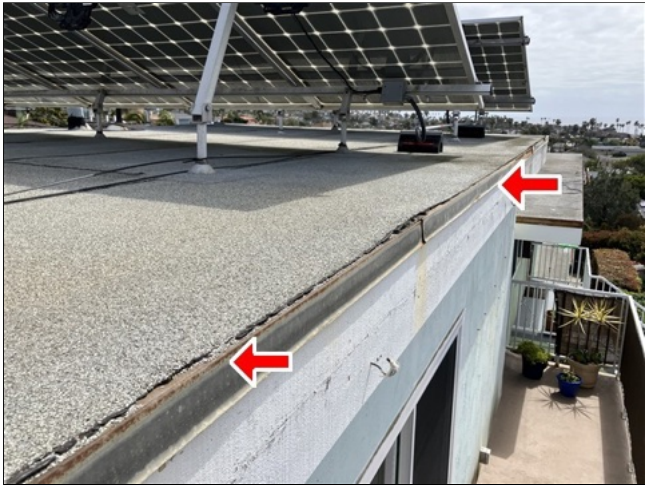
1.0 Item 3(Picture) roll roofing defects observed around the perimeter

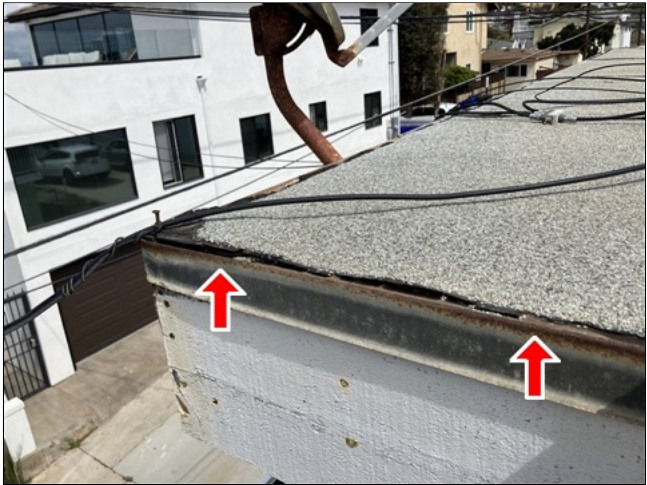
1.0 Item 4(Picture) roll roofing defects observed around the perimeter

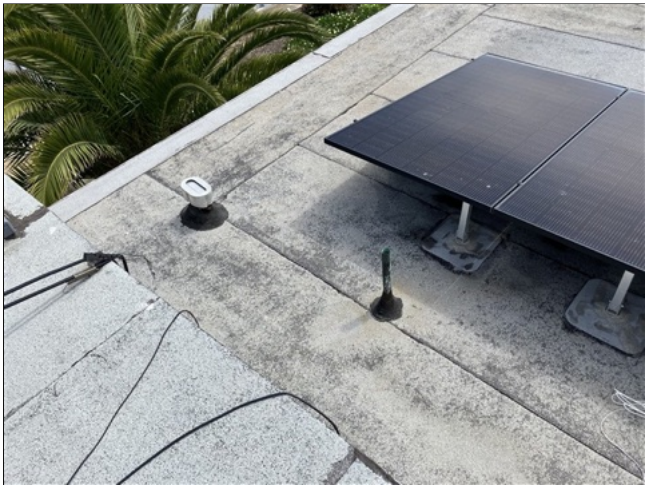
1.0 Item 5(Picture) roll roofing deterioration visible / recommend further evaluation and correction as needed

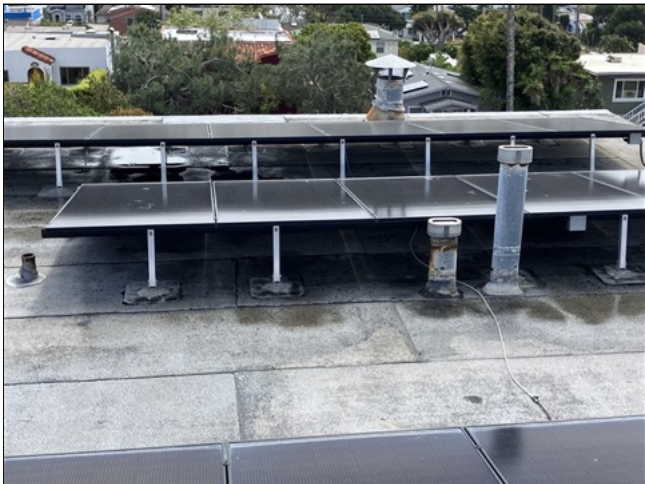
1.0 Item 6(Picture) roll roofing deterioration visible / recommend further evaluation and correction as needed

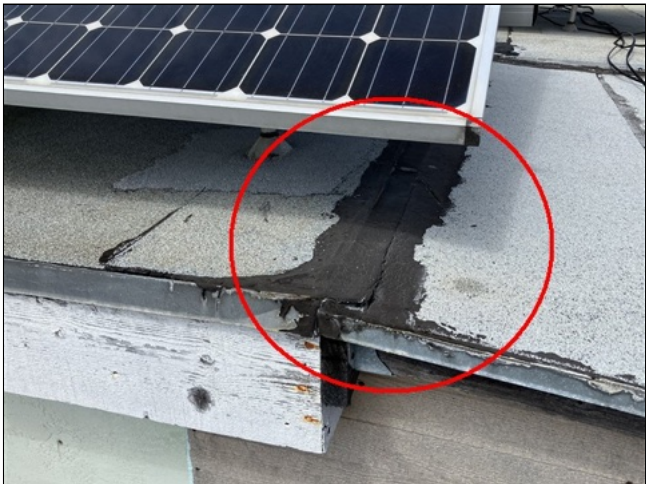
1.0 Item 7(Picture) possible evidence of repairs observed / recommend further evaluation of repair

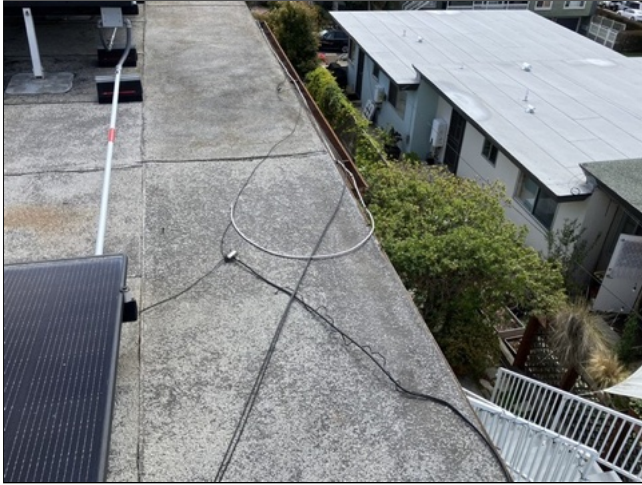
1.0 Item 8(Picture) roll roofing deterioration visible / recommend further evaluation and correction as needed

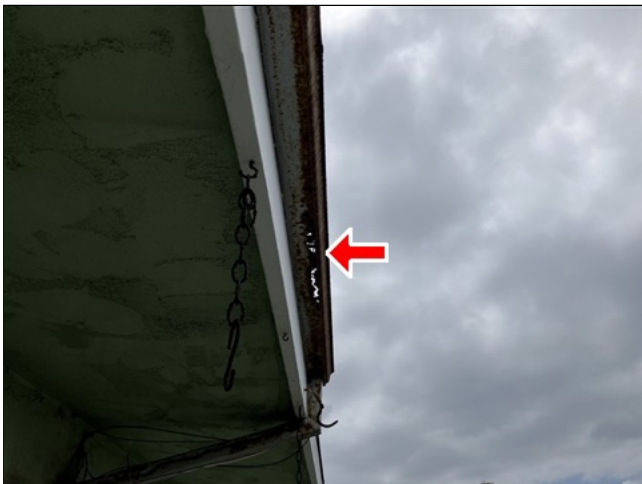
Defects or deficiencies were observed at one or more areas of the downspout components. It is recommended to have the system evaluated by a rain gutter specialist and repaired/replace as needed.

1.1 Item 1(Picture) oxidation defects visible at rain gutters

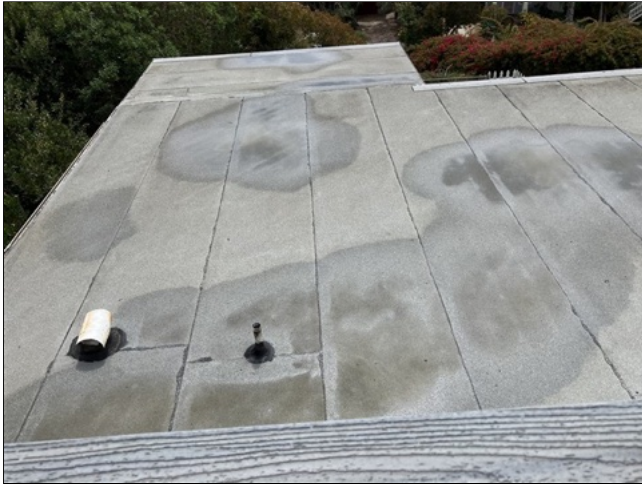
(2) Areas of the roof drainage system appeared inadequate or may require additional improvements or corrections to assure proper drainage. It is recommended to have the roof drainage system evaluated by a licensed roofer for improvements and corrections as needed.

1.1 Item 3(Picture) ponding visible at roof covering / evidence of possible inadequate drainage

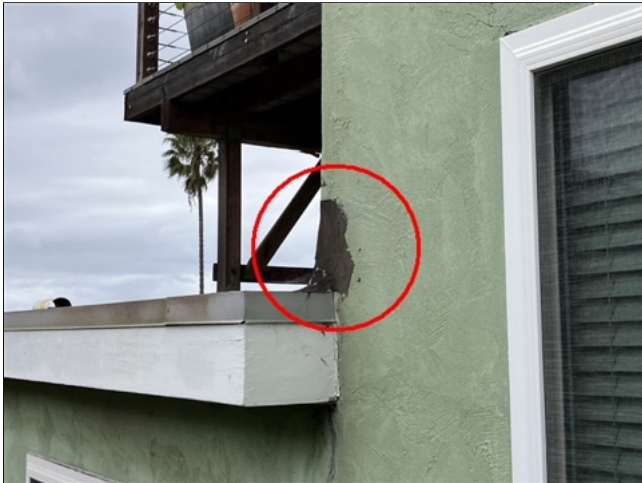
(1) Repairs were visible at areas of the flashing systems. Because it is outside the scope of this inspection to evaluate or warranty repairs, it is recommended to have a licensed roofer evaluate the repairs to insure a properly functioning flashing system.

1.2 Item 1(Picture) possible evidence of repairs observed / recommend further evaluation of repair

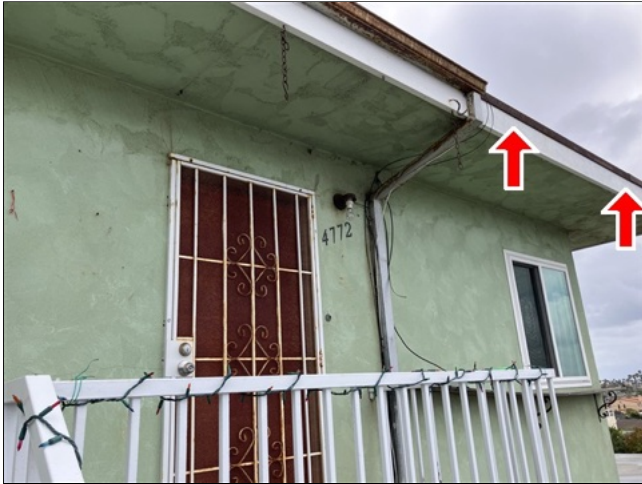
(2) The flashings at the chimney, vent penetrations, or transitions were missing, deteriorated, or had other observable defect. It is recommended to have all flashings systems evaluated by a licensed roofer and repaired/replaced as needed.

1.2 Item 2(Picture) oxidized flashings observed

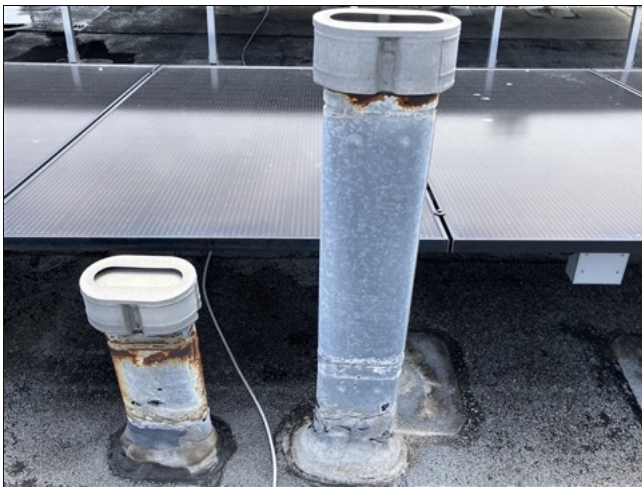
One or more of the vent terminations were aged and appeared to have exceeded or are near to exceeding their serviceable life. It is recommended to have the vent terminations evaluated to determine remaining life expectancy and replacement as needed.

1.5 Item 1(Picture) aged vents observed / oxidation visible

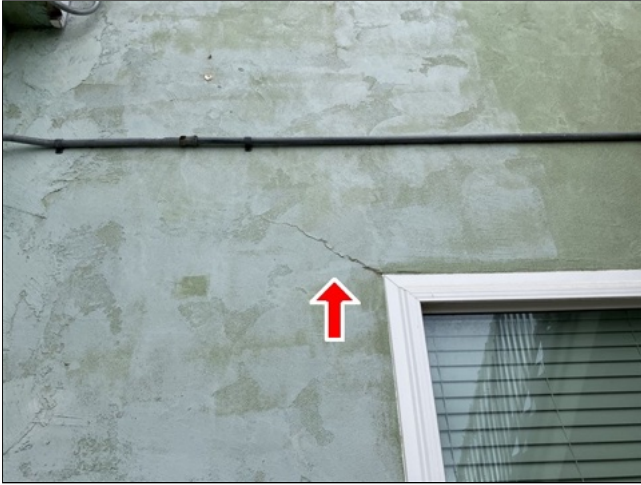
2.0 Item 5(Picture) cracks visible at stucco

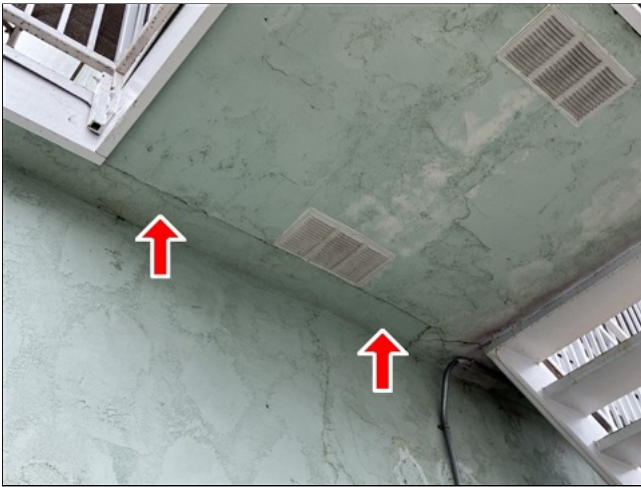
2.0 Item 7(Picture) cracks visible at stucco

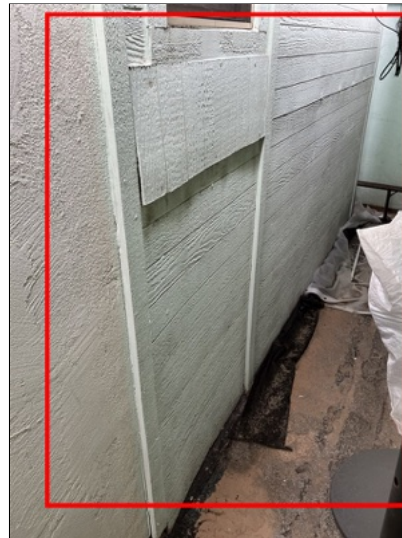
2.0 Item 8(Picture) view from second floor patio: substandard siding installation / recommend further evaluation and correction as needed

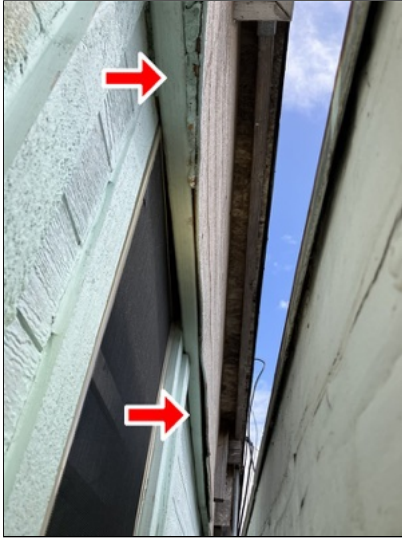
2.0 Item 9(Picture) view from second floor patio: substandard siding installation / recommend further evaluation and correction as needed

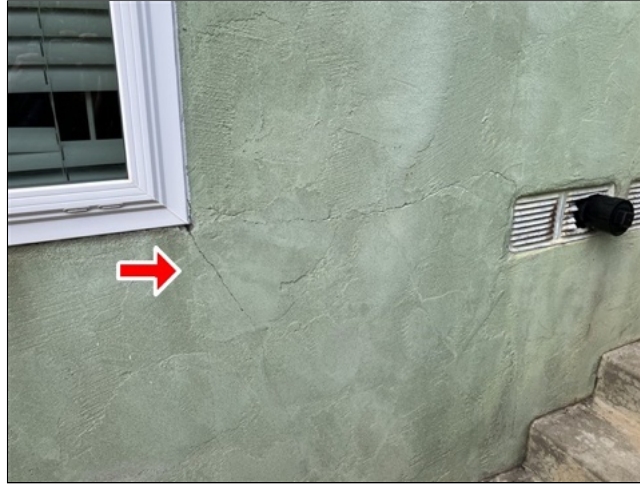
2.0 Item 10(Picture) crack visible at stucco

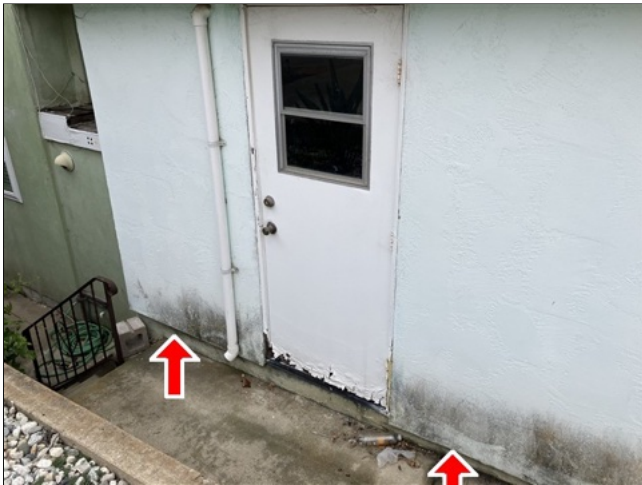
(2) There were visible stains observed on the stucco. These are often seen around windows, chimneys, at roof connections, or where stucco is in contact with the soil indicating possible moisture intrusion or other defect. Because determining the cause of the staining is beyond the scope of this inspection, consult with a stucco specialist for further evaluation and correction as needed.

2.0 Item 11(Picture) stucco stains visible

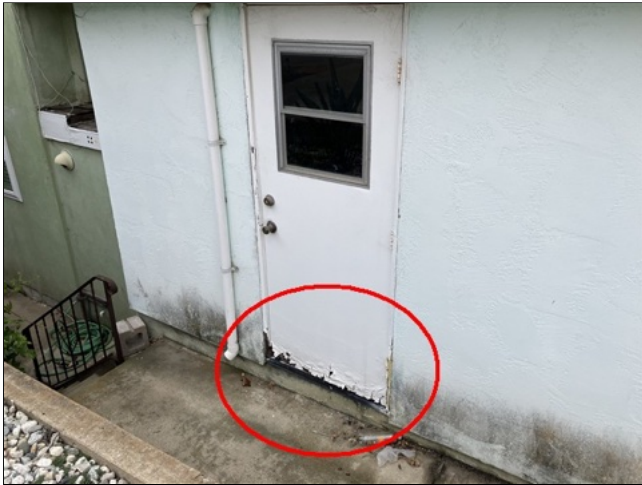
Possible WDO (wood destroying organisms) evidence or damage was observed at areas of the exterior door systems. It is recommended to have a licensed pest control company evaluate all WDO related defects and remediate as needed.

2.1 Item 1(Picture) possible WDO evidence or damage observed / maintenance / repairs / or replacement needed

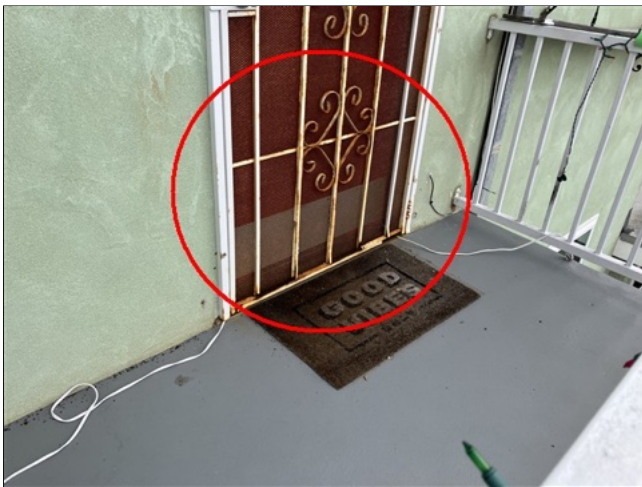
2.1 Item 3(Picture) unit 4772: oxidation visible at security door

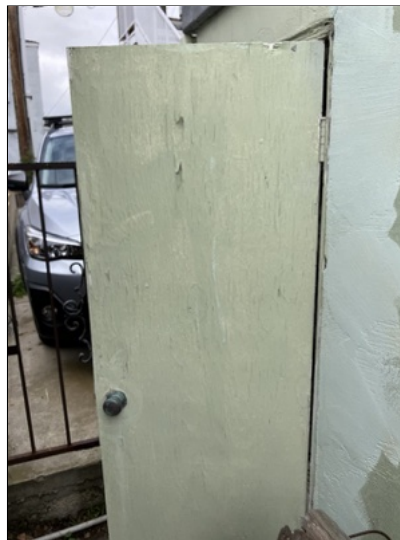
2.1 Item 4(Picture) stairwell storage area door defects observed

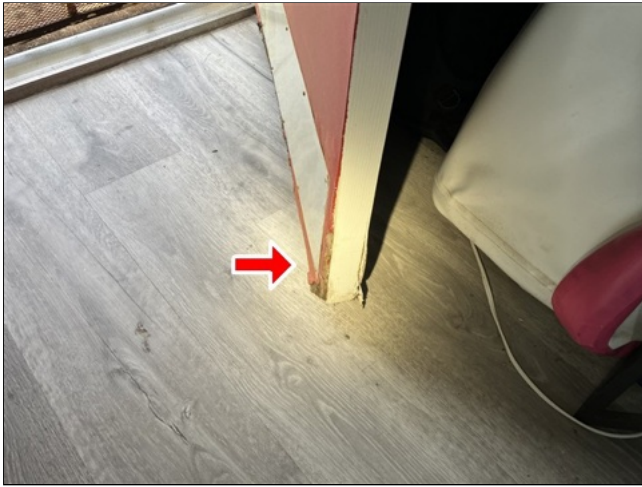
2.1 Item 5(Picture)

Exterior door components had visible damage, did not function properly, or had other observable defect. It is recommended to have the doors evaluated by a qualified tradesman and repaired/replaced as needed.

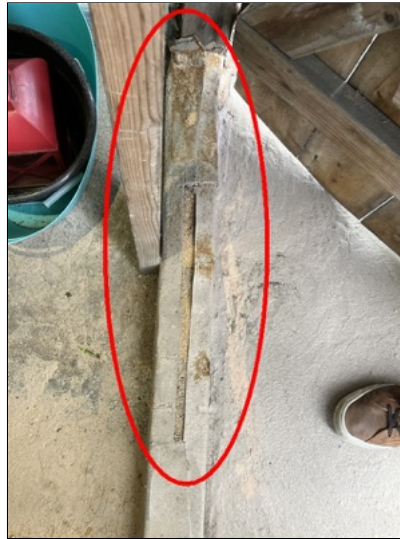
2.1 Item 6(Picture) 4772 patio door: possible WDO evidence or damage observed

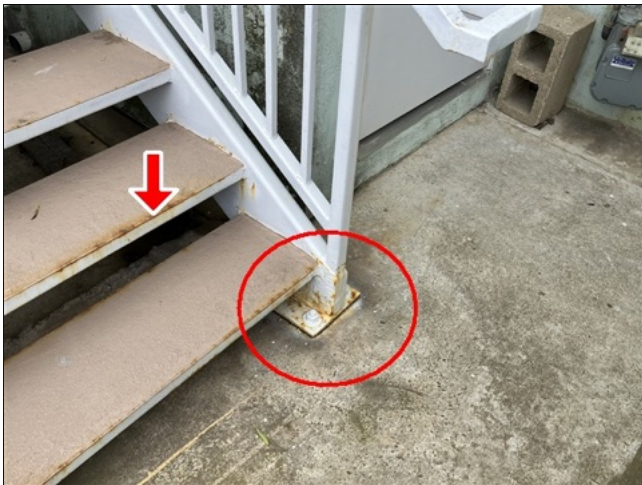
2.3 Item 1(Picture) oxidation visible at stair system

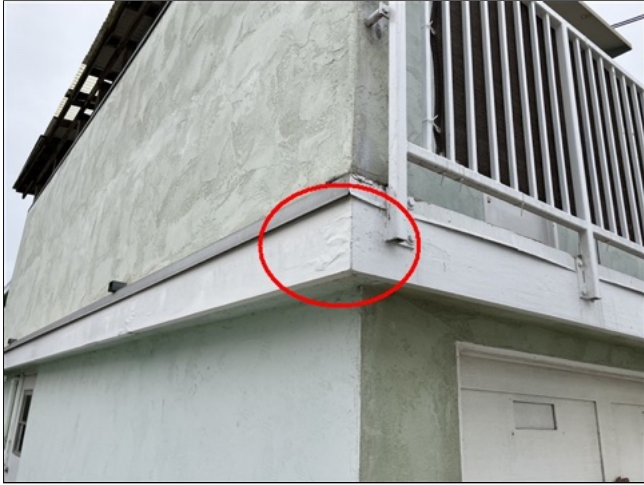
2.3 Item 3(Picture) possible WDO evidence or damage observed

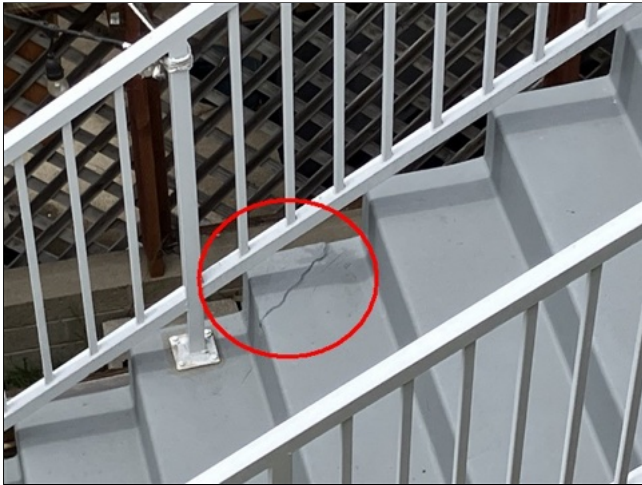
2.3 Item 6(Picture) crack visible at concrete stair

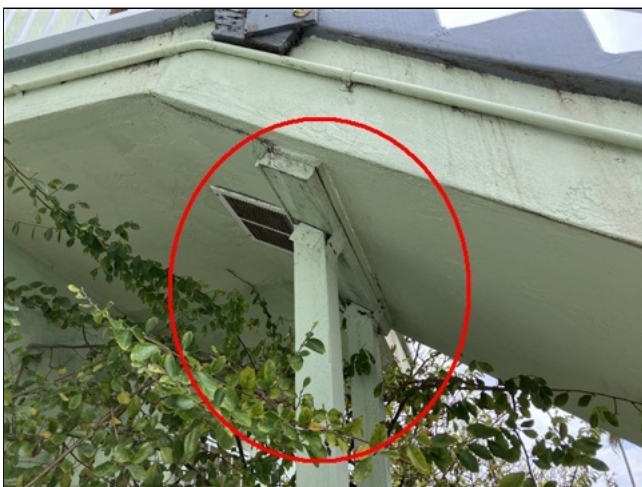
2.3 Item 9(Picture) substandard deck stair support installation observed

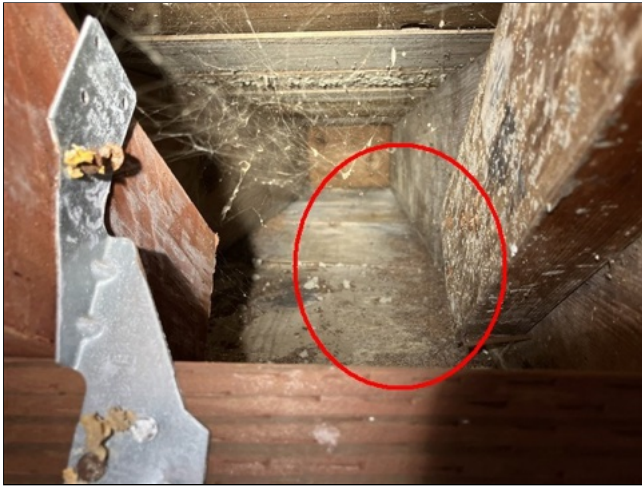
2.3 Item 11(Picture) stairwell storage area: possible WDO evidence or damage observed

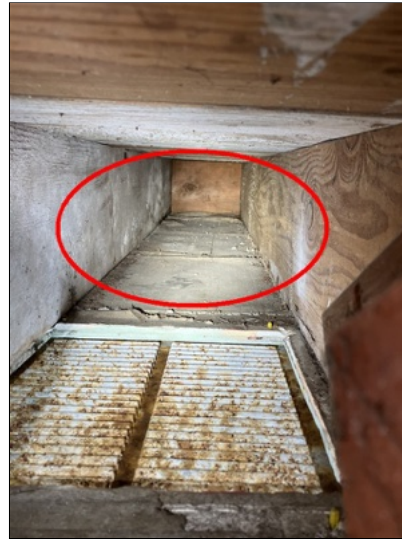
2.3 Item 12(Picture) stairwell storage area: possible WDO evidence or damage observed / moisture stains or damage visible

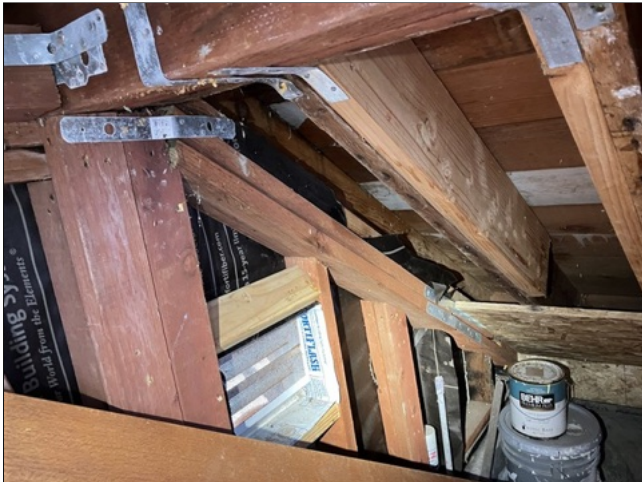
2.3 Item 13(Picture) stairwell storage area: possible evidence of substandard repairs observed / recommend further evaluation of repair

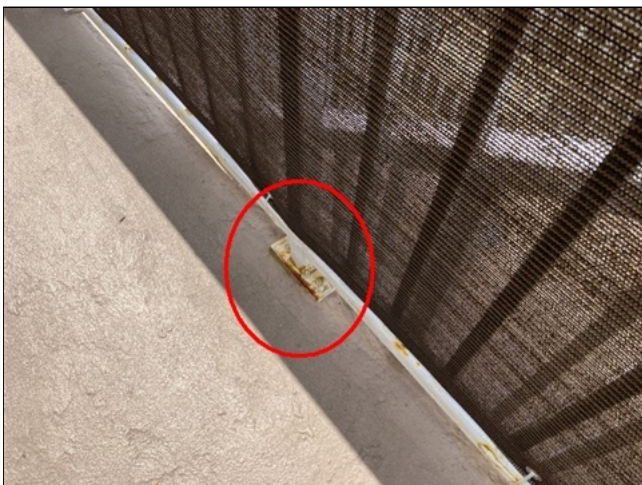
2.3 Item 15(Picture) oxidation visible at railing

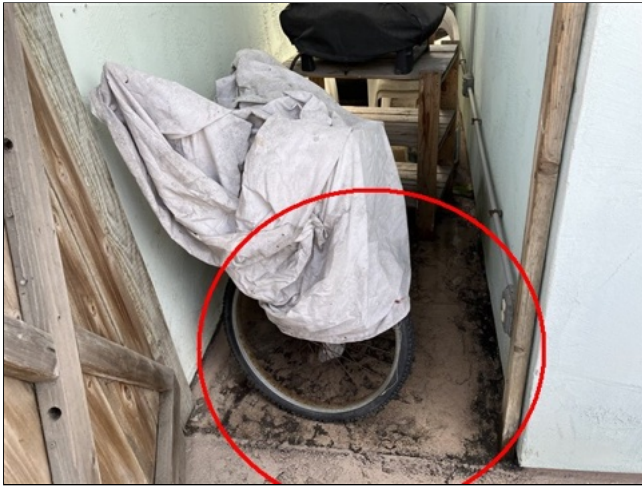
2.3 Item 16(Picture) ponding water observed / evidence of possible inadequate drainage

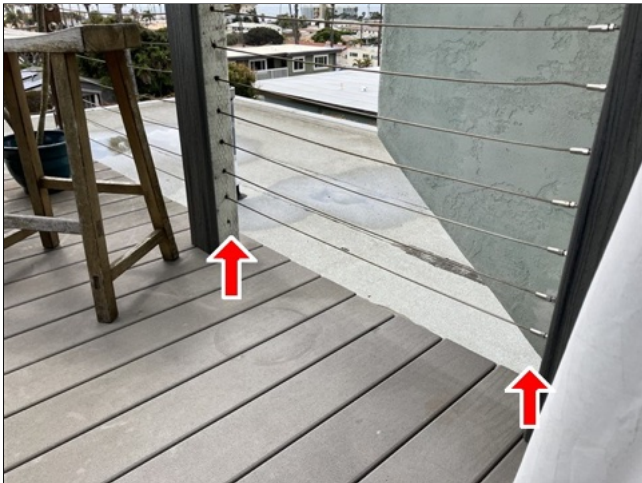
(2) Areas of the stair or guard railing systems were damaged, deteriorated, or had other observable defect. Because a defective or inadequate railing system can create a safety fall hazard, it is recommended to have a qualified contractor evaluate the exterior railing systems and repair/replace as needed.

2.3 Item 18(Picture) unit 4772: missing cable railing / loose cable railings

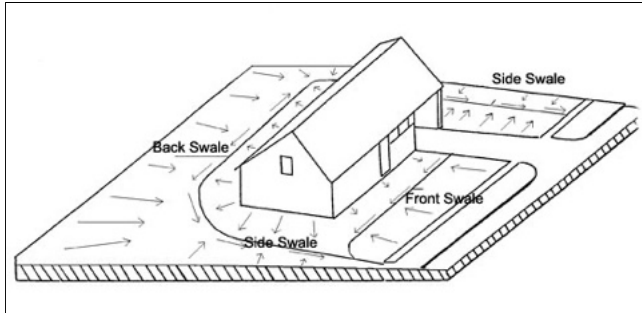
2.4 Item 1(Picture)

(1) Insufficient slope or potentially poor drainage was observed at areas of the driveway, walkways, or landscaping which can increase moisture related damages and defects to the structure. Drainage or landscaping corrections and improvements are recommended. It is recommended to contact a licensed landscaping contractor for evaluation and correction as needed.

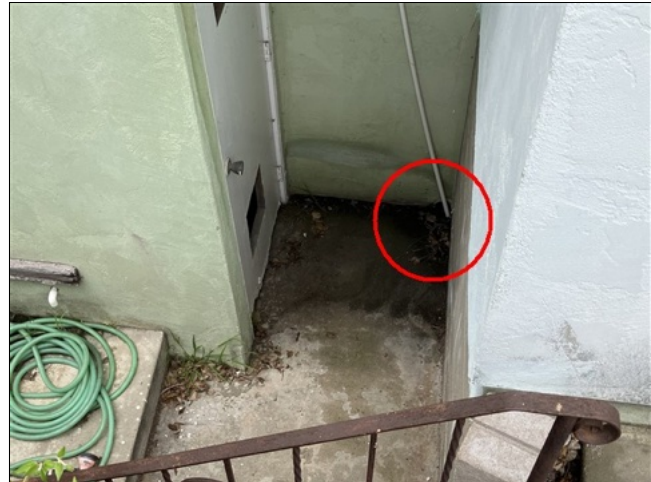
2.4 Item 2(Picture) exterior drain observed / evidence of inadequate drainage observed

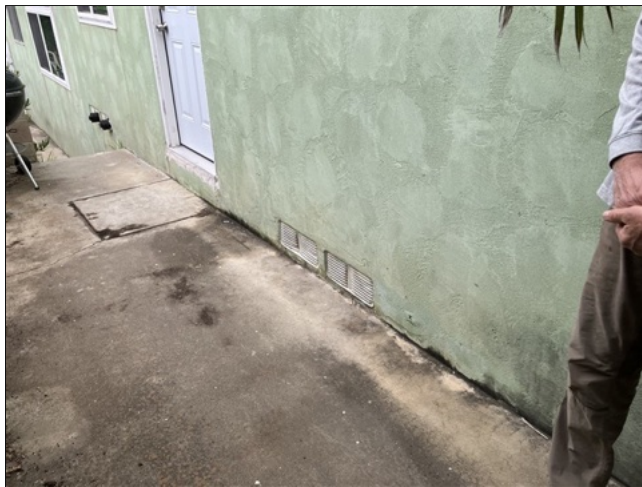
2.4 Item 3(Picture) grading or drainage improvements/ corrections are recommended to achieve positive slope away from the property

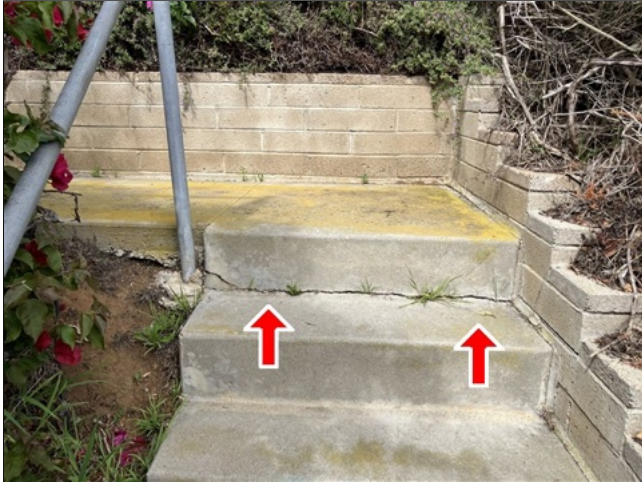
(2) Cracking, damage, or other visible defect was observed at areas of the exterior hardscape (driveway, walkway, stairs, patio, etc.). It is recommended to have these evaluated by a licensed contractor and repaired/replaced as needed.

2.4 Item 5(Picture) crack visible at concrete stair

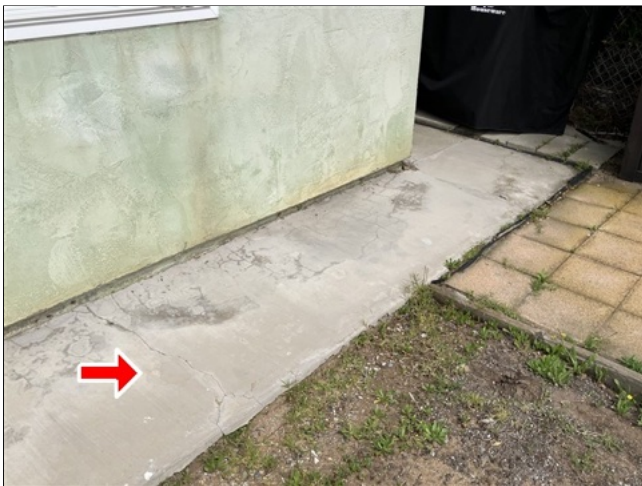
2.4 Item 7(Picture) cracks visible at concrete walkway

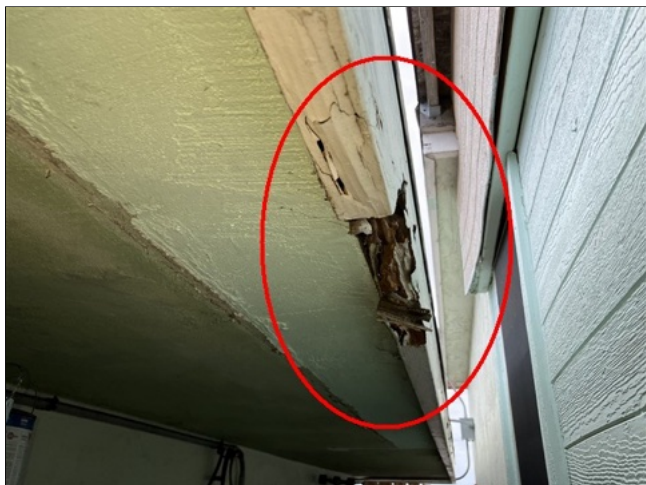
Possible WDO (wood destroying organisms) evidence or damage was visible at areas of the eaves, soffits, or fascia boards. It is recommended to have a licensed pest control company evaluate all WDO related defects and remediate as needed.

2.5 Item 1(Picture) unit 4772: possible WDO evidence or damage observed

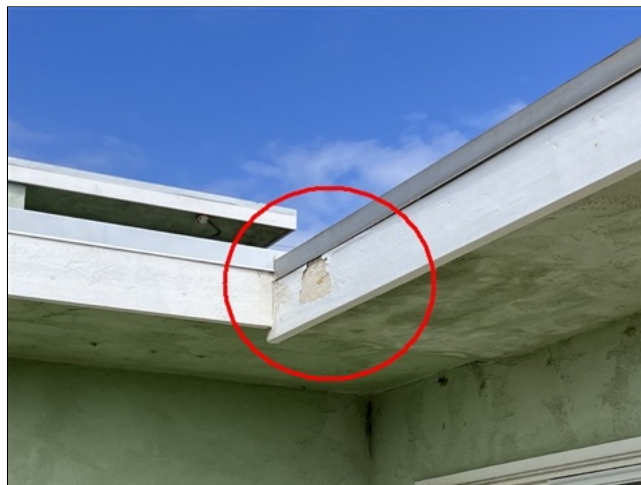
Areas of the eaves, soffits, or fascia boards were separated, damaged or had other visible defect that should be evaluated and repaired/replaced as needed.

2.5 Item 2(Picture) fascia paint maintenance/repairs needed

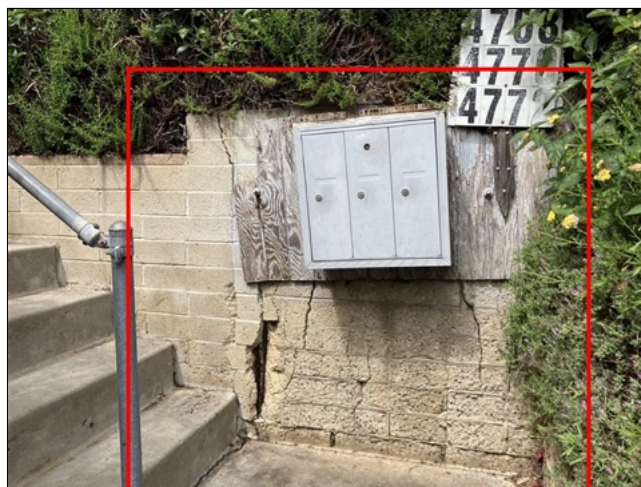
While retaining walls are not covered as part of the scope of the inspection, a defect was observed in the retaining wall and should be evaluated further by a landscaping contractor or engineer.

2.6 Item 2(Picture) retaining wall defects observed

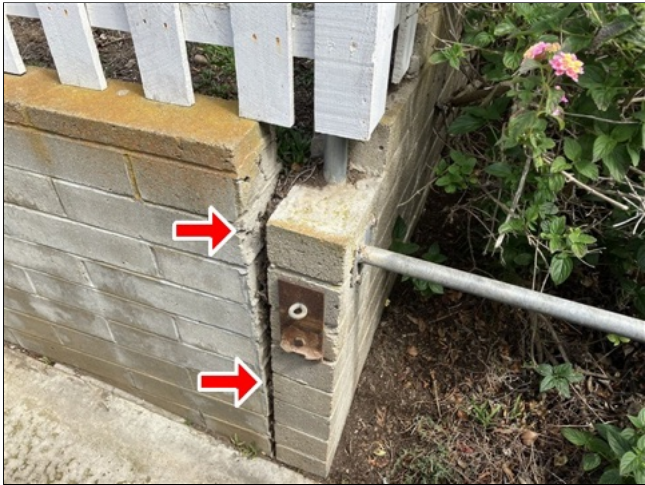
2.6 Item 3(Picture) retaining wall defects observed

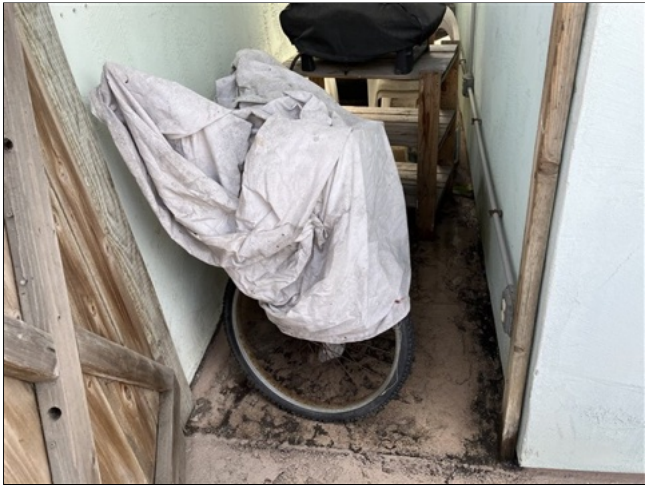
(2) Note: One or more areas of the exterior were not accessible, not visible for inspection, or otherwise not inspected due to the limitations of the scope of the inspection outlined in the attached Standards of Practice. Further inspection of these areas may reveal defects that would otherwise go unnoticed. Further evaluation is recommended.

2.6 Item 4(Picture) limited access and/or visibility

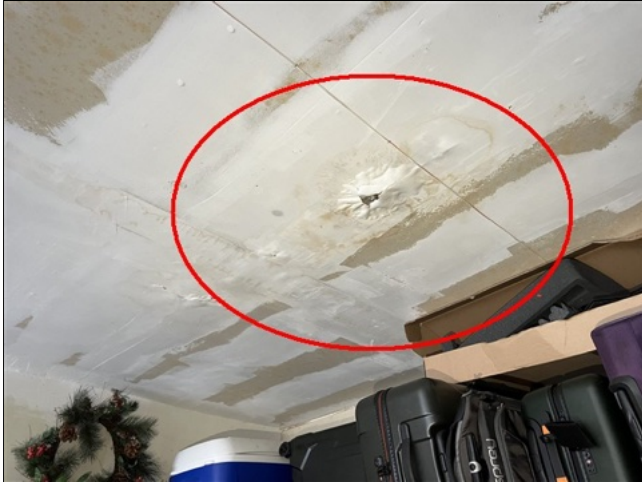
There were moisture stains or other possible signs of moisture intrusion at the garage ceilings and/or walls. No moisture was observed at the time of the inspection. It is recommended to have this evaluated by a licensed contractor to determine the cause of penetration, identification of hidden damages if present, and correction as needed.

3.2 Item 1(Picture) unit 4770 garage: moisture stains or damage visible / recommend further evaluation and correction as needed

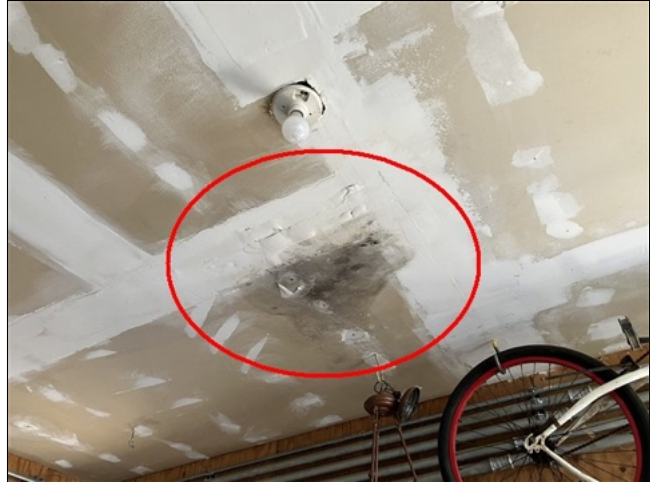
3.2 Item 2(Picture) unit 4772 alley side: moisture stains or damage visible / recommend further evaluation and correction as needed

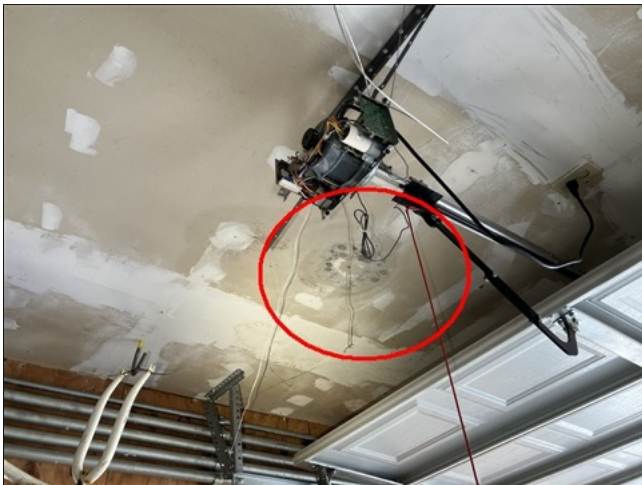
3.2 Item 3(Picture) unit 4772 alley side: moisture stains or damage visible / recommend further evaluation and correction as needed

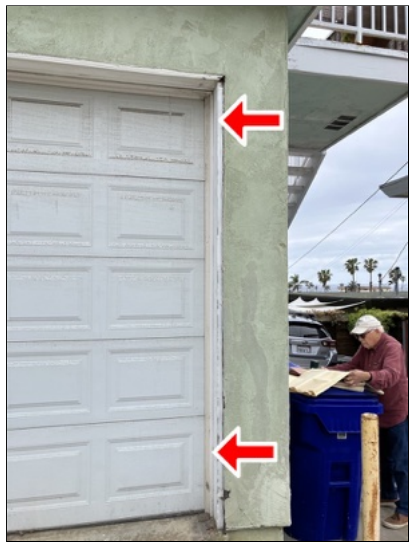
One or more of the garage door systems or components was damaged, did not operate properly when tested, or had other observable defect. It is recommended to have the door system evaluated by a qualified contractor and repaired/ replaced as needed.

3.4 Item 1(Picture) missing garage door trim

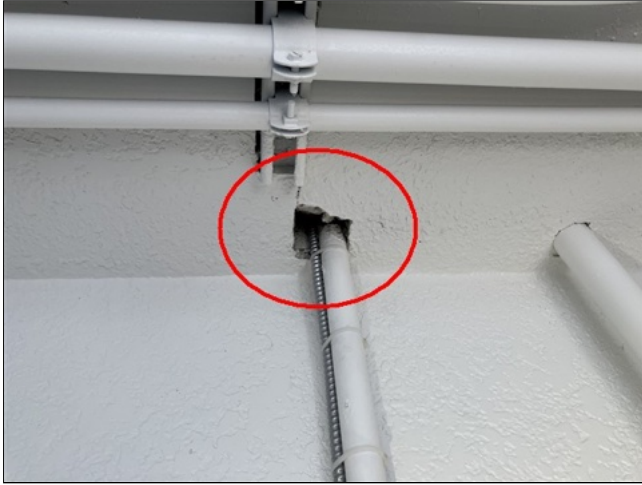
(2) Damages, missing drywall, or other defects to the walls or ceilings were observed. It is recommended to have these walls and ceilings evaluated by a qualified tradesman and repaired/replaced as needed.

4.0 Item 4(Picture) laundry room: ceiling maintenance/ repairs needed

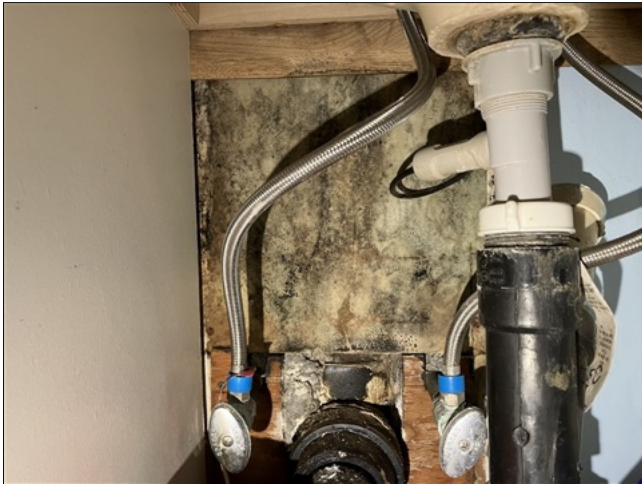
(3) There were stains or other possible signs of past moisture intrusion on the ceiling or walls. Only further evaluation and investigation can determine the cause and identify presence of hidden damages.

4.0 Item 5(Picture) unit 4770 bathroom #2: moisture stains or damage visible / possible evidence of fungal activity

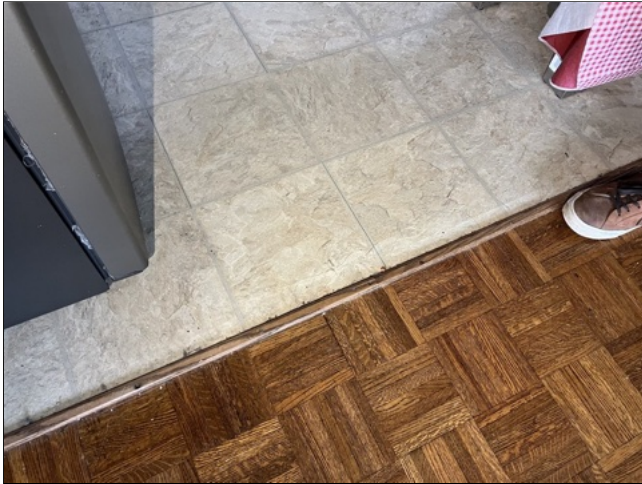
The floor coverings appeared aged with consistent signs of deterioration and may have exceeded or is near to exceeding their expected serviceable life. Further evaluation is recommended to determine remaining life expectancy or replacement as needed.

4.1 Item 1(Picture) unit 4768: aged flooring / maintenance/repairs needed

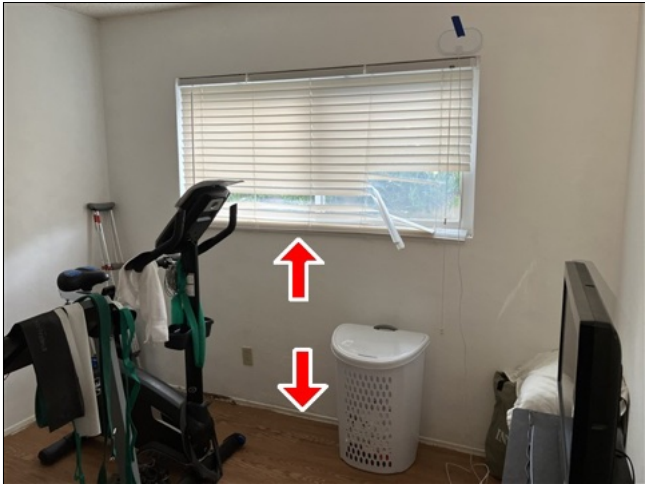
When the second exit in a bedroom is a window, specific size requirements have been established for egress. A window sill height may not exceed 44 inches from the floor and the openable portion of the window must exceed 5.7 sq/ft (5.0 sq/ft if on the ground level) and comply with height/width distance minimums. While these requirements may not have been required at the time of construction, as a safety upgrade, it is recommended to have this evaluated by a licensed contractor and upgrade as needed.

4.5 Item 2(Picture) unit 4768: bedroom window egress upgrades recommended

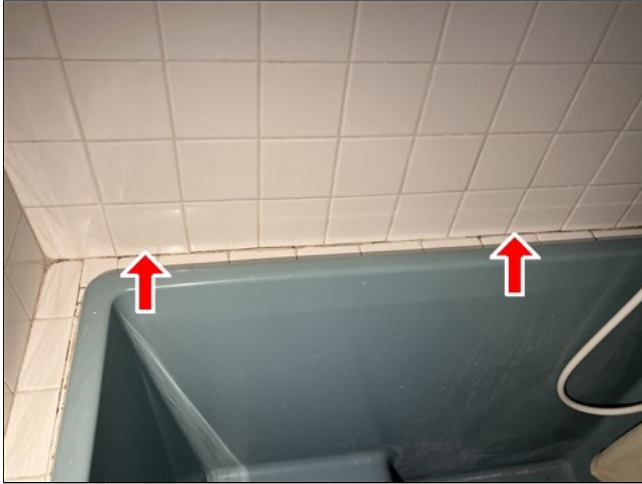
(1) The caulking or grout was missing, separated, or had other observable defect at areas of one or more of the tub/shower wall or floor systems. It is recommended to have these evaluated and repaired as needed.

4.6 Item 1(Picture) unit 4770: caulking or appropriate sealant maintenance/repairs needed

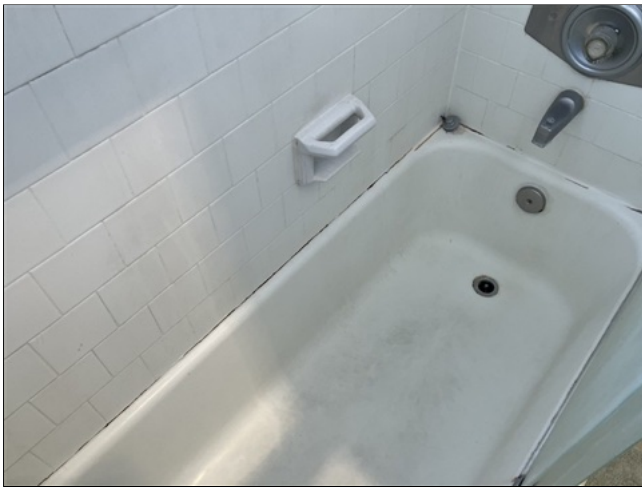
(2) One or more of the shower pan, tub, or wall surround systems appeared aged with signs of deterioration and may have exceeded or are near to exceeding their expected serviceable life. Further evaluation from a licensed contractor is recommended to determine remaining life expectancy or repair/replace as needed.

4.6 Item 2(Picture) unit 4772: aged tub/wall surround system observed

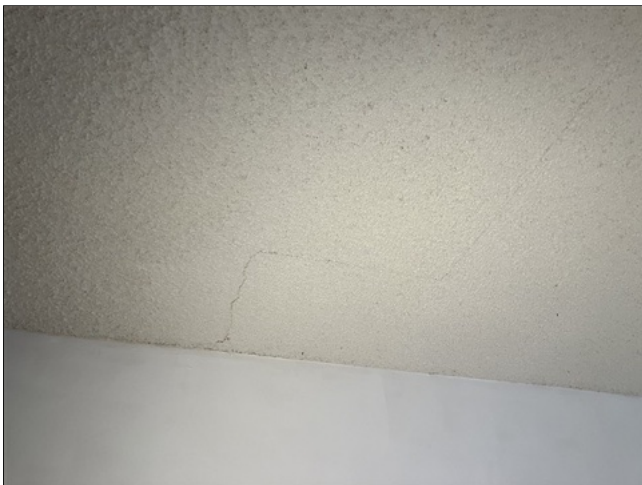
4.8 Item 1(Picture) popcorn ceiling texture materials installed before 1978 may contain asbestos

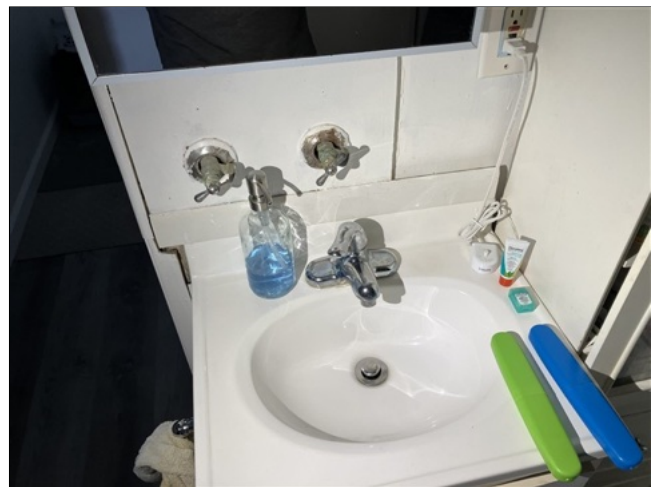
(3) Unit 4770 - Disclaimer: It is outside the scope of this inspection to determine original construction from later additions or modifications. Some evidence was observed that may indicate modifications from the original construction. Any changes from the original construction should be evaluated by a qualified contractor, architect, or engineer to determine if modifications were performed according to the appropriate building regulations at the time of construction.

4.8 Item 8(Picture) unit 4770: bathroom #2 appeared  
to be an addition

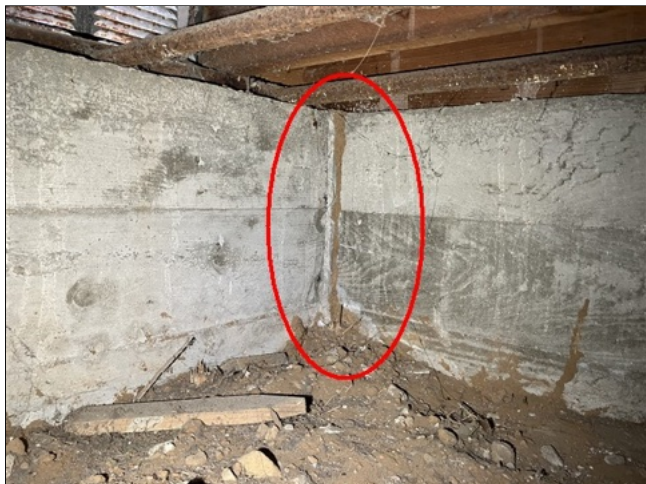
(1) Possible WDO (wood destroying organisms) evidence or damage was visible at areas of the structural flooring system. It is recommended to have a licensed pest control company evaluate all WDO related damages and remediate as needed.

5.2 Item 1(Picture) possible WDO evidence or damage observed

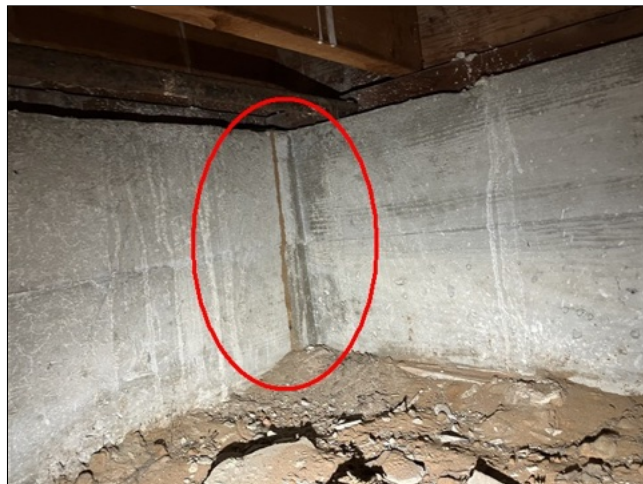
5.2 Item 2(Picture) possible WDO evidence or damage observed

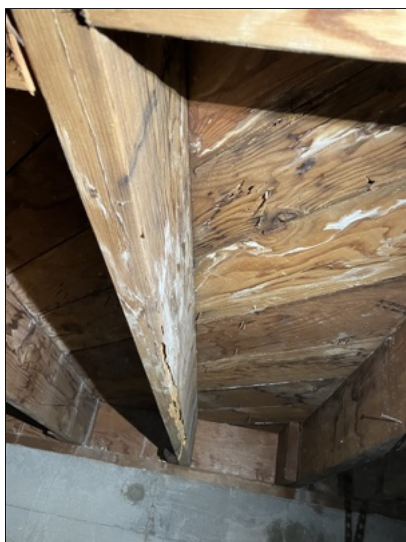
(2) Moisture stains or other evidence of past moisture intrusion were observed at areas of the flooring system. No moisture was observed at the time of the inspection. Only further evaluation and investigation can determine the cause and identify presence of hidden damages.

5.2 Item 3(Picture) subfloor area: moisture stains or damage visible

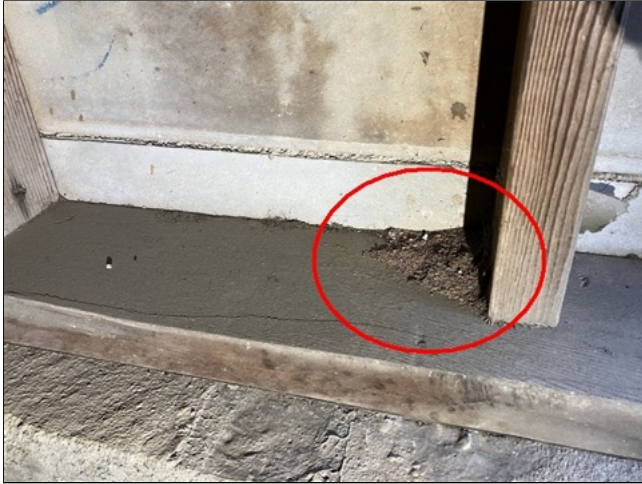
(2) Possible WDO (wood destroying organisms) evidence or damage was visible. It is recommended to have a licensed pest control company evaluate all WDO related damages and remediate as needed.

5.3 Item 4(Picture) subfloor area: possible WDO evidence or damage observed

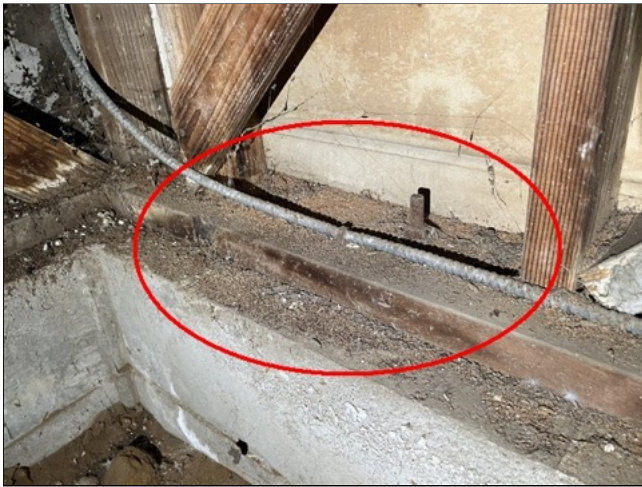
5.3 Item 6(Picture) subfloor area: possible WDO evidence or damage observed

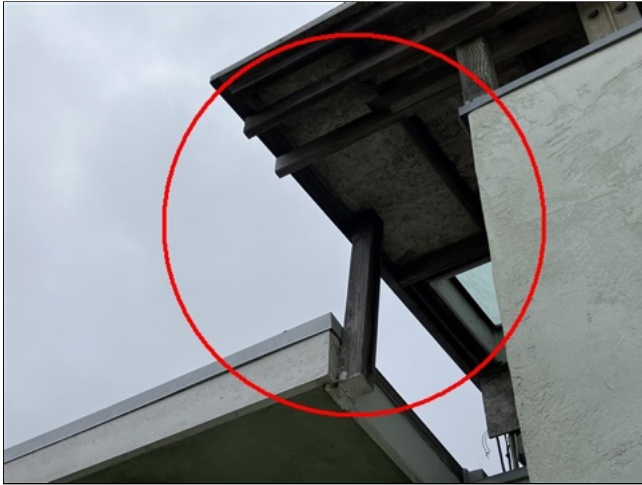
(2) Disclaimer: It is outside the scope of this inspection to determine original construction from later additions or modifications. Some evidence was observed that may indicate modifications from the original construction. Any changes from the original construction should be evaluated by a qualified contractor, architect, or engineer to determine if modifications were performed according to the appropriate building regulations at the time of construction.

5.7 Item 1(Picture) possible evidence of modifications to original construction observed / substandard installation or building material was observed / recommend further evaluation

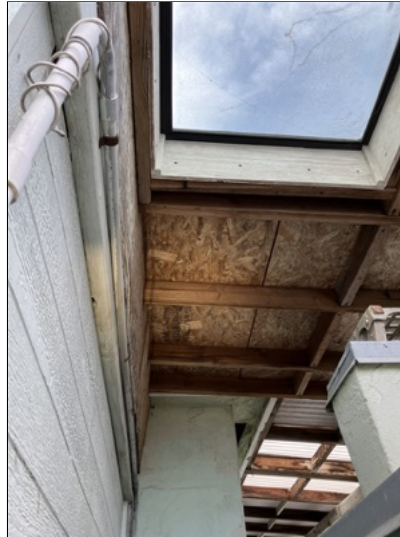
5.7 Item 2(Picture) possible evidence of modifications to original construction observed / substandard installation or building material was observed / recommend further evaluation

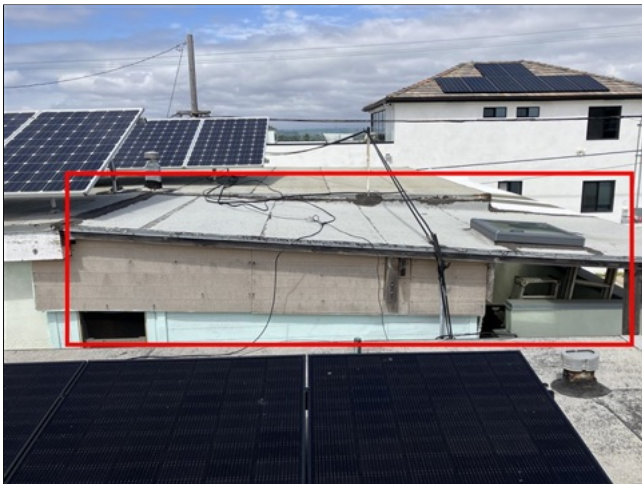
5.7 Item 3(Picture) possible evidence of modifications to original construction observed / substandard installation or building material was observed / recommend further evaluation

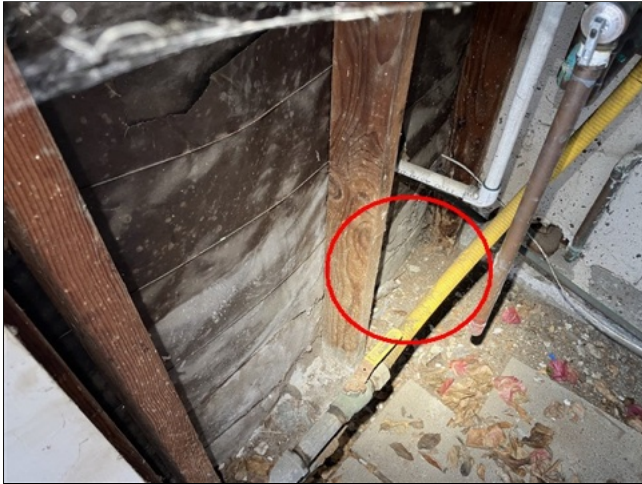
(1) The water heater shed was damaged, deteriorated, or has other visible defect that should be evaluated by a qualified tradesman and repaired/replaced as needed.

6.0 Item 1(Picture) water heater storage shed:  
possible WDO evidence or damage observed
