# Inspection Report

**Property Address:**  
4768-72 Coronado Ave  
San Diego CA 92107

**Foresight Building Inspection**

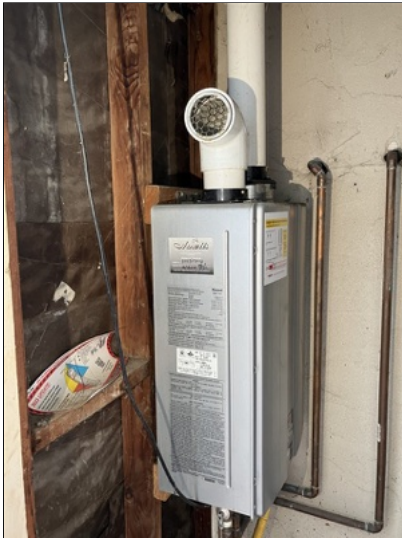
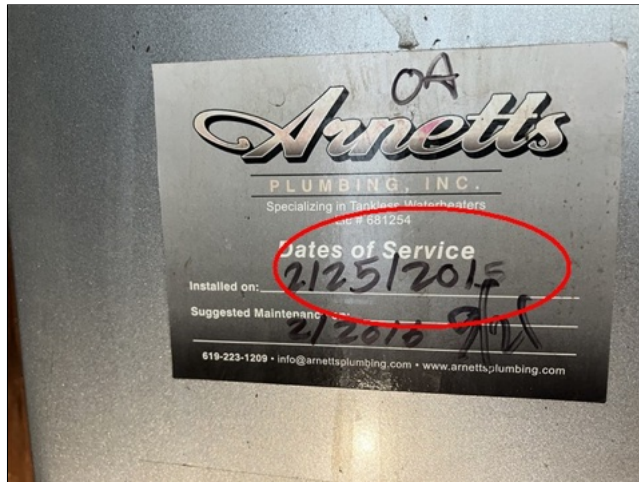
(2) The water heater was operational at the time of the inspection but one or more components was near to exceeding their expected serviceable life. Further evaluation from a qualified plumber is recommended to determine current servicing/maintenance needs and the remaining life expectancy.

6.0 Item 2(Picture) tankless water  
heater

6.0 Item 3(Picture) installed 2015

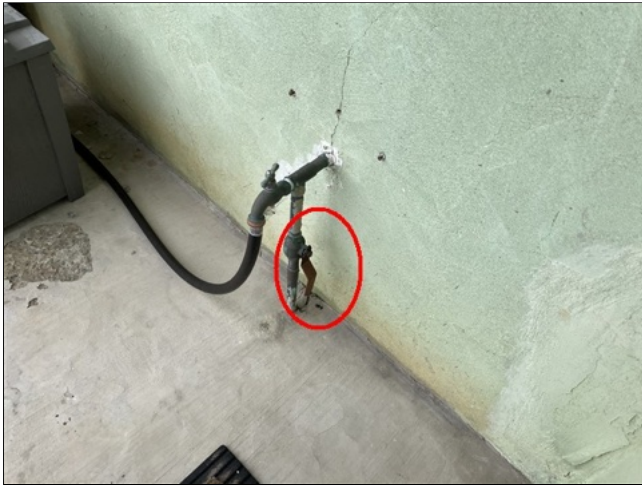
6.1 Item 1(Picture) near unit 4768: water shut off valve for all units

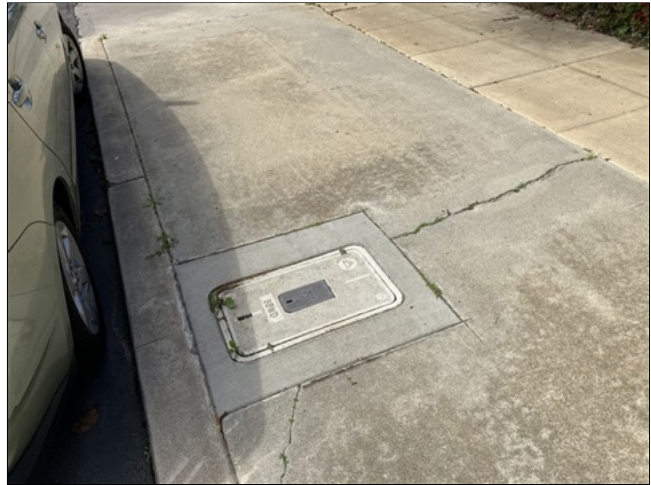
6.1 Item 2(Picture) water meter and main shut-off

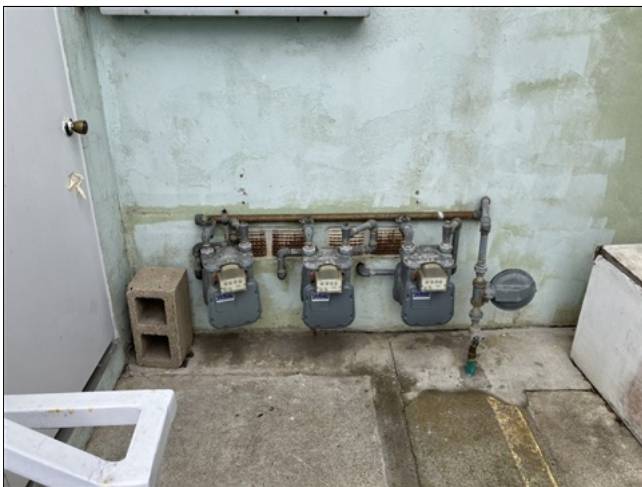
6.2 Item 1(Picture) 3 meters and main disconnects

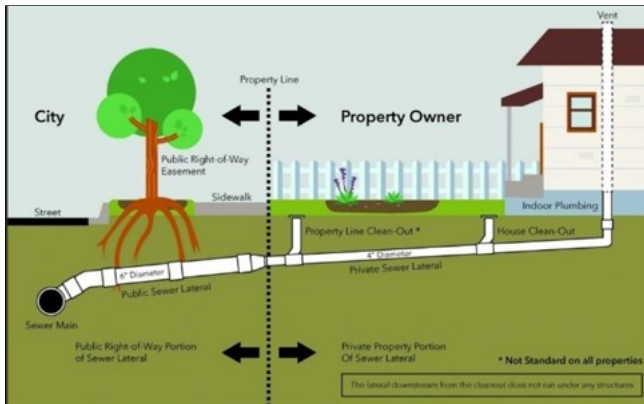
6.3 Item 1(Picture)

(1) Plumbing DWV (drain, waste, vent) systems may have hidden defects that can only be detected with further inspection from a qualified plumber who provides drain video/camera inspections. Because the scope of this inspection is limited to only visible and accessible systems and components, it is recommended to contact a licensed plumber for further inspection and evaluation.

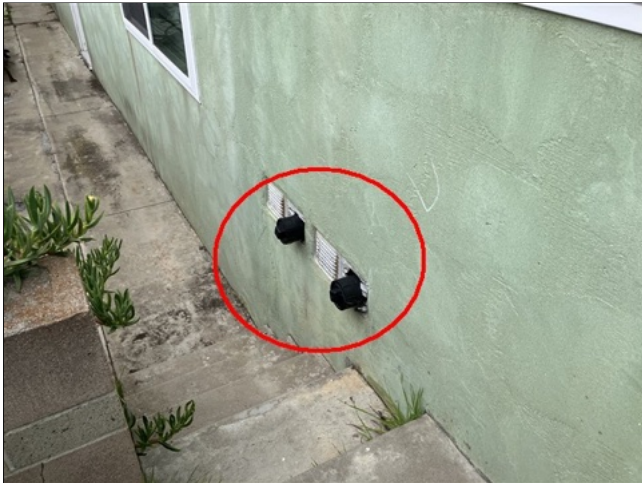
6.3 Item 3(Picture) sewer camera inspection recommended

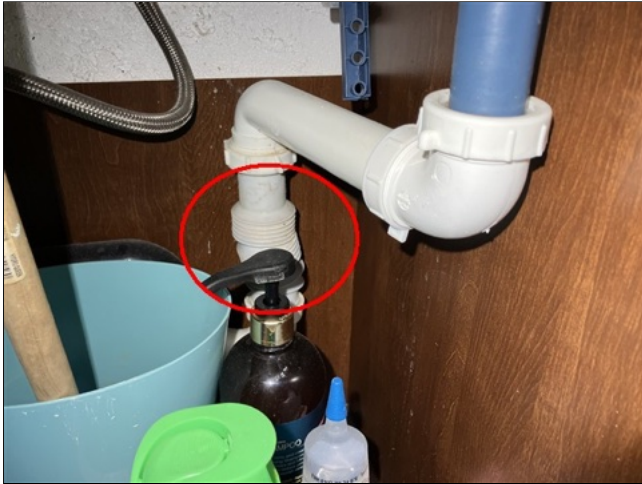
(2) A corrugated flexible plastic material was observed at one or more of the sink drain systems. While these are often used in repairs by home owners and handy-men, they should be treated as a temporary repair. It is recommended to have corrugated pipe replaced with appropriate hard drain pipe material.

6.3 Item 5(Picture) unit 4772 (alley side) bathroom: substandard drain material

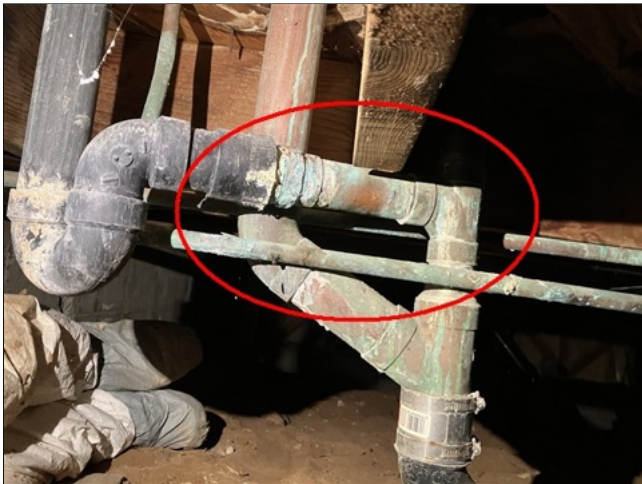
(3) The DWV (drain,waste,venting) system or components appeared aged with signs of deterioration and may have exceeded or are near to exceeding their expected serviceable life. Further evaluation from a qualified plumber is recommended to determine remaining life expectancy and replacement as needed.

6.3 Item 6(Picture) subfloor area: oxidation visible at copper branch drain

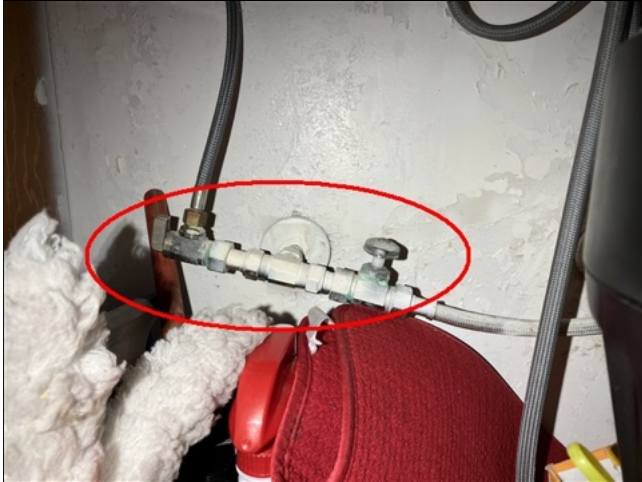
One or more of the plumbing fixture/appliance supply valves or hoses appeared aged or had visible signs of oxidation and may have exceeded or are near to exceeding their expected serviceable life. It is recommended to have a licensed plumber evaluate to determine remaining life expectancy or replace as needed.

6.4 Item 1(Picture) unit 4770: aged water supply valves/hoses observed

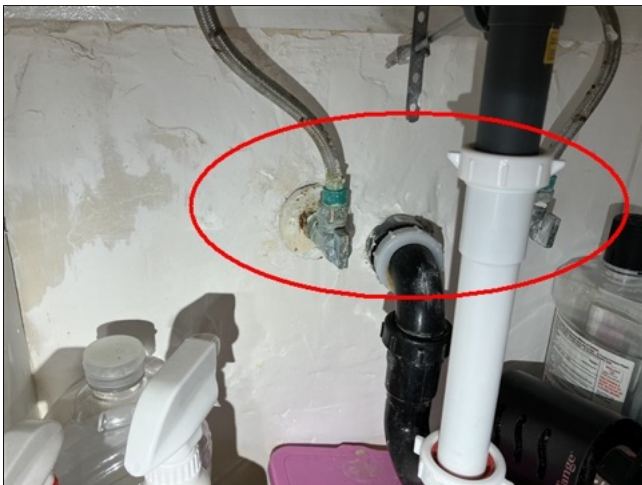
6.4 Item 3(Picture) unit 4772: aged water supply valves/hoses observed

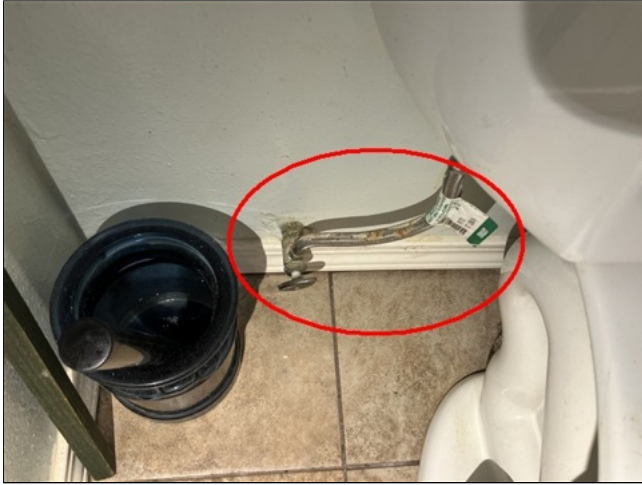
There was leaking, deterioration, or other visible defect observed at one or more of the plumbing fixture/appliance supply hoses or valves. It is recommended to have the valves and hoses evaluated by a licensed plumber and repaired/replaced as needed.

6.4 Item 5(Picture) unit 4772 (alley side): oxidation visible at valve/hose

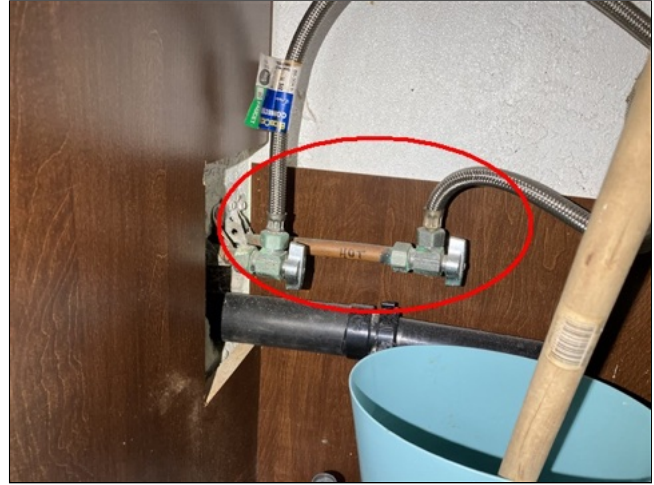
6.4 Item 6(Picture) unit 4772 (alley side): oxidation visible at valve/hoses

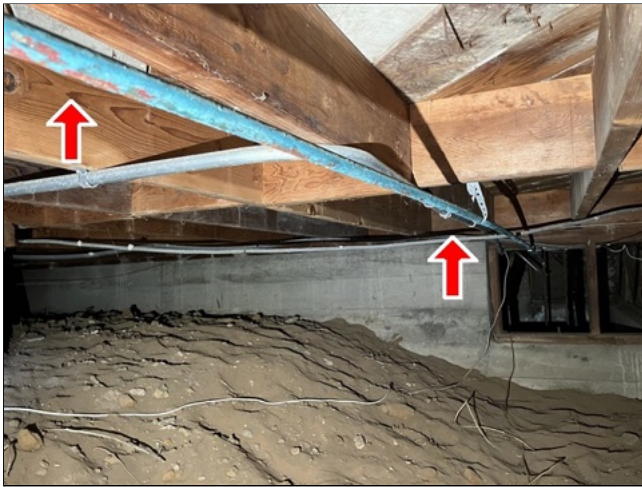
6.4 Item 7(Picture) subfloor area: oxidation visible at water supply pipe

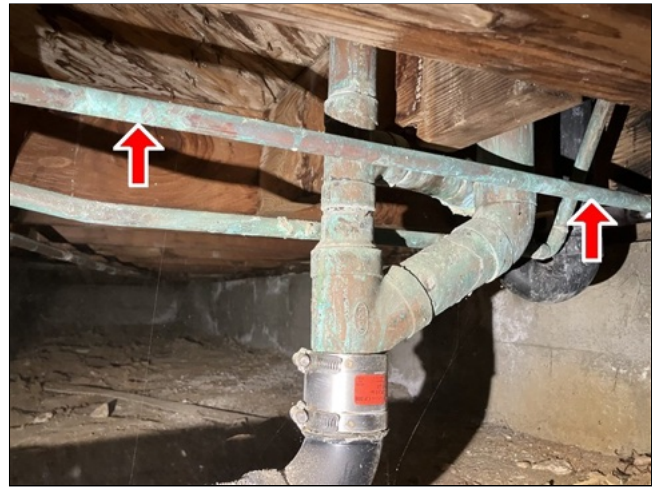
6.4 Item 8(Picture) subfloor area: oxidation visible at water supply pipe

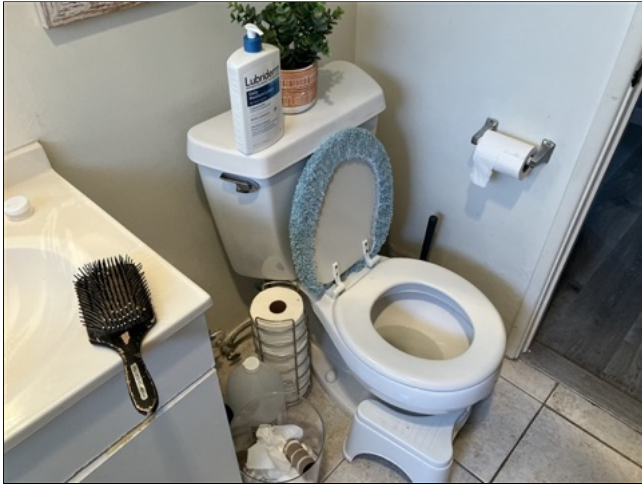
(1) One or more of the plumbing fixtures (toilets, sinks, faucets, tub/shower valves, etc.) were loose, leaked during operation, or had other observable defect. It is recommended to have the fixtures evaluated by a licensed plumber and repaired/replaced as needed.

6.5 Item 1(Picture) unit 4772: loose toilet / flushing mechanism did not operate properly when tested / toilet did not appear to be 1.6 gpf

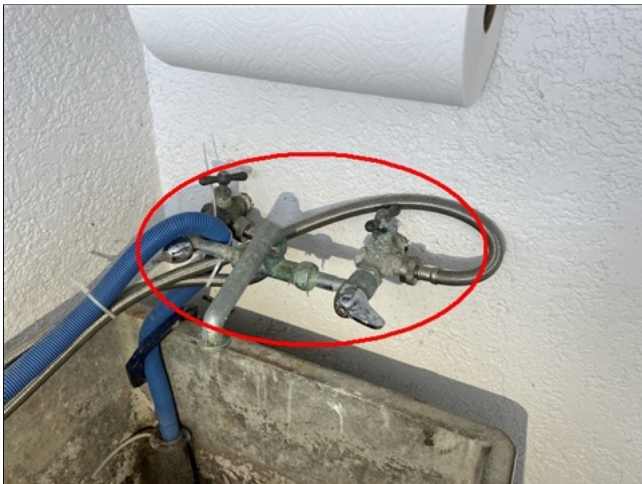
(2) One or more of the plumbing fixtures (sinks, faucets, tubs, etc.) appeared aged and may have exceeded or are near to exceeding their expected serviceable life. It is recommended to have the aged fixtures evaluated by a qualified plumber to determine remaining life expectancy and replacement as needed.

6.5 Item 3(Picture) laundry room: aged sink basin faucet

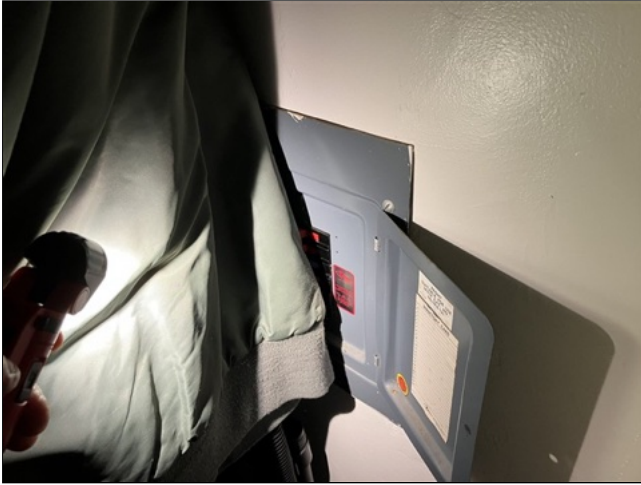
The location of one or more of the electrical distribution panels did not comply with modern panel location standards. Panels are no longer permitted to be installed in bathrooms and clothes closets. Height limitations and other location restrictions have also been modified over the years to improve safety and accessibility. Because these changes may not have been required at the time of construction, it is recommended to have a licensed electrician evaluate and upgrade as needed.

7.2 Item 3(Picture) unit 4772: electrical panel location upgrade recommended

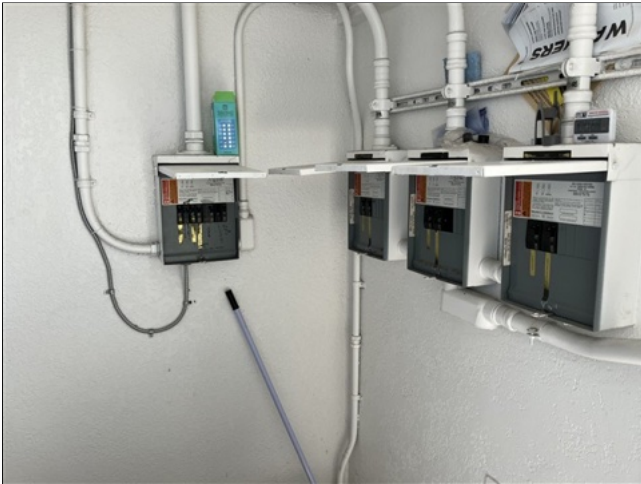
7.2 Item 4(Picture) subpanels located in the laundry room

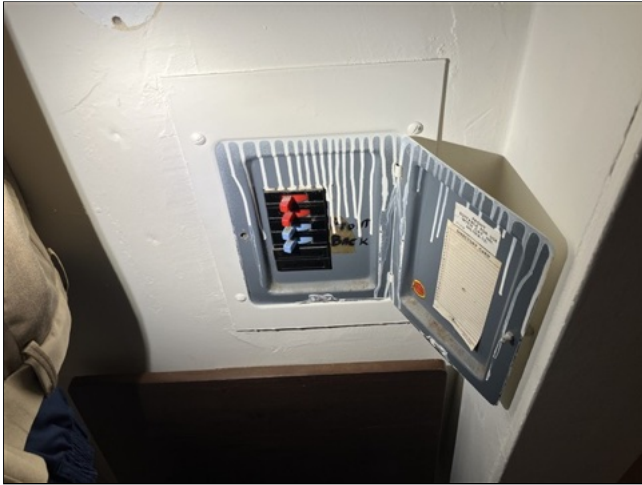
(1) One or more Zinsco electrical panels (sometimes labelled as Sylvania or Magnetrip depending on the decade it was installed) were observed. Zinsco panels and their components have been considered problematic by some industry professionals due to their higher rate of failure. Because failure of any component within the electrical system is an electrical safety concern, Further evaluation of the panel and its components by a licensed electrician is recommended.

7.3 Item 1(Picture) unit 4768: a Zinsco panel performance and safety inspection by a qualified person is recommended

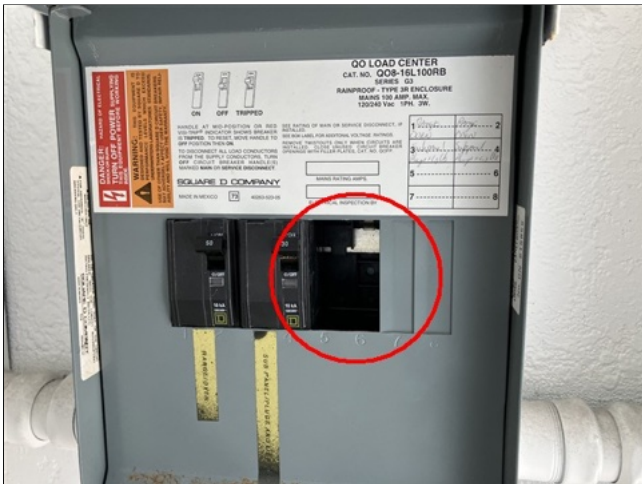
(2) There was one or more empty breaker slots in the electric panel that should be filled with an appropriate breaker blank cover.

7.3 Item 3(Picture) laundry room subpanel: missing breaker blank

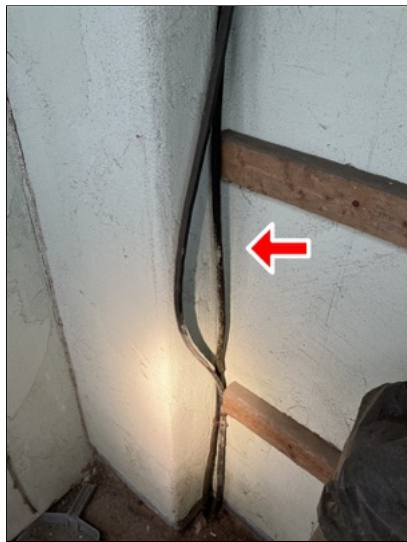
Improper wiring method, damages, or other defects were observed at areas of the branch circuit wiring or breaker system. All electrical system and component defects should be considered safety hazards. It is recommended to have the systems evaluated by a licensed electrician and repaired/replaced as needed.

7.4 Item 1(Picture) view from second floor patio: exposed wire appeared subject to damage

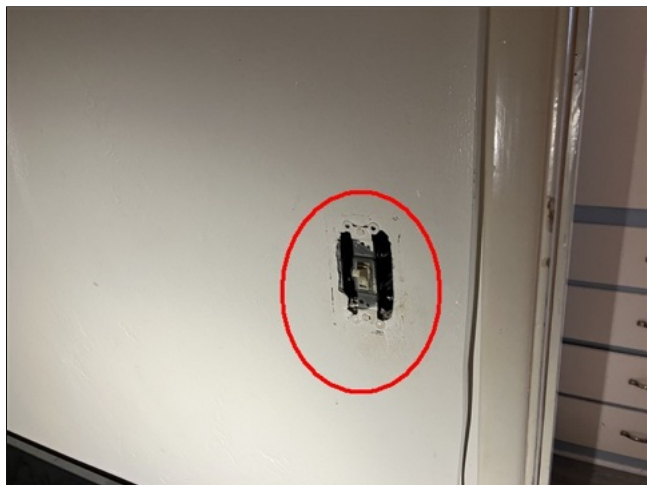
Defects were observed at one or more of the outlets, switches, or fixtures. All electrical system and component defects should be considered safety hazards. It is recommended to have a licensed electrician evaluate all outlets, switches, and fixtures and repair/replace as needed.

7.5 Item 3(Picture) unit 4772: missing switch cover

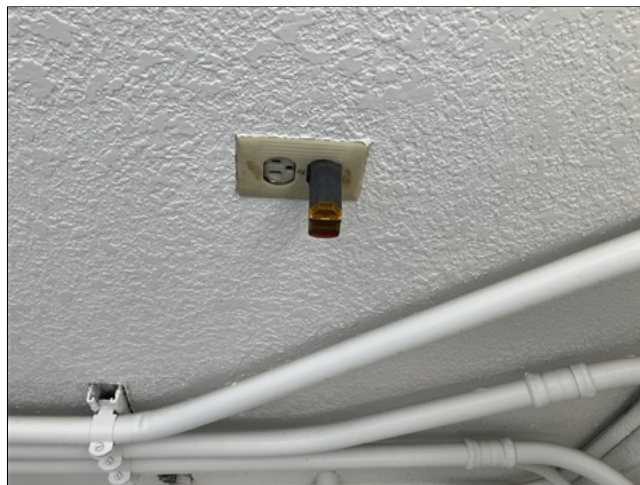
7.5 Item 4(Picture) laundry room: no power at outlet

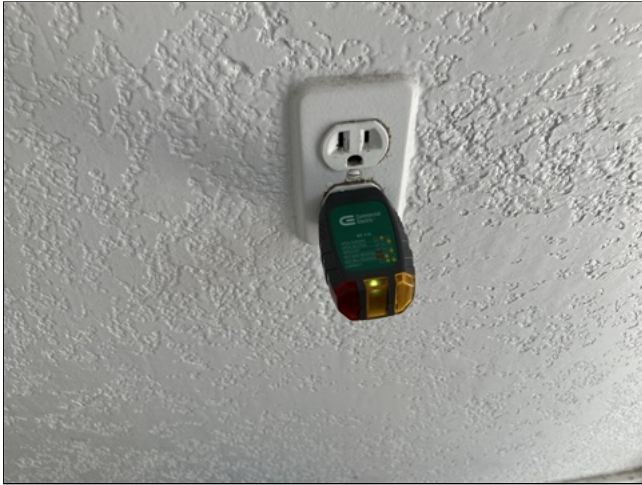
(2) One or more of the tested three-pronged outlets did not appear to be grounded. Buildings with older wiring systems used two-pronged outlets which were not grounded. These often get replaced with a modern three-pronged outlets, but unless a ground wire is installed or the replacement outlet is a GFCI, this is not permitted. It is recommended to have a licensed electrician evaluate all non-grounded three-pronged outlets and repair/replace as needed.

7.6 Item 5(Picture) laundry room: non-grounded three-pronged outlets observed

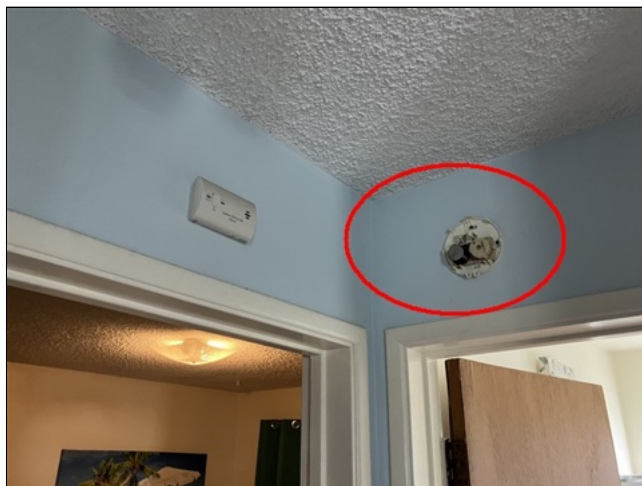
7.7 Item 4(Picture) unit 4772: missing hallway smoke detector

If there is no visible installation date or the age cannot be verified, it is recommended to install a new detector with a visible date to facilitate future replacement. It is recommended to test detectors according to the manufacturers specifications. Consult with the local fire department for tips and other useful information on smoke alarm installation and maintenance.

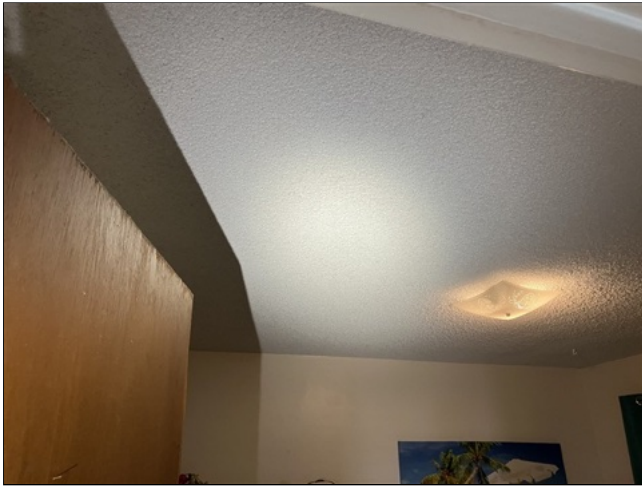
7.7 Item 5(Picture) unit 4772: missing bedroom smoke detectors

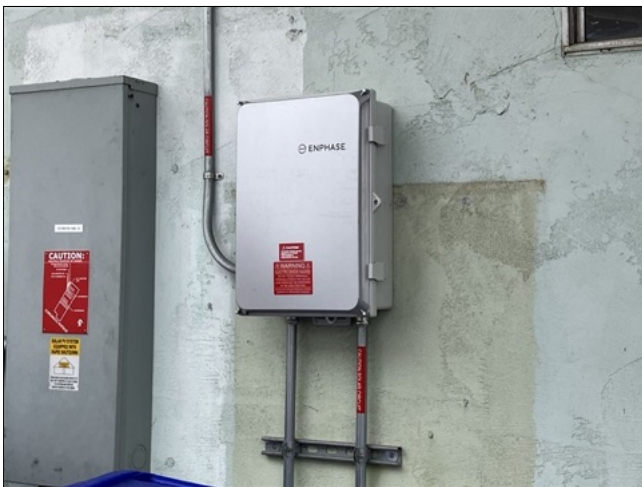
7.8 Item 1(Picture) solar system and components were not inspected or tested as part of the scope of this inspection

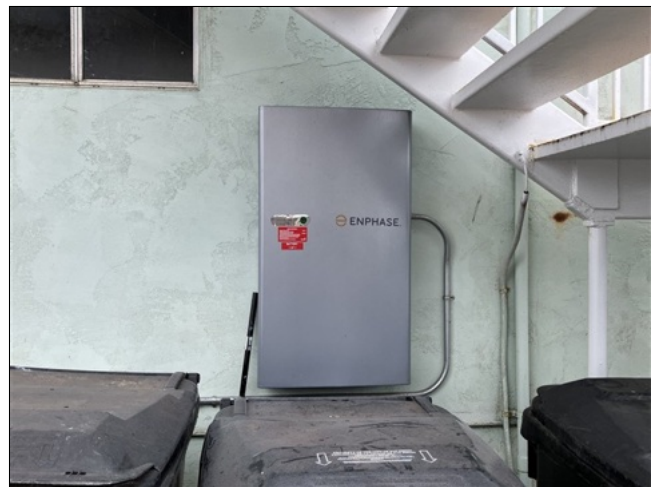
7.8 Item 2(Picture) solar system and components were not inspected or tested as part of the scope of this inspection

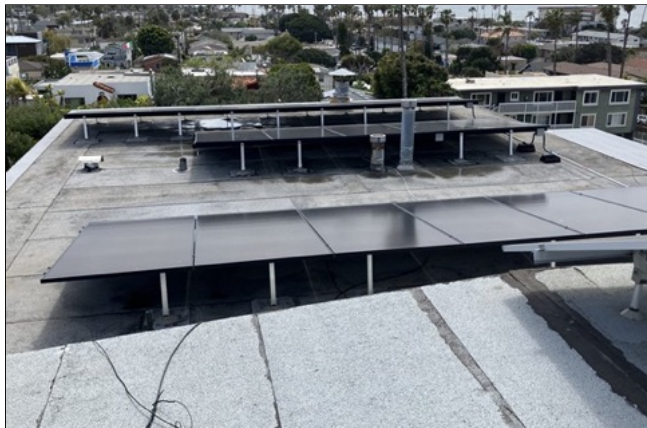
7.8 Item 3(Picture) solar system and components were not inspected or tested as part of the scope of this inspection

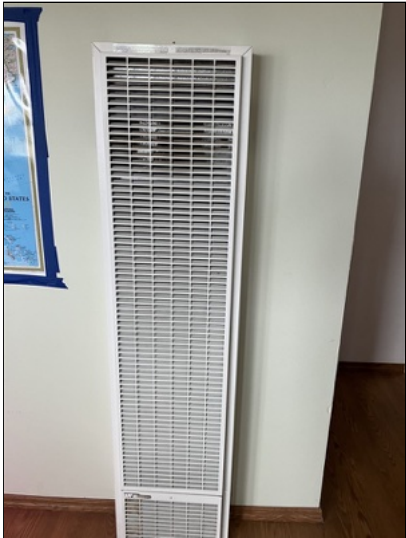
Because no current visible maintenance or service record was observed, a performance and safety inspection by a licensed HVAC technician is recommended. An annual inspection by a technician can report any defects outside the scope of this inspection and provide an estimated life expectancy for the system and components.

8.2 Item 1(Picture) unit 4768 wall furnace: no visible maintenance record observed

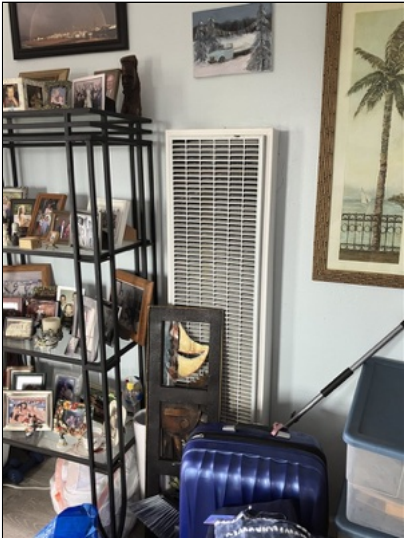
8.2 Item 2(Picture) unit 4772 wall furnace: no visible maintenance record observed

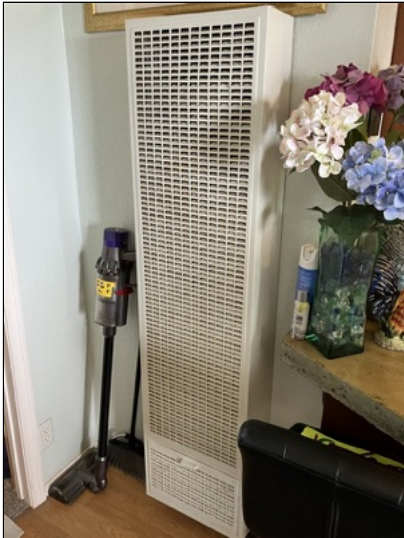
8.2 Item 3(Picture) unit 4772 (alley-side) wall furnace: no visible maintenance record observed

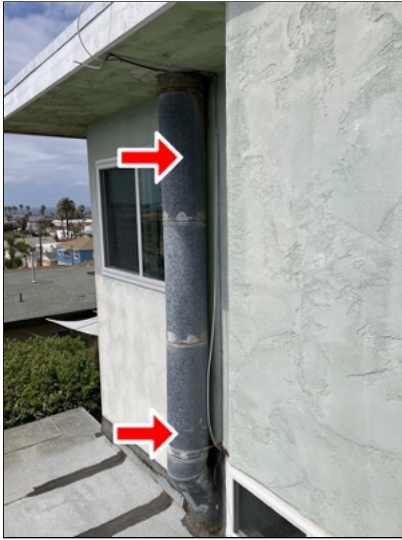
8.9 Item 1(Picture) exposed chimney flue appeared to be a safety hazard / recommend further evaluation and correction as needed

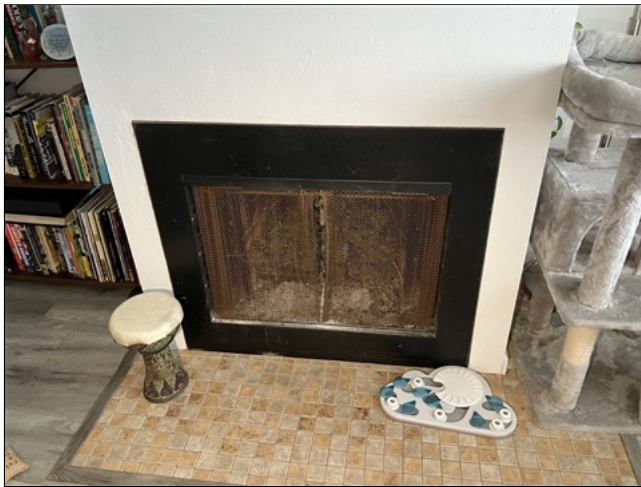
8.10 Item 1(Picture) unit 4770: a fireplace and chimney flue performance and safety inspection by a qualified person is recommended

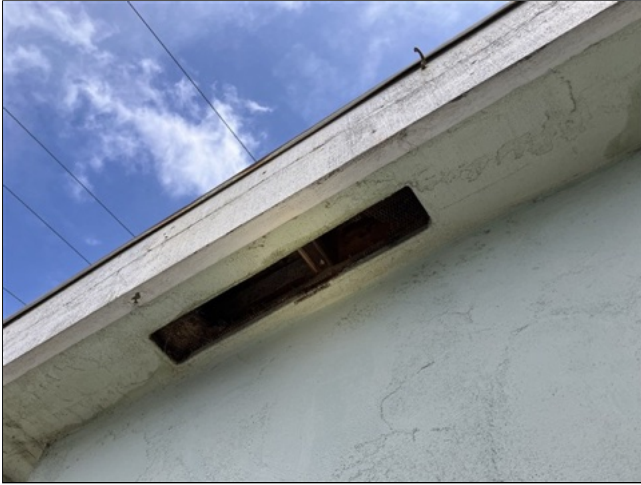
**Comments:** Repair or Replace  
(1) One or more of the crawlspace, attic, or garage vent screens were missing, deteriorated, or had other observable defect. Vent screens help control pest intrusion. It is recommended to have all damaged or missing vents evaluated and repaired/replaced as needed.

9.2 Item 3(Picture) deterioration/oxidation visible at vent screens

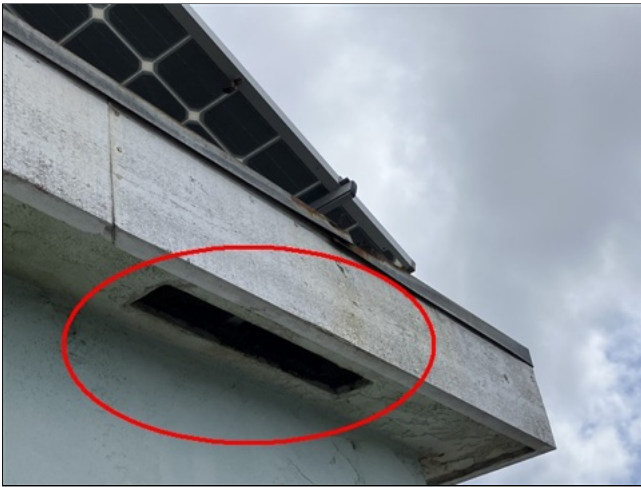
9.2 Item 5(Picture) deterioration/oxidation visible at vent screens

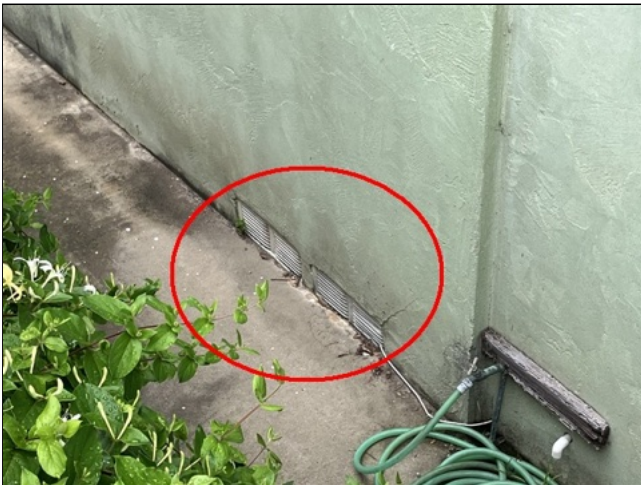
(2) One or more of the subfloor vents are below grade which increases the possibility for water intrusion into the subfloor area. It is recommended to have the vents evaluated by a licensed contractor and corrected as needed.

9.2 Item 6(Picture) vent appeared below grade level or was susceptible to moisture intrusion

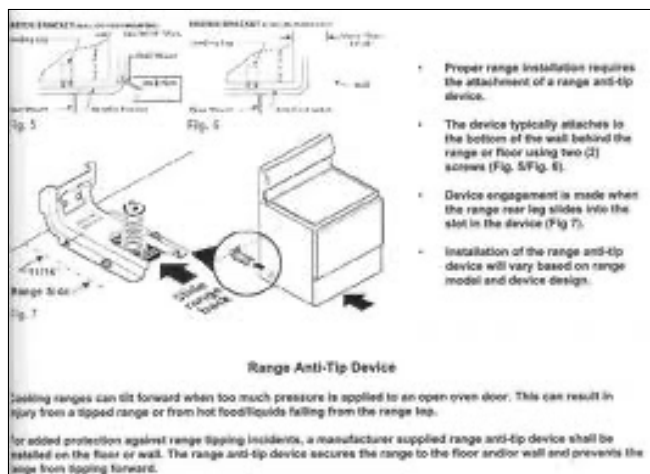
10.1 Item 1(Picture)

(1) It did not appear that an **anti-tip bracket** was installed on the range oven. These simple yet over-looked safety devices can prevent the appliance from tipping over causing potential serious injury or death. For more information on range oven safety, please see the following link from the United States Consumer Product Safety Commission:

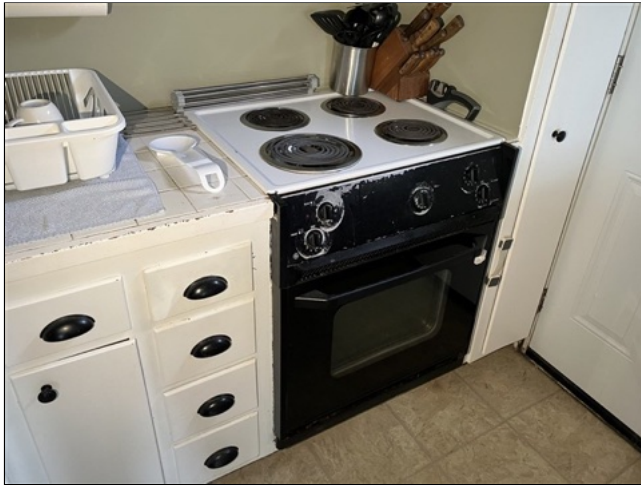
Multiple kitchen appliances appeared aged and appeared to have exceeded or are near to exceeding their expected serviceable life.

10.7 Item 1(Picture) unit 4768: aged range oven

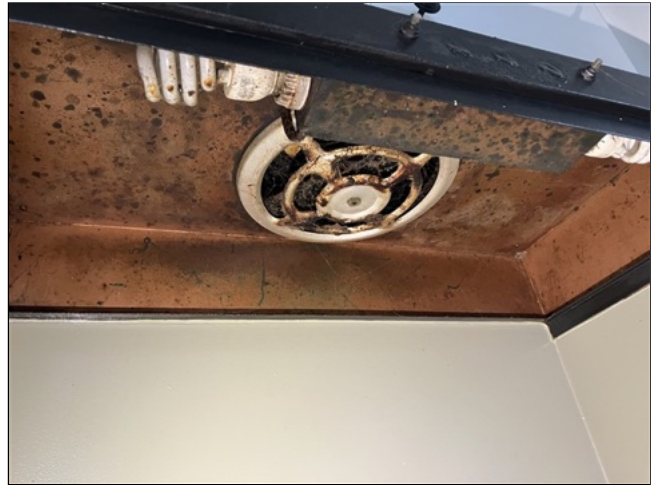
10.7 Item 2(Picture) unit 4768: aged hood

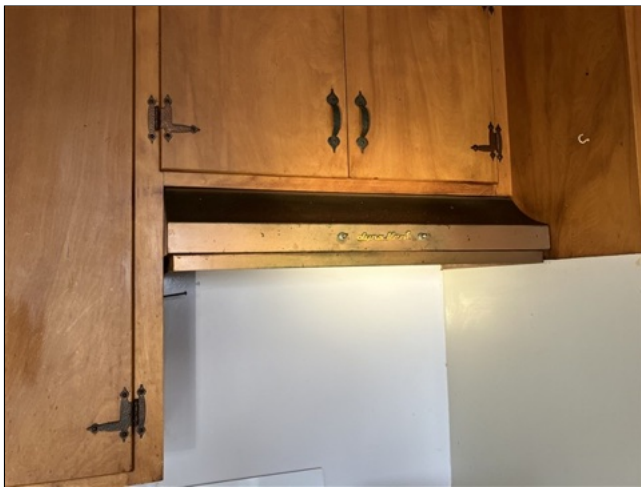
One or more of the range hoods appeared aged and may have exceeded or are near to exceeding its expected serviceable life. Further evaluation from a qualified appliance technician is recommended to determine remaining life expectancy or replacement as needed.

10.7 Item 3(Picture) unit 4772: aged range hood
