Summary of Inspector's Major Findings

LOCATED AT:
22587 Waterbury St
Woodland Hills, CA 91364

INSPECTED ON:
Wednesday, October 15, 2025

Inspector, Seth Keena Certified CREIA Inspector #165987
FIT Property inspectors
818-224-8869

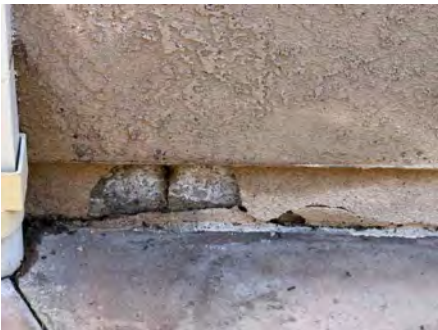
CR FE s-14: Access to the slab is limited as it is covered with finish flooring, vegetation etc. in most cases. We did check the accessible and viewable portions of the slab and one or more cracks were observed. Cracks are normally caused by movement in surrounding soil which Crack are caused by soil conditions, negative grading and/or drainage conditions. It can also be caused by construction deficiencies during the building process. We recommend further evaluation and corrections by a specialist in the appropriate trade.

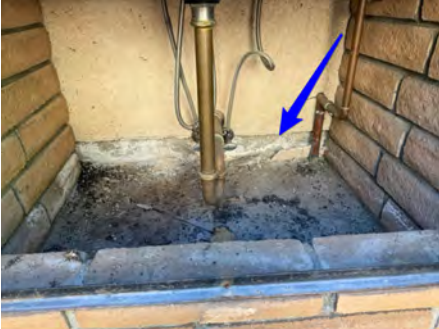
CR FE s-15: There was a condition known as efflorescence on portions of the slab. This is a white deposit left when moisture evaporates. It indicates that the foundation is experiencing wet and dry cycles. We recommend improvement of the exterior grading, exterior/landscape drainage, planters, landscaping, gutter and gutter downspouts as needed to correct this condition. This condition can cause settlement and deterioration of the foundation. This could also be caused by a high water table. We recommend further evaluation and corrections by a specialist in the appropriate trade.

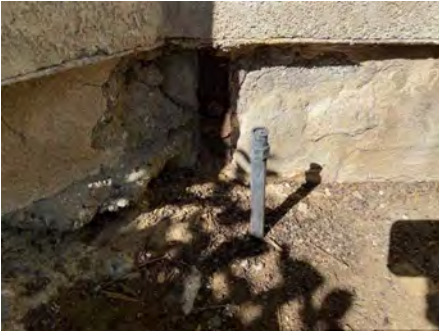
CR FE s-16: There is rebar or other metal foundation components that are exposed causing it to rust and flake the concrete. We recommend this be corrected by a specialist in the appropriate trade.

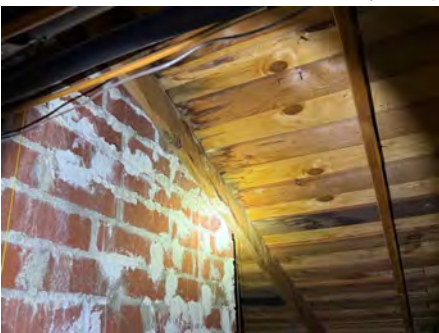
CR FE s-24: The wood sheathing in the attic space appears newer but shows signs of water staining and/or water damage. This sheathing likely was installed during the most recent roof replacement, and the observed staining is consistent with potential water intrusion from the roof system. We recommend further evaluation and corrections by a specialist in the appropriate trade.

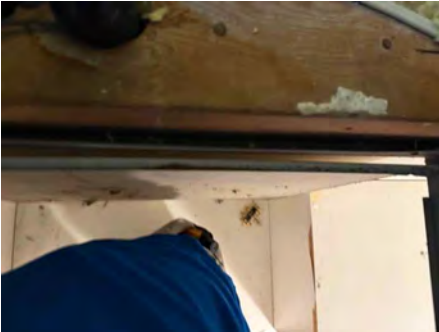
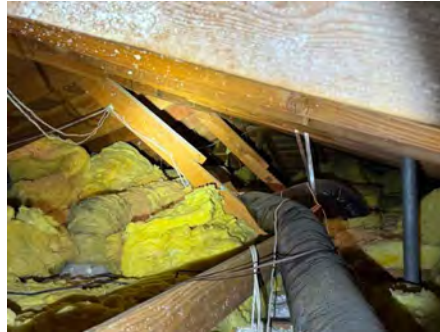
CR s-27: Some of the fiberglass batt insulation pieces are out of place or missing. This will cause energy loss and increase heating and cooling cost. It is recommend this be corrected by a specialist in the appropriate trade.

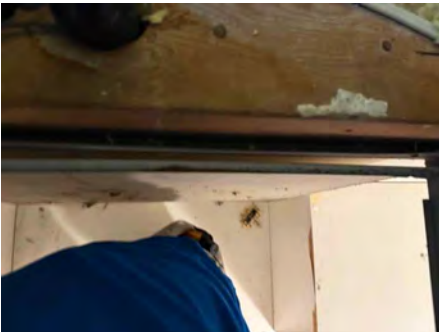
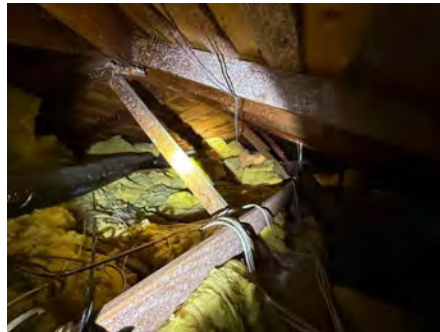
CR s-28: The insulation is deteriorated, which can lead to heat and energy loss. We recommend having it evaluated and upgraded by a qualified insulation specialist or contractor.

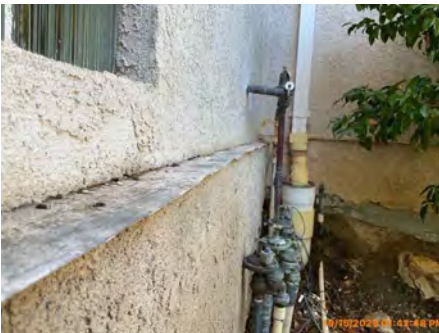
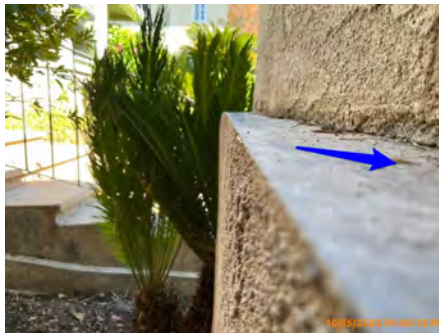
CR s-44: There is one or more sections of exterior flashing that are slopped towards the structure. This condition is conducive to moisture intrusion, damage and deterioration. Recommend this be corrected by a specialist in the appropriate trade.

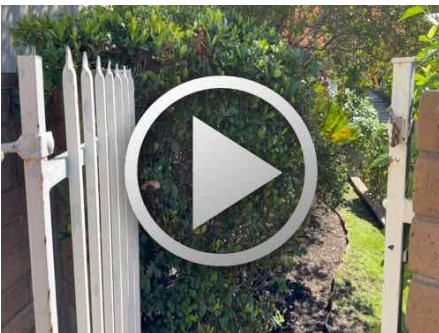
SC CR s-47: All gates that provide access the the pool, spa, lake, pond, river and/or ocean should be self-closing, and self-latching from a half open swing. This is to prevent children from trespassing. We recommend the corrections be performed by a specialist in the appropriate trade.

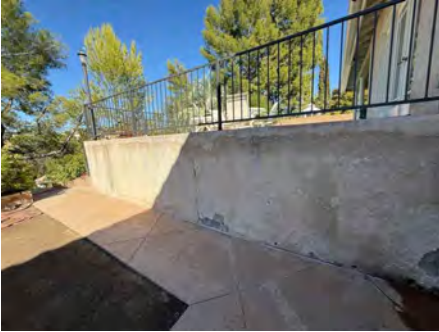
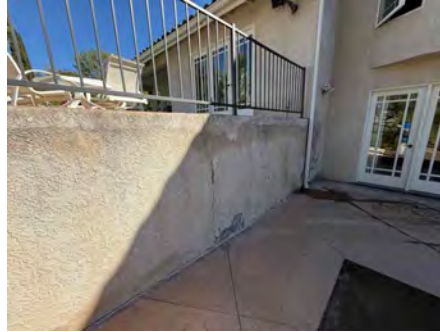
CR FE s-49: The retaining wall running front to back in the backyard, separating the two levels is cracked and water damaged. The drainage has also failed. Further evaluation and corrections by a specialist in the appropriate trade is recommended.

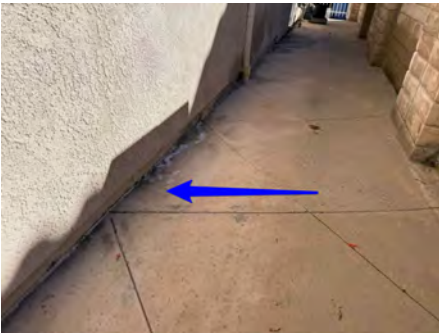
CR FE s-50: The dirt, soil and/or hardscape are sloped towards the structure in one or more areas. Soil, concrete etc. that is sloped towards the structure, which will cause water to accumulate at the base of the structure and in some cases cause water intrusion and foundation issues. Corrections like regrading, concrete jacking (lifting), adding drainage, adding roof, gutters, etc. are a few of the possible corrections used to correct negative grading. It is recommend this be addressed and corrected by a specialist in the appropriate trade.

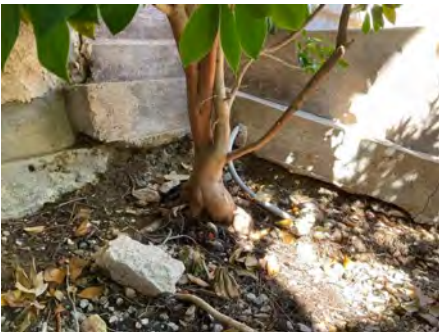
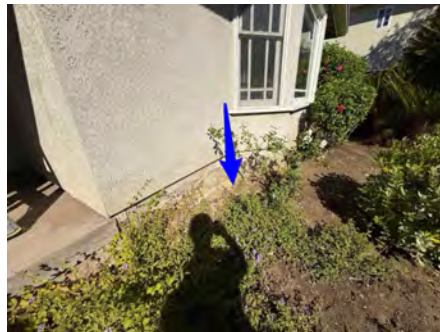
CR FE s-51: The property is showing of erosion which is expected on a hillside property. We recommend further evaluation and corrections by a specialist in the appropriate trade.

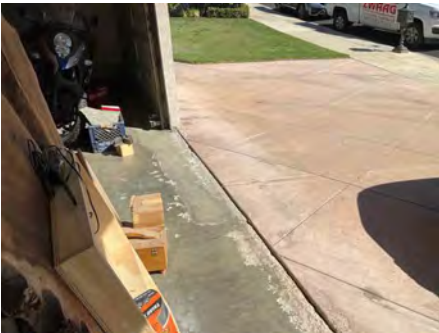
CR s-57: Concrete can expand a half inch for every 10 feet due to thermal expansion. There is usually a mastic or tar fibrous board filling the void in between the garage slab and the driveway, this allows room for thermal expansion. The expansion joint filler material also limits water that can enter in between the driveway and the garage slab as this condition can create settlement or lifting of the driveway. This expansion joint filler was deteriorated/missing. We recommend this be corrected by a specialist in the appropriate trade.

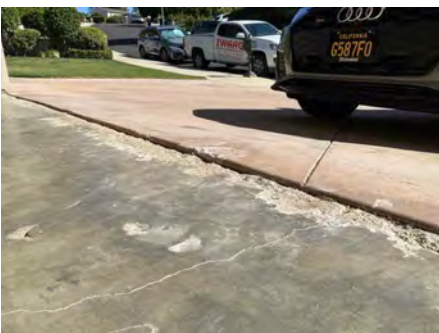
SC CR FE s-58: The driveway has a height difference at the expansion joint and/or cracks. Either the driveway has lifted or the garage slab has settled. Uneven transitions may create trip hazards and can be indicative of negative soil conditions. Further evaluation and corrections by a specialist in the appropriate trade is recommended.

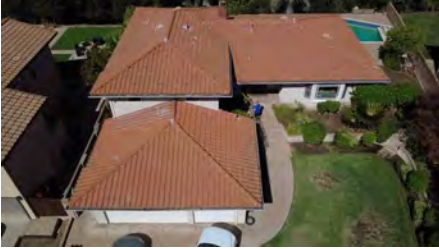
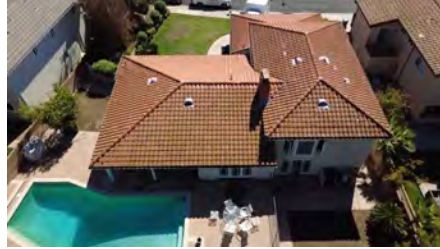
s-71: The tile roof is in serviceable condition, with exceptions noted below. Attention to the items listed, together with routine maintenance, will keep it functional and maximize its useful life.

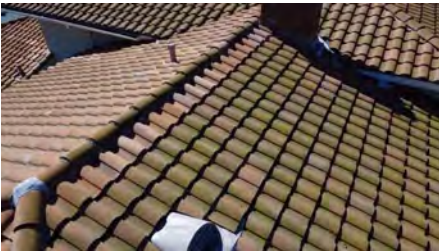
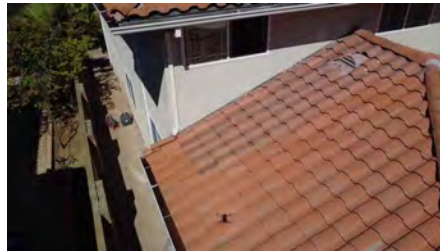
FE s-72: The materials used to patch the roof differ in color and/or newer from the original roofing material. This is indicative of a roof that has had maintenance performed. We recommend inquiring with the owner and/or HOA in regard to the conditions noted

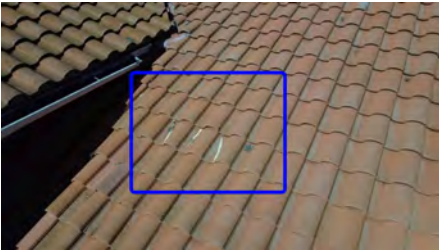
CR FE s-73: There is patching that is substandard and current future leakage is possible. We recommend repair or replacement to prevent leakage. We recommend the further evaluation and corrections by a specialist in the appropriate trade.

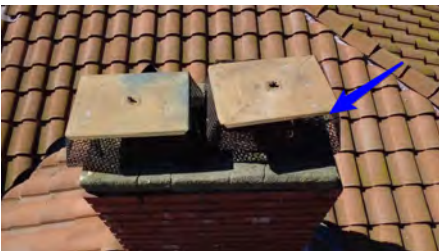
CR s-75: The spark arrester/cap is loose and out of place. We recommend correcting the condition noted.

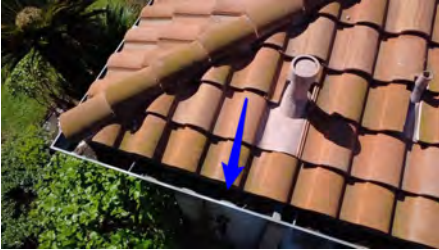
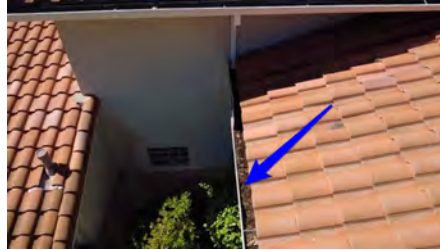
CR s-77: Debris, leaves, dirt, etc. was present in the gutters, which limited our visual inspection. Debris in gutters could be a sign they are not functioning properly or they simply have not been cleaned regularly. We recommend correcting the condition noted.

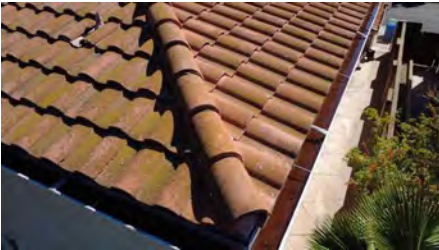
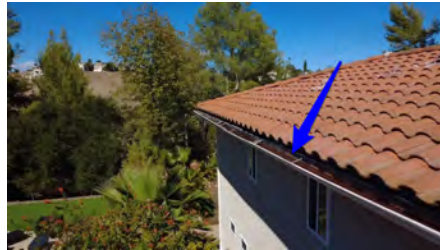
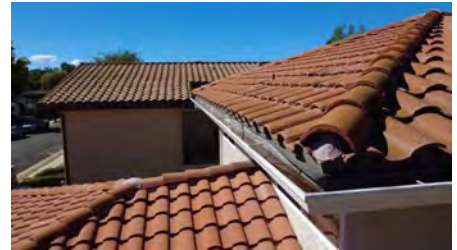
CR s-78: The gutters are not draining as they they are damaged, improperly sloped and/or clogged at the downspout. Recommend this be corrected by a specialist in the appropriate trade.

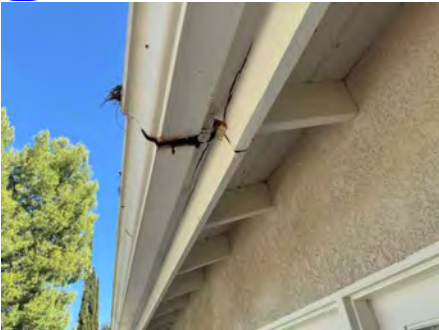
CR s-79: The gutters are severely deteriorated. Gutter replacement should be expected.

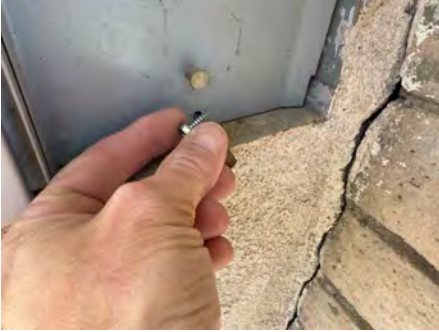
SC CR s-92: The pointed screws installed in the electrical panel should be replaced with blunt end screws to minimize the chance of piercing a wire. We recommend this be corrected by a specialist in the appropriate trade.

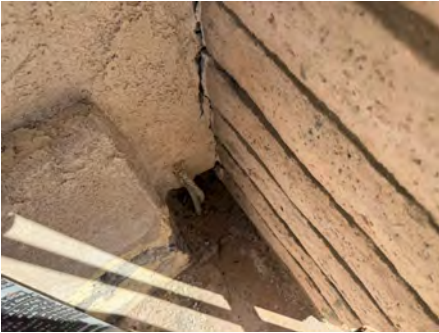
CR FE s-94: The grounding clamp, conductor or conduit is buried in soil or encased in concrete. Proper termination of conductors could not be verified. Grounding termination locations should be accessible. It is recommend this be corrected by a specialist in the appropriate trade.

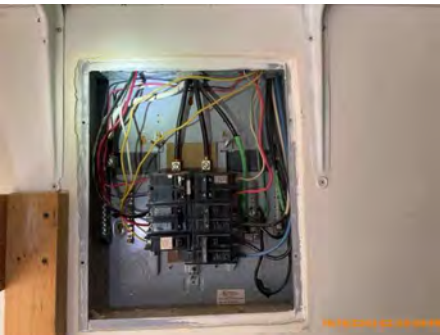
SC CR s-98: The pointed screws installed in the electrical subpanel should be replaced with blunt end screws to minimize the chance of piercing a wire. We recommend this be corrected by a specialist in the appropriate trade.

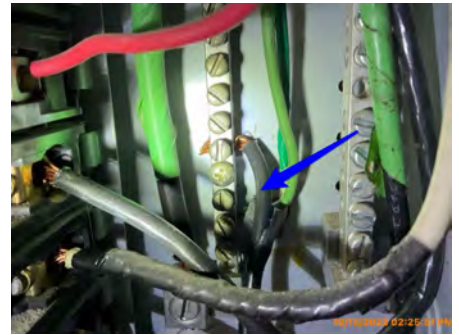
SC CR s-100: There was a conductor being used that was not the correct color for the application it was being used for. We recommend this be corrected by a specialist in the appropriate trade.

Should be white

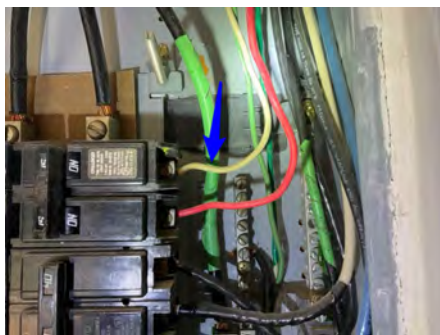
Should be green

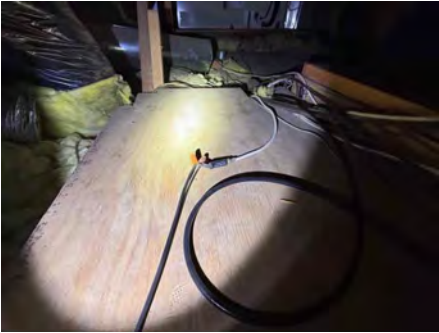
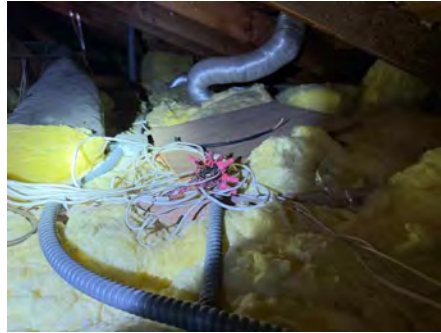
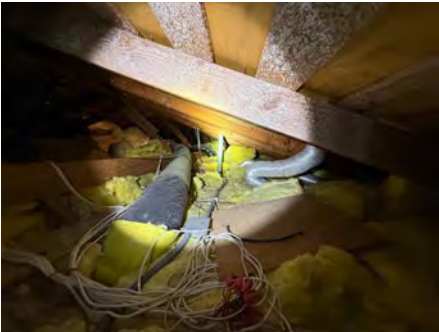
SC CR s-106: Running splices, which are improper connections outside of a junction box, are used in several areas. All splices should be made with approved connectors inside a junction box to prevent accidental contact or mechanical damage. It is recommend this be corrected by a specialist in the appropriate trade.

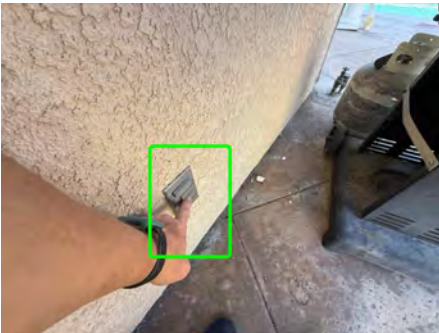
SC RU s-109: GFCI protection was not found at all receptacles outside where this feature is now required. We recommend GFCI protection be installed at all outdoor receptacles as an upgrade.

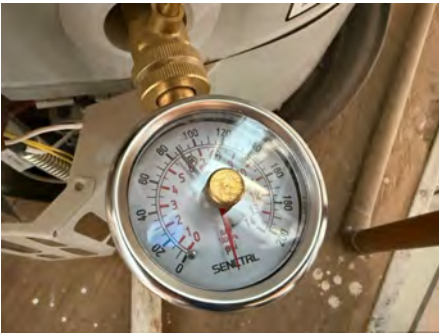
CR s-125: The system water pressures was 89 PSI, measured at the exterior bib, water heater or washer hook up. Normal/recommended is 40-75 PSI This can result in unnecessary leakage and damage of system valves, seats and washers. We recommend that the pressure reduction valve be adjusted or replaced.

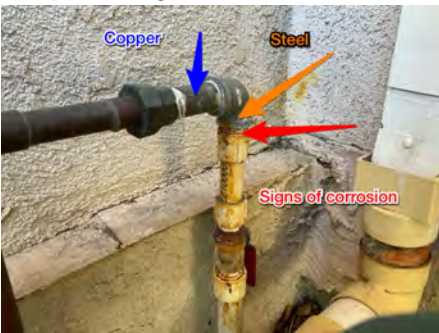
CR s-127: Copper piping is contacting directly with galvanized piping. There should be a buffer in between the two materials. This configuration is not approved and can lead to premature deterioration of the plumbing. We recommend this be corrected by a specialist in the appropriate trade.

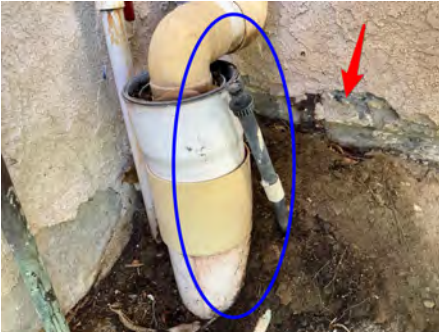
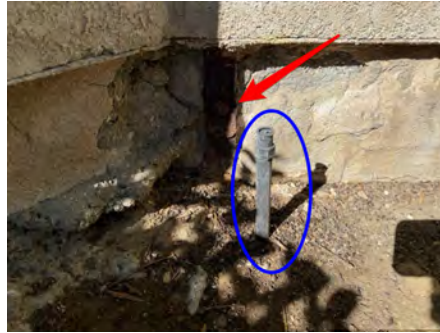
CR s-131: There are sprinklers too close to the structure. This can cause saturation and deterioration of the building envelope and/or foundation, settlement of the foundation etc. We recommend these sprinklers be removed or drip lines be installed. We recommend this be corrected by a specialist in the appropriate trade.

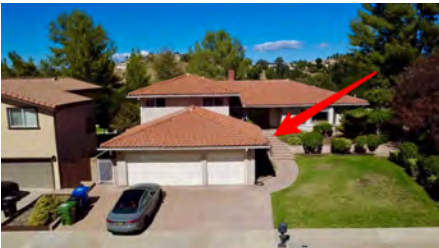
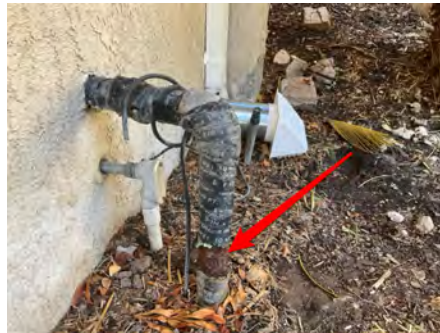
SC CR s-135: The accessible and observed gas piping is severely corroded. We recommend the gas piping be primed and painted if possible, replacement may be needed. We recommend this be corrected by a specialist in the appropriate trade.

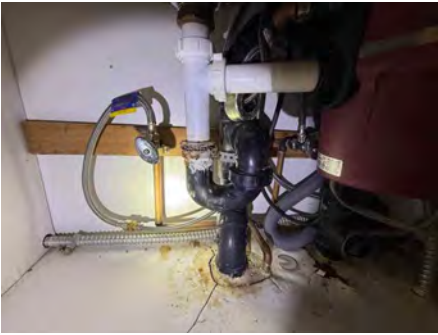
CR FE s-141: There was water stains and/or damage underneath the cabinets. These appear to be older. No active leak was observed during the inspection.

P-trap could leak again any anytime

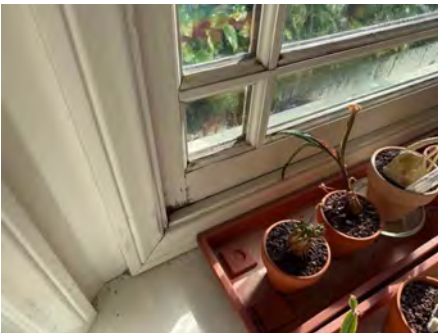
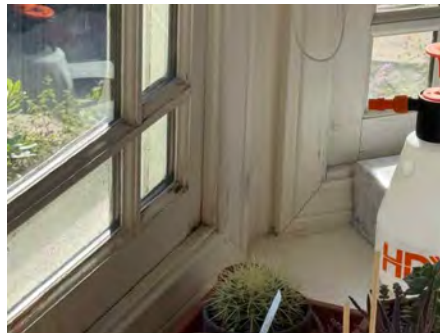
CR s-145: There is condensation, damage from condensation or others signs the hermetic seal(s) (thermal seals) has failed in one or more multi-pane windows in this area. We recommend this be corrected by a specialist in the appropriate trade.

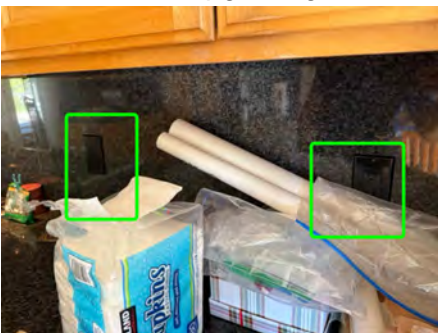
SC RU s-149: Some or all of the countertop outlet(s) are not GFCI protected, which was typical for the time this home was built but doesn't meet current safety standards. For added protection, especially around water, upgrading to GFCI outlets is recommended. This should be done by a qualified electrician.

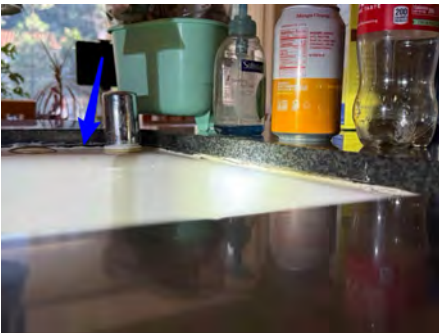
CR s-157: The sink has separated from the counter. The supports are not proper or failing. This condition is conducive to moisture damage under the sink. We recommend this be corrected by a specialist in the appropriate trade.

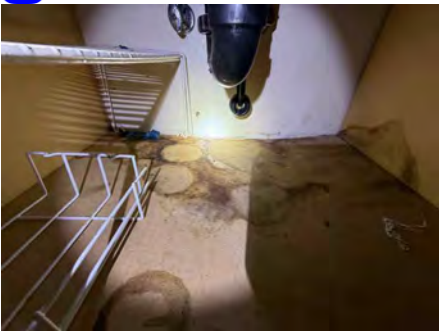
CR s-170: The cabinets are water damaged. We recommend correcting the condition noted.

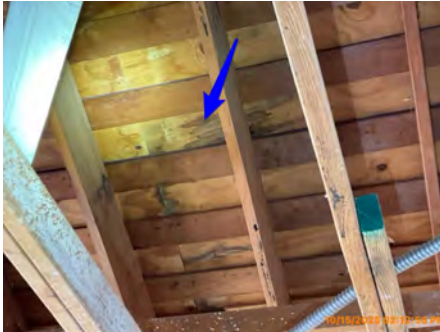
CR FE s-189: There was water stains and/or water damage observed at the ceiling. We recommend finding the source of the water and correcting the condition noted. We recommend further evaluation and corrections by a specialist in the appropriate trade.

Water stains on newer sheathing

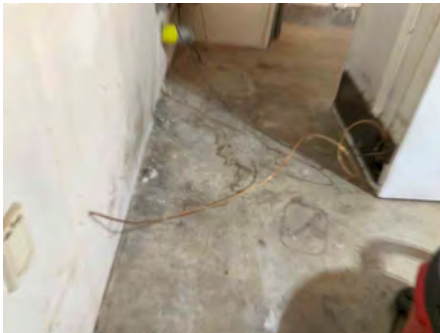
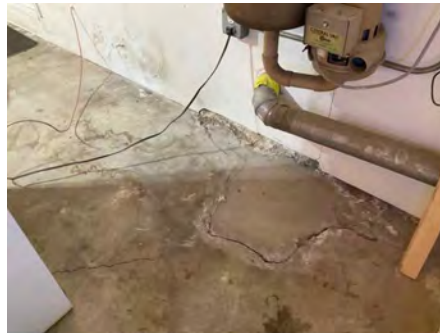
CR s-190: The concrete slab in the garage was Damaged and cracked with the cracks having variances in heights that . Further evaluation and corrections by a specialist in the appropriate trade is recommended.

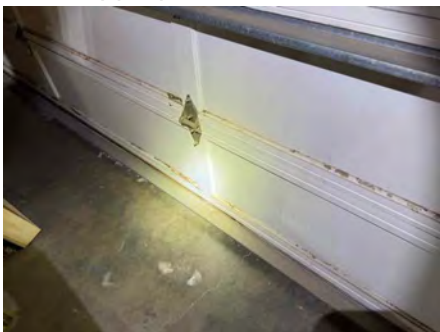
CR FE s-193: The garage door was water damaged. We recommend further evaluation by a specialist in the appropriate trade.

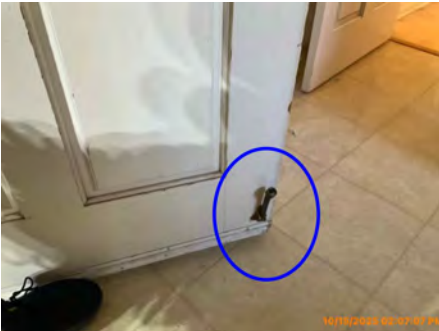
SC CR s-200: There was a prop open/kickstand device on the door. This should be removed for safety reasons. We recommend correcting the condition noted.

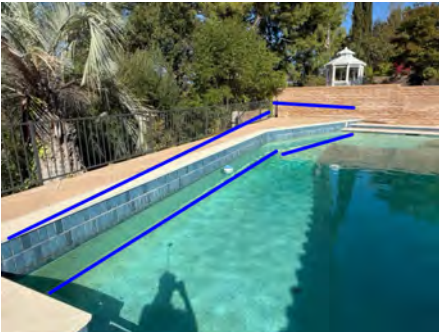
CR FE s-218: There are areas of the spa tile/stone that are not adhered well and/or missing. This is evident by the hollow sound made when they are tapped or by the missing tiles. This is a sign the tile in this area is failing. We recommend this be corrected by a specialist in the appropriate trade.

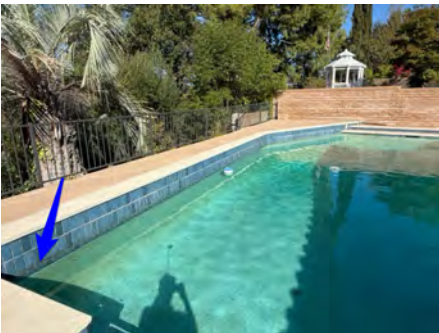
CR FE s-219: The water level at the tiles were different from one side of the pool to the other. This is indicative of a pool that has settled. In some cases this can be caused by a bad tile installation. We recommend further evaluation and corrections by a specialist in the appropriate trade.

Water at the bottom of the second tile

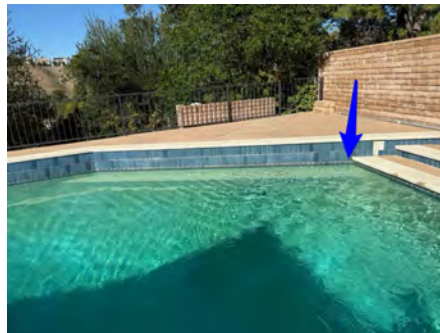
3 row of tiles above the water line

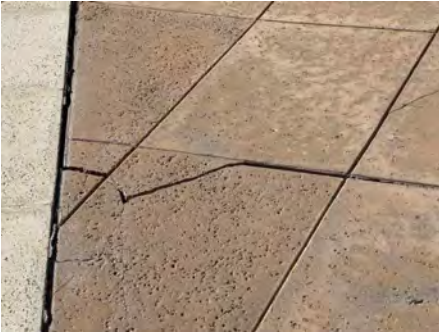
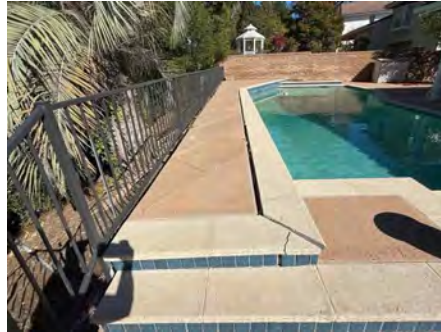
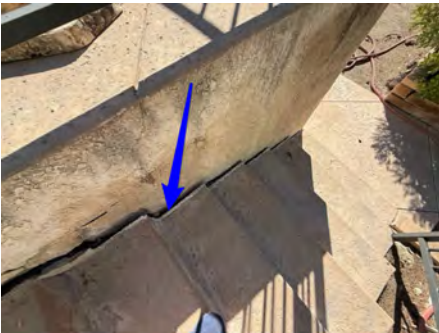
CR s-222: The pool flat work/decking and stairway and the pool has been cracked. We recommend the further evaluation and corrections by a specialist in the appropriate trade.

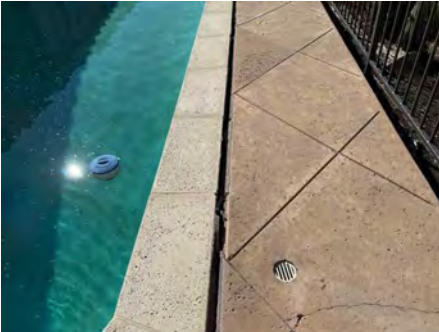
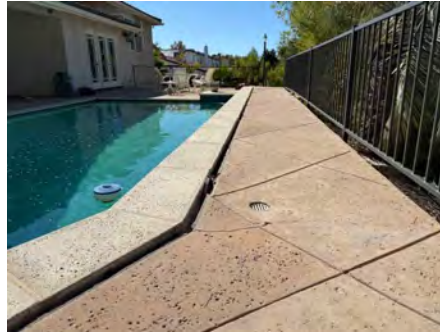
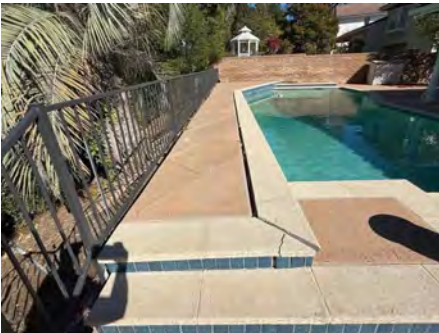
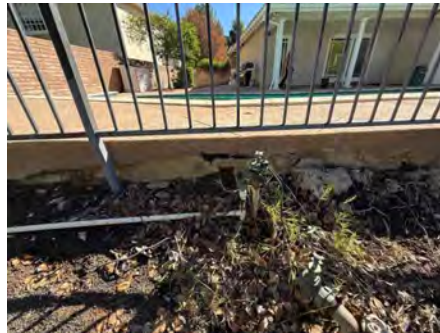
CR FE s-223: The back side of the pool deck has pulled away from the coping/bonding beam of the pool. This has opened up a several inch wide void. Further evaluation and corrections by a specialist in the appropriate trade is recommended..

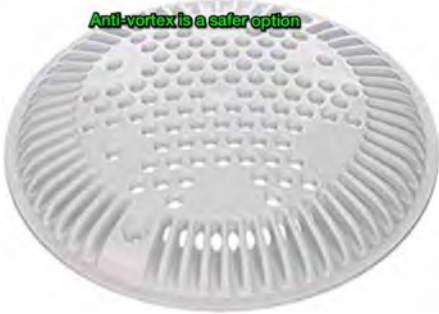
SC CR s-226: The drain cover(s) observed was the flat, older style covers that are considered unsafe due to the possibility of entrapment due to the vacuum it can create. We suggest upgrading to anti-vortex style drain covers for an increased margin of safety. We recommend the corrections be performed by a specialist in the appropriate trade.

Anti-vortex is a safer option

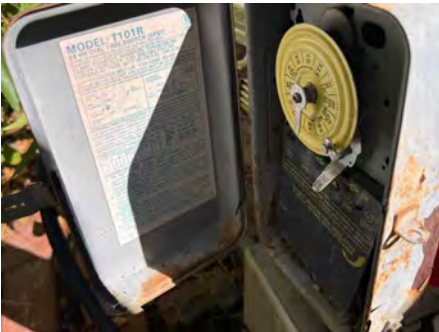
SC CR s-229: The water proof gaskets is deteriorated on the timer. This condition is conducive to moisture intrusion and deterioration of the wiring and timer. We recommend this be corrected by a specialist in the appropriate trade.

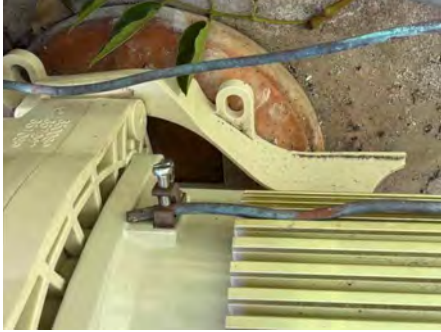
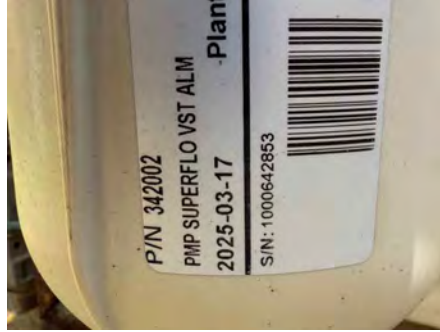
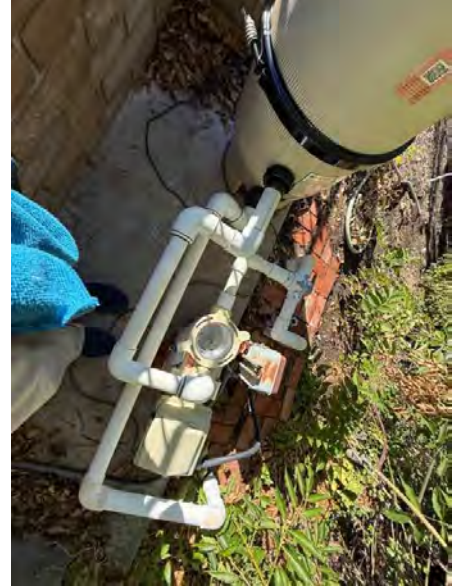
s-232: The pump(s) were serviceable at the time of the inspection with the exceptions below. The pumps were newer 'variable' speed models which save energy.

CR s-233: The pump or pumps were not secured to their base. It is suggested that the pump be adequately secured to the base it sits on. The reason is to protect the attached plumbing from breakage due to torque movement when the pump is turned on and off. It is recommend this be corrected by a specialist in the appropriate trade.

RU s-234: Excessive noise was observed while the pump was operating. This is an indication of excessive wear, especially of the bearings and the end of the pump's serviceable life. Replacement should be expected.

CR s-236: We observed a broken, filter basket at one or more pumps. We recommend the baskets be replaced so the units will work better and last longer. This should be corrected as soon as possible by a specialist in the appropriate trade, for example a pool contractor , who is competent, licensed, bonded and insured.

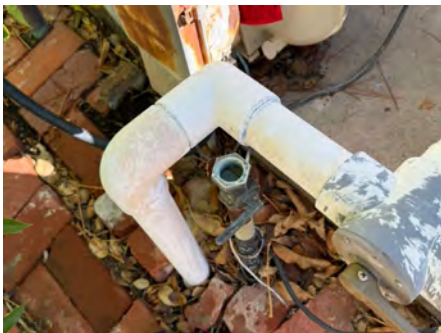
RU s-239: There is no GAS spa/pool heater with the equipment. We recommend this be upgraded by a specialist in the appropriate trade.

SC CR s-240: The gas line should be capped until it is used. Recommend this be corrected by a specialist in the appropriate trade.

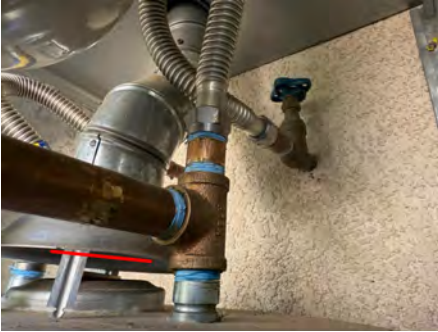
SC CR s-321: The draft hood of the water heater vent is not sitting level, not inline and/or is not secured. This condition is conducive to carbon monoxide leakage. We recommend this be corrected by a specialist in the appropriate trade.

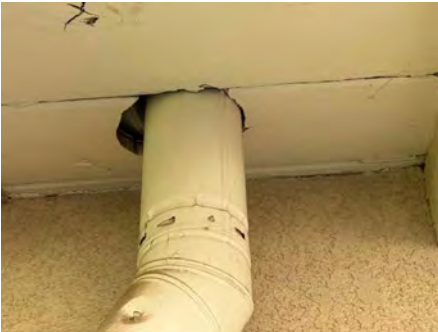
SC CR s-322: The water heater vent is installed too close to a combustibile surface. We recommend this be corrected by a specialist in the appropriate trade.

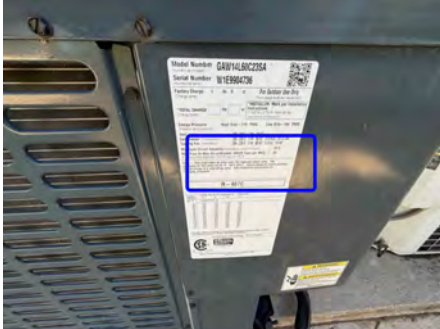
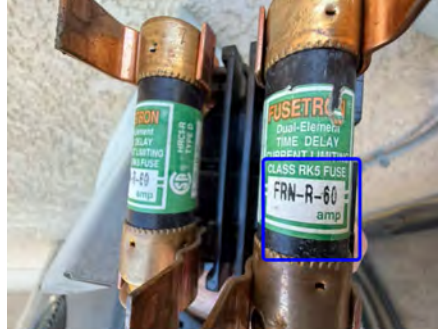
SC CR s-362: The air conditioning condenser is 'over-fused' in the local disconnect and/or breaker panel. This means the fuse and/or breaker is larger than the manufacturer's recommended max amperage for unit and/or the conductors (wires) installed are too small for the breaker and/or fuses. We recommend this be corrected by a specialist in the appropriate trade.

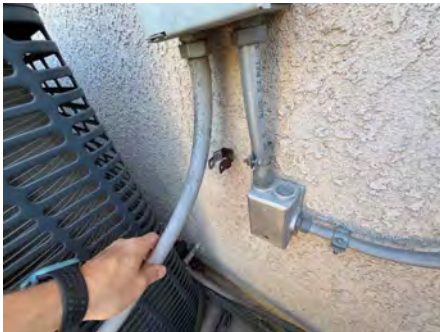
SC CR s-363: The conduit/wiring is loose and should be secured for safety and protection. We recommend this be corrected by a specialist in the appropriate trade.

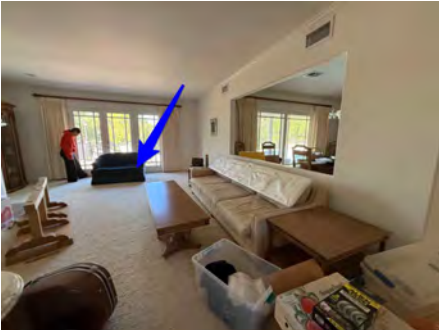
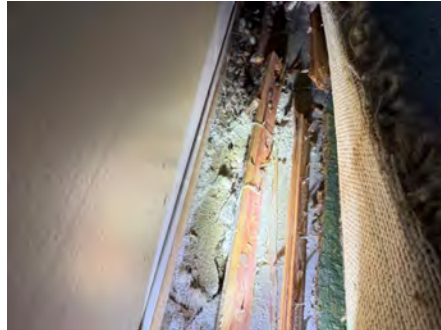
CR FE s-369: The concrete slab is cracked at the back door. Further evaluation and corrections by a specialist in the appropriate trade is recommended.

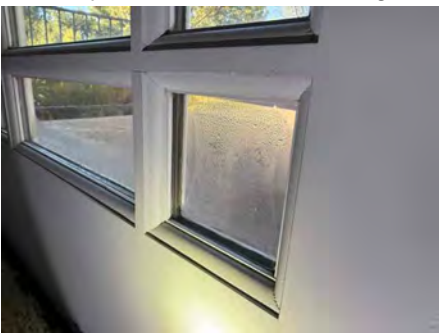
CR s-370: There is condensation between the panes of glass in the double pane lens in the door or the seal is bulging out. This indicates a failed seal. We recommend the lens assembly be replaced, which is the only method for correcting this deficiency.

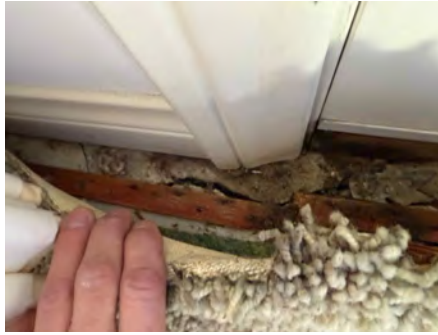
CR FE s-371: There is water intrusion coming from the door(s) in this area. We recommend further evaluation and corrections by a specialist in the appropriate trade.

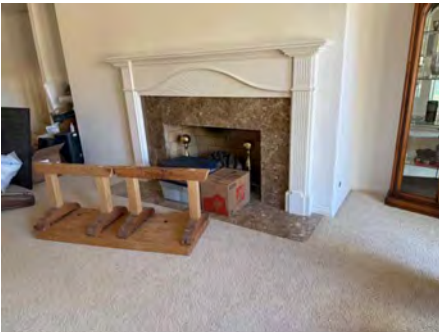
FE s-375: The NFPA (National Fire Protection Association) 211 standards state that upon a sale or transfer of property a level II camera inspection should be conducted on a fireplace and chimney. Please note that a change in burning habits can result in a fire loss or personal injury if the system does not meet or exceed the industry standards and/or manufacturers requirements. This means that a change in operation or use, such as property resale, is the time of higher risk. We suggest a level II inspection by an insured, qualified fireplace and chimney specialist.

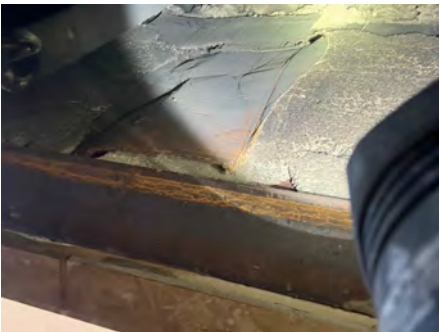
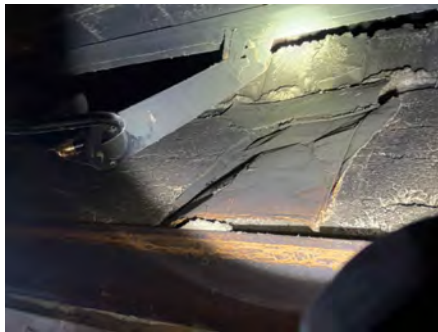
SC CR FE s-376: There were one or more cracks and voids observed in the firebox and/or firebox throat. We recommend further evaluation and corrections by a specialist in the appropriate trade.

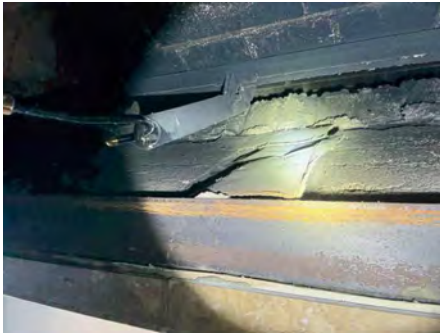
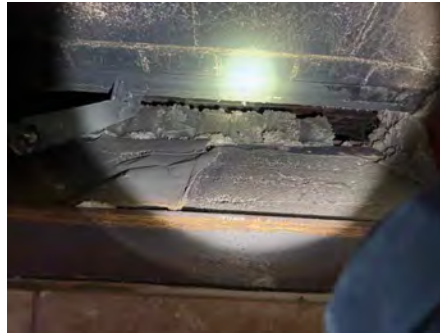
SC CR s-378: There is a piece of combustible cardboard in the throat of the fireplace fire box. Recommend this be corrected by a specialist in the appropriate trade.

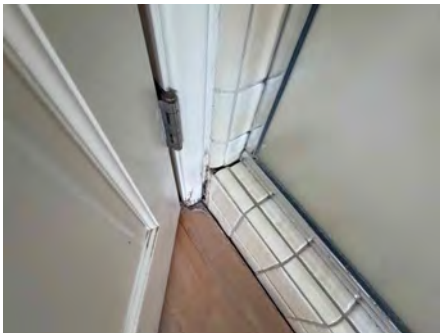
CR s-382: The wood/wood-like flooring is water damaged. It is recommend this be corrected by a specialist in the appropriate trade.

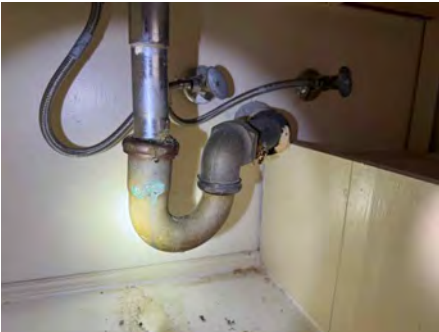
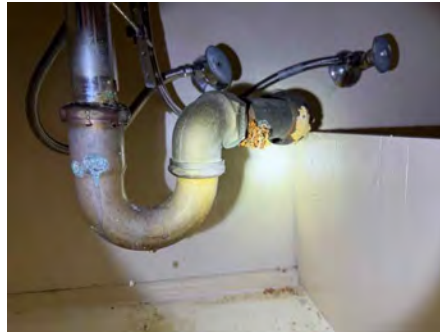
CR s-396: There is corrosion and a slow leak at the drain pipes in this area. We recommend this be corrected by a specialist in the appropriate trade.

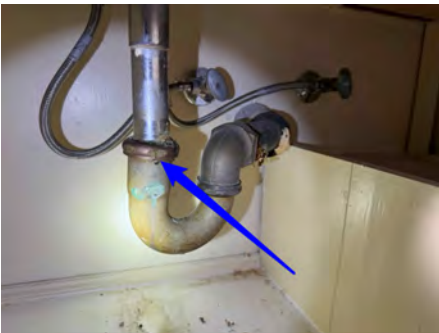
CR s-397: There was a leak observed after the sink was filled with water and then drained. We recommend correcting the condition noted.

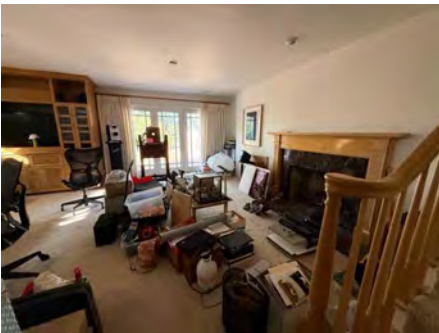
CR FE s-430: The ceiling is water damaged/stained. We recommend the source of the water be found. If repairs have not been made then such actions should be taken. We recommend this be corrected by a specialist in the appropriate trade.

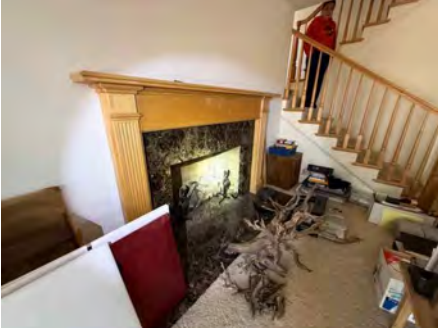
FE s-436: The NFPA (National Fire Protection Association) 211 standards state that upon a sale or transfer of property a level II camera inspection should be conducted on a fireplace and chimney. Please note that a change in burning habits can result in a fire loss or personal injury if the system does not meet or exceed the industry standards and/or manufacturers requirements. This means that a change in operation or use, such as property resale, is the time of higher risk. We suggest a level II inspection by an insured, qualified fireplace and chimney specialist.

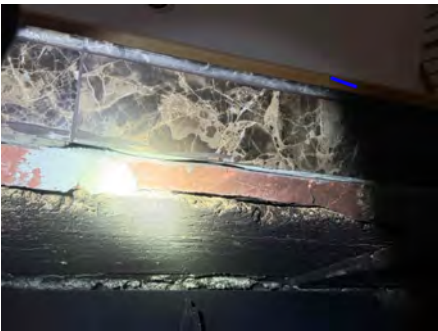
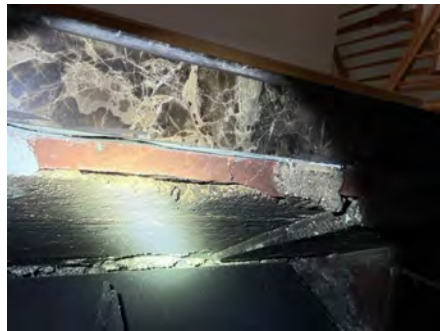
SC CR s-437: The fireplace lintel was corroded/rusted, the lintel is the horizontal metal support at the top of the firebox. We recommend correcting the condition noted.

SC CR s-438: There is one or more void(s) observable in the firebox or around the firebox. These voids need to be sealed with mortar or an approved fire sealant for safety. We recommend further evaluation and corrections by a specialist in the appropriate trade.

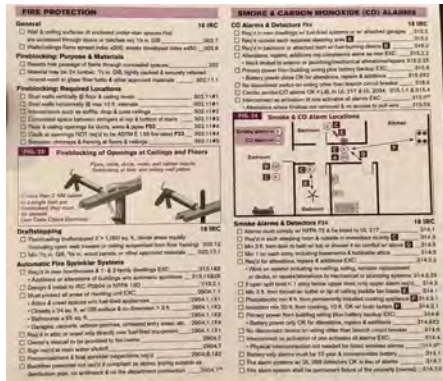
SC CR s-456: There was no carbon monoxide detectors present where required . Correcting the condition noted is recommended.

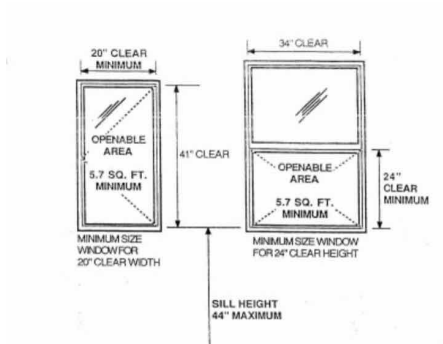
SC RU s-478: The bottom of the windows in this area are higher than 44 inches. Current building standards require the bottom of the window to be no higher than 44 inches. Since this is an older structure correction is not required but emergency egress plans should be considered. Lowering the window height should be considered if windows are replaced.

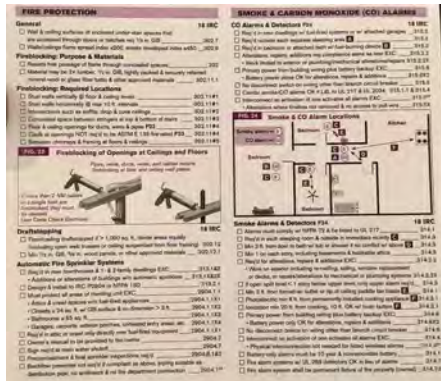
SC **CR** **s-485:** There was no smoke detectors present where required. Correcting the condition noted is recommended.

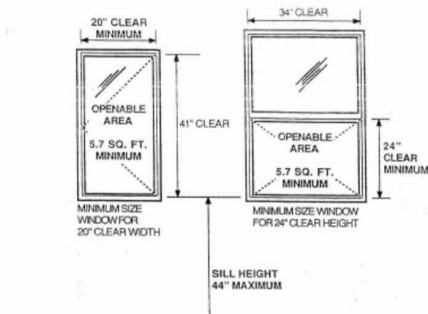
SC **RU** **s-490:** The bottom of the windows in this area are higher than 44 inches. Current building standards require the bottom of the window to be no higher than 44 inches. Since this is an older structure correction is not required but emergency egress plans should be considered. Lowering the window height should be considered if windows are replaced.
