Inspection Report

Property Address:
10280 Caminito Rio Branco
San Diego CA 92131

Date: 8/5/2025	Time: 09:00 AM	Report ID: 20250805-10280-Caminito-Rio-Branco
Property: 10280 Caminito Rio Branco San Diego CA 92131	Customer: Keenan Kribs	Real Estate Professional: Ted Kavich Ready Homes

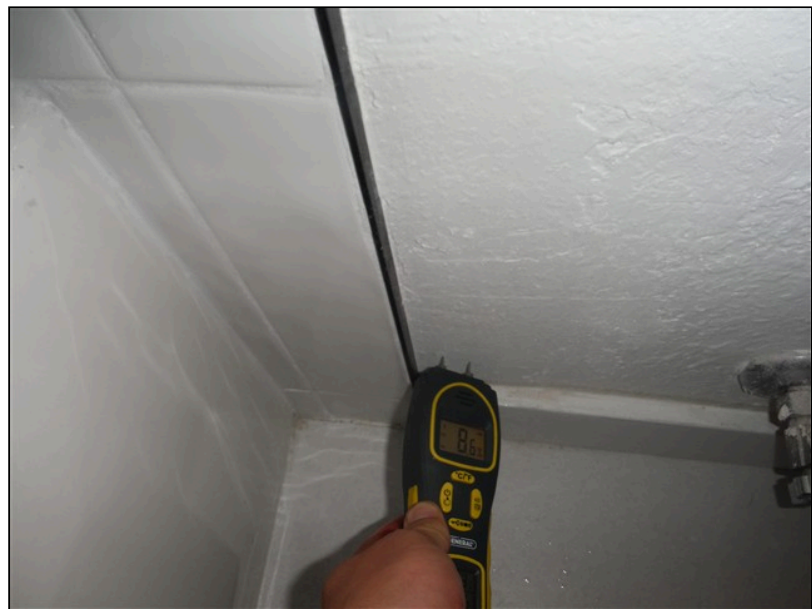
5.0 Item 1(Picture)

(1) A representative sampling for moisture was preformed at accessible interior walls using a moisture meter. (*areas prone to moisture, such as kitchens, bathrooms, below grade walls, exterior walls with doors/windows*).

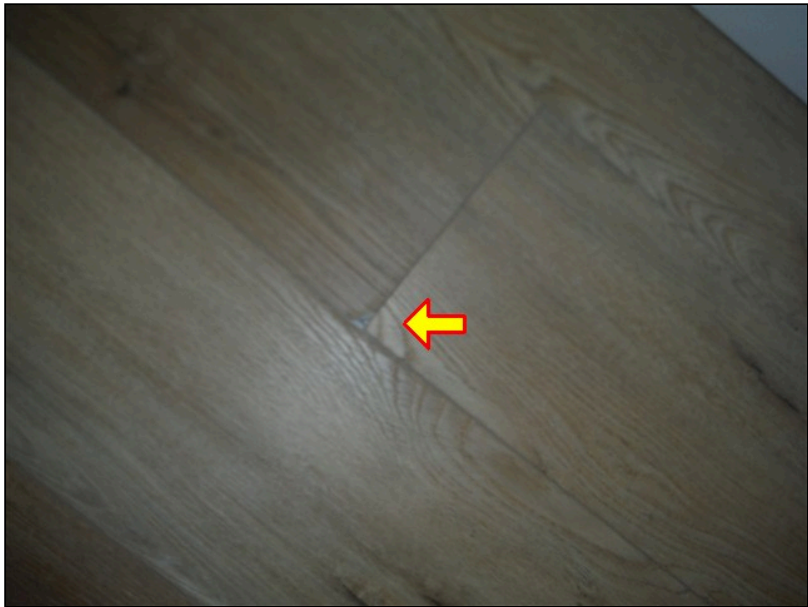
5.3 Item 2(Picture)

(2) There is damaged flooring observed in one or more areas. We recommend necessary

repairs or replacing by a qualified licensed flooring contractor.

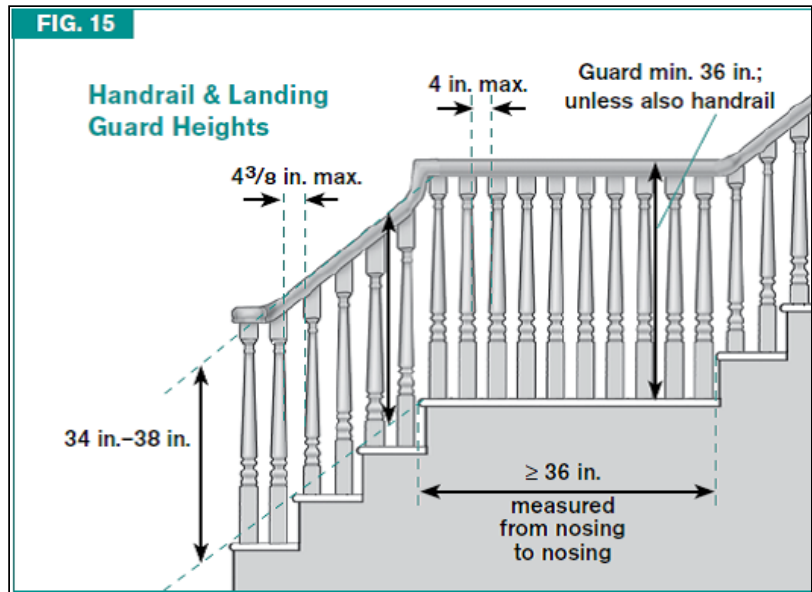
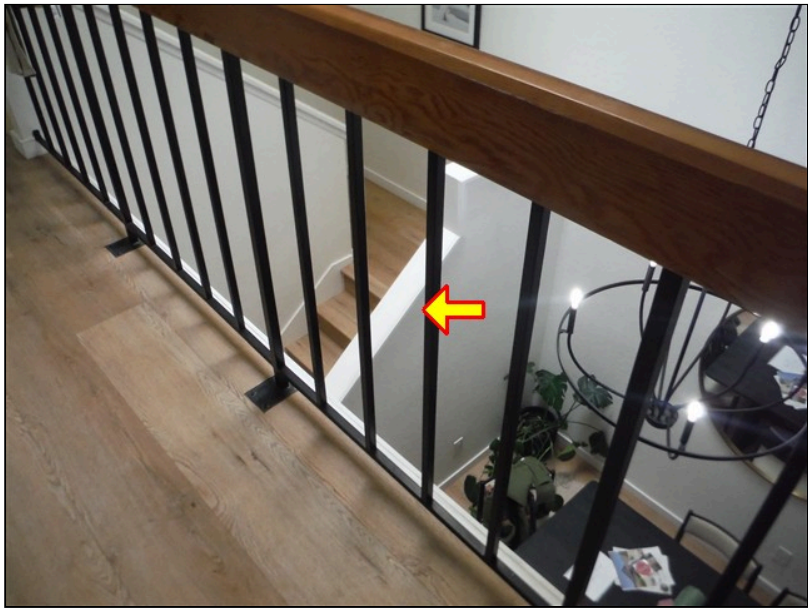
(1) While the railing/baluster spacing may have been standard at time of construction, it does not comply with current safety standards. The large openings can allow pets or children to fall through. We recommend installing additional pickets, or other form of

barrier to prevent injuries by a qualified licensed contractor.

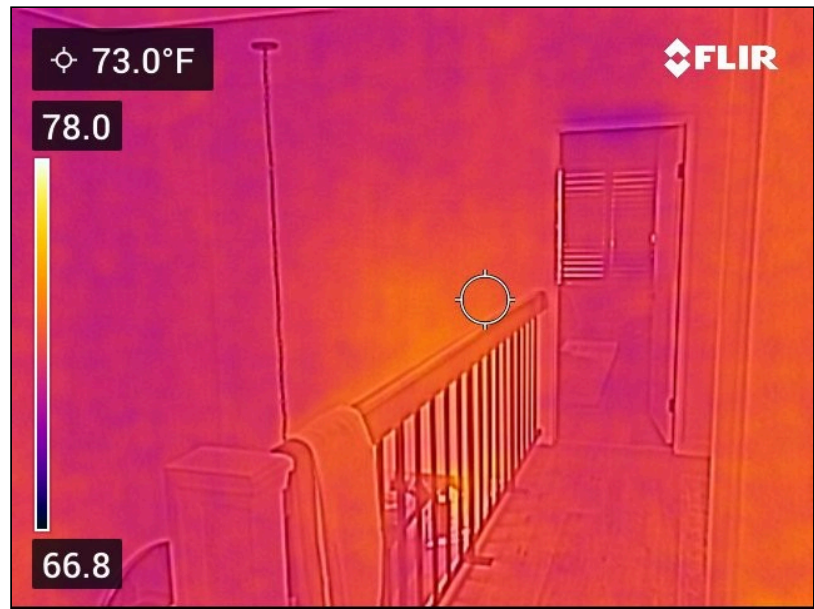
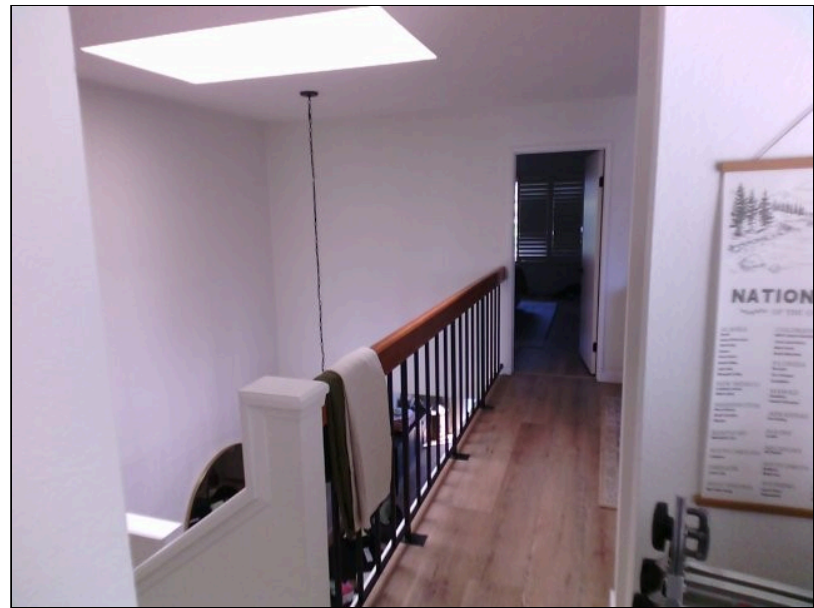
An infrared (thermal imaging) scan was performed throughout the house and garage at the time of the inspection using a hand held infrared (thermal imaging) inspection camera. No anomalies were found at the time of the inspection using this camera.

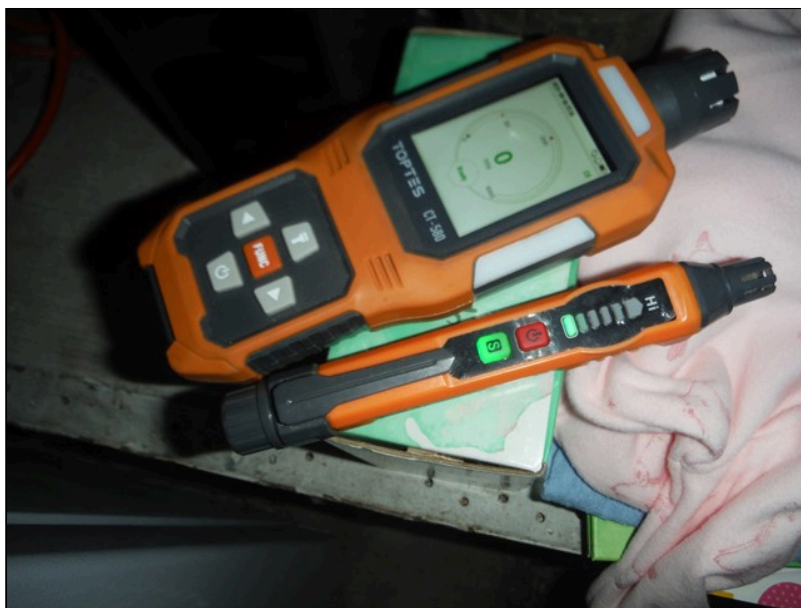
8.6 Item 3(Picture)

(2) A gas and carbon monoxide leak test was conducted at accessible gas fittings and appliances using gas and CO leak detectors. There were no gas or CO leaks detected at the time of the inspection.

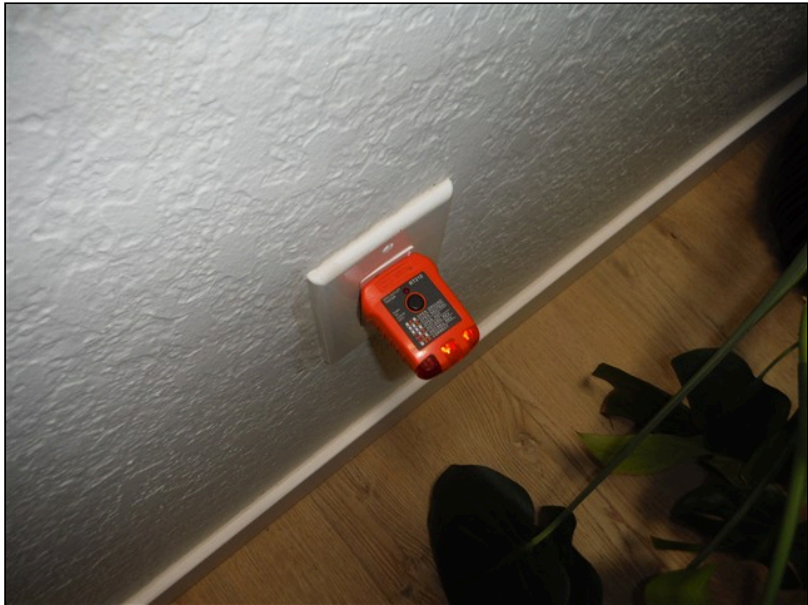
9.5 Item 3(Picture)

(2) A representative number of receptacles throughout the house and garage were tested for power, polarity and grounding according to our standards-of-practice. These receptacles observed to be ok at the time of the inspection **unless otherwise noted.**

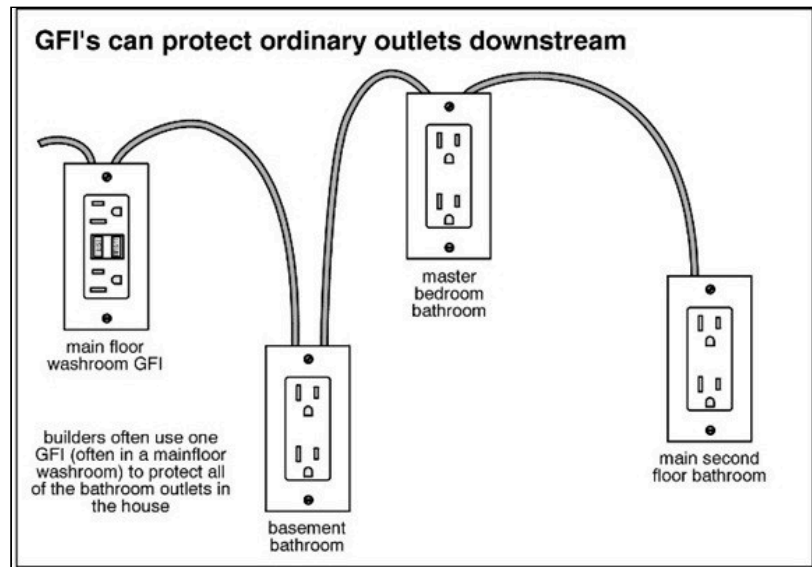
9.6 Item 1(Picture)

All accessible GFCI receptacles were tested and were functioning properly at the time of the inspection unless otherwise reported. Sometimes a tripped GFCI receptacle may be difficult to find. If you do not have power at certain receptacles please check all GFCI's and reset the tripped GFCI receptacle. If the GFCI doesn't reset than replacement of the GFCI receptacle will be required.

Note: We recommend upgrading all receptacles within 6 feet of any plumbing fixtures, outside/ exterior, in the garage, and any non fixed appliance receptacles in the kitchen to GFCI protected receptacles by a qualified licensed electrician for safety.

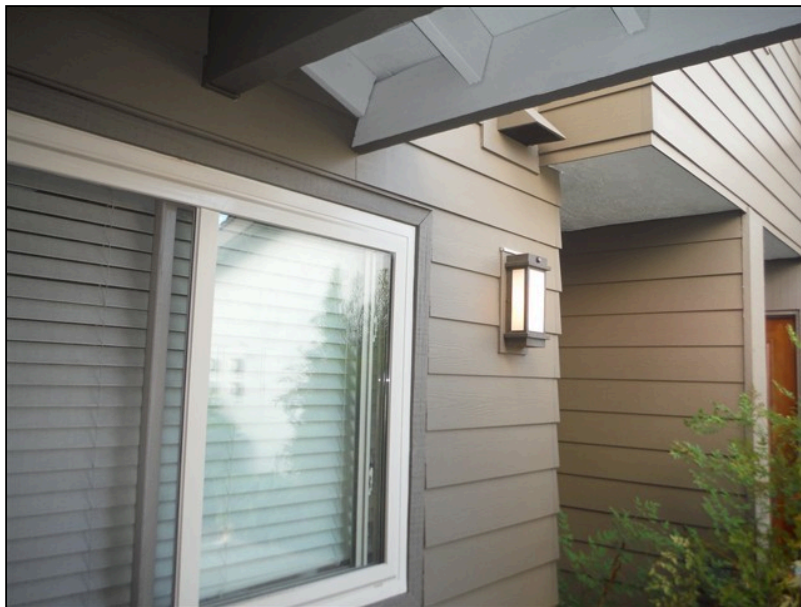
9.9 Item 1(Picture)

A representative number of exterior lights were tested and were found to be functional at the time of the inspection.

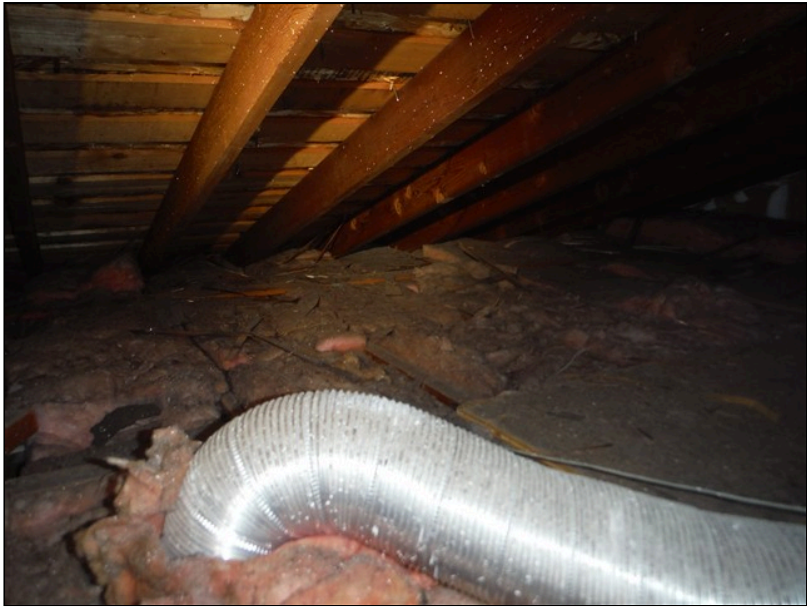
13.0 Item 4(Picture)

(4) View of the insulation in the attic. Appears to be functioning as intended **unless otherwise reported.**

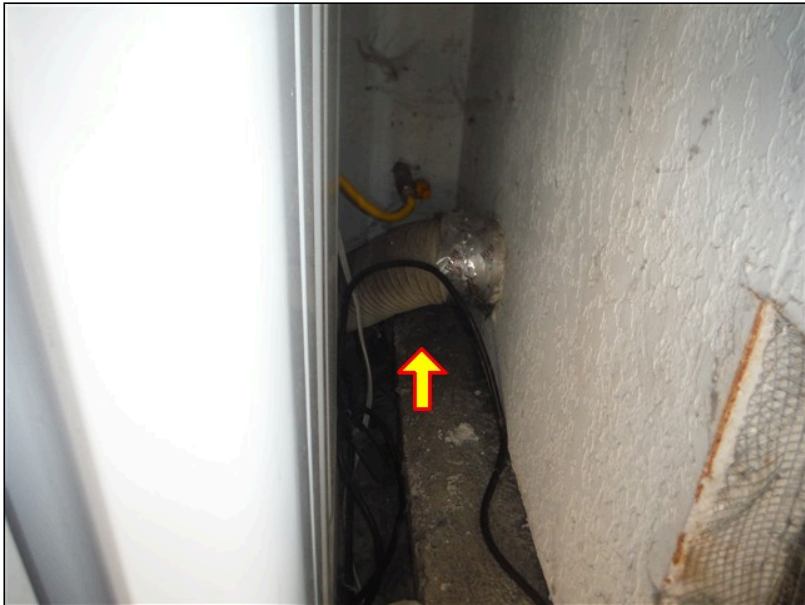
13.1 Item 1(Picture)

The dryer vent piping is plastic vinyl and is not recommended due to the increased risk of fires associated with this type of dryer duct. We recommend changing to metal flex or a metal type vent piping.

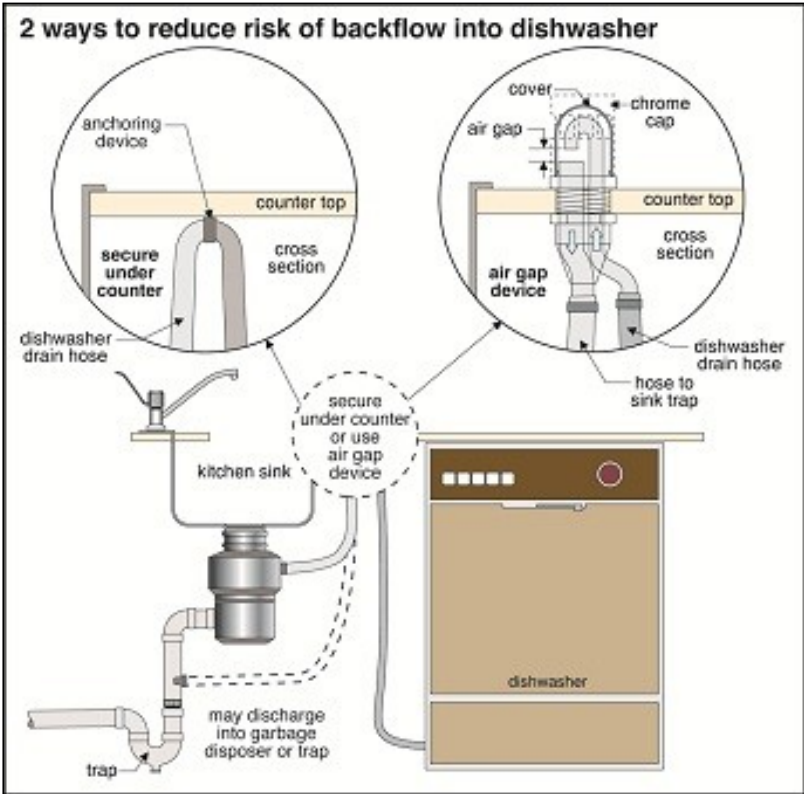
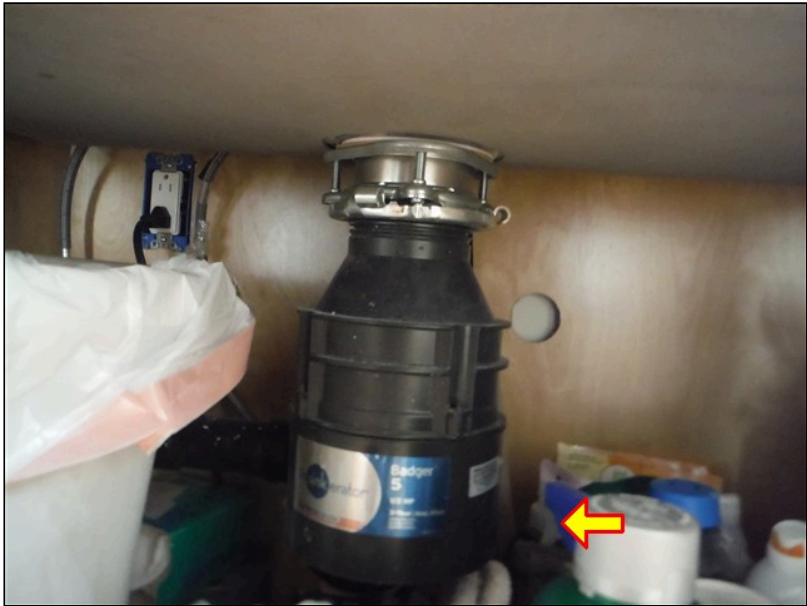
Some dishwashers may have a built-in high loop. Removing the dishwasher to determine proper installation is beyond the scope of our general home inspection. We recommend having an air gap device or high loop installed by a qualified licensed appliance contractor.

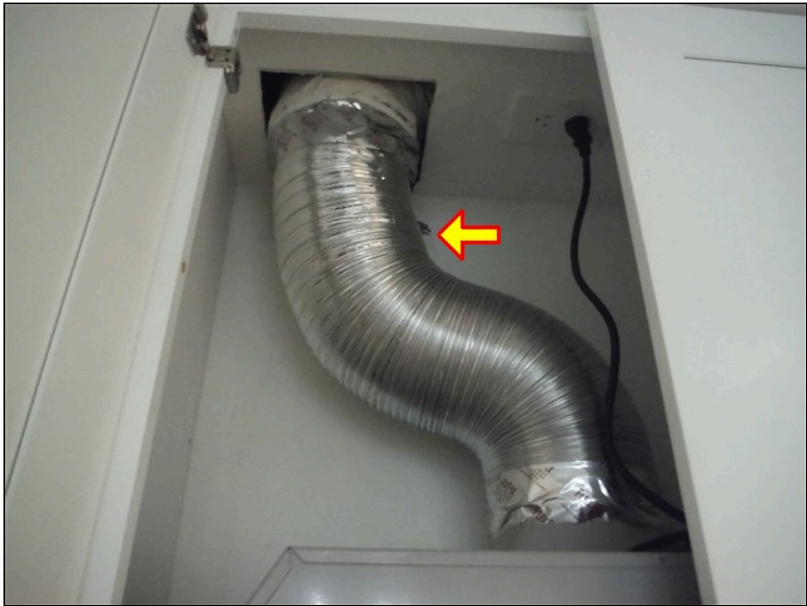
14.2 Item 1(Picture)

The range exhaust vent has a corrugated flex / aluminum type duct. Most manufactures recommend a smooth wall rigid duct. Flexible metal ducts could cause grease build-up. We recommend replacing the duct to an approved rigid sheet metal duct by a qualified person.

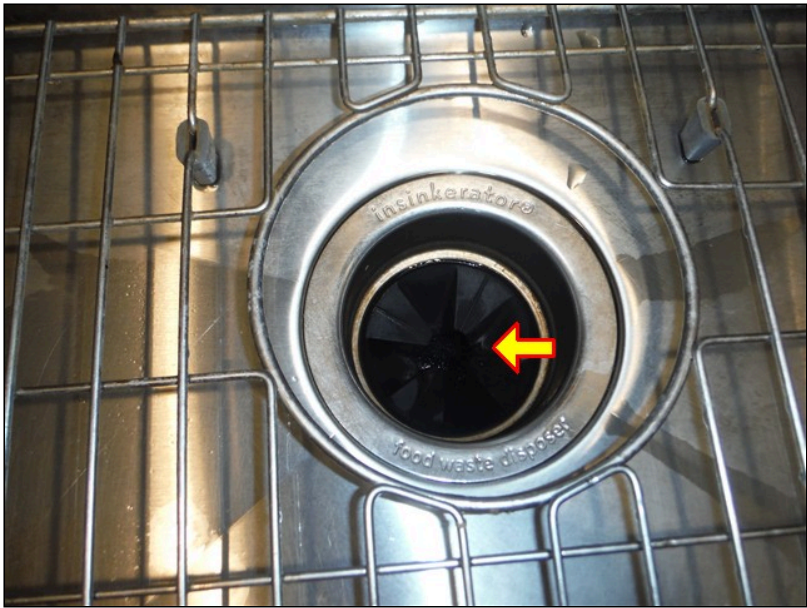
14.3 Item 1(Picture)

The food waste disposer cutting plates are rusted. We recommend replacing as needed by qualified person.

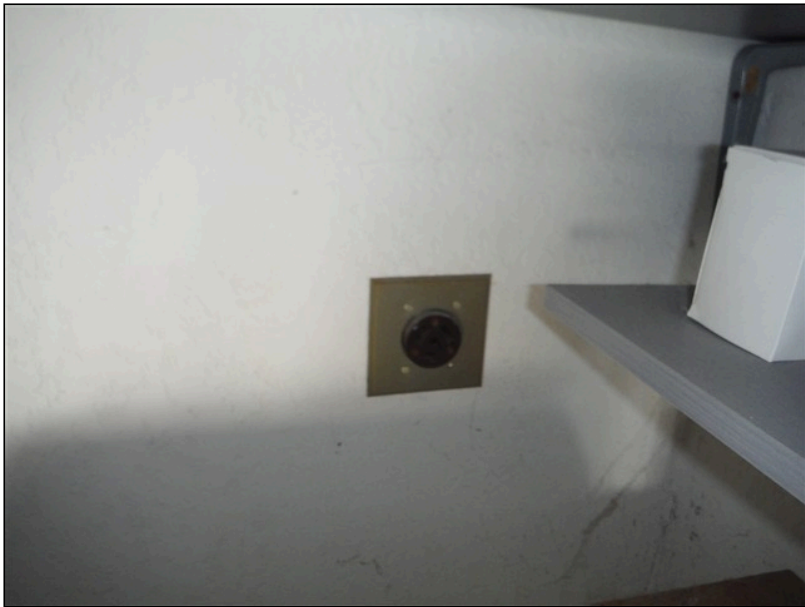
14.5 Item 1(Picture)

(1) There is a three prong 220 volt receptacle installed for the dryer. Most new electric dryers require a four prong receptacle. If you install an electric dryer, you may need to upgrade the receptacle or the dryer power cord. We recommend necessary corrections by a qualified licensed electrician.

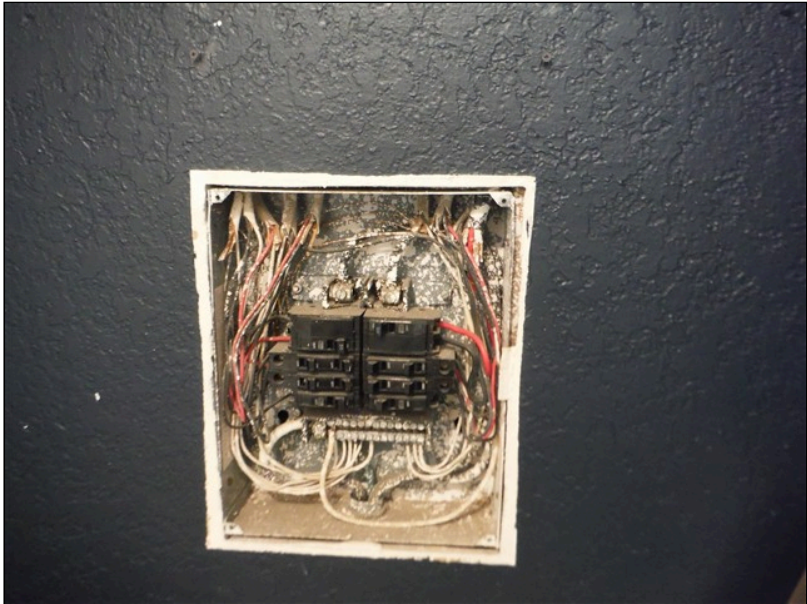
15.3 Item 1(Picture)

Findings
The sub panel is located in the hallway.
