## HOME INSPECTION REPORT

**2901 Webster Avenue  
San Diego, Ca 92113**

Client: Stephen Michea  
July 8, 2024  
File #240708AC

Prepared by: Chad Fisher, B.S.S.E., Certified CREIA Inspector

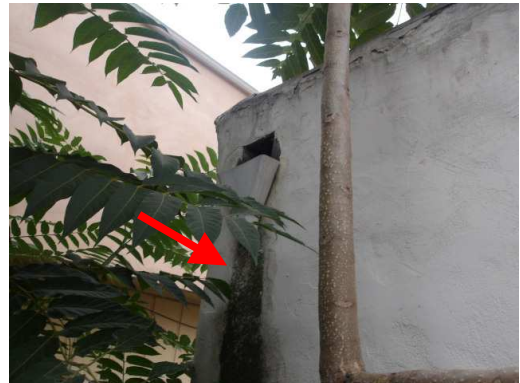
- The roof drain downspout at the northeast corner of the garage is missing and should be replaced.

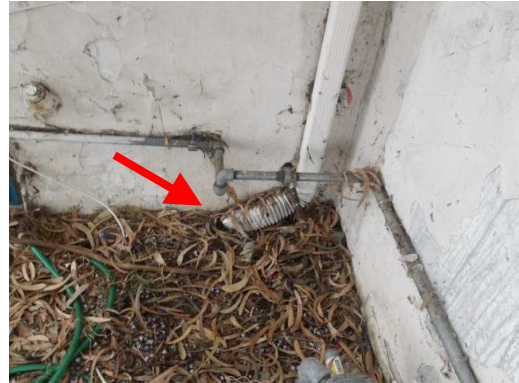
- The roof drain downspout at the west side of the house discharges to the area around the foundation and should discharge away from the foundation.

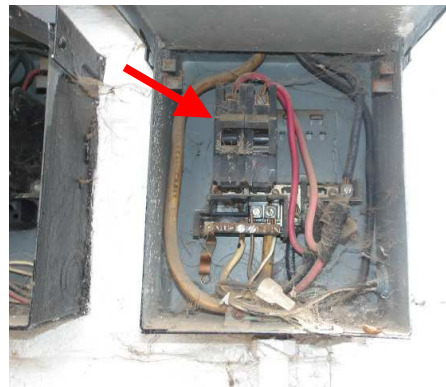
- The capacity of the main breaker is only 40 amps. The Client should be aware that this may not be sufficient for modern day appliances or for adding circuits.
- There is no inside coverplate for the panel. This is a safety hazard and the panel is in need of repair or replacement.

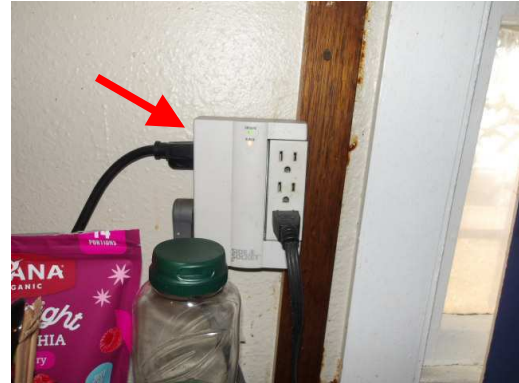
- There is only one outlet in the kitchen. This is not sufficient for modern day appliances and the kitchen electrical system should be properly upgraded.

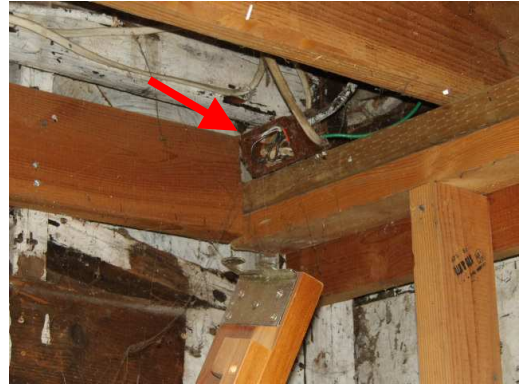
- There is an uncovered junction box in the northwest corner of the garage. All junction boxes should be properly covered as required by local building codes.

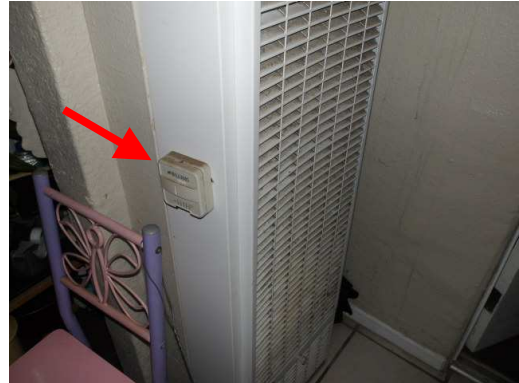
- The thermostat is located on the furnace. This condition will cause the furnace to cycle on and off more than typical and the thermostat should be properly relocated.

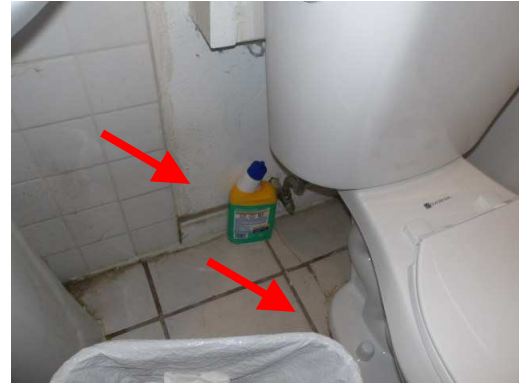
- The flooring in the bathroom is sagging and the water damaged lower walls in this area tested elevated moisture with a Protimeter Surveymaster electronic moisture meter. This condition is apparently caused by plumbing leakage. The cause for this condition should be determined and corrected.

- It is recommended that a licensed plumbing contractor be contacted for further inspection and of the plumbing lines and for repairs.

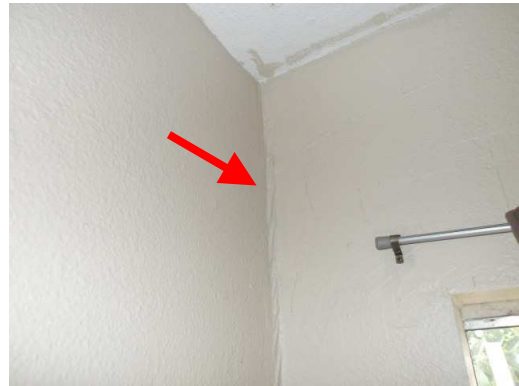
- Water intrusion can cause damage to the structure, as well as promote the growth of mold and mildew. It is beyond the scope of this inspection to determine the presence of potentially harmful mold and mildew. It is recommended that a qualified indoor air quality specialist be contacted for comprehensive investigation and for recommendations.
- There are cracks in the walls and ceilings in places throughout the house, and the wall seams are damaged in places, especially in the north side of the southeast bedroom. These conditions are apparently caused by some movement of the structure.

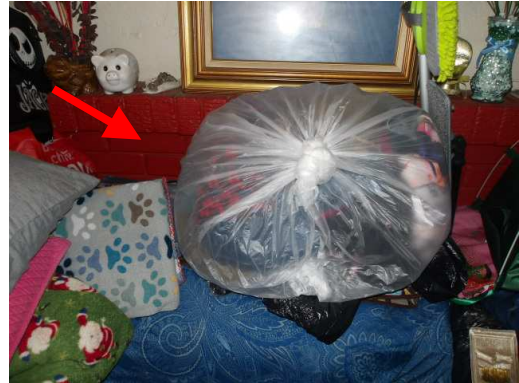
- The fireplace was blocked by storage at the time of the inspection and was not inspected. It is recommended that a certified chimney sweep be contacted for further inspection of the fireplace and chimney.

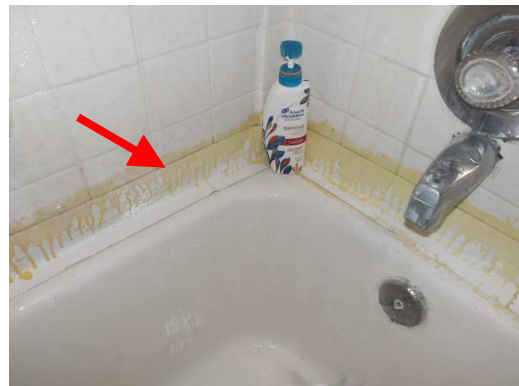
- The tub has been patched around the drain. The cause for this condition was not determined.
- The shower walls/tub junctions have been patched. The patch should be removed and these area properly repaired as necessary.

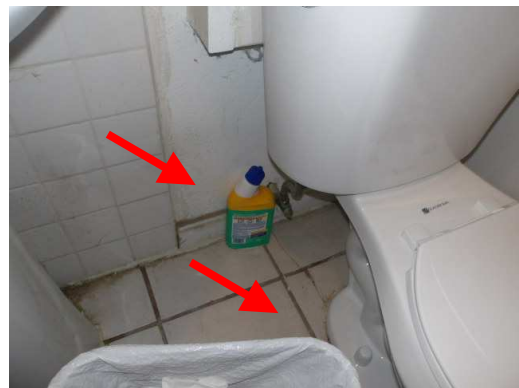
- As mentioned above, the flooring around the commode is sagging and there is some water damage to the lower walls around the commode. Because of this condition this area was tested for the presence of elevated moisture with a Protimeter Surveymaster electronic moisture meter and was found to contain excessive moisture at the time of the inspection. This condition is apparently caused by plumbing leakage. The cause for this condition should be determined and corrected. It is recommended that a qualified indoor air quality specialist be contacted for comprehensive investigation and for recommendations for the reasons stated above.

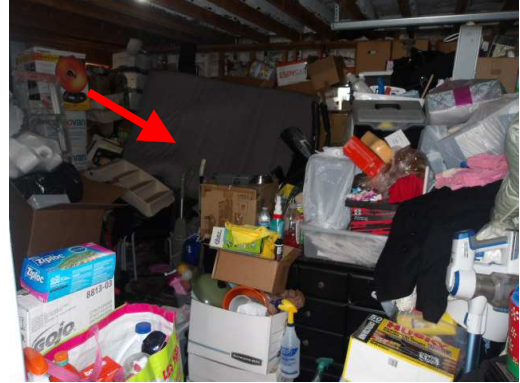
- The majority of the interior of the garage was inaccessible because of storage and were not inspected. It is recommended that the Buyer examine the interior of the garage after the stored items have been removed.

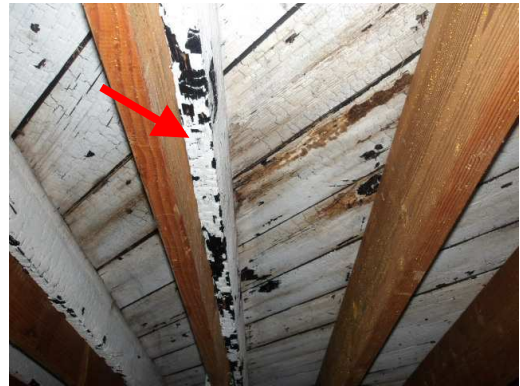
- There is some fire damage to the framing and sheathing in the garage. The fire damaged areas have not been scraped, sealed, and painted, indicating that the fire damage may not have been properly evaluated. It is recommended that a licensed contractor specializing in the evaluation and repair of fire damage be contacted for further inspection of the framing and sheathing and for repairs.

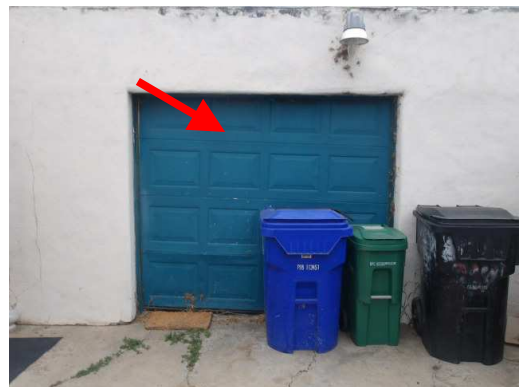
- The garage vehicle door is dented and crooked. The south garage vehicle door support also appears to have been disconnected. The door is in need of repair. It is recommended that a licensed garage door company be contacted for further inspection of the door and opener and for repairs.

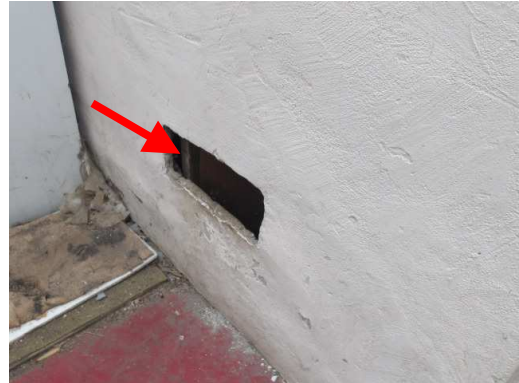
- One of the garage vent screens is missing and should be rescreened.

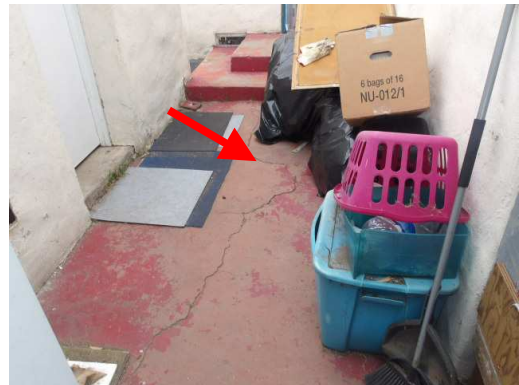
- There is evidence of water ponding on the walkway at the rear of the house. The drainage should be improved in this area and water should not be allowed to pond in areas adjacent to the foundation.

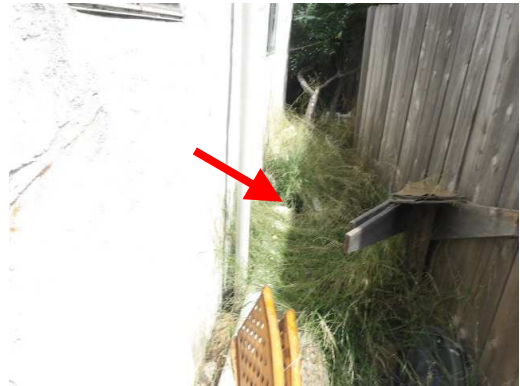
- The soil level is too high around the garage. This condition can cause deterioration of the wood framing. The soil level should be lowered to a level no higher than the concrete foundation walls. It is recommended that a licensed structural pest control company be contacted for further inspection and repair recommendations. In correcting the soil level care must be taken to avoid creating ponding near the foundation.

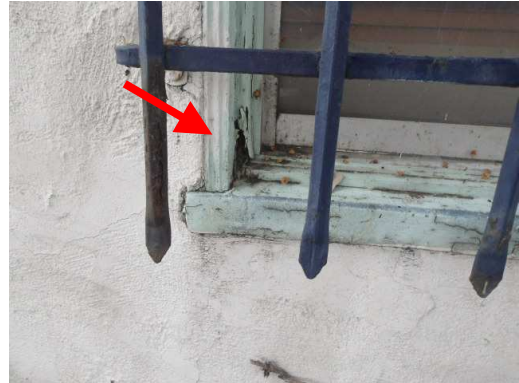
- The wood window framing is deteriorated in places. It is recommended that a licensed structural pest control company be contacted for further inspection and repair recommendations.

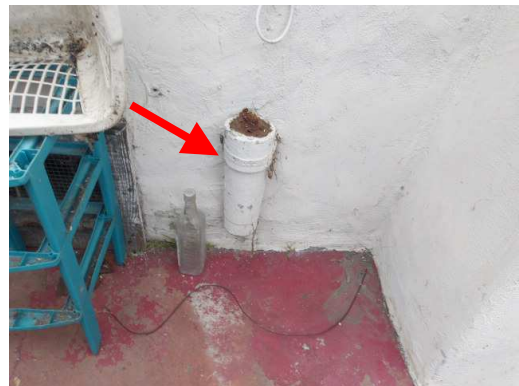
- It is beyond the scope of this inspection to determine the presence of asbestos, however, there is an unused gas vent constructed of a fibrous cement type material which may contain asbestos visible outside at the east side of the house. The presence of asbestos can pose a health hazard. It is recommended that a qualified asbestos specialist be contacted for further inspection and for recommendations.

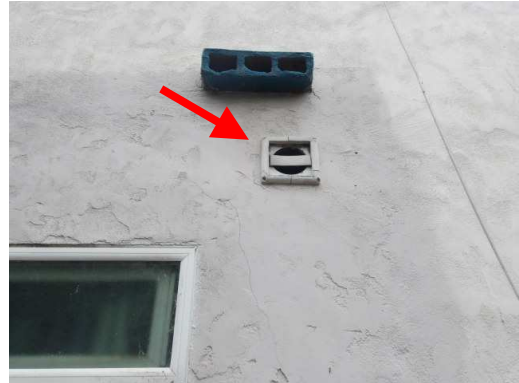
- The bathroom vent fan backdraft damper is damaged and is in need of repair or replacement.

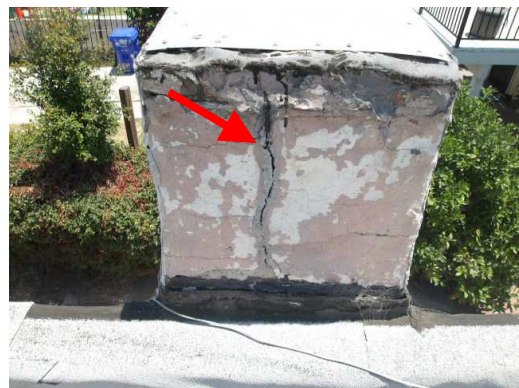
- The top of the chimney is cracked. This condition is apparently caused by some settlement of the chimney.

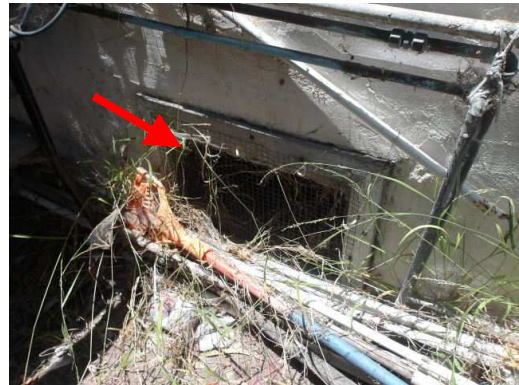
- The access hatches are smaller than 18 inches in height and 24 inches in width and do not meet current accessibility standards. One of the access hatches was sealed shut and the foundation crawl space was only inspected from the access hatches because of these conditions.

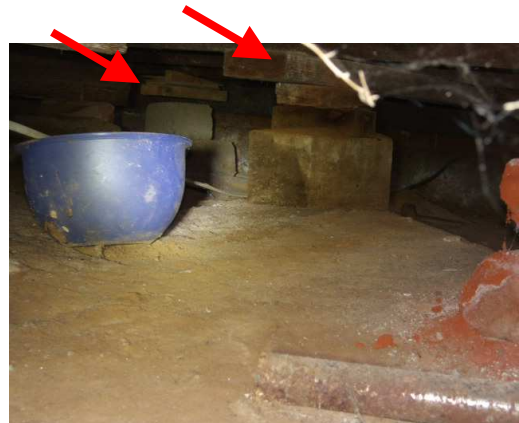
- Some of the posts consist of stacked blocks and there may not be concrete piers for these posts. All posts should be continuous and provided with piers for support.

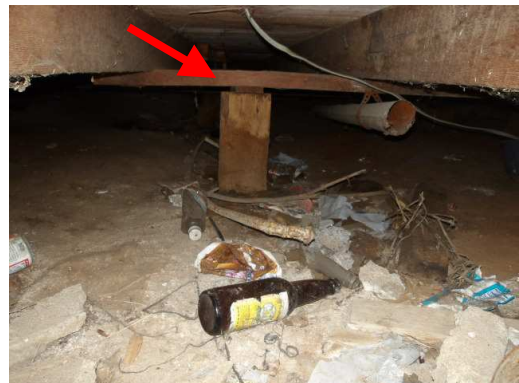
- There are some added supports for the living room, however, there are no piers for these supports and these supports provide little support.

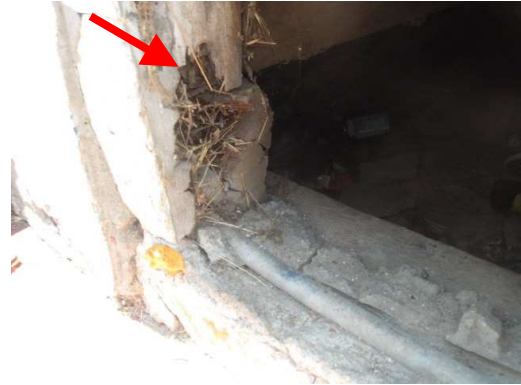
- There is some deterioration to the wood framing, especially near the north most access hatch. It is recommended that a licensed structural pest control company be contacted for further inspection and repair recommendations.

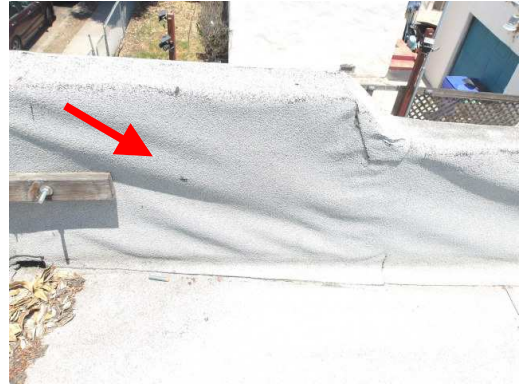
- There are wrinkles in the roofing in places. This condition is caused by incomplete bonding of the roofing plys.

- It is recommended that a licensed roofing contractor be contacted for inspection of the entire roof and for further recommendations.

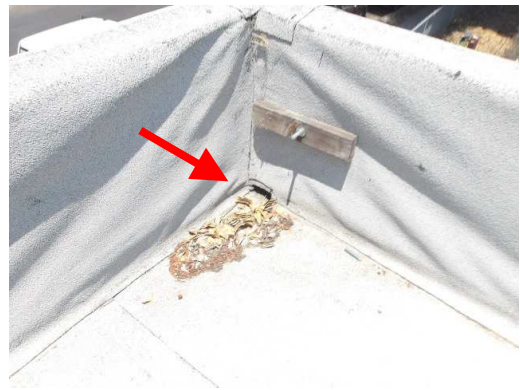
- There are no secondary roof drains present. Current local building codes require secondary roof drains. This may not have been required at the time of construction.

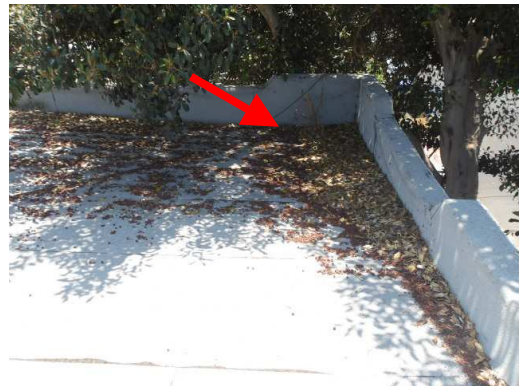
- There is debris present on the surface of the roof. The roof should be cleared of debris.

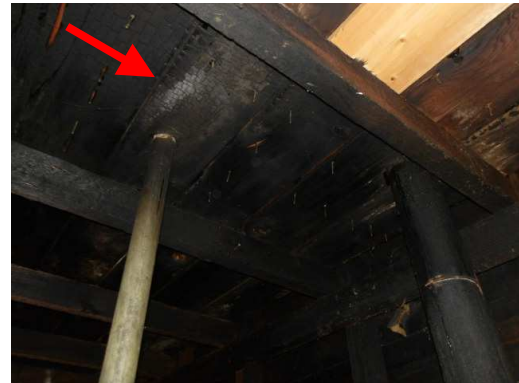
- There is some fire damage to the framing and sheathing in the attic space. The fire damaged areas have not been scraped, sealed, and painted, indicating that the fire damage may not have been properly evaluated. It is recommended that a licensed contractor specializing in the evaluation and repair of fire damage be contacted for further inspection of the framing and sheathing and for repairs.

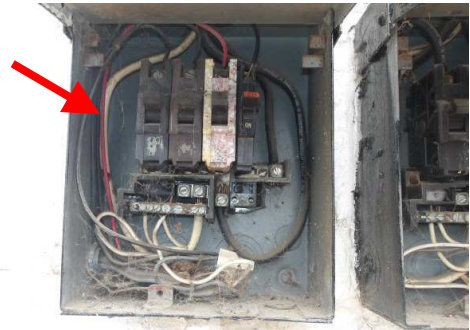
- The panels do not have inside coverplates. This is a safety hazard and the panels are in need of repair or replacement.
- There is no main breaker for the left panel and this panel is small and may not be sufficient for modern day appliances or for adding circuits.

- It is recommended that a licensed electrical contractor be contacted for further inspection of the electrical panels and for recommendations.

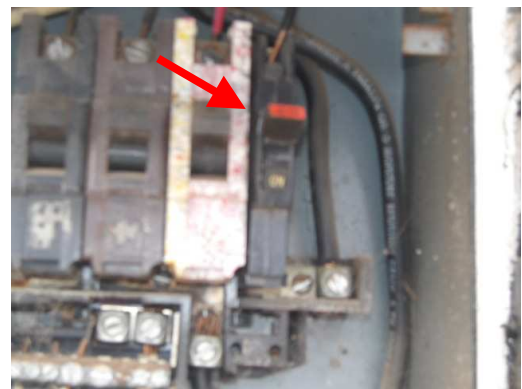
- One of the left panel breakers is of the Federal Pacific “Stab-Lok” type. This type of breaker has been shown to be a hazard in some cases.

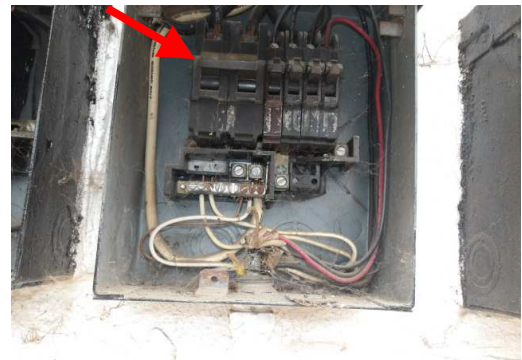
- The capacity of the main breaker for the right panel is only 40 amps. The Client should be aware that this may not be sufficient for modern day appliances or for adding circuits.

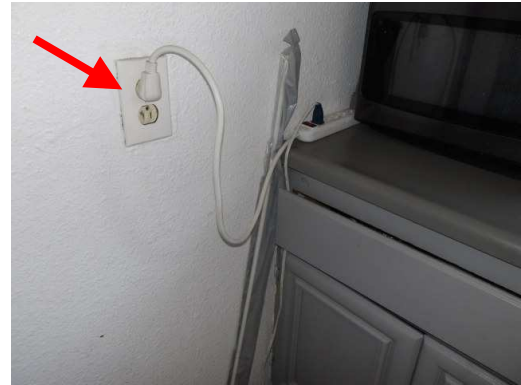
- The outlet in the southeast corner of the living room in 221 South 29<sup>th</sup> Street is loose and is in need of resealing. This outlet reportedly sometimes trips a breaker when in use and this outlet is in need of repair or replacement.
- There is only one kitchen countertop outlet in the 219 South 29<sup>th</sup> Street and two kitchen countertop outlets in 221 South 29<sup>th</sup> Street and the kitchen electrical systems should be properly upgraded.

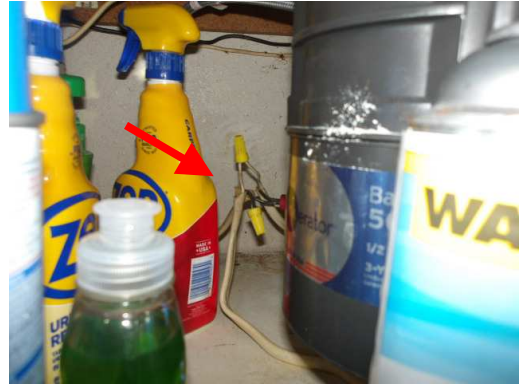
- There are exposed wire splices in the cabinet space under the kitchen sink in 219 South 29<sup>th</sup> Street. All wires should be properly spliced inside of approved junction boxes as required by local building codes.

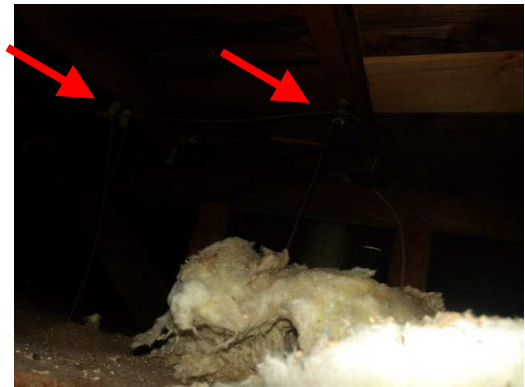
- The knob and tube type wiring in the attic space appears to be in service at this time. Knob and tube type wiring is an outdated type wiring system and it is recommended that a licensed electrical contractor be contacted for further inspection and recommendations.

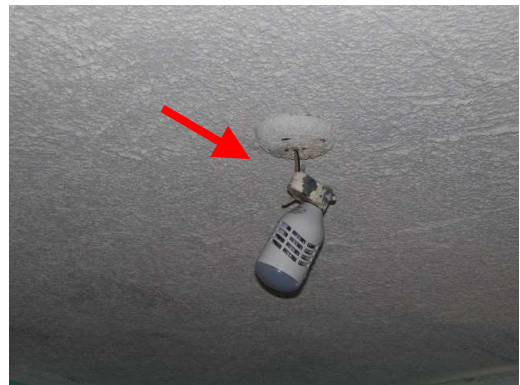
- Some of the light fixtures are missing their globes.
- The bedroom light fixture in 221 South 29<sup>th</sup> Street is hanging by its wires and is in need of repair.

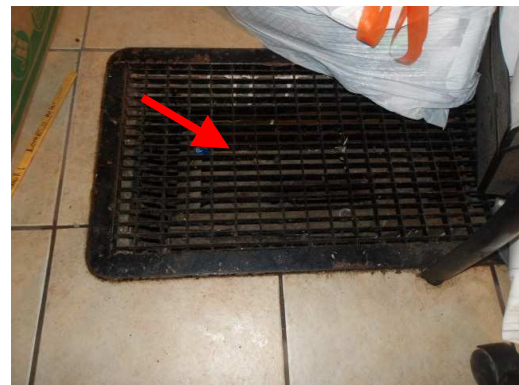
- There is an accumulation of dust and debris inside the furnace for 221 South 29<sup>th</sup> Street and the furnace should be cleaned.

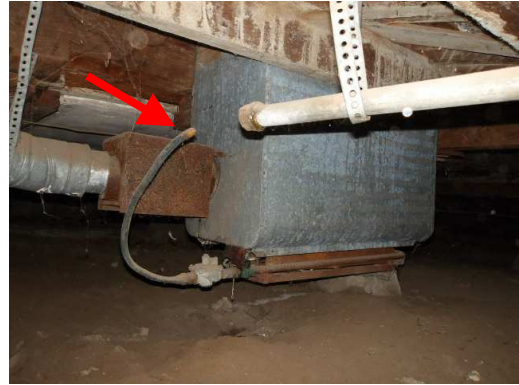
- The furnaces have been disconnected in the foundation crawl space and were not tested.

- The furnaces appears to be beyond their expected service life.
- There is currently no heat provided to the homes. It is recommended that a licensed heating contractor be contacted for further inspection of the furnaces and for repair or replacement recommendations.

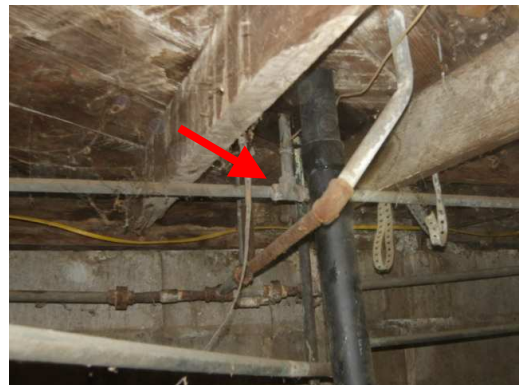
- There are galvanized steel water supply lines visible in the foundation crawl space. Galvanized steel water lines have limited service life and tend to corrode and scale on the inside, reducing water flow at the fixtures. It appears that the galvanized steel water supply lines have been abandoned and replaced by the copper water supply lines, however, it is not possible to confirm by visual inspection if all portions of the galvanized steel piping, particularly those portions inside the walls, have been replaced. It is recommended that a licensed plumbing contractor be contacted for further inspection of the water supply system and for recommendations.

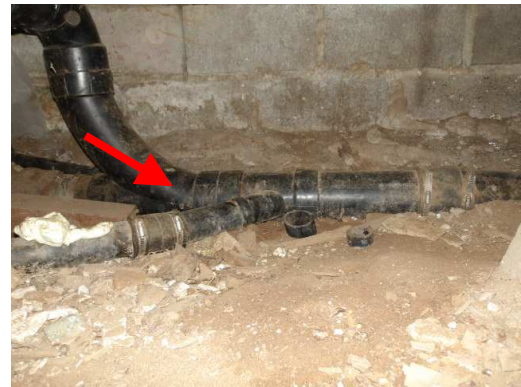
- The drain in the east side of the foundation crawl space is not sloped correctly and should be properly reconfigured such as the drain line slopes continuously downward away from the fixtures.

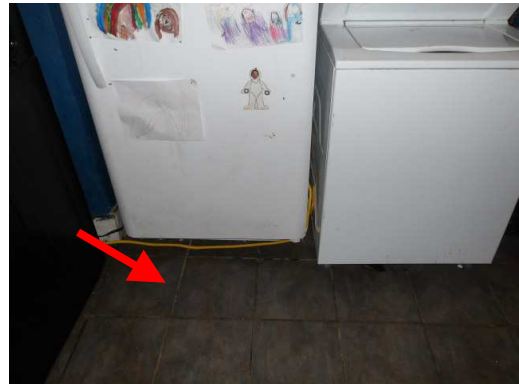
- The dryer discharges into the kitchen. The dryer be properly vented to the outside.
- The flexible gas line passes in front of the appliances and is exposed to damage. this condition should be properly corrected.

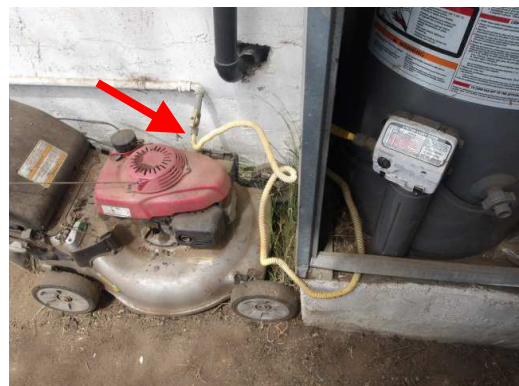
- There is no sediment trap present in the gas supply line. The absence of a sediment trap can cause the water heater to malfunction and manufacturers of gas fired water heaters generally require the presence of a sediment trap. It is recommended that the Client consider installing a sediment trap.
- A portion of the flexible gas line is outside the closet and is exposed to damage. This condition should be properly corrected.

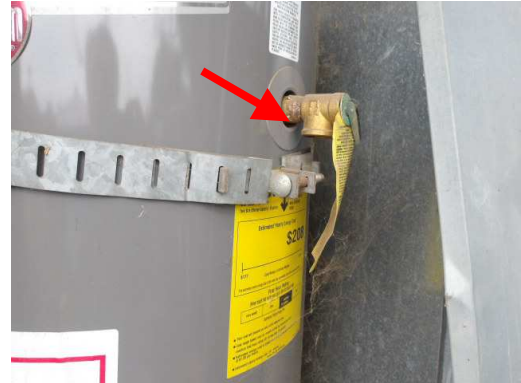
- There is no water heater expansion tank installed. Most local jurisdictions require an expansion tank to limit pressure buildup in the water supply system.

This may not have been required at the time of installation, however, it is recommended that an expansion tank be properly installed.

- The pressure-temperature relief valve discharge is not vented to an approved location and the discharge should be properly extended close to the ground.

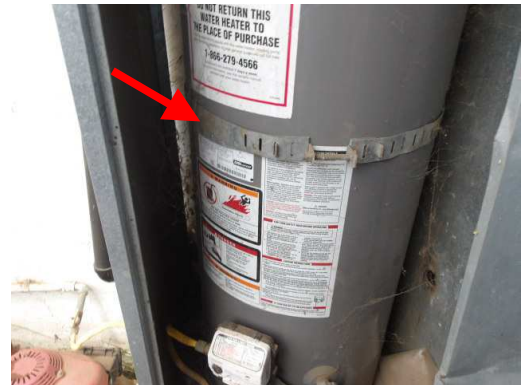
- The water heater is secured by seismic restraints, however, the lower restraint is too high and should be relocated to the lower 1/3 of the water heater.

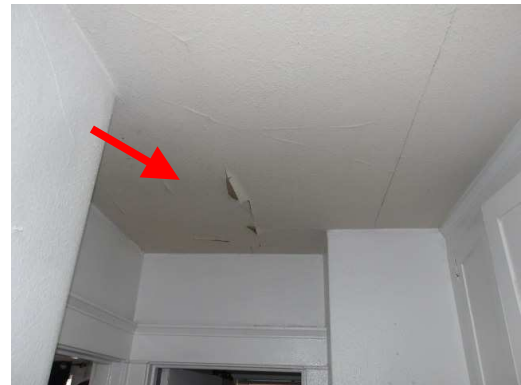
- There are cracks in the walls and ceilings in places throughout the building. These conditions are apparently caused by some movement of the structure.
- The ceilings in 219 South 29<sup>th</sup> Street are damaged in the hallway and kitchen.

- The damaged and patched areas are apparently the result of roof leakage. Water intrusion can cause damage to the structure, as well as promote the growth of mold and mildew. It is beyond the scope of this inspection to determine the presence of potentially harmful mold and mildew. It is recommended that a qualified indoor air quality specialist be contacted for comprehensive investigation and for recommendations.

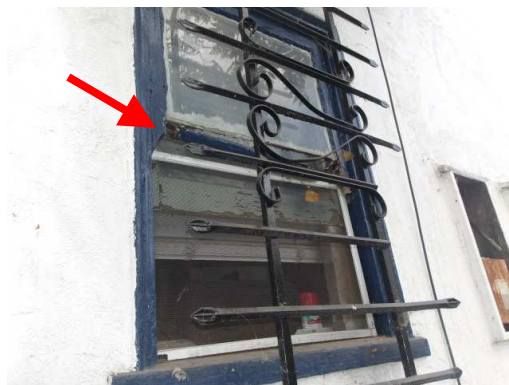
- The bathroom window in 219 South 29<sup>th</sup> Street is damaged and is in need of repair or replacement.

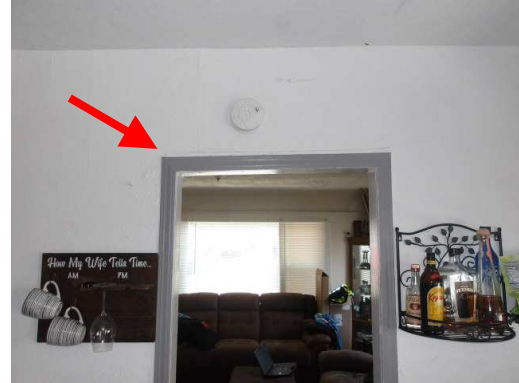
- Several of the door frames are out of square. This condition is apparently caused by some movement of the structure.

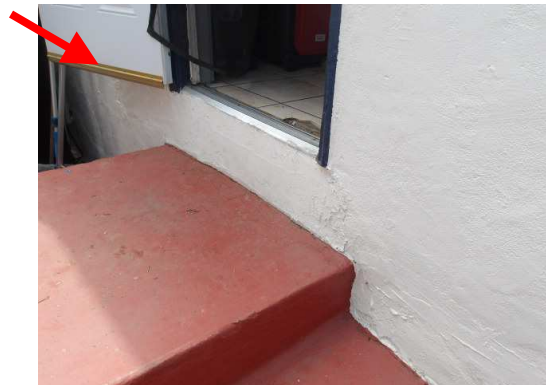
- Some of the doors have been removed.
- The doors to the outside from the kitchens swing toward the exterior, which have lower floor levels. Local building codes require that a 36" landing no more than 1 inch lower than the threshold be installed so that the door does not swing over a lower floor level. These conditions should be corrected.

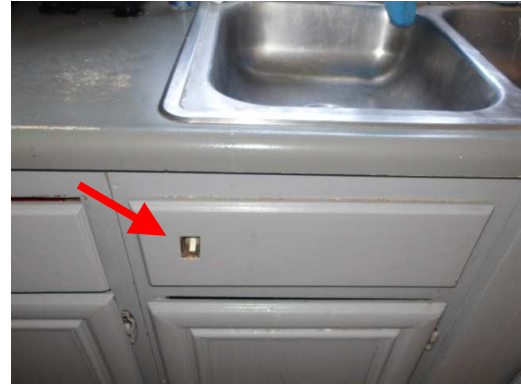
- The garbage disposal is operational at this time, however, the switch is located in the front of the sink cabinet and should be provided with a safety cover or relocated to prevent possible accidental activation.

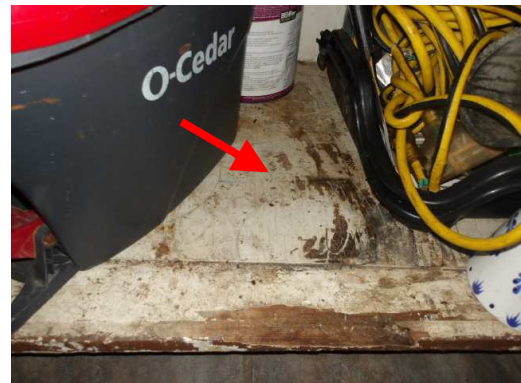
- There is some water damage to the interior of the cabinet underneath the sink. The cause for this condition could not be determined by visual inspection, however, because of this condition this area was tested for the presence of elevated moisture with a Protimeter Surveymaster electronic moisture meter and was found to be dry at the time of

the inspection. The Client is advised that the absence of moisture at this time does not necessarily indicate that any previous leakage has been successfully repaired or that future leakage will not occur. It is recommended that a qualified indoor air quality specialist be contacted for comprehensive investigation and for recommendations for the reasons stated above.

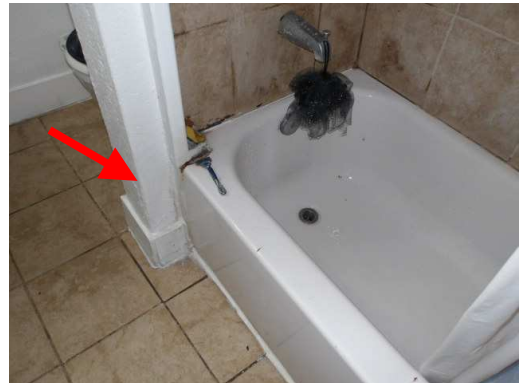
- The surface of the tub is scratched and corroded and should be properly repaired and refinished to prevent additional corrosion.
- There is some water damage to the wall next to the tub. This condition is possibly caused by shower overspray. Because of this condition this area was tested for the presence of elevated moisture with a Protimeter Surveymaster electronic moisture meter and was found to contain excessive moisture at the time of the inspection. The cause for this condition should be determined and corrected. It is recommended that a qualified indoor air quality specialist be contacted for comprehensive investigation and for recommendations for the reasons stated above.

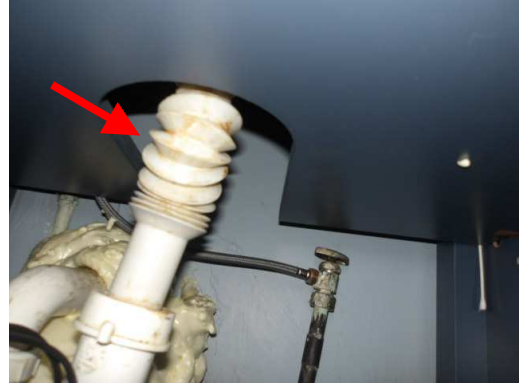
- The drain line is connected underneath the sink with a corrugated flexible connector and should be properly connected with approved fittings as required by local building codes.

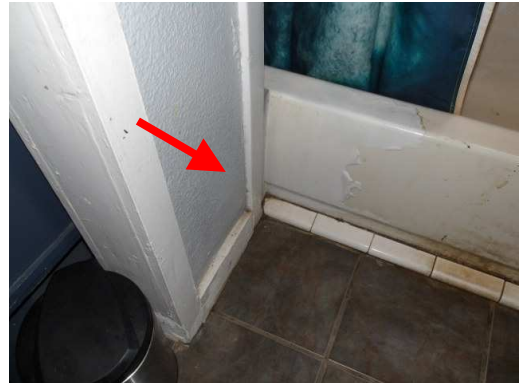
- The tub surface is flaking off in places.
- There is some water damage to the wall next to the tub. This condition is possibly caused by shower overspray. Because of this condition this area was tested for the presence of elevated moisture with a Protimeter Surveymaster electronic moisture meter and was found to contain excessive moisture at the time of the inspection. The cause for this condition should be determined and corrected. It is recommended that a qualified indoor air quality specialist be contacted for comprehensive investigation and for recommendations for the reasons stated above.

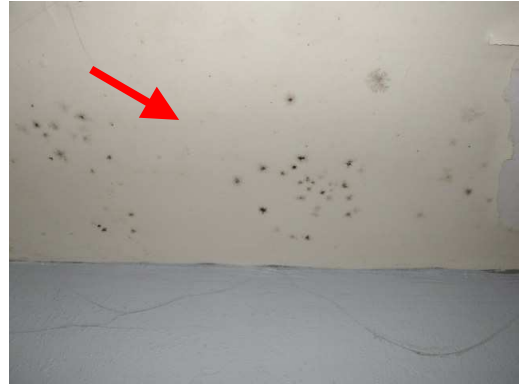
- There is what appears to be mold or mildew present on the bathroom ceiling. Some types of mold and mildew can present a health hazard. It is beyond the scope of this inspection to determine the presence of potentially harmful mold and mildew. It is recommended that a qualified indoor air quality specialist be contacted for comprehensive investigation and for recommendations.

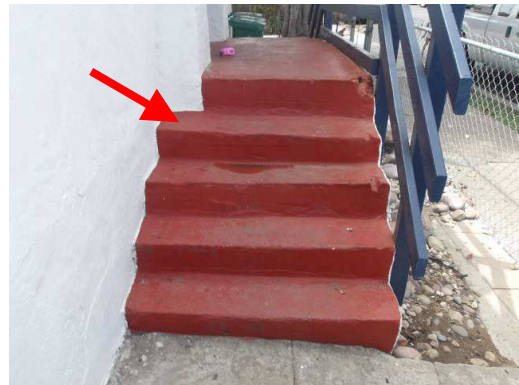
- The concrete step spacing is not uniform. This condition constitutes a tripping hazard and should be corrected.

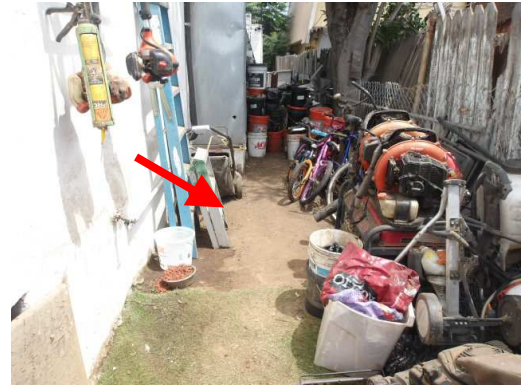
➤ The soil slopes toward the foundation at the rear of the house. The drainage should be improved in this area and the earth should be regraded so that the soil slopes away from the foundation a minimum of 6 inches for a distance of 10 feet and water drains freely to the street or to another proper drainage discharge area. When a distance of 10 feet is not possible because of a barrier or property line, the soil may slope at the same rate to a swale which drains to the street or to another proper drainage discharge area. In correcting the drainage care must be taken to keep the soil level a minimum of 6 inches below the top of the foundation wall to prevent possible moisture intrusion into the wall assembly and deterioration of the wood framing.

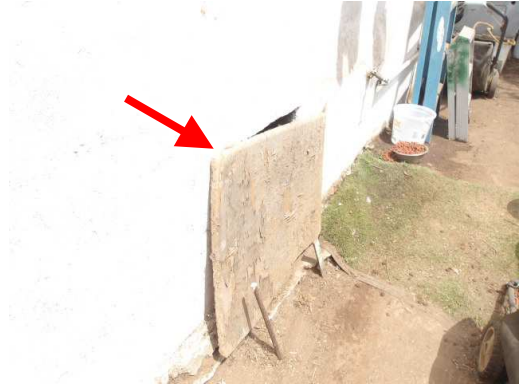
- The hatch cover is missing and should be replaced.

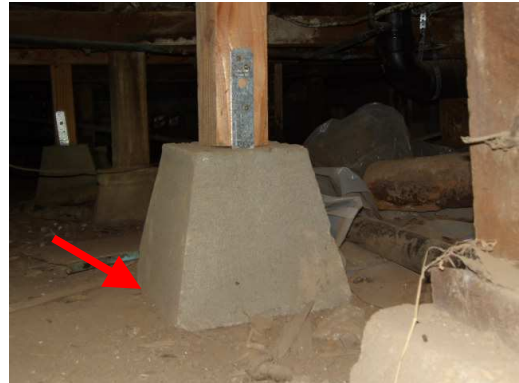
- It could not be determined by visual inspection whether there is rebar in the foundation walls as required by current standards.
- The sill plates do not appear to be fastened to the top of the foundation walls with anchor bolts. Houses built after approximately 1933 are required to have the sill plates anchored to the foundation walls to improve resistance to seismic (earthquake) forces.
- Several of the posts are supported by pier tops without piers. Piers should be properly installed for proper support.

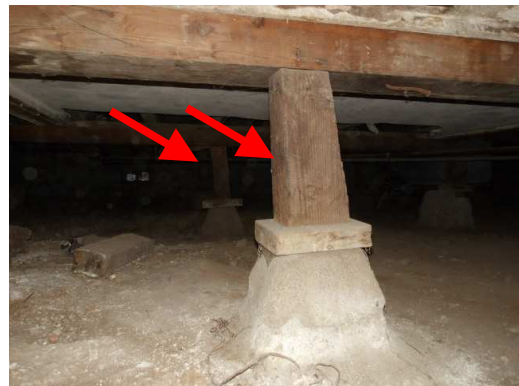
- Some of the posts are crooked. This condition is possibly caused by some movement of the structure.

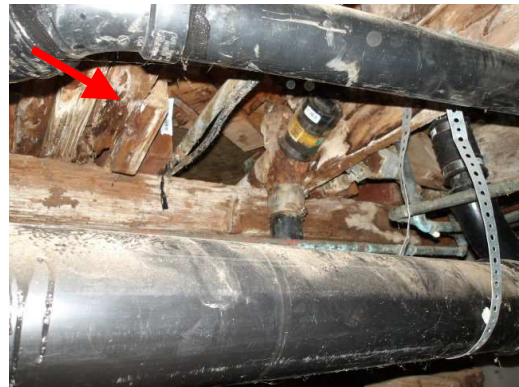
- There is some water staining and deterioration to the sub-flooring in the areas of the bathrooms. It is recommended that a licensed structural pest control company be contacted for further inspection and repair recommendations.
