# *Home Inspections San Diego*

## Property Inspection Report

122 Elder Avenue , Chula Vista, CA 91910  
Inspection prepared for: Shannon Medina  
Real Estate Agent: Patrick Adams -

Date of Inspection: 7/17/2026 Time: 12:00 p.m.

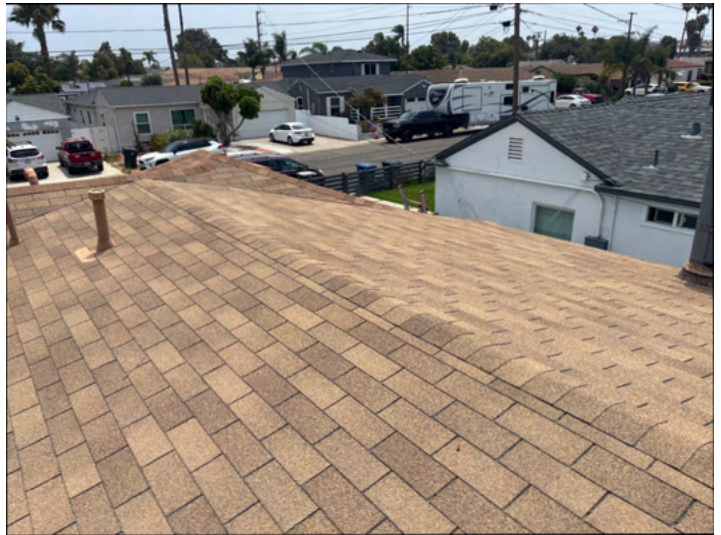
Picture of the composition shingle roof.

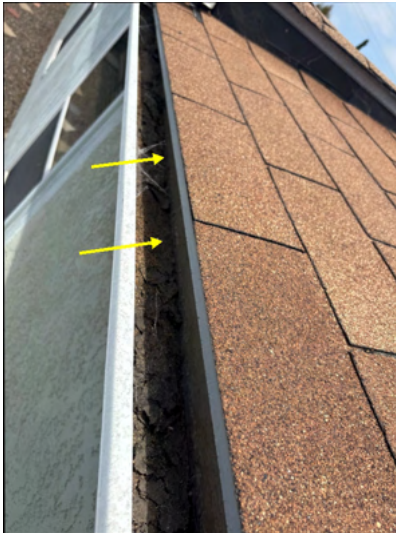
A rain gutter and or gutters are full of debris, tree leaves and or soil which we recommend you clean to facilitate proper drainage.

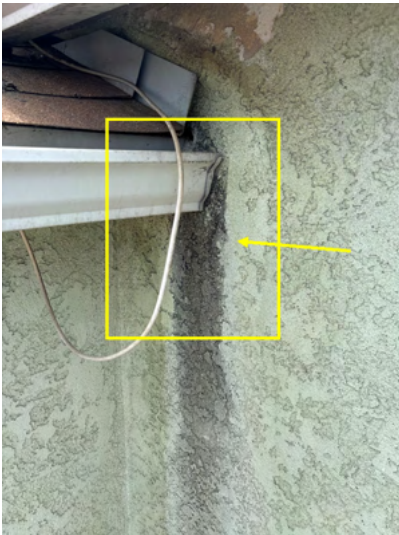
| Page 20 Item: 1 | Stucco | <ul style="list-style-type: none"> <li>• The stucco color coat the exterior of the home shows signs of weathering to its finish. (Stains on the exterior finish). This condition should be noted as fogging and or service to the color coat may be necessary to correct these areas. Please consult with licensed stucco contractor on the correction of this condition. Location: Front of the home at the garage intersection. Note: This appears to have been caused by a leak at the rain gutter and or improperly installed kick out flashing.</li> <li>• The current condition of the stucco color shows signs of flaking. This condition may have been caused by an improper application of paint and or moisture behind the stucco surface. This condition should be noted as it may require scraping of the stucco, installation of texture and color coat or painting to match. We recommend the overall condition of the stucco in this area evaluated by a licensed stucco contractor. Location: Front of the home (right side of the garage).</li> </ul> |

The stucco color coat the exterior of the home shows signs of weathering to its finish. (Stains on the exterior finish). This condition should be noted as fogging and or service to the color coat may be necessary to correct these areas. Please consult with licensed stucco contractor on the correction of this condition. Location: Front of the home at the garage intersection. Note: This appears to have been caused by a leak at the rain gutter and or improperly installed kick out flashing.

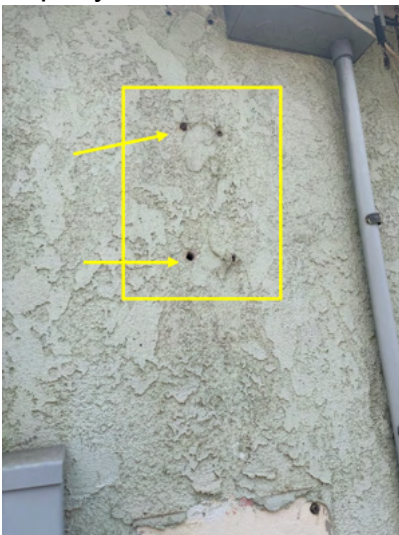
There is hole and or holes in the stucco. We recommend the correction of this condition by a licensed stucco contractor to prevent water intrusion into the wall cavity. Location: Right side of the home.

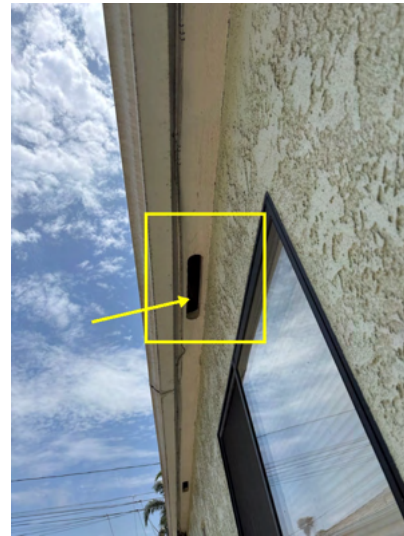
| Page 25 Item: 4 | Fascia/Soffit | <ul style="list-style-type: none"> <li>• A screen and or screens for the eaves venting is damaged. Replacement or repair is recommended as it could promote insect and or pest intrusion into the attic area. Location: Right side of the home and at the electrical to junction box intersection at the right side of the home.</li> <li>• The fascia board and eaves shows signs of weathering and may require future maintenance, painting and or service. We recommend a licensed painting contractor evaluate the overall condition of the fascia board and eaves. Location: Throughout.</li> </ul> |

A screen and or screens for the eaves venting is damaged. Replacement or repair is recommended as it could promote insect and or pest intrusion into the attic area. Location: Right side of the home and at the electrical to junction box intersection at the right side of the home.

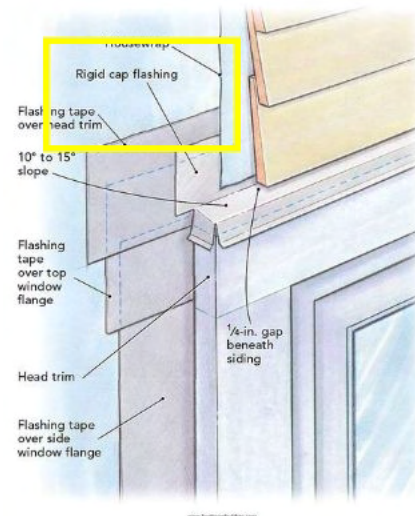
The header flashing is missing at the wood window frame intersection. We recommend you have this condition corrected by a licensed contractor to prevent water intrusion inside the wall cavity. Location: Throughout.

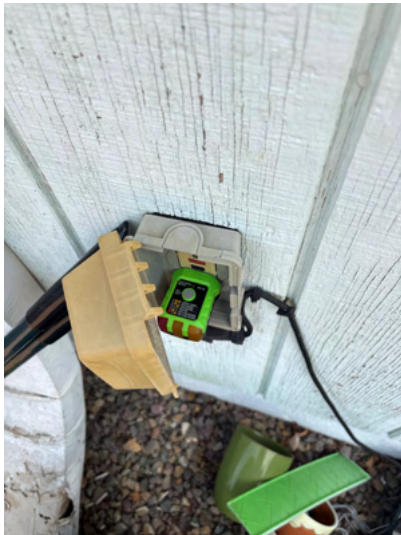
| Page 26 Item: 8 | Electrical | <ul style="list-style-type: none"> <li>• A G.F.C.I. outlet and or outlets attached to the exterior of the home were not functioning at the time of the inspection. We recommend you have this condition further evaluated by a licensed electrician. Location: Rear of the home.</li> <li>• Current standards require a G.F.C.I. outlet to be installed in all areas that are exposed to water and is recommended for safety. The current outlet or outlets attached to the exterior of the home are not G.F.C.I. protected. We recommend you have this condition corrected by a licensed electrician as it could pose a safety concern. Location: Front of the home attached to sprinkler system. Note: This outlet is ungrounded which we recommend you have grounded.</li> </ul> |

A G.F.C.I. outlet and or outlets attached to the exterior of the home were not functioning at the time of the inspection. We recommend you have this condition further evaluated by a licensed electrician. Location: Rear of the home.

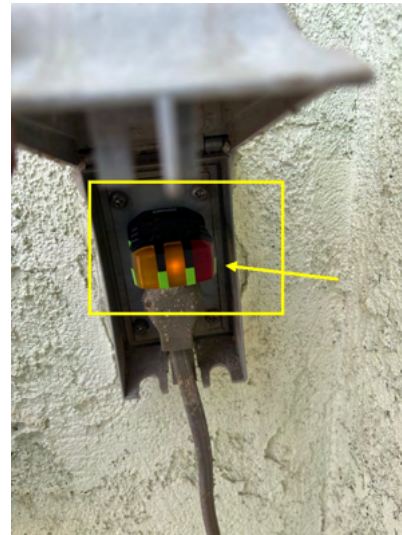
Current standards require a G.F.C.I. outlet to be installed in all areas that are exposed to water and is recommended for safety. The current outlet or outlets attached to the exterior of the home are not G.F.C.I. protected. We recommend you have this condition corrected by a licensed electrician as it could pose a safety concern. Location: Front of the home attached to sprinkler system. Note: This outlet is ungrounded which we recommend you have grounded.

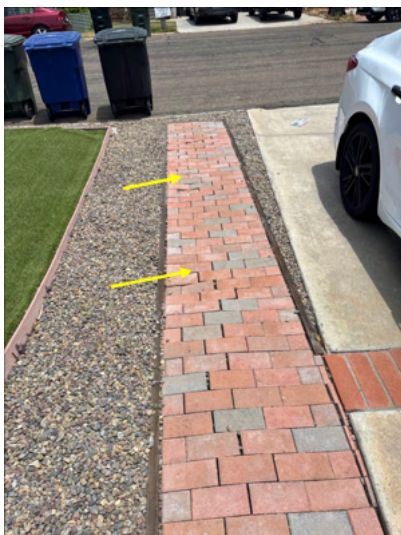
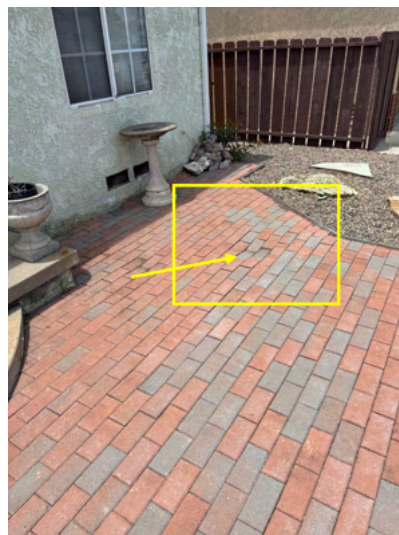
| Page 29 Item: 4 | Flatwork/Steps | <ul style="list-style-type: none"> <li>• The brick walkway located at the front of the home shows signs of settling. This walkway is not considered part of the foundation, but this should be noted as it could pose a trip hazard.</li> </ul> |

The brick walkway located at the front of the home shows signs of settling. This walkway is not considered part of the foundation, but this should be noted as it could pose a trip hazard.

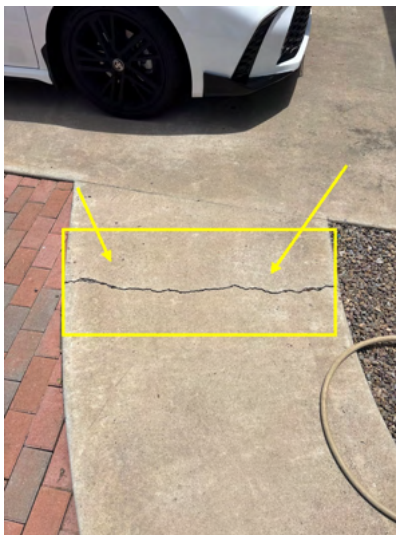
The walkway shows minor settling cracks. The walkway is not part of the foundation, but this condition should be noted.

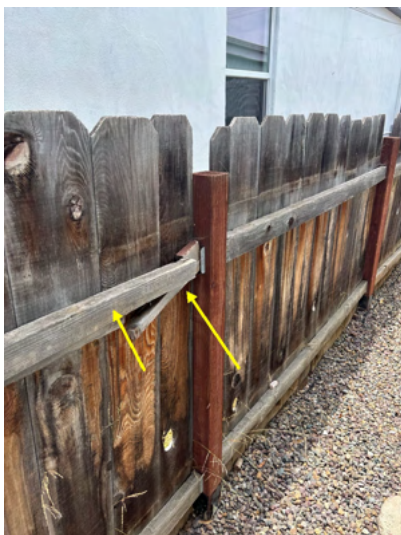
Original/older wood fencing remains on the property. Due to the current condition of the fencing, replacement may be necessary as sections/pieces of the fencing are damaged and their posts show signs of wear. Due to the overall condition of the fencing, we recommend it evaluated by a licensed fencing contractor. Location: Left side and rear of the property.

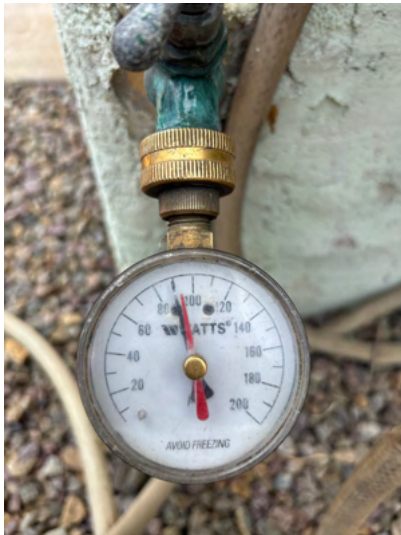
| Page 33 Item: 12 | Pressure Regulator | <ul style="list-style-type: none"> <li>• The water pressure tested at the hose bib is 90 psi. Standards recommend the water pressure between 40-80 psi. with the current water pressure within the standards. We were unable to locate the water pressure regulator and or there is not one present. We recommend the addition of a water pressure regulator to ensure the water pressure does not exceed the recommended amount as it could cause damage to the copper water lines.</li> </ul> |

Standards require that water pressure should be at 40-80 psi. The current pressure is the above the standards.

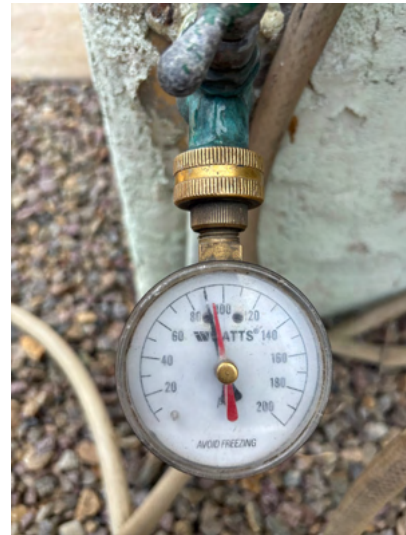
90 p.s.i.

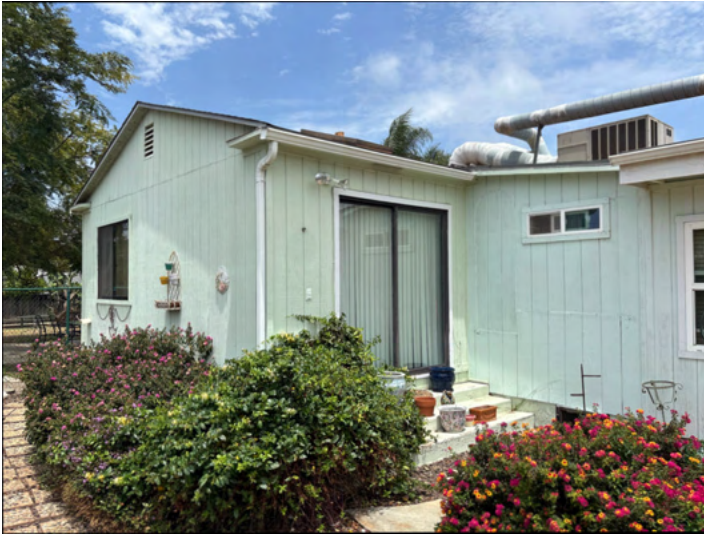
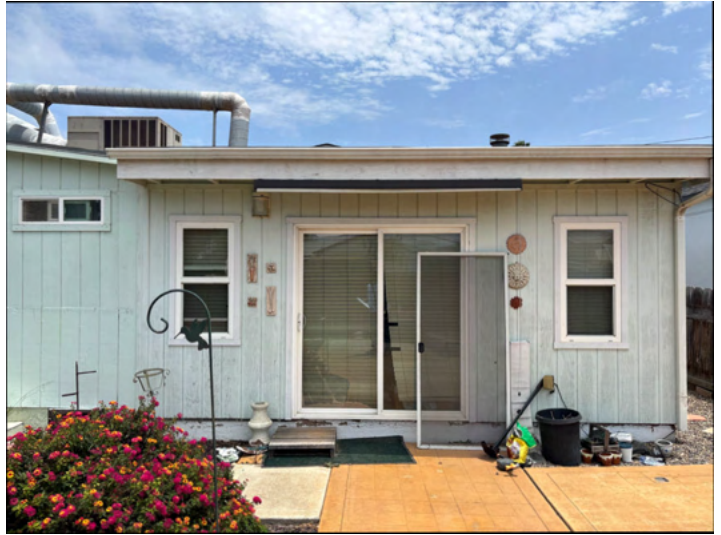
An addition has been added to the home (family room, masterbedroom suite and bedroom 4 suite). Therefore, you should request documentation that should include permits and any warranties or guarantees that might be applicable. We are unable to determine if this addition is considered part of the square footage of the home.

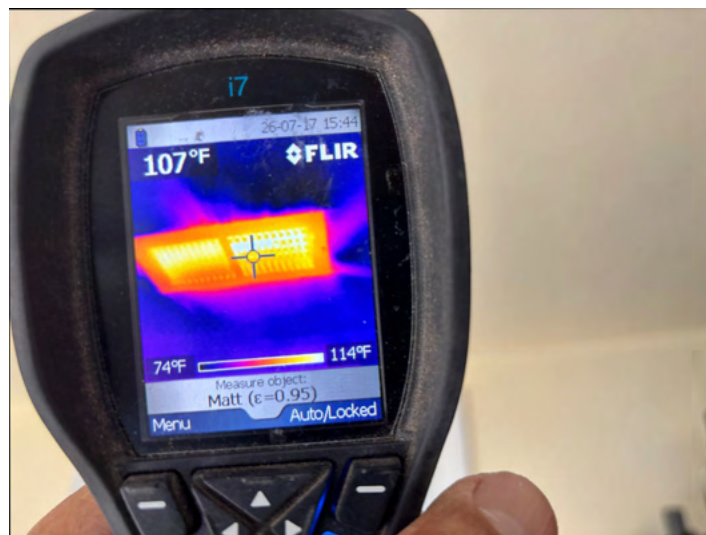
The temperature at the registers was 105-110 degrees.

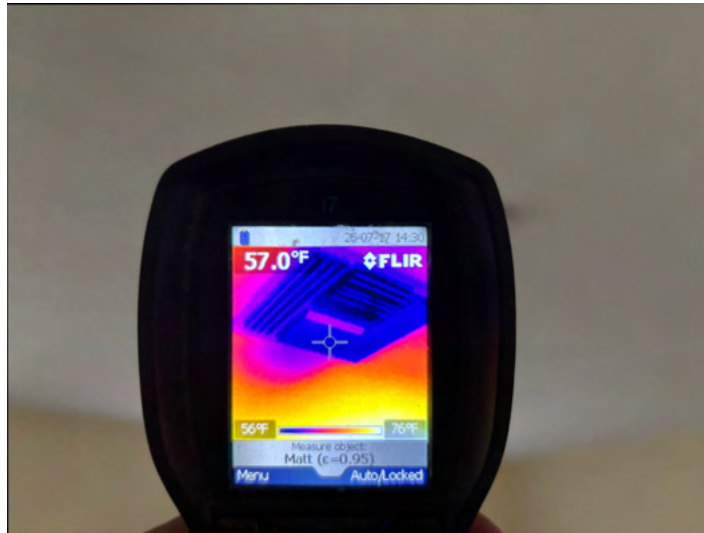
The temperature at the registers on the cool setting is 54-60 degrees.

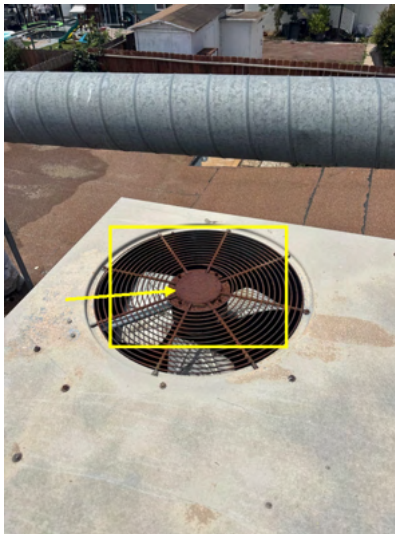
The air conditioner condenser unit is in satisfactory condition, but does show signs of rusting on the fan motor housing.

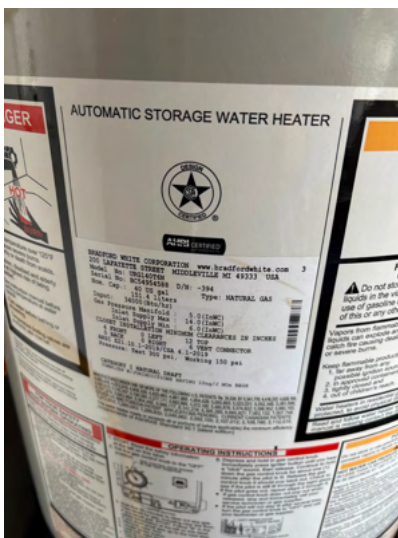
Water heater identification tag.

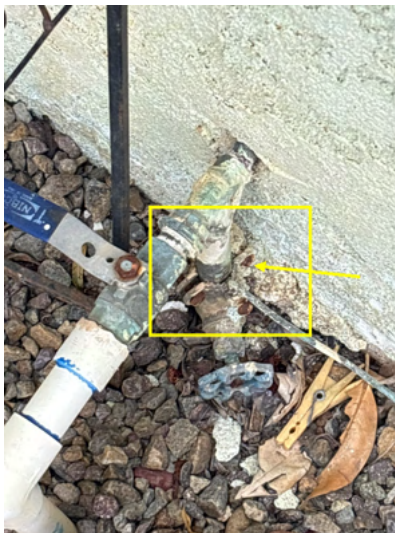
| Page 40 Item: 7 | Main water valve | <ul style="list-style-type: none"> <li>• A gate valve was installed for the main water shut off; a ball is recommended. We recommend the correction of this condition by a licensed plumber. We have not tested the functionality of this valve as it is prone to leakage if disturbed. Location: Front of the home.</li> </ul> |

A gate valve was installed for the main water shut off; a ball is recommended. We recommend the correction of this condition by a licensed plumber. We have not tested the functionality of this valve as it is prone to leakage if disturbed. Location: Front of the home.

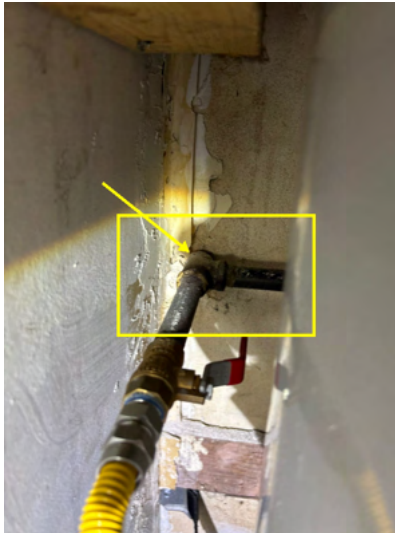
A gas line "T" has been installed from the gas line of the water heater to a supply line for the laundry gas dryer. This type of connection may inhibit the amount of gas supplied to both of these units simultaneously. Therefore, we recommend you have a licensed plumber evaluate this type of condition to ensure the diameter of the gas feed line is adequate for the amount of gas needed.

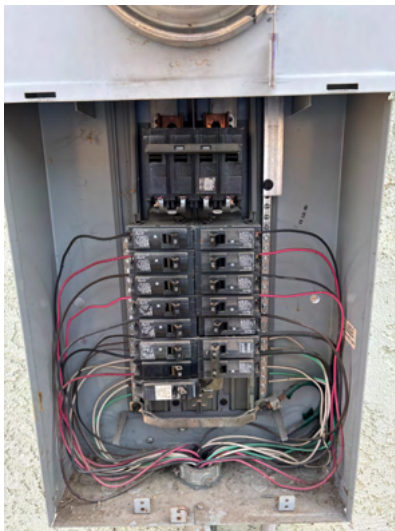
Picture of the main electrical panel.

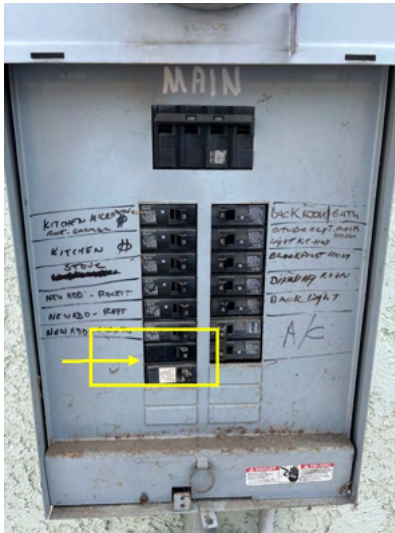
We recommend you label all the breakers and their exact location to comply with the current standards.

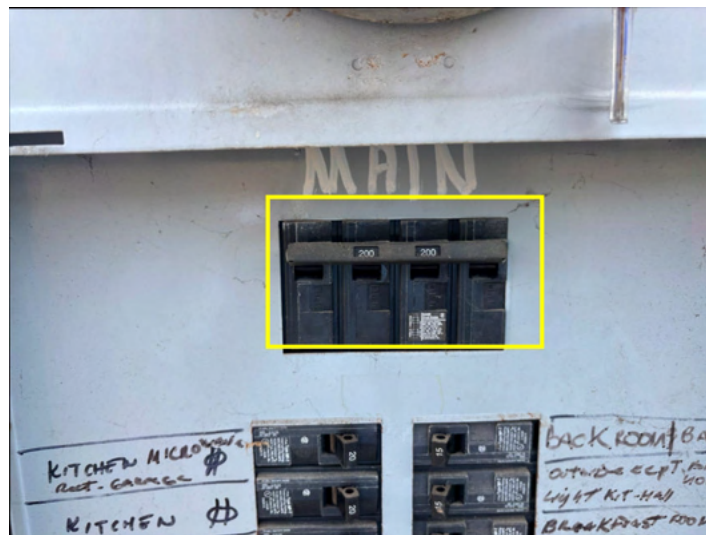
200 amp.

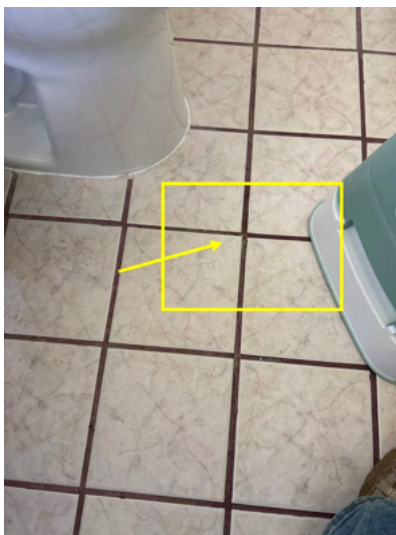
Newer and or upgraded tile flooring was installed on the bathroom floor and there are pieces that are uneven. (High and low spots). This condition should be noted as it could pose a potential trip hazard.  
Location: Bathroom 2.

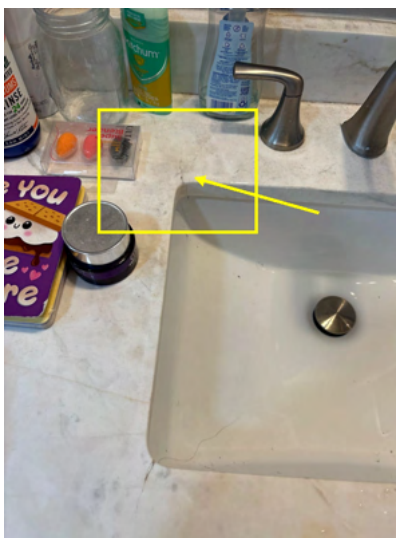
There is a hairline crack and or cracks is present on the solid surface counter top(s). Location: Bathroom 3.

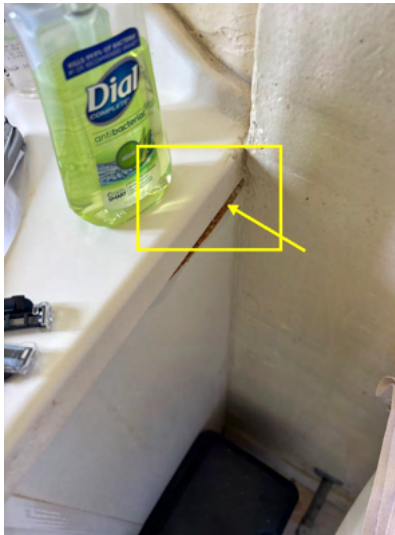
There are stains and or damage to the wood finish present on the sink of the cabinet. We have tested this area for moisture at the time of the inspection and there was no moisture present. Location: Bathroom 2.

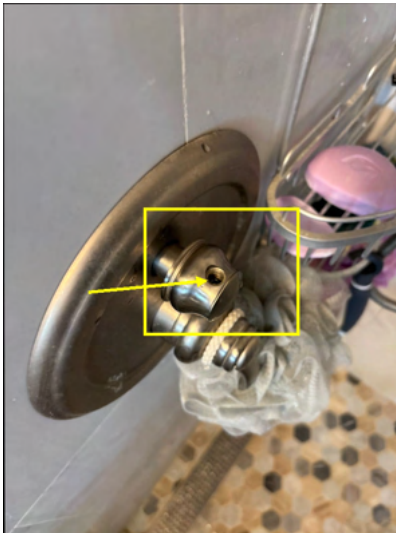
Damaged and or missing item: Center diverter handle. Replacement recommended. Location: Bathroom 3.

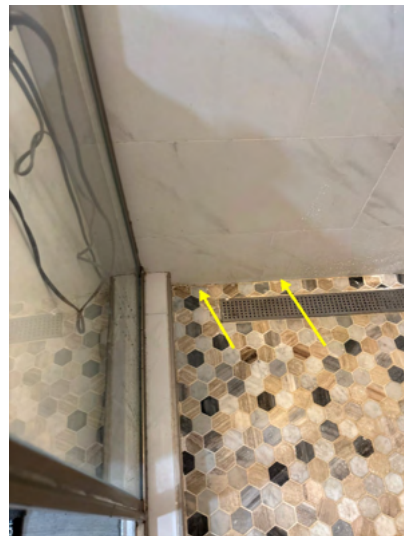
The floor of the shower is in need of additional grout and or sealant at the floor to wall intersection. Location: Bathroom 3.

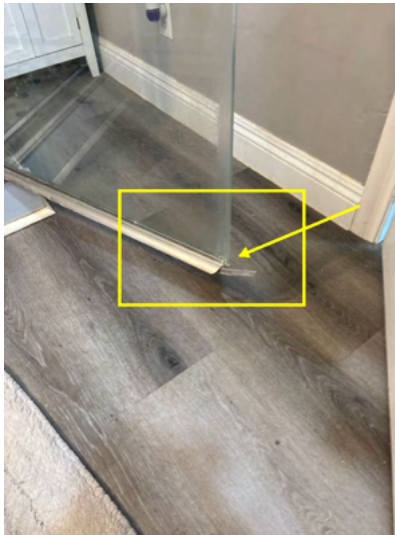
The shower door is missing or has a damaged water diverter located at the base of the shower door. We recommend you have this item repaired to prevent water seepage through the base of the shower door. Location: Bathroom 3.

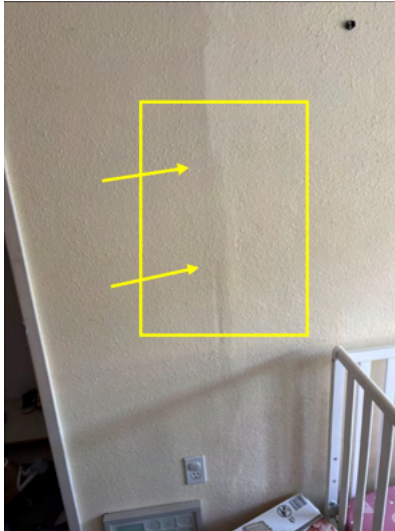
There has been repair made to a wall and or walls in an interior room and the texture does not match exactly. Location: Bedroom 2.

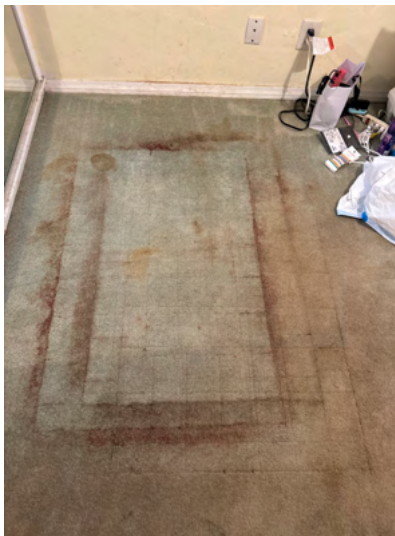
The carpet appears to be in satisfactory condition; although, it is in need of cleaning. We are unable to determine if the stains can be removed from the carpet and may require replacement.

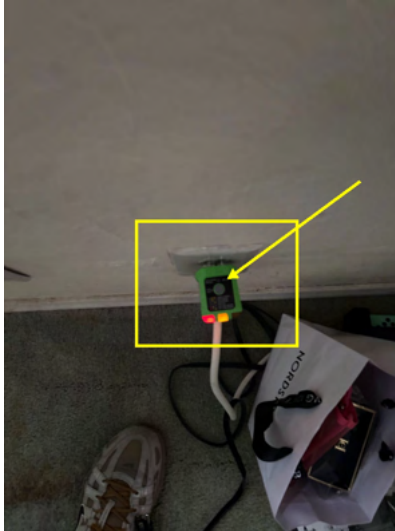
The hot (black) and neutral (white wire) have been reversed on the interior room outlet and or outlets (reversed polarity). We recommend you have this condition corrected by a licensed electrician.  
Location: Bedroom 2.

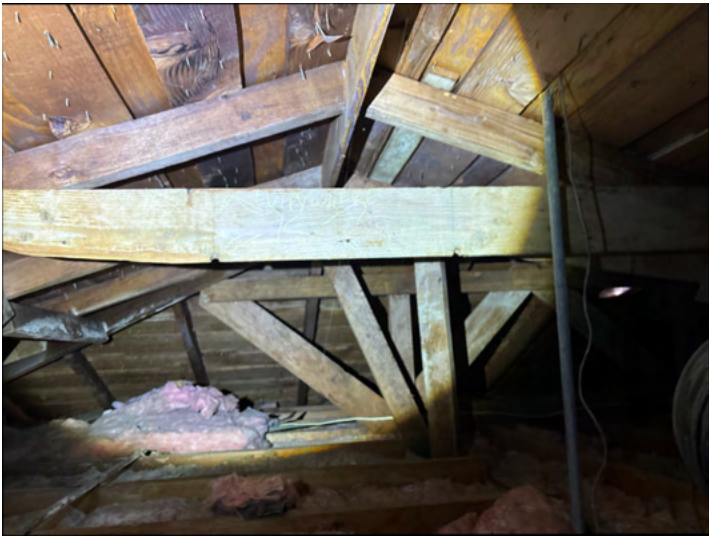
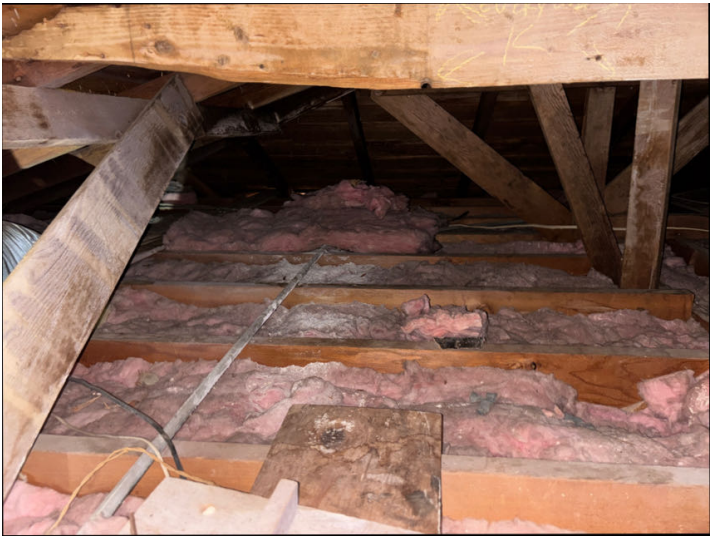
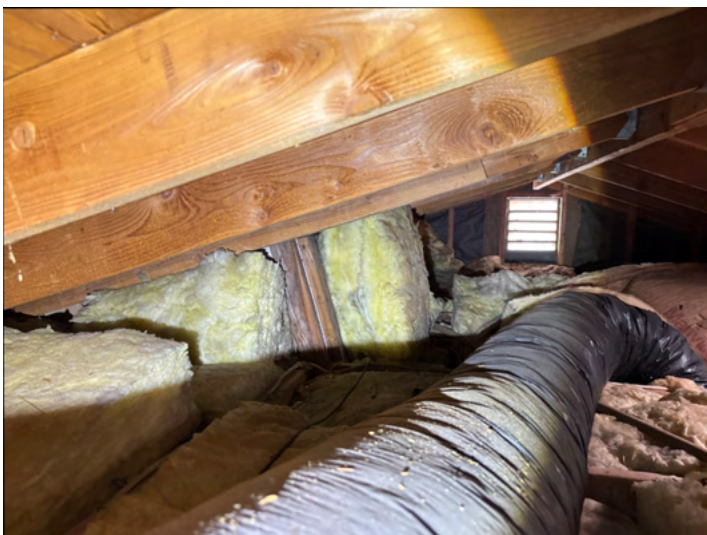
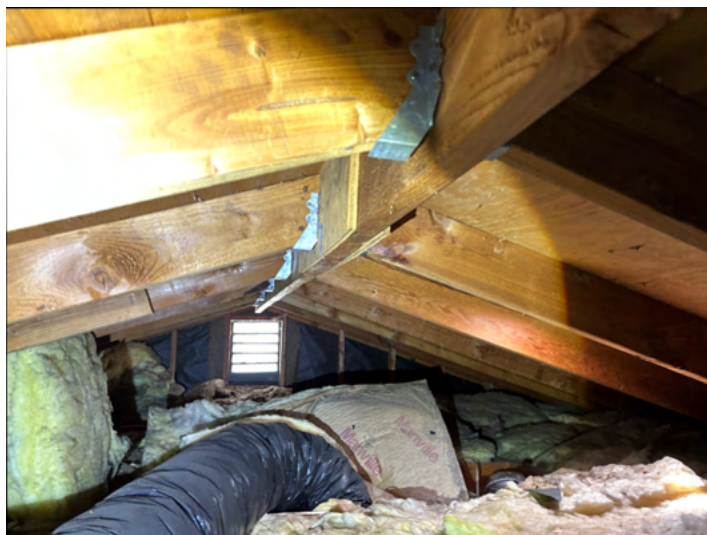
- Observations:
- Framing- Conventional rafter type framing present.
  - There are signs of insect and or water damage to the framing members (markings from termite company). Home Inspections San Diego doesn't perform any insect or water damage inspections. Please review your termite report regarding this condition.

Framing- Conventional rafter type framing present.

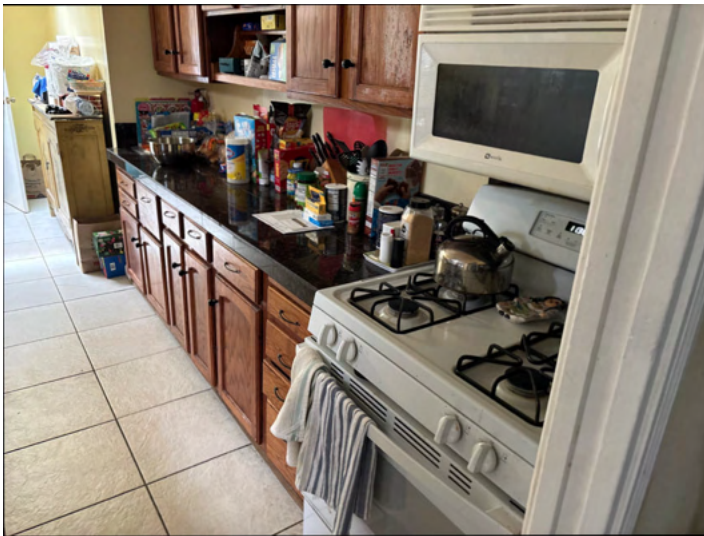
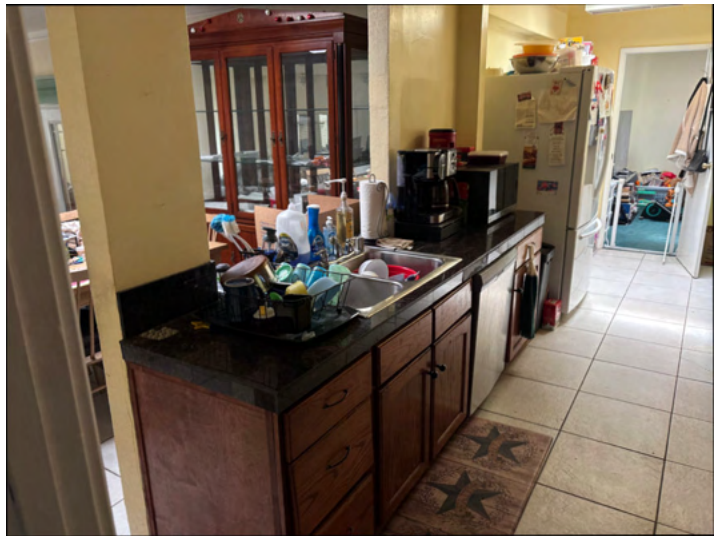
Picture of the kitchen.

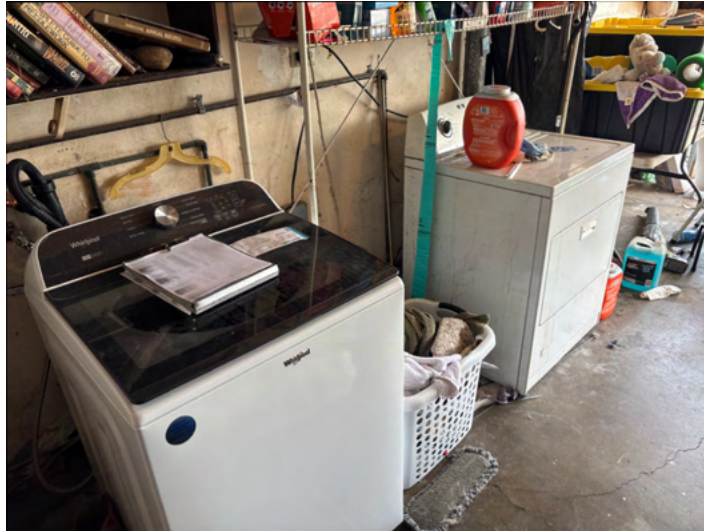
Washing machines and dryers are above the scope of this inspection and we recommend you consult with the existing homeowner or seller regarding any guarantees or warranties on these appliances if they are to remain with the property.

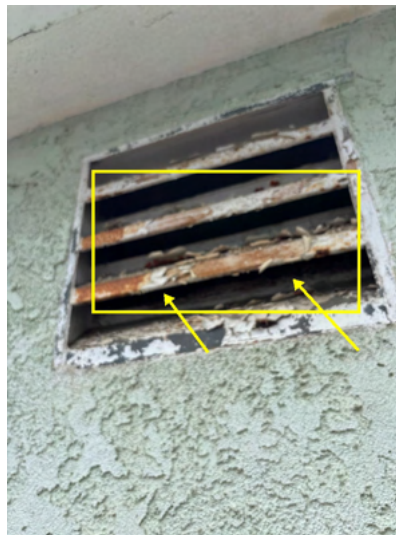
A screen and or screens for the garage cross ventilation is damaged and or missing. We recommend the replacement of this screen as it could promote insect and or pest entrance into the garage interior. Location: Left side of the garage.

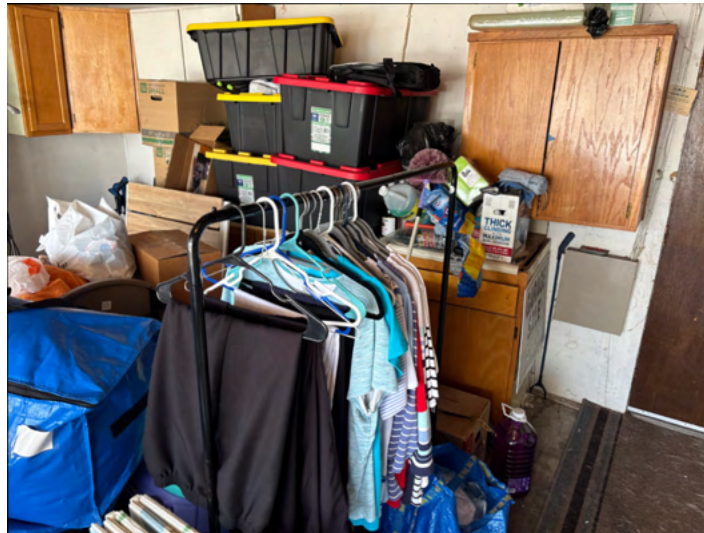
A physical inspection has been made to the garage. The existing homeowner's personal belongings remain throughout the garage and the inspection of the walls and floor has been limited. Home Inspections San Diego does not move personal belongings. Upon the removal of their personal belongings, drywall and or plaster repair may be necessary. We are unable to determine if all the cabinets and or shelving are to remain in the garage.

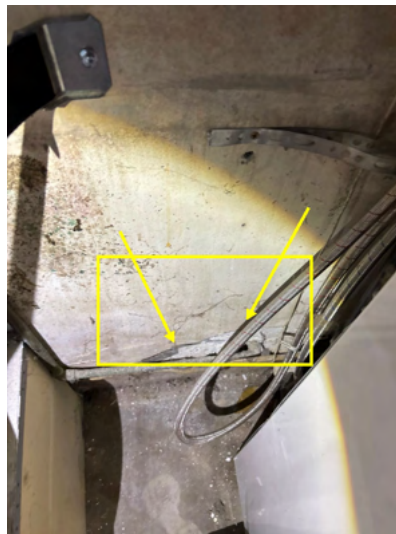
There is plaster and or drywall damage present on the garage wall(s) and this area has not been returned to its original state. Repair to the plaster and or drywall in these areas would be necessary. Location: Behind the washing machine.

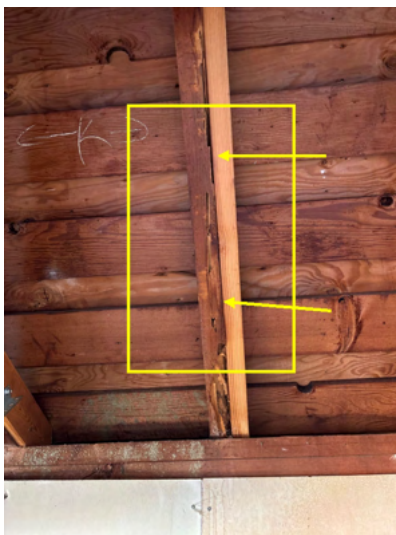
There are signs of insect and or water damage to the framing members. Home Inspections San Diego doesn't perform any insect or water damage inspections. Please review your termite report regarding this condition. Location: Left side of the garage.

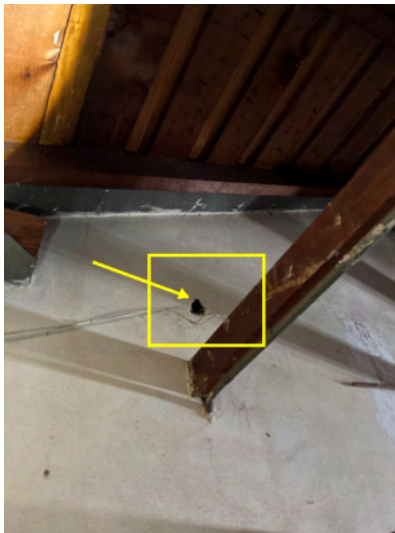
The firewall is the wall and or ceiling that separates the house from the garage. There has been a hole and or holes cut and the drywall has not been returned to its original state. We recommend the correction (repair of the drywall in this area) to maintain the necessary firewall separation between the house and garage. Location: Right side of the garage.

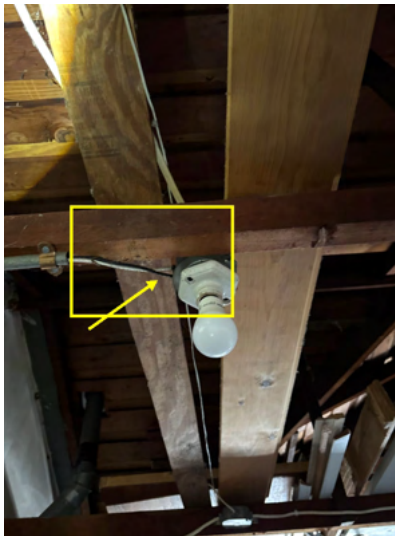
The light wiring in the correct was not installed in the correct conduit which we recommend you have corrected as it could pose a safety concern.

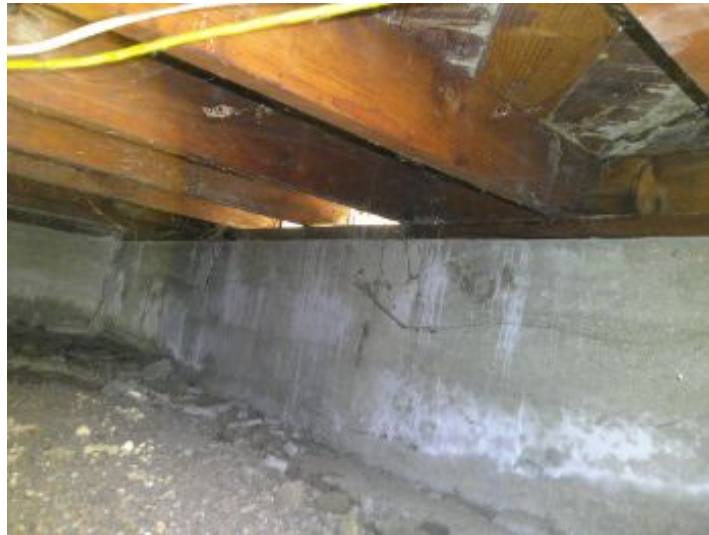
Picture of the raised foundation exterior walls.

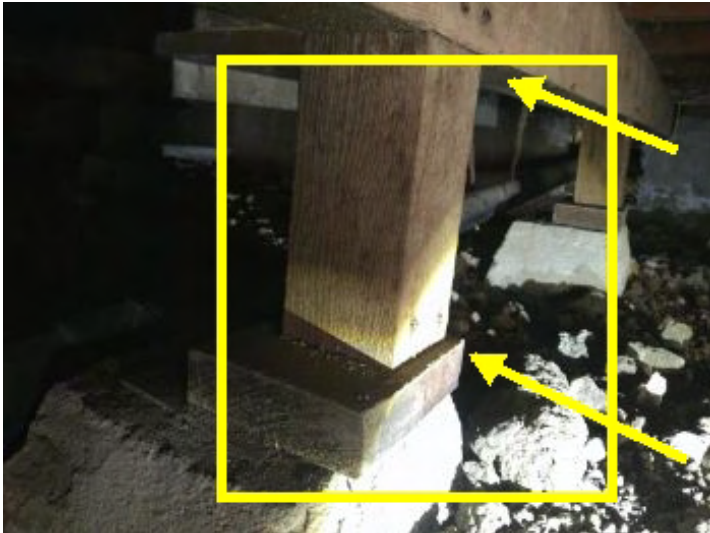
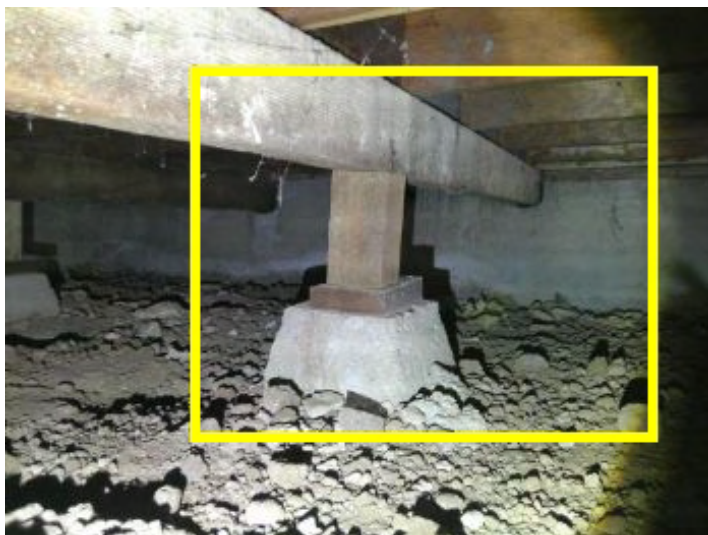
The original post and pier framing remains throughout the property. Current standards do require steel attachments (seismic retrofitting) at the post and pier connections; although, this type of floor framing was common during the construction era of this property.

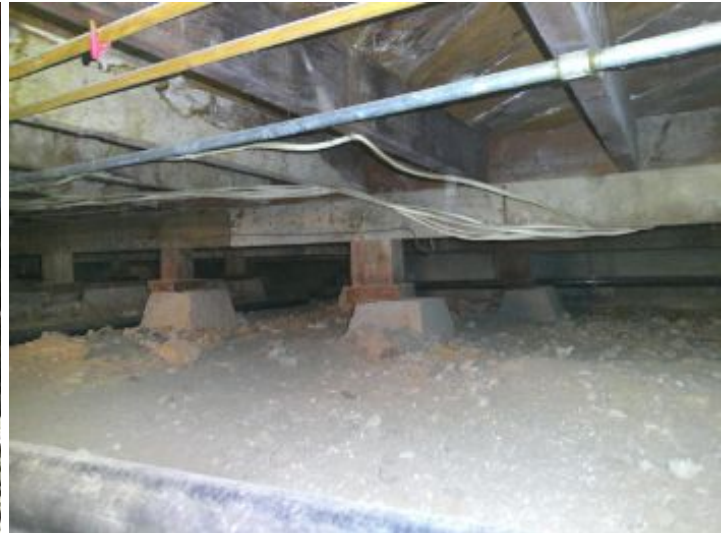
Picture of the floor framing.

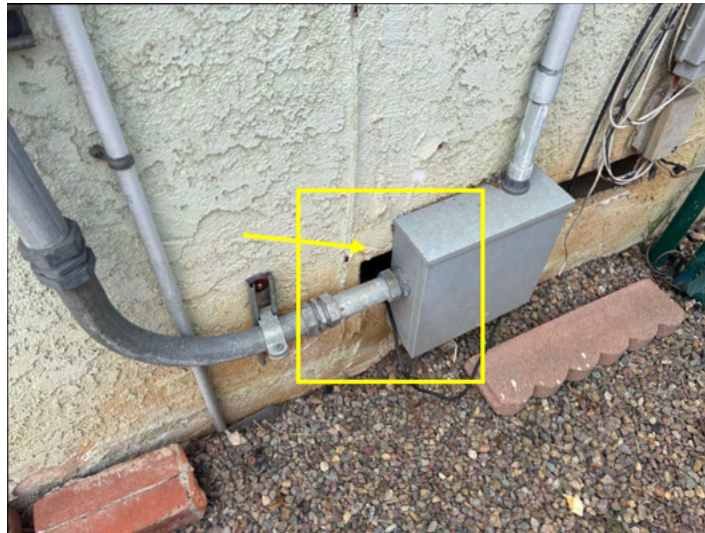
A foundation ventilation screen and or screen is damaged and or missing. We recommend you repair and or the addition of the vent screens as they could promote animal/pest intrusion under the raised foundation. Location: Right side of the home at the electrical junction box intersection.

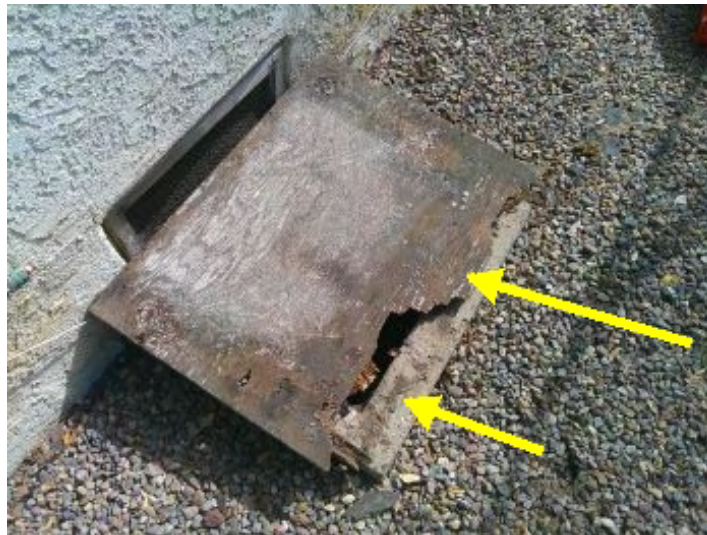
The wood access panels' for the raised foundation openings are older and do not fit tight at the openings'. Future repair and or replacement to the access covers' may be necessary and is recommended.

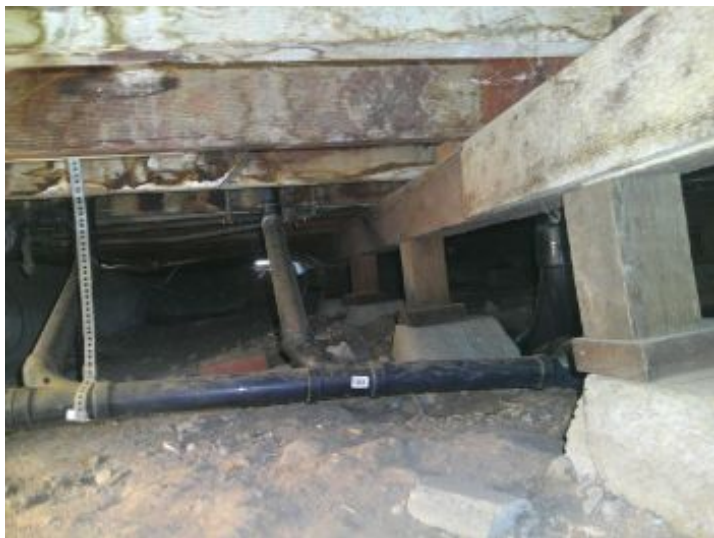
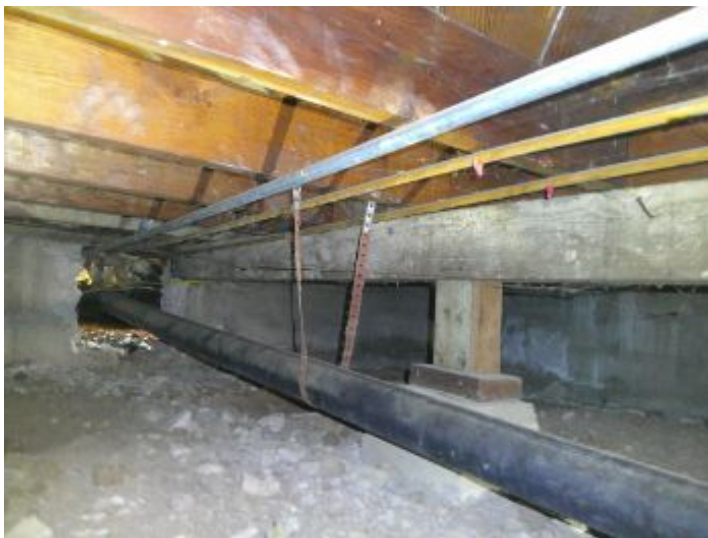
The correct type of plastic drain pipe support (ABS drain pipe) was not installed. Listed plastic hangers are recommended and to be installed every four feet. Location: Throughout the raised foundation.

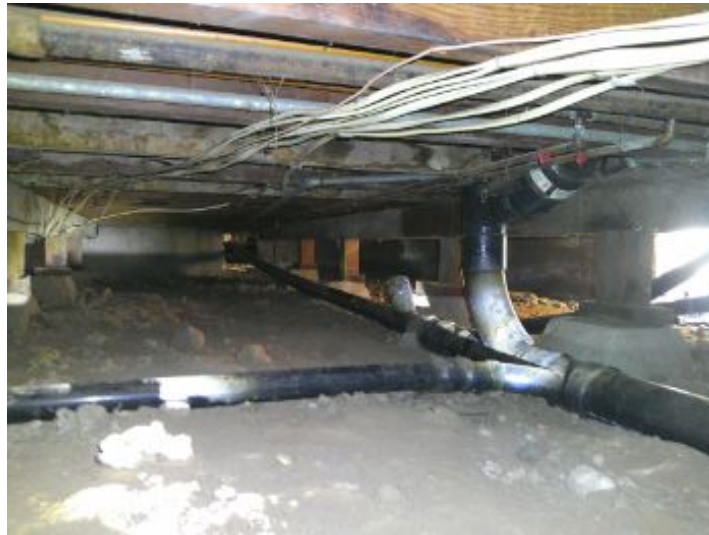
There has been new A.B.S. piping installed under the raised foundation and this piping has not been supported every 4 feet which is recommend to comply with the current standards. Location: Throughout the raised foundation.

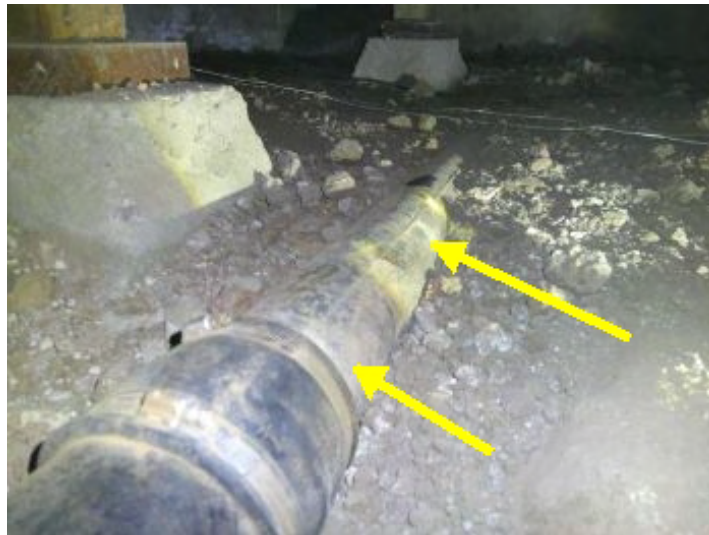
- A section of the original cast iron main drain remain under the raised foundation. Due to its age, we are unable to determine its exact life expectancy and may require future replacement. We recommend you have this drain evaluated by a licensed plumber to determine its exact life expectancy.

A section of the original cast iron main drain remain under the raised foundation. Due to its age, we are unable to determine its exact life expectancy and may require future replacement. We recommend you have this drain evaluated by a licensed plumber to determine its exact life expectancy.

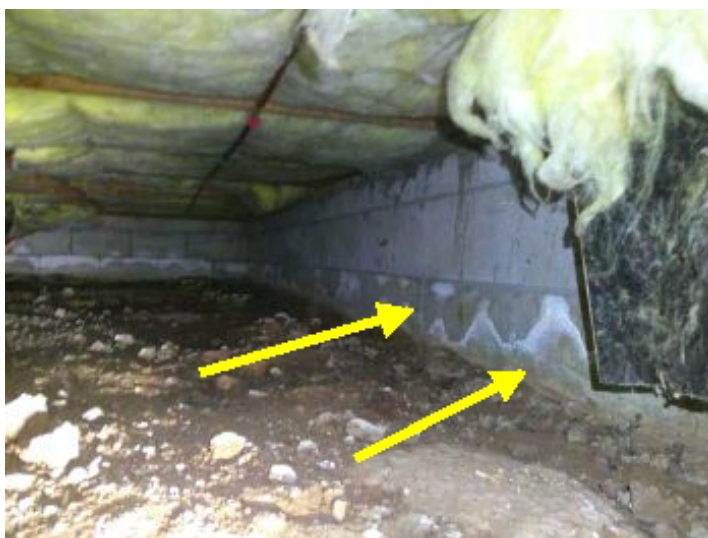
- There are signs of water efflorescence (white powder on the foundation walls) under the house foundation. This condition appears to have been caused by poor drainage and or poor sealant. We recommend you have corrected (addition of drainage ) to prolong the life expectancy of the house foundation. The homeowner has been advised of this condition at the time of the inspection. Location: Right rear of the home under the masterbedroom addition.

There are signs of water efflorescence (white powder on the foundation walls) under the house foundation. This condition appears to have been caused by poor drainage and or poor sealant. We recommend you have corrected (addition of drainage ) to prolong the life expectancy of the house foundation. The homeowner has been advised of this condition at the time of the inspection. Location: Right rear of the home under the masterbedroom addition.
