HOME INSPECTION

6224 Rose Lake Ave
San Diego, CA 92119

08/01/2025

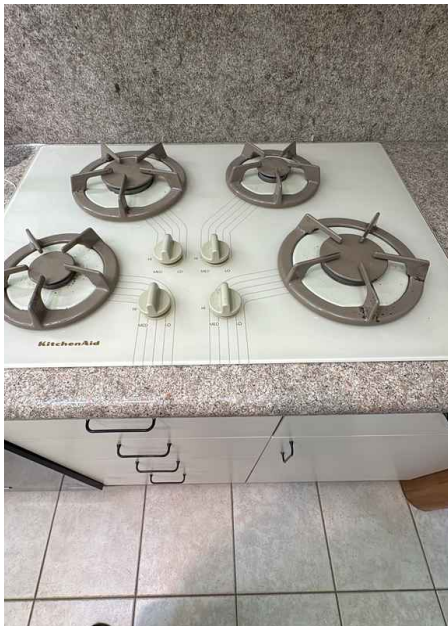
**RANGES/COOKTOP: Range - Aged**

The range appears to be older than its expected service life. According to InterNACHI the average life of a gas range is 15-17 years and an electric range is 13-15 years. Some units may last for more or less time depending on quality and usage.

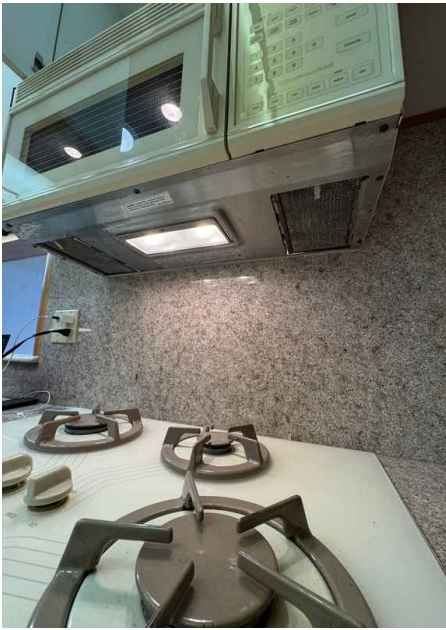
**RANGE HOOD/VENT: Range Hood - Aged**

Note: The range hood/vent appears to be past its expected service life. The average life of a range hood is 14 years. Some units may last for more or less than 14 years depending on quality and usage. To see a complete list of life expectancies for just about every component in a house, please visit our list of Life Expectancy.

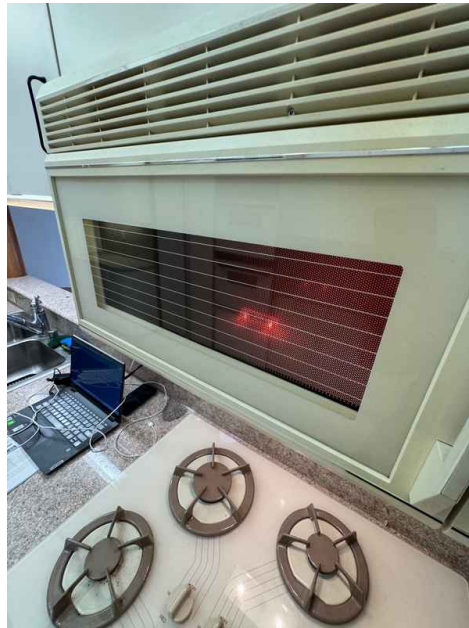
**MICROWAVE COOKING EQUIPMENT (Built-in): MICROWAVE - AGED**

Note: The microwave was functional at time of the inspection, but it is an older unit. (more than 9 years) According to InterNACHI the average life span of a microwave is 9 years. See <https://www.nachi.org/life-expectancy.htm>

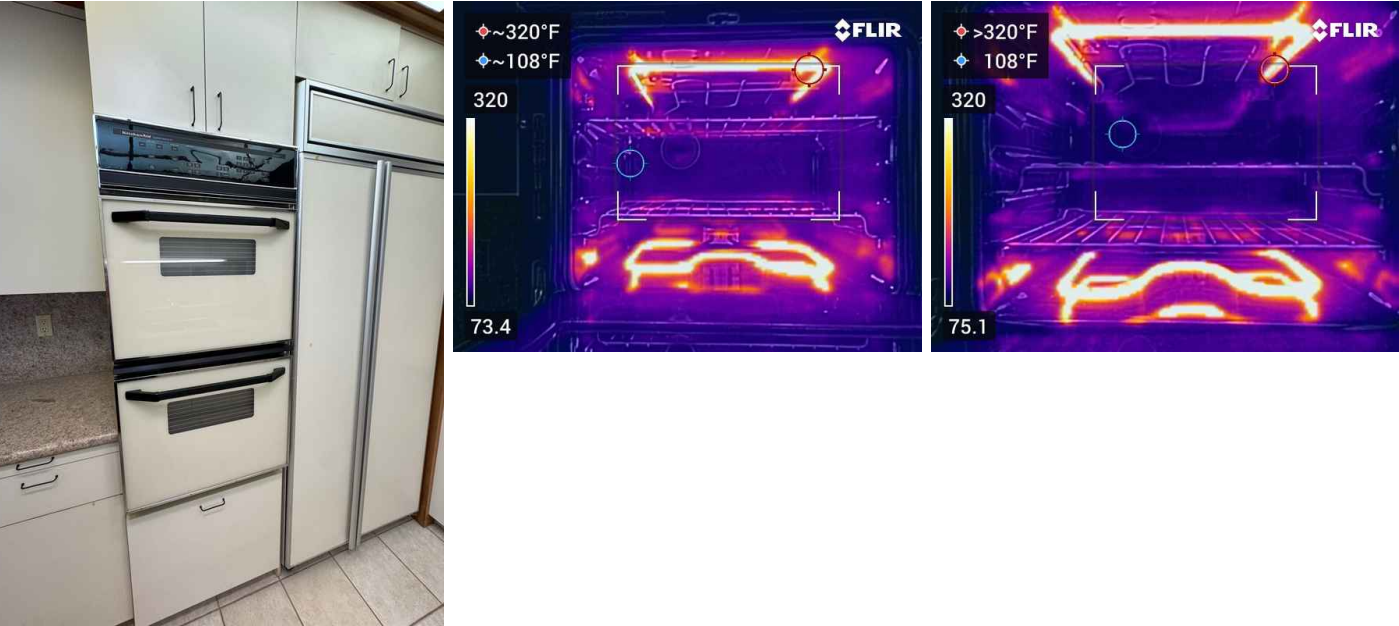
WALL OVEN: Wall Oven - Aged

Note: The wall oven appears to be older than its expected service life. According to InterNACHI the average life of a gas oven is 10-18 years and an electric range is 13-15 years. Some units may last for more or less time depending on quality and usage. To see a complete list of life expectancies for just about every component in a house, please visit our list of Life Expectancy.

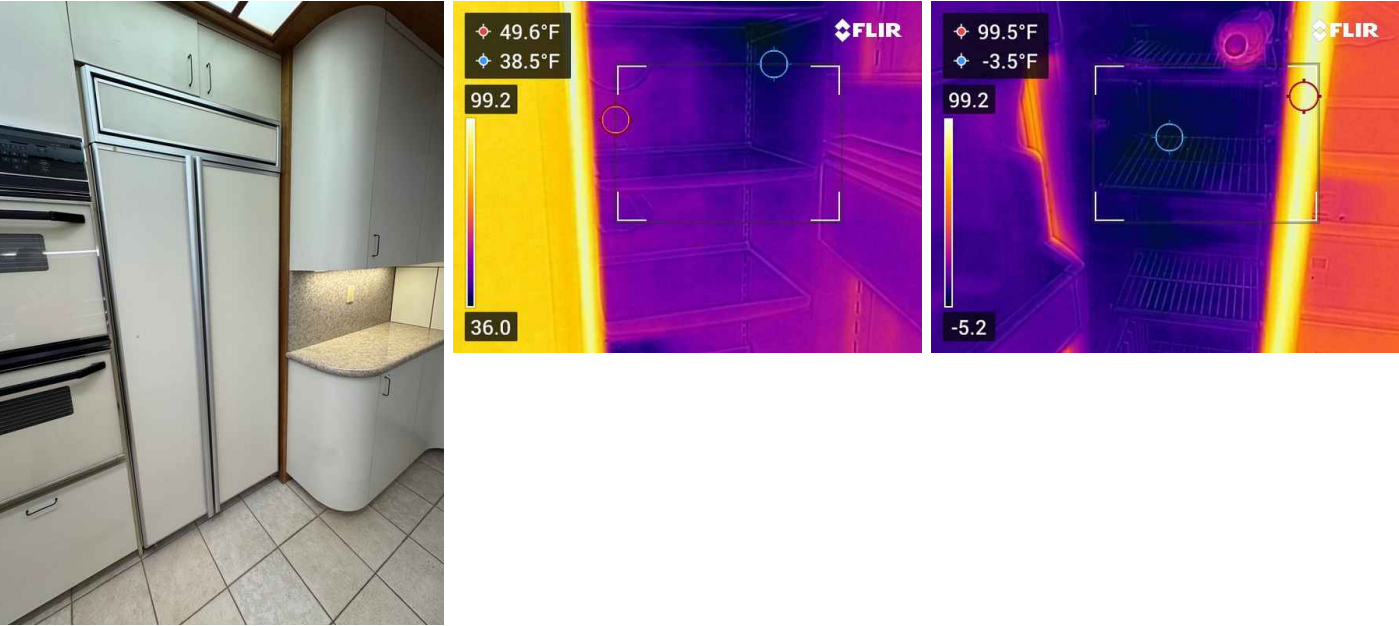
REFRIGERATOR: AGED - 13+ Years

Note: The refrigerator appears to be older than its expected service life. The average life of expectancy is 9-13 years. Some units may last for more or less time depending on quality and usage. To see a complete list of life expectancies for just about every component in a house, please visit our list of Life Expectancy.

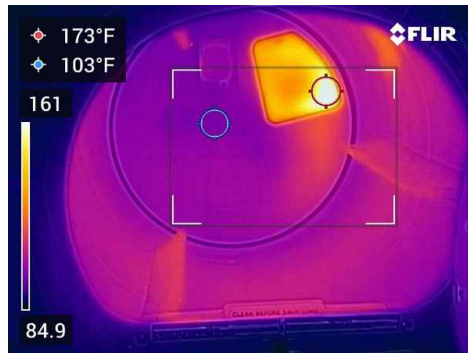
**WASHER/DRYER: Washer Hoses Replace**

Washer hoses are a common source of flooding in a home. We recommend installing new braided steel washer hoses to reduce the risk of leaks caused by burst hoses in the house. Any hoses left in the house or more than 5 years old should be replaced.

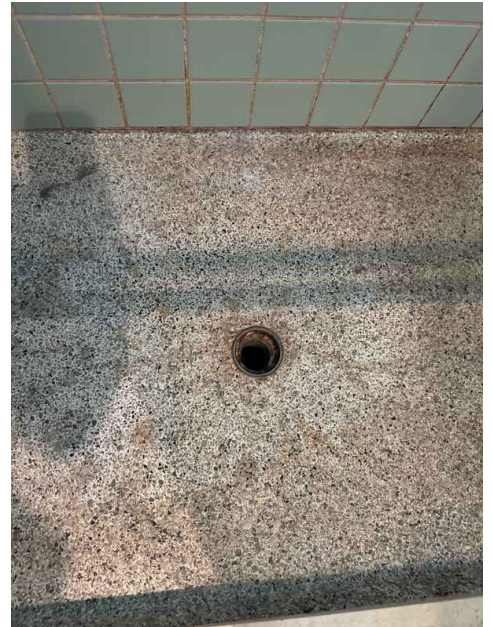
3.2.1 INTERIOR DRAIN, WASTE AND VENT SYSTEMS

FITTING - CORRODED AT SHOWER

The shower drain fitting is corroded and the cover is missing or loose. This can indicate that additional corrosion is occurring behind the shower which cannot be determined. We advise further review by a licensed plumber to determine what parts require replacement, which may include the shower pan.

Contact a qualified professional.

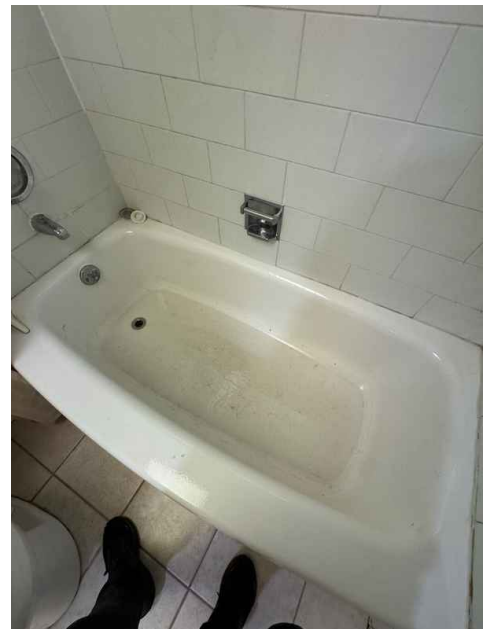
3.2.2 INTERIOR DRAIN, WASTE AND VENT SYSTEMS

Slow drainage was noted at the tub/shower. We advise professional cleanout or necessary corrections.

Contact a qualified plumbing contractor.

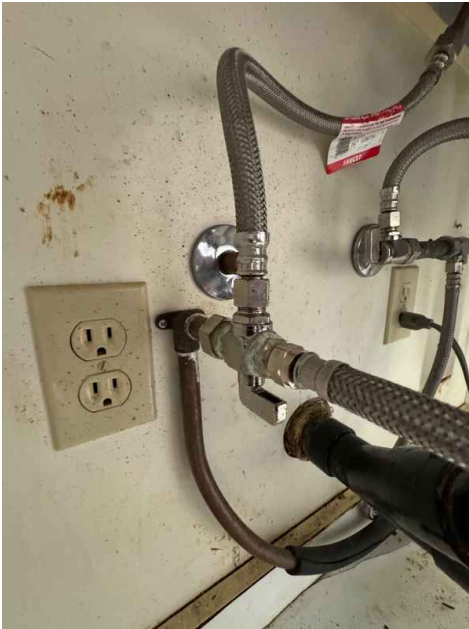
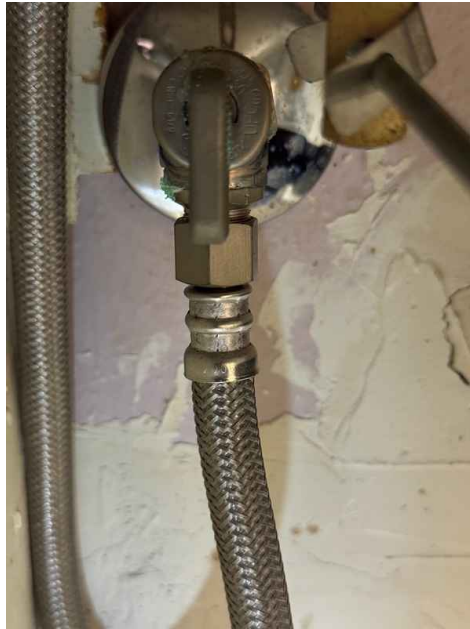
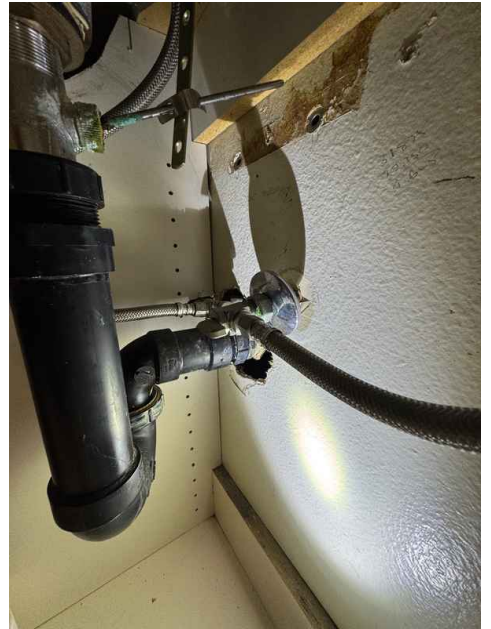
3.3.1 FAUCETS, VALVES AND CONNECTED FIXTURES

ANGLE STOP - CALCIUM/RUST

Calcium/rust deposits were observed at the angle stop valves. This can be caused by high water pressure, poor installation, or poor quality of the valves. These deposits can corrode the valves and eventually cause a leak/flood. We recommend having all damaged angle stop valves replaced by a qualified plumber to avoid leaks and the resulting property damage.

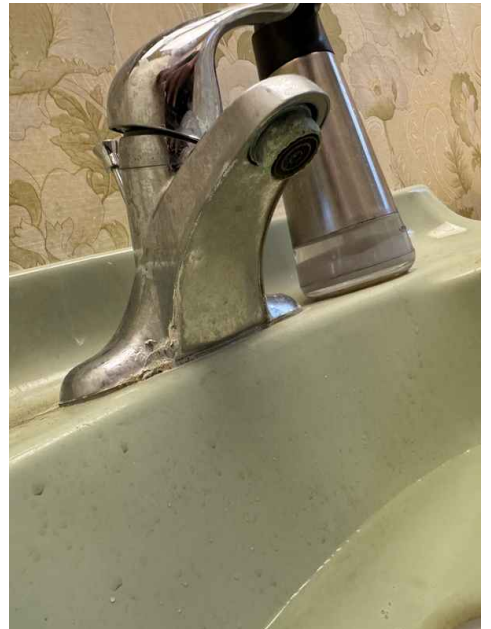
3.3.2 FAUCETS, VALVES AND CONNECTED FIXTURES

FAUCET - CORRODED

The sink faucet was corroded. We recommend replacement to prevent future leaks.

Contact a qualified plumbing contractor.

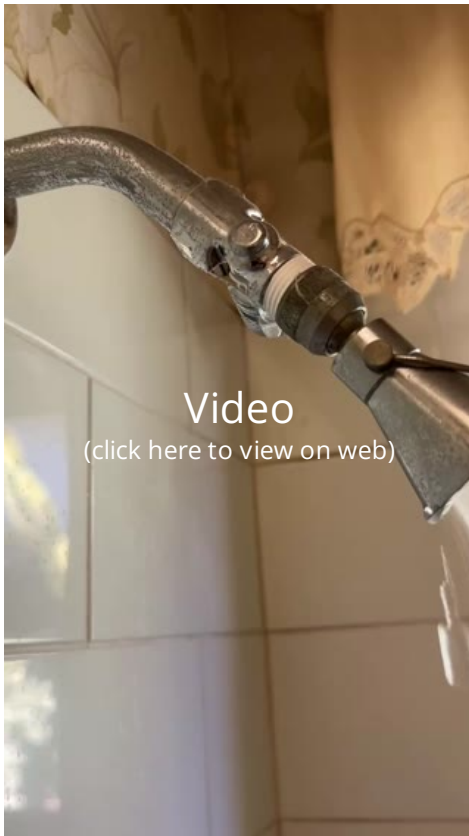
3.3.3 FAUCETS, VALVES AND CONNECTED FIXTURES

SHOWER HEAD - LEAKS FROM CONNECTION

Water leaks from the shower head connection to the hose or shower arm when operated. We recommend repair as needed by a qualified plumber to prevent excessive amounts of water from exiting the shower enclosure.

Contact a qualified professional.

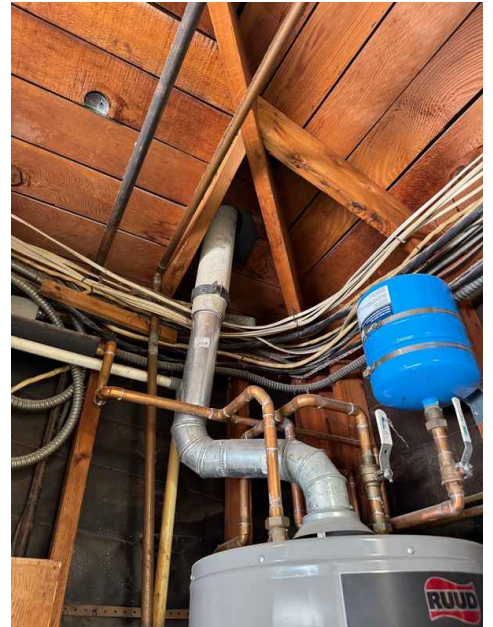
3.7.2 WATER HEATER(S), FLUES AND VENTS

A cementitious-type flue was present which may contain asbestos and other hazards. The only way to confirm the presence or absence of asbestos is through lab testing. In addition, this type of flue can deteriorate over time causing blockage inside the flue which is a Carbon Monoxide hazard. We recommend removal by a qualified contractor.

Contact a qualified professional.

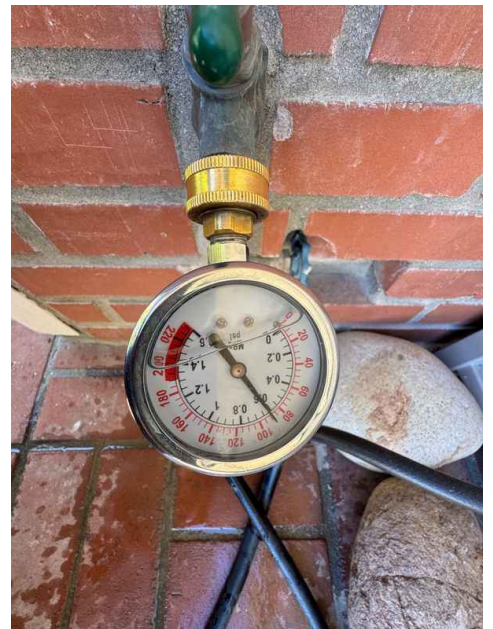
3.10.1 WATER PRESSURE AND REGULATOR

High water pressure noted. This can cause water lines, faucets and water supplied appliances to fail and leak. We advise having a licensed plumber repair or install a new pressure regulator, to allow a PSI range of 50-70.

Contact a qualified plumbing contractor.

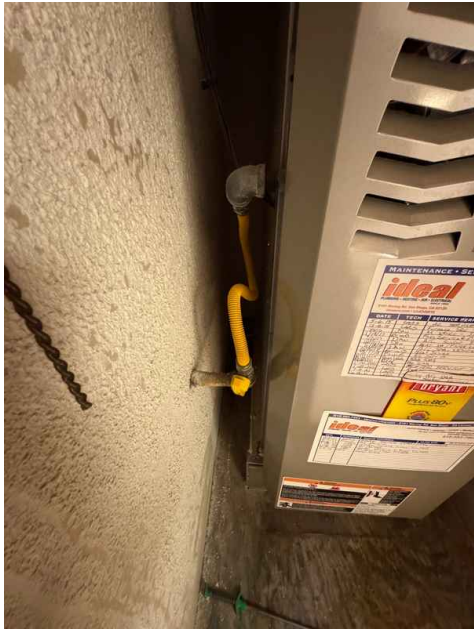
3.11.1 GAS STORAGE AND DISTRIBUTION SYSTEMS

The gas supply pipe (at the water heater and/or furnace) contained no sediment trap. A sediment trap is generally recommended by the manufacturer. The purpose of a sediment trap is to prevent particulates or moisture from condensation from entering and clogging the water heater/furnace gas valve, which can cause the water heater/furnace to shut down.

Contact a qualified professional.

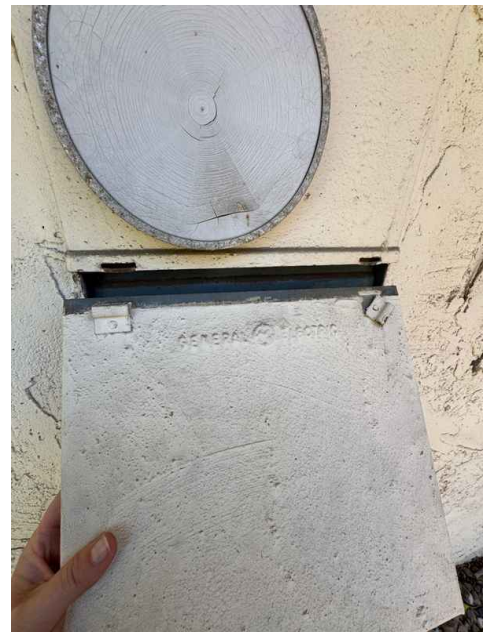
The hinges at the main panel are damaged or missing. We recommend repair by a qualified person for safety.

Contact a qualified professional.

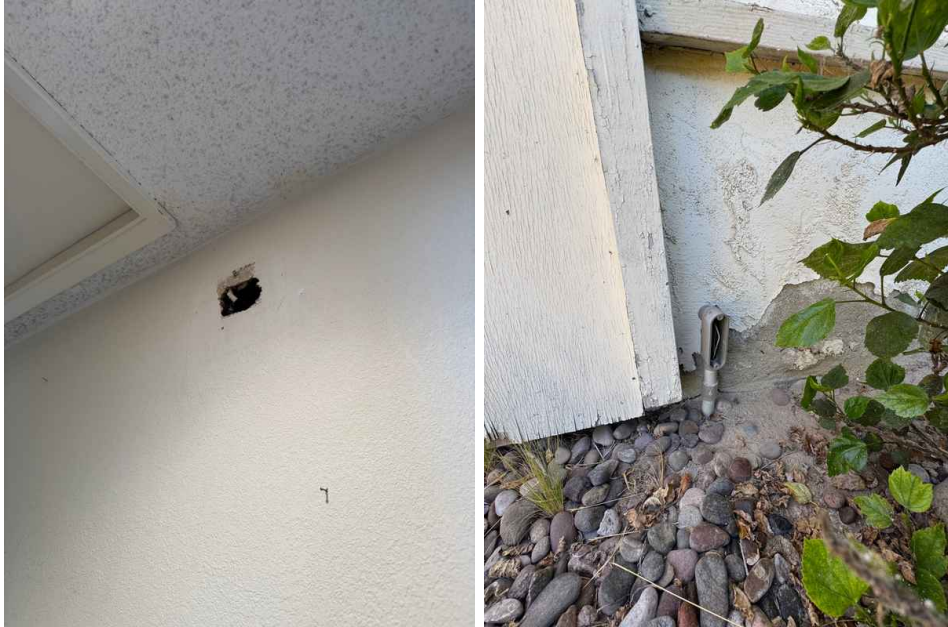
4.7.1 JUNCTION BOXES (Observable)

OPEN JUNCTION BOX

Open junction box noted. Whenever wires are joined together the junction box must have a cover for safety. We advise installing an approved cover plate for safety.

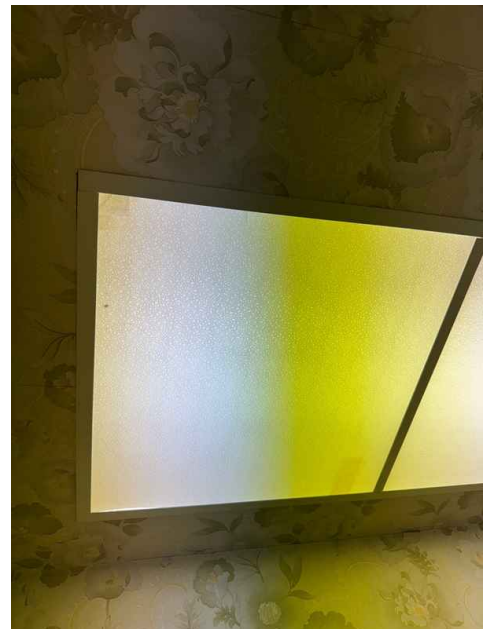
4.8.1 CONNECTED DEVICES AND FIXTURES
(Representative number, excluding low-voltage items)

LIGHTS - CRACKED/MISSING DIFFUSER

A damaged or missing diffuser noted at the fluorescent light fixture. We advise replacement of diffuser by qualified person.

Contact a qualified professional.

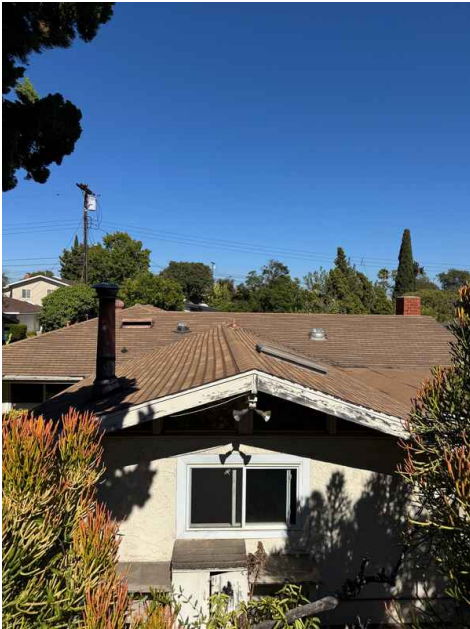
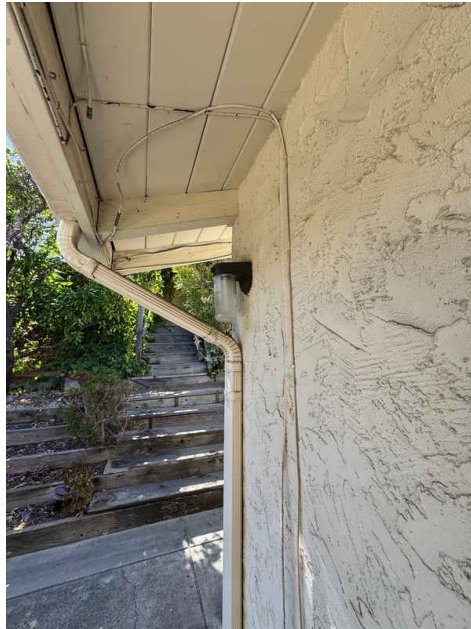
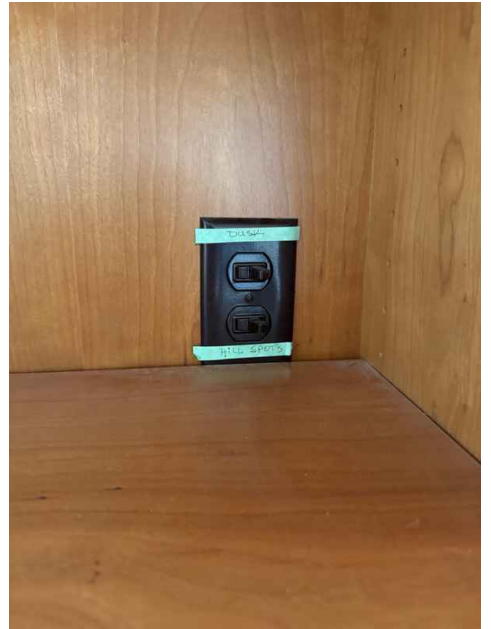
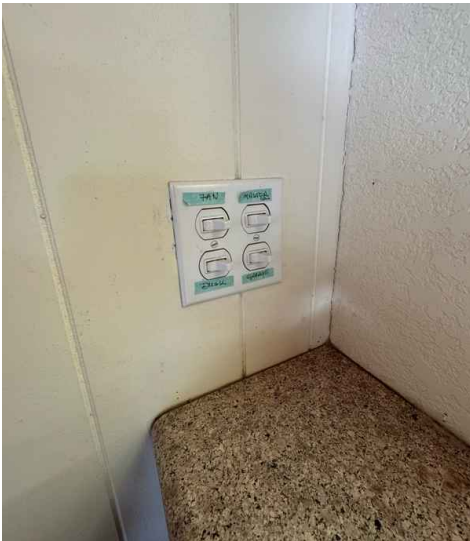
The inspector could not confirm the functionality of the majority of exterior lights. This may be due to a bad bulb, dusk sensors and or possibly an electrical problems. Advise changing the bulb and testing. If light fails to work, further repairs may be required by an electrician.

Recommendation
Contact a qualified professional.

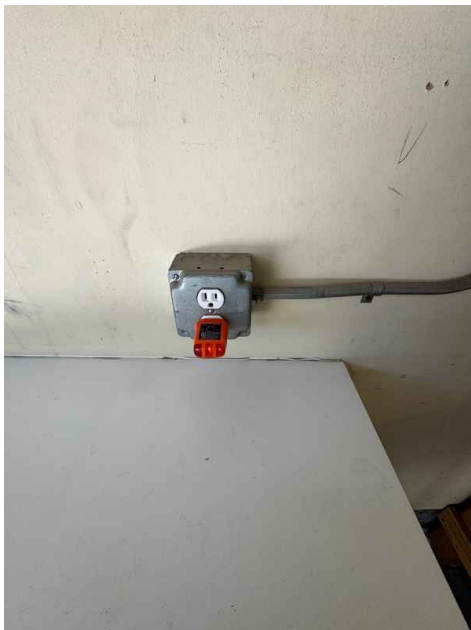
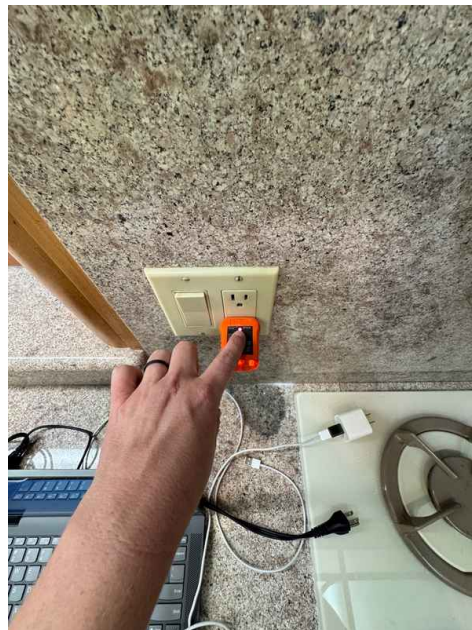
4.11.2 OPERATION OF GFCI (GROUND FAULT CIRCUIT INTERRUPTERS)

We recommend upgrading all receptacles within 6 feet of plumbing fixtures, outside, and in garage to GFCI.

Contact a qualified electrical contractor.

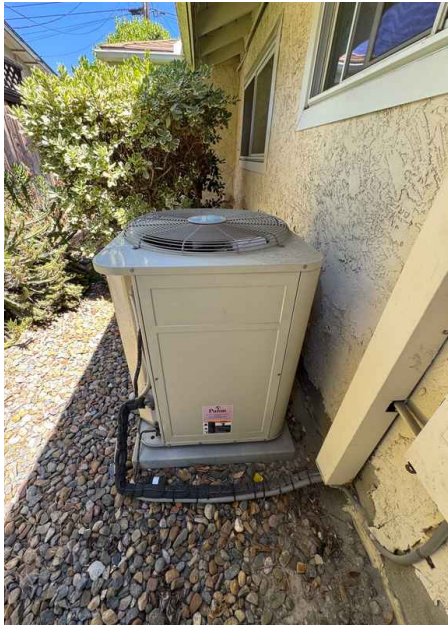
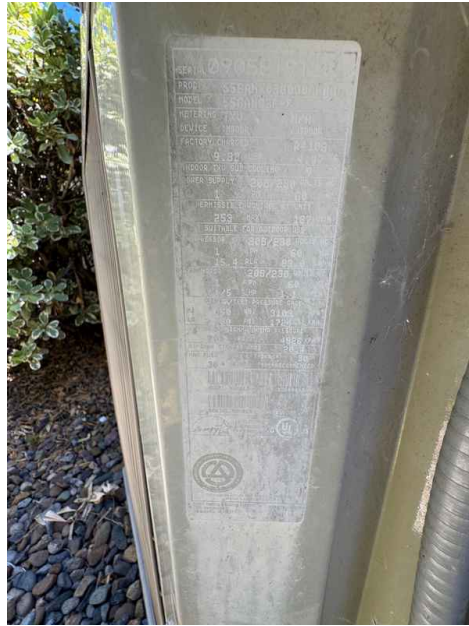
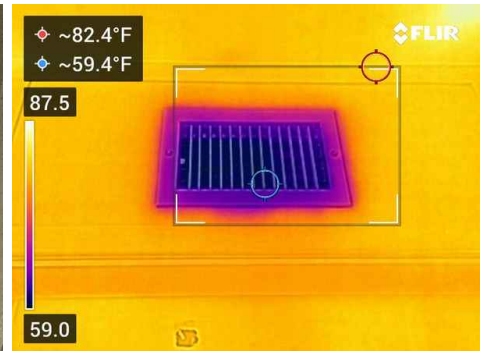
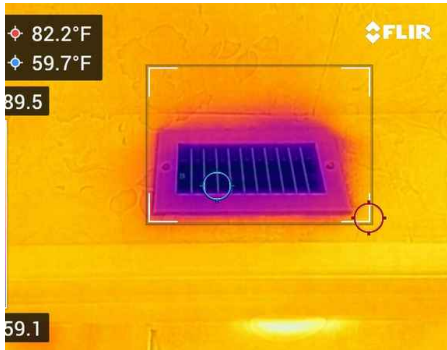
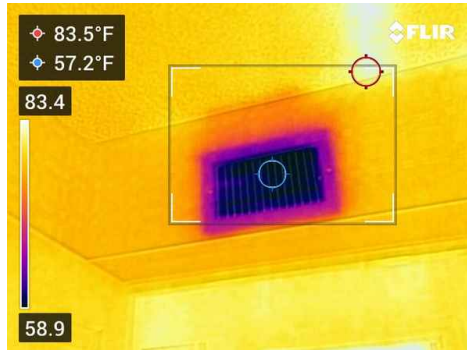
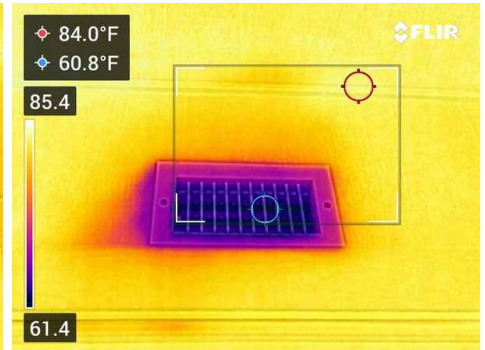
COOLING AND AIR HANDLER EQUIPMENT: AC- One Unit Test - Inspected

An air test was performed by using a thermal camera on the AC systems to determine the difference in temperatures of the supply and return air. The difference was between 14 degrees and 22 degrees which indicates units are cooling as intended. This indicates that the AC units are cooling properly. This is not an exhaustive test and cannot predict the performance of the AC on extremely hot or humid days. We do recommend an annual tune-up by a qualified HVAC contractor.

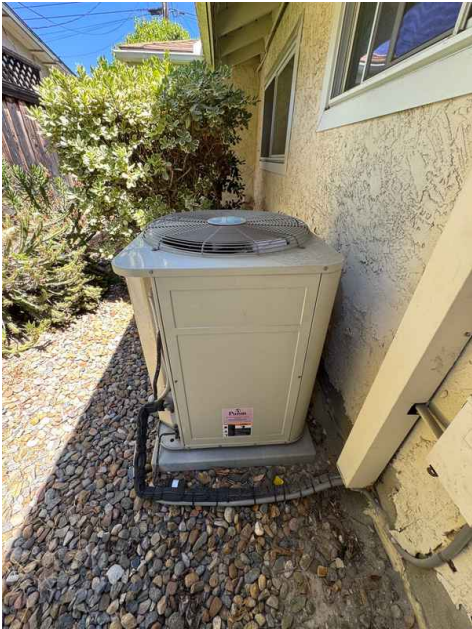
AC unit(s) are not strapped to pad(s). Most manufacturers installation instructions require strapping condensers to the pads. Movement of the units due to internal vibration (or earthquake) can damage the refrigerant lines and their connections.

Recommendation
Contact a qualified professional.

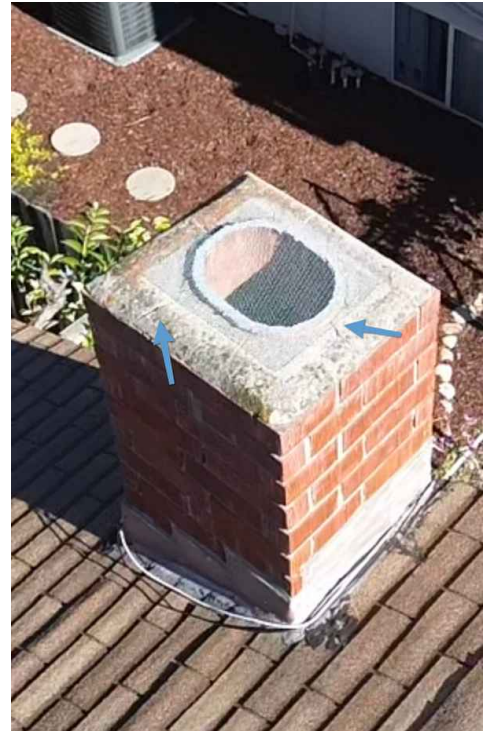
**Maintenance Item****CHIMNEY CROWN/CAP CRACKED**

The chimney crown (mortar cap) is cracked. We advise repair to avoid moisture intrusion and further deterioration.

Contact a qualified chimney contractor.

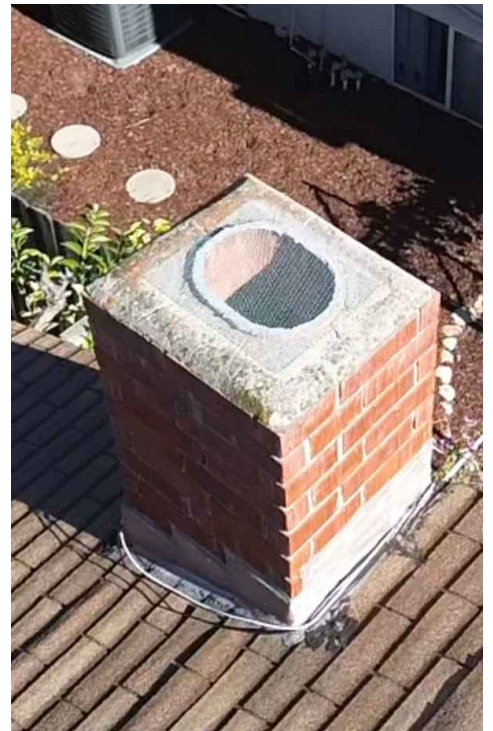
7.2.2 FIREPLACES (including Gas/LP firelogs) AND CHIMNEYS

No spark arrester/ rain cap was present. Spark arresters prevent cinders from falling onto the roof which is a fire hazard. The rain cap prevents water from entering the chimney flue. We recommend installing a spark arrester/ rain cap by a qualified person.

Contact a qualified professional.

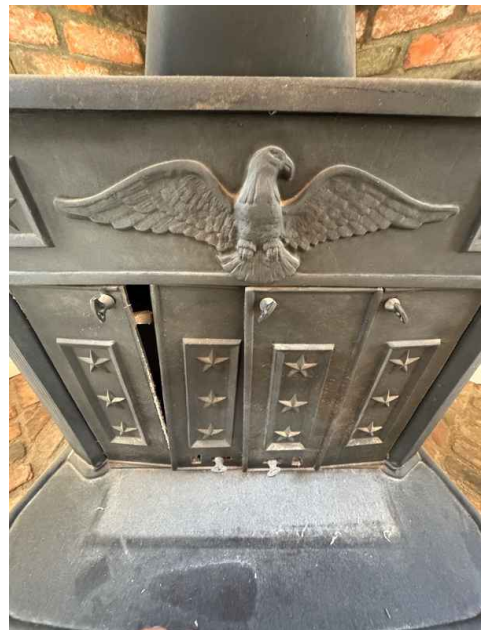
DOORS - DAMAGED/OFF TRACK

The fireplace doors are damaged/ off track. We advise repair or replacement as necessary.

Contact a qualified professional.

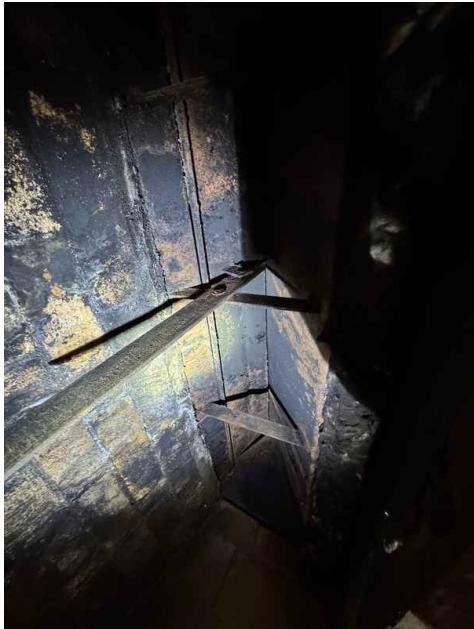
RUSTED - SMOKE SHELF

The metal components inside the fireplace are rusted and damaged. This fireplace should not be used until it is inspected for safety by a licensed chimney sweep. We recommend further evaluation by a licensed chimney sweep.

Contact a qualified fireplace contractor.

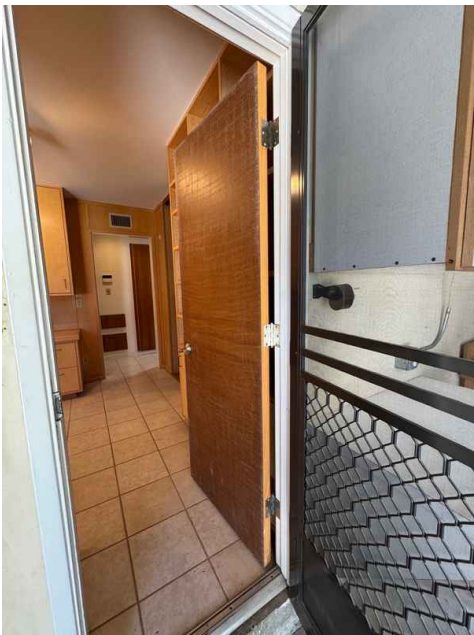
FIRE RATING CERT - MISSING

We recommend further evaluation by a licensed door contractor.

Contact a qualified professional.

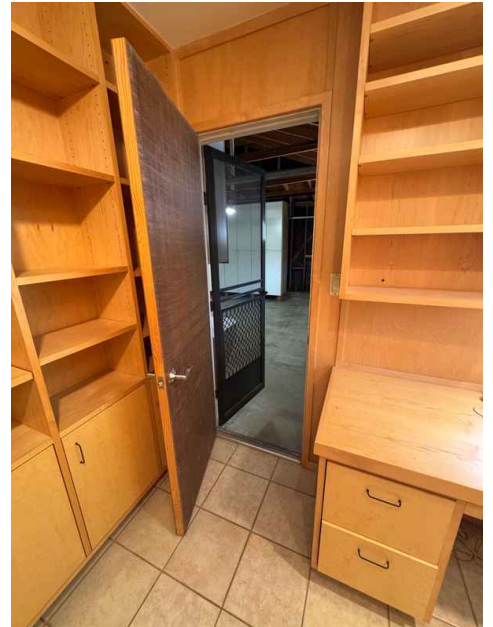
8.3.1 AUTO CLOSER (GARAGE DOOR)

The required auto-closing hinge was not installed and requires installation at door to garage. We recommend installing.

Contact a qualified professional.

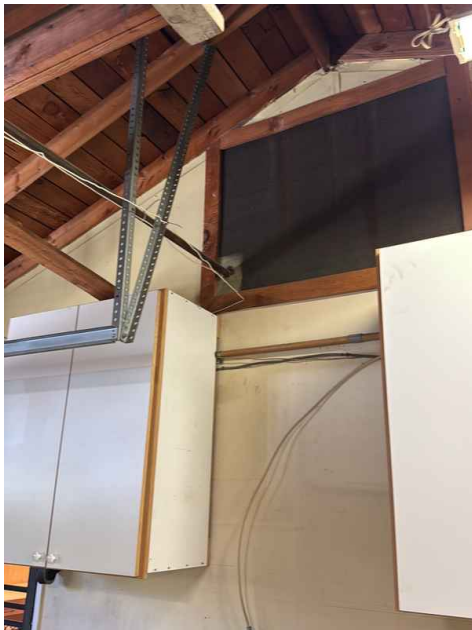
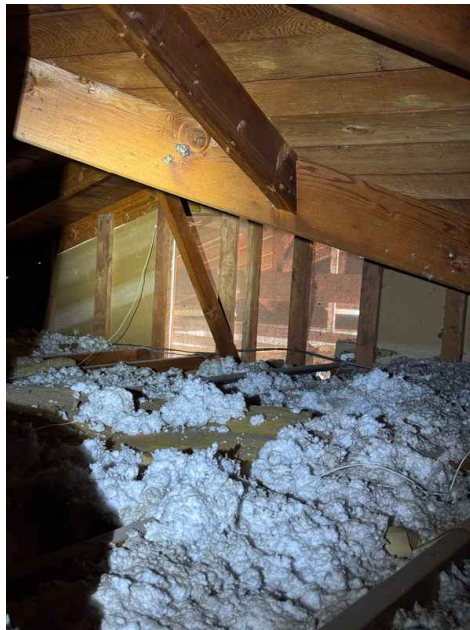
8.4.1 FIRE WALL

Hole (s) in the fire wall was observed in the garage. Wherever the garage shares a wall with adjacent living space, a fire-rated drywall must be installed and intact for fire resistive performance. We recommend having the holes patched with fire-rated drywall by a qualified person.

Contact a qualified professional.

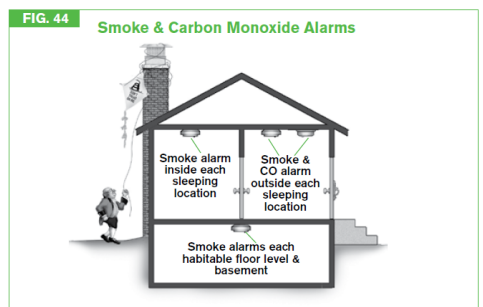
SMOKE DETECTOR - MISSING - LOCATION

Smoke detector(s) are missing. These detectors are required. We recommend replacement of approved smoke detectors prior to occupancy for safety.

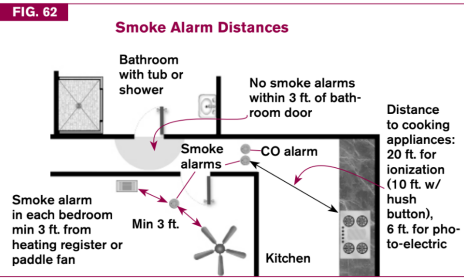
SMOKE DETECTOR 3' - REGISTER

Smoke Alarms require a minimum 3' horizontal clearance from HVAC supply registers. A detector was found which did not meet this requirement. We advise relocating the detector to avoid false alarms or damage to the detector.

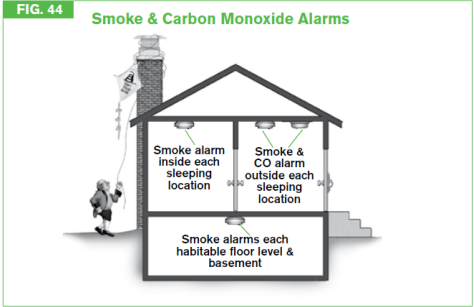
8.7.1 CARBON MONOXIDE
DETECTOR(S)

Carbon Monoxide detectors are required in homes with any gas burning appliances (furnace, range, water heater), fireplaces, or wood burning stoves and/or an attached garage. Please see the [new law regarding Carbon Monoxide detectors](#). This house does not have a CO detector as required. We recommend installing CO detectors according to manufacturer's directions (depending on brand) near each group of bedrooms. For added safety, additional CO detectors should be added to each sleeping room but this is not required by law.

Contact a qualified professional.

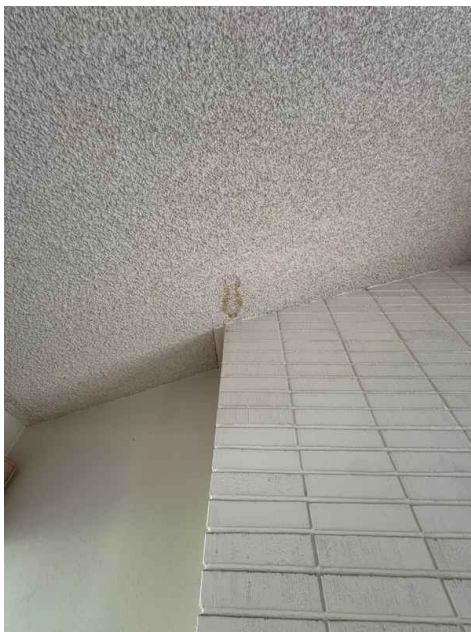
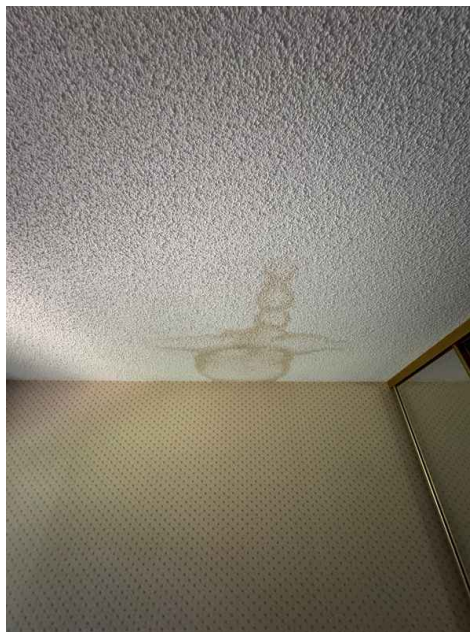
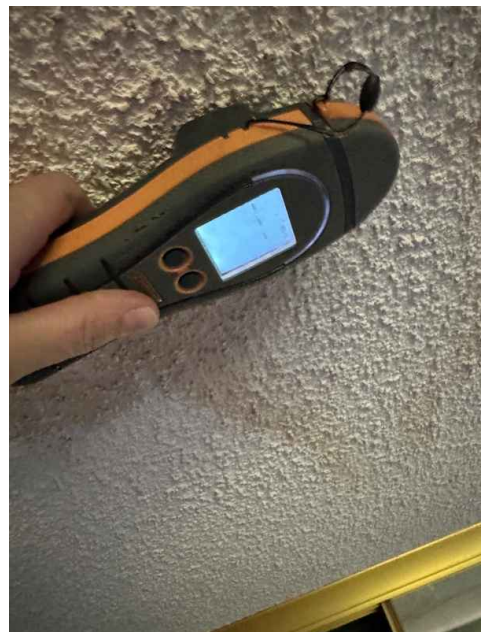
STAINS - UNKNOWN - DRY

Staining was noted on the ceiling. The staining was tested for moisture and found to be dry at the time of the inspection. The inspector was unable to determine the cause. Further investigation is recommended.

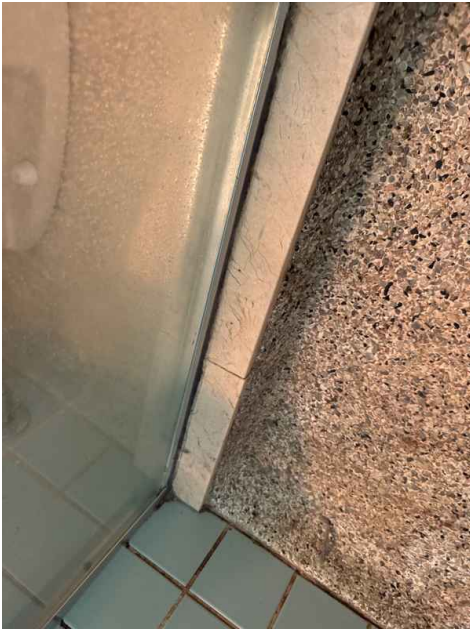
9.6.2 TUB/SHOWER ENCLOSURE

TILE ENCLOSURE OLD-NO LEAKS

The tile tub/shower enclosure is worn/aged and may be at or near the end of its useful life. As tile tub/shower enclosures age they can allow moisture intrusion/damage behind the wall which is not visible to a home inspector. Determining if water damage exists in the wall would require removal of the tiles and wallboard.

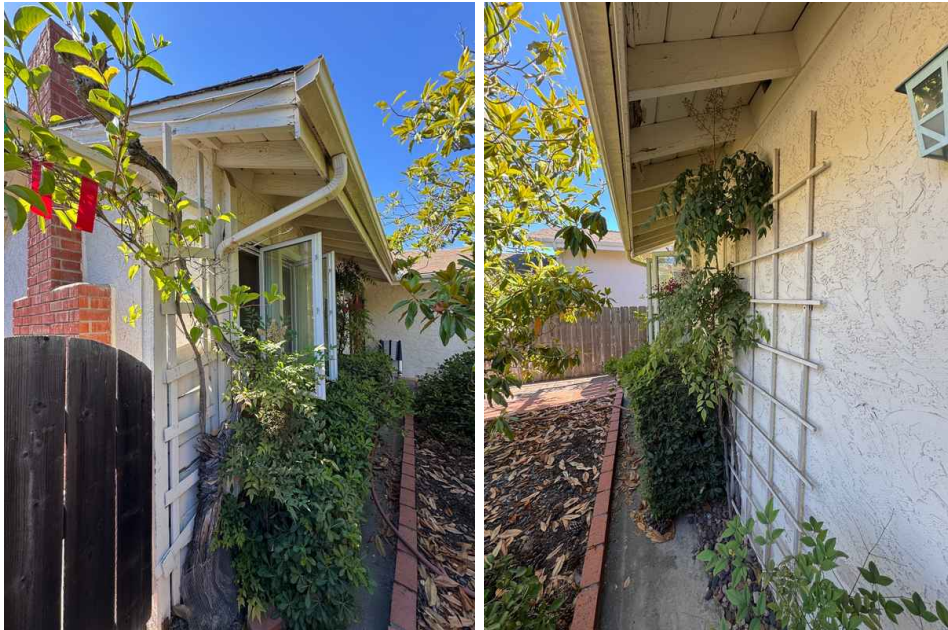
10.5.1 WALL SIDING FLASHING AND TRIM

STUCCO - DAMAGED

There is damaged/ deteriorated stucco observed at several areas. We recommend necessary repairs by a licensed stucco contractor.

Contact a stucco repair contractor

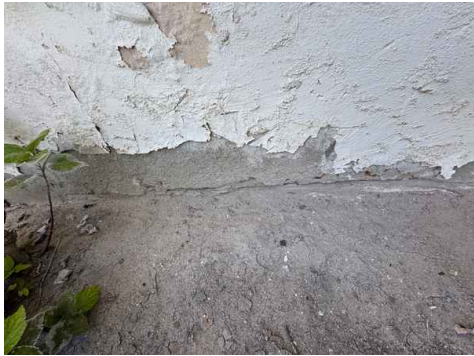
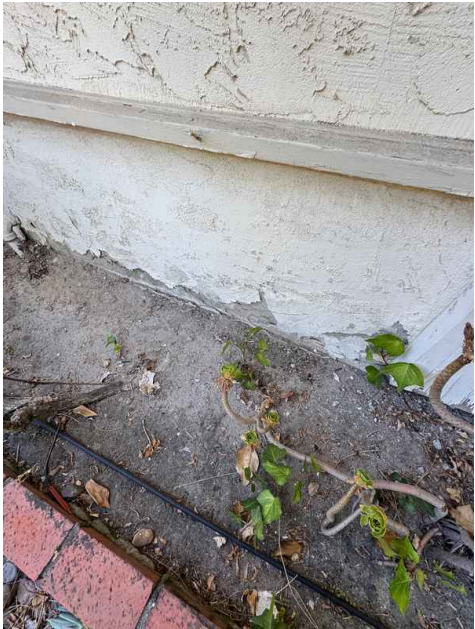
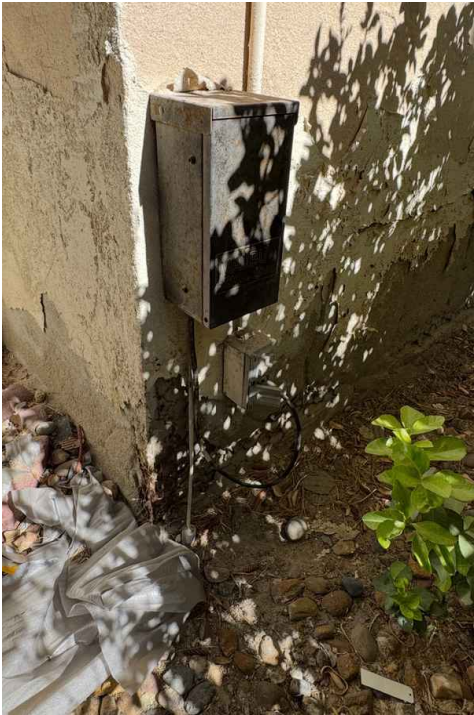
10.5.2 WALL SIDING FLASHING
AND TRIM

SIDING - FAILING

Siding is failing at nail heads and end cuts. Water absorption is present and blisters and deterioration are observed. We recommend repair or replacement as necessary.

Recommendation
Contact a qualified siding specialist.

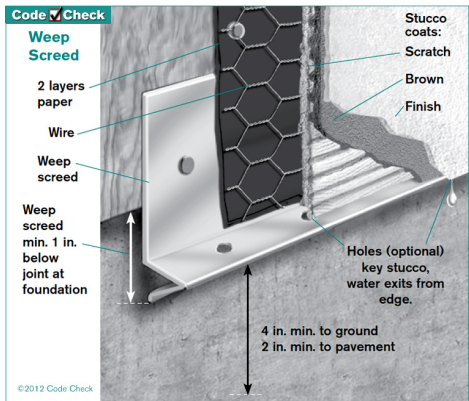
WEEP SCREED - ADD OLDER HOME

Stucco on older homes built prior to the 1970s was installed without a weep screed. The weep screed is a metal band at the bottom of the stucco which has holes to allow the stucco to "breathe" and water to "weep" from the stucco. Having the soil in contact with stucco will lead to stucco damage due to moisture. Common cracks and deterioration were observed at several locations. Installing a weep screed will be needed to avoid cracking and deterioration.

Contact a stucco repair contractor

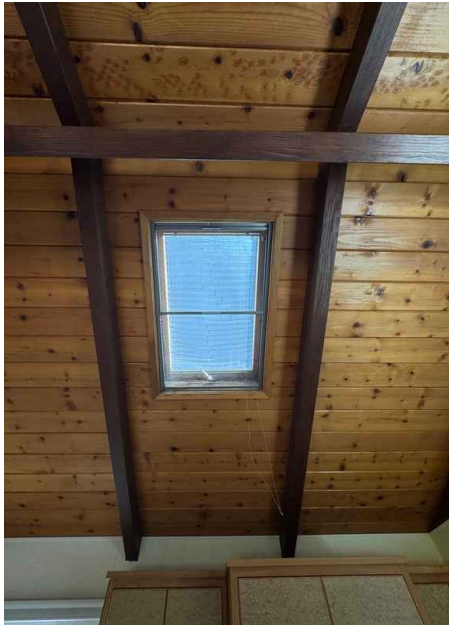
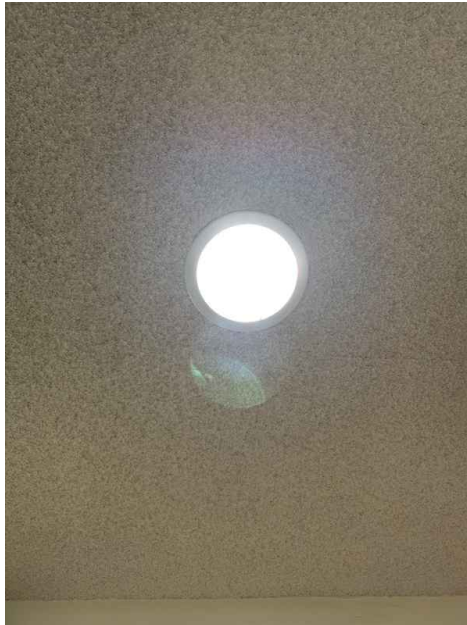
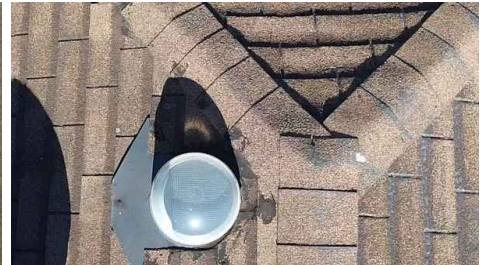
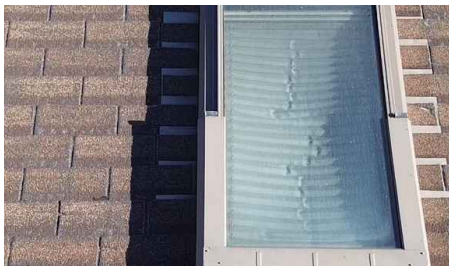
SKYLIGHTS: Skylights - Present

Skylight (s) are installed in the home. As manufacturers differ in design and installation methods, improper or non-standard sealing methods are impossible to detect without an intrusive roof inspection by a licensed roofing contractor. Skylights may leak at any time.

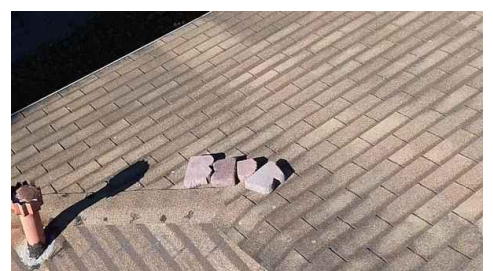
Excessive leaves and debris were noted on the roof. Leaves and debris can hold unwanted moisture on the roof. We advise professional cleaning.

Maintenance Item

Recommendation
Contact a qualified professional.

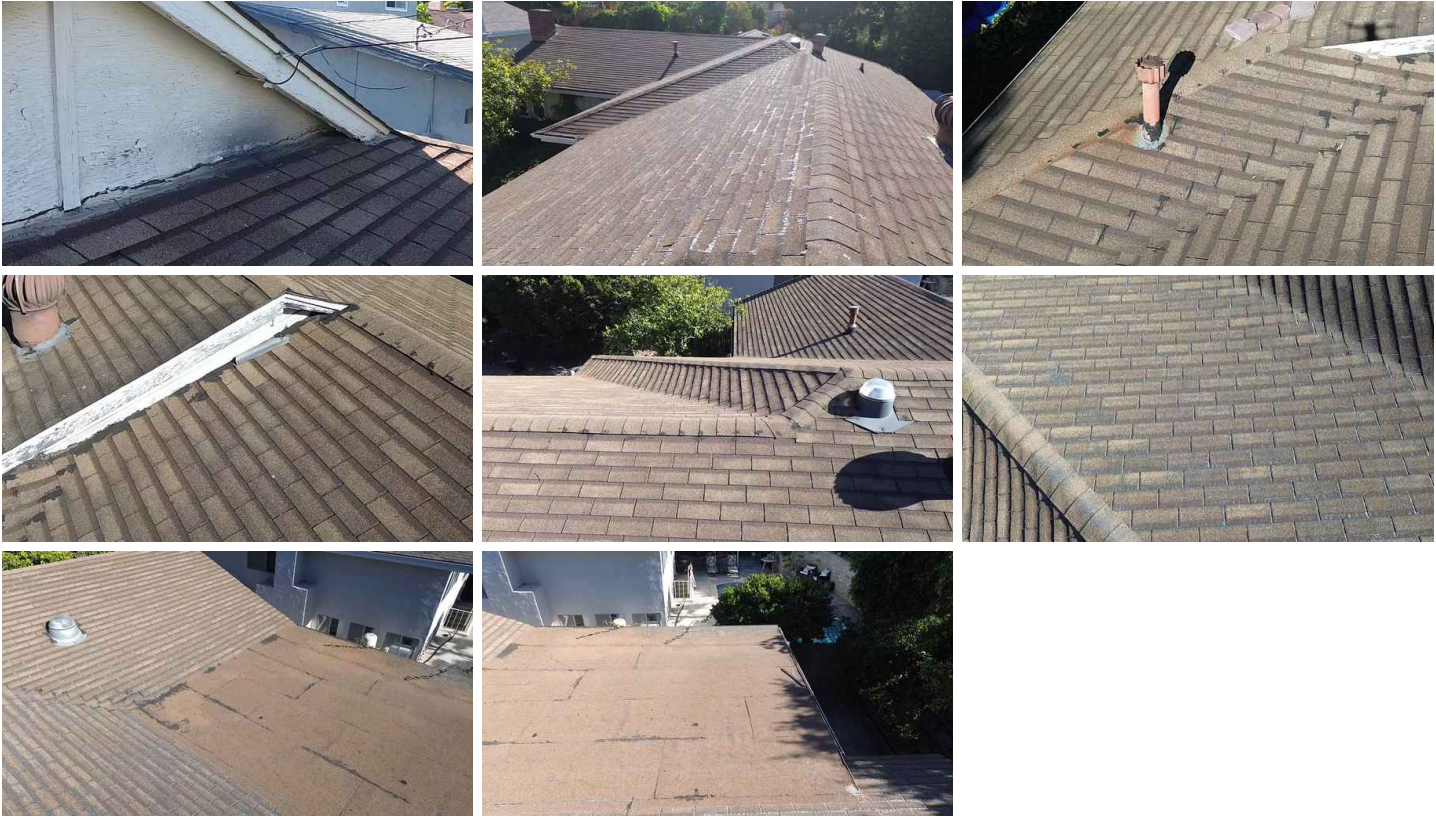
11.2.2 ROOF COVERINGS (Surface of roofing materials)

REPLACE ROOF

The roof shows extensive wear and deterioration and is in need of replacement. We advise consulting a licensed roofing contractor for estimates prior to the end of your contingency period.

Action Item or Further Review

Recommendation
Contact a qualified roofing professional.

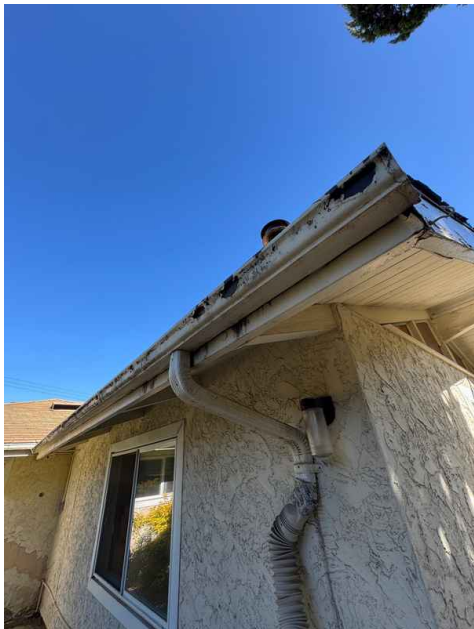
11.6.1 ROOFING DRAINAGE SYSTEMS
(Rain Gutters, Scuppers)

GUTTERS - END OF LIFE -OLD

The gutters had severe general corrosion/rusting/aging visible and appeared to be at or near the end of their useful life. We recommend that before the expiration of your contingency period, you consult with a qualified contractor to discuss replacement costs.

Action Item or Further Review

Recommendation
Contact a qualified gutter contractor

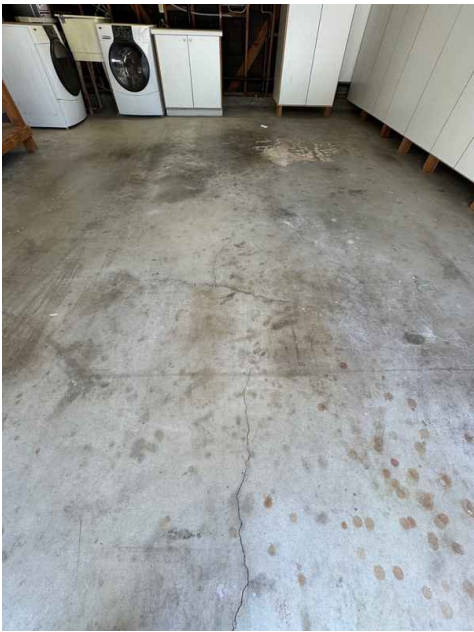
12.3.1 SLAB (Observable Evidence of Structural Defects - Concrete Floors)

GARAGE CRACKING- NO CONTROL JOINTS

Random shrinkage cracking was visible in the garage floor slab. No control joints were installed in the concrete floor. Control joints are grooves or cuts in the floor designed to control the location of cracking taking place as part of the curing process. This does not appear to be a structural defect, cracking may worsen with time.

Recommend monitoring.

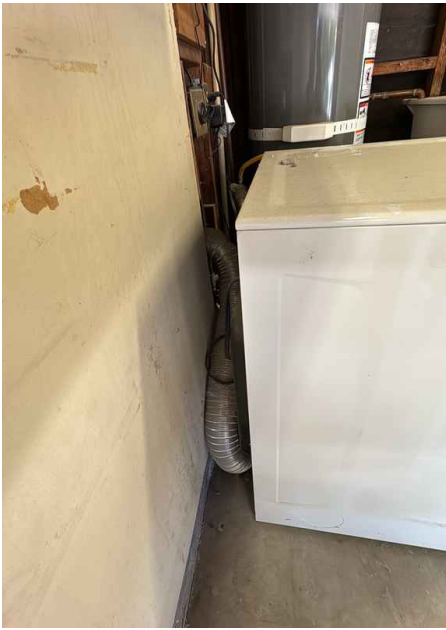
CLOTHES DRYER VENTING SYSTEM: Dryer vent - Inspected

At the time of the inspection, the Inspector observed no deficiencies in the condition of the dryer vent.
