HOME INSPECTION

6224 Rose Lake Ave
San Diego, CA 92119

08/01/2025

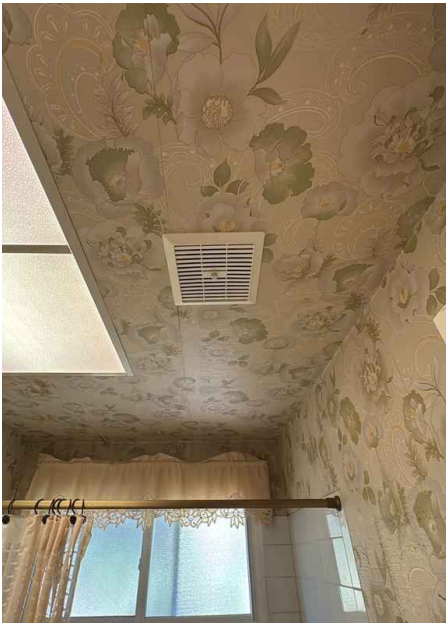
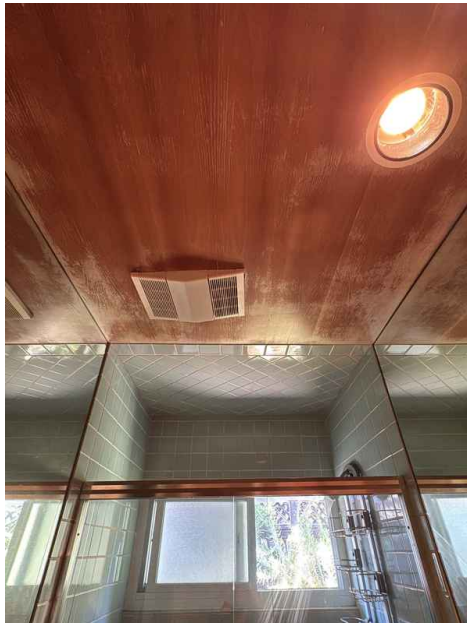
**BATHROOM VENTING: Exhaust Fans - Tested**

The exhaust fan(s) were tested and were functional at the time of inspection. (This is not an exhaustive test, and does not evaluate the performance or effectiveness of the vent(s).)

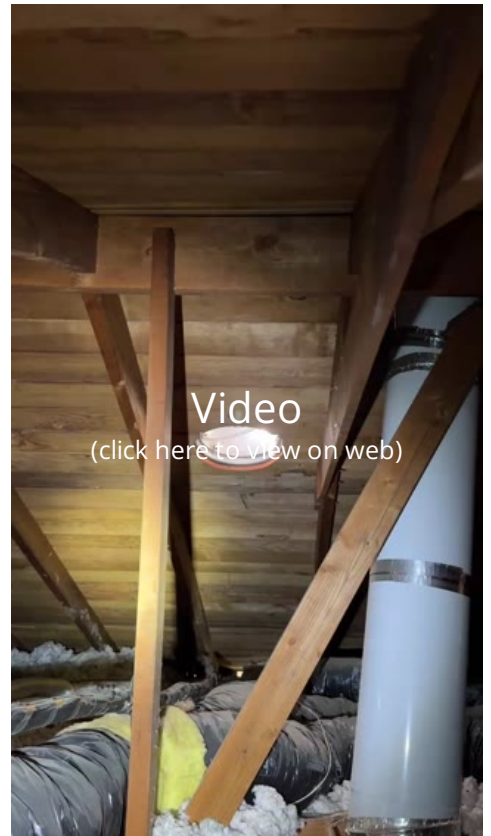
TURBINE VENT - RUSTED

Turbine vent(s) on roof is rusted and no longer turns freely. We recommend repair or replacement.

Contact a qualified professional.

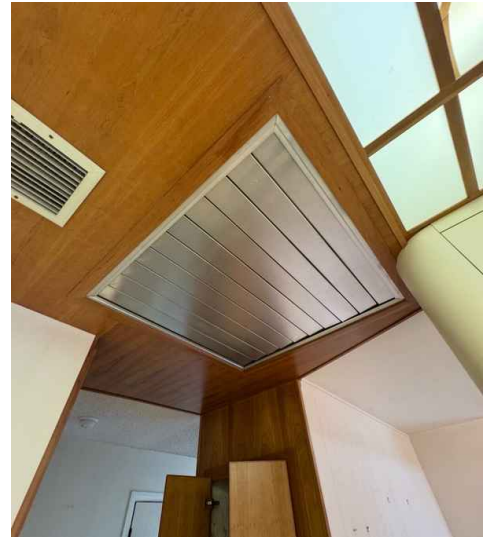
The whole house fan did not operate when tested. We recommend necessary repairs or replacement by a qualified licensed contractor.

Contact a qualified professional.

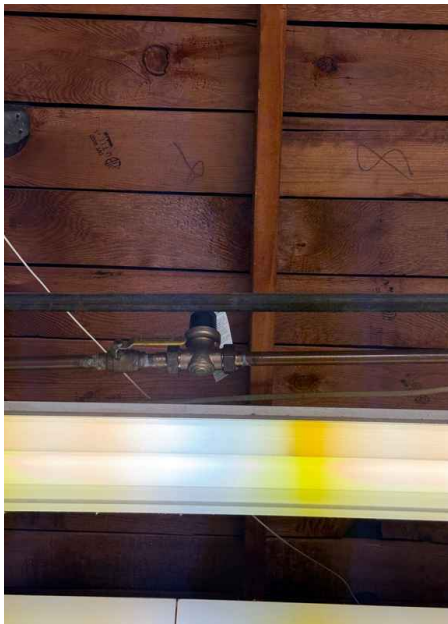
MAIN WATER SHUT-OFF DEVICE: Location - Garage

The main water shut-off valve is located in the garage.

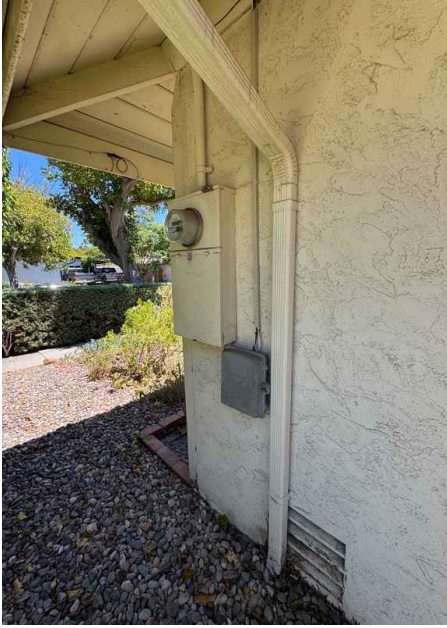
MAIN PANEL AND DISTRIBUTION PANELS: Main - Right

The main Electrical panel is located at the right exterior side of the house (facing front).

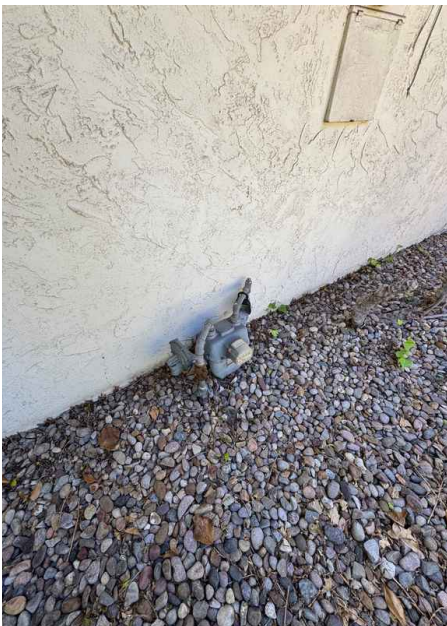
**MAIN GAS SHUT OFF VALVE: Gas shut off - Right**

The main gas shut-off valve is located at the gas meter at the right side of the house (facing the front).
