## Inspection Report

1245 Saxony Rd  
Encinitas CA 92024

| <b>Date:</b> 4/4/2026 | <b>Time:</b> 09:00 AM | <b>Report ID:</b><br>20260404-1245-Saxony-Rd |

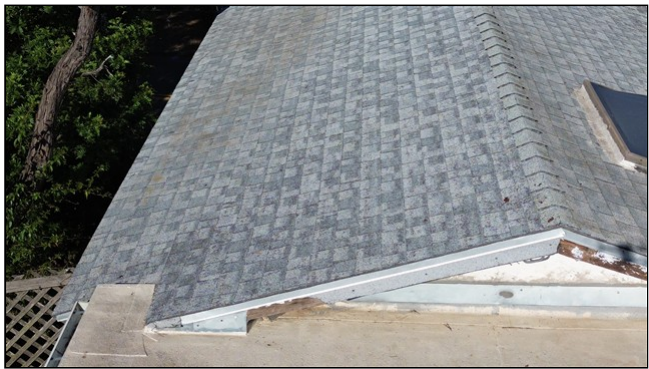
1.0 Item 2(Picture)

(1) There are several metal roof flashings that are rusted. We recommend they be cleaned, painted and/ or replaced as needed by a qualified licensed roof contractor.

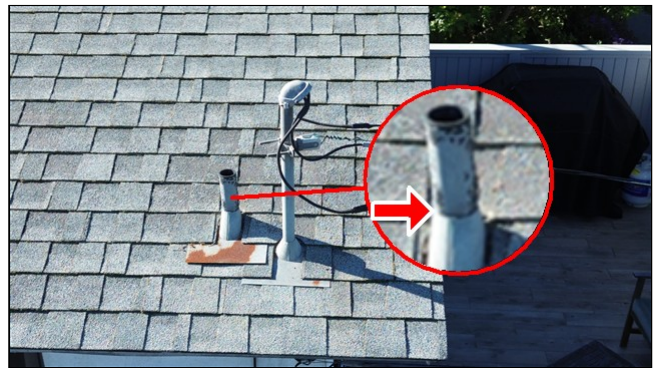
1.1 Item 4(Picture)

(2) Sealant around the roof flashings/ penetrations is cracked. We recommend further evaluation and/or necessary corrections by a qualified licensed roofer.

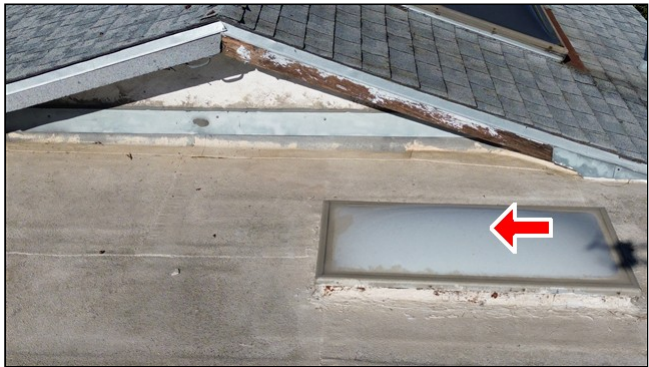
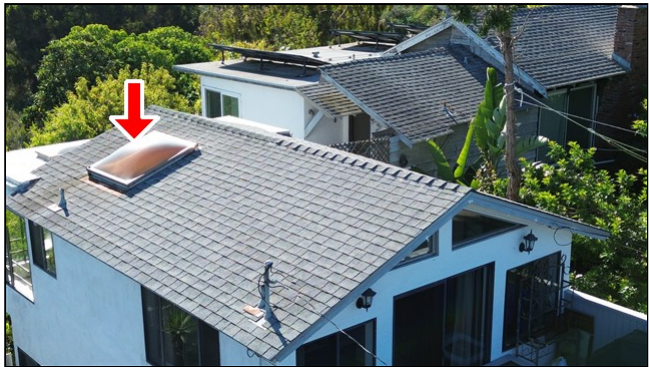
The skylight on the flat roof has excessive sealant applied around it. This condition may indicate previous leak repairs and can be a sign of ongoing or recurring water intrusion issues. We recommend necessary repairs and further evaluation by a licensed certified contractor to ensure the skylight is properly sealed and functioning as intended.

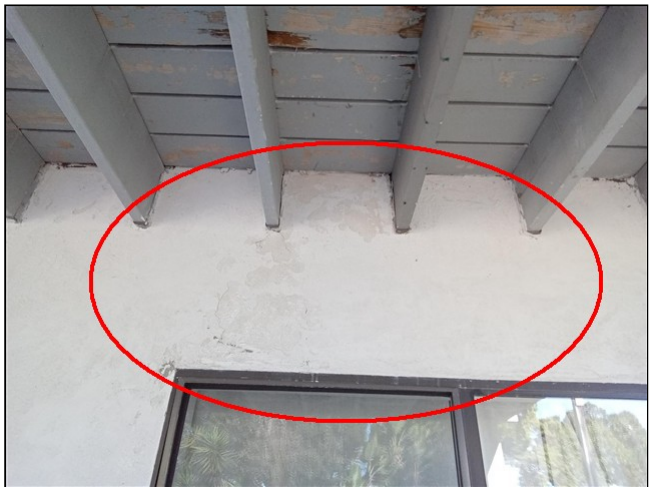
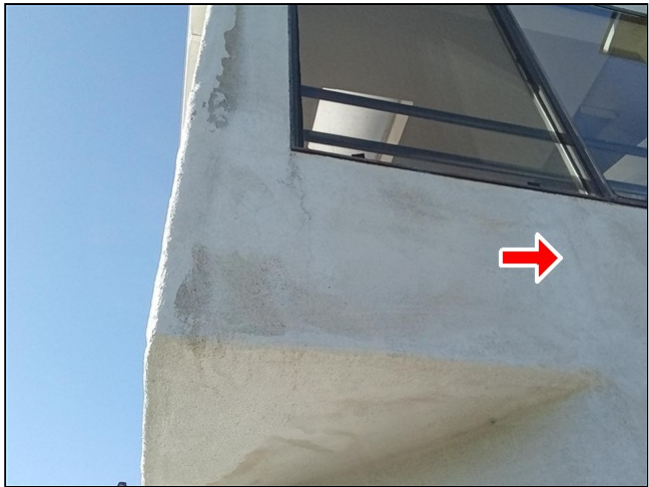
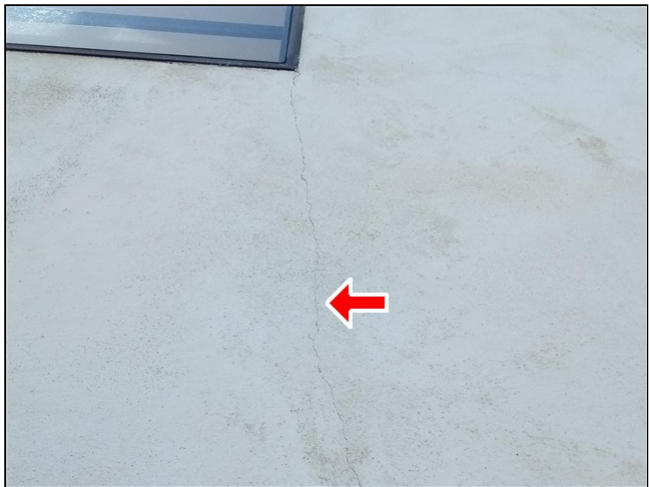
(1) There is damaged/ deteriorated stucco observed at several areas. We recommend necessary repairs where needed by a licensed stucco contractor.

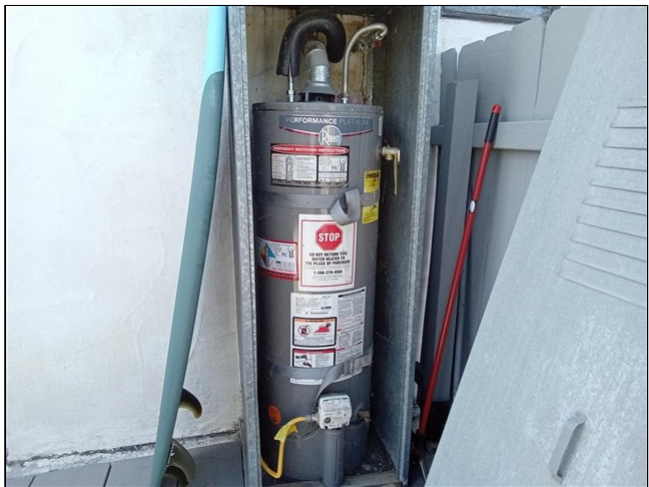
3.0 Item 2(Picture)

(2) The water heater was inspected and was found to be operational at the time of the inspection. We did not evaluate the efficiency or recover rate of the water heater which is beyond the scope of a general home inspection. If concerned we recommend you consult a licensed plumber. We recommend flushing the water heater routinely flushed as regular maintenance.

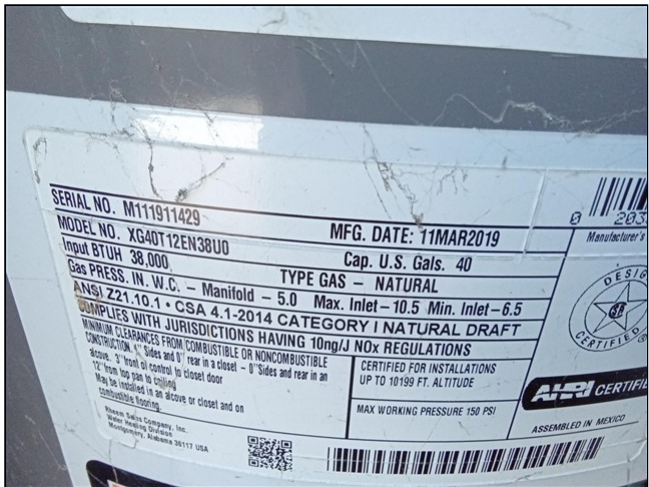
3.0 Item 3(Picture)

(3) The temperature of the water was tested using a thermal camera during the inspection and was found to be operating within normal range.

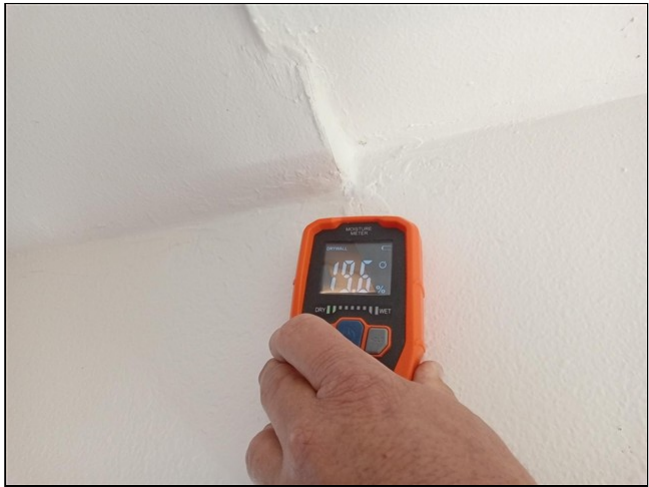
4.0 Item 1(Picture)

(1) A representative sampling for moisture was preformed at accessible interior walls using a moisture meter. (*areas prone to moisture, such as kitchens, bathrooms, below grade walls, exterior walls with doors/windows*). An elevated moisture was not detected at the time of the inspection.

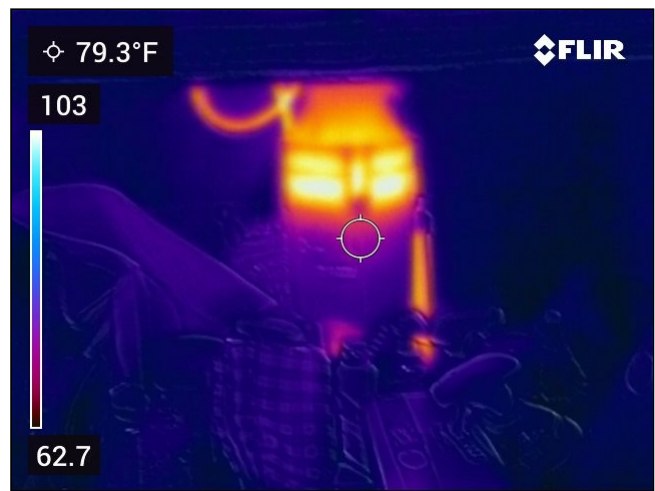
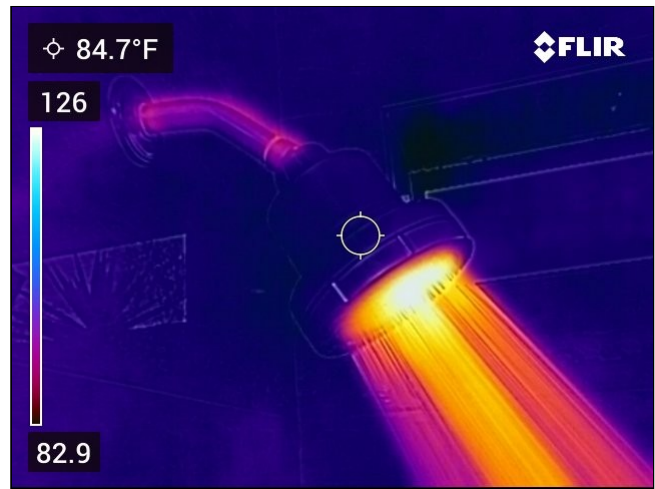
An infrared (thermal imaging) scan was performed throughout the house and garage at the time of the inspection using a hand held infrared (thermal imaging) inspection camera. No anomalies were found at the time of the inspection using this camera.

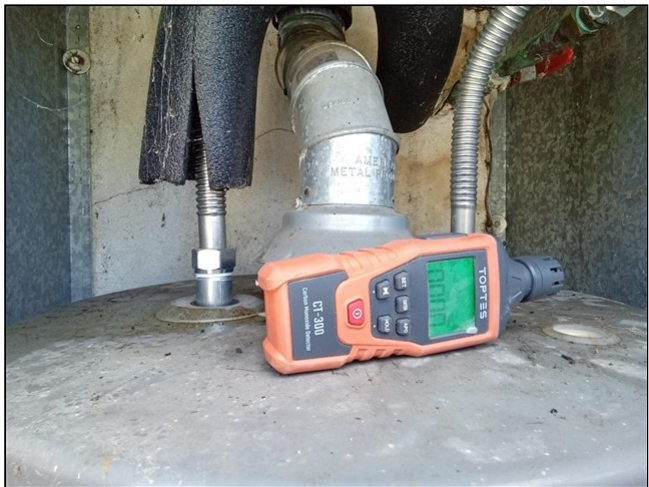
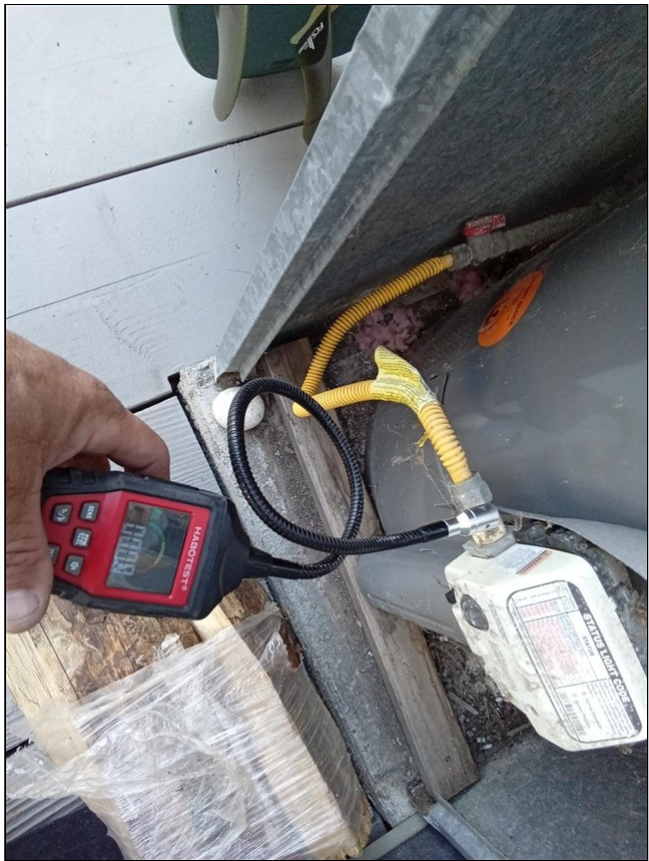
A gas and carbon monoxide leak test was conducted at accessible gas fittings and appliances using gas and CO leak detectors. There were no gas or CO leaks detected at the time of the inspection.

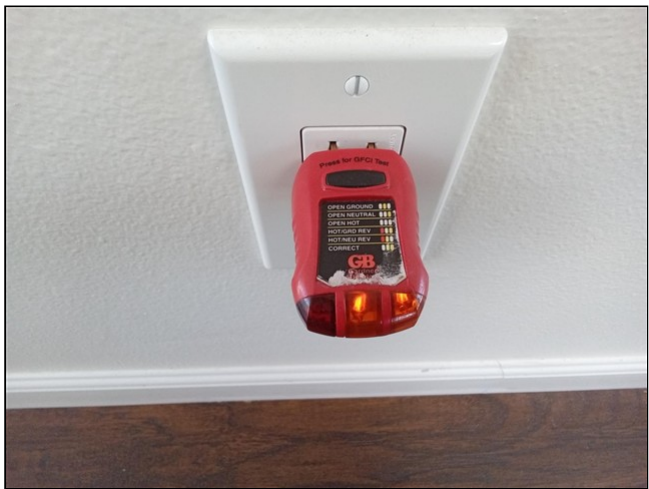
7.5 Item 1(Picture)

A representative number of receptacles throughout the house and garage were tested for power, polarity and grounding according to our standards-of-practice. These receptacles were observed to be functioning properly at the time of the inspection, unless otherwise noted. Note: Receptacles that are blocked/ covered and otherwise inaccessible were not inspected.

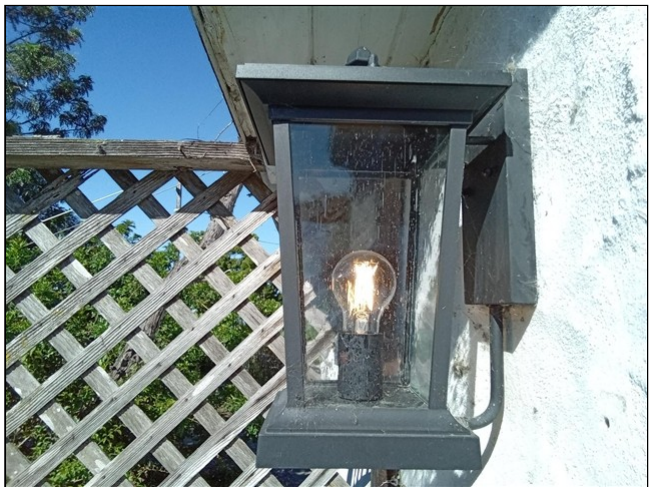
7.8 Item 2(Picture)

(2) A representative number of exterior lights were tested and were found to be functional at the time of the inspection.

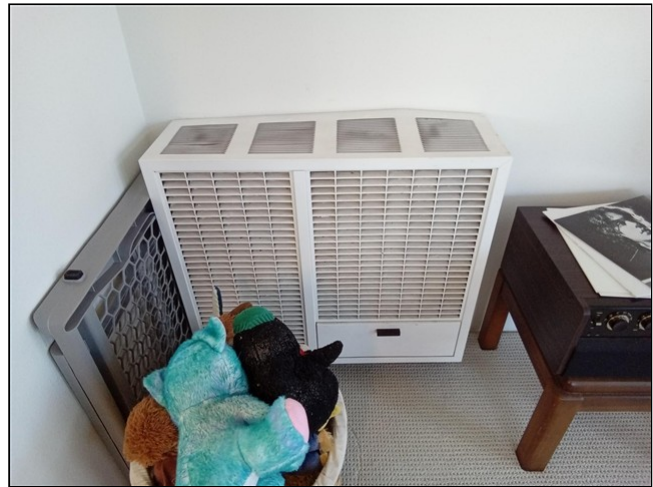
8.1 Item 1(Picture)

(1) The wall furnace did not operate when tested at the time of the inspection. We recommend further evaluation of the furnace and related components by a qualified licensed HVAC contractor prior to the end of your contingency and repairs or replacement made as needed.

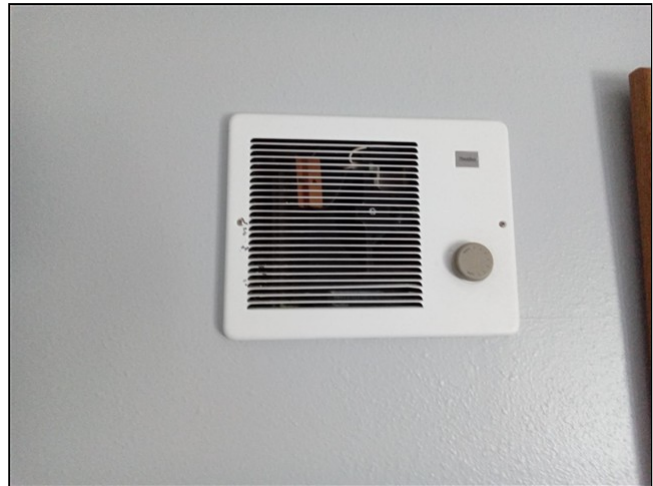
8.1 Item 2(Picture)

(2) The wall furnace in the second bedroom was tested and was functional/ operated at the time of the inspection.

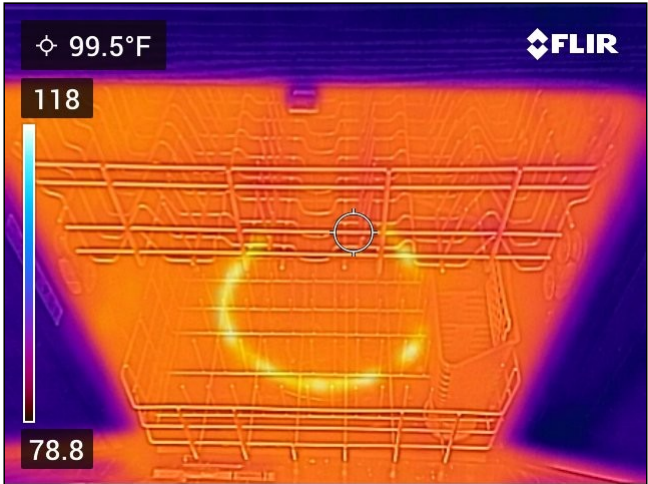
12.0 Item 1(Picture)

The dishwasher was tested and functioned properly at the time of the inspection. This is not an exhaustive test and does not verify the cleaning efficiency of the dishwasher.

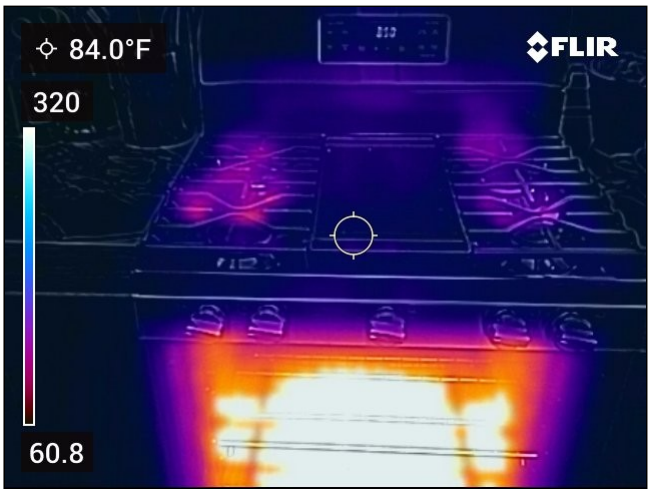
12.1 Item 1(Picture)

The range/oven was tested and was functional at the time of the inspection. This test is not exhaustive and does not confirm the performance, accuracy, or effectiveness of the oven.

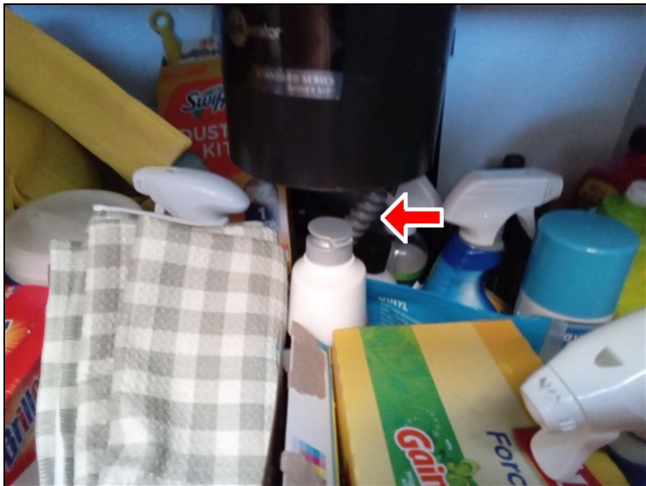
12.3 Item 1(Picture)

plugged in instead of being hard wired. This is a recommended upgrade.

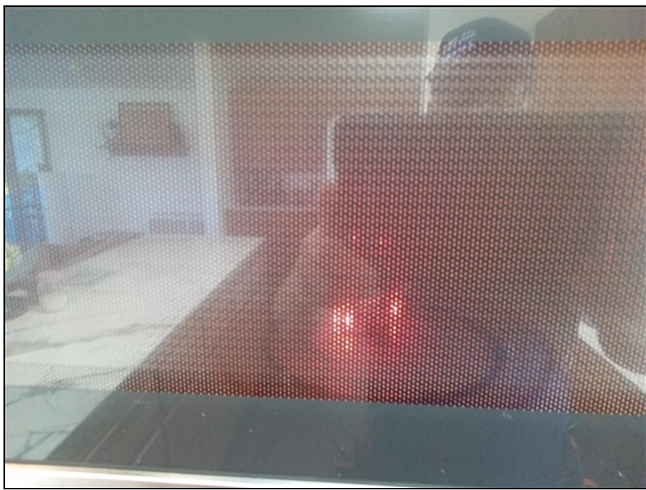
12.4 Item 1(Picture)

**Findings**  
The built in microwave was tested with a microwave testing device and was functional at the time of the inspection. This is not an exhaustive test, and does not predict the performance of the microwave.

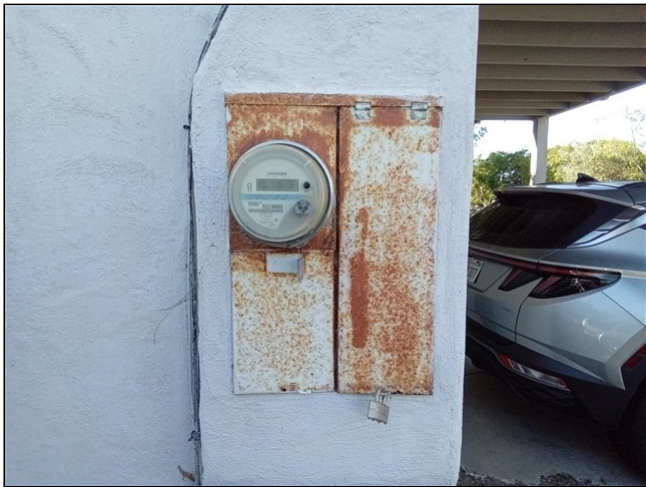
13.1 Item 1(Picture)

The Main Electrical panel is located at the left exterior side of the house (facing front).
