HOME INSPECTION REPORT

On Friday, May 7, 2021 The HomeTeam Inspection Service made a visual inspection of 4704 Rim Rock Rd, Oceanside, CA 92056. Enclosed please find a written, narrative report of our findings in accordance with the terms of our Inspection Agreement.

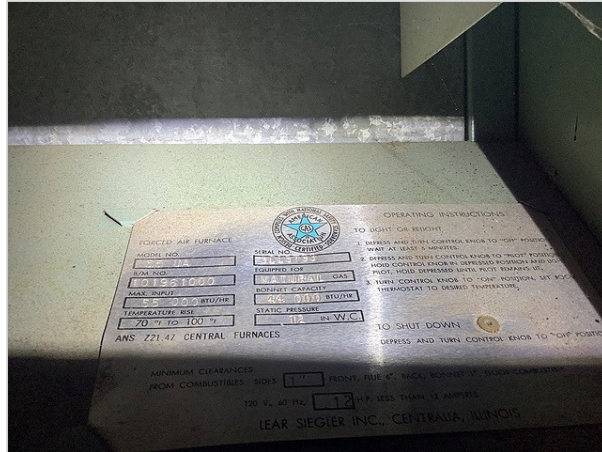
Photo 16

Furnace data tag

> **At least one section of the B-vent (exhaust) is in contact with combustible material.** Generally, B-vents should have at least one inch of clearance from insulation or combustible materials. Suggest repair by a qualified party to ensure adequate clearance from combustibles.

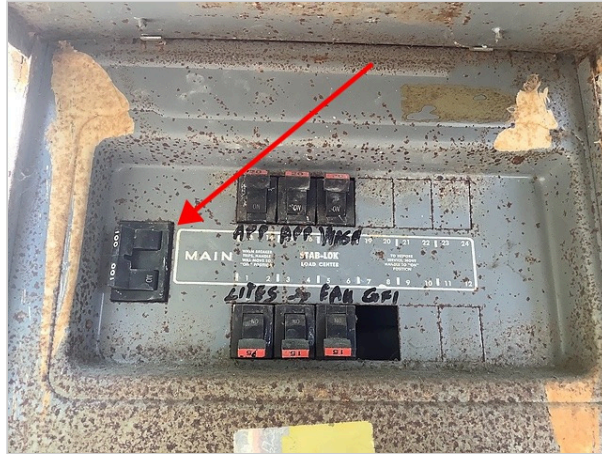
Photo 20

Main electrical shutoff

> An open knockout observed in electric service panel. All service panel openings should be covered to prevent access to high voltage and risk of electrical shock. Electrical related repairs should be performed by a qualified electrician.

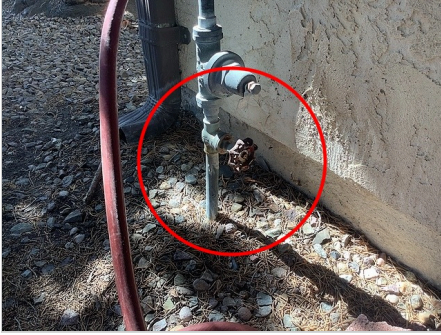
Photo 37

Main water shutoff

> Water pressure tested high(in excess of 80 psi). Consult with a professional plumber to determine an appropriate course of action, which may include adding a pressure regulator.

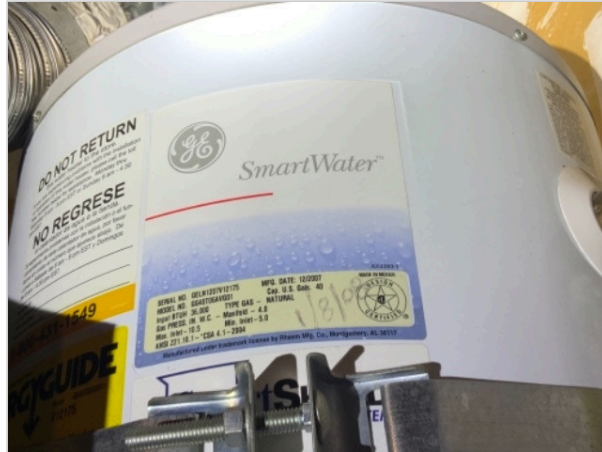
Photo 39

Water heater data tag

The water heater flue pipe is not sealed where it enters the chimney. To prevent noxious fumes from entering the structure, the flue/chimney connection should be properly sealed. Consult with a qualified plumber for repair.

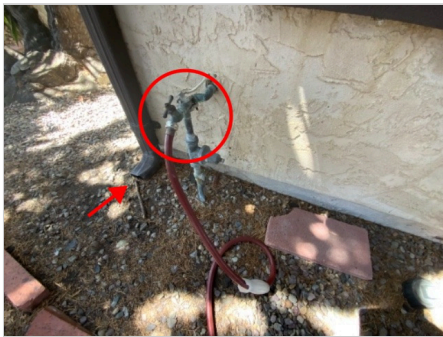
Photo 45

Note: Cross connections observed on at least one hose bib (missing vacuum breaker). Cross connections are a possibility wherever supply plumbing and solid or liquid waste could come together and contaminate potable water with waste to create a serious health issue. Home inspection standards require the inspector to look for and call out any cross connections observed.

Front left

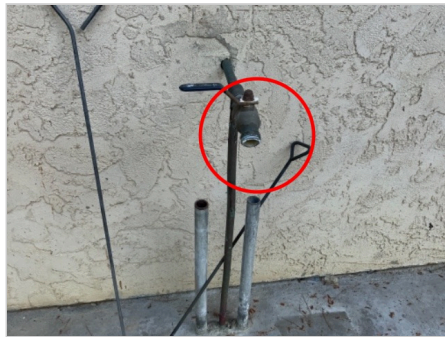
Photo 46

Rear of home

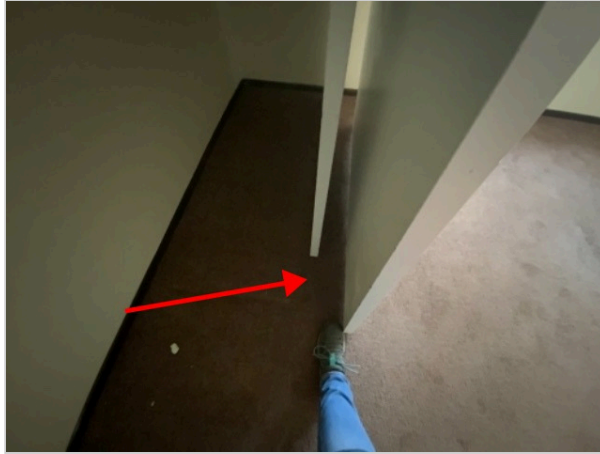
Photo 50

> **Door guide(s) for closet door(s) observed to be missing.** Missing or broken door guides can allow doors to easily be knocked from their tracks and even cause the door to fall. Suggest repair by a qualified party.

Bedroom

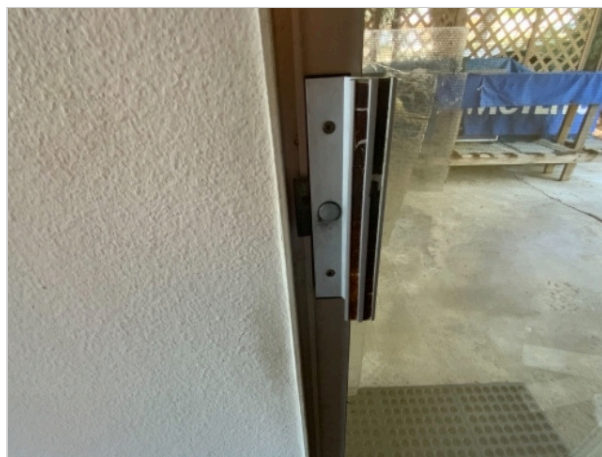
Photo 62

> **Exterior door(s) observed with incorrectly functioning door hardware causing issues with latching and locking function.** Suggest adjustment, repair or replacement by a qualified party. For personal security reasons, HomeTeam suggests that you consult with a qualified locksmith for exterior door hardware concerns.

Patio door

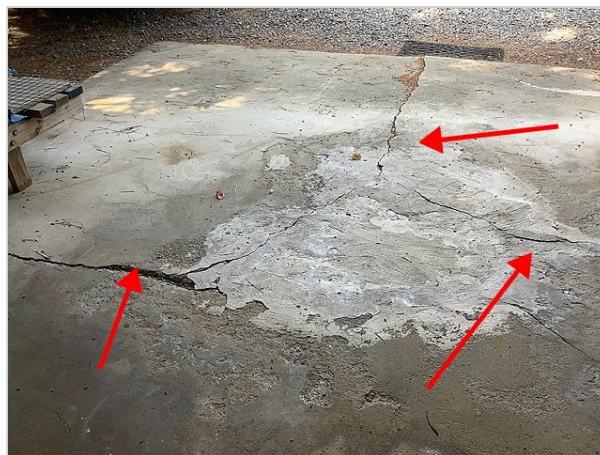
Photo 67

Patio slab in at least one area appears to be cracked and showing signs of upheaval at separation. Suggest that a concrete specialist review and repair to enhance aesthetics.

Back Patio

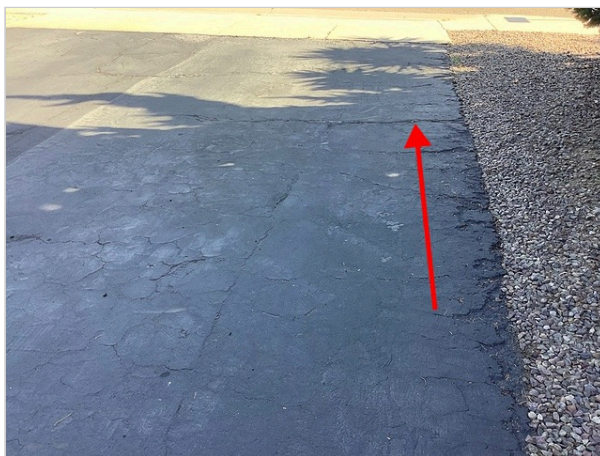
Photo 68

> **Crack(s) observed in concrete garage, driveway, or walkway.** Cracks that have separated and/ or have experienced upheaval at crack itself are of greater concern than those that have not. Suggest filling with epoxy or caulking to limit moisture intrusion and monitoring for further movement.

Driveway
