**BPG Inspection, LLC**

**9806 Old Ridge Road  
Spring Valley CA 91977**

Client(s): McDonald  
Inspection Date: 2/5/2025  
Inspector: Brian Chatfield ,

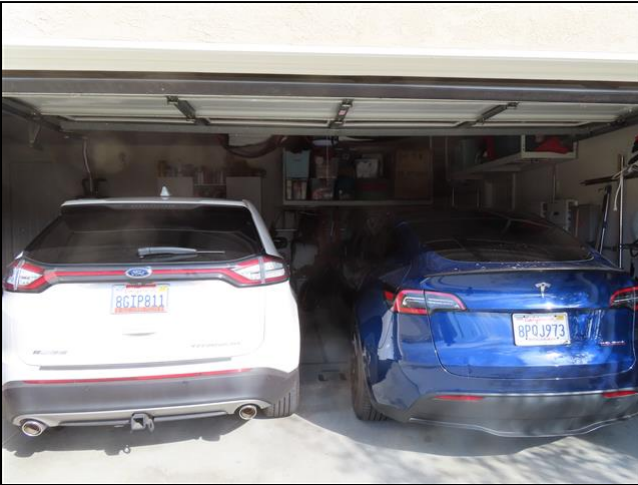
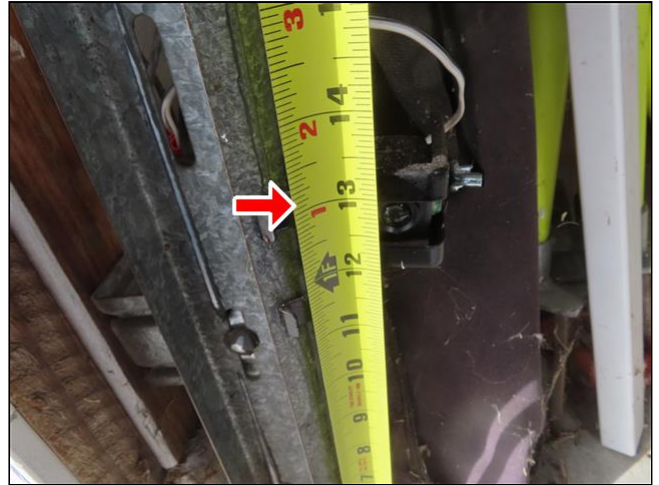
- ❌ 5. 1. There are holes/damage in the fire-resistive barrier between the garage and interior. This condition can allow more rapid spread of smoke and flames in the event of a fire.
- All voids should be repaired.
2. Plastic passes through the fire separation wall. Plastic can disintegrate in a fire, allowing the fire to enter the penetration. Fire caulking was not visible in these areas.
- A qualified plumber should replace the plastic piping with approved material or add fire caulking as needed.

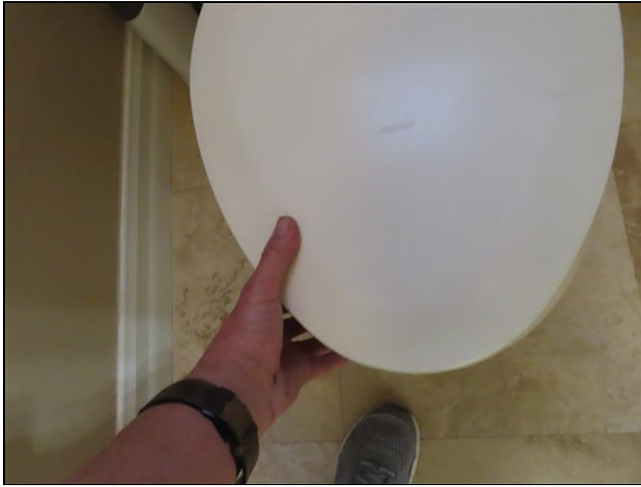
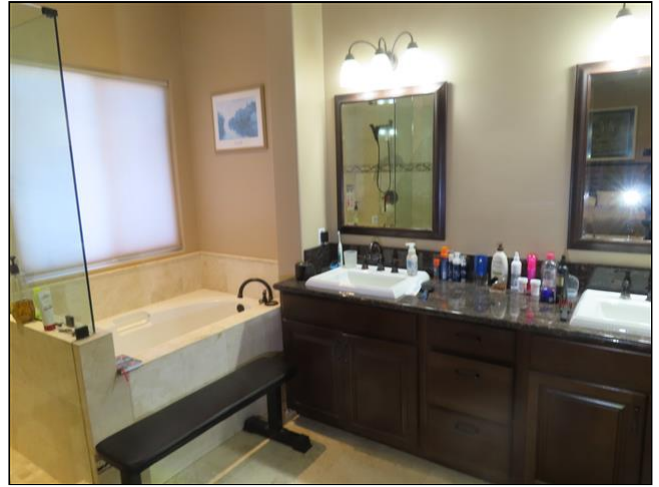
- ☒ 9. The master bathroom toilet is not securely attached at the floor. This could allow leaks at or into the floor. A qualified technician should make repairs or modifications as necessary.

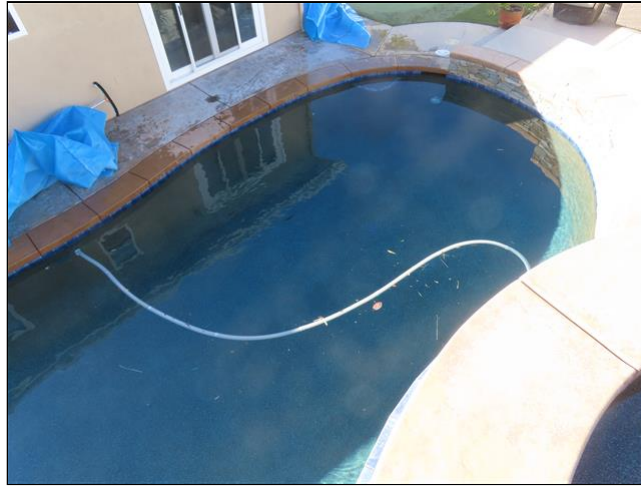
- ❌ 12. The built-in slide excluded from this inspection report. The National Swimming Pool Institute has established safety guidelines regarding minimum design requirements for such equipment. Verification of these installation guidelines is beyond the scope of this inspection. If you are concerned about safety, consider either removing the equipment or use extreme caution (including close adult supervision) when the equipment is used.

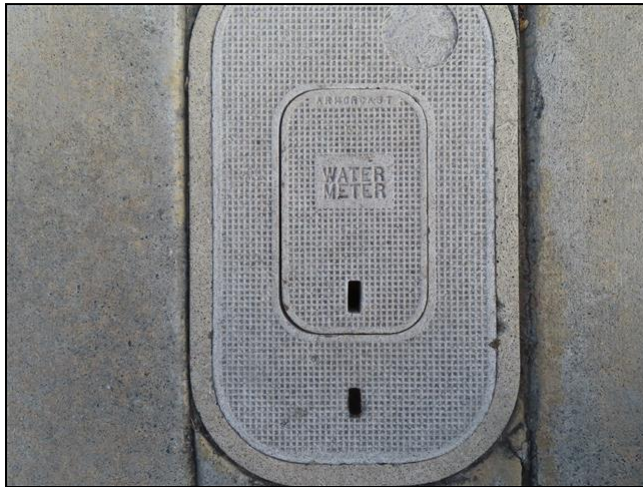
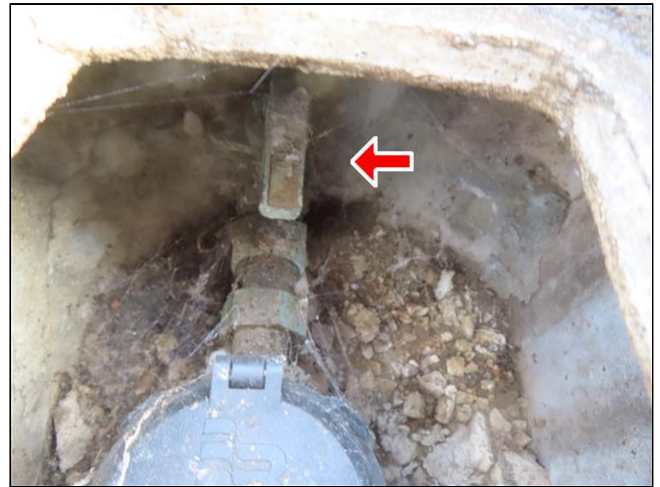
Main water meter.

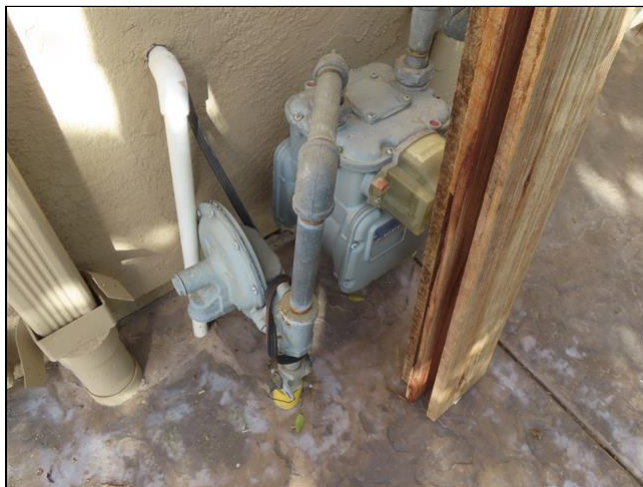
Gas meter.

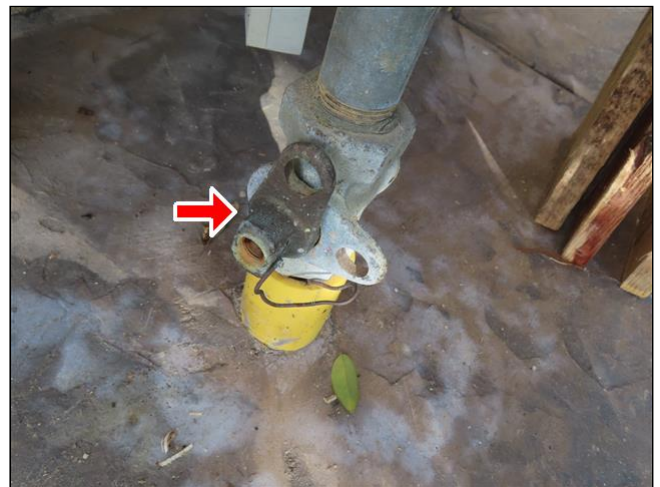
Main gas shut-off.

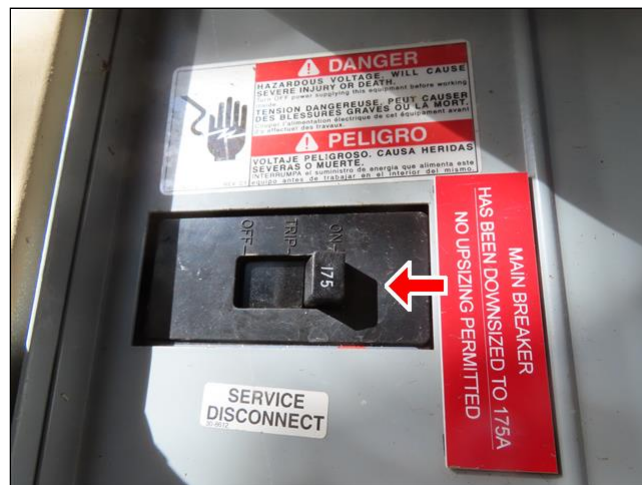
Main breaker.

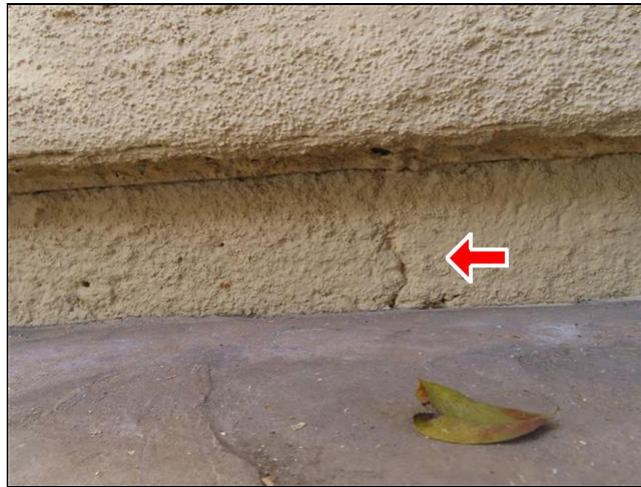
19. There are hairline crack(s) in the garage foundation stem wall. Not all cracks in concrete foundations are indicative of structural problems. Cracks may be due to either normal expansion-contraction cycles, shrinkage of concrete or mortar, or settlement that has stopped. A technician could evaluate the cracks and repair as needed.

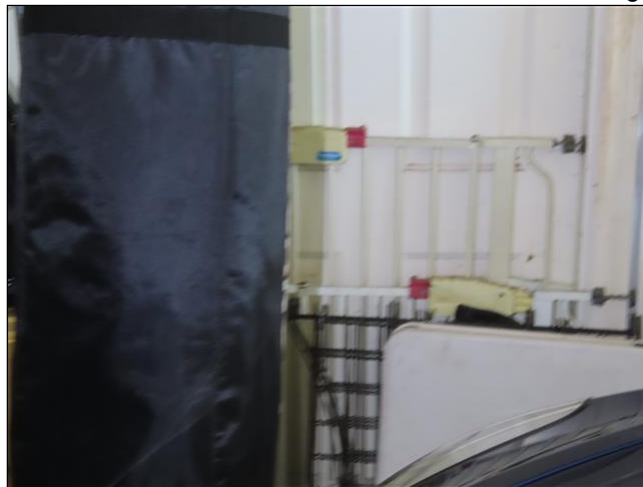
45. The garage side entry pedestrian door was blocked by stored personal belongings and could not be tested. - Proper operation of the door and related hardware should be verified before closing.

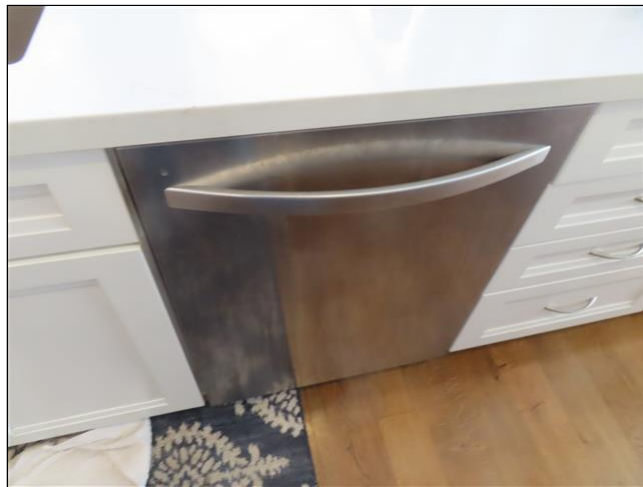
52. There is no air gap device connected to the dishwasher drain line (this dishwasher may feature an internal, anti-backflow prevention device but we cannot ascertain this).
- An air gap should be installed per the manufacturer's specifications unless it can be determined if the dishwasher has a back-flow device.
