# PROPROPERTY INSPECTION AND SERVICES INC.

## PROPERTY INSPECTION REPORT

15718 Creek Hills Rd  
El Cajon, CA 92021

Hardev Shergill  
07/31/2025

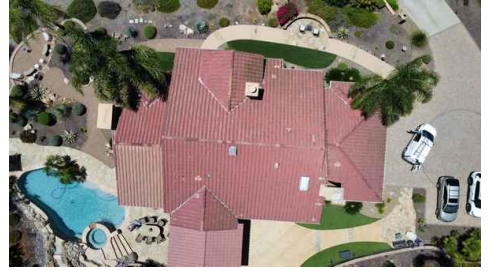
### 4.3.1 Flashings

#### TAR USED AS FLASHING

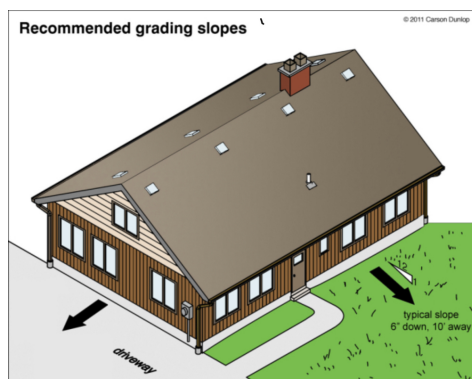
### 5.1.2 Grading

#### GROUND DRAINS

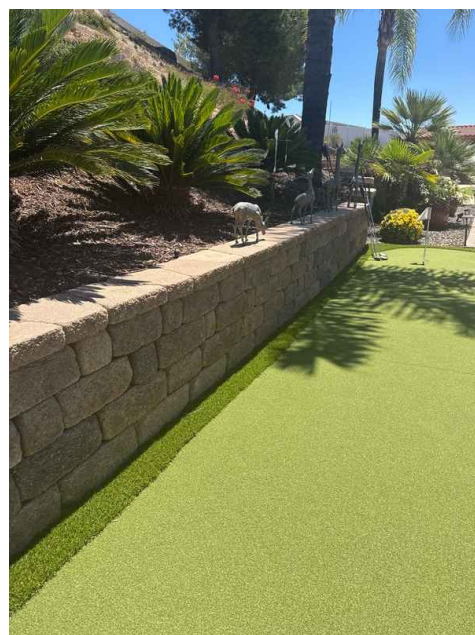
5.6.2 Retaining Walls

**WALKOFF HAZARD(S)**

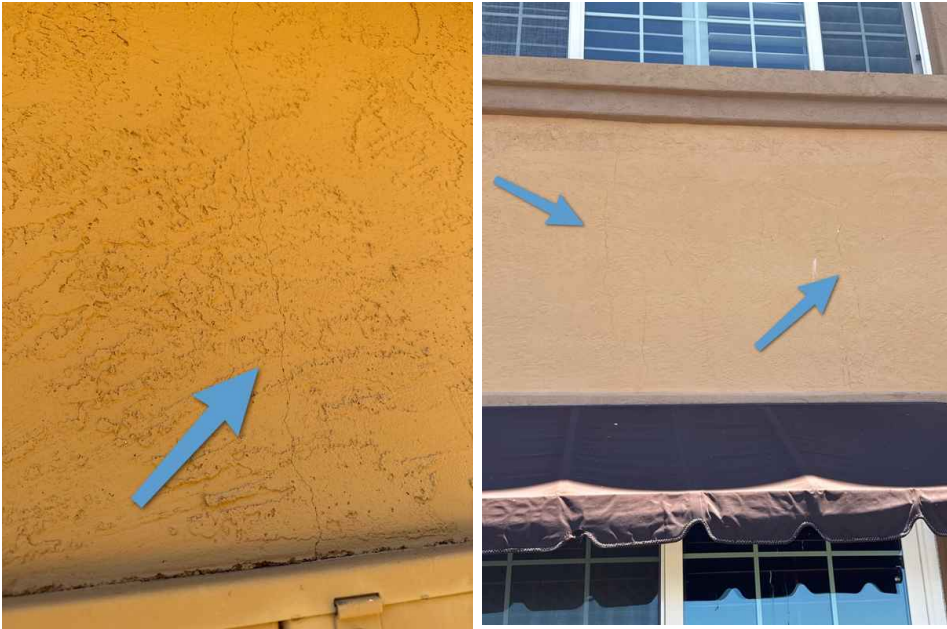
## 6.1.2 Exterior Walls / Trim

**STUCCO - STAINING**

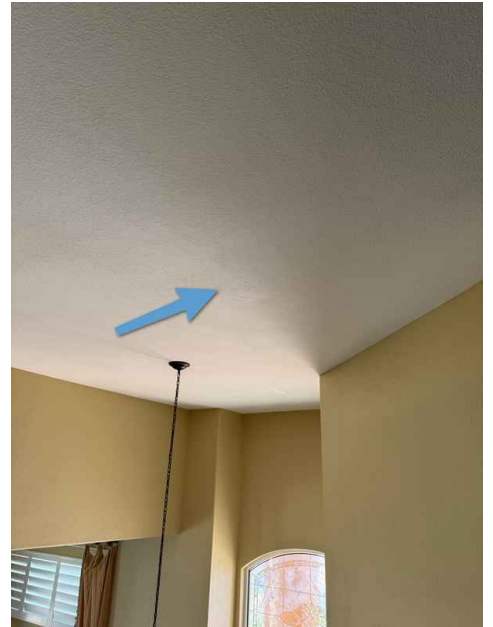
## 7.5.3 Ceiling

**WATER STAINS - DRY**

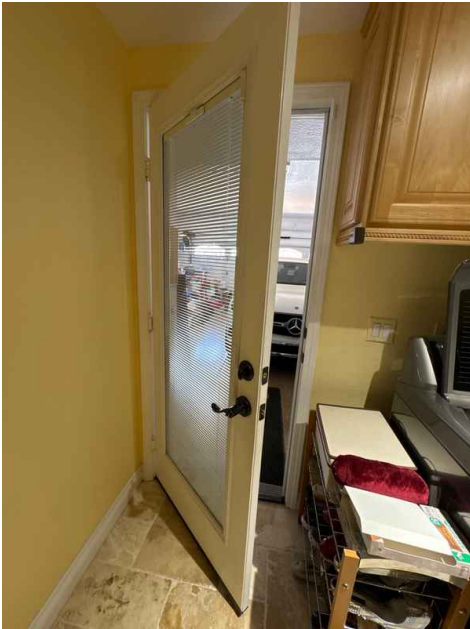
## 8.6.1 Floor, Walls, Ceiling

**FLOORS / WALLS OBSCURED**

Floor and / or wall areas were obscured by stored items and couldn't be fully evaluated.

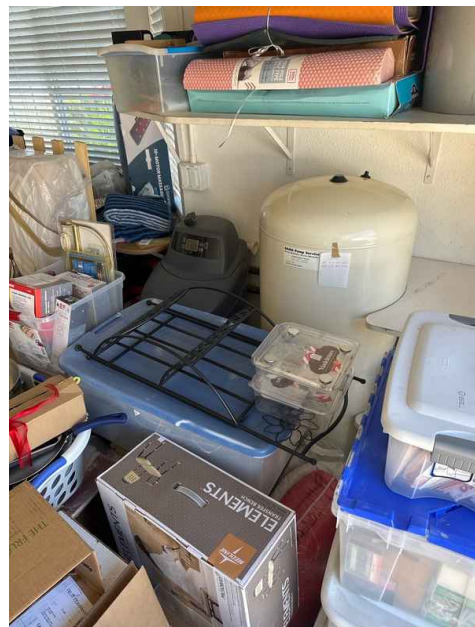
**Note:** A water softener system / water treatment device was installed on the premises. These are specialty systems and are excluded from this inspection. Comments in this report related to this system are made as a courtesy only and are not meant to be a substitute for a full evaluation by a qualified specialist. Water softeners typically work by removing unwanted minerals (e.g. calcium, magnesium) from the water supply. They prevent build-up of scale inside water supply pipes, improve lathering while washing, and prevent spots on dishes. Recommend consulting with the property owner about this system to determine its condition, required maintenance, age, expected remaining life, etc.

Contact a qualified professional.

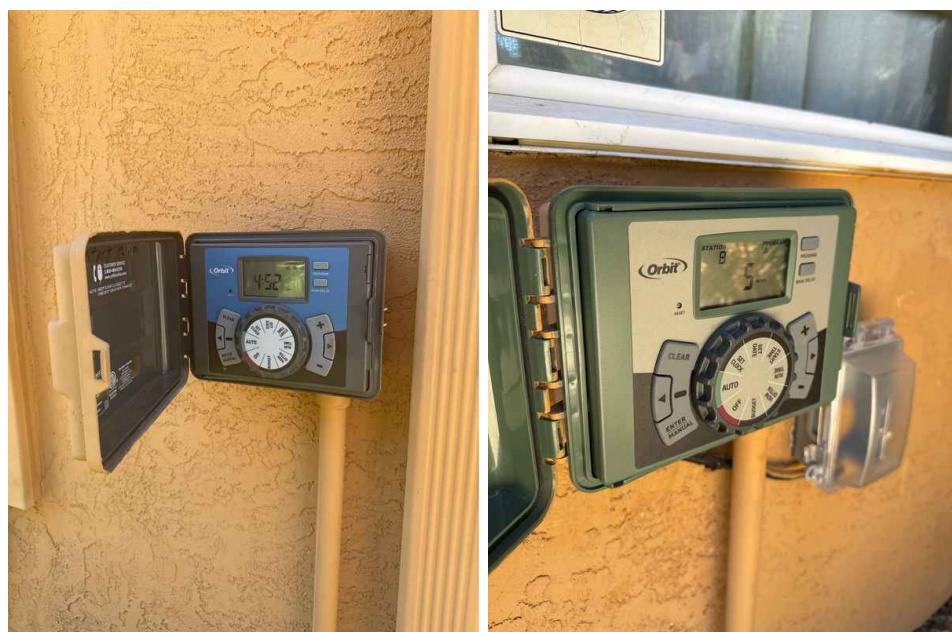
## IRRIGATION / SPRINKLERS

**Note:** This property appeared to have a yard irrigation (sprinkler) system and is excluded from this inspection. Comments in this report related to this system are made as a courtesy only and are not meant to be a substitute for a full evaluation. When this system is operated, recommend verifying that water is not directed at building exteriors, or directed so water accumulates around building foundations. Sprinkler heads may need to be adjusted, replaced or disabled. Consider having a qualified plumber verify that a backflow prevention device is installed per standard building practices to prevent cross-contamination of potable water. Recommend that a qualified specialist evaluate the irrigation system for other defects (e.g. leaks, damaged or malfunctioning sprinkler heads) and repair if necessary.

Contact a qualified professional.

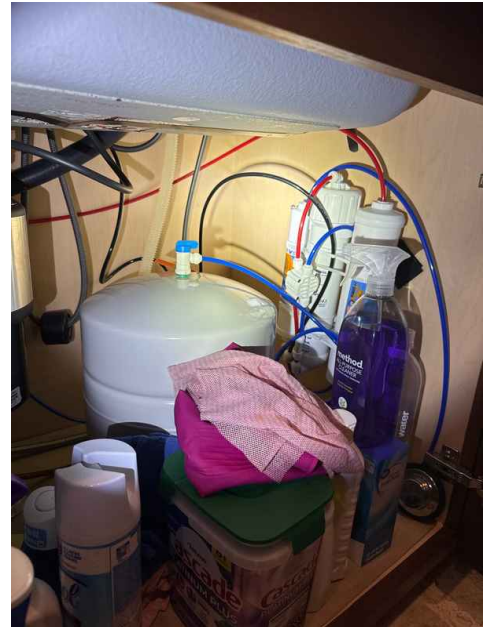
**Note:** A water filtration / reverse osmosis system was installed on the premises. These are specialty systems and are excluded from this inspection. Comments in this report related to this system are made as a courtesy only and are not meant to be a substitute for a full evaluation by a qualified specialist. Filter cartridges typically need replacing periodically. Cleaning and other maintenance may also be needed. Recommend consulting with the property owner about this system to determine its condition, required maintenance, age, expected remaining life, etc.

Contact a qualified professional.

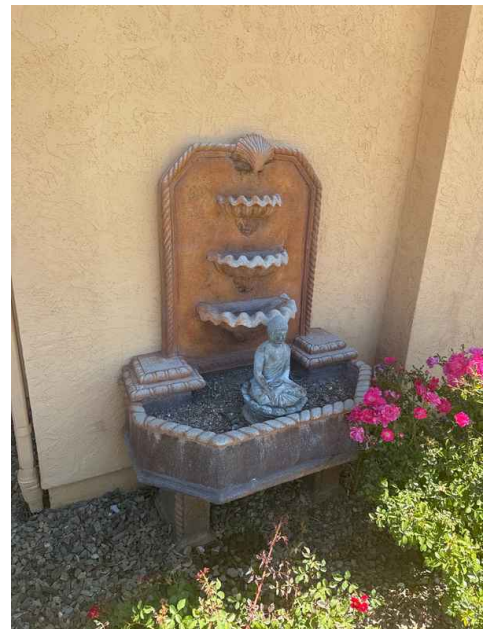
**WATER FEATURE**

An exterior built in pond is installed on the property. Built in ponds and their related components are out of the scope of our general home inspection and was not inspected by our company. Recommend further evaluation by a qualified person to verify proper installation and operation prior to the end of your contingency period if concerned.

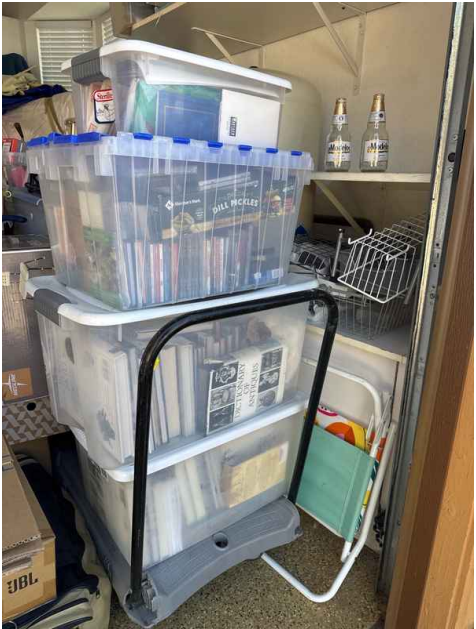
GARAGE

The main water supply shut-off was located in a difficult location to access at time of inspection. Recommend that the client familiarize themselves with the location and make repairs to provide easier access.

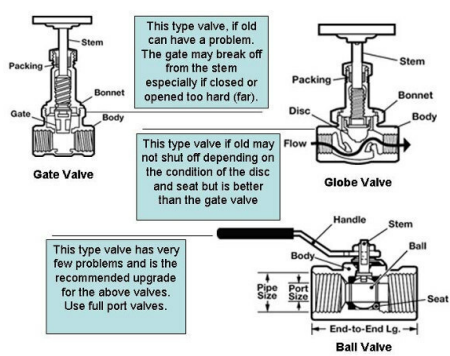
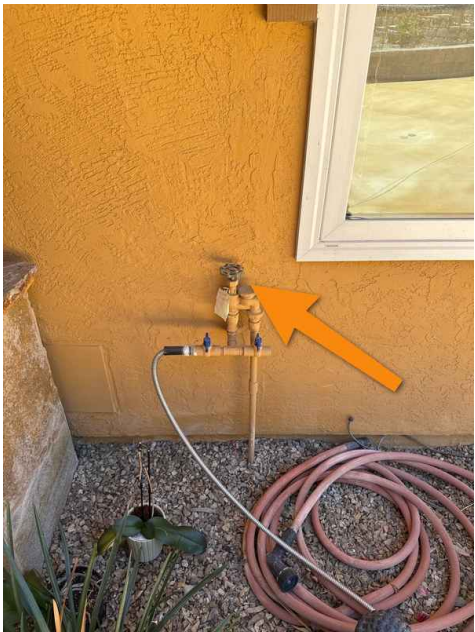
The home appears to be equipped with an older-style shut off valve at one or more areas. Gate valves are known to be less effective than a newer-style ball valve. Advise consulting a licensed plumbing contractor for replacement as necessary.

Contact a qualified plumbing contractor.

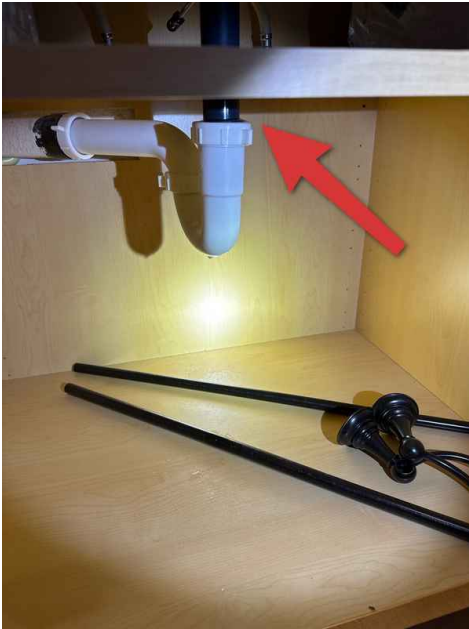
##### **DRAIN LEAK**

One or more leaks were found at the sink drain. A qualified plumber should repair as necessary.

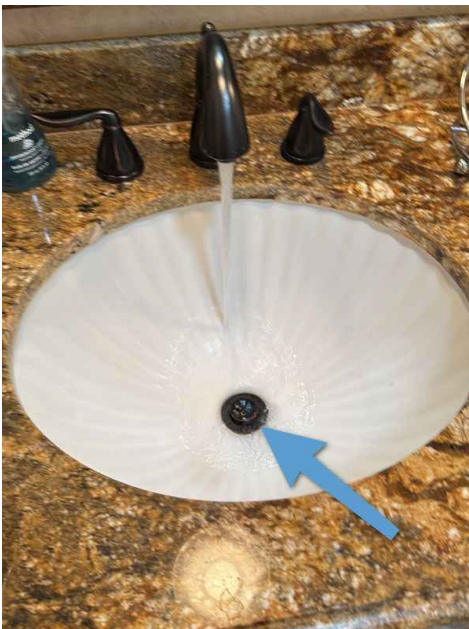
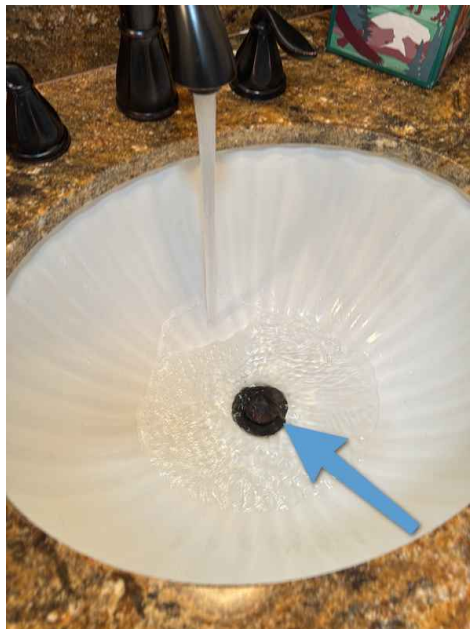
#### **STOPPER ISSUE**

The sink stopper was inoperable and/or ineffective when tested. Recommend necessary repairs or replacement by a qualified person.

Contact a qualified plumbing contractor.

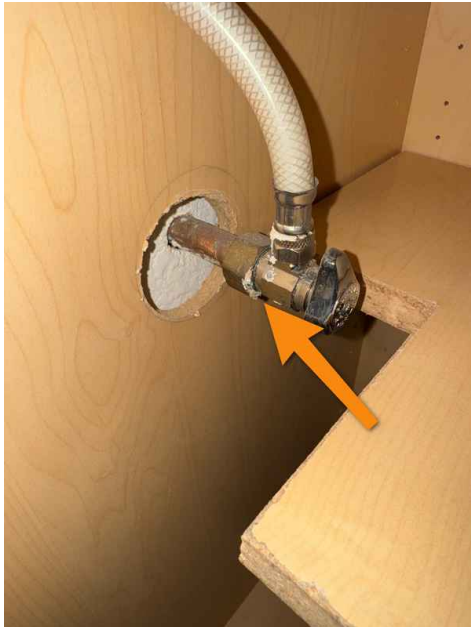
#### **SHUT-OFF VALVES CORRODED**

Shut-off valves were corroded. This indicates a past leak and could possibly leak again in the future. Recommend repairs be made by a qualified licensed plumbing contractor.

Contact a qualified plumbing contractor.

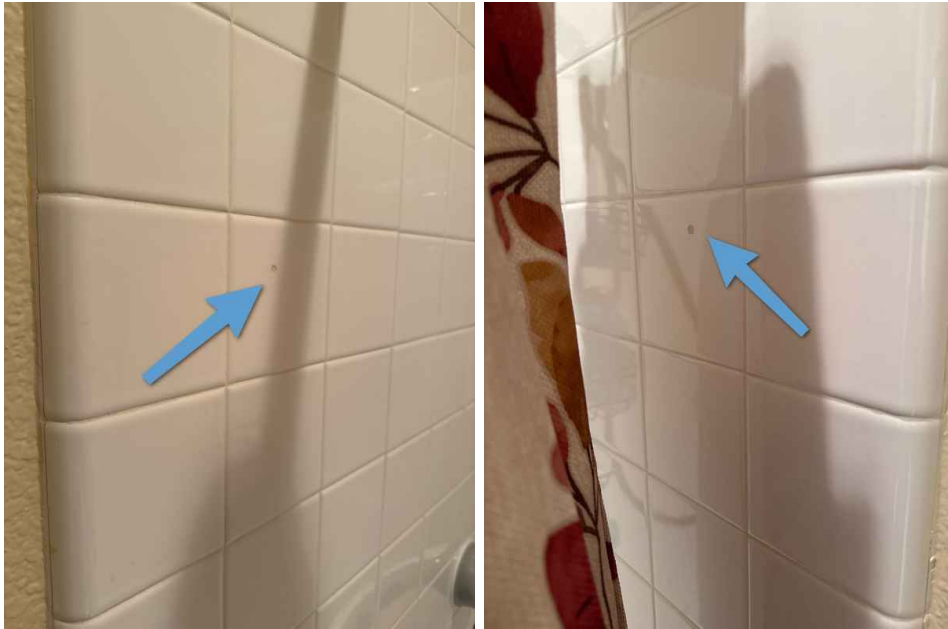
Tile in one or more locations were chipped. Recommend that a qualified professional repair as needed.

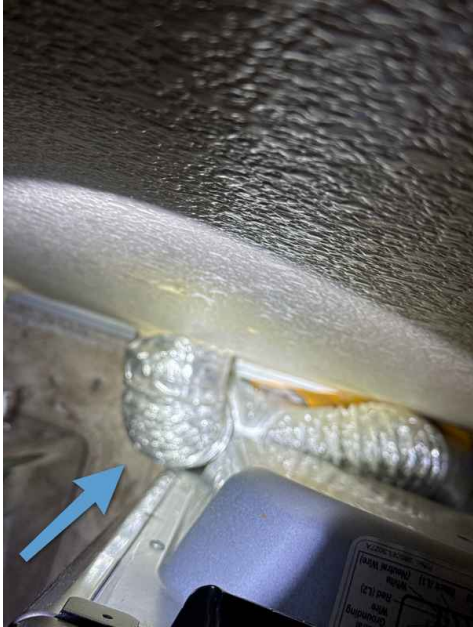
#### **REPLACE FOIL/NYLON DUCT**

Replace plastic or foil, accordion-type ducting material with rigid or corrugated semi-rigid metal duct. Most manufacturers specify the use of a rigid or corrugated semi-rigid metal duct, which provides maximum airflow. The flexible plastic or foil type duct can more easily trap lint and is more susceptible to kinks or crushing, which can greatly reduce the airflow. Flexible Nylon ducting is no longer approved in most areas for dryer venting due to the possibility of a fire hazard and has never been approved for use on gas dryers. Clean the dryer vent and exhaust duct periodically. Check the outside dryer vent while the dryer is operating to make sure exhaust air is escaping. If it is not, the vent or the exhaust duct may be blocked. A handyman is recommended for periodic cleaning of vent and duct.

**FLEXIBLE FOIL** These may look like flexible metal but don't hold their shape if bent.

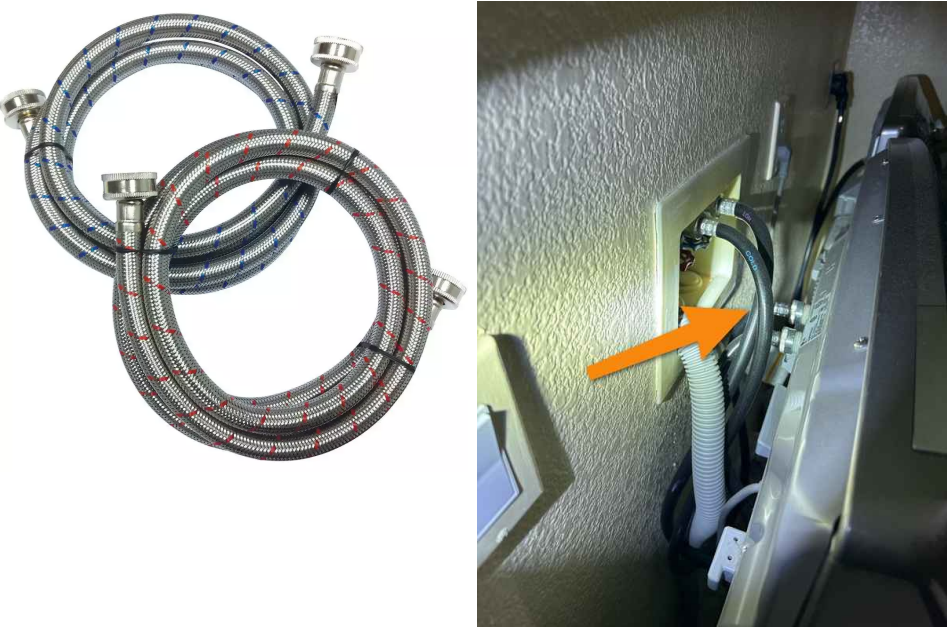
**LAUNDRY HOSE UPGRADE**

The laundry area is equipped with rubber supply lines. This type of line is prone to dry rot and failure. Advise upgrades to new steel braided hoses to prevent this condition.

Contact a handyman or DIY project

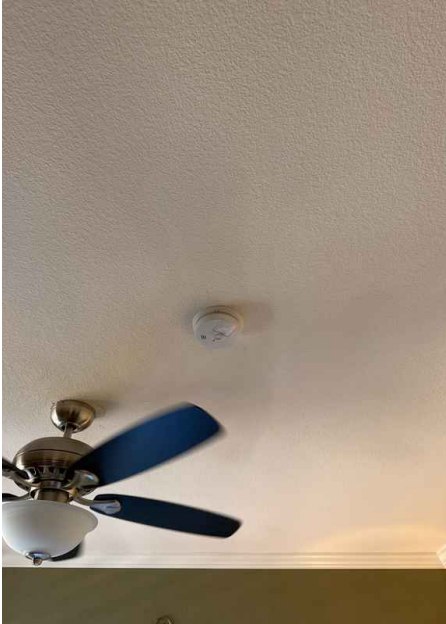
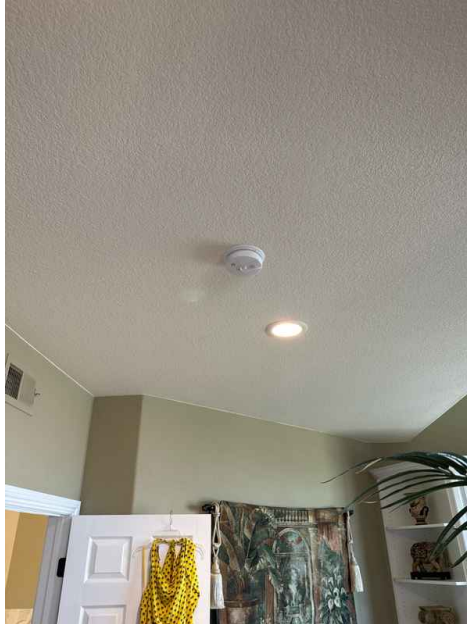
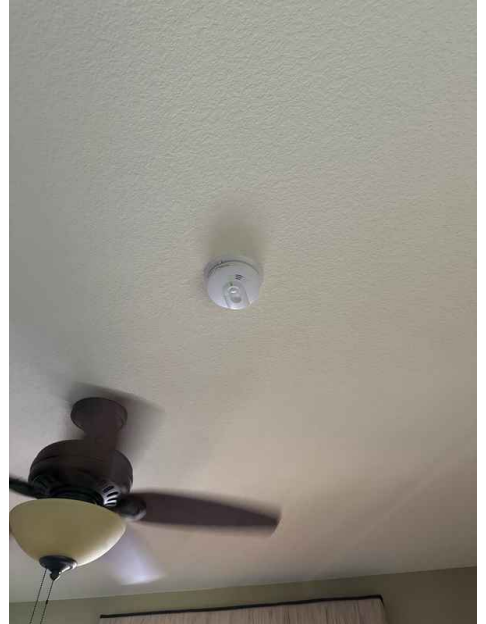
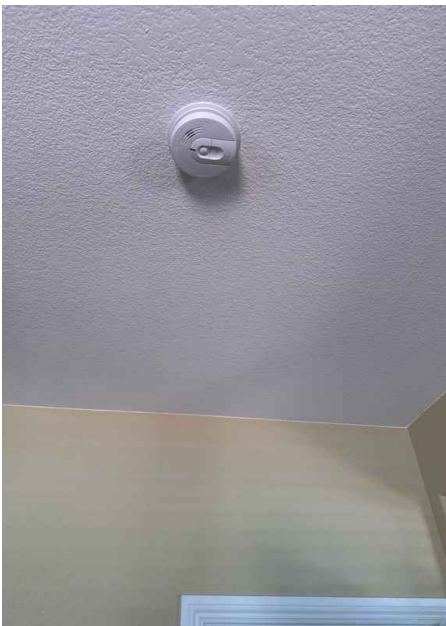
Smoke detectors were installed on each floor and in each bedroom, however, they were not tested. We recommend testing the detectors for proper function before occupying the home.

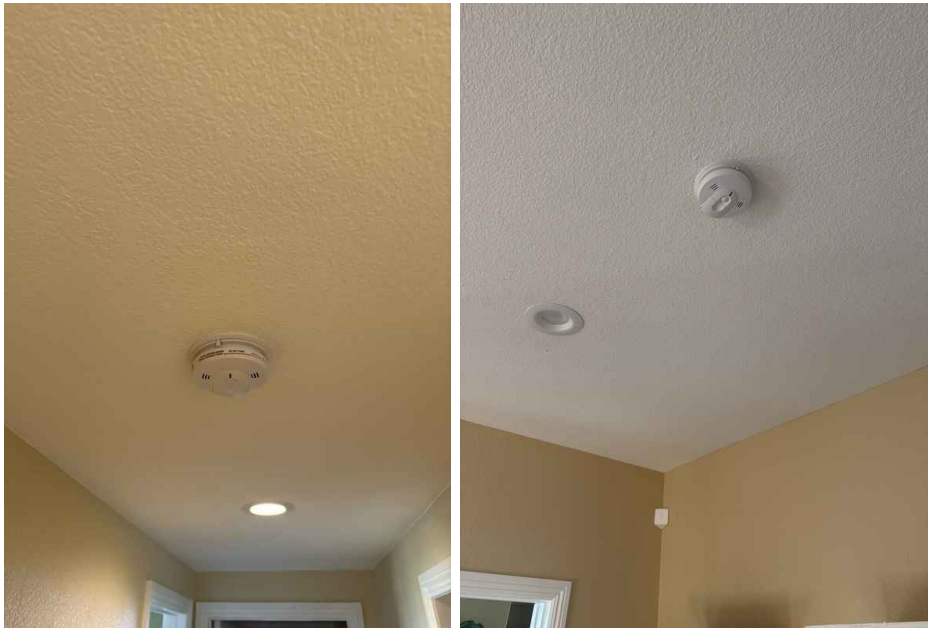
Carbon Monoxide detectors are required in homes with any gas-burning appliances (furnace, range, water heater), fireplaces, or wood-burning stoves and/or an attached garage. Please see the new law regarding Carbon Monoxide detectors.

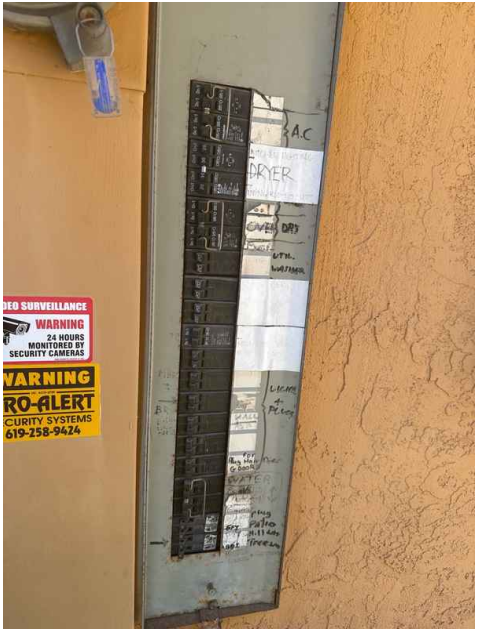
Some labels are present, but illegible or confusing. Recommend correction by a licensed electrical contractor or qualified professional for safety.

Recommendation  
Contact a qualified professional.

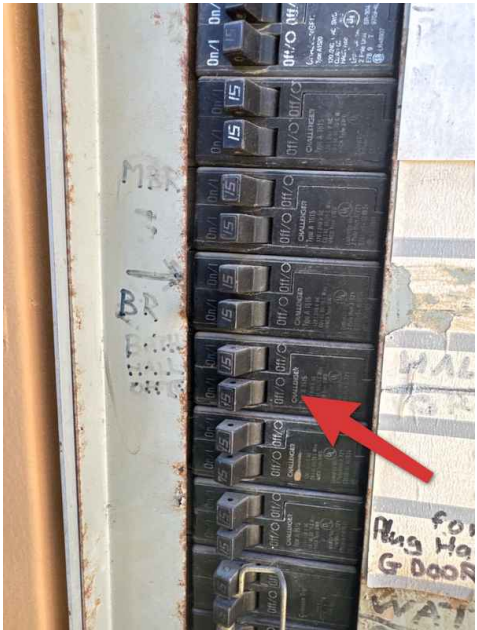
Challenger panels built and installed in the 1980s and 1990s were found to have an issue where they were overheating under normal conditions at the metal “bus bar.” This led to expansion and contraction of the bus bar, and electrical arcing between the bus bar. Over time, these components could melt down, causing a shock or fire hazard. Challenger breaker panels started facing recalls in 1988. Recommend consulting with a licensed electrician for options on replacement.

Recommendation  
Contact a qualified electrical contractor.

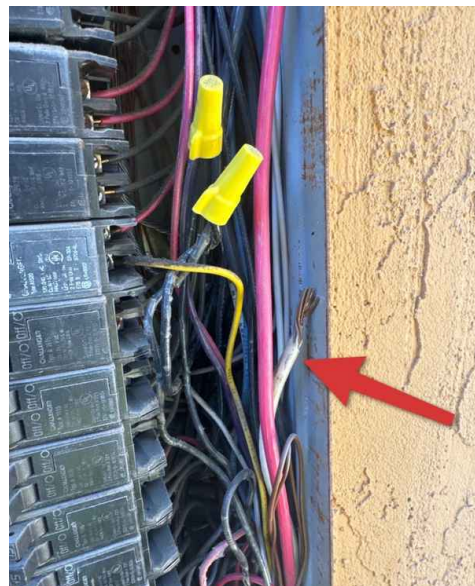
10.4.1 Panel Wiring & Breakers  
**LOOSE WIRES NOT TERMINATED**

One or more wires inside the panel were loose, and were not terminated. This poses a safety hazard for shock and/or fire. Recommend that a qualified electrician remove any abandoned wiring or repair as necessary. For example, by trimming wires to length and installing wire nuts.

Contact a qualified electrical contractor.

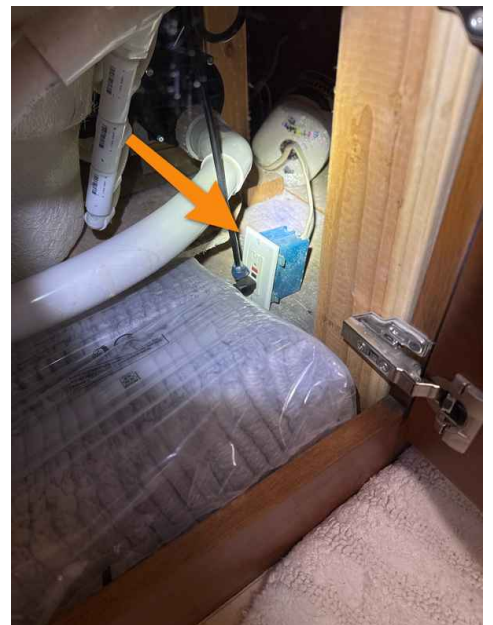
One or more receptacles were not properly secured and loose. Recommend a licensed electrician repair as necessary.

Contact a qualified electrical contractor.

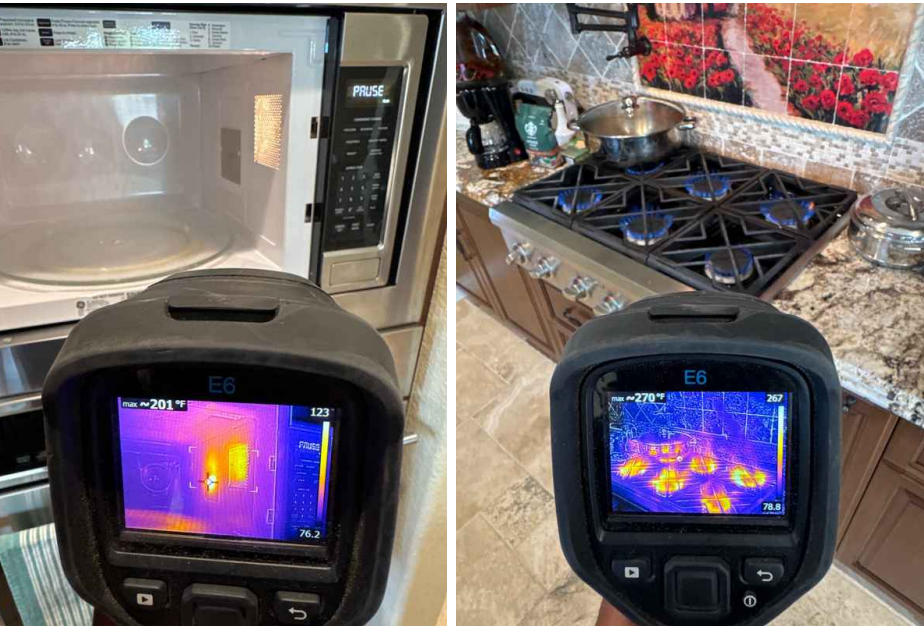
The microwave was tested using a microwave tester and was functional at the time of the inspection. This test is not exhaustive and does not confirm the performance, accuracy, or effectiveness of the unit.

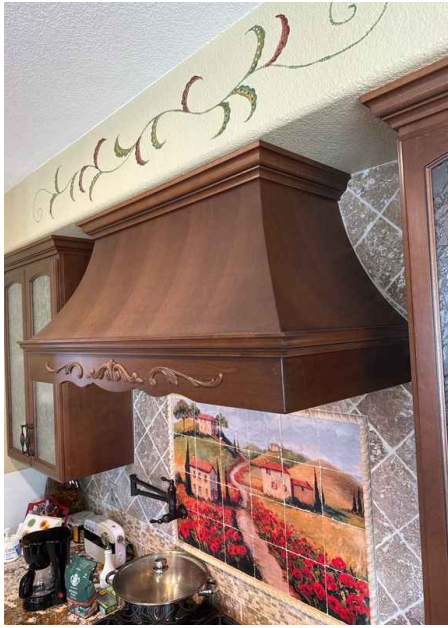
The range exhaust vent was tested and was functional at the time of the inspection. This is not an exhaustive test, and does not evaluate the performance or effectiveness of the unit.

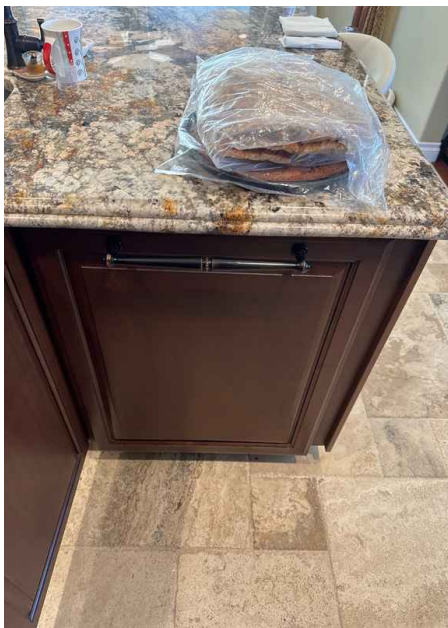
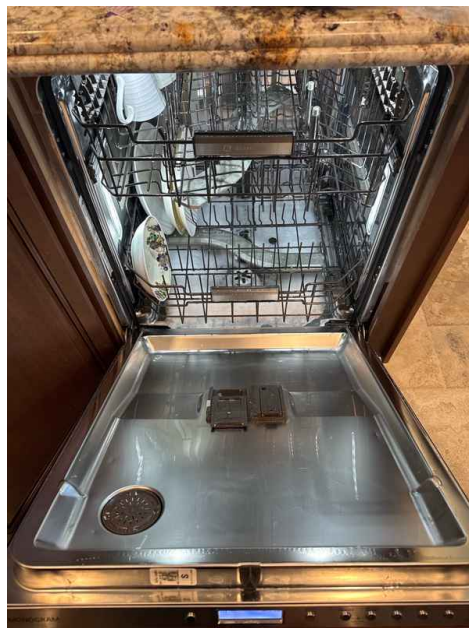
The dishwasher was tested and functioned properly at the time of the inspection. This is not an exhaustive test and does not verify the cleaning efficiency of the dishwasher.

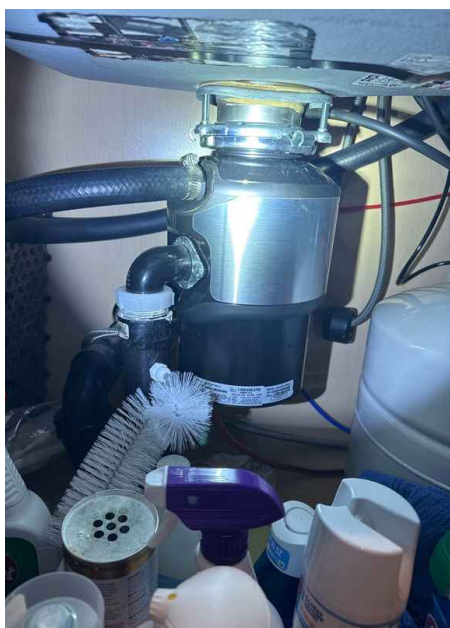
The food waste disposer was tested and functioned properly at the time of the inspection. This is not an exhaustive test and does not verify the efficiency of the unit.

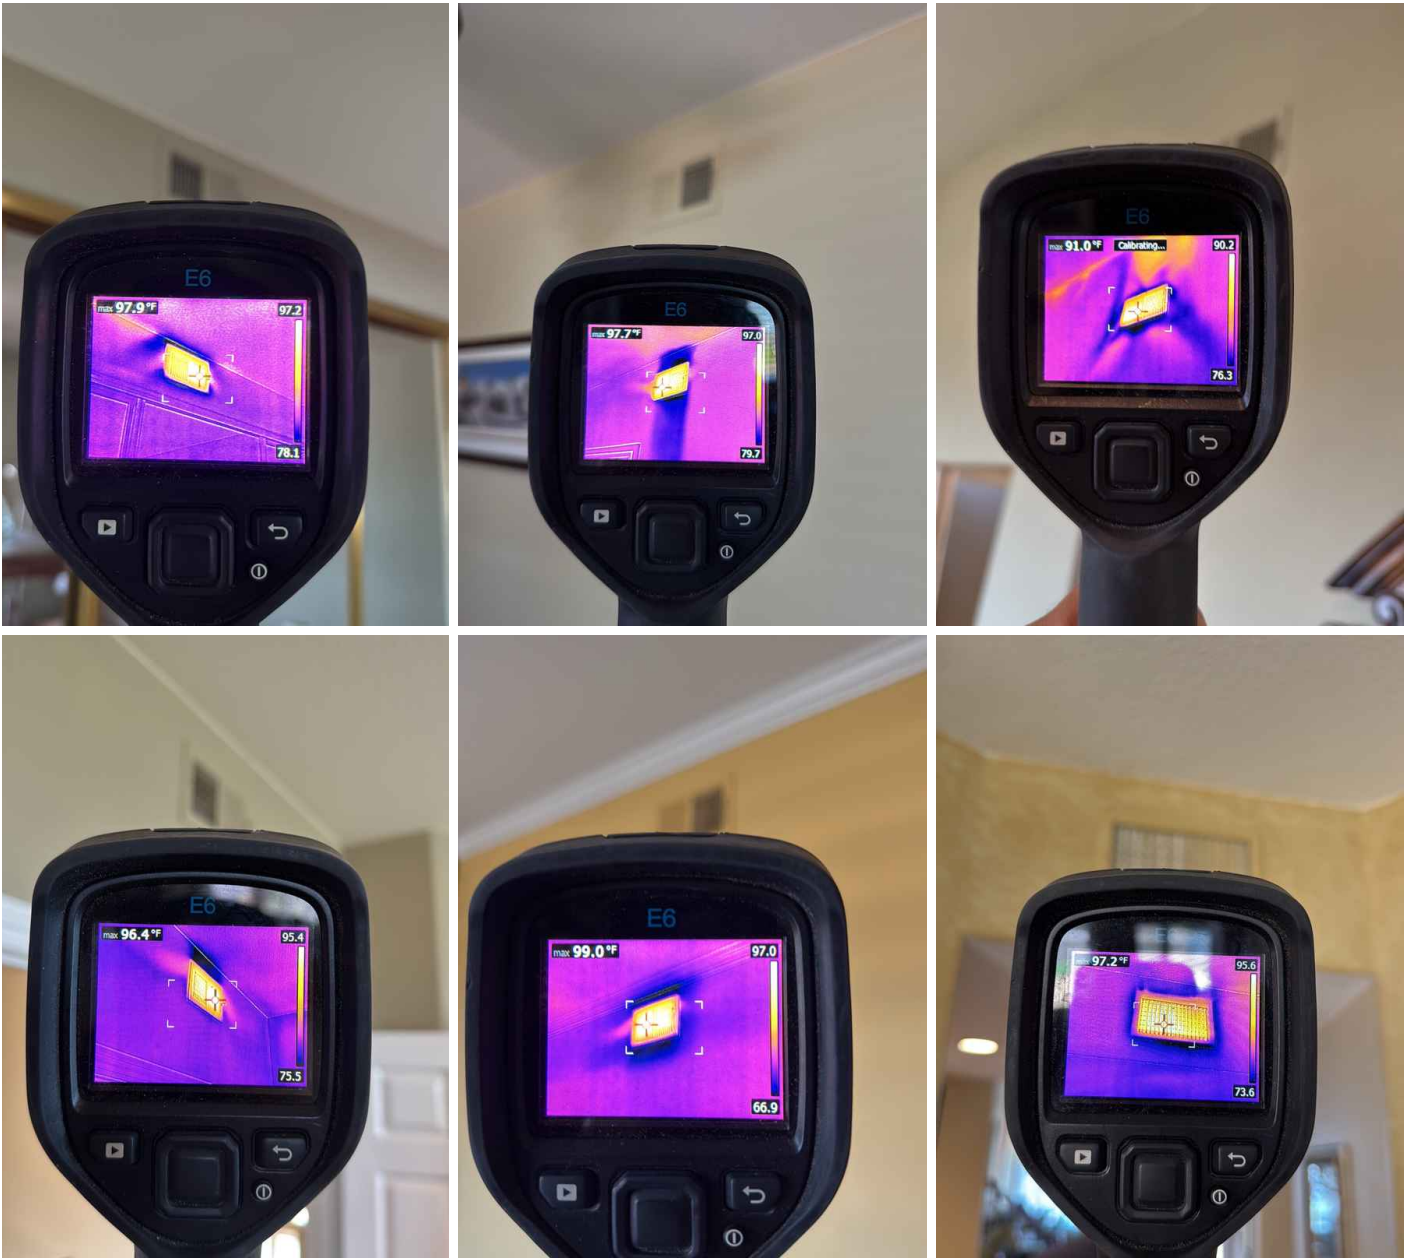
Heat system appears to be in working order.

The photo(s) below is/are a thermal image of the supply air temperature at register(s) at the time of this inspection.

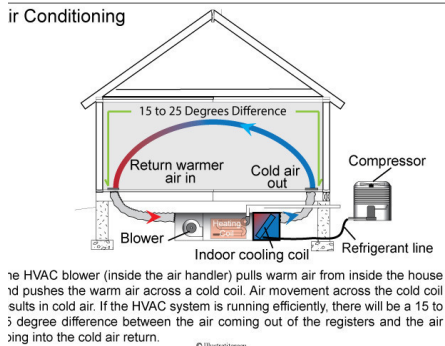
20 F\*, Under 14\* F

A common way of inspecting a homes air conditioning system is by obtaining temperature measurements in the home before and after air cycles through the air conditioning system. Temperature readings are taken at a vent blowing into a room (supply side) of the AC system and deducted from temperature readings taken at the air filter (return side). The difference in temperature called a "temperature split" or differential, gives an indication of how well the air conditioning system is performing overall. The national average for a system in the US should read between 15 and 25 degrees.

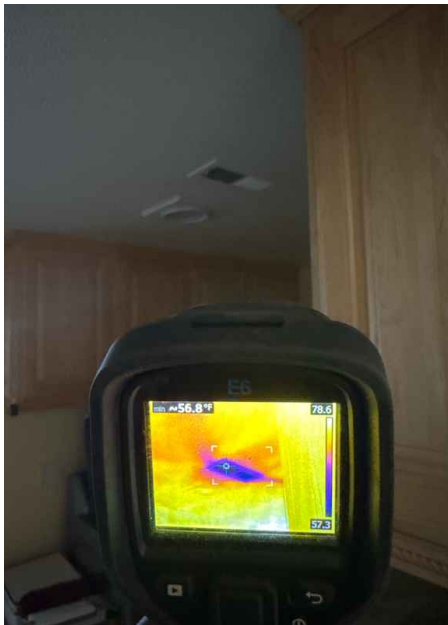
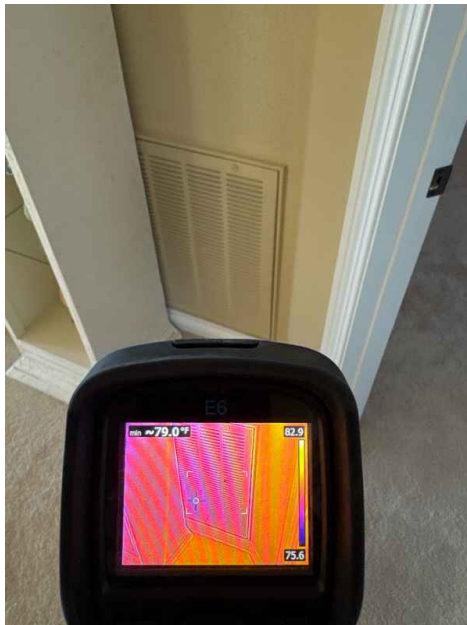
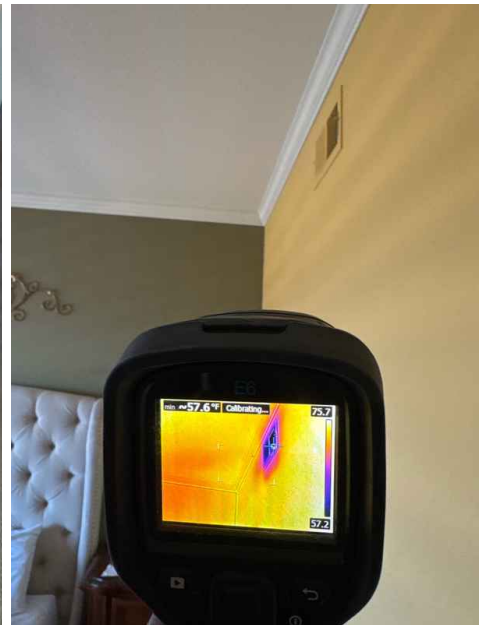
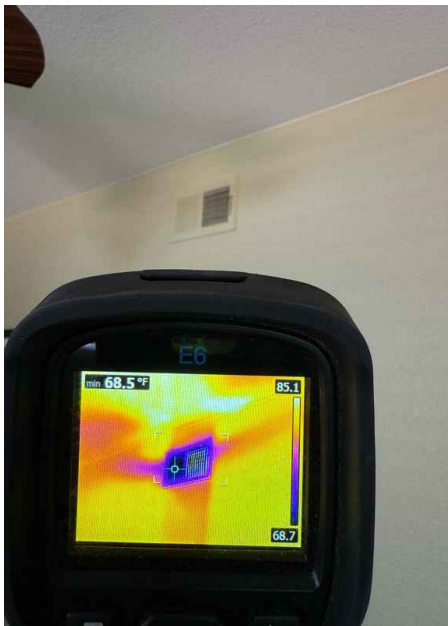
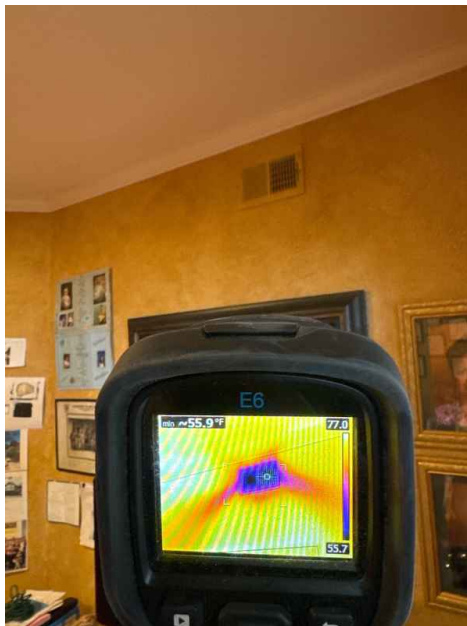
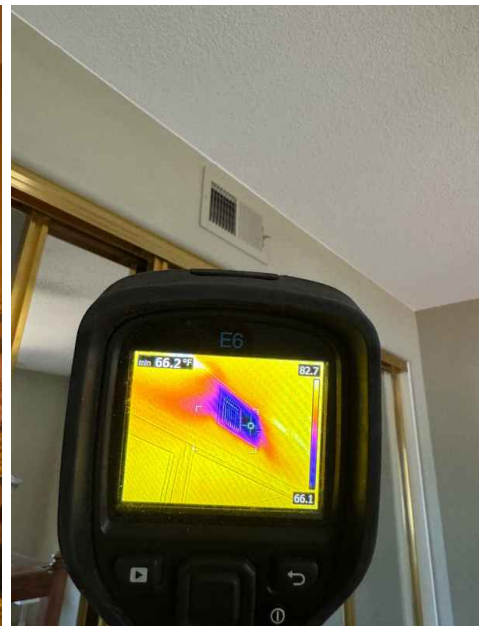
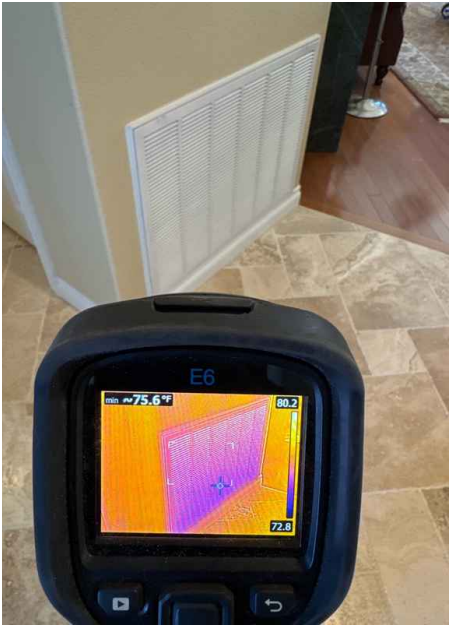
The photo(s) below is/are a thermal image of the air temperature at supply and return air register(s) at the time of this inspection.

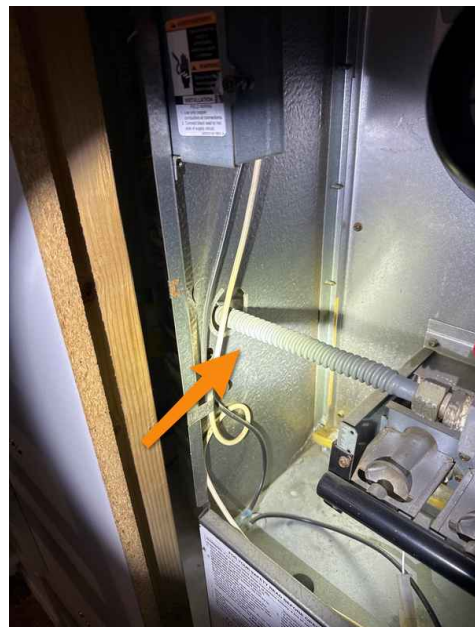
## 12.2.3 Heating / Forced Air

**FLEXIBLE GAS LINE PASSES THROUGH FURNACE WALL**

The flexible gas line passes through the sidewall of the furnace. This soft flex gas line is easily damaged if it contacts the sharp edge of the furnace wall. We recommend that a licensed HVAC contractor and repair as necessary to comply with today's safety standards.

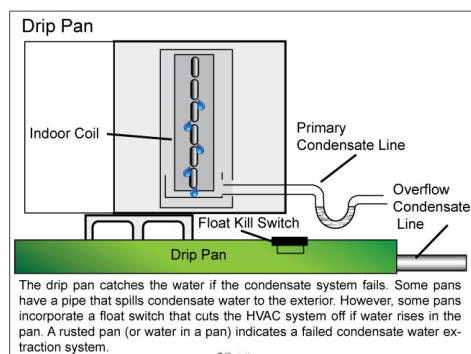
## 12.3.1 Air Conditioner

**NO CONDENSATION CATCH PAN INSTALLED**

No condensation catch pan installed under the evaporative case. In the event the condensate drain line becomes clogged water from the condensate line will overflow onto whatever is below/around the unit, potentially causing water damage. Recommend a qualified licensed HVAC contractor evaluate the unit and add if allowed.

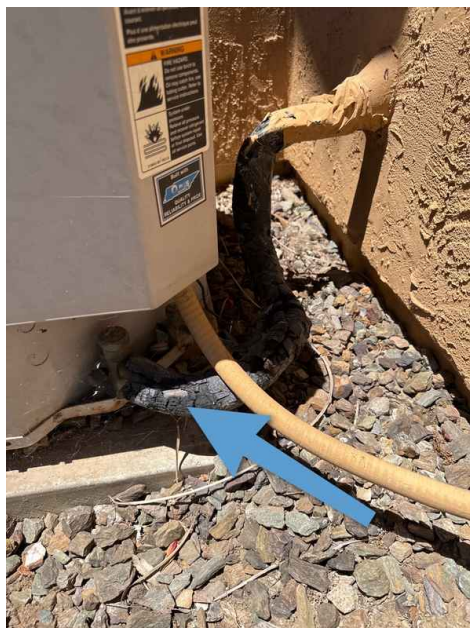
#### 12.3.4 Air Conditioner

##### REFRIGERANT LINE INSULATION DETERIORATED

Insulation on the air conditioning refrigerant lines was deteriorated or missing in some areas. This may result in reduced efficiency and increased energy costs. In attics it can cause sweating. Recommend that a qualified person replace or install insulation as necessary.

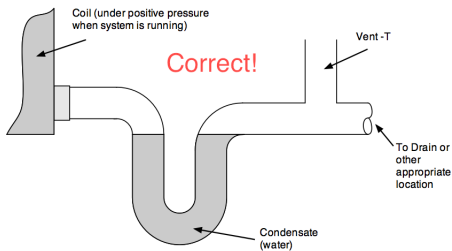
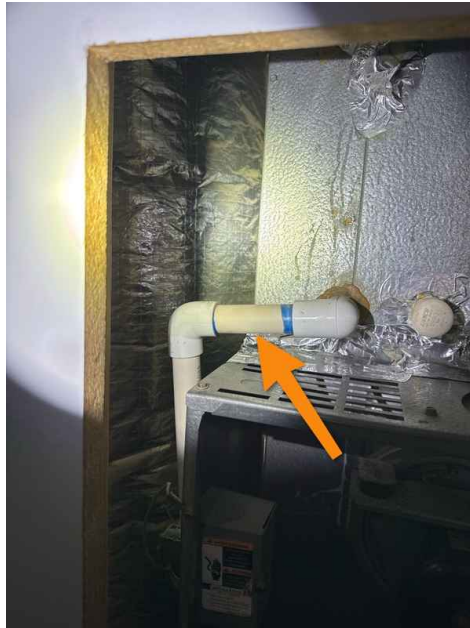
## 12.3.5 Air Conditioner

**CONDENSATE DRAIN LINE TRAP MISSING**

The P trap for the primary condensation drain was missing. The intended purpose of the p-trap is to allow condensate to flow from the equipment while simultaneously preventing air leakage into or out of the unit. Recommend further evaluation and repair by a qualified professional.

Contact a qualified HVAC professional.

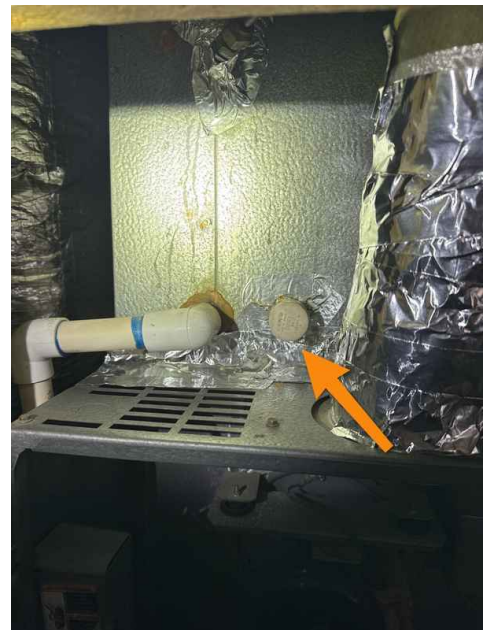
## 12.3.6 Air Conditioner

**SECONDARY DRAIN NOT INSTALLED**

The secondary condensation drain (or equivalent) at the evaporative coil was not installed at the time of the inspection. This may not have been required at the time of installation. However, this is a recommended retrofit. The secondary condensation drain acts as a redundancy to prevent leaks in the event the primary drain becomes clogged. Advise consulting a licensed HVAC contractor for necessary correction.

Contact a qualified HVAC professional.

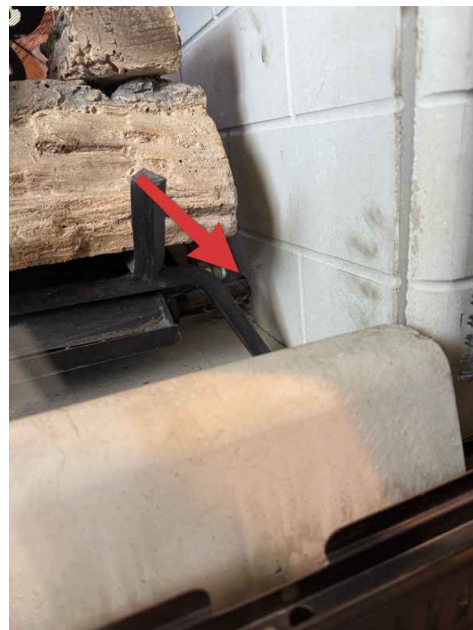
The opening where the fireplace gas line penetrates the refractory panel is not sealed. Super-heated gasses can enter the wall cavity. Fire hazard. Recommend that a qualified contractor repair as necessary.

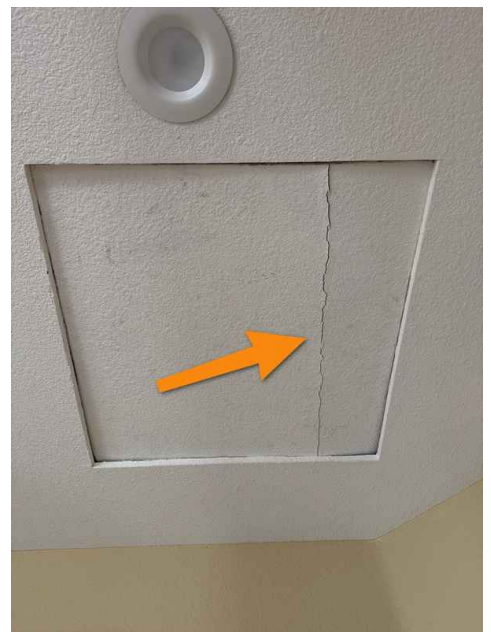
### ACCESS PANEL DAMAGED

The drywall access panel was damaged. Replacement of the panel is recommended to be performed by a qualified professional.
