## **Confidential Inspection Report**

**474 Via Juarez**  
**Newbury Park, CA 91320**

**Prepared for: D.W. Homes, INC**

**For D.W. Homes, INC**  
**474 Via Juarez**  
**Newbury Park, California 91320**  
**Date 09/08/2026.**

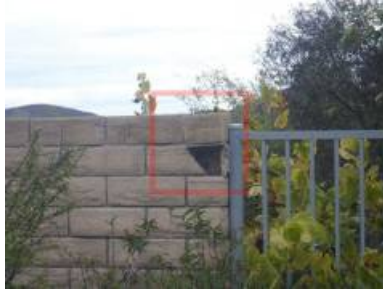
**Attention Needed** - The fencing needs to be repaired. Damaged fencing materials noted. Repair is recommended to prevent any further damages.

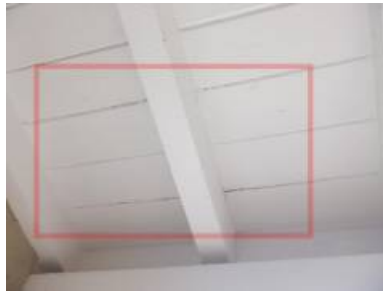
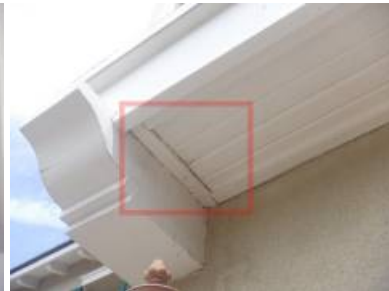
**4.14 Roof Gutter System:**

**Attention Needed** - The gutter system on the roof edge appears to be leaking or inadequately sloped to carry the water to the downspouts. Leakage at gutter system noted. Repairs are recommended.

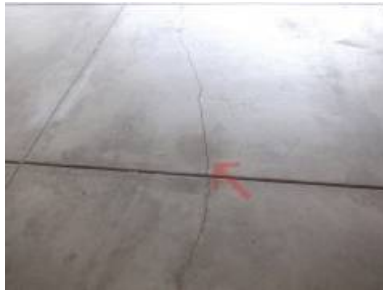
- 5.6 *Safety Reverse Switch on the Automatic Opener:* Yes - The door opener is equipped with an automatic reverse safety switch. There is an electronic beam safety reverse system installed. It appears to be functional.
- 5.7 *Outside Entry Door:* The outside entry door to the garage is satisfactory.
- 5.8 *Floor Condition:* **Attention Needed** - The garage floor needs some minor repair to prevent further deterioration. To prevent further deterioration of the slab floor, it is recommended that the cracks be sealed.

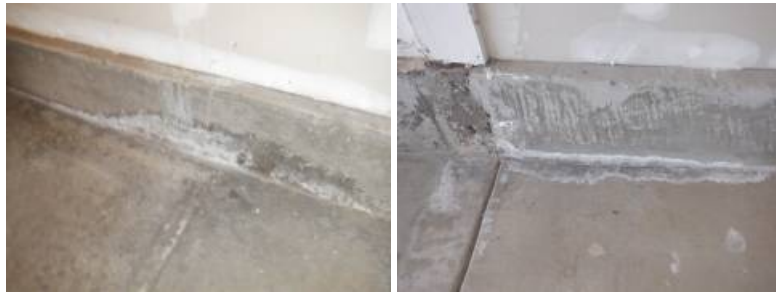
- 5.9 *Garage Walls Condition:* The wall covering appears to meet the minimum fire separation standards. However, it is not possible to verify after the sheetrock is finished.
- 5.10 *Garage Ceiling:* Yes - There appears to be a fire rated separation between the garage ceiling and the living areas above.
- 5.11 *Fire Rated Entry Door to Structure:* Yes - There is a fire rated door separating the garage from the living areas of the house.
- 5.12 *Garage Foundation:* **Attention Needed** - The visible portions of the foundation under the garage needs some minor attention. Efflorescence observed - previous water entry.

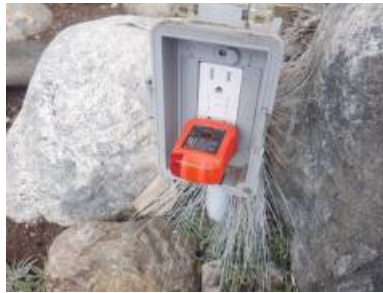
**Action Necessary** - All outside outlets, for safety reasons, should be Ground Fault Circuit Interrupt protected. Non-operational GFCI receptacles noted. Repair or replacement is recommended for safety.

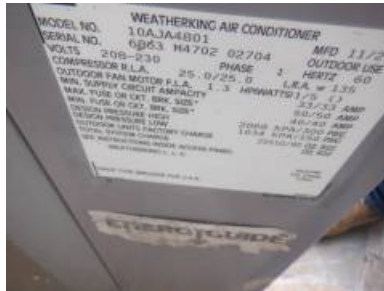
7.1 Model/ Serial Number/ Size: Brand - Weather King; Model # ; Serial # ; This unit was manufactured about .2002. The typical service life for an AC unit is 12 - 15 years.

**Attention Needed** - Although this unit was operational during the inspection, the age and/or condition is such that you may need to replace it in the near future.

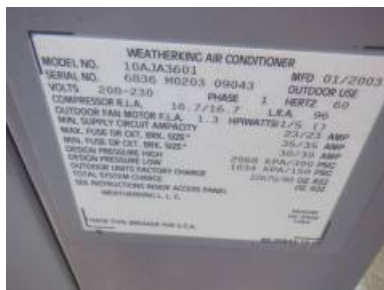
7.12 Model/ Serial Number/ Size: Brand - Weather King; Model # ; Serial # ; This unit was manufactured about .2003. The typical service life for an AC unit is 12 - 15 years.

**Attention Needed** - Although this unit was operational during the inspection, the age and/or condition is such that you may need to replace it in the near future.

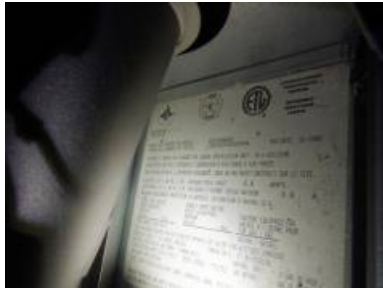
- 7.25 Heating System Type: A forced air furnace is installed as the primary source of heat.
- 7.26 Fuel Source: The fuel source is natural gas.
- 7.27 Model/Serial Number/Size: Brand - Weather King; Model # ; Serial # ; This unit was manufactured about .2002. The typical service life for a forced air natural gas furnace is 18 - 20 years.  
**Attention Needed** - Although operational at the time of the inspection, the age and/or condition of this unit is such that you may need to replace it in the near future.

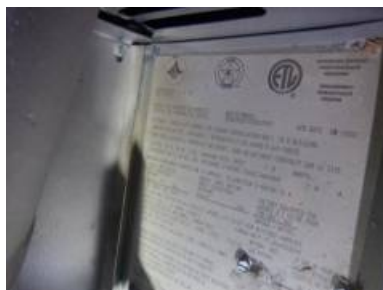
- 7.46 Heating System Location: Attic.
- 7.47 Heating System Type: A forced air furnace is installed as the primary source of heat.
- 7.48 Fuel Source: The fuel source is natural gas.
- 7.49 Model/Serial Number/Size: Brand - Weather King; Model # ; Serial # ; This unit was manufactured about .2002. The typical service life for a forced air natural gas furnace is 18 - 20 years.  
**Attention Needed** - Although operational at the time of the inspection, the age and/or condition of this unit is such that you may need to replace it in the near future.

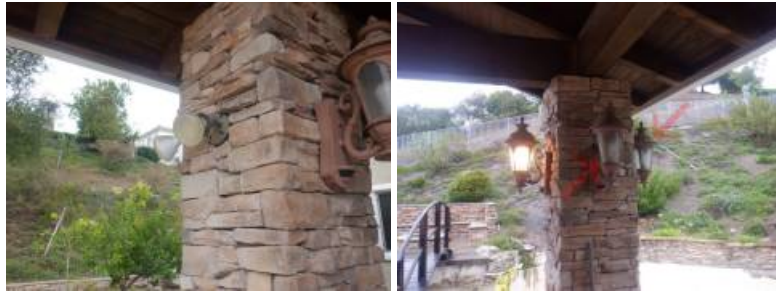
*8.19 Exterior Lighting:*

**Attention Needed** - Some portion of the exterior security lighting is not functioning as intended. Some bulbs are non-operational or there are no bulbs present. Further Evaluation is Recommended.

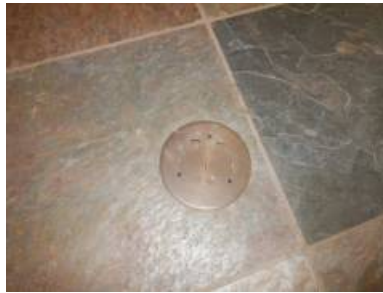
**Attention Needed** - At least one outlet noted needs a new outlet cover. Unsecured floor outlet cover - Missing hardware noted. Attention is recommended for safety.

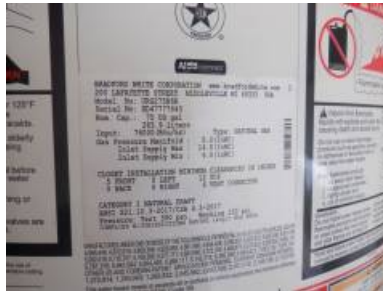
- 9.21 *Location:* Garage.
- 9.22 *Model & Serial Numbers:* Brand - Bradford White ; Model # - ; Serial # - ; Manufactured approximately 2021. The average service life for a water heater is 10 - 12 years.

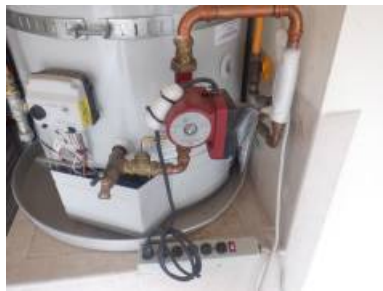
**9.25 Electric Service to Water Heater:** Satisfactory - The electric service to the water heater appears to be installed in an acceptable manner. Recirculation Pump.

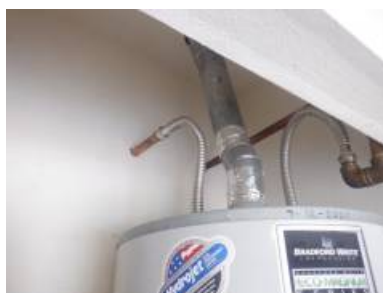
**9.31 Water Piping Condition:** **Attention Needed** - There is no cold water bond on water piping. Not to Current Plumbing Standards.

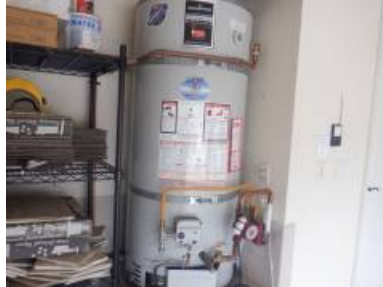
- 9.34 *Drain Valve:* Yes - There is a drain valve installed on the lower side of the water heater.
- 9.35 *Temperature & Pressure Relief Valve:* Satisfactory - The temperature and pressure relief valve is of the correct rating for the water heater.
- 9.36 *Safety Overflow Pipe:* Satisfactory - The overflow pipe is correctly installed.
- 9.37 *Seismic Strapping* **Action Necessary** - Unit requires three straps. 75 Gallon and larger are considered commercial which requires three straps.

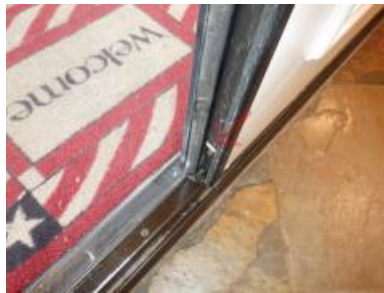
*10.2 Outside Entry Door:*

**Attention Needed** - The outside entry door to the kitchen needs some minor adjustment or repair. Locking hardware at base of door is in need of repair. Non-operational hardware noted. Attention is recommended.

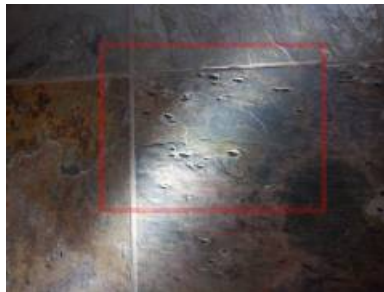
*10.6 Floor:*

**Attention Needed** - The flooring in the kitchen is in need of attention to prevent further deterioration. The floor covering material is Slate. Pitting within flooring noted. Repair as needed to prevent any further deterioration.

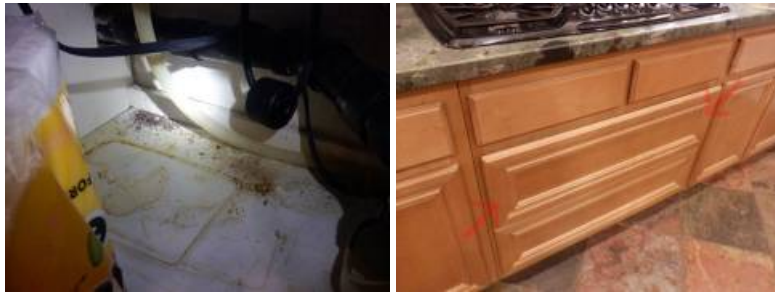
**Attention Needed** - At least one cabinet door or drawer is in need of some minor repair. Water damage to cabinetry. No elevated moisture was noted at the time of inspection. Repair as needed. Sliding hardware to at least one cabinetry drawers needs attention. Drawer does not close as intended. Adjustment or repair is recommended.

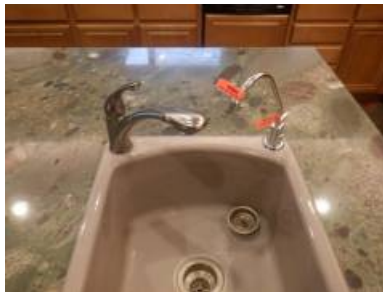
**10.9 Faucet and Supply Lines:**

**Attention Needed** - The water supply to the faucet at kitchen island was shut-off at time of inspection. Further evaluation is recommended.

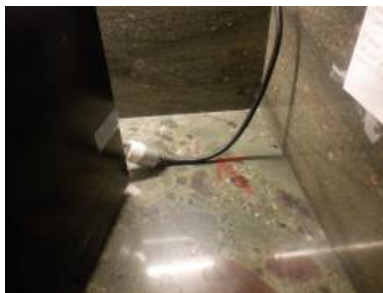
**10.18 Microwave Oven:**

**Action Necessary** - There is a microwave unit installed. However, The unit is powered by an extension cord. Substandard Electrical, Safety Concern.

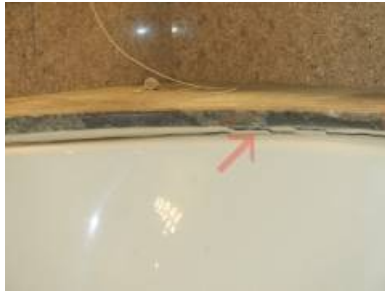
- 12.12 Caulking/Water Contact Areas: **Attention Needed** - The caulking in the water contact areas appears to need attention. Damage may result if not corrected. The wall at the tub or shower seam needs to be caulked to prevent moisture from entering the wallboard.

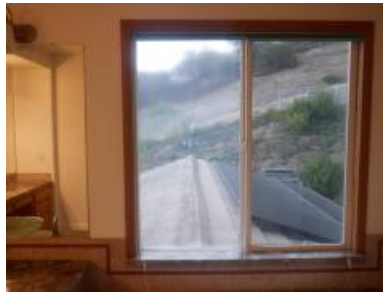
- 12.15 Walls: Satisfactory - The walls in this bathroom are satisfactory.
- 12.16 Windows: **Attention Needed** - At least one window or associated hardware in this bathroom needs attention. Imperfections in window noted. There appears to be a film/tint installed on window. Further evaluation is recommended.

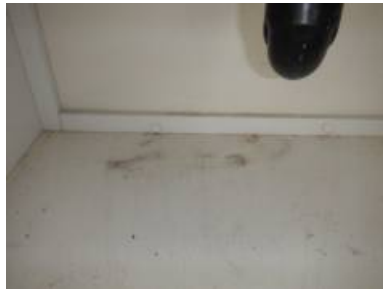
12.20 Vanity Cabinet:

**Attention Needed** - The vanity cabinet shelf has stains noted. No elevated moisture was measured. Possible Past Leak.

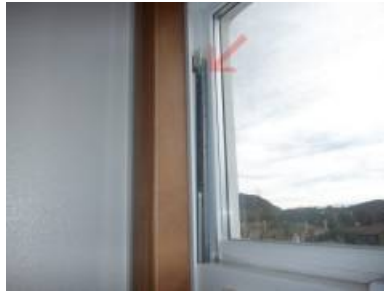
**12.34 Windows:**

**Action Necessary** - At least one window or associated hardware in this bathroom needs repair or replacement. The spring or slide that holds the window in the up position does not function properly. It needs to be replaced.

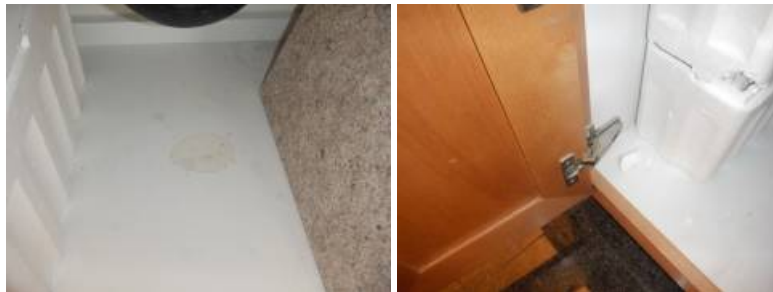
**Attention Needed** - The vanity cabinet shelf has stains noted. No elevated moisture was measured. Possible Past Leak.

At least one hinge at cabinetry is in need of adjustment or repair. Loose hinge noted. Attention is recommended.

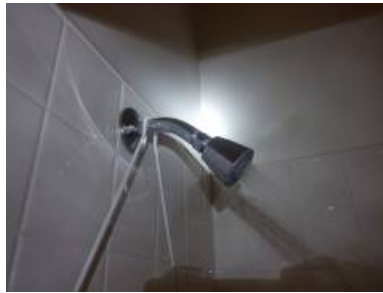
**Attention Needed** - The shower head or mixing valve needs some attention so that it will function as intended. Leakage at shower head conception noted. Adjustment or repair is recommended.

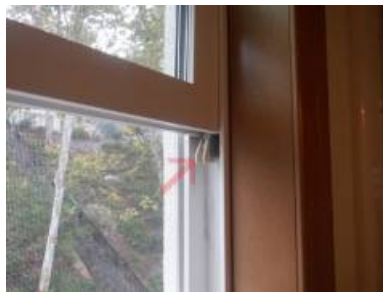
- 12.51 Walls:** Satisfactory - The walls in this bathroom are satisfactory.
- 12.52 Windows:** **Attention Needed** - At least one window or associated hardware in this bathroom needs attention. Binding at slides or sliding hardware noted. Adjustment or repair is recommended.

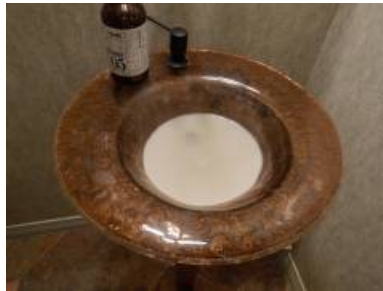
- 12.56 Vanity Cabinet:** Pedestal no vanity.
- 12.57 Basin and Drain Fixture:** **Action Necessary** - The basin or drainage fixture is damaged or deteriorated to the point that action is necessary. The basin does not drain as intended. Standing water within basin noted at time of inspection. Further evaluation by a licensed plumber is needed.

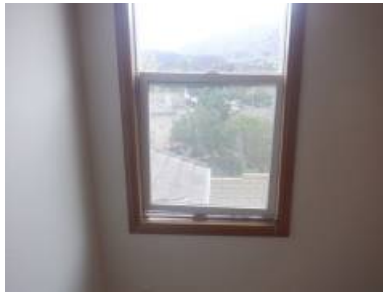
- 13.1 Entry Door:* Satisfactory - The entry door on this room is functional.
- 13.2 Closet:* Satisfactory - The closet is functional and of average size. The closet is lighted.
- 13.3 Walls:* Satisfactory - The walls in the room appear to be satisfactory.
- 13.4 Ceiling:* Satisfactory - The ceiling is functional.
- 13.5 Light Fixture:* Satisfactory - Light is in working order.
- 13.6 Ceiling Fan:* Satisfactory - There is a ceiling fan installed in this room. It appears to be functional.
- 13.7 Floor:* Satisfactory - The floors are in satisfactory condition. The floor covering material is Bamboo.
- 13.8 Windows:* **Action Necessary** - At least one window or associated hardware in this room needs repair. The spring or slide that holds the window in the up position is nonfunctional. It needs to be replaced.

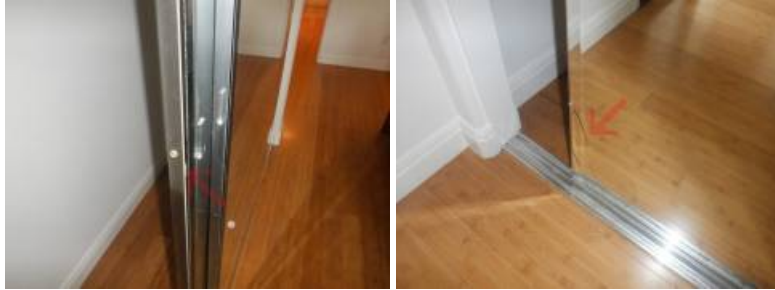
- 13.19 Entry Door:* Satisfactory - The entry door on this room is functional.
- 13.20 Closet:* **Action Necessary** - Some portion of the closet door or interior fixtures needs repair or replacement. It is not functional as is. Glass & Frame separation and Cracked glass at mirrored closet door. Repair or replacement is indicated. Safety Concern.

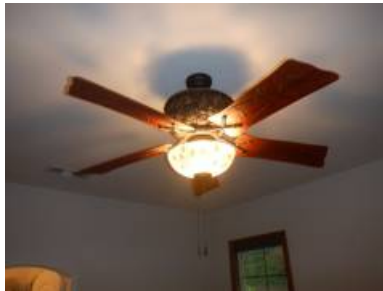
13.24 Ceiling Fan:

**Action Necessary** - The ceiling fan installed in this room did not function using normal controls. Further evaluation is recommended.

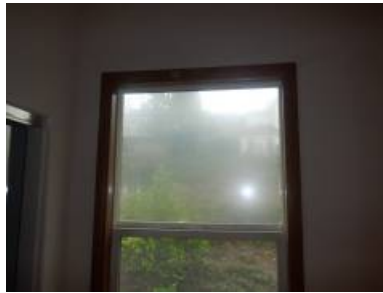
**Action Necessary** - At least one window or associated hardware in this room needs repair. The thermal seal is broken. Although it is keeping the elements out, it has a clouded appearance. This condition will worsen.

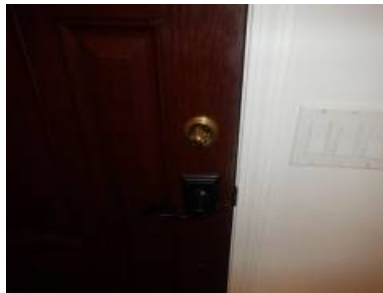
14.2 Front Entry Door:

**Action Necessary** - The main entry door or its associated hardware needs repair or replacement. Deadbolt locking hardware needs some attention. Locking hardware does not disengage as intended. Repair or replacement is recommended. Fire Egress Concern.

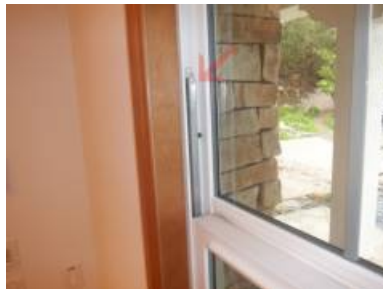
14.14 Windows:

**Action Necessary** - At least one window or associated hardware in this room needs repair. The spring or slide that holds the window in the up position is nonfunctional. It needs to be replaced.

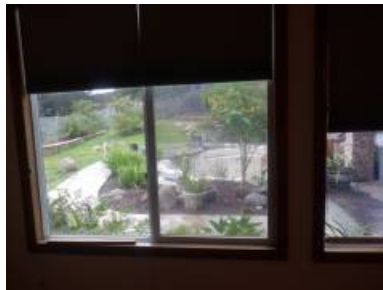
*14.26 Windows:*

**Attention Needed** - At least one window or associated hardware in this room needs attention. Imperfections in window noted. There appears to be a film/tint installed on window. Further evaluation is recommended.

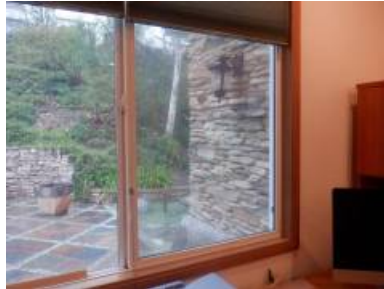
attention. Imperfections in window noted. There appears to be a film/tint installed on window. Further evaluation is recommended.

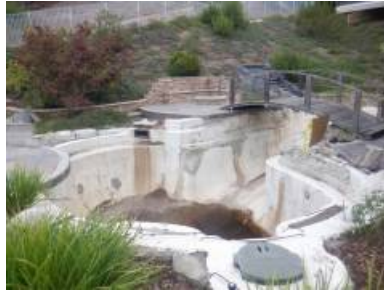
15.1

**Attention Needed** - The pool was not inspected; However, per Senate Bill 442, inspectors are required to report on pool fencing and alarms. No enclosure or alarms were present at time of inspection. Pool Safety Concern.  
No other comments are made in regards to the pool/spa area.
