**BPG Inspection, LLC**

Client(s): Camberos  
Inspection Date: 4/22/2026  
Inspector: Mark Kirkland ,

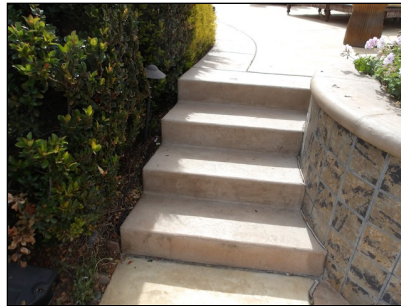
- ❌ 2. A proper handrail is needed on the exterior steps on the rear of the building near the pool. No rail is installed.
- Handrailings should be installed, to reduce the potential for personal injury at this location.

The steps are narrow and not standard width. This can cause possible injury. A licensed contractor and/or specialist should repair the steps to meet current standards.

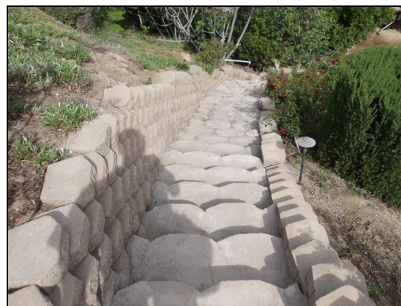
- ❌ 3. A proper handrail is needed on the exterior steps on the rear of the building. No rail is installed.
- Handrailings should be installed, to reduce the potential for personal injury at this location.

The steps are uneven in rise and run. The current industry standards require the maximum riser height of 7 3/4 inches with a maximum variation between steps of 3/8 an inch. An excessive variation could pose a trip hazard. We recommend upgrading your steps to current industry standards and having a qualified technician perform repairs as needed.

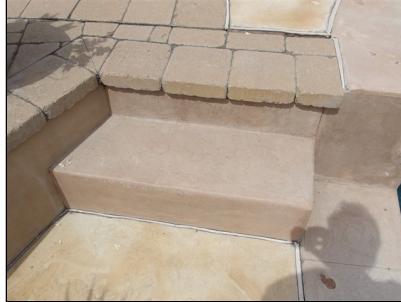
- ✘ 4. The steps are uneven in rise and run. The current industry standards require the maximum riser height of 7 3/4 inches with a maximum variation between steps of 3/8 an inch. An excessive variation could pose a trip hazard. We recommend upgrading your steps to current industry standards and having a qualified technician perform repairs as needed.

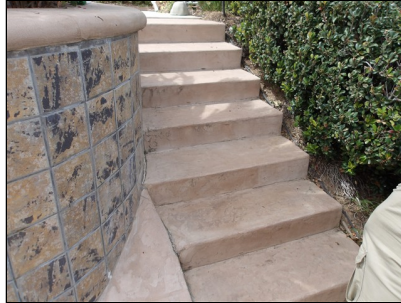
Pool area

- ✘ 5. A proper handrail is needed on the exterior steps at the pool area. No rail is installed.  
- Handrailings should be installed, to reduce the potential for personal injury at this location.

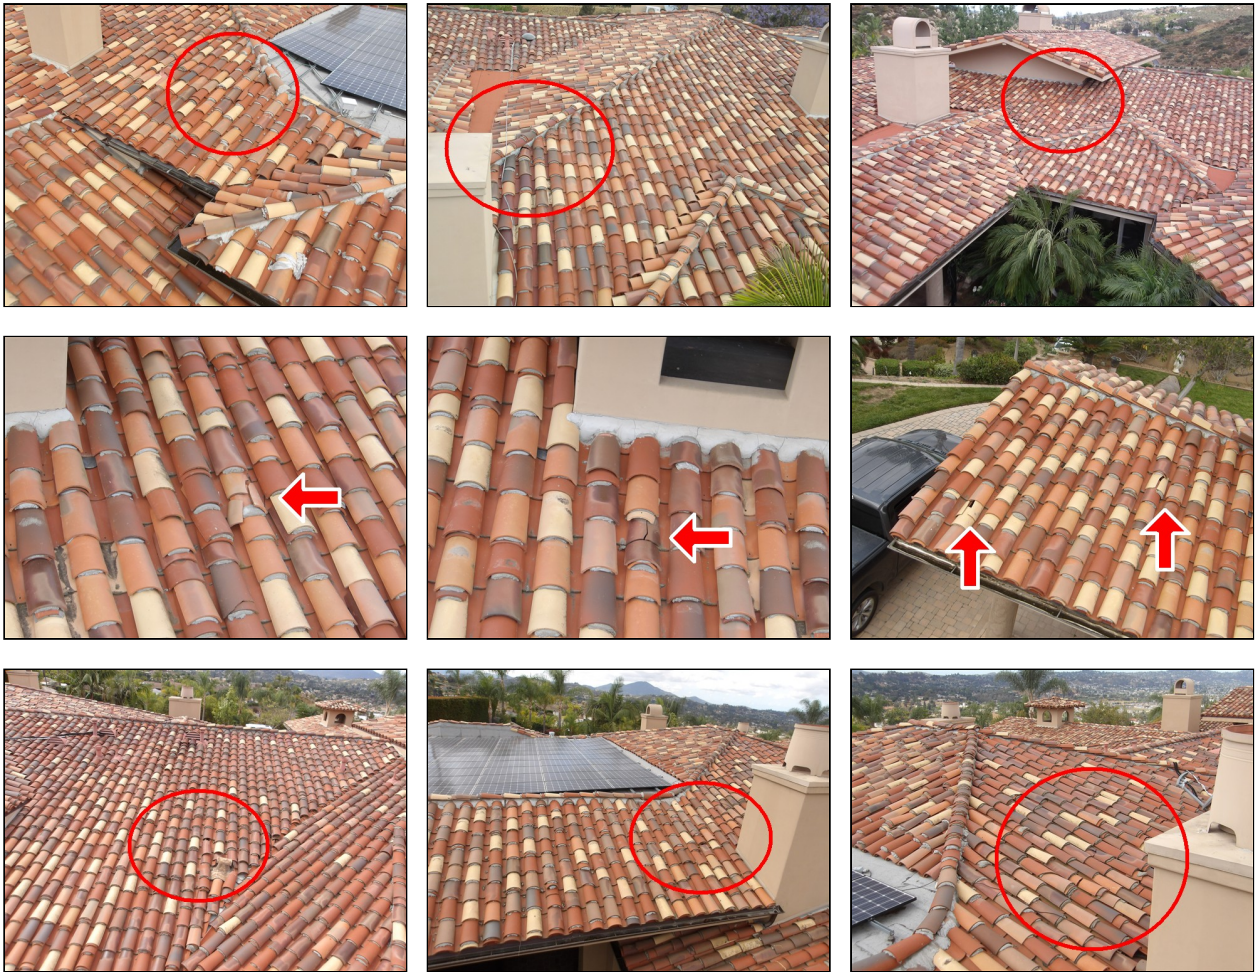
- ✘ 6. Roof tiles were noted to be cracked, damaged, or displaced. Further evaluation and repairs/replacement is needed. Since inspectors do not walk on concrete/clay/composite roof tiles, there could be additional tile defects. Have the roofing technician who corrects this/these reported conditions, check the rest of the roof.

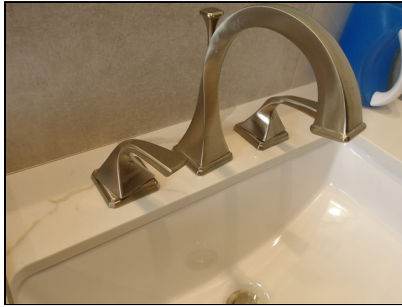
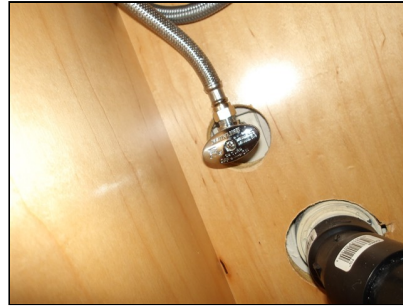
8. The water is off to the sink in the right side middle bedroom bathroom. We are unsure of why the water is off. Inspectors do not turn on valves that are shut off. Have a plumber evaluate the reason the water is off and perform necessary repairs.

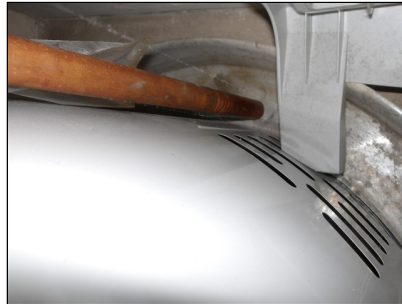
- ❌ 9. The discharge pipe for the temperature & pressure relief valve on the water heater does not terminate outside the foundation, currently into water pan in laundry room water heater. A qualified technician should make any needed repairs or corrections.

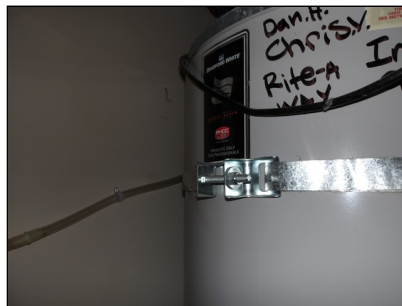
- ❌ 10. The water heater's capacity is greater than 52 gallons and there are only two seismic straps installed in laundry room. The straps are loose and also allow movement. The California Office of the State Architect has published standards with which all water heater installations in the state must comply when buildings are sold or transferred. These standards require adequate restraint provided by an approved metal strapping, located one third down from the top and another approximately 4" above the control valve. If the heater is larger than 52 gallons, then approved strapping rated for a larger tank or additional strapping or engineered strapping may be required. A third strap is recommend at times to comply with the California Office of the State Architect standards for seismic strapping of water heaters.

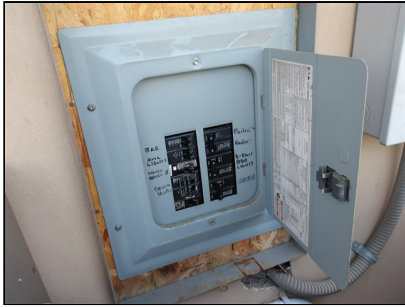
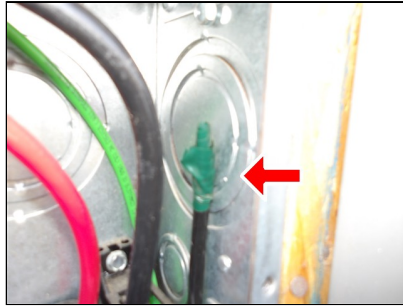
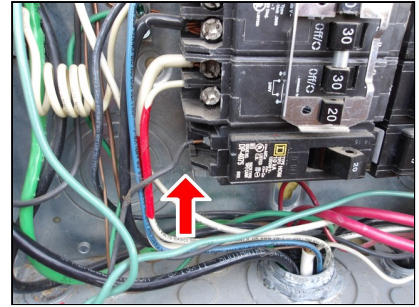
- ❌ 11. The problem(s) discovered in the exterior cabana sub panel such as uncapped abandoned wires, 20 amp breaker on size 14 wire, and any other problems that an electrician may discover while performing repairs need correcting. We recommend a licensed electrician inspect further and correct as needed.

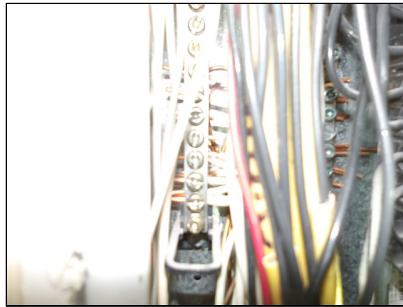
- ✖ 12. The problem(s) discovered in the master bedroom sub panel such as double lugged neutral wires at buss, frayed wires, knock out missing, and any other problems that an electrician may discover while performing repairs need correcting. We recommend a licensed electrician inspect further and correct as needed.

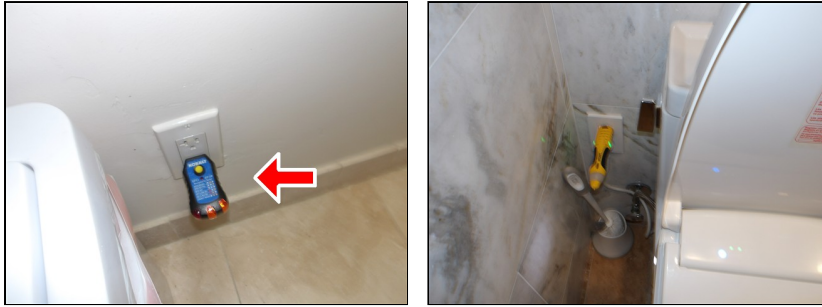
- ✖ 14. No GFCI (ground fault circuit interrupter) protection is present at all locations per current industry standards. Several in garage, cabana lower wall near bath sink, half bath near toilet. This may not have been required at the time of construction but current industry standards requires GFCI protection in all bathrooms, garages, exteriors, laundry rooms, basements and kitchens. **As a safety upgrade, consider installing GFCI protection at all recommended locations.**

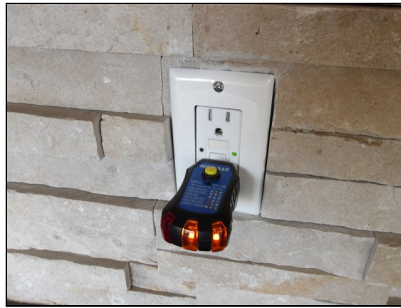
- ❌ 15. When tested, the GFCI outlet at the exterior cabana did not function properly. It failed to trip. This is an indication of a defective or improperly-wired GFCI. A qualified electrician should make repairs or modifications as necessary.

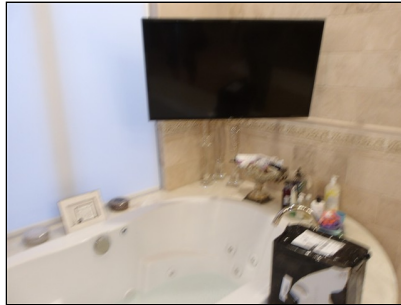
- ❌ 16. There is a TV directly over the bathtub in the master bathroom. We were unable to find the receptacle or prove that the TV is protected by GFCI. If GFCI protection can't be confirmed then a qualified technician should install proper GFCI protection.

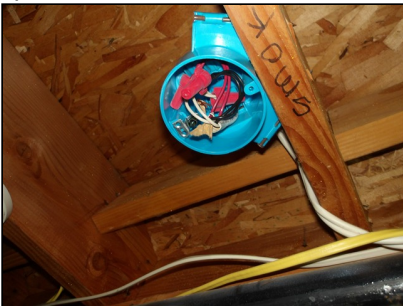
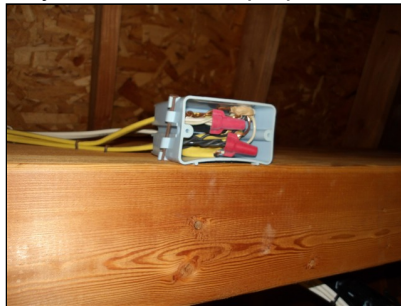
- ❌ 17. There are several open junction boxes at various locations in the attics. Lack of covers can create a shock or fire hazard.
- A qualified technician should check the system and install proper covers on all junction boxes.

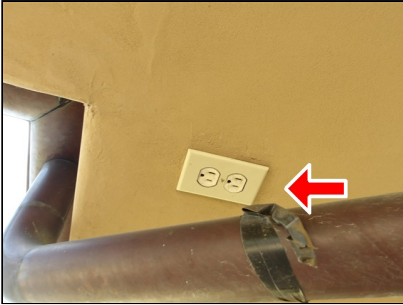
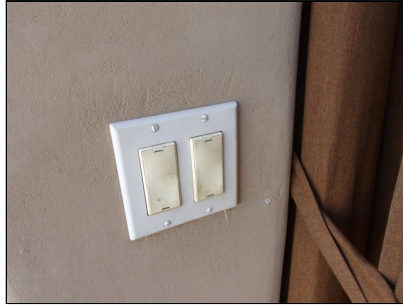
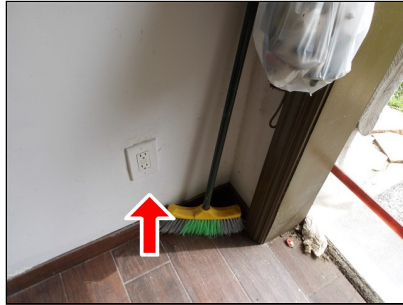
- ❌ 18. Several exterior outlet and switches at the front exterior, left side cabana, prayer house entryway, does not have an exterior rated cover installed. A qualified technician should install exterior rated covers at all exterior locations.

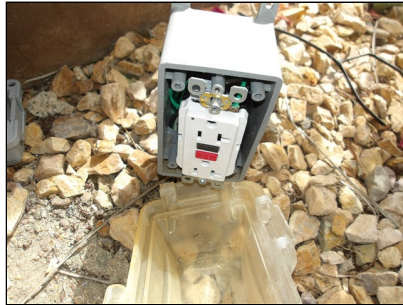
- ❌ 19. The outside outlet cover at the exterior prayer house is damaged and needs repaired or replaced.

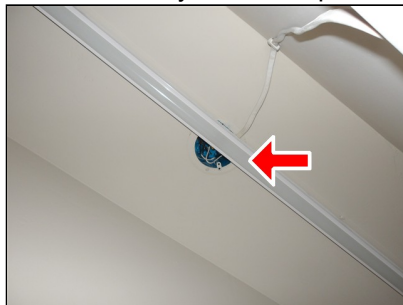
- ❌ 20. The light fixture has an improper junction box for the light at the bedroom closet in middle bedroom. Their are exposed wires. A qualified technician should make any needed repairs.

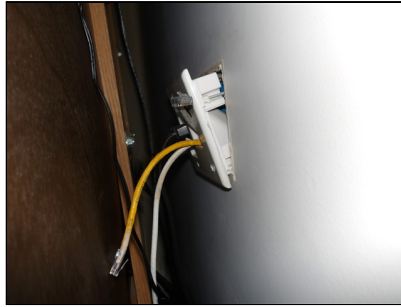
- ❌ 21. One or more receptacles is loose in the wall at master bedroom. A qualified electrician should make any needed repairs.

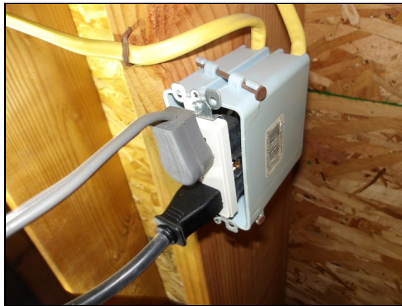
attic

- ❌ 22. One or more cover plates for receptacles and switches are missing or damaged in the building. This can be a shock hazard. All missing or damaged cover plates should be replaced with new cover plates.

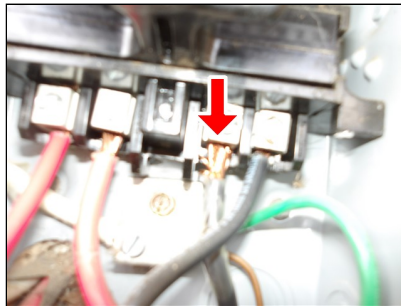
- ❌ 23. Two of the AC electric disconnects has frayed wire connections at the rear exterior of the home. A licensed electrician should perform repairs.

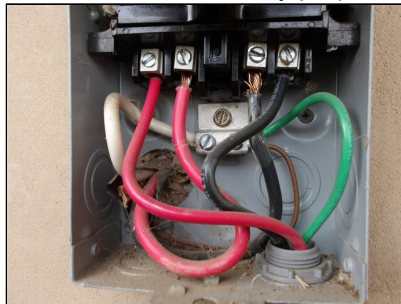
- ❌ 24. The protective "deadfront" cover for the local HVAC disconnect, which helps prevent hazardous shocks, is missing at rear exterior.  
- A properly fitting deadfront cover should be installed for safety purposes.

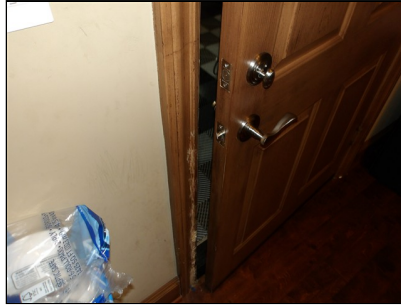
- ❌ 25. The passage door from the garage bedroom to the garage needs the self closer adjusted. Failed to close and latch. A qualified technician should make repairs or modifications as necessary to restore the fire separation.

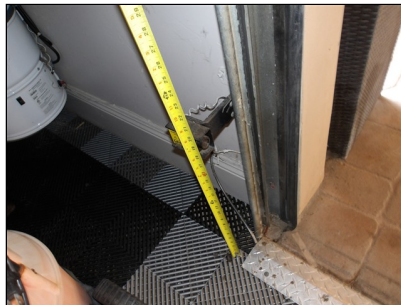
- ❌ 26. The optical sensor or track beam installed on the garage door opener (which activates the reversing eye system) is installed at an incorrect height. This could allow small children or animals to move under the beam without activating the safety feature. This is a safety concern.
- The optical sensor or track beam should be installed six inches above the floor of the garage or in accordance with the manufacturer's specifications.

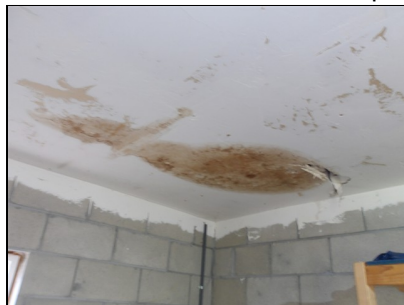
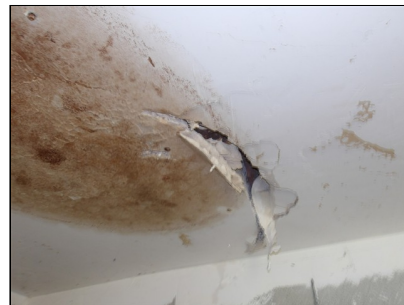
- ❌ 27. Water stain/damage is present in the detached pool equipment storage room ceiling. The source of the leak should be identified and necessary repairs performed before any attempt is made to restore surface appearance. A licensed roofer should evaluate the roof and make repairs.

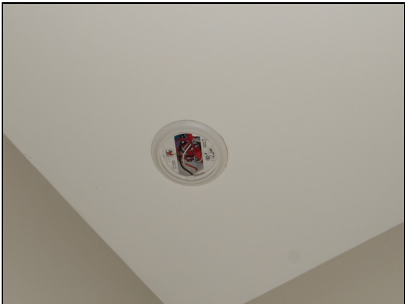
- ❌ 29. The number of smoke detectors is less than would be required by modern standards. Missing in one bedroom right side of home. Most cities want the detectors in each bedroom, hallway leading to the bedrooms and if multi-storied, at the top and bottom of the staircase at each level. Smoke detectors should be installed as needed according to manufacturers recommendations and the local building and state safety requirements.

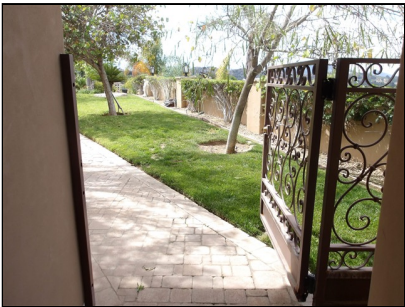
- ✘ 33. **As of January 1, 2018 Pool Safety Act (Senate Bill 442)**, California law requires new or remodeled pools and spas to have 2 of 7 child protective safety barriers. **While existing pools and spas are not required to add additional safety barriers, we suggest when it comes to protecting our young and vulnerable , all pools and spas should have 2 of 7 appropriate safety barriers identified in the Pool Safety Act.** Conformance of several of the items cannot be determined by a visual inspection. We recommend that the current owner or their representative provide any and all documentation to ensure compliance or have a qualified pool contractor further evaluate and perform any needed repairs.

**The exterior fences and gates do not meet current industry standards. The gate stays open, no gate other than car gate on other side of the house and no secondary barrier device. We recommend adding additional safety features to comply with Senate Bill 442.**

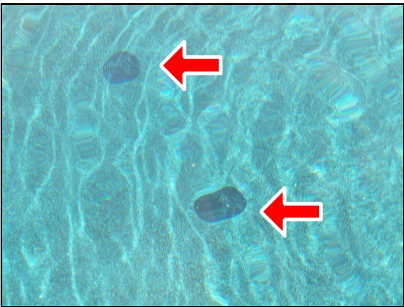
We recommend upgrading these components to meet present industry standards. The present industry standard is to have two drains at the pool and two at the spa with proper drain covers manufactured after December 19, 2008. In Addition, every suction drain on a pool mush have a split (dual) drain or be equiped with a safety vacuum release system or an automatic pump shut off system. The existing drain cover/s do not appear to meet industry standards and we were unable to identify the required safety devices. We recommend further evaluation and repair by a qualified pool contractor.

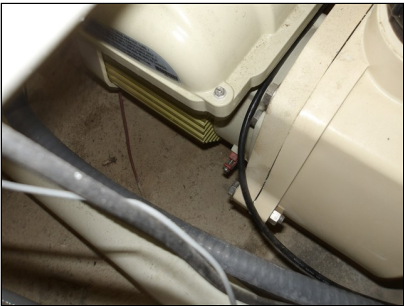
- ❌ 36. Two pool pumps lacks proper bonding to ground. Equipment that is not bonded can be a shock hazard. A qualified licensed electrician should make any needed modifications.

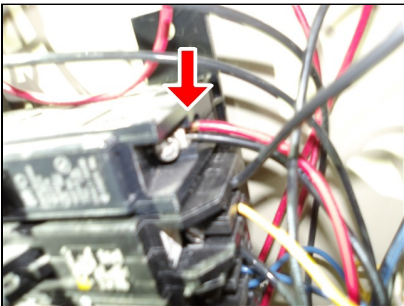
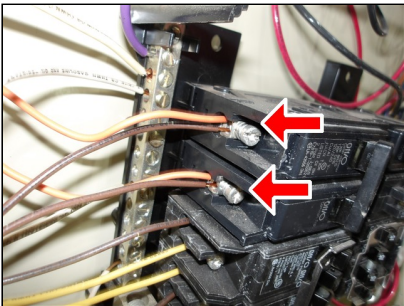
- ❌ 37. The problem(s) discovered in the pool sub panel such as double wired circuits, and any other problems that an electrician may discover while performing repairs need correcting. We recommend a licensed electrician inspect further and correct as needed.

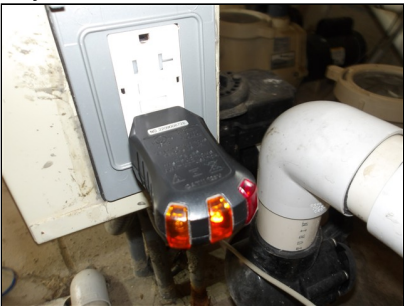
- ❌ 38. When tested, the GFCI outlet at the pool and spa area did not function properly. The receptacle is improperly wired hot and neutral reverse. This is an indication of a defective or improperly-wired GFCI. A qualified electrician should make repairs or modifications as necessary.

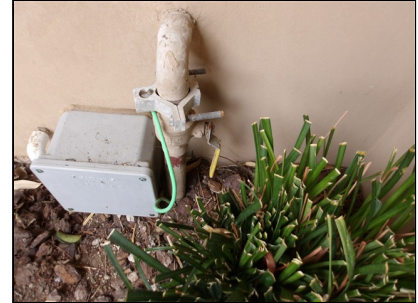
39. In an emergency, the locations of the various shut-offs for the utilities should be readily accessible and well known. We strongly recommend familiarizing yourself and other occupants of this building with their exact locations and their operation. You can find information about their locations under this section or in the Plumbing and Electrical systems. We observed several water disconcert valves at the exterior of the home. We recommend labeling the water shut off valves.

Multiple water shut off valves

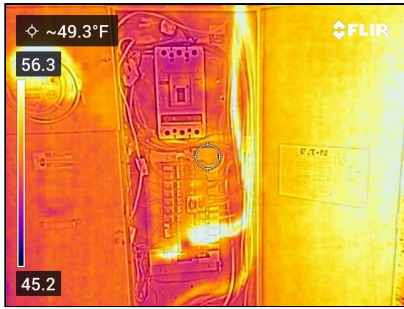
No abnormal heat in electric panels

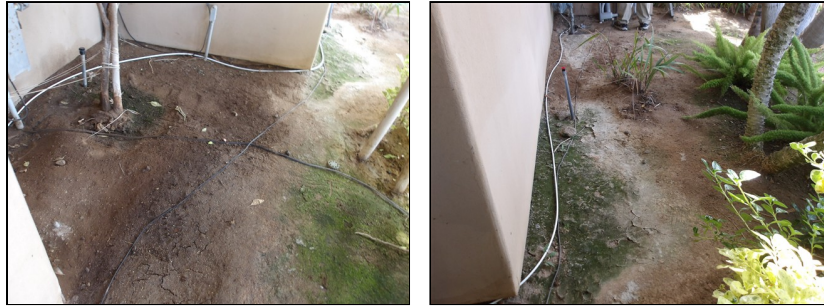
48. No weep holes are present at the base of the retaining wall at the right side of the property. Weep holes are often installed in retaining structures to facilitate drainage and relieve water pressure behind the wall.
- If the need for additional drainage becomes apparent, weep holes should be installed to reduce the pressure on the retaining structure, and extend its effective life.

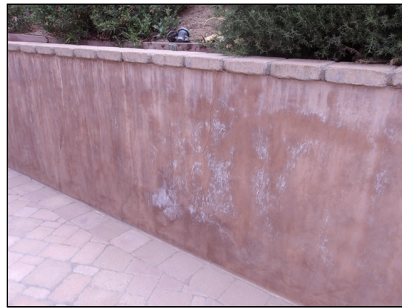
49. A condition known as efflorescence is evident on portions of the retaining walls. This whitish, fuzzy material is a mineral deposit left when moisture in the concrete evaporates. The presence of efflorescence and water marks often indicates an occasional surplus of moisture on the outside of the wall. The efflorescence was minor in the opinion of the inspector. The areas should be monitored for signs of excess moisture and repaired by a licensed technician if needed.

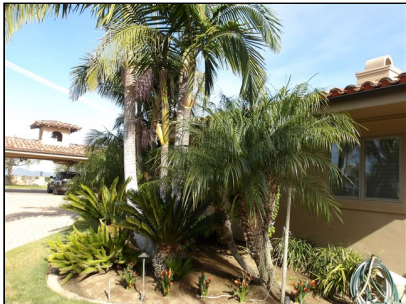
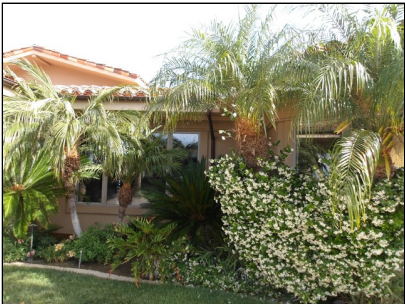
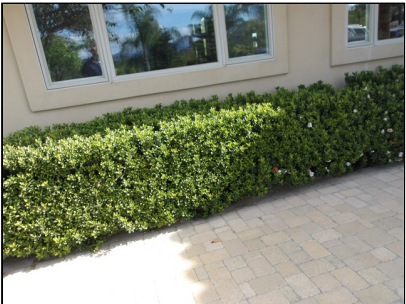
58. Vegetation on the property should be maintained to prevent overgrowth and encroachment onto and possible damage to the structure.

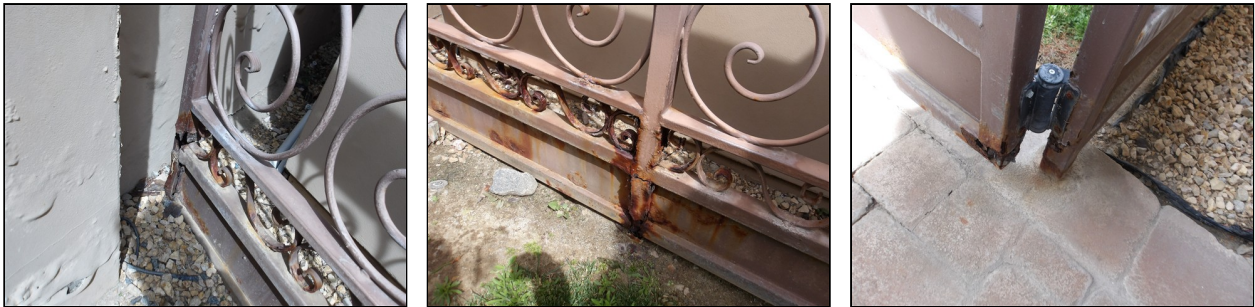
60. The metal fencing has heavy corrosion, damaged and deteriorated. - Damaged fence elements should be repaired if possible, or replaced as necessary.

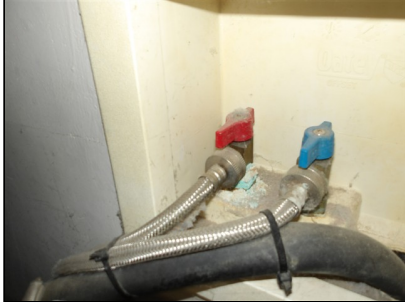
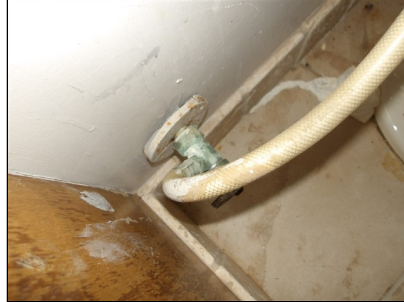
68. There is surface corrosion in the visible supply and/or waste piping at several valves, fixture and drains in the home. We observed no signs of active leaks at the time of the inspection but leaks can develop anytime without

warning. All valves and fixtures should be evaluated during your final walk through and before close of escrow to verify that no new leaks have developed.

- This piping should be evaluated for leaks on a regular basis and repaired by a qualified technician when necessary.

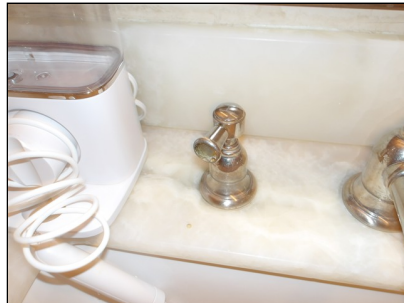
69. One hot water faucet handle in master bathroom is missing. A qualified technician should repair or replace the handle.

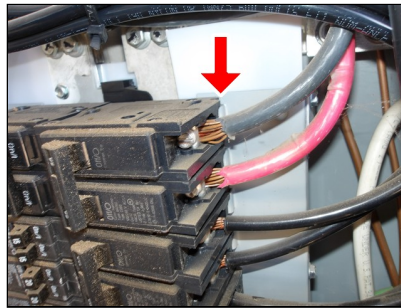
77. The main electric panel at the front exterior have one or more wires with excessive sheathing removed. A licensed contractor and/or specialist should repair the wires.

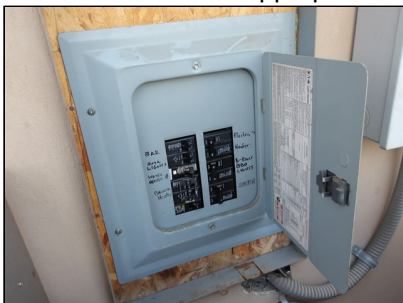
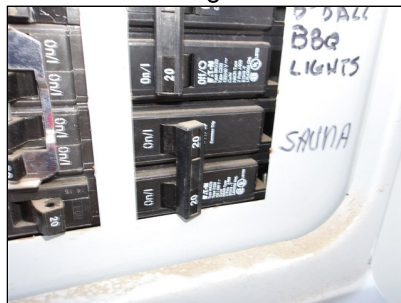
78. One or more breakers in the exterior cabana sub panel are in the off position at the time of this inspection. We did not activate the breakers, or energize the circuits because doing so could create a hazard.
- The owner may have information as to why the breakers are in the OFF position. If it is not functional, a licensed electrician should make appropriate repairs before closing escrow.

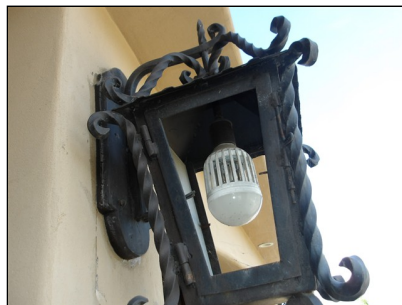
82. Several light fixtures are loose and/or not sealed at the exterior walls. A qualified licensed electrician should make any needed corrections.
83. Several exterior lights are damaged and/or have corrosion. A licensed contractor and/or specialist should repair or replace all damaged lights.

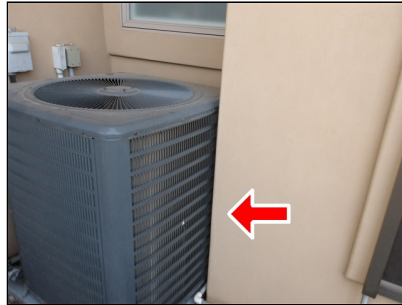
86. The compressor is too close to the structure to allow proper ventilation around the cooling coils. A qualified HVAC contractor should make any needed repairs or modifications.

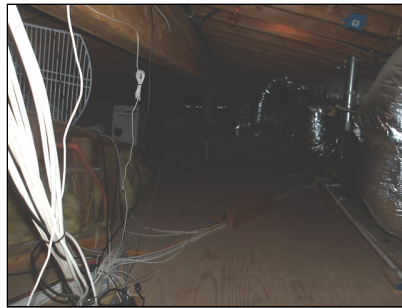
87. We could not access one or more attic areas due to one or all of: no access, low headroom, vaulted ceilings, insulation concealing the rafters, duct work, temperature, unsafe conditions, storage, etc. Further evaluation is advised if the client has concerns about these areas.

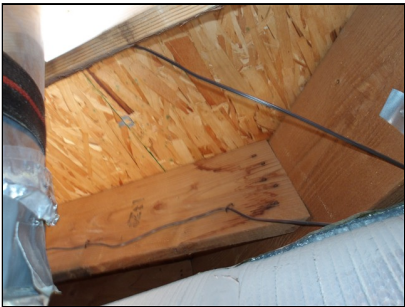
master bedroom attic

88. Water stains are evident on the roof sheathing. However, we could not confirm an active leak.
- The source should be identified and necessary repairs performed.

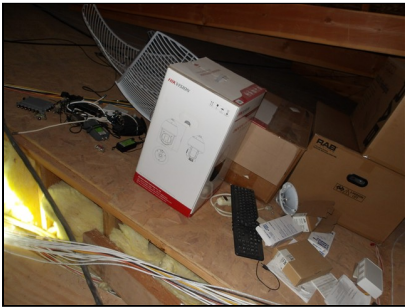
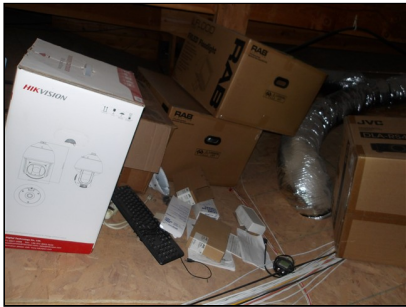
89. Inspecting for the presence or absence of rodents or other wildlife in the property is outside the scope of a home inspection. While we did not observe any outward signs of an infestation today, such as feces, trails or traps, a home inspection cannot provide any guarantee that any property will remain free from an infestation in the future. We encourage you to inquire with the seller for any history of wildlife intrusions at the property and you may also wish to contact your pest control providers to see if they offer services that help prevent wildlife intrusions.
90. This attic space has abandoned items that should be removed. A technician can do the work.

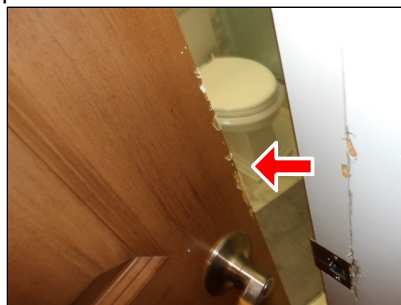
100. The interior door to the bathroom in the far right rear bathroom is damaged in several areas. The door is still functional but should be repaired by a qualified technician.

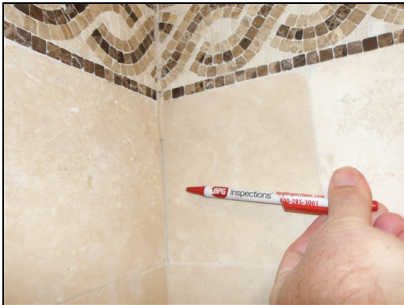
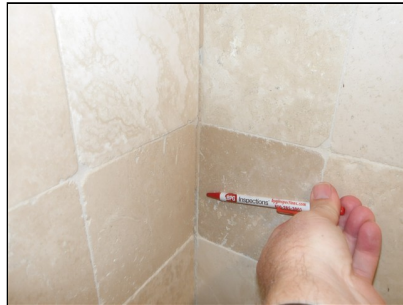
107. The grout is cracked, deteriorated and/or missing in several areas at the cabana, garage, far right side bathroom. Damaged or missing grout can cause leaks and moisture damage. A licensed contractor and/or specialist should perform repairs.

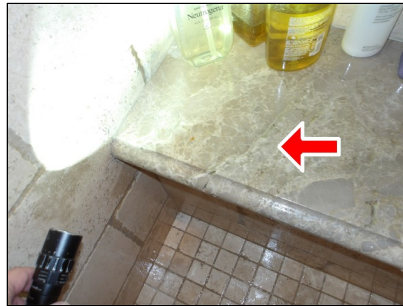
109. Deterioration and a possible crack was noted on the shelf in the master bathroom shower. A qualified technician should repair the damaged areas.

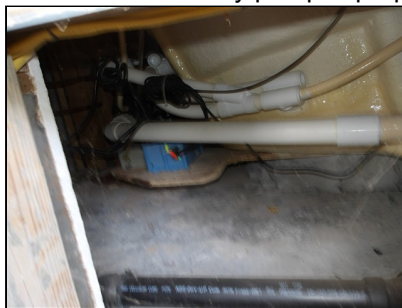
111. There is an access panel for the jet tub at the rear exterior of the home. There is limited access inside the panel to inspect the jet tub and its components. We were unable to verify if the jet tub is properly bonded. We saw no GFCI for the jet tub. We recommend having the seller identify the GFCI location for the jet tub. A licensed contractor and/or specialist should gain access and verify pump is properly bonded and perform additional repairs as needed.

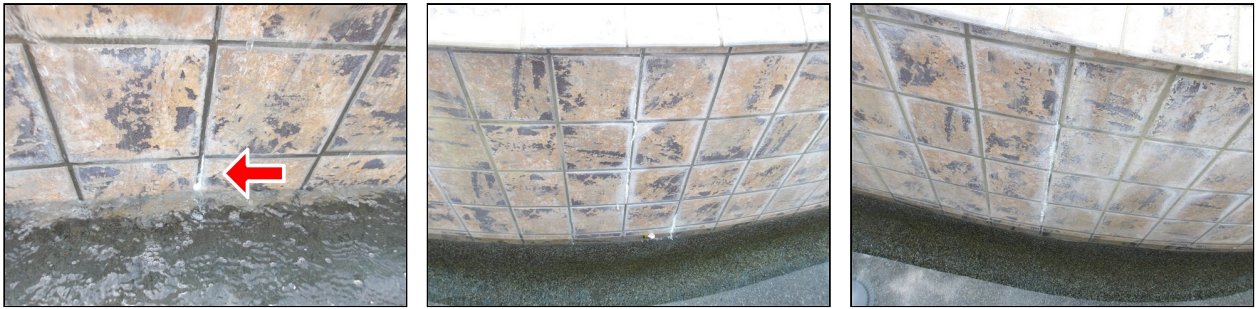
116. Calcium build up/spots was noted at the spa and/or pool surface. Have the pool water tested ( take a water bottle sample to a pool supply store for free testing ) and follow the pool technician's recommendations for correction/ removal and prevention of surface calcium, if calcium is present.
