# INSPECTION REPORT

**75720 MCLACHLIN CIR**

**PALM DESERT, CA 92211**

Inspection Date: **Friday, May 8, 2026**

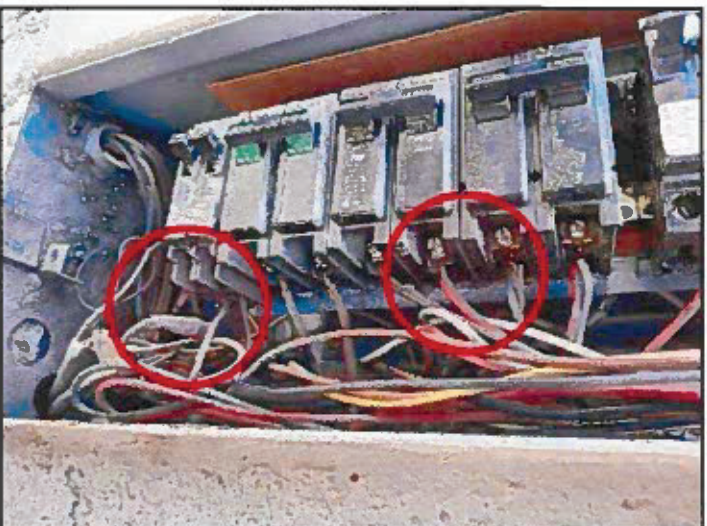
##### **Condition:** • Double taps

There is three breakers that have more than one line going into the breaker this is called double taps , two lines to one breaker can cause over heating , recommend a electrician to repair.

**Implication(s):** Fire hazard

3 double taps

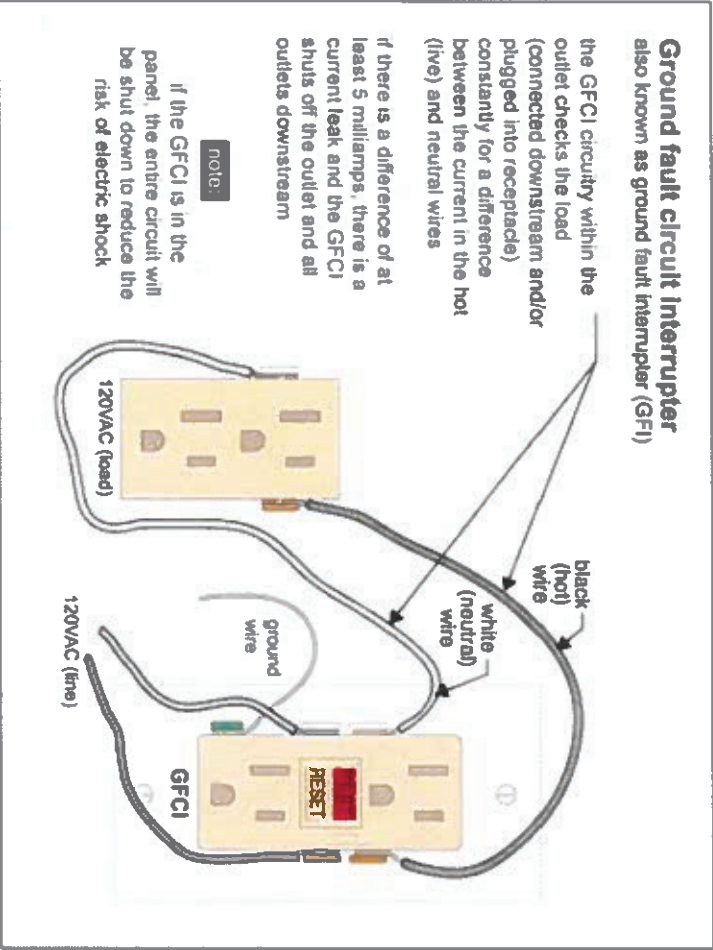
##### **Condition:** • GFCI/GFI needed (Ground Fault Circuit Interrupter)

Recommend GFCI's in the garage and exterior area . Recommend a electrician to improve.

Missing GFCI exterior plugs

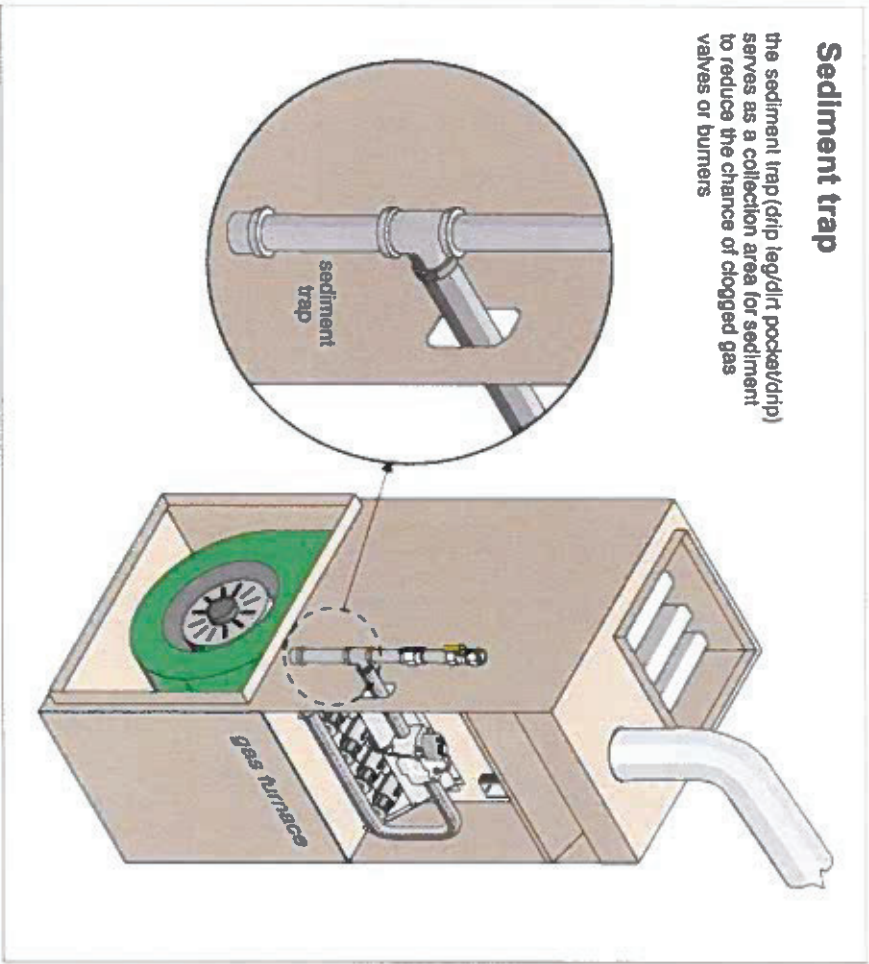
**Sediment trap**

##### **Condition:** • No drip leg (sediment trap, dirt pocket)

The heater and hot water tank are missing a drip leg , this is to stop any particles from reaching the burner area. Recommend a plumber to repair.

the sediment trap (drip leg/drip pocket/drip) serves as a collection area for sediment to reduce the chance of clogged gas valves or burners

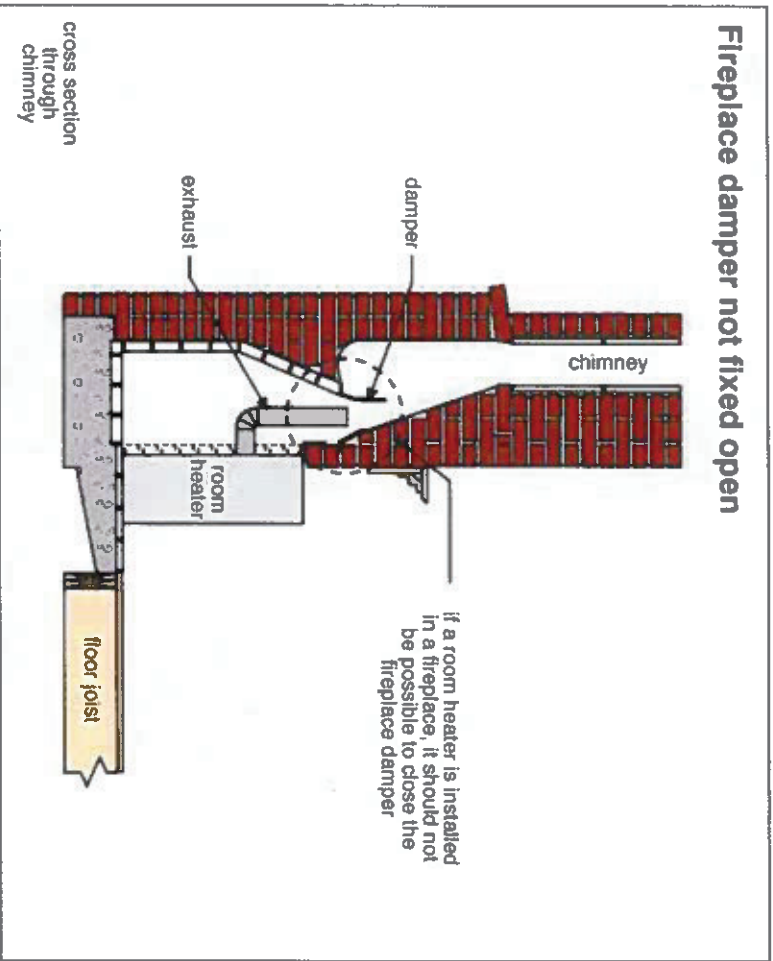
##### **Condition:** • Damper in existing fireplace not fixed open

The Damper clamp is to stop the ability for someone lighting a fire and forgetting to open the damper. If damper is left closed gases could enter the house , recommend a handyman to repair.

**Implication(s):** Hazardous combustion products entering home

Missing damper clamp

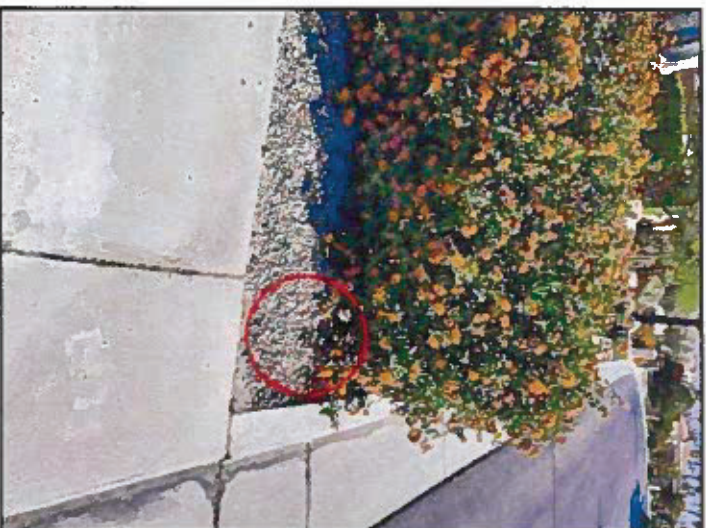
Unknown main meter shut off

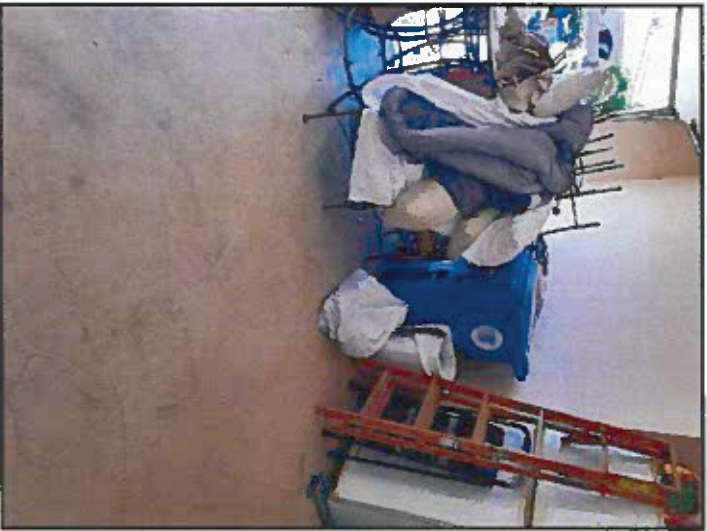
Recommend doing a walk through the house and garage when it is empty, unable to see a lot of the walls and floors due to furniture. also the cabinets .

Clutter in garage area

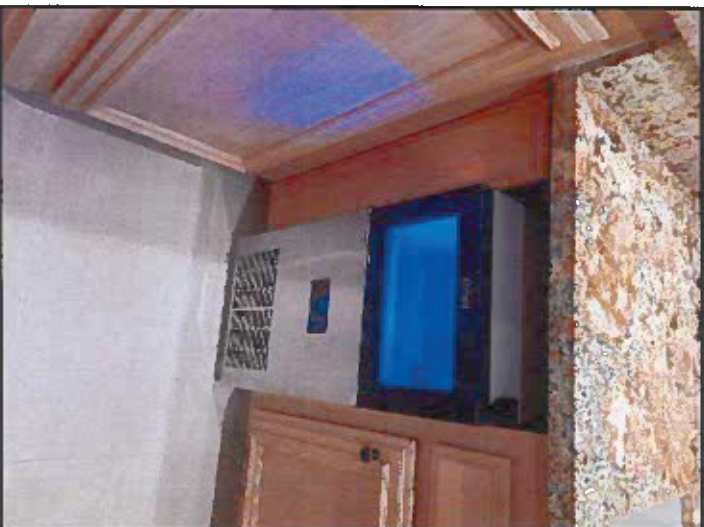
*Confirm ice maker works*

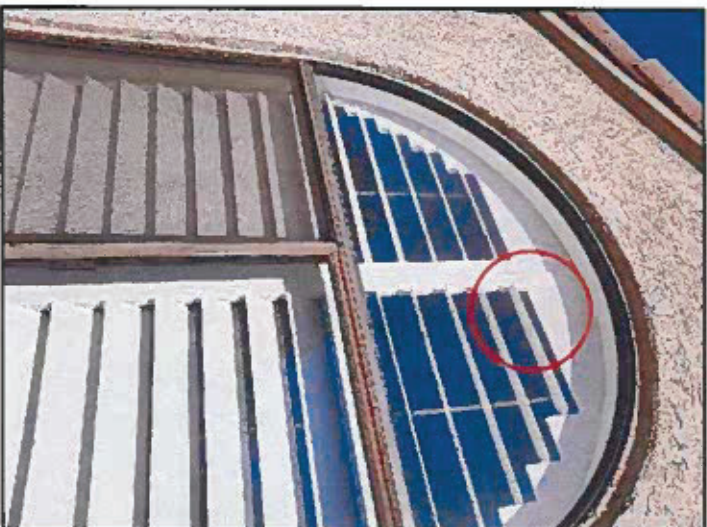
**Condition:** • **Lost seal on double or triple glazing**

There was 1 window that has the seal in the middle lost or broken, recommend a window company to evaluate and repair what windows are needing repair. This is the front of the house.

*Lost seal on window front area*
