## SUMMARY

332 Bandini Pl, Vista, CA 92083

Martin Keith  
08/28/2026

Mark Taibo  
A Better Home Inspection By Forsters,  
Inc.  
(800) 720-2844  
[Info@ForsterHomeInspections.com](mailto:Info@ForsterHomeInspections.com)

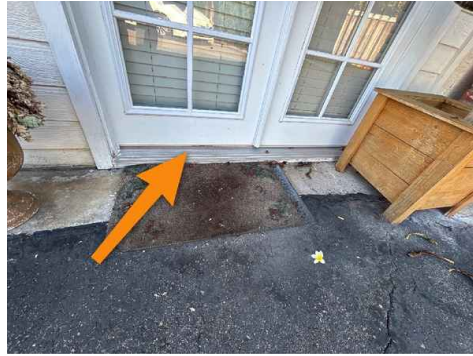
Front of Property

Weather-stripping was found to be damaged, degraded, or missing in one or more areas at the time of inspection. Proper weather-stripping is essential for:

We recommend correcting or replacing the weather-stripping as needed to restore its effectiveness and ensure the comfort and protection of the home.

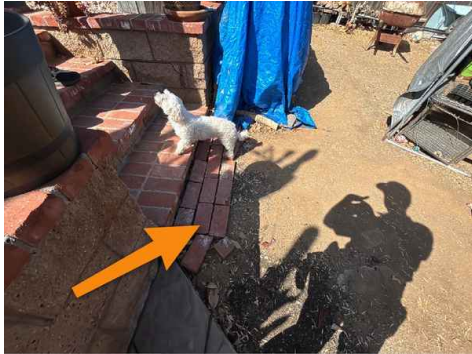
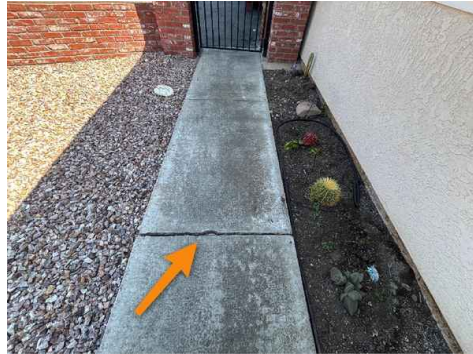
The driveway and/or walkway(s) exhibit damage, including loose or missing material, in one or more areas around the property. This condition can lead to:

We recommend that a licensed professional conduct a further evaluation to assess the extent of the damage and recommend appropriate repairs to ensure safety and restore the integrity of the surfaces.

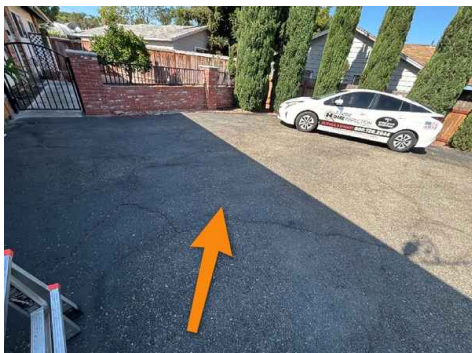
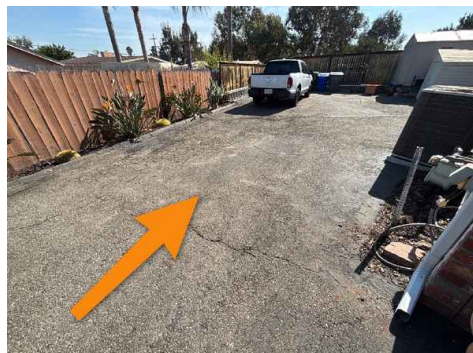
The driveway and walkway areas display visible signs of cracking, heaving, or displacement. These conditions may be attributed to factors such as:

- Poor soil compaction: Insufficiently compacted soil can lead to uneven settling and surface damage.
- Expansive soils: Soil that expands and contracts with moisture levels can cause significant surface movement.
- Tree roots: The growth of nearby tree roots can exert pressure on the surfaces, leading to displacement.

We recommend seeking further evaluation and correction from a licensed professional to address these issues and prevent further damage.

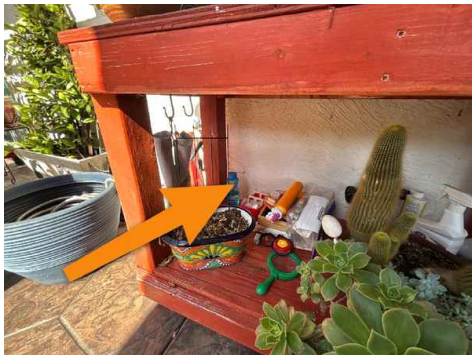
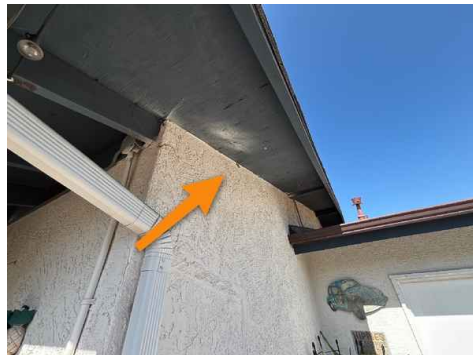
Noticeable chips and damage have been identified on the siding at various locations around the home. These imperfections may lead to further deterioration or moisture intrusion if not addressed.

- Detailed evaluation by a licensed stucco professional: A thorough inspection should be conducted to assess the extent of the damage.
- Repairs or corrections as necessary: Based on the evaluation, the damaged areas should be repaired to prevent further issues and maintain the integrity of the siding.

Contact a stucco repair contractor

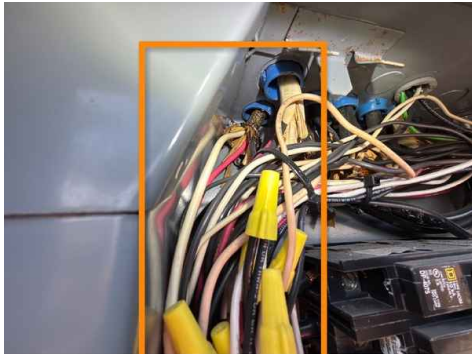
Main Panel

- Fire hazard: Cloth wiring is more prone to deterioration over time, increasing the risk of overheating and electrical fires.
- Non-compliance: Older wiring may not meet modern safety standards, potentially compromising the safety of the electrical system.

Recommend further evaluation and correction by a licensed electrician to assess the extent of cloth wiring, verify the condition of the electrical system, and make necessary updates to improve safety and compliance with current standards.

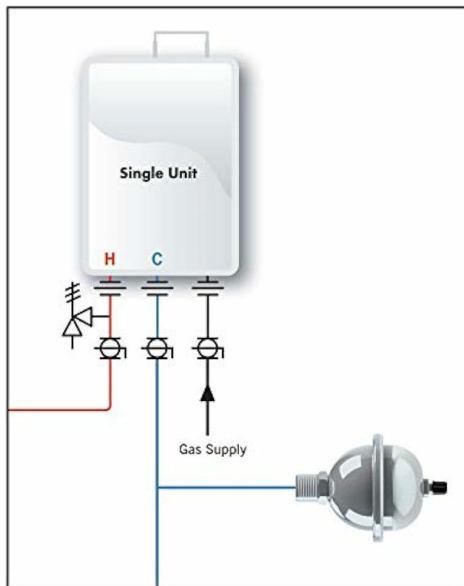
Tankless Water Heater

- Increased pressure: Without an expansion tank, the pressure from expanding heated water may stress plumbing components, leading to leaks or even pipe bursts.
- Damage to fixtures: Excessive pressure can wear down or damage plumbing fixtures and water heaters over time.

Recommend further evaluation and correction as needed by a licensed professional to install an expansion tank and ensure safe operation of the plumbing system.

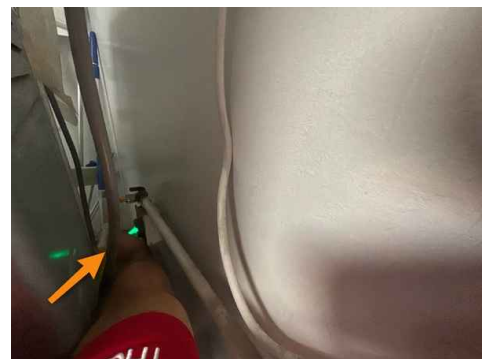
Laundry Room

No power was detected at the 220-volt dryer outlet during the inspection, indicating a potential electrical issue. This condition can lead to:

Recommend further evaluation and correction as needed by a licensed electrician to restore power and ensure the outlet is functioning safely and properly.

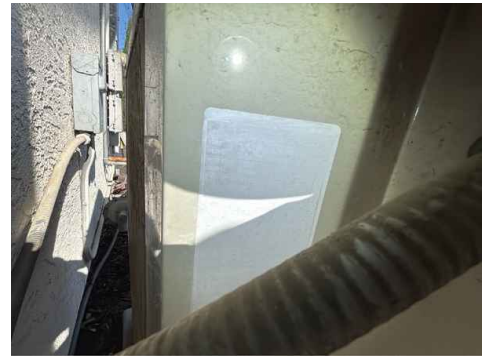
MFD 2005

- System age, condition, and maintenance history can significantly impact performance, energy efficiency, and potential repair or replacement costs.

Recommend obtaining all available service records from the seller and having a licensed HVAC contractor re-evaluate the entire system to assess its current condition, estimate remaining life expectancy, and identify any needed repairs or upgrades prior to contingency removal.

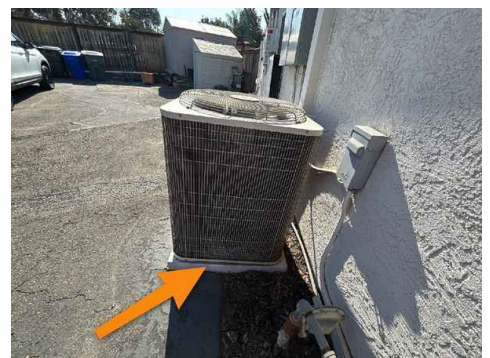
The AC condenser unit is not secured to the ground or base, which is required by California standards to reduce the risk of movement or damage. This condition can lead to:

- Potential shifting or tipping of the unit during seismic activity or strong vibrations.
- Damage to refrigerant lines, electrical connections, or the unit itself.

Recommend further evaluation and correction as needed by a licensed HVAC contractor to properly secure the condenser unit in accordance with California seismic safety requirements.

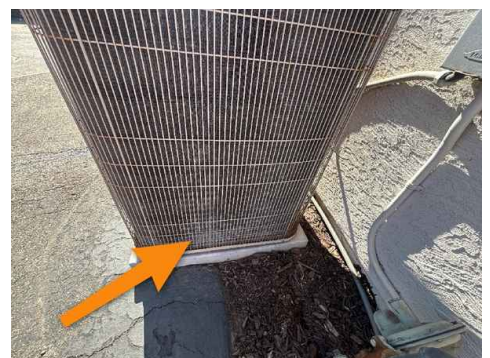
Damage was observed to the cooling fins on the AC condenser unit. These fins are critical for releasing heat from the system and maintaining efficient operation. This condition can lead to:

- Reduced cooling efficiency and increased energy consumption.
- Potential overheating and strain on the HVAC system, leading to premature failure.

Recommend further evaluation and correction as needed by a licensed HVAC contractor to assess the extent of the damage and perform any necessary repairs to restore proper function.

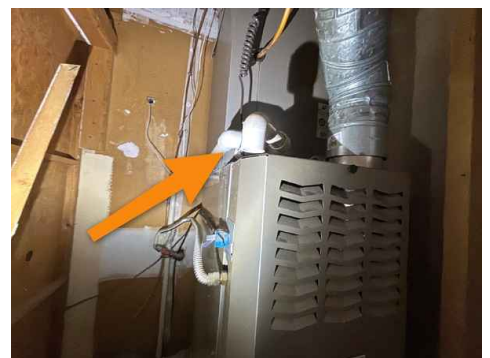
Heater Closet

A disconnected or missing condensation drain line was observed on the HVAC system. This piping is essential for directing condensate safely away from the unit and the interior of the building. This condition can lead to:

- Water damage to surrounding materials, including walls, ceilings, or flooring.

Recommend further evaluation and correction as needed by a licensed HVAC contractor to properly secure and route the condensation line to the exterior of the building in accordance with current code requirements.

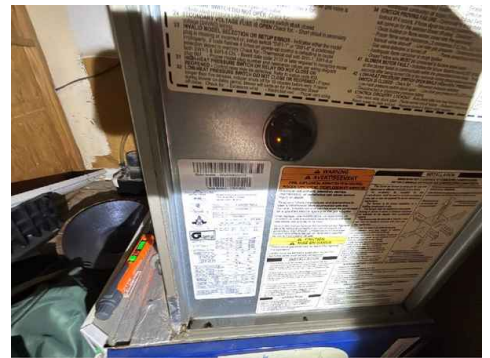
MFD 2006

- Age alone does not determine condition, but older systems may be less efficient and closer to the end of their service life.

Recommend obtaining all available service and maintenance records from the seller and having a licensed HVAC contractor re-evaluate the entire system to assess its current condition, estimate remaining life expectancy, and identify any potential repair or replacement costs prior to contingency removal.

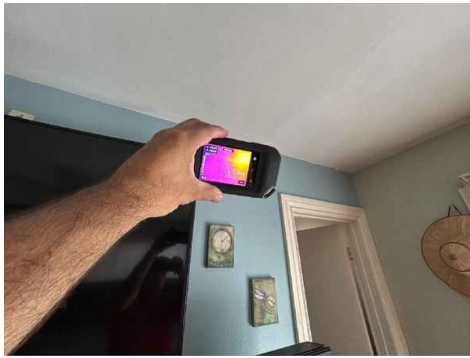
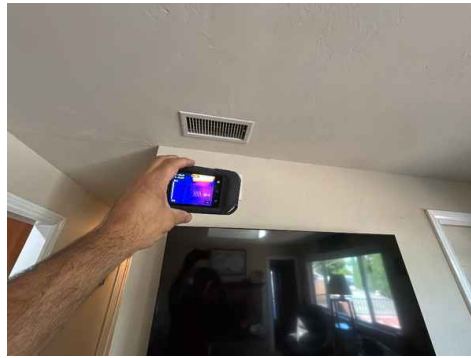
The differential split—the temperature difference between return and supply air—was measured outside the expected performance range at the time of inspection. For most systems, a typical differential is approximately 14–20°F under normal operating conditions, though this can vary depending on system type and ambient temperatures. This condition can lead to:

- Reduced system efficiency, which may affect comfort levels and increase energy costs.
- Potential underlying issues such as restricted airflow, improper refrigerant charge, or component malfunction.

Recommend further evaluation and correction as needed by a licensed HVAC professional to determine the cause of the irregular temperature split and confirm proper system operation.

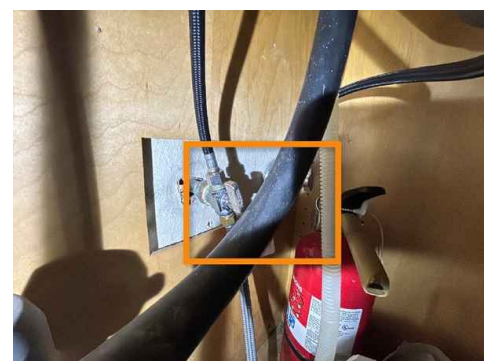
Kitchen Sink

Corrosion was observed on the one or more sink water shutoff valve(s), which may compromise their functionality. This condition can lead to:

- Potential leaks, which could cause water damage to cabinets, flooring, or surrounding areas.
- Difficulty operating the valve, potentially hindering water shutoff in an emergency or during maintenance.

Recommend further evaluation and correction as needed by a licensed plumber to ensure the shutoff valve(s) are functional and to prevent potential leaks or failures.

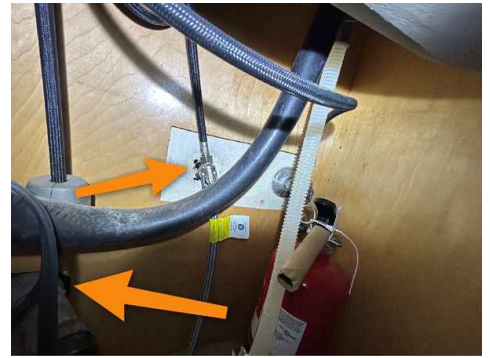
Kitchen Sink

Open plumbing penetrations were observed at the sink plumbing drain lines in one or more areas. This condition can lead to:

- Potential entry points for pests, which can create unsanitary conditions and damage surrounding materials.
- Energy loss or drafts, which can reduce efficiency and comfort within the home.

Recommend sealing the openings as needed.

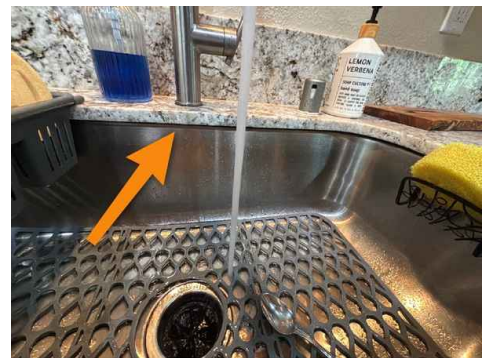
Kitchen

Dark caulking or grout was observed around the sink. This condition can lead to:

- Compromised integrity of the seal, allowing water intrusion and potential damage to surrounding areas.

Recommend removal and replacement of the affected caulking or grout as needed by a qualified professional to restore a clean, functional, and properly sealed surface.

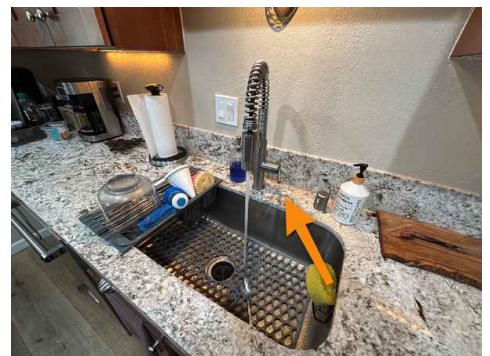
Kitchen

The hot and cold water supplies for the sink faucet are reversed, which does not comply with standard plumbing practices. This condition can lead to:

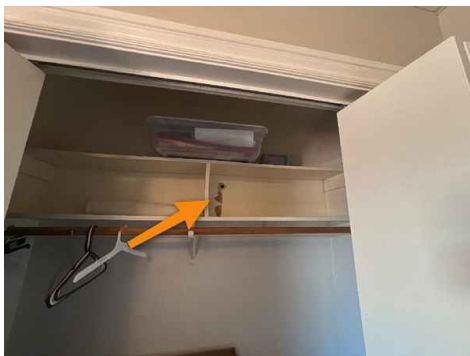
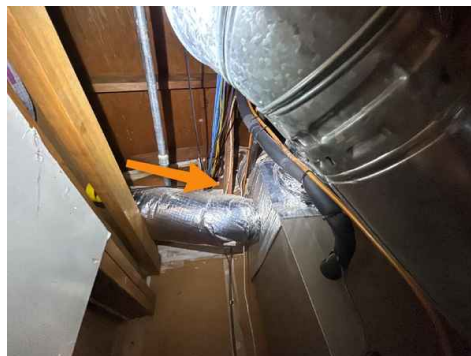
- Potential structural concerns or exposure of wiring, insulation, or plumbing behind the damaged areas.
- Aesthetic issues that may require patching, painting, or refinishing.

Recommend further investigation and correction as needed by a qualified professional to ensure proper repair and restoration of the affected areas.

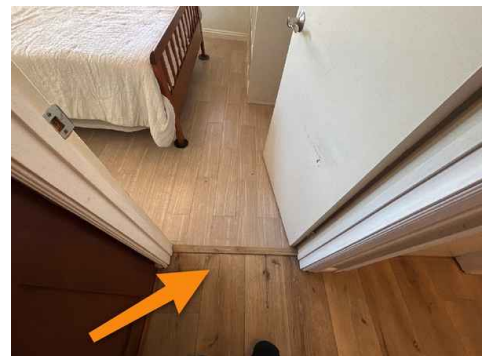
Right Middle Bedroom

- Tripping hazards and potential injury if the threshold shifts or becomes detached.

Recommend re-securing or repairing the threshold as needed by a qualified professional to ensure safety and proper function.

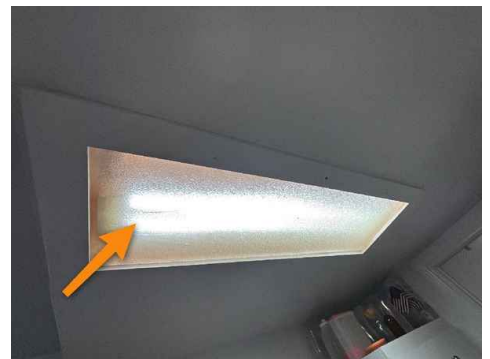
Laundry Room

- Exposure to elements: The absence of a protective lens may lead to deterioration of the bulb and other internal components.

We recommend further evaluation and correction as needed by a licensed professional to restore the fixtures and ensure safe operation.

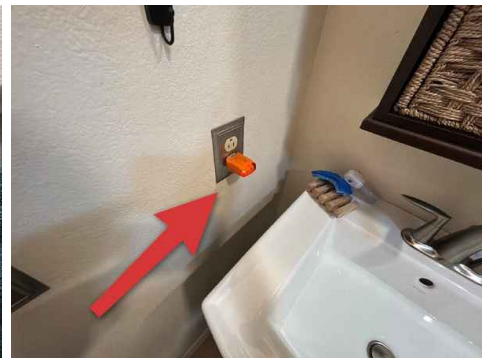
Master Bathroom

No GFCI protection was observed for one or more outlets. Lack of GFCI protection can lead to:

- Increased risk of electrical shock: GFCI outlets are designed to protect against shock in areas exposed to moisture, such as outdoor locations.
- Non-compliance with current electrical standards: Modern electrical codes require GFCI protection in exterior and other moisture-prone areas for enhanced safety.

To address these safety concerns and ensure compliance with electrical standards, it is recommended to seek further evaluation and correction by a licensed professional to upgrade these outlets by installing ground fault circuit interrupter (GFCI) receptacles where needed.

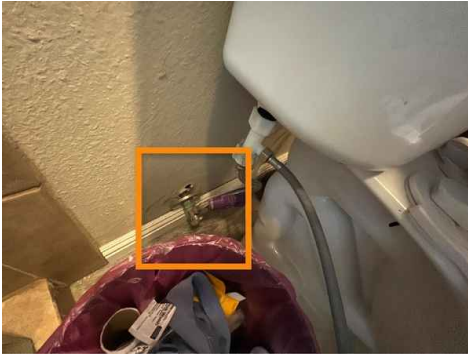
Hall Bathroom

### TOILET - WATER SUPPLY LOOSE

The water supply line is loose in one or more areas. Recommend further evaluation and correction as needed by licensed professional.

Recommendation  
Contact a qualified professional.

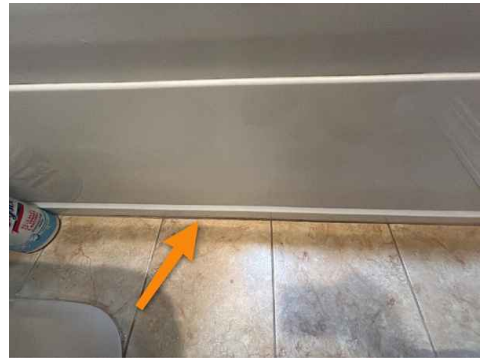
Master Bathroom

**TUB/SHOWER - AREA CAULK / GROUT MISSING**

Caulking or grout was missing, deteriorated, or in need of maintenance in the bathtub/shower area(s). All areas may not be shown. This condition can lead to:

- Water intrusion behind tiles or fixtures, potentially causing mold growth or structural damage.
- Reduced effectiveness of waterproofing, leading to leaks and long-term deterioration.

Recommend sealing the affected areas with proper caulking or grout to prevent water intrusion and maintain the integrity of the bathtub/shower enclosure. A qualified professional should perform the repair as needed.

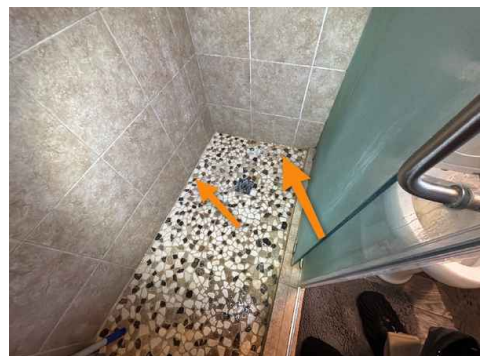
Hall Bathroom

Dark caulking was observed in one or more areas around the tub(s) and/or shower(s), which may indicate mold, mildew, or deterioration. This condition can lead to:

- Potential mold or bacterial growth, which can impact indoor air quality and hygiene.
- Reduced effectiveness of the seal, leading to possible water intrusion and damage to surrounding materials.

Recommend scraping, cleaning, and re-caulking all affected areas as needed by a qualified professional to ensure a proper seal and prevent further issues.

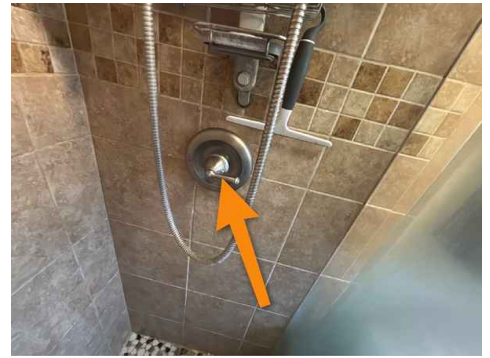
Master Bathroom

**FAUCET/FIXTURE(S) - DAMAGE / CORROSION / RUST**

Damage, corrosion, and/or rust was noted on one or more plumbing fixtures during the inspection. This condition can lead to:

- Reduced functionality or failure of the fixture due to deterioration.
- Potential for water leaks or unsanitary conditions if the issue progresses.

Recommend further evaluation and correction as needed by a licensed plumber to determine the extent of the damage and replace or repair the affected fixture(s).
