## HOME INSPECTION REPORT

**4667 Lotus Street  
San Diego, Ca 92107**

Client: Leanne Tibiatowski  
August 20, 2026  
File #260820BC

Prepared by: Chad Fisher, B.S.S.E., Certified CREIA Inspector

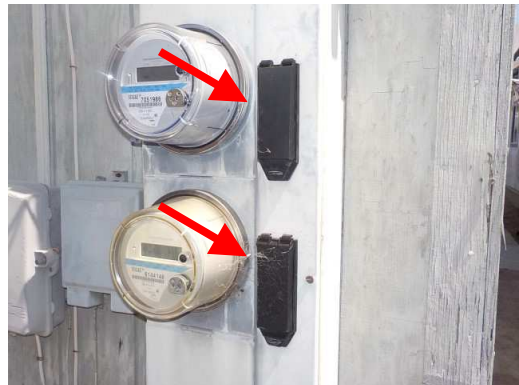
- The disconnects are not labeled and it was not determined if the 40 or 50 amp breaker is for this house. The breakers should be properly labeled.
- The capacity of the main breaker is no more than 50 amps. The Client should be aware that this may not be sufficient for modern day appliances or for adding circuits.

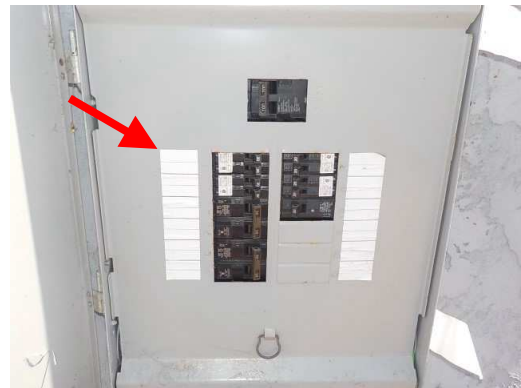
- The panel is not labeled and should be properly labeled.

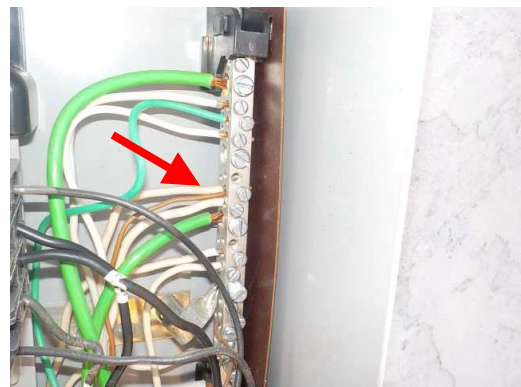
- There are two white neutral wires connected to one connection point in the sub-panel. Local building codes require that there be only one neutral wire connected to each connection point and the “doubled-up” neutral wires should be properly separated.

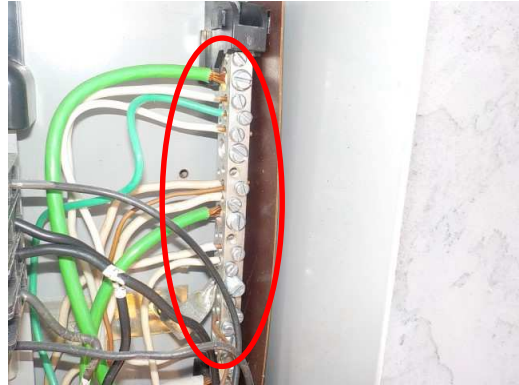
- There are white neutral wires and bare copper ground wires connected to a common bus in the sub-panel. This condition has been shown to be a hazard in some cases and it is recommended that the neutral wires be properly separated from the ground wires.

- It is recommended that a licensed electrical contractor be contacted for further inspection of the electrical panels and for recommendations.

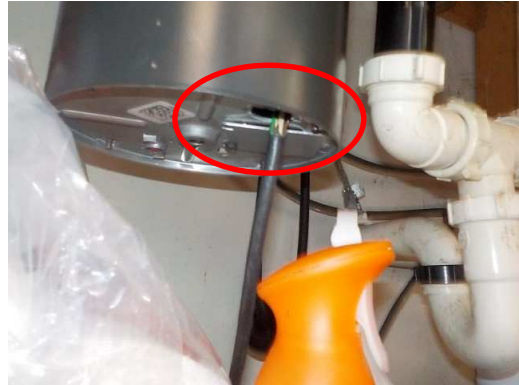
- The electrical cord in the cabinet underneath the kitchen sink is loose from the underside of the garbage disposal and should be properly secured in place.

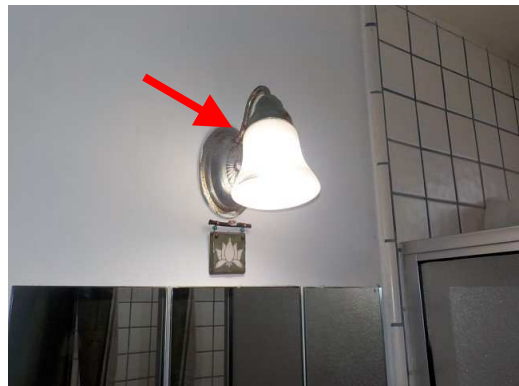
- The light in the hall bathroom flickered “on” and “off” during the inspection.

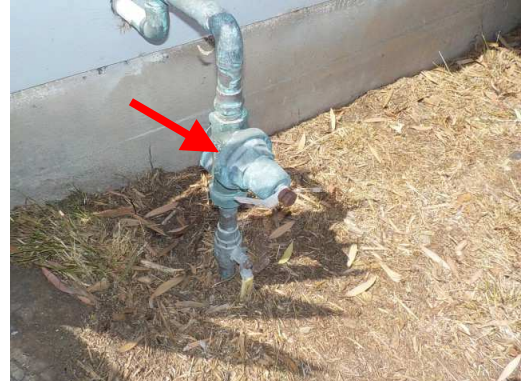
- The water pressure was measured at the east hose bib. The water pressure is 90 p.s.i. This is higher than the maximum recommended water pressure of 80 p.s.i. It is recommended that the pressure regulator be adjusted or repaired/replaced to limit the water pressure to a maximum of 80 p.s.i. The pressure regulator is located near the main water shut-off outside at the northeast corner of the house.

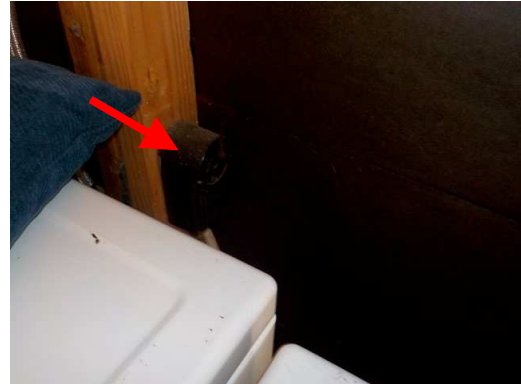
- There was no power to the 240 volt outlet at the time of the inspection, it appears that this circuit may have been disconnected.

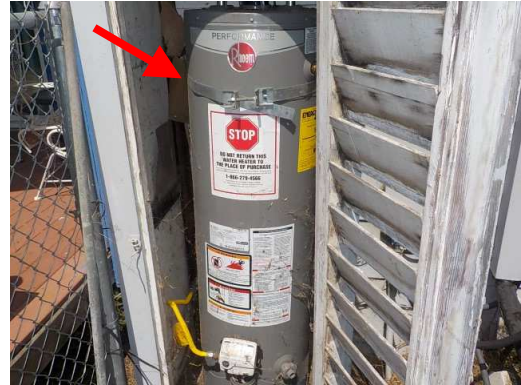
- The water heater is not adequately secured by seismic restraints because there is only one restraint. The water heater should be properly restrained as required by California state law.

- It is recommended that a licensed plumbing contractor be contacted for further inspection of the water heater and for repair or replacement recommendations.

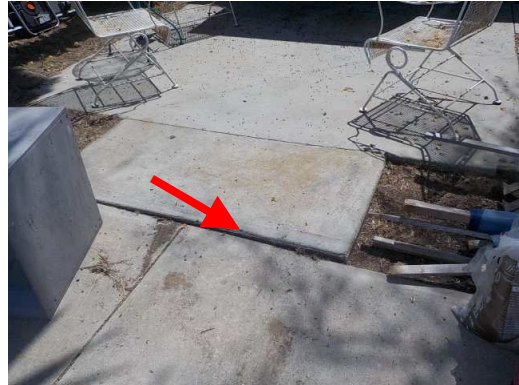
- There is a vertically offset joint in the concrete patio at the southwest corner of the house which constitutes a tripping hazard. This condition should be corrected. This condition is possibly caused by tree roots.

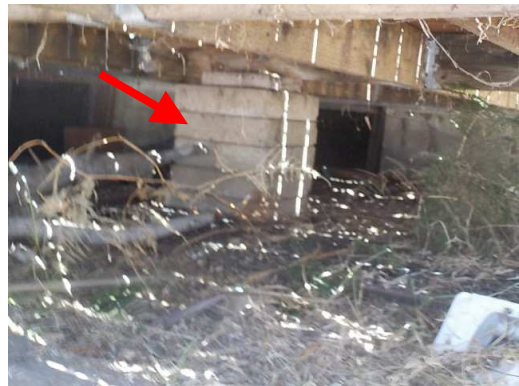
- There is earth/wood contact at deck in places. It is recommended that a licensed structural pest control company be contacted for further inspection and repair recommendations.
- There is a stack of concrete blocks supporting the middle of the deck. This is considered a temporary support and the deck should be properly supported.

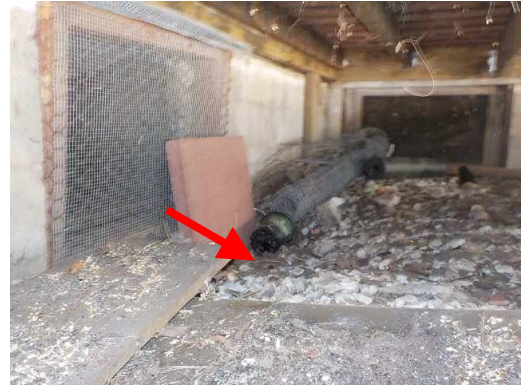
- The fence gate at the northeast corner of the 4669 Lotus Street does not work properly and is in need of repair.
- The soil slopes toward the foundation under the deck. The drainage should be improved in this area and the earth should be regraded so that the soil slopes away from the foundation a minimum of 6 inches for a distance of 10 feet and water drains freely to the street or to another proper drainage discharge area. When a distance of 10 feet is not possible because of a barrier or property line, the soil may slope at the same rate to a swale which drains to the street or to another proper drainage discharge area. In correcting the drainage care must be taken to keep the soil level a minimum of 6 inches below the top of the concrete foundation wall to prevent possible moisture intrusion into the wall assembly and deterioration of the wood framing.

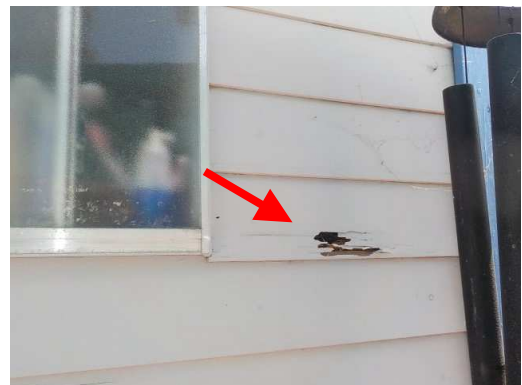
- The wood siding is deteriorated in places, especially near the bathroom window. It is recommended that a licensed structural pest control company be contacted for further inspection and repair recommendations.

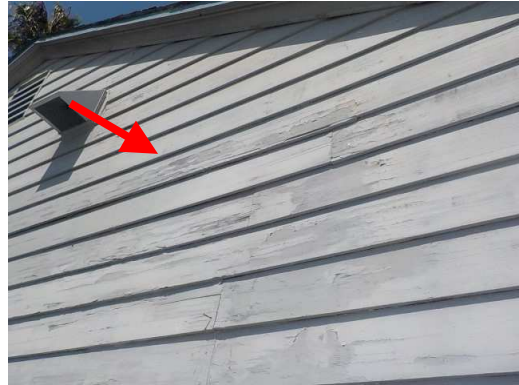
- The wood siding is weathered and is in need of painting/resealing. The wood siding should be kept well painted/sealed.

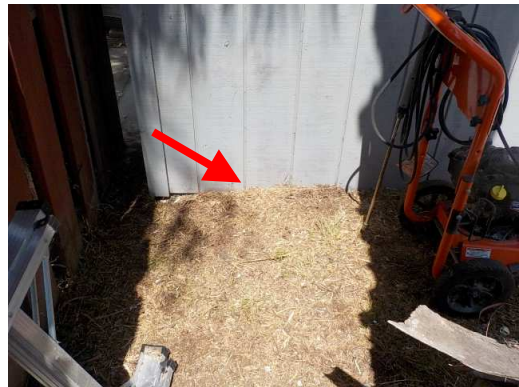
- There is earth/wood contact at siding at the laundry room. It is recommended that a licensed structural pest control company be contacted for further inspection and repair recommendations.

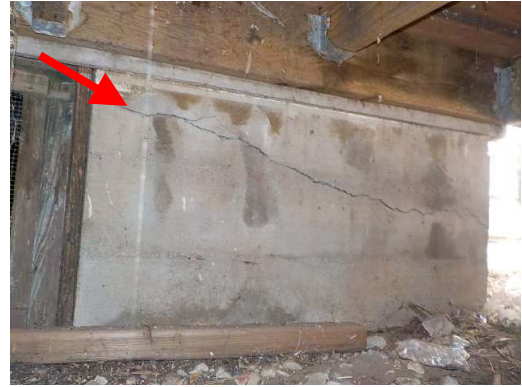
- There is a horizontal crack in the foundation wall outside at the southeast corner of the house. This crack is apparently caused by the reinforcing steel in the concrete footing being located too close to the surface of the foundation wall. The foundation walls become wet and the moisture penetrates the concrete to the steel. The moist steel then rusts and expands producing the horizontal cracking. This process can be accelerated by the presence of certain additives or contaminants in the concrete.

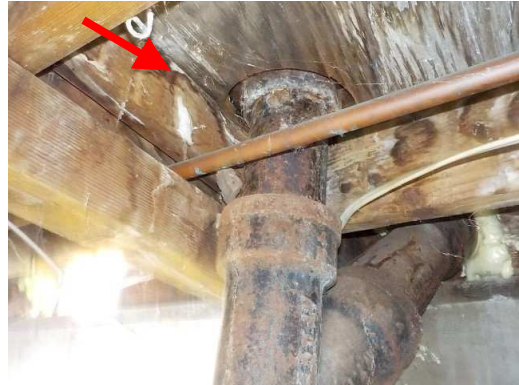
- There is some water staining to the sub-flooring in the areas of the bathroom. This condition is typical of houses of this age and the sub-flooring was dry at the time of the inspection. It is recommended that a qualified indoor air quality specialist be contacted for comprehensive investigation and for recommendations for the reasons stated above.

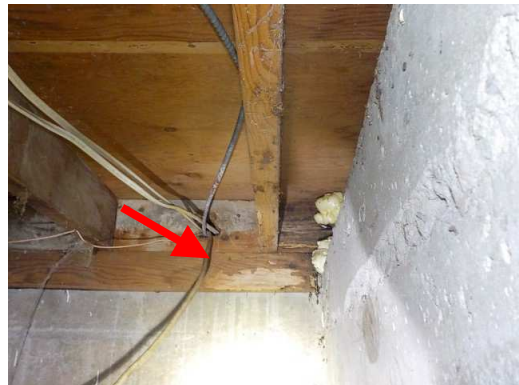
- There is some deterioration to the wood framing, especially under the addition. It is recommended that a licensed structural pest control company be contacted for further inspection and repair recommendations.

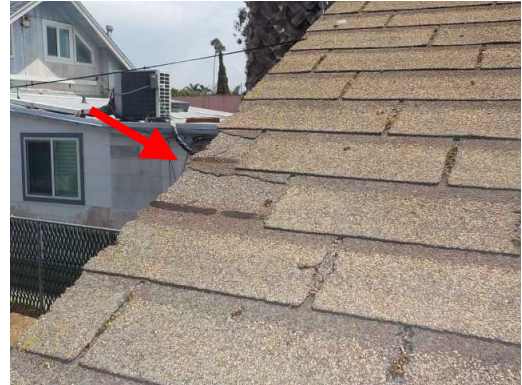
- The shingles are cupped and brittle and are showing signs of aging. The roof is deteriorating and damaged in places and appears to be at or past its expected lifespan.

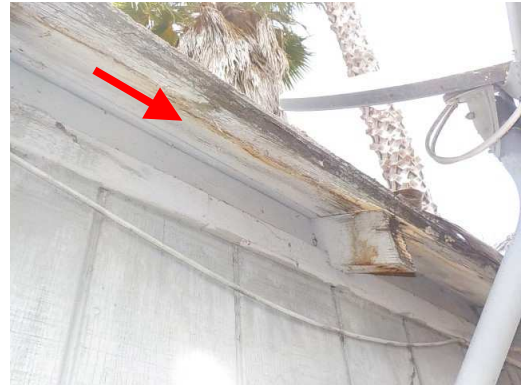
- There are some water stains in the eaves in places. These conditions are apparently caused by leakage of the roof.

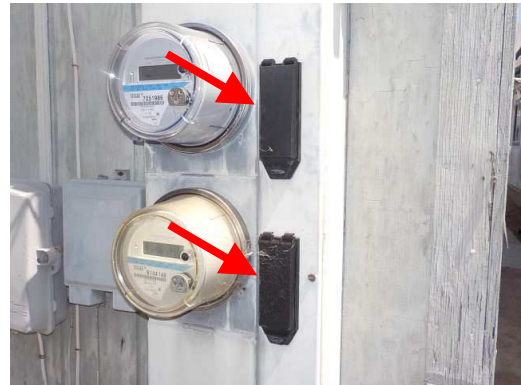
- The disconnects are not labeled and it was not determined if the 40 or 50 amp breaker is for this house. The breakers should be properly labeled.

- The capacity of the main breaker is no more than 50 amps. The Client should be aware that this may not be sufficient for modern day appliances or for adding circuits. It is recommended that a licensed electrical contractor be contacted for further inspection and possibly upgrading to a new, larger main panel.

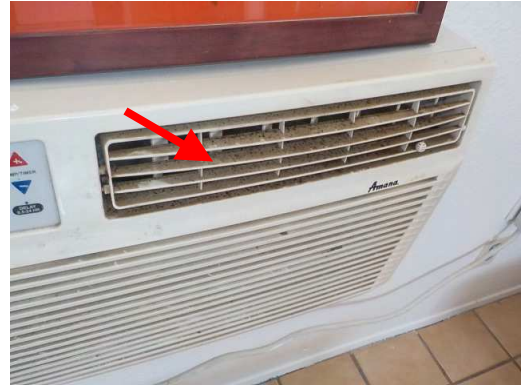
- There is what appears to be mold or mildew present in the unit. Some types of mold and mildew can present a health hazard. It is beyond the scope of this inspection to determine the presence of potentially harmful mold and mildew. It is recommended that a qualified indoor air quality specialist be contacted for comprehensive investigation and for recommendations.

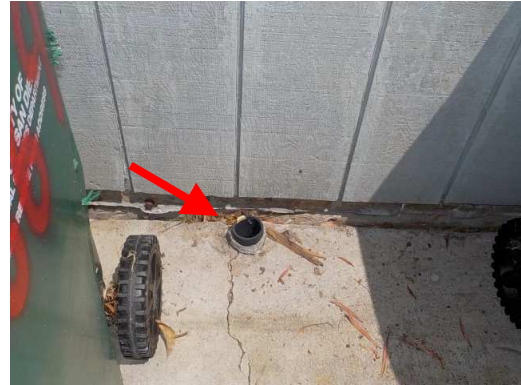
- One of the drain cleanout caps is missing at the south side of the kitchen and should be replaced. The cause for this condition was not determined.

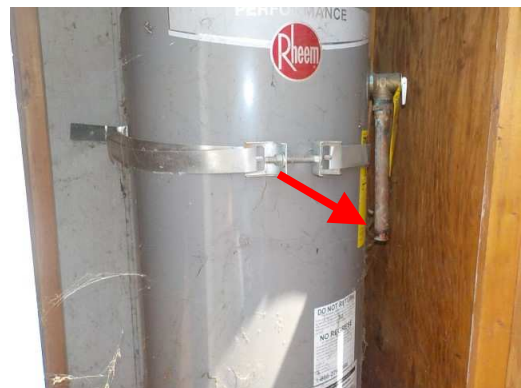
- There is no sediment trap present in the gas supply line. The absence of a sediment trap can cause the water heater to malfunction and manufacturers of gas fired water heaters generally require the presence of a sediment trap. It is recommended that the Client consider installing a sediment trap.
- There is no water heater expansion tank installed. Most local jurisdictions require an expansion tank to limit pressure buildup in the water supply system. This may not have been required at the time of installation, however, it is recommended that an expansion tank be properly installed.
- The pressure-temperature relief valve discharge is not vented and the discharge should be properly extended to within 6 to 24 inches of the ground or to a drain.

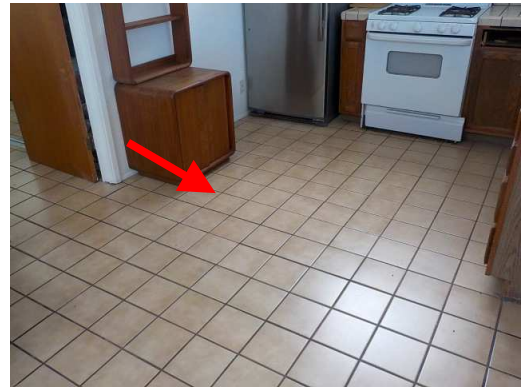
- The tile flooring is cracked and loosely bonded in places, especially in the kitchen. These conditions are possibly caused by movement of the slab.

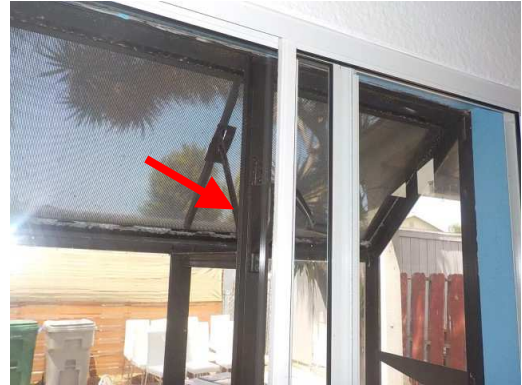
- There is a cracked pane in the kitchen window.

- The kitchen window crank hits the secondary window and is hard to operate. This condition should be properly corrected.

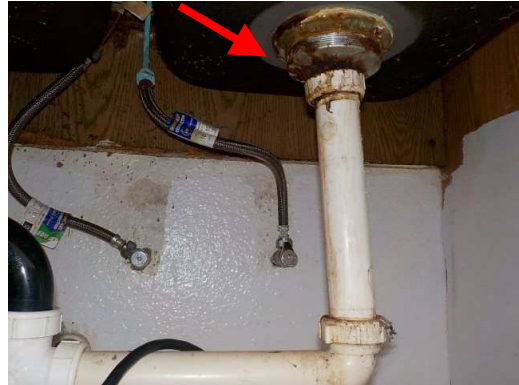
- The drain leaked underneath the sink and is in need of repair.

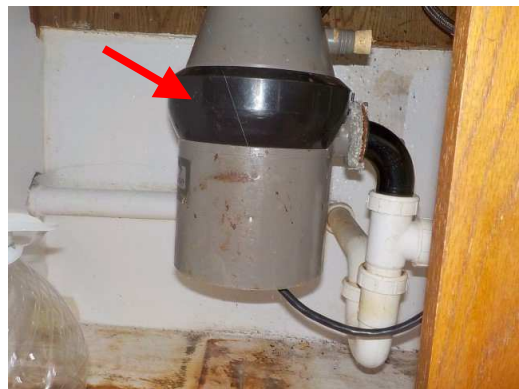
- The garbage disposal is noisy when in use and the cause for this condition should be determined and corrected.

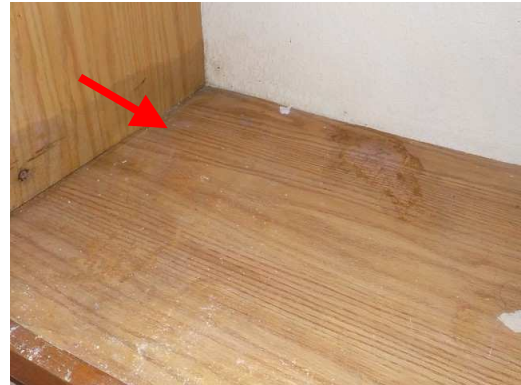
- There is some water damage to the interior of the cabinet underneath the sink. The cause for this condition could not be determined by visual inspection, however, because of this condition this area was tested for the presence of elevated moisture with a Protimeter Surveymaster electronic moisture meter and was found to be dry at the time of the inspection. The Client is advised that the absence of moisture at this time does not necessarily indicate that any previous leakage has been successfully repaired or that future leakage will not occur. It is recommended that a qualified indoor air quality specialist be contacted for comprehensive investigation and for recommendations for the reasons stated above.

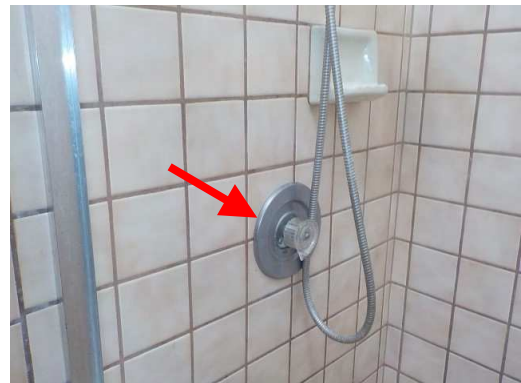
- The faucet handle rotates without a stopping point and is in need of repair.

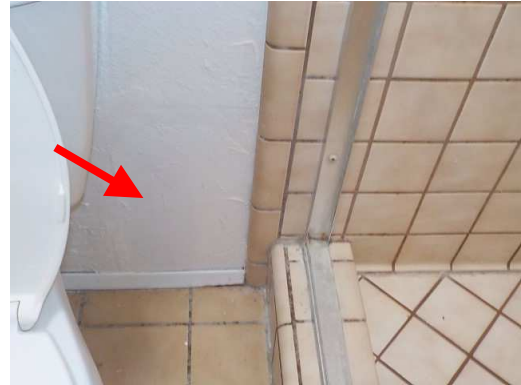
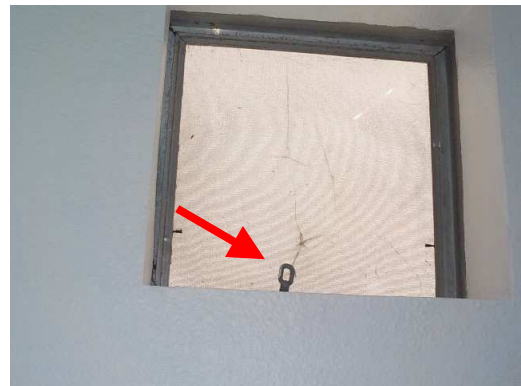
- The toilet flushed when tested, however, it is loose from the floor and is crooked. The toilet is in need of repair.
- This bathroom is equipped with a skylight for ventilation, however, the opening arm for the skylight was not located and the skylight should be made operational.

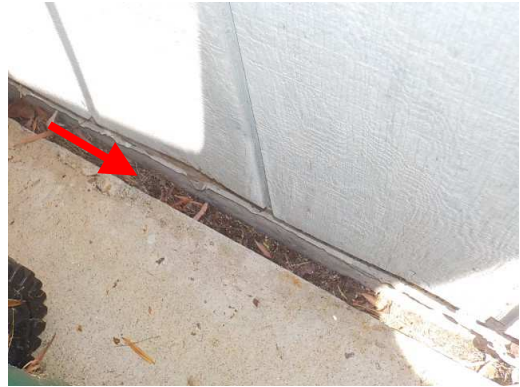
- There is a gap approximately 1 inch in width between the south walkway and the house. This condition can allow water to infiltrate the soils underneath the foundation and this gap should be filled.

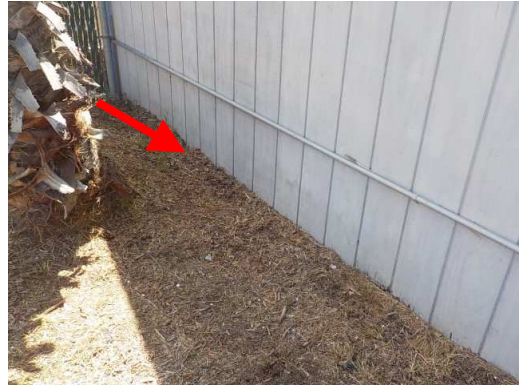
- The soil level is too high at the north side of the house. This condition can cause deterioration of the wood framing. The soil level should be lowered to a level no higher than the concrete foundation wall and should not be in contact with the siding. It is recommended that a licensed structural pest control company be contacted for further inspection and repair recommendations. In correcting the soil level care must be taken to avoid creating ponding near the foundation.

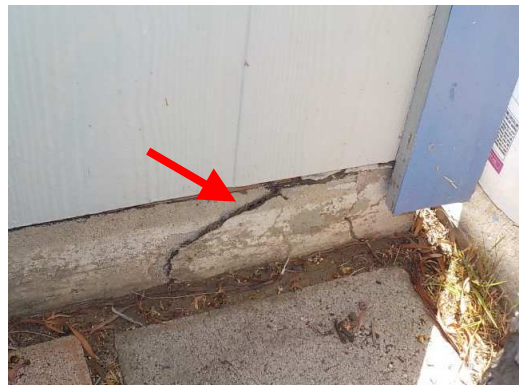
- The concrete has spalled away from the edge of the foundation at the west side of the house in at least two places. This condition is apparently caused anchor bolts being placed too close to the edge of the foundation wall during construction. When the foundation walls become wet, moisture penetrates the concrete to the steel anchor bolts. The moist steel then rusts and expands producing the spalled areas. There is no evidence that this condition is structurally significant.

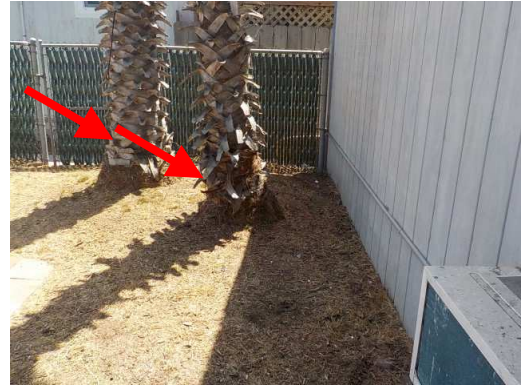
- There are trees growing close to the foundation at the north side of the house. There is no evidence of structural damage to the foundation from tree roots at this time, however, the house should be periodically monitored for signs of distress and the tree removed and the roots killed if necessary.
