# Inspection Report

J Bixler Inspections

23732 Parrotts Ferry Rd Spc 1  
Columbia, CA 95310

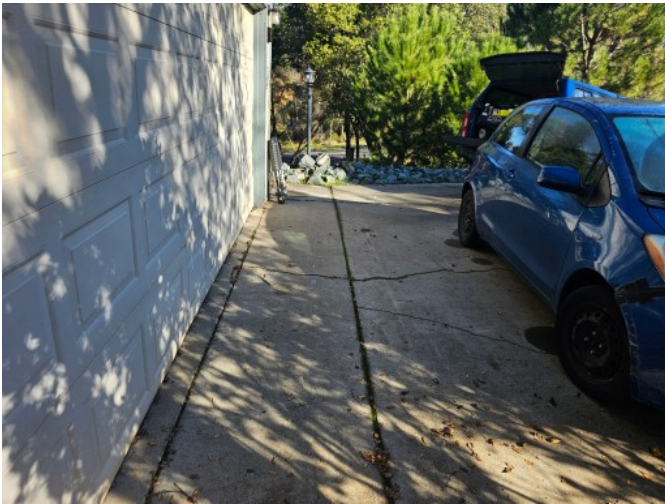
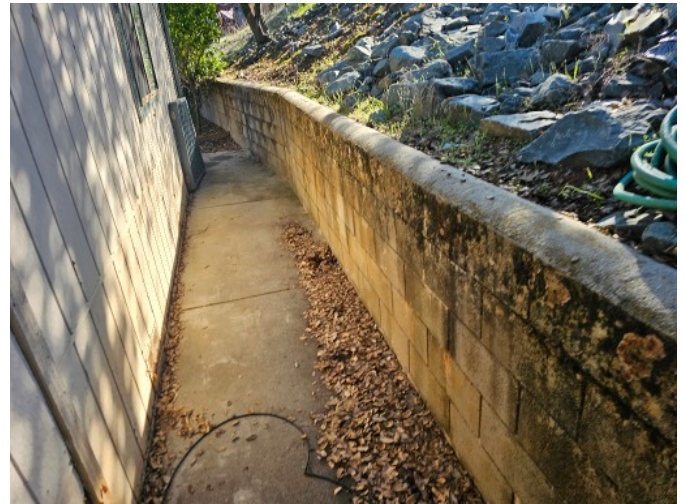
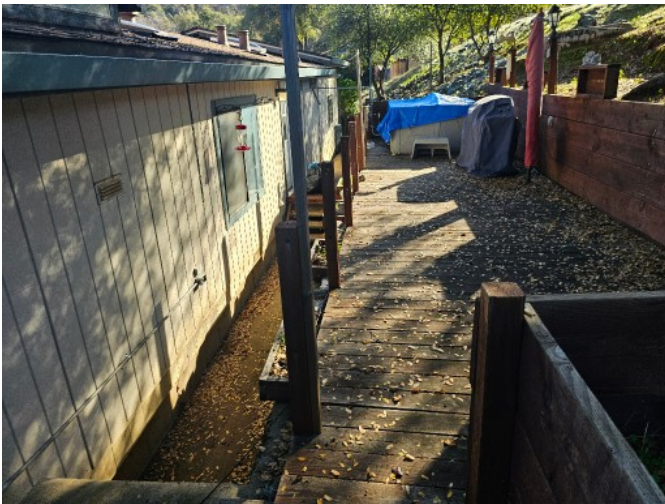
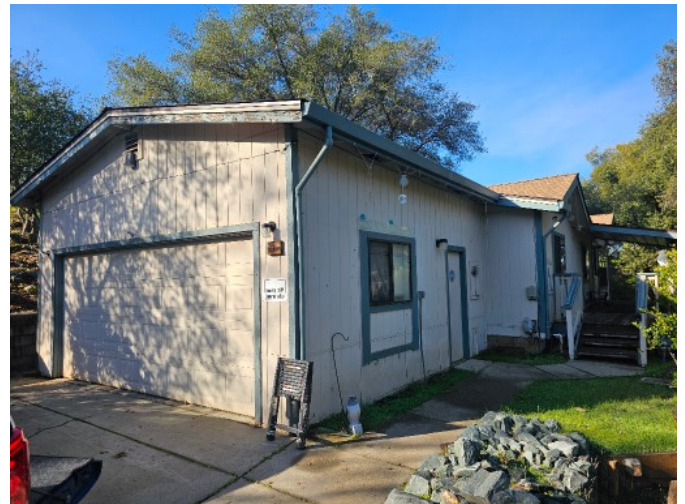
Grading of the soil near the foundation appears to be in serviceable condition.

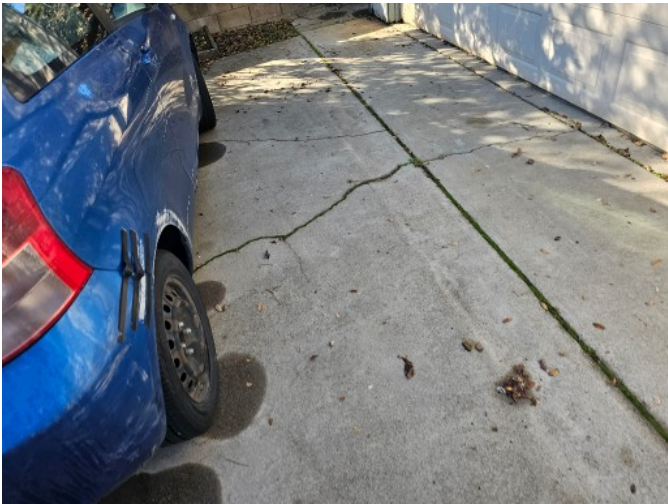
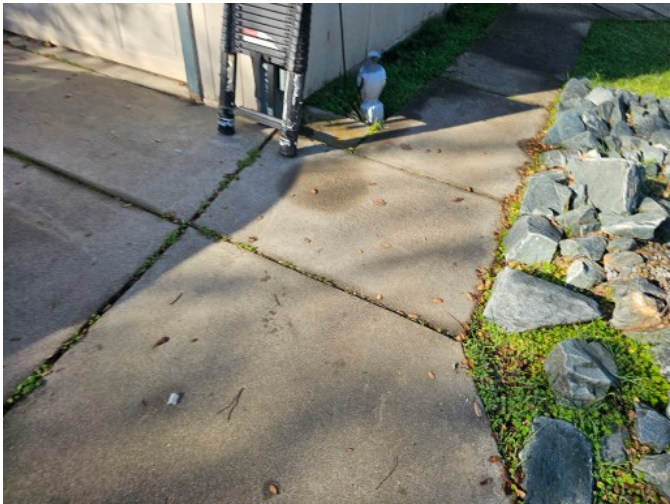
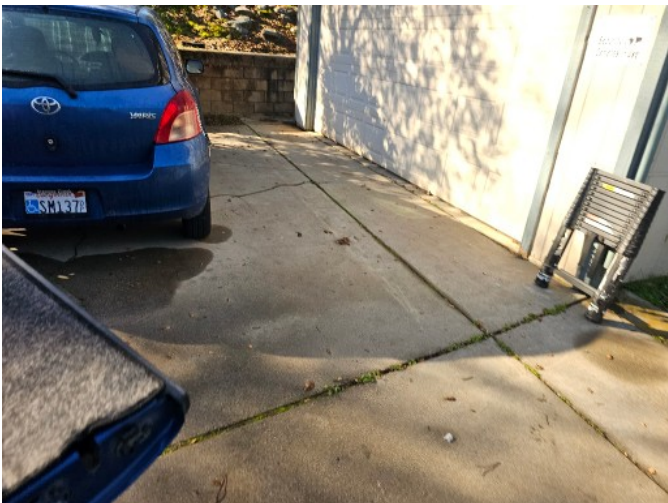
Common cracks were observed in the driveway.

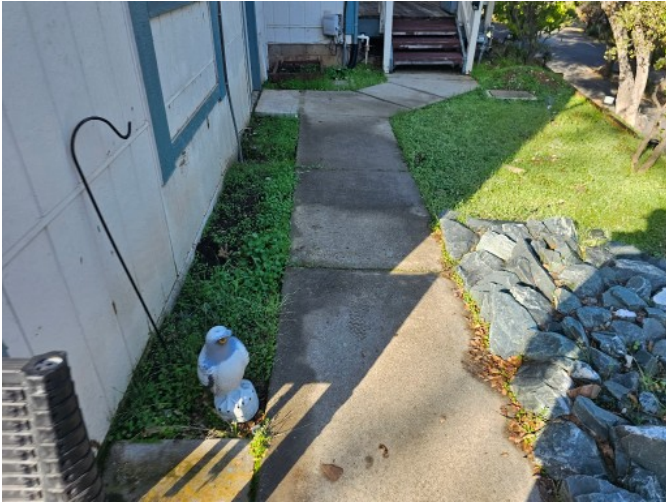
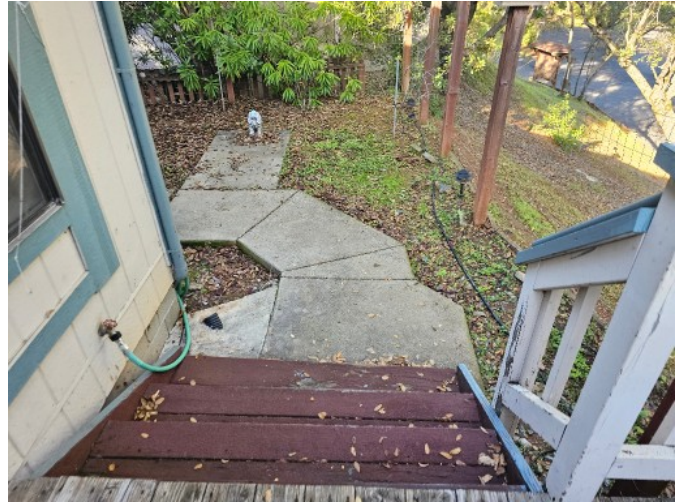
The visible areas of the sidewalk appeared to be in serviceable condition at the time of the inspection.

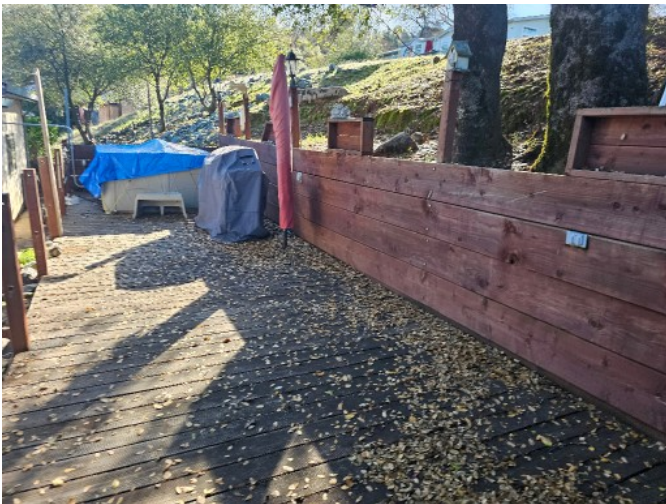
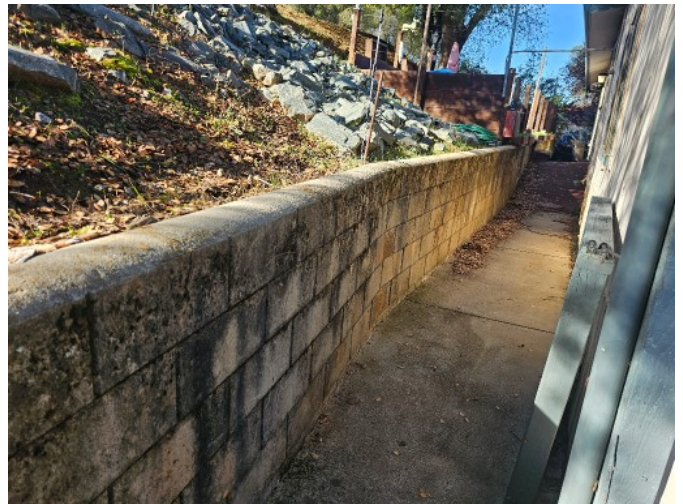
The visible and accessible portions of the retaining walls appeared to be in serviceable condition at the time of the inspection.

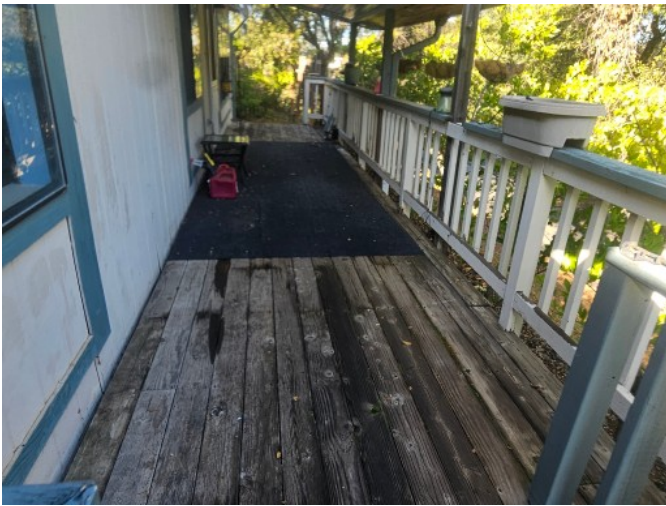
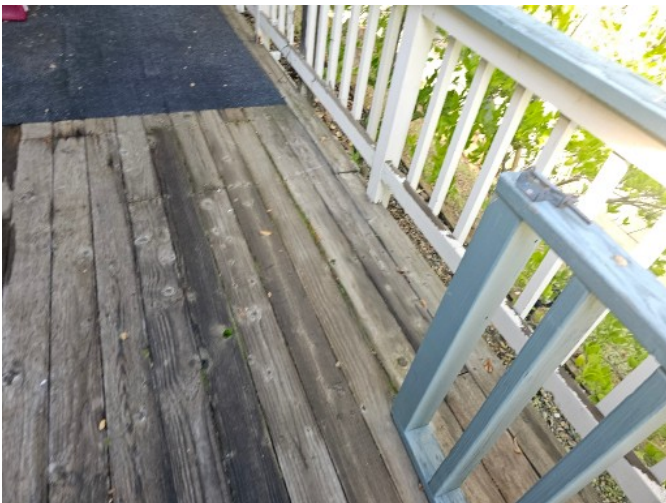
The deck showed signs of rot. See termite report for further break down and cost estimates.

The surface appeared weathered. Recommend cleaning and maintenance as needed.

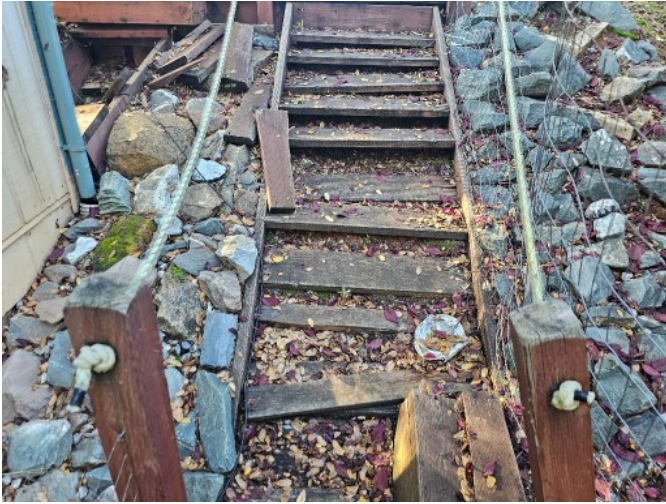
The stairs along back were broken. Recommend repair and/or replacement.

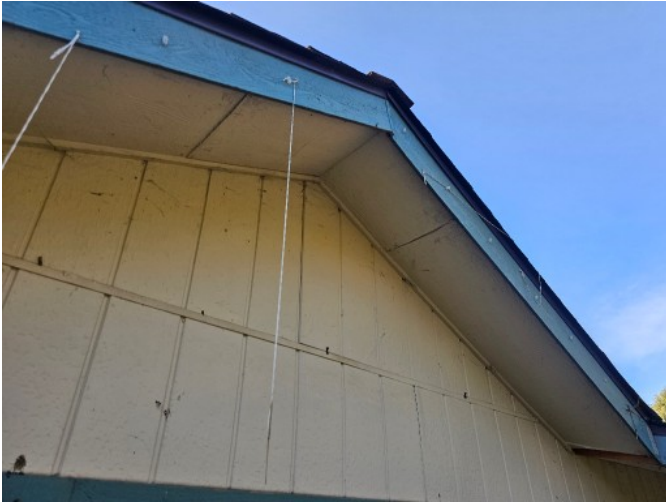
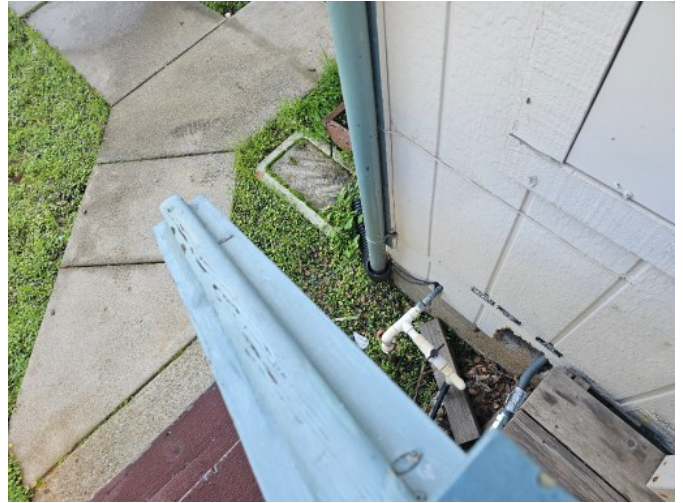
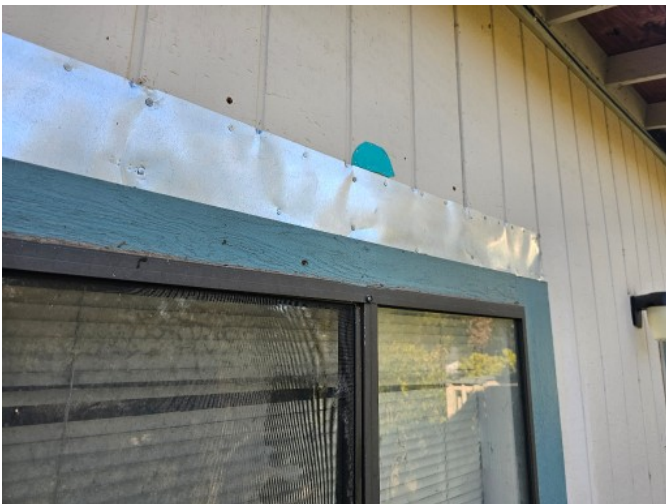
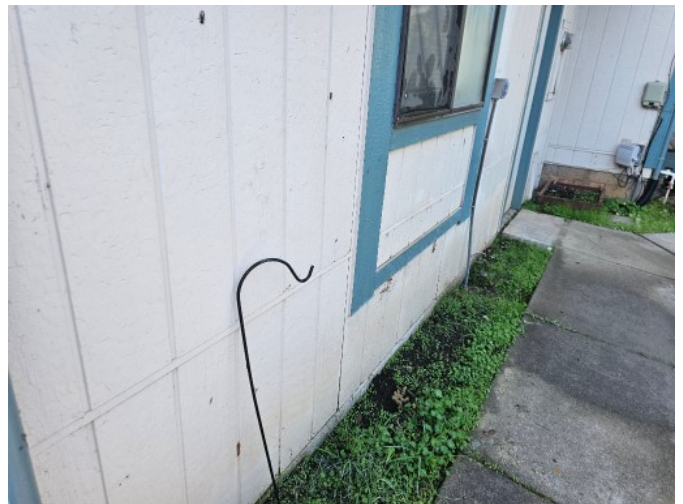
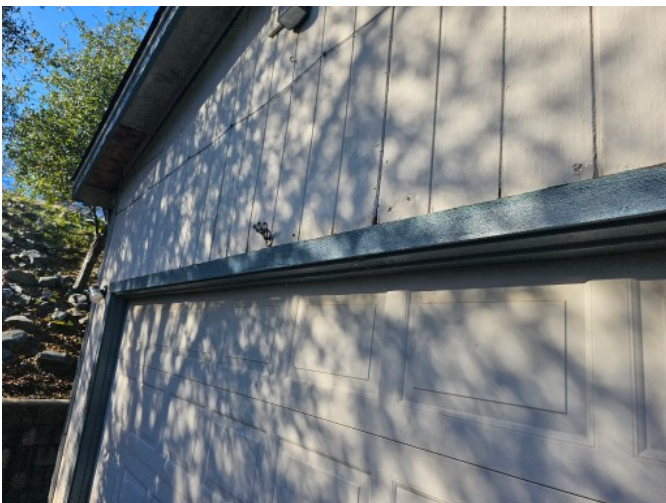
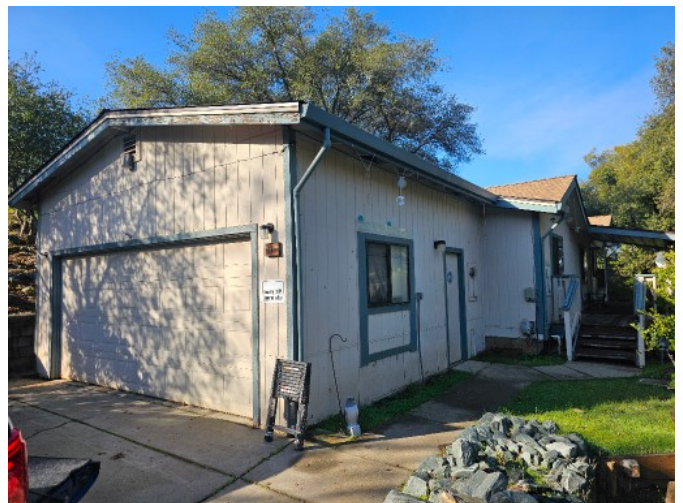
### 2.3) Exterior Wall Conditions

Rot was observed around the home. Contact or see termite report for break down and costs for repairs.

Peeled paint was observed, recommend pressure washing and repainting as needed.

The paint/finish of the siding/walls was weathered. Recommend maintenance as needed by a qualified contractor.

Woodpecker damage was noted. Recommend sealing and/or repair.

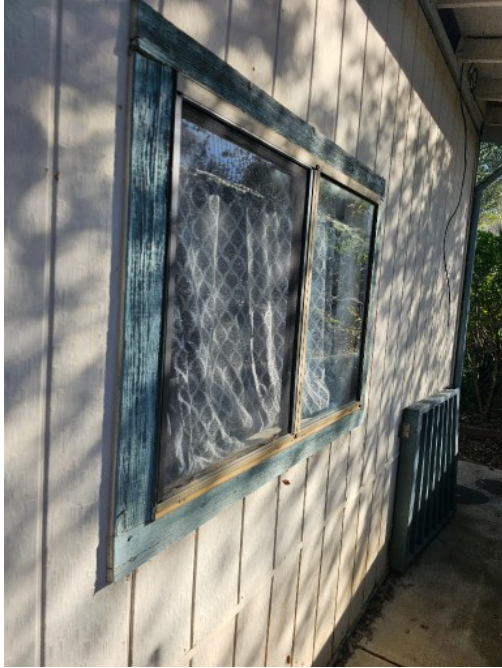
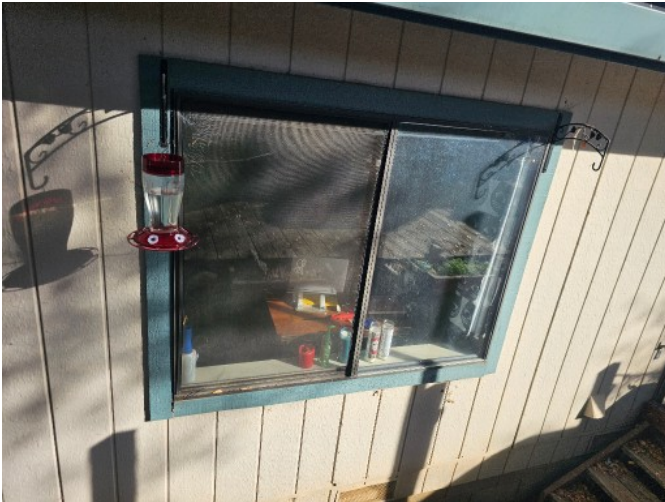
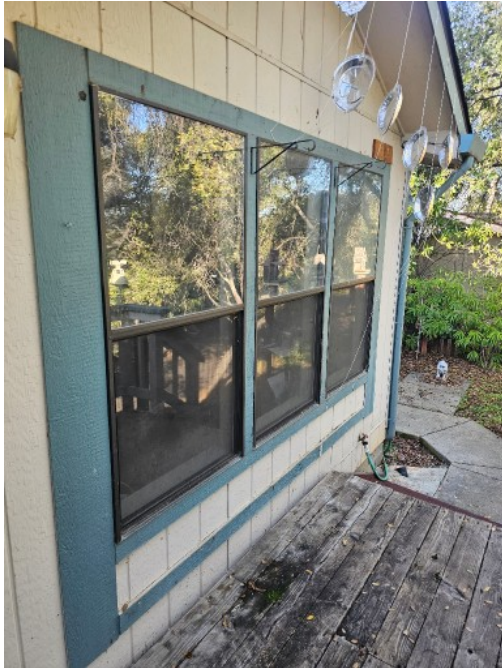
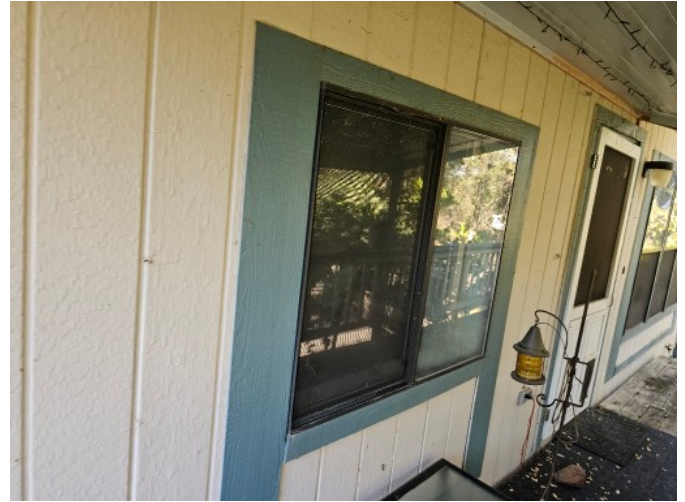
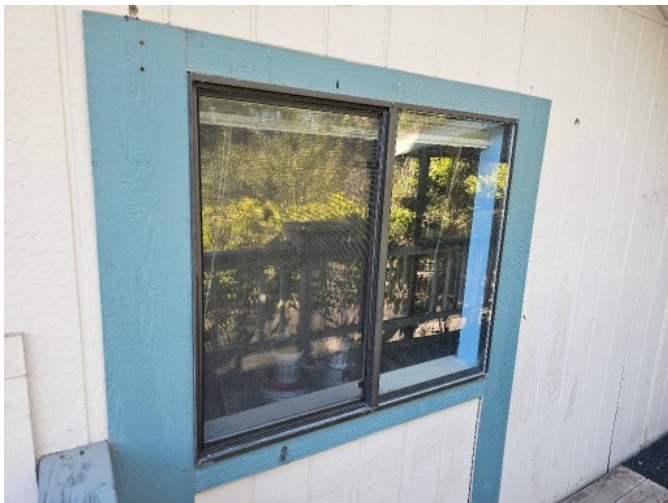
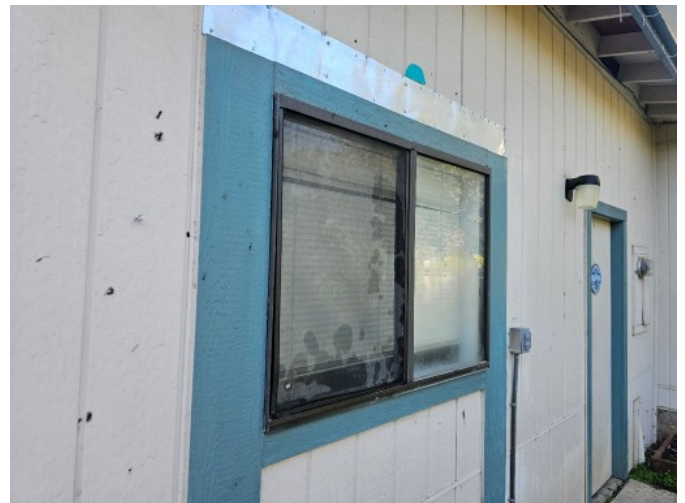
#### 2.4) Window Conditions

Some single-pane windows were observed. Although these appeared to be functional, updating windows is recommended in the future for energy purposes.

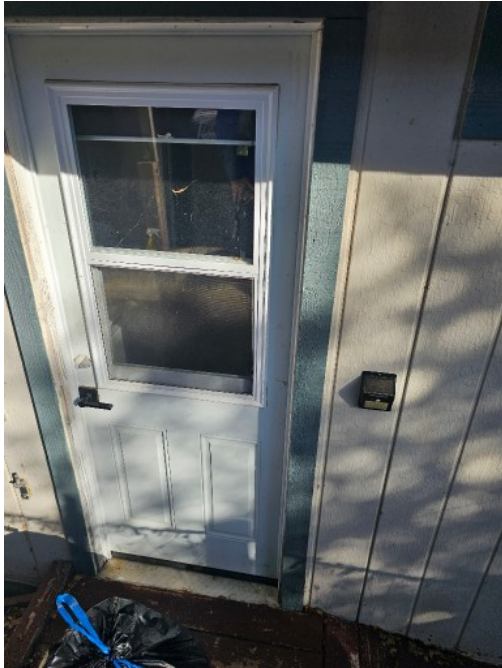
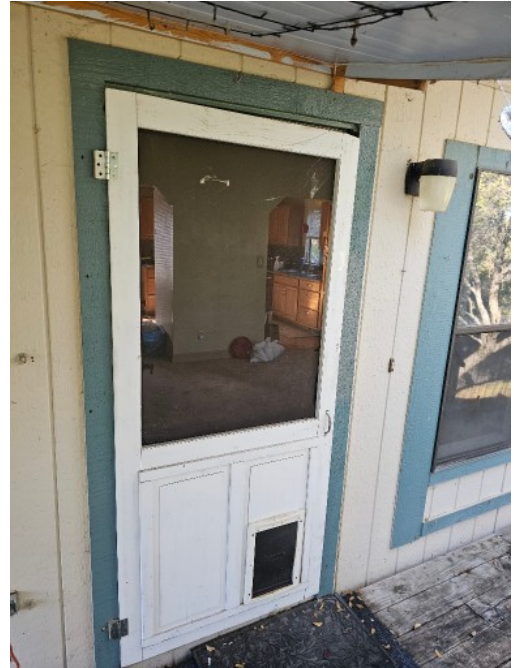
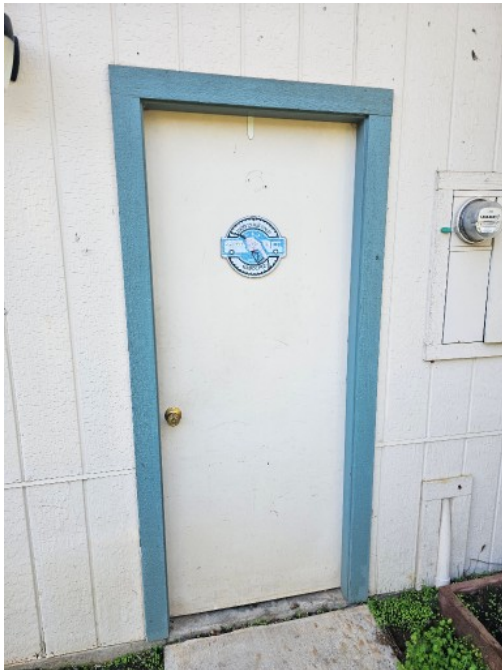
### 2.5) Exterior Door Conditions

The door(s) appeared to be in serviceable condition at the time of the inspection.

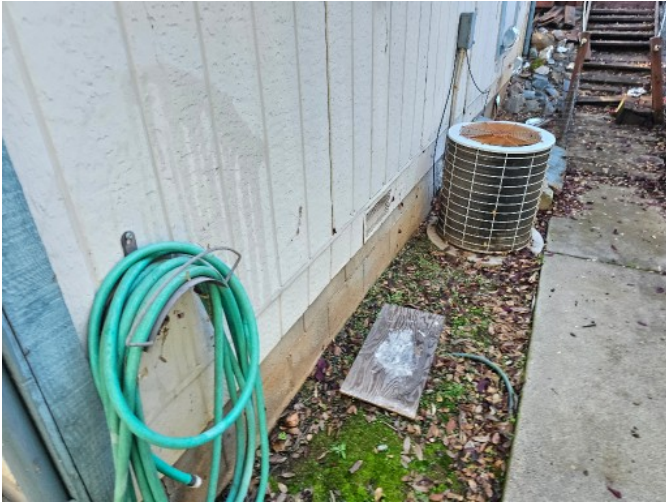
### 2.6) Faucet Conditions

The hose faucets appeared to be in serviceable condition at the time of the inspection. These should be drained prior to freezing temperatures.

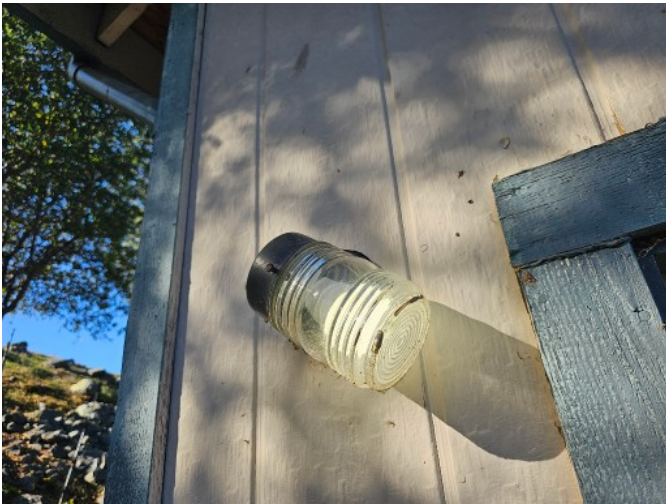
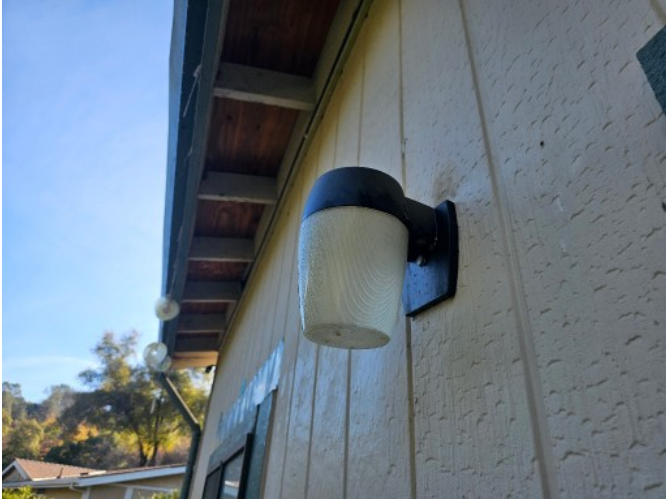
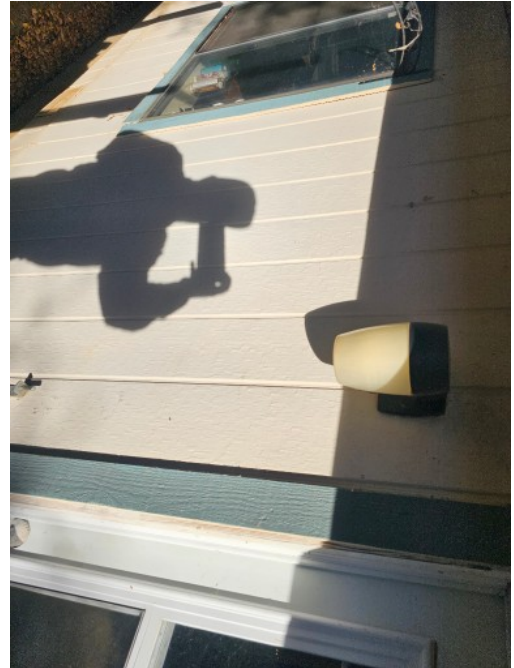
### 2.7) Lights

Some of the exterior lights appear to need new bulbs.

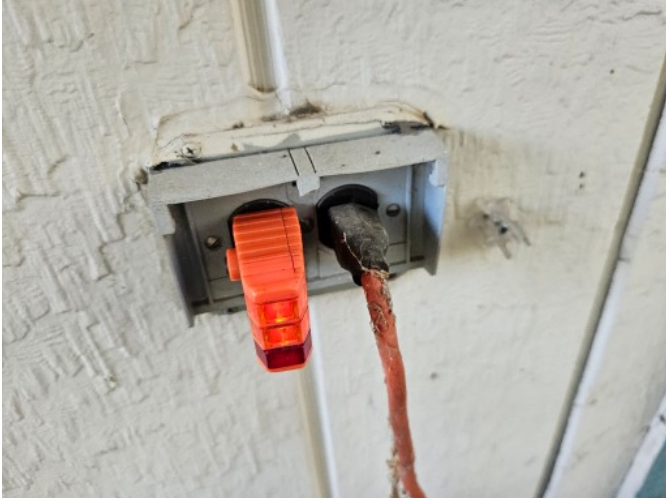
## 2.8) Outlet

Appears Serviceable.

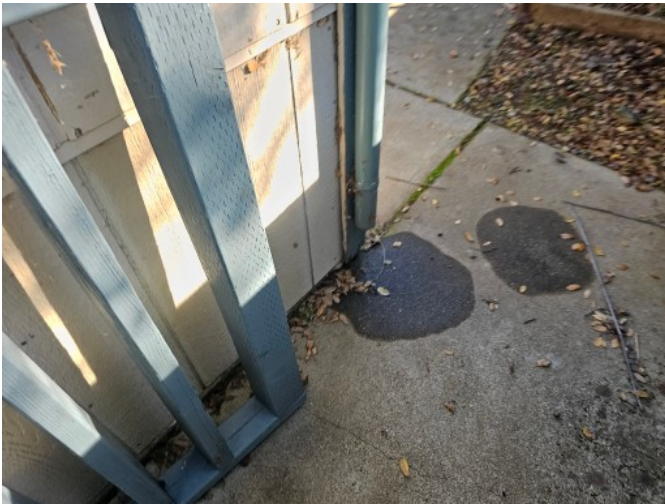
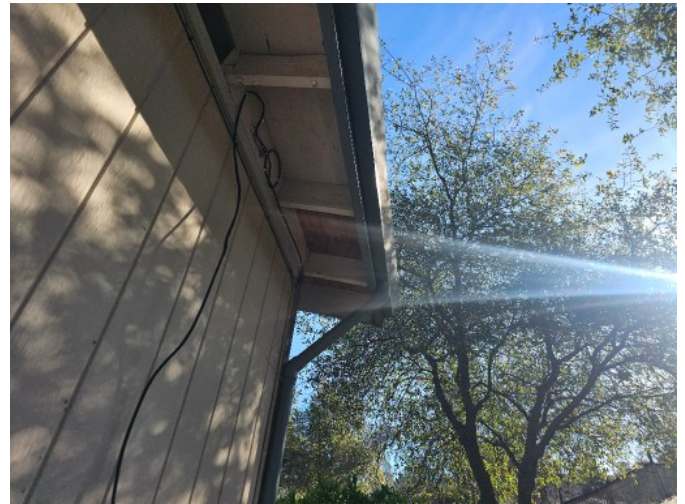
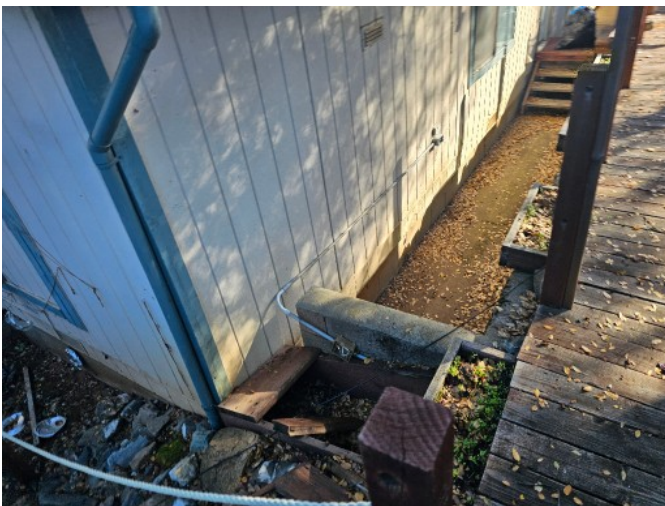
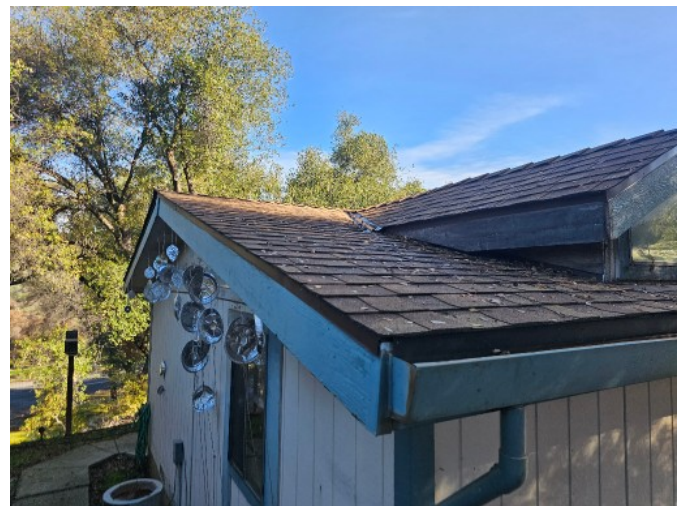
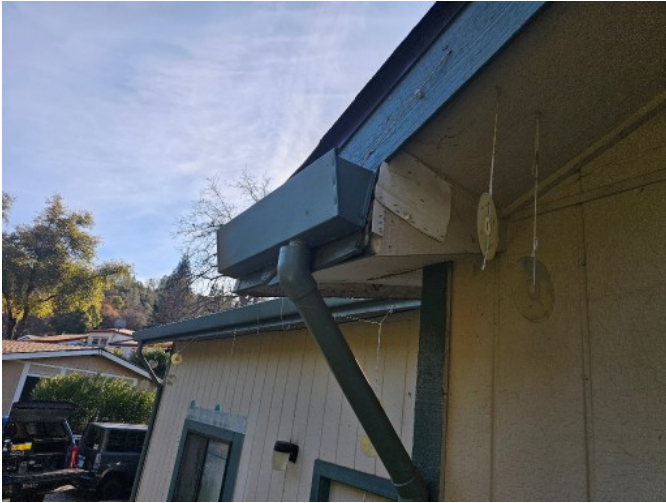
### 3.2) Gutter & Downspout Conditions

The gutter system appeared to be in serviceable condition at the time of the inspection.

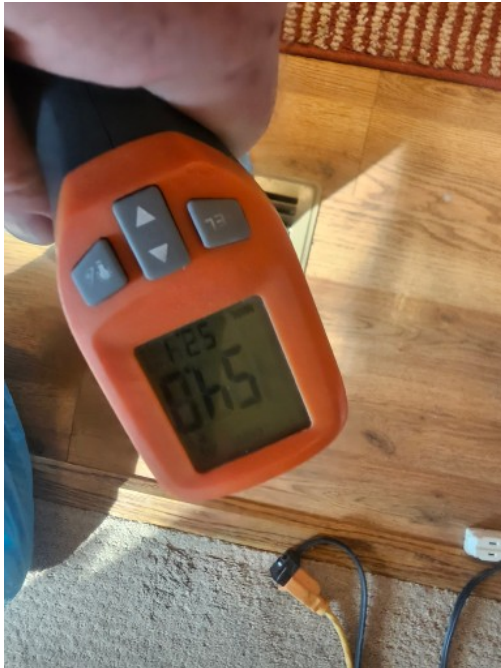
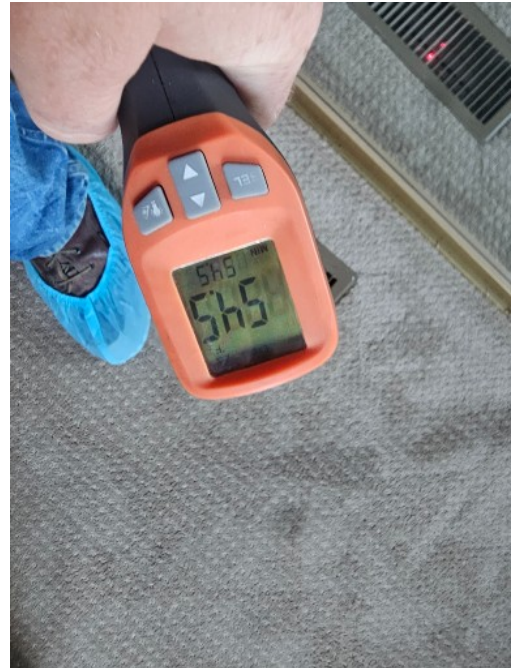
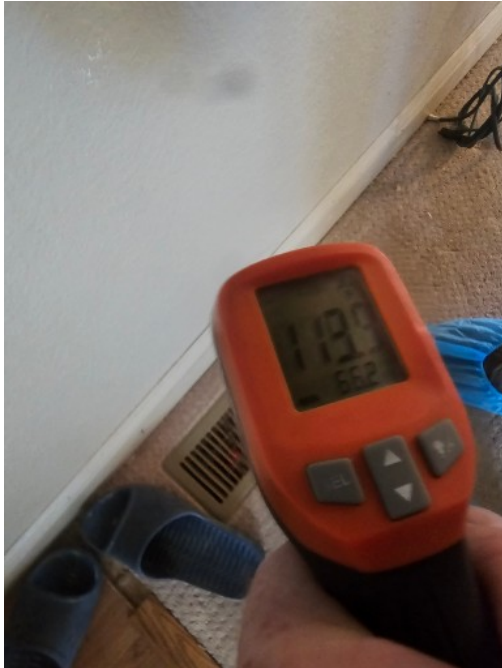
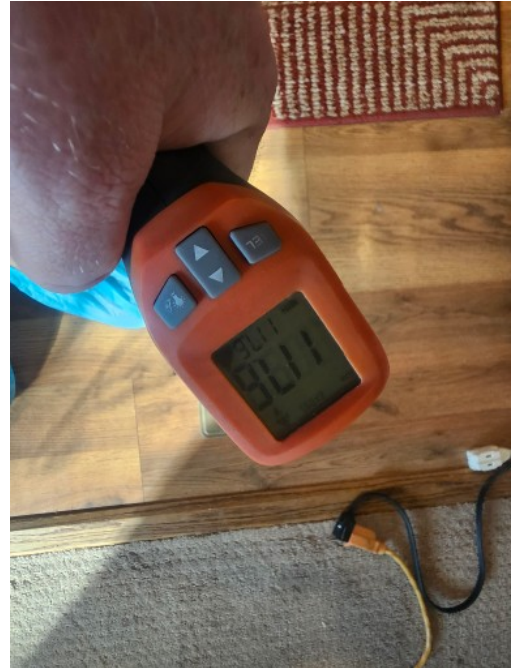
#### 4.2) Distribution Conditions

The visible and accessible areas of the distribution system appeared to be in serviceable condition at the time of inspection.

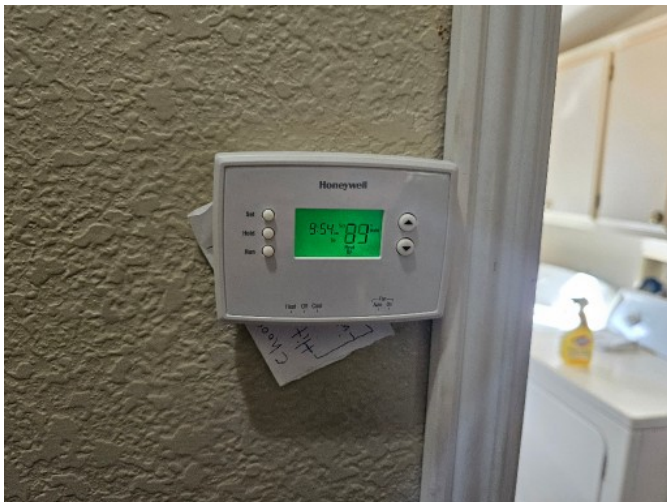
#### 4.3) Thermostat Condition

The thermostat was broken or loose. Recommend resealing, repair, and/or replacement.

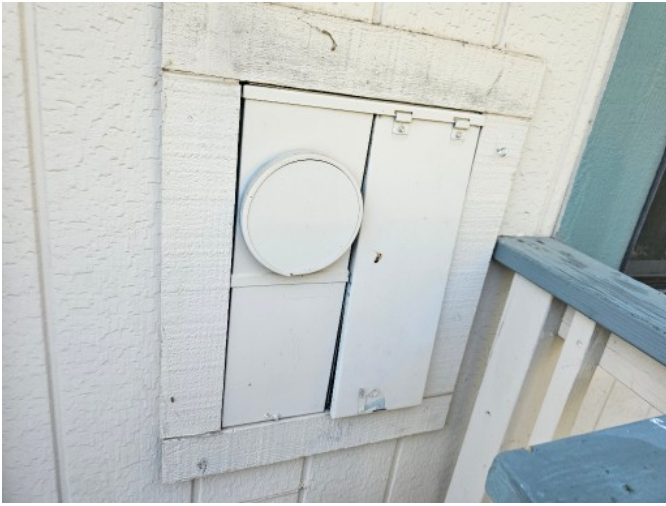
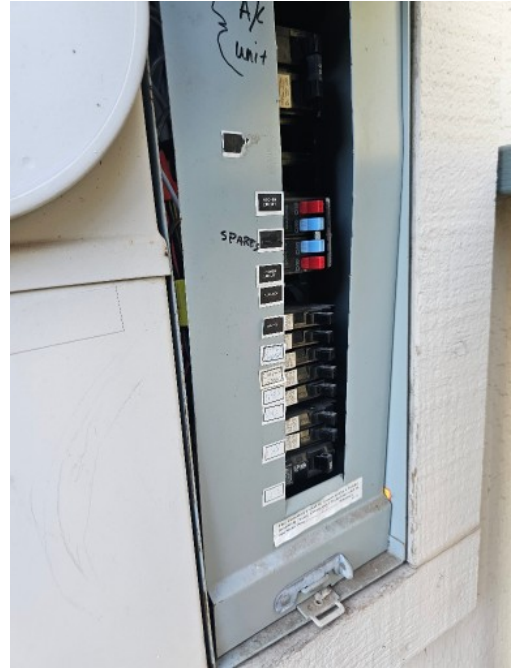
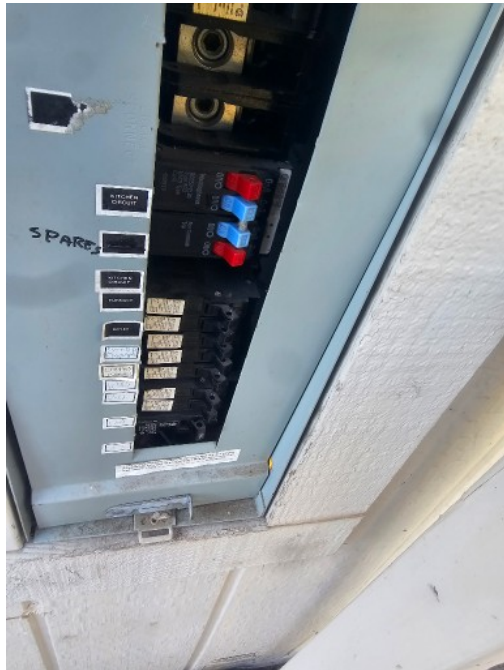
#### 5.2) Electrical Panel Conditions

Some unprofessional electrical work was noted throughout home and some of the breakers were tripping when everything was in use. It's recommended that an electrician be called for full evaluation of the electrical system prior to closing.

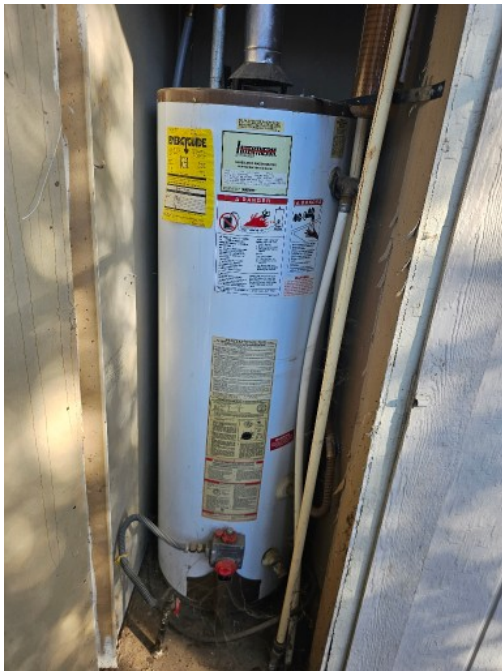
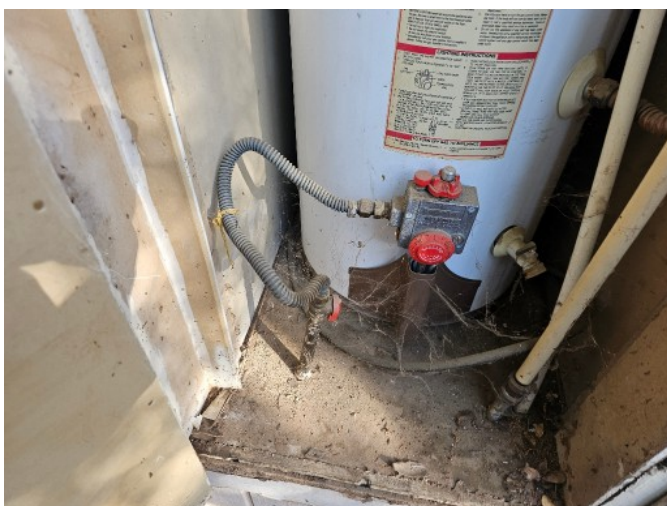
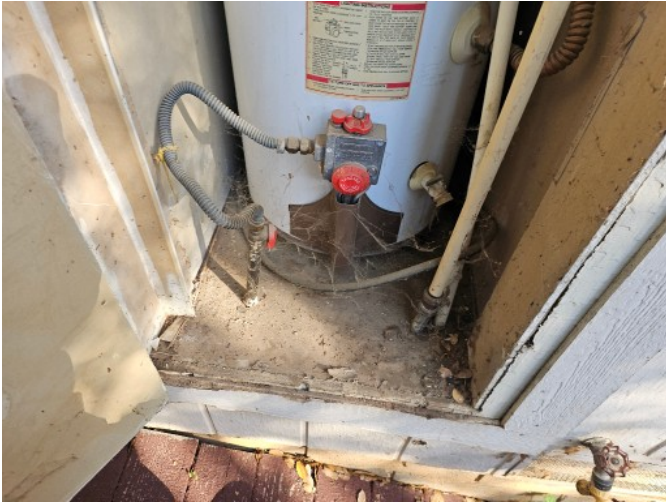
#### 6.4) Water Heater Conditions

The water heater was missing the proper earthquake straps as required by California state law.

The water heater did not have a pan. Recommend having a pan installed underneath the water heater to catch any overflow/drips.

Due to the age and/or conditions observed, the water heater is past or approaching the end of its useful life. **Replacement is recommended.**

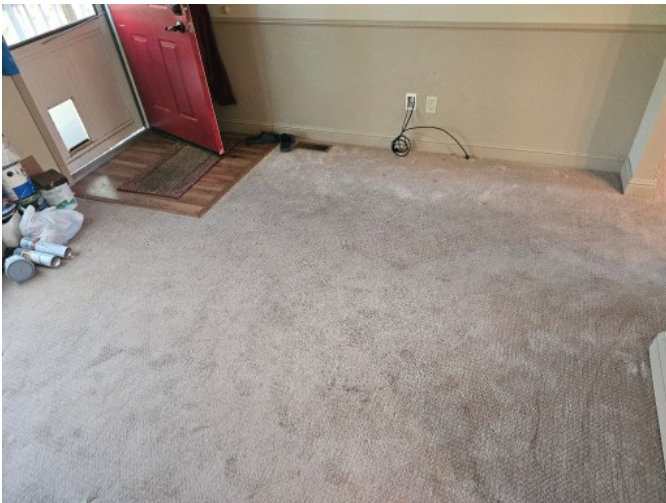
### 7.3) Floor Conditions

Minor stains and wear were noted at the carpet.

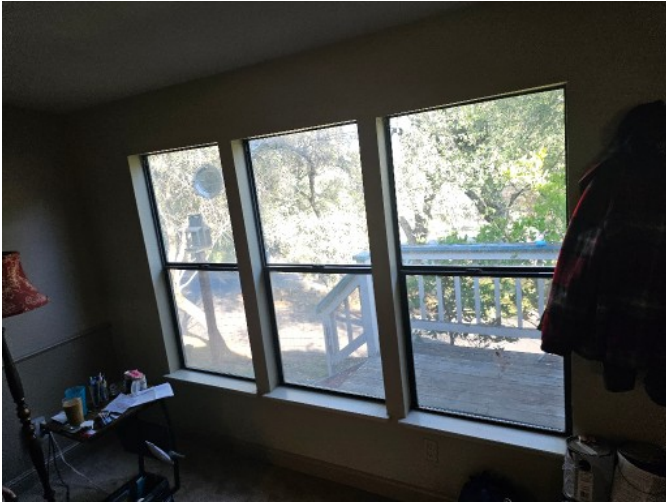
### 7.4) Interior Window Conditions

Some windows were difficult to operate. Recommend oiling, adjustment, and/or repairs as needed.

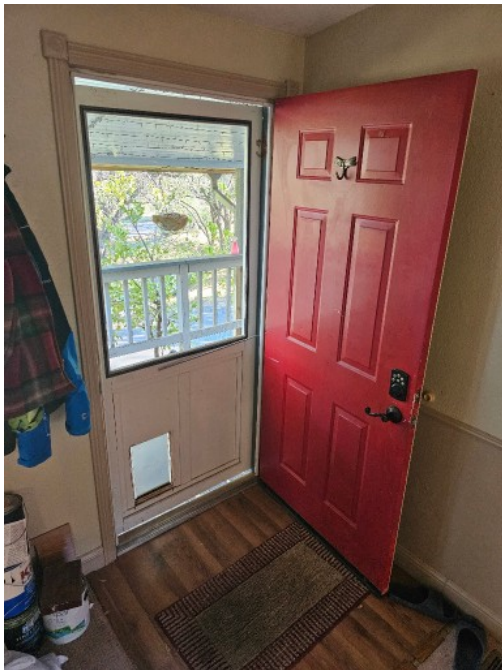
### 7.5) Interior Door Conditions

A minor amount of moisture damage was noted on the inside right base of entry door. Recommend repair or replacement.

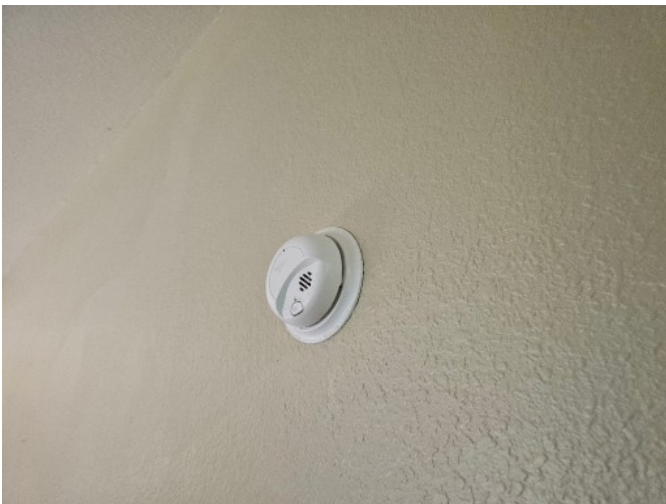
7.8) Smoke Detector Conditions

There were no carbon monoxide detectors found at the time of inspection. Current state laws require the installation of these devices. Client should contact the local Fire Marshall's office for proper locations.

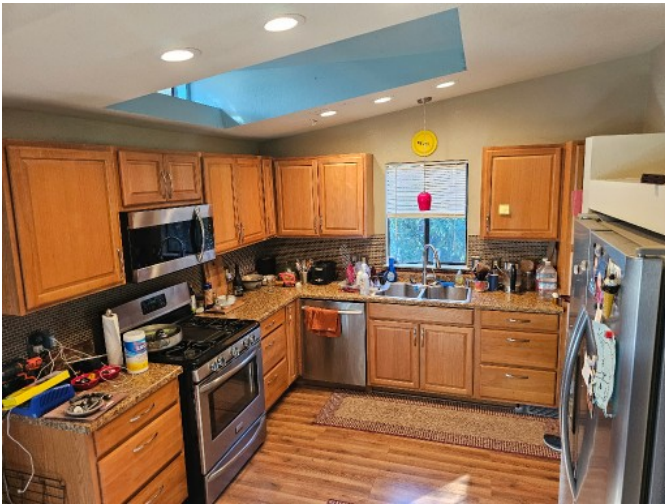
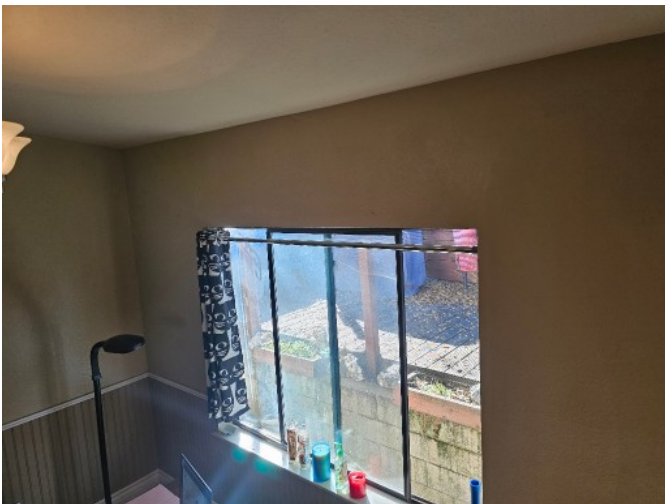
#### 8.1) Wall Conditions

Some flaking was noted at the texture around skylight.

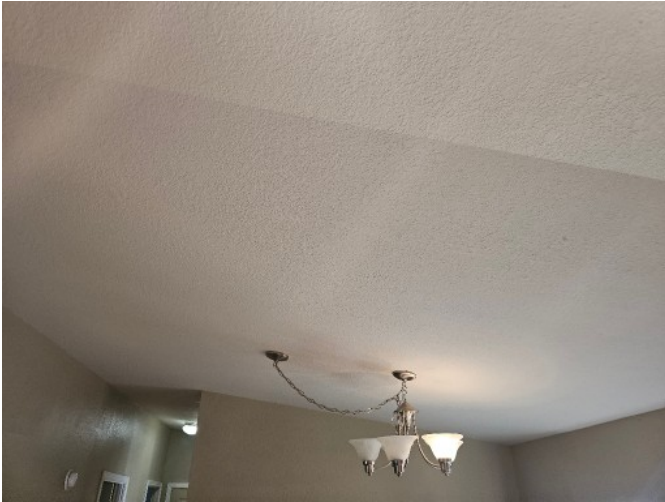
#### 8.2) Ceiling Conditions

Common cracks were observed at the ceiling.

Patching/spackling was observed at the ceiling. The client should obtain disclosure information from the seller.

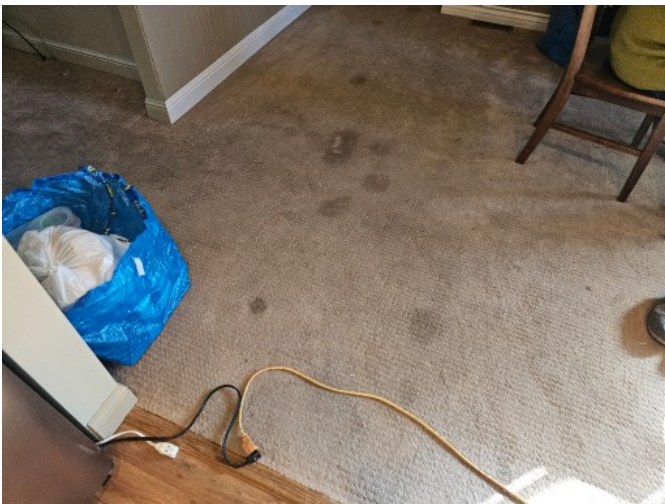
### 8.3) Floor Conditions

Stains at the carpeting/floor covers were observed at the time of inspection. In most cases, the stains can be removed by a professional cleaning service but may need to be replaced in some cases. Recommend evaluation by a flooring professional prior to close.

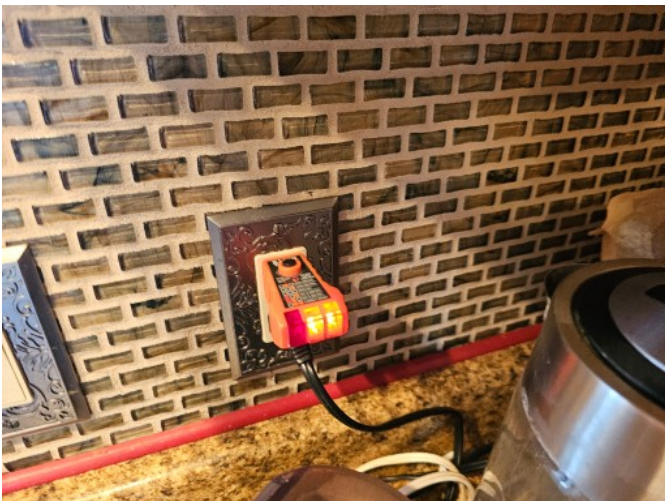
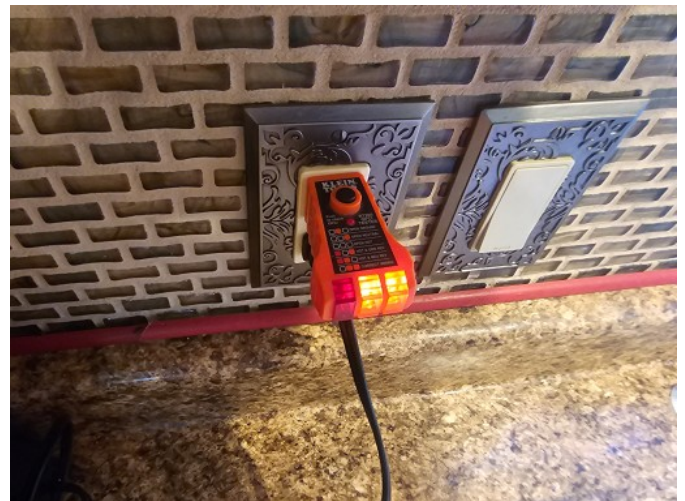
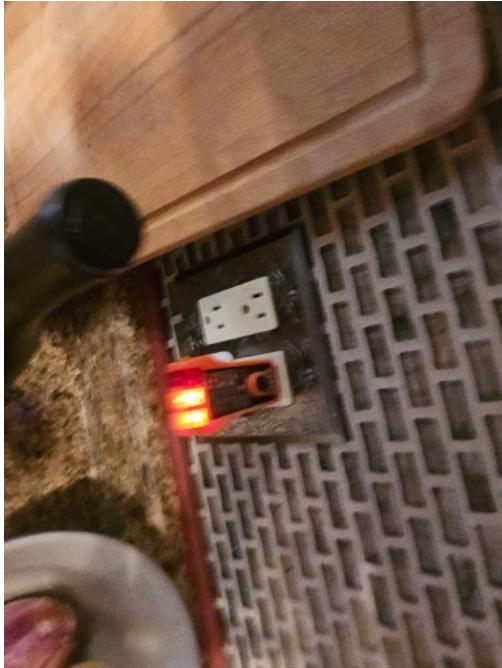
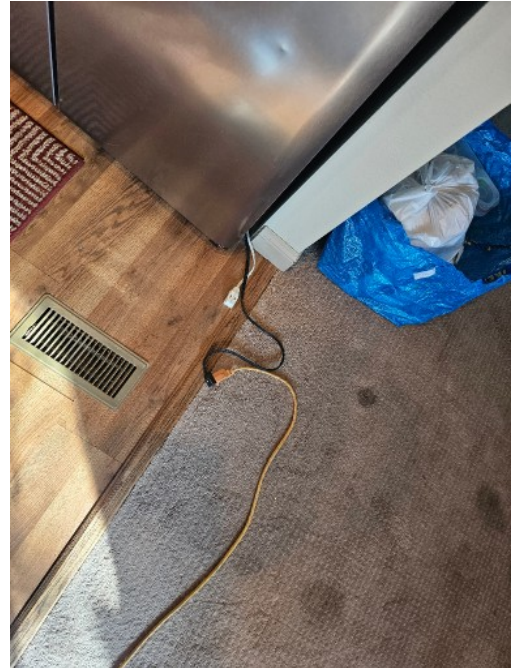
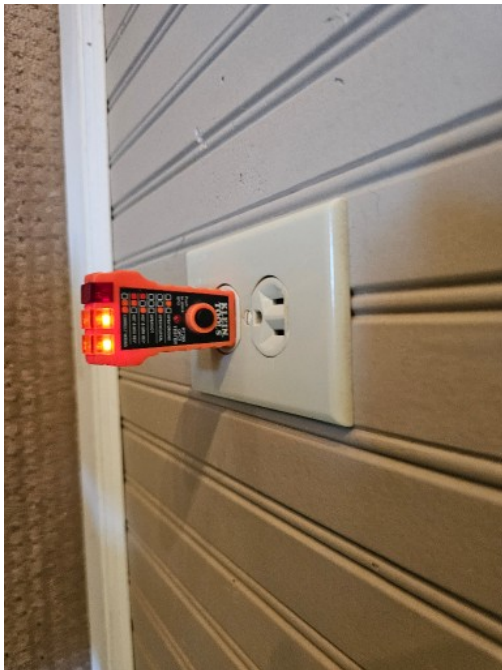
### 8.5) Electrical Conditions

The refrigerator was plugged into an extension cord that ran across the room and the circuit for refrigerator was not working correctly. It is suggested that a "Licensed Electrical Contractor" be contacted for further evaluation and repair.

GFIC (Ground Fault Interrupter Circuit) receptacle circuit (a safety device for outlets near water) recommended.

Missing receptacle or switch covers were observed at the time of inspection. Recommend covers be installed for safety.

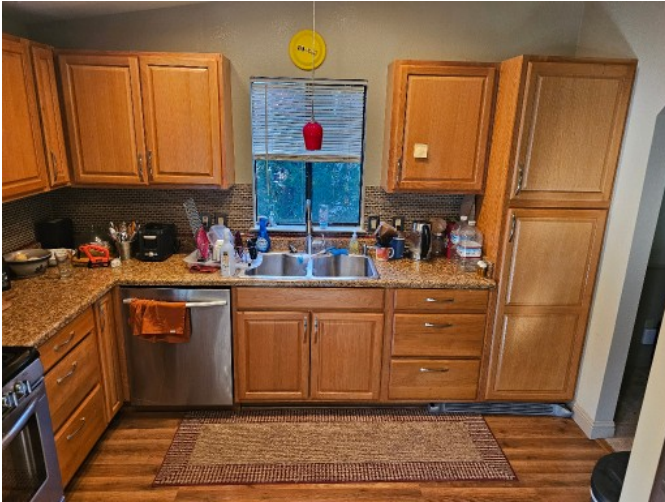
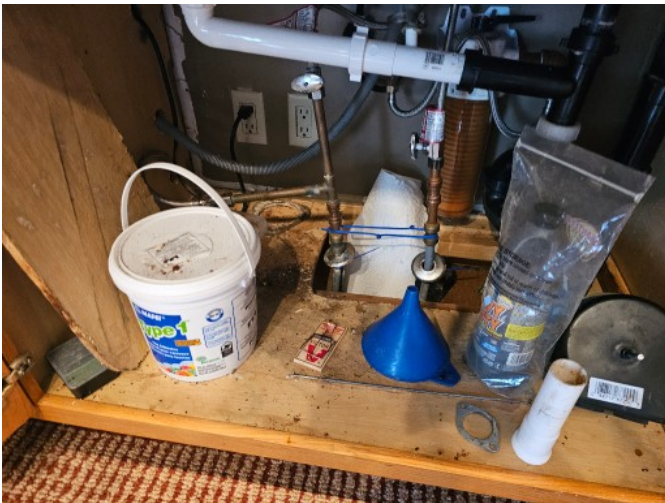
### 8.8) Cabinet Conditions

The false bottom below the sink was water damaged. Recommend replacement and/or repair. (The inspector cannot verify the extent of the damage. Some hidden damage may be revealed during repair)
