# Inspection Report

J Bixler Inspections

23732 Parrotts Ferry Rd Spc 1  
Columbia, CA 95310

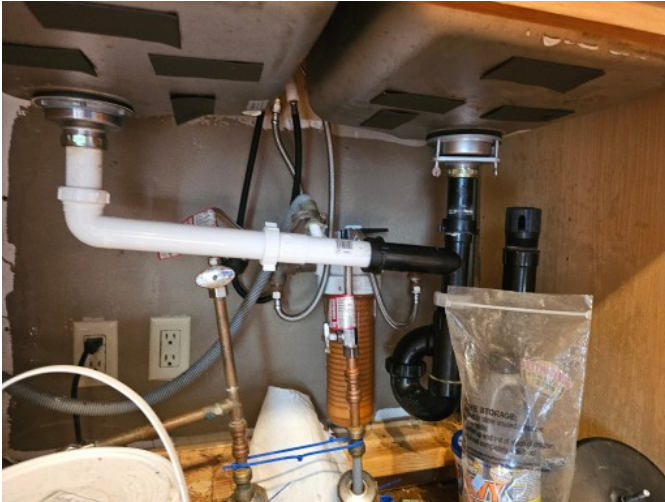
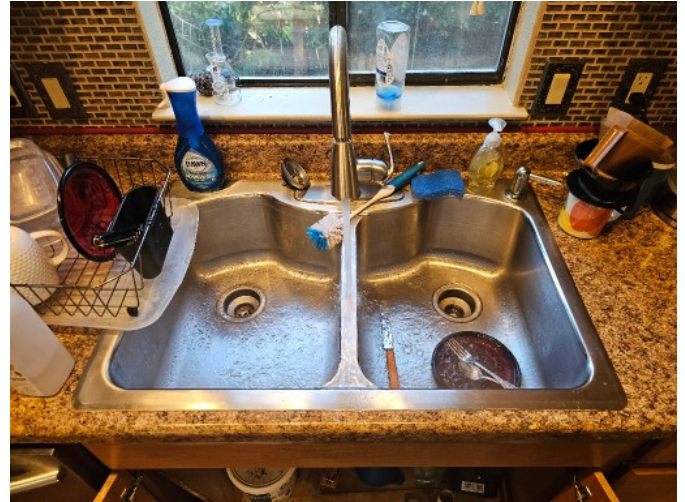
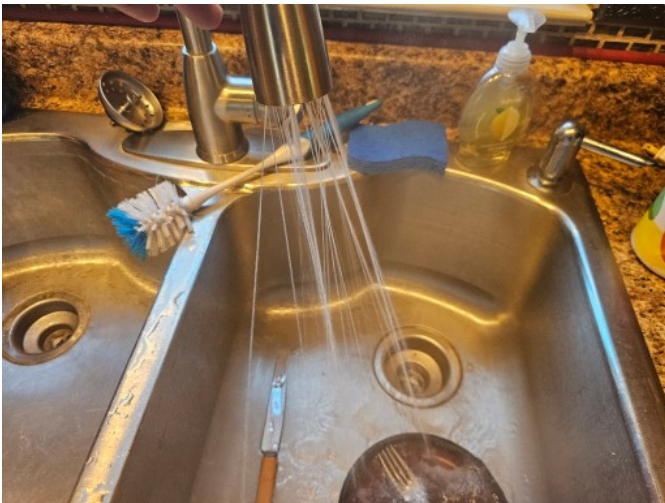
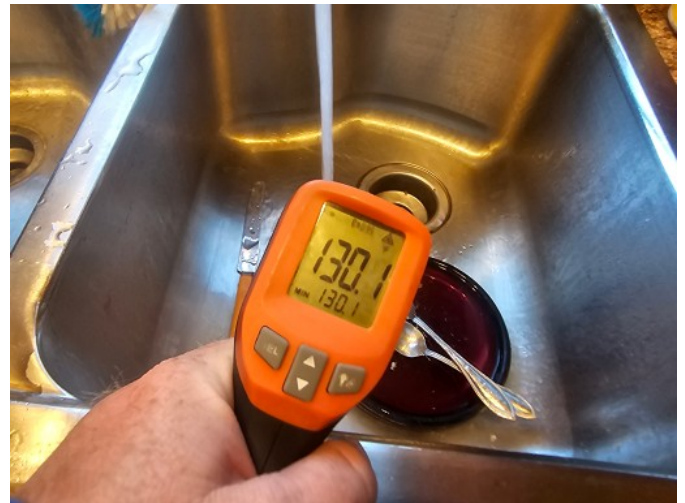
### 8.9) Sink Plumbing Conditions

The kitchen sink appeared to be in serviceable condition at the time of the inspection. The faucet appeared to be in serviceable condition at the time of the inspection. The visible areas of the plumbing under the kitchen sink appeared to be in serviceable condition at the time of the inspection.

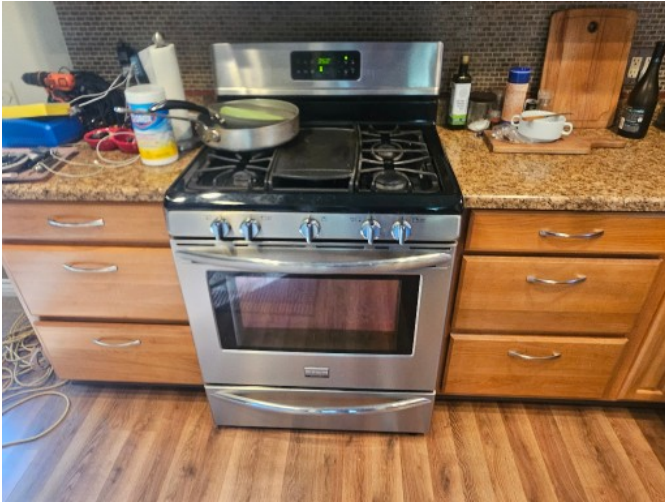
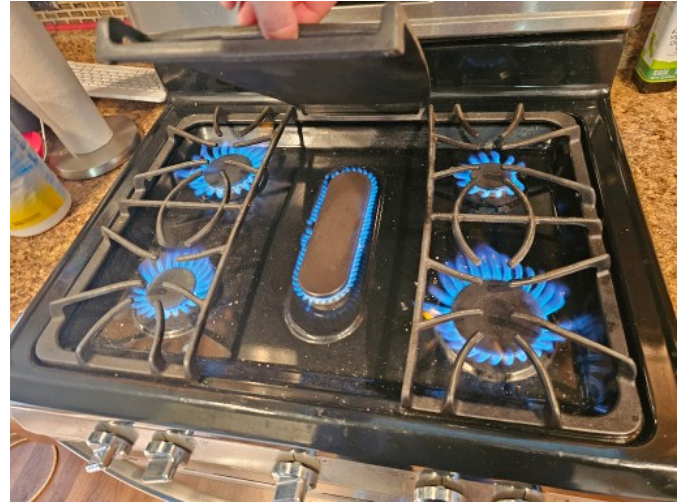
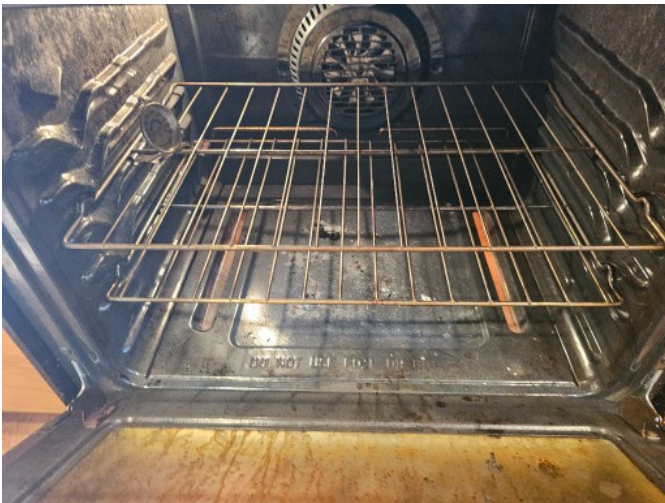
**8.10) Stove - Range Condition**

The oven was in operational condition at the time of the inspection. This does not however guarantee future conditions after the time of inspection.

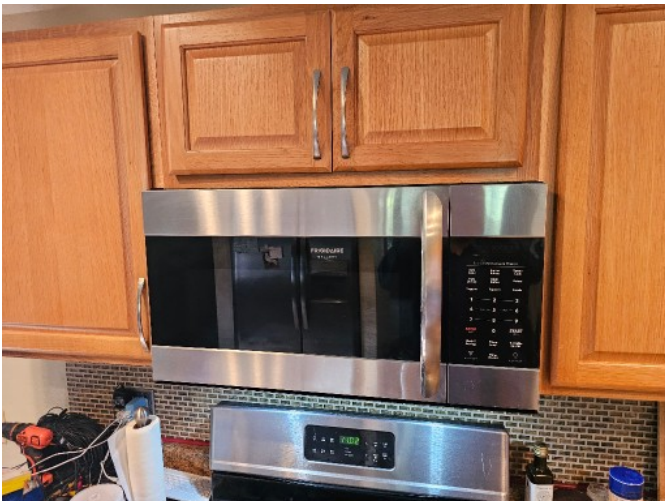
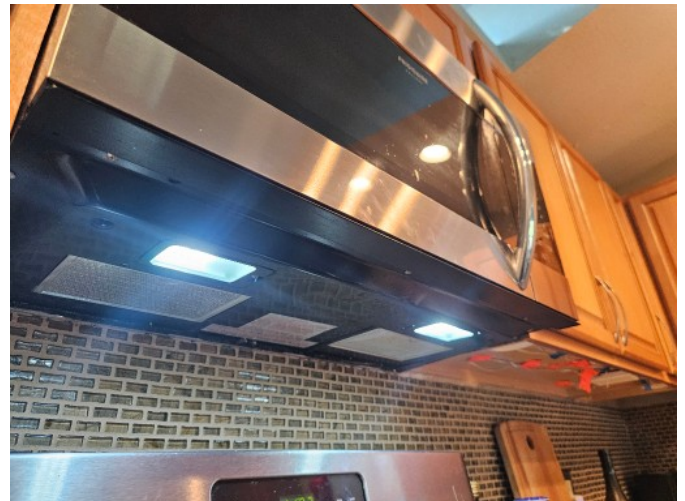
#### 8.11) Hood Fan Conditions

The fan / hood and light were in operational condition at the time of the inspection.

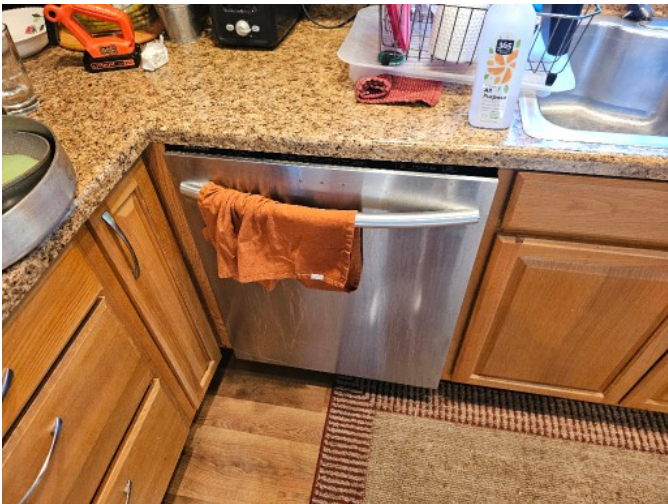
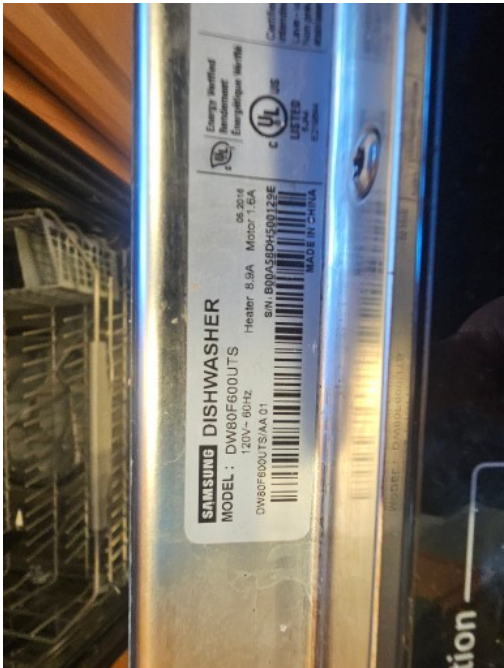
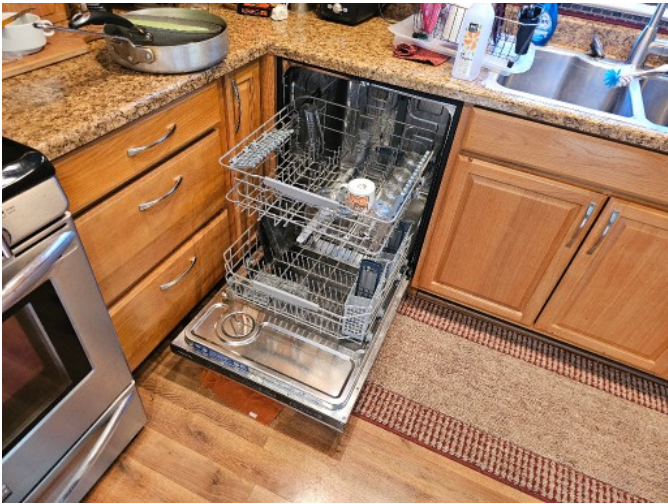
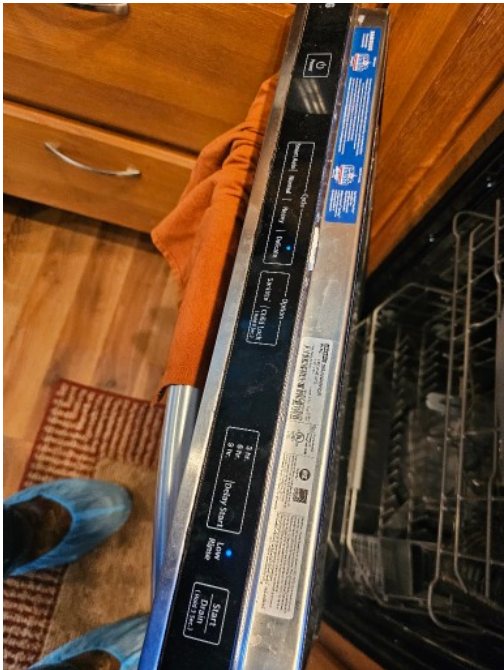
### 8.12) Dishwasher Conditions

There was no high loop or air gap for the dishwasher. Recommend having a high loop or air gap installed to prevent back-flow into the dishwasher.

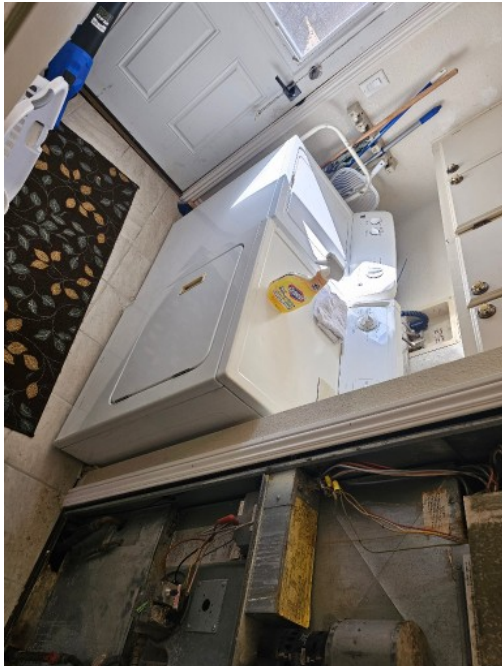
#### 9.1) Laundry Room Conditions

The visible and accessible portions of the laundry plumbing components appeared to be in serviceable condition at the time of inspection.

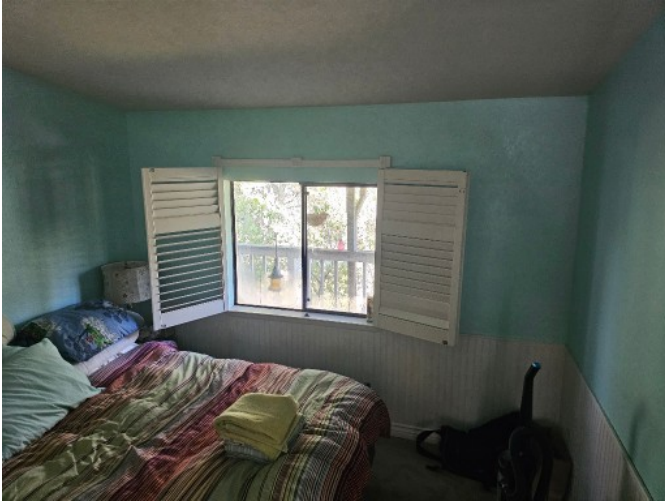
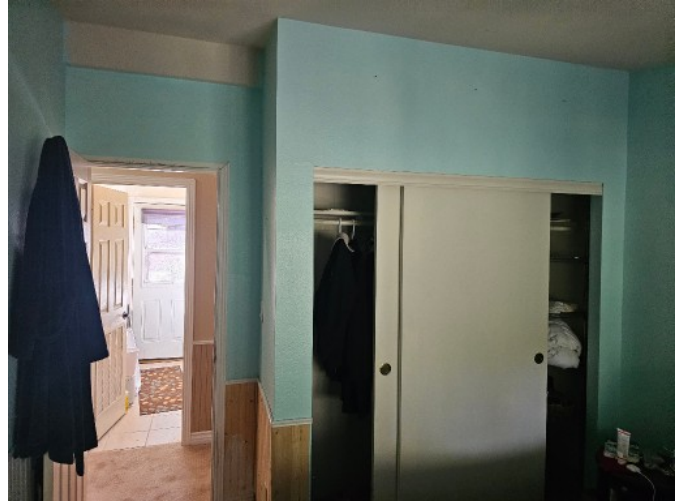
**10 Bedroom 1****Walls - Ceilings - Floors****10.1) Wall Conditions**

The general condition of the walls appeared to be in serviceable condition at the time of the inspection.

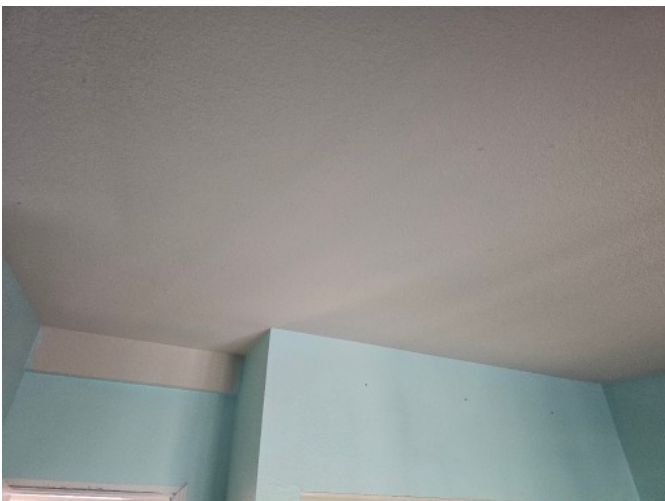
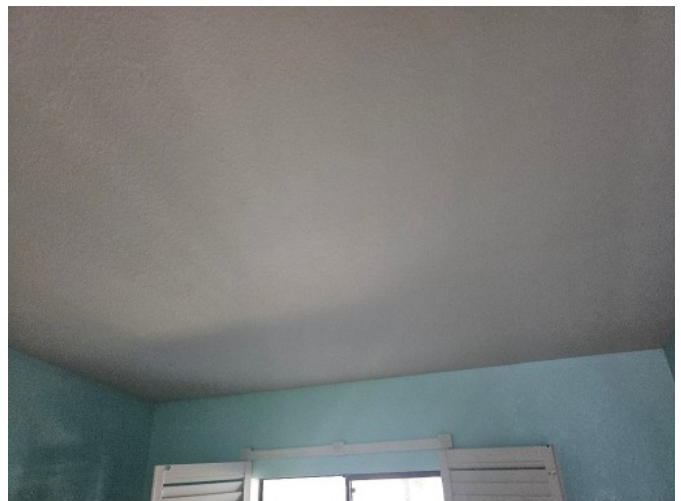
**10.2) Ceiling Conditions**

The general condition of the ceilings appeared to be in serviceable condition at the time of the inspection.

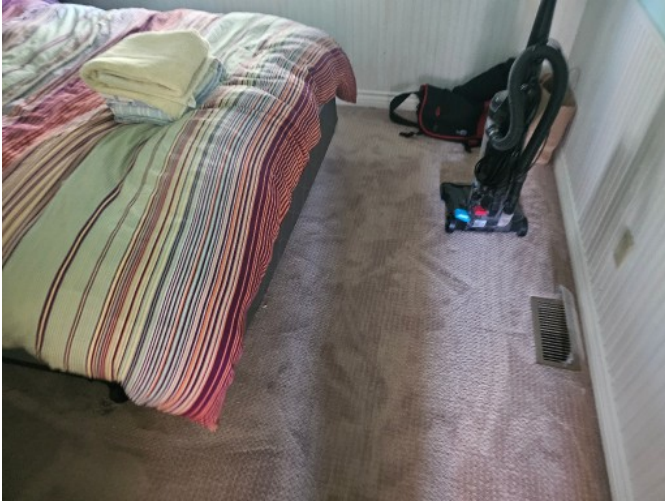
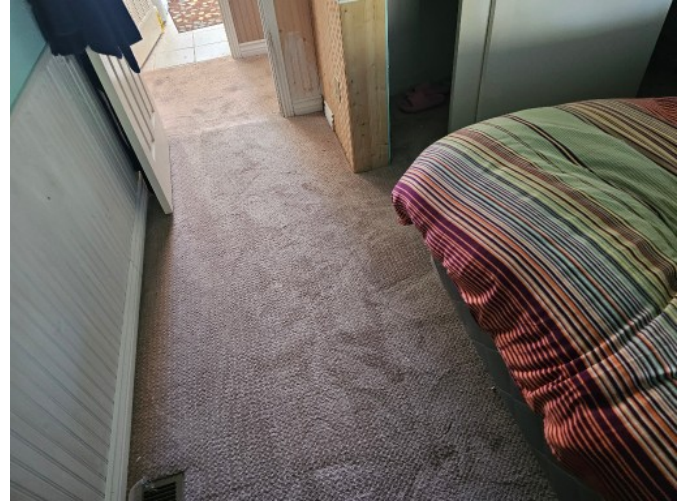
### 10.3) Floor Conditions

The general condition of the visible and accessible portions of the floors appeared to be in serviceable condition at the time of the inspection.

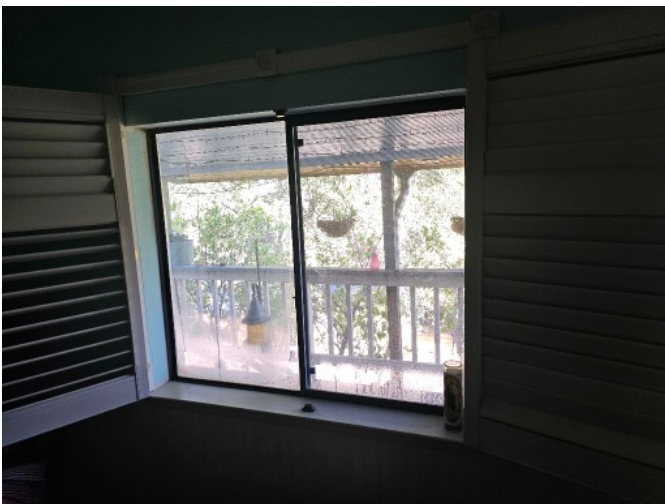
### 10.4) Interior Window Conditions

The sample of windows tested were operational at the time of the inspection.

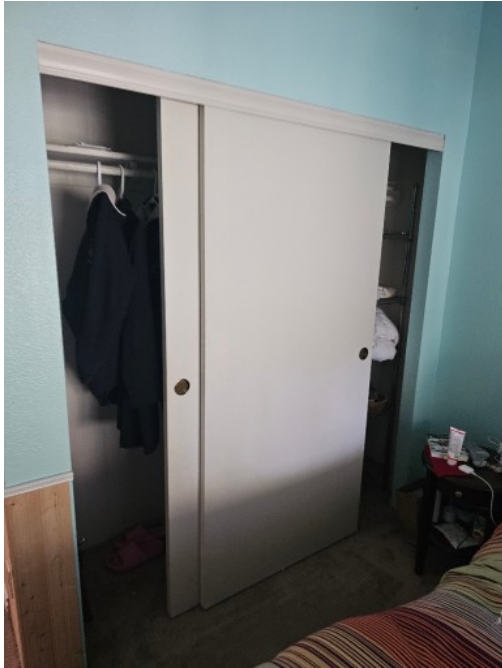
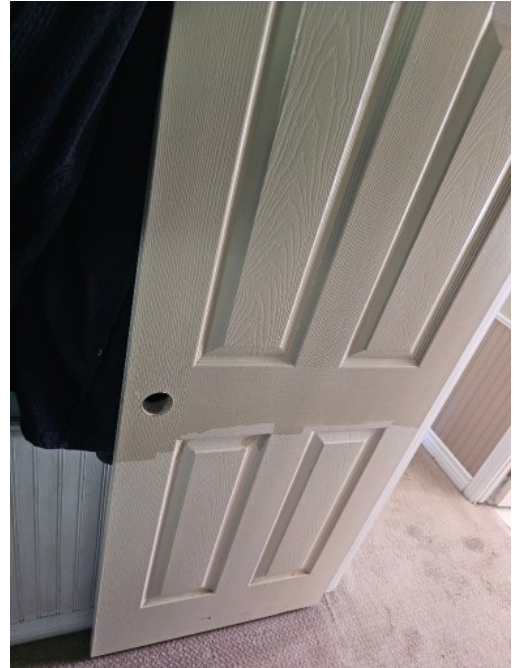
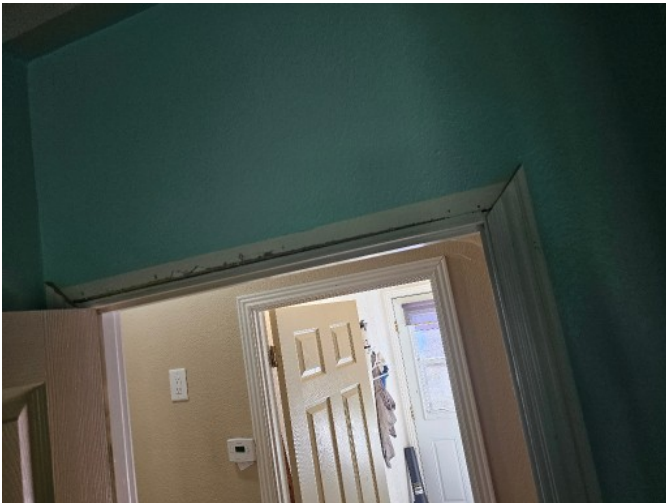
### 10.5) Interior Door Conditions

Some missing hardware and trim were noted at some of the doors. Recommend finishing.

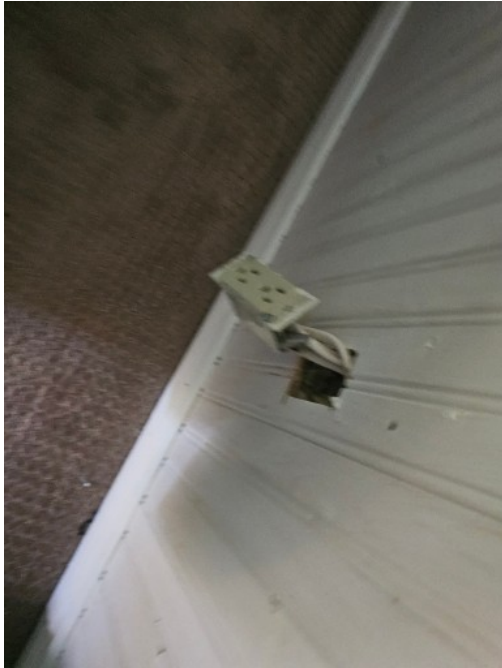
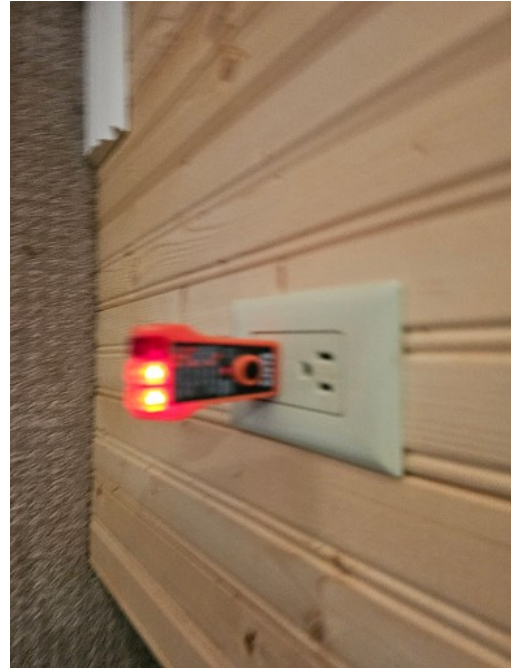
### 10.6) Electrical Conditions

A loose/damaged outlet was observed at the time of inspection. Recommend further evaluation and repair by a licensed electrician prior to close.

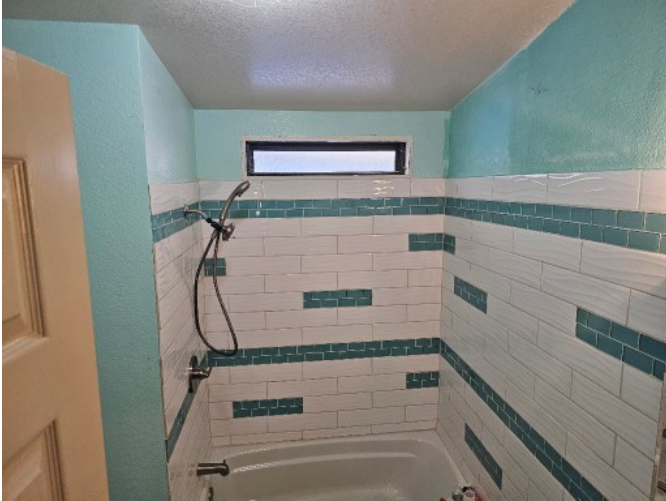
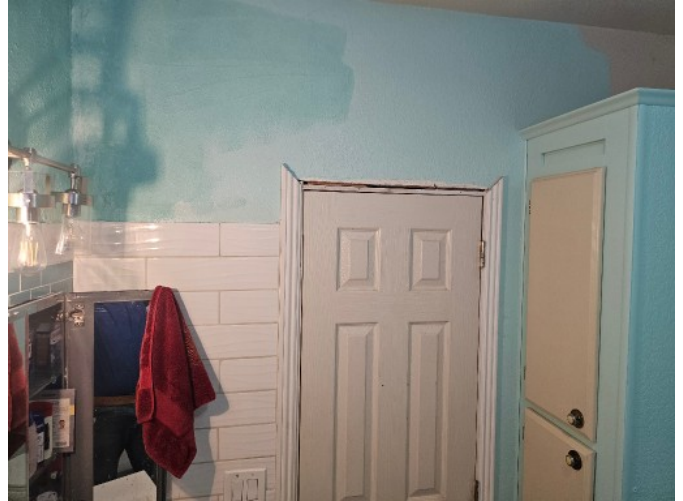
**11 Bath 1****Walls - Ceilings - Floors****11.1) Wall Conditions**

The general condition of the walls appeared to be in serviceable condition at the time of the inspection.

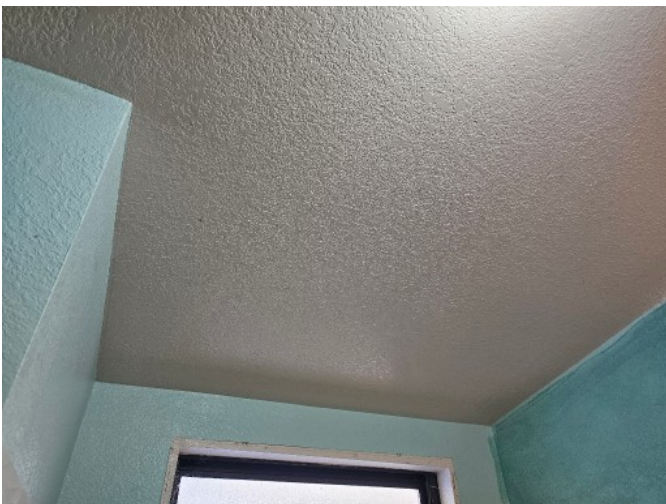
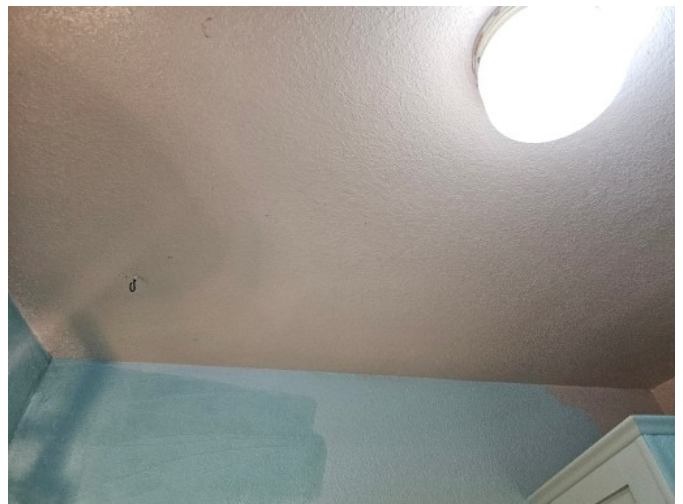
**11.2) Ceiling Conditions**

The general condition of the ceilings appeared to be in serviceable condition at the time of the inspection.

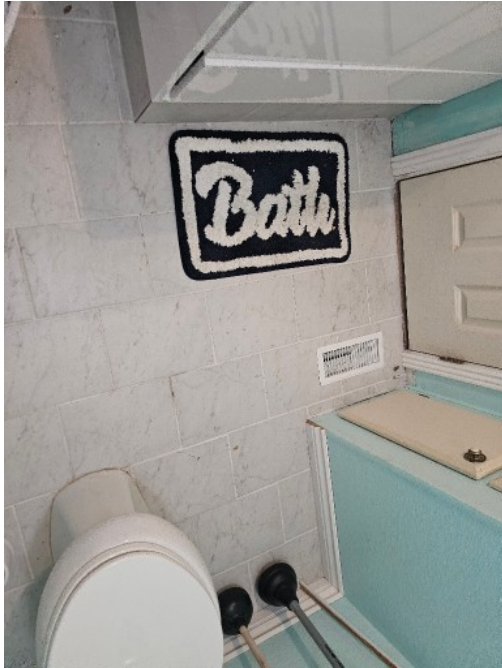
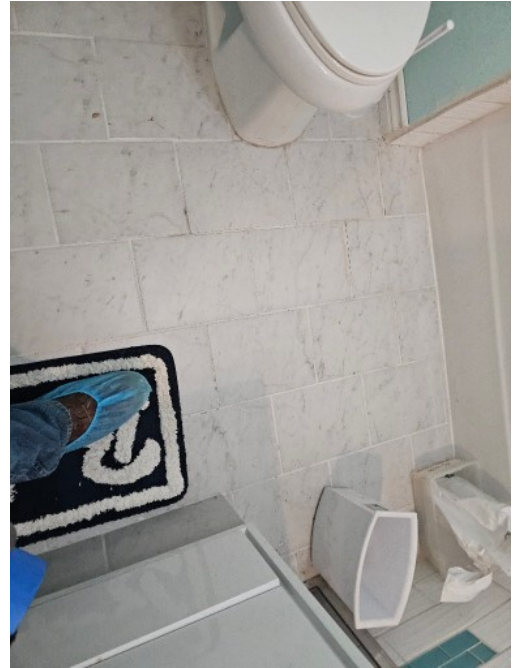
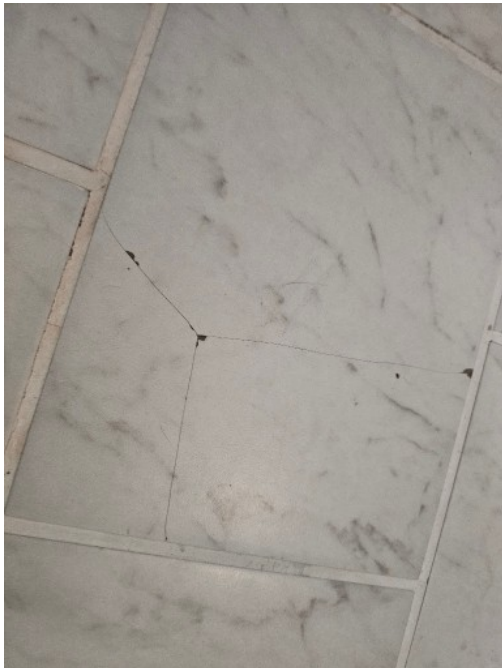
**11.3) Floor Conditions**

Tiles had loose or missing grout. Recommend proper tile work by a qualified contractor.

Cracked floor tiles were observed at the time of inspection. Recommend repair as needed.

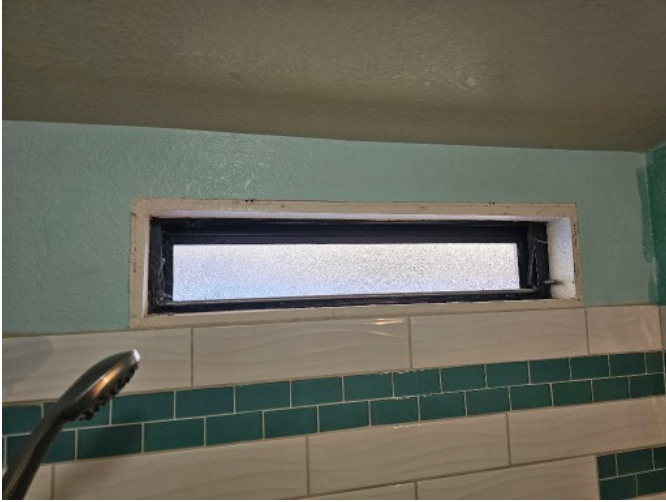
### 11.4) Bathroom Window Conditions

The sample of windows tested were operational at the time of the inspection.

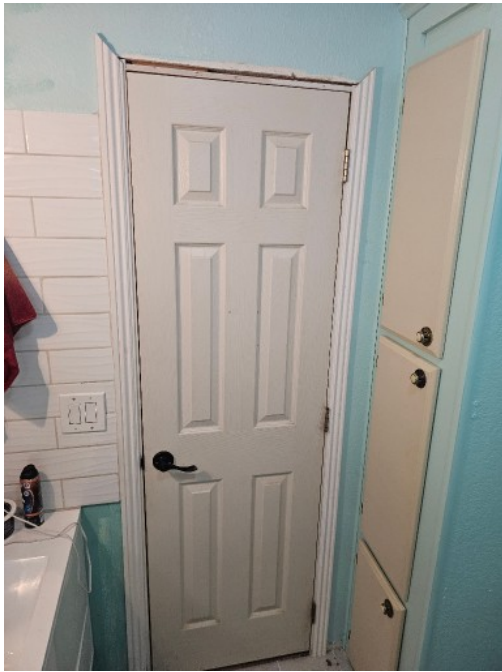
### 11.5) Bathroom Door Conditions

Some missing trim and finish work was noted at the door. Recommend finishing.

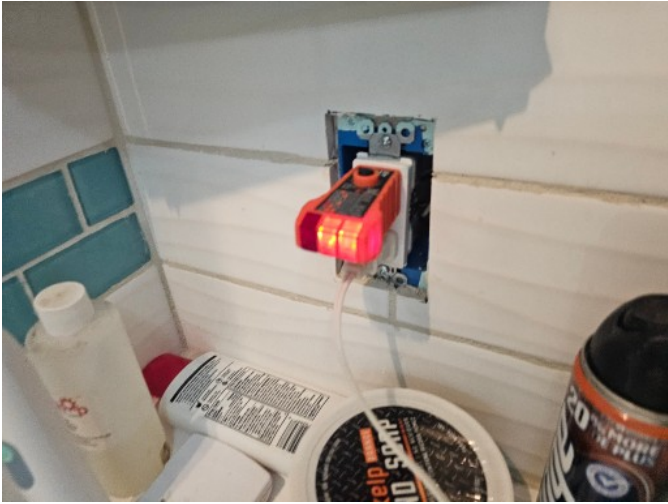
### 11.6) Electrical Conditions

The outlet was missing the appropriate cover.

GFCI (Ground Fault Circuit Interrupter) receptacle circuit (a safety device for outlets near water) recommended.

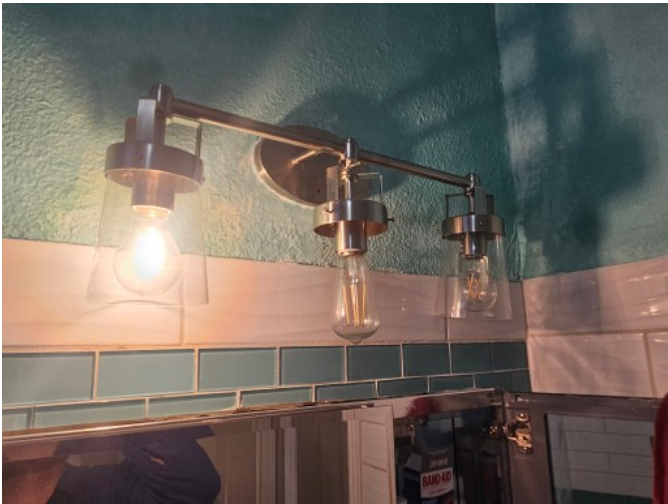
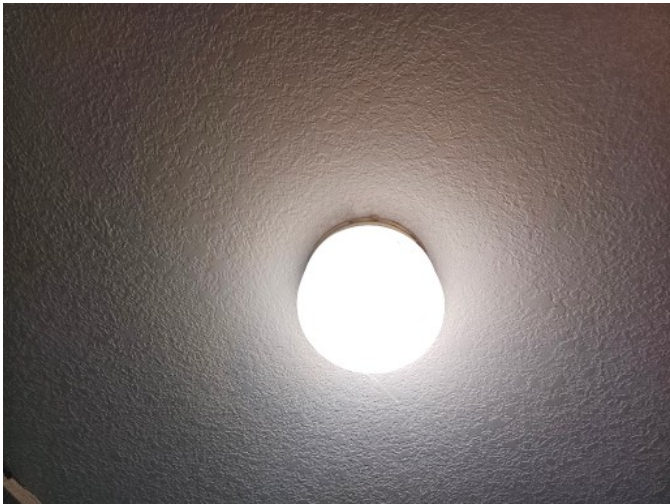
11.7) Lighting Conditions

Appears Serviceable.

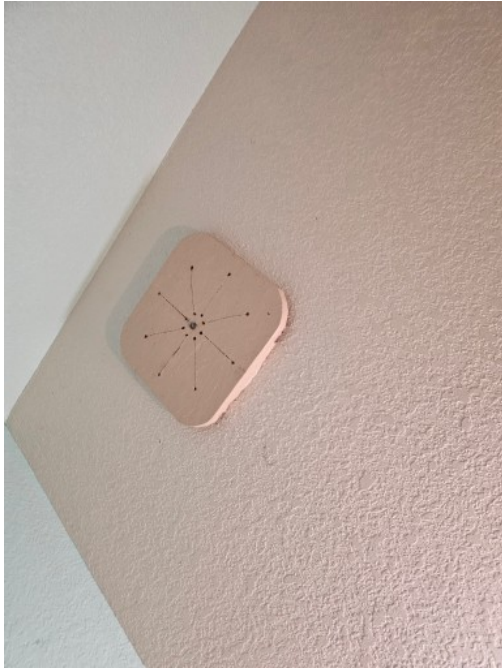
11.8) Vent Fan Conditions

The exhaust fan did not operate or was disconnected. Please refer to limitations of inspection regarding mold / moisture related conditions.

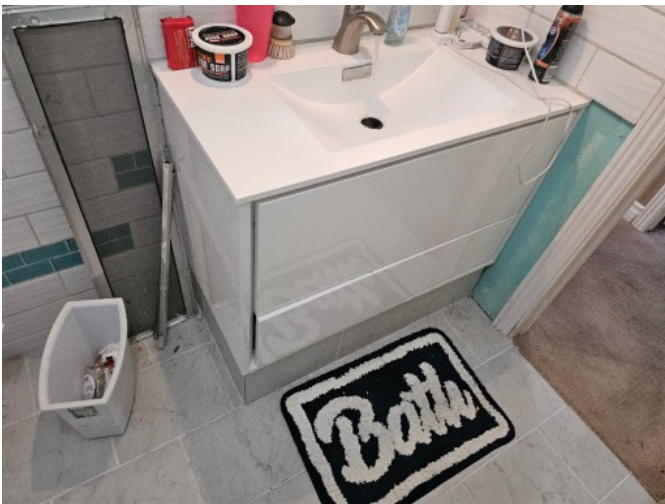
### 11.9) Counter - Cabinet Conditions

The drawers wouldn't open correctly. Recommend adjustments and/or repair.

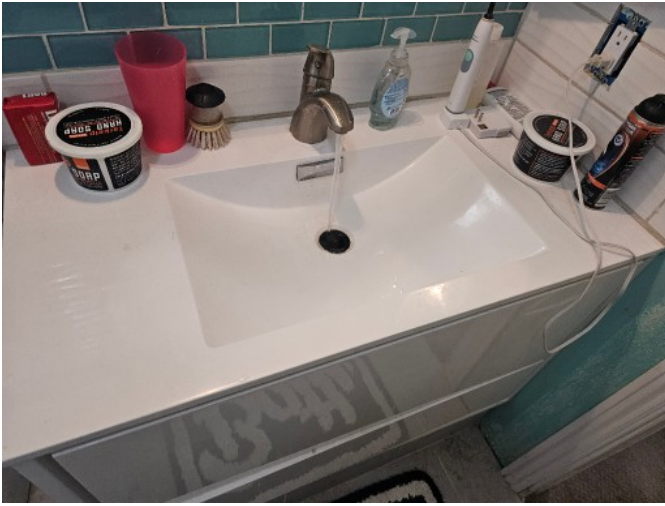
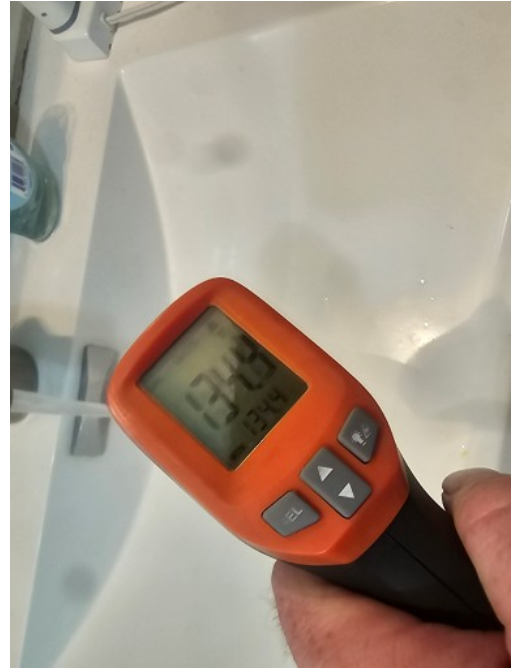
### 11.10) Sink Conditions

The sink appeared to be in serviceable condition at the time of inspection in bath.

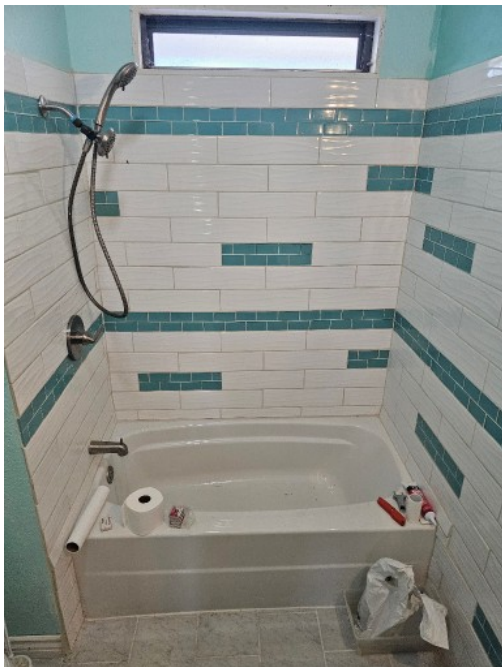
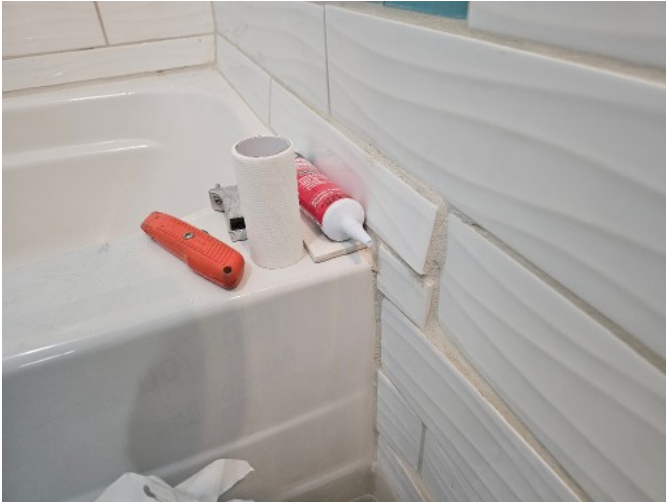
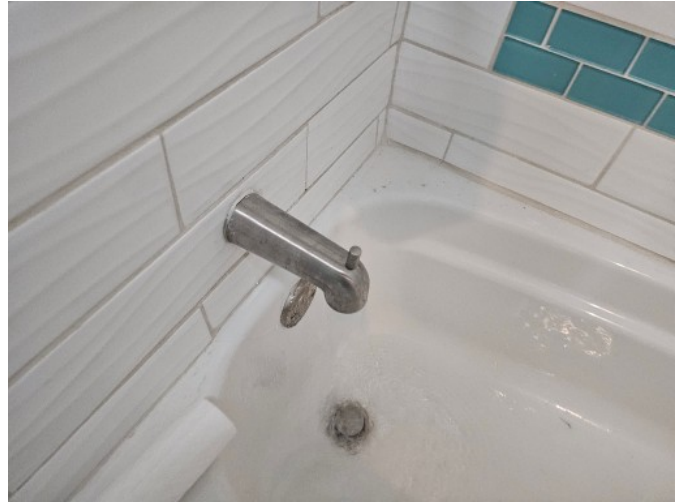
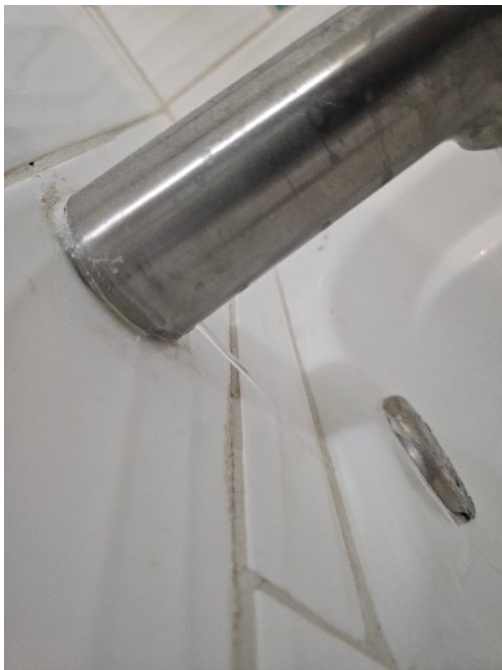
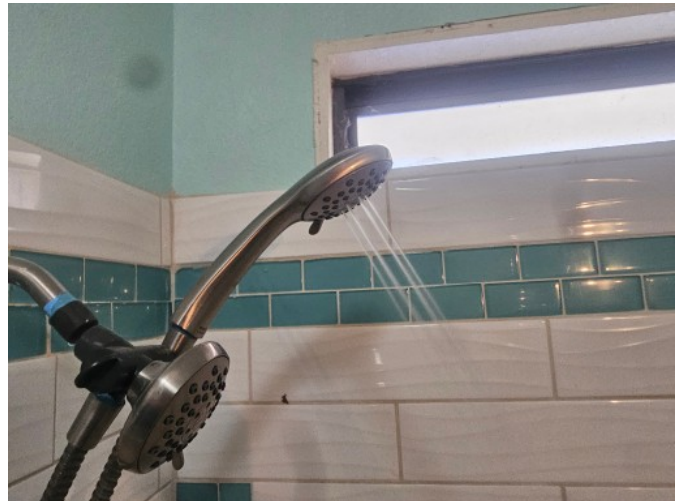
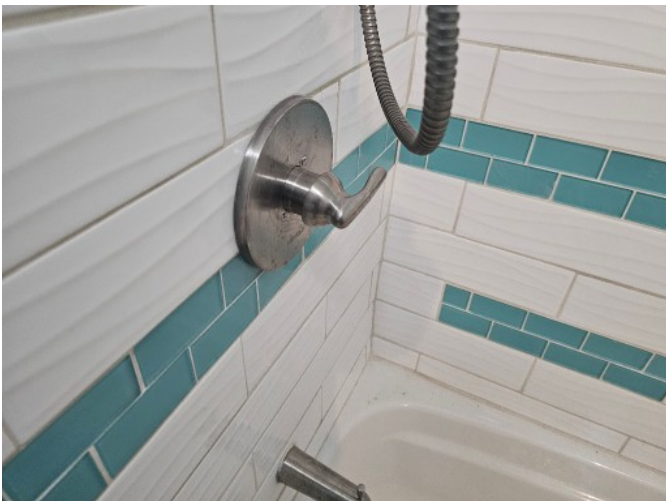
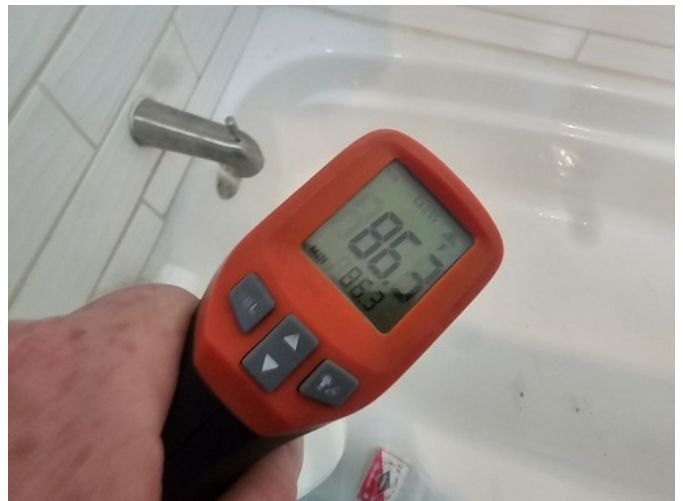
#### 11.11) Shower - Tub Conditions

Unprofessional tile work was noted around the tub and enclosure, which has lead to bottom row buckling away from wall. Recommend further evaluation and repair or replacement.

The bathtub faucet was leaking. Recommend repair.

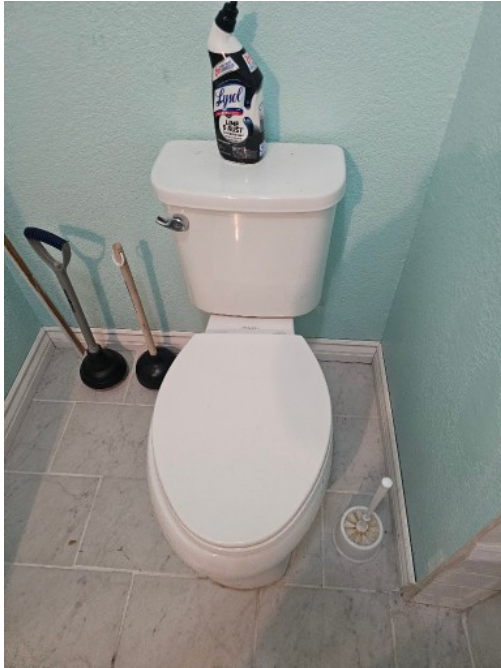
## 11.12) Toilet Conditions

The toilet appeared to be in serviceable condition at the time of inspection in bath.

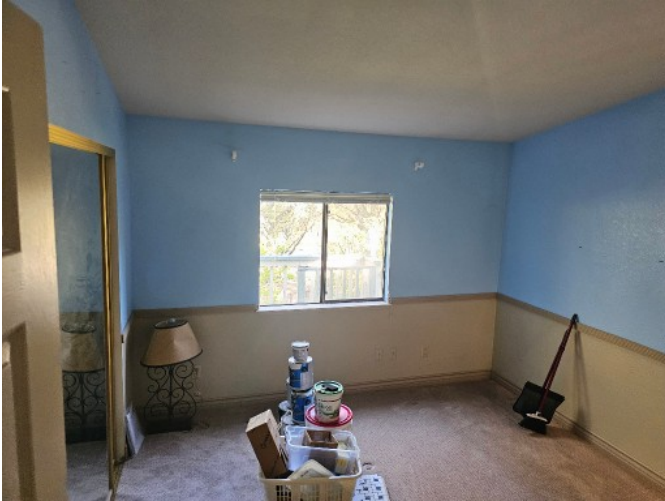
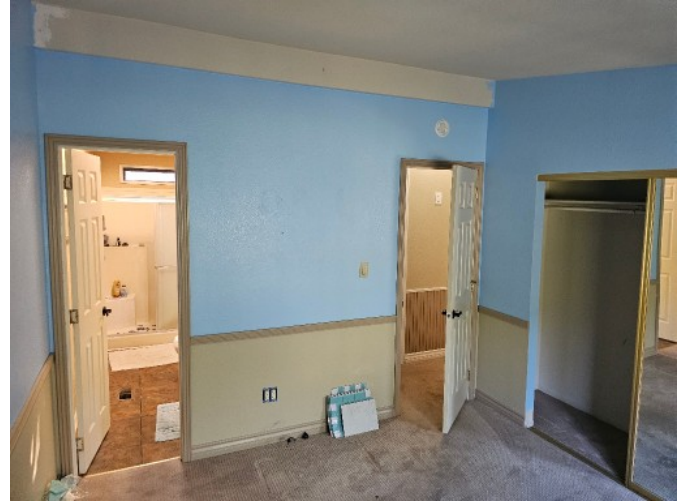
#### 12.1) Wall Conditions

The general condition of the walls appeared to be in serviceable condition at the time of the inspection.

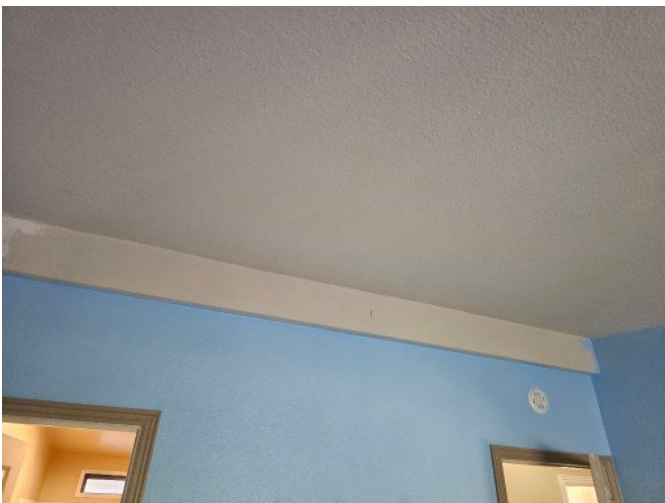
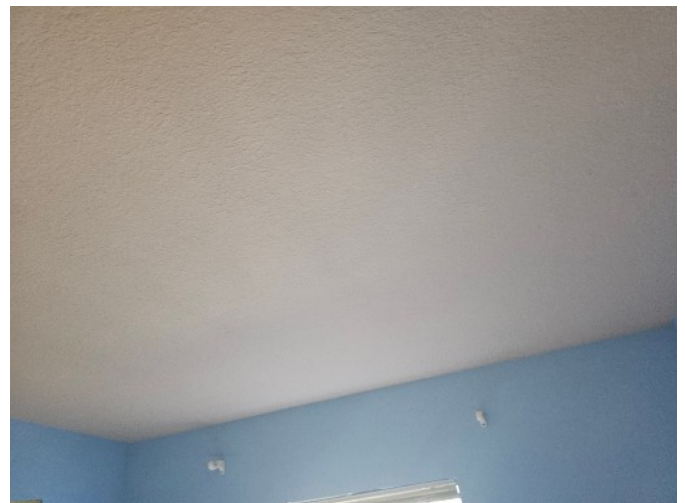
#### 12.2) Ceiling Conditions

The general condition of the ceilings appeared to be in serviceable condition at the time of the inspection.

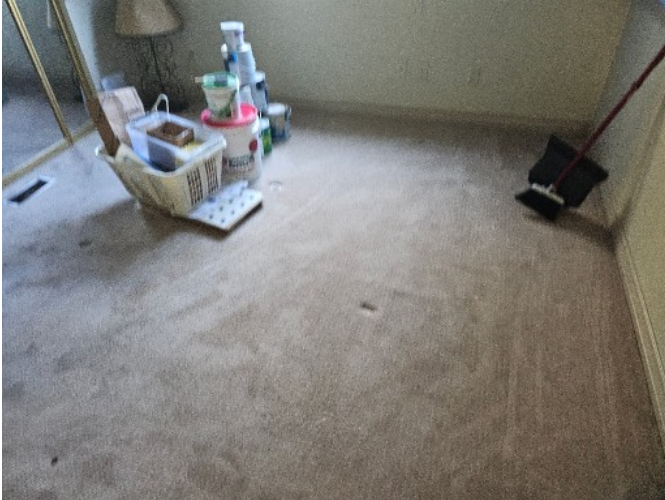
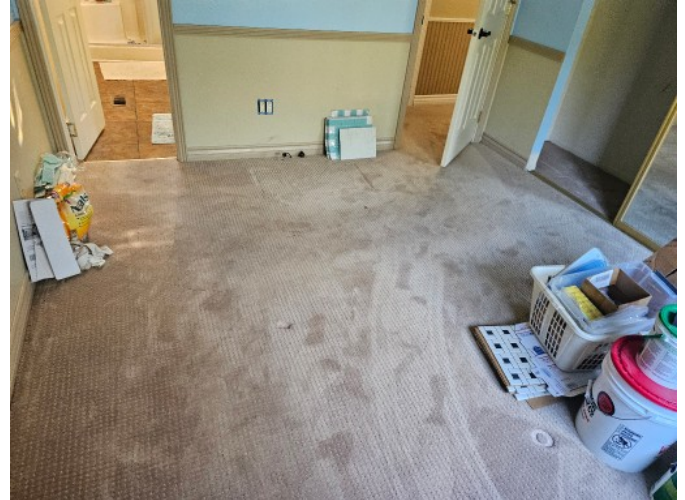
### 12.3) Floor Conditions

The carpets appear to be worn.

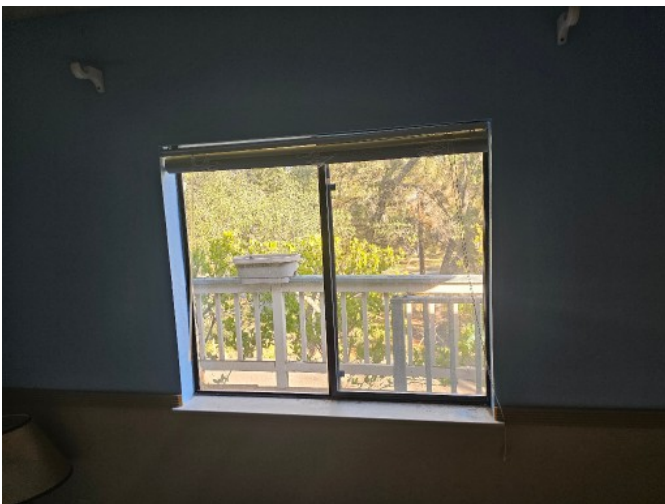
#### 12.4) Interior Window Conditions

Moisture stains were noted at the windowsill(s). This is common with aluminum windows due to the condensation. Recommend wiping down and/or maintenance as needed.

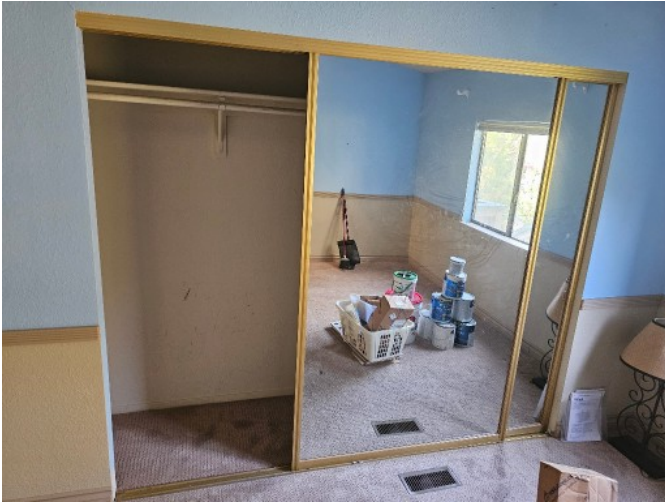
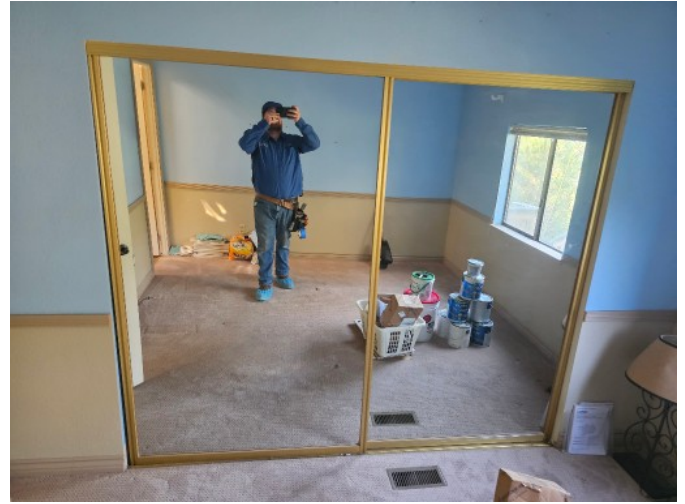
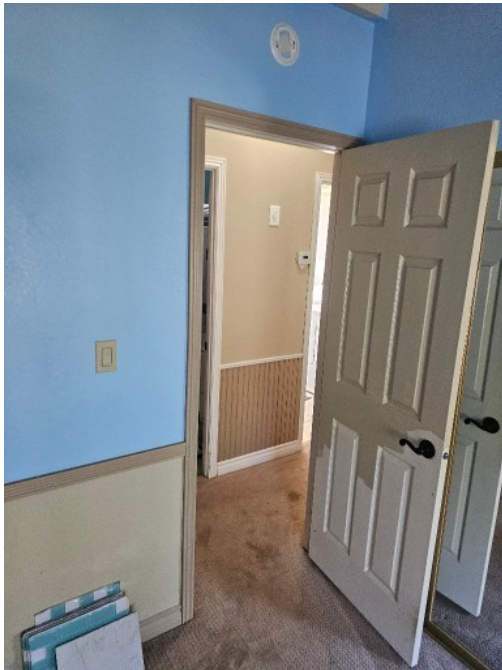
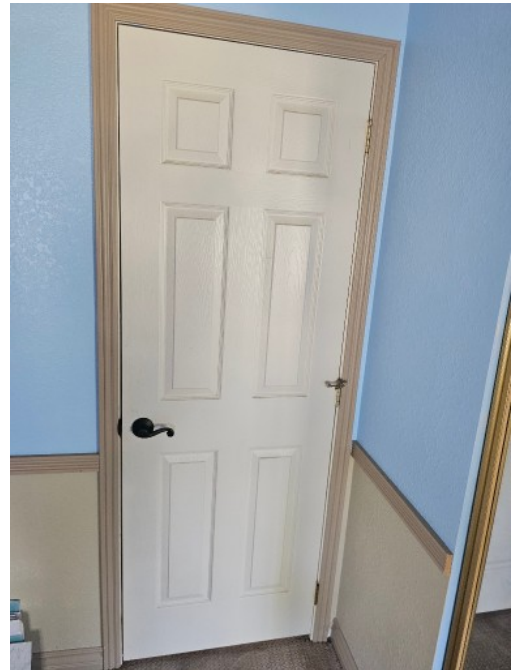
#### 12.5) Interior Door Conditions

The interior doors appeared to be in serviceable condition at the time of the inspection.

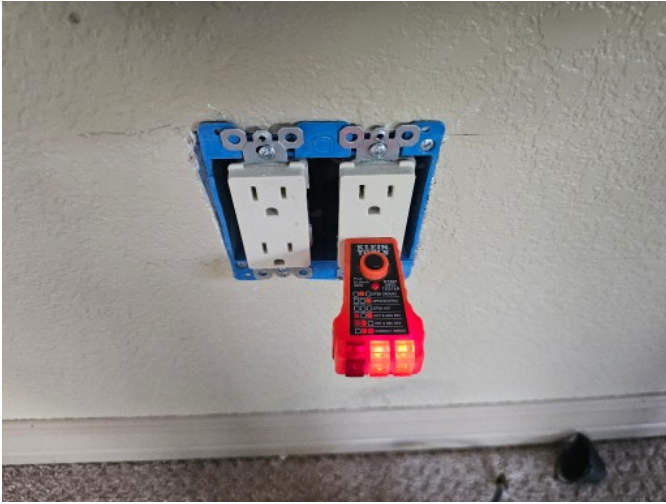
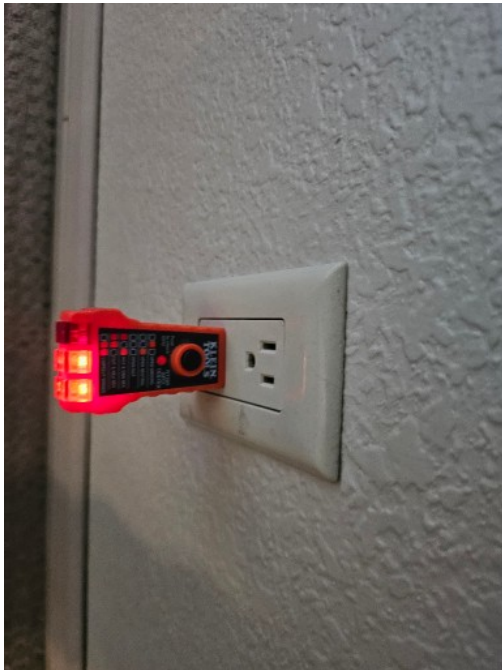
### 12.6) Electrical Conditions

Missing receptacle or switch covers were observed at the time of inspection. Recommend covers be installed for safety.

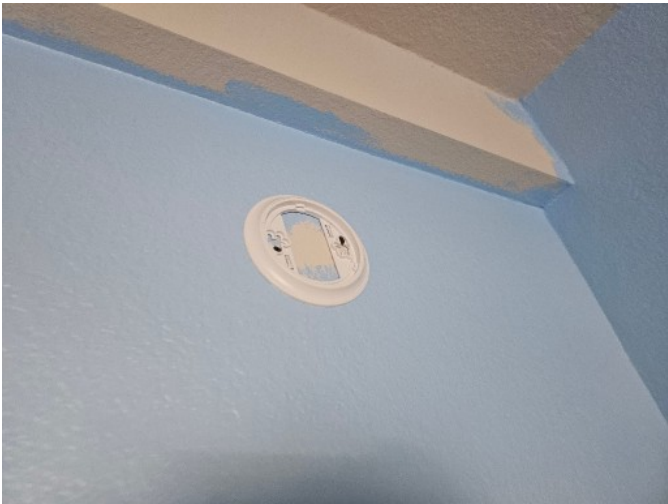
### 12.7) Smoke Detector Conditions

The smoke detector was missing or removed.

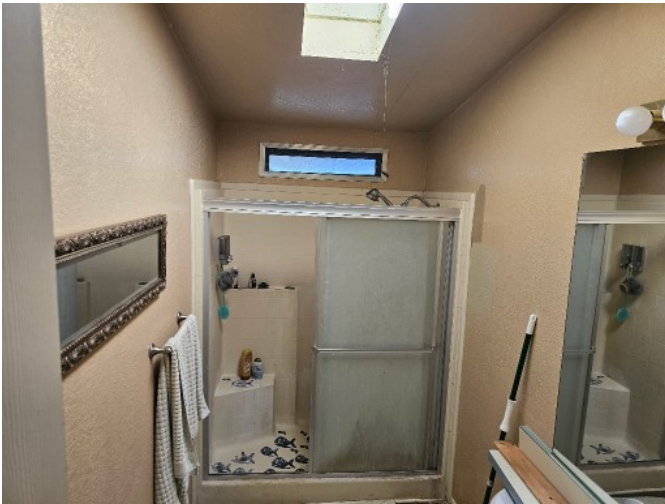
#### 13.1) Wall Conditions

There were common/typical settlement-type cracks observed at the interior walls.
