# Inspection Report

J Bixler Inspections

23732 Parrotts Ferry Rd Spc 1  
Columbia, CA 95310

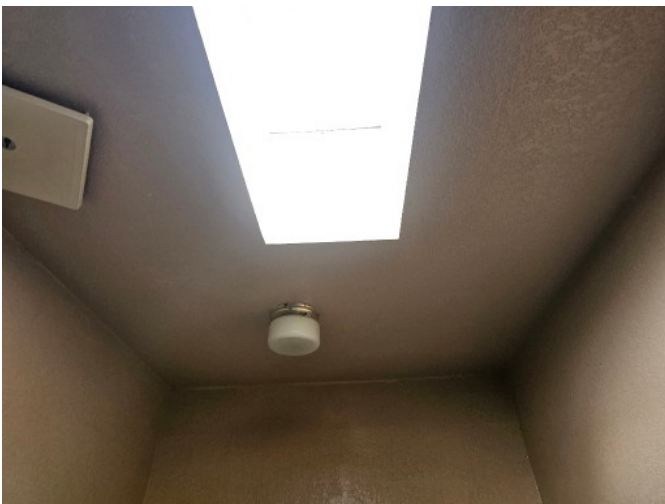
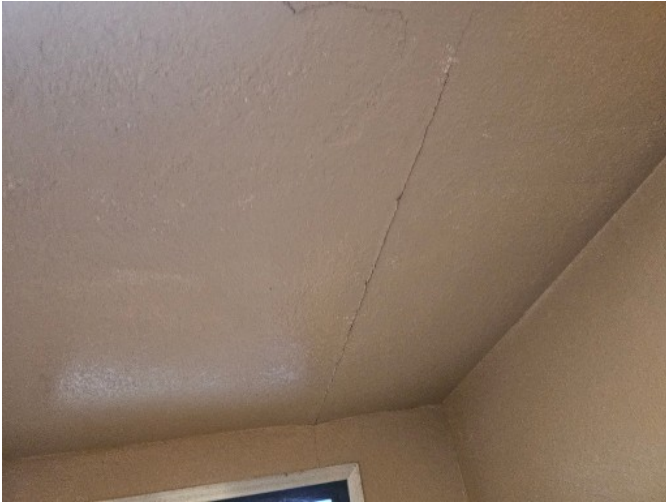
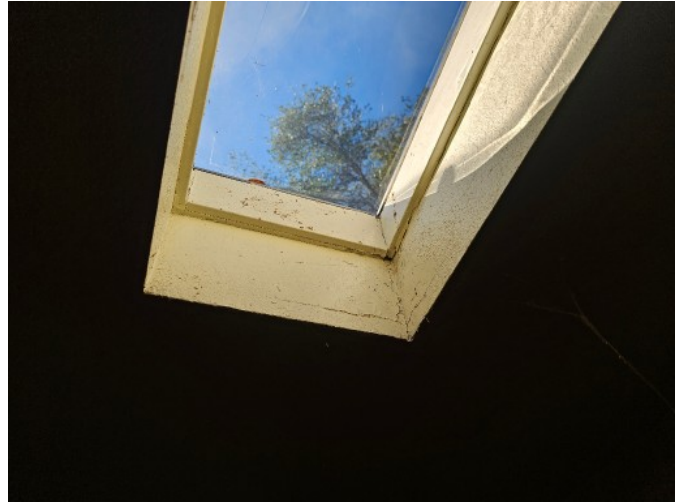
#### 13.2) Ceiling Conditions

Some moisture damage was noted around the skylight. Recommend removing any damaged materials for further investigations and repairs or replacement.

Common cracks were observed at the ceiling.

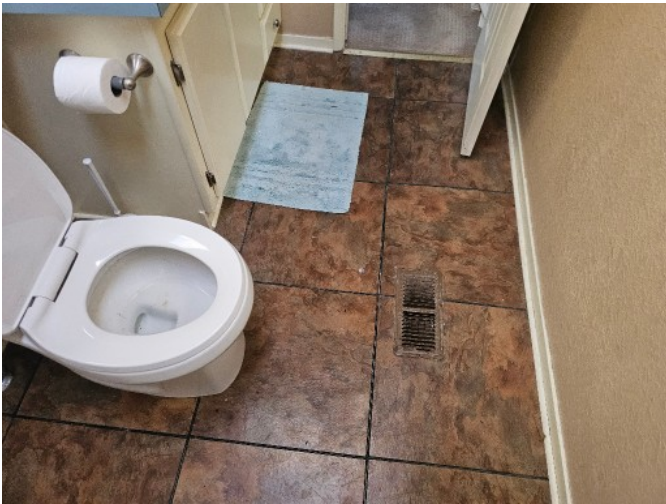
### 13.3) Floor Conditions

Soft and buckled flooring with sloping was noted. This area may need to be opened up for further investigations and repairs or replacement.

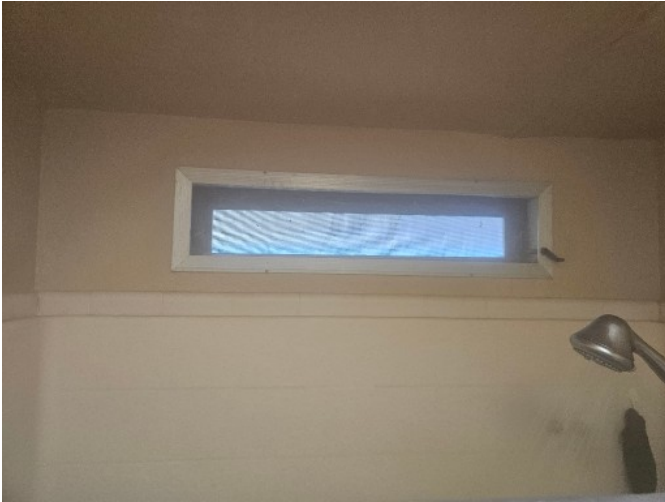
### 13.4) Bathroom Window Conditions

Appears Serviceable.

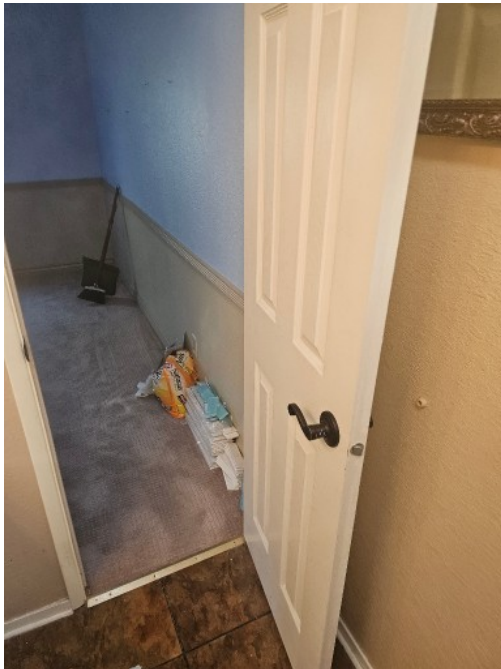
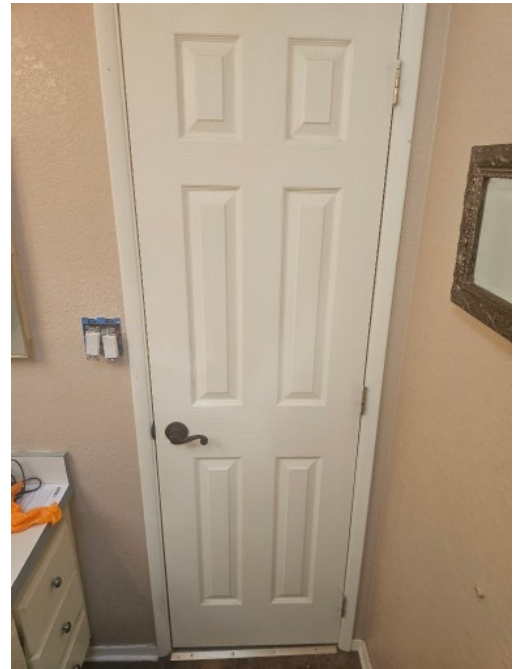
### 13.5) Bathroom Door Conditions

The interior doors appeared to be in serviceable condition at the time of the inspection.

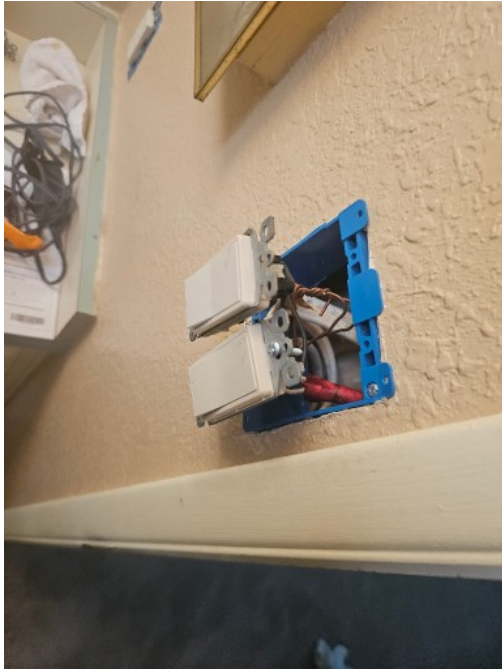
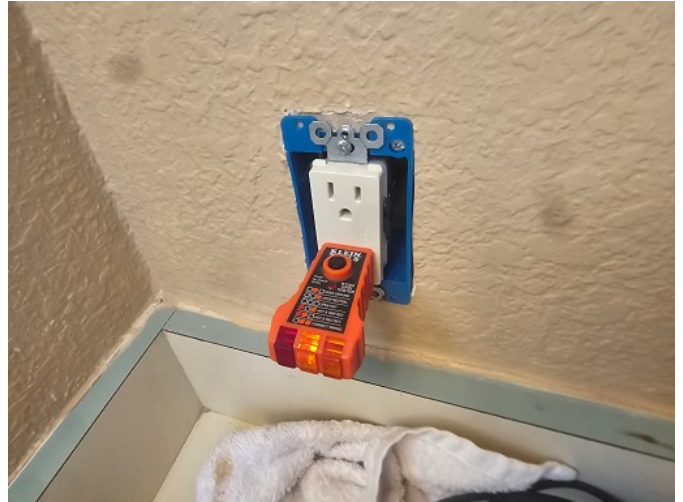
### 13.6) Electrical Conditions

GFIC (Ground Fault Interrupter Circuit) receptacle circuit (a safety device for outlets near water) recommended.

Three-pronged outlets did not test for proper ground at the time of inspection. Recommend further evaluation and repairs by a licensed electrician prior to close.

The switches were loose and pulled from wall. When turned on, they would sometimes trip breaker. It's recommended that an electrician be contacted for full evaluation and repairs.

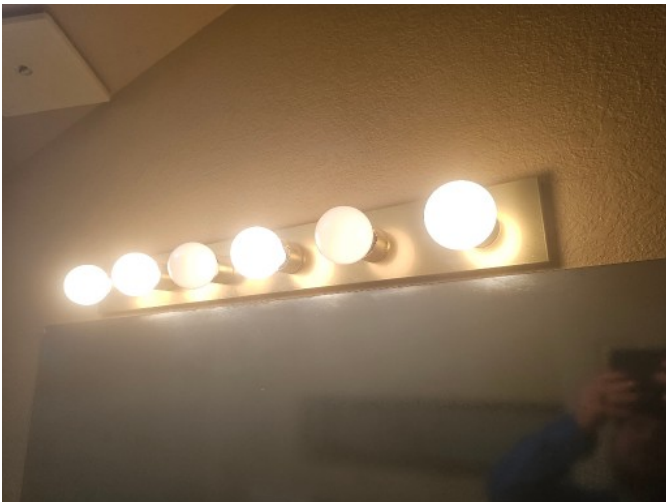
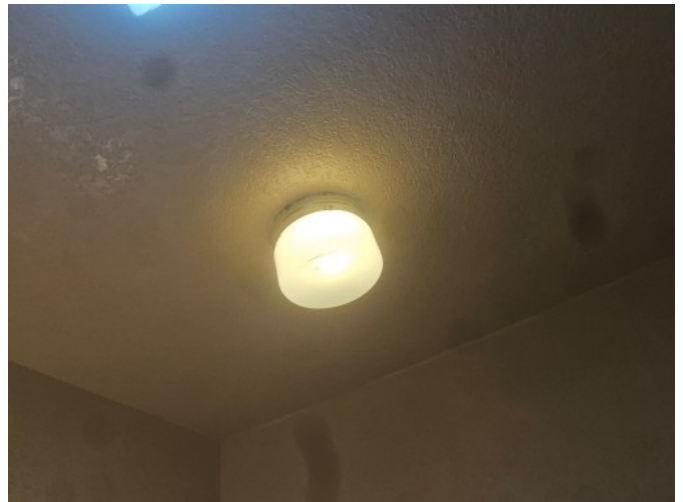
### 13.7) Lighting Conditions

Appears Serviceable.

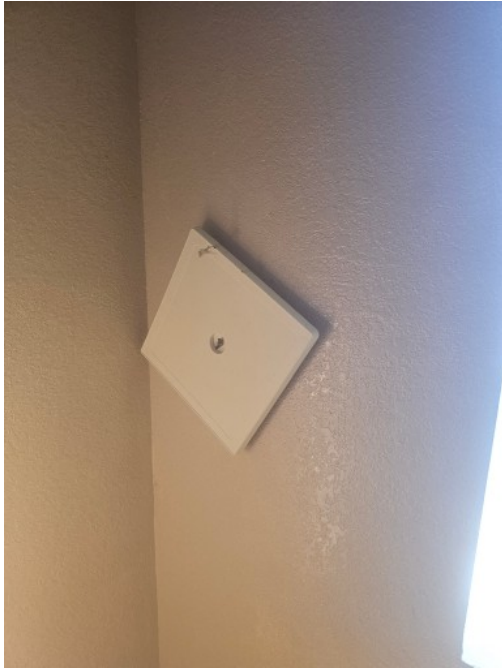
### 13.8) Vent Fan Conditions

Appears Serviceable.

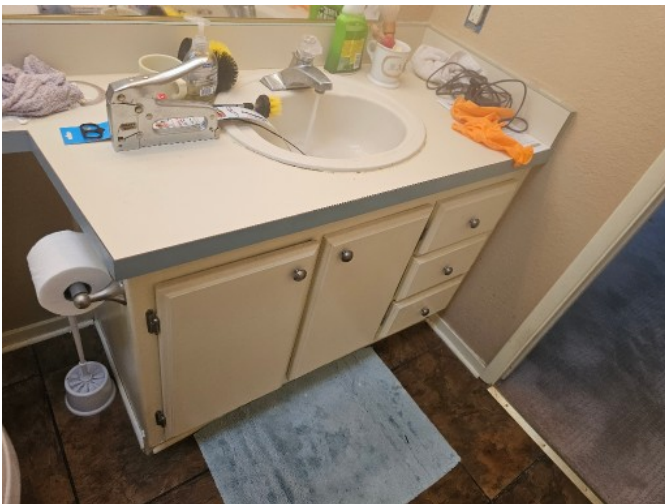
### 13.9) Counter - Cabinet Conditions

Minor wear was observed at the counter/cabinets.

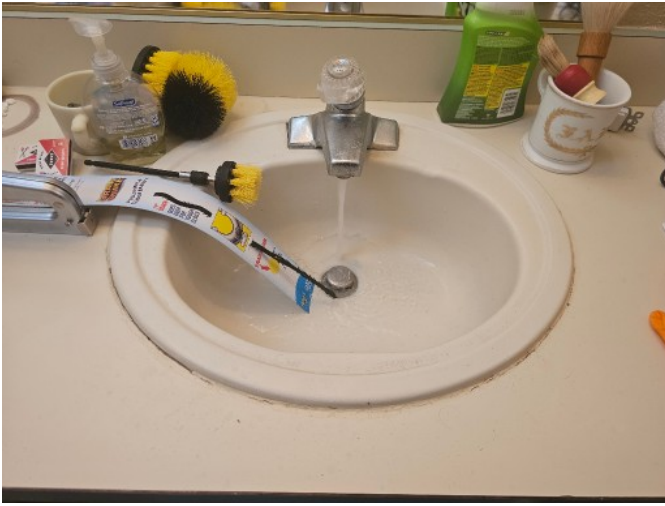
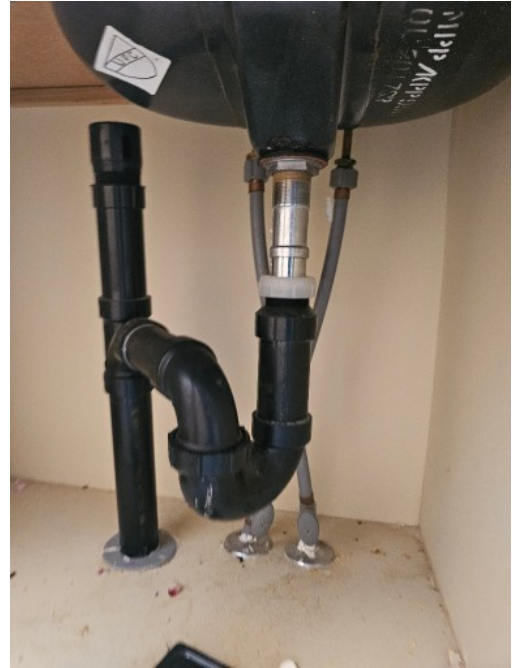
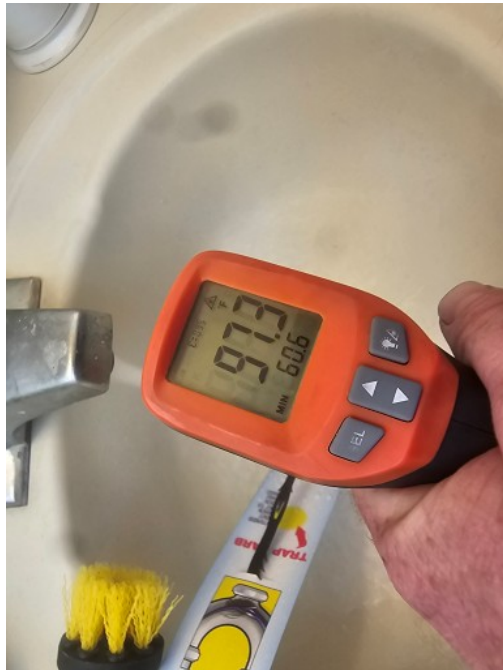
### 13.10) Sink Conditions

The sink appeared to be in serviceable condition at the time of inspection.

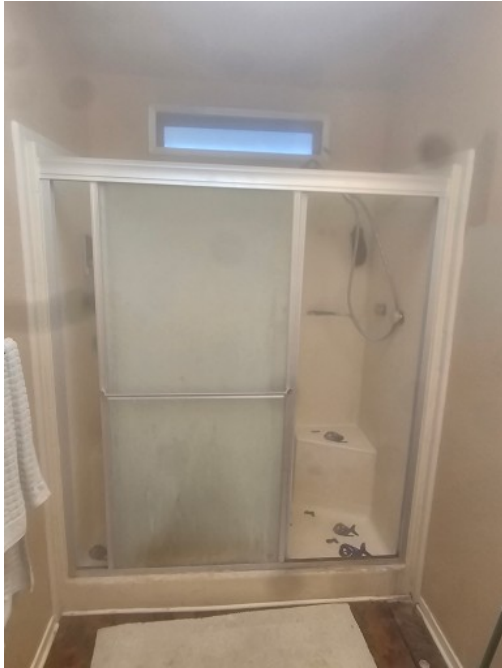
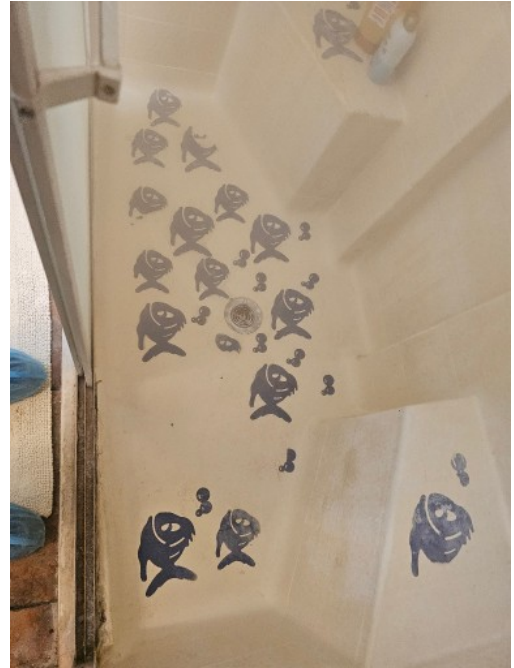
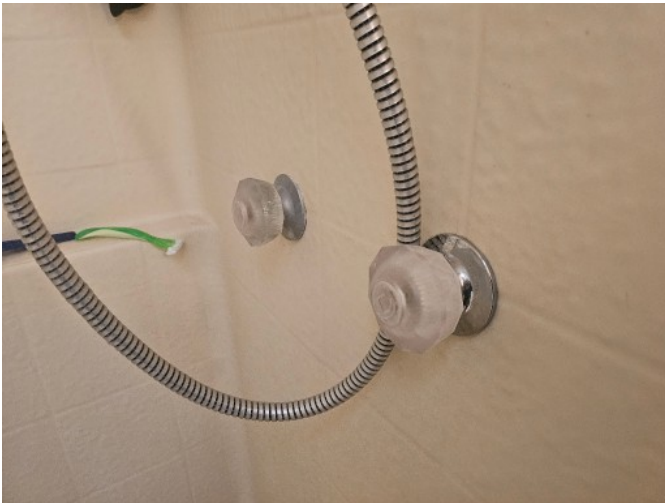
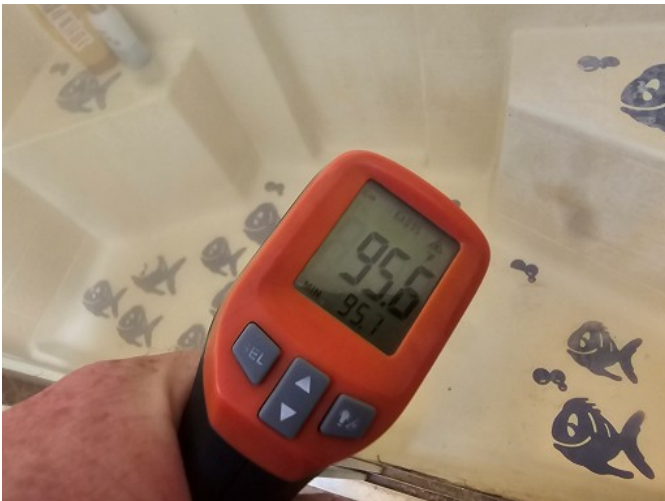
#### 13.11) Shower - Tub Conditions

Deteriorated or old caulking was noted around the pan and shower enclosure. Recommend removing the comprised caulking and resealing as needed.

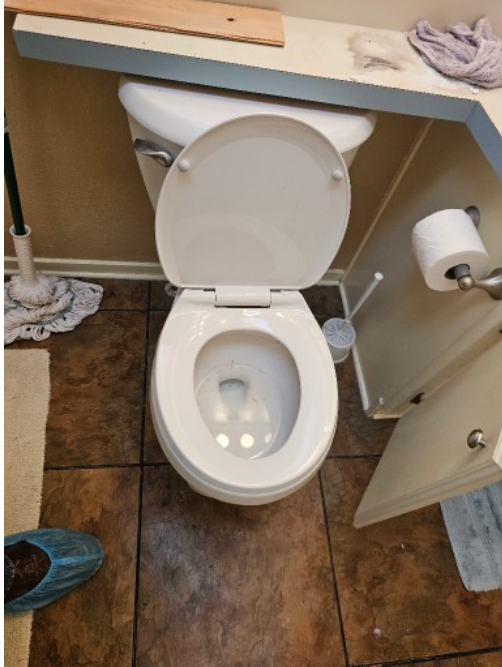
**13.12) Toilet Conditions**

The toilet appeared to be in serviceable condition at the time of inspection.

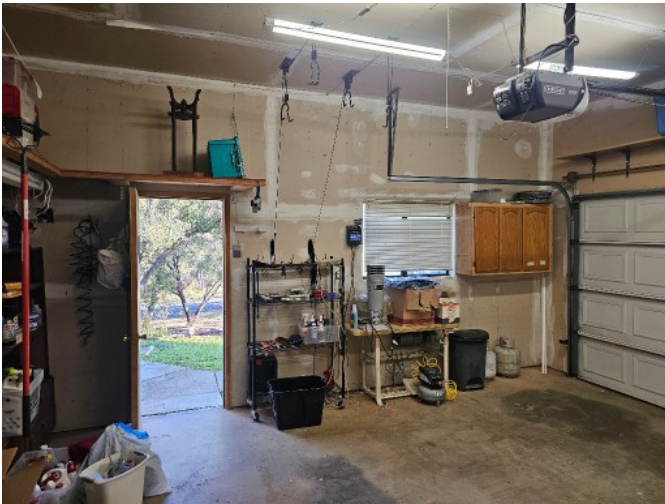
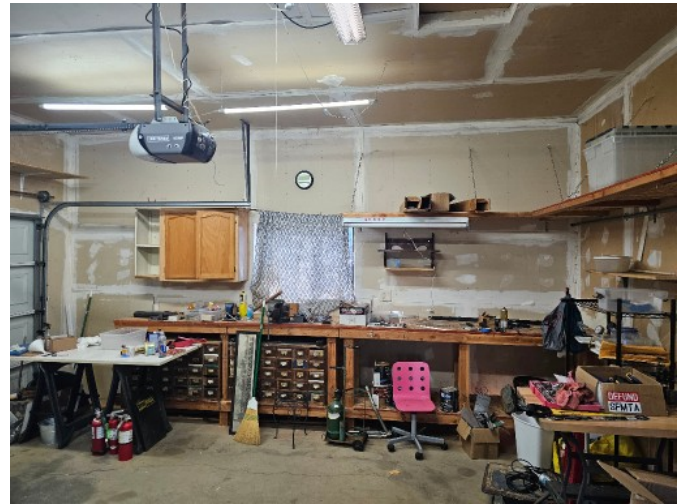
#### 14.1) Wall Conditions

The general condition of the walls appeared to be in serviceable condition at the time of the inspection.

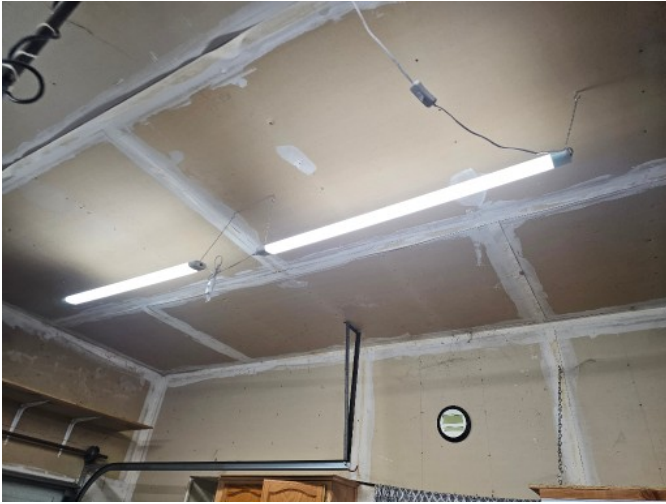
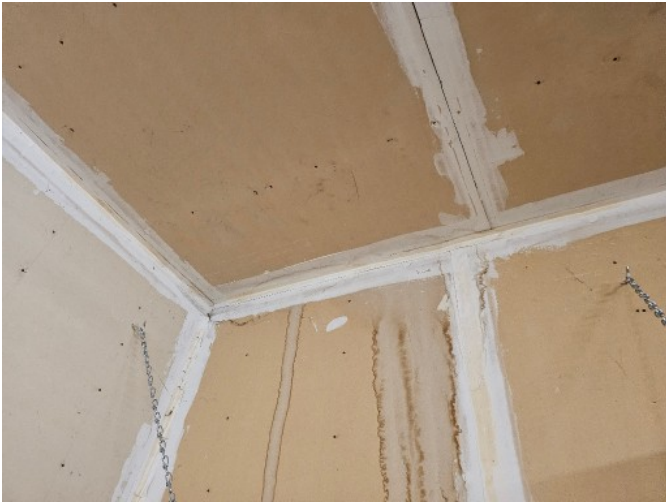
#### 14.2) Ceiling Conditions

Some staining and moisture damage were noted to the ceiling at the garage to home connection. Hidden damage may exist in areas not readily visible or accessible. It's recommended that any damaged sheetrock and material be removed for further investigations and repairs or replacement.

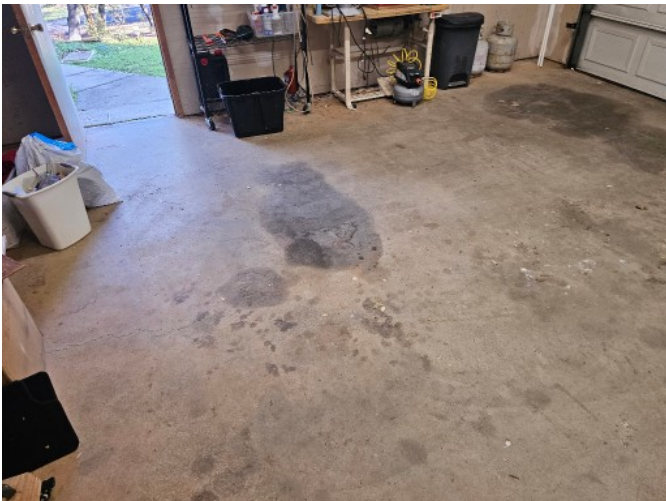
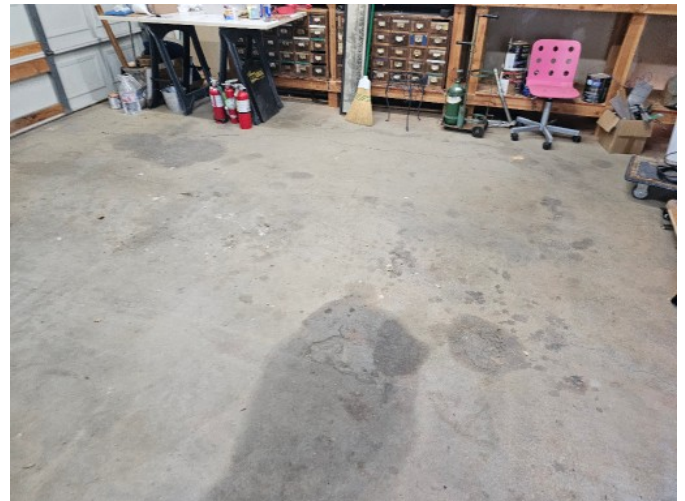
### 14.3) Floor Conditions

Common/typical cracks were observed at the floor.

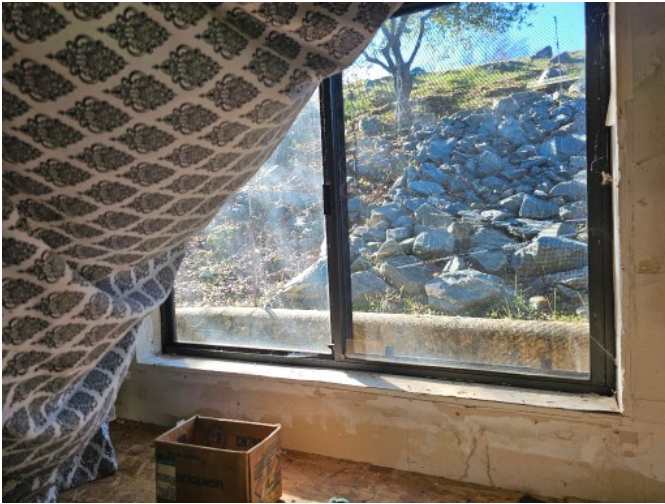
#### 14.4) Window Conditions

Some windows were difficult to operate. Recommend oiling, adjustment, and/or repairs as needed.

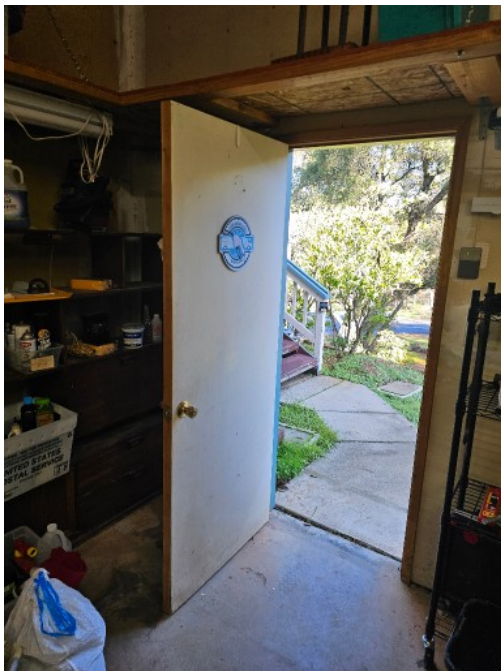
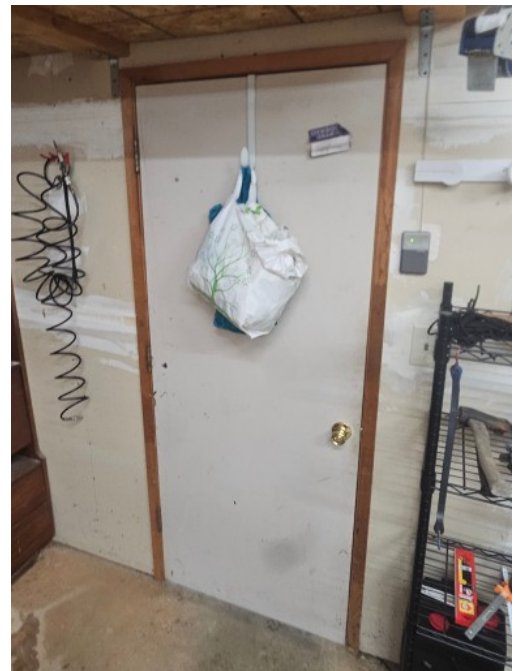
#### 14.5) Door Conditions

The interior doors appeared to be in serviceable condition at the time of the inspection.

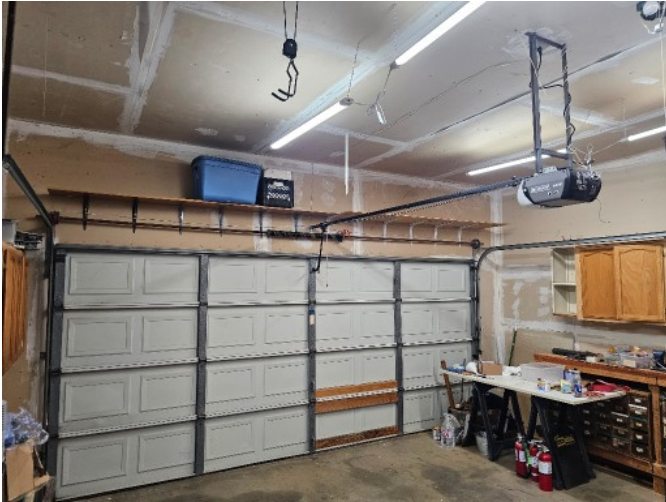
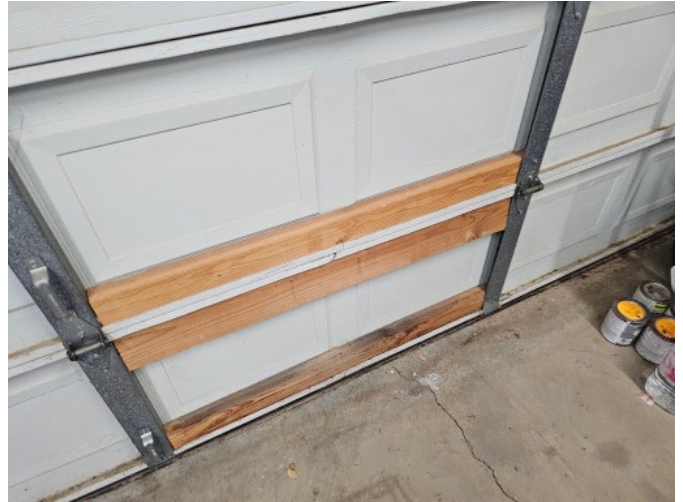
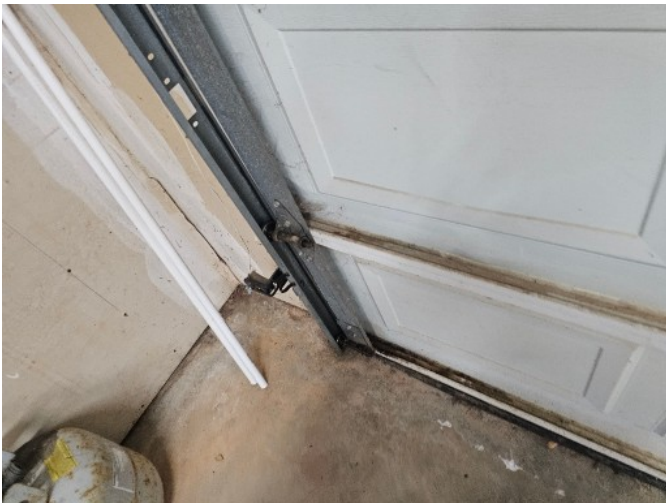
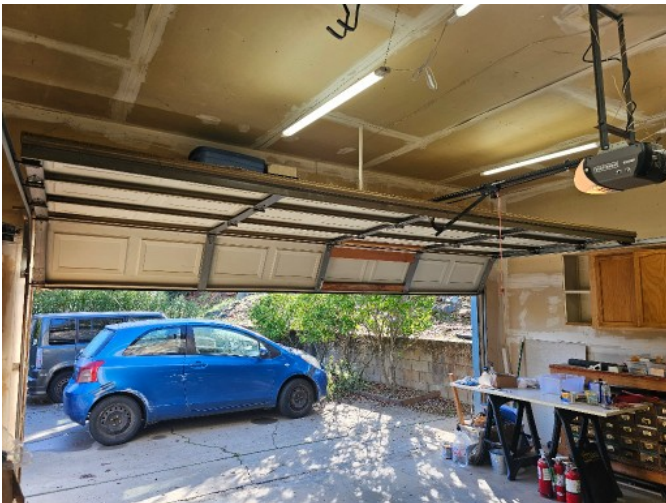
#### 14.6) Vehicle Door Conditions

The two lower garage door panels had dents and some minor damage.

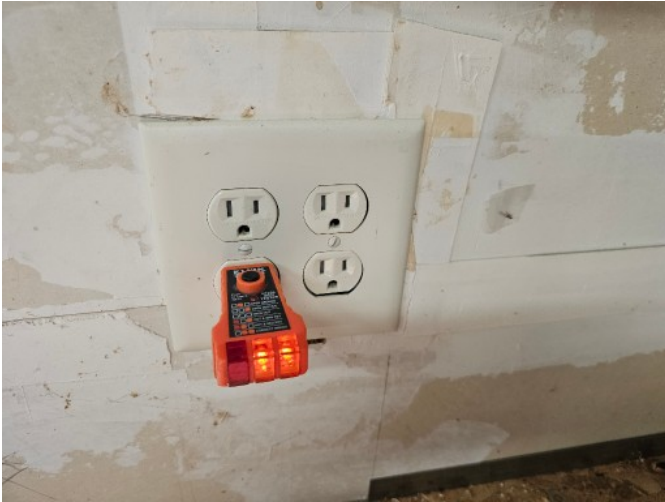
#### 14.7) Electrical Conditions

Missing receptacle or switch covers were observed at the time of inspection. Recommend covers be installed for safety.

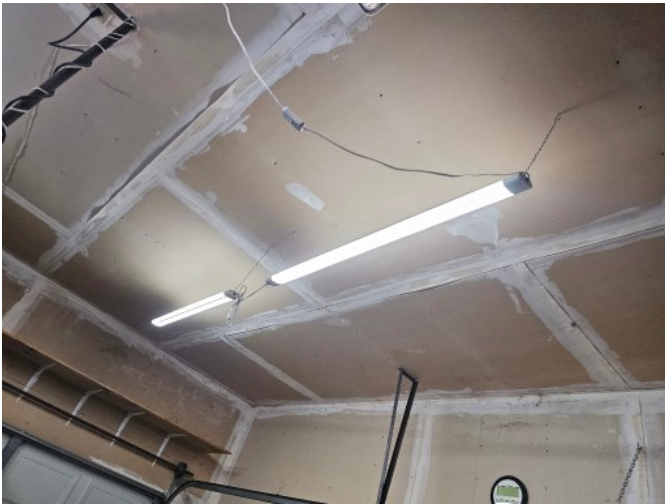
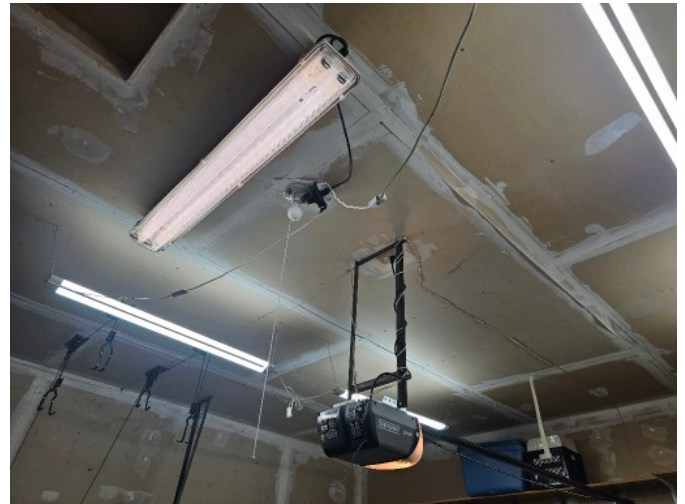
#### 14.8) Lighting Conditions

Appears Serviceable.

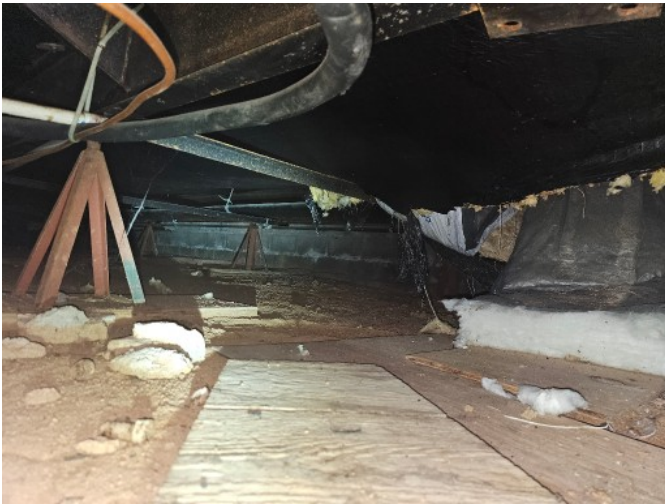
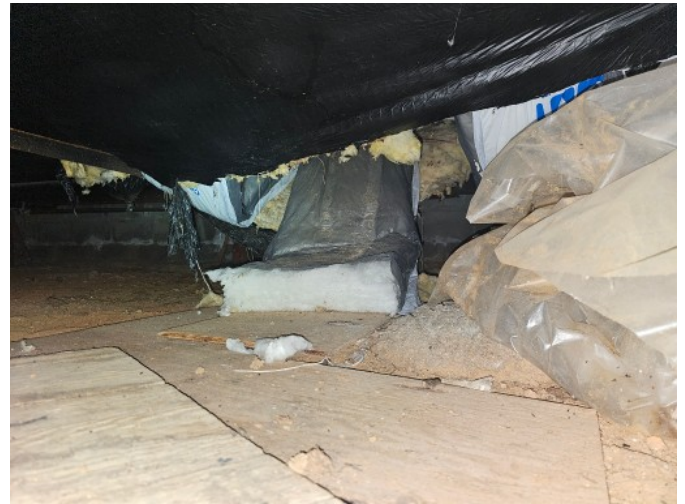
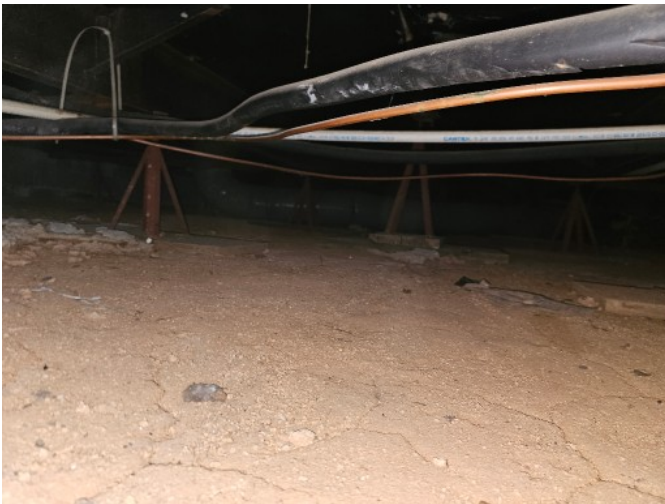
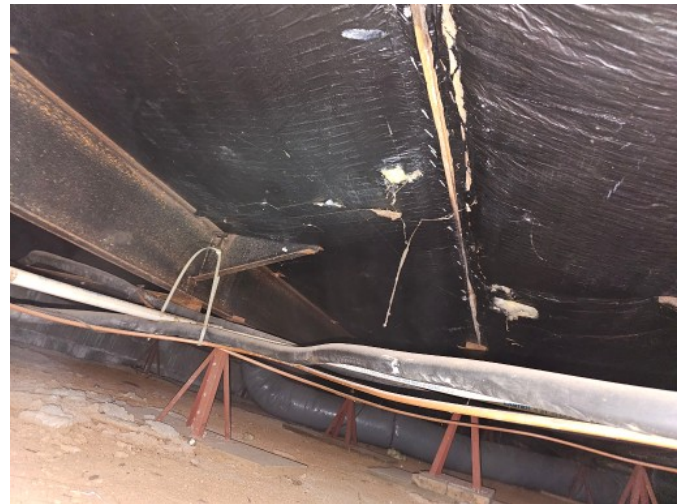
#### 15.1) Foundation Conditions

The visible and accessible portions of the concrete foundational wall appeared serviceable.

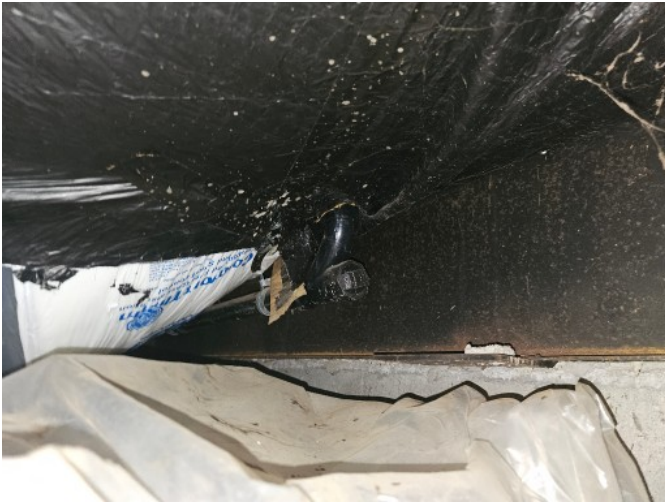
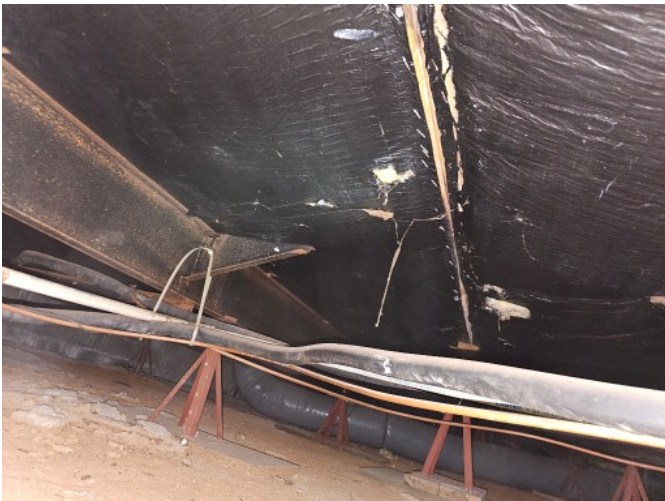
**15.2) Flooring Support Conditions****R**

Some of the covering was torn and cut. Recommend patching and/or repair.

This was a prefabricated home. These homes have a thick covering stapled to the underside, which prevents an inspection of the flooring structure and components within. There are areas that may need to be opened up for further investigation due to conditions found within home.
