Kevin Kelpin 7177 Sunny Place Yucca Valley, CA 92284

**Client Information:** Andrew Alder-Larue (2/7/2024) 76 Calle Manzanita Rancho Mirage, CA 92270

## Pool Area

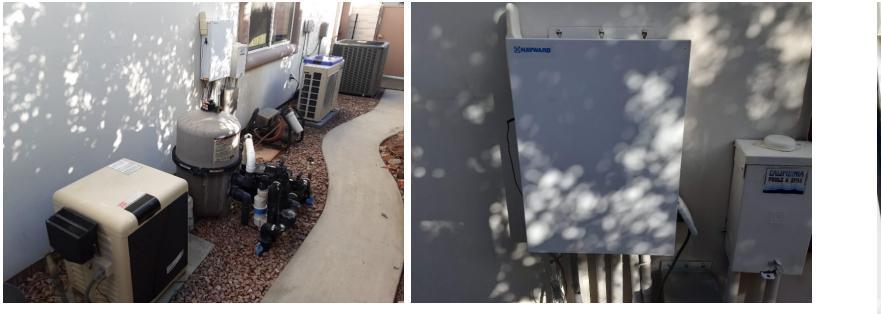
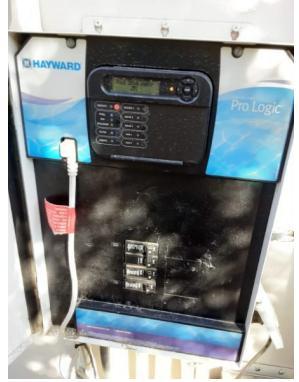
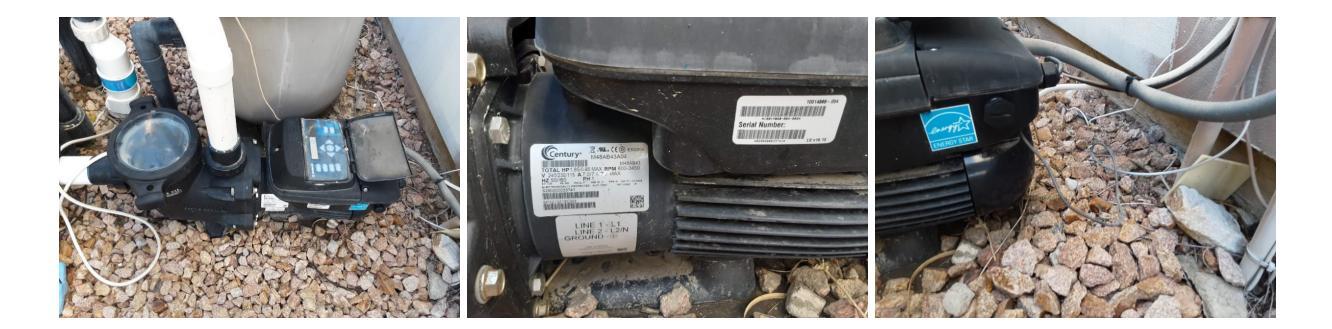
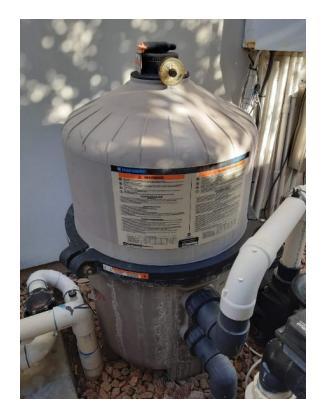
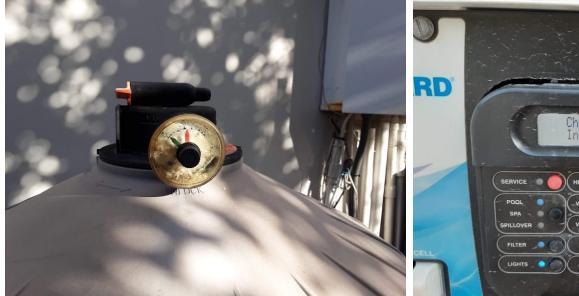
All systems were tested from the control panel and returned back to there original settings (Auto Mode) after testing. The exact age of the filter pump could not be determined from the data tag. The unit was tested and operational. Bonding wire was installed on the unit. No defects noted at cartridge filter. There was a "Check System - Inspect Cell" error code at the control panel. The Pool/Spa lights were non-operational at time of inspection. The spa jets were operational.
