**Prepared For:**  
Nyla Quintana Sturgis

**Property Address:**  
4801 Boone Dr  
Fremont CA 94538

HouseMaster Home Inspections of Northern California

**Inspection Date:** 9/17/2024

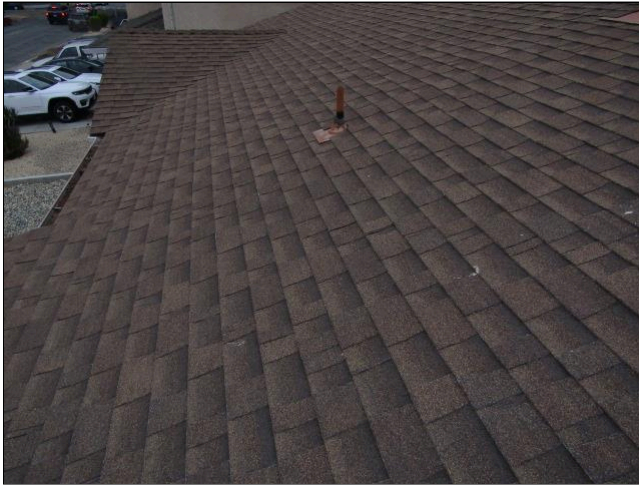
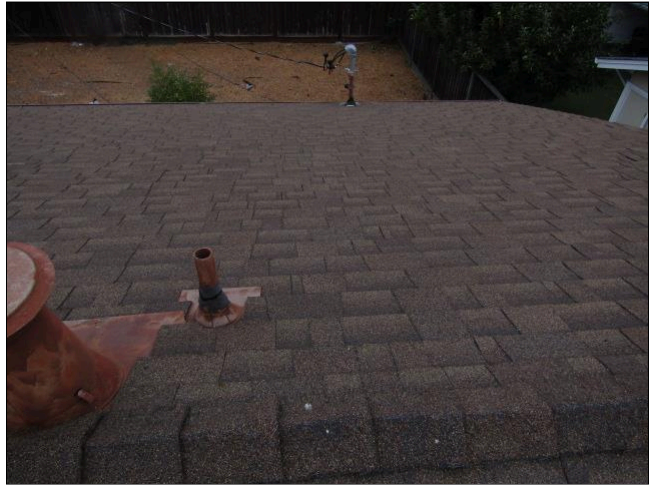
| ● | | | | | <p><b>1.0 ROOFING</b><br/>Minor granular loss observed. Material is approaching or at mid span of its life. Recommend monitor conditions and correct as needed.</p> |
