PROPROPERTY INSPECTION AND SERVICES INC.

PROPERTY INSPECTION REPORT

9180 Tokaj Ln
Spring Valley, CA 91977

06/02/2025

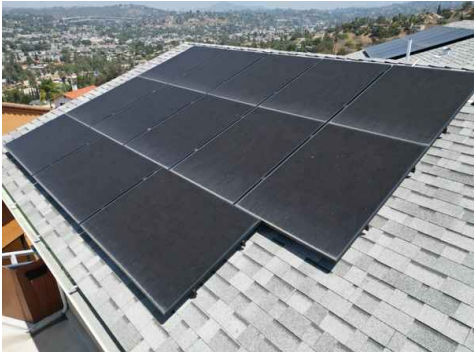
4.2.1 Coverings

WOVEN VALLEY

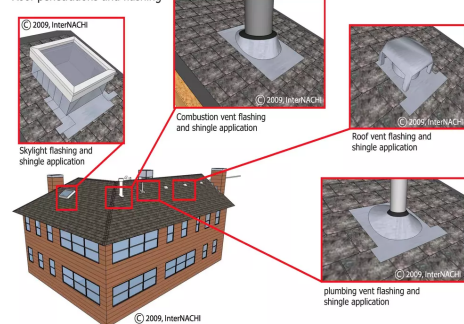
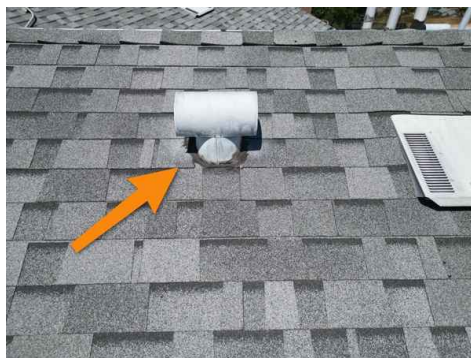
4.4.1 Skylights, Chimneys & Other Roof Penetrations

Roof penetrations and flashing

Contact a qualified roofing professional.

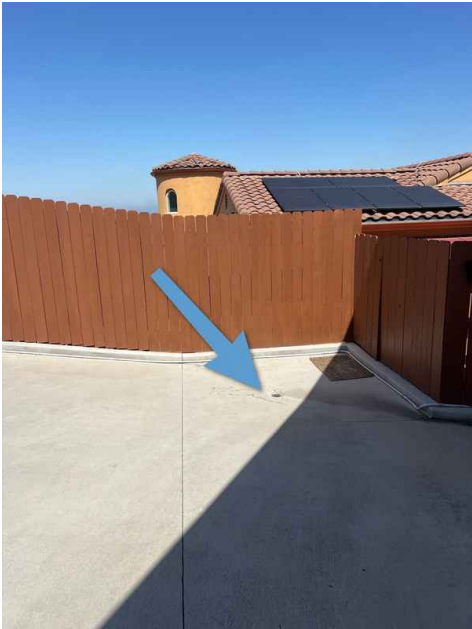
5.1.2 Grading

HILLSIDE SETTING

Contact a qualified structural engineer.

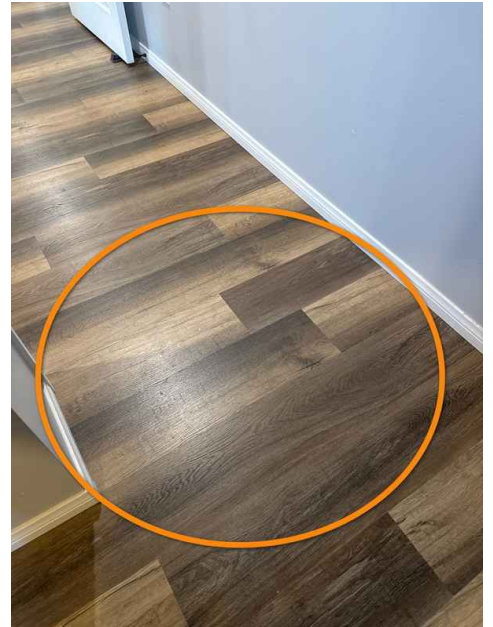
The wood sub flooring at several locations were observed to be noisy/ squeaky when walked on. There are many causes of squeaky/creaking sub-floors such as loose nails, failed or missing adhesive, or wood rubbing together due to lack of support. Recommend necessary repairs as needed by a qualified licensed contractor.

Contact a qualified flooring contractor

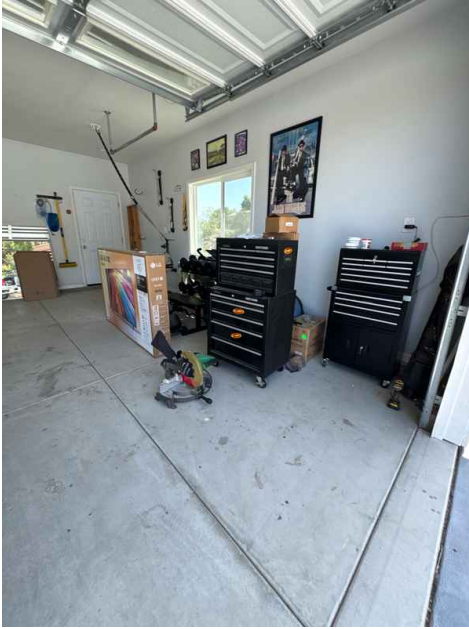
Floor and / or wall areas were obscured by stored items and couldn't be fully evaluated.

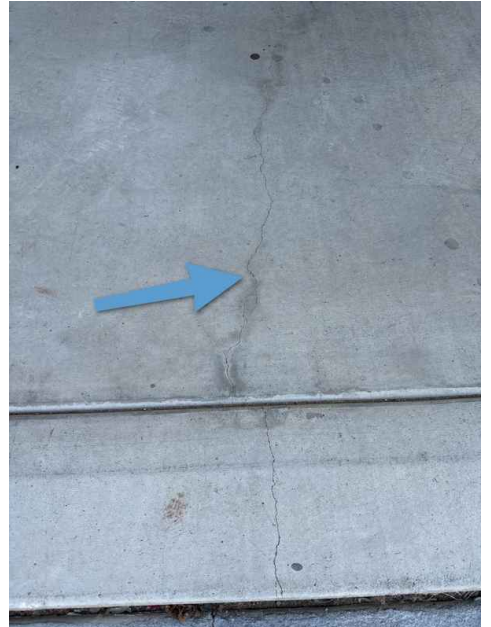
10.6.2 Floor, Walls, Ceiling

CRACKING

Typical settlement cracks were present on the concrete surface. If a concern, have a concrete contractor to evaluate for repair. At a minimum these cracks are recommended to be sealed by a qualified person to prevent further damage.

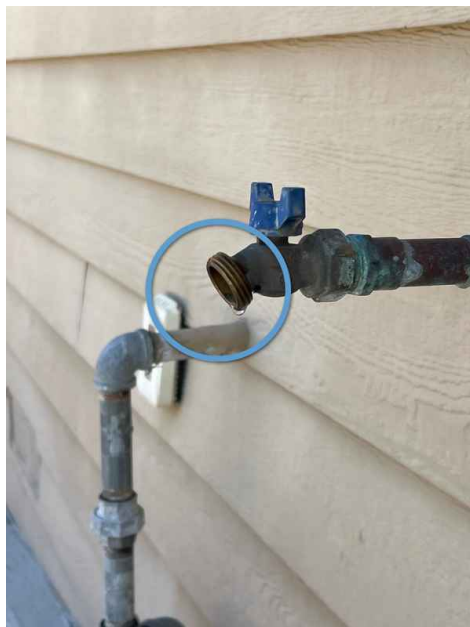
11.3.2 Supply Lines

CORROSION PIPES / FITTINGS

Supply lines and/or fittings were corroded. This indicates a past leak and could possibly leak again in the future. Recommend repairs be made by a qualified licensed plumbing contractor.

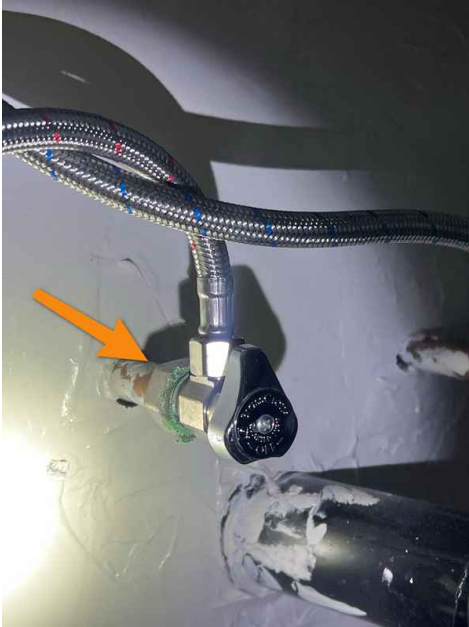
11.6.3 Sinks / Fixtures

PREVIOUS LEAK

Evidence of previous possible leaks were noted at the drain line below the sink. Area appeared dry at the time of the inspection. Advise monitoring and repair by a licensed plumbing contractor.

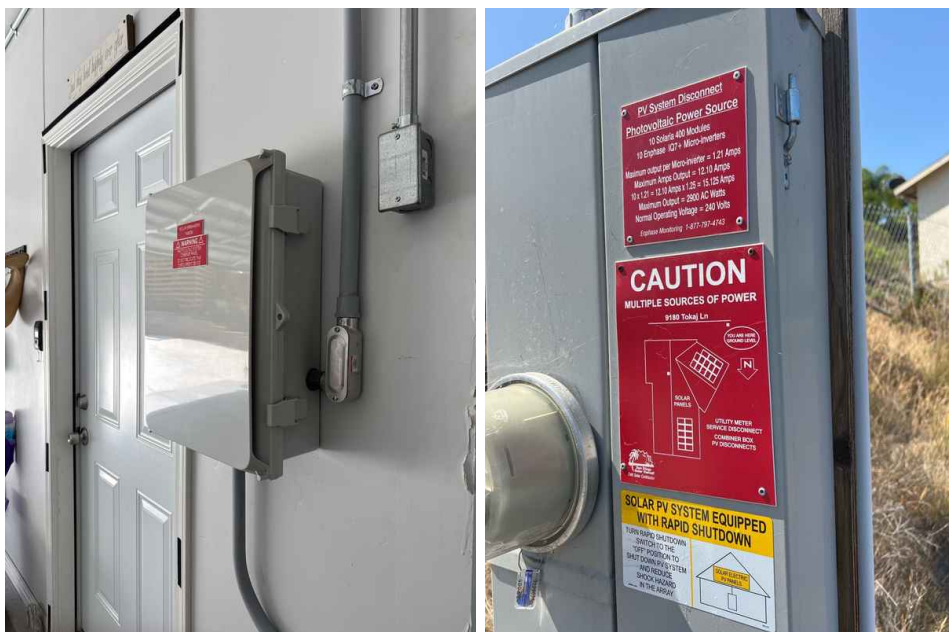
12.3.1 Panels

UNABLE TO INSPECT

I was unable to open and evaluate an electrical panel. The panel is excluded from this inspection. Recommend that repairs, modifications, and/or cleanup should be made as necessary so panels can be opened and fully evaluated.

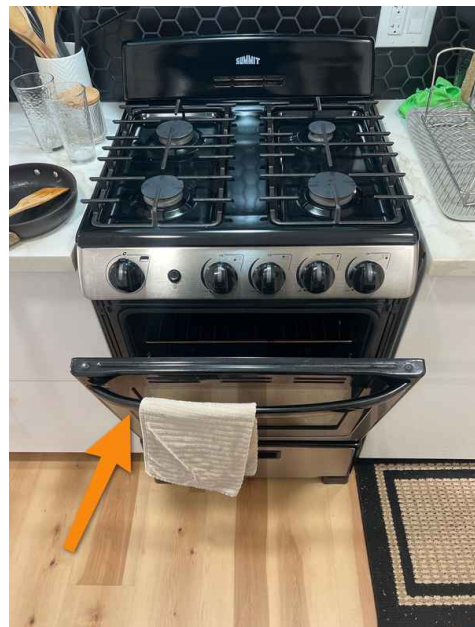
13.3.2 Range/Oven/Cooktop

RANGE / OVEN ANTI-TIP BRACKET NOT INSTALLED / INEFFECTIVE

The range could tip forward. An anti-tip bracket may not be installed or may be ineffective. This is a potential safety hazard since the range can tip forward when weight is applied to the open door, such as when a small child climbs on it or if heavy objects are dropped on it. Anti-tip brackets have been sold with all free-standing ranges since 1985. Recommend installing an anti-tip bracket to eliminate this safety hazard.

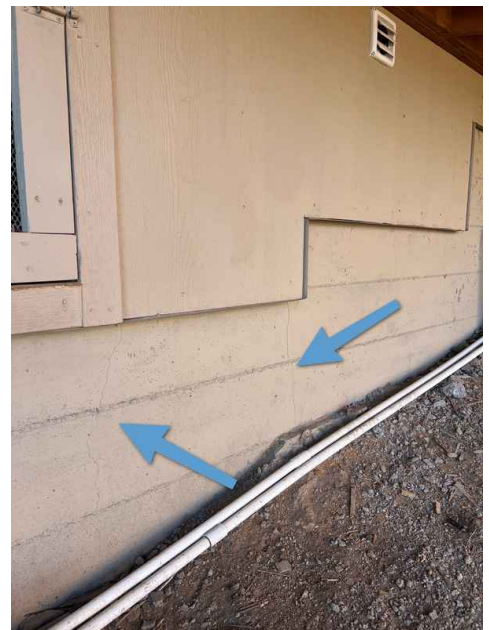
VERTICAL CRACKS

There are some vertical cracks in the foundation walls, which are probably attributable to shrinkage and have little structural significance. Generally speaking, cracks that are less than 1/8" are not commonly regarded as being structurally significant. Nonetheless, they should be monitored to see if there is active movement in this area, because such cracks can become a contentious and litigious issue. These cracks will need to be sealed to prevent moisture intrusion and widening.

Contact a qualified professional.
