HOME INSPECTION

4973 Brookburn Dr San Diego, CA 92130

Edmond Hsieh 02/25/2025

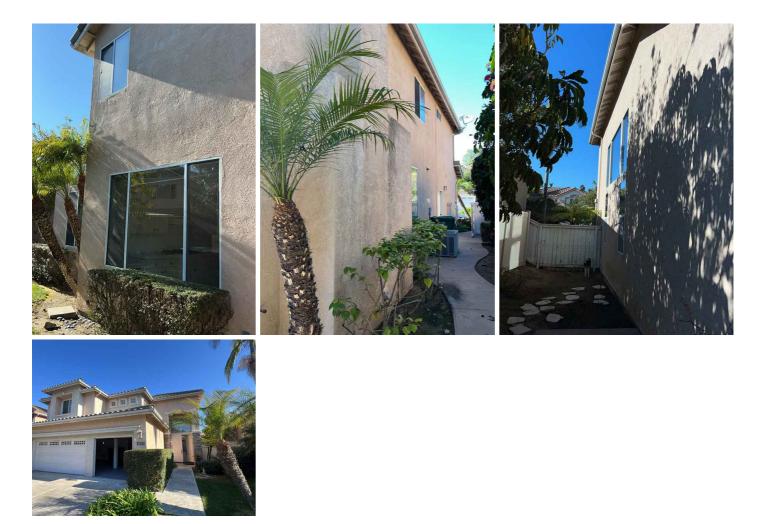
General: Photos Of Typical Exterior Elevations

Photos of elevations and exteriors.

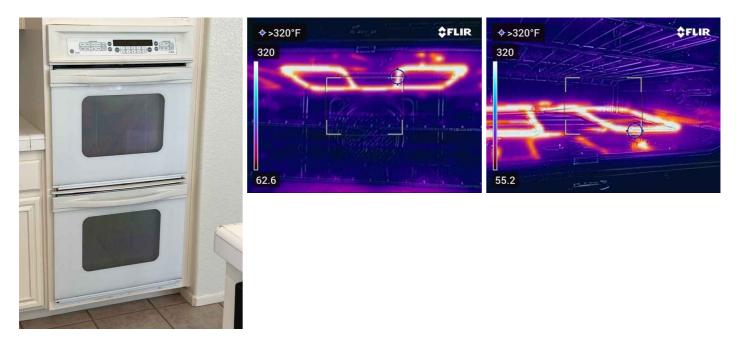
WALL OVEN: Wall Oven - Two - INSPECTED

Both of the wall ovens were tested and were functional at the time of the inspection.

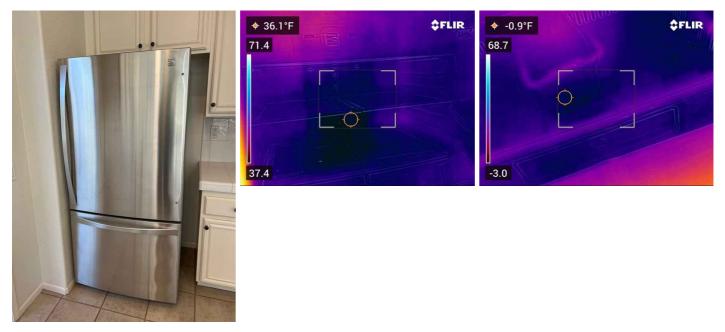
REFRIGERATOR: REFERIGERATOR - INSPECTED

The interior temperatures of the refrigerator and freezer were observed using a thermal camera, and the refrigerator appeared to be functional. This is not an exhaustive test and does not assess the efficiency of the refrigerator. Appliances are not moved to inspect the walls, floors, or other components behind them. We recommend that you keep a good home warranty in place which covers the appliances.

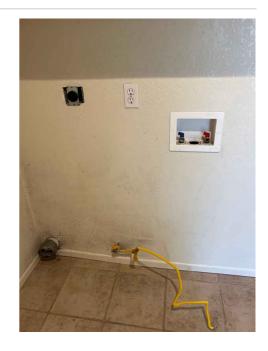
NOT PRESENT

No clothes washer or dryer was present at time of inspection.

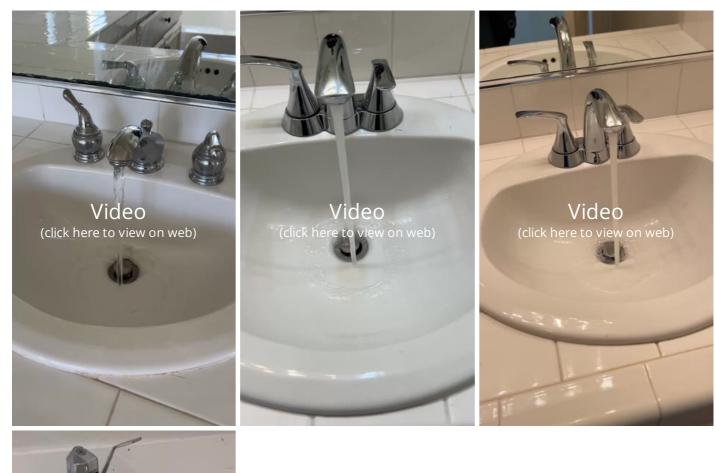
INTERIOR DRAIN, WASTE AND VENT SYSTEMS: Drain Check - Inspected

We attempt to evaluate drain pipes by flushing every drain that has an active fixture while observing its draw and watching for blockages or slow draining. All bathroom and kitchen fixtures were tested for an extended period of time during the inspection. Home inspectors only run clean water through the drains. This is not a conclusive test and flushing toilet paper, human waste, food debris or soap suds may cause drains to clog. Only a video-scan of the drains and main line would confirm its actual condition. We advise having a sewer camera inspection performed by The Real Estate Inspection Company to verify the condition.

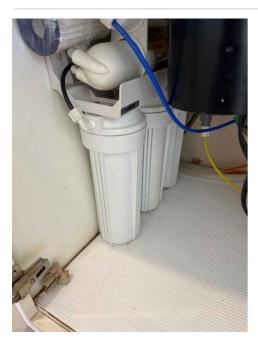
WATER FILTER*

We do not inspect water filtration units. We recommend contacting the installer for information on life expectancy or condition.

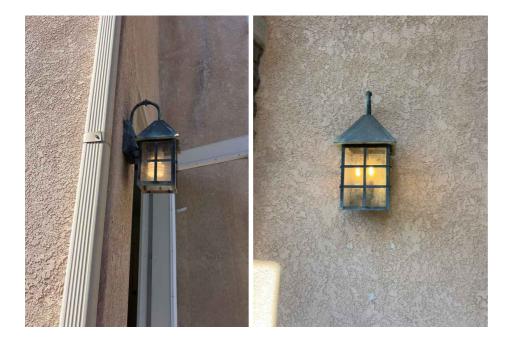
EXTERIOR LIGHTING: Exterior Lights - Inspected

Switch-operated exterior lights were tested and were functional at the time of the inspection.

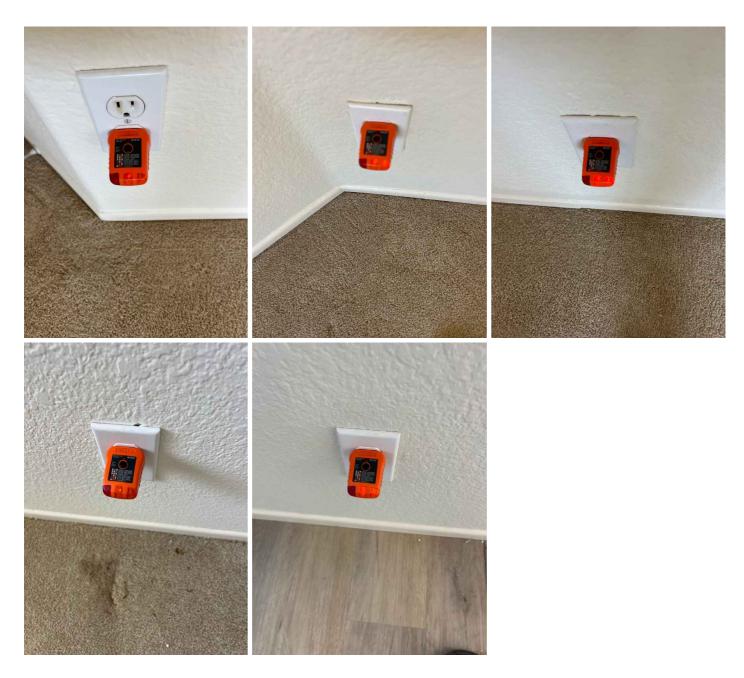
POLARITY AND GROUNDING OF RECEPTACLES: Outlets - Inspected

A representative number of receptacles were tested for power, polarity, and grounding according to standards of practice.

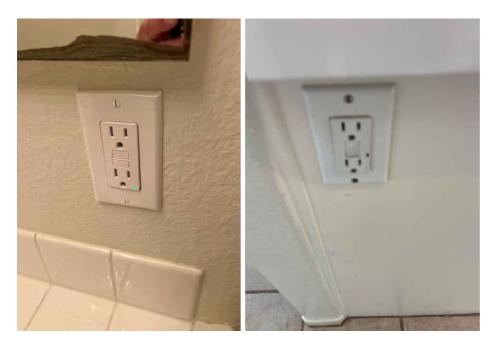
OPERATION OF GFCI (GROUND FAULT CIRCUIT INTERRUPTERS): GFCI - INSPECTED

All accessible GFCI receptacles were tested and were functioning properly unless otherwise noted.

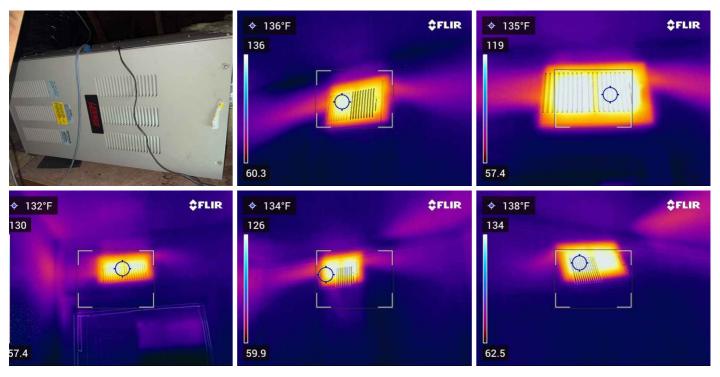
HEATING EQUIPMENT: Furnace - INSPECTED

The heating equipment was tested and functioned properly at the time of inspection. Notable exceptions will be listed below.

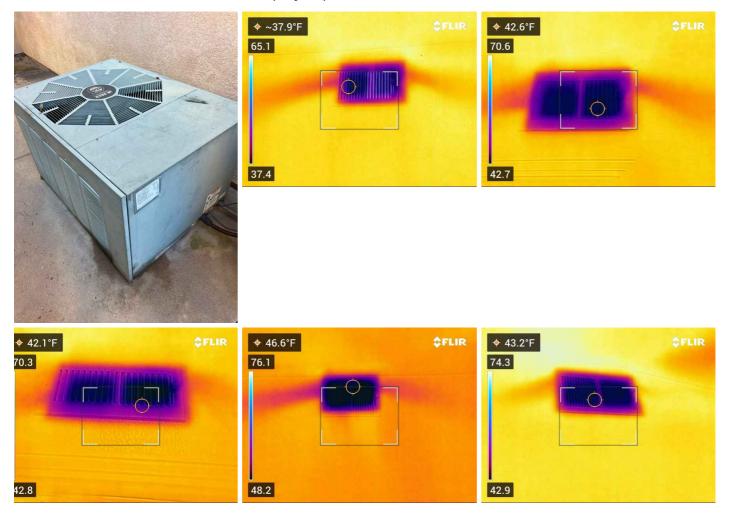
COOLING AND AIR HANDLER EQUIPMENT: AC- One Unit Test - Inspected

An air test was performed by using a thermal camera on the AC systems to determine the difference in temperatures of the supply and return air. The difference was between 14 degrees and 22 degrees which indicates units are cooling as intended. This indicates that the AC units are cooling properly. This is not an exhaustive test and cannot predict the performance of the AC on extremely hot or humid days. We do recommend an annual tune-up by a qualified HVAC contractor.

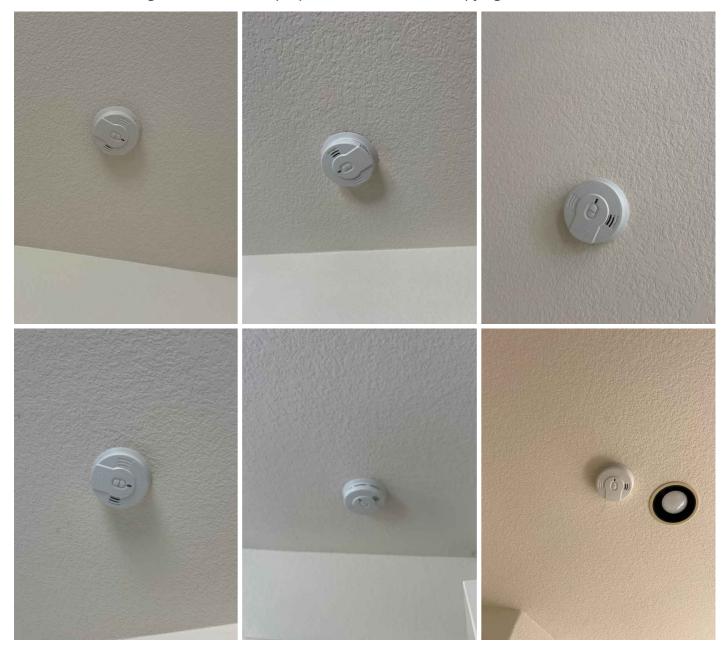
SMOKE DETECTORS: Smoke Detectors - Present (multi-story)

Smoke detectors were installed on each floor and in each bedroom, however, they were not tested. We recommend testing the detectors for proper function before occupying the home.

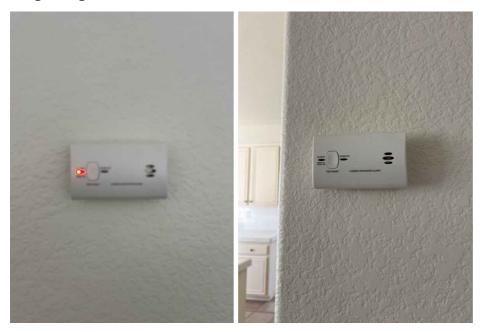
CARBON MONOXIDE DETECTOR(S): CO Detector - Enough Present

Carbon Monoxide detectors are required in homes with any gas-burning appliances (furnace, range, water heater), fireplaces, or wood-burning stoves and/or an attached garage. Please see the new law regarding Carbon Monoxide detectors. This house has CO detector(s) installed as required.

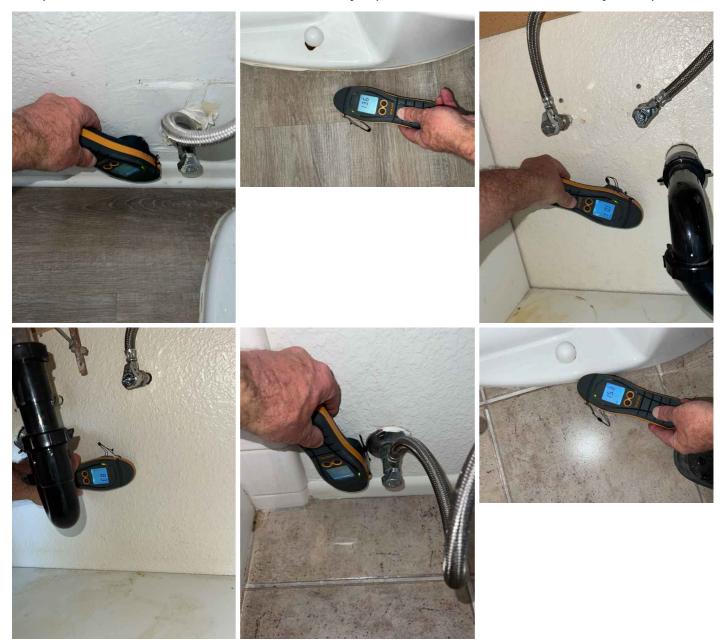
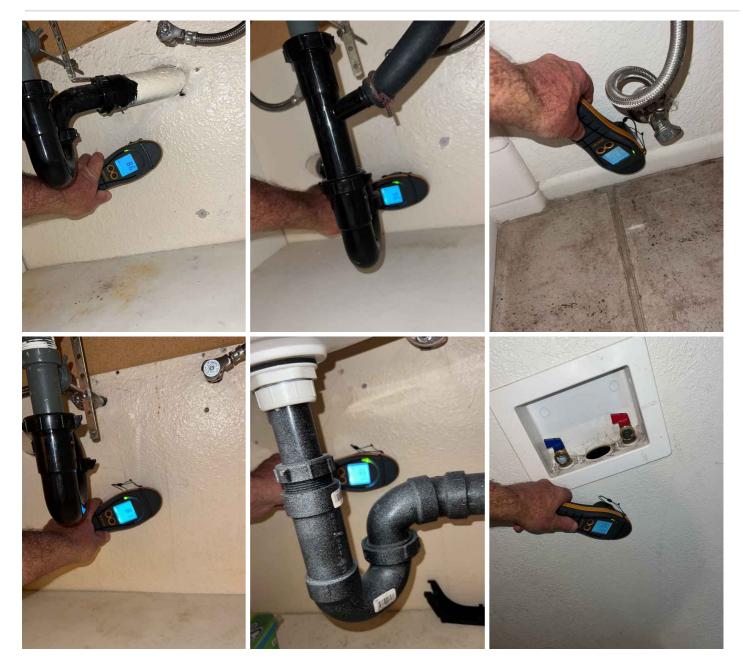
INTERIORS - General and Visual Mold Assessment : Moisture Meter - Inspected

Note: A representative sampling for moisture was performed using a moisture meter at interior walls, ceilings, and cabinets in areas prone to moisture, such as kitchens, bathrooms, interior below-grade walls, or exterior walls with doors/windows. No elevated moisture was detected at the time of inspection. This is not an exhaustive test and only represents the conditions on the day of inspection.

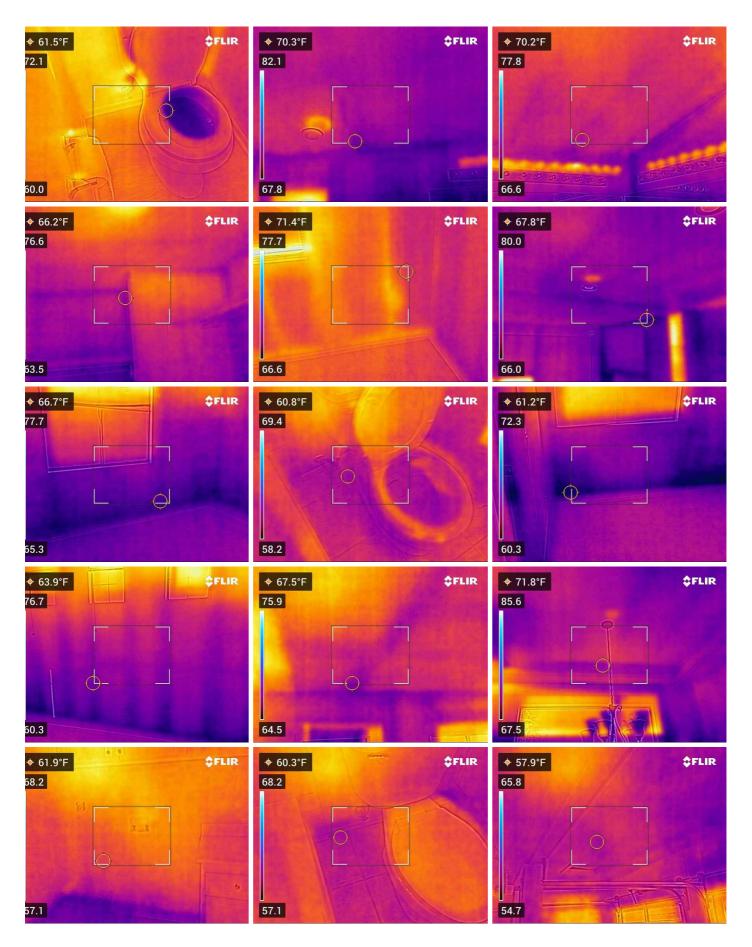
INFRARED INSPECTION FINDINGS: Thermal Camera Scan - Images

An infrared scan was performed in the house. No anomalies were found unless otherwise noted in the defect summary below.

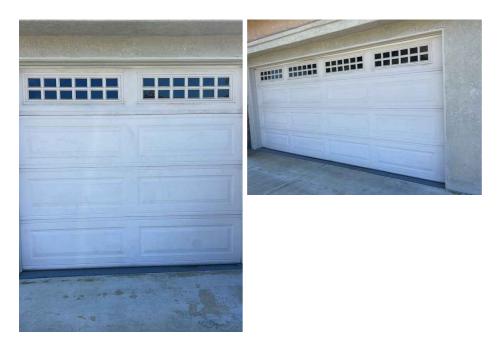
GARAGE VEHICLE DOORS: Garage Door/Hardware - Inspected

The garage door hardware including the door, track, and springs appear to be functioning as intended.

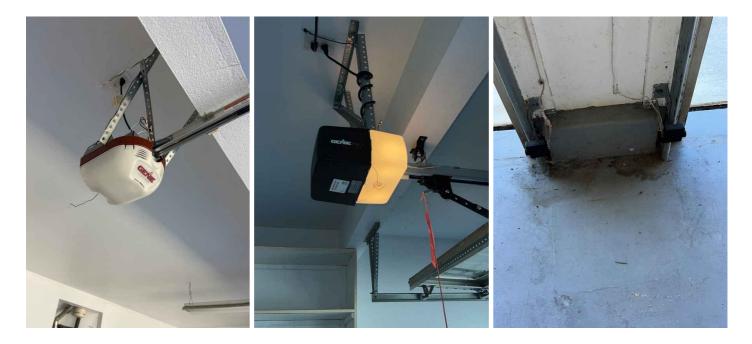
GARAGE DOOR OPERATORS: Sensors Tested - Multiple

Sensors are in place and both garage doors reversed when tested.

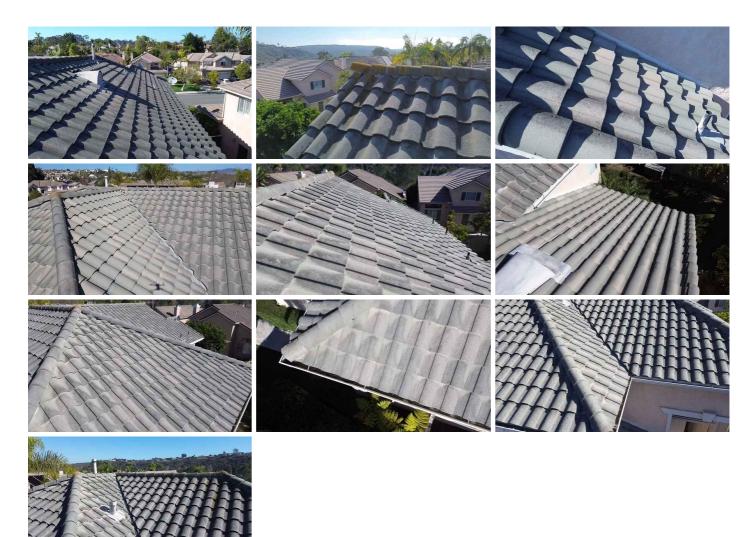
ROOF COVERINGS (Surface of roofing materials): Roof Covering - Inspected

The roof shows normal wear for its age and type; appears to be in serviceable condition. Notable exceptions will be listed below.

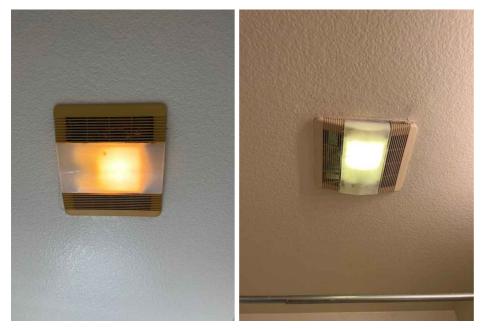
BATHROOM VENTING: Exhaust Fans - Tested

The exhaust fan(s) were tested and were functional at the time of inspection. (This is not an exhaustive test, and does not evaluate the performance or effectiveness of the vent(s).)

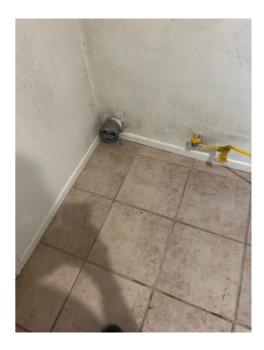
CLOTHES DRYER VENTING SYSTEM NO CLOTHES DRYER VENT

No clothes dryer vent connection was present.
