## SUMMARY

1360 Santa Victoria Road 2, Chula  
Vista, CA 91913

Mike Blair  
07/30/2026

Curtis Kelley  
Certified Home Inspector  
West Ivy Inspections  
6197969077  
westivyave@gmail.com

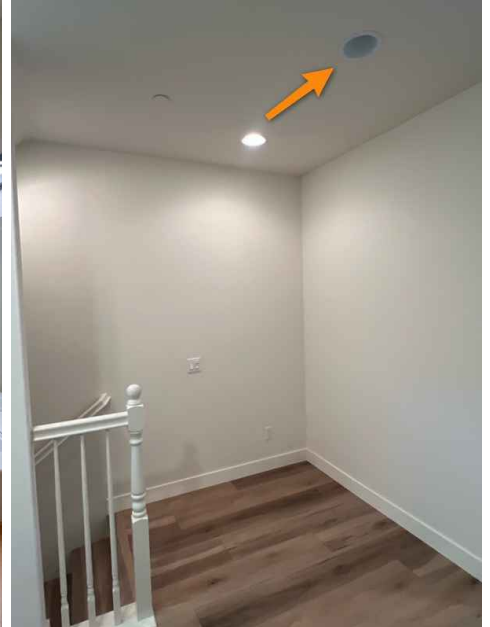
Primary Bathroom 2nd Floor

One or more lights appear to be inoperable at the time of the inspection (possibly due to bulb). Recommend replacing bulb(s) and checking the operation of the fixture(s). If light(s) fail to work, we recommend further evaluation by a licensed electrical contractor before the removal of contingencies to determine repairs necessary at this time.
