Home Inspection Report

98 Madonna Lane Newbury Park, CA

Prepared For: Anne Obriecht
Inspected On Wed, Nov 6, 2024 at 8:47 AM

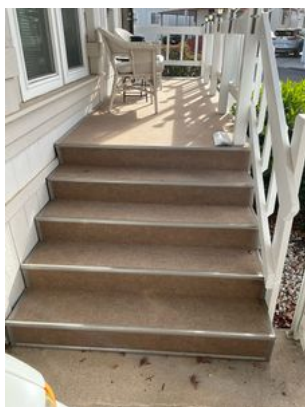
Steps to front entrance deck

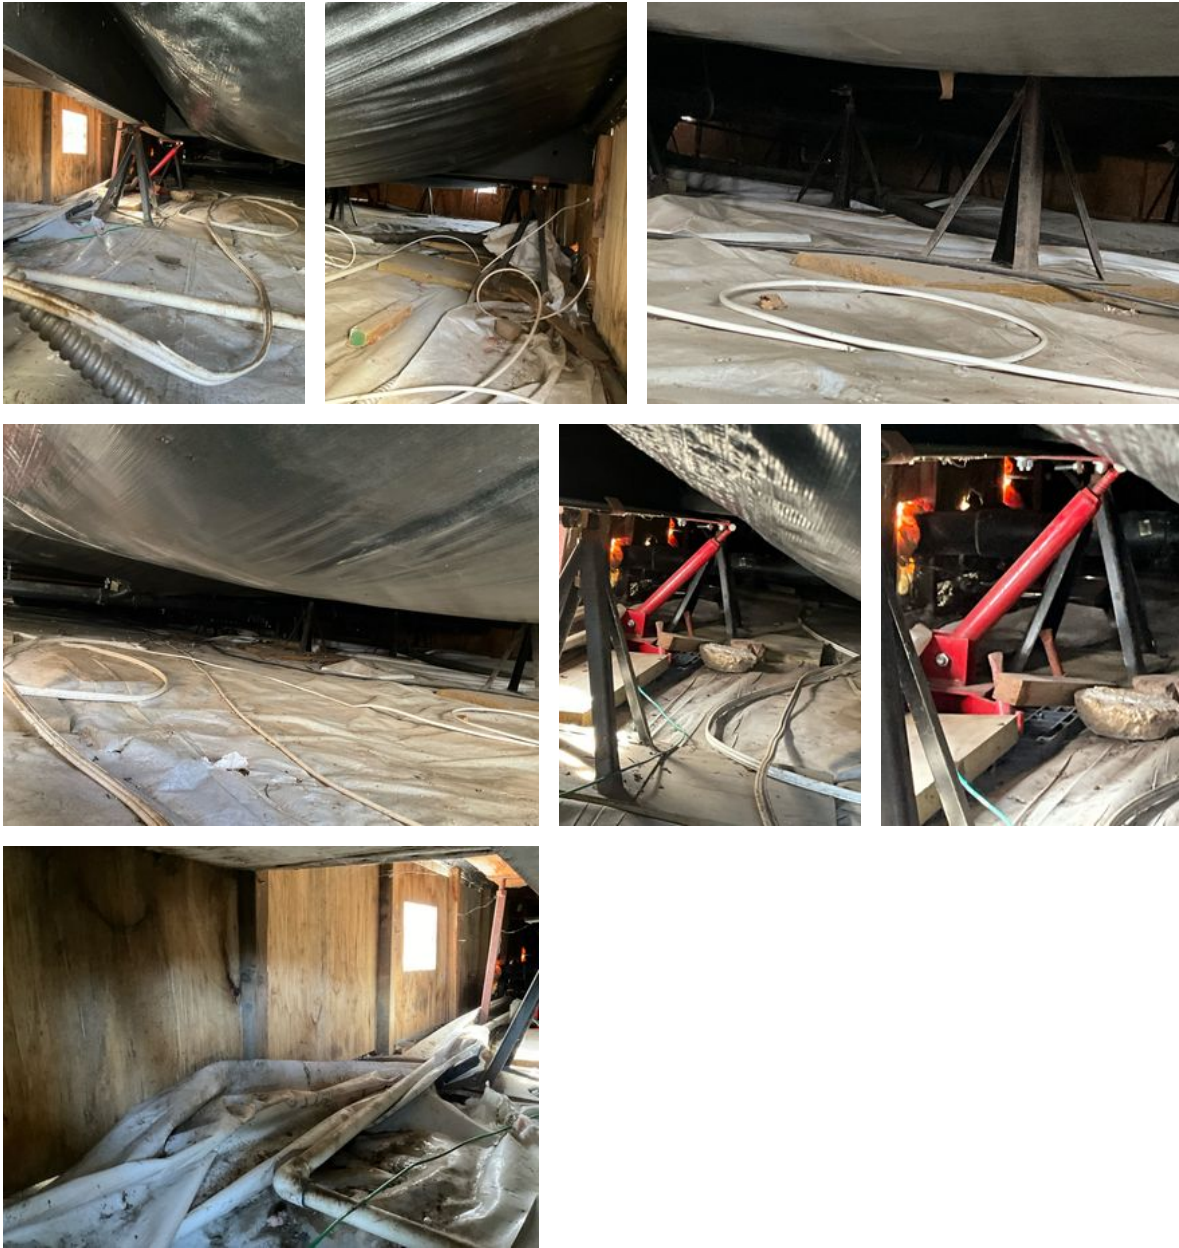
Overview Photos Of Crawlspace

Condition: Satisfactory

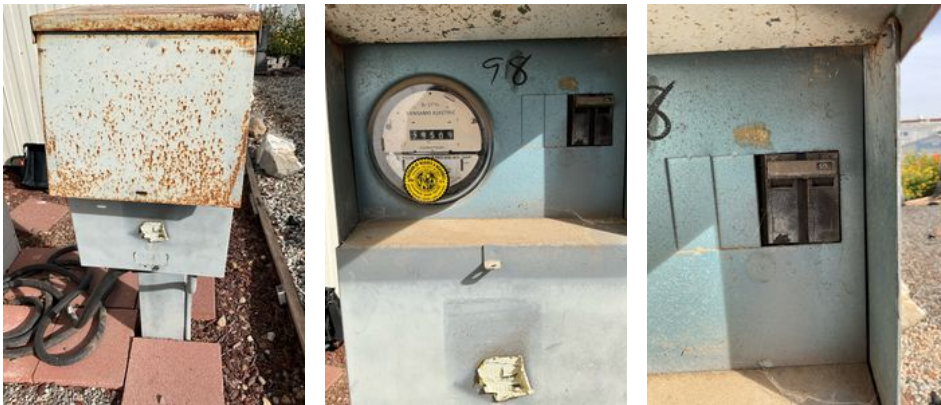
Photo of Panel

Condition: Further Evaluation Required

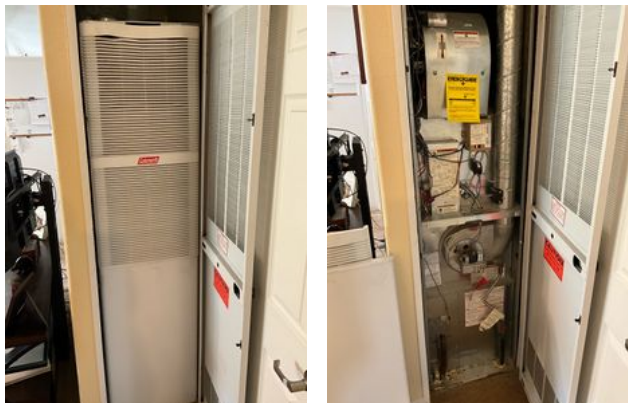
Condition: Satisfactory

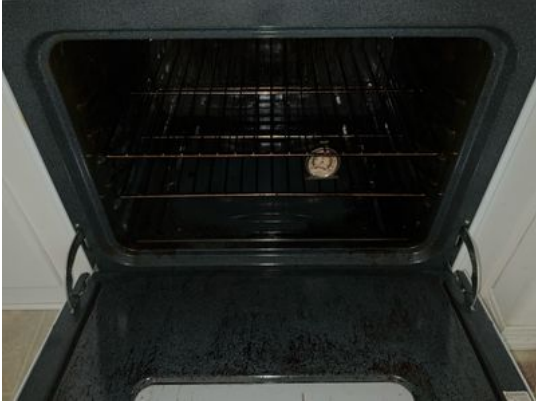
Condition: Satisfactory

The bake feature was the only feature operated. Oven was tested for basic heating element functionality only. Gas leaks cannot be detected with this inspection.

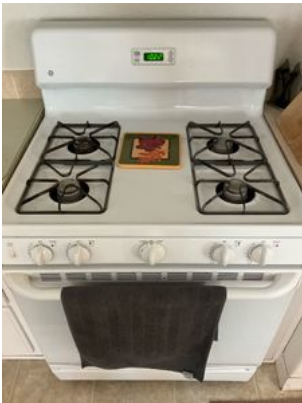
Condition: Satisfactory

The Cooktop/range was a limited inspection, checking various components and functions to ensure the appliance is operating safely and efficiently. The inspection included testing the gas burners by igniting each burner to check for a steady, blue flame (indicating proper combustion). The inspection also included ensuring igniter for each gas, burner spark consistently, and ignite the burner quickly. Inspection cannot determine the BTU output by each burner or "if/how well" the burners will cook food. Leaks cannot be determined with this inspection.

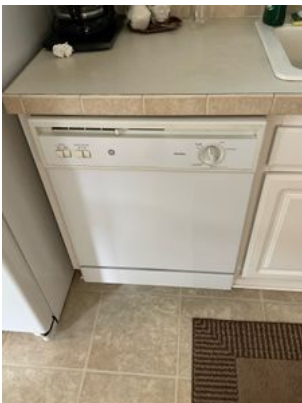
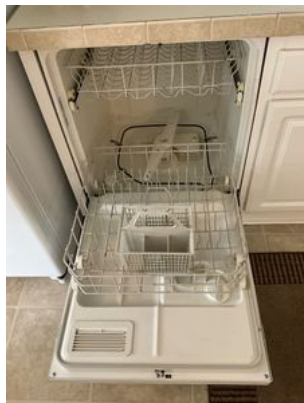
Condition: Satisfactory

Dishwasher inspection was limited and does not include an inspection of the water pump or any hoses inside or beneath the unit. Dishwasher is fully operational; however, I cannot tell you if or how well the dishwasher actually cleans or dries dishes. This inspection allowed for one fill and one drain cycle only. Inspection did not run the dishwasher for any full cycles.

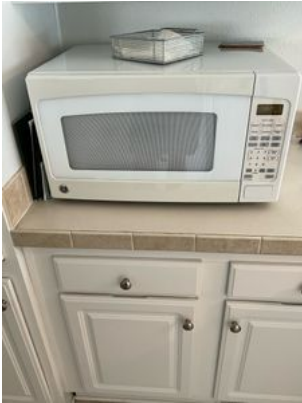
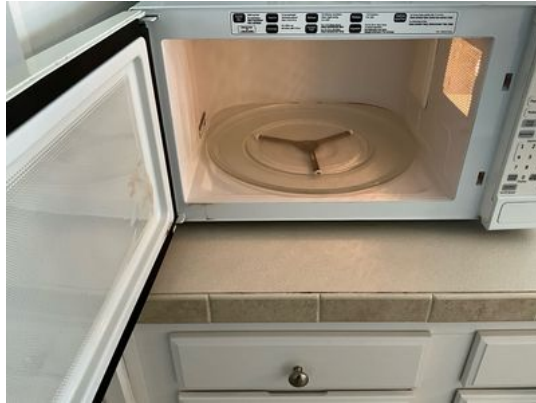
Condition: Satisfactory

The following was inspected to ensure the appliances, safe, functional, and efficient:

- Visual inspection: checked the exterior and interior for any visible damage.
- Functionality test: ran the microwave on various settings to ensure it heats food properly and the controls work as expected. Checked the timer and clock functions to ensure they are accurate.
- Seal: checked the door and seal, ensuring the door closes properly and the seal is intact.
- Ventilation: ensured the microwave's ventilation system is clear of obstructions and functioning incorrectly.

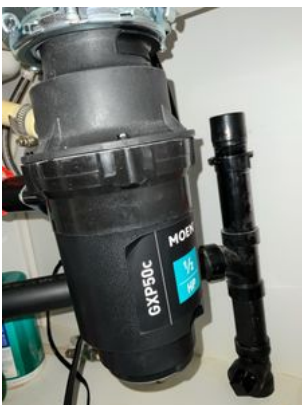
Condition: Satisfactory

Garbage disposal inspection involves checking various components and functions to ensure the unit is operating correctly and safely. I checked the power supply, verifying that disposal is receiving power. I also checked the switch operation,
